*Hawaii Department of Transportation  
Research Contract No. 69876  
Research Project No. STP-1500(115) – Phase III*

## **DEVELOPMENT AND CRASH TESTING OF THE HAWAII CONCRETE POST AND BEAM BRIDGE RAIL**

MwRSF Research Report No. TRP-03-478b-25

July 15, 2025

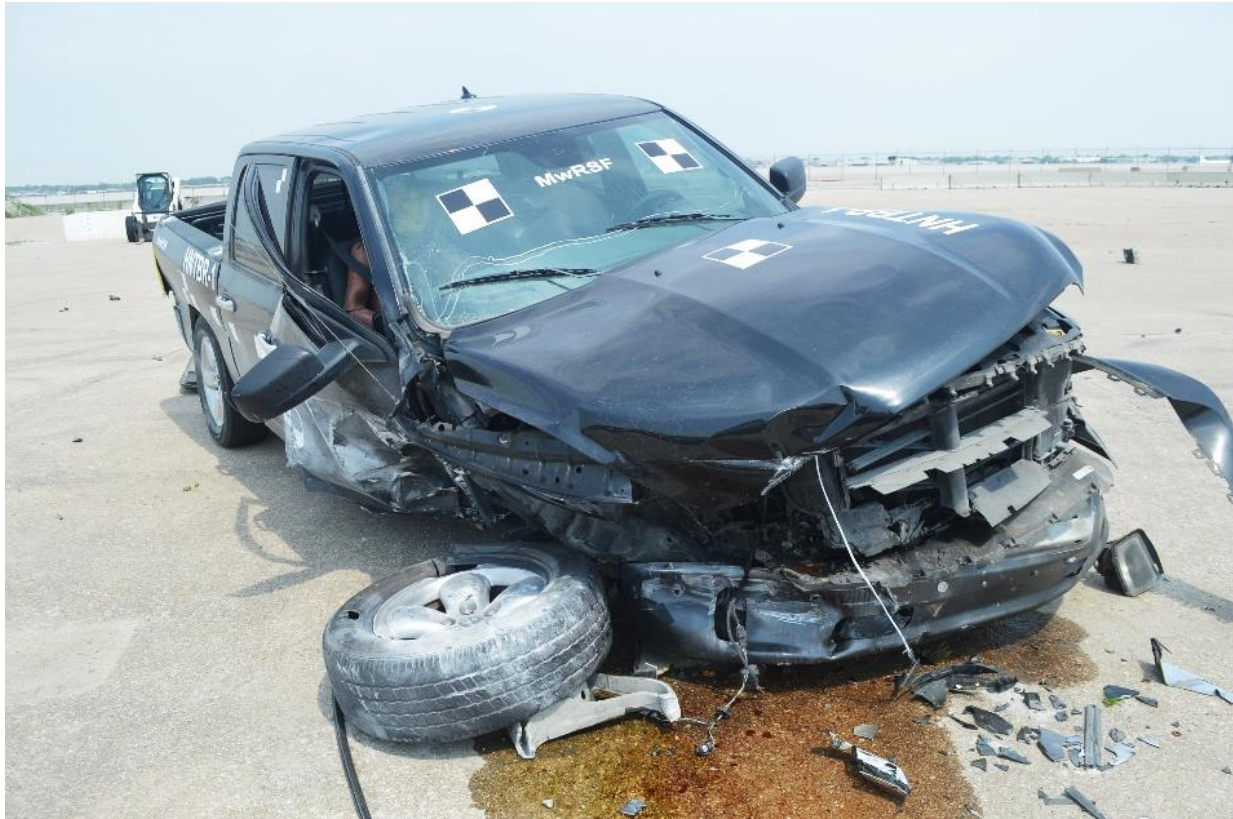
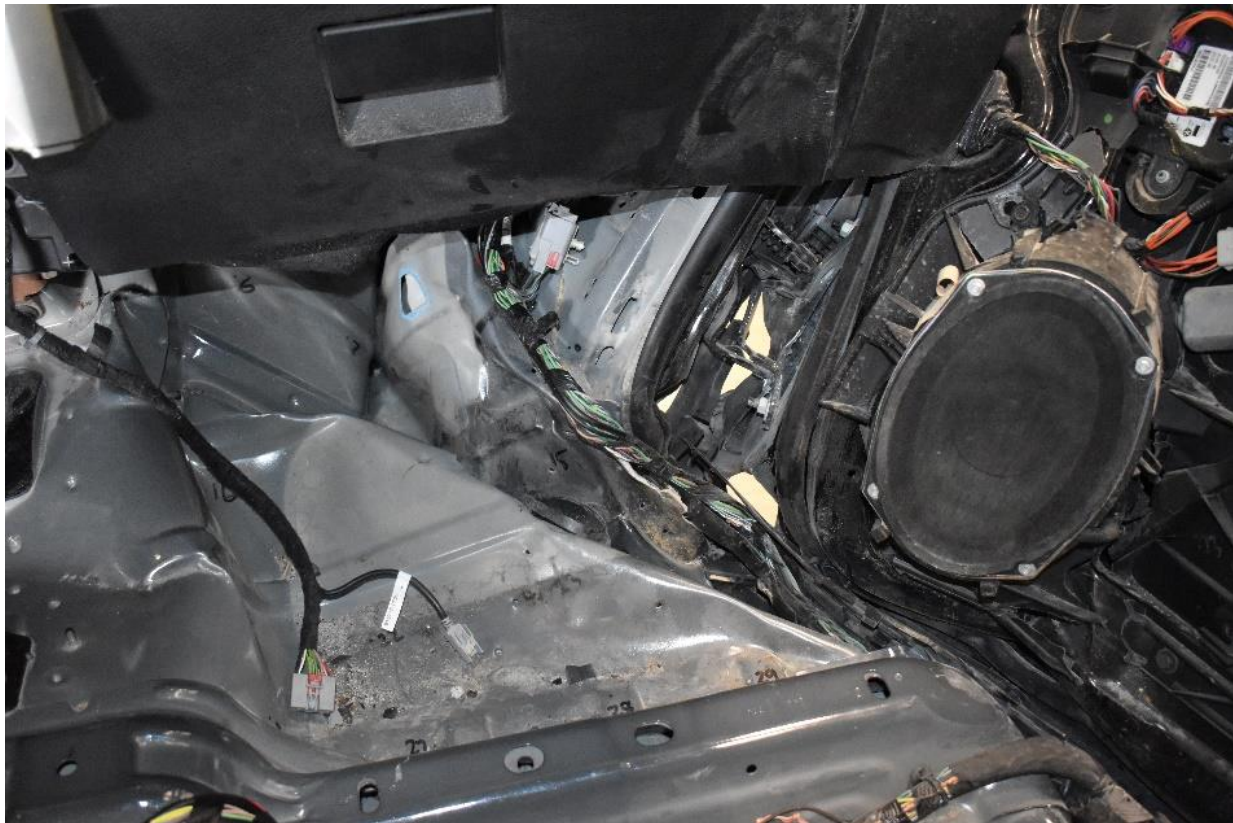
Figure 5. Vehicle Damage and Excessive Wheel and Toe Pan Intrusion – Test No. HNTBR-1

Upon the failure of test no. HNTBR-1, an investigation into the potential causes of the excessive toe pan deformations was conducted. Vehicle deformations were caused by the impact-side wheel snagging on the bridge railing and being shoved back toward the occupant compartment as the vehicle traveled downstream. Through a review and comparison of the previous crash tests on the original Natchez Trace Bridge Railing and the Hawaii Modified Natchez Trace Bridge Rail [2, 4, and 6], three factors were identified as contributors to the MASH test failure: (1) increased impact severity of the MASH test compared to the previous crash testing standards, (2) the limited curb-to-rail offset of the Hawaii Modified Natchez Trace Bridge Rail, and (3) the angled bottom edge of the upper railing.

The mass of the MASH pickup truck is significantly greater than the mass of the pickup truck specified in NCHRP Report 350. Even though the speed and impact angle for the TL-3 pickup tests were the same, the increased mass resulted in a 14 percent increase in targeted impact severity. This increase in impact severity likely contributed to increased loading during redirection and increased damage to the vehicle. Unfortunately, the MASH impact conditions were not something that could be changed, so the increased impact severity would have to be accounted for in the redesign process.

The shape of the upper rail also contributed to this snag. Most open concrete bridge rails have a rectangular shaped upper rail, whereas the Hawaii Modified Natchez Trace Bridge Rail had an angled lower edge that was more susceptible to gouging and snag, as highlighted in Figure 6. Thus, the severity of the rim snag described above was increased by the angled lower edge of the railing.

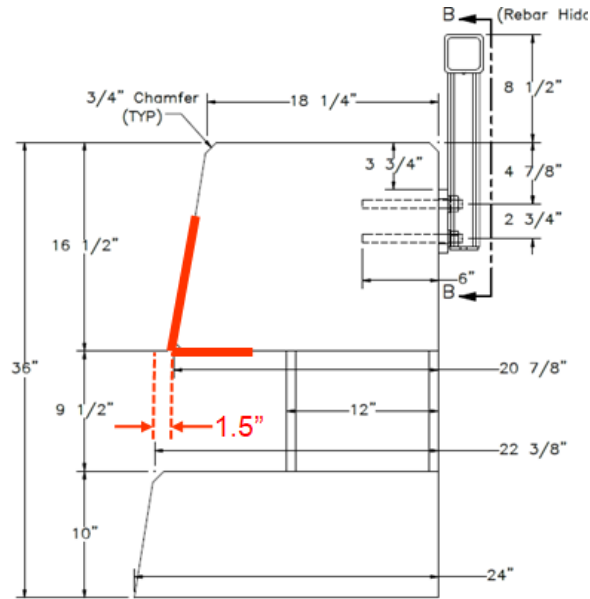
Figure 6. Limited Curb-to-Railing Offset and Angled Lower Edge of Railing

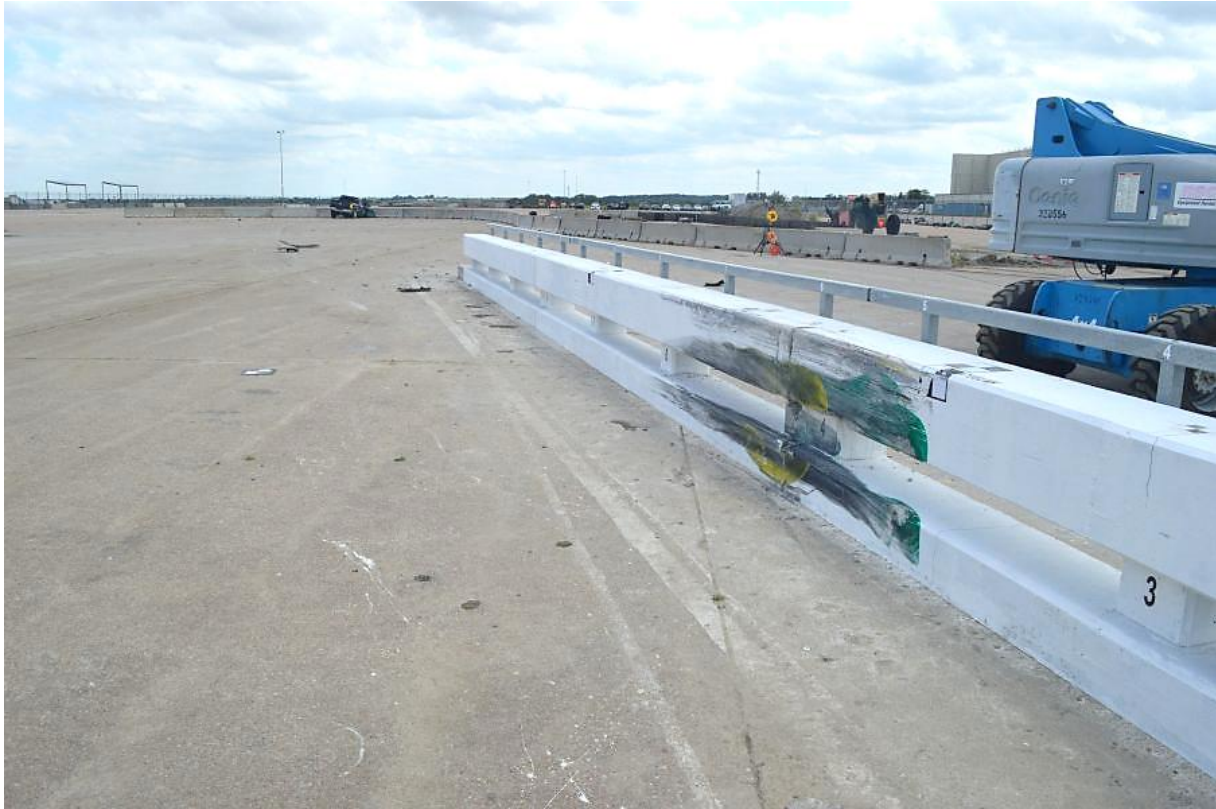
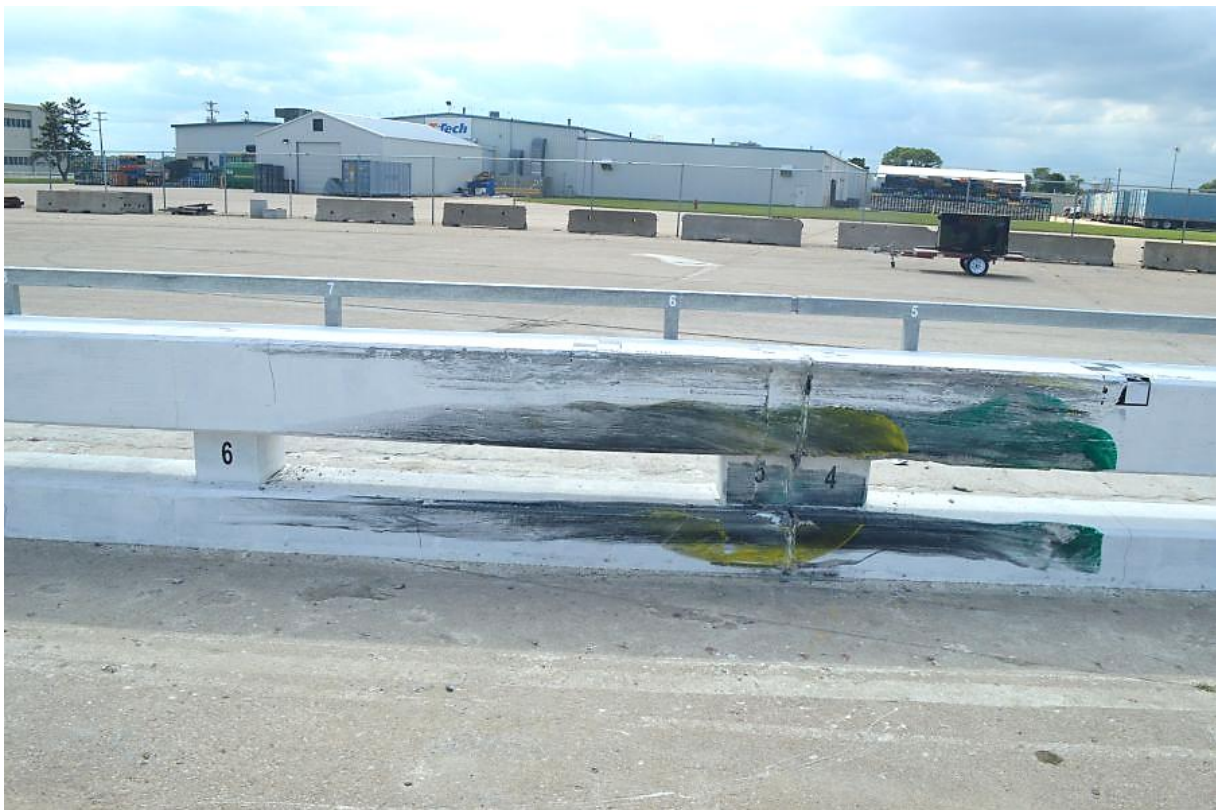
Damage to the barrier was minimal, as shown in Figures 41 through 43. Barrier damage consisted of concrete spalling, gouging, and contact marks on the front face of the concrete segments. The length of vehicle contact along the concrete rail was 12 ft – 7¼ in., beginning approximately 44 in. downstream from post no. 3. Contact marks were observed on the face of the barrier throughout the contact region. A 41-in. long and 1½-in. wide gouge was observed on the lower edge of the upper rail beginning 23 in. upstream from the centerline of post no. 4. Several other smaller gouges were located on the front faces of the top rail within the contact region. Concrete spalling was also observed on the edge of the curb adjacent to the expansion joint. The pedestrian handrail was undamaged as it was only contacted by disengaged vehicle components.

Figure 41. System Damage, Test No. HNTBR-2

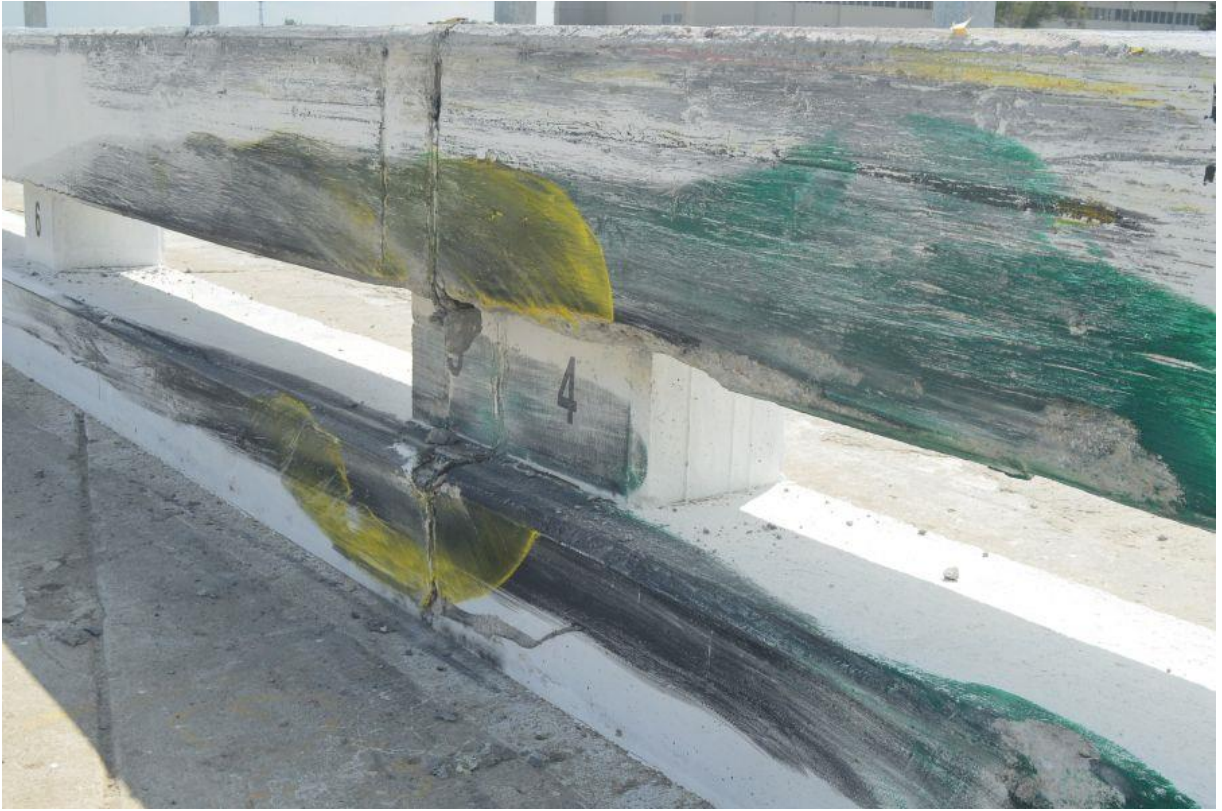
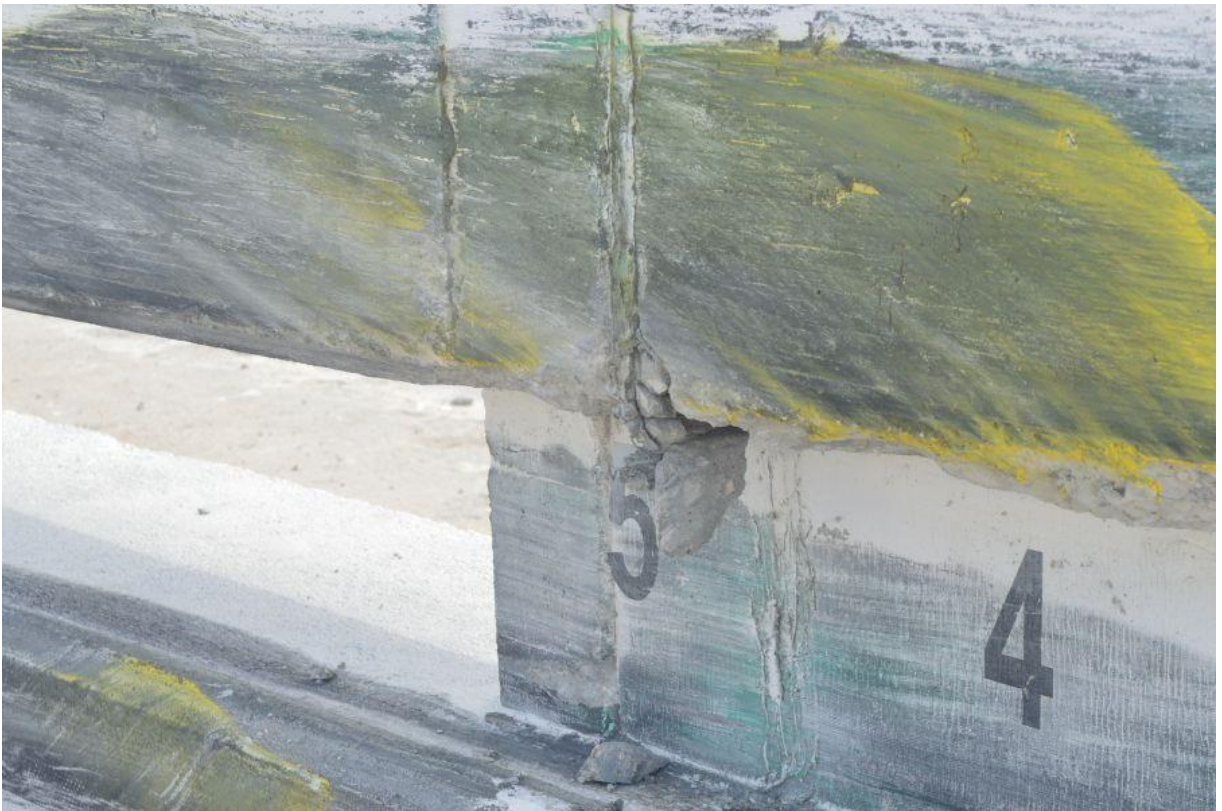
Figure 42. Curb and Concrete Rail Damage, Test No. HNTBR-2

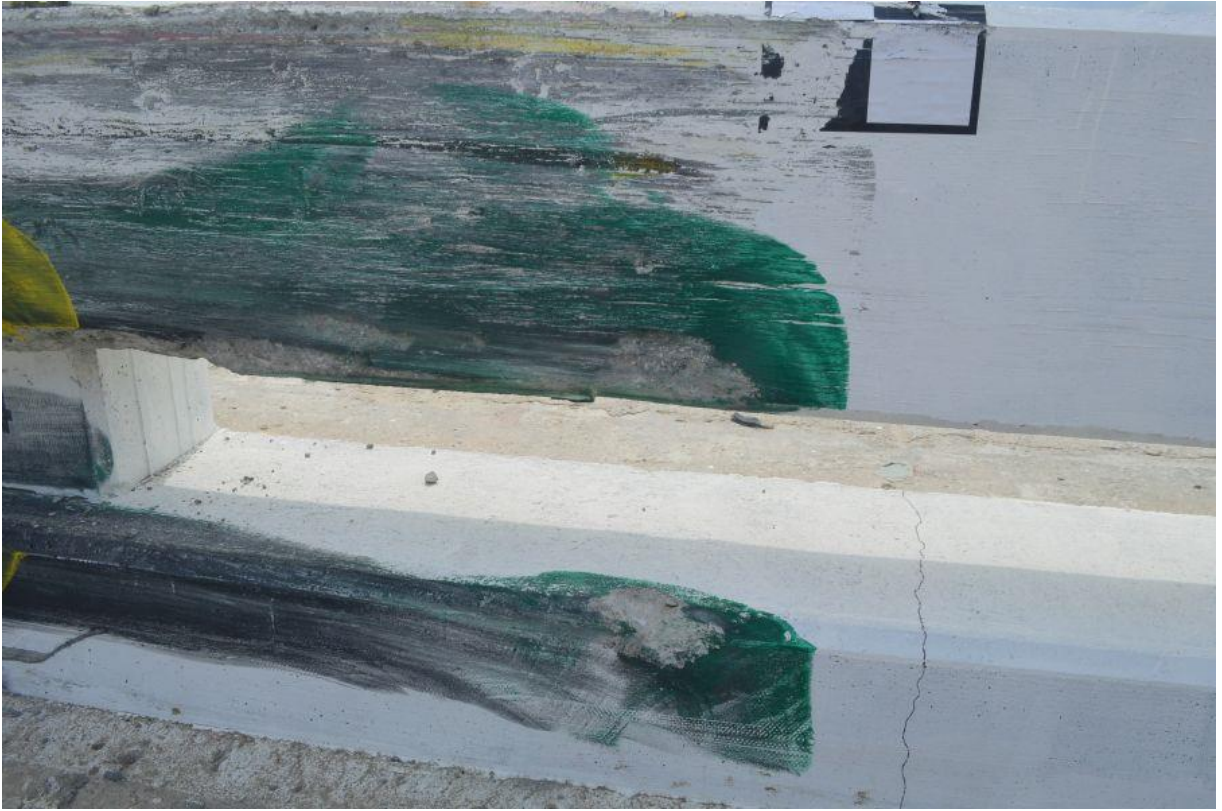
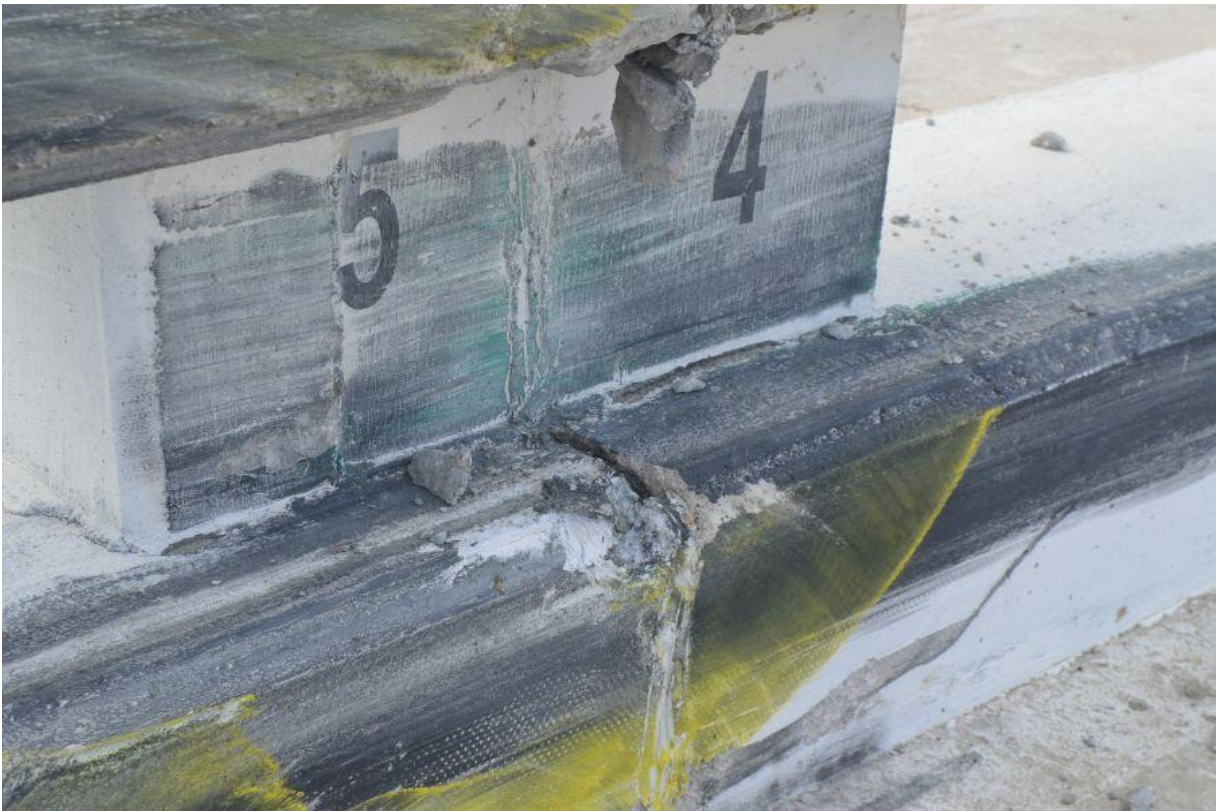
Figure 43. Curb and Concrete Rail Damage, Test No. HNTBR-2

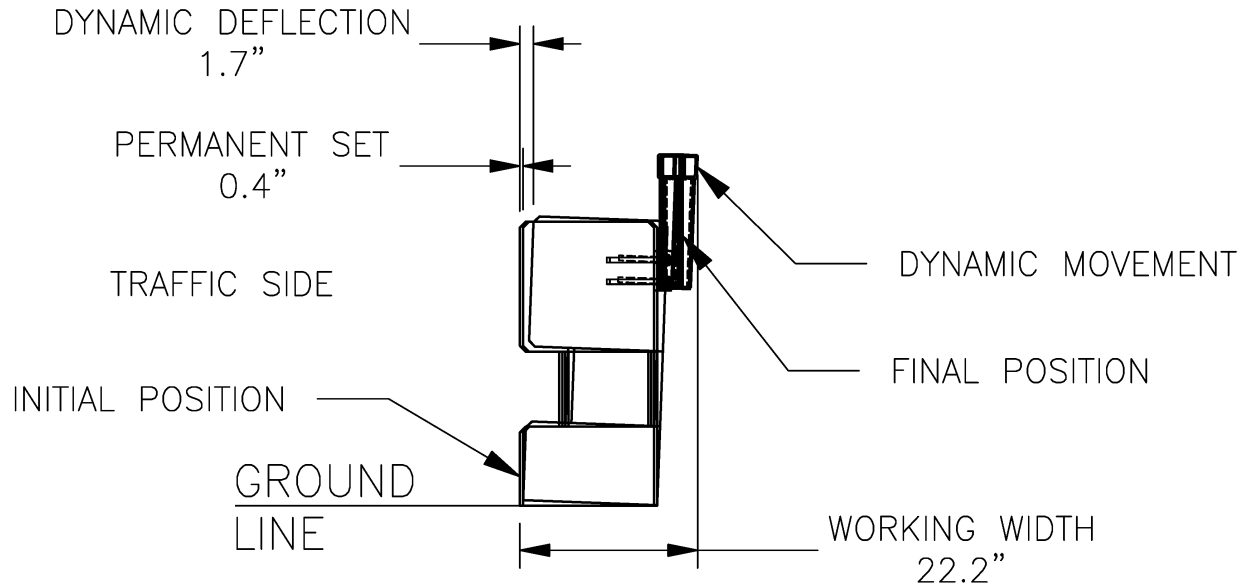
The maximum lateral permanent set of the barrier system was 0.4 in. located on the downstream side of expansion joint no. 1, as measured in the field. The maximum lateral dynamic barrier deflection was 1.7 in. located on the downstream side of expansion joint no. 1, as determined from high-speed digital video analysis. The working width of the system was found to be 22.2 in., also determined from high-speed digital video analysis. A schematic of the permanent set deflection, dynamic deflection, and working width is shown in Figure 44.

Figure 44. Permanent Set, Dynamic Deflection, and Working Width, Test No. HNTBR-2

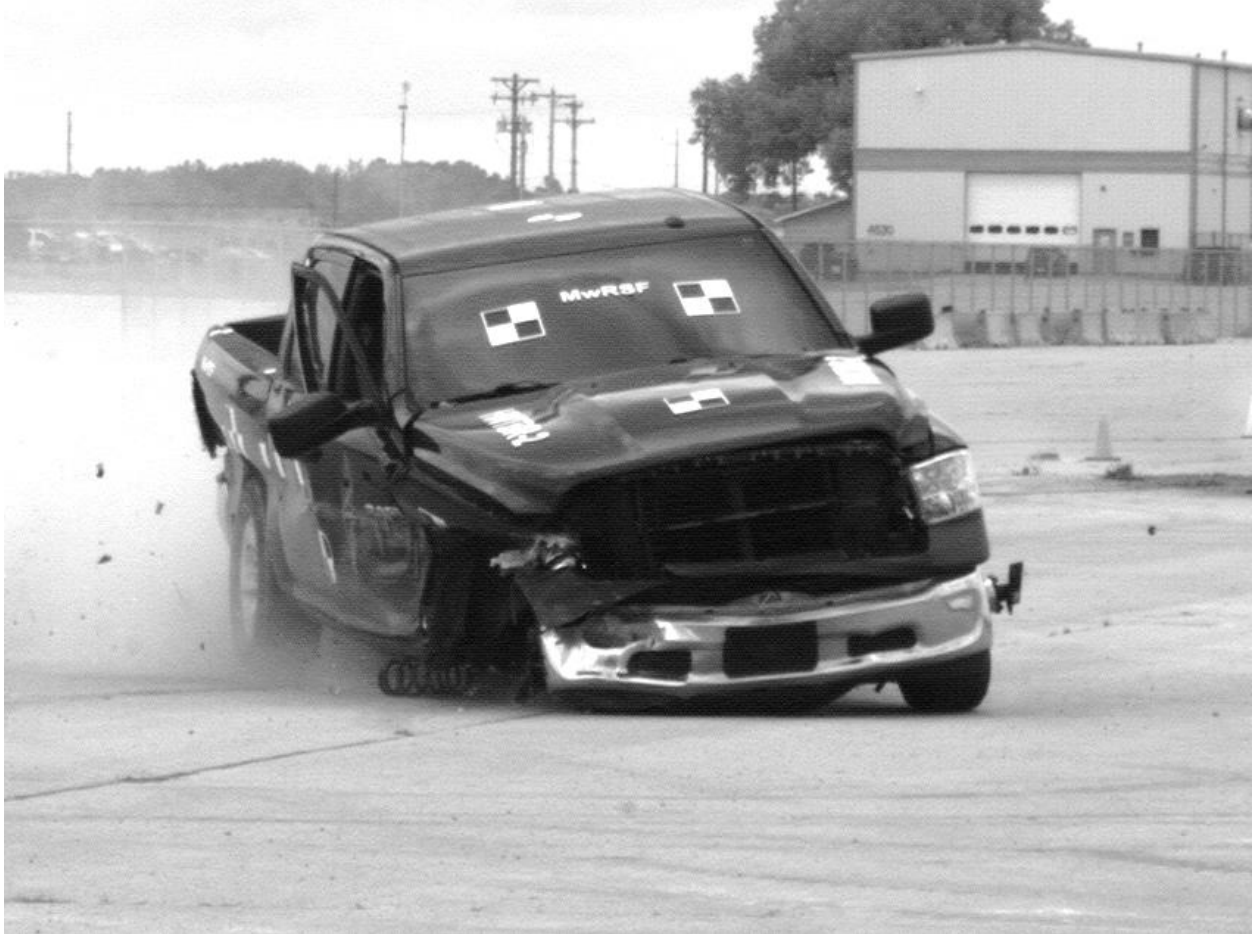
The damage to the vehicle was severe, as shown in Figures 45 through 49. Note that there was a secondary impact with a row of containment barriers downstream from the test article which contributed to the damage on the front of the vehicle. Vehicle damage prior to the secondary impact is shown in Figure 45. The impact side of the vehicle, or the passenger's side, is referred to as the vehicle's right side throughout this report. The non-impact side, or driver's side, is referred to as the vehicle's left side. The majority of the damage was concentrated on the right-front corner and right side of the vehicle where the impact occurred. The right side of the front bumper was bent rearward and scraped. The right-front headlight and grille were disengaged from the vehicle. Scrapes and dents were observed throughout the right-side of the vehicle including the fender, doors, rear quarter panel, and rear bumper. Cracks were observed on the right side of the windshield, and the right-front side window was disengaged from the vehicle due to a combination of door flexure and contact with the dummy. Note, neither the side window nor the dummy contacted the bridge railing.

Figure 45. Vehicle Damage before Secondary Impact, Test No. HNTBR-2

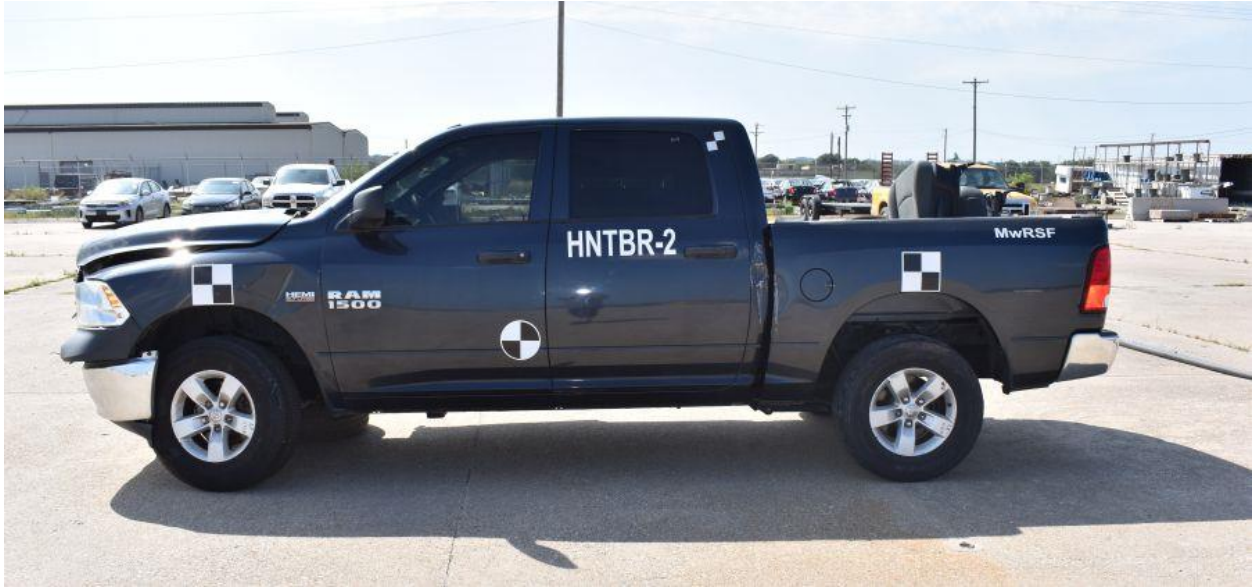
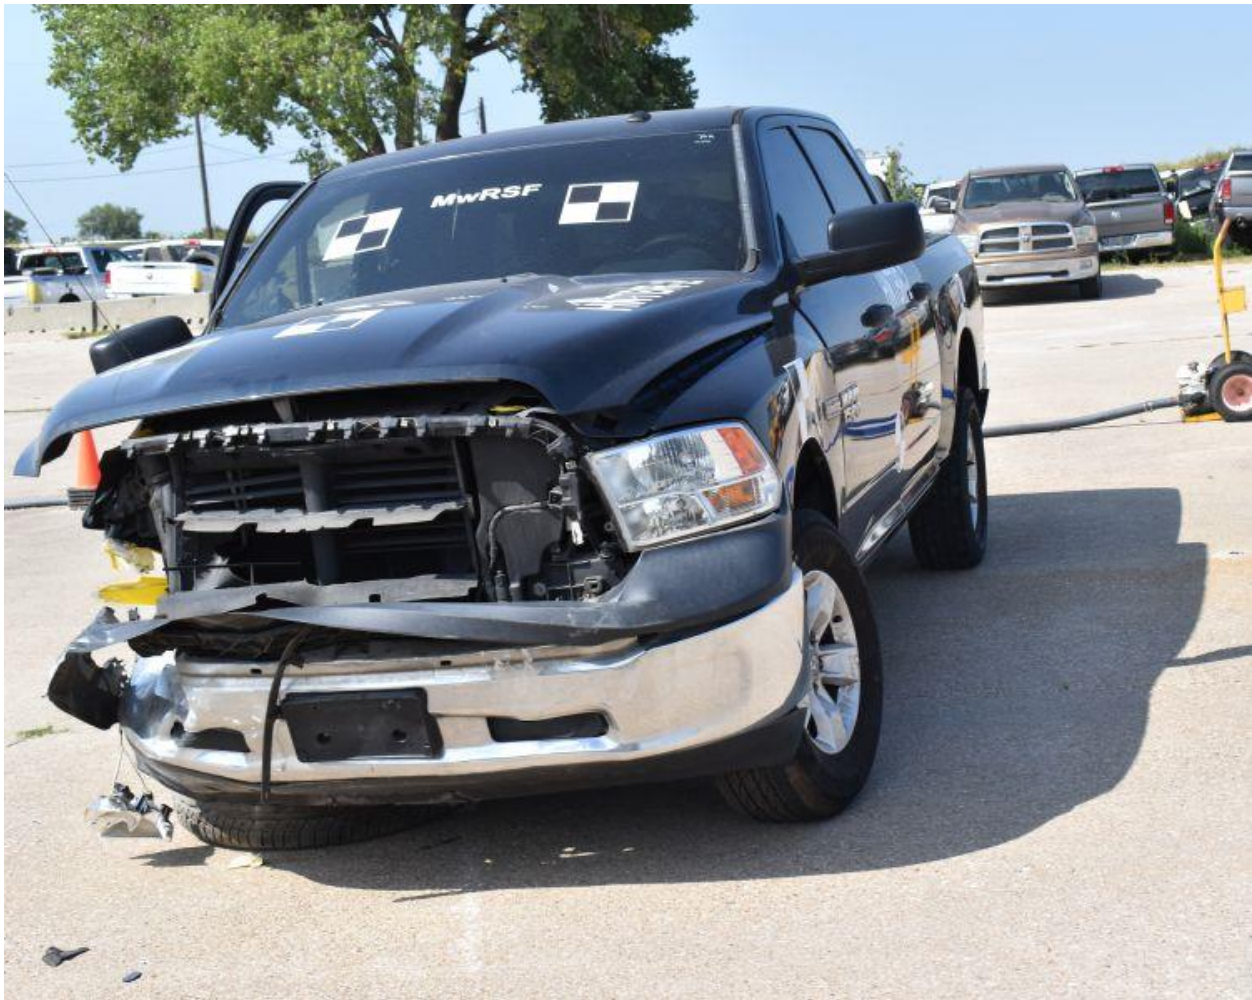
Figure 46. Vehicle Damage, Test No. HNTBR-2

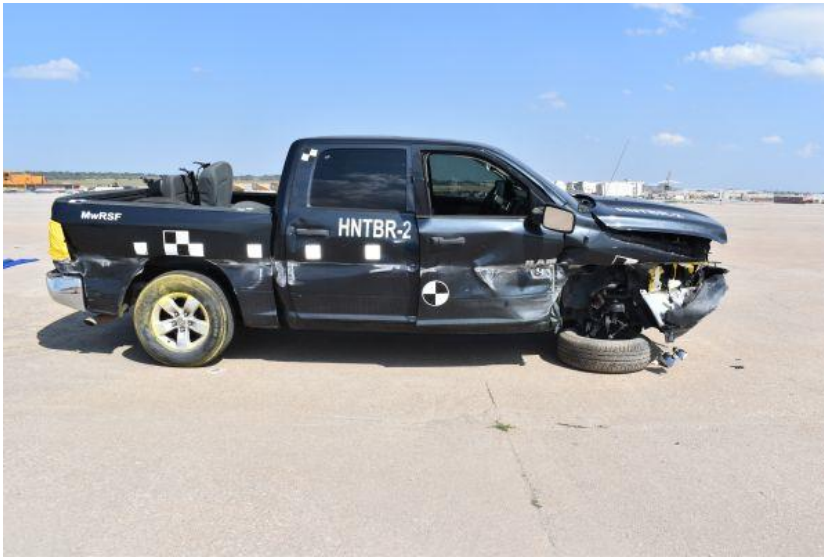
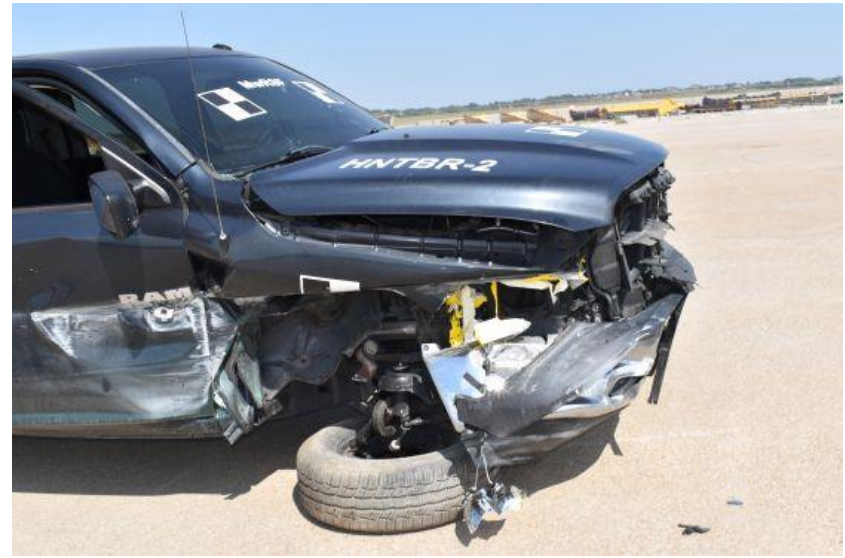
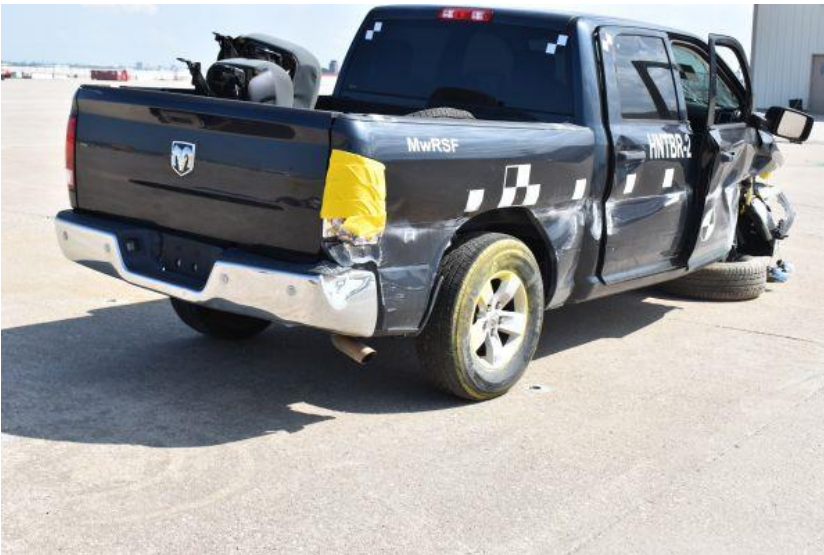
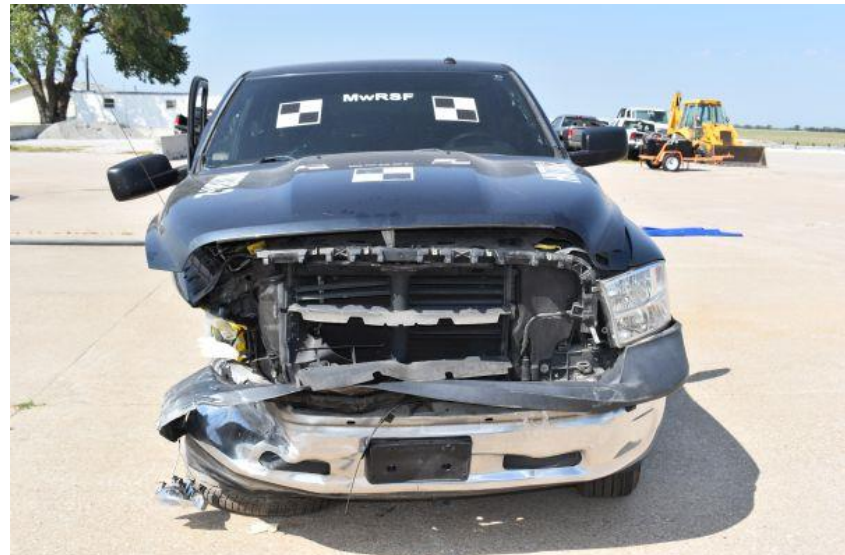
Figure 47. Vehicle Damage, Test No. HNTBR-2

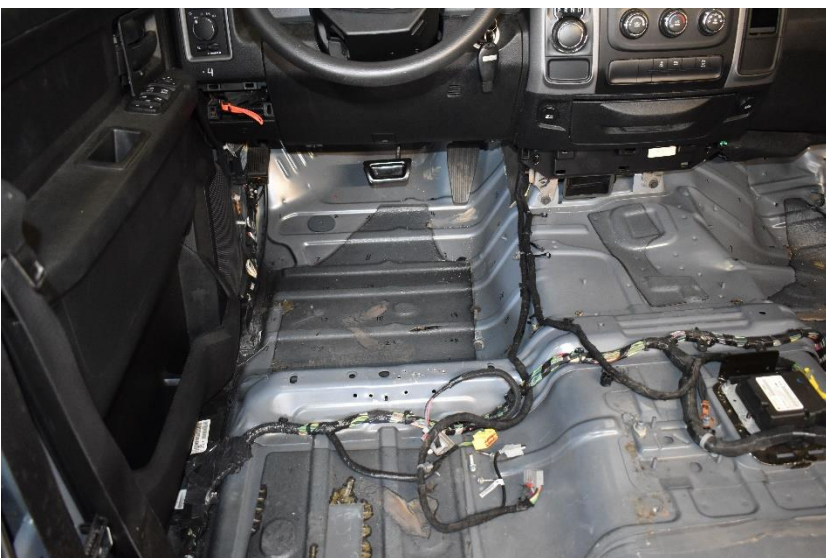
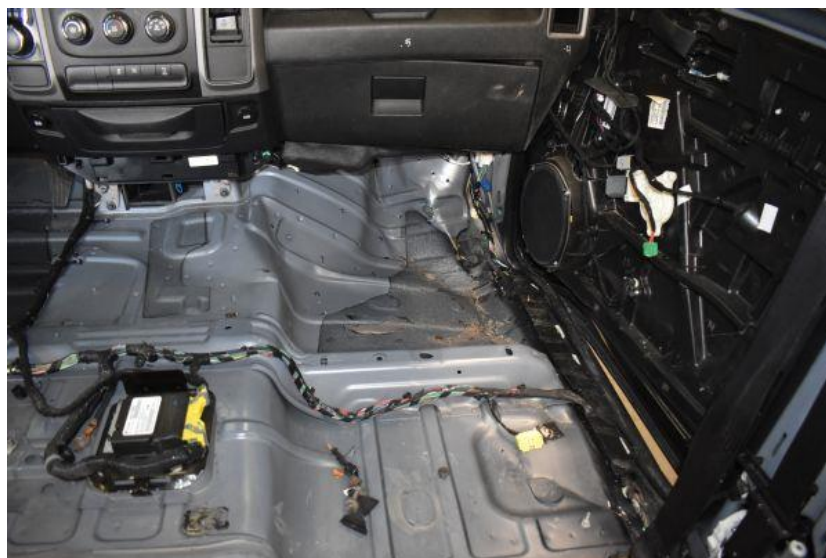
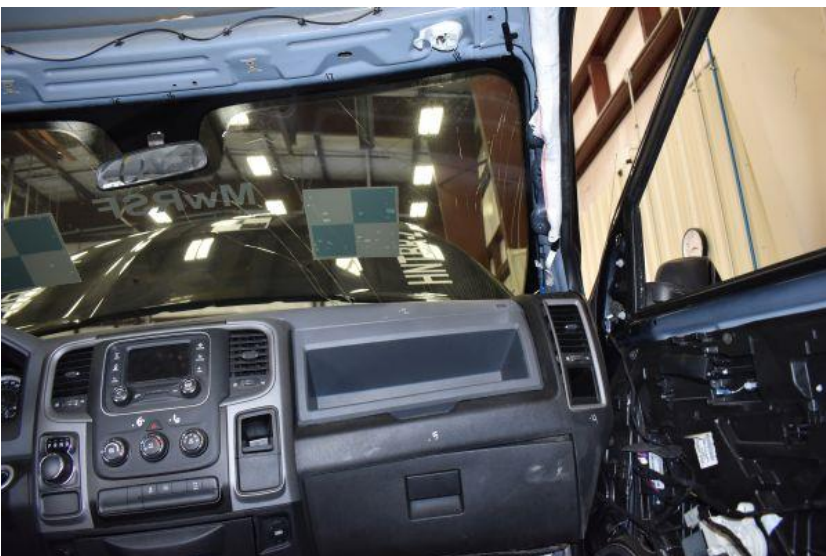
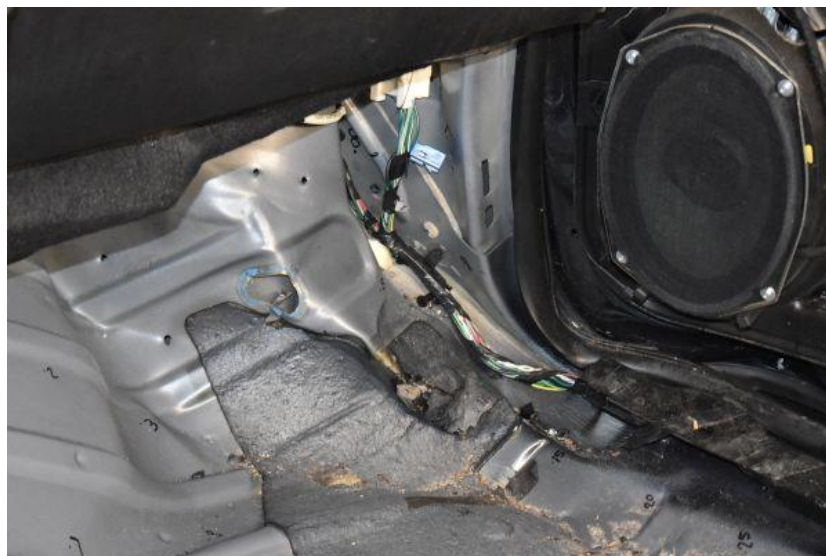
The maximum occupant compartment intrusions are listed in Table 5, along with the intrusion limits established in MASH for various areas of the occupant compartment. The maximum intrusion was 4.4 in. to the side front panel, which was within the 12 in. MASH limit.

Figure 48. Vehicle's Floor Pan and Interior Compartment Damage, Test No. HNTBR-2

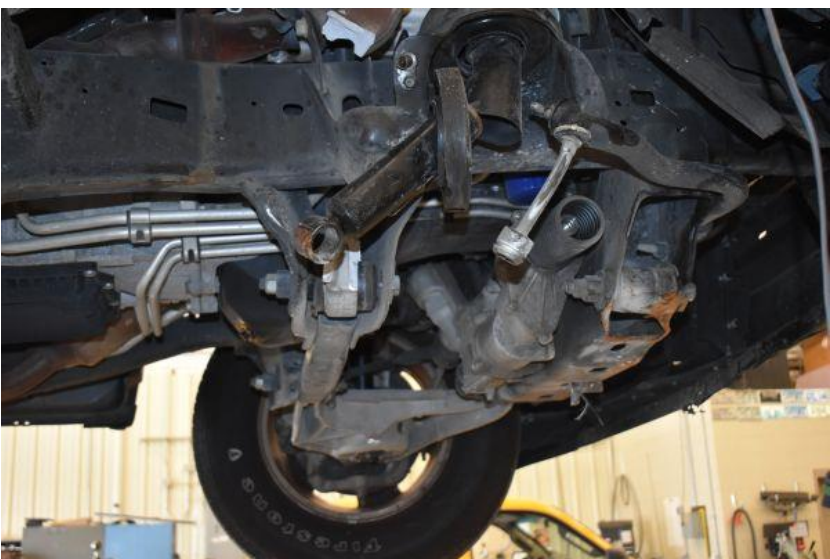
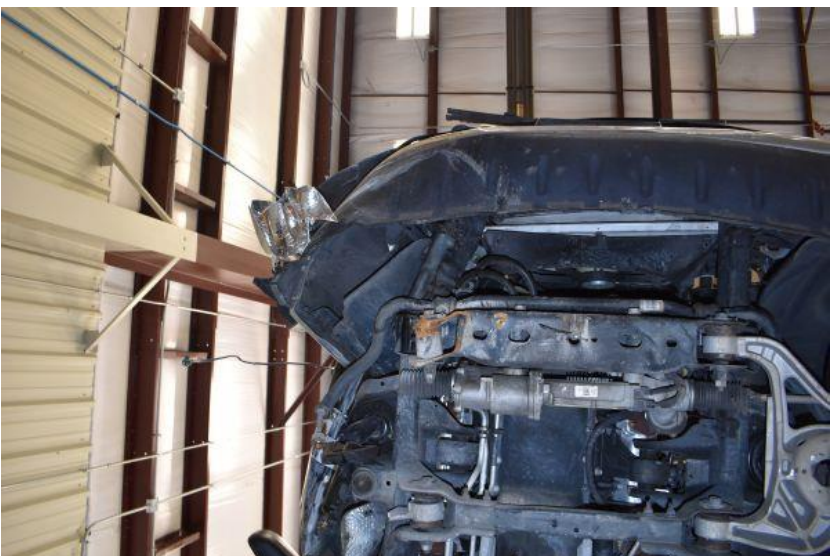
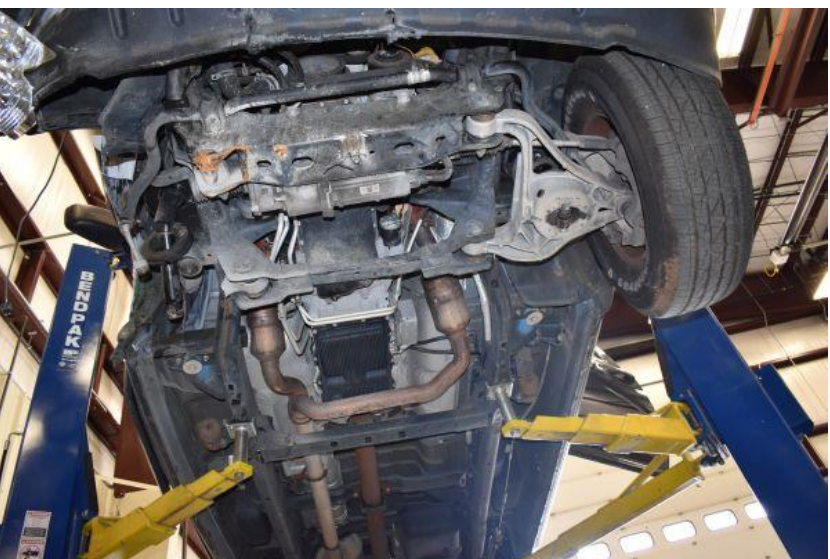
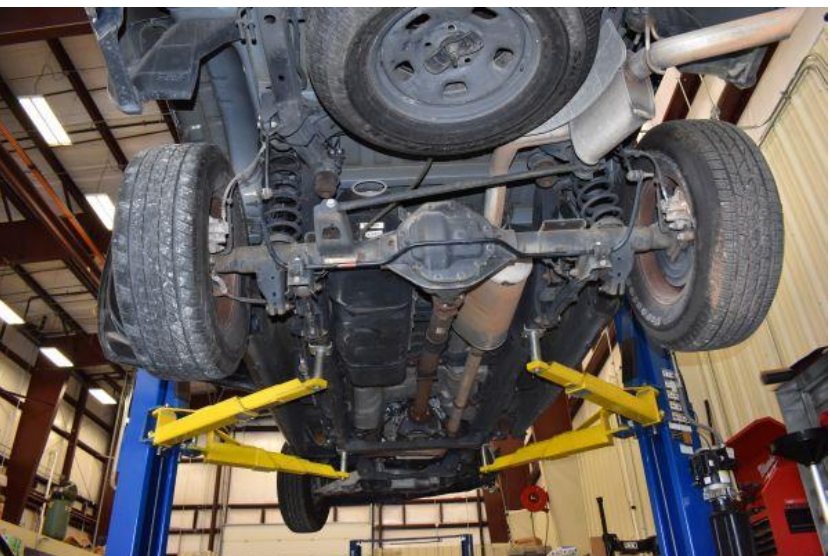
On the undercarriage, the right-front side spring was disengaged and the right-front shocks were bent rearward. The left-side end link was bent rearward, and the left steering knuckle was disengaged. The right lower control arm disengaged from the vehicle, and the right upper control arm was bent backward. The right tie rod disengaged and the steering rack case was fractured. The right end of the front engine cross member was scraped and twisted slightly, and the rear cross member was bent and slightly scraped. The right frame horn was bent and twisted inward, and the left frame horn was bent outward. The right-front wheel detached from the vehicle and the right rear wheel was scraped.

Figure 49. Vehicle's Undercarriage Damage, Test No. HNTBR-2

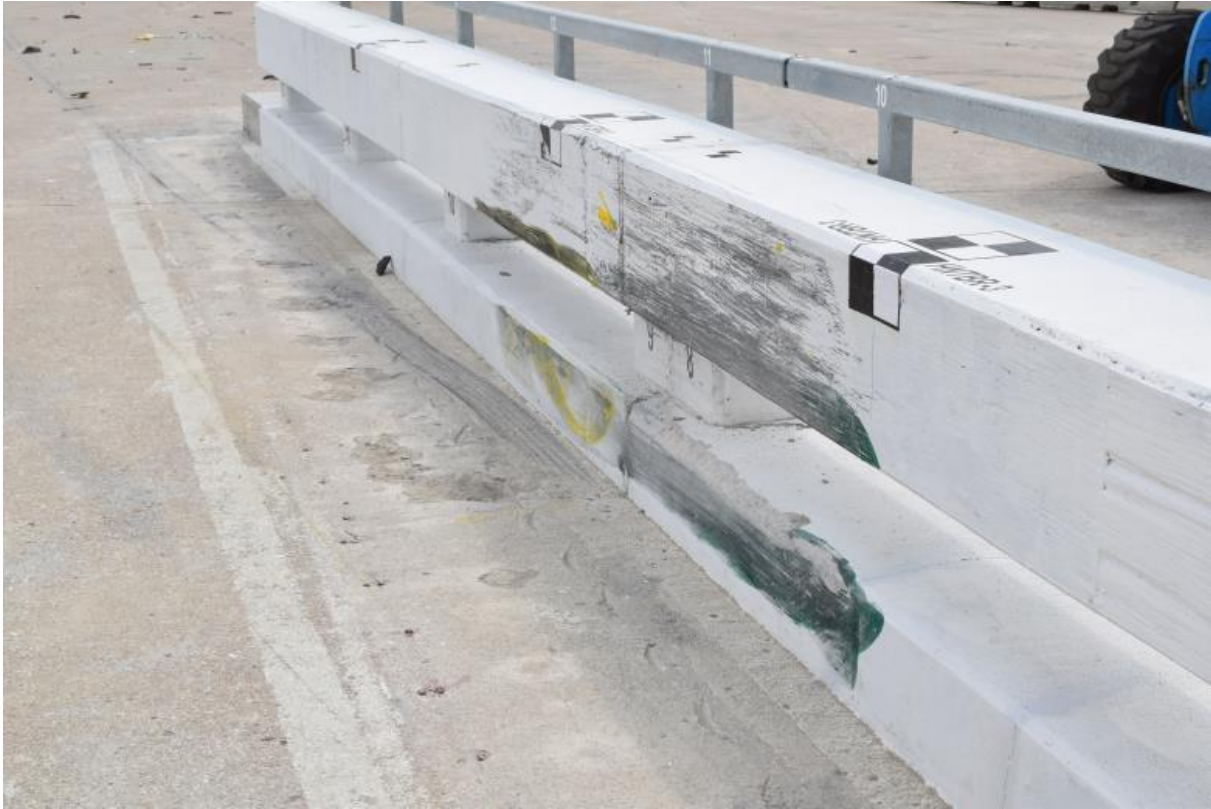
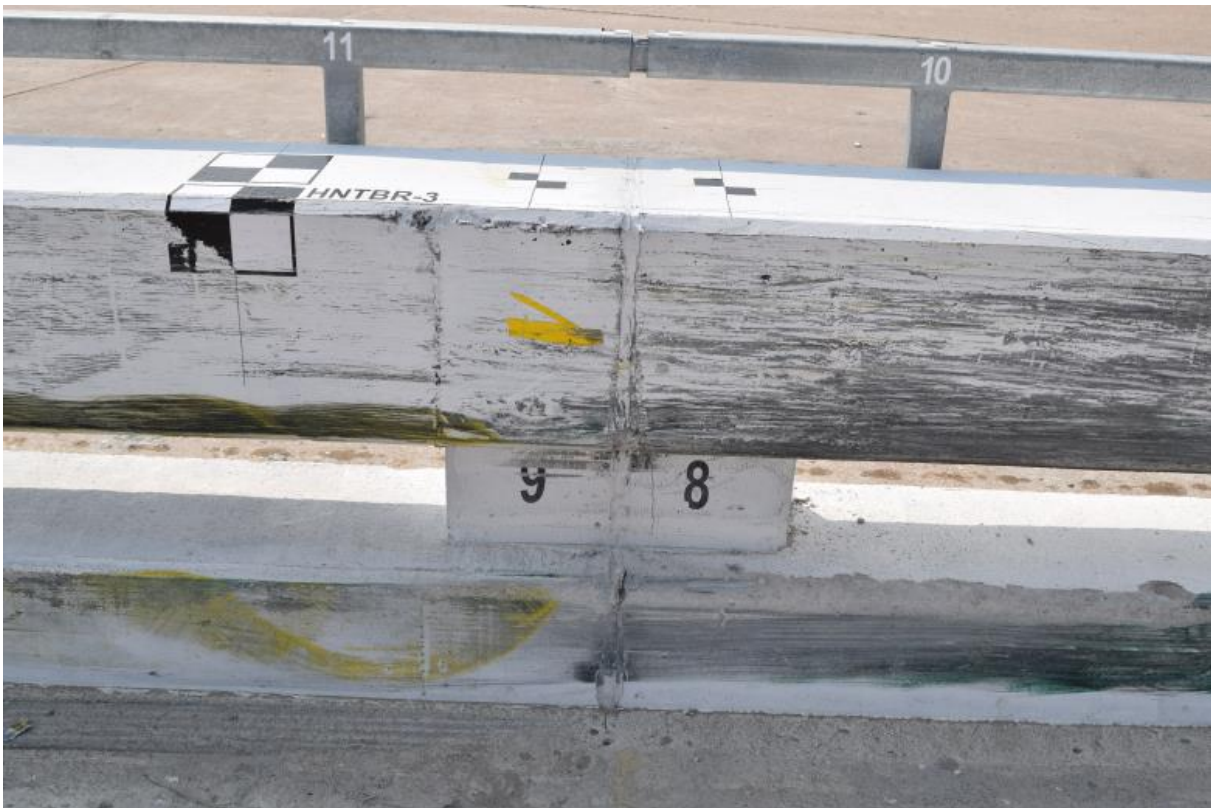
Damage to the barrier was minimal, as shown in Figures 56 through 58. The length of vehicle contact along the concrete rail was 10 ft, beginning 51 in. upstream from expansion joint no. 2. Barrier damage consisted of concrete spalling and contact marks on the upper rail and lower curb of the concrete bridge rail. Concrete spalling on the top edge of the curb began near impact and continued downstream for 50 in. (to the expansion joint.). Various contact marks, minor gouges, and hairline cracks were found on the front face of both the upper rail and the lower curb throughout the contact region. Contact marks were also observed on the face of post nos. 8 and 9, which were adjacent to the expansion joint.

Figure 56. System Damage, Test No. HNTBR-3
