*Hawaii Department of Transportation  
Research Contract No. 69876  
Research Project No. STP-1500(115) – Phase III*

## **DEVELOPMENT AND CRASH TESTING OF THE HAWAII CONCRETE POST AND BEAM BRIDGE RAIL**

MwRSF Research Report No. TRP-03-478b-25

July 15, 2025

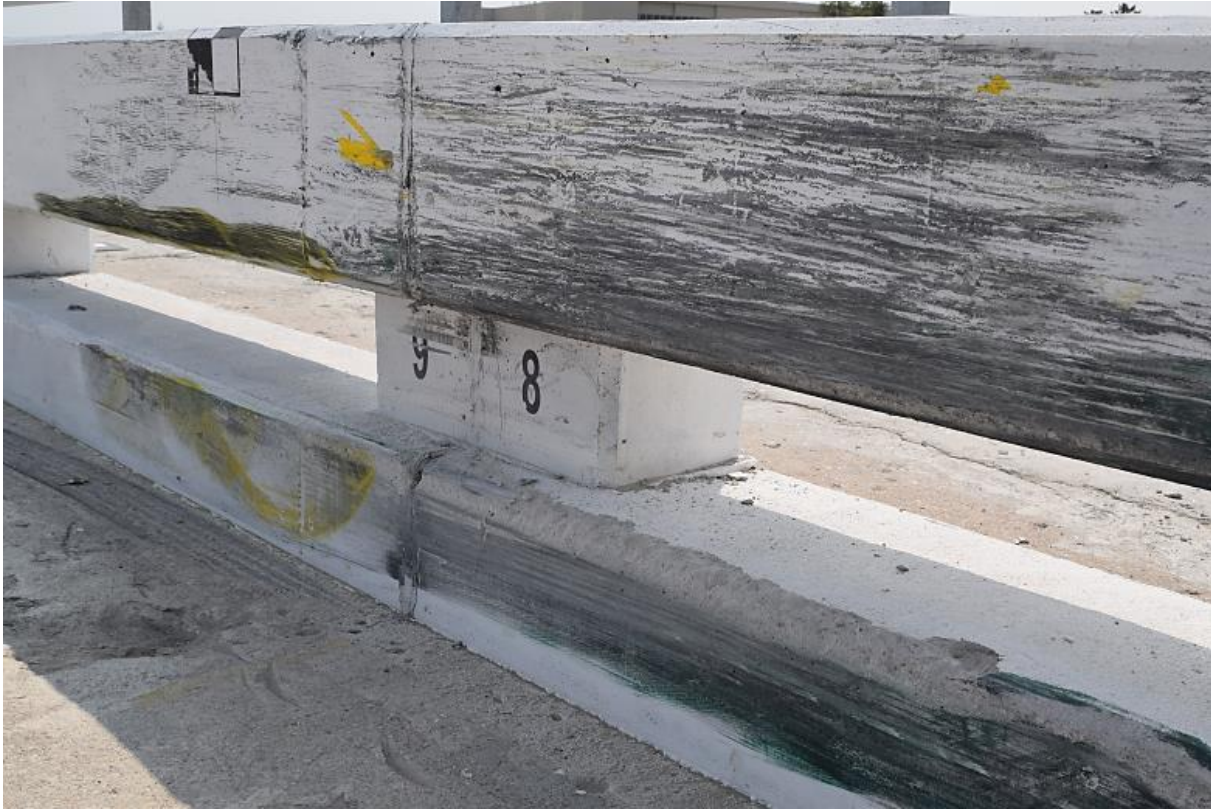
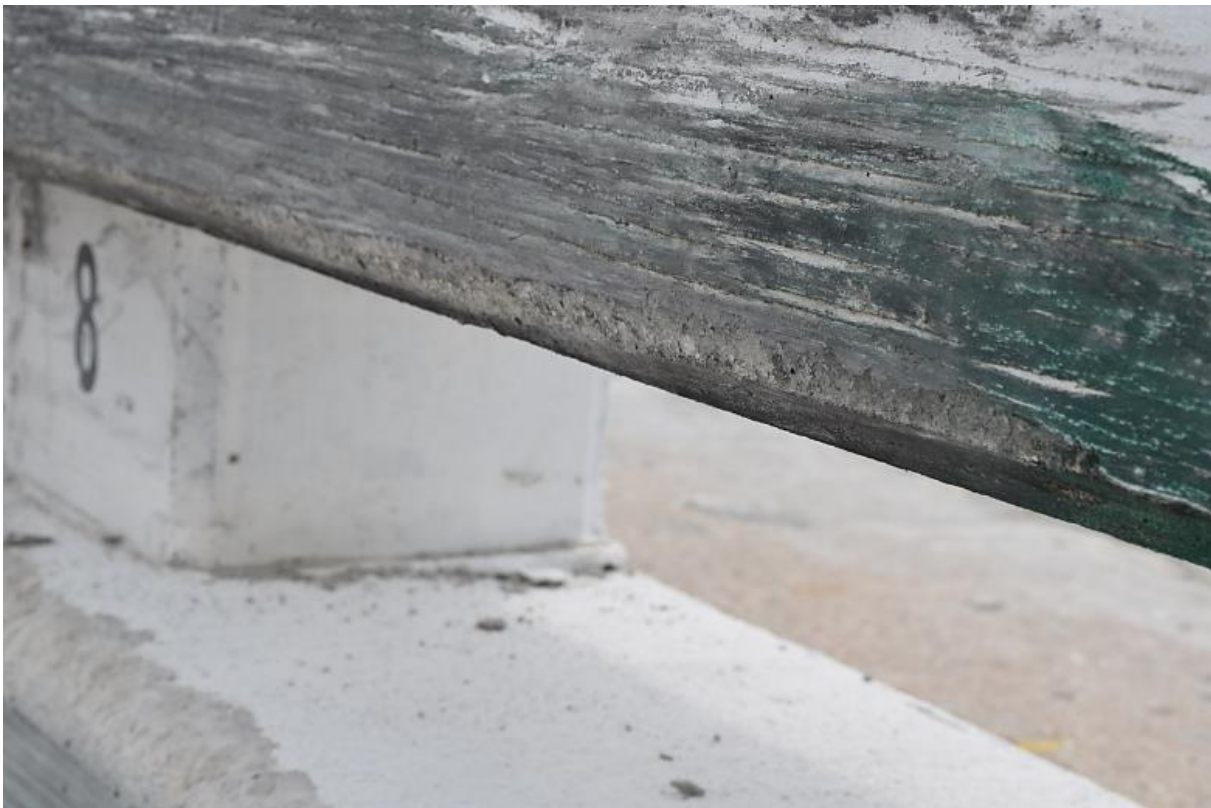
Damage to the barrier was minimal, as shown in Figures 56 through 58. The length of vehicle contact along the concrete rail was 10 ft, beginning 51 in. upstream from expansion joint no. 2. Barrier damage consisted of concrete spalling and contact marks on the upper rail and lower curb of the concrete bridge rail. Concrete spalling on the top edge of the curb began near impact and continued downstream for 50 in. (to the expansion joint.). Various contact marks, minor gouges, and hairline cracks were found on the front face of both the upper rail and the lower curb throughout the contact region. Contact marks were also observed on the face of post nos. 8 and 9, which were adjacent to the expansion joint.

Figure 57. Curb and Concrete Rail Damage, Test No. HNTBR-3

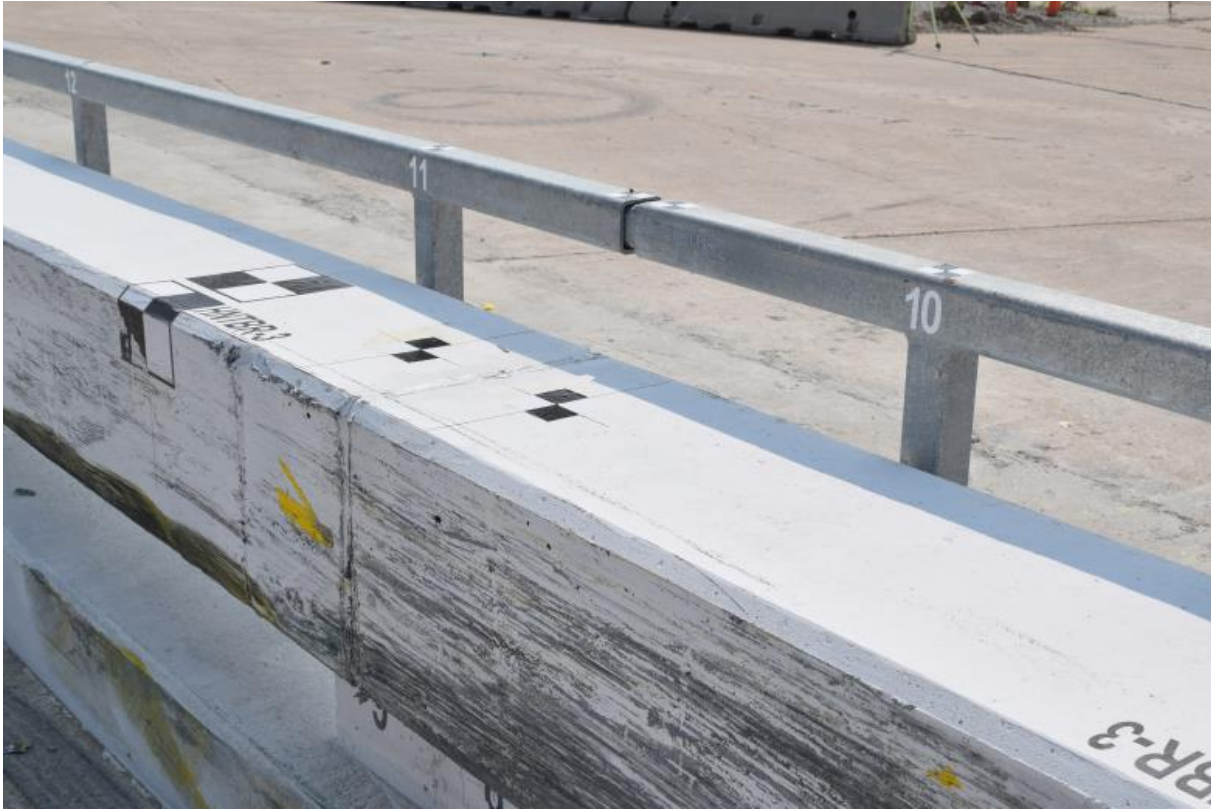
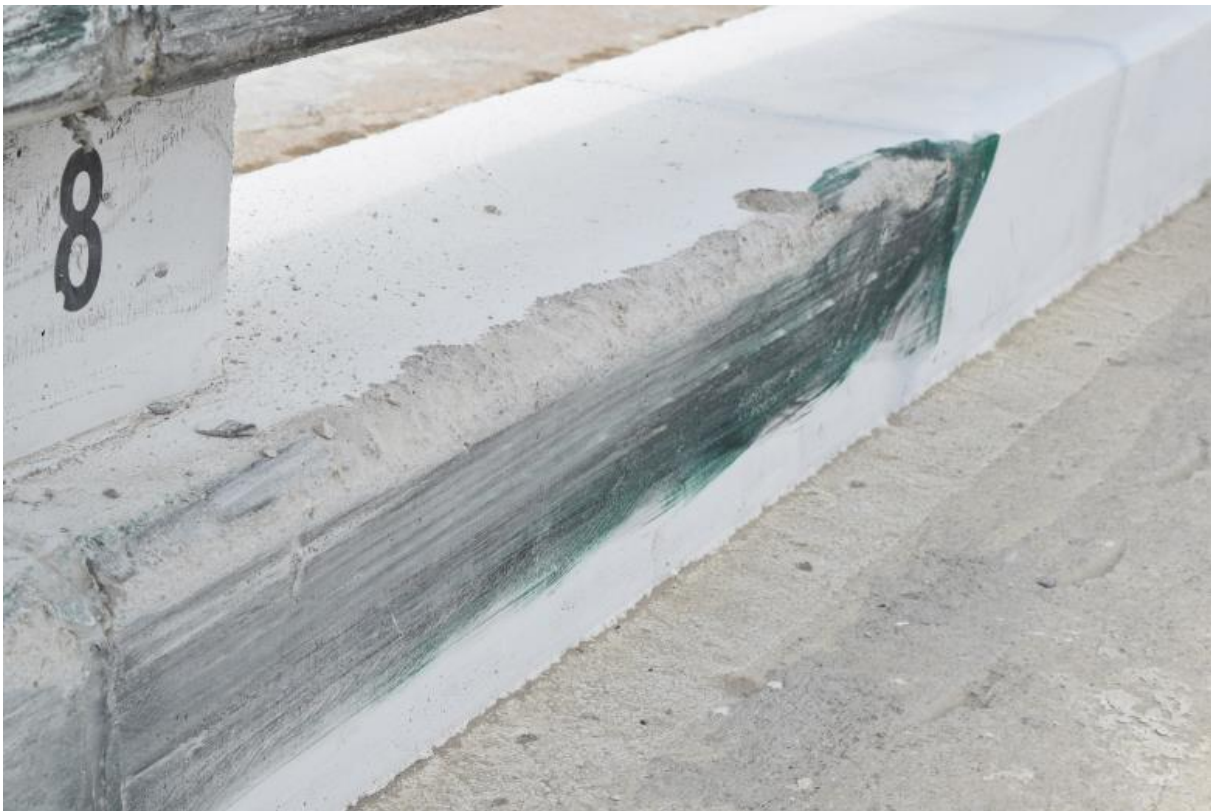
Figure 58. Curb and Concrete Rail Damage, Test No. HNTBR-3

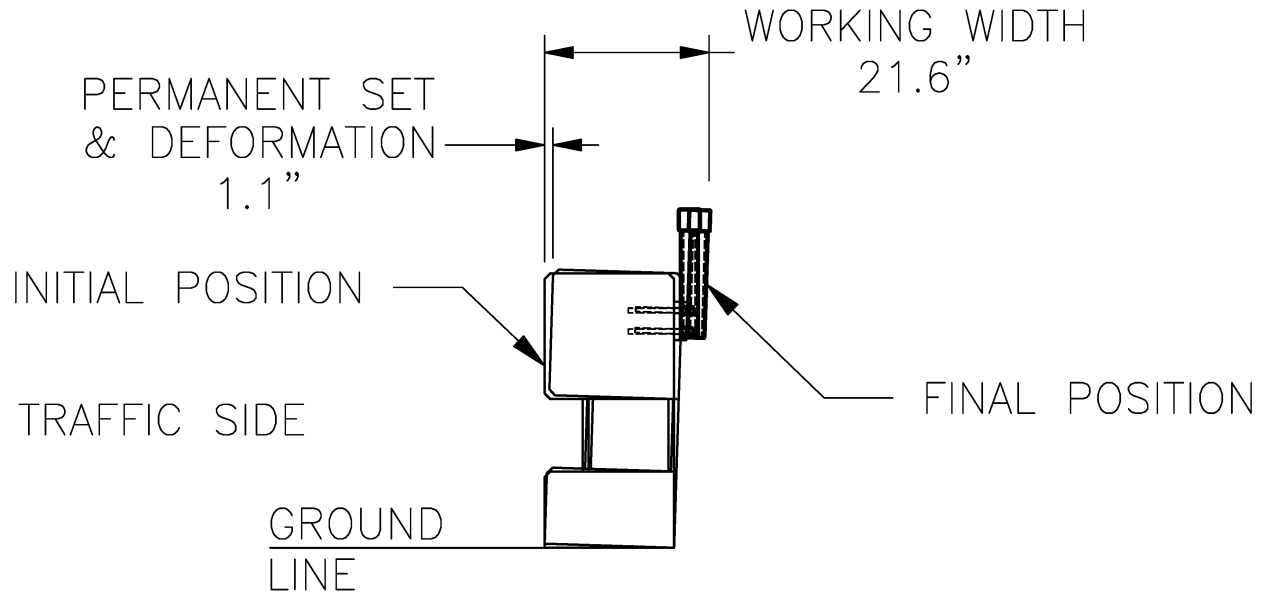
The maximum lateral permanent set of the barrier system was 1.1 in. at the upstream end of the third bridge rail segment, as measured in the field. The maximum lateral dynamic barrier deflection was 1.1 in. at the upstream end of the third bridge rail segment, as determined from high-speed digital video analysis. The working width of the system was found to be 21.6 in., also determined from high-speed digital video analysis. A schematic of the permanent set deflection, dynamic deflection, and working width is shown in Figure 59.

Figure 59. Permanent Set, Dynamic Deflection, and Working Width, Test No. HNTBR-3

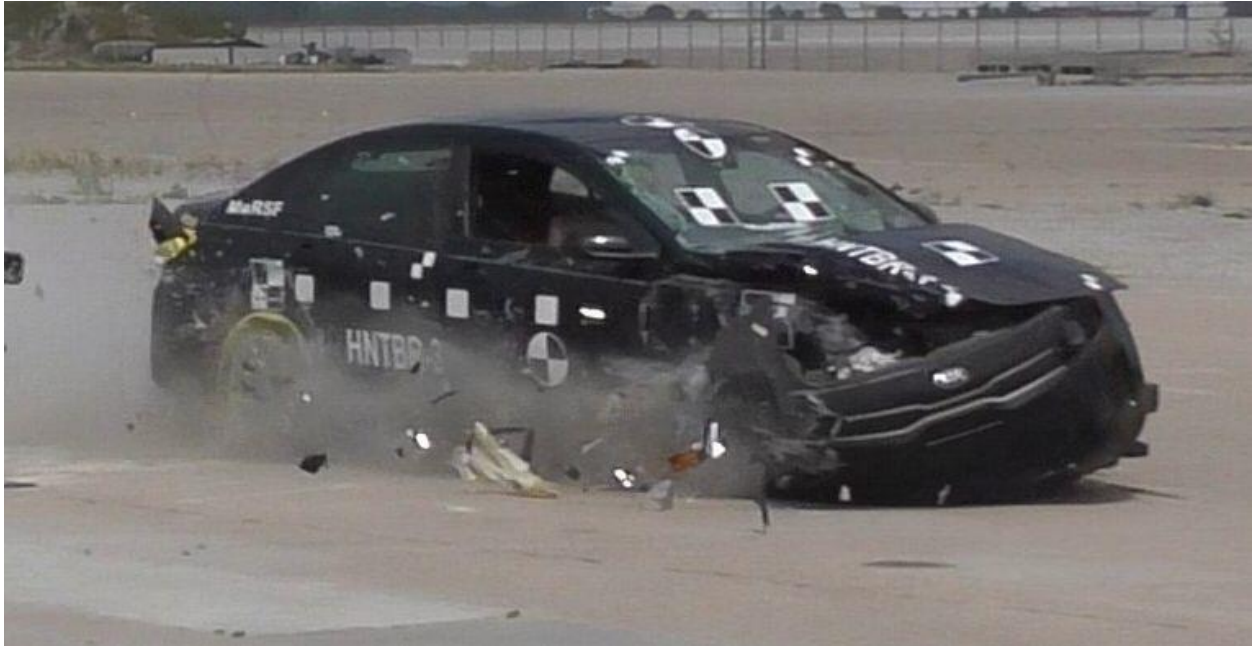
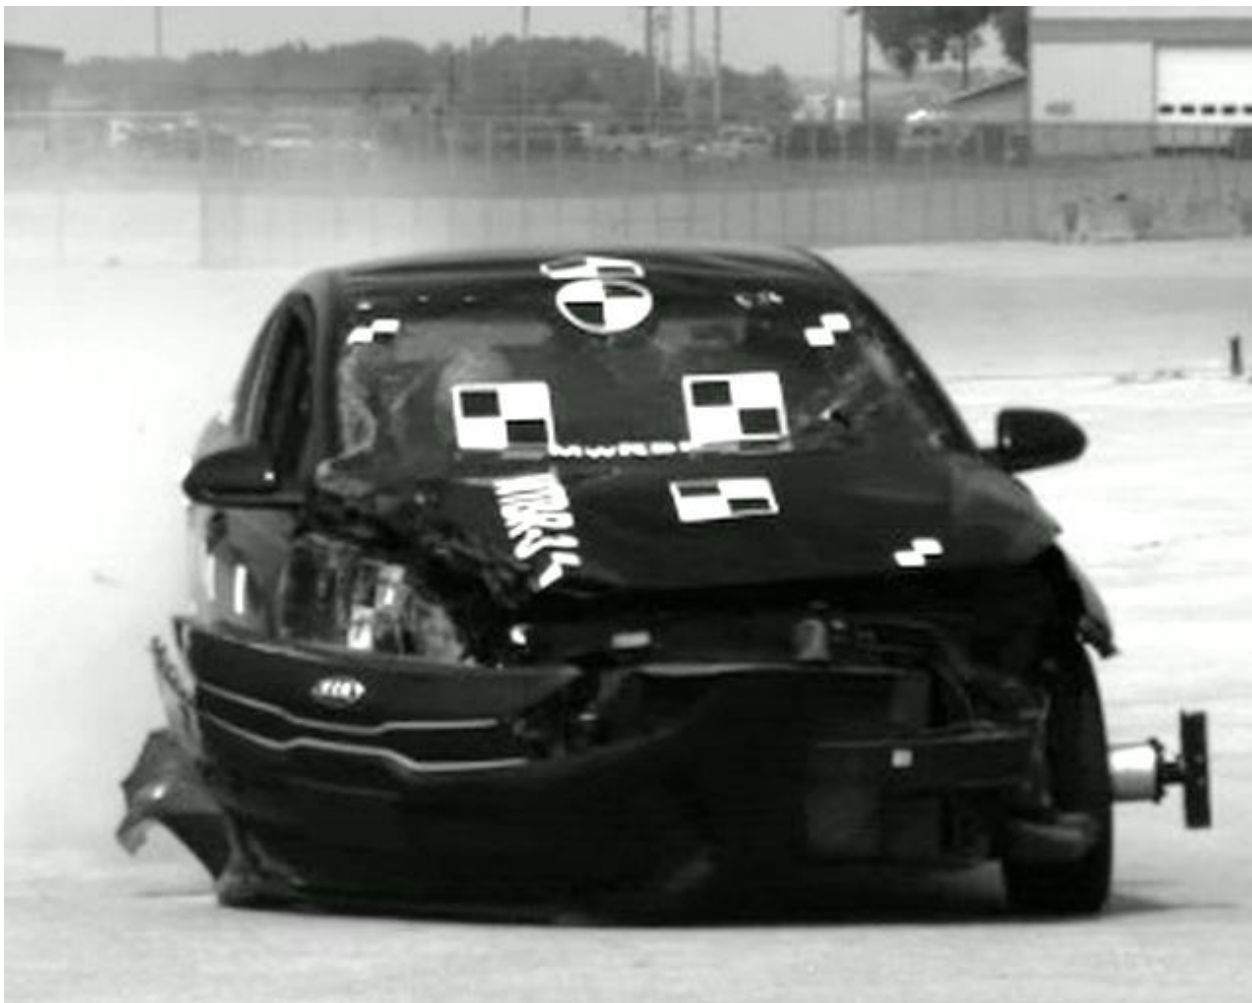
The damage to the vehicle was severe, as shown in Figures 60 through 63. Note that there was a secondary impact with a row of containment barriers downstream from the test article. Vehicle damage prior to the secondary impact is shown Figure 60. The impact side of the vehicle, or the passenger's side, is referred to as the vehicle's right side throughout this report. The non-impact side, or driver's side, is referred to as the vehicle's left side. The majority of the damage was concentrated on the right-front corner and right side of the vehicle where the impact had occurred. The front bumper cover detached, and the front bumper was pushed back into the radiator. Both front headlights were disengaged from the vehicle, and the hood was deformed. The front fender was dented and crushed. The base of the A-pillar was deformed and crushed inward. The right-front door's leading edge was dented and scraped, and the right-front window was detached from the vehicle. The right-rear door was dented along its length, and the right quarter panel was dented inward. The entire right side of the vehicle was scraped from the front fender to the rear bumper. The front half of the roof was kinked and buckled.

Figure 60. Vehicle Damage before Secondary Impact, Test No. HNTBR-3

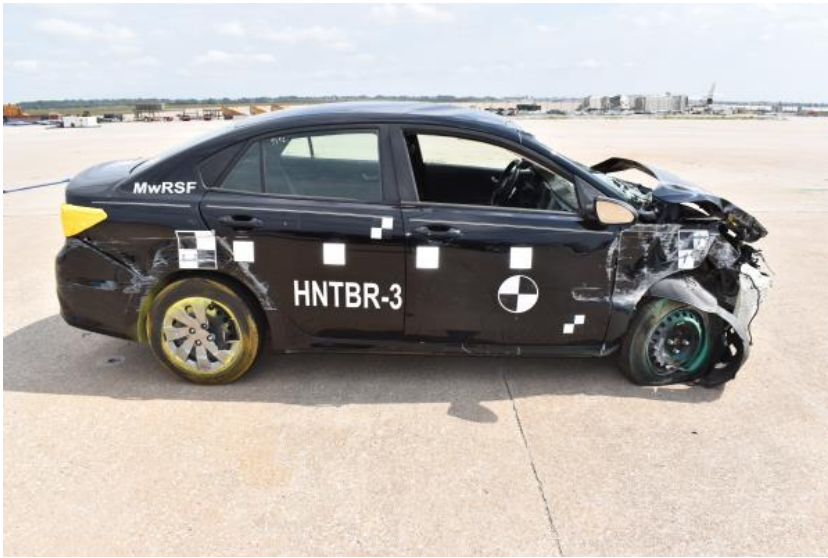
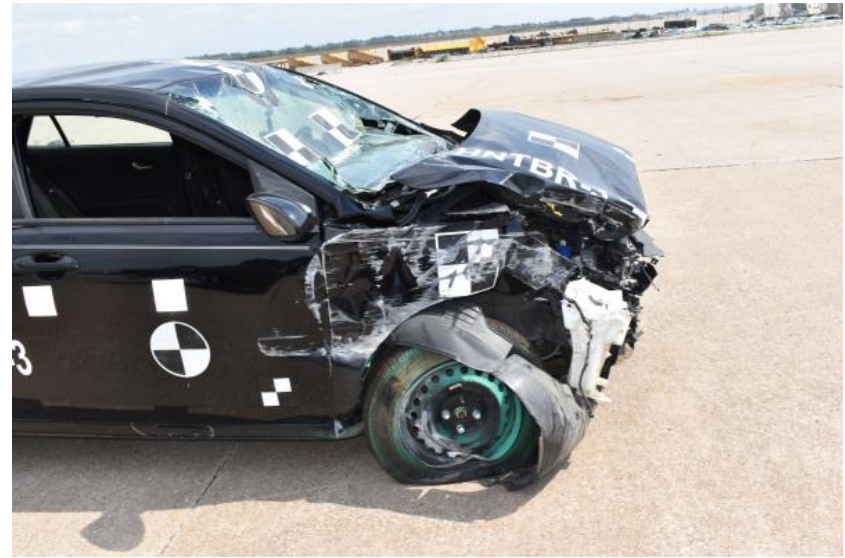
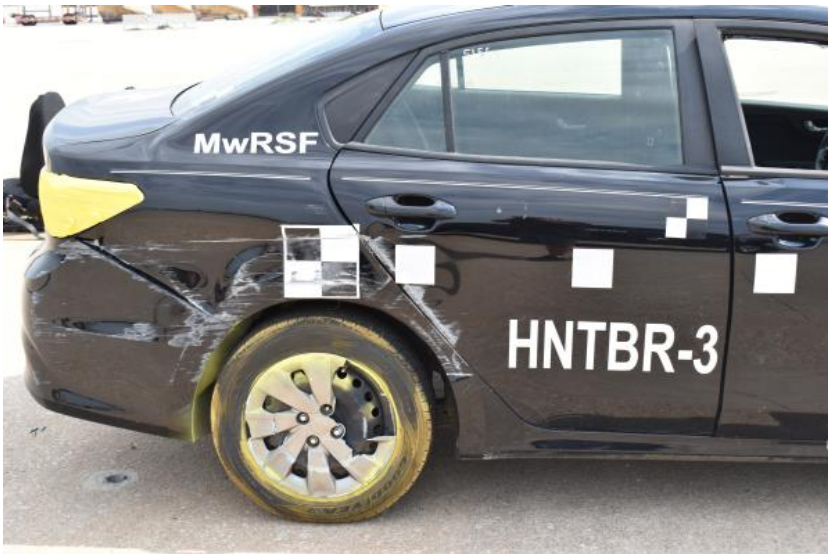
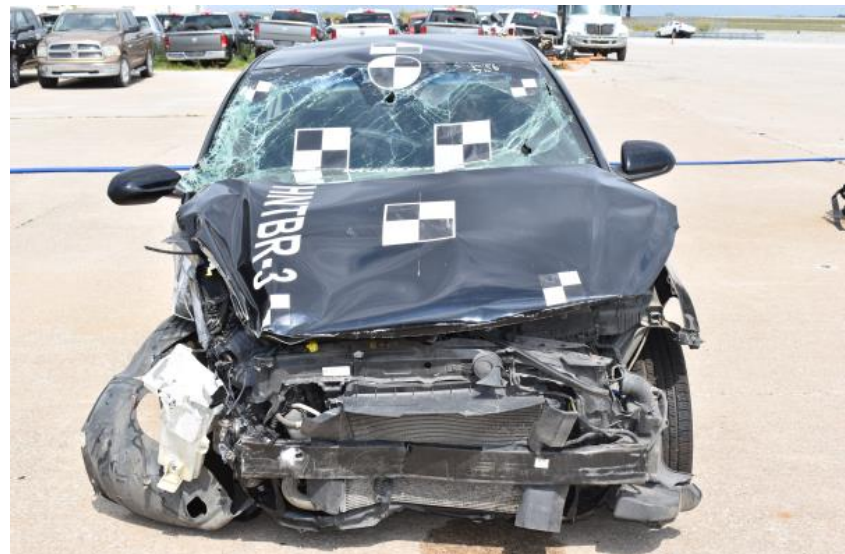
Figure 61. Vehicle Damage, Test No. HNTBR-3

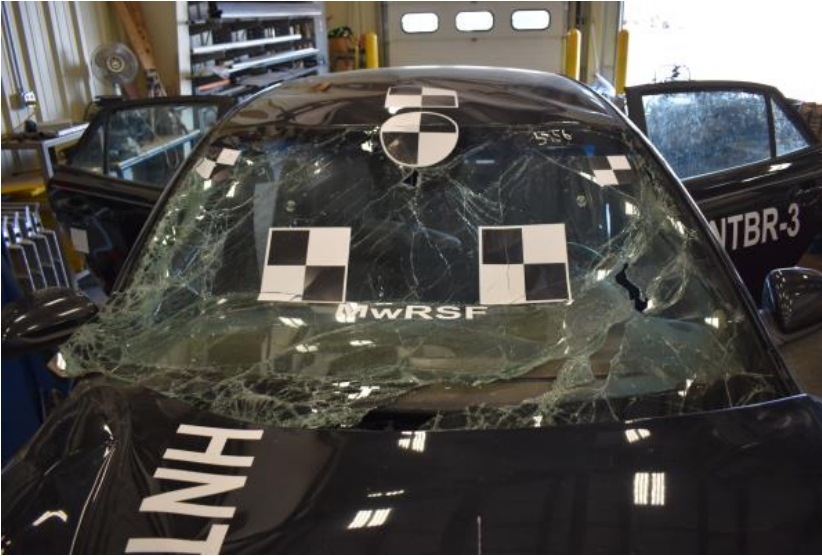
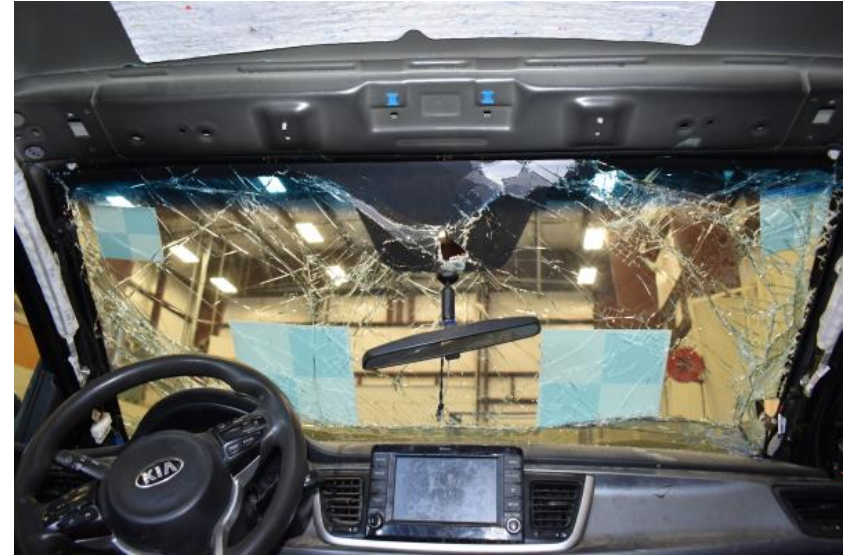
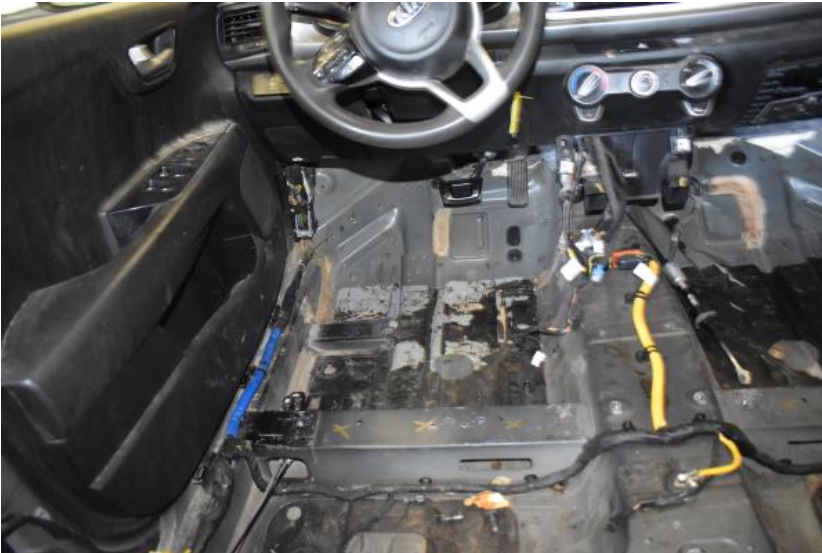
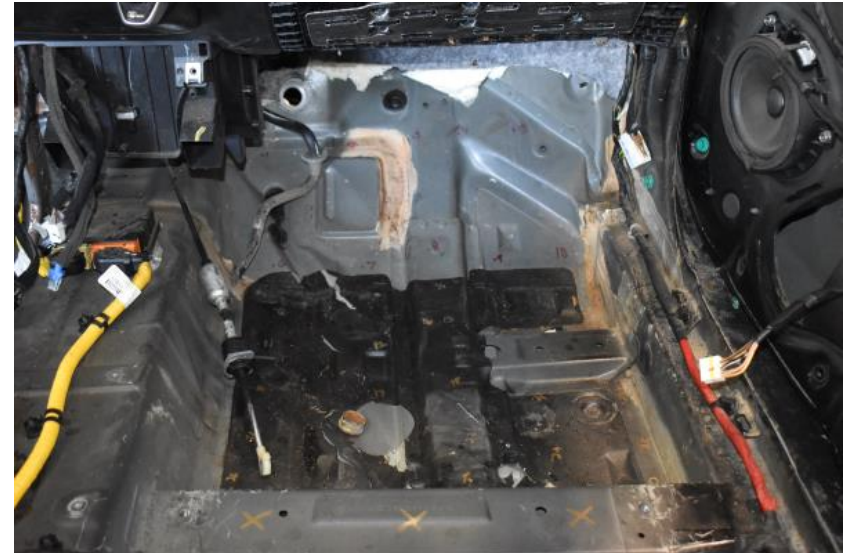
The windshield shattered and tore, with a maximum deformation of 4.2 in. However, this damage was caused by loading and deformations at the base of the A-pillar rather than direct contact between the bridge rail and windshield. Furthermore, a secondary impact with a row of containment barriers downstream of the test article contributed to additional damage and deformations to the windshield. Thus, the windshield damage was not in violation of MASH safety criteria. Note, similar 1100C windshield and front window damage has been observed in previous evaluations of MASH-crashworthy concrete barriers [13, 14].

Figure 62. Vehicle's Interior Compartment Damage, Test No. HNTBR-3

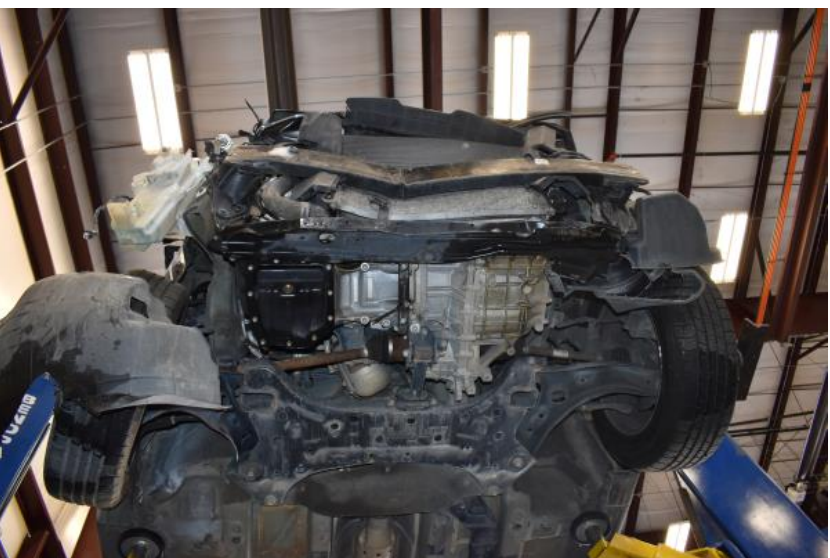
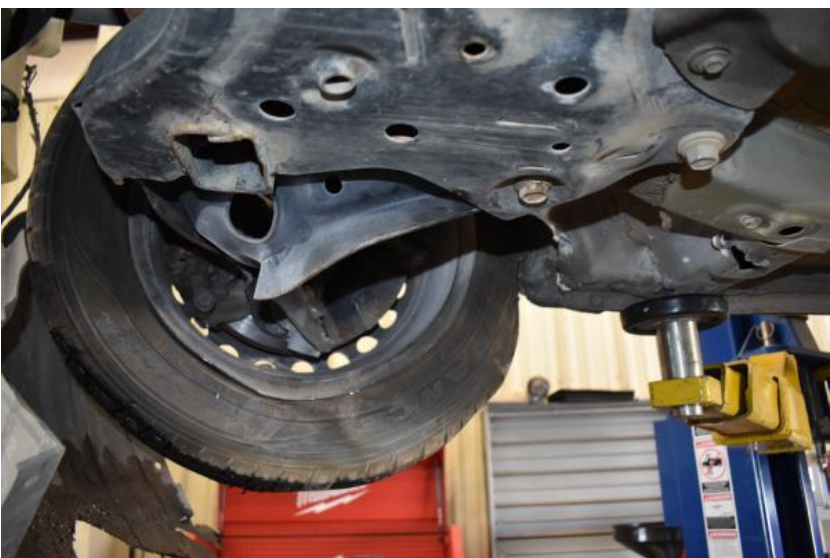
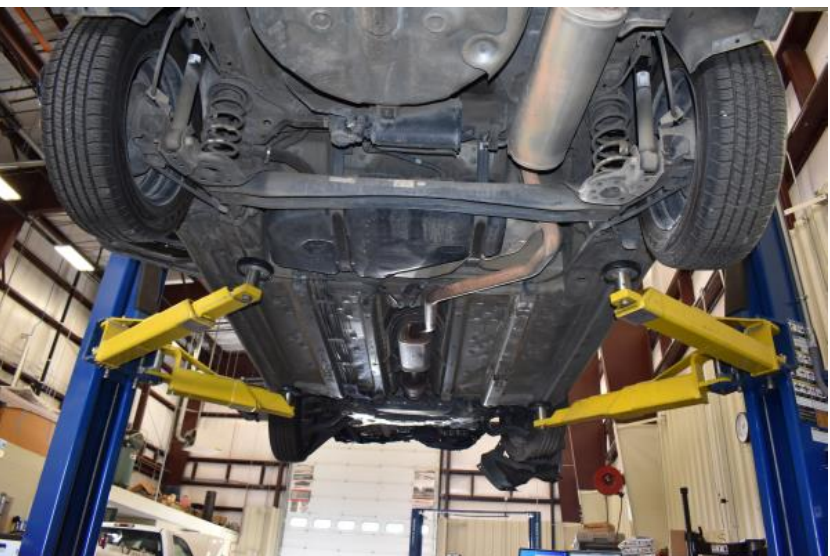
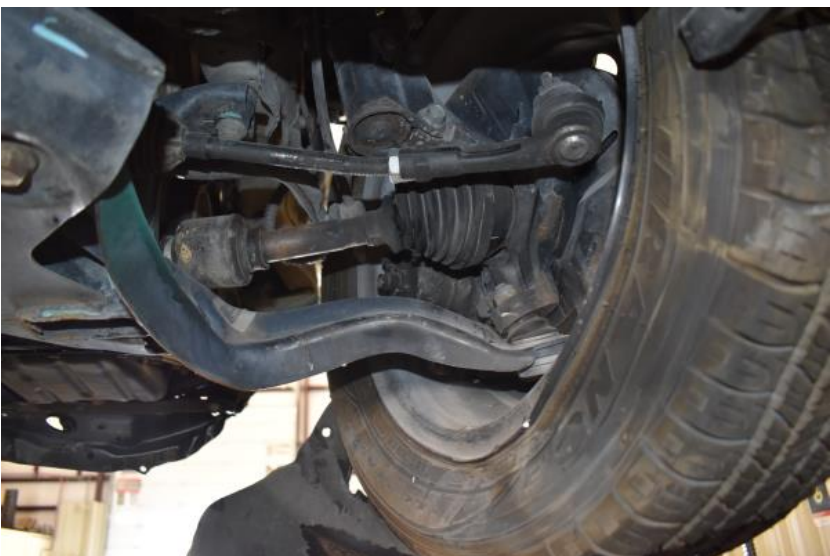
was cracked. The bumper bracket at the frame horn was crushed rearward, with the frame horn crushed rearward on both sides. There was also minor buckling of the right-side floor pan.

Figure 63. Vehicle's Undercarriage Damage, Test No. HNTBR-3
