# Midwest Pooled Fund Program

# EVALUATION OF FLARED APPROACH GUARDRAIL TRANSITIONS: TEST NO. FLAGT-2

MwRSF Research Report No. TRP-03-439c-25

December 12, 2025

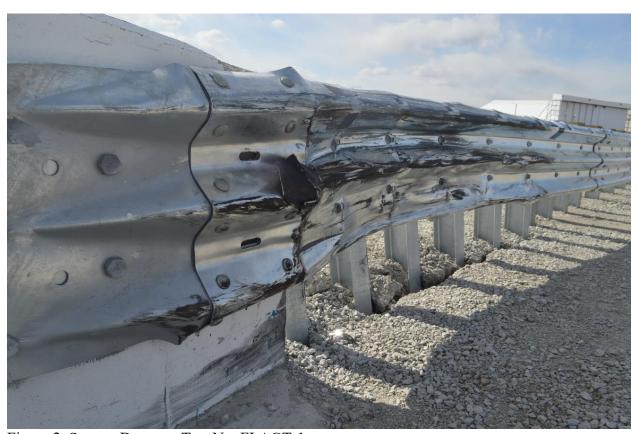
Figure 2. System Damage, Test No. FLAGT-1

The previous crash test on a flared AGT, test no. FLAGT-1, failed to satisfy MASH safety performance criteria for two reasons: (1) the longitudinal ORA of –24.23 g's exceeded the MASH limit of ±20.49 g's, and (2) the 12.0-in. intrusion into the toe pan area of the occupant compartment exceeded the MASH limit of 9 in. After examining all available data for this test, it became evident that both the excessive decelerations and excessive occupant compartment crush were the result of the vehicle snagging on the upstream end of the buttress and the large kink in the guardrail that formed adjacent to the buttress. The large kink in the nested thrie beam was a damage characteristic not observed in previous MASH testing of AGTs. Additionally, a large soil crack formed along the front flange of the AGT posts, as shown in Figure 2, which was not typical of previous AGT crash testing.

These unusual damage characteristics were the result of excessive guardrail deflections within the downstream region of the AGT. System deflections were expected to be higher than previous MASH AGTs due to the 30 percent increase in impact severity associated with the 15:1 flare. However, the lateral deflections of the flared AGT in test no. FLAGT-1 were significantly higher than predicted by the Phase I numerical simulations. To prevent vehicle snag, the system deflections needed to be reduced.

It was noted that the AGT posts did not plastically bend during the impact. Instead, the soil behind the posts shifted, opening the large soil crack along the front of the posts and allowing the

posts to rotate back. Installing larger and deeper embedded posts would result in more soil resistance, increased lateral stiffness to the AGT, and reduced deflections during impact. Therefore, the 6.5-ft long W6x9 posts in the nested thrie beam region of the AGT were replaced with 7.5-ft long W6x15 posts, as shown in Figure 3. Note, all other barrier components were identical to the system configuration evaluated in test no. FLAGT-1, including the 15:1 flare rate.

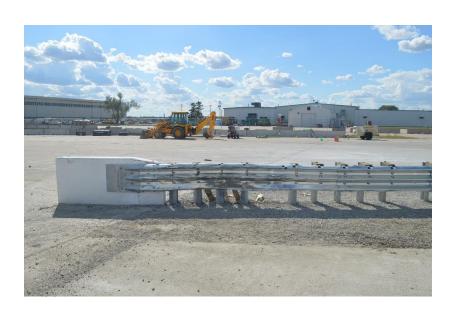
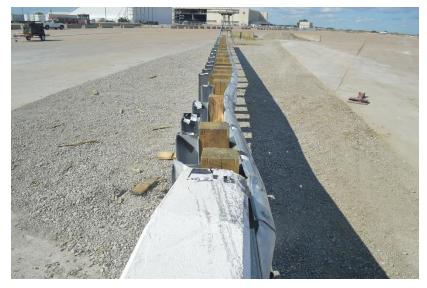
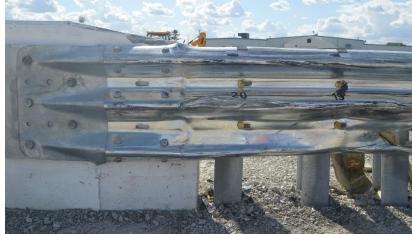
Figure 46. Concrete and Thrie-Beam Damage, Test No. FLAGT-2

Damage to the barrier was moderate, as shown in Figures 45 through 49. Barrier damage consisted of contacts marks, deformation to the thrie-beam rail, post rotations, and blockout fracture. The length of vehicle contact along the barrier was 12 ft - 4 in., beginning 4 in. downstream from post no. 16 and extending downstream. Contact marks were observed on the top surface of the concrete buttress beginning at the upstream end and continuing downstream for 47 in., as shown in Figure 46. No contact marks were observed on the lower chamfer of the buttress below the guardrail.

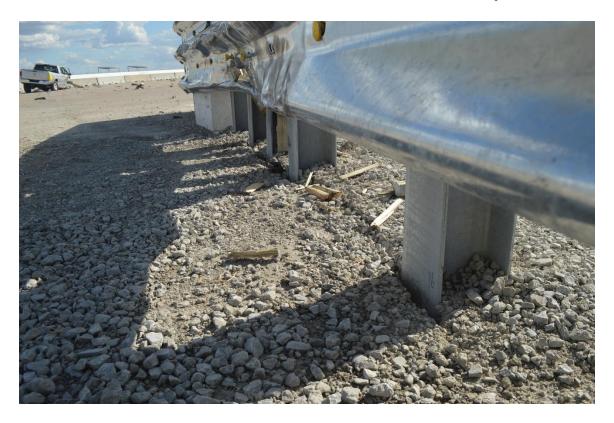
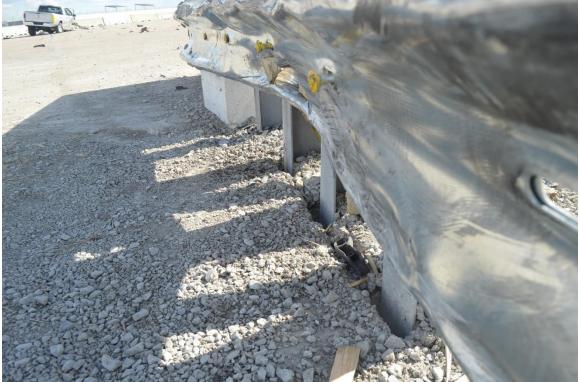
Figure 49. Soil Disturbance, Test No. FLAGT-2

Post nos. 15 through 20 were displaced backward and a small crack in the soil formed along the front flanges of these posts. A soil heave formed behind the posts. Post nos. 18 and 19 were also twisted and deflected downstream. The wooden blockouts at post nos. 17 and 18 were fractured and the attachment bolts at these posts were bent. Contact marks were found on the upstream front flanges of post nos. 17 and 19 and the upstream face of the blockout at post no. 19 above the guardrail.

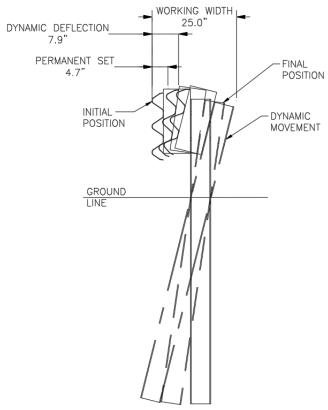
Figure 50. Permanent Set, Dynamic Deflection, and Working Width, Test No. FLAGT-2

The maximum lateral permanent set of the barrier system was 4.7 in., which occurred at the rail at post no. 17, as measured in the field. The maximum lateral dynamic barrier deflection was 7.9 in. located at the rail at post no. 17, as determined from high-speed video analysis. The working width of the system was found to be 25.0 in., also determined from high-speed video analysis. A schematic of the permanent set deflection, dynamic deflection, and working width is shown in Figure 50.

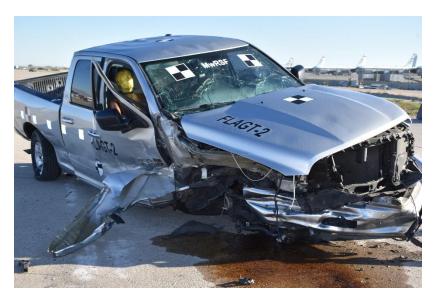
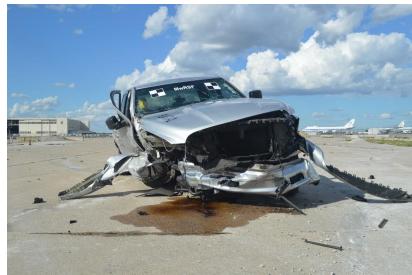
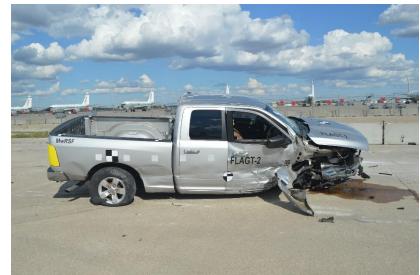
Figure 51. Vehicle Damage, Test No. FLAGT-2

The damage to the vehicle was severe, as shown in Figures 51 through 53. The maximum occupant compartment intrusions are listed in Table 5, along with the intrusion limits established in MASH for various areas of the occupant compartment. There were no penetrations into the occupant compartment, however, the toe pan/wheel well deformation of 9.9 in. violated the MASH limit of 9.0 in. Complete occupant compartment and vehicle deformations and the corresponding locations are provided in Appendix E. MASH defines intrusion or deformation as the occupant compartment being deformed and reduced in size with no observed penetration. Outward deformations, which are denoted as negative numbers in Appendix E, are not considered crush toward the occupant and are not evaluated by MASH criteria.

The majority of the damage was concentrated on the right-front corner and right side of the vehicle where the impact had occurred. The bumper cover was disengaged on the right end and the radiator was crushed inward on the right side. The right fender was barely attached to the vehicle after impact, and the frame was completely crushed inward approximately 1 ft at the front

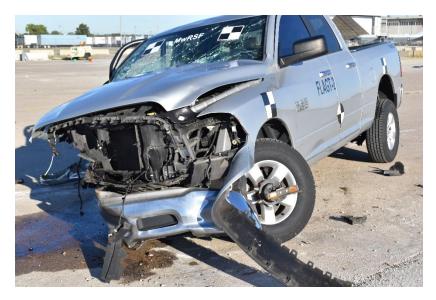
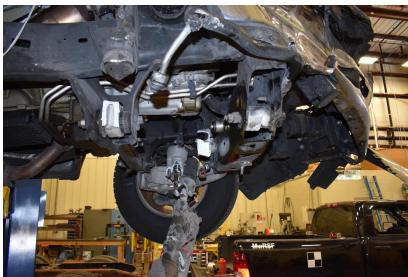
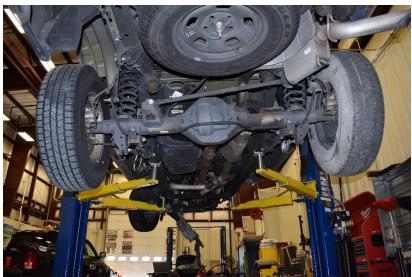
Figure 53. Vehicle Interior and Undercarriage Damage, Test No. FLAGT-2

The undercarriage was damaged as well. The right-front shock and spring were disengaged, and the rear shock was dented slightly. The sway bar was shifted to the right side, and there was a scrape on the outside of the right sway bar. The right passenger control arm was fractured and disengaged from the vehicle. The right passenger steering knuckle was disengaged at the ball joint, while the left side steering knuckle was scraped. The right tie rod was disengaged from the vehicle. The gear box was detached from the frame and steering shaft, and the gear box was cracked in several places. The rear axle was bent, and there was a puncture in the oil pan. There were several bends and kinks in the right side of the frame, and the entire frame appeared twisted. There was scraping on the bottom of every cross member on the right side, and the middle cross member appeared to be buckled in the middle. The right-front cab mount was crushed and disengaged. The toe pan was visibly damaged, and there was a small gouge on the right side of the gas tank from contact with the drive shaft.
