DEVELOPMENT AND EVALUATION OF THE MIDWEST GUARDRAIL SYSTEM (MGS) PLACED ADJACENT TO A 2:1 FILL SLOPE

MwRSF Research Report No. TRP-03-185-10

February 24, 2010

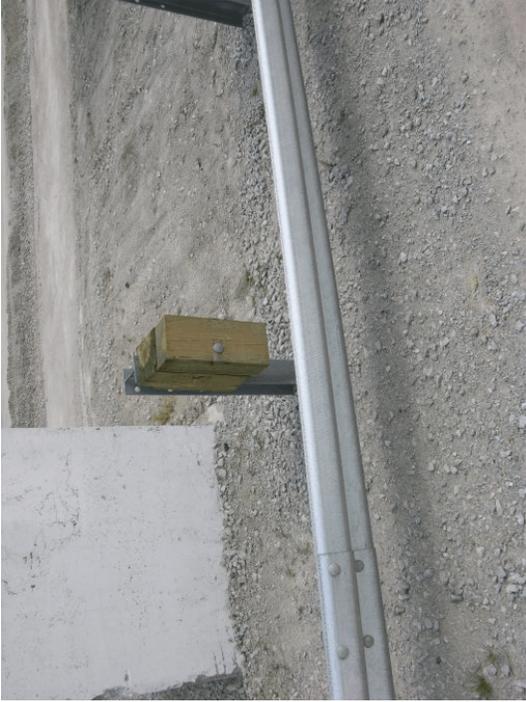
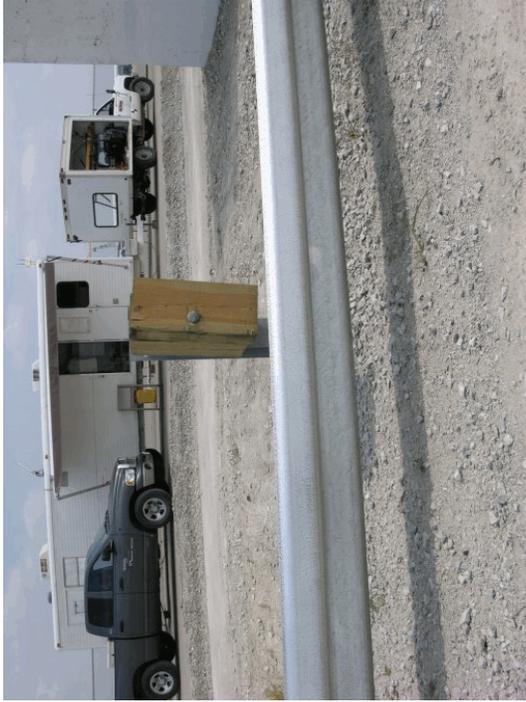
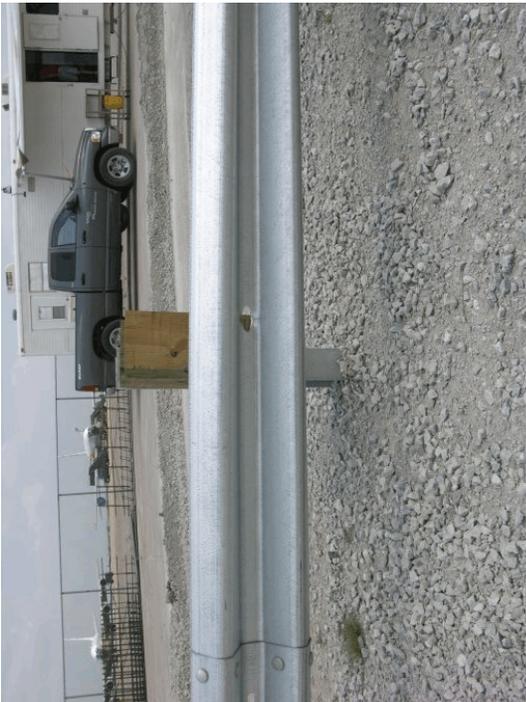
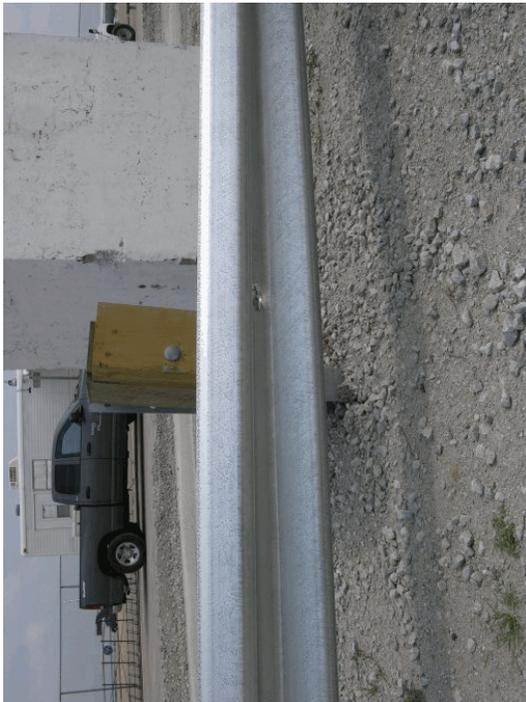
Figure 33. System Damage, Test No. MGS221-1

Damage to the barrier was moderate, as shown in Figures 33 through 41. Barrier damage consisted of deformed guardrail posts, disengaged wooden blockouts, contact marks on a guardrail section and posts, and deformed and fractured W-beam rail. The length of the vehicle contact along the MGS system was approximately 8.8 m (29 ft - 1½ in.), which spanned from 305 mm (12 in.) upstream from the centerline of post no. 13 through the midspan between post nos. 17 and 18.

Moderate deformation and flattening of the impacted section of W-beam rail occurred between post nos. 13 through 17. Contact marks were found on the guardrail between post nos. 12 and 18 and on the backside of the W-beam between post nos. 23 and 26. A 686-mm (27-in.) long diagonal tear in the rail occurred 127 mm (5 in.) downstream of post no. 5. A 25-mm (1-in.) long

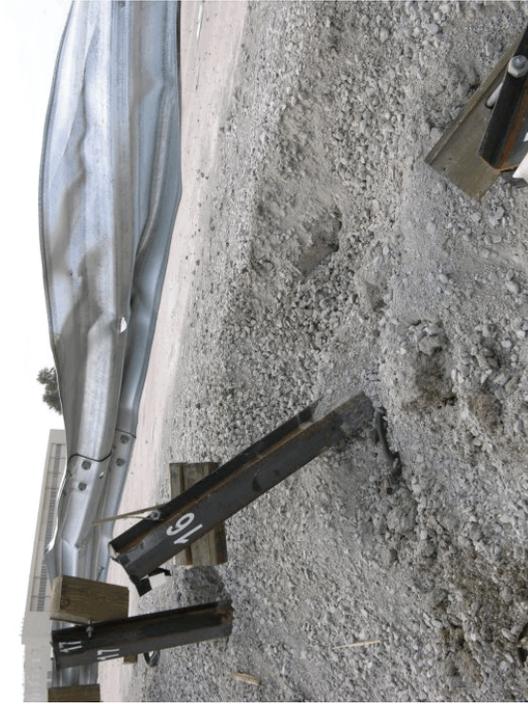
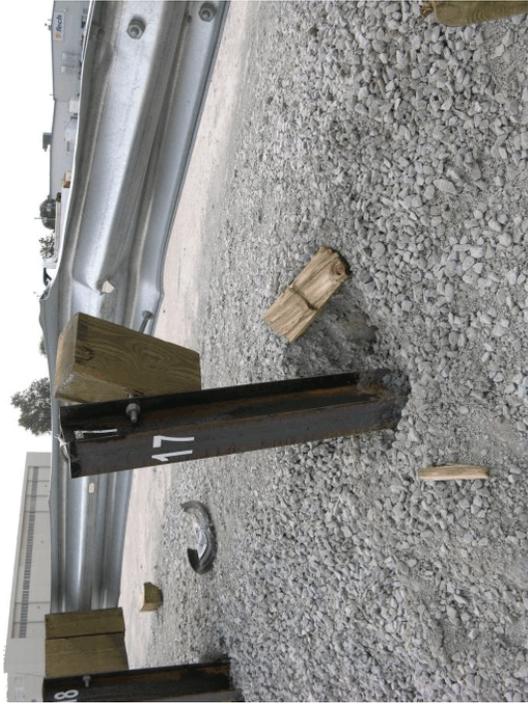
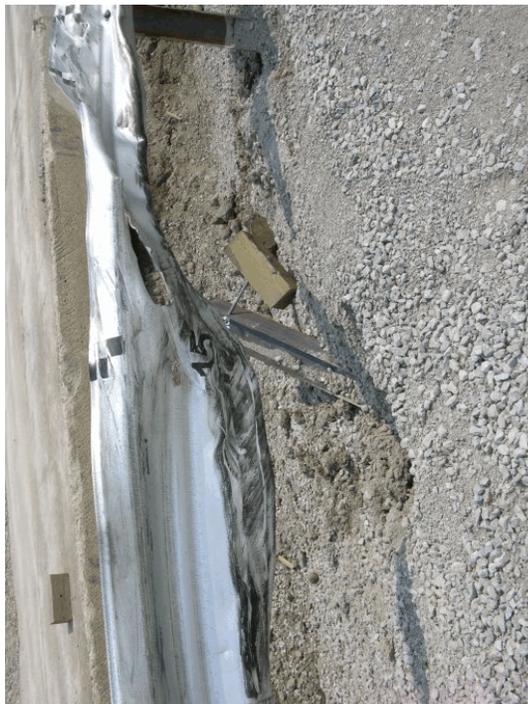
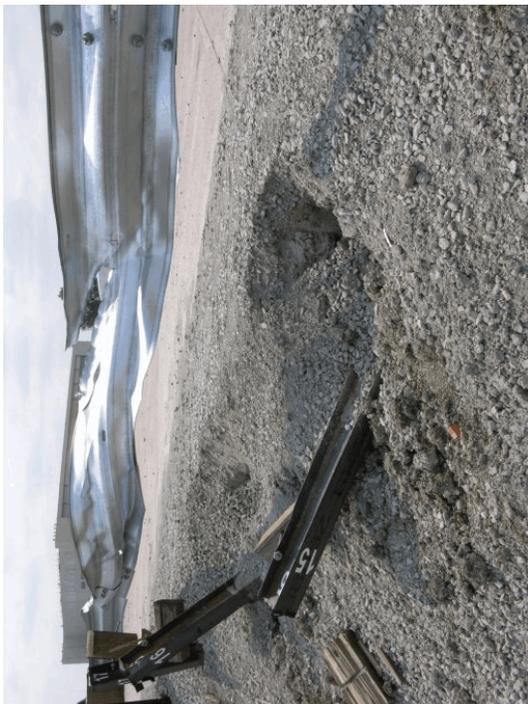
Figure 36. Post Nos. 11 through 14 Damage, Test No. MGS221-1

Steel post nos. 3 through 12 encountered minor twisting. Steel post nos. 13 through 17 twisted and rotated backward with major soil failure visible at the ground level. Steel post nos. 18 through 20 were undamaged. Steel post nos. 21 and 22 bent slightly, while post no. 23 bent downstream and rotated clockwise. The rear flange of post no. 23 was bent toward the web due to vehicle contact. Steel post nos. 24 through 26 bent downstream and backward and twisted counter-clockwise. The front and back flanges were bent backward at the top of steel post nos. 24 and 25. The upstream and downstream anchorage systems moved longitudinally. For the upstream anchorage, soil gaps of 102 mm (4 in.) and 38 mm (1½ in.) were found on the upstream and downstream sides of post no. 1, respectively, and for post no. 2, soil gaps of 64 mm (2½ in.) and 51 mm (2 in.) were found on the upstream and downstream sides, respectively. For the downstream anchorage, soil gaps of 13 mm (½ in.) and 51 mm (2 in.) were found on the downstream side of post nos. 28 and 29, respectively, while no soil gaps were found on the upstream sides of these posts. In addition, post no. 28 and 29 were uplifted out of the ground 102 mm (4 in.) and 229 mm (9 in.), respectively. However, the wooden posts in both anchorage systems were not damaged.

The wooden blockout at post no. 14 encountered damage on the front face, but it remained attached. The wooden blockouts at post nos. 15 through 17 were fractured and mostly removed from the post. All other wooden blockouts remained undamaged.

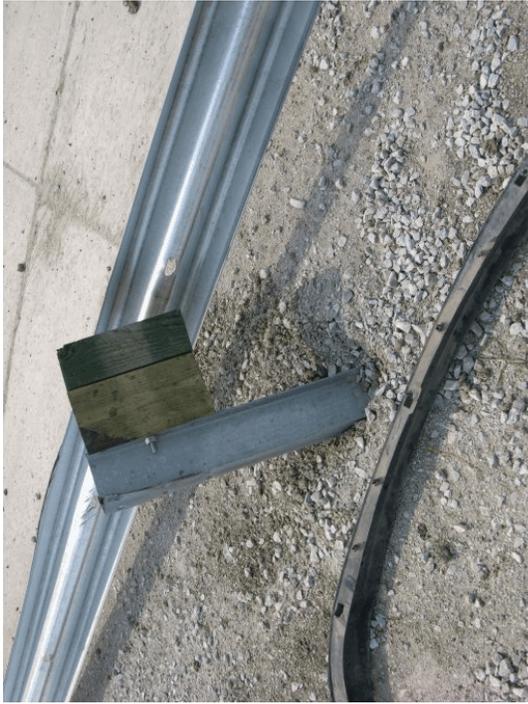
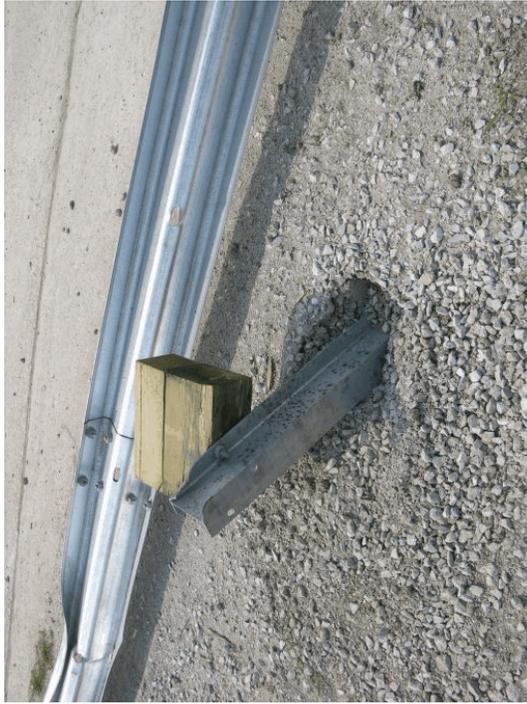
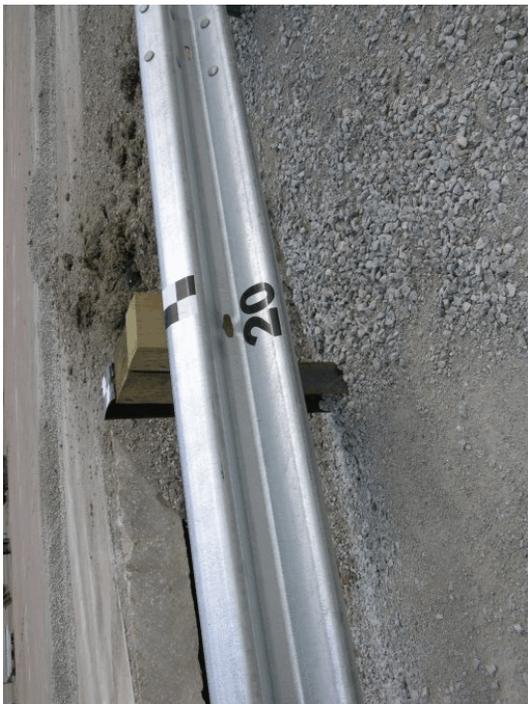
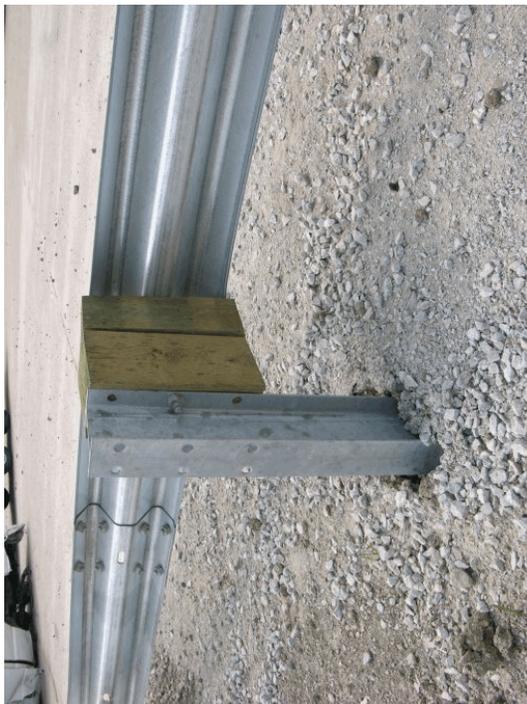
Figure 37. Post Nos. 15 through 17 Damage, Test No. MGS221-1

The vehicle override was attributed to the slow release of post no. 15 from the guardrail, thus causing the W-beam to be pulled downward. In addition, the vehicle override was also attributed to the failure of the vehicle's front suspension shortly after impact, thus preventing the guardrail from capturing the pickup truck's left-front tire.

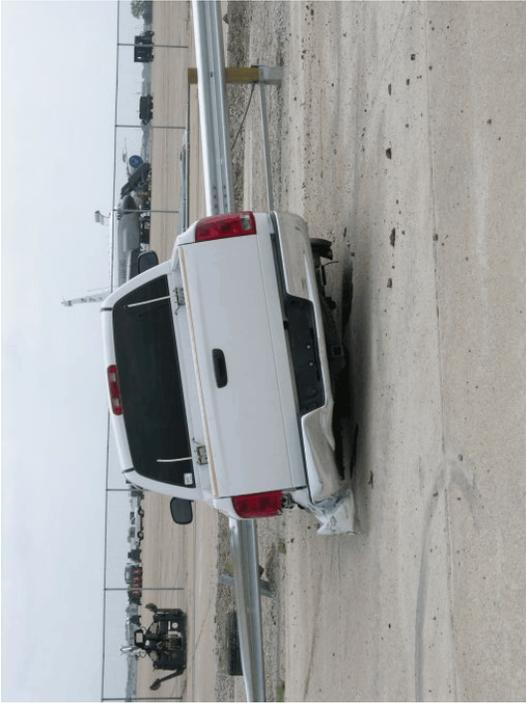
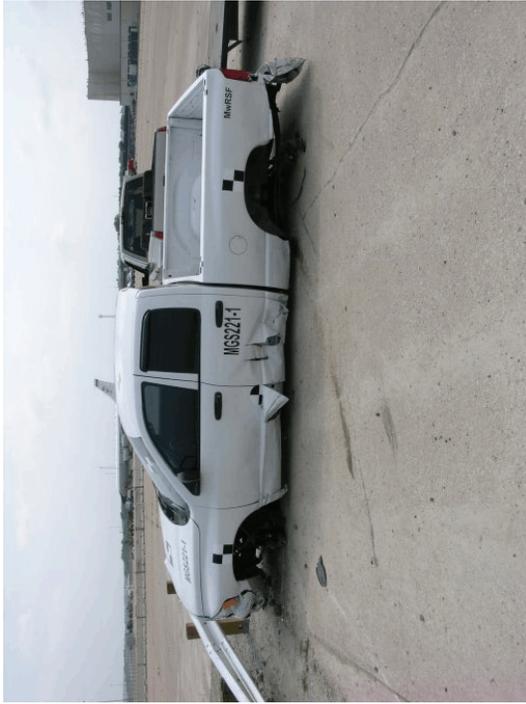
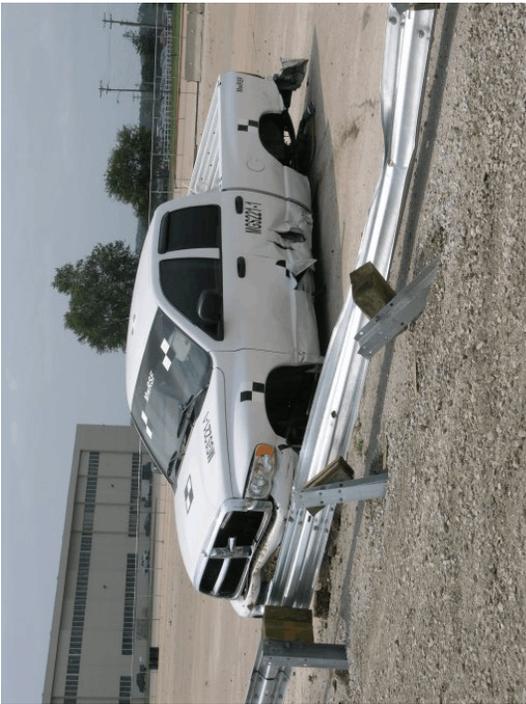
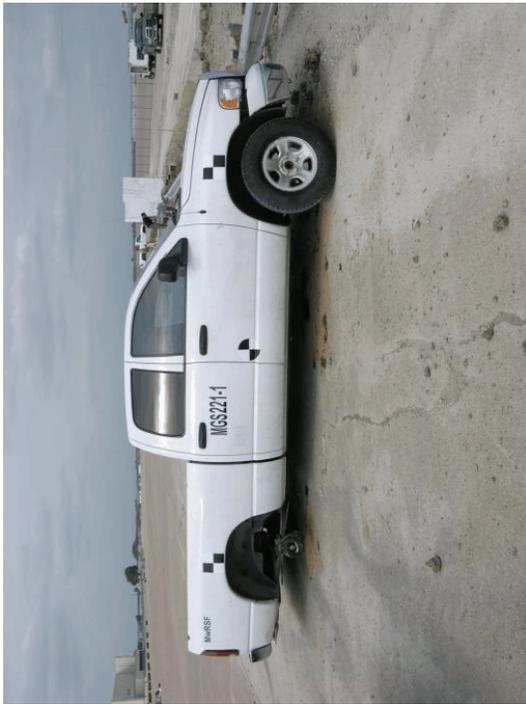
Figure 42. Vehicle Damage, Test No. MGS221-1

Exterior vehicle damage was moderate, as shown in Figures 42 through 44. Occupant compartment deformations to the left side and center of the floor pan were judged insufficient to cause serious injury to the vehicle occupants, as shown in Figure 45. Maximum longitudinal deflections of 6 mm (¹/₄ in.) were located throughout the left-side floor pan. Maximum lateral deflections of 13 mm (¹/₂ in.) were located at the rear-center of the left-side floor pan. Maximum vertical deflections of 13 mm (¹/₂ in.) were located on the floor pan near the left-side door. Complete occupant compartment deformations and the corresponding locations are provided in Appendix E.

Damage was concentrated on the left-front corner of the vehicle. The left-front corner was deformed inward toward the engine compartment. The left side of the grill was fractured and removed. The center of the front bumper buckled. The left-front, left-rear, and right-rear tires disengaged from the vehicle. Sheet metal tearing and major deformations were found along the lower portion of the left-side doors and the left-rear fender. The left side of the rear bumper was deformed upward. The left-side taillight was fractured, while the right-side taillight was slightly dislodged. The left-front, right-front, and right-rear brake lines were severed. The left-rear and right-rear shocks were fractured. The left-front upper control arm and left-front tie rod were fractured. The drive shaft was fractured and separated at the transmission yoke. The left-front sway bar linkage was

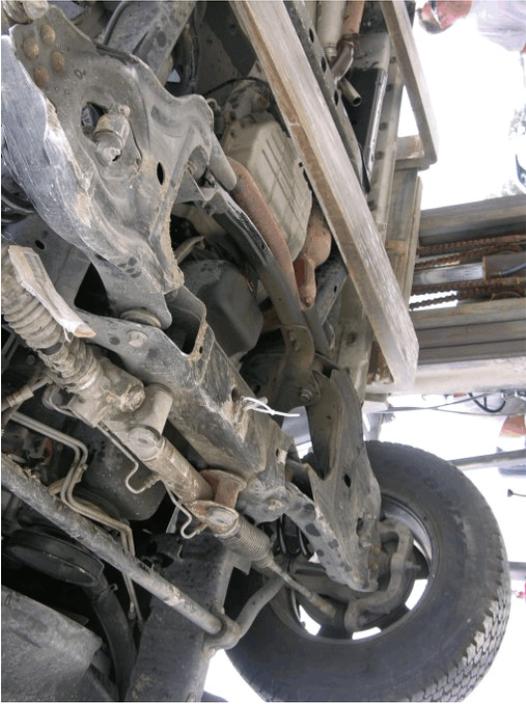
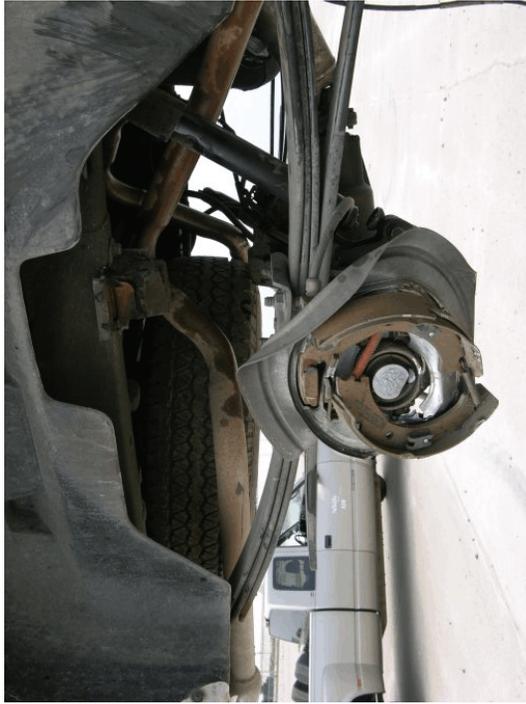
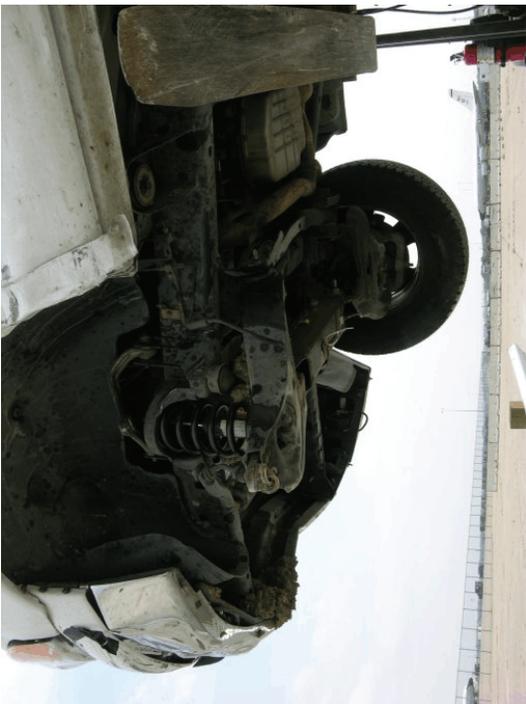
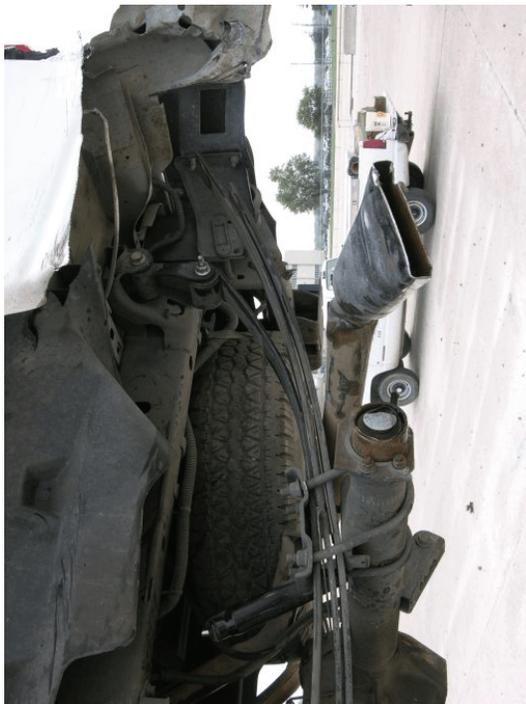
Figure 44. Undercarriage Damage, Test No. MGS221-1

bent. Both ends of the rear axle fractured before the brake housing. The gas tank heat shield was deformed and bent. The roof, hood, and right side of the vehicle and all window glass remained undamaged.

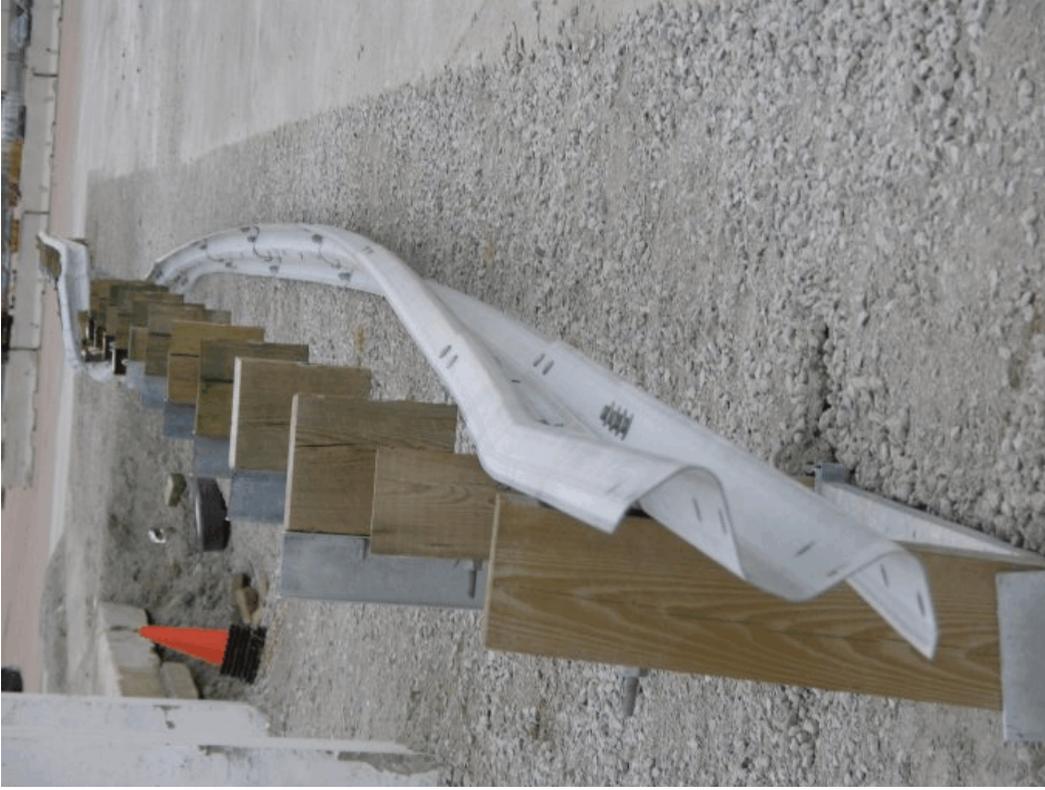
Figure 58. System Damage, Test No. MGS221-2

Damage to the barrier was moderate, as shown in Figures 58 through 64. Barrier damage consisted of deformed W-beam and guardrail posts, disengaged wooden blockouts, and contact marks on a guardrail section and posts. The length of the vehicle contact along the MGS system was approximately 12.42 m (40 ft - 9 in.), which spanned from 394 mm (15½ in.) upstream of the centerline of post no. 13 through 597 mm (23½ in.) downstream from the centerline of post no. 19.

Moderate deformation and flattening of the impacted section of W-beam rail occurred between post nos. 14 through 17. Contact marks were found on the guardrail between post nos. 12 and 20. Buckling in the rail occurred around the upstream cable anchor bracket. The guardrail buckled at post nos. 12 through 18. Rail buckle points also occurred at the midspans between post nos. 13 and 14, 14 and 15, and 15 and 16, at 229 mm (9 in.) and 508 mm (20 in.) downstream from post no. 15, at 330 mm (13 in.) downstream from post no. 16, and at 508 mm (20 in.) upstream from post no. 19. The W-beam rail sustained yielding around the post bolt slots at post nos. 2 through 19. The W-beam was pulled off post nos. 2 through 18.

The permanent set of the barrier system is shown in Figure 58. The maximum lateral permanent set rail and post deflections were 1,067 mm (42 in.) at the midspan between post nos. 15 and 16 and 864 mm (34 in.) at post no. 14, respectively, as measured in the field. The maximum lateral dynamic rail and post deflections were 1,463 mm (57.6 in.) at the centerline of post no. 15 and 805 mm (31.7 in.) at post no. 14, respectively, as determined from high-speed digital video analysis. The working width of the system was found to be 1,631 mm (64.2 in.).

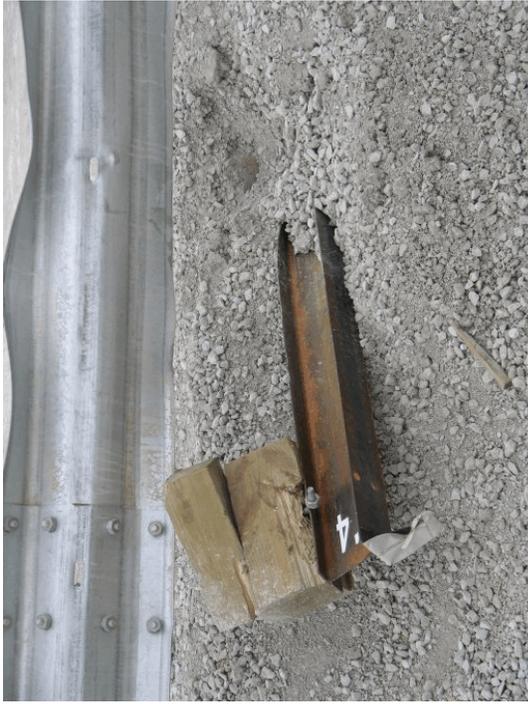
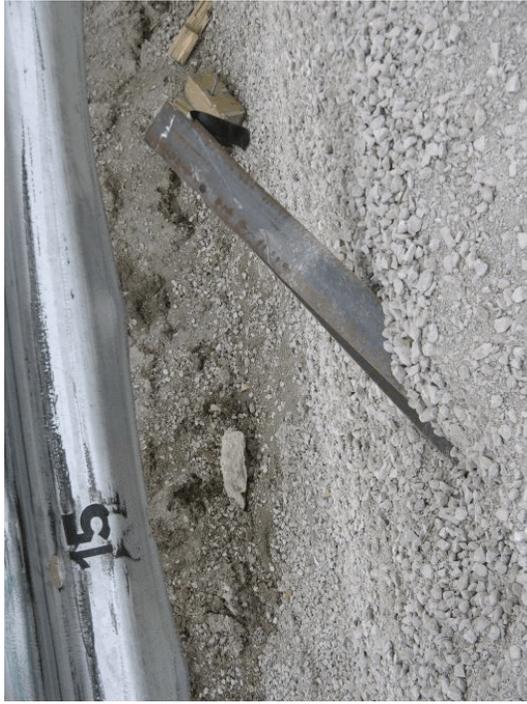
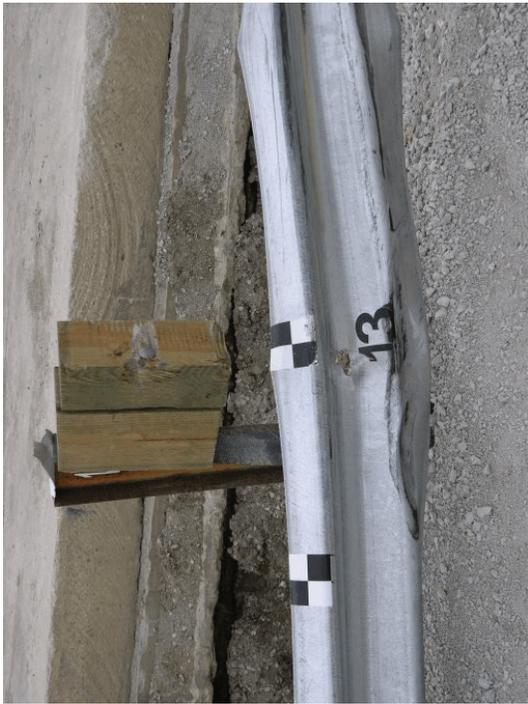
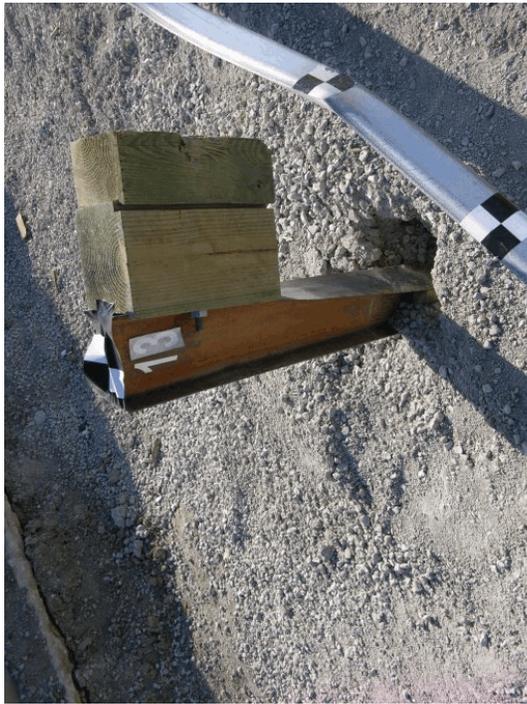
Figure 61. Post Nos. 13 through 15 Damage, Test No. MGS221-2

Steel post nos. 12 through 14 twisted and rotated backward. Post no. 14 also bent downstream to the ground. Post nos. 15 through 18 are bent and twisted downstream in the soil. Post no. 15 also encountered minor scraping and denting on the traffic face of the post. Post no. 16 encountered tearing in the flange at the bolt hole. The upstream and downstream anchorage systems moved slightly longitudinally. For the upstream anchorage, soil gaps of 121 mm (4¾ in.) and 89 mm (3½ in.) were found on the upstream sides of post nos. 1 and 2, respectively. For the downstream anchorage, a soil gap of 25 mm (1 in.) was found on the downstream side of post no. 29. However, the wooden posts in both anchorage systems were not damaged.

The wooden blockouts at post nos. 12, 13, and 18 encountered minor crush on the upstream traffic-side face. The wooden blockouts at post nos. 15 through 17 were fractured and removed from the posts. All other wooden blockouts remained undamaged.
