# MID-AMERICA TRANSPORTATION CENTER

Report # MATC-UNL: 100

## **Safety Investigation and Guidance for Work-Zone Devices in Freight Transportation Systems Subjected to Passenger Car and Truck Impacts with New Crash Standards**

### **Midwest Roadside Safety Facility**

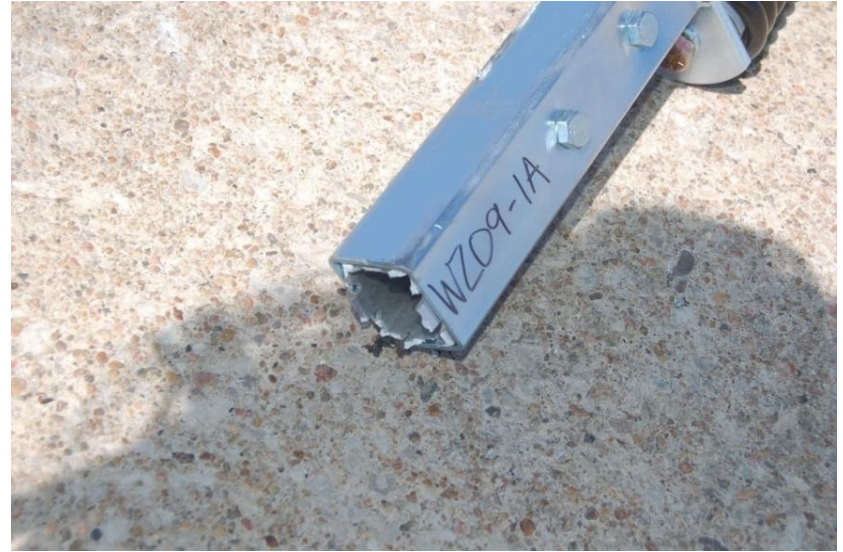
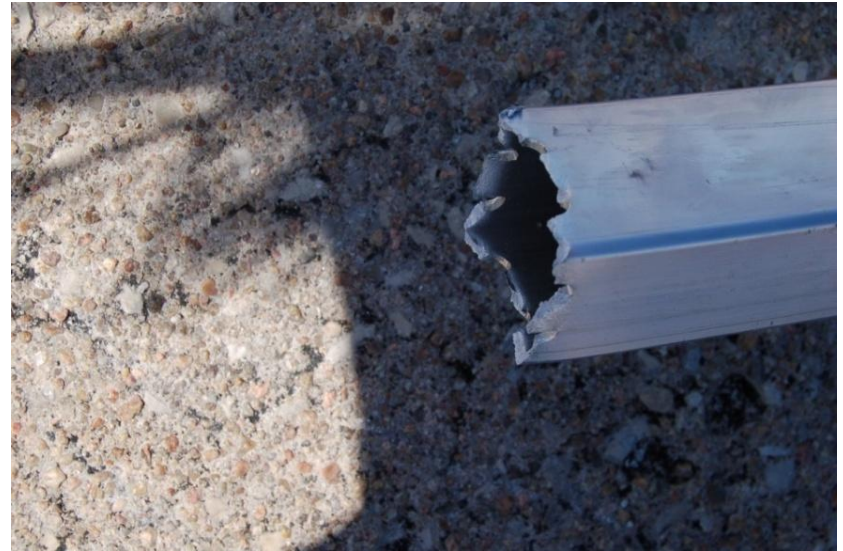
Figure 53. System Damage, Test No. WZ09-1A

Following test no. WZ09-1, a safety performance evaluation was conducted, and the performance of System No. 1A was determined to be unacceptable according to the MASH criteria. It was deemed unacceptable due to the flag holder penetrating the roof, the sign panel penetrating the windshield, windshield indentation greater than 3 in. (76 mm), and significant windshield cracking. Deformations of, and intrusion into, the occupant compartment did occur as System No. 1A penetrated into the occupant compartment on the right side of the windshield when the corner of the sign panel sliced through the windshield and also when the metal flag holder penetrated the roof into the occupant compartment.

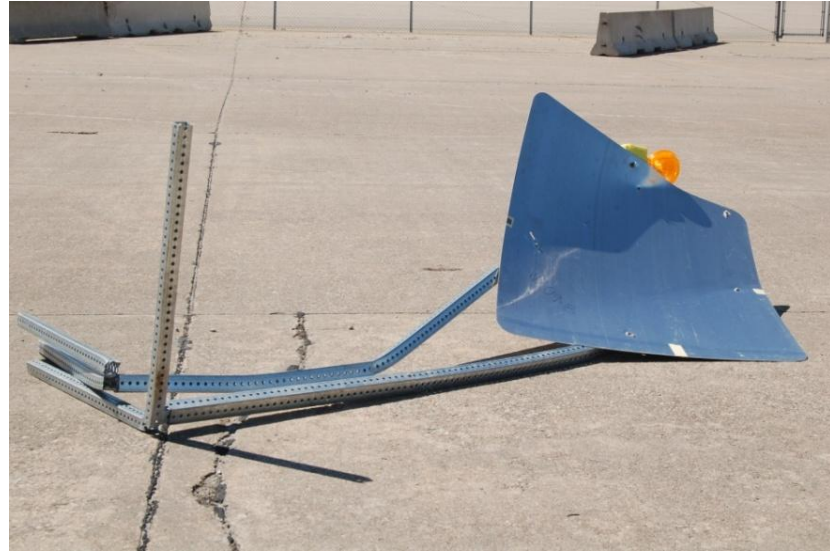
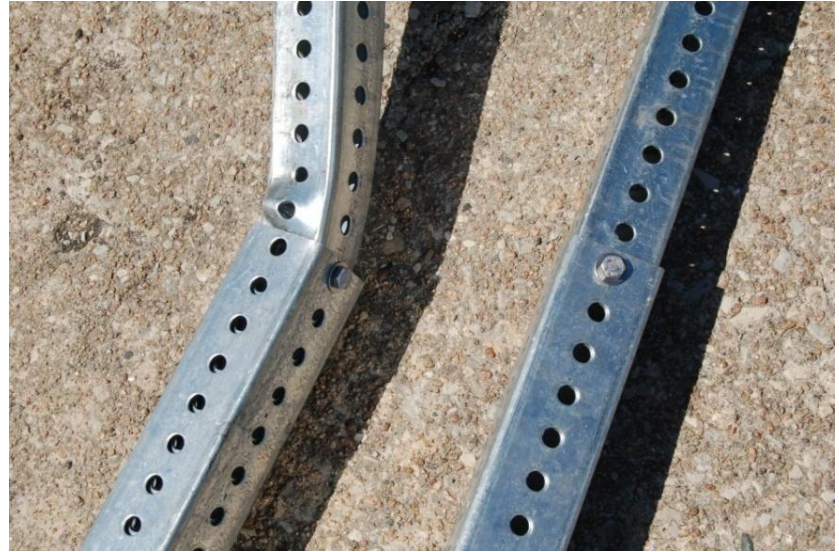
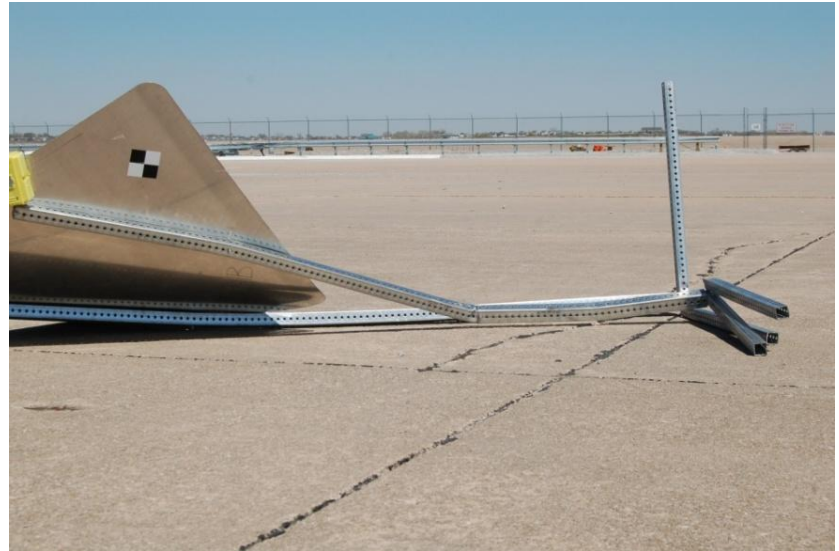
Figure 55. System Damage, Test No. WZ09-1B

System No. 1B was also determined to be unacceptable according to the MASH criteria due to the light and mast penetrating the windshield, windshield indentation greater than 3 in. (76 mm), and significant windshield cracking, which caused the obstruction of driver visibility and the loss of structure in both glass layers in the windshield. Deformations of, and intrusion into, the occupant compartment did occur as System No. 1B penetrated into the occupant compartment near the upper-center region and upper-left corner of the windshield when the light, mast, and sign panel contacted the windshield. The vehicle's trajectory did not intrude into adjacent traffic lanes.

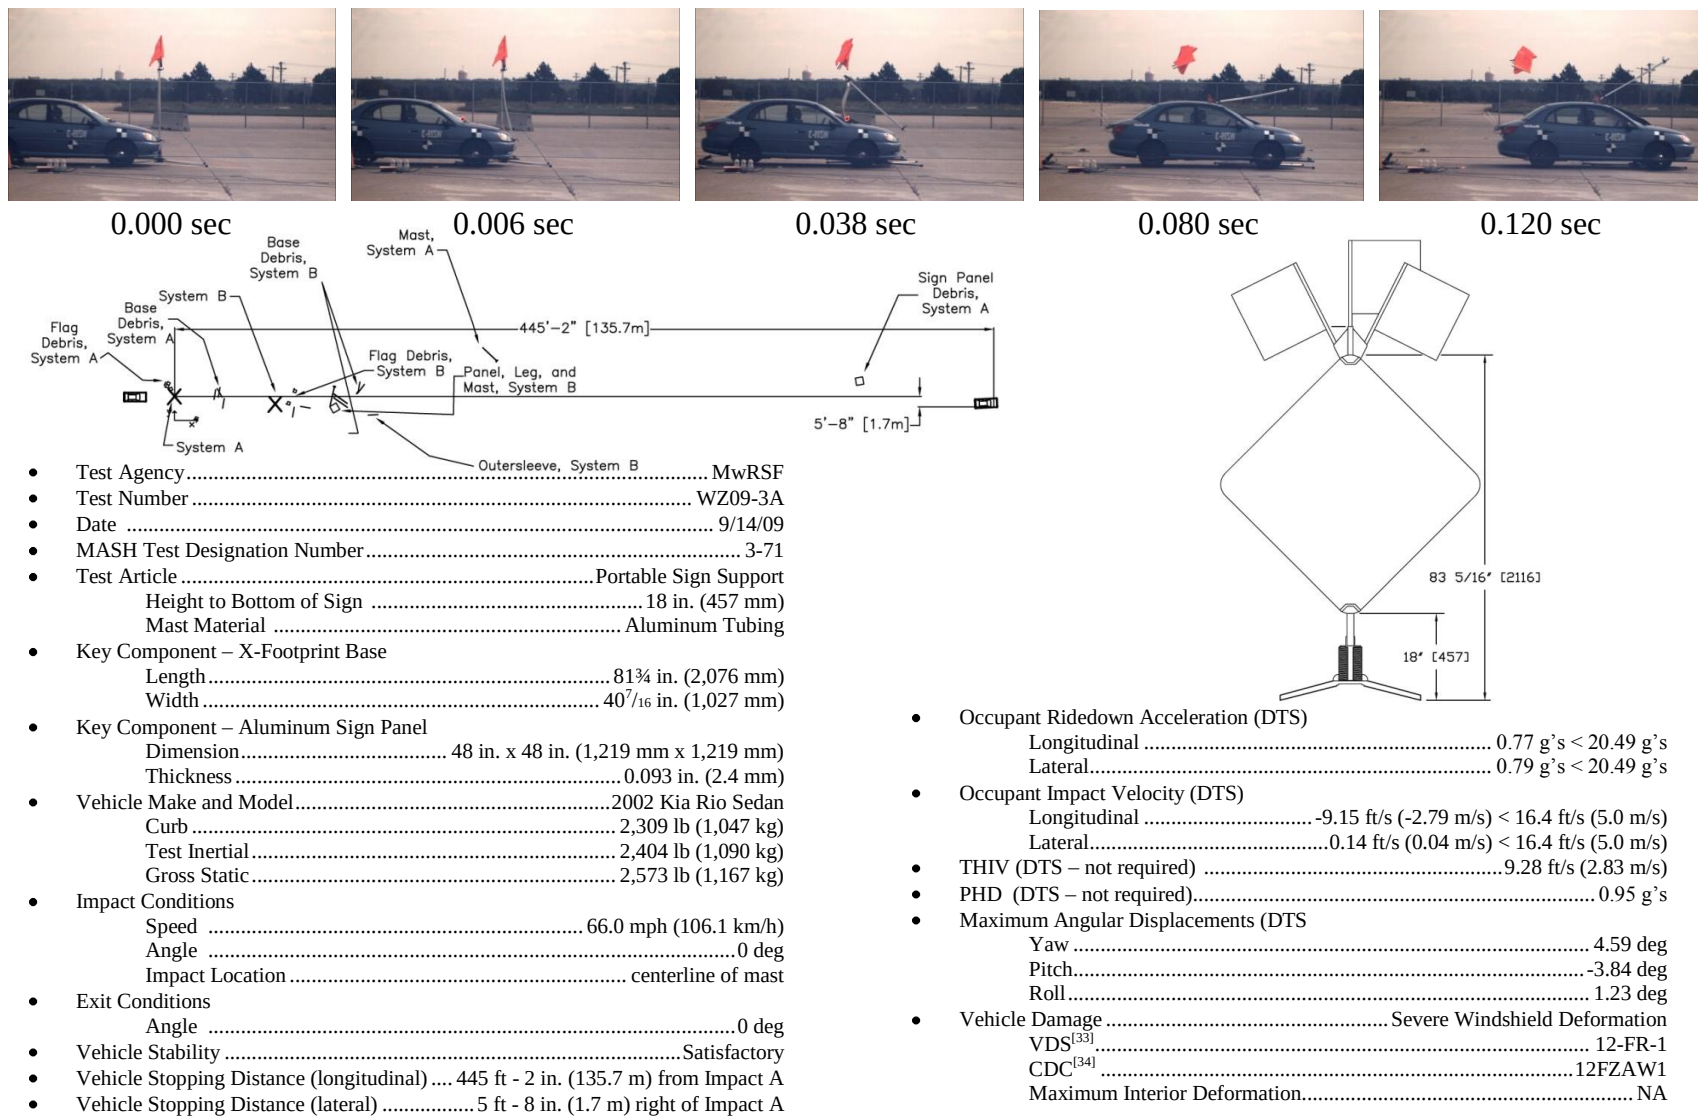
indentation greater than 3 in. (76 mm). Deformations of the occupant compartment did occur as the sign panel from System No. 3A contacted and indented the windshield a maximum of 4 in. (102 mm). The top of the mast contacted the back of the sign panel that was intact with the windshield and roof and left a small hole in the panel. In the event that the sign panel releases from the windshield, there is a potential for the mast to contact and penetrate the roof.

Figure 73. Summary of Test Results and Sequential Photographs, Test No. WZ09-3A

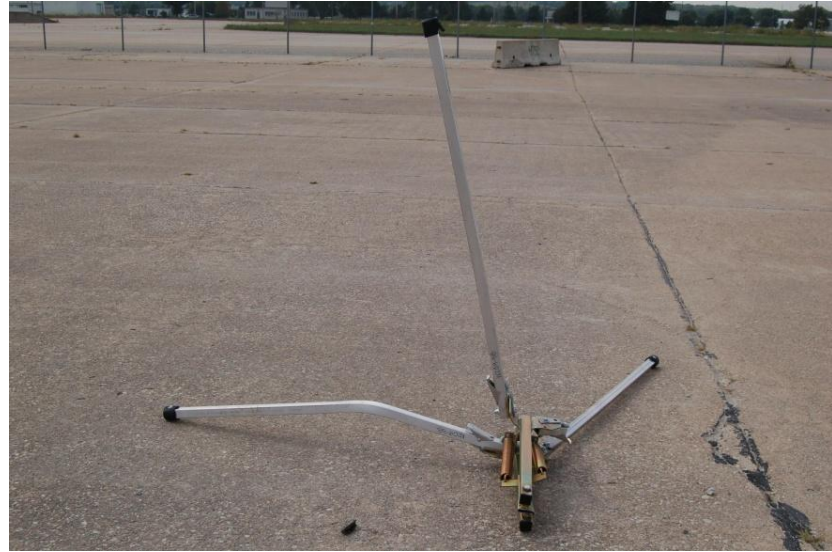
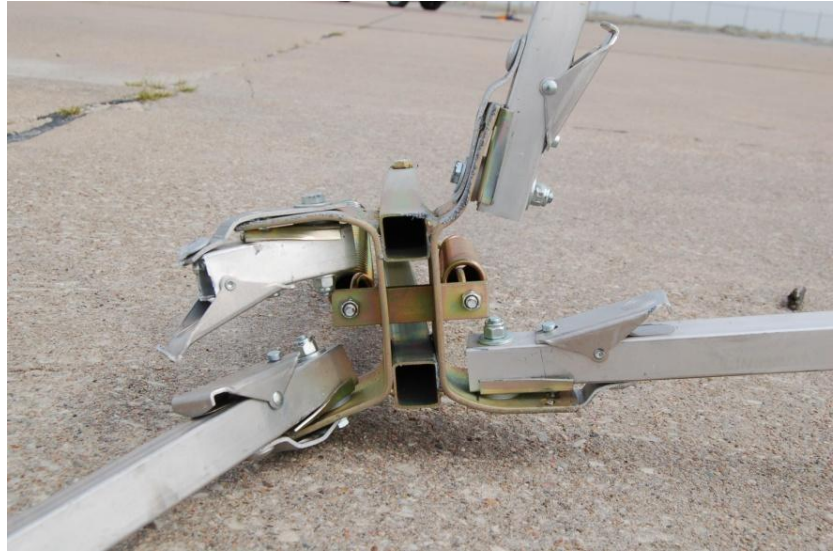
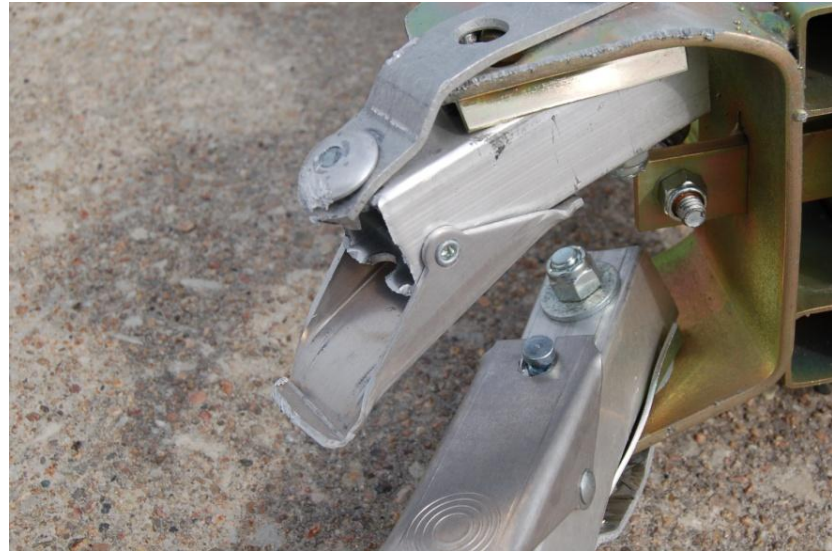
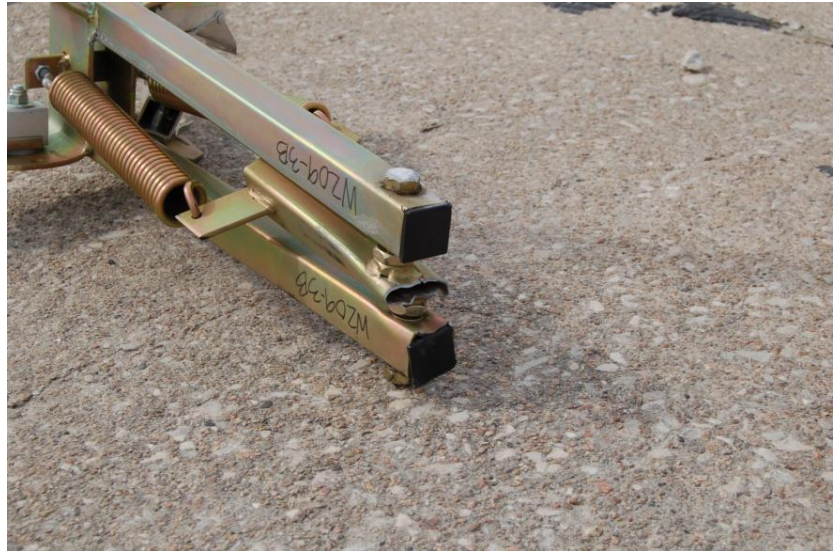
Figure 84. System Damage, Test No. WZ09-3B

System No. 3B was determined to be acceptable according to the MASH criteria since the maximum deformation on the left side of the windshield was only 2¼ in. (57 mm). Windshield cracking was insufficient to cause obstruction of visibility, and the horizontal fiberglass crossbrace did not appear to have the potential for windshield penetration. The vehicle's trajectory did not intrude into adjacent traffic lanes.

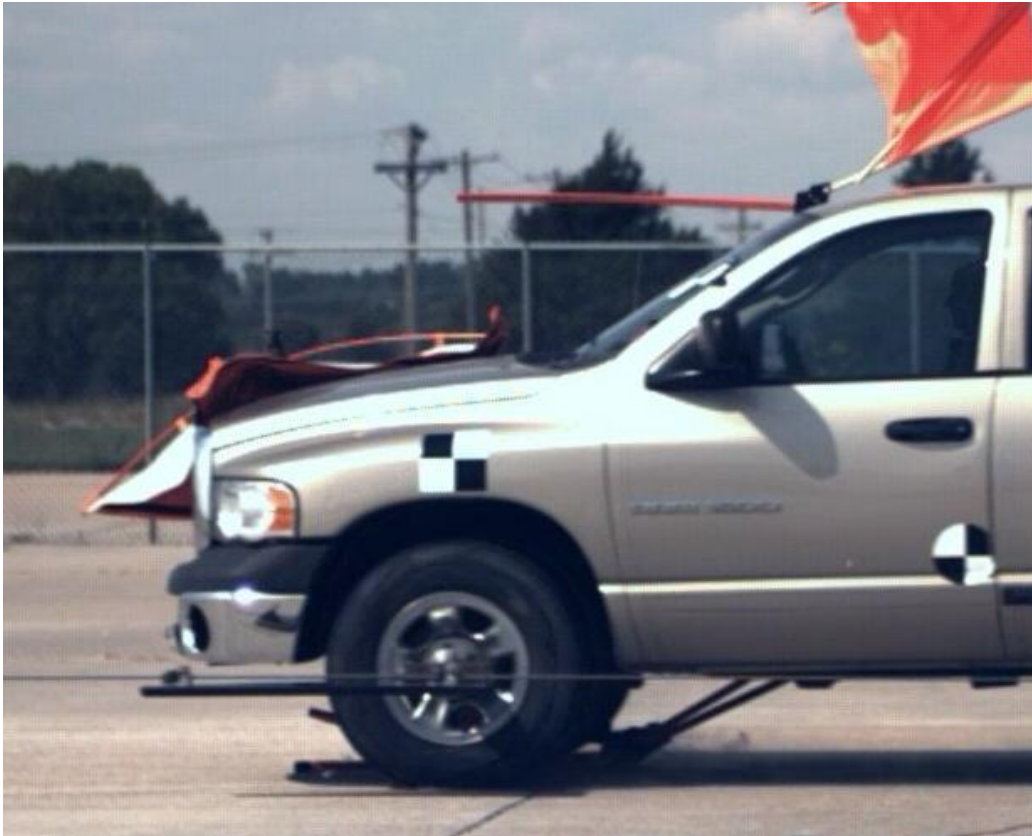
Stands with excessive stub lengths remaining after impact can potentially catch on the undercarriage of the vehicle and drag along under the vehicle with heavy contact (System No. 4A). When the legs are oriented head-on to the vehicle, the stand can rotate such that the legs contact and penetrate the vehicle's floorboard. Even though the ground clearance is much greater for the pickup truck when compared to the small car, the potential for penetration has been shown to be a problem with both vehicles. As shown in Figure 102, when the vertical springs at the base were pushed over, the two front legs of the system were forced upward into the undercarriage of the pickup truck resulting in one leg penetrating the left-side floorboard.

Figure 102. System No. 4A, X-Footprint Base Floorboard Penetration
