PERFORMANCE LEVEL 2 TESTS ON THE MISSOURI 30 IN. NEW JERSEY SAFETY SHAPE BRIDGE RAIL

RES1 (OO99) P450
TRANSPORTATION RESEARCH REPORT TRP-03-27-91

Midwest Roadside Safety Facility
Civil Engineering Department
W348 Nebraska Hall
University of Nebraska-Lincoln
Lincoln, Nebraska 68588-0531

November 1991

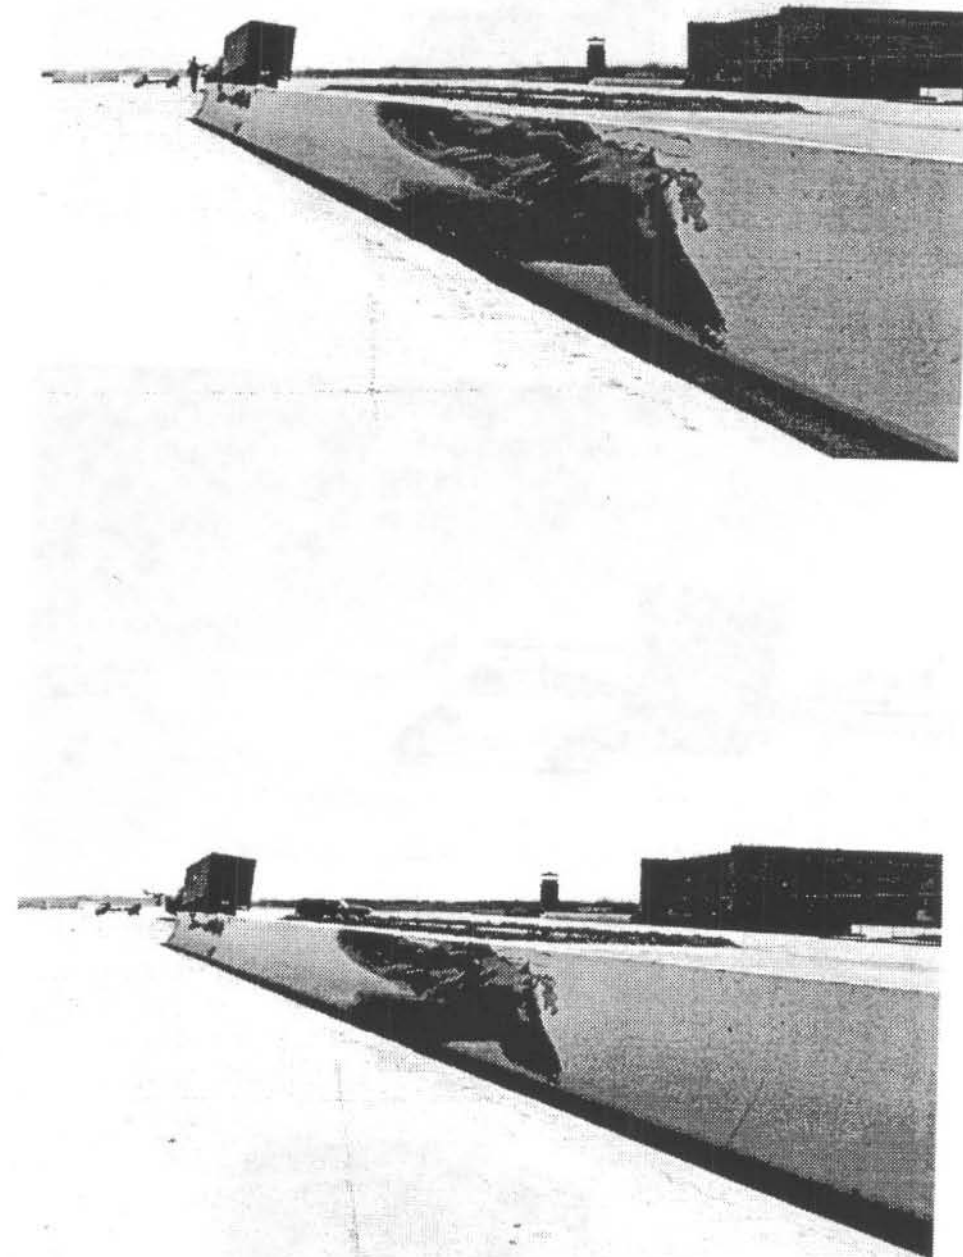
FIGURE 17. Bridge Rail Damage, MS30-1

Bridge rail damage is shown in Figure 17. Concrete spalling occurred at the point of impact due to the right front wheel crushing into the bridge rail. Spalling also occurred along the top of the rail due to the undercarriage of the vehicle sliding along the top of the rail. No visible lateral movement of the rail occurred as a result of the collision. Tire marks were visible on the face of the rail for a length of about 17 ft after impact.

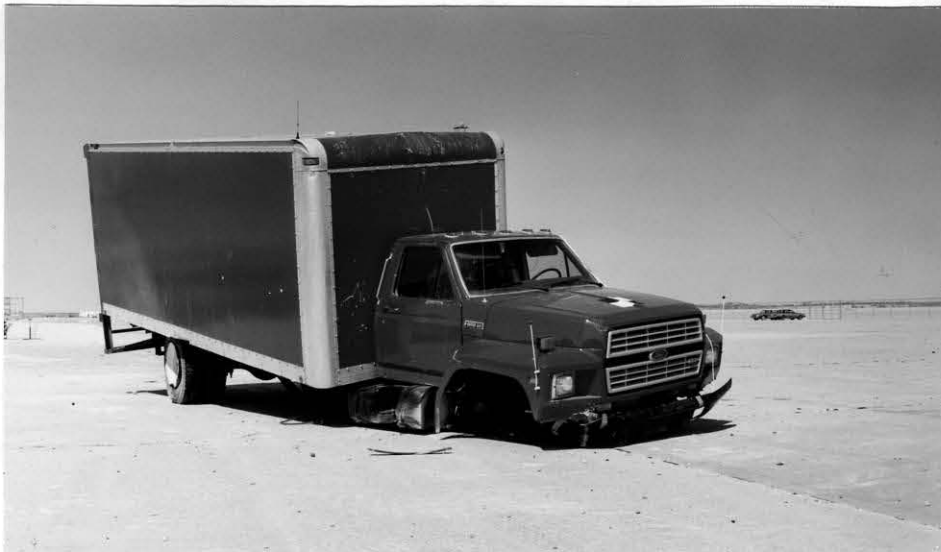
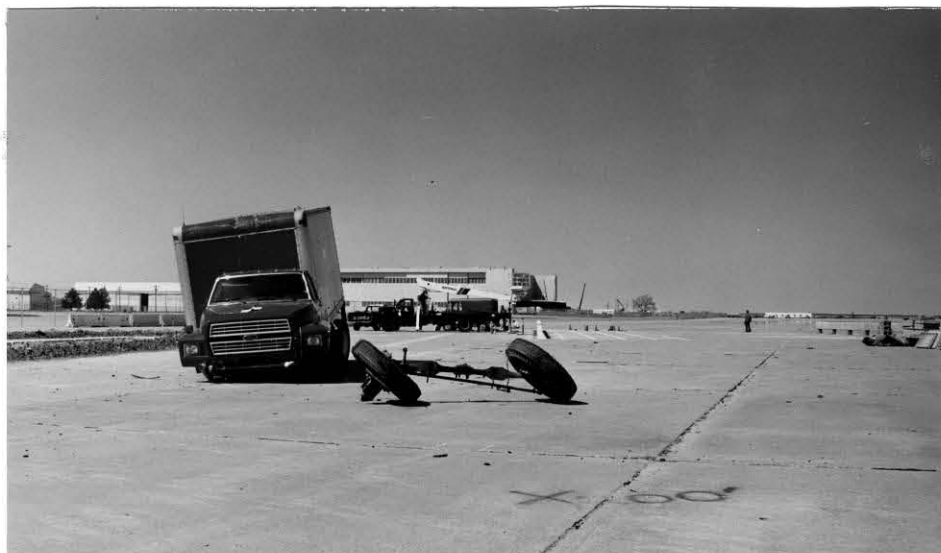
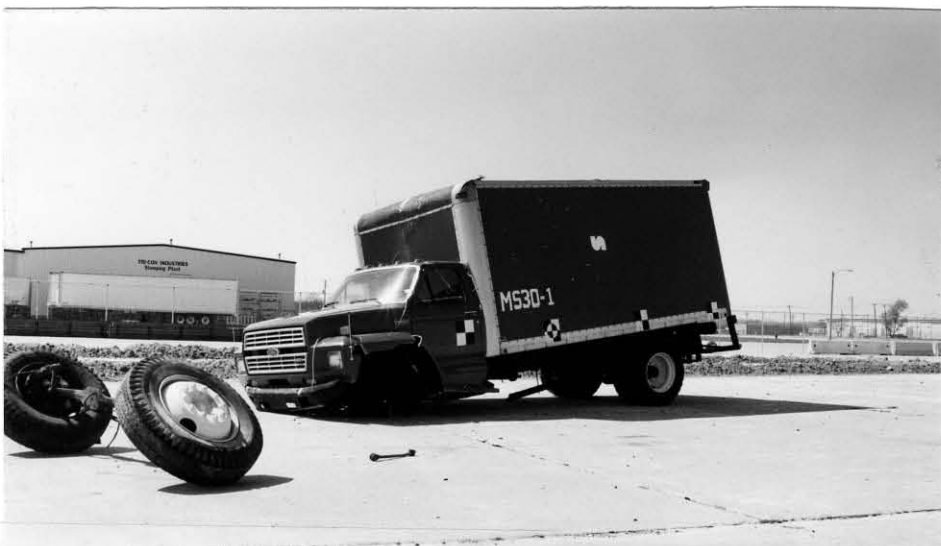
FIGURE 18. Test Vehicle Damage, MS30-1

Vehicle damage is shown in Figure 18. Most of the vehicle damage occurred to the undercarriage. The front axle assembly was disengaged from its original position. The right rear wheels were damaged and the drive shaft was separated from the transmission. There was no intrusion or deformation of the occupant compartment.

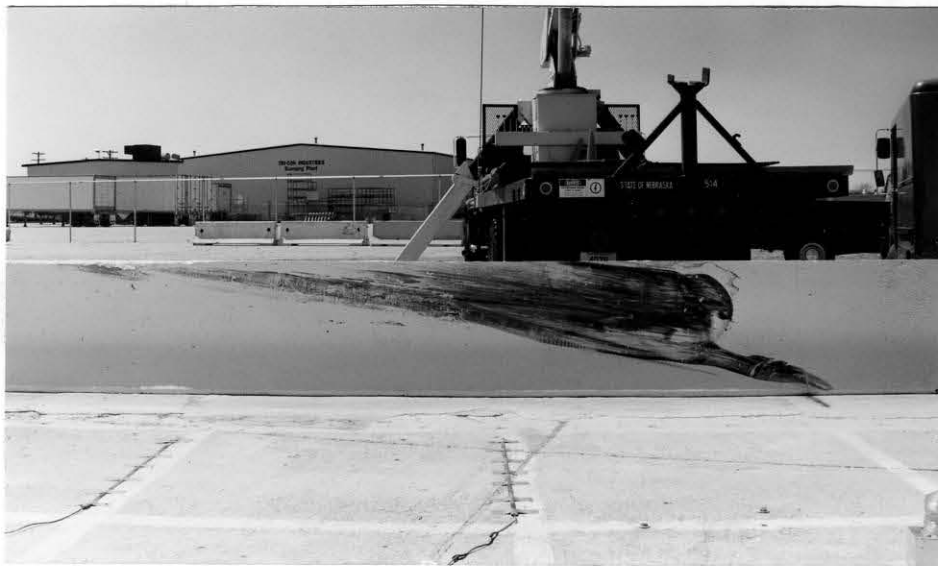
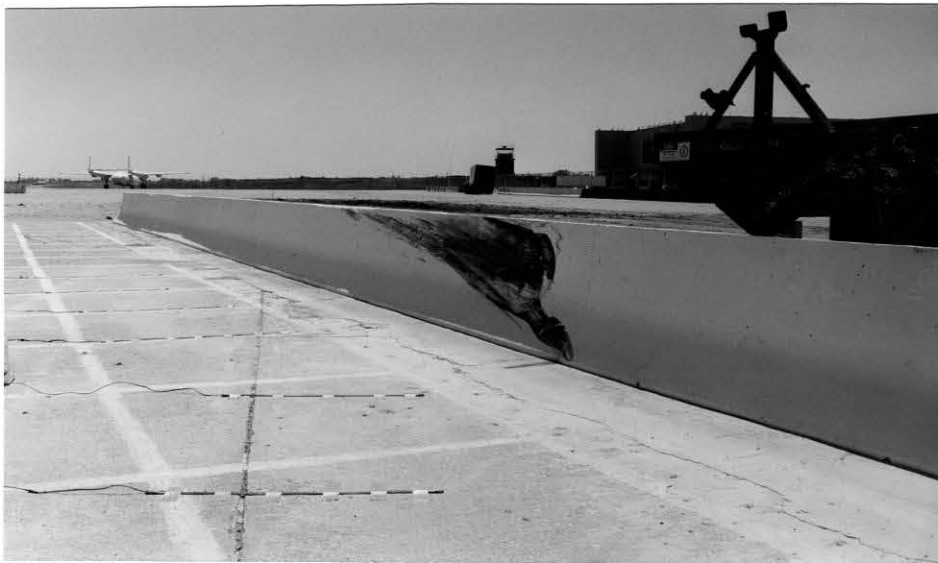
FIGURE 23. Bridge Rail Damage, MS30-2

Bridge rail damage is shown in Figure 23. This damage was minimal. Tire and paint marks, along with scrapes, accounted for the majority of the damage. The marks on the bridge rail indicated that the vehicle was in contact for approximately 12 ft. No visible lateral movement of the bridge rail occurred as a result of the collision.

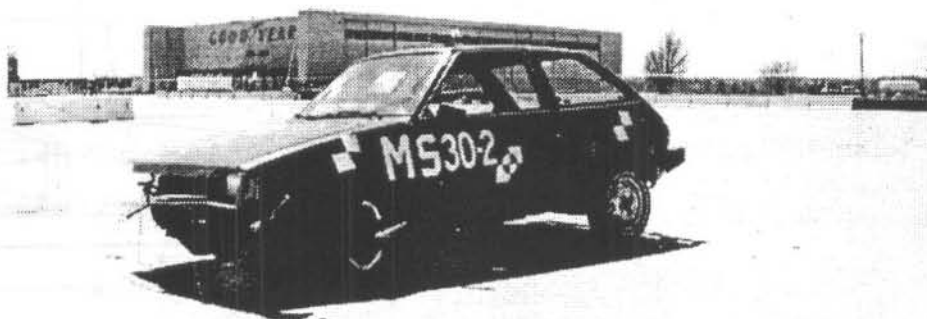
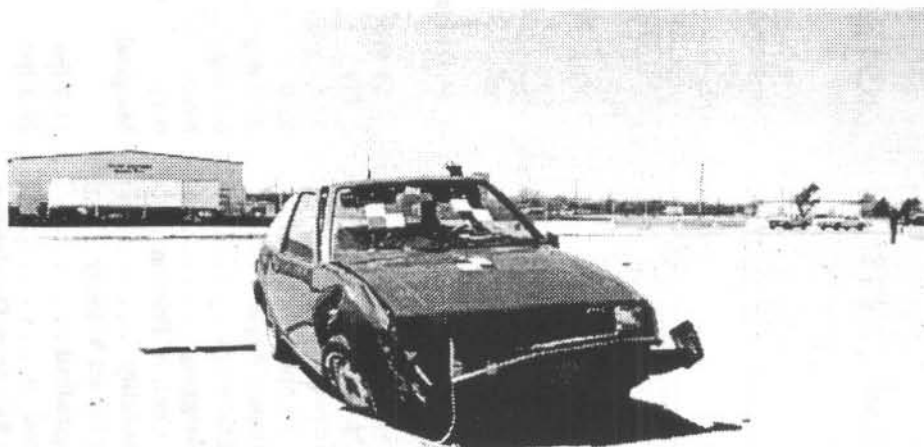
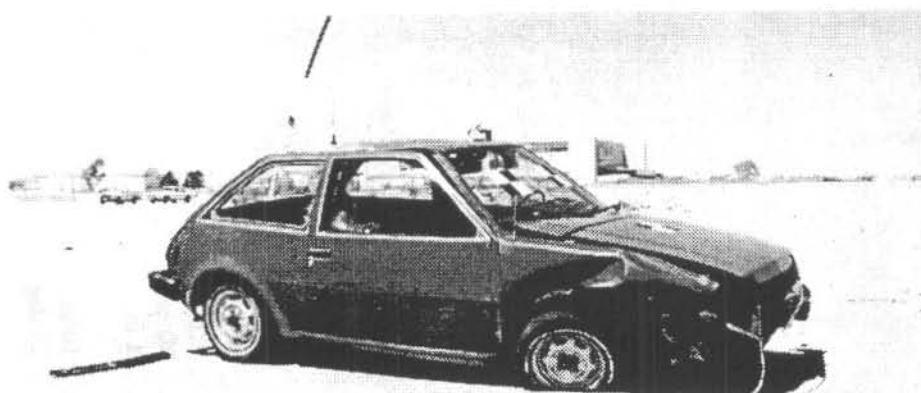
FIGURE 24. Test Vehicle Damage, MS30-2

Vehicle damage is shown in Figure 24. The damage was mainly to the right front corner, consisting of wheel, bumper, fender, and axle damage. Slight buckling of the roof was also apparent. There was no intrusion or deformation of the occupant compartment.

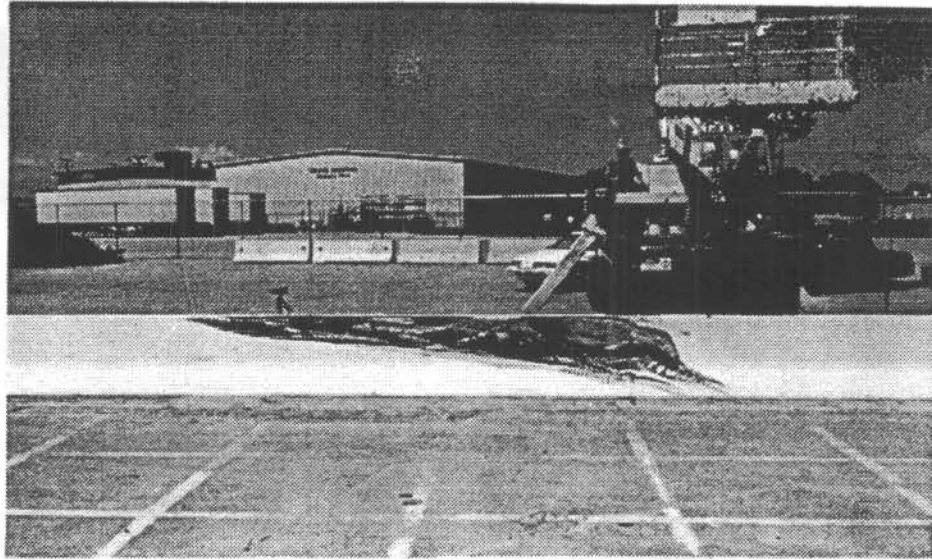
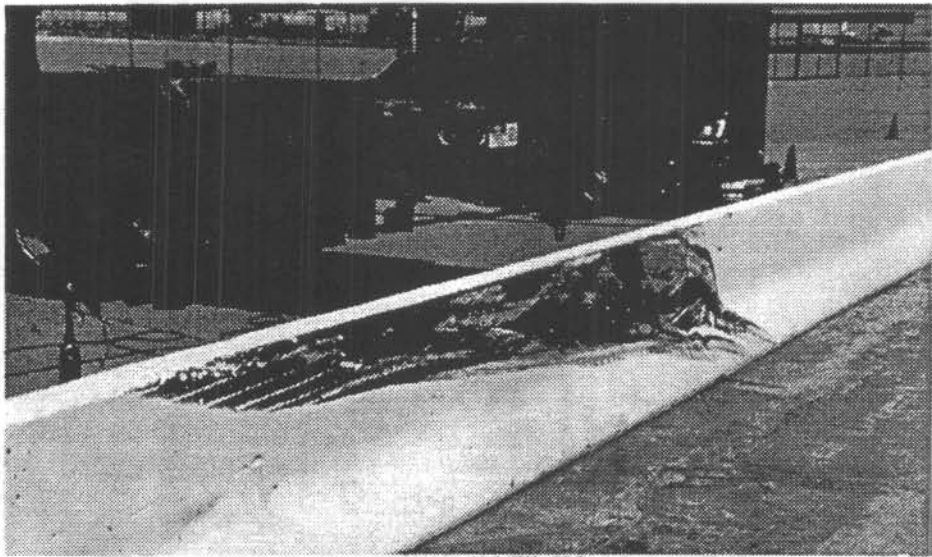
FIGURE 29. Bridge Rail Damage, MS30-3

Bridge rail damage is shown in Figure 29. The damage was minimal. Tire marks and scrapes accounted for the majority of the damage. The marks on the rail were approximately 12 ft long. No visible lateral movement of the bridge rail occurred as a result of the collision.

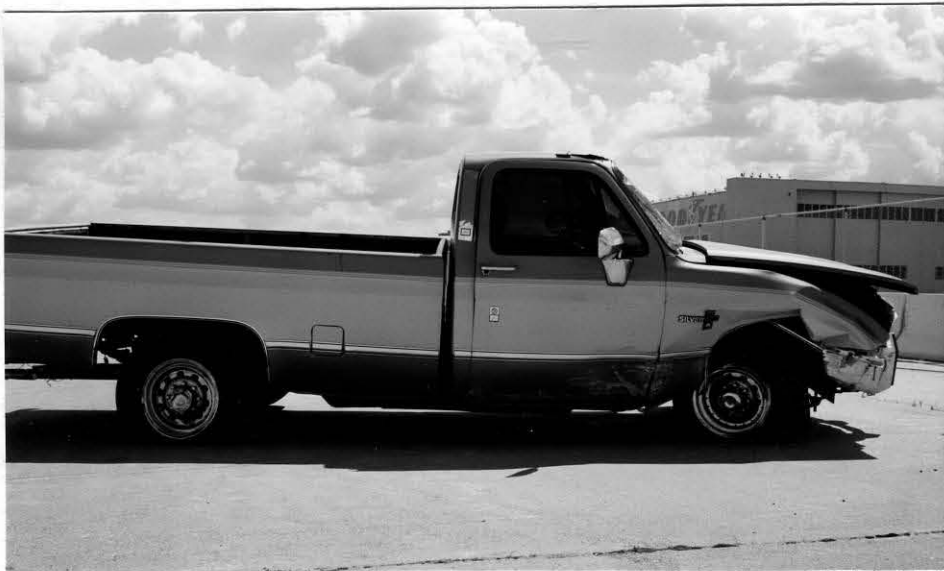
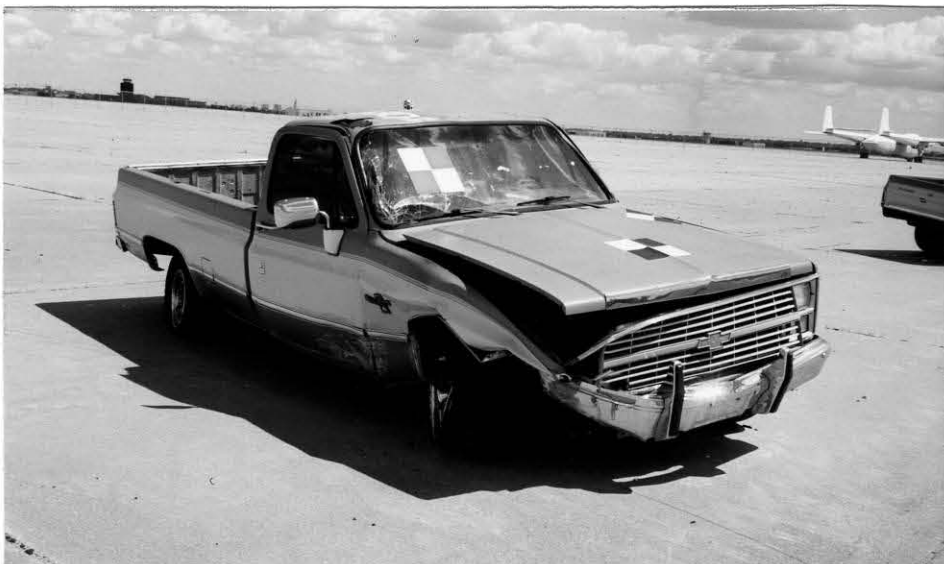
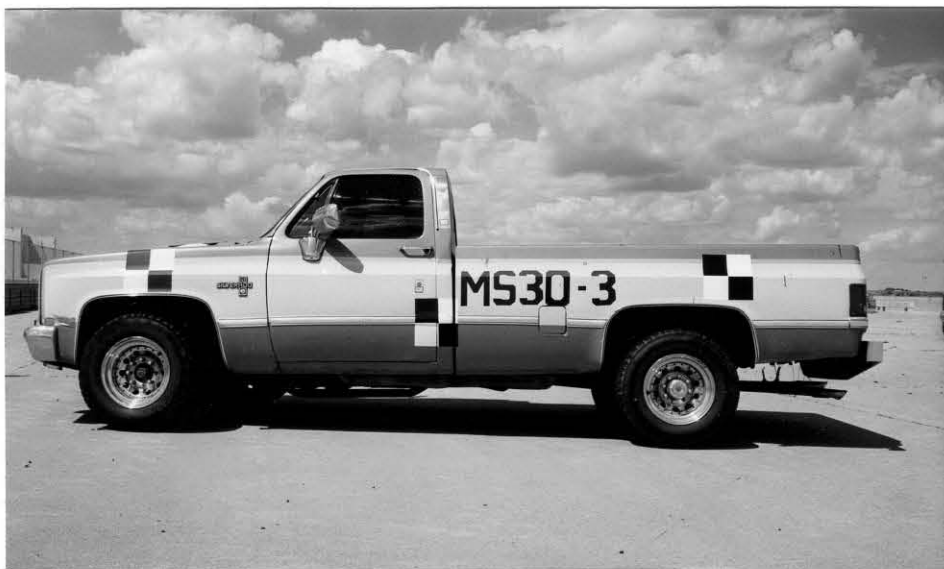
FIGURE 30. Test Vehicle Damage, MS30-3

Vehicle damage is shown in Figure 30. The damage was mainly to the right front corner of the vehicle. The passenger side door and rear wheel was also slightly damaged. The lower right corner of the windshield was also broken. There was no intrusion or deformation of the occupant compartment.
