DESIGN AND EVALUATION OF A LOW-TENSION CABLE MEDIAN BARRIER SYSTEM

MwRSF Research Report No. TRP-03-195-08

December 8, 2008

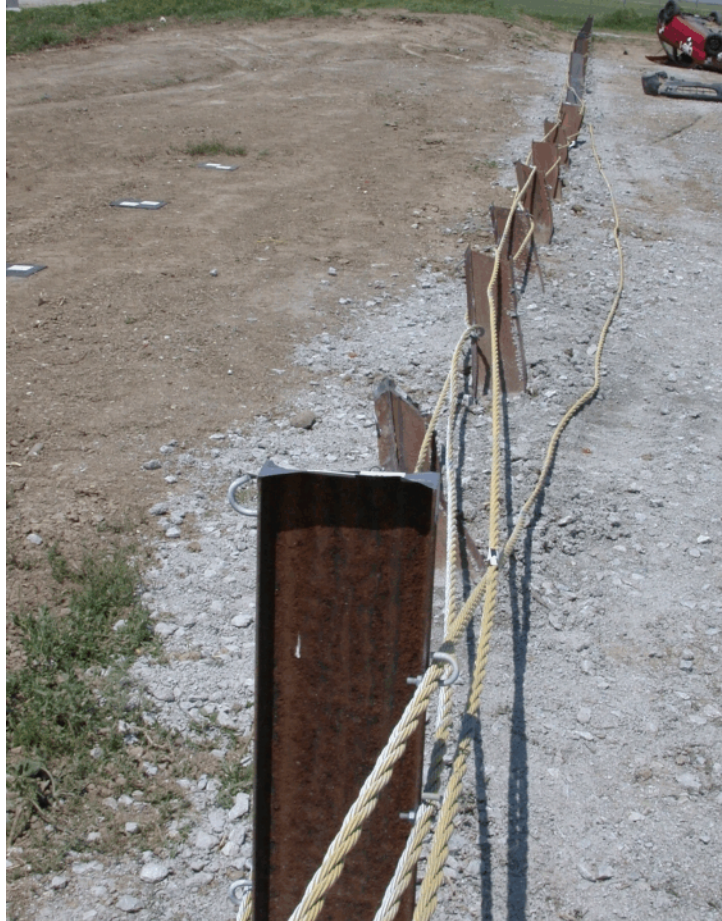
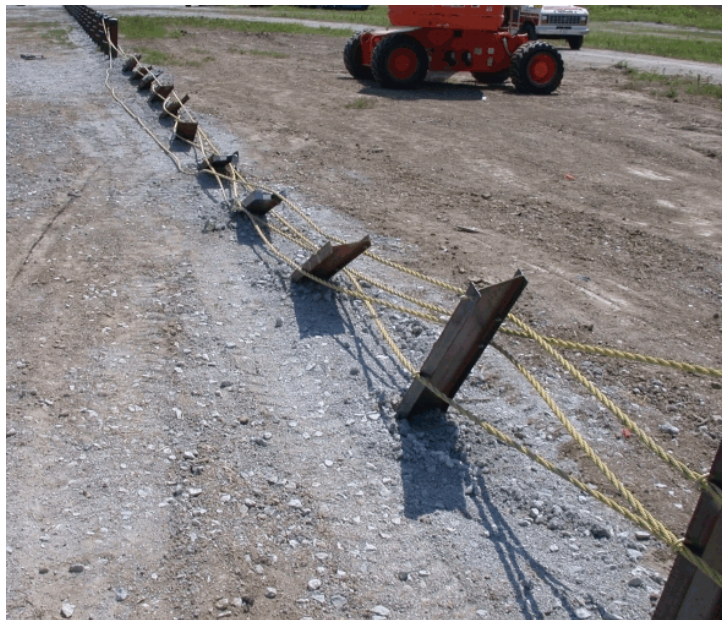
Figure 43. System Damage, Test CMB-1

Damage to the barrier was moderate, as shown in Figures 43 through 45. Barrier damage consisted of bent and twisted guardrail posts and detached cables. The length of vehicle contact along the cable median barrier system was approximately 12.8 m (42 ft), which spanned from post no. 41 through post no. 48.

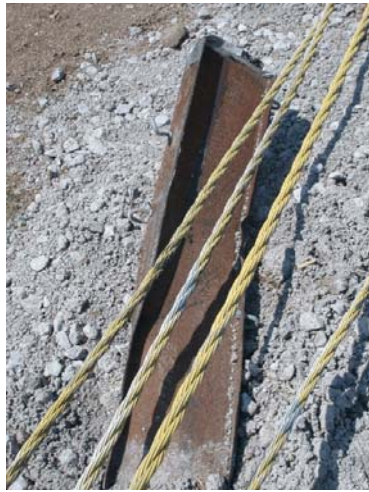
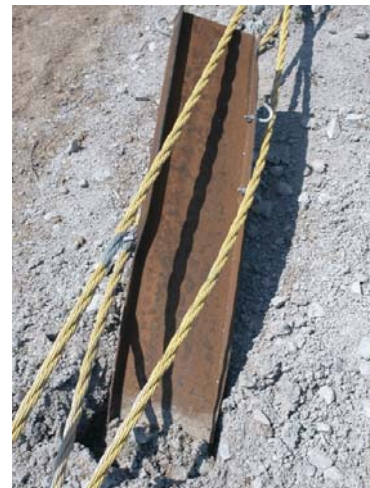
Figure 44. Post Nos. 41 through 46 Damage, Test CMB-1

Soil gaps less than 3 mm (0.125 in.) wide developed at posts nos. 36 through 39. No other damage was visible to these posts. Post no. 40 had soil gaps of 16 mm (0.625 in.) on the front, 3 mm (0.125 in.) on the back, and 3 mm (0.125 in.) downstream. Post no. 42 had a 51-mm (2-in.) soil gap on the backside of the system. A 38-mm (1.5-in.) soil gap was created on both the front and back sides of post no. 44. A 13-mm (0.5-in.) soil gap was formed on the upstream side of post no. 45 due to post bending below the ground surface. Post no. 46 had soil gaps of 64 mm (2.5 in.) on the backside and 19 mm (0.75 in.) on the front side. A soil gap of 3 mm (0.125 in.) was created on the front side of post no. 47. Post nos. 49 and 50 had soil gaps due to the post bending beneath the ground surface. Post no. 50 had a 3-mm (0.125-in.) soil gap behind the post. A 25 mm (1-in.) soil gap was formed on the upstream side of post no. 51, while a 3-mm (0.125-in.) gap was found on the backside. A 13-mm (0.5-in.) soil gap was formed on the upstream side of post no. 52.

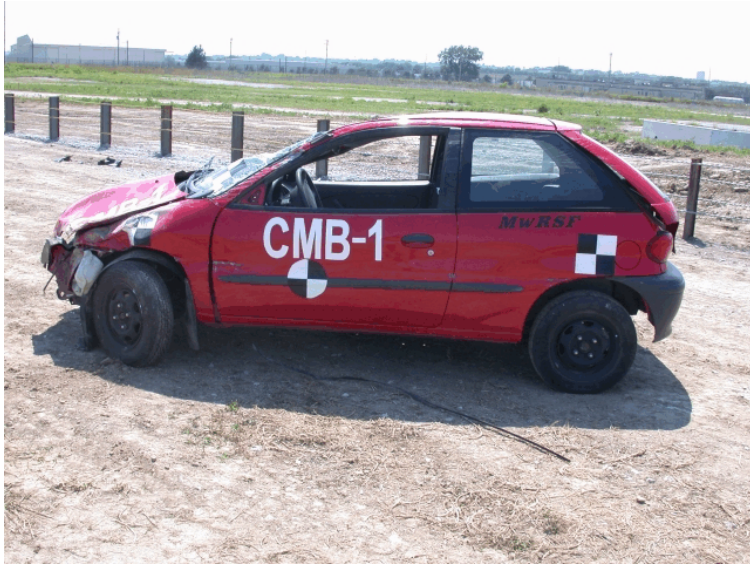
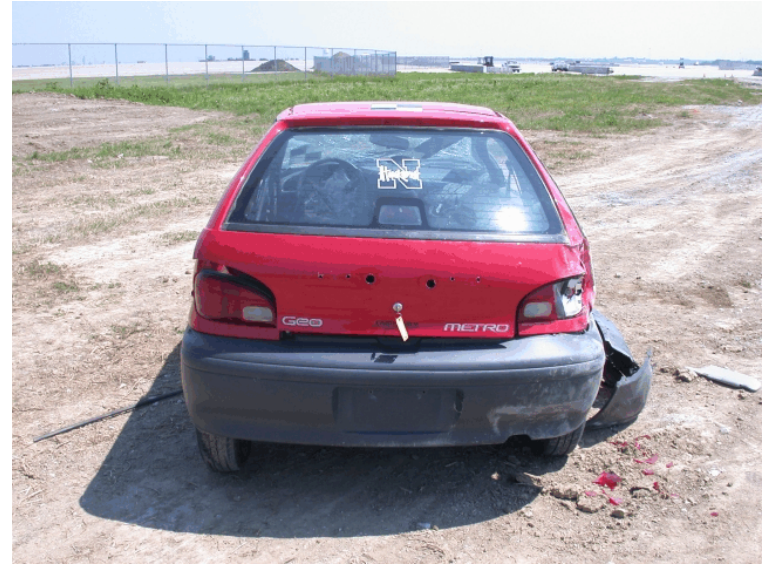
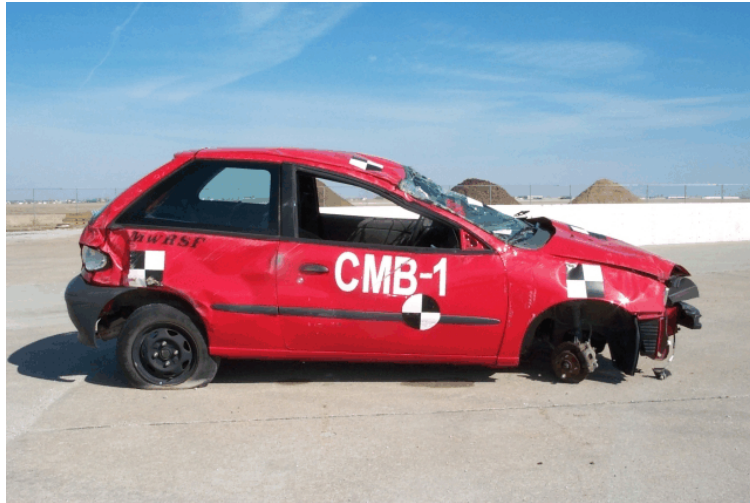
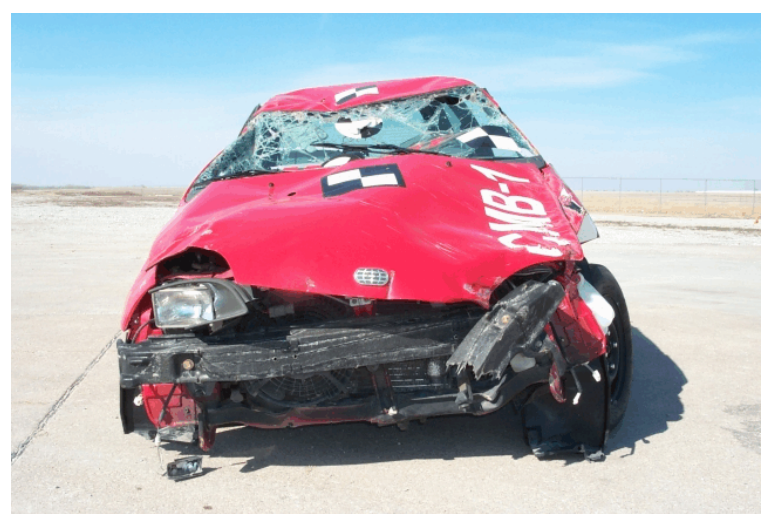
Figure 47. Vehicle Damage, Test CMB-1

Exterior vehicle damage was extensive, as shown in Figures 47 through 49. Occupant compartment deformations occurred, especially to the roof and windshield due to vehicle rollover.

The front-right fender crushed inward. A large gouge extended from the wheel well to the left-side door. Cable contact marks were found along the entire left side of the vehicle. The front bumper cover disengaged from the vehicle. The right-front wheel and tire disengaged from the vehicle. The right-rear tire was deflated. The vehicle's hood sustained severe damage and deformation. The front of the roof crushed inward due to vehicle rollover. The windshield crushed inward and was shattered. The right-side and left-side door window glass shattered and was removed.

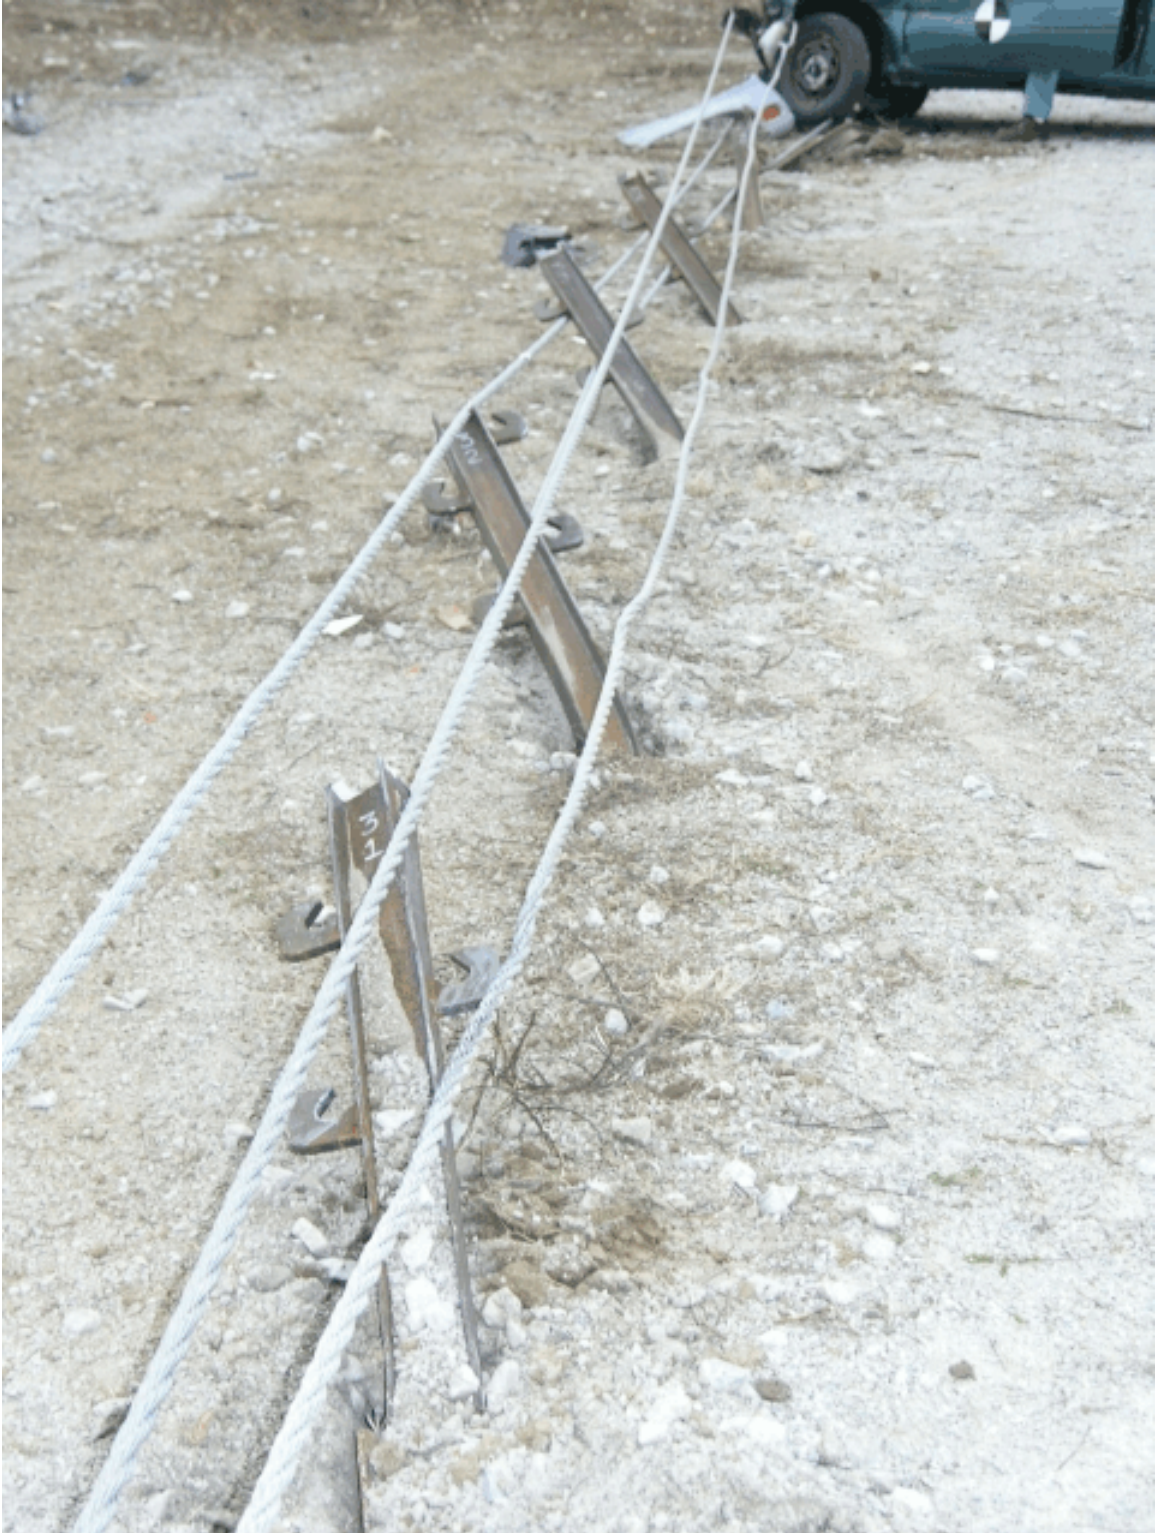
Figure 67. System Damage, Test CMB-2

Damage to the barrier was moderate, as shown in Figures 67 through 69. Barrier damage consisted of bent and twisted guardrail posts and detached cables. The length of vehicle contact along the cable median barrier system was approximately 19.5 m (64 ft), which spanned from post no. 30 through post no. 38.

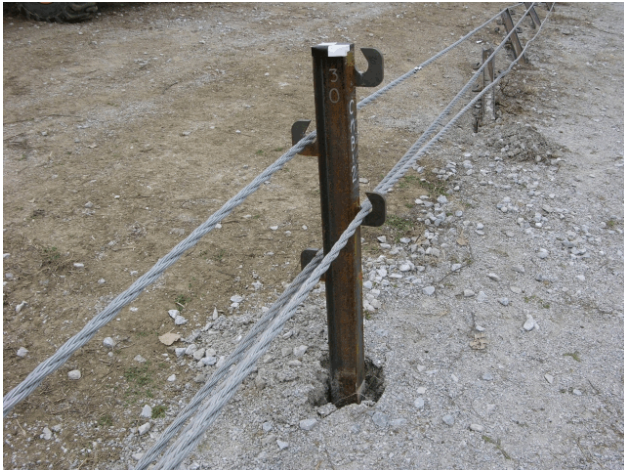
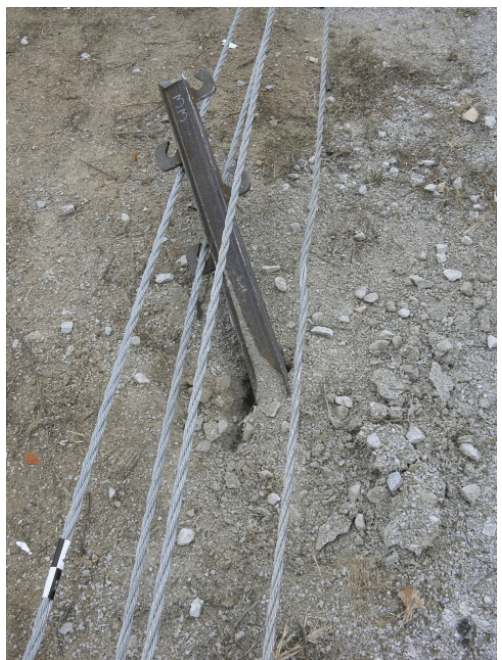
Figure 68. Post Nos. 30 through 33 Damage, Test CMB-2

Post no. 29 had a small crack in its front flange on the downstream edge and a 13 mm (0.5-in.) soil gap on the traffic-side face. Post no. 30 had soil gaps on each face, including gaps of 13 mm (0.5 in.) on the back side, 64 mm (2.5 in) on the traffic side, 127 mm (5 in.) on the downstream side, and 102 mm (4 in.) on the upstream side. Post nos. 31 through 35 sustained significant damage to the soil surrounding the posts. Post no. 36 was pulled out of the ground, and soil was strewn downstream. Post no. 36 created a soil gap of 229 mm (9 in.) front to back and 787 mm (31 in.) upstream to downstream. Post no. 38 had only a 3-mm (0.125-in.) soil gap on its front side.

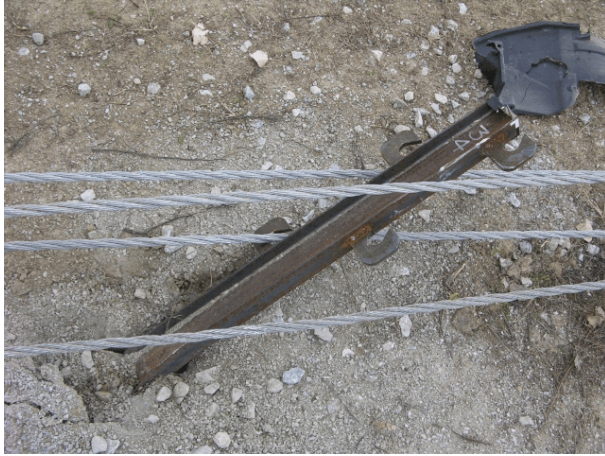
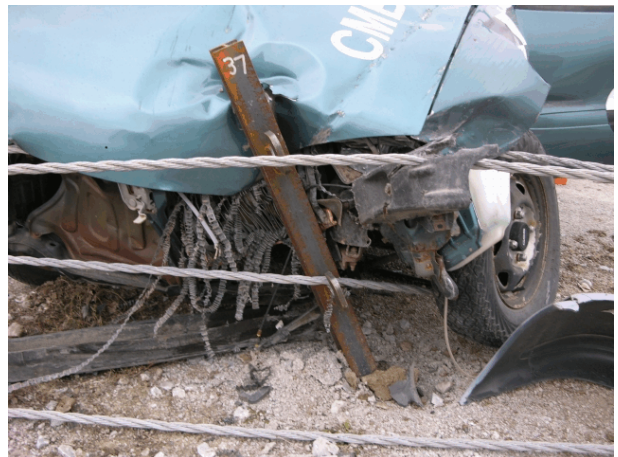
Figure 69. Post Nos. 34 through 37 Damage, Test CMB-2

and scratches were sustained to the lower-middle cable hook due to contact with the vehicle. Contact marks were found on the bottom cable hook from the cable rubbing against it. Post nos. 32 through 35 were bent to the ground without twisting. Scratches were observed on post nos. 32 and 35 between the top and lower-middle cable hook as well as at the bottom cable hook. Post no. 36 was bent at the ground level, twisted clockwise, and was pulled out of the ground. Severe local bending occurred to the upstream front flange of post no. 36 at the top cable hook. Post no. 37 was bent at the ground level with slight twisting. Following the test, the post remained attached to the vehicle. Post no. 38 had minor scratches on the traffic-side face between the top and lower-middle cable hooks. Post no. 39 had very minor scratches between the top and lower-middle cable hooks.

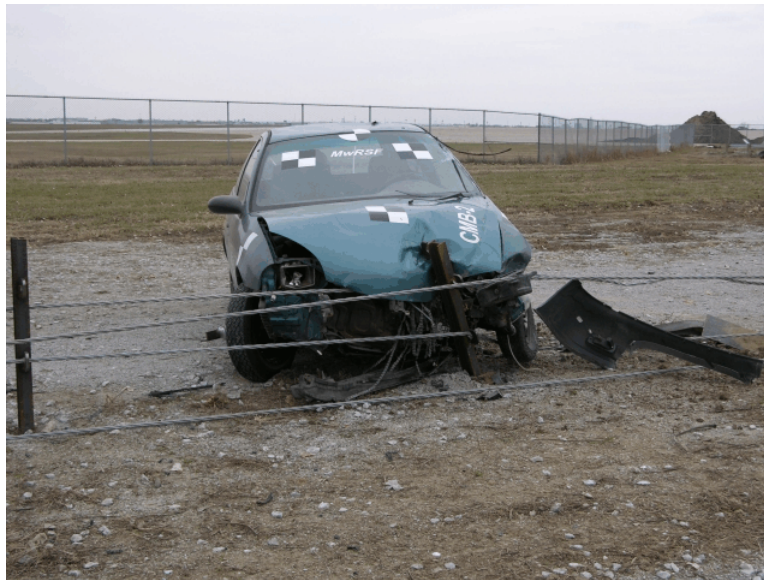
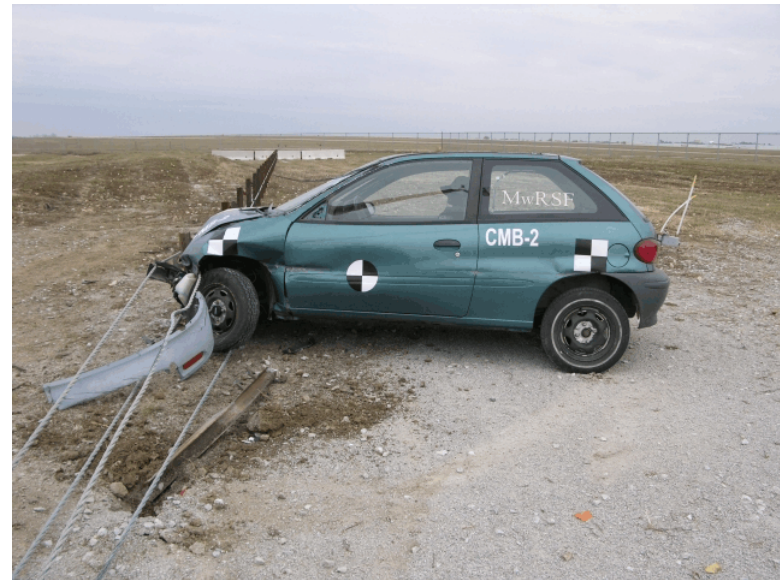
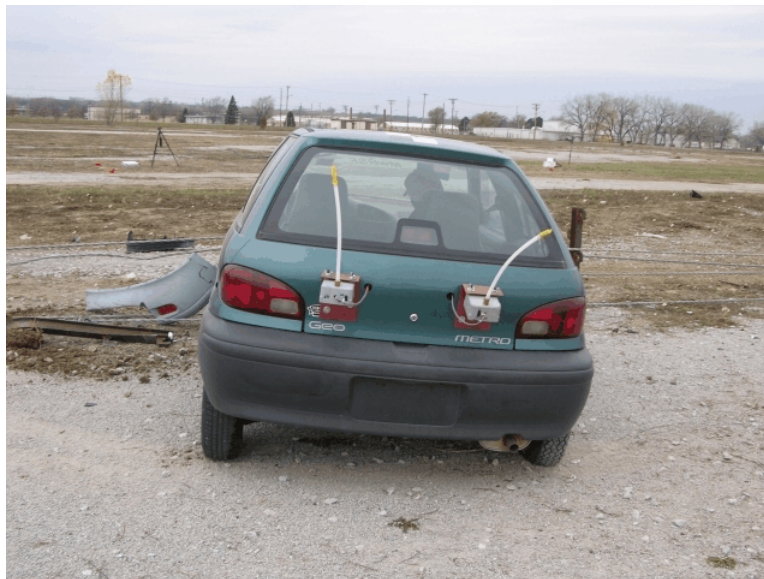
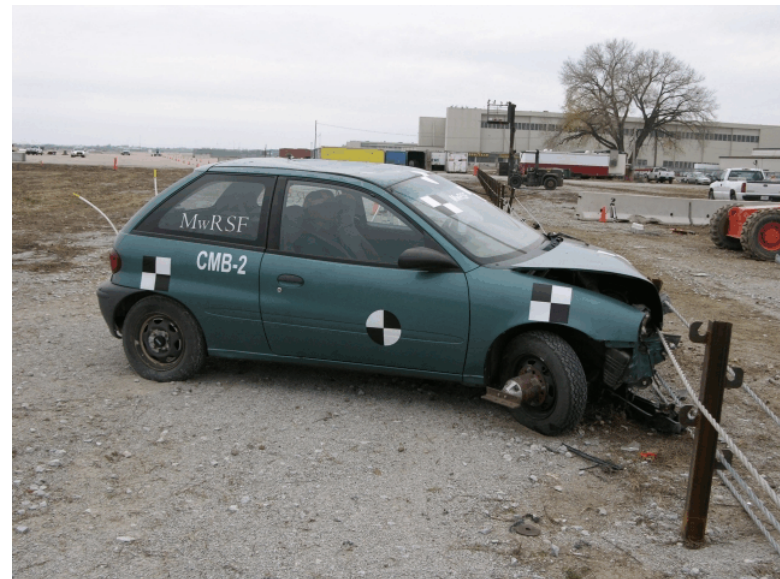
Figure 71. Vehicle Damage, Test CMB-2

Vehicle damage was moderate, as shown in Figures 71 through 73. Minimal damage was observed in the interior occupant compartment of the vehicle. Complete occupant compartment deformations and the corresponding locations are provided in Appendix E.

Damage was concentrated to the front and left sides of the vehicle. The front bumper, grill, and headlights were disengaged. The radiator was severely damaged, and the left-side support was no longer attached. The engine hood buckled. The engine hood, left rear bumper, and roof encountered scratches from cable contact. The left-front quarter panel deformed backward into the

engine compartment and windshield trim. The windshield wipers were fractured and disengaged from the vehicle. The left-side mirror was disengaged. The right-front tire was deflated. The left side of the windshield was moderately cracked.

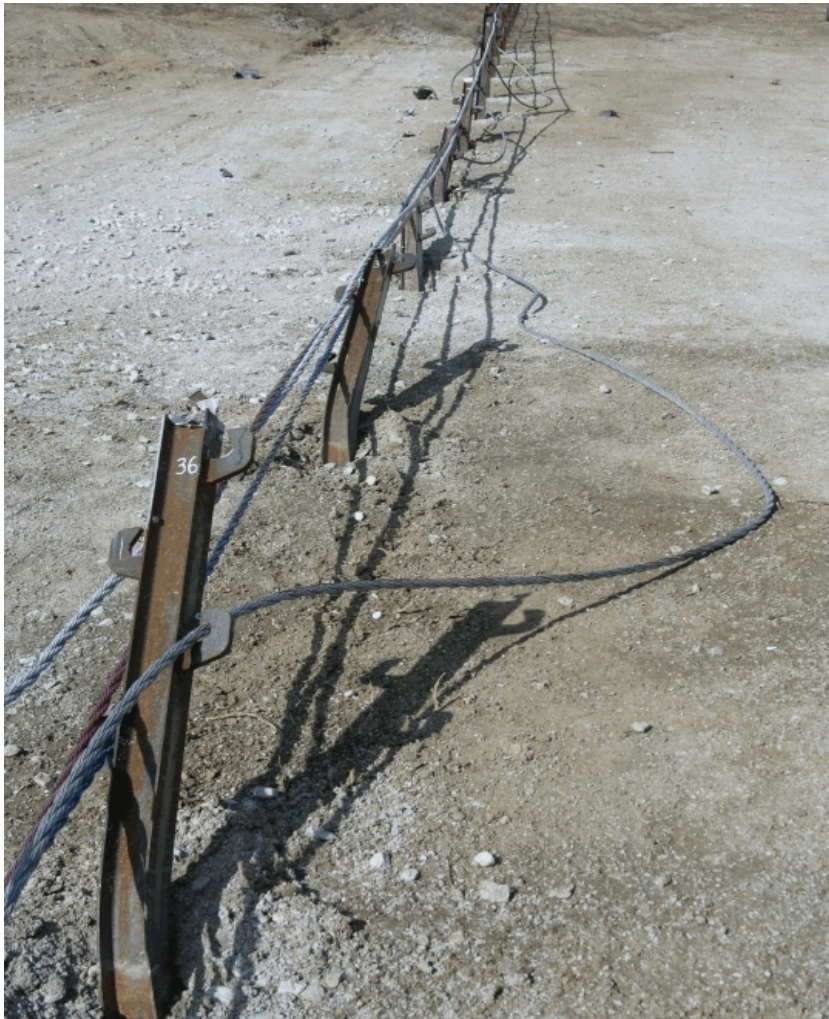
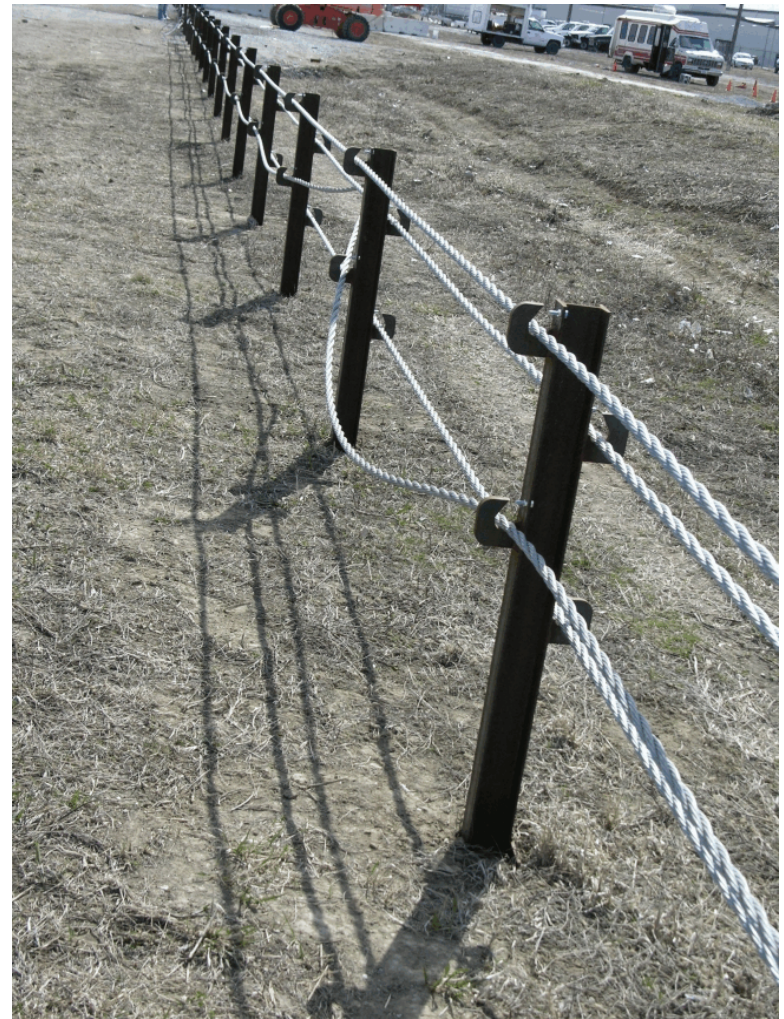
Figure 90. System Damage, Test CMB-3

Damage to the barrier was moderate, as shown in Figures 90 through 92. Barrier damage consisted of deformed guardrail posts, disengaged cables, and deformed retaining bolts. The length of the vehicle contact along the cable median barrier was approximately 24.0 m (78.7 ft), which spanned from the middle of post nos. 30 and 31 through post no. 40.

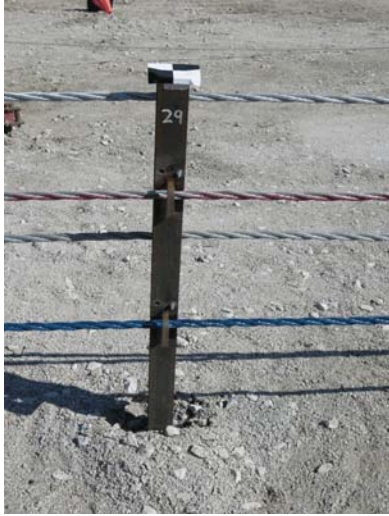
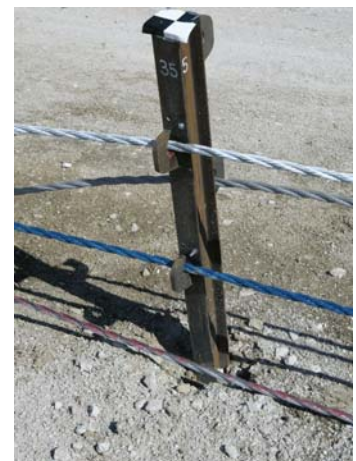
Figure 91. Post Nos. 29 through 33 and 35 Damage, Test CMB-3

A 25-mm (1-in.) soil gap was formed on the front face of post no. 27. At post no. 29, soil damage on the back side occurred with dimensions 229 mm (9 in.) by 279 mm (11 in.). At post no. 30, a soil damage area on the back side was created with dimensions 305 mm (12 in.) by 342 mm (13.5 in.). Post nos. 31 through 41 experienced significant damage to the soil surrounding the post bases.

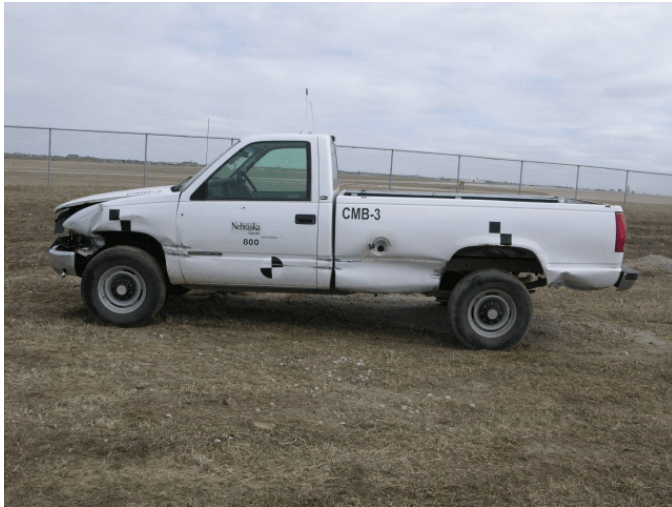
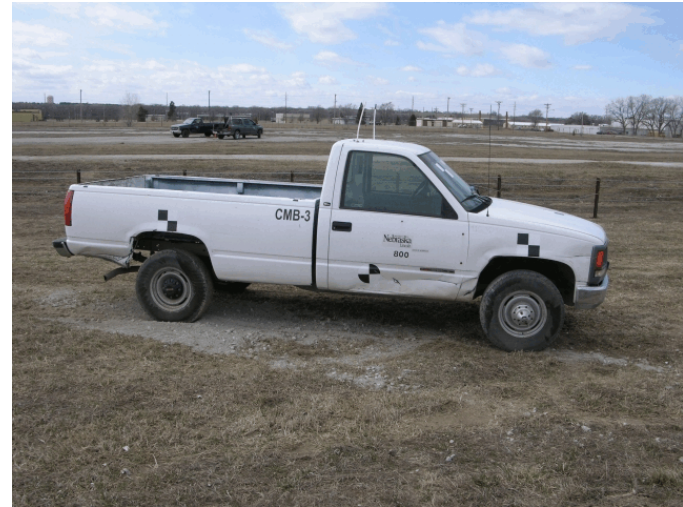
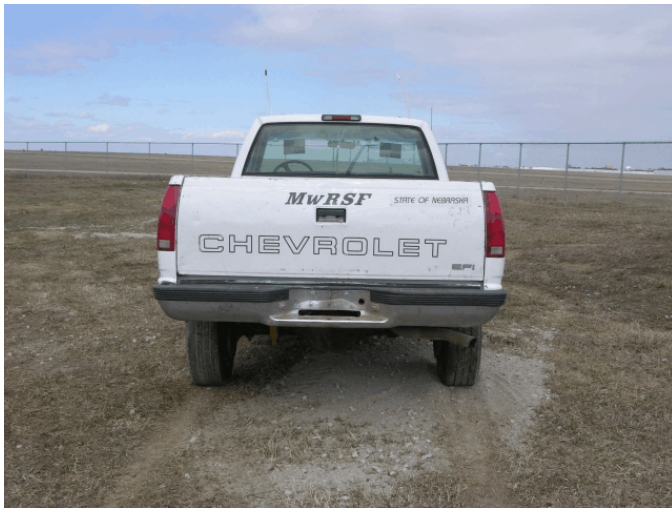
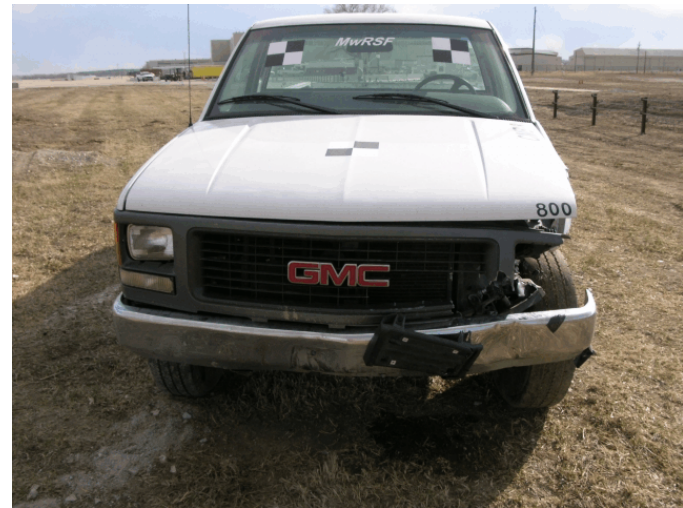
Figure 95. Vehicle Damage, Test CMB-3

Exterior vehicle damage was moderate, as shown in Figures 95 and 96. Minimal damage was observed in the interior occupant compartment of the vehicle. Complete occupant compartment deformations and the corresponding locations are provided in Appendix E.

Damage was concentrated to the left-front corner of the vehicle. The left side of the front

bumper was dented near the left-front quarter panel. The left side of the grill was fractured. Contact marks were found on the entire left and right sides of the vehicle as well as on all four tires. The left-front and right-front quarter panels were dented, buckled, and deformed inward toward the engine compartment. The right-side door encountered a large dent in the bottom quarter of the door. The truck bed was buckled inward behind both the left-rear and right-rear wheels. Both front headlight assemblies fractured, and the left-side headlight disengaged from the vehicle. The roof and rear of the vehicle and all window glass remained undamaged.
