FULL-SCALE VEHICLE CRASH TESTS ON THE IOWA RETROFIT CONCRETE BARRIER RAIL

TRANSPORTATION RESEARCH REPORT TRP-03-015-88

Civil Engineering Department W348 Nebraska Hall University of Nebraska-Lincoln Lincoln, Nebraska 68588-0531

January, 1989

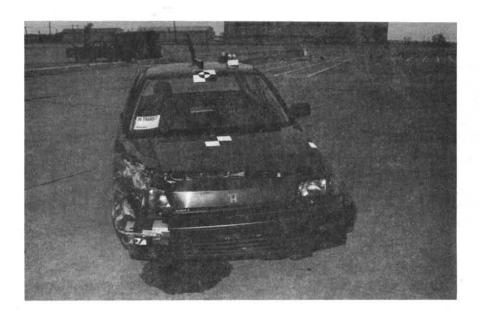
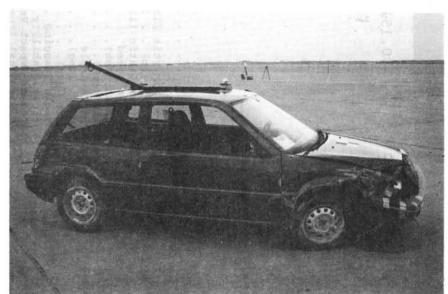
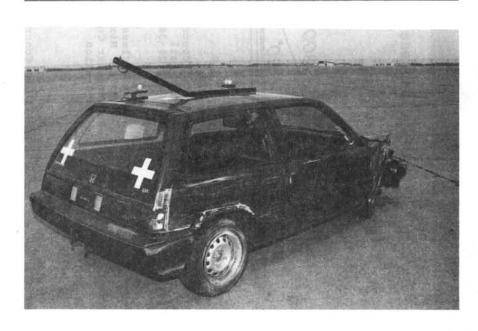
FIGURE 18. PHOTOGRAPHS OF VEHICLE DAMAGE, TEST 12-1

Photographs of the vehicle damage are shown in Figure 18. As evident, the vehicle damage was marginal. The TAD and VDI damage classifications are shown in Figure 17. Photographs of the minimal damage to the retrofit concrete barrier rail are shown in Figure 19. Only paint and tire marks were evident.

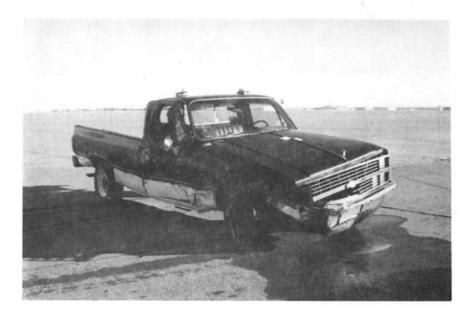
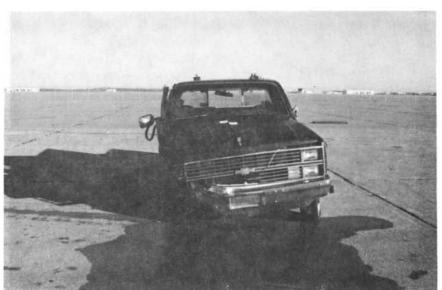
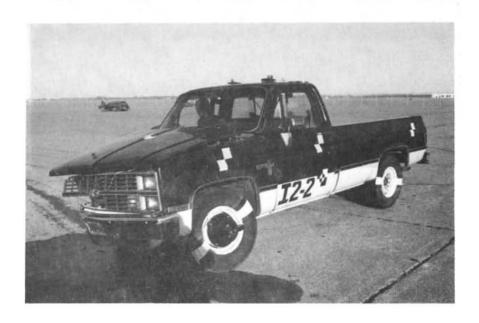
FIGURE 21. PHOTOGRAPHS OF VEHICLE DAMAGE, TEST 12-2

Photographs of the vehicle damage are shown in Figure 21.

As evident, the vehicle damage was marginal. The TAD and VDI damage classifications are shown in Figure 20. Photographs of the minimal damage to the retrofit concrete barrier rail are shown in Figure 22. Minor concrete spalling and paint and tire marks were evident.

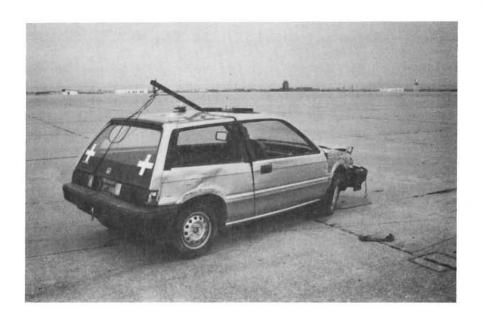
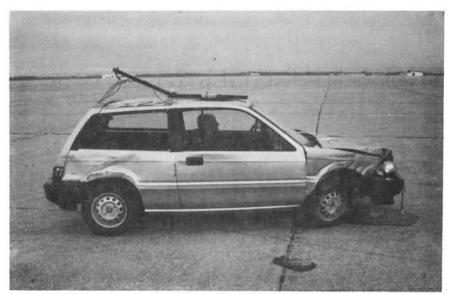
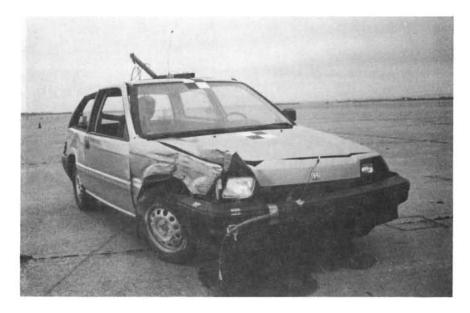
FIGURE 24. PHOTOGRAPHS OF VEHICLE DAMAGE, TEST 12-3

Photographs of the vehicle damage are shown in Figure 24. As evident, the vehicle damage was marginal. The TAD and VDI damage classifications are shown in Figure 23. Photographs of the minimal damage to the retrofit concrete barrier rail are shown in Figure 25. Only paint and tire marks were evident.
