DESIGN AND EVALUATION OF A LOW-TENSION CABLE GUARDRAIL END TERMINAL SYSTEM

MIDWEST ROADSIDE SAFETY FACILITY

MwRSF Research Report No. TRP-03-131-08

July 15, 2008

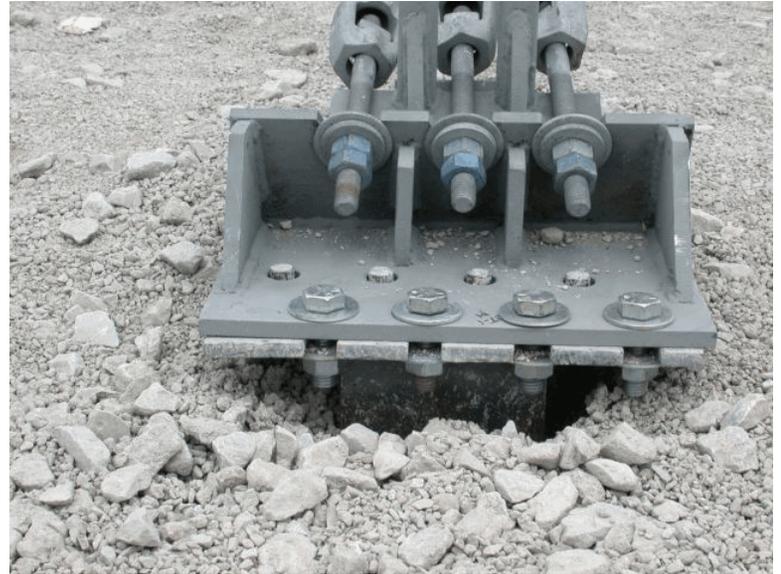
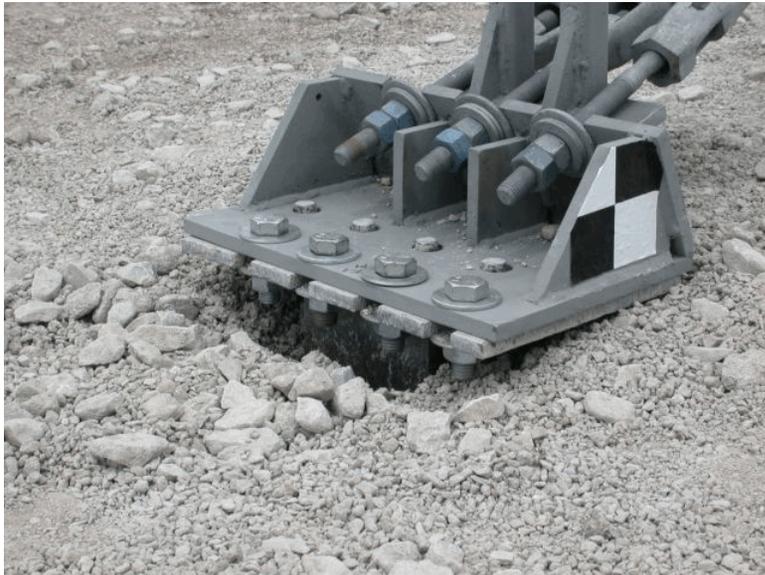
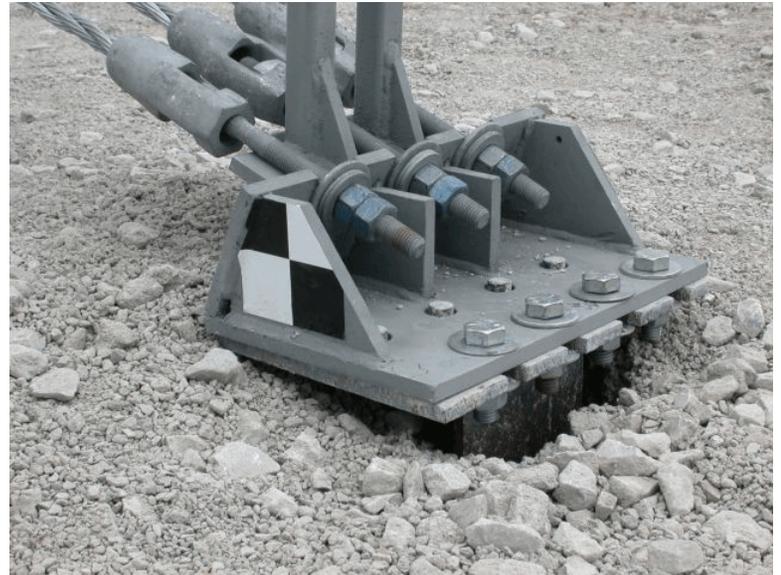
Figure 32. System Damage, Test CT-1

Damage to the cable guardrail end terminal was moderate, as shown in Figures 32 through 36. Barrier damage consisted of contact marks on posts, deformed line posts, disengaged cable, and deformed cable hooks. The length of vehicle contact along the cable system was approximately 39.3 m (128 ft - 11 in.), which spanned from post no. 3 through post no. 8.

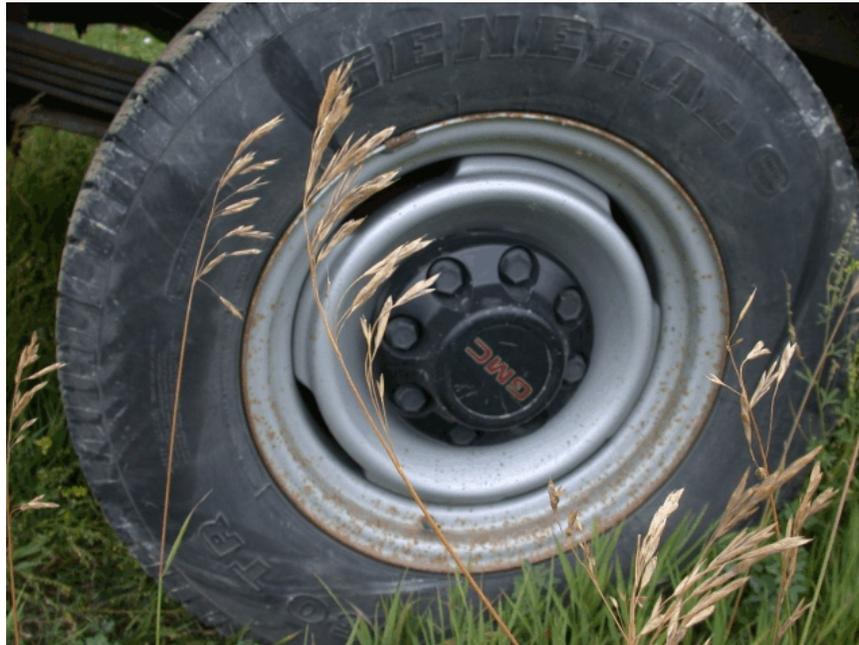
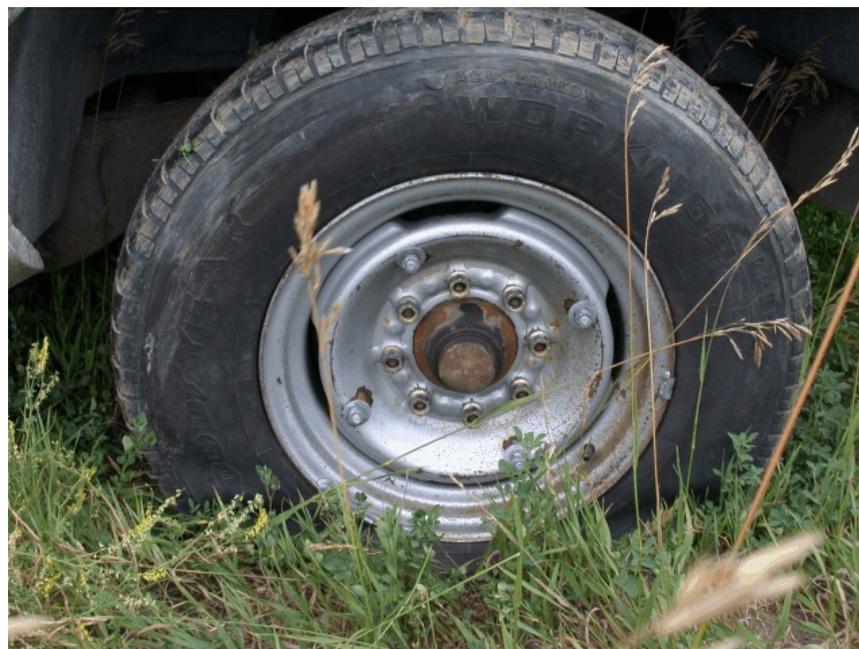
Figure 38. Vehicle Damage, Test CT-1

Exterior vehicle damage was minimal, as shown in Figures 37 through 40. Occupant compartment deformations to the left side and center of the floorboard were judged insufficient to cause serious injury to the vehicle occupants. The maximum lateral deformation was measured to be 13 mm (0.5 in.) at the center of the left-side dashboard. The maximum longitudinal and vertical deformations were measured to be 6 mm (0.25 in.) distributed throughout the floor pan. Complete occupant compartment deformations and the corresponding locations are provided in Appendix C.

Damage was concentrated on the left-front corner and left and right sides of the truck. Scrapes, gouges, and contact marks were found along the entire right and left sides of the vehicle. Contact marks were found on all four tires, and the right-front tire was deflated. The right-rear quarter panel was dented and scraped. A dent was found on the left side of the bumper. The grill and headlights were broken. The back side, roof, undercarriage, and all window glass remained undamaged.

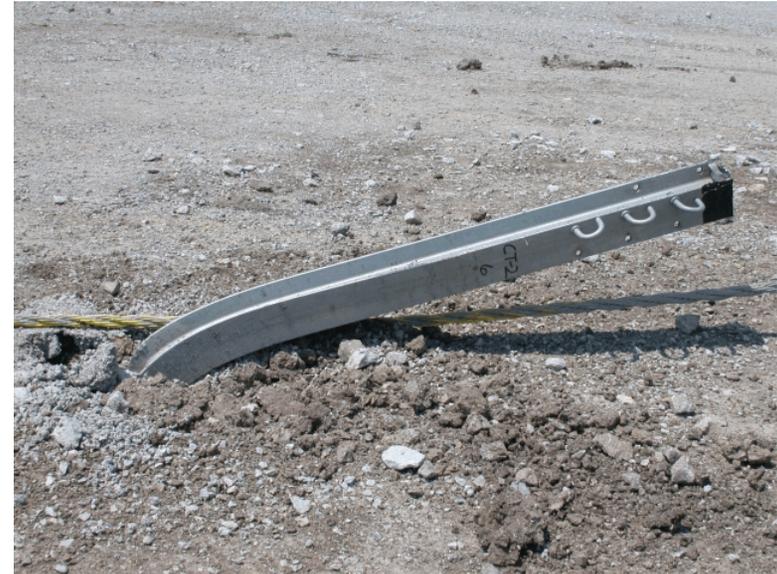
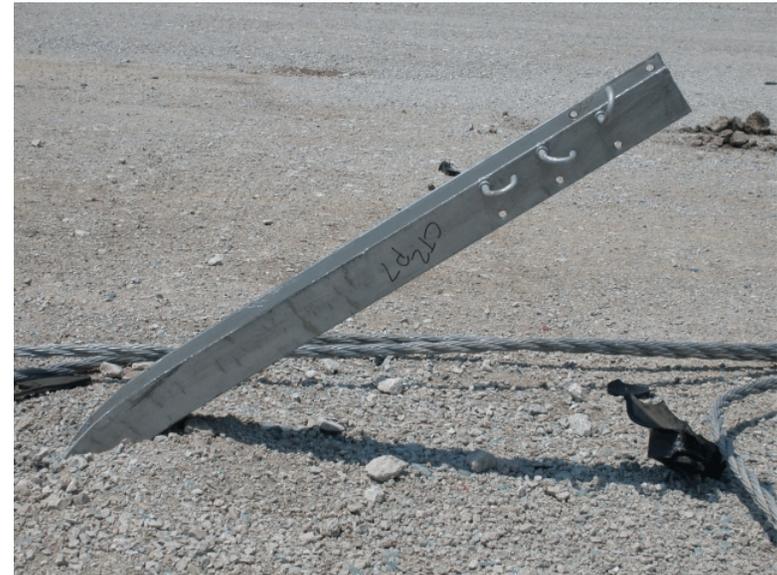
Figure 54. Post Nos. 1 and 2 Damage, Test CT-2

The cable release lever at post no. 1 was dented, scratched, and disengaged from the system. The cable release lever was located 3.05 m (10 ft) downstream of post no. 8 and 3.35 m (11 ft) laterally away from the traffic-side face of the system. Minor scratching and scraping around the bolt locations was found on post no. 2. Minor buckling and flange twisting was found on the top section of post no. 2. The top section of post no. 2 was located 0.91 m (3 ft) upstream from post no. 8 and 6.10 m (20 ft) laterally away from the traffic-side face of the system. Post nos. 3 through 8 rotated downstream in the soil and bent about the weak axis. However, post nos. 6 and 7 were bent nearly to the ground. Heavy contact marks were visible on the upstream flanges of post nos. 3 through 7.

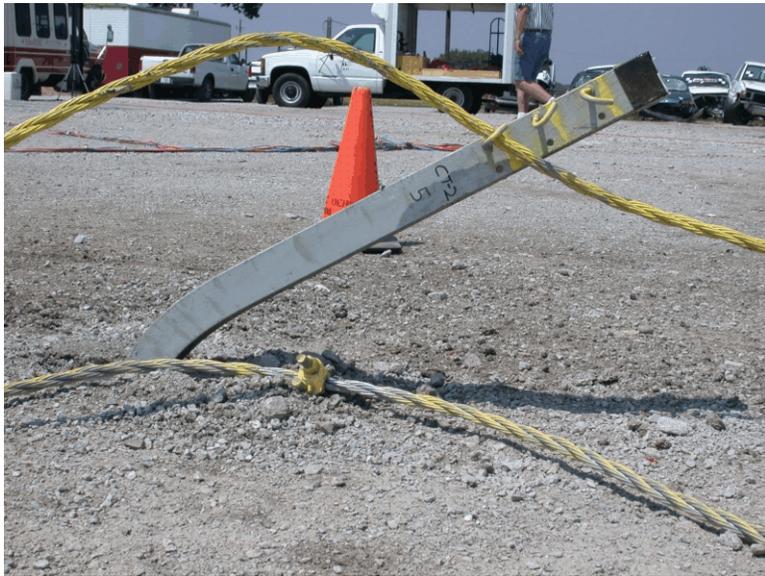
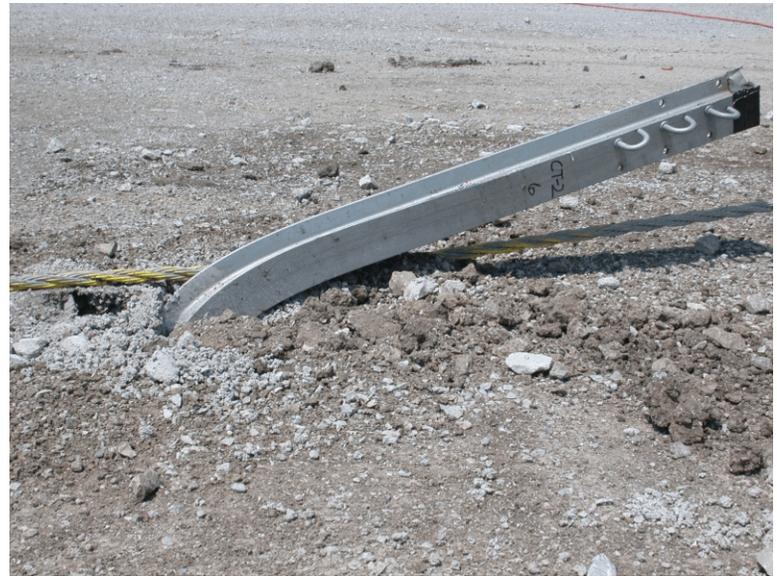
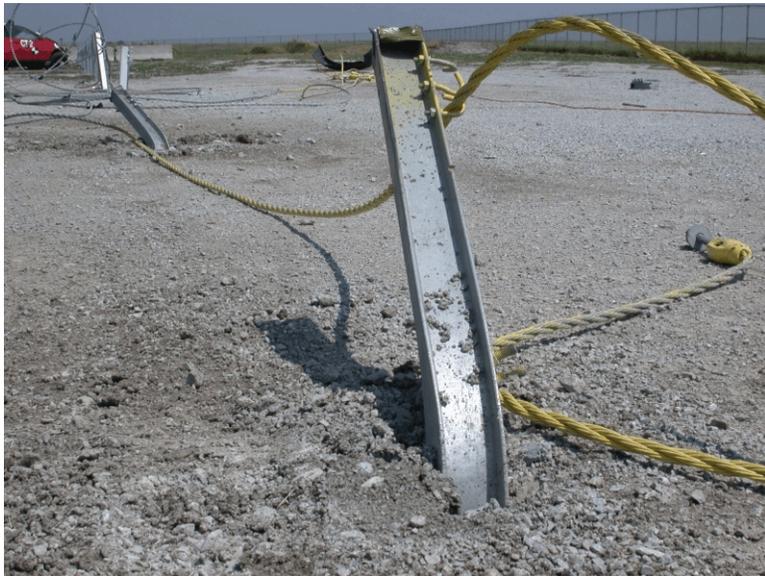
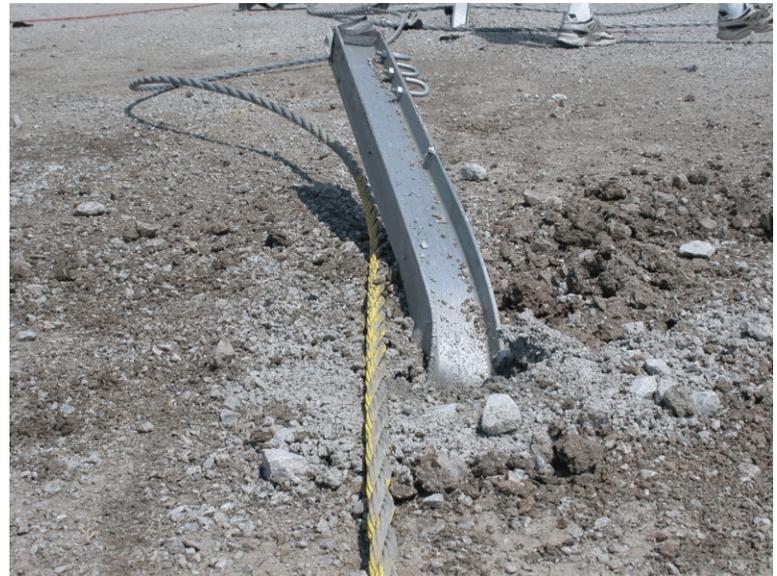
Figure 55. Post Nos. 3 and 4 Damage, Test CT-2

All of the hook bolts on post nos. 3 through 8 were deformed, but remained attached to the posts. All three cables disengaged from post nos. 3 through 7, except the bottom cable remained attached to post no. 5. The threaded cable end fittings were fractured at the nut locations.

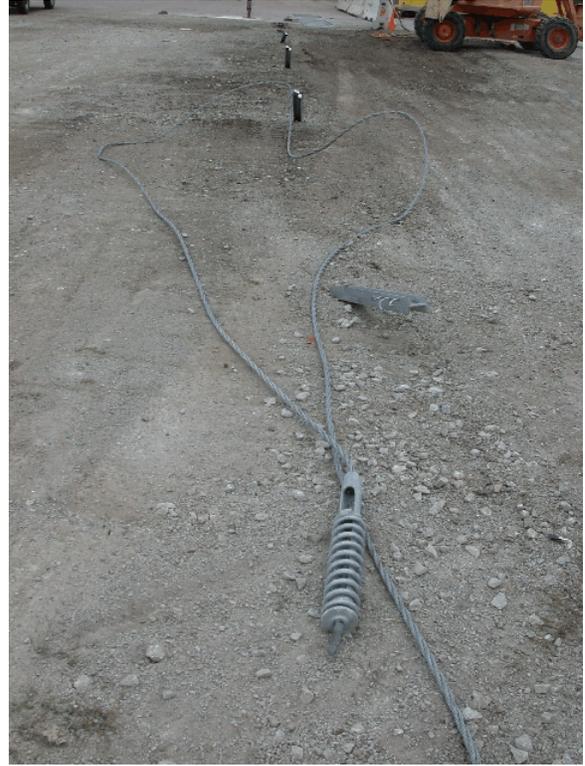
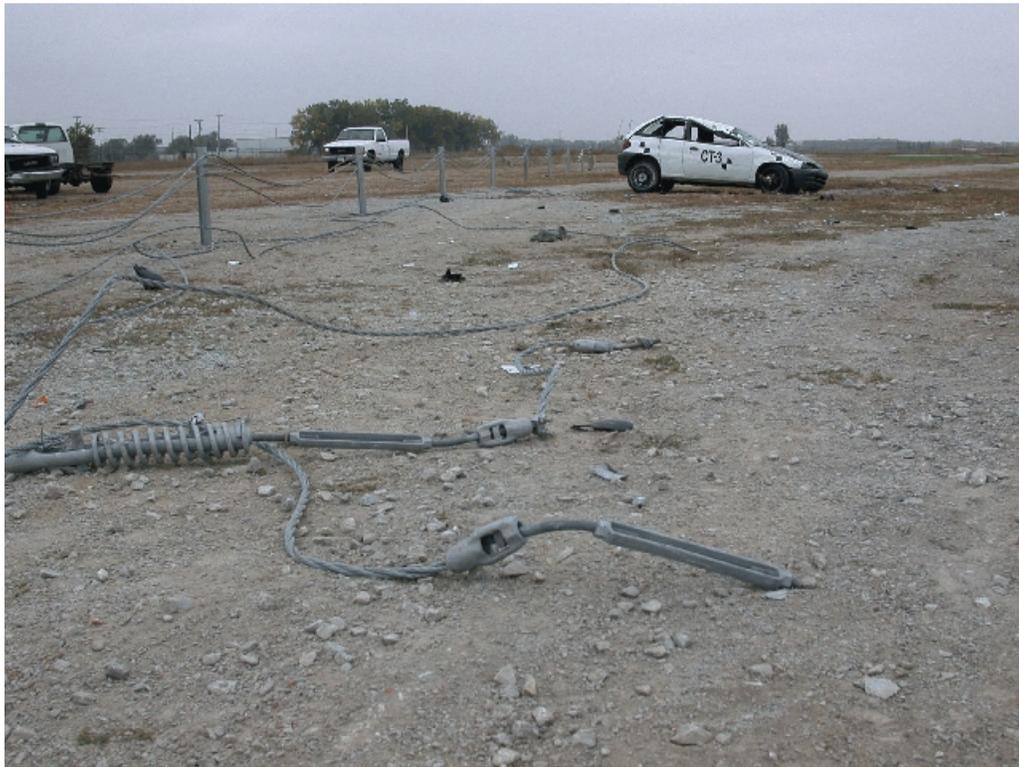
Figure 74. System Damage, Test CT-3

Damage to the cable guardrail end terminal was moderate, as shown in Figures 74 through 81. Barrier damage consisted of contact marks on posts, deformed line posts, disengaged cable and deformed cable hooks. The length of vehicle contact along the cable system was approximately 24.0 m (78 ft - 8 in.), which spanned from post no. 1 through post no. 7.

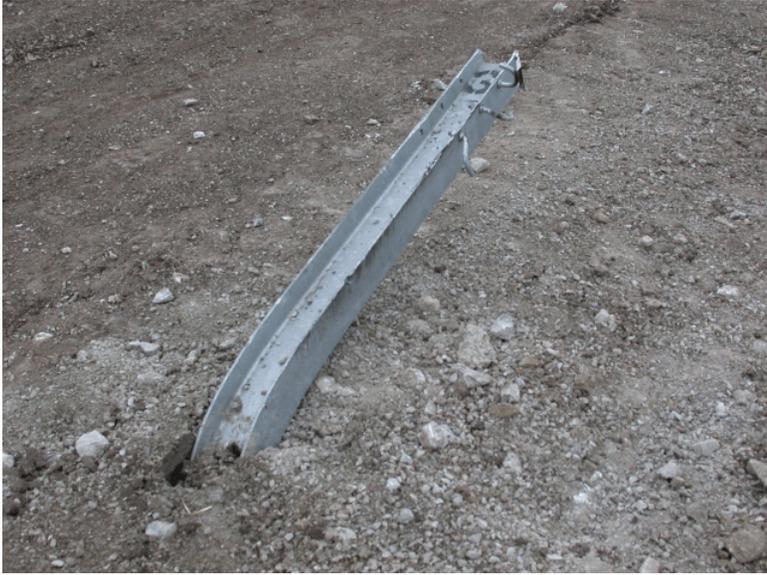
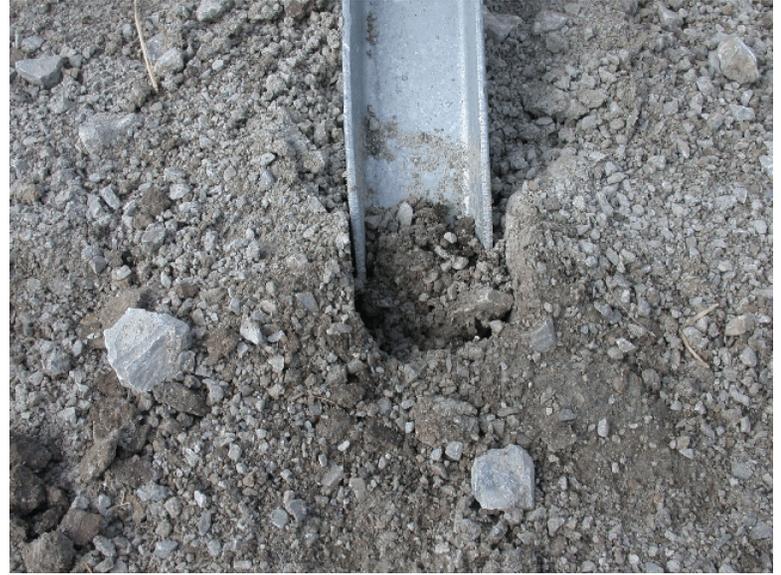
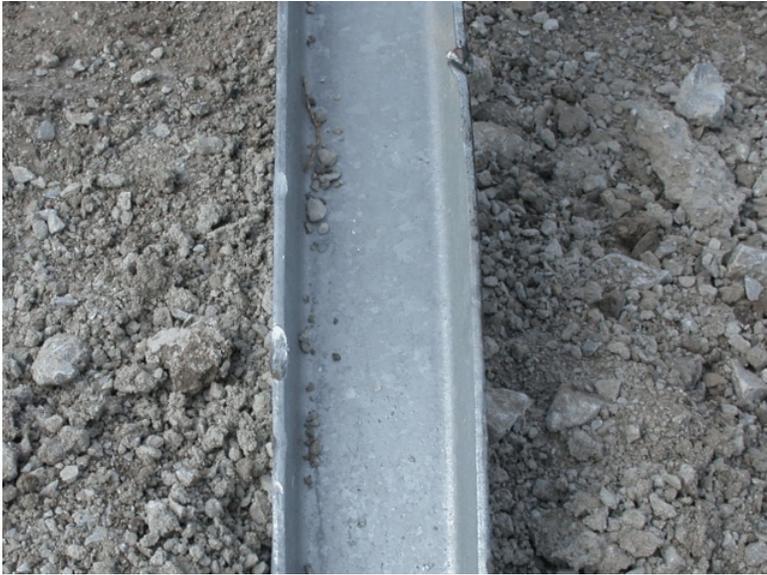
Figure 77. Post No. 2 Damage, Test CT-3

Minor scrapes were found around the edge of the anchor bracket keeper plate. The brass keeper rod was deformed. The cable release lever disengaged from the system. The upstream and traffic-side edges of the bearing strut of post no. 2 was damaged. The top portion of post no. 2 disengaged from the system, and contact marks were found on this portion of the post. Post no. 3 was bent downstream with very little rotation and twisting. Contact marks and scrapes were found on the upstream edge of the traffic-side and backside flanges. Post no. 4 bent downstream and encountered contact marks and gouges along the upstream edges of the traffic-side and backside flanges. Post no. 5 was bent downstream with little twisting and rotation. Post no. 6 bent to almost in contact with the ground and rotated backwards in the soil slightly. Post no. 7 was bent downstream, although not as

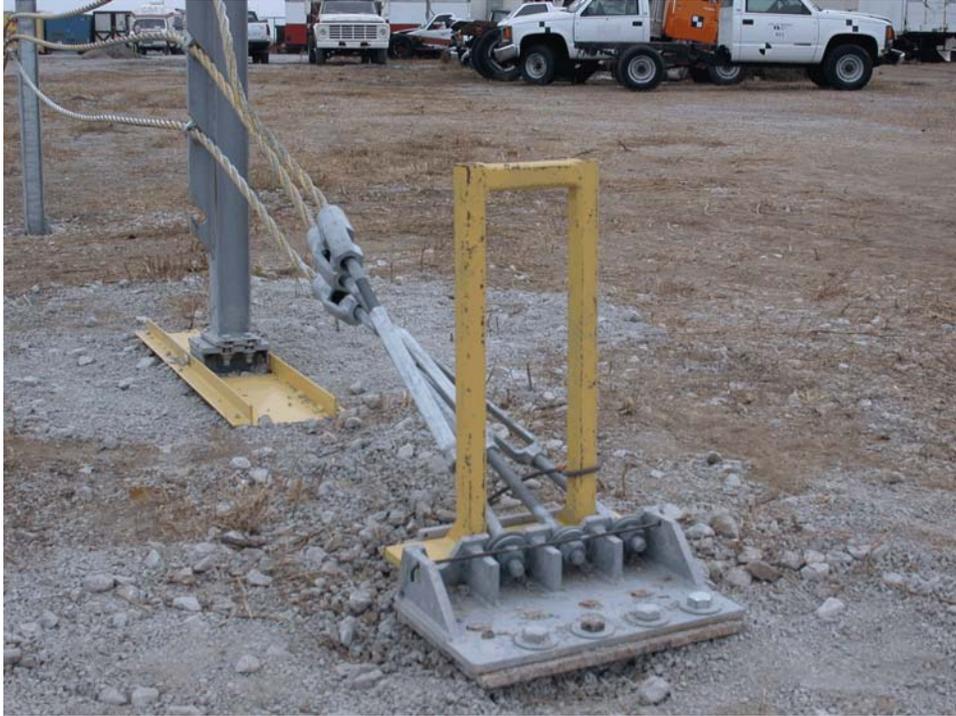
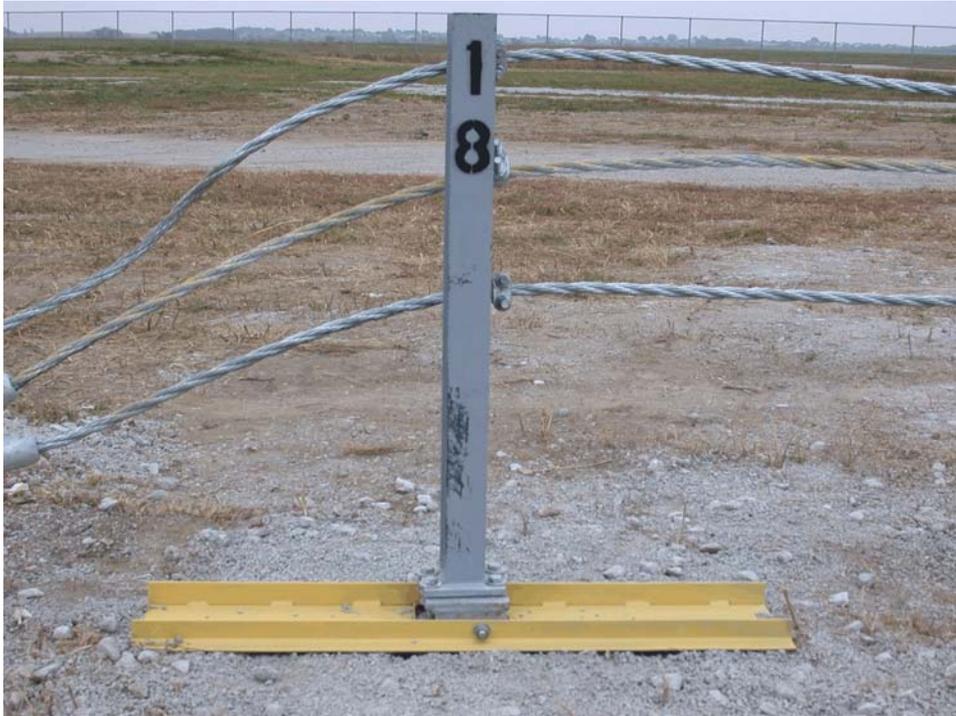
Figure 80. Post Nos. 6 and 7 Damage, Test CT-3

severe as post nos. 3 through 6. The remainder of the downstream posts showed no evidence of movement nor damage.

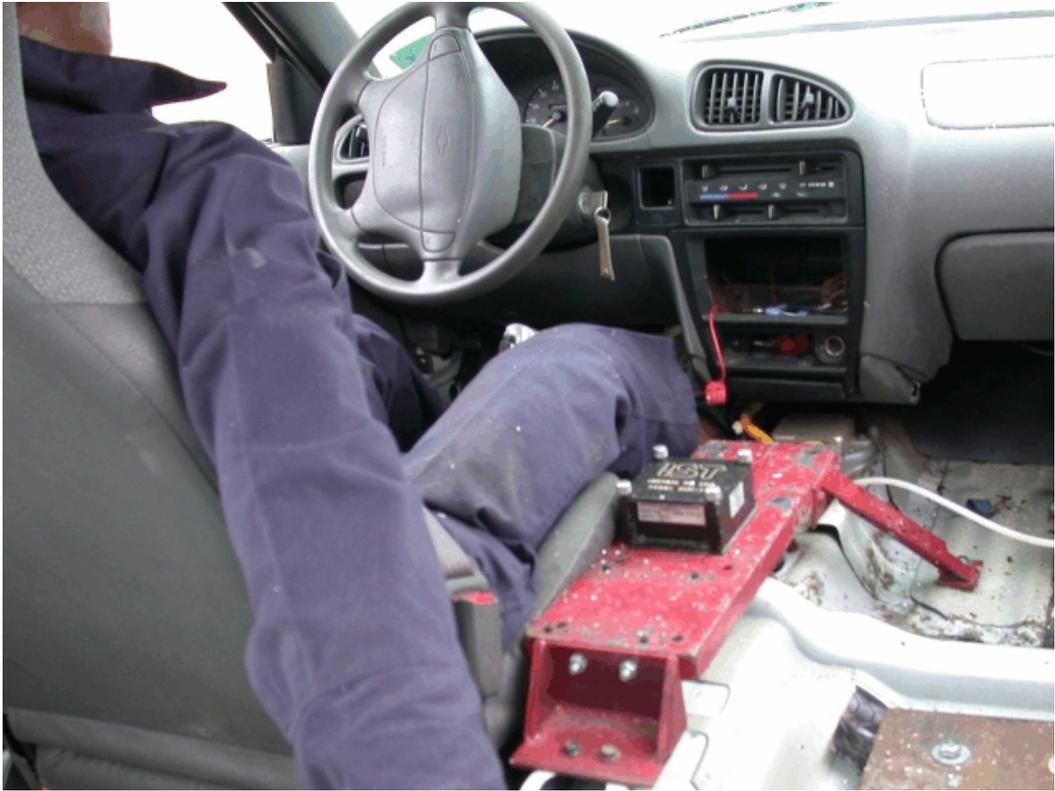
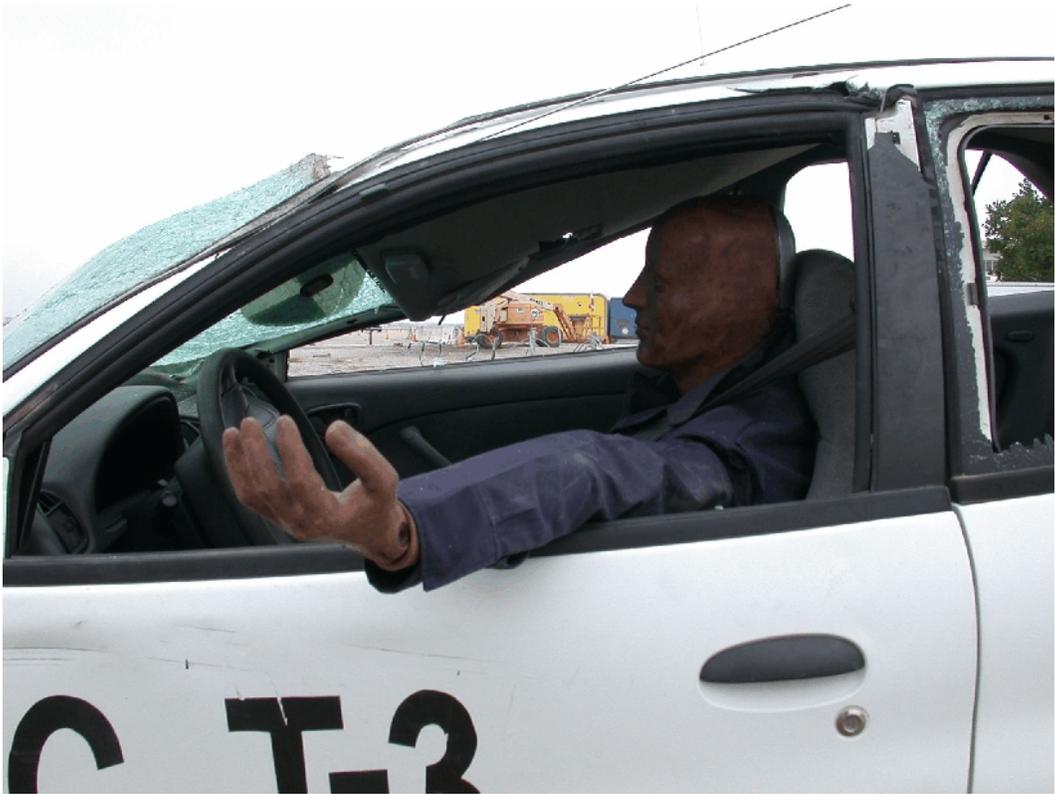
Figure 84. Occupant Compartment Damage, Test CT-3

Interaction with the cable release lever which detached from the system and penetrated the floorpan is believed to have induced vehicle rollover. Therefore, test no. CT-3 was determined to be unacceptable according to the TL-3 safety performance criteria of test designation no. 3-30 found in NCHRP Report No. 350 due to vehicle rollover.

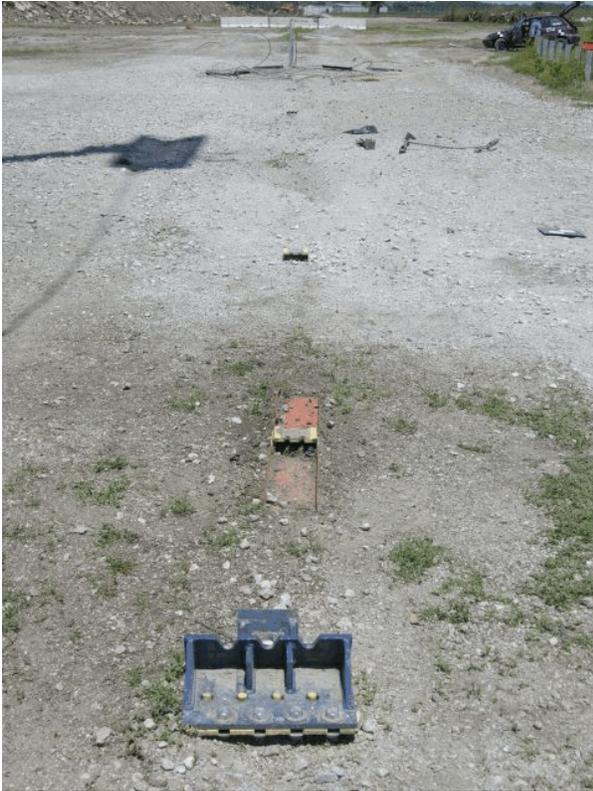
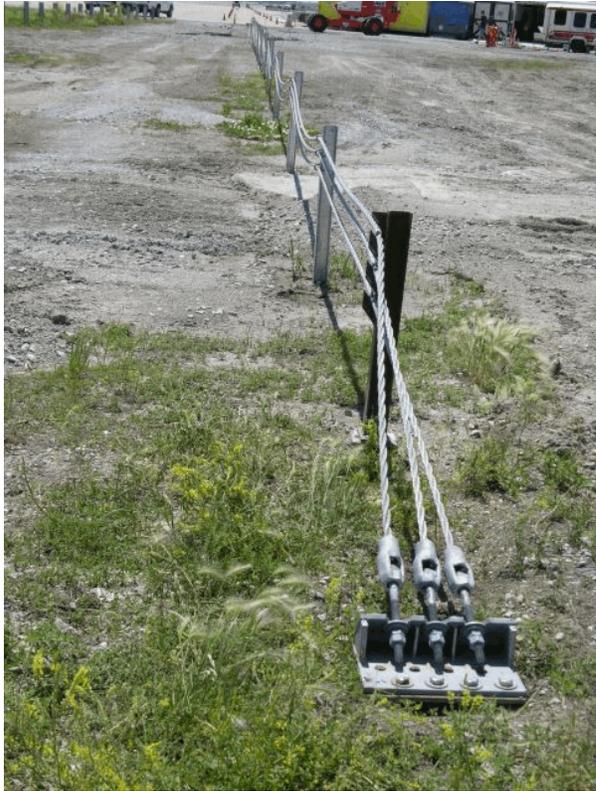
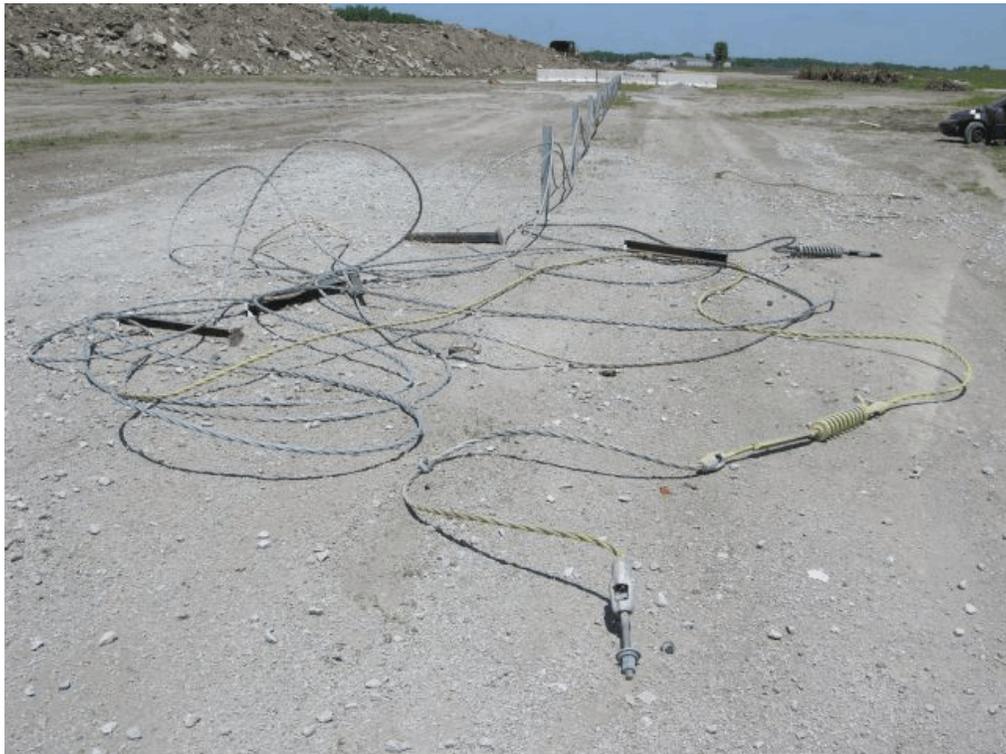
Figure 102. System Damage, Test CT-4

Damage to the cable guardrail end terminal system was moderate, as shown in Figures 102 through 106. Barrier damage consisted of contact marks on posts, deformed and disengaged line posts, disengaged cables, and deformed cable hooks. The length of vehicle contact along the cable system was approximately 24.0 m (78 ft - 8 in.), which spanned from post no. 1 through post no. 7.

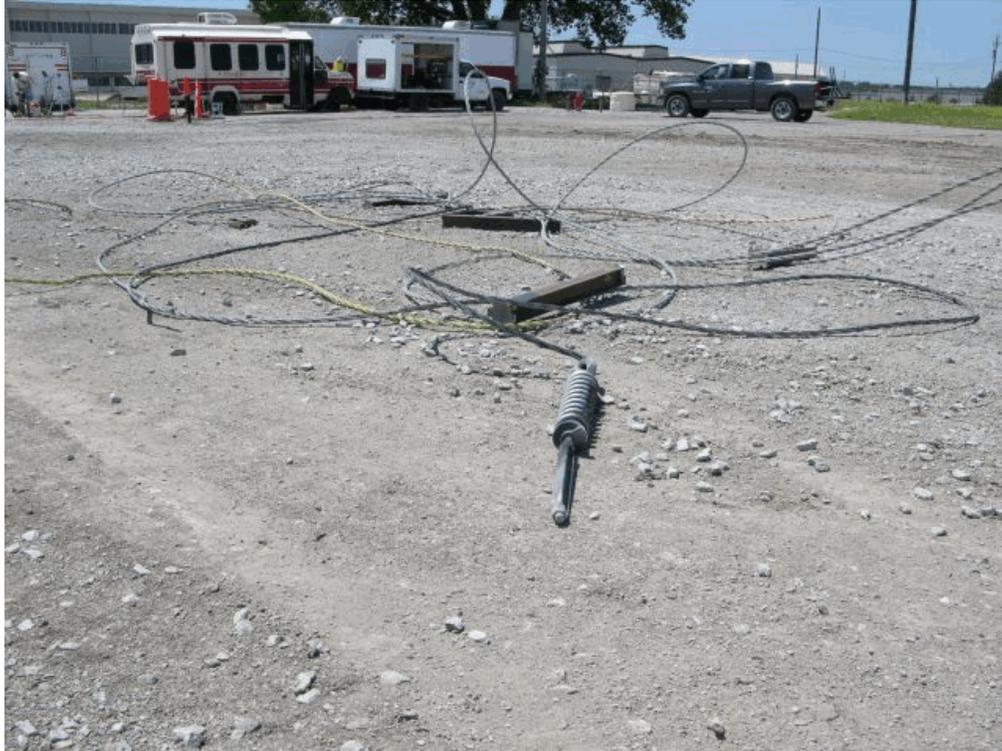
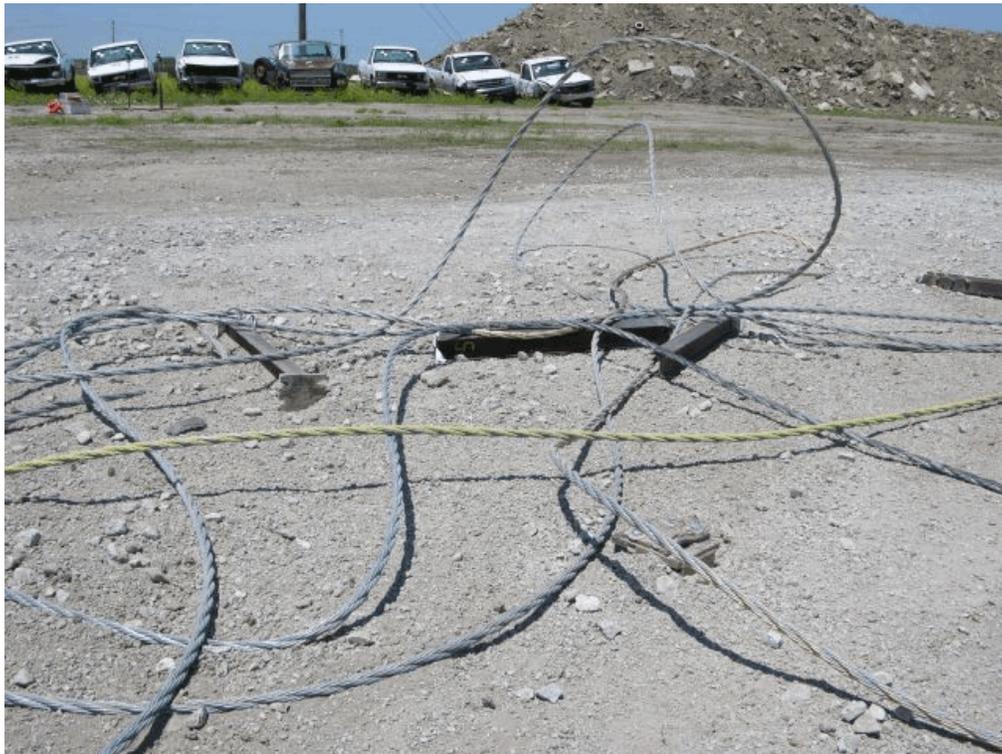
Figure 106. Post Nos. 3 through 7 Damage, Test CT-4

Post nos. 3 through 5 were bent. The welds between post no. 7 and the slip plate fractured. The slip plate of post no. 7 remained attached to the foundation portion of the post and was deformed on the upstream edge. Post no. 2 came to rest 8.66 m (28 ft - 5 in.) downstream from its original position and 0.89 m (2 ft - 11 in.) laterally away from the traffic-side face of the barrier. Post no. 3 came to rest 22.83 m (74 ft - 11 in.) downstream from its original position and 76 mm (3 in.) laterally behind the barrier. Post no. 4 came to rest 17.35 m (56 ft - 11 in.) downstream from its original position and 1.68 m (5 ft - 6 in.) laterally behind the barrier. Post no. 5 came to rest 10.90 m (35 ft - 9 in.) downstream from its original position and 1,092 mm (3 ft - 7 in.). Post no. 6 came to rest 4.88 m (16 ft) downstream from its original position and 1,194 mm (3 ft - 11 in.) laterally behind the barrier. Post no. 7 came to rest 940 mm (3 ft - 1 in.) downstream from its original position and 762 mm (30 in.) laterally behind the barrier. The remainder of the downstream posts showed no evidence of movement nor damage.
