TEST REPORT No. 2

ALUMINUM BRIDGE RAIL SYSTEMS

Texas A&M Research Foundation

March 1980

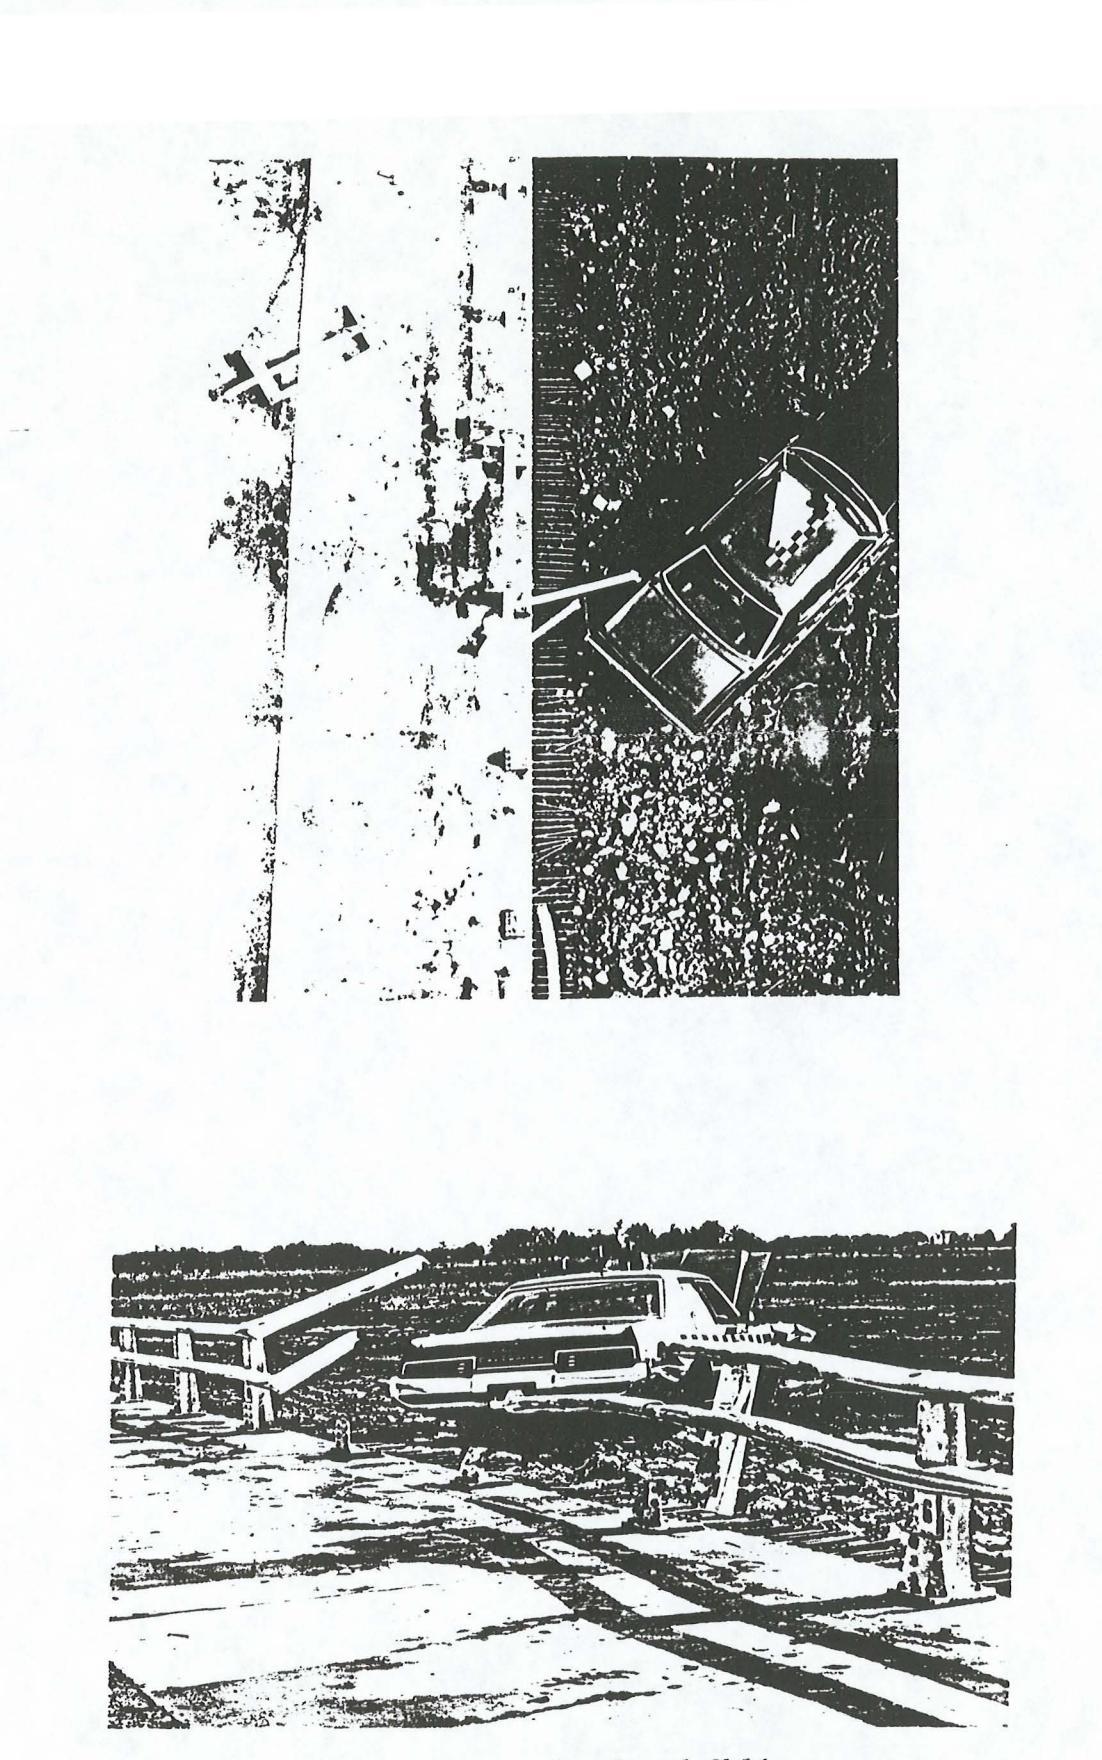
Figure 5. Overhead and Oblique Views of Test Area After Test 4182-2.

Figures 3 and 4 depict the vehicle and test area before and after the impact. Figure 5 includes overhead and oblique views of the impact area. It can be seen that posts 7, 8 and 9 were separated from their base-plate flanges. The overhead view shows a detached section of rail from posts 8 and 9. A section of the top rail from posts 7 and 8 was thrown about 46 m (150 ft) from the point of impact approximately in the direction of initial vehicle travel.

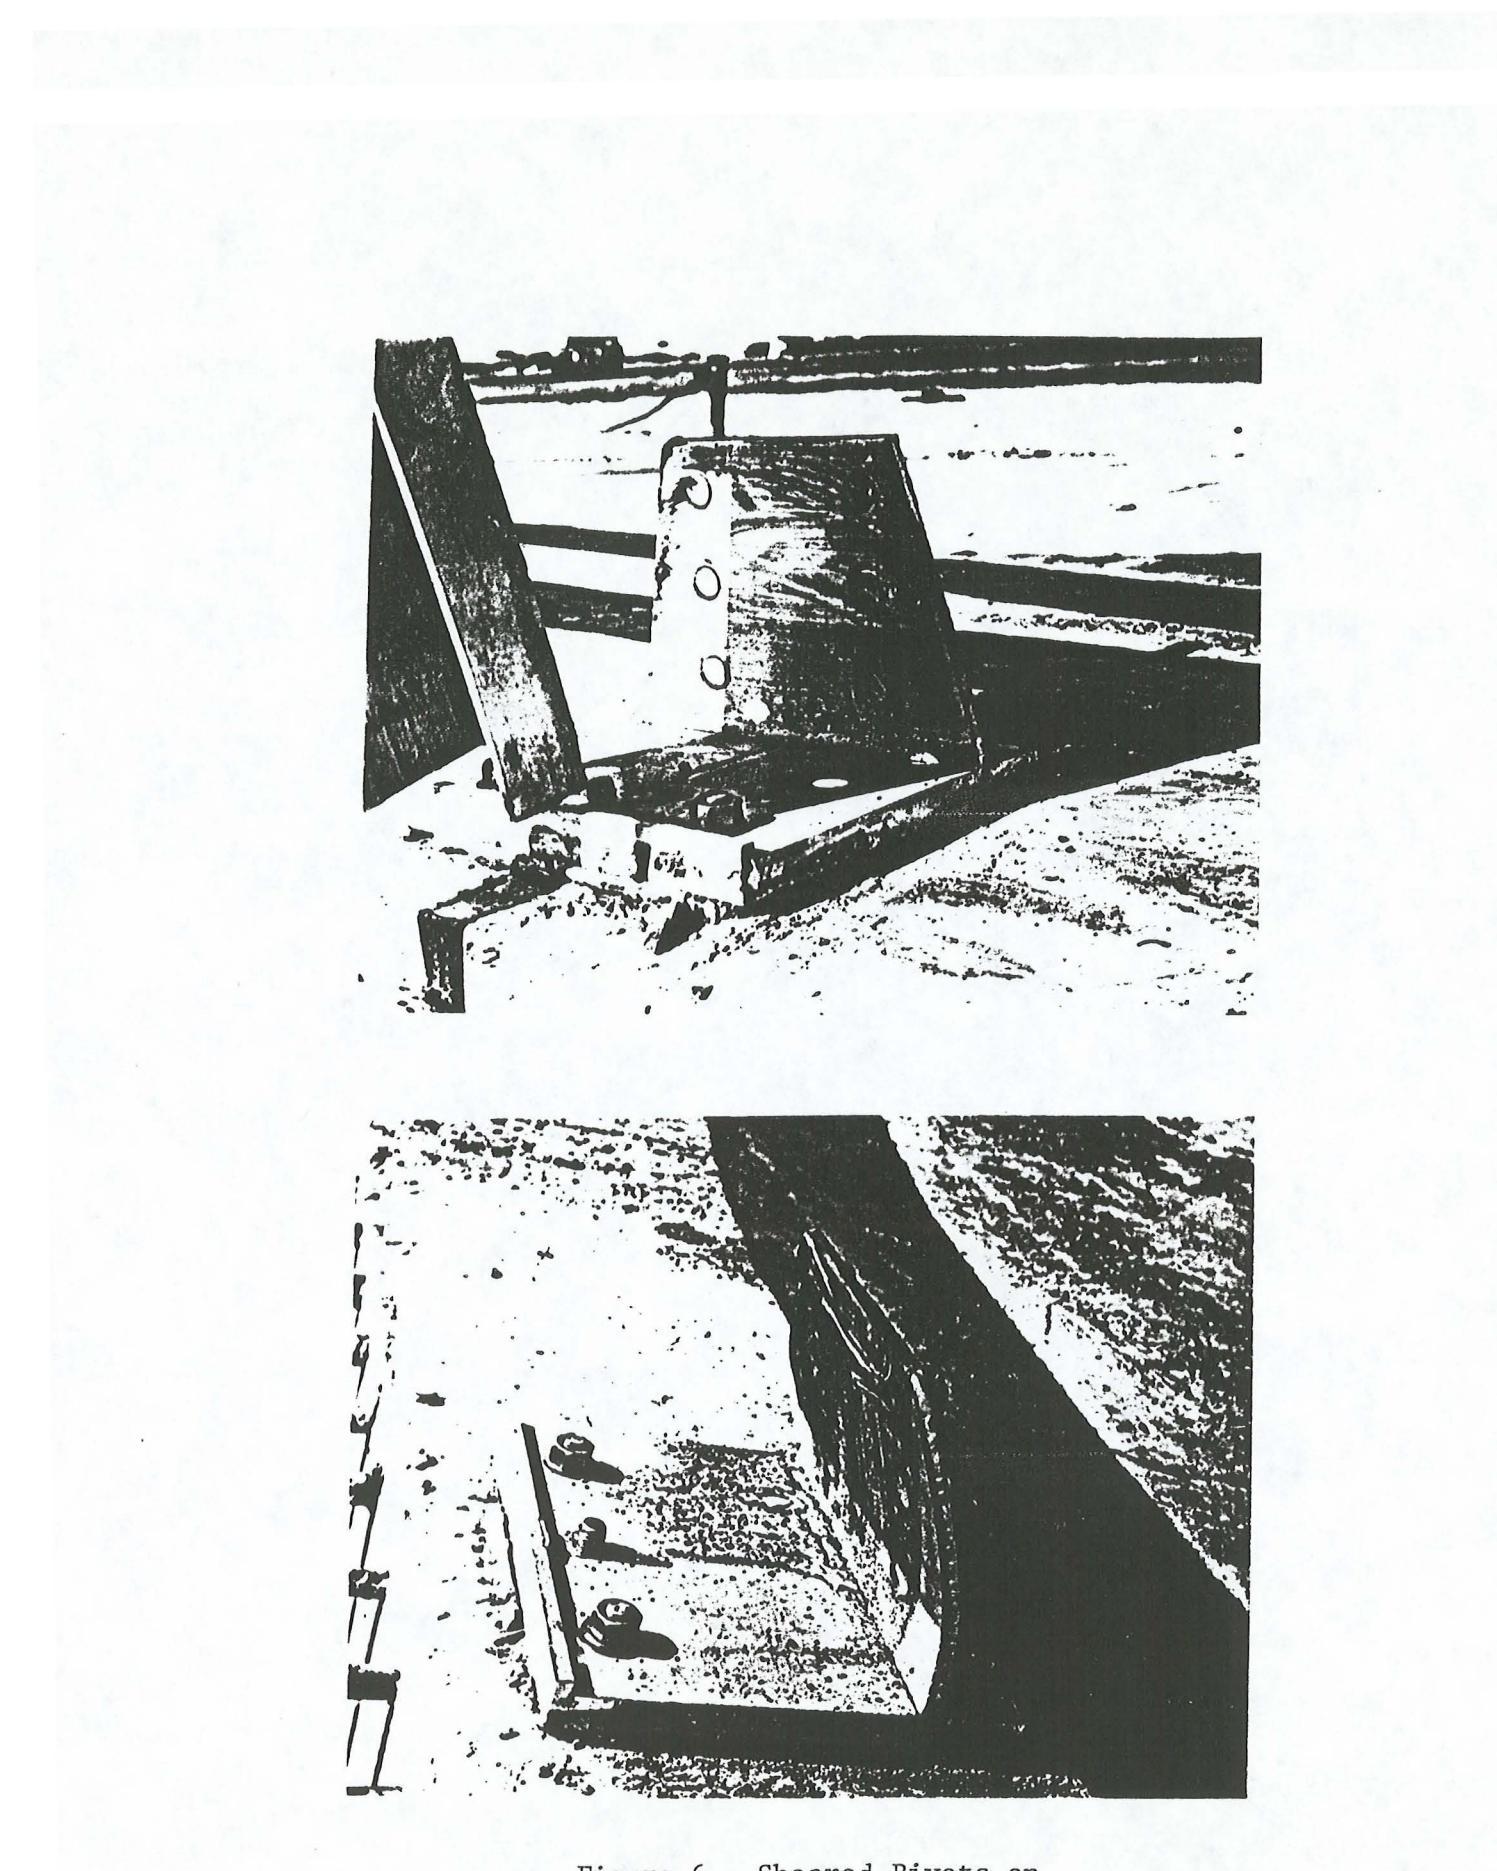
Figure 6. Sheared Rivets on Post Mountings After Test 4182-2.

The posts separated from the base-plates through shearing of the rivets as shown in Figure 6. The vehicle was not significantly redirected or contained, and traveled approximately 6.1 m (20 ft) from the rail before plowing to a stop in the soft earth behind the rail installation.
