Midwest State's Regional Pooled Fund Research Program Fiscal Year 1996-1997 (Year 7) NDOR Research Project Number SPR-3(017)

DEVELOPMENT OF A 7.62-m LONG SPAN GUARDRAIL SYSTEM

MwRSF Research Report No. TRP-03-72-99 April 6, 1999

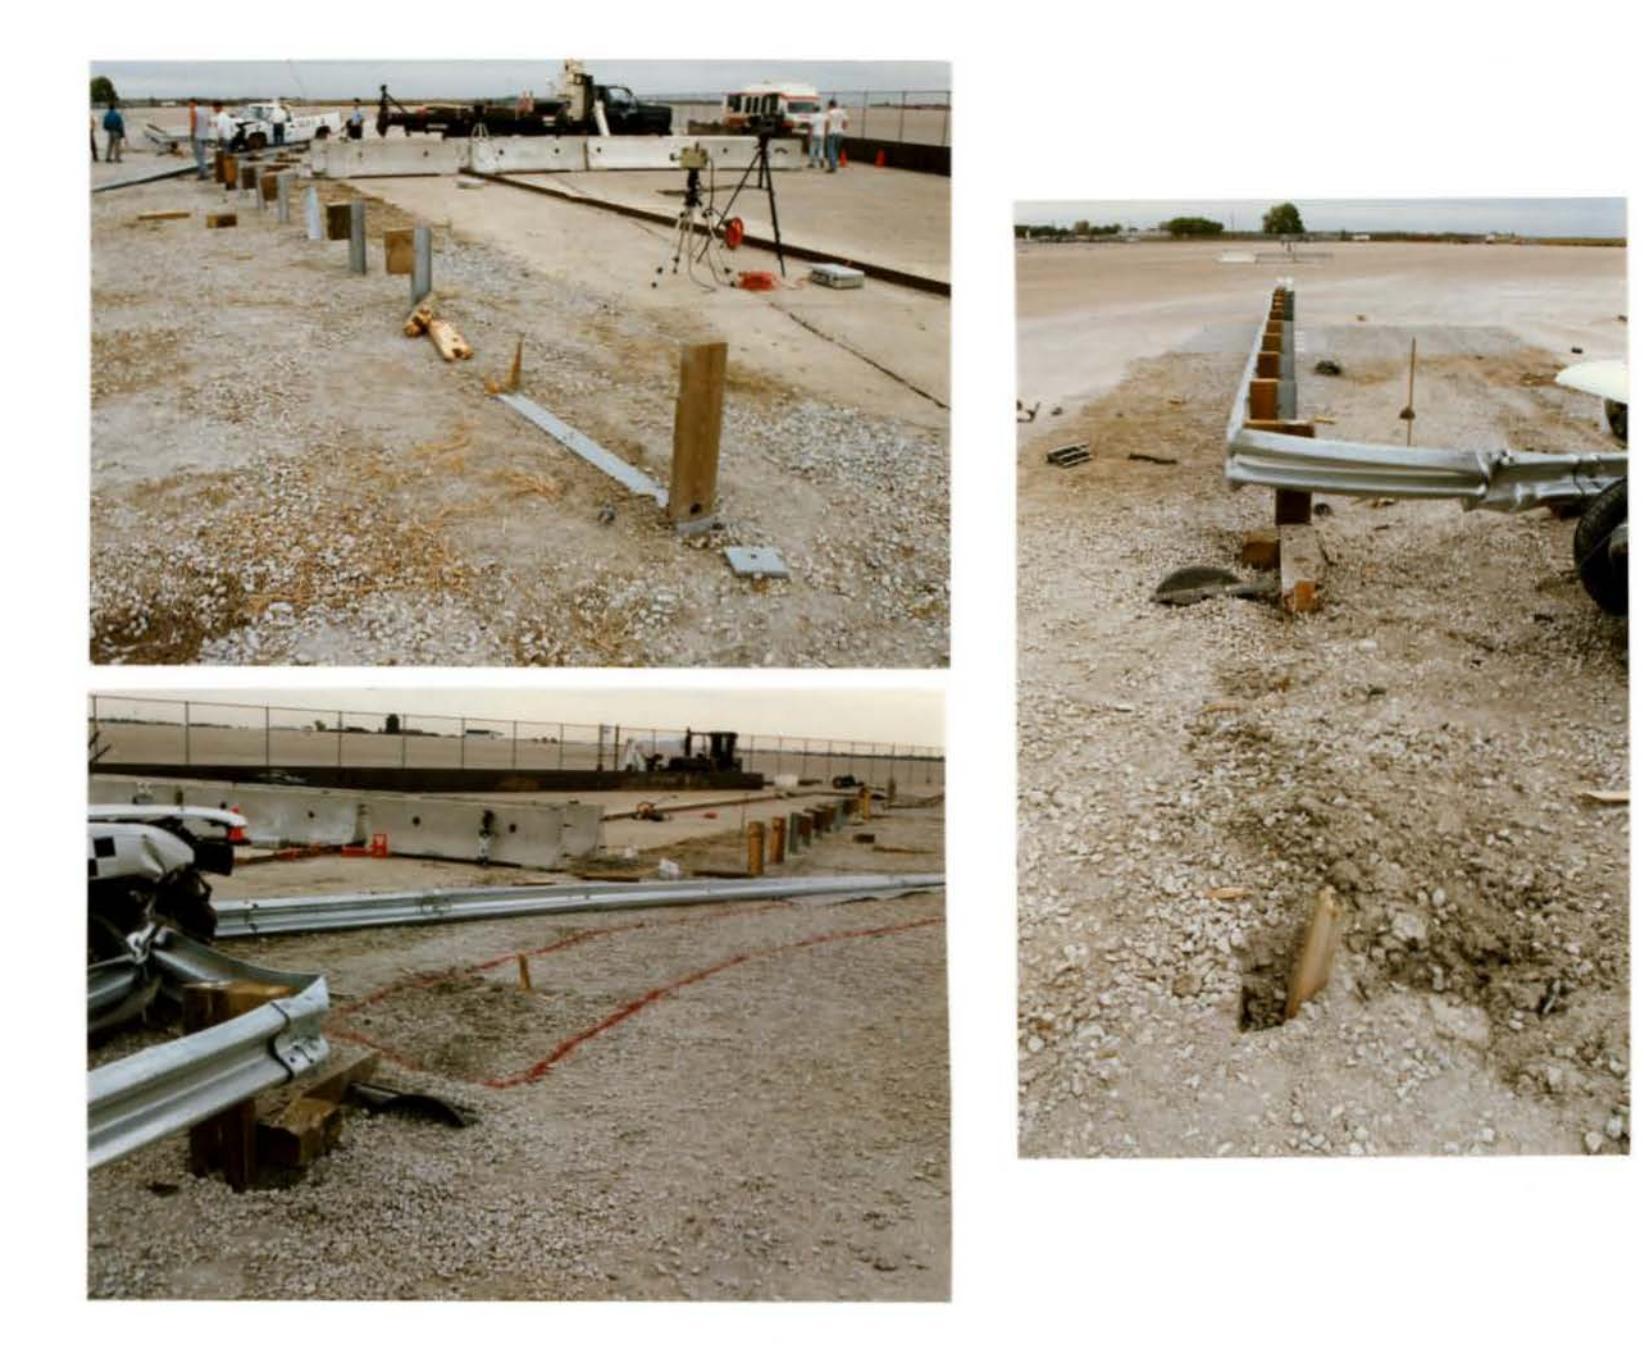
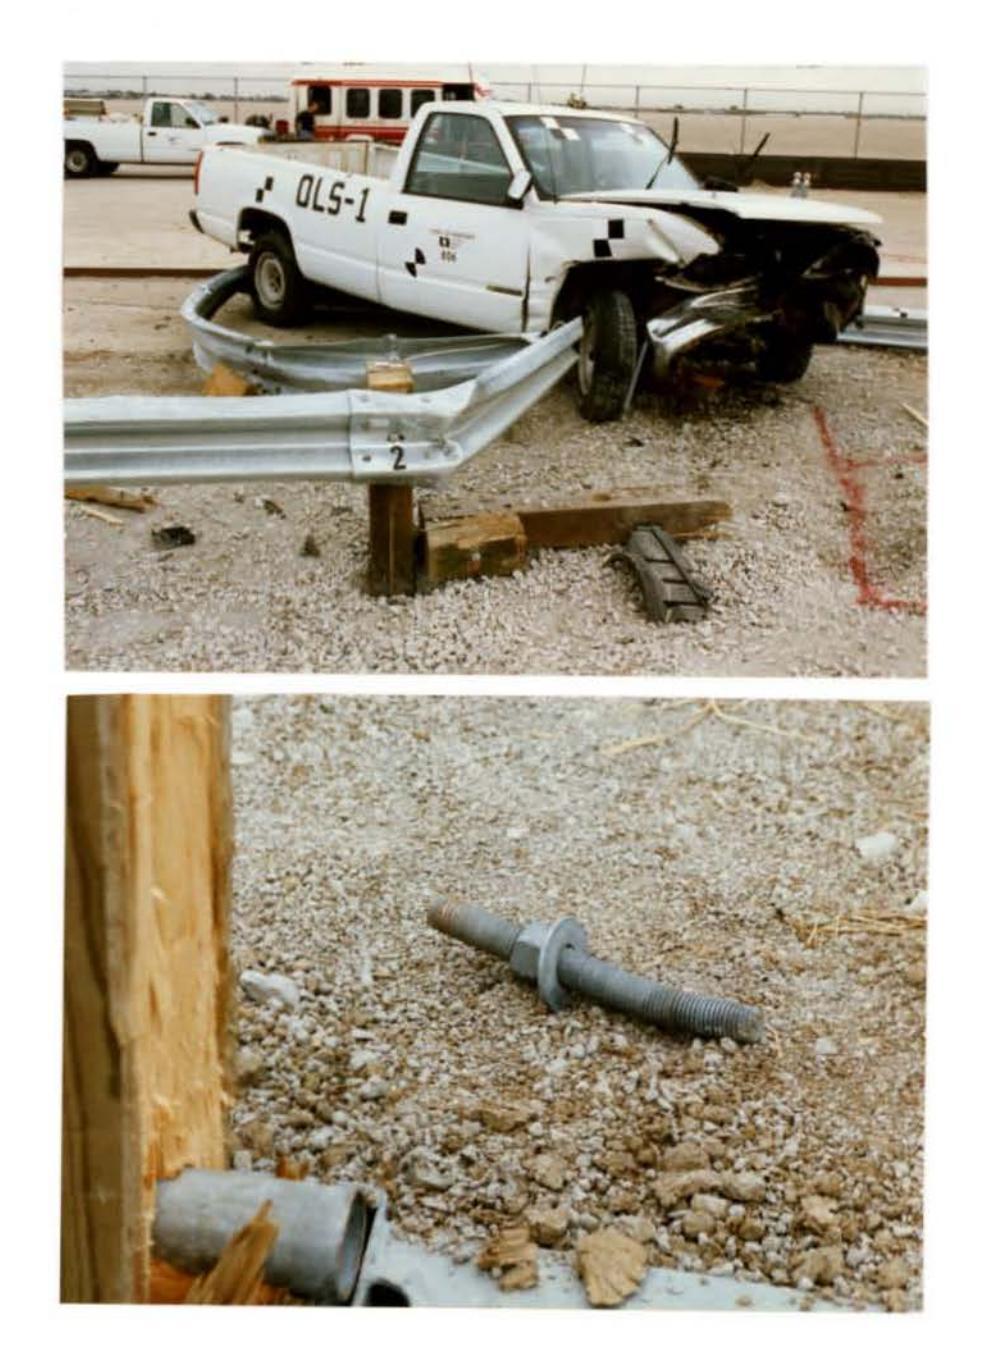
Figure 17. Long-Span Guardrail System Damage, Test OLS-1 (Design No. 1)

Damage to the barrier was extensive, as shown in Figures 17 through 19. Barrier damage consisted mostly of deformed W-beam, contact marks on a guardrail section, deformed and fractured guardrail posts, and rupture of the cable anchor system on the upstream end. The BCT's cable anchor system failed during the test due to structural inadequacies in manufacturing of the swaged fitting, as shown in Figure 19. The lower bolt that anchors the cable between the two BCT posts of the cable anchor pulled out of the swaged fitting. The inside fitting threads became smooth as the bolt was pulled out. The end of the bolt was bent and the bolt threads were deformed, as shown in Figure 19. As shown in Figures 17 through 18, the failure of the BCT cable anchor system caused significant damage to the posts and guardrail.

Four steel posts, post nos. 8 through 11, were twisted and deformed. Both BCT posts were damaged with complete fracture of post no. 14 and partial splitting of post no. 15. Four CRT posts, nos. 3 through 5 were completely fractured, while post nos. 6 and 7 were partially split and remained standing. No significant post or guardrail damage occurred downstream of post no. 2.

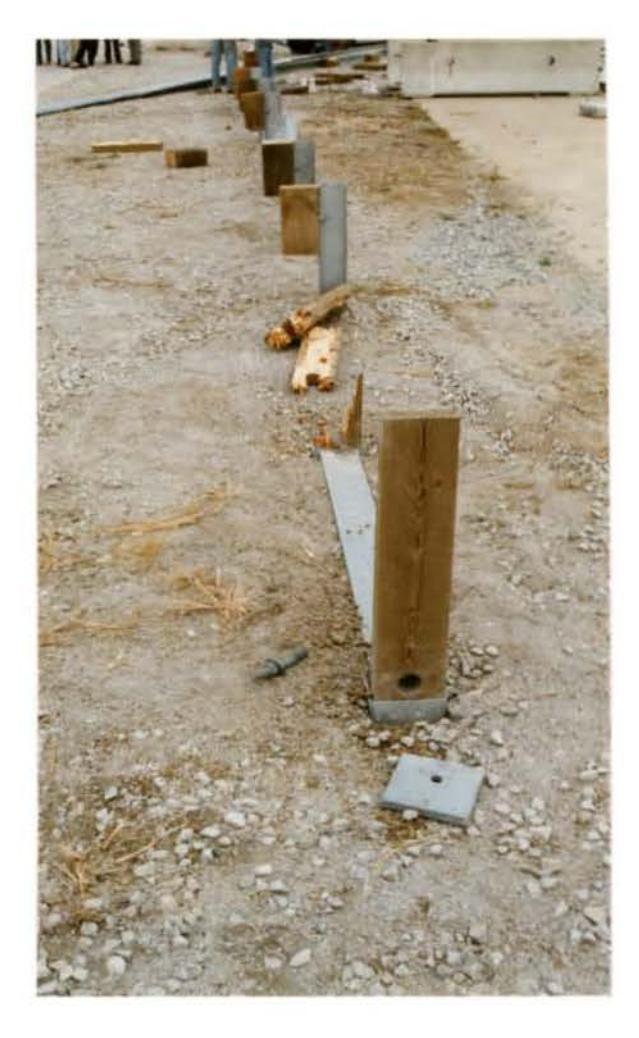
Figure 18. Long-Span Guardrail System Damage, Test OLS-1 (Design No. 1)

The W-beam pulled off of post nos. 5 through 15. Contact marks were found on the guardrail between post nos. 3 and 4. Major guardrail buckling occurred upstream of post no. 2 and at post no. 3, with the buckling point at 3,810-mm downstream from post no. 5, as shown in Figure 18.

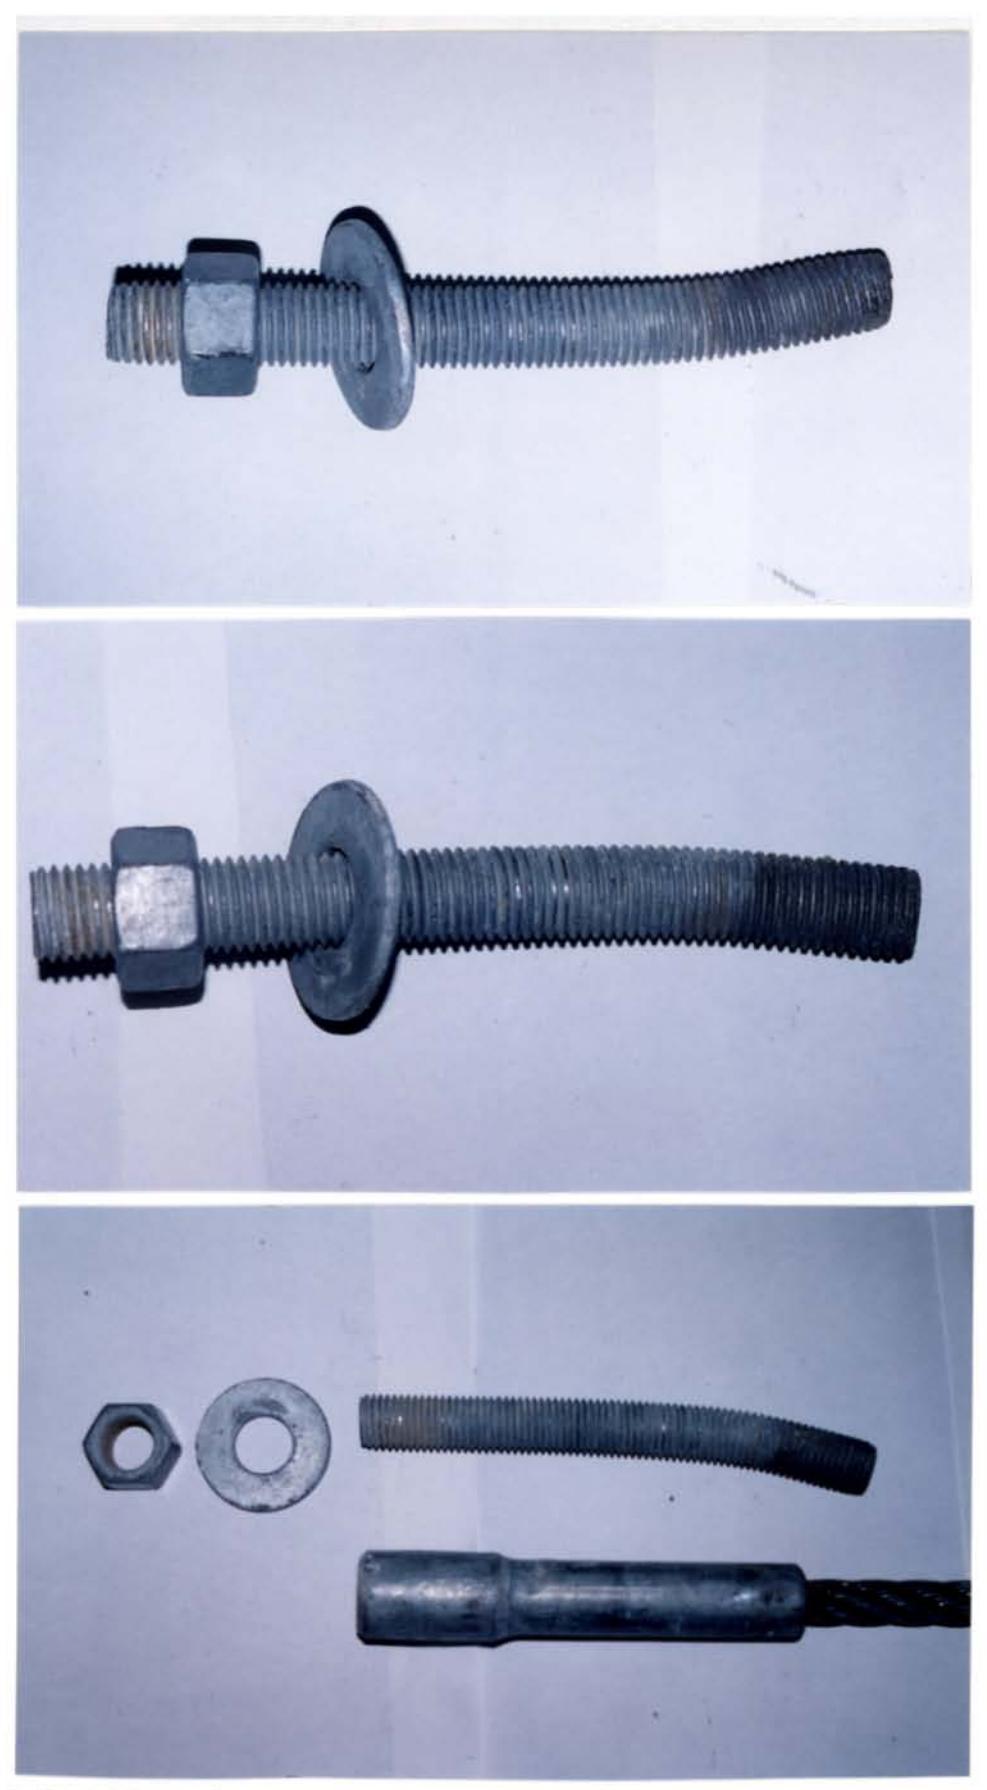
Figure 19. BCT Cable Anchor Damage, Test OLS-1 (Design No. 1)

An analysis of the test results revealed that the vehicle did not override the long-span guardrail during the impact prior to the cable anchor failure. The lower cable anchor stud pulled out of the swaged fitting due to structural inadequacies in manufacturing. The release of the swaged fitting caused the guardrail to loose its tensile capacity. In addition, the loss of tensile capacity led to significant vehicle penetration into the guardrail system.

Following this investigation, MwRSF researchers determined that the safety performance of the long-span guardrail system (Design No. 1) could be significantly improved if the cable anchor system remains intact and develops the guardrail's tensile capacity. In order to overcome the loss of guardrail tensile capacity during test OLS-1, several modifications were made to the long-span guardrail system. The cable in the simulated BCT cable anchor system was replaced with a new cable that was more consistent with the required specifications. In addition, three other modifications were made to the guardrail system configuration prior to the retest. First, the downstream simulated anchorage device was replaced with an anchorage system more closely resembling a BCT but installed tangent to the guardrail system. Secondly, the total length of the test installation was increased to 53.34 m, while the final modification was to incorporate additional

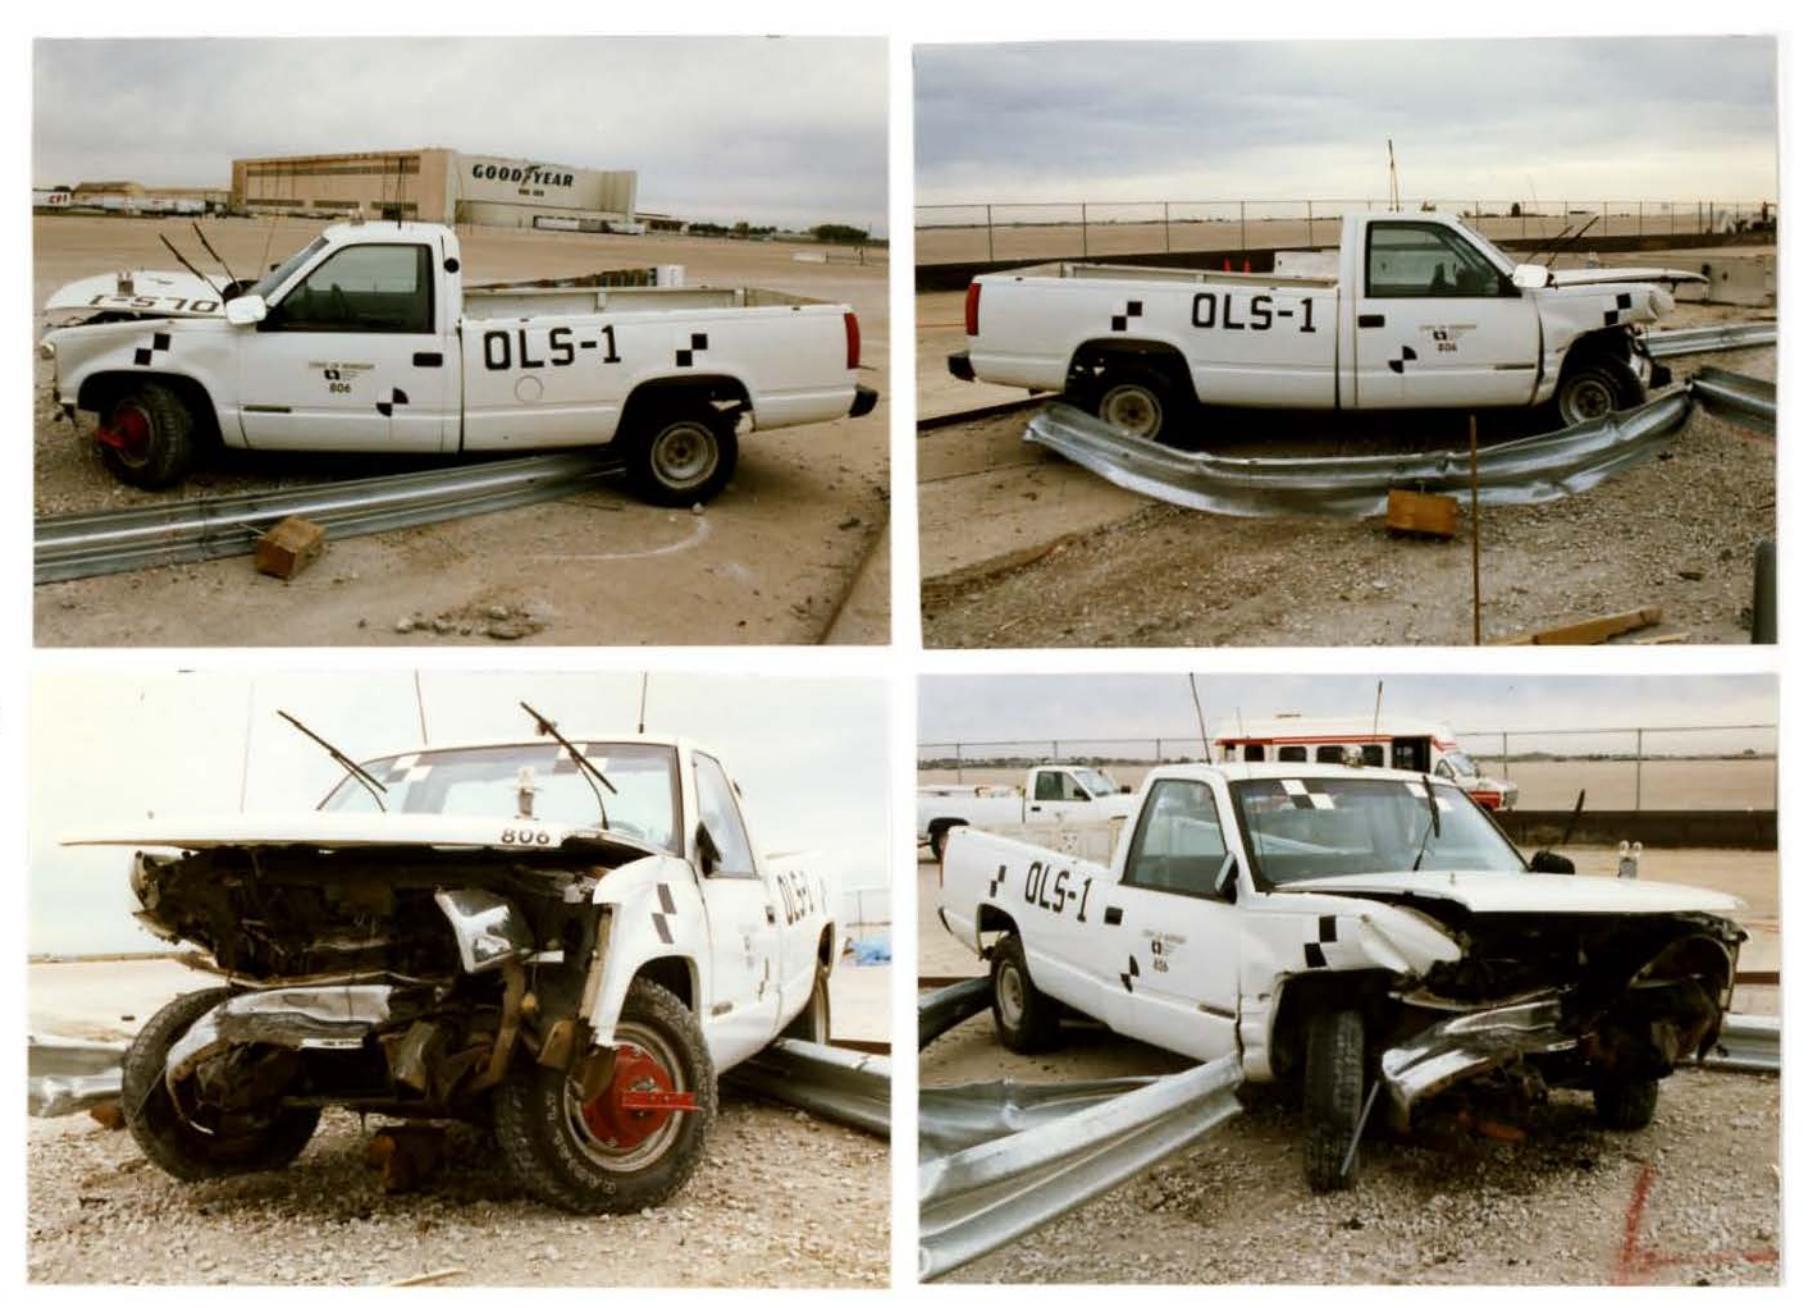
Figure 20. Vehicle Damage, Test OLS-1 (Design No. 1)

Exterior vehicle damage was moderate, as shown in Figure 20. Occupant compartment damage was negligible. The vehicle experienced extensive frontal crush, as shown in Figure 20. The radiator was crushed inward toward the engine, and the engine was displaced into the firewall. Deformation occurred to both the left-front and right-front quarter panels. Damage to the left-side door occurred on the lower-rear corner. The front bumper was ripped off of the bumper mounts, flattened, and pushed inward toward the engine compartment. Frame damage was evident by the closing of the gap between the vehicle box and cab as well as the damage to the undercarriage, as shown in Figure 20.

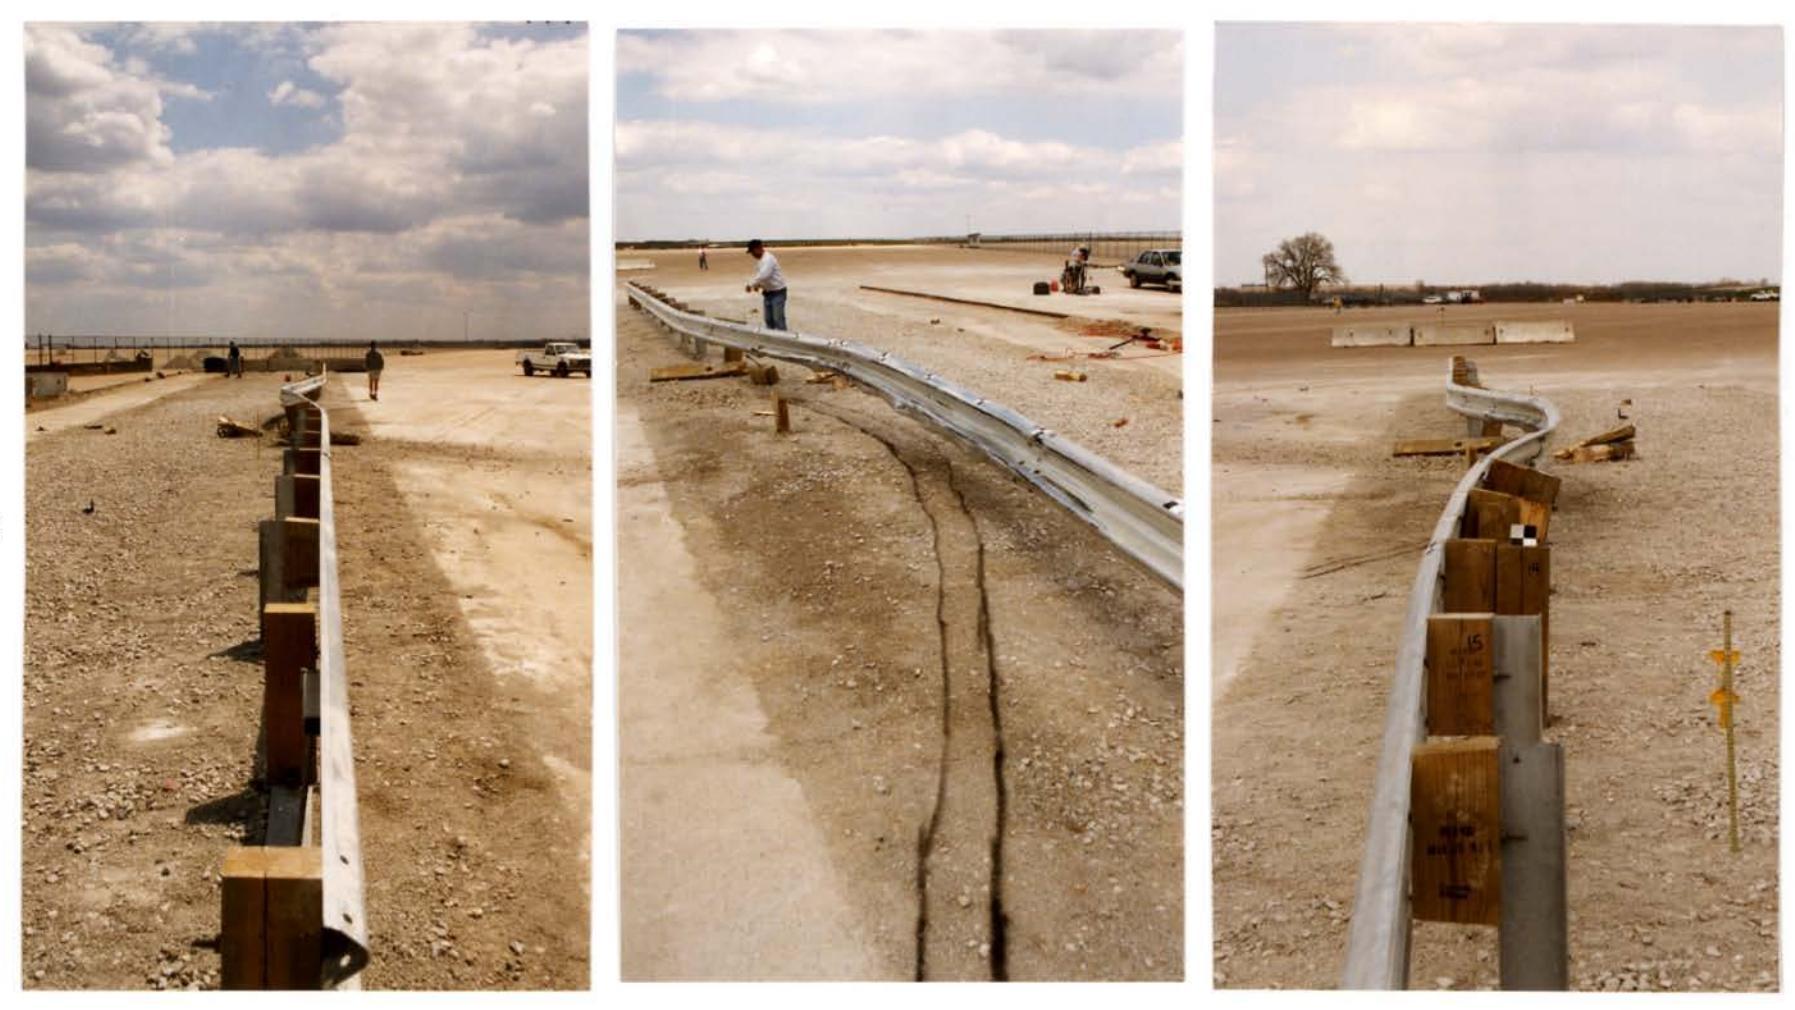
Figure 31. Long-Span Guardrail System Damage, Test OLS-2 (Design No. 2)

Damage to the barrier was moderate, as shown in Figures 31 through 34. Figures 35 and 36 show the damage to the entire length of the CRT posts, nos. 9 through 14. Barrier damage consisted mostly of deformed W-beam, contact marks on a guardrail section, and deformed and fractured guardrail posts. The W-beam damage consisted of moderate deformation and flattening of the lower portion of the impacted section between post nos. 9 and 12. The W-beam was released from post nos. 2 and 25. Contact marks were found on the guardrail between post nos. 9 and 12.

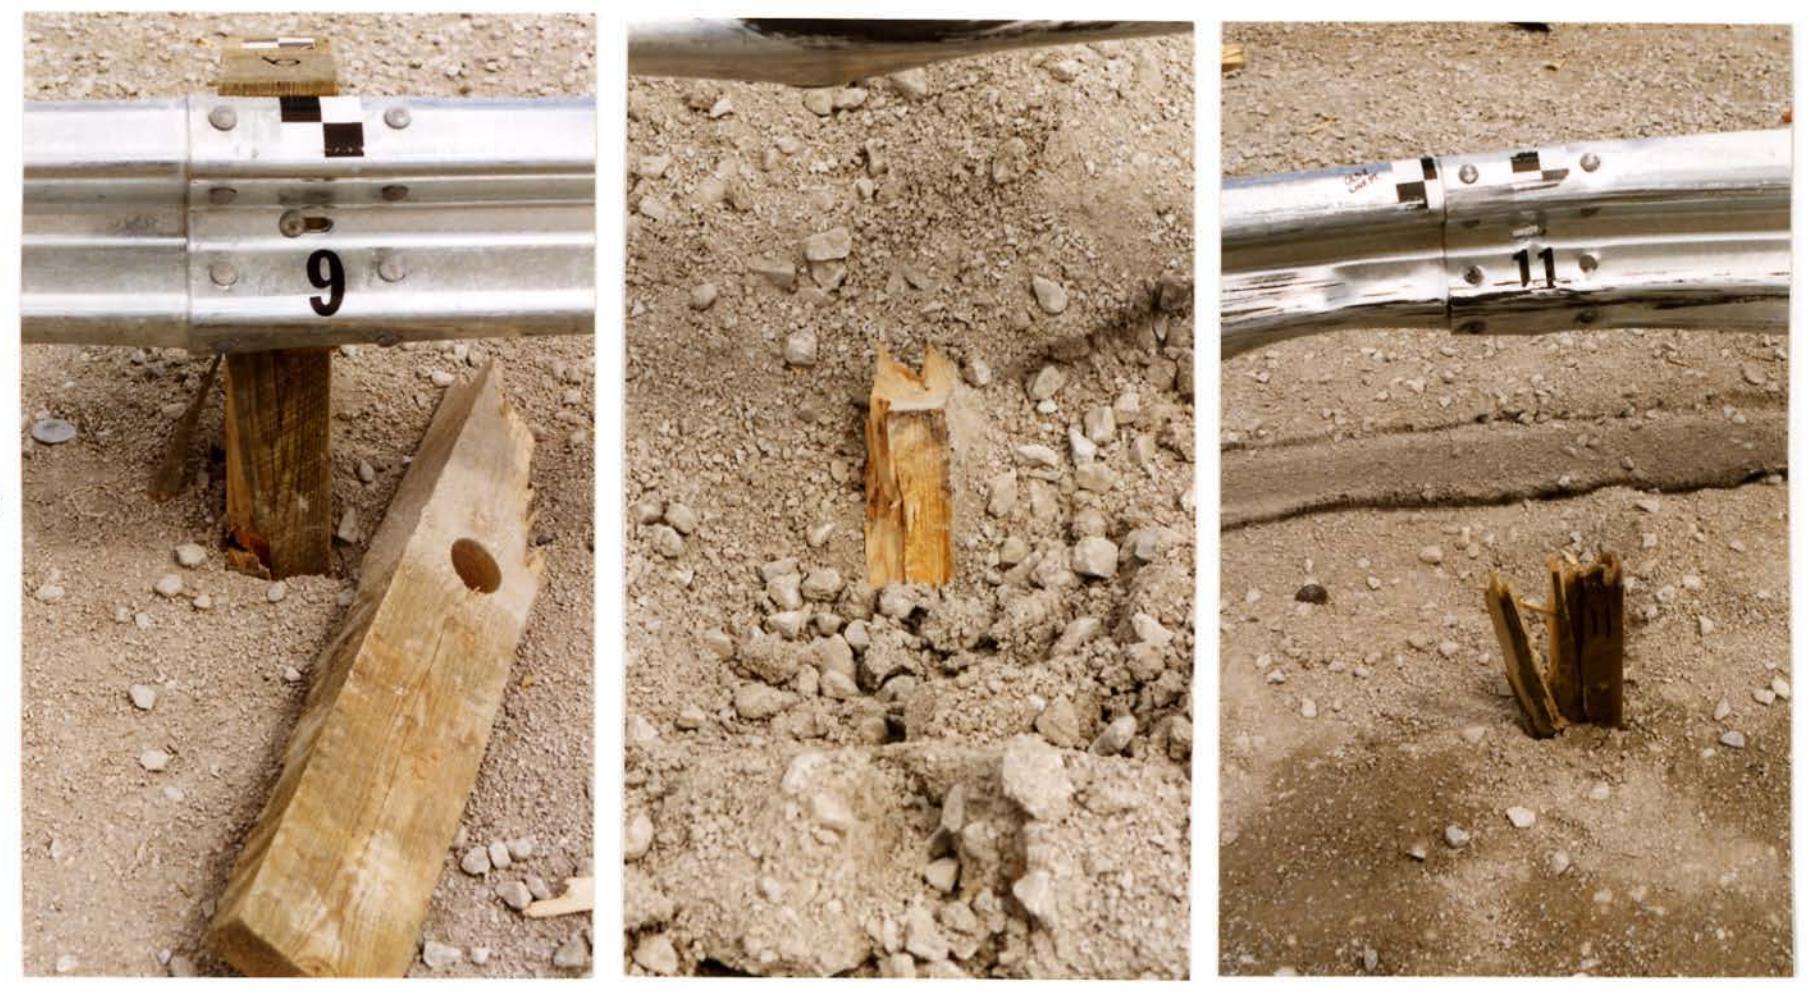
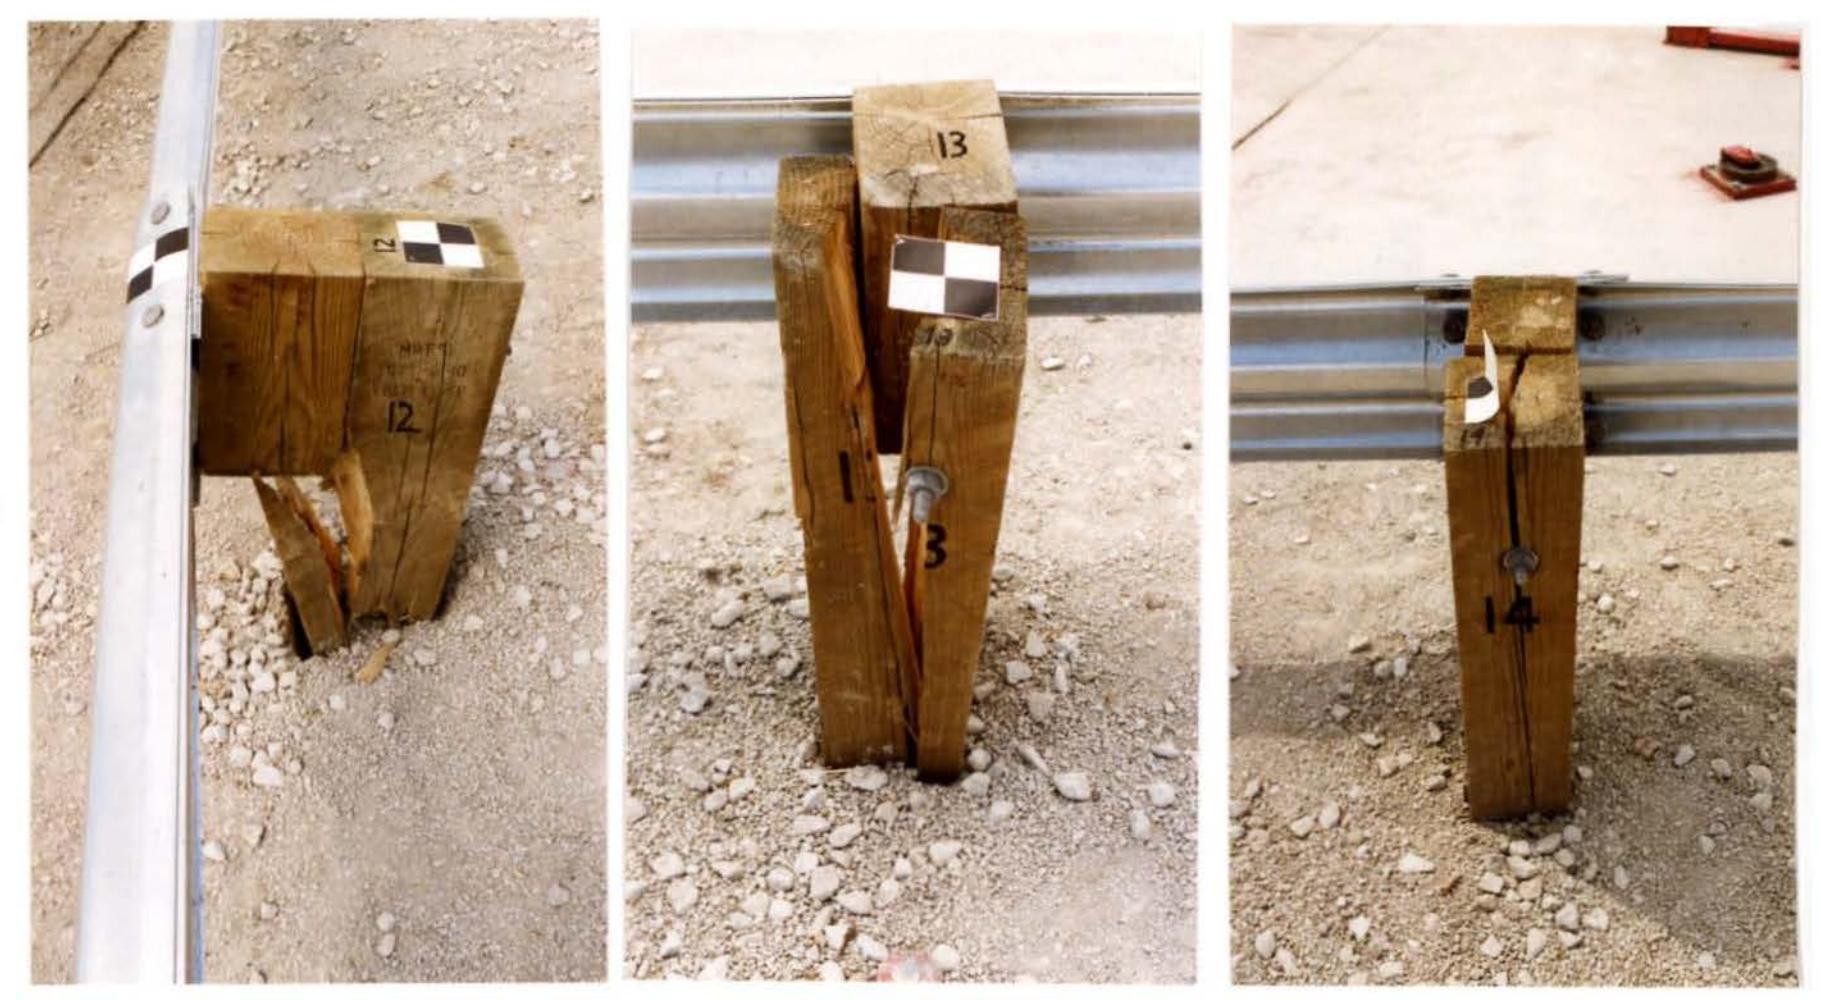
Figure 32. Final CRT Post Positions, Test OLS-2 (Design No. 2)

Two CRT posts, post nos. 10 and 11 completely fractured while CRT post nos. 12 through 14 split longitudinally and remained standing, as shown in Figures 32, 33, 35, and 36. CRT post no. 9 fractured between the breakaway holes but remained upright, as shown in Figure 32. Steel post no. 8 slightly twisted as shown in Figure 34. No significant post or guardrail damage occurred upstream of post no. 15 nor downstream of post no. 7.

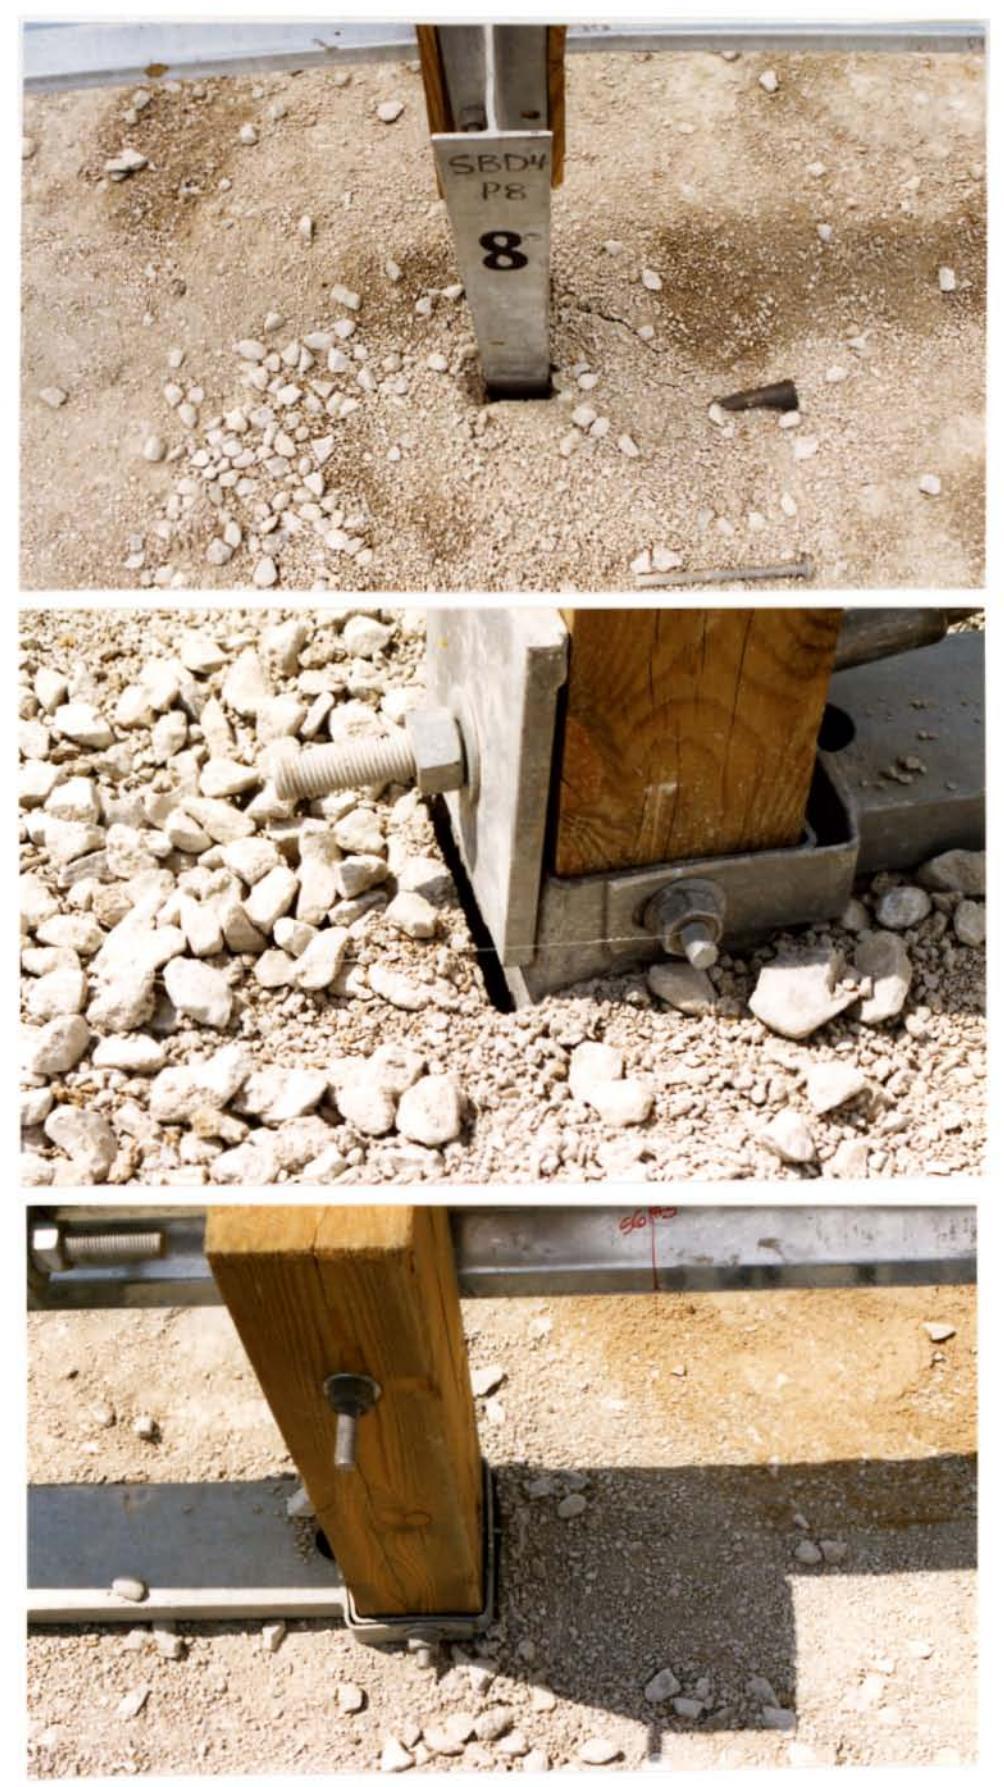
Figure 34. Permanent Set Deflections, Test OLS-2 (Design No. 2)

lateral permanent set rail and post deflections were approximately 956 mm at 5,715 mm downstream from the centerline of post no. 12 and 286 mm at post no. 12, respectively, as measured in the field. The maximum lateral dynamic rail and post defections were 1,342 mm at 6,668 mm downstream from the centerline of post no. 12 and 802 mm at post no. 10, respectively, as determined from the high-speed film analysis.

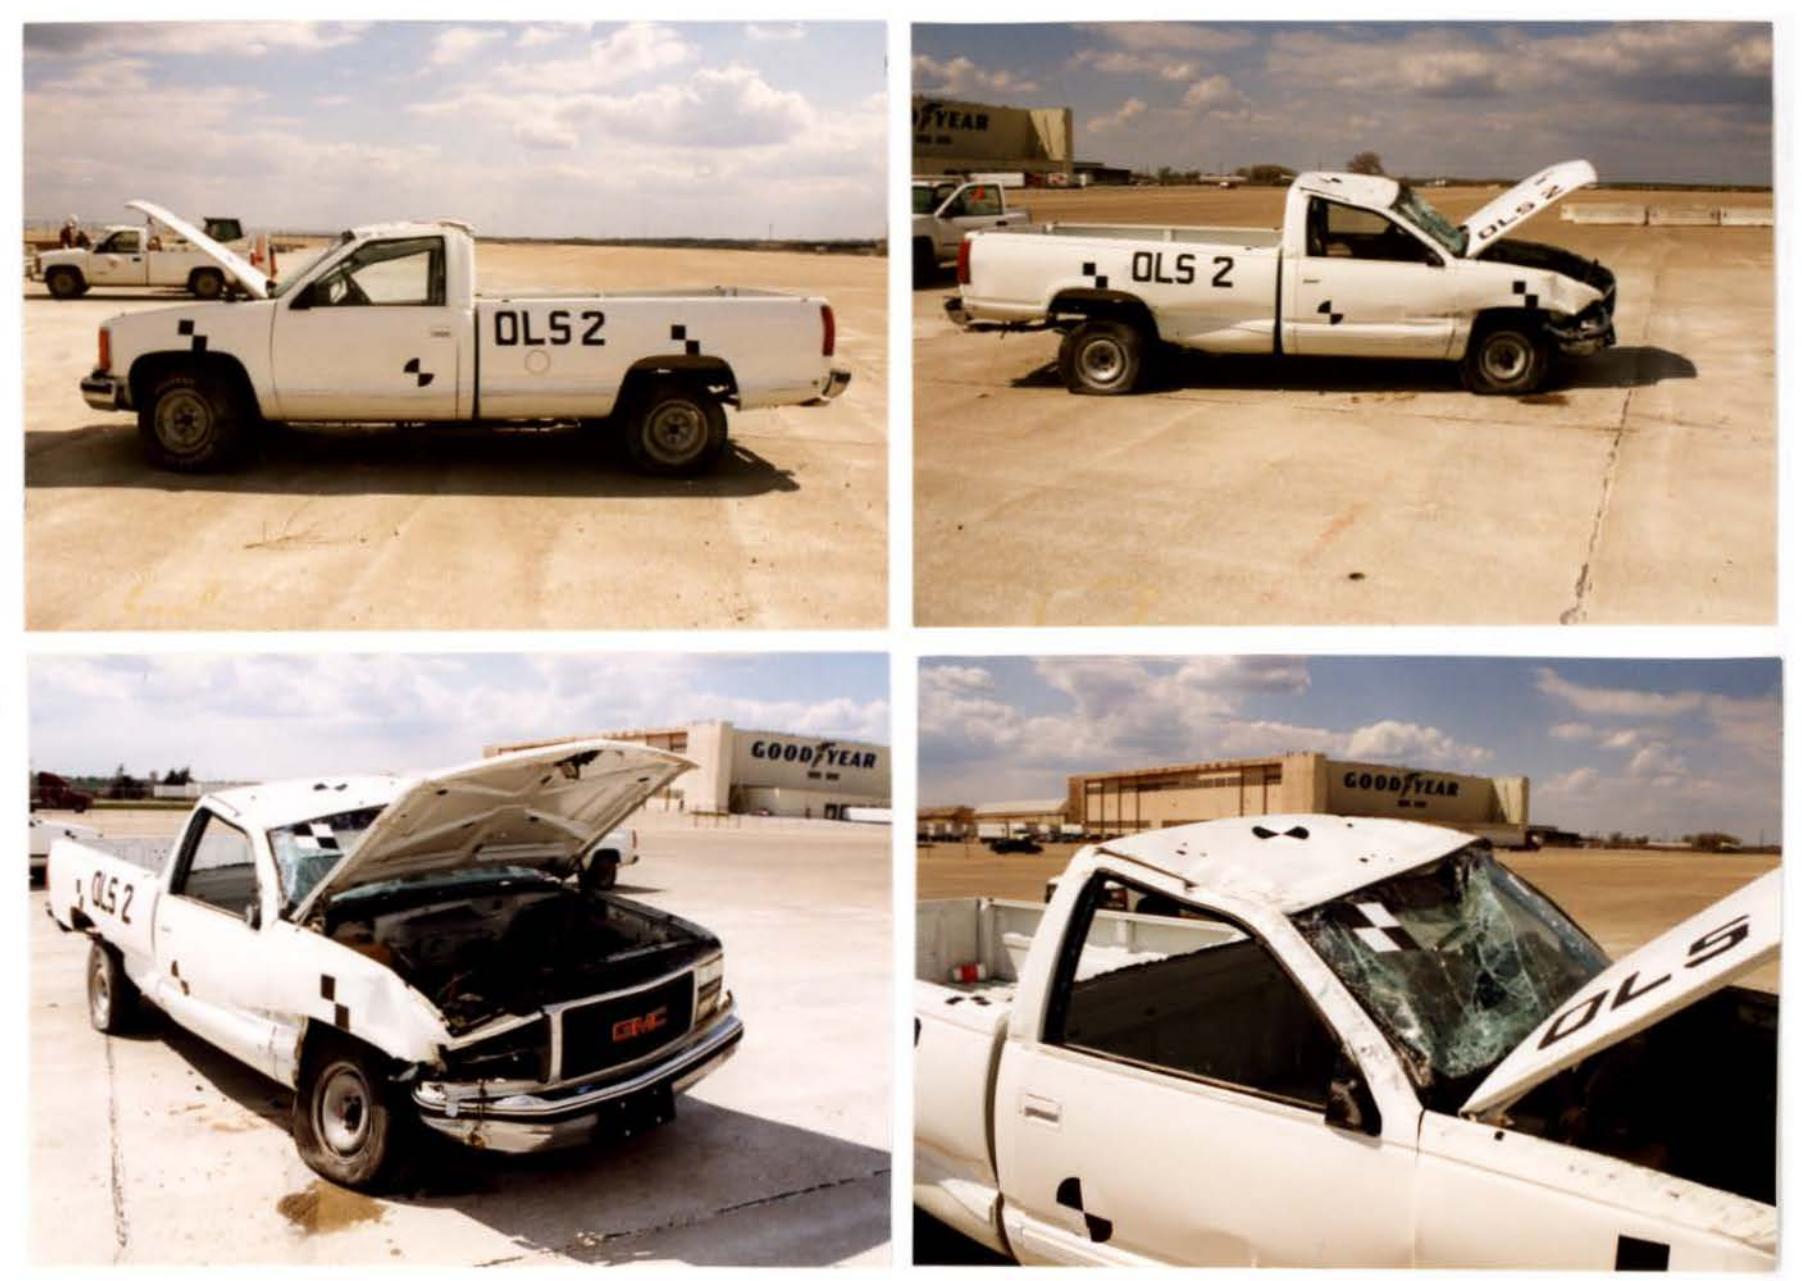
Figure 37. Vehicle Damage, Test OLS-2 (Design No. 2)

Exterior vehicle damage was extensive, as shown in Figure 37. Minimal occupant compartment deformations occurred with only slight deformation of the firewall. The right-front quarter panel was crushed inward, and the right side of the front bumper was also bent back toward the engine compartment. The right-front wheel assembly was deformed slightly. The right-front and right-rear wheels sustained tire holes and rim damage. Longitudinal deformations, due to vehicle-rail interlock, were observed along the entire right side of the vehicle. The front, rear, and left-side window glass as well as the roof's sheet metal were severely crushed during vehicle rollover. The right-side window glass remained undamaged. The engine hood popped open after vehicle rollover.
