GUARDRAIL AND GUARDRAIL TERMINALS INSTALLED OVER CURBS

MIDWEST ROADSIDE SAFETY FACILITY

MwRSF Research Report No. TRP-03-83-99

March 21, 2000

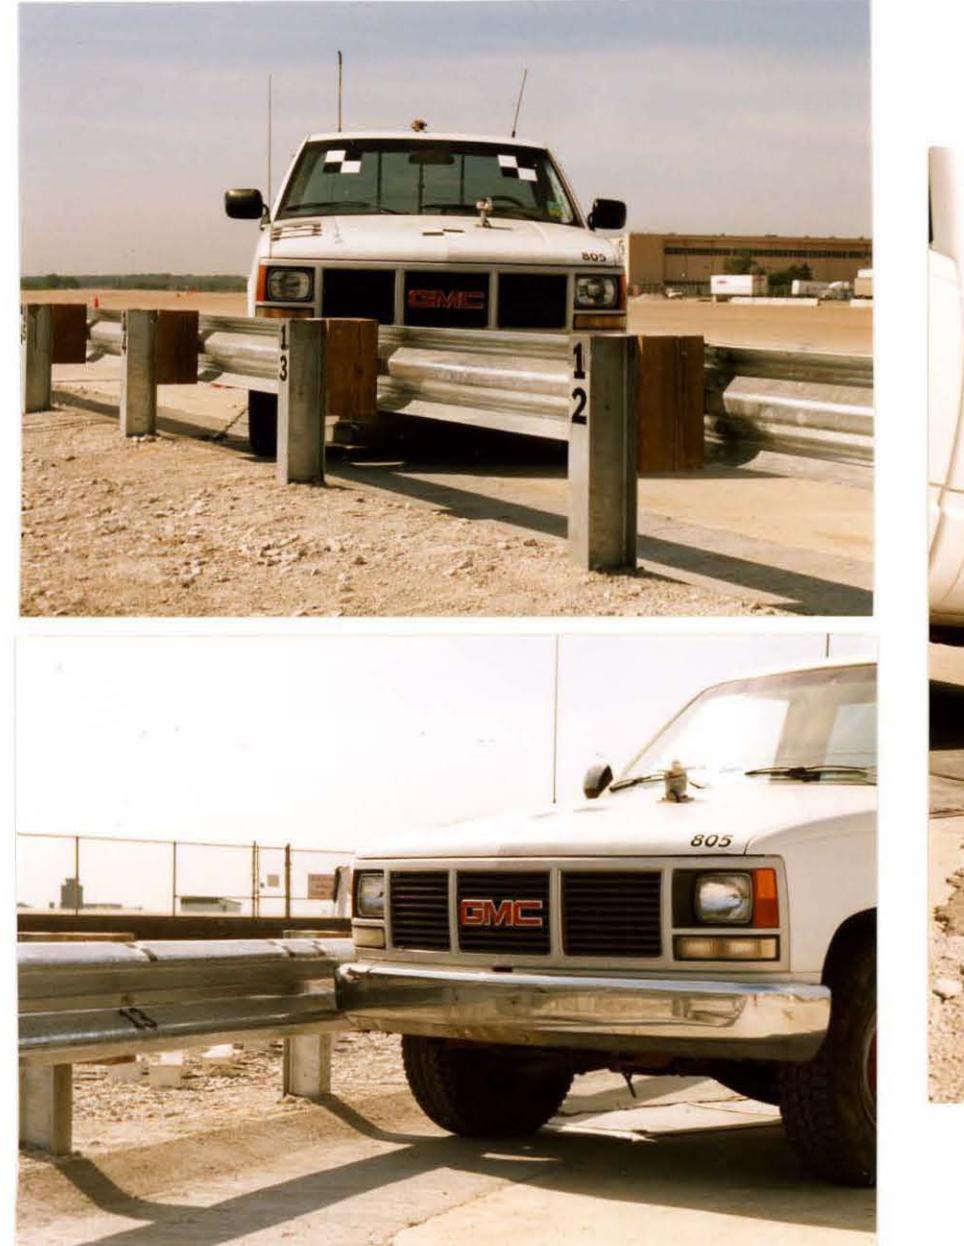
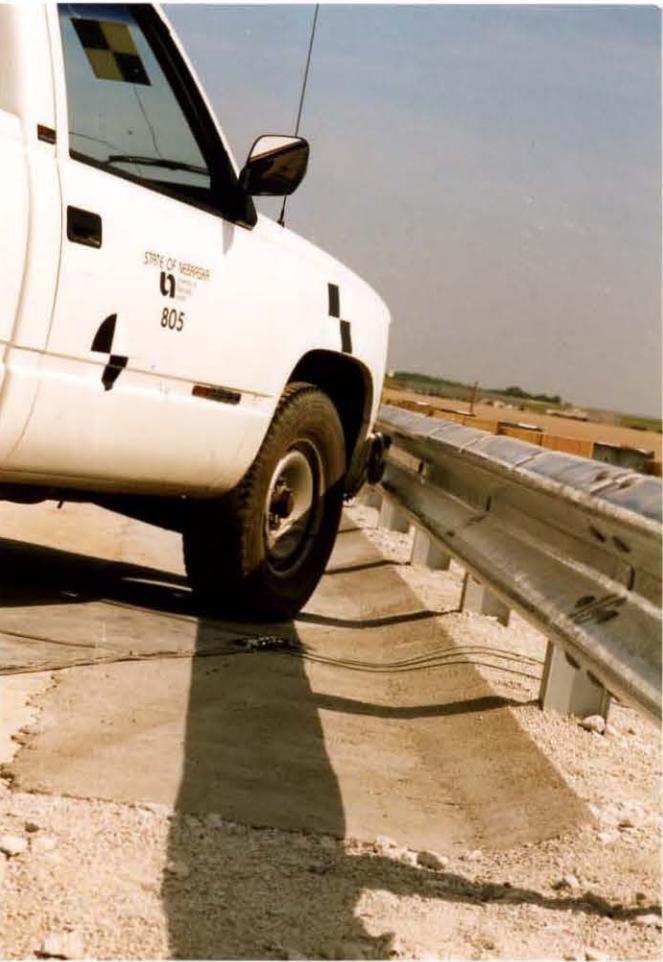
Figure 11. Impact Location, Test NEC-1

Damage to the barrier was extensive, as shown in Figures 12 through 16. Actual vehicle impact occurred midway between post nos. 13 and 14. Barrier damage consisted mostly of deformed guardrail posts, contact marks on a guardrail section, and deformed and fractured W-beam rail. As

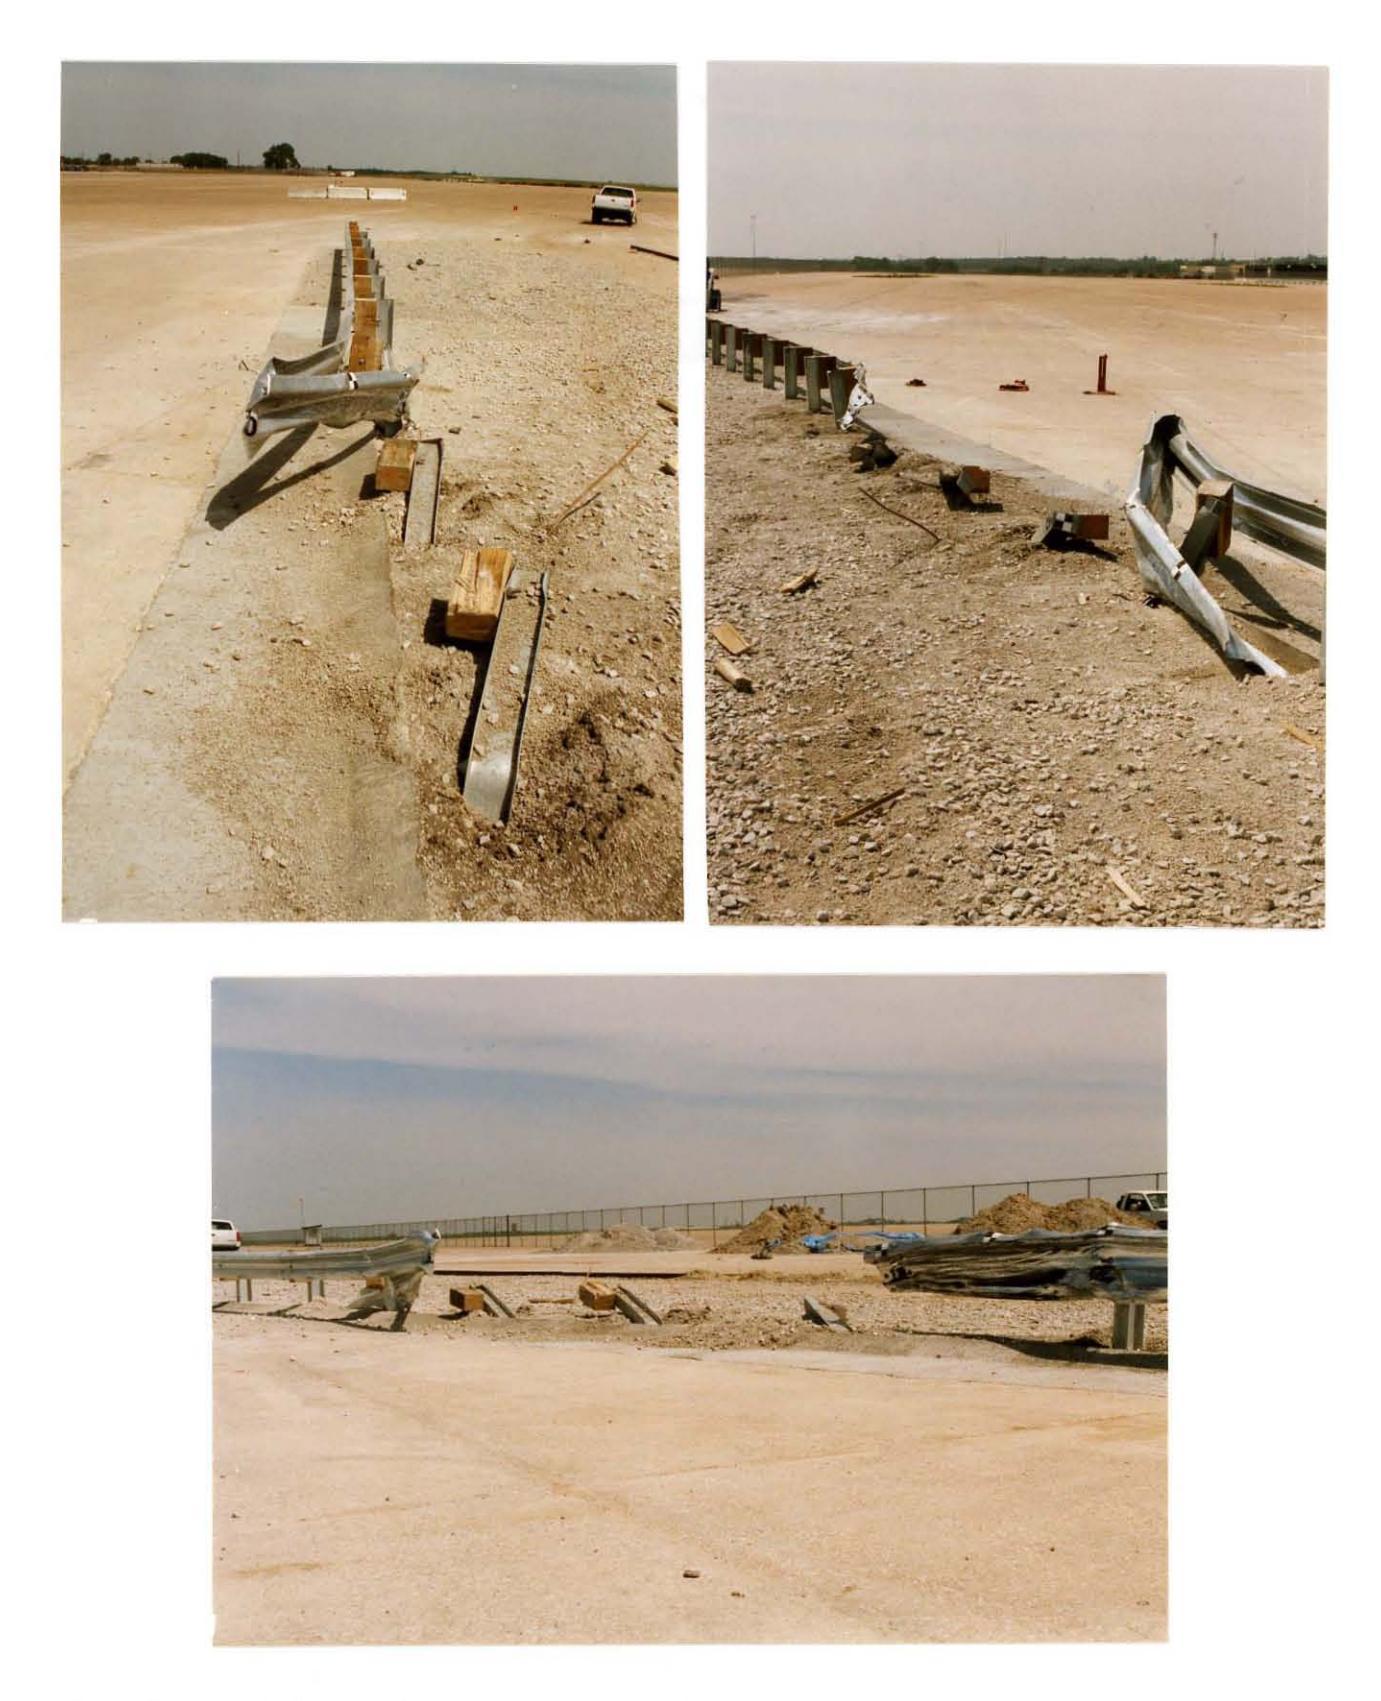
Figure 12. Guardrail Over Curb System Damage, Test NEC-1

shown in Figures 12 through 15, the failure of the W-beam splice at post no. 12 caused significant damage to the posts and guardrail located downstream.

Three steel posts, post nos. 10 through 12, were twisted and bent toward the ground. Two other steel posts, post nos. 13 and 14 were rotated 102 mm and 51 mm at the ground, respectively. Both downstream BCT posts, post nos. 1 and 2, were partially split down the middle and remained standing. Post no. 3 through 8 twisted in the clockwise (CW) direction when looking at the traffic side of the rail. The slots in the guardrail at these post were also damaged. No significant post or guardrail damage occurred upstream of post no. 14.

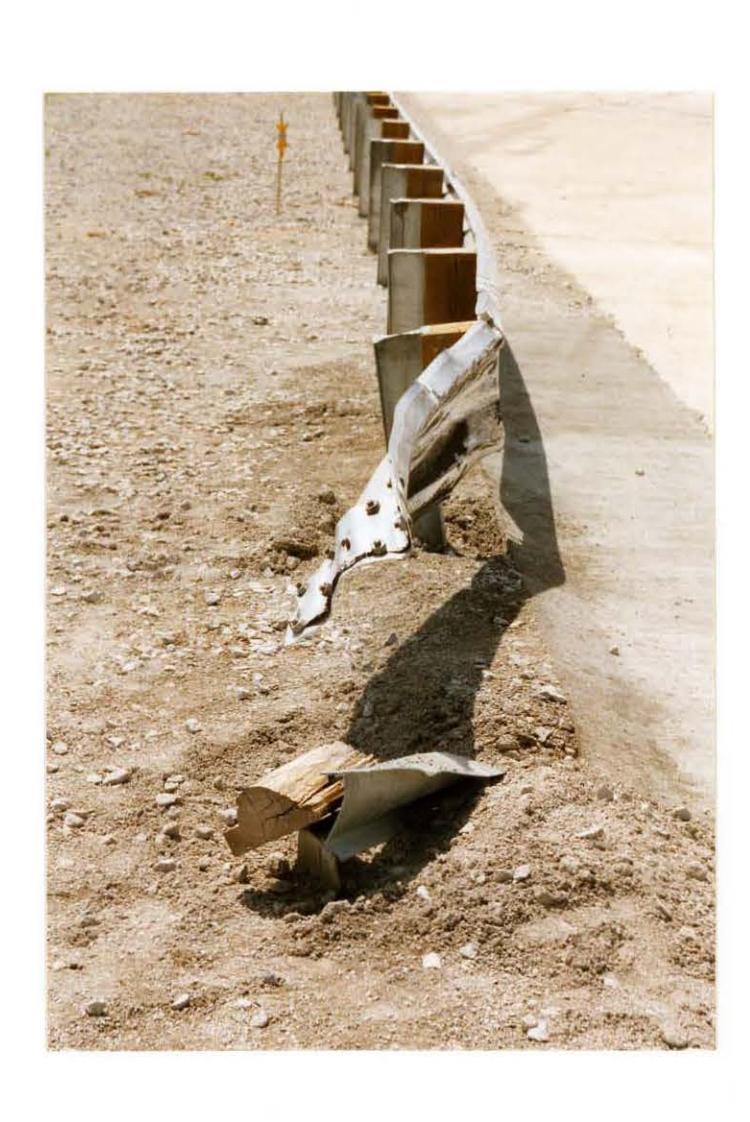
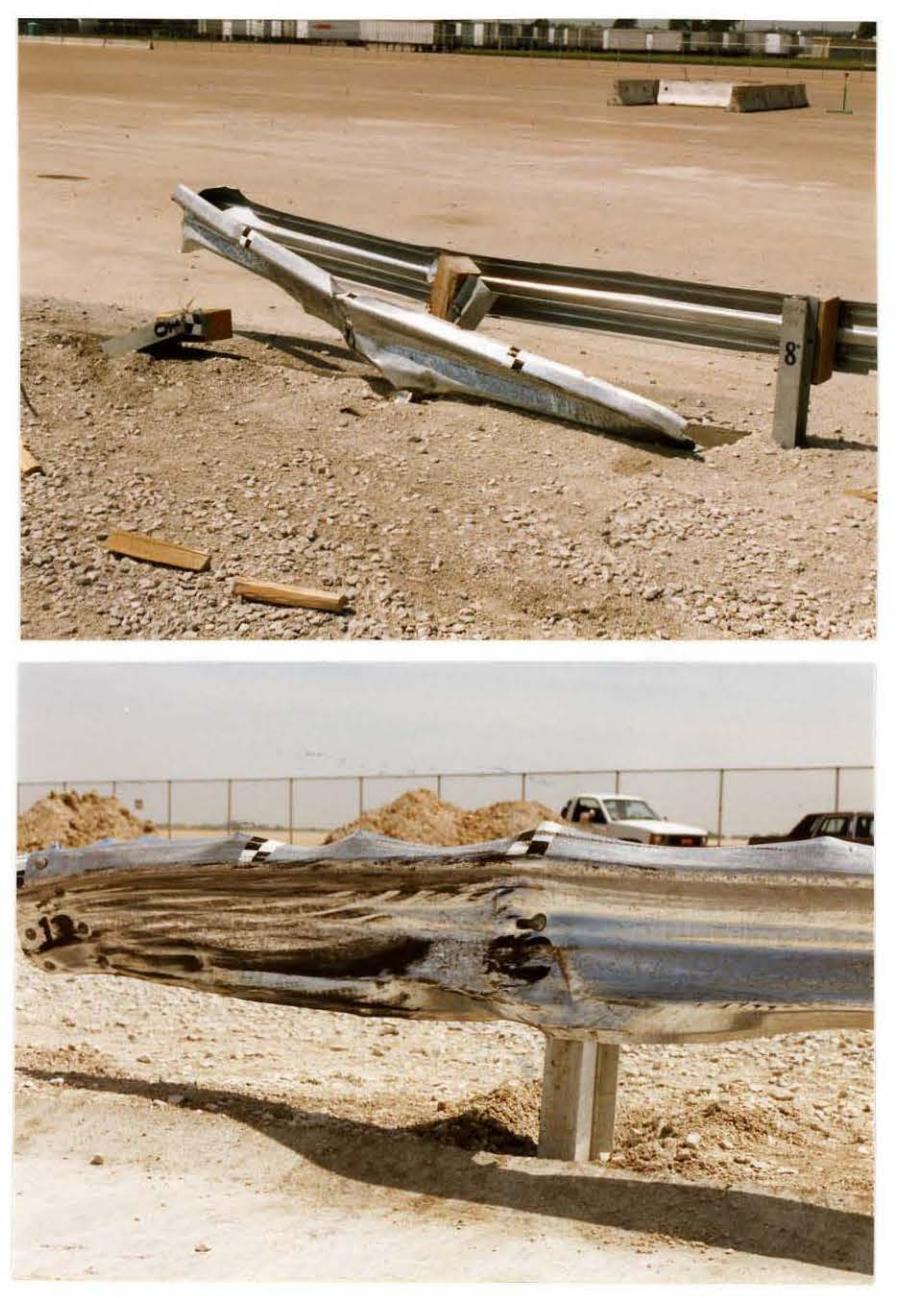
Figure 13. Guardrail Over Curb System Damage, Test NEC-1

Minor guardrail bucking occurred 102-mm downstream of post no. 14. The W-beam pulled off of post nos. 10 through 12. The W-beam fractured at post no.12 and folded about the location of post no. 10 with the final location of the W-beam behind post no. 9, as shown in Figures 12 and 13. Contact marks were found on the guardrail between post nos. 10 and 13. The W-beam's lower hump was flattened along the distance of 1600-mm downstream of post no. 14 through post no. 12.
