# DEVELOPMENT OF AN ECONOMICAL GUARDRAIL SYSTEM FOR USE ON WIRE- FACED, MSE WALLS

Publication No. FHWA-CFL/TD-12-009

FEBRUARY 2012

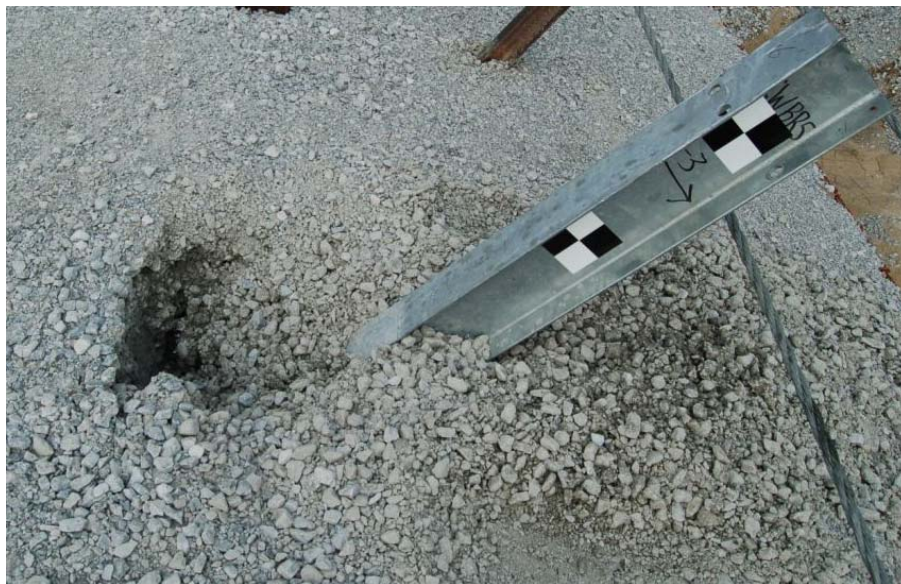
Figure 13. Photo. Typical Damage - 6-ft (1.8-m) Long, W6x8.5 (W152x12.6) Post at Breakpoint of 3H:1V Fill Slope.

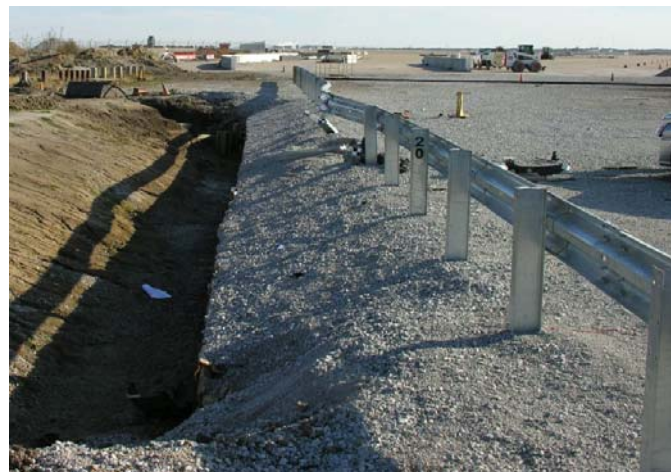
c. Downstream View

**Figure 61. Photo. System Damage, Test No. MGSGW-1.**

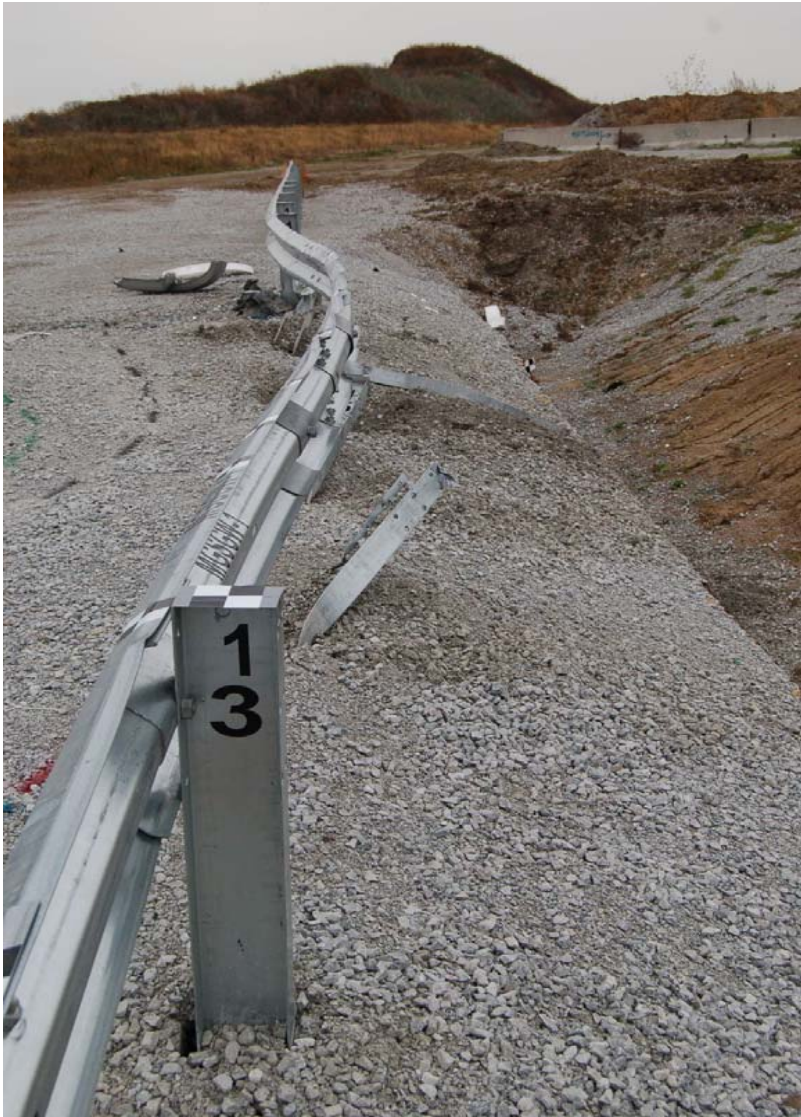
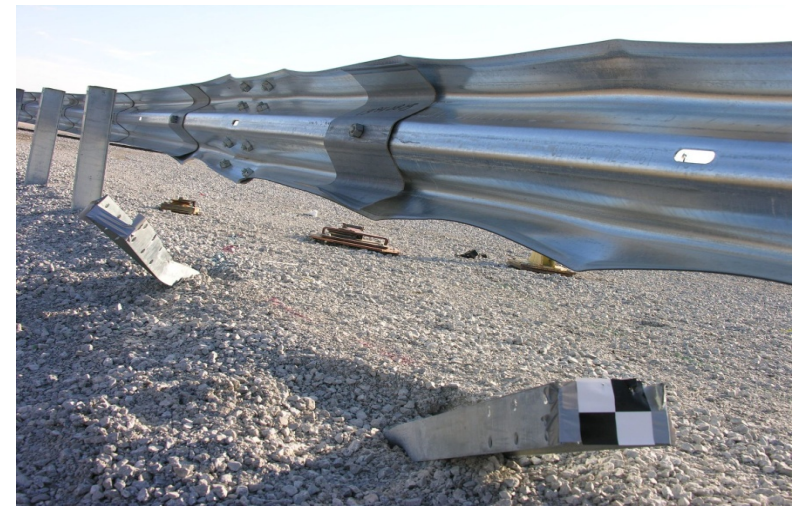
a. Permanent Set Deflection

b. Front Side

c. Back Side

**Figure 62. Photo. System Damage, Test No. MGSGW-1.**

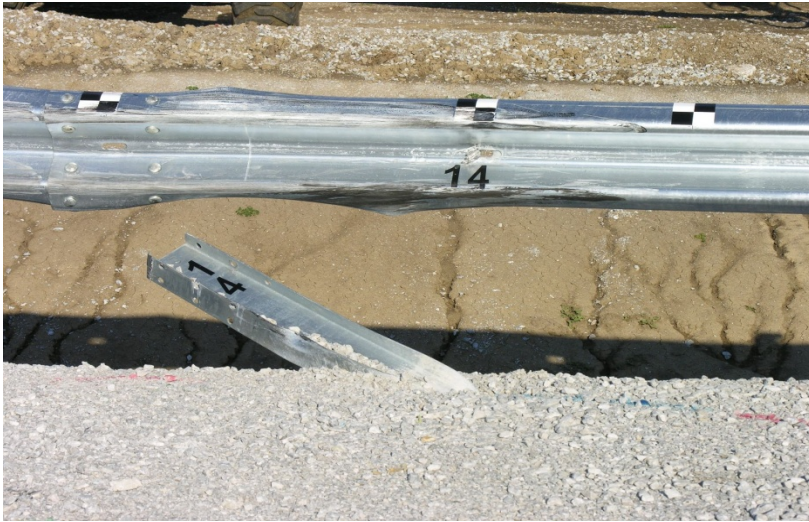
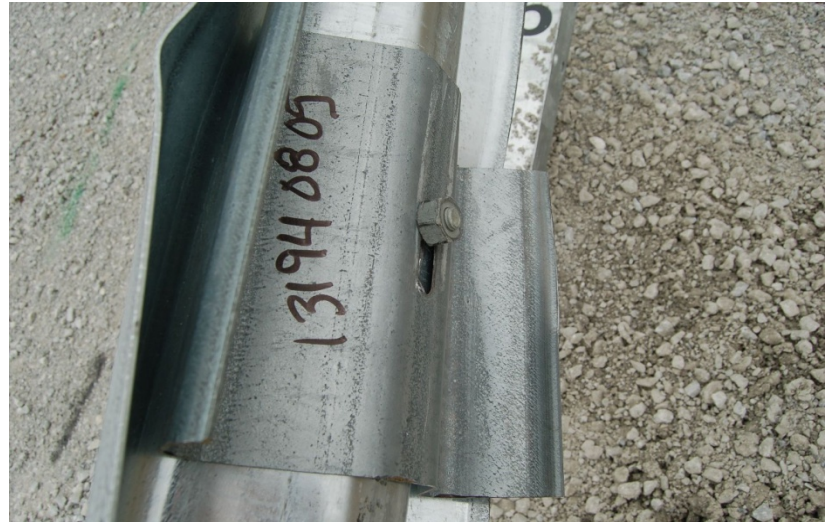
a. Rail at Post No. 14, Front View

b. Rail at Post No. Back View

d. Backing Plate at Post No. 14

Figure 63. Photo. System Damage, Test No. MGSGW-1.

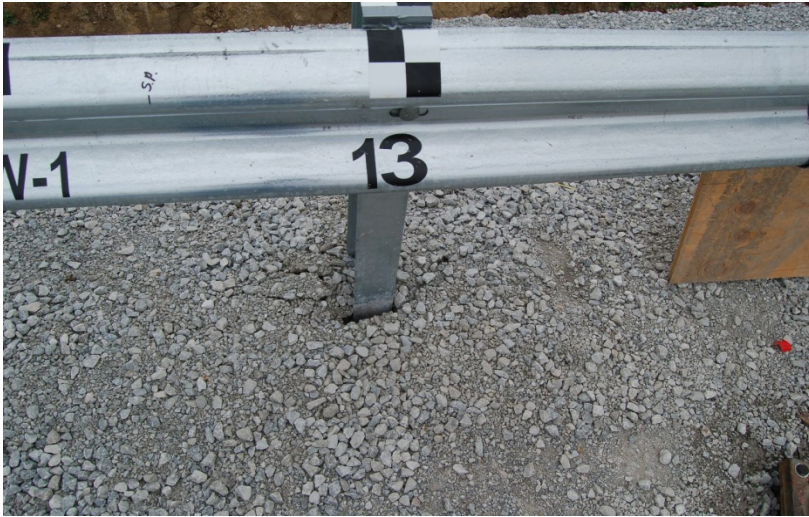
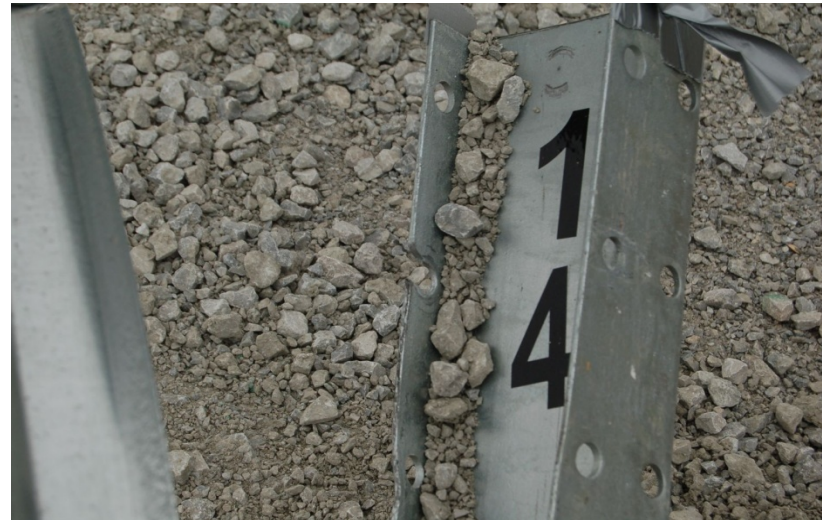
a. Post No. 13, Front Side

b. Post No. 14, Front Side

d. Post No. 14, Post Bolt Hole Tear

**Figure 64. Photo. Post Nos. 13 and 14 Damage, Test No. MGSGW-1.**

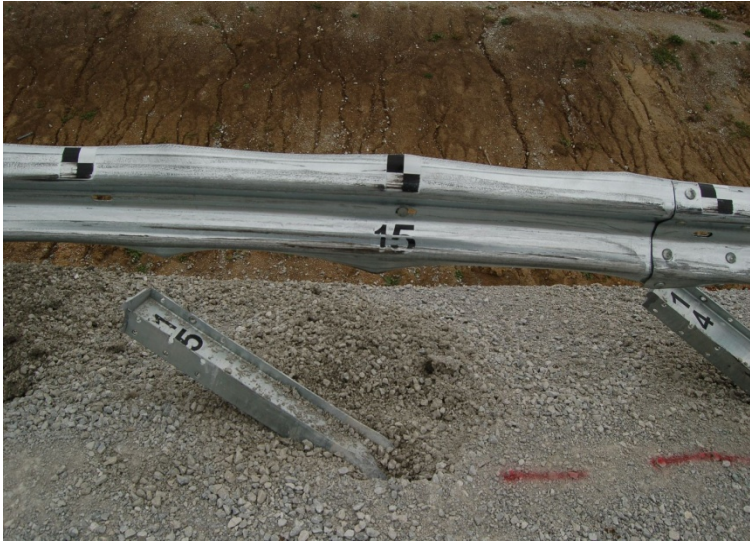
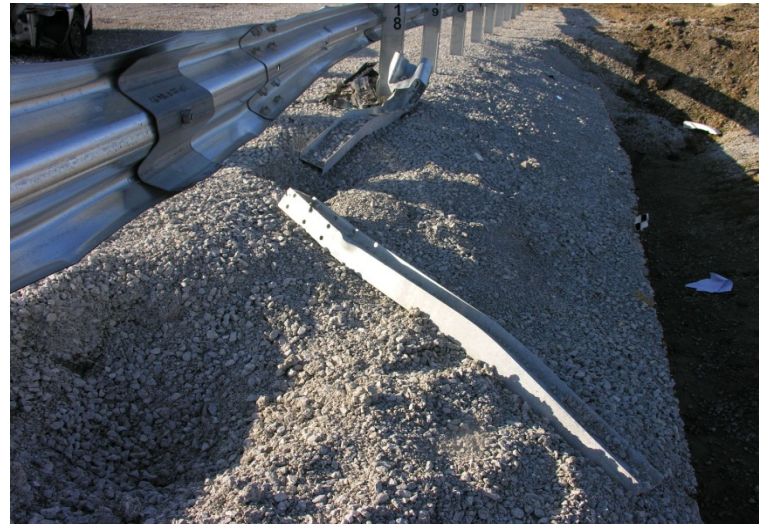
a. Post No. 15, Front View

b. Post No. 16, Downstream View

d. Post Nos. 15 and 16, Upstream View

**Figure 65. Photo. Post Nos. 15 and 16 Damage, Test No. MGSGW-1.**

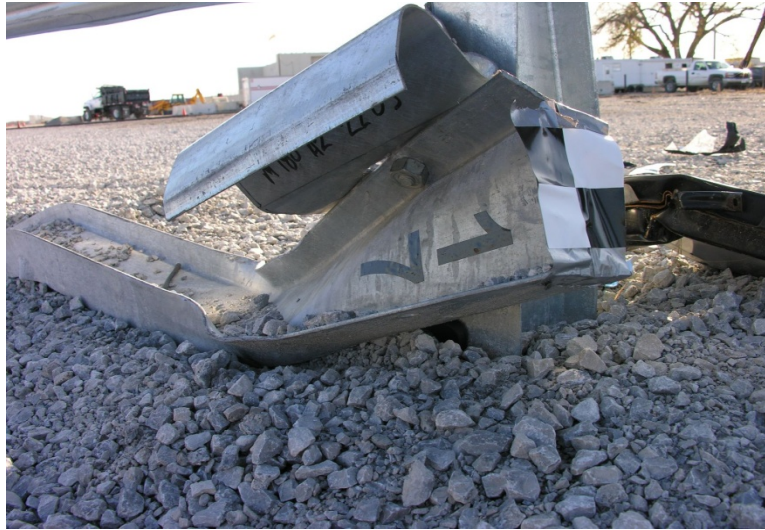
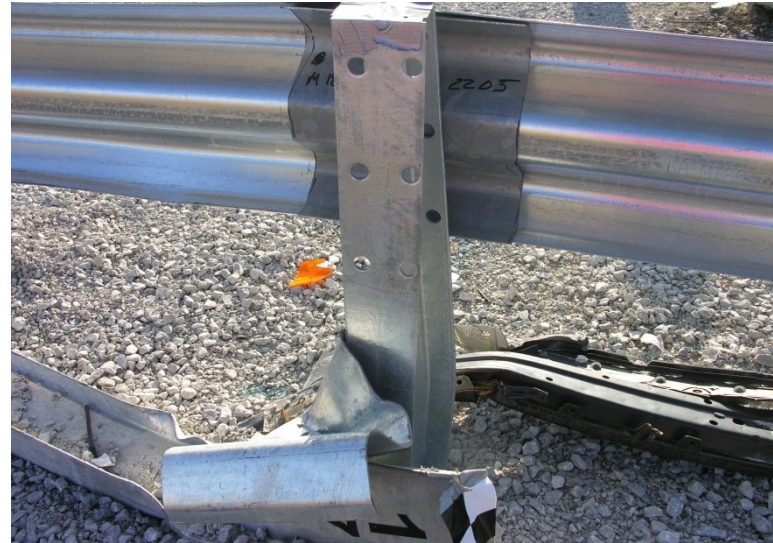
a. Post Nos 17, Top Portion

b. Post No. 18, Front View

d. Post No. 18, Rear View

**Figure 66. Photo. Post Nos. 17 and 18 Damage, Test No. MGSGW-1.**

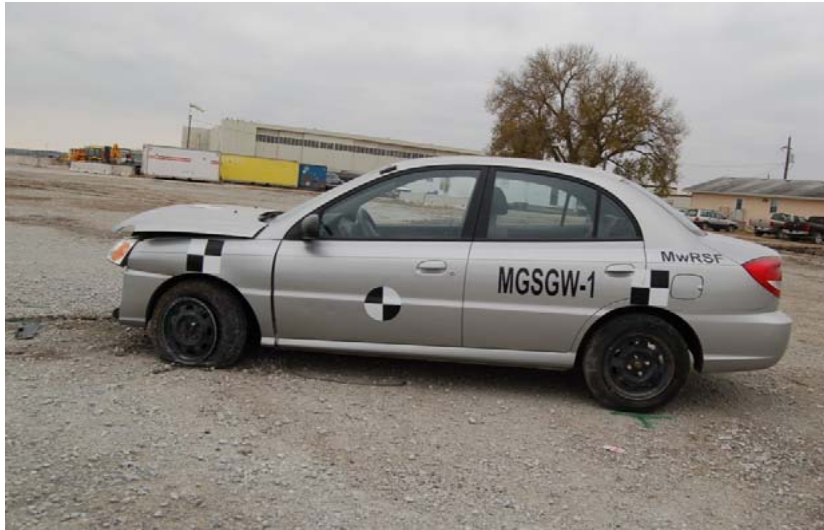
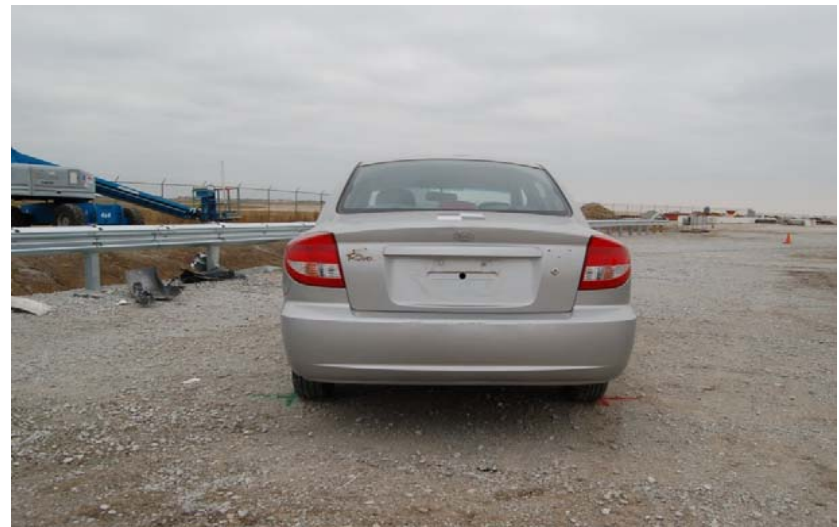
a. Left Side

b. Front

d. RearMGSGW-1

Figure 67. Photo. Vehicle Damage, Test No. MGSGW-1.

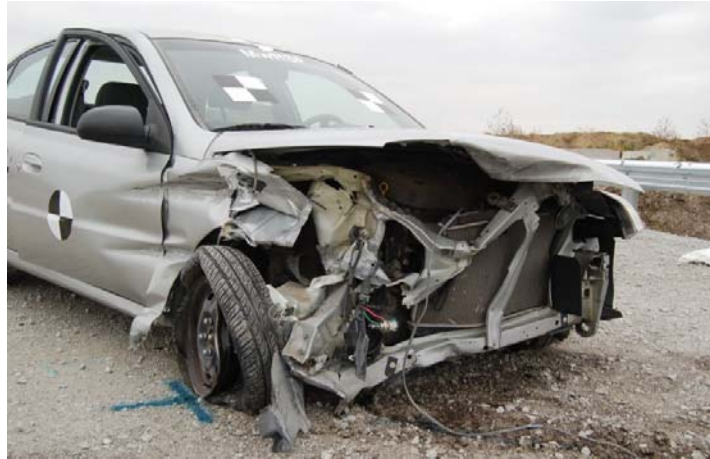
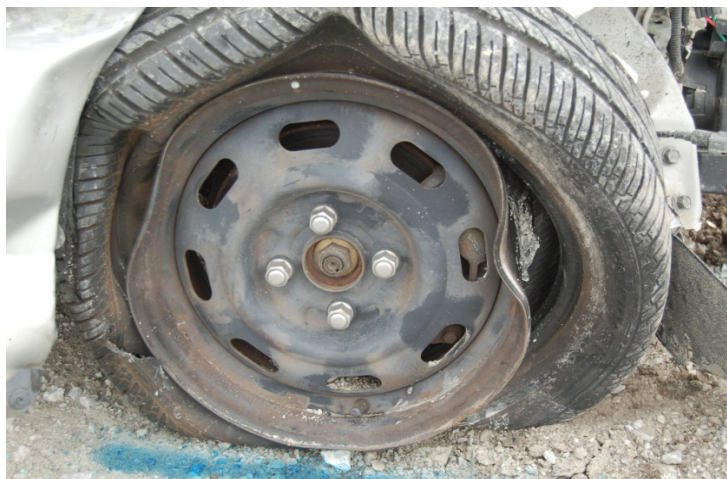
a. Impact Side Quarter View

b. Rail Interlock

c. Impact Side Wheel

**Figure 68. Photo. Vehicle Damage, Test No. MGSGW-1.**

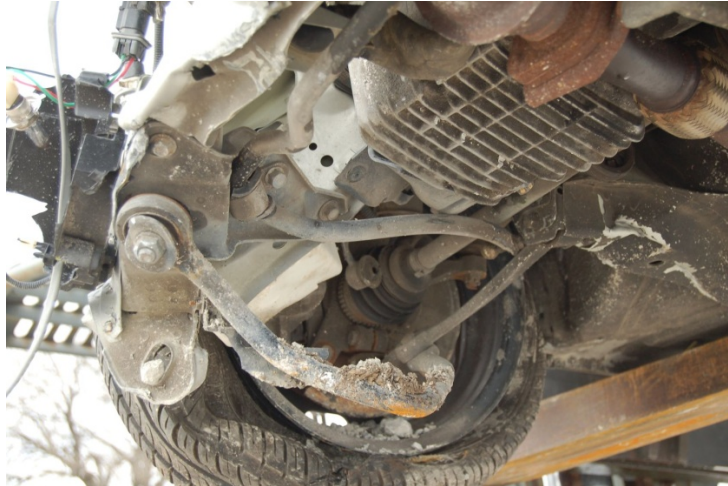
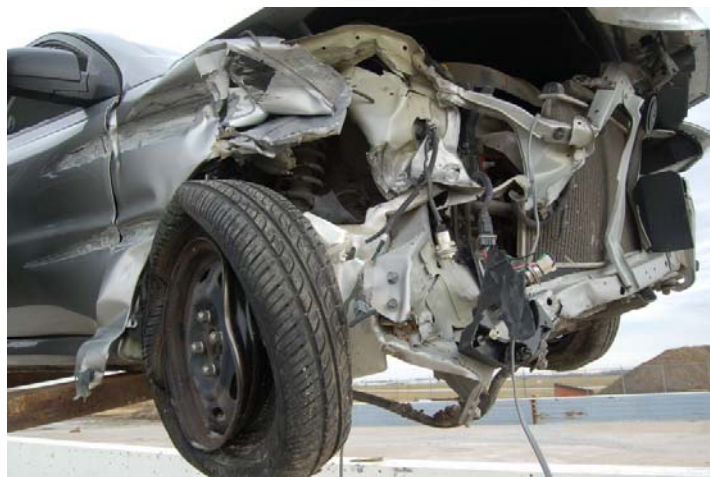
a. Impact Side Suspension

b. Axle/Transmission Connection

c. Impact Side

**Figure 69. Photo. Vehicle Undercarriage Damage, Test No. MGSGW-1.**

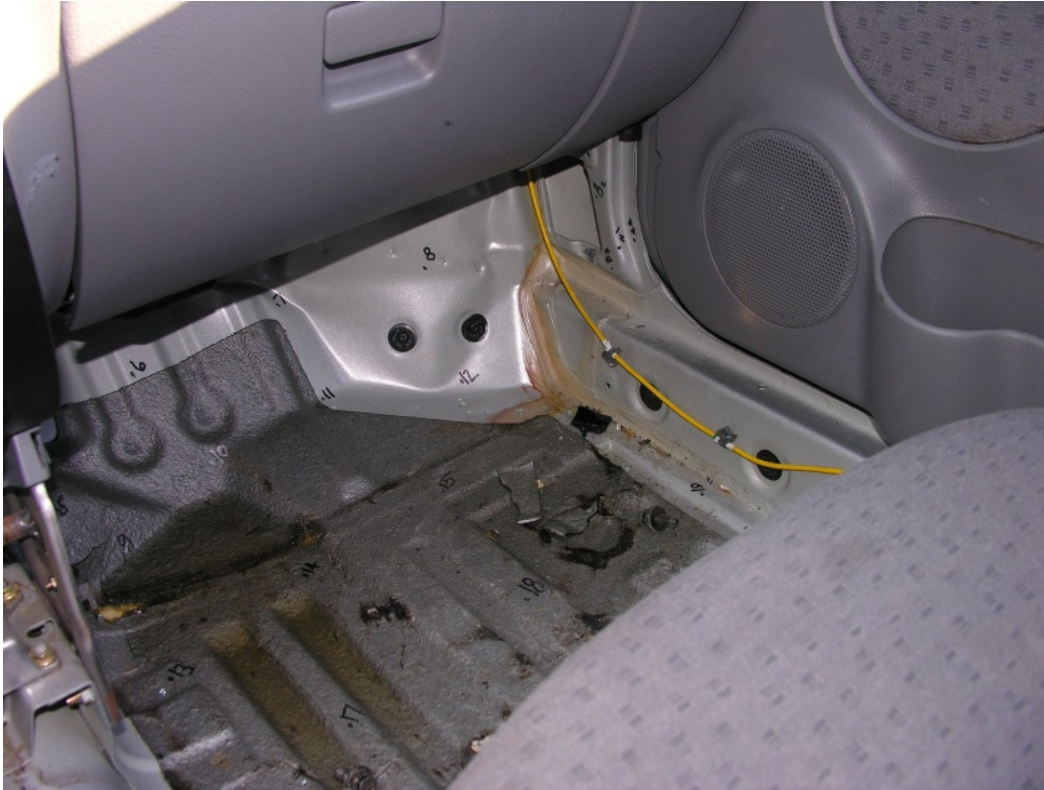
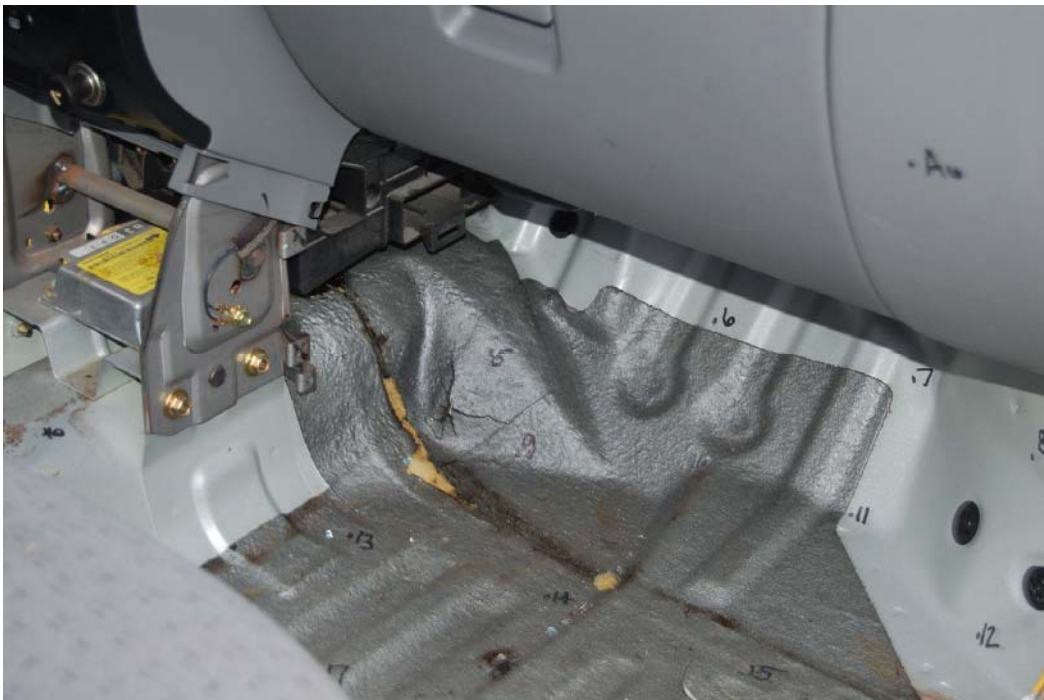
a. Impact Side Firewall

b. Impact Side Tunnel

**Figure 70. Photo. Vehicle Occupant Compartment Damage, Test No. MGSGW-1.**

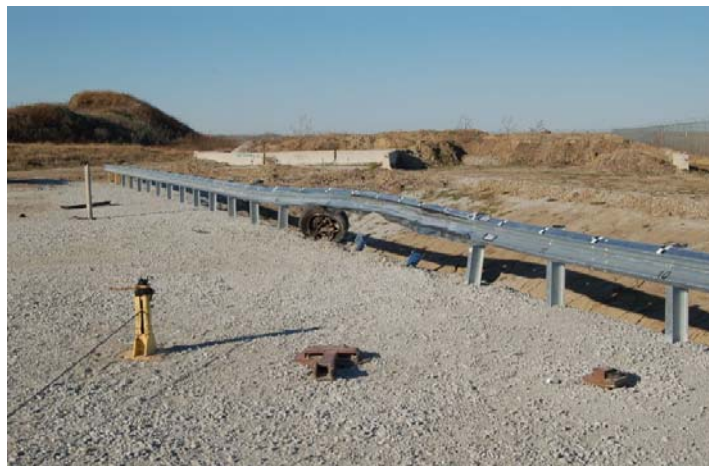
c. Front View

**Figure 79. Photo. System Damage, Test No. MGSGW-2.**

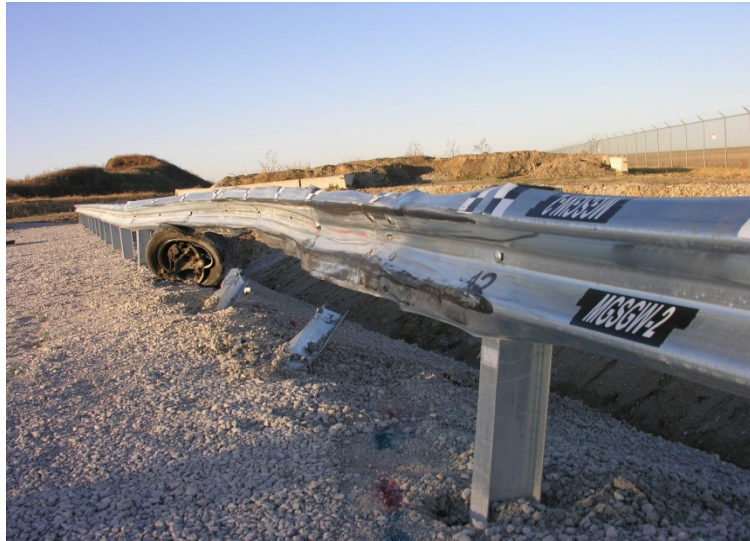
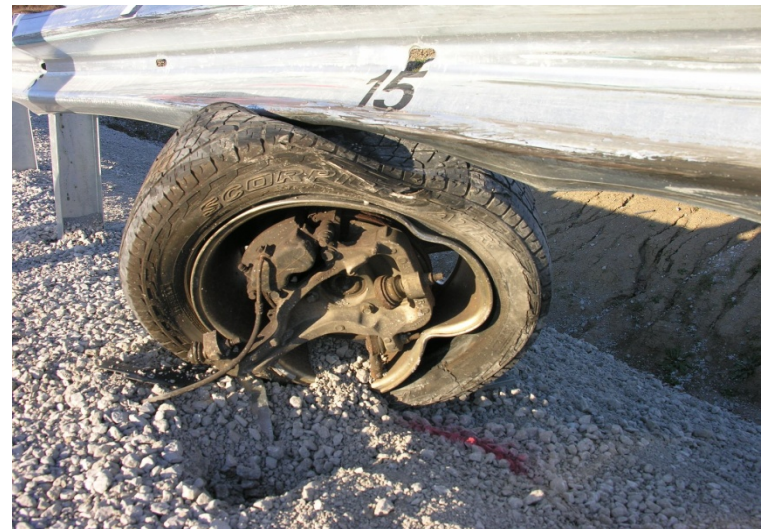
a. Impacted Rail

b. Impacted Rail Rear View

d. Wheel Lodged Under Rail

Figure 80. Photo. System Damage, Test No. MGSGW-2.

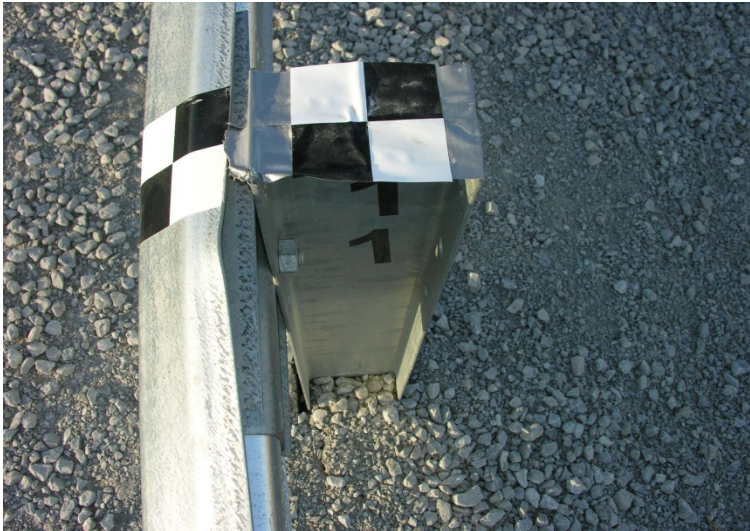
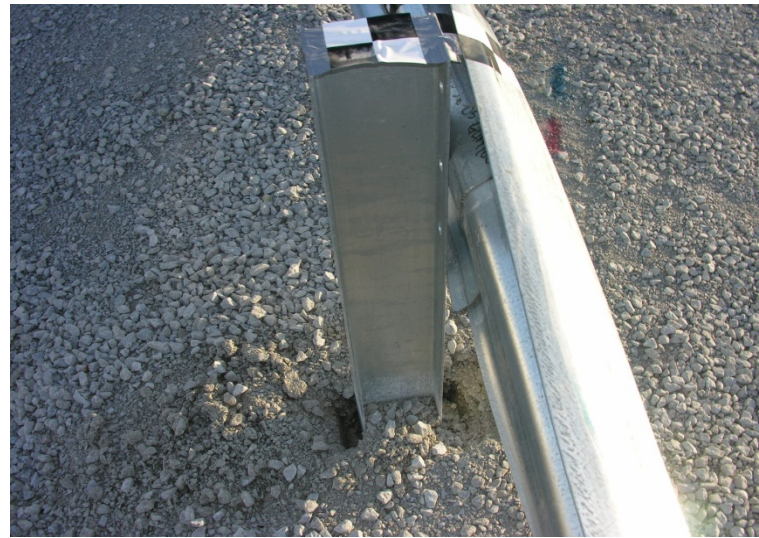
a. Post No. 11 Top View

b. Post No. 12 Upstream View

d. Post No. 12 Downstream View

**Figure 81. Photo. Post Nos. 11 and 12 Damage, Test No. MGSGW-2.**

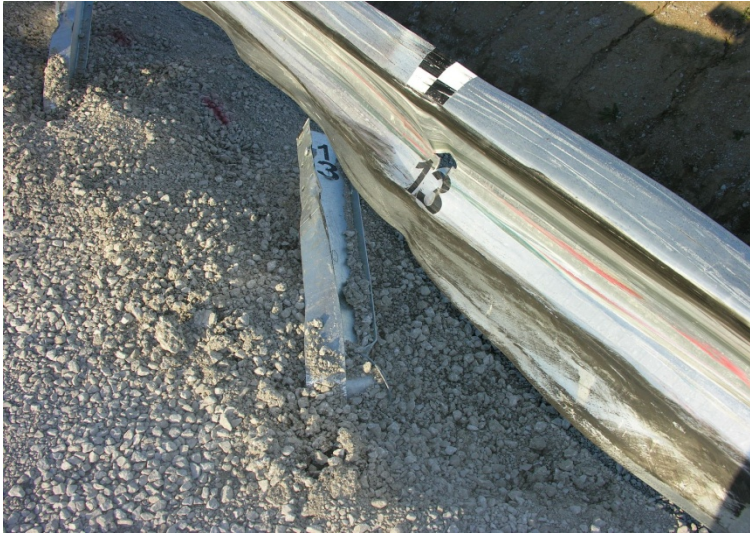
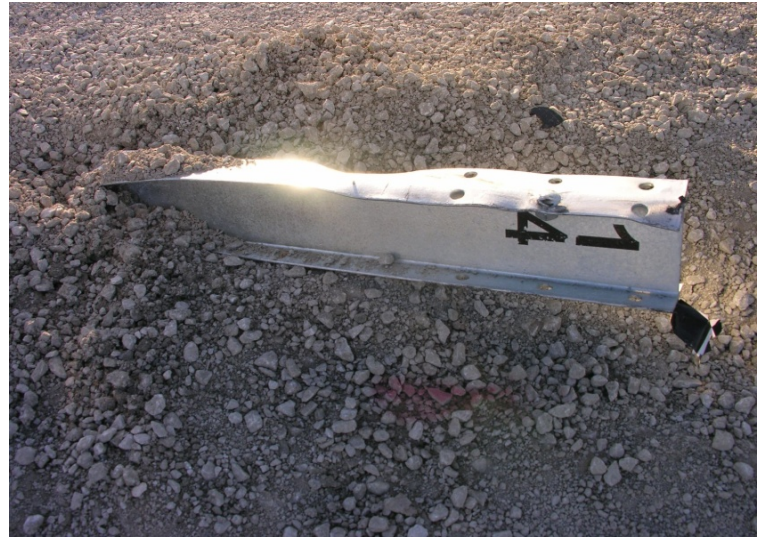
a. Post No. 13 Front View

b. Post No. 14 Front View

d. Post No. 14 Rear View

**Figure 82. Photo. Post Nos. 13 and 14 Damage, Test No. MGSGW-2.**

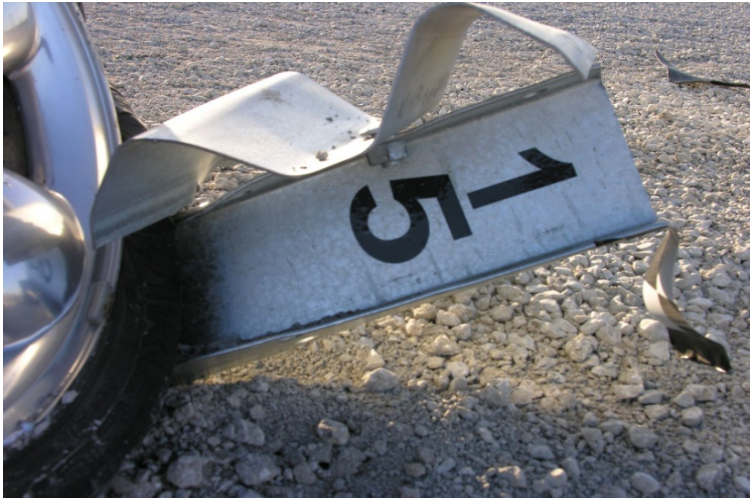
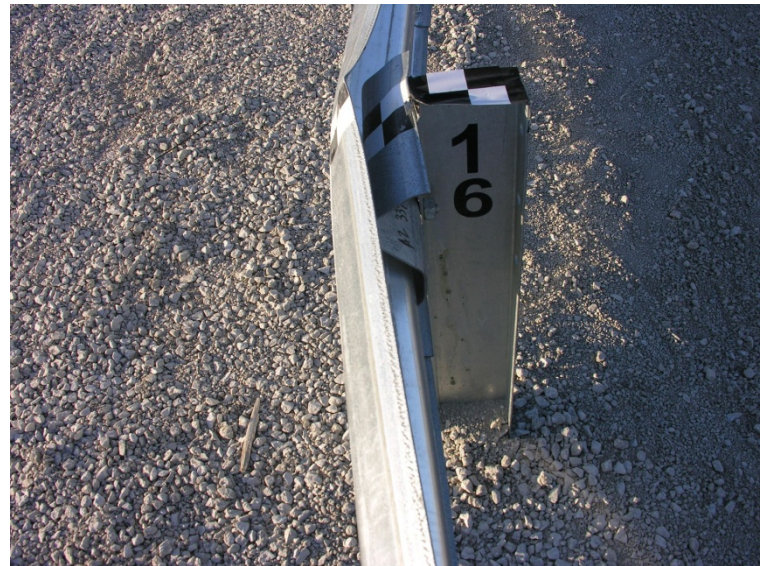
a. Post No. 15 Upstream View

b. Post No. 16 Rear View

d. Post No. 16 Upstream View

**Figure 83. Photo. Post Nos. 15 and 16 Damage, Test No. MGSGW-2.**

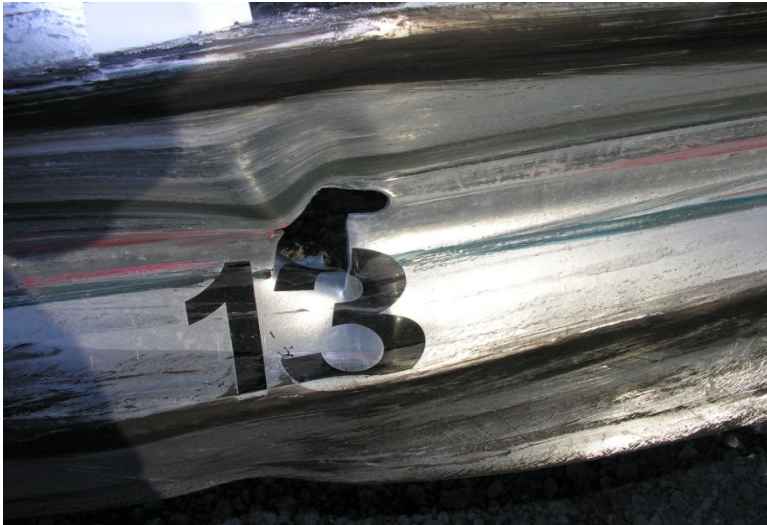
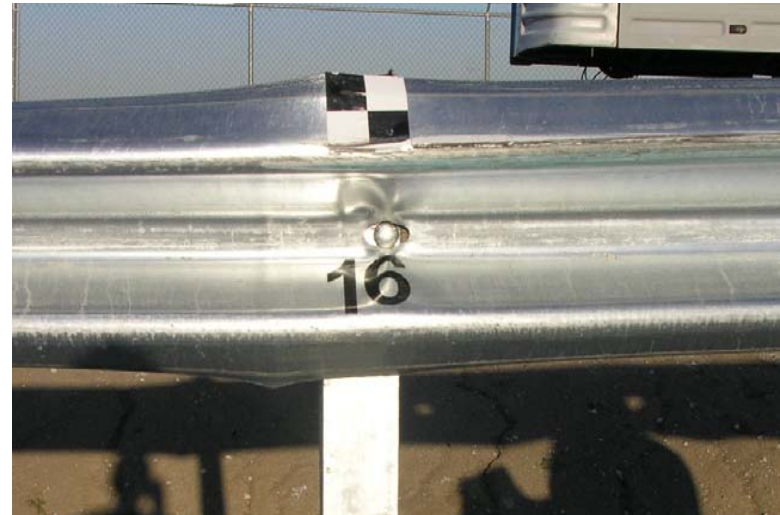
a. Post No. 13

b. Post No. 14

d. Post No. 16

**Figure 84. Photo. Post Bolt Location Rail Damage Photographs, Test Nos. MGSGW-2.**

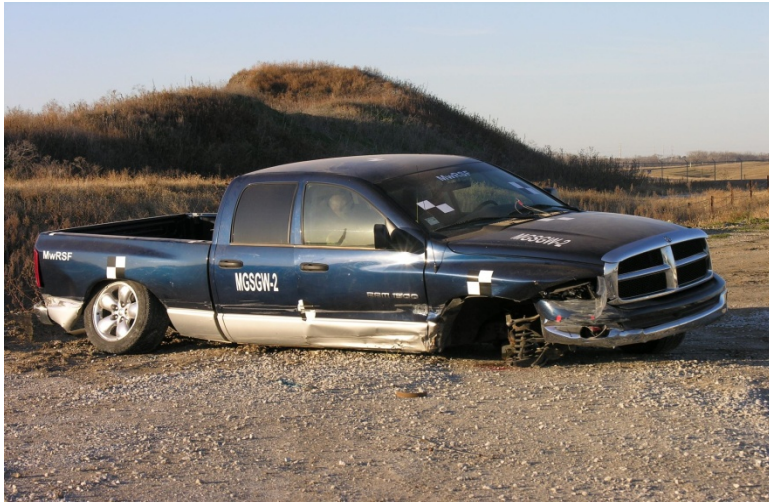
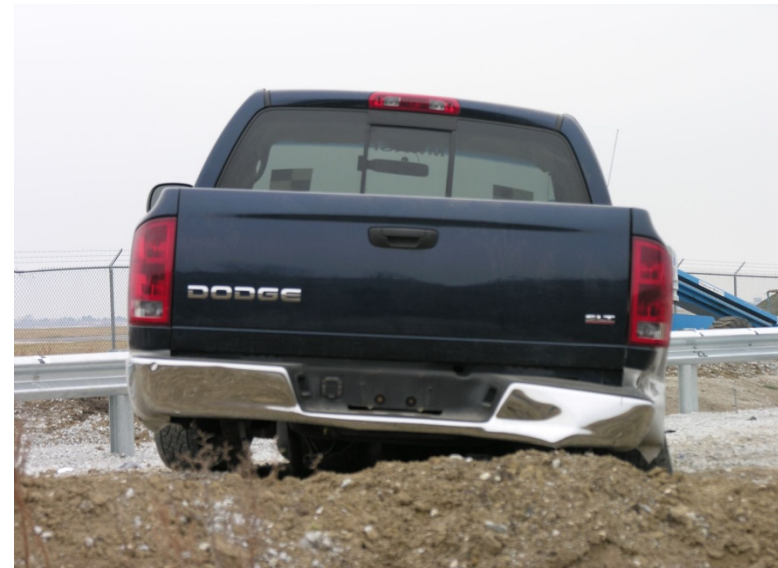
a. Right Side

b. Front

d. Rear

Figure 85. Photo. Vehicle Damage, Test No. MGSGW-2.

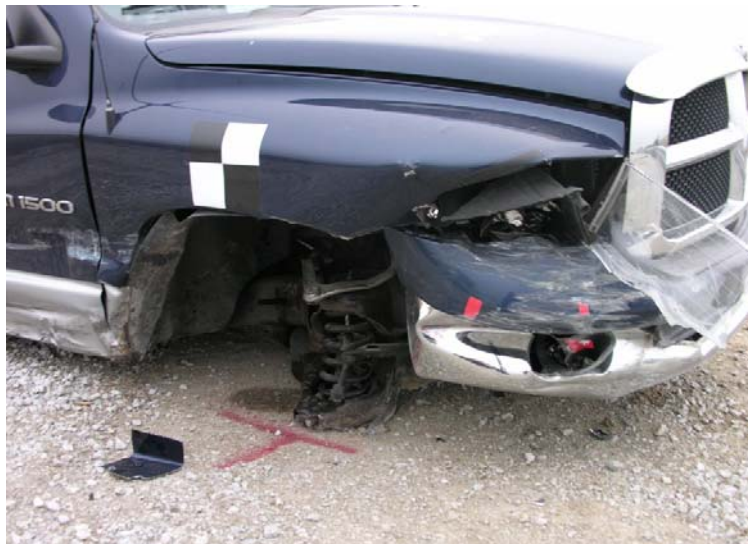
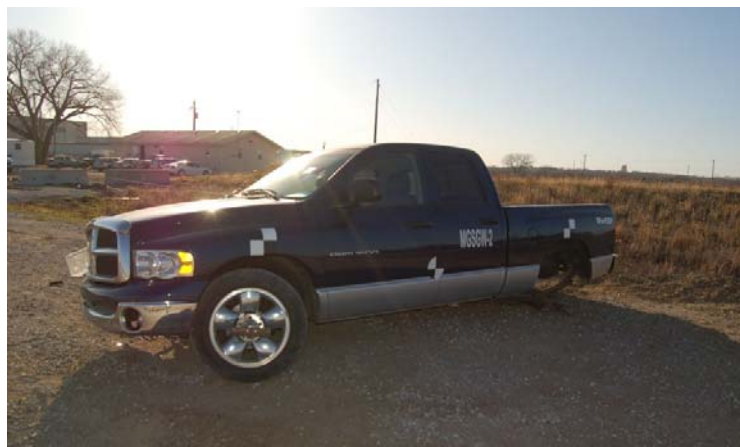
a. Right Side Bumper and Wheel Well

b. Right Side Rear Quarter

c. Left Quarter

**Figure 86. Photo. Vehicle Damage, Test No. MGSGW-2.**

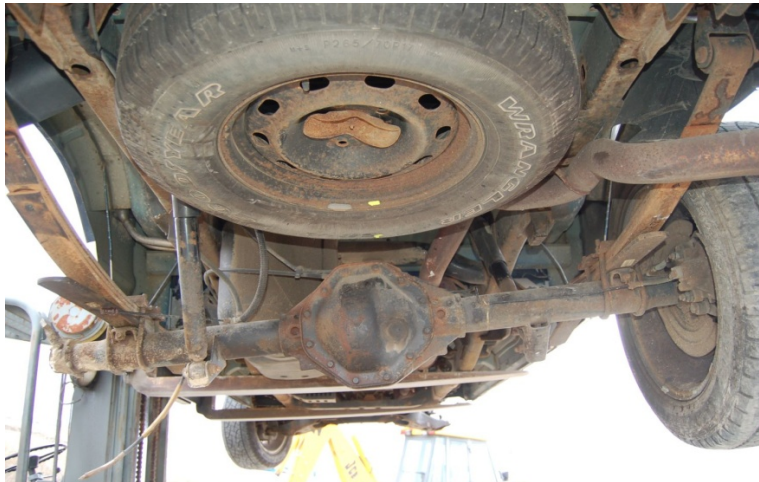
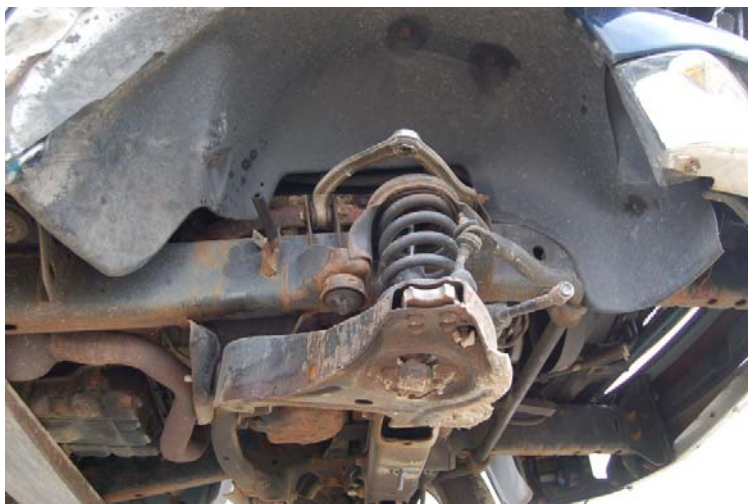
a. Rear Axle/Suspension

b. Drive Shaft

c. Right Side Suspension

**Figure 87. Photo. Vehicle Undercarriage Damage, Test No. MGSGW-2.**

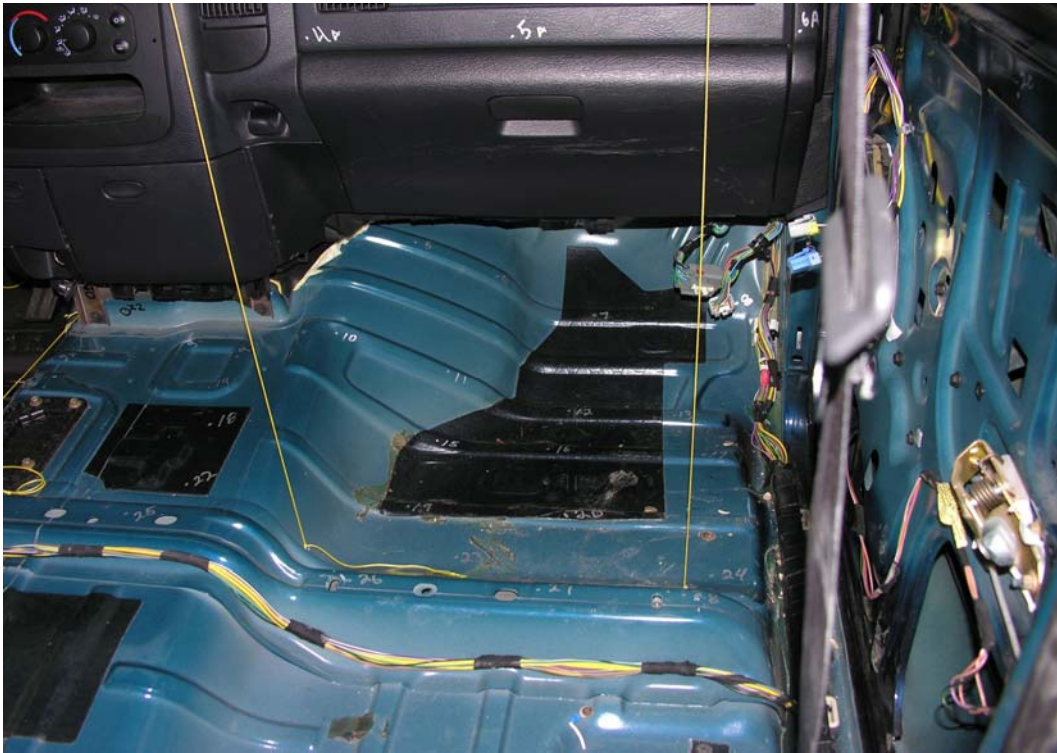
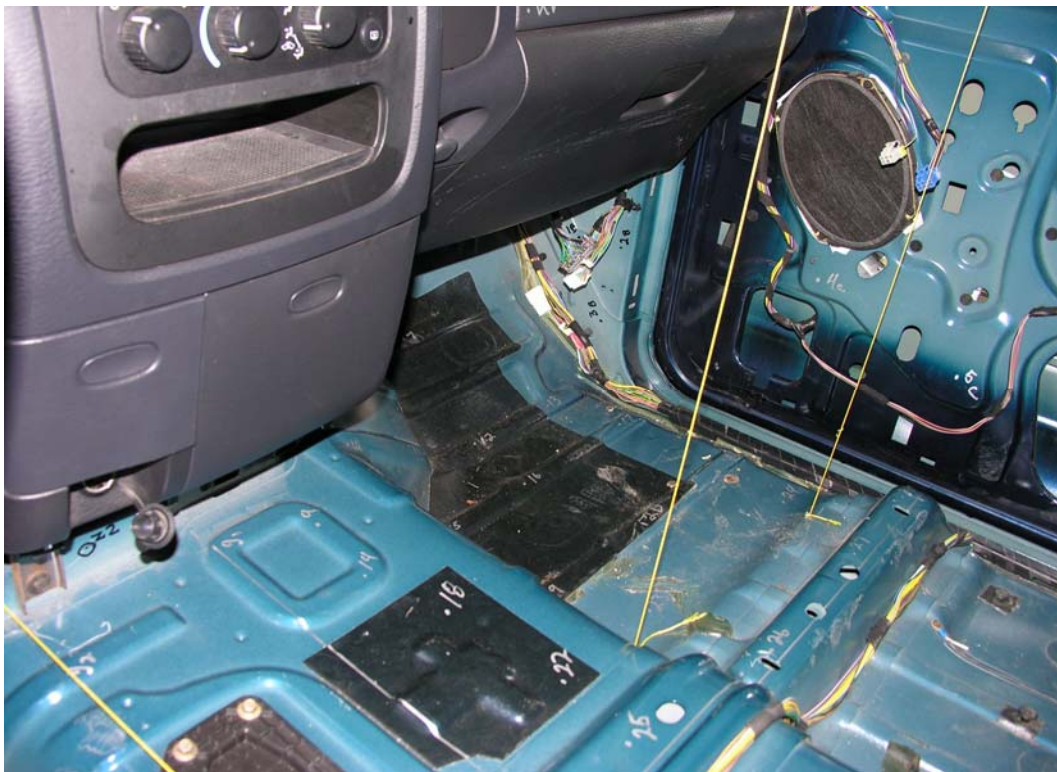
a. Impact Side Floorboard

b. Impact Side Door

**Figure 88. Photo. Vehicle Occupant Compartment Damage, Test No. MGSGW-2.**
