TESTING AND EVALUATION OF MASH TL-3 TRANSITION BETWEEN GUARDRAIL AND PORTABLE CONCRETE BARRIERS

Submitted by

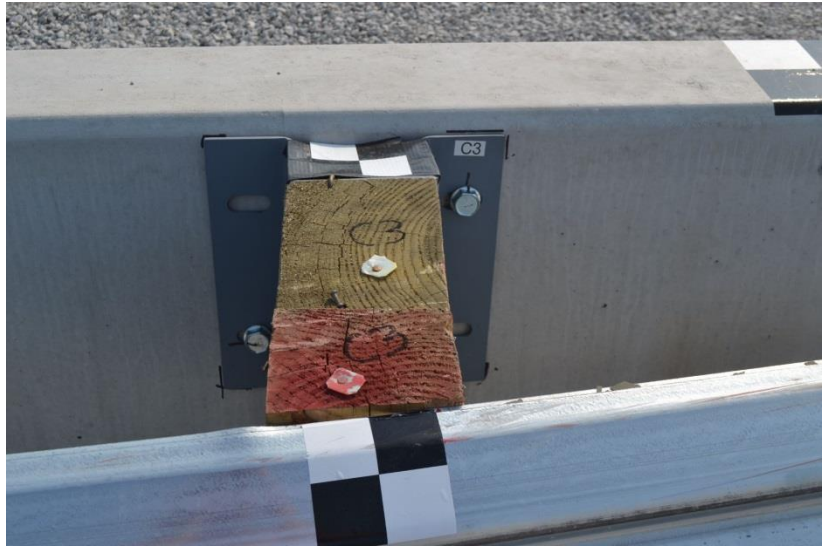
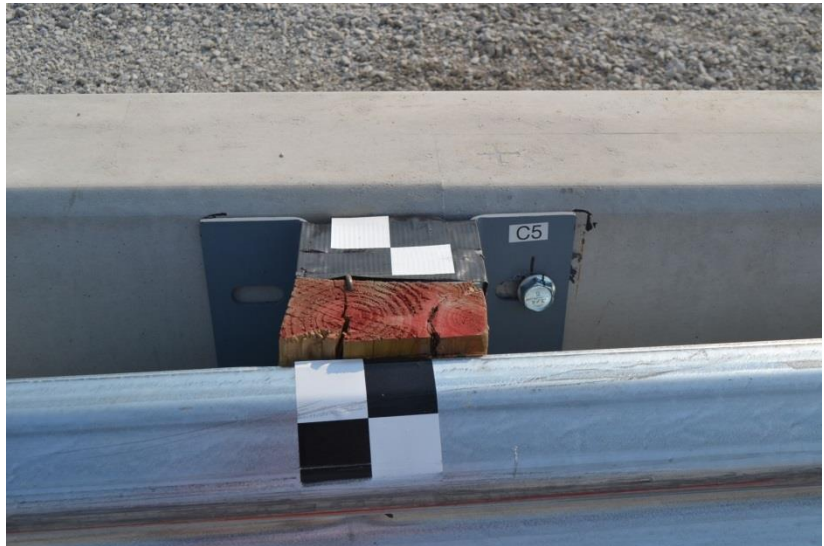
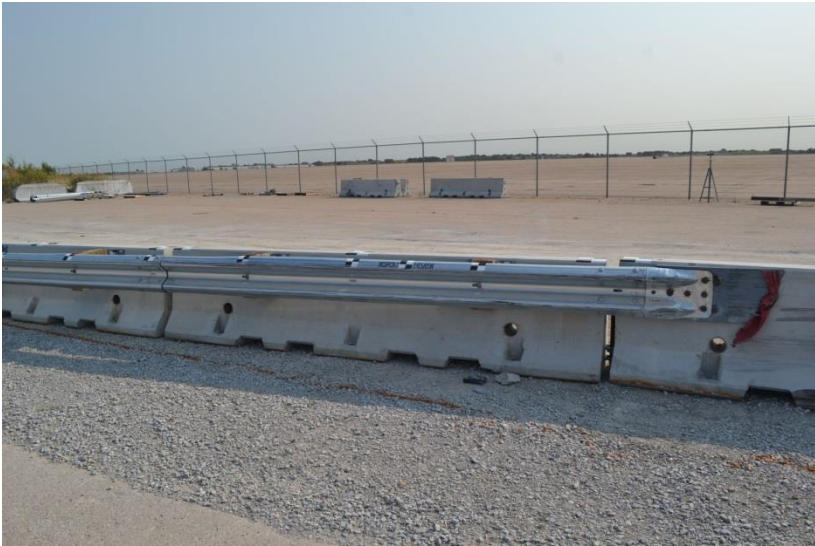
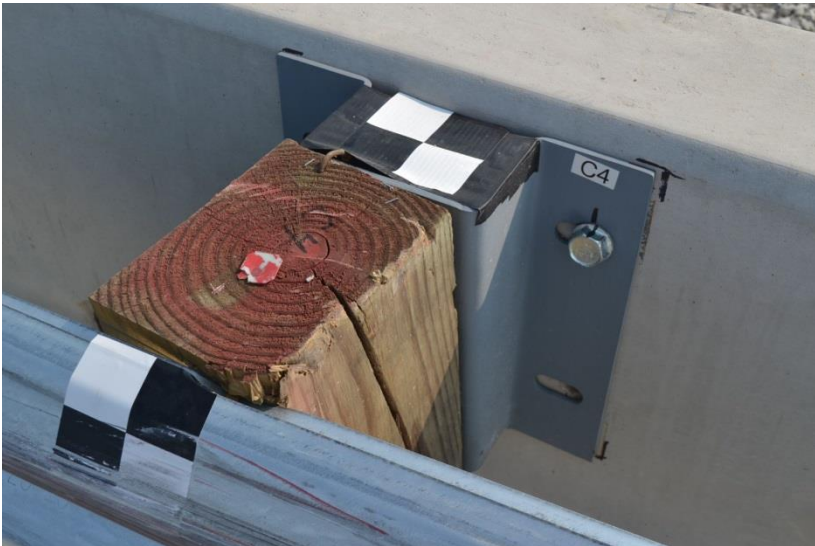
Figure 106. Rail and Blockout Damage Between End Shoe and Blockout C3, Test No. MGSPCB-3

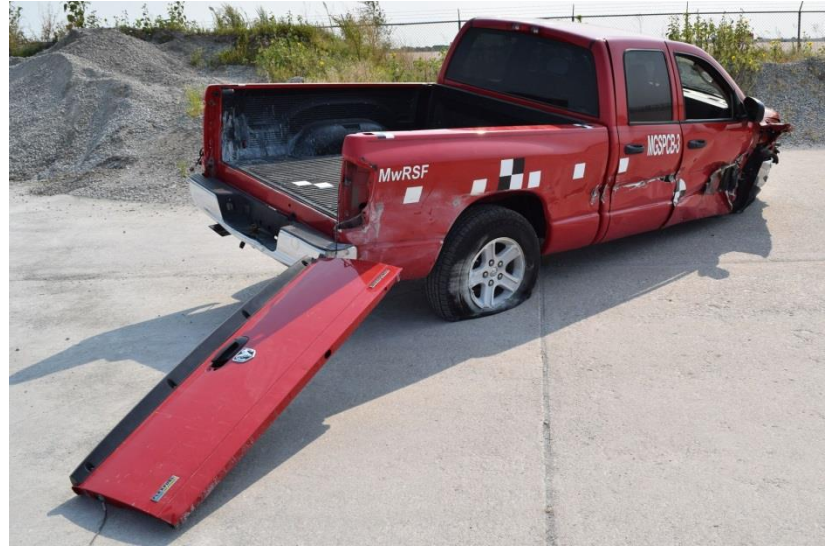
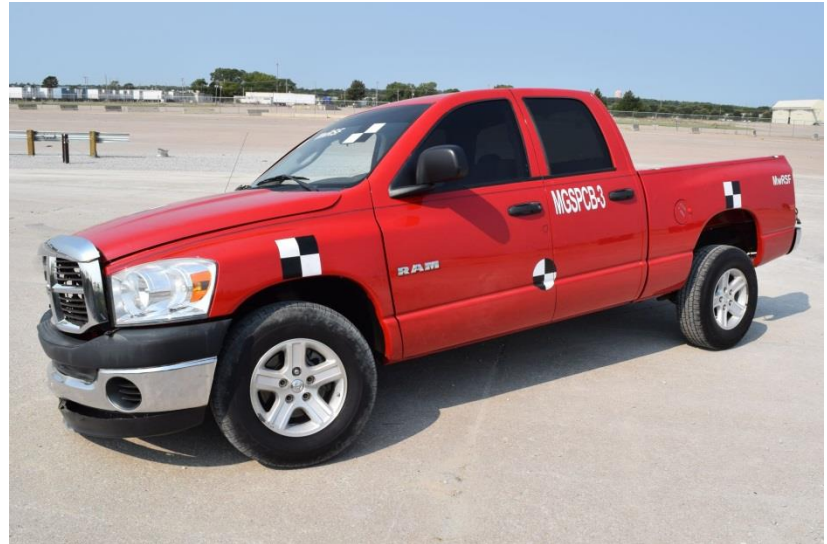
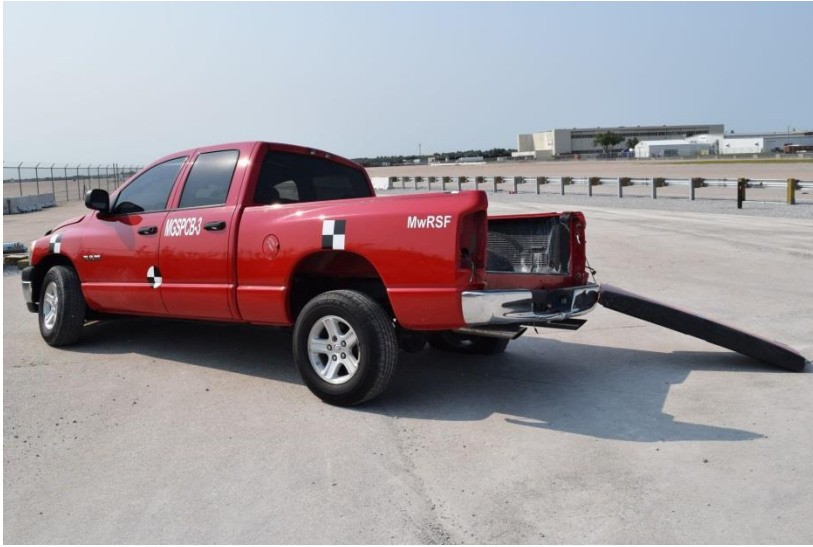
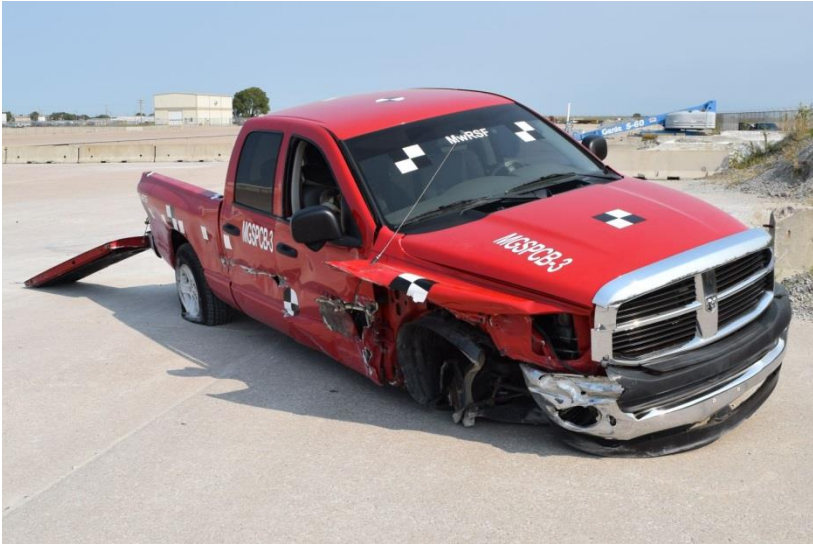
Figure 107. Vehicle Damage, Test No. MGSPCB-3

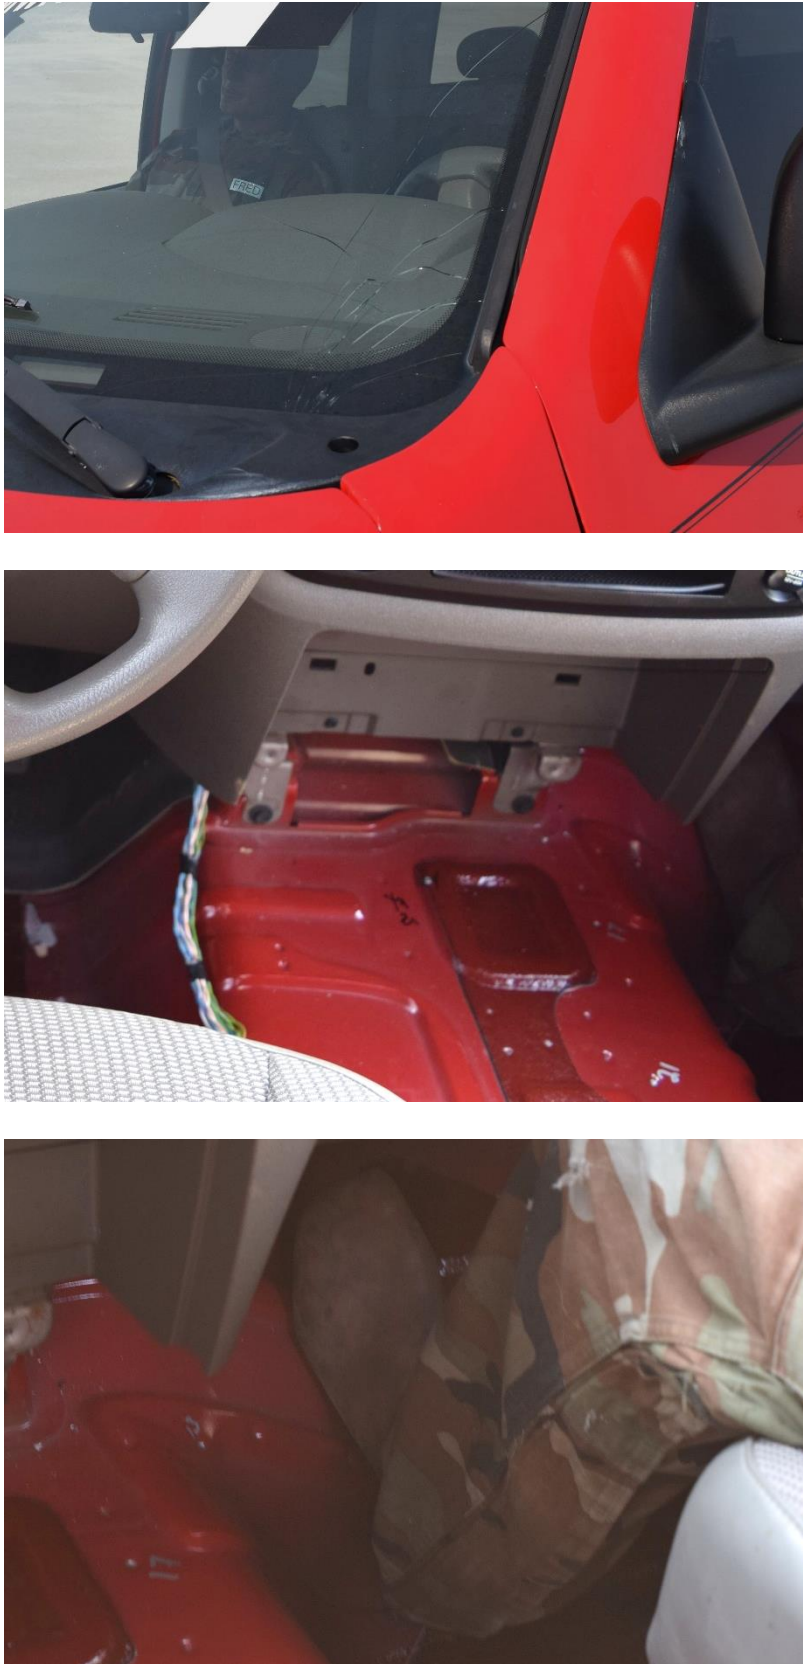
Figure 108. Windshield Damage and Occupant Compartment Deformation, Test No. MGSPCB-3

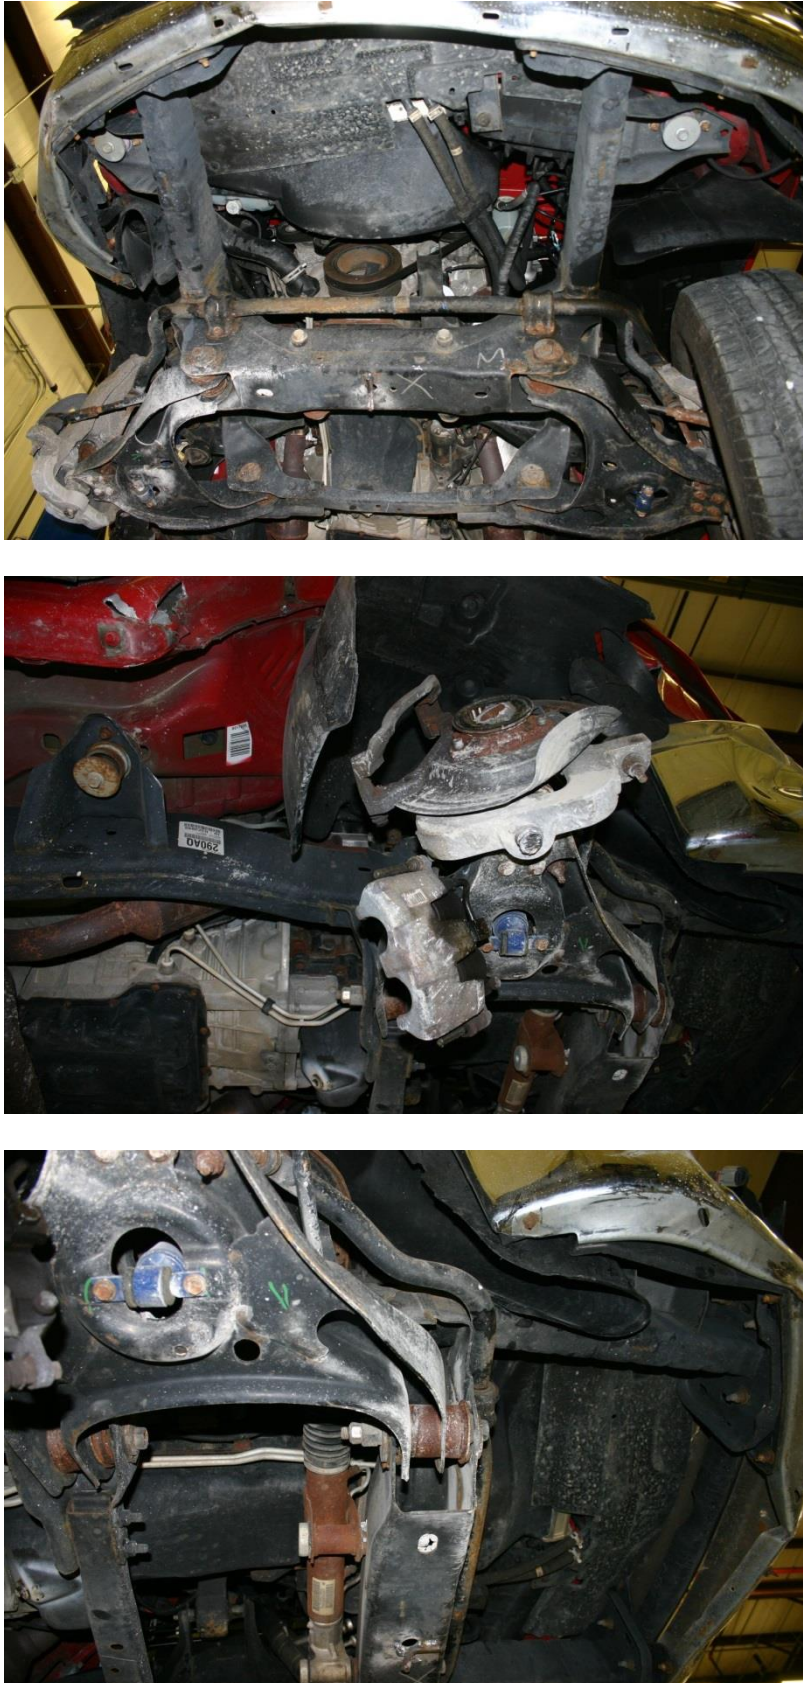
Figure 109. Undercarriage Damage, Test No. MGSPCB-3

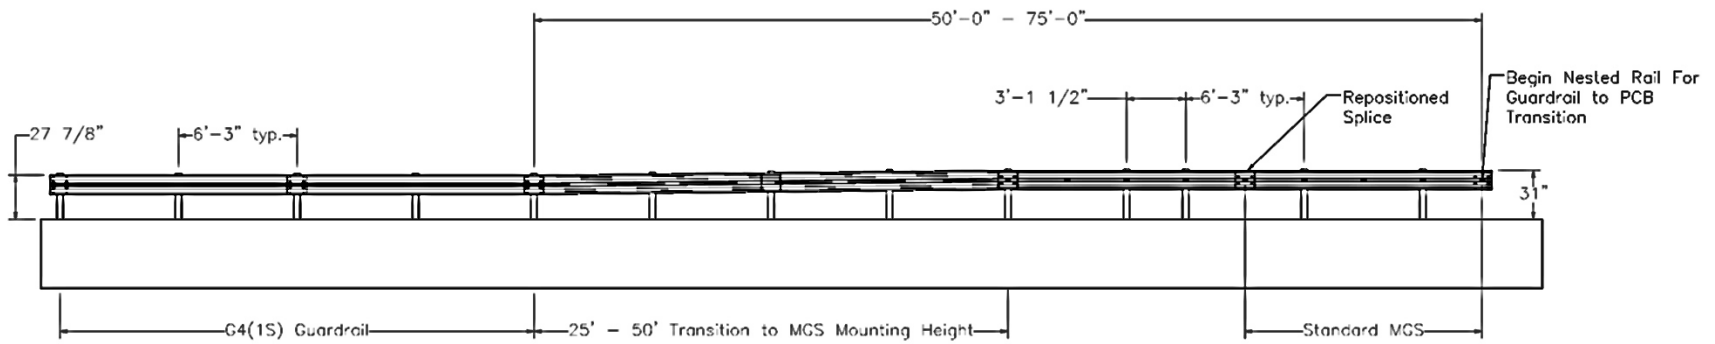
Figure 111. Schematic for Transitioning between G4(1S) and MGS Prior to Guardrail to PCB Transition, Half-Post Spacing in MGS Option

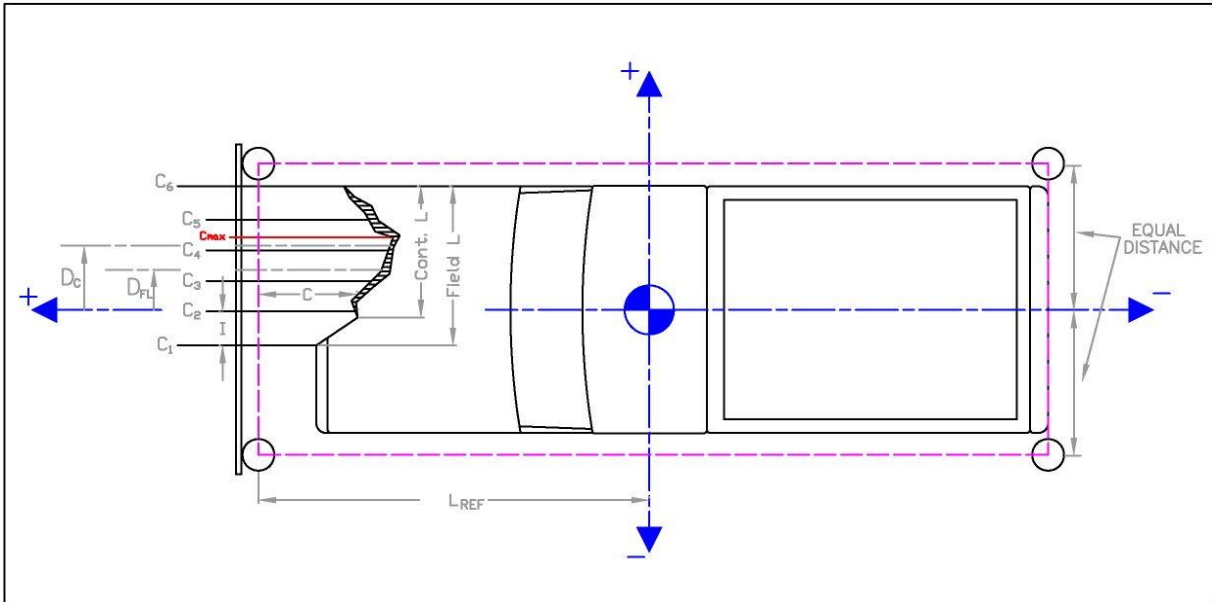
in.	(mm)
Distance from C.G. to reference line - L-REF:	100	(2540)
Total Vehicle Width:	78.5	(1994)
Width of contact and induced crush - Field L:	78 1/2	(1994)
Crush measurement spacing interval (L/5) - I:	15.7	(399)
Distance from center of vehicle to center of Field L - D _{FL} :	0	(0)
Width of Contact Damage:	78 1/2	(1994)
Distance from center of vehicle to center of contact damage - D _C :	0	(0)

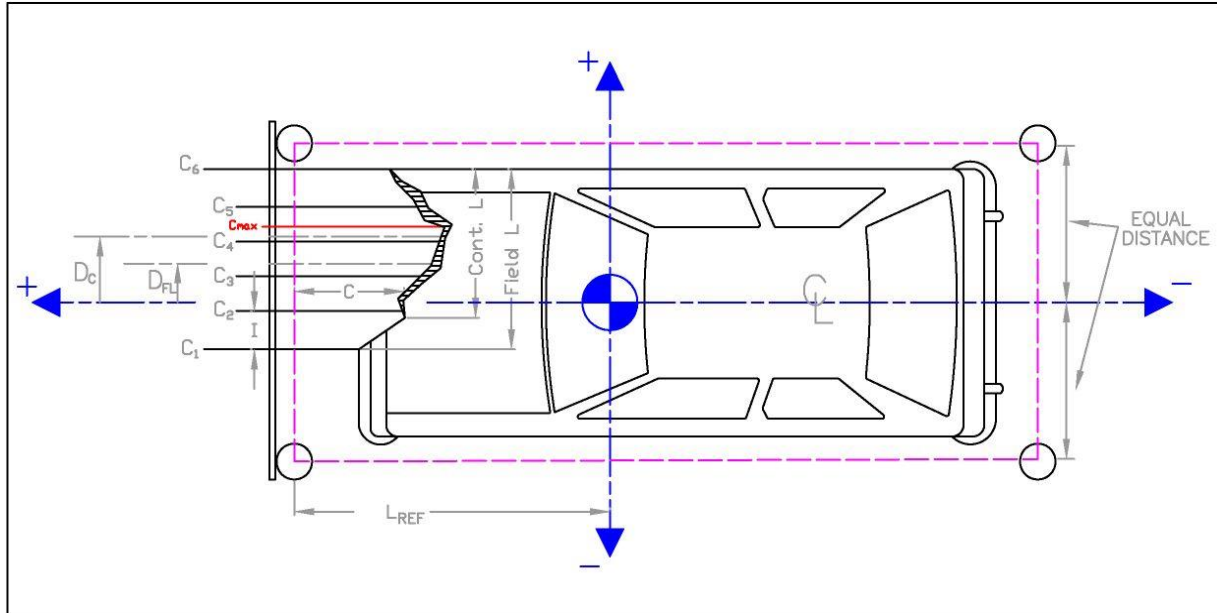
in.	(mm)
Distance from C.G. to reference line - L _{REF} :	74	(1880)
Total Width of Vehicle:	61 3/4	(1568)
Width of contact and induced crush - Field L:	61 3/4	(1568)
Crush measurement spacing interval (L/5) - I:	12 1/3	(314)
Distance from center of vehicle to center of Field L - D _{FL} :	0	(0)
Width of Contact Damage:	24 3/8	(619)
Distance from center of vehicle to center of contact damage - D _C :	18 5/8	(473)

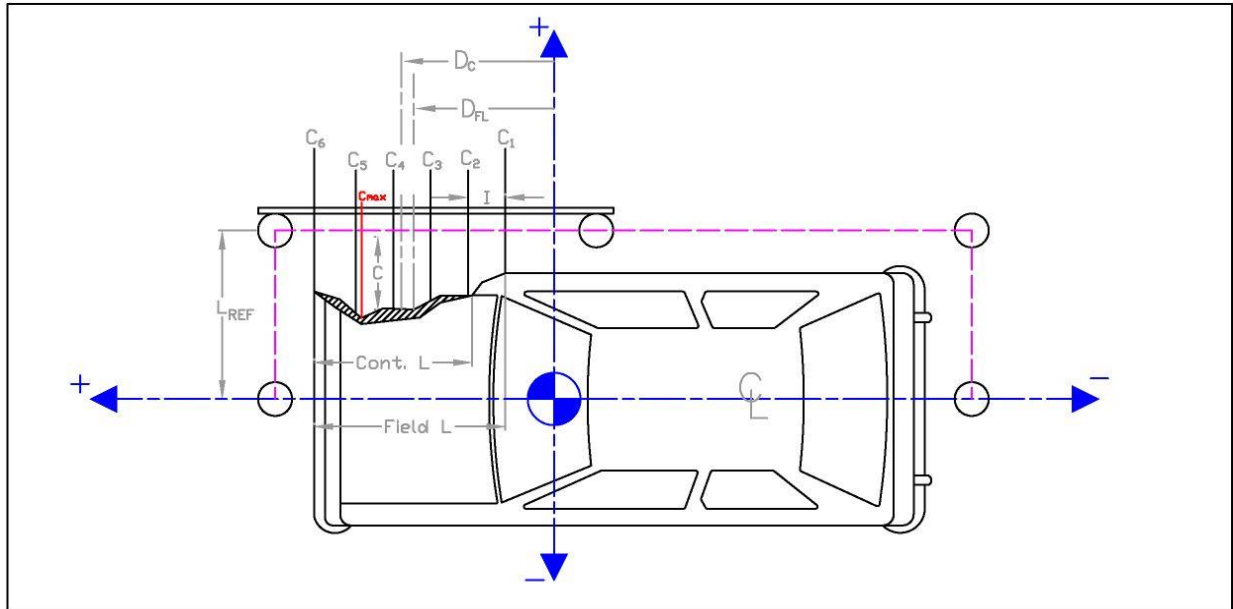
in. (mm)
Distance from centerline to reference line - L_{REF}: 39.5 (1003)
Total Vehicle Length: 167.5 (4255)
Width of contact and induced crush - Field L: 167.5 (4255)
Crush measurement spacing interval (L/5) - I: 33.5 (851)
Distance from vehicle c.g. to center of Field L - D_{FL}: -15.625 -(397)
Width of Contact Damage: 167.5 (4255)
Distance from vehicle c.g. to center of contact damage - D_C: -15.625 -(397)

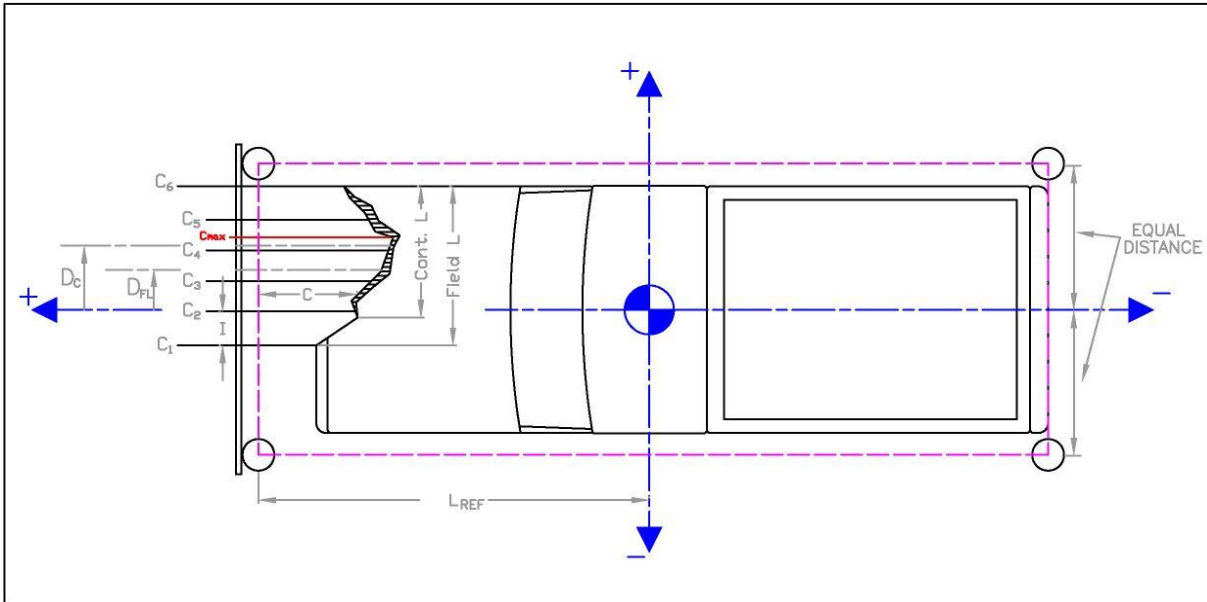
in.	(mm)
Distance from C.G. to reference line - L _{REF} :	110	(2794)
Total Vehicle Width:	78	(1981)
Width of contact and induced crush - Field L:	39	(991)
Crush measurement spacing interval (L/5) - I:	7.8	(198)
Distance from center of vehicle to center of Field L - D _{FL} :	19 1/2	(495)
Width of Contact Damage:	19 1/2	(495)
Distance from center of vehicle to center of contact damage - D _C :	29 1/4	(743)

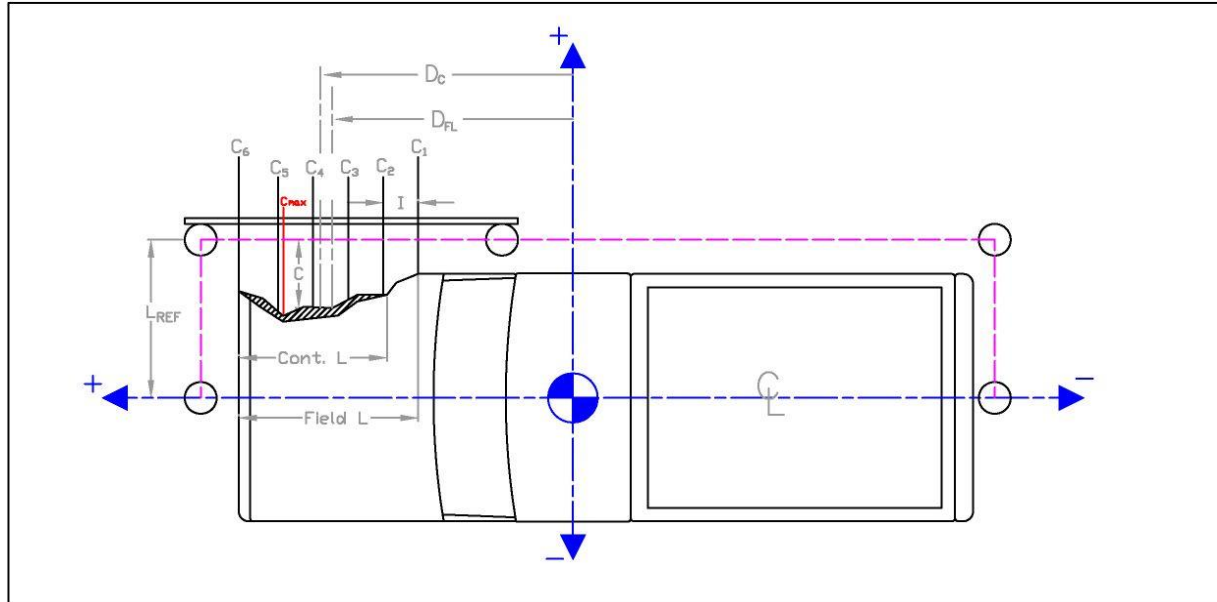
in. (mm)
Distance from centerline to reference line - L_{REF}: 45 (1143)
Total Vehicle Length: 227.5 (5779)
Width of contact and induced crush - Field L: 227 1/2 (5779)
Crush measurement spacing interval (L/5) - I: 45.5 (1156)
Distance from vehicle c.g. to center of Field L - D_{FL}: -11 1/3 (-288)
Width of Contact Damage: 227 1/2 (5779)
Distance from vehicle c.g. to center of contact damage - D_C: -11 1/3 (-288)
