SAFETY PERFORMANCE EVALUATION OF MINNESOTA'S ALUMINUM TYPE III BARRICADES

MwRSF Research Report No. TRP-03-101-00

October 19, 2000

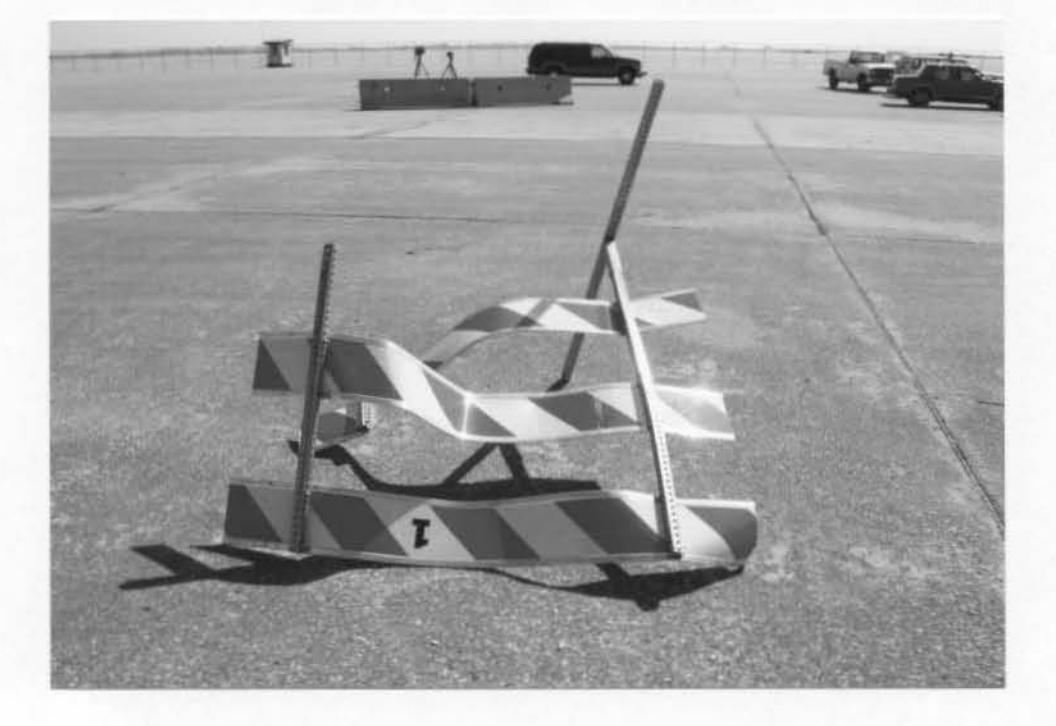
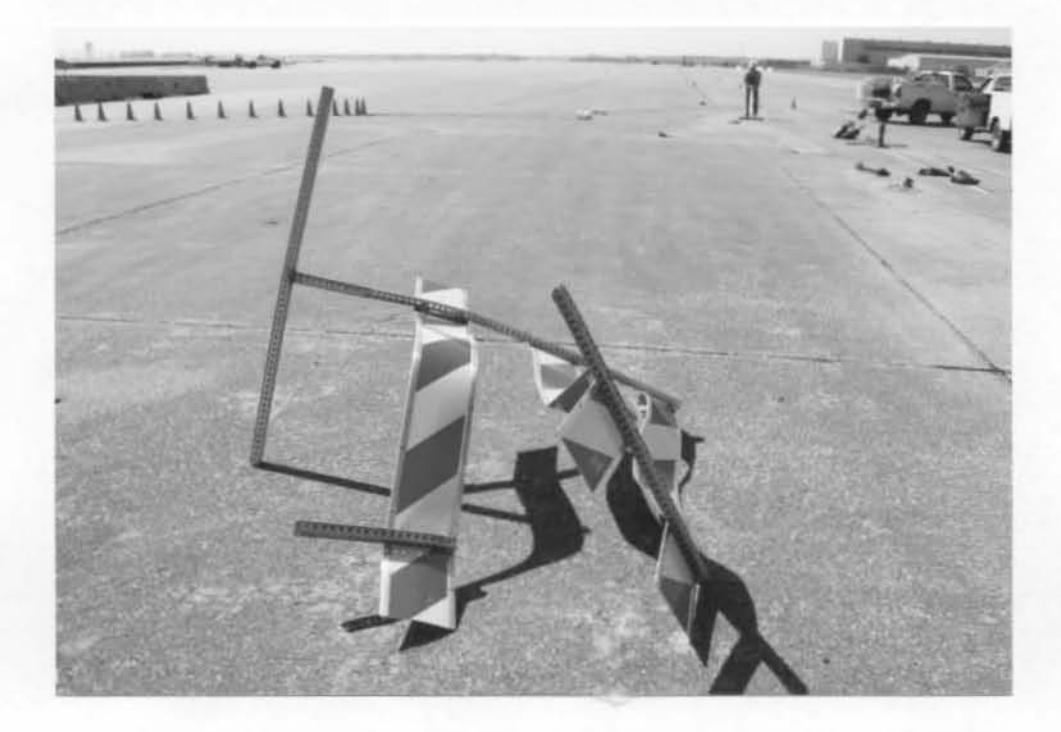
Figure 22. System No. 1 Damage, Test MNB-1

Damage to System Nos. 1 and 2 is shown in Figures 21 through 25. System No. 1 encountered moderate damage. The leg on the left side was bent and disengaged from the mast. The left mast fractured above the lower panel. The vertical mast on the right side was deformed. All three of the barricade panels encountered deformations as well as scuff and scrape marks. The sandbags were torn open with the sand scattered along the path of the vehicle, starting at the initial position of the barricade.

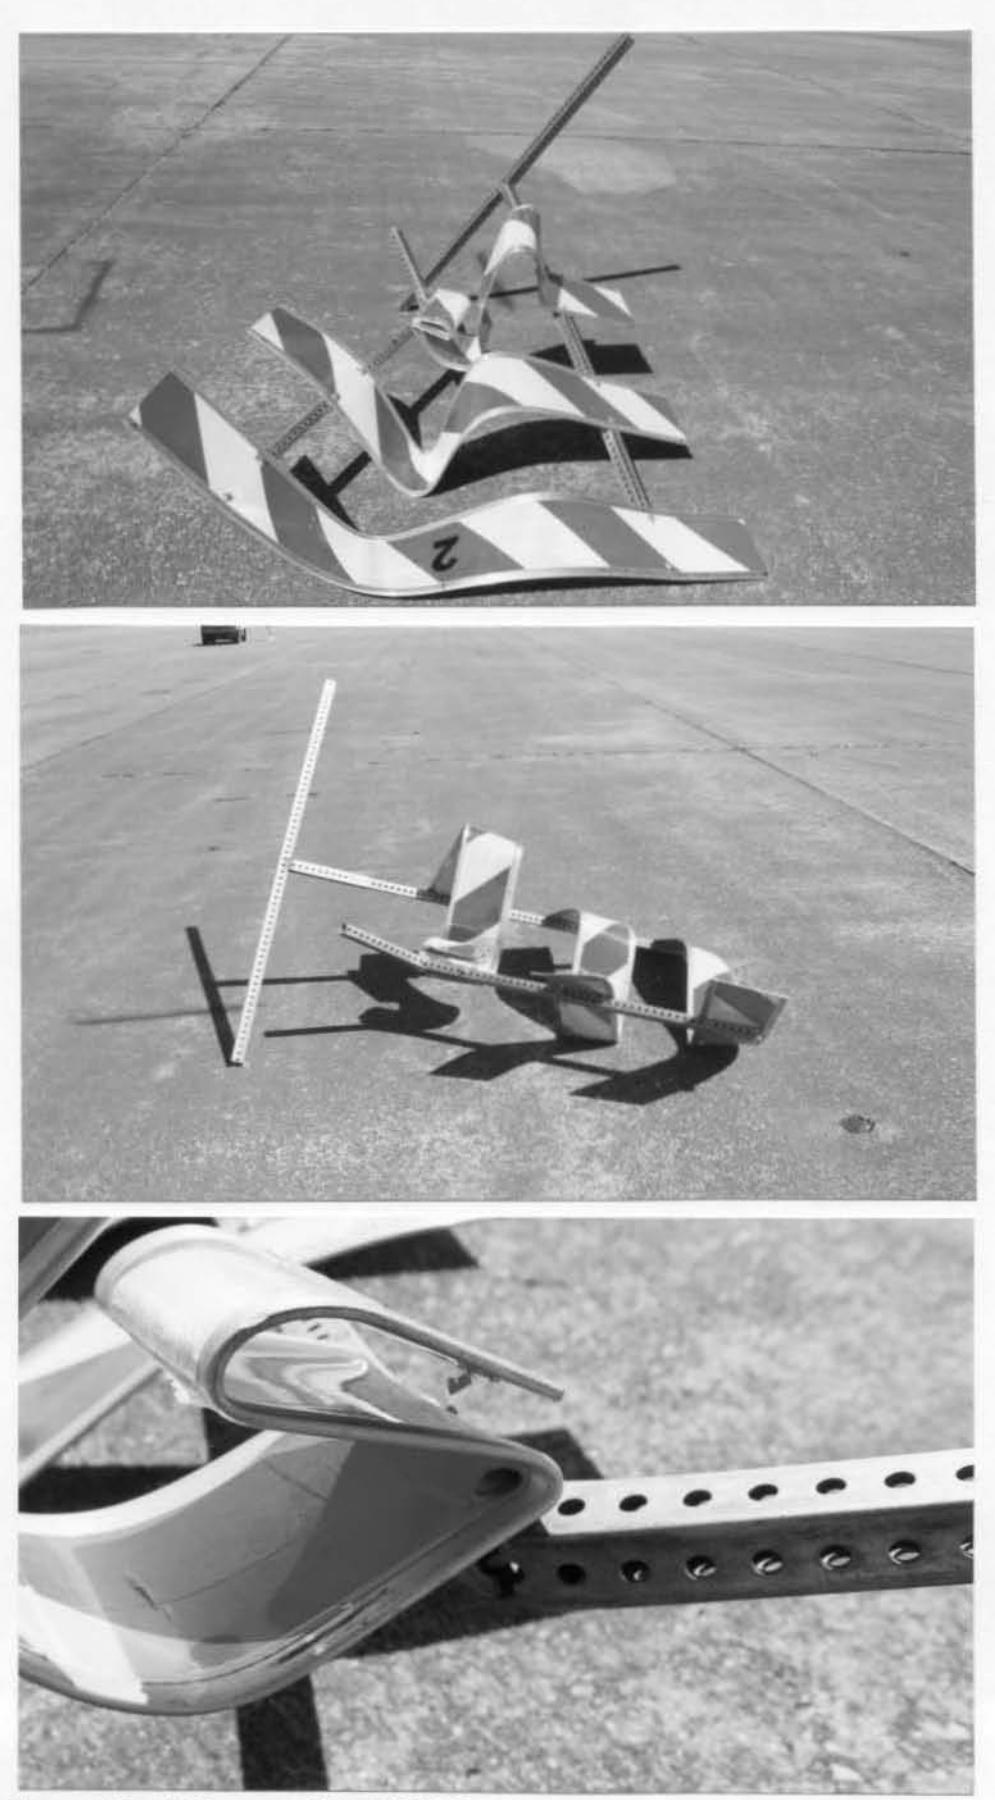
Figure 24. System No. 2 Damage, Test MNB-1

System No. 2 encountered moderate damage. The leg closest to the vehicle disengaged and fractured at the vertical upright portion of the leg. The mast closest to the vehicle was bent to an approximate angle of 60 degrees and at a location below the bottom panel. All three of the barricade panels buckled from the side closest to the vehicle to the side furthest from the vehicle. All components of the barricade encountered scuff and scrape marks. Two of the sandbags were torn open with the sand scattered along the path of the vehicle to approximately 7.62-m downstream from the initial position of the second barricade. The other two sandbags remained undamaged.

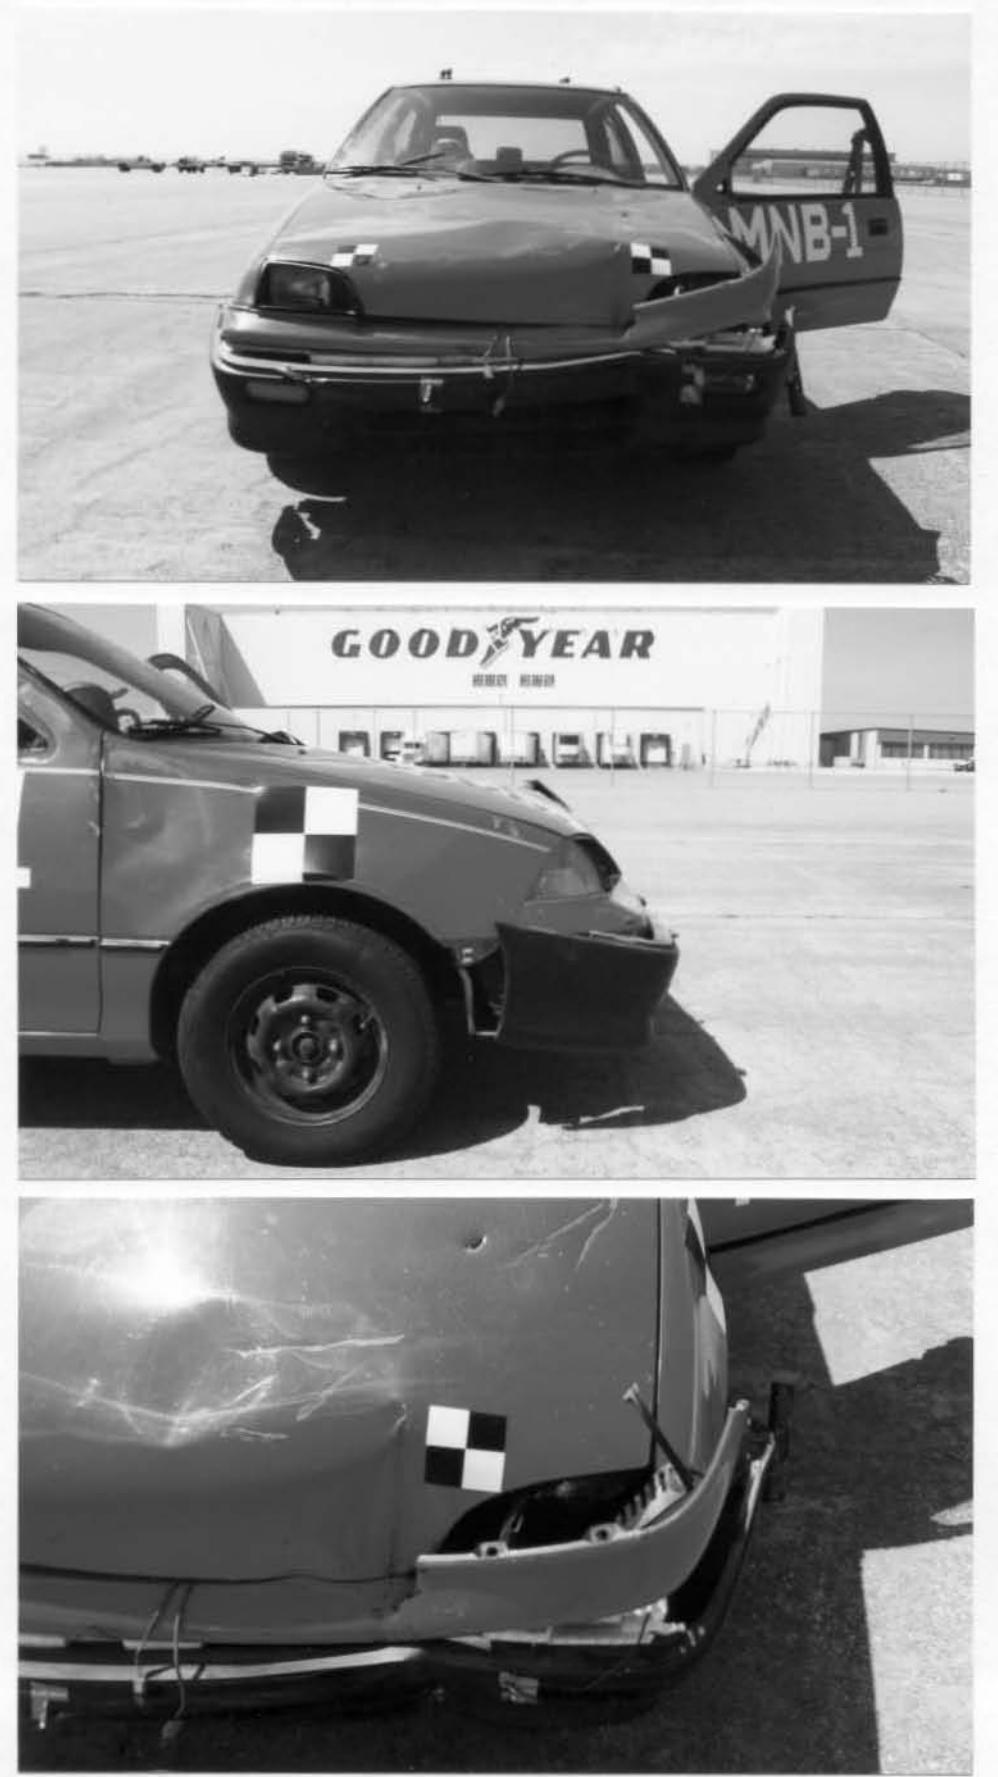
Figure 26. Vehicle Damage, Test MNB-1

Exterior vehicle damage is shown in Figures 26 and 27. The front bumper and lower plastic shield encountered dents, contact and scuff marks, and tears at each of the quarter points. Both sides of the bumper disengaged from the bumper clips. Contact marks and scrape marks were also found on the hood and both front fenders. A 51-mm long hole was found on the hood near the center of the left-quarter point. The right-front fender was dented near the door area. The plastic shield around left-front headlight was deformed and disengaged from the front of the vehicle. The left-front fog light was broken. A 102-mm long scrape was located along the right-side door frame. The

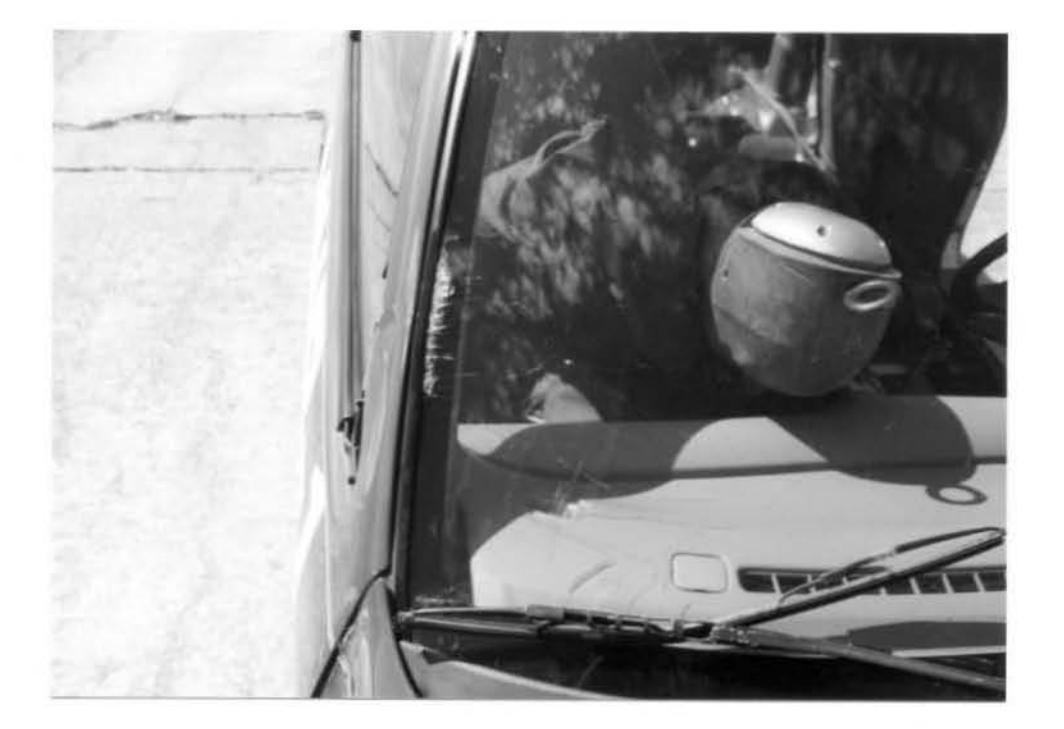
Figure 27. Windshield Damage, Test MNB-1

right-side door encountered a major scrape near the front-right fender. The right windshield wiper blade was partially ripped off of the wiper arm. The right-side windshield sustained minor cracking near the right-outside edge. However, the degree of cracking was judged insufficient to hinder visibility nor cause weak spots in both layers of glass. No damage was found to have occurred to the parking lights, headlights, nor right-side fog light. There were no interior occupant compartment deformations to the vehicle.

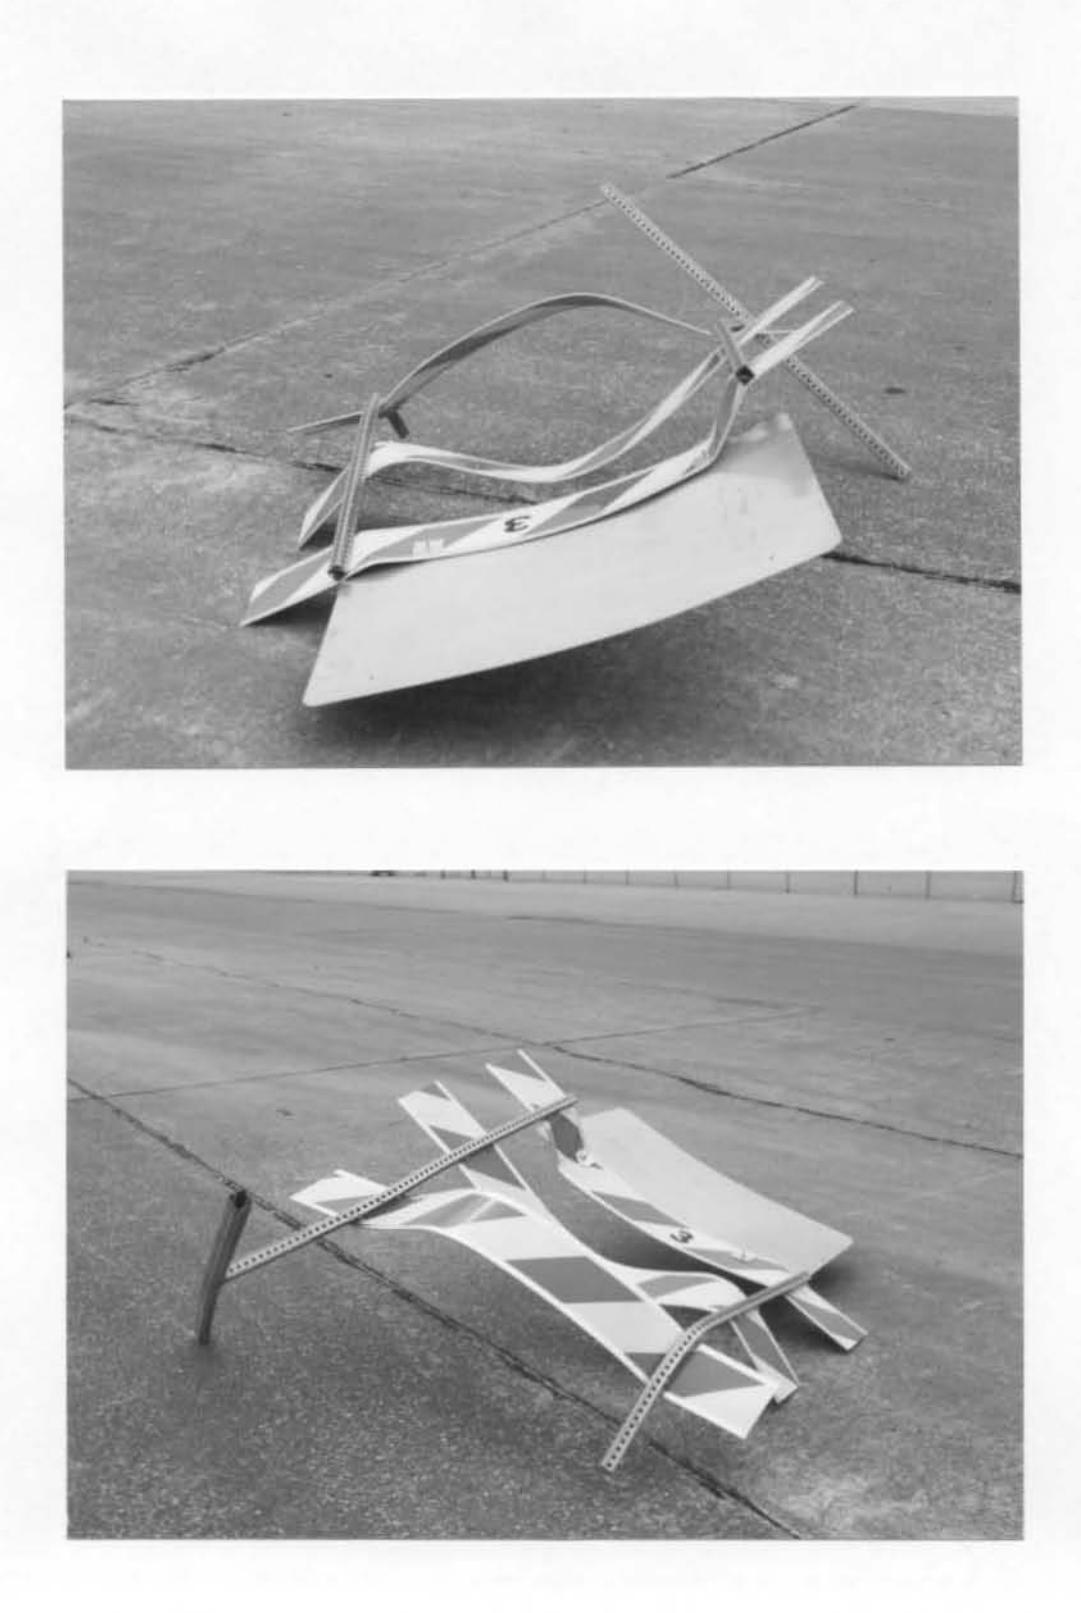
Figure 34. System No. 3 Damage, Test MNB-2

Damage to System Nos. 3 and 4 is shown in Figures 33 through 36. System No. 3 encountered moderate damage. The left-side leg was slightly deformed and disengaged from the mast. The left-side mast fractured above the bottom panel. The vertical mast on both sides deformed with the one on the left encountering more severe deformations. All three of the barricade panels as well as the sign panel encountered deformations and scuff and scrape marks. The sandbags were torn open with the sand scattered along the path of the vehicle.

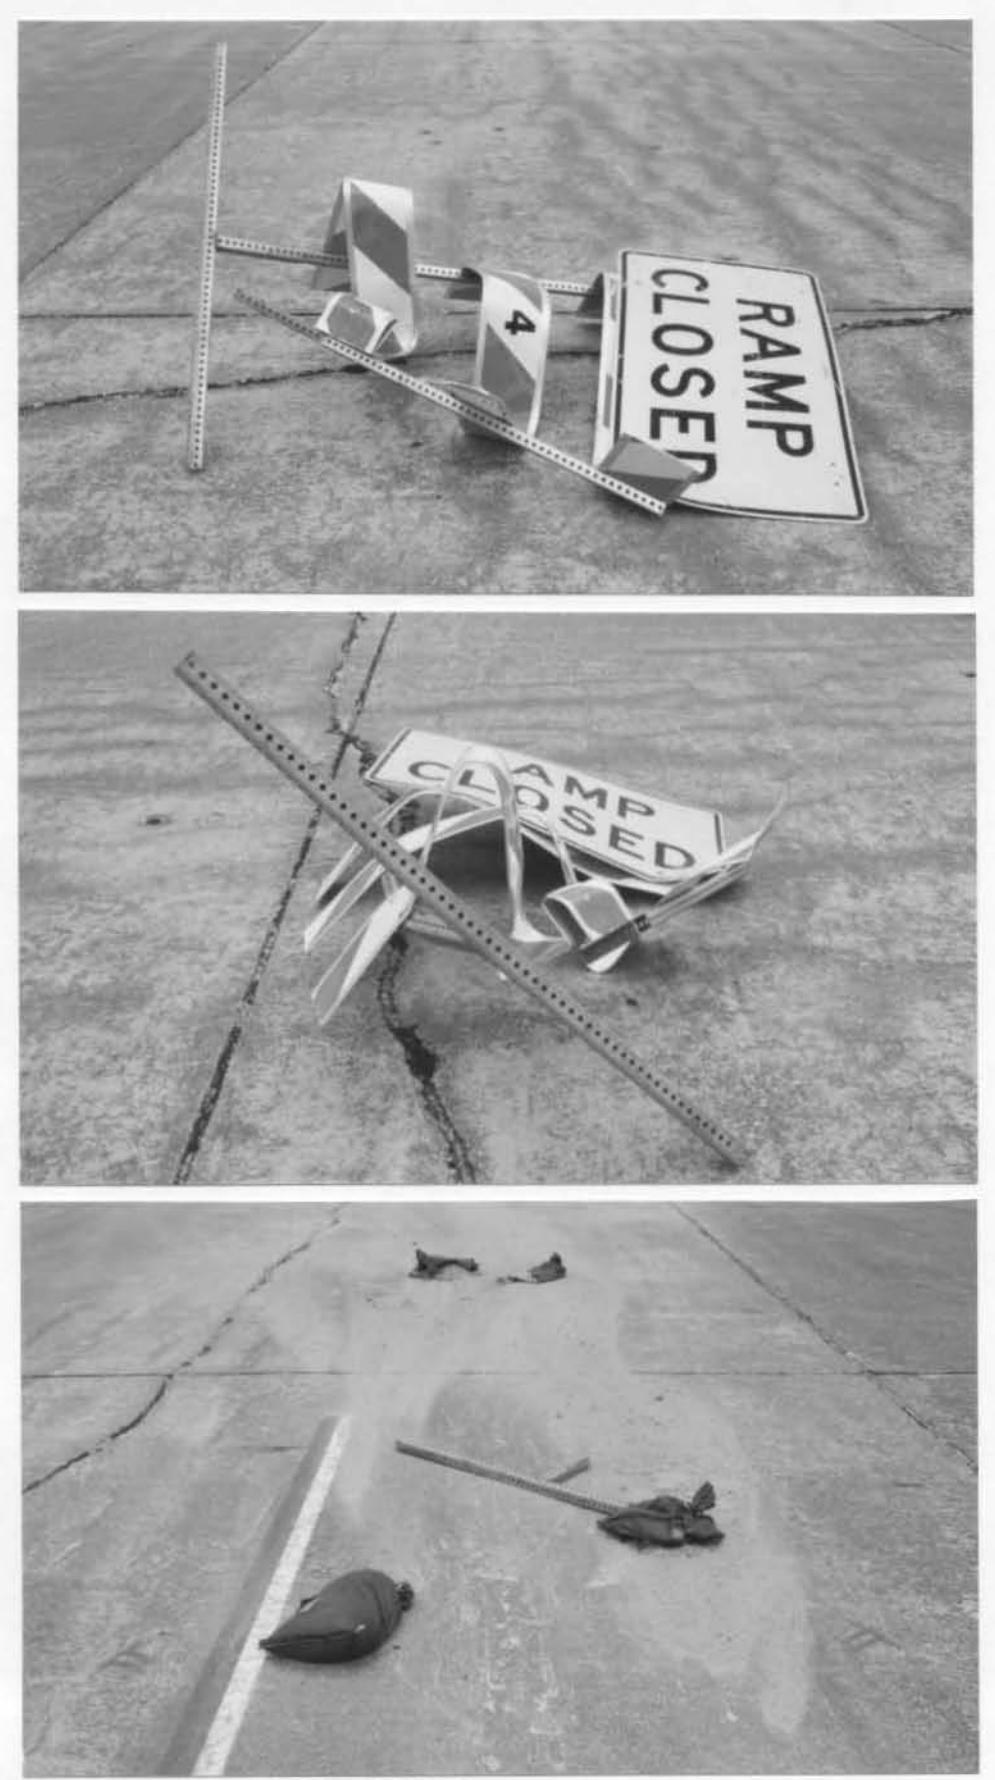
Figure 35. System No. 4 Damage, Test MNB-2

System No. 4 encountered moderate damage. The leg closest to the vehicle disengaged and was slightly deformed. The mast closest to the vehicle was bent to an approximate angle of 45 degrees and at a location below the bottom panel. The mast on the non-impact side was also deformed. All three of the barricade panels buckled from the side closest to the vehicle to the side furthest from the vehicle. The sign panel was also deformed. Three of the sandbags were torn open with the sand scattered along the path of the vehicle. The other sandbag remained undamaged.

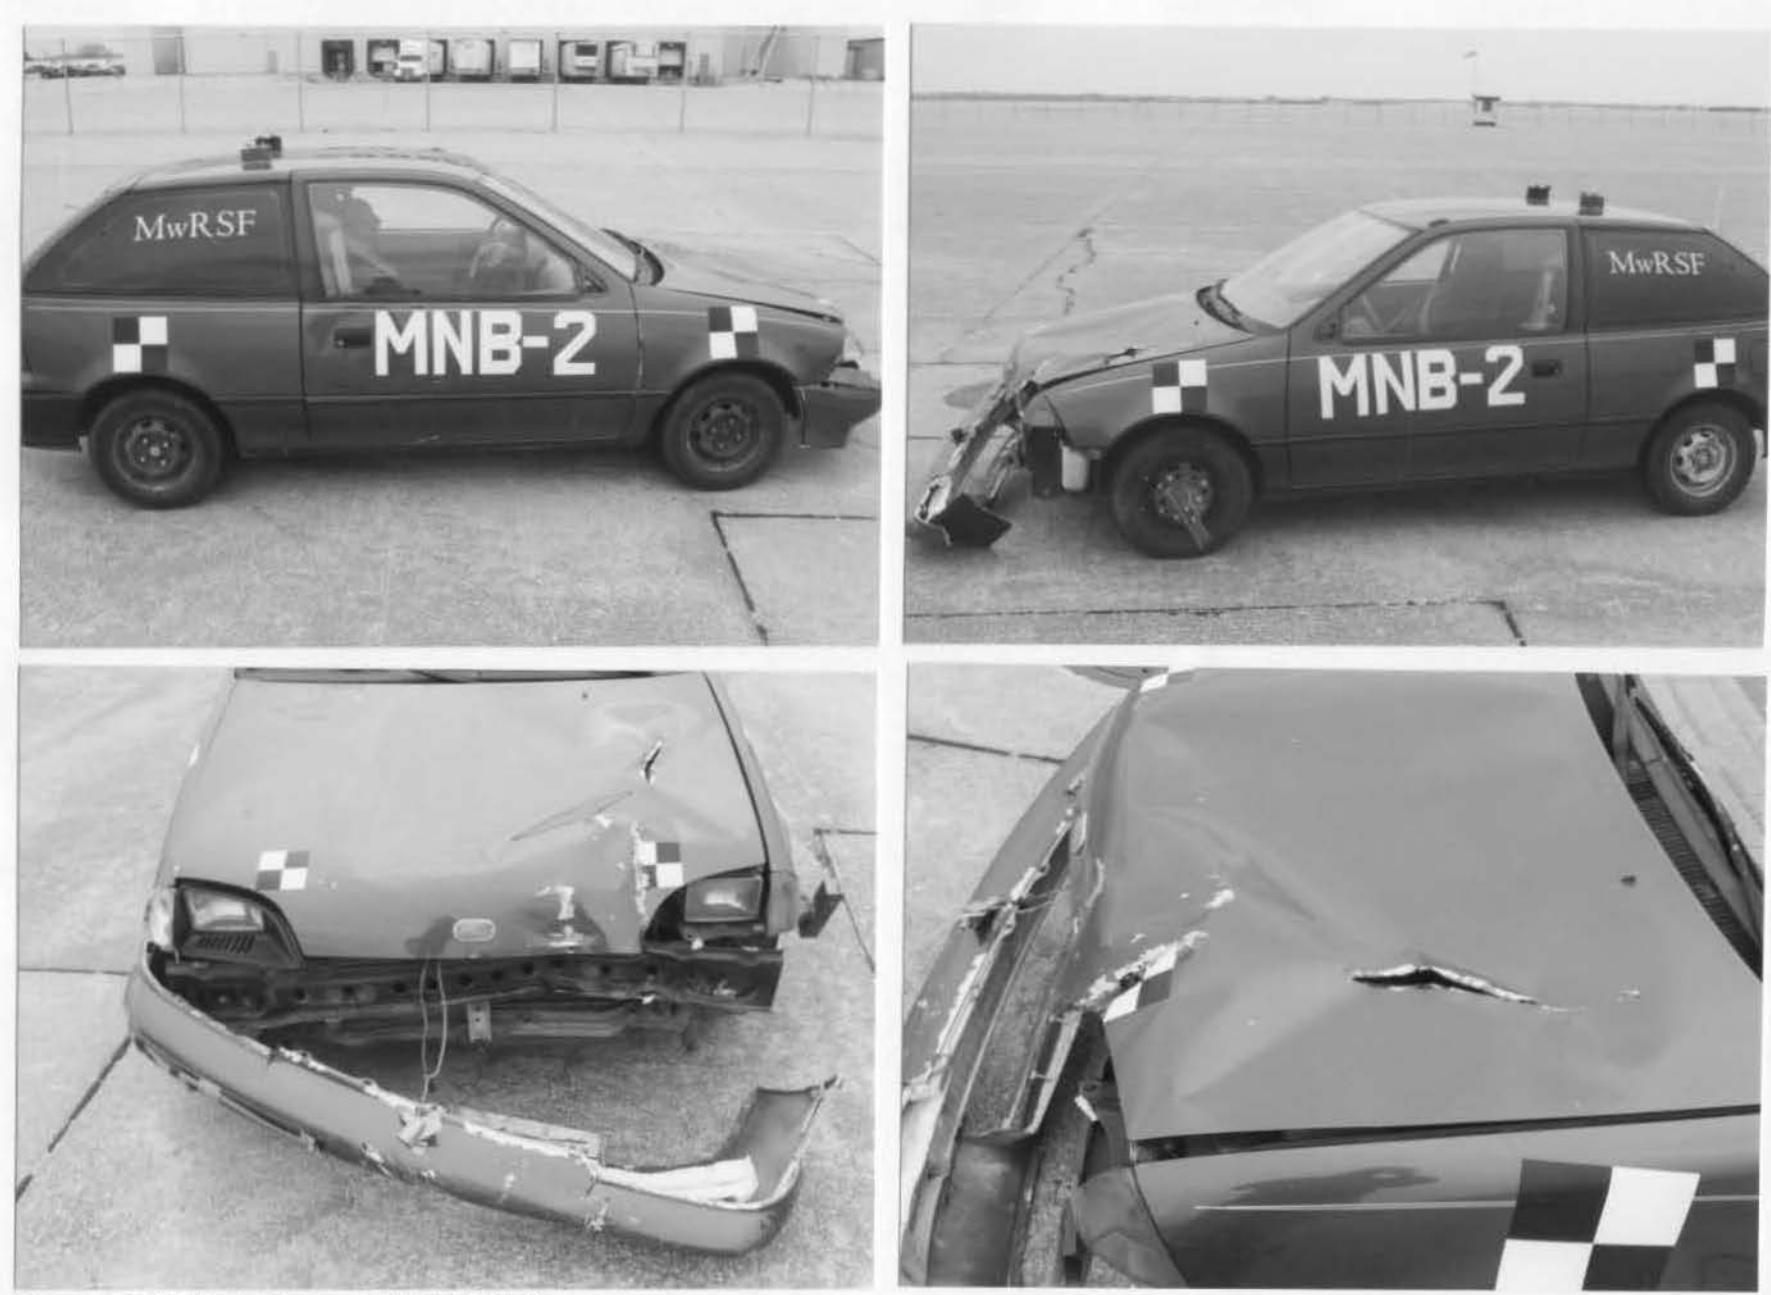
Figure 37. Vehicle Damage, Test MNB-2

Exterior vehicle damage is shown in Figures 37 and 38. The left side of the front bumper and lower plastic shield disengaged from the bumper clips. The center of the hood encountered a major dent. A 279-mm long cut was located along the left-side quarter-point of the hood. Scuff and scape marks were found on the hood, the bumper, the top of both front fenders, the right side of the roof, and the lower-center region of the right-side door. A tear was found in the right-front fender near the parking light. The right-side parking light and the left-side fog light were broken. The windshield on the right side sustained minor starring and cracking near the top-left, top-right, and lower-center regions of the windshield. The windshield on the left side sustained "spider web" cracking and slight cracking of both layers of glass. However, the degree of cracking was judged insufficient to hinder visibility nor cause weak spots in both layers of glass. The headlights, right fog light, and left parking light were undamaged. There were no interior occupant compartment deformations to the vehicle.
