Hawaii Department of Transportation Research Project Number 68212 Research Project No. STP-1500(092)R – Phase III

CRASH TESTING AND EVALUATION OF THE HDOT 34-IN. TALL, AESTHETIC CONCRETE BRIDGE RAIL WITH PEDESTRIAN HANDRAIL AND SIDEWALK: MASH TEST DESIGNATION NOS. 3-10 AND 3-11

MwRSF Research Report No. TRP-03-456-22

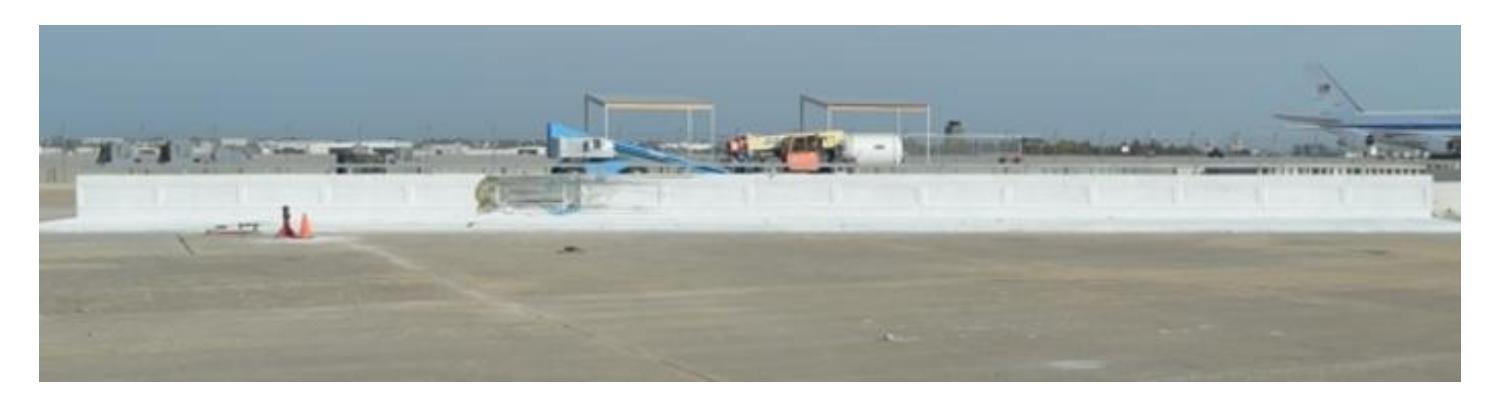
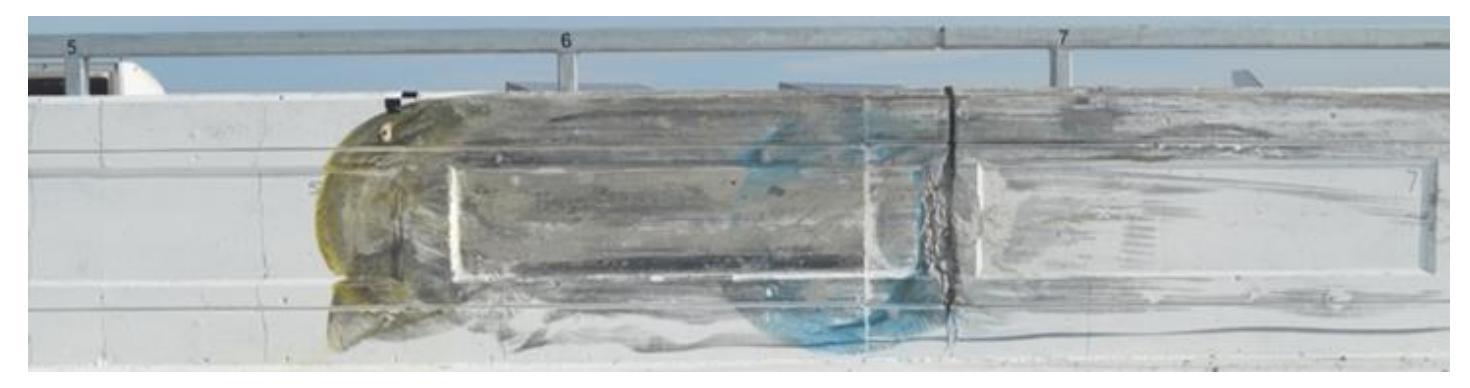
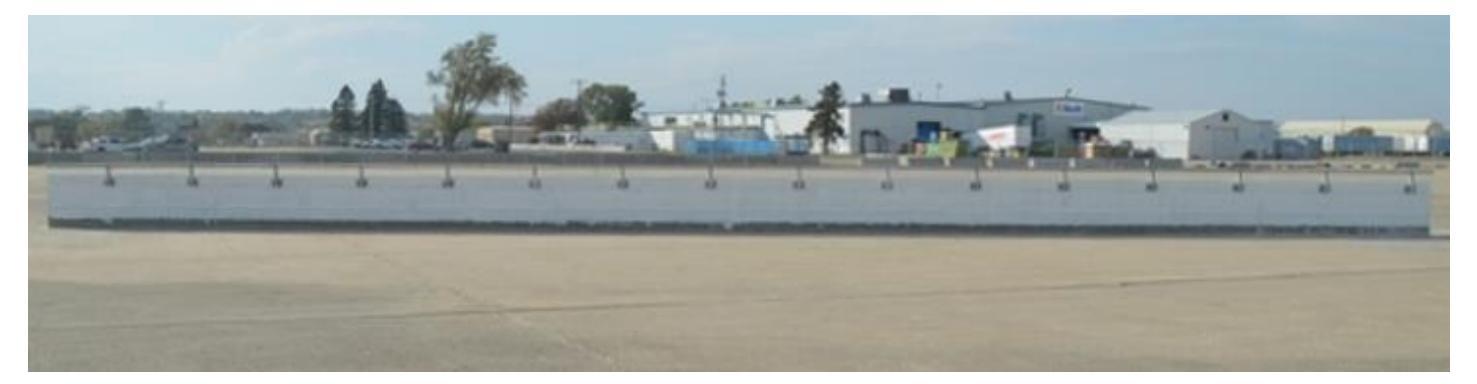
Figure 43. System Damage, Test No. HP34S-1

Damage to the barrier was minimal, as shown in Figures 43 through 48. Barrier damage consisted of contact marks on the front face of the concrete segments and minor concrete spalling and cracking. The length of vehicle contact along the barrier was approximately 14 ft - 11 in., which spanned across barrier segment nos. 2 and 3.

Barrier segment no. 2 had two cracks at expansion joint no. 2. The first crack was at the base that extended 67 in. upstream from the expansion joint, and a second $9\frac{1}{2}$ -in. crack originating near the bottom of the chamfer near the top of the barrier. There were two $\frac{1}{2}$ -in. cracks at the bottom of base plate no. 7 near the upstream bolt and three cracks ranging from $\frac{1}{2}$ in. to 4 in. at the bottom of base plate no. 8, also near the upstream bolt. There was a 60-in. long contact mark on the pedestrian handrail that initiated 20 $\frac{1}{4}$ in. downstream from post no. 6, and the handrail was displaced $\frac{1}{2}$ in. laterally between post nos. 7 and 8.

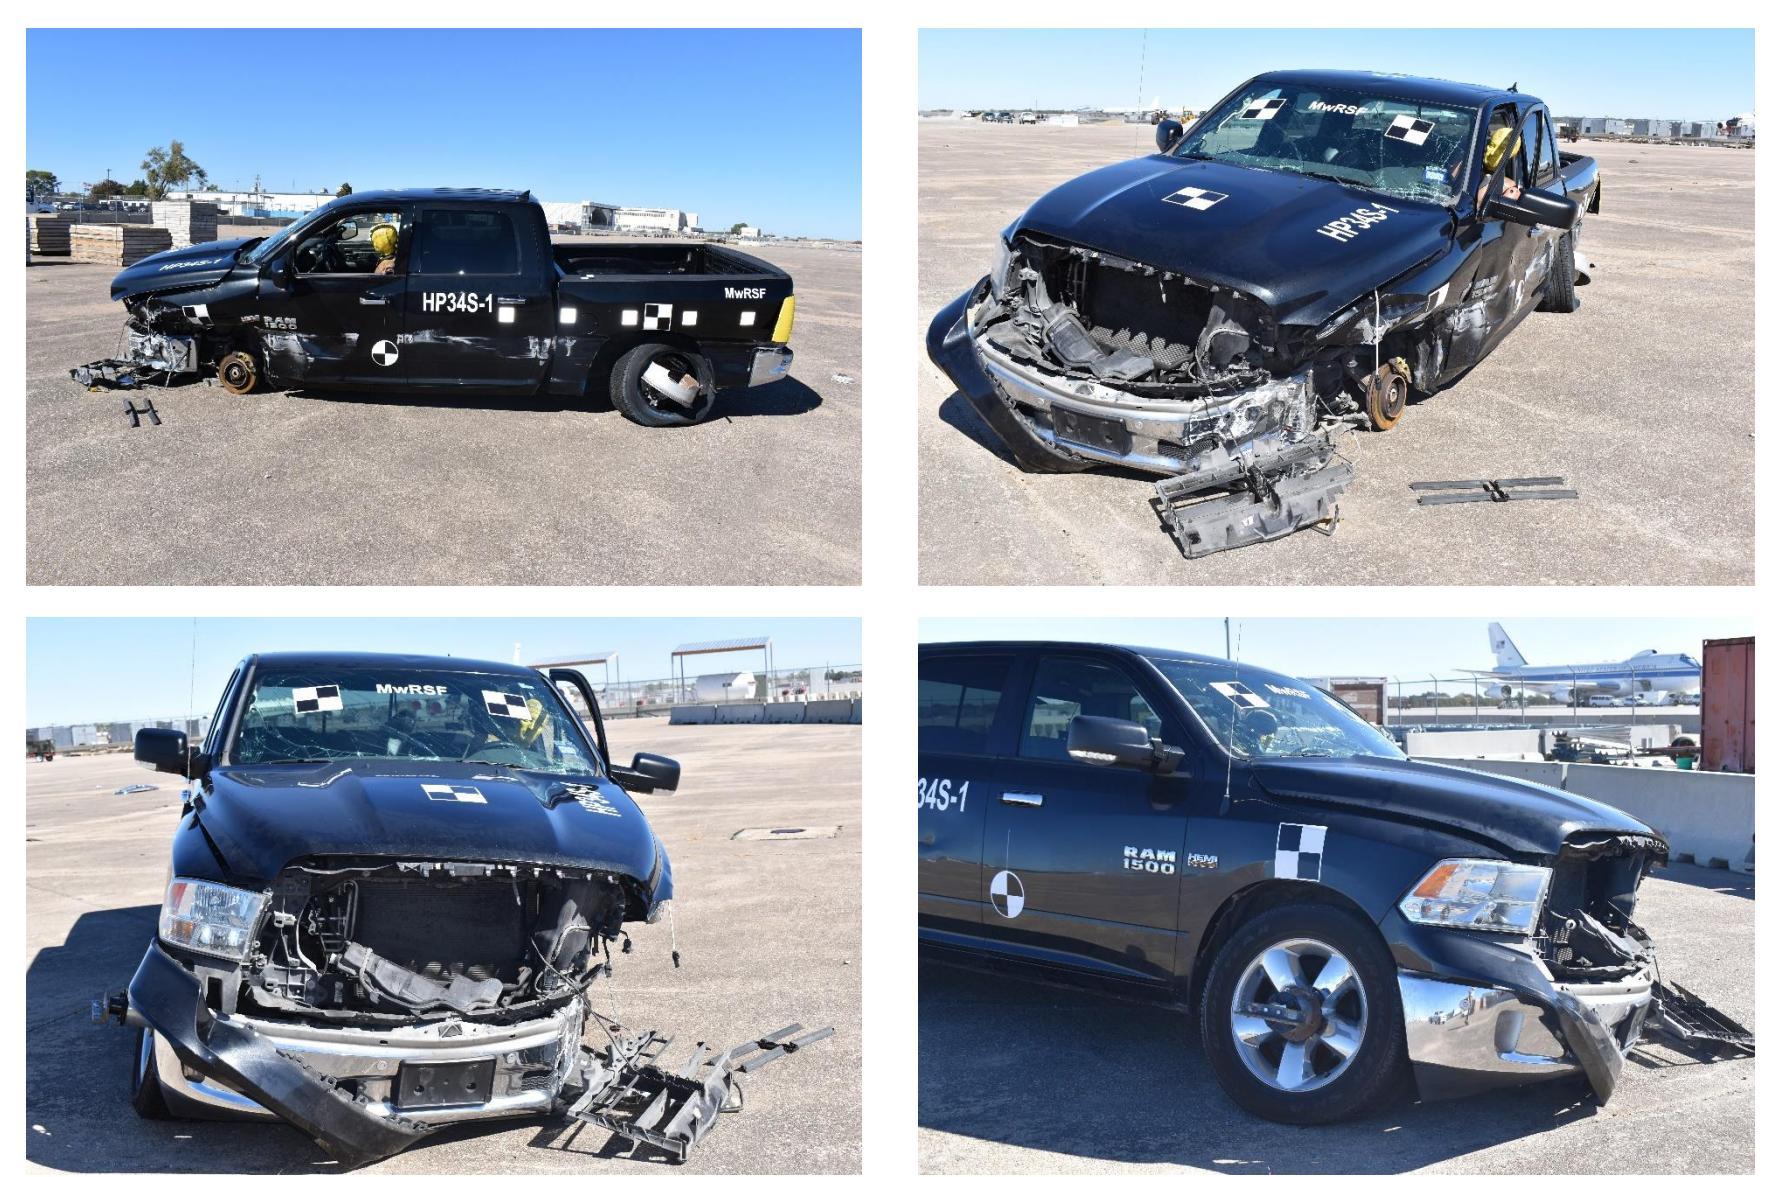
Figure 50. Vehicle Damage, Test No. HP34S-1

Majority of the damage was concentrated on the left-front corner and left side of the vehicle where the impact had occurred. The left side of the front bumper was crushed inward and backward. The left-front fender was crushed inward toward the centerline of the vehicle and engine compartment. The left-front wheel was disengaged from the vehicle, the tire was punctured and deflated, and the rim was fractured along three of the five spokes extending from the hub. The leftrear wheel rim was fractured and separated into multiple pieces. The tire remained engaged with the fractured pieces of the rim. The left-front and left-rear fenders, both left-side door panels, and the left-rear bumper were crushed inward and scraped. The grille and left headlight were disengaged from the vehicle. Both left-side doors, the truck bed, and the left side of the rear bumper were crushed inward. The right-front fender was displaced rearward, causing difficulty in opening the right-front door. The bottom of the right-front tire was angled away from the vehicle. The leftfront side window shattered, and the windshield was cracked across its entire length. The left-front side window damage was not due to contact with the test article.

The left-front lower control arm was fractured and disengaged from the vehicle. The leftfront shock and suspension spring were disengaged from the left-front lower control arm and displaced backwards. The Panhard bar was bent upward, and the left-front control arm was bent but remained engaged with the steering linkage. The anti-roll bar was bent into a "U"-shape and disengaged. The rear bearing joint of the right-front lower control arm was fractured, and the rightfront spring and suspension were displaced forward. The lateral engine cradle support beam was bent downward into a "U"-shape. The left-front frame horn was crushed inward. The gas tank was scraped and the oil pan was displaced slightly left and backward.

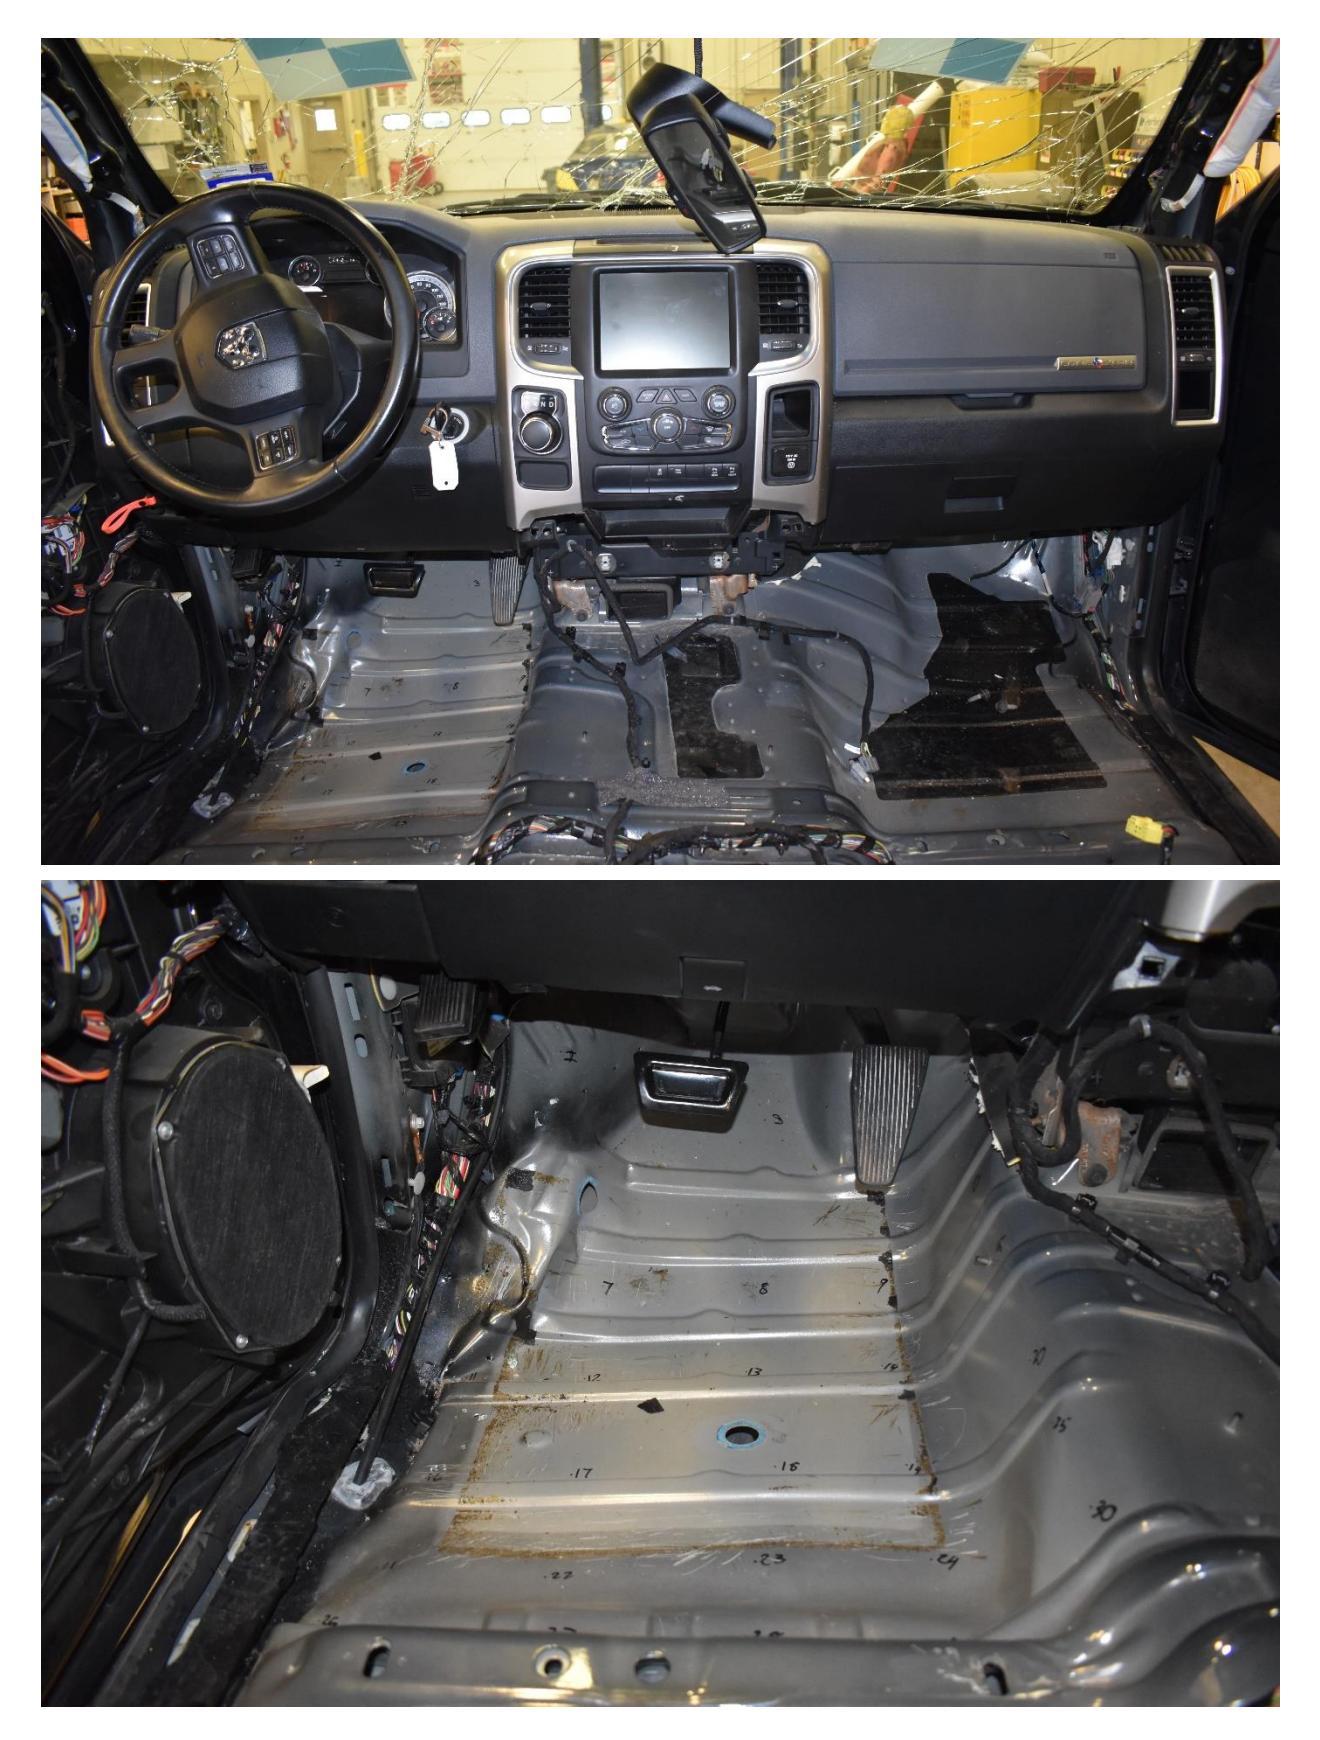
Figure 52. Occupant Compartment Damage, Test No. HP34S-1

The damage to the vehicle was moderate, as shown in Figures 50 through 53. The maximum occupant compartment intrusions are listed in Table 5, along with the intrusion limits established in MASH 2016 for various areas of the occupant compartment. Complete occupant compartment and vehicle deformations and the corresponding locations are provided in Appendix C. MASH 2016 defines intrusion or deformation as the occupant compartment being deformed and reduced in size with no observed penetration. There were no penetrations into the occupant compartment, and none of the established MASH 2016 deformation limits were violated. Outward deformations, which are denoted as negative numbers in Appendix C, are not considered crush toward the occupant and are not evaluated by MASH 2016 criteria.

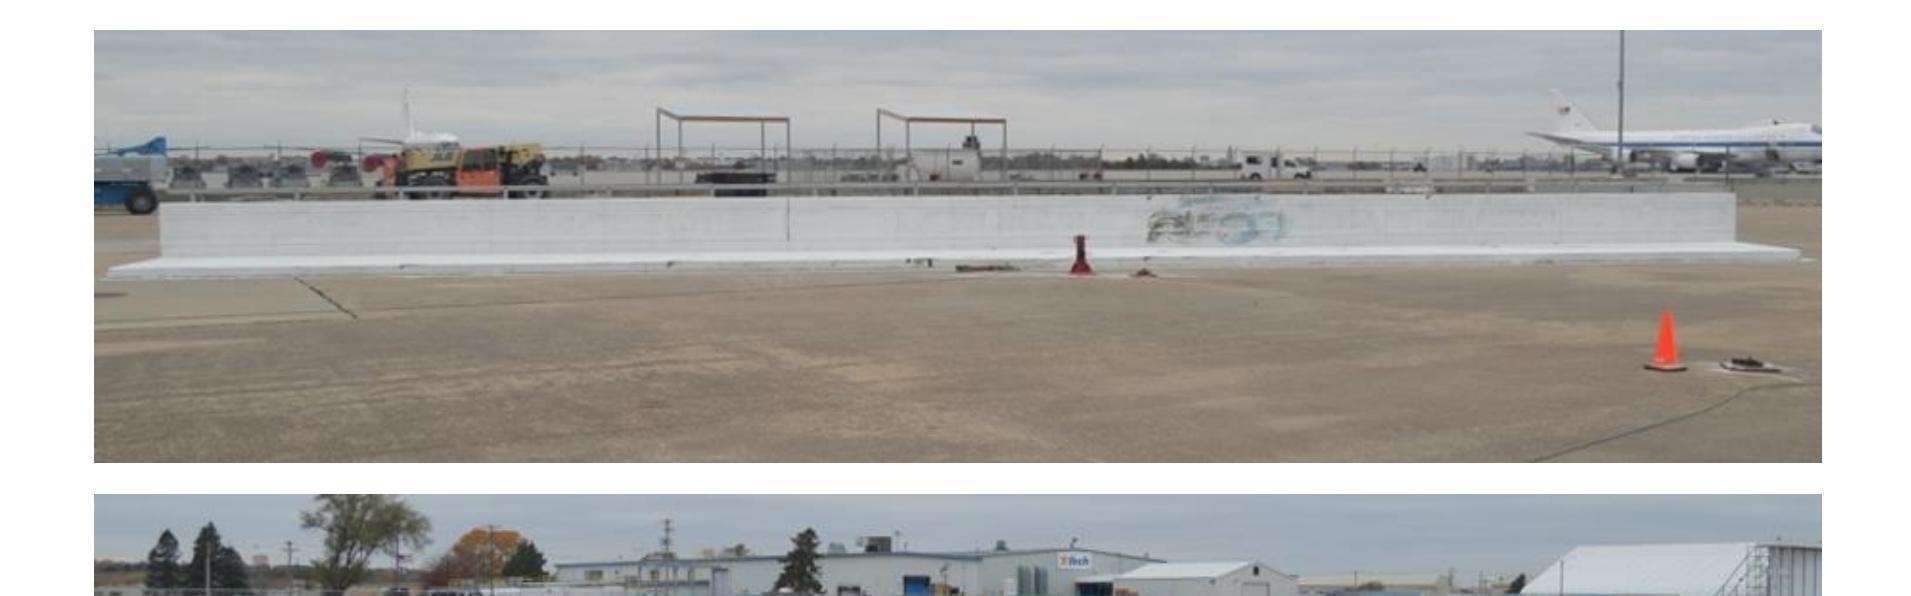
Figure 65. System Damage, Test No. HP34S-2

There was minor gouging in the concrete near the impact point and along the contact length and larger gouging at the expansion joint immediately downstream from the impact point. There was a ¹/₂-in. deep, 15-in. tall gouge that initiated on the slope in the recessed window immediately upstream from expansion joint no. 3 where steel rebar was exposed. There was also a gouge in barrier segment no. 4, initiating at the expansion joint that ended near the slope in the adjacent downstream window. Concrete scraping and minor chipping were observed along the upstream, lower, upper, and downstream edges of the upstream aesthetic recess of barrier segment no. 3, as well as along the top, impact-side edge of the concrete barrier. No contact marks were observed on the pedestrian rail.

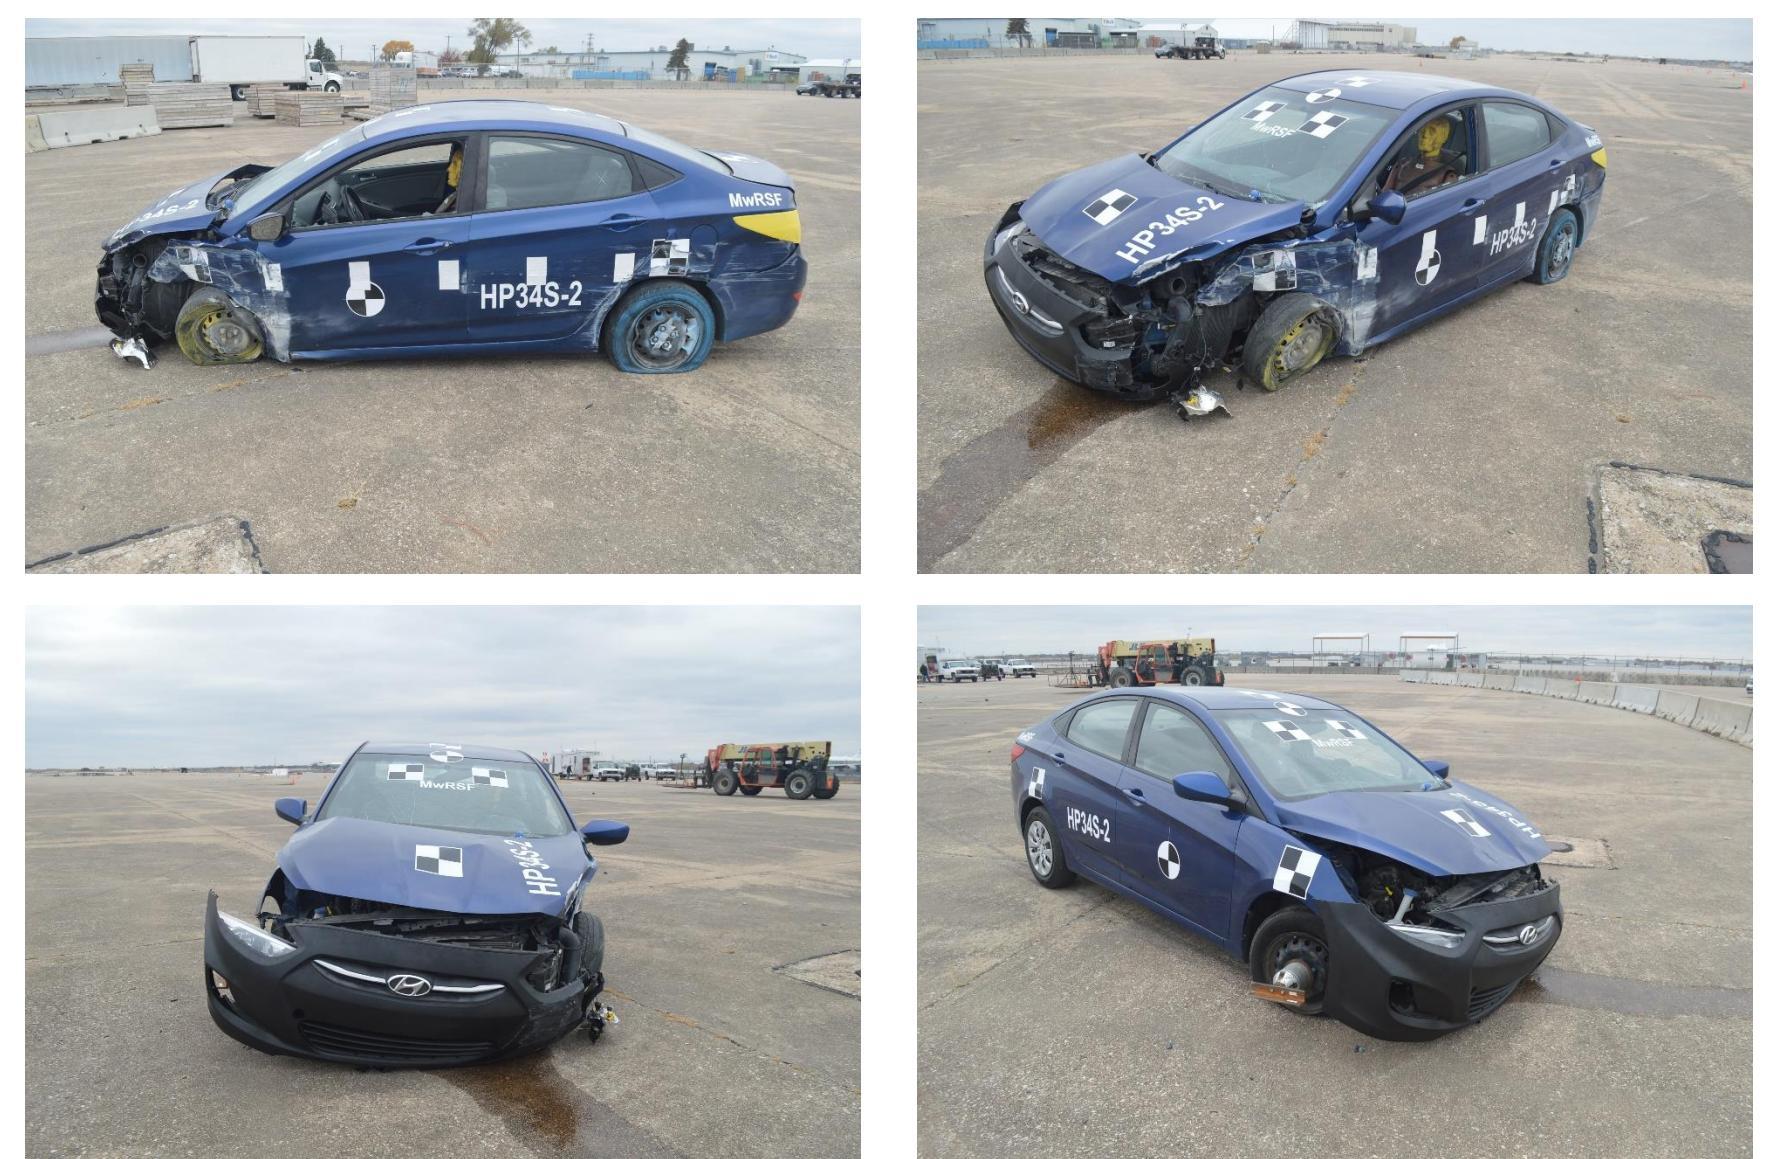
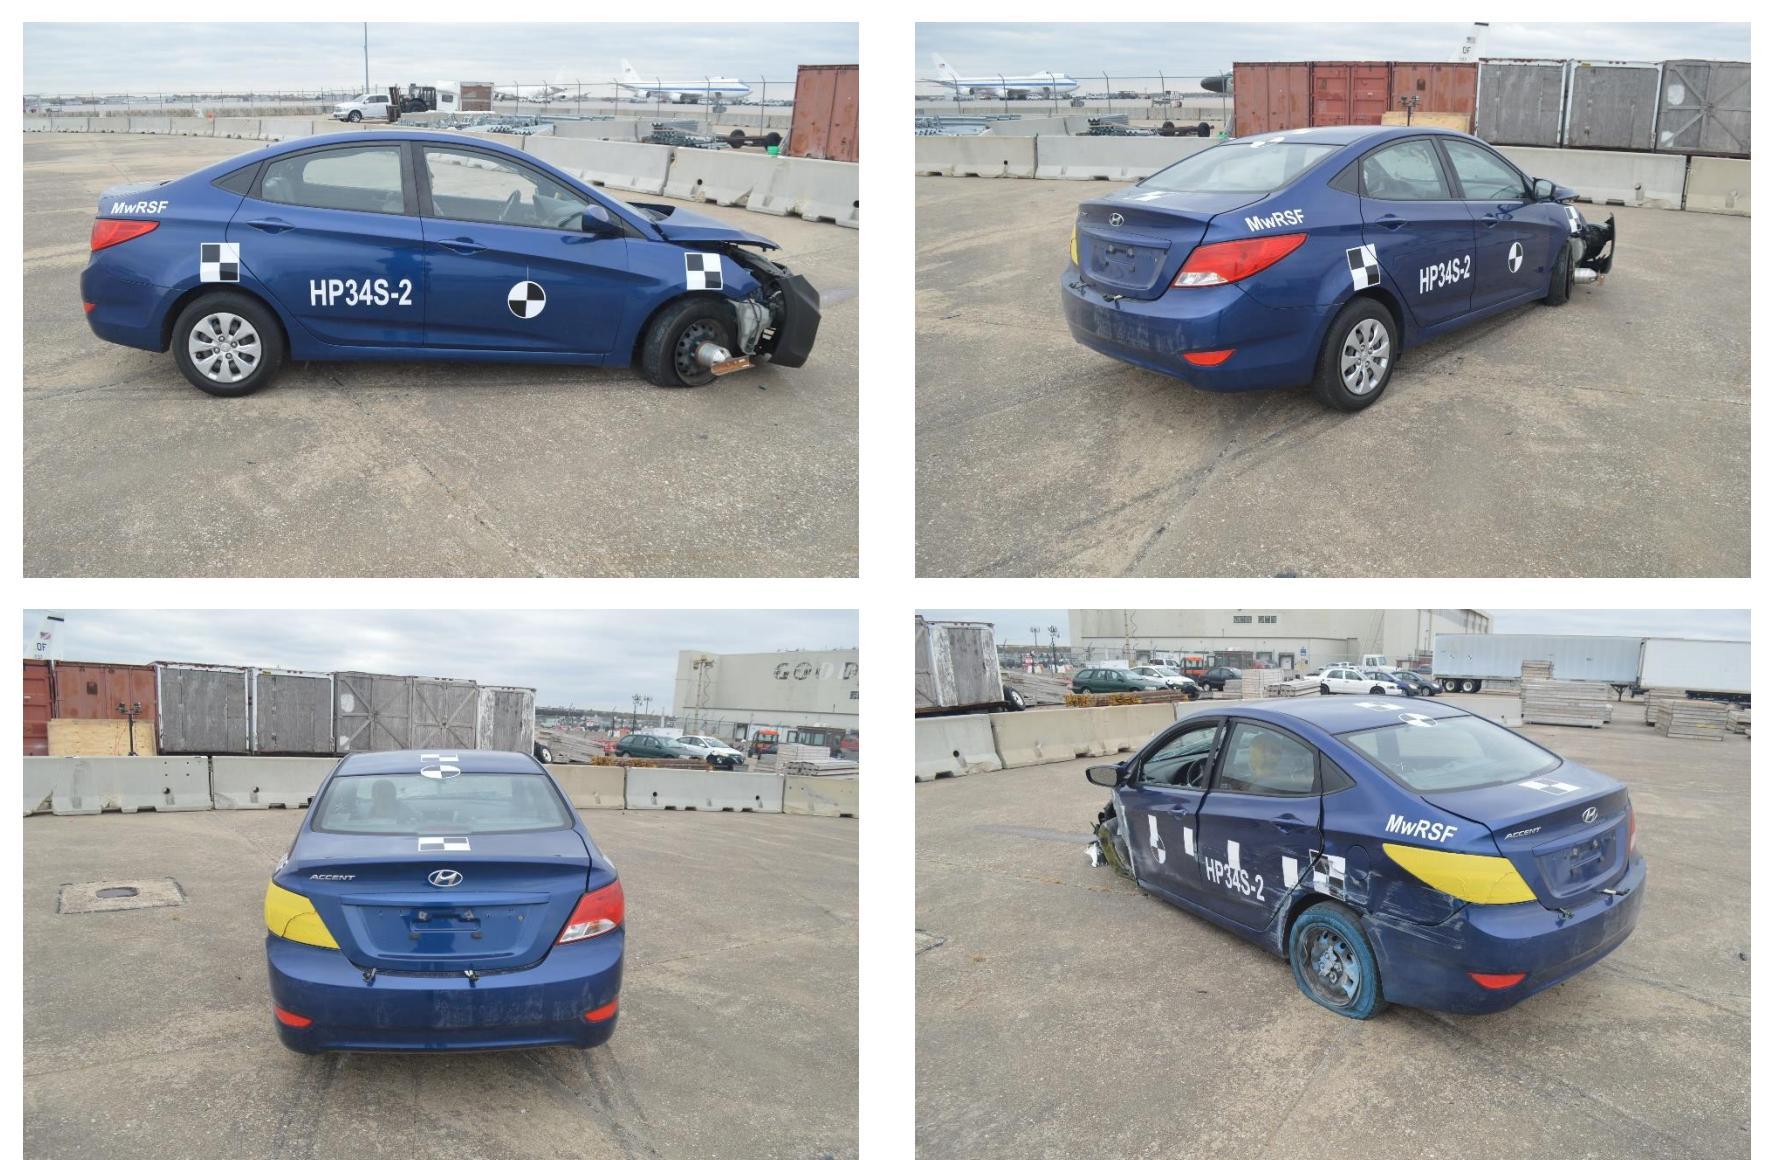
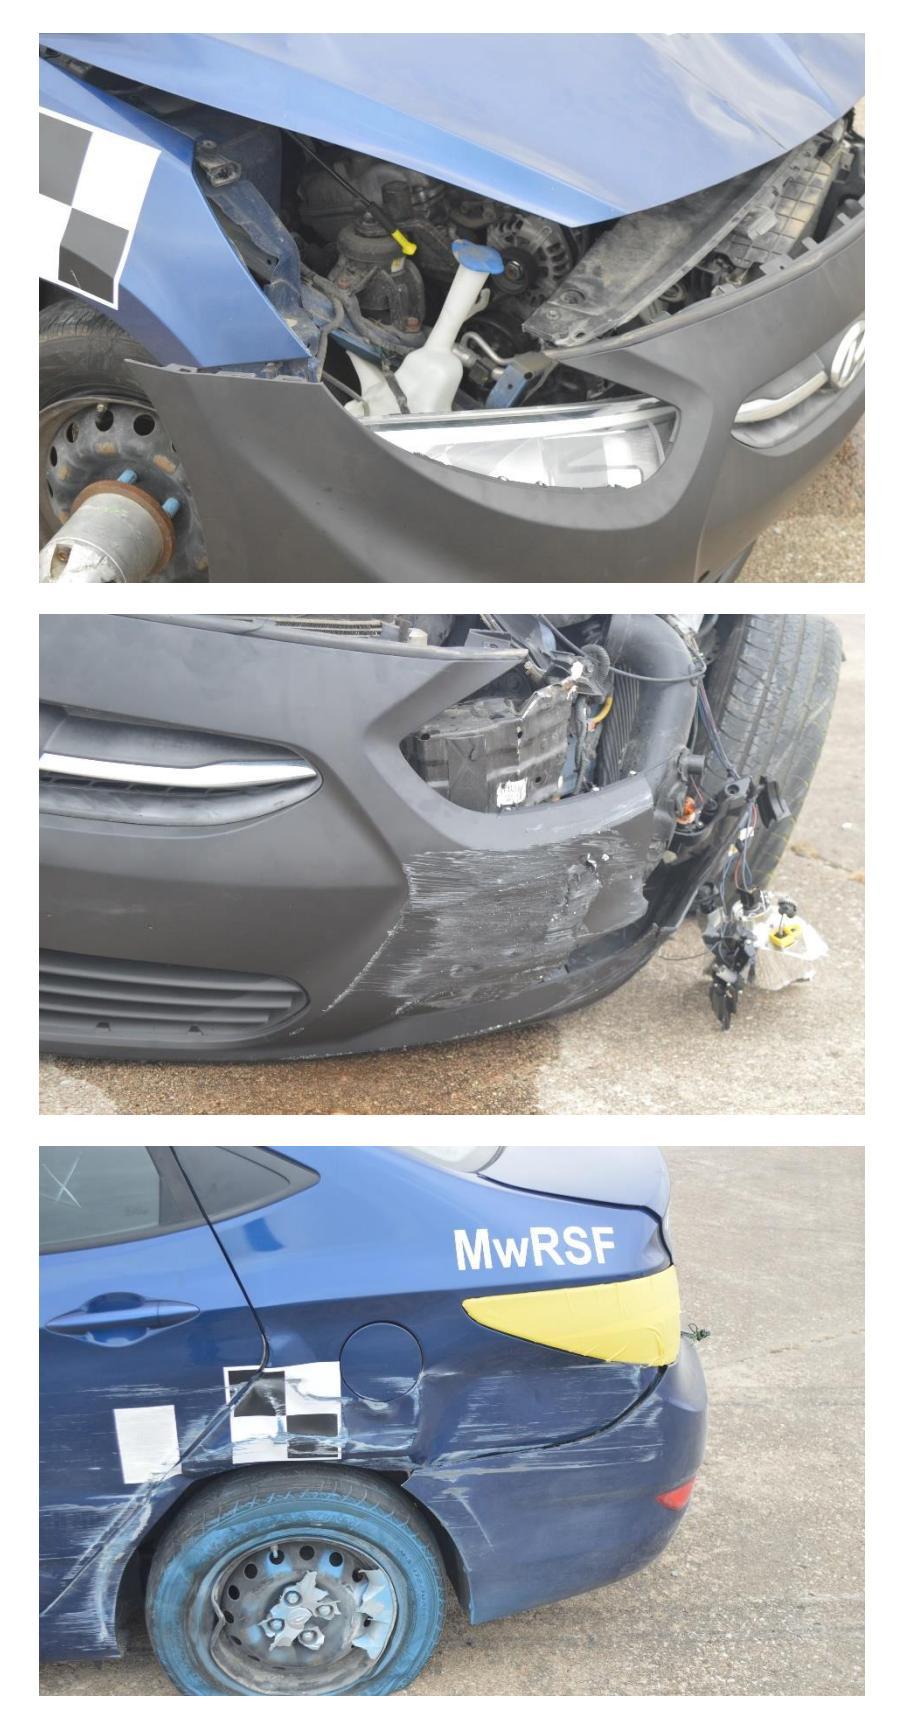
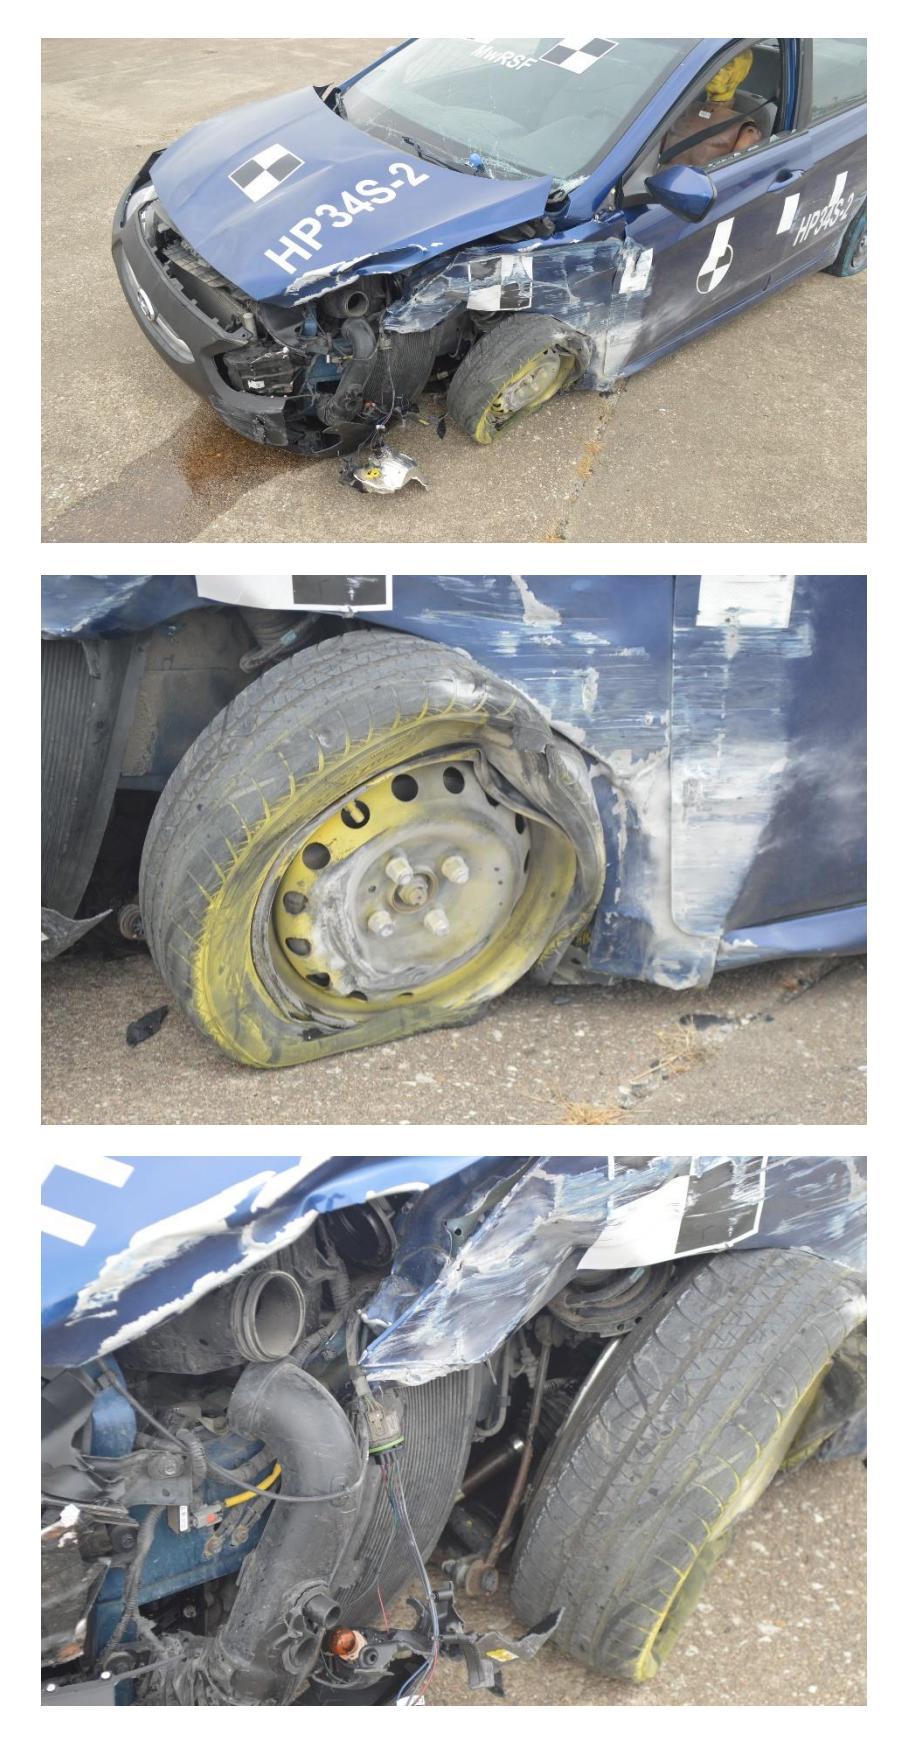
Figure 68. Vehicle Damage, Test No. HP34S-2

The left-front frame horn was bent laterally and upward. The left-front shock was bent backward but remained engaged with the suspension. The anti-roll bar was bent upwards at the left side of the vehicle. The left-side steering connection to the wheel hub was rotated, and the entire steering linkage was warped. The left-front upper control arm was sheared at the connection to the wheel hub, and the lower control arm was bent with scrapes observed along the bottom surface. The left-side tie rod was partially disengaged at both ends. Much of the undercarriage was scraped, including the transmission tunnel, oil pan, floorpan, and gas tank.
