ISO 17025 LABORATORY  
TESTING CERT # 2937.01

*Hawaii Department of Transportation  
Research Contract No. 68212  
Research Project No. STP-1500(092) – Phase II*

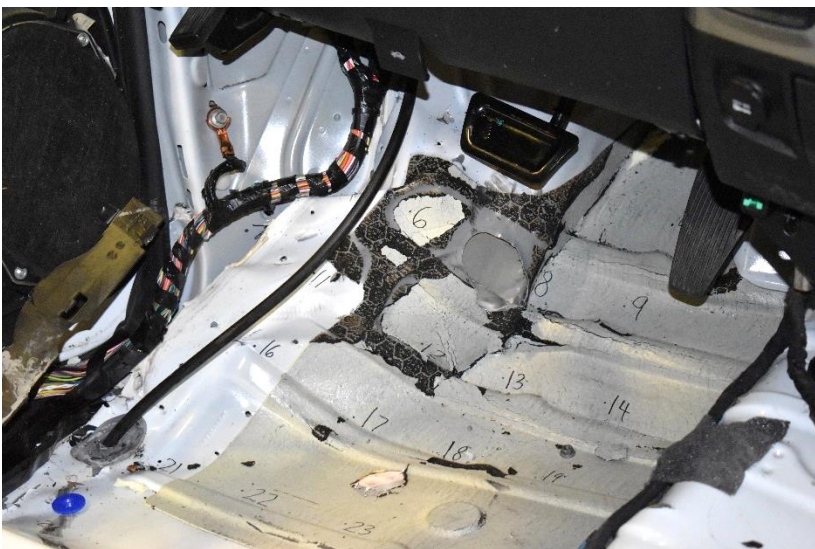
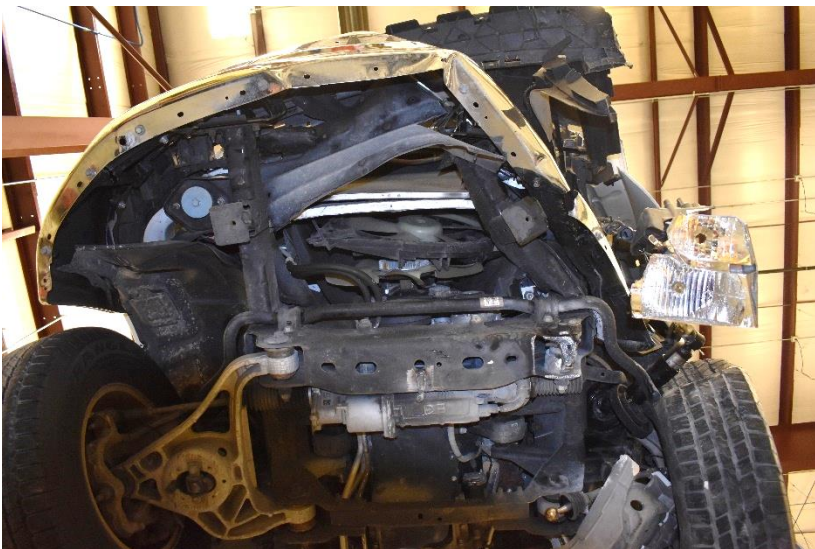
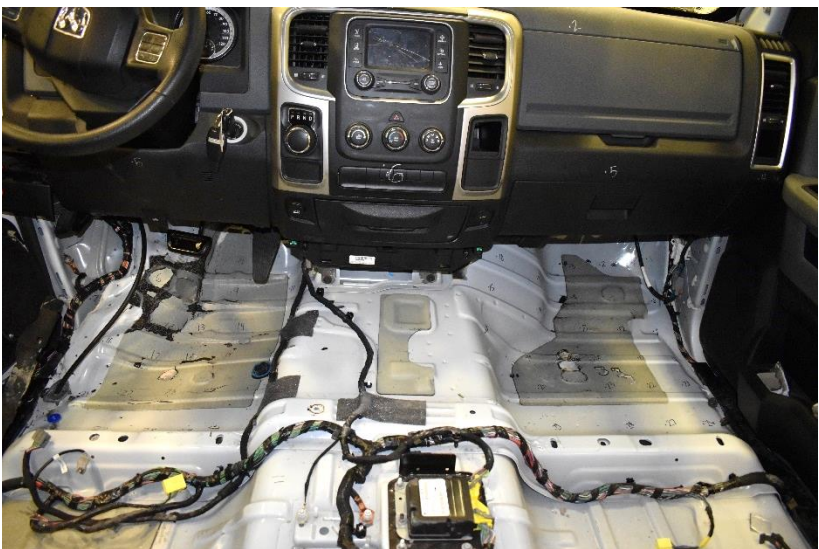
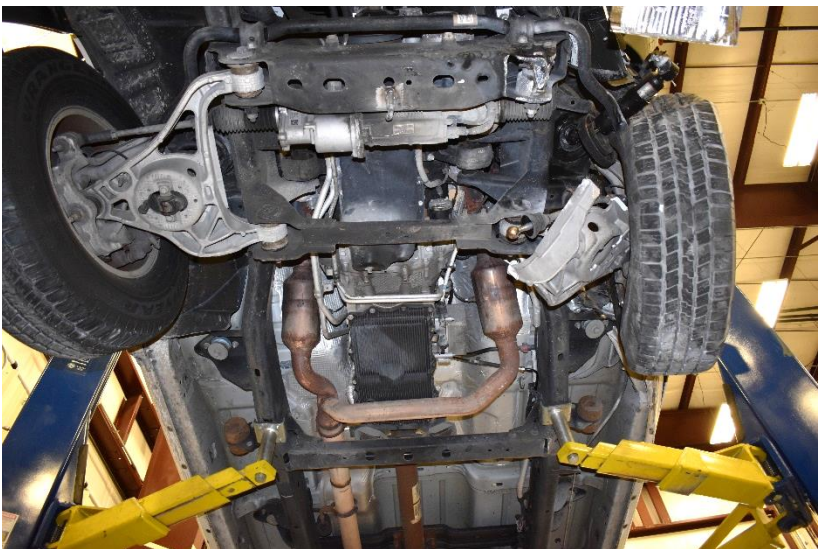
Figure 89. Interior and Undercarriage Damage, Test No. HMDBR-1

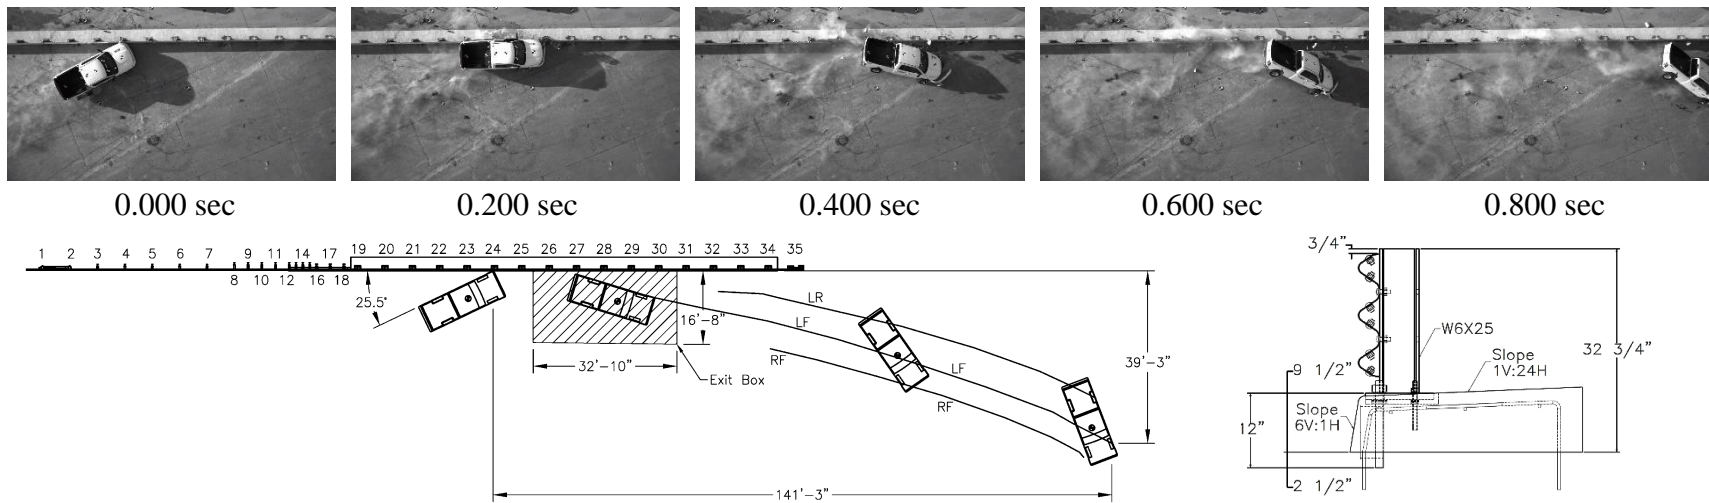
- Test Agency .....MwRSF
- Test Number..... HMDBR-1
- Date..... 12/18/2020
- MASH 2016 Test Designation No.....3-11
- Test Article.....Hawaii Modified Delaware Thrie-Beam Bridge Rail

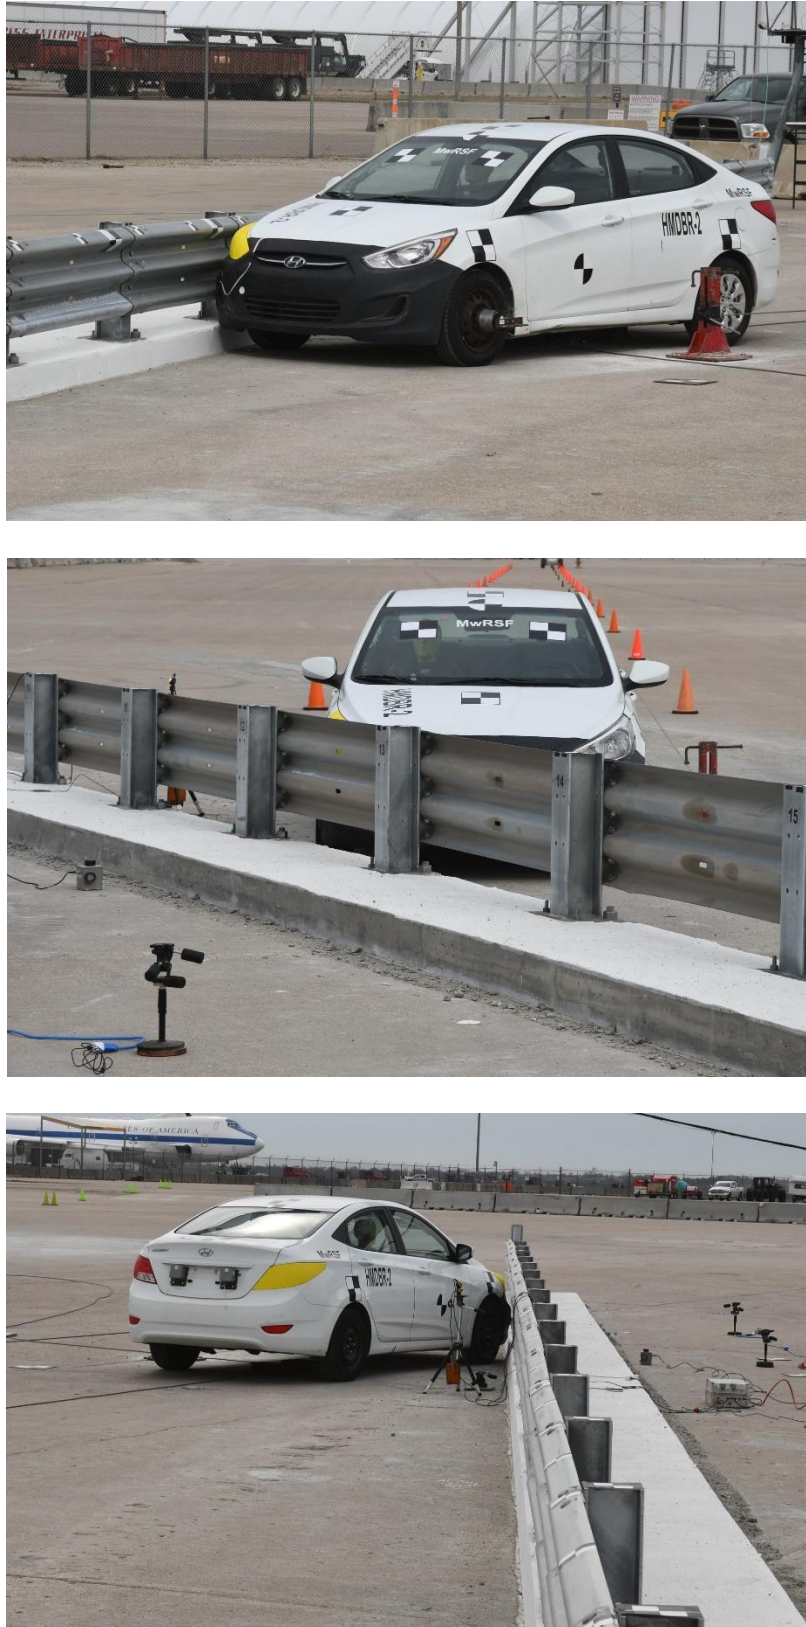
Figure 92. Target Impact Location, Test No. HMDBR-2

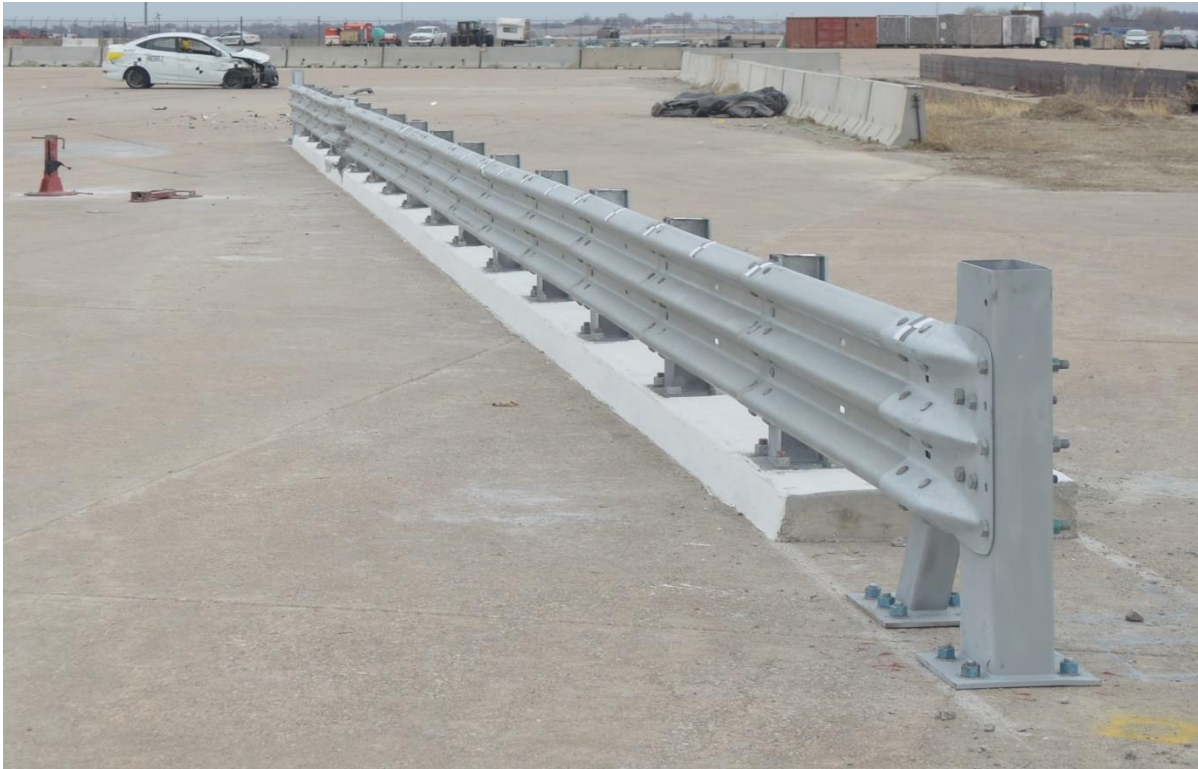
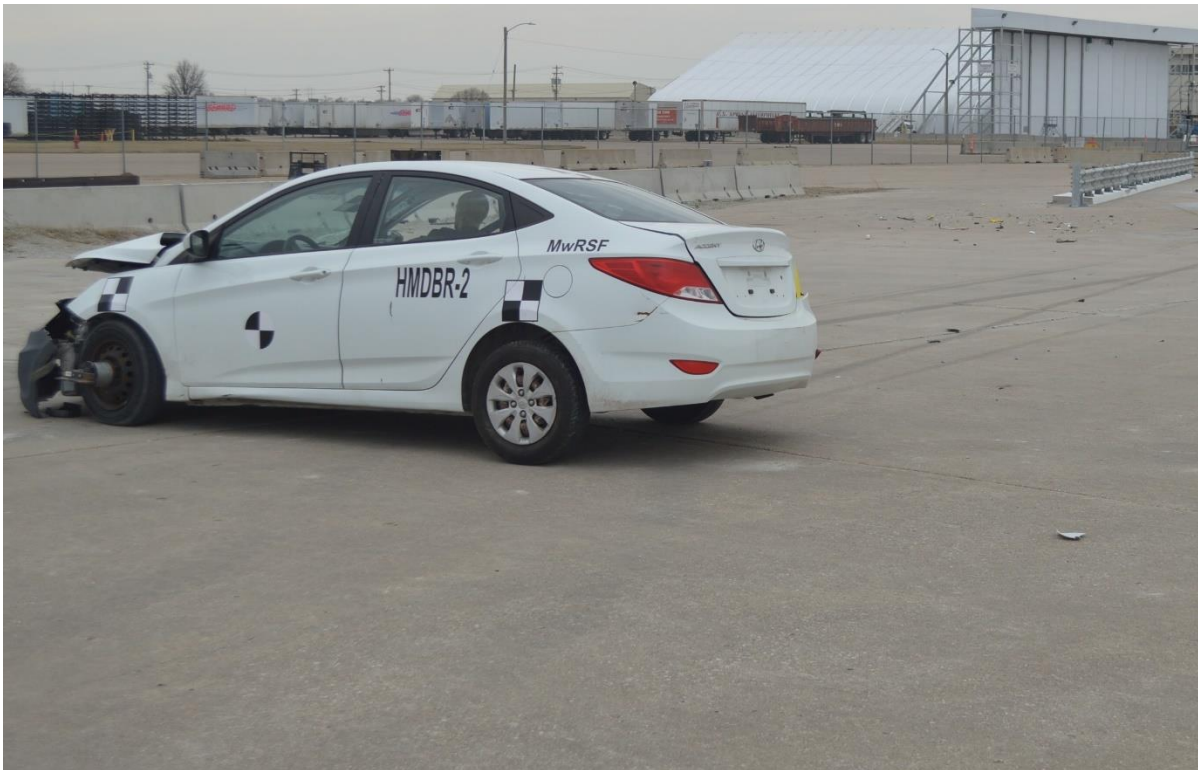
Figure 97. Vehicle Final Position and Trajectory Marks, Test No. HMDBR-2

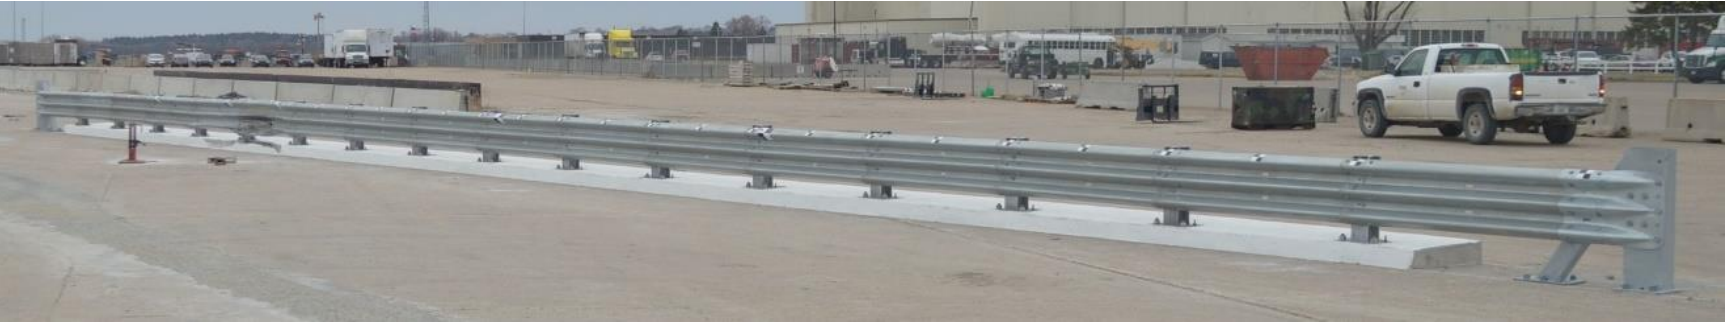
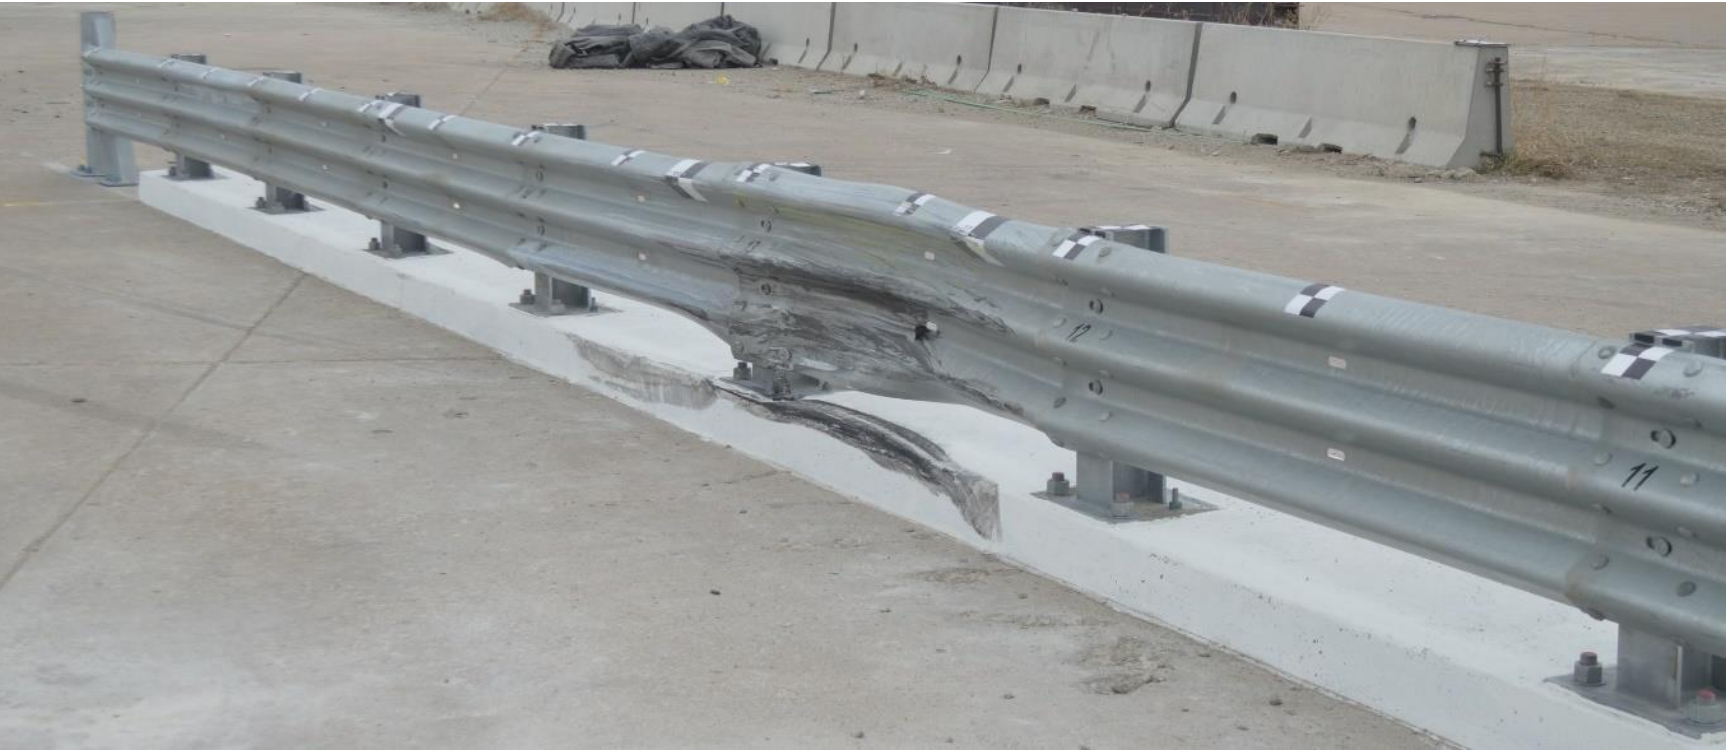
Figure 98. System Damage, Test No. HMDBR-2

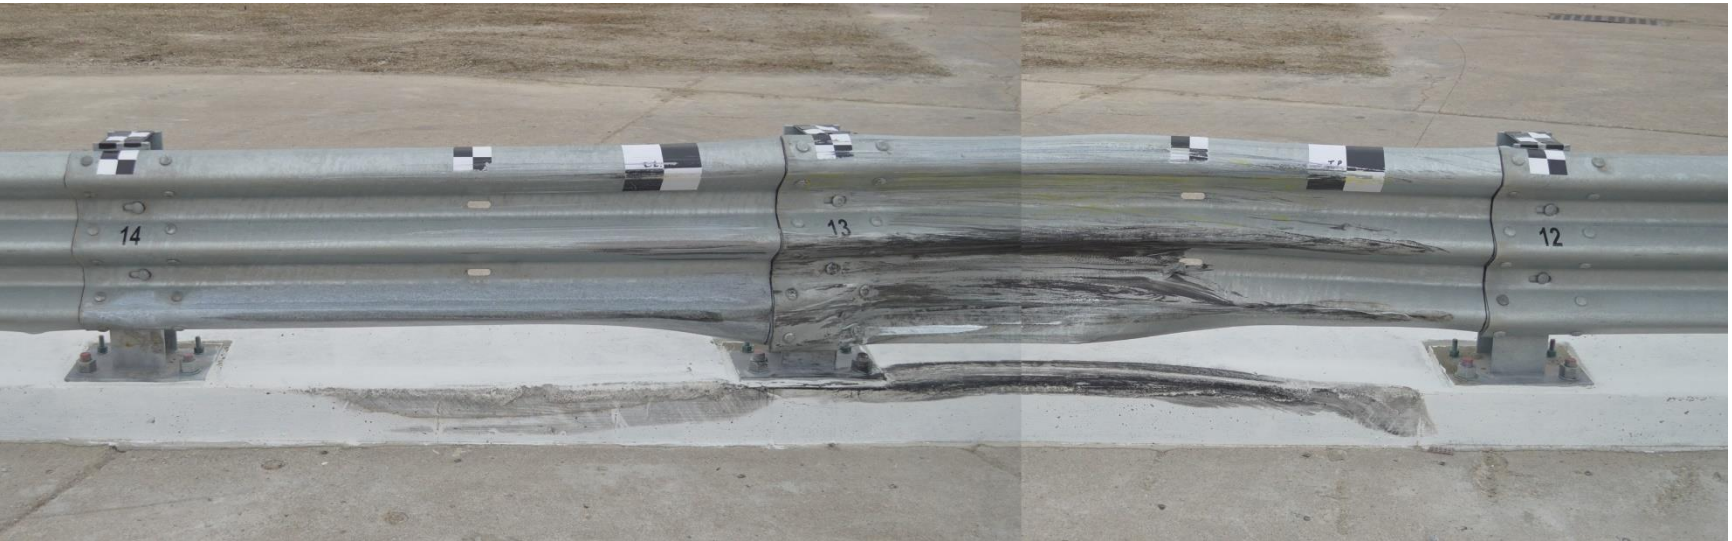
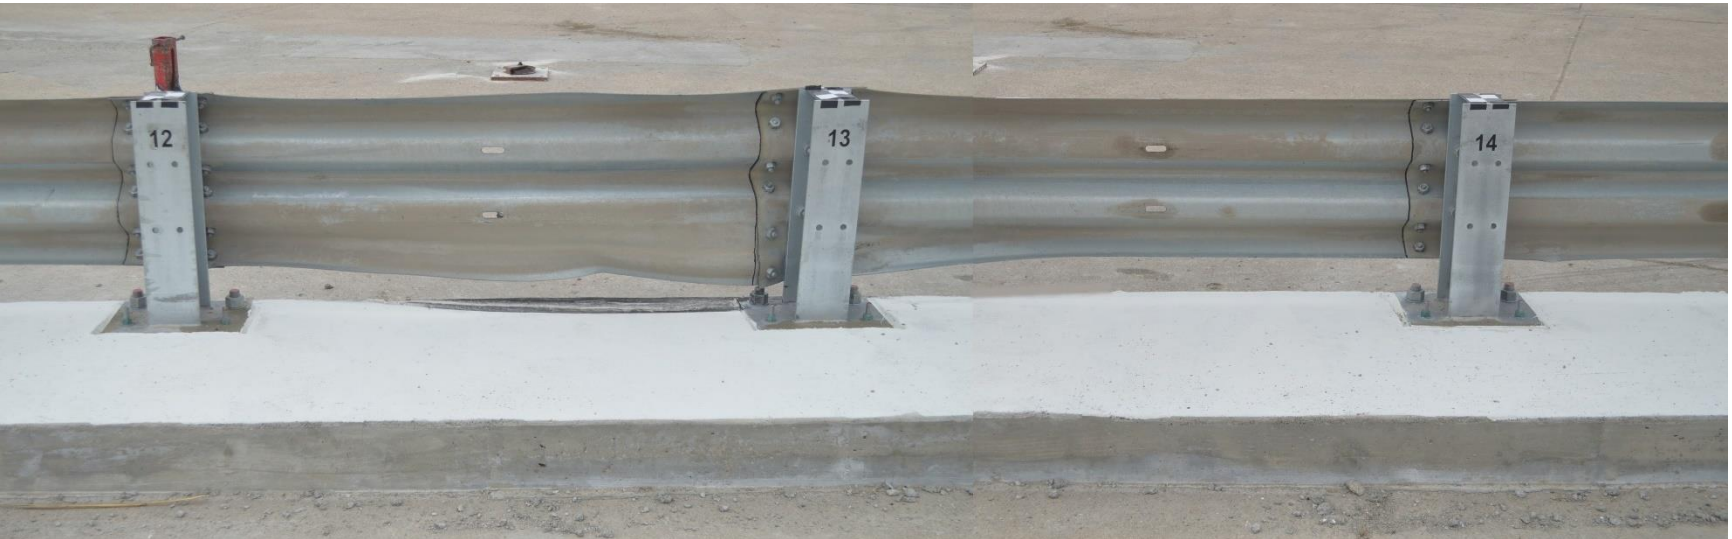
Figure 99. Rail Damage, Test No. HMDBR-2

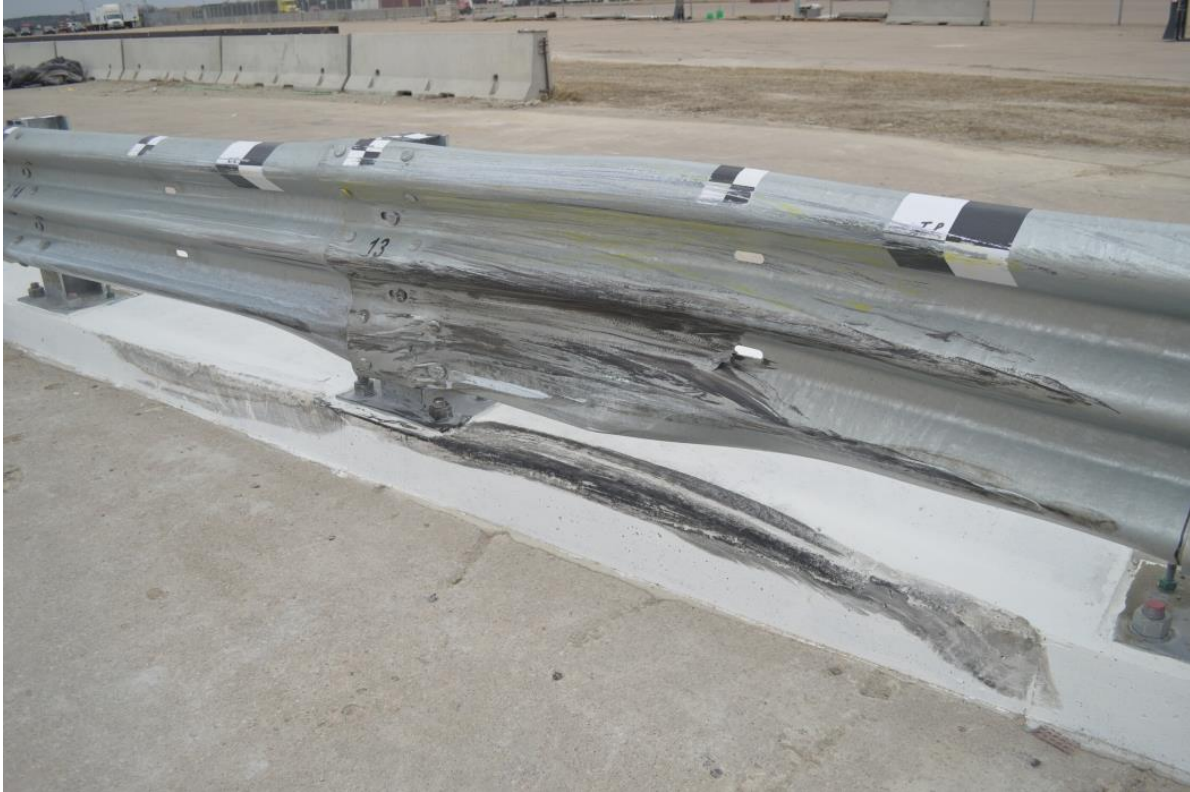
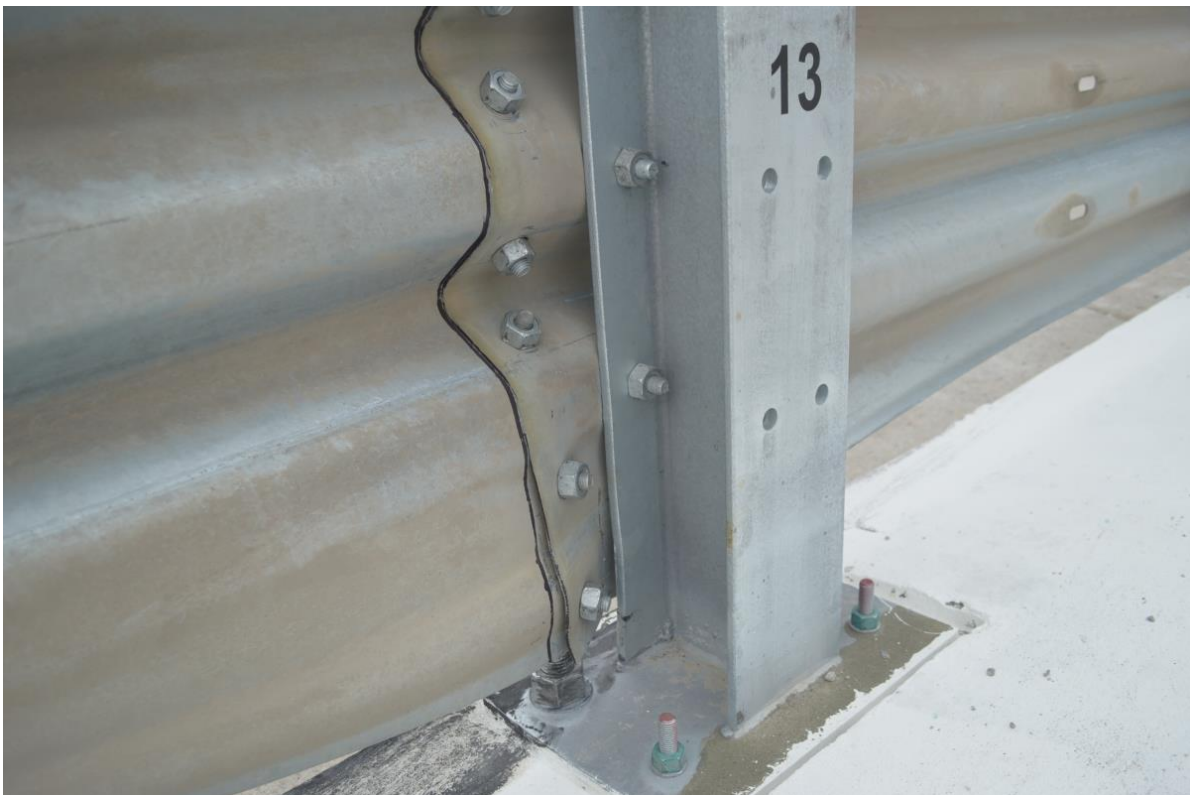
Figure 100. System Damage, Post No. 13, Test No. HMDBR-2

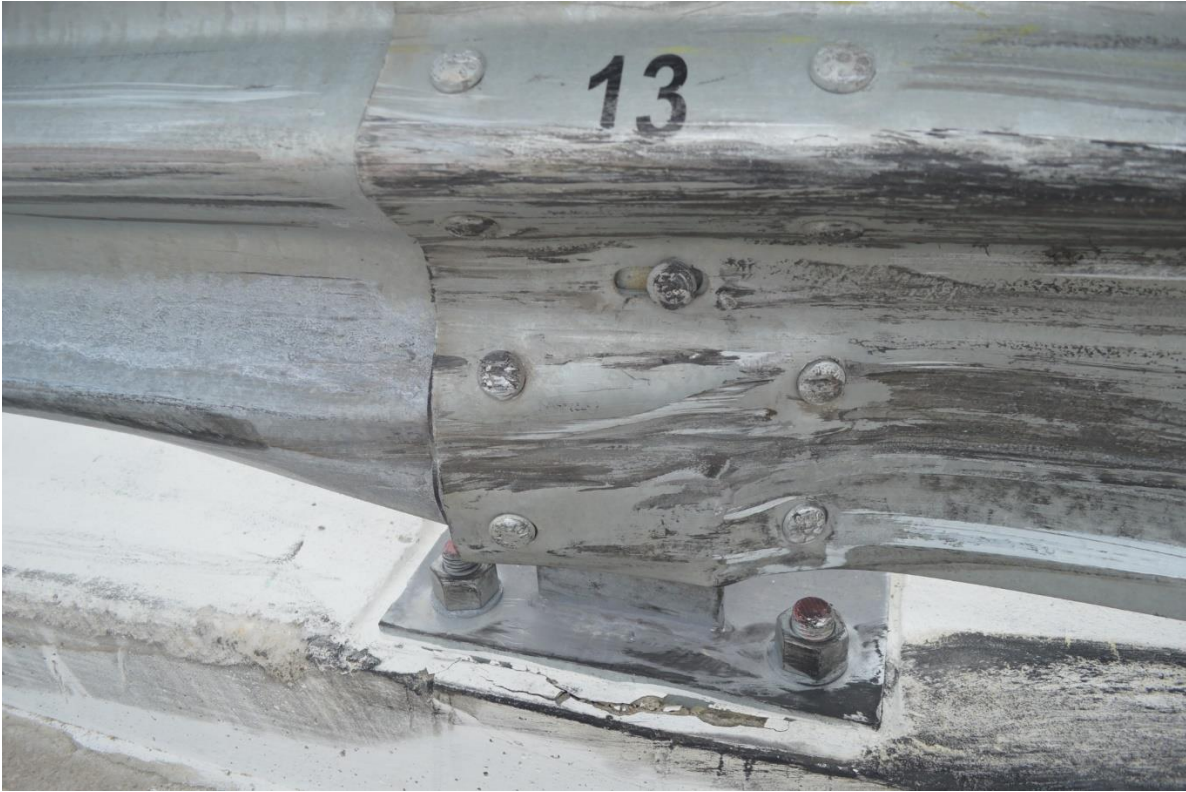
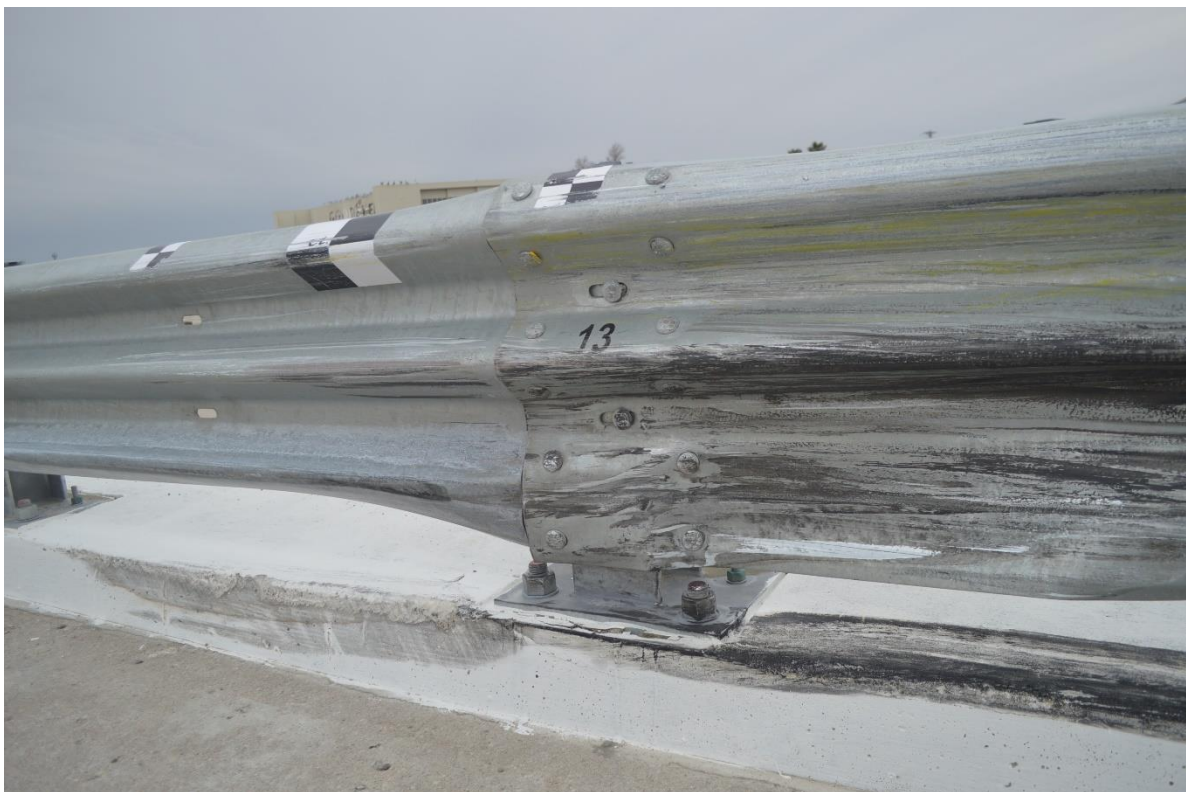
Figure 101. Sidewalk Damage and Contact Marks, Test No. HMDBR-2

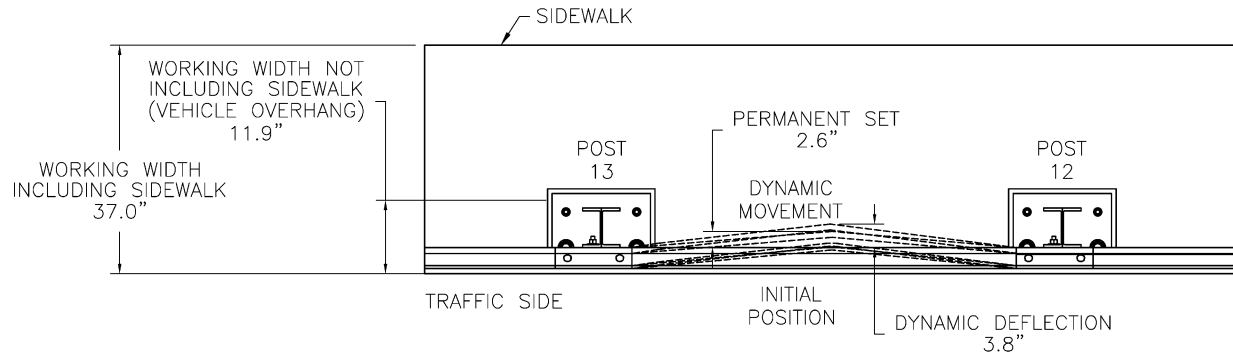
Figure 102. Permanent Set, Dynamic Deflection, and Working Width, Test No. HMDBR-2

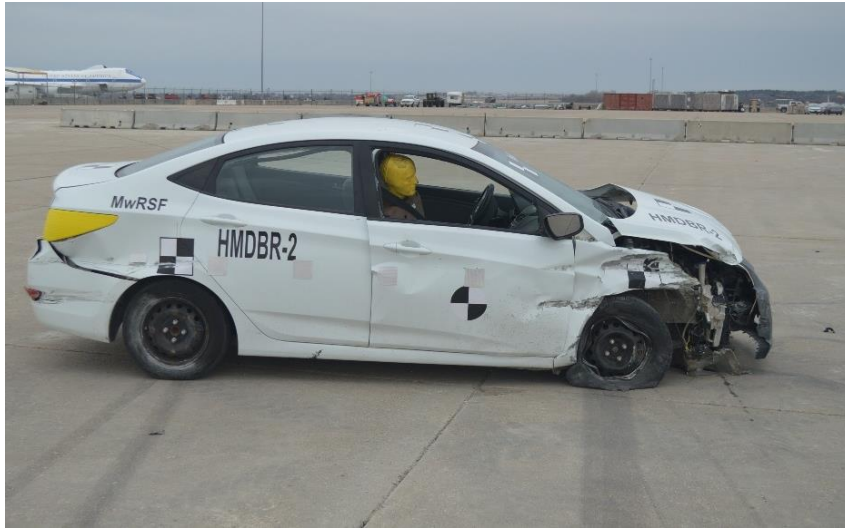
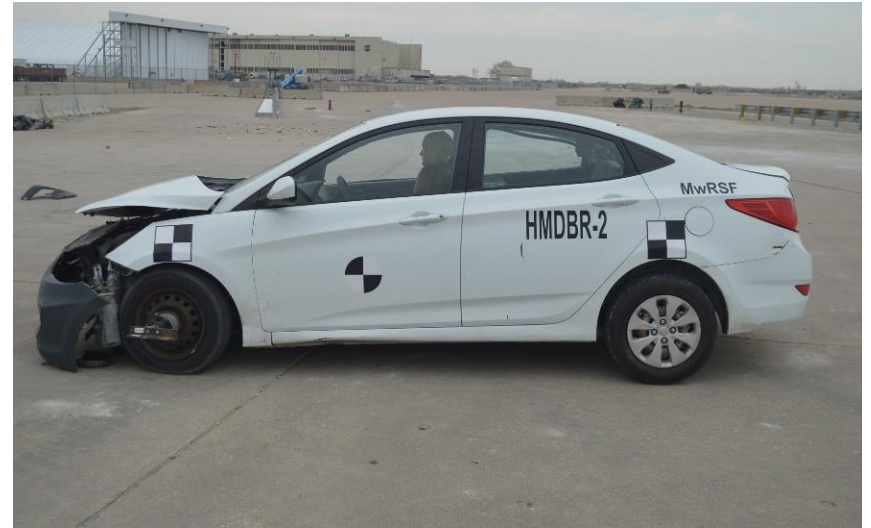
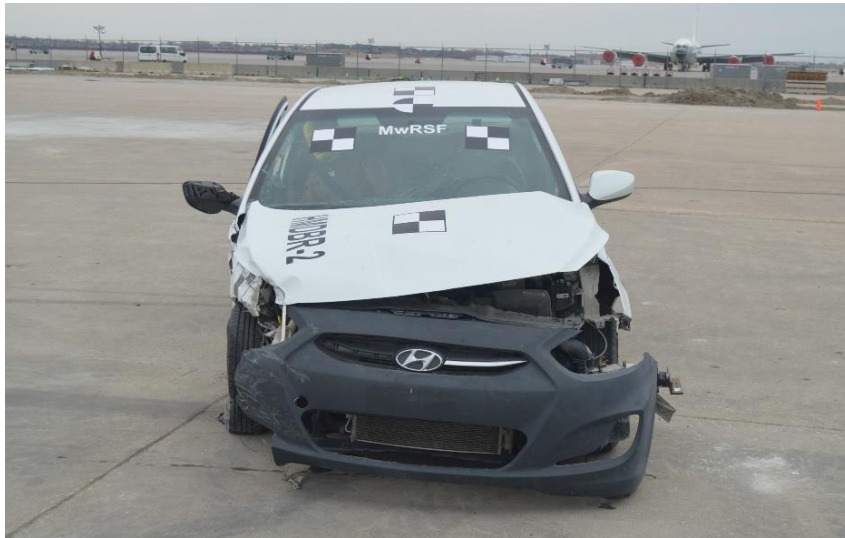
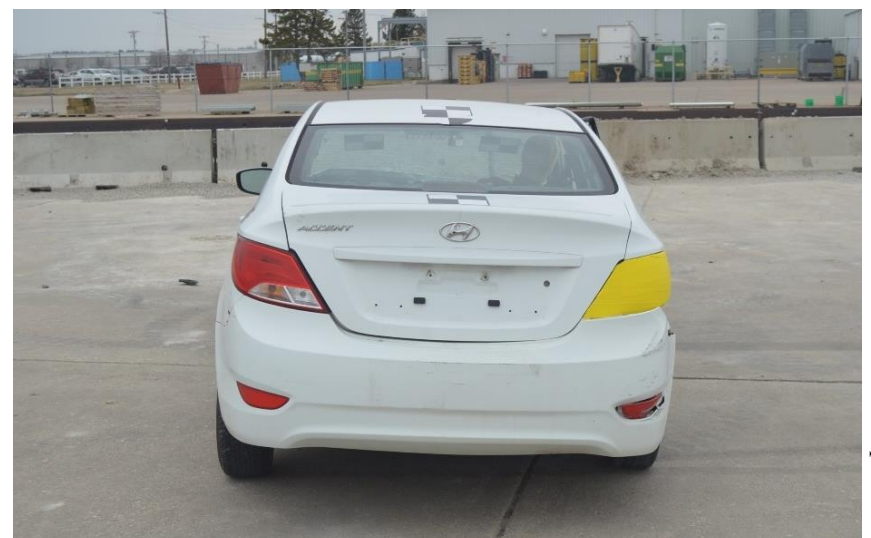
Figure 103. Vehicle Damage, Test No. HMDBR-2

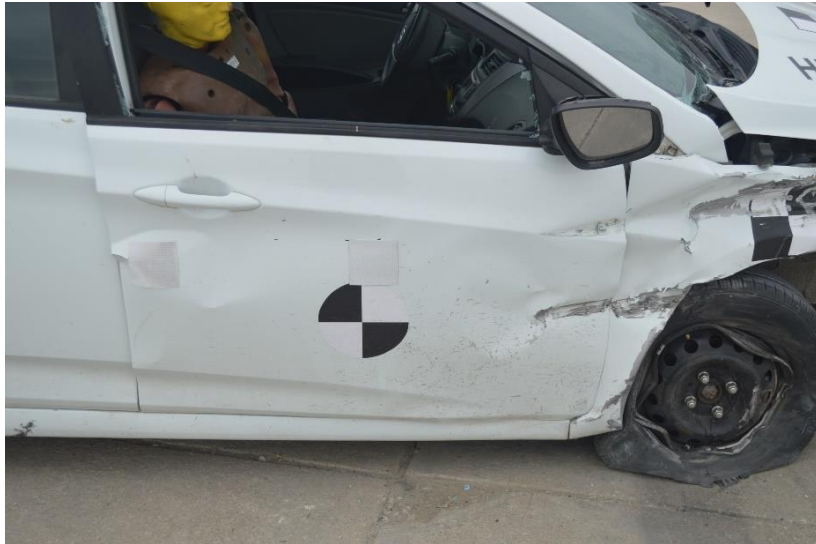
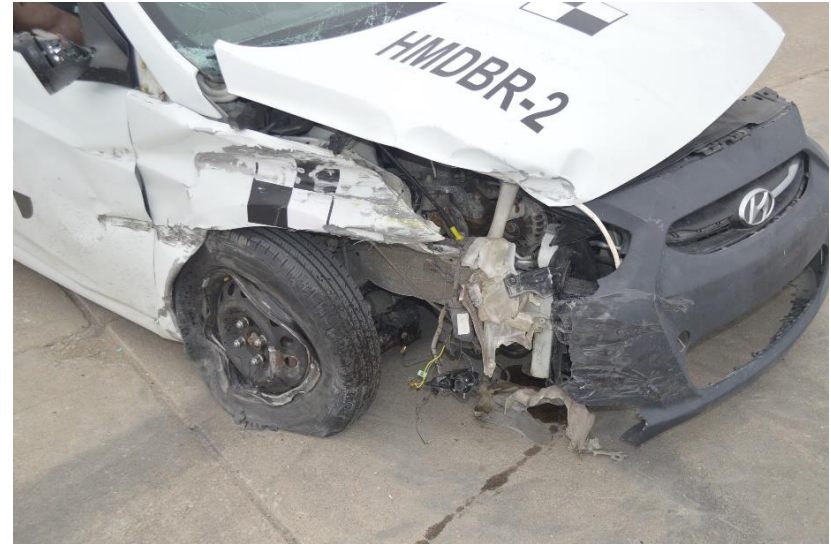
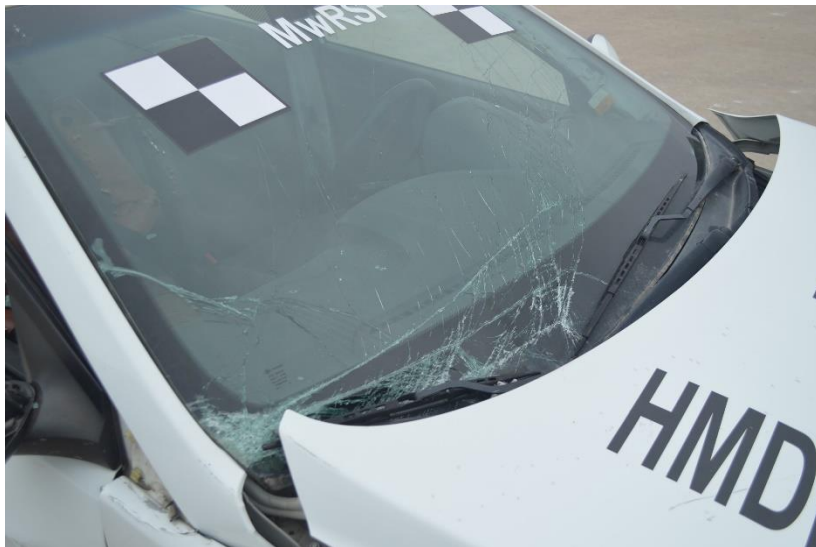
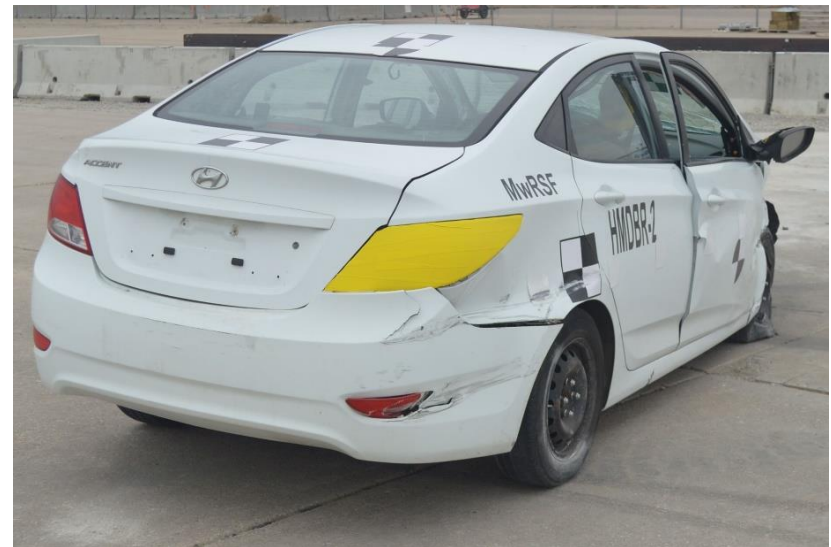
Figure 104. Vehicle Damage, Test No. HMDBR-2

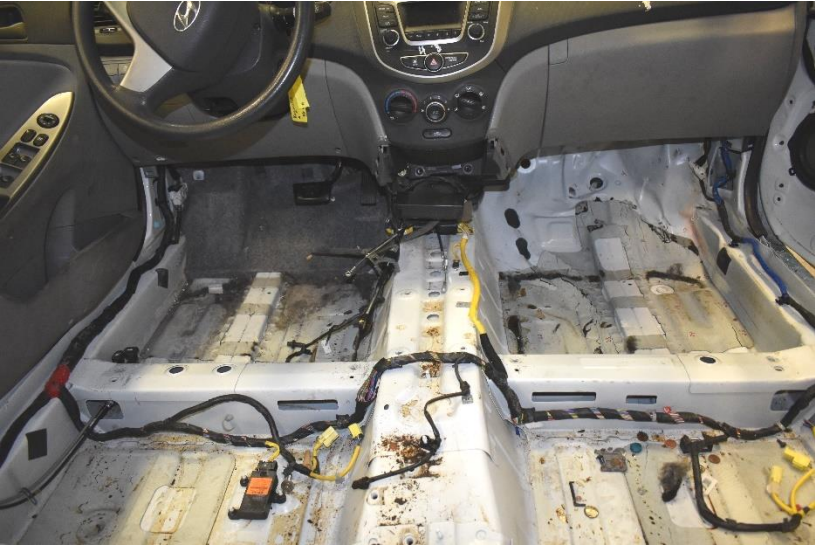
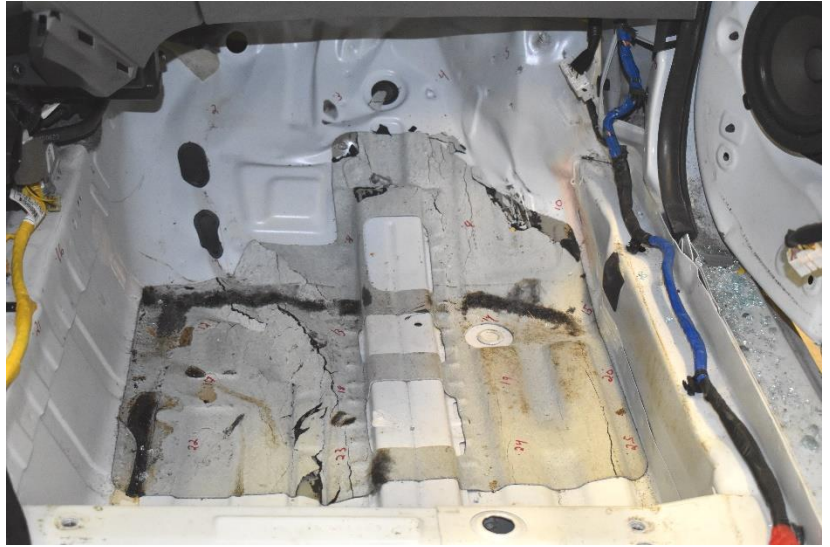
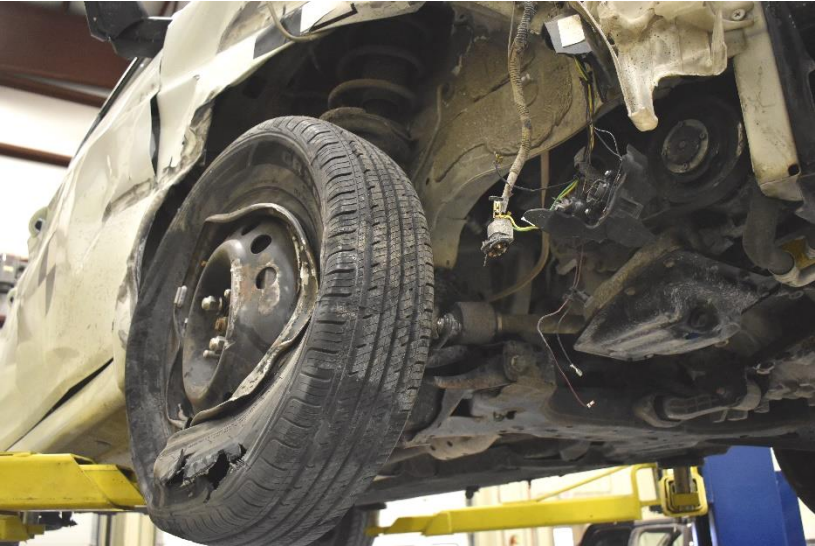
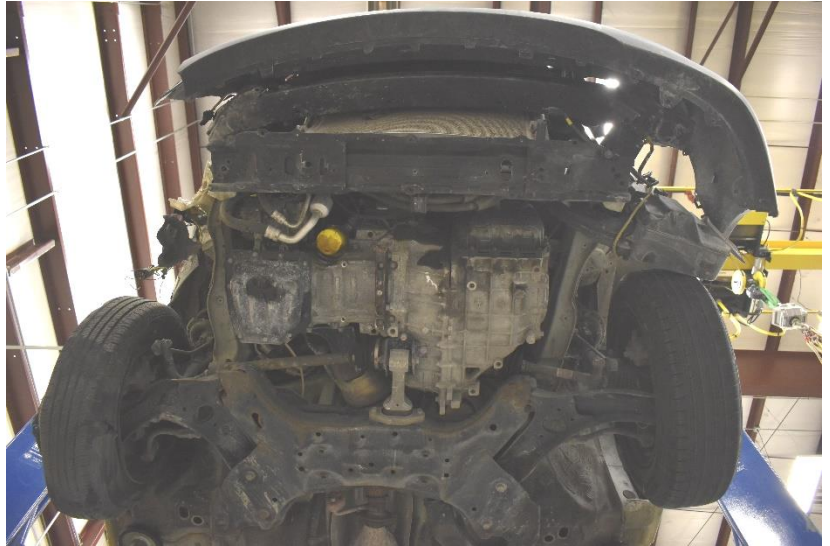
Figure 105. Interior and Undercarriage Damage, Test No. HMDBR-2

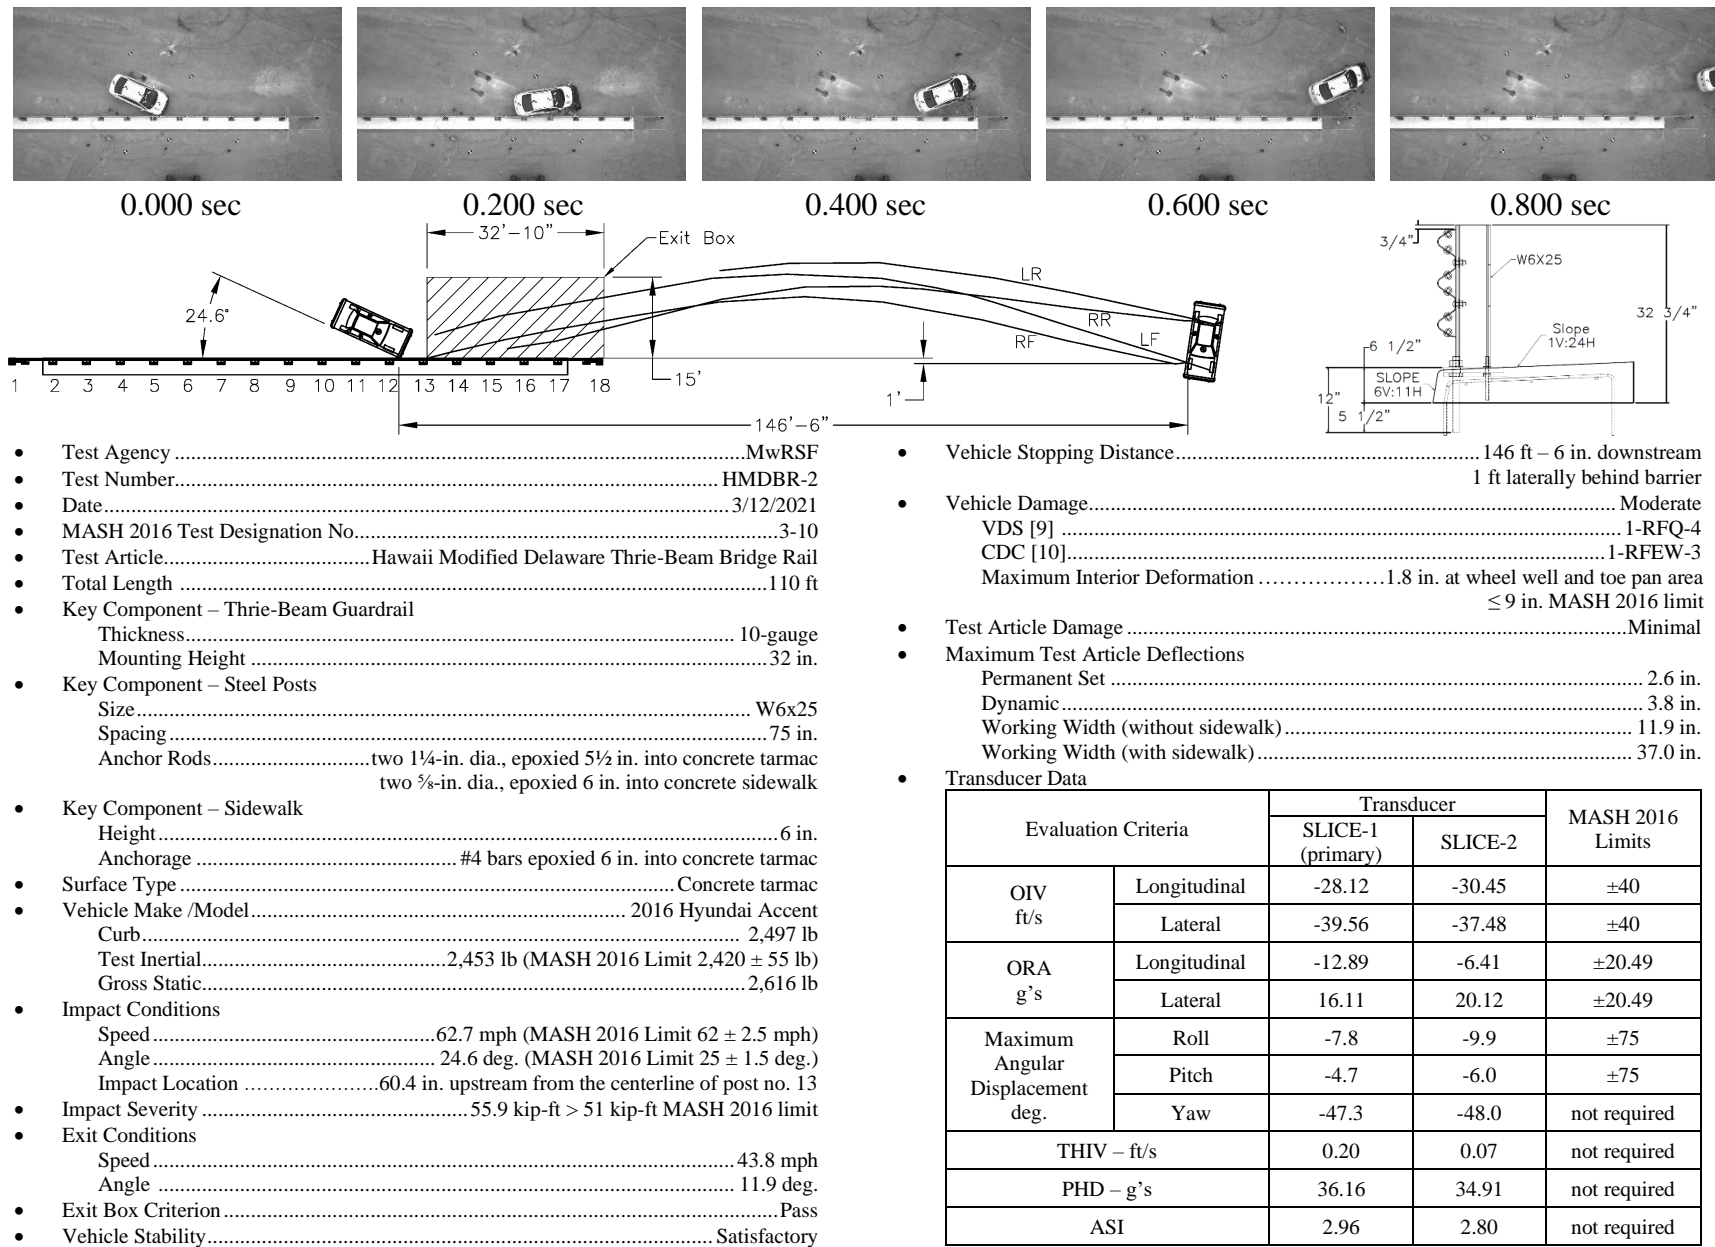
Figure 107. Summary of Test Results and Sequential Photographs, Test No. HMDBR-2

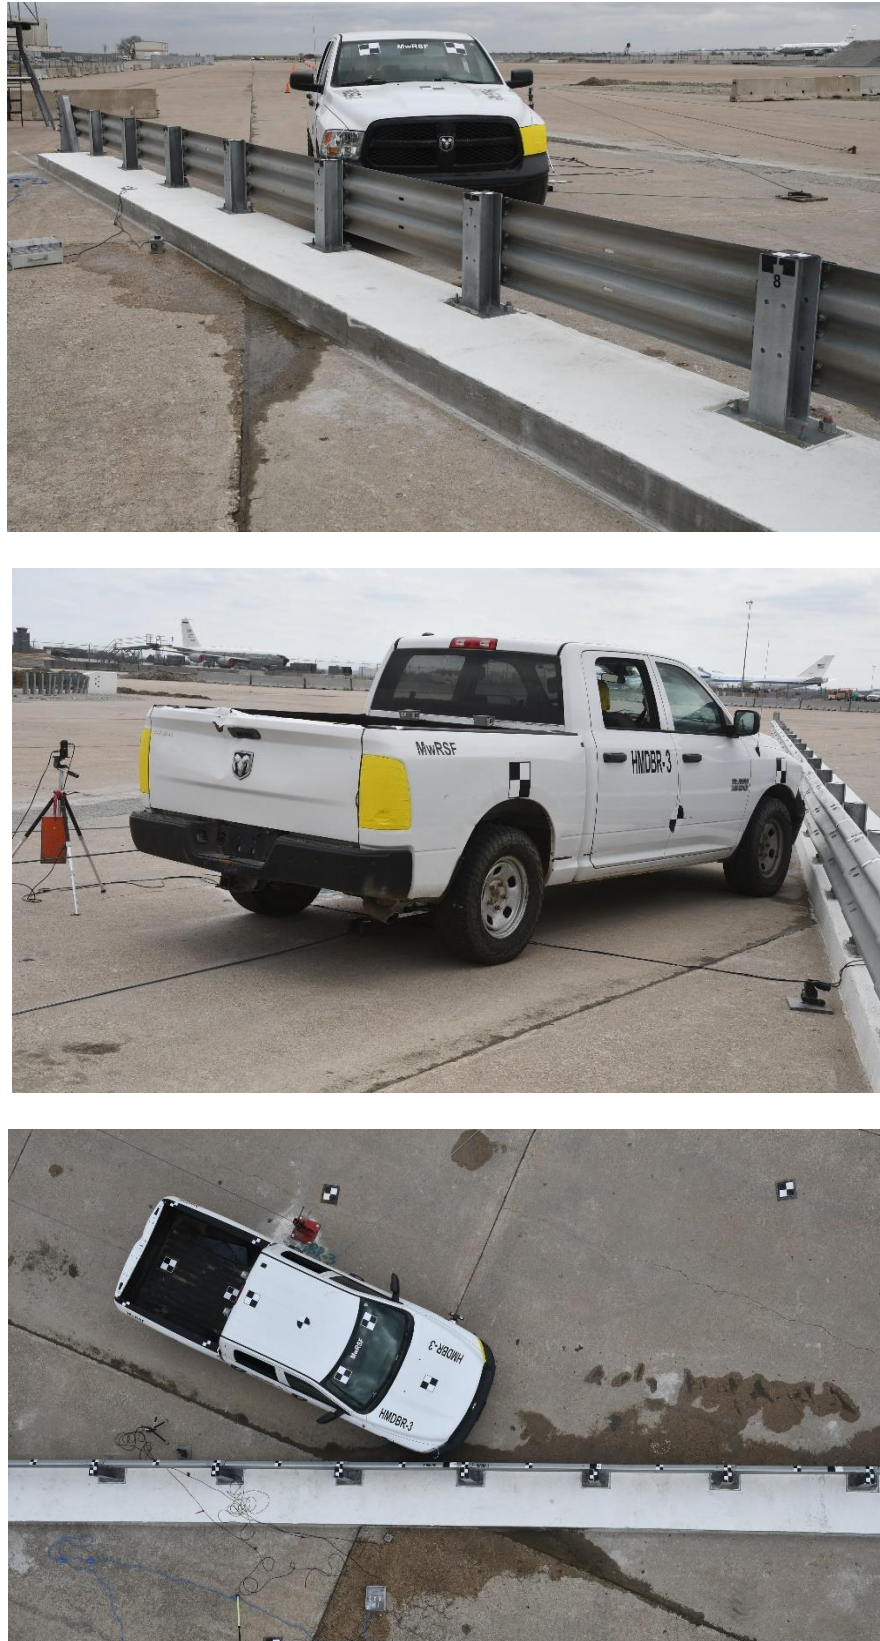
Figure 108. Target Impact Location, Test No. HMDBR-3
