ISO 17025 LABORATORY  
TESTING CERT # 2937.01

*Hawaii Department of Transportation  
Research Contract No. 68212  
Research Project No. STP-1500(092) – Phase II*

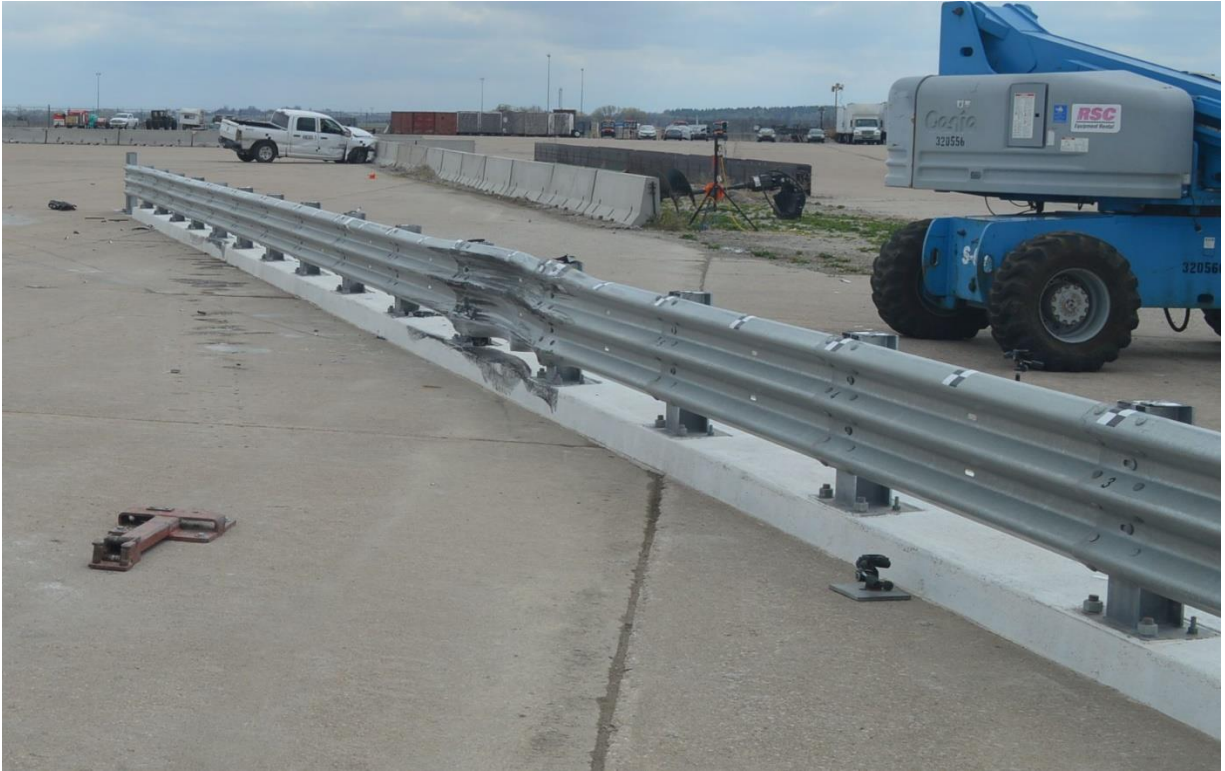
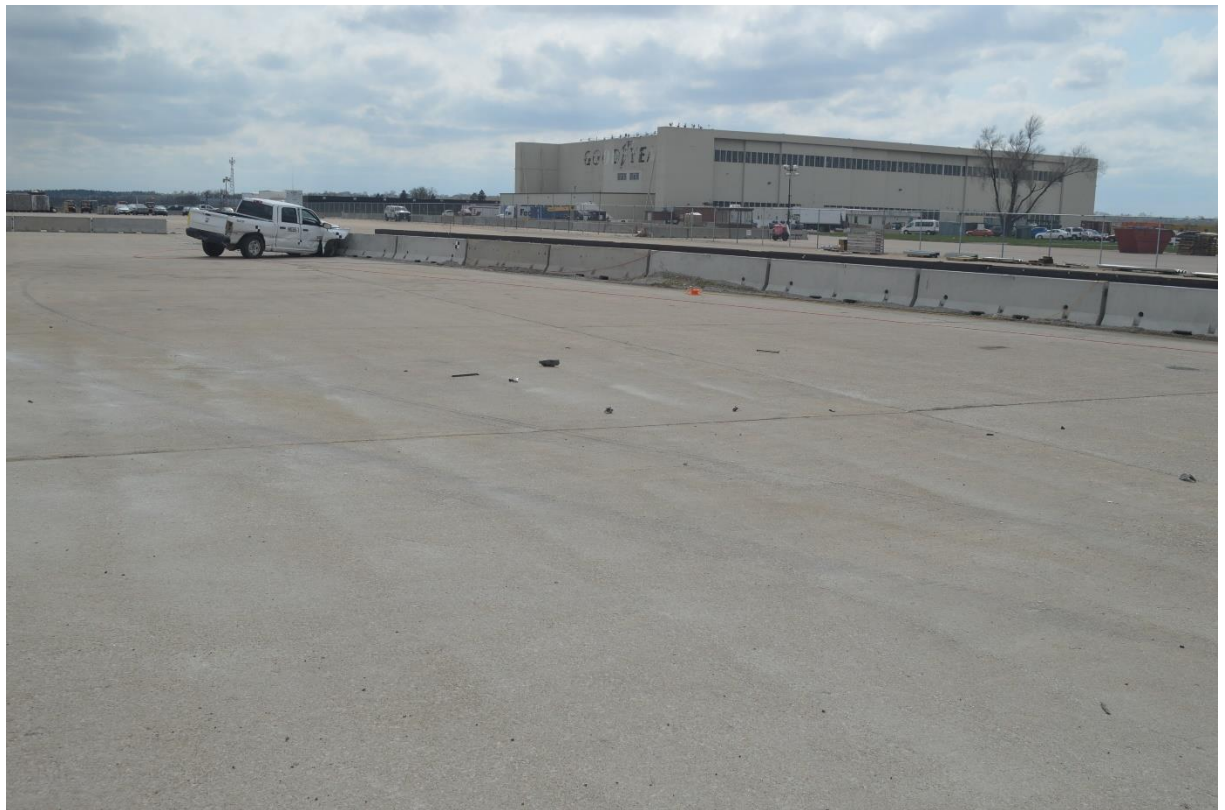
Figure 113. Vehicle Final Position and Trajectory Marks, Test No. HMDDBR-3

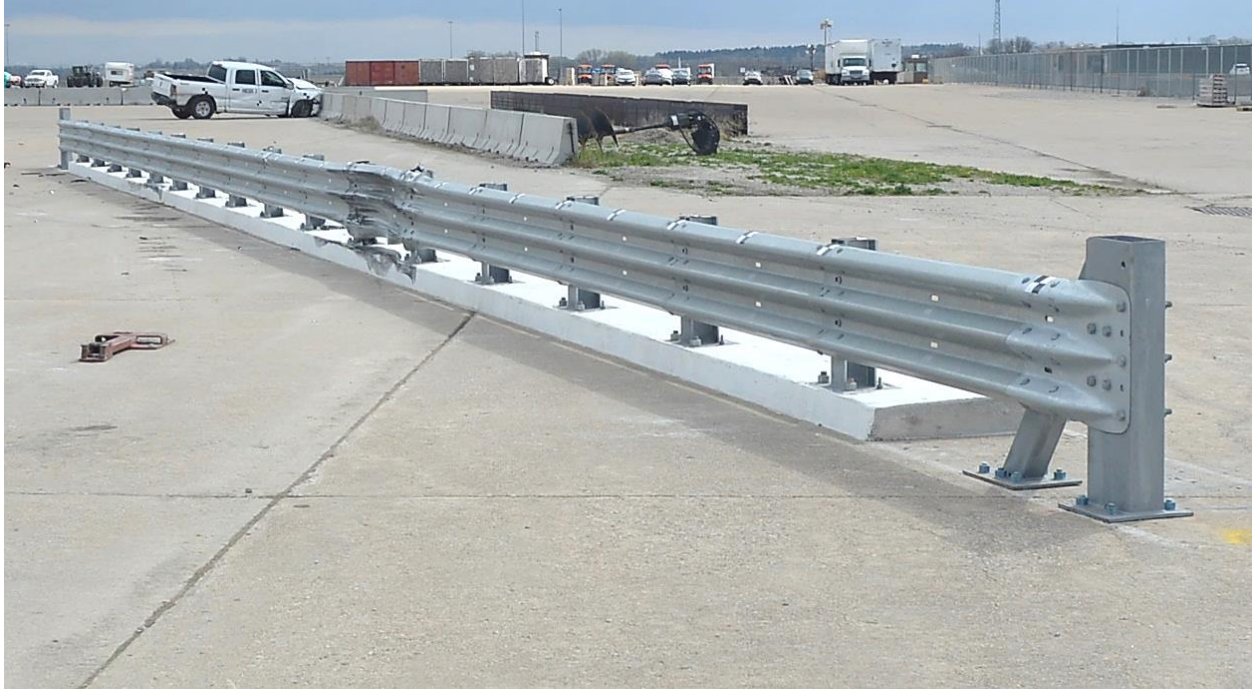
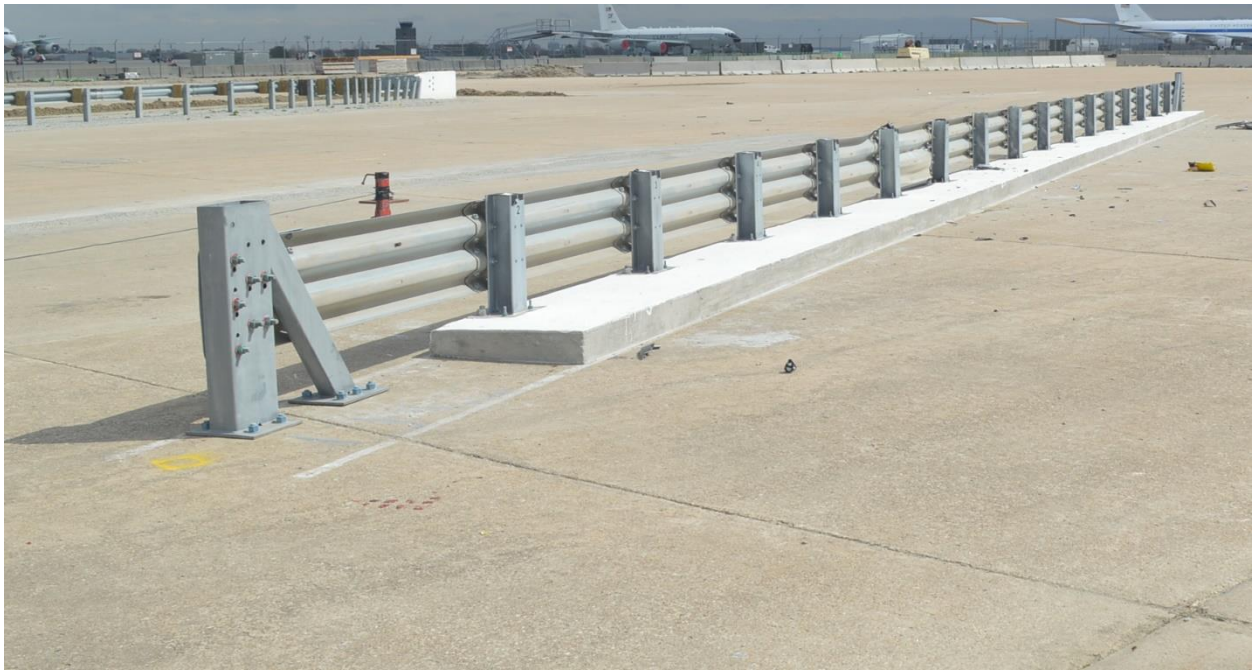
Figure 114. System Damage, Test No. HMDBR-3

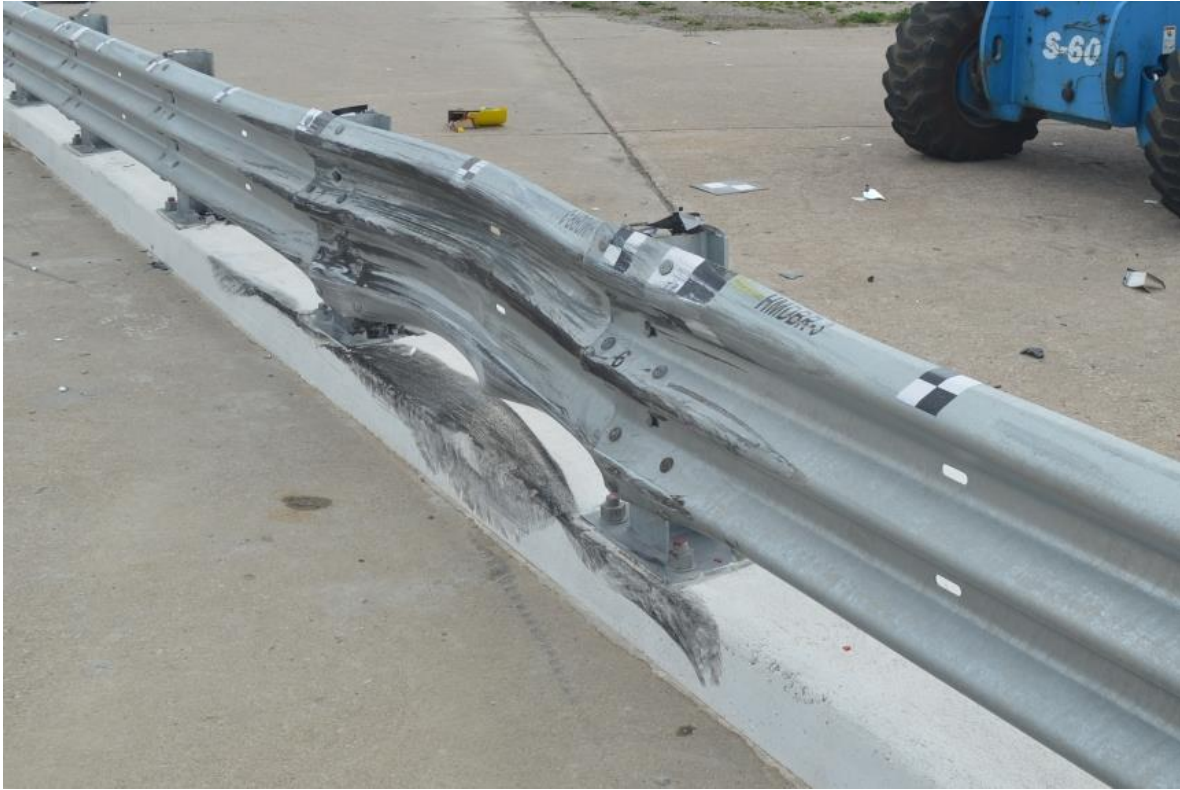
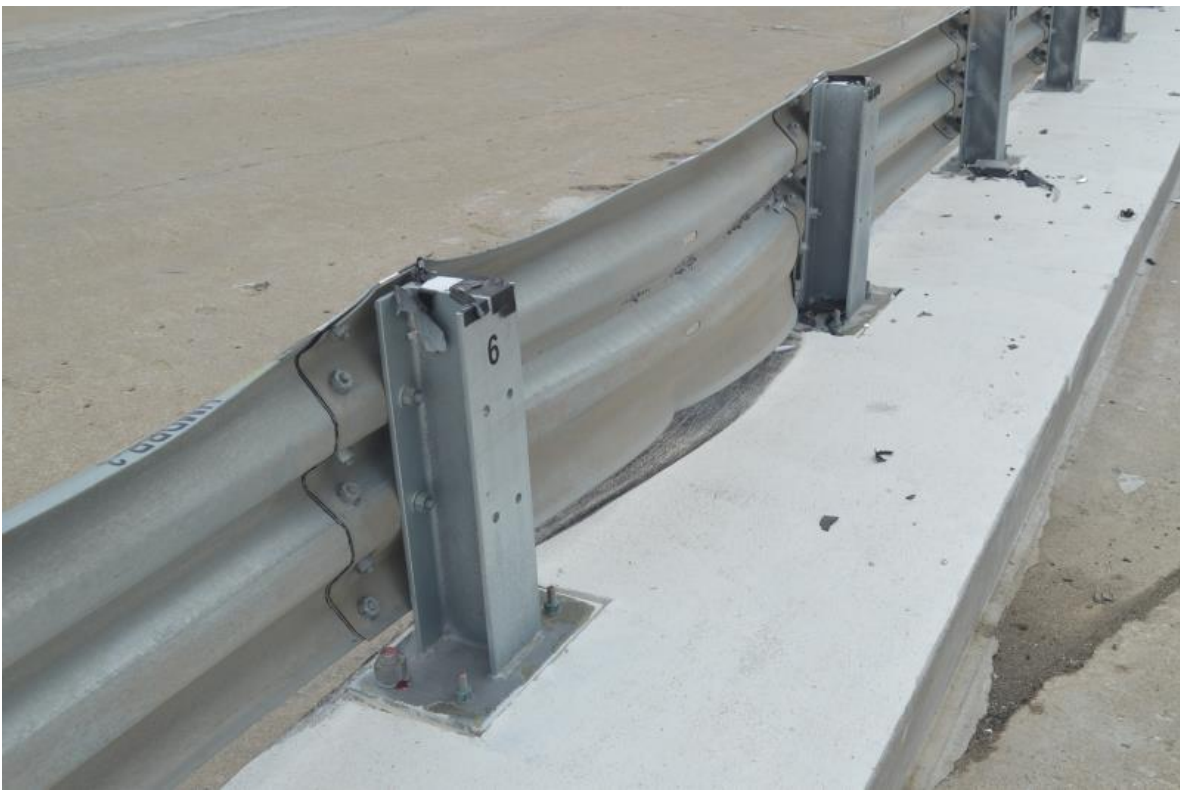
Figure 115. Rail Damage, Test No. HMDBR-3

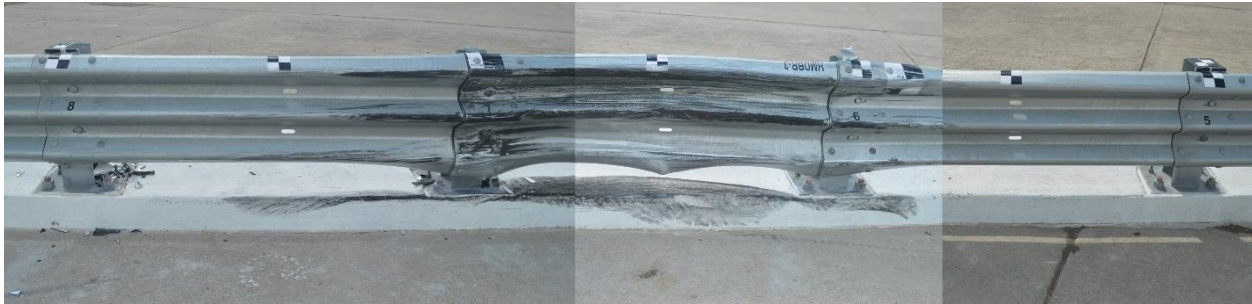
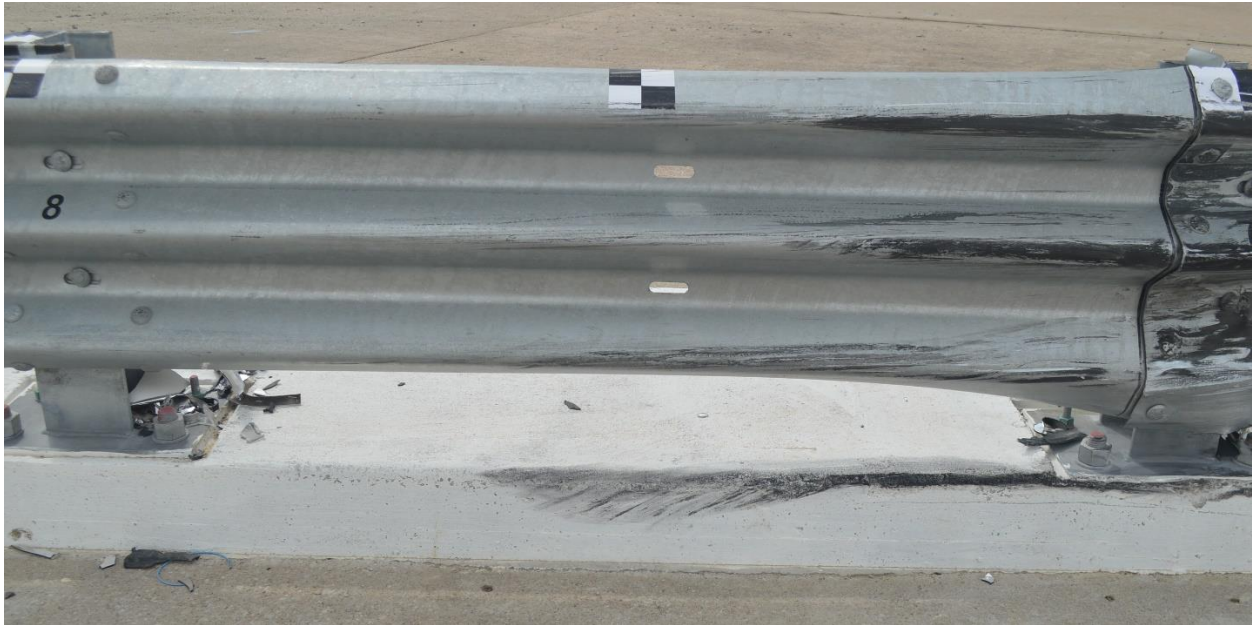
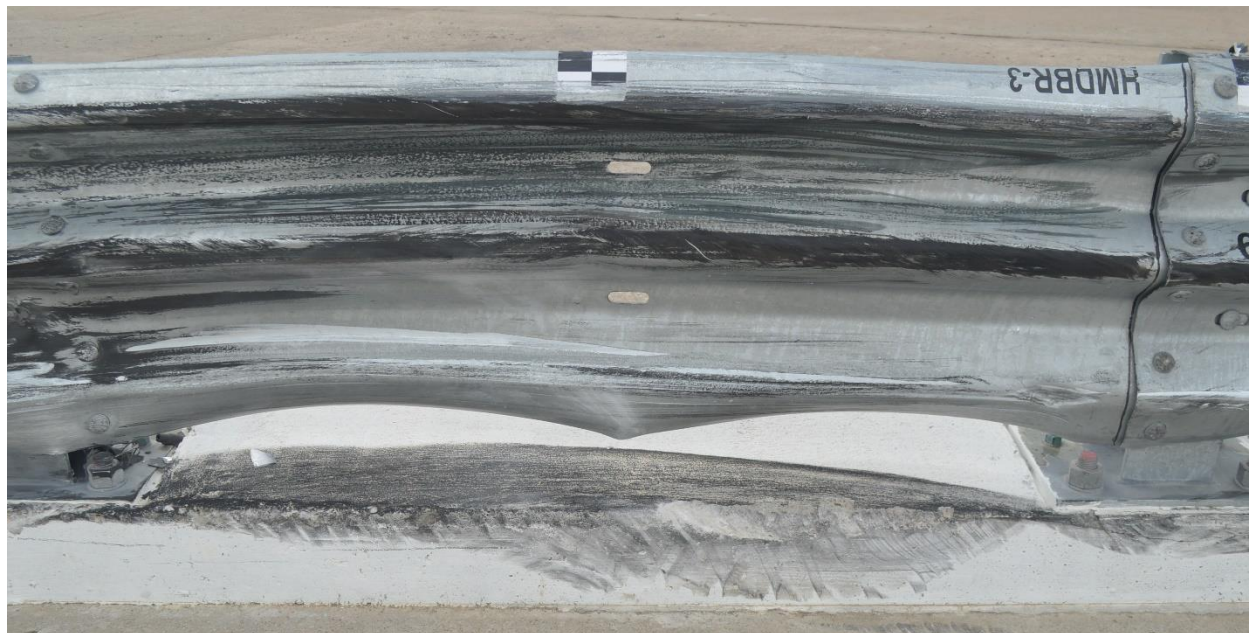
Figure 116. Curb Damage and Contact Marks, Test No. HMDBR-3

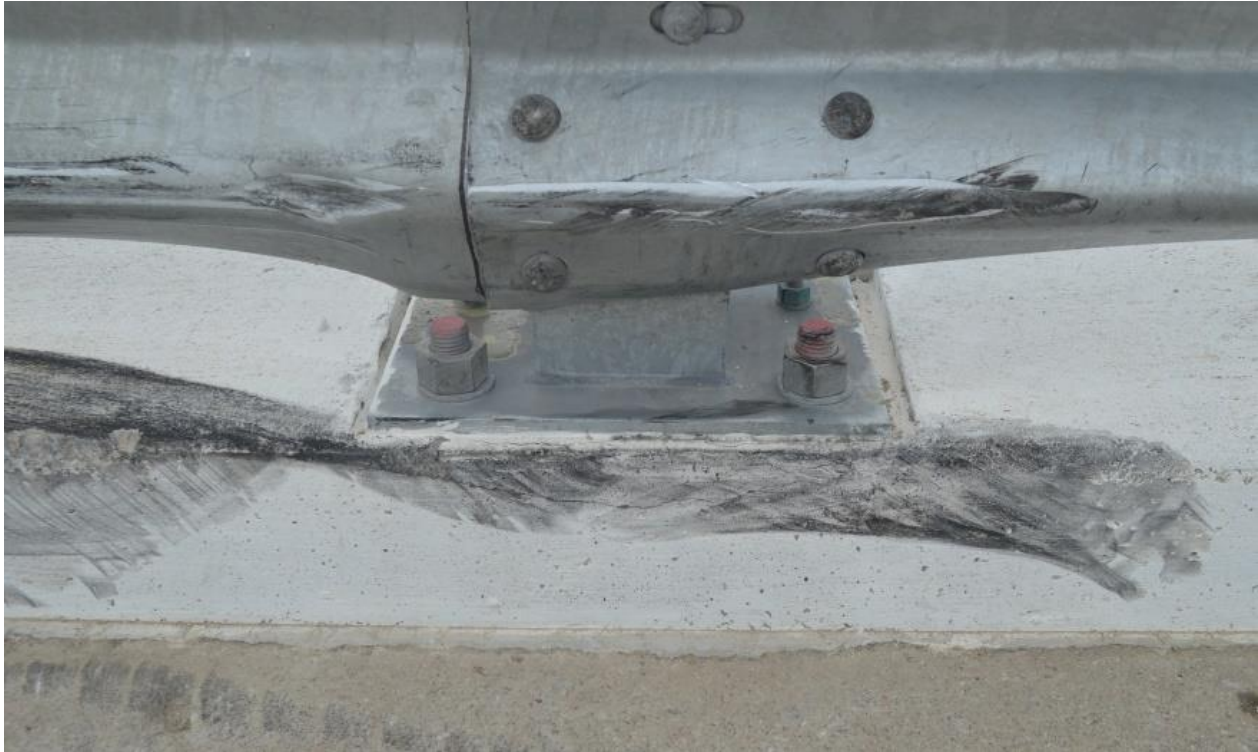
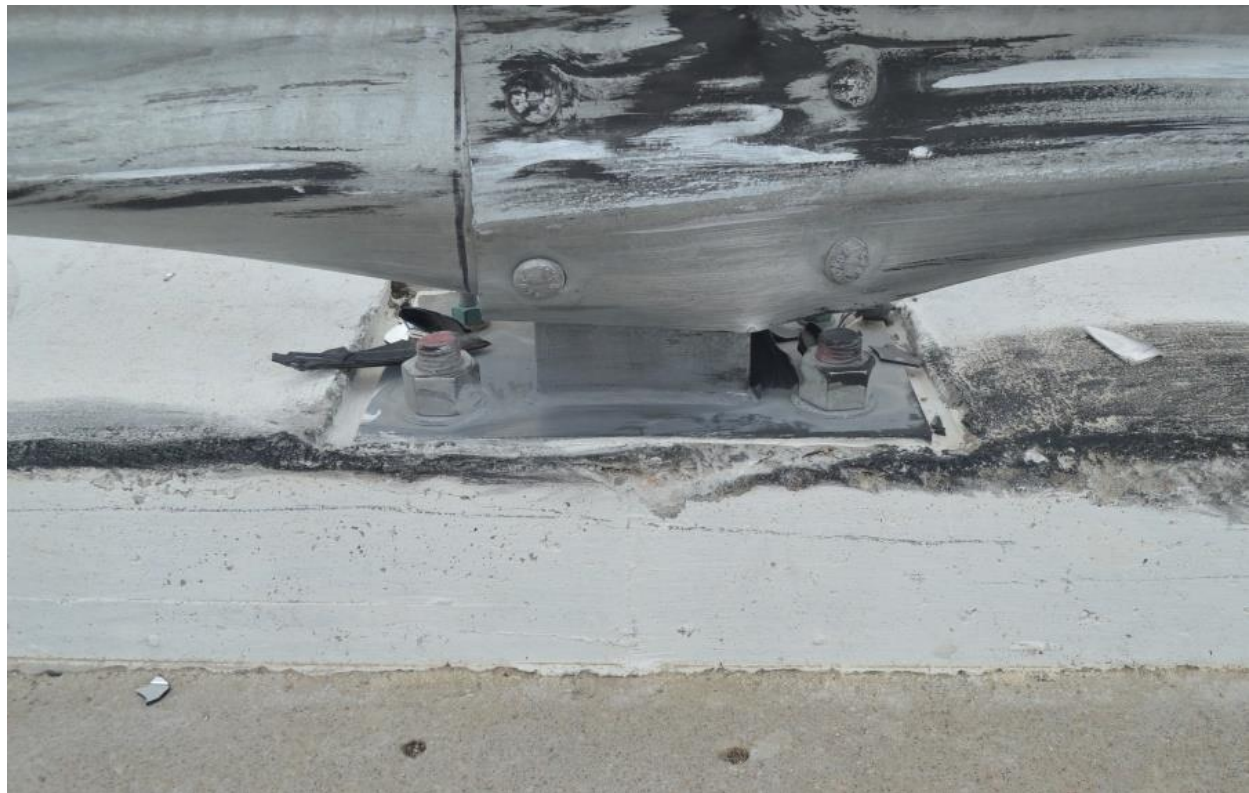
Figure 117. Curb Damage at Post No. 6 (Top) and Post No. 7 (Bottom), Test No. HMDBR-3

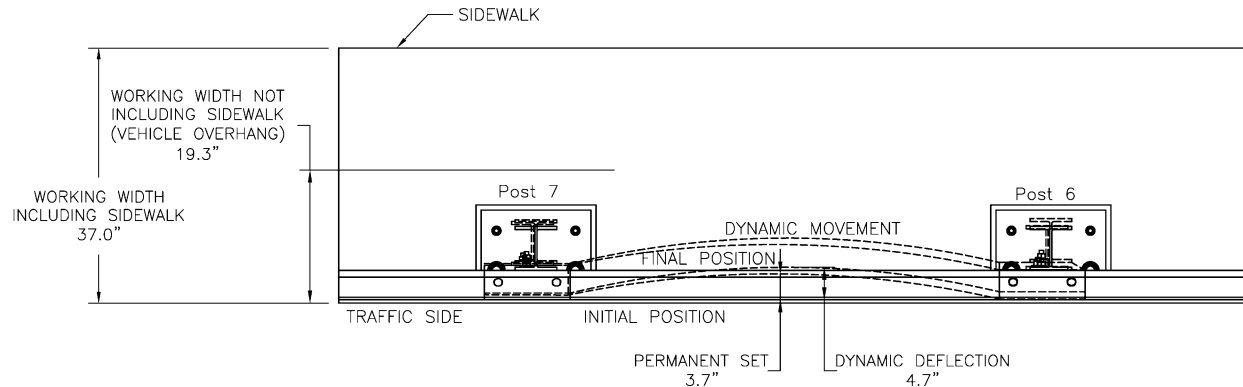
Figure 118. Permanent Set, Dynamic Deflection, and Working Width, Test No. HMDBR-3

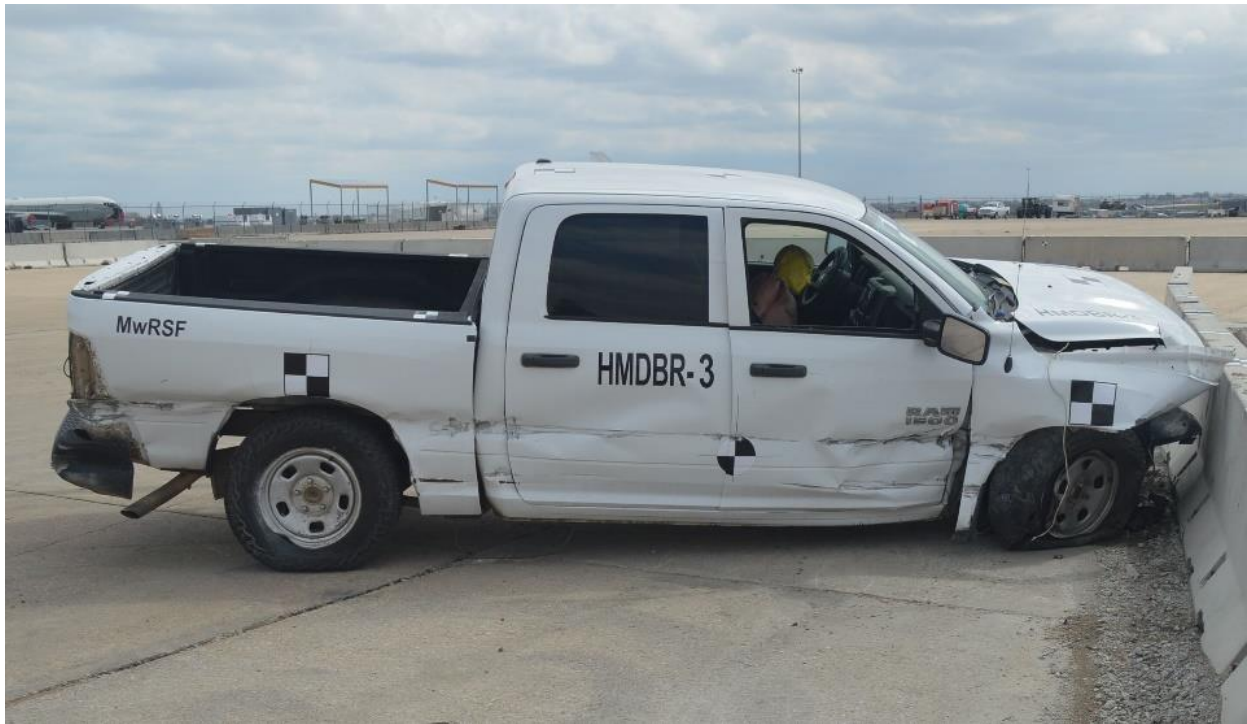
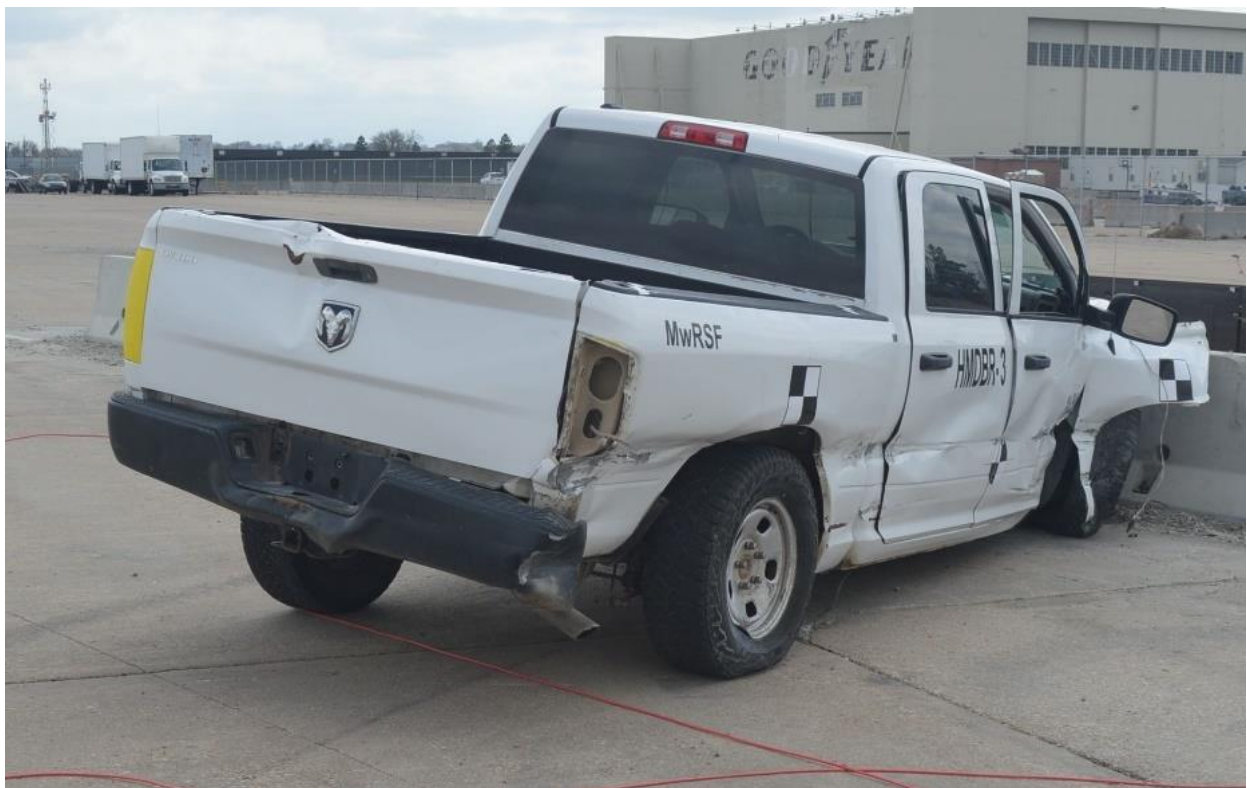
Figure 119. Vehicle Damage, Test No. HMDBR-3

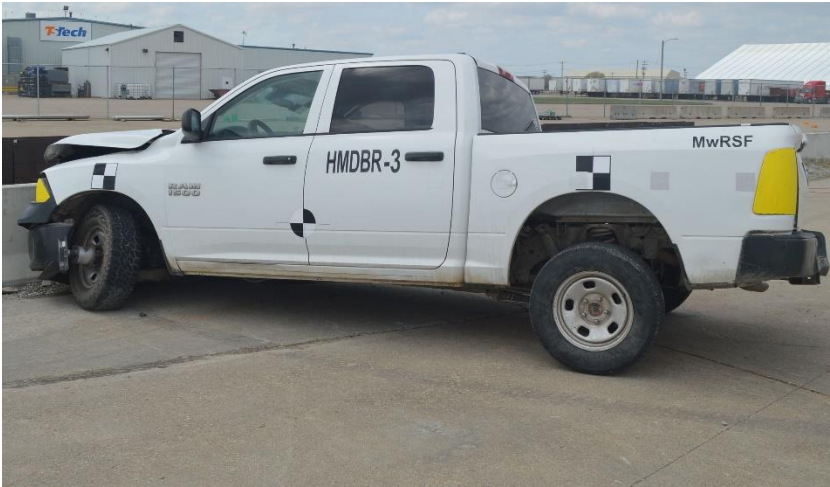
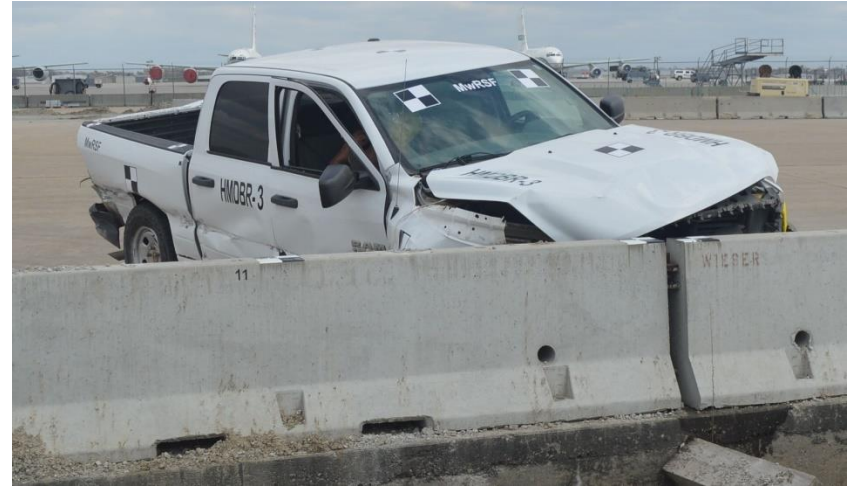
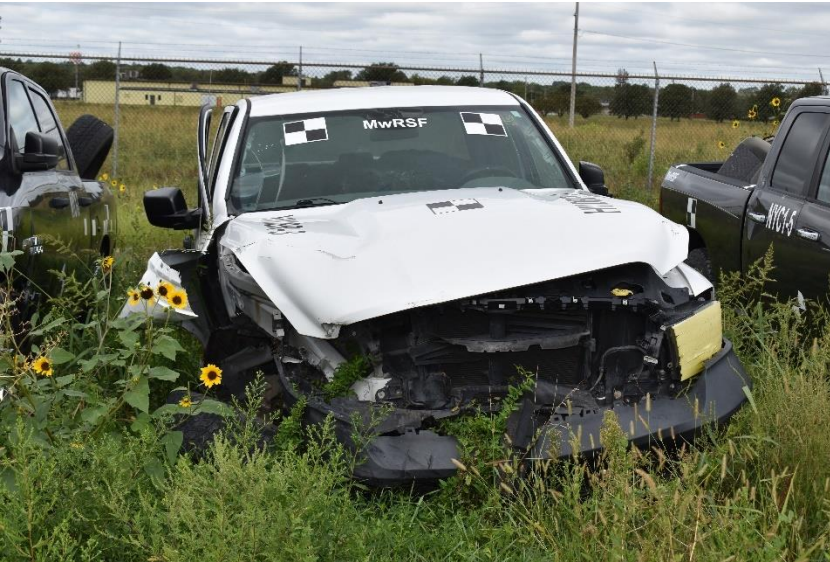
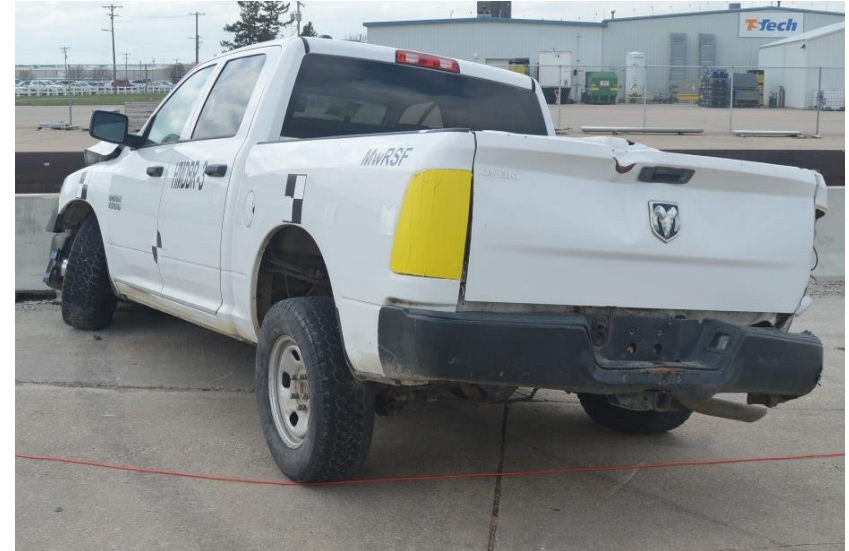
Figure 120. Vehicle Damage, Test No. HMDBR-3

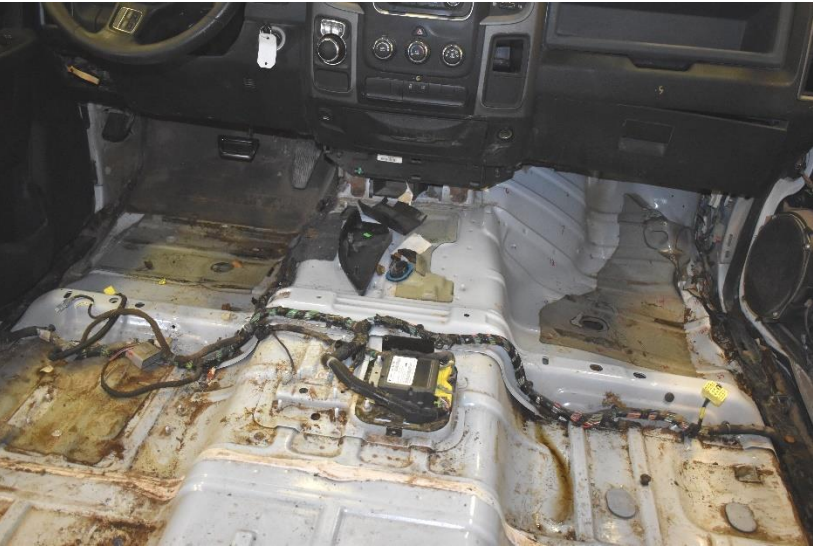
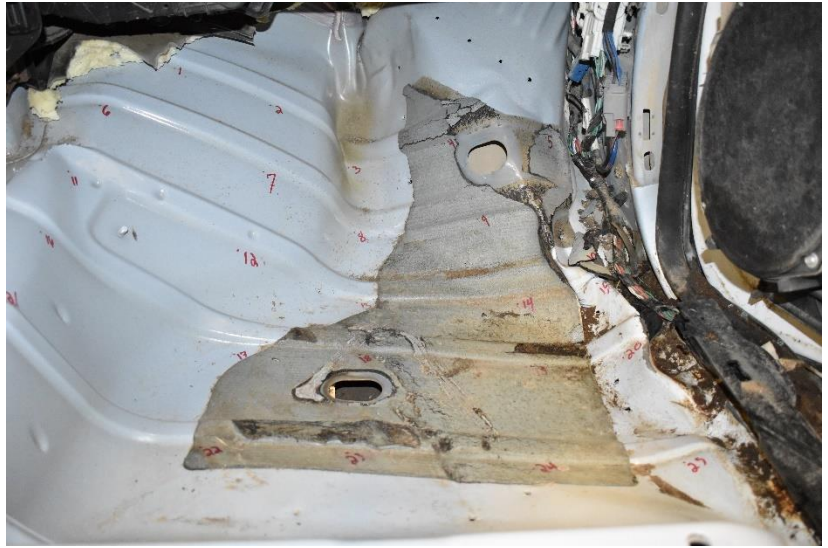
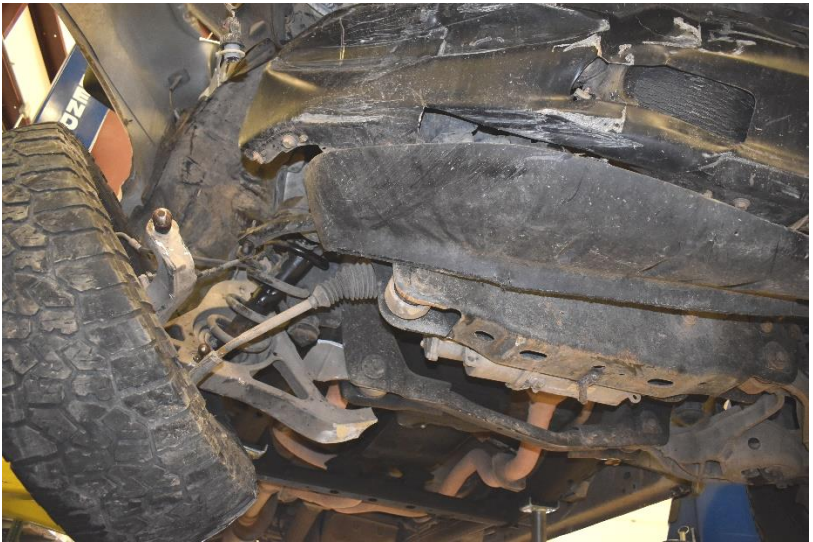
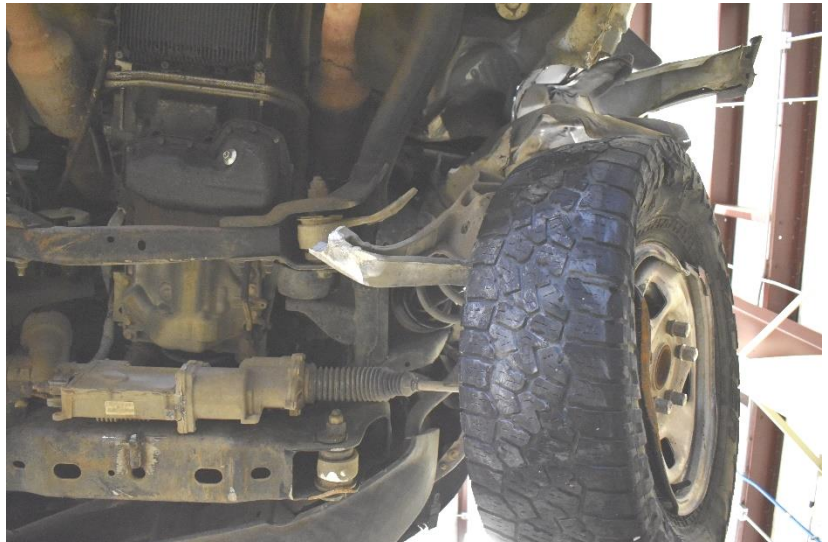
Figure 121. Interior and Undercarriage Damage, Test No. HMDBR-3

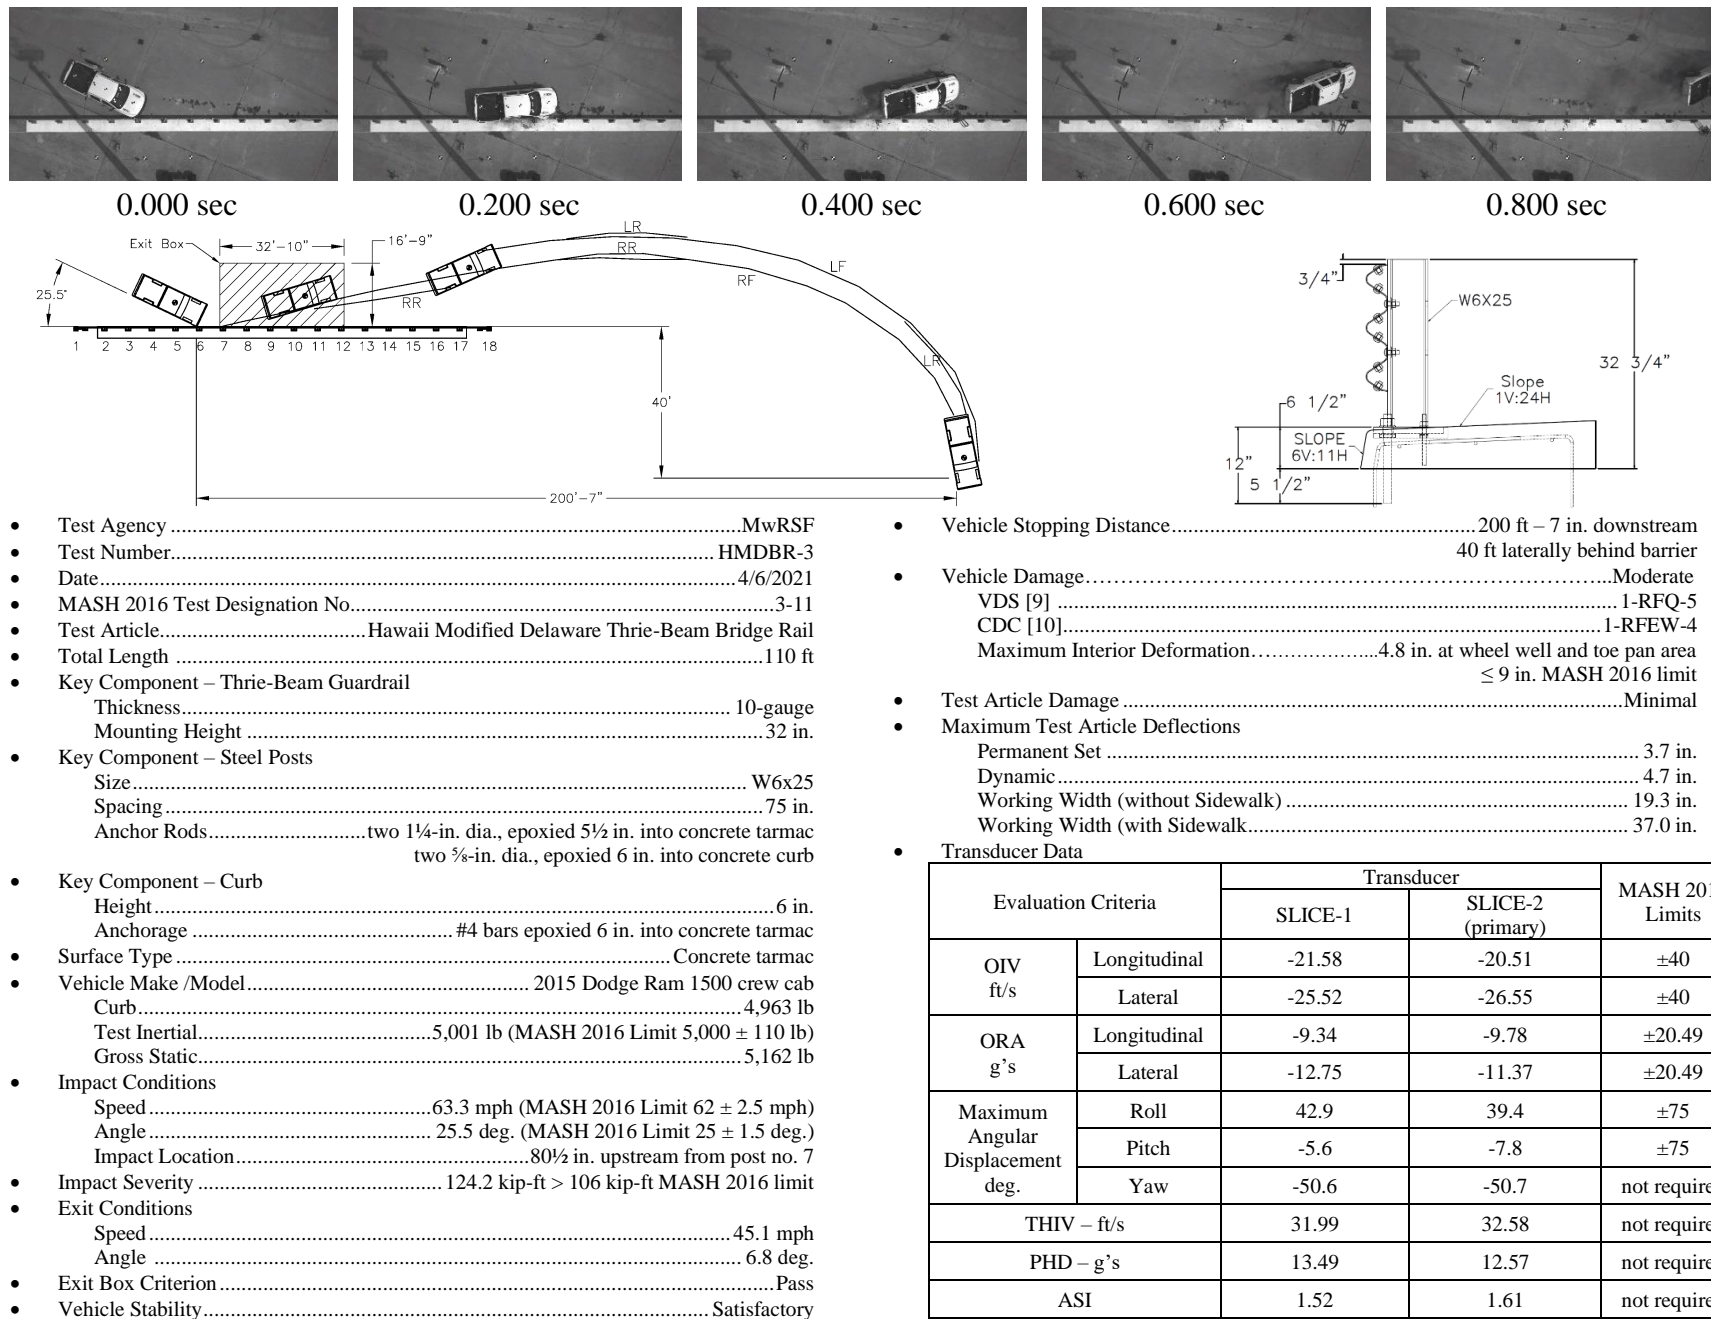
Figure 123. Summary of Test Results and Sequential Photographs, Test No. HMDBR-3

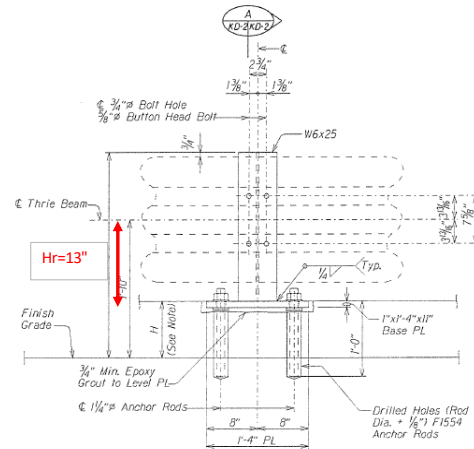
CIP-1 (published values with D=1.5)	CIP-2 (published values with D=1)	Comments
D	1.5	1	MASH recommends
Zp (in^3)	18.9	18.9	W6x25
σy (ksi)	50	50	A992
Hr (in)	13	13	
Fy (kips)	109.04	72.69	
Spacing (ft)	6.25	6.25	Full post spacing
Fp (kip/ft)	17.45	11.63

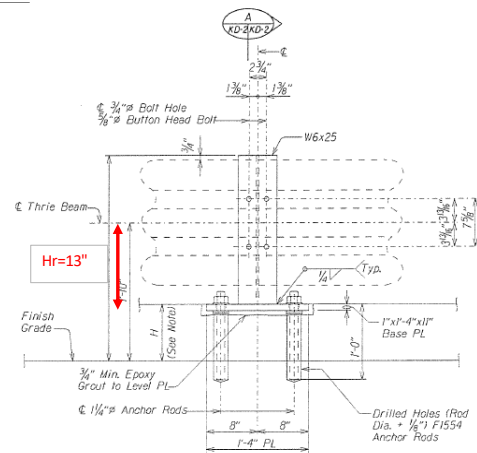
CIP-1 (published values with D=1.5)	CIP-2 (published values with D=1)	Comments
D	1.5	1	MASH recommends
Zp (in^3)	18.9	18.9	W6x25
σy (ksi)	50	50	A992
Hr (in)	13	13	
Fy (kips)	109.04	72.69	
Spacing (ft)	6.25	6.25	Full post spacing
Fp (kip/ft)	17.45	11.63
