PERFORMANCE LIMITS FOR 6-IN. (152-MM) HIGH CURBS PLACED IN ADVANCE OF THE MGS USING MASH VEHICLES PART II: FULL-SCALE CRASH TESTING

MwRSF Research Report No. TRP-03-221-09

October 30, 2009

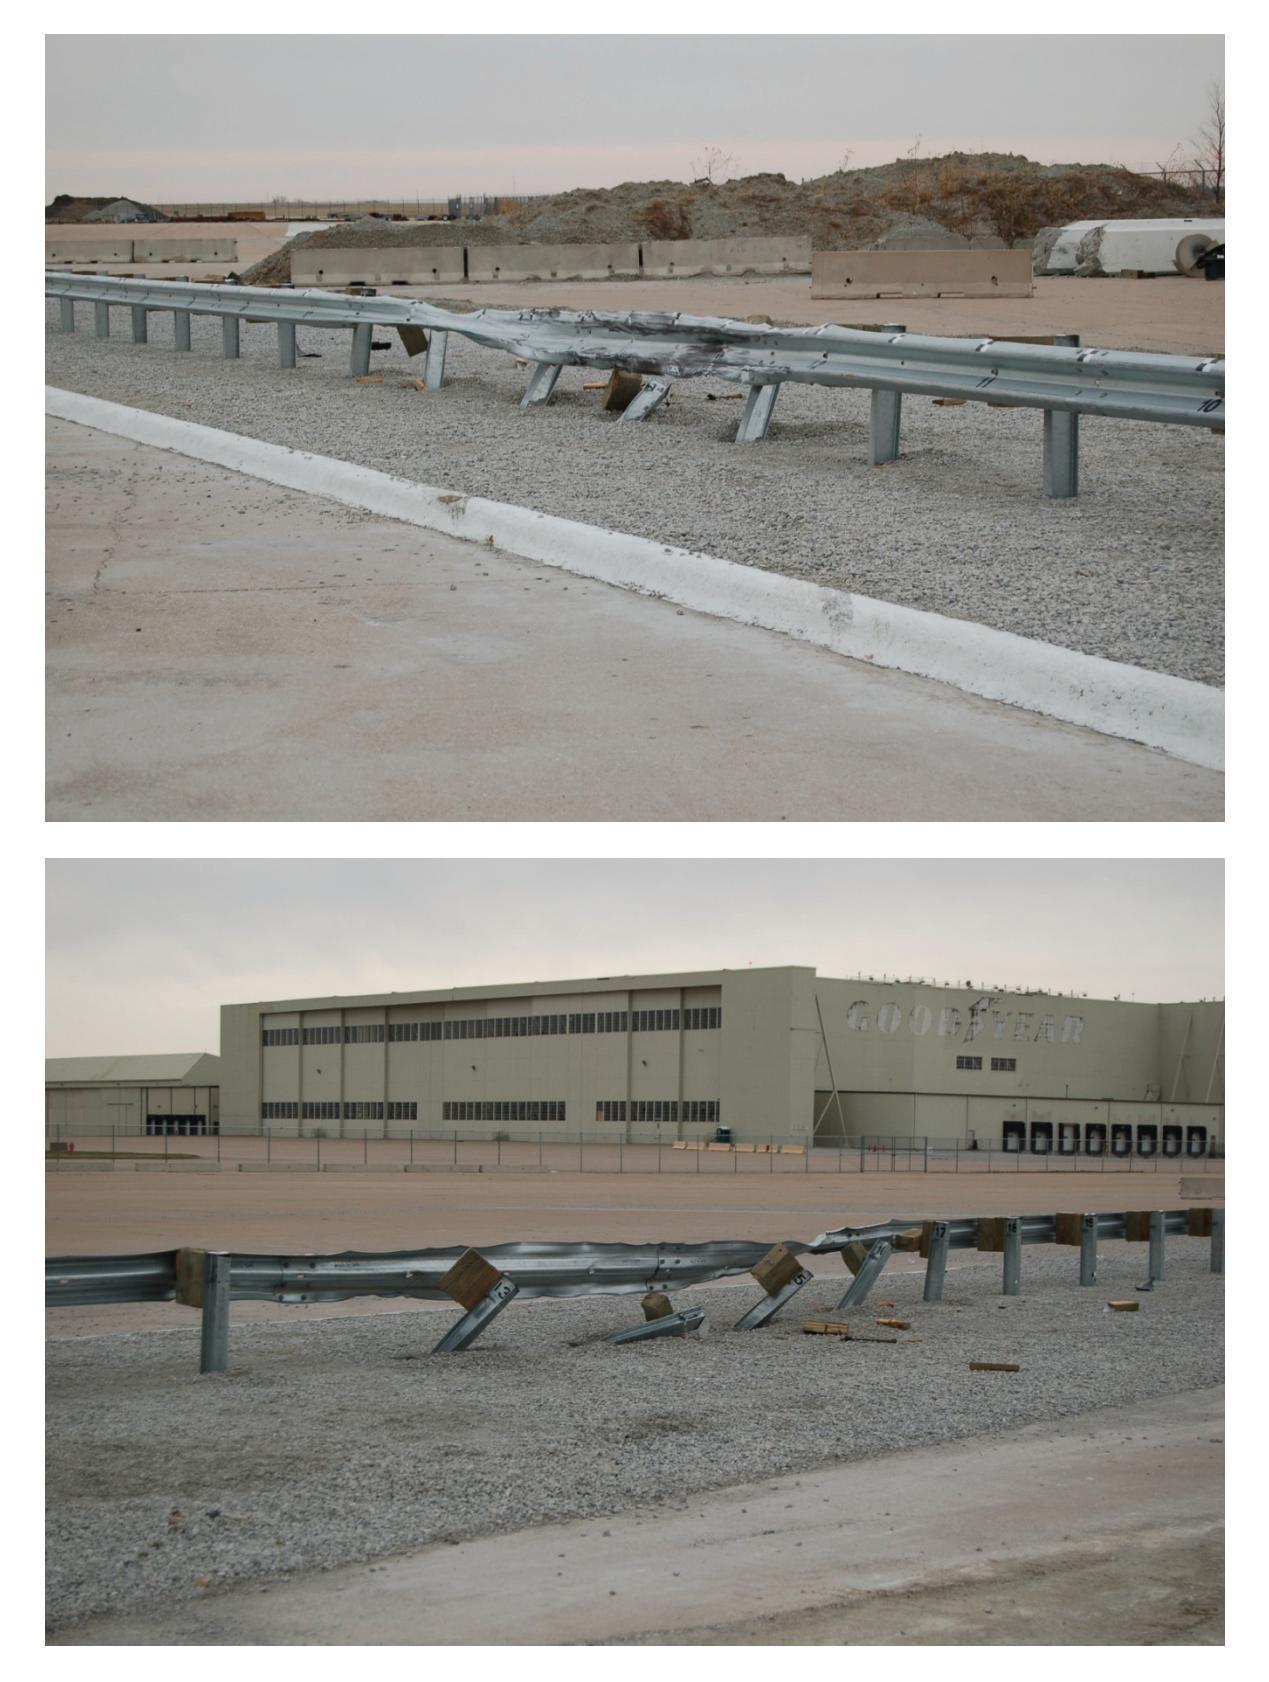
Figure 27. System Damage, Test No. MGSC-5

Damage to the barrier was moderate, as shown in Figures 27 through 38. Barrier damage consisted of deformed guardrail posts, disengaged wooden blockouts, contact marks on several sections of guardrail and the curb, and deformed W-beam rail. Five areas of contact between the vehicle and guardrail occurred, with the most substantial damage occurring at the original impact point. Three regions of light scuff marks occurred downstream of the original impact as the vehicle rolled. The final contact area occurred when the vehicle landed upside-down on the guardrail. The length of the original vehicle contact along the system was approximately 30 ft-3 in. (9.22 m), which spanned from 12 in. (305 mm) downstream of post no. 12 through the centerline of post no. 17.

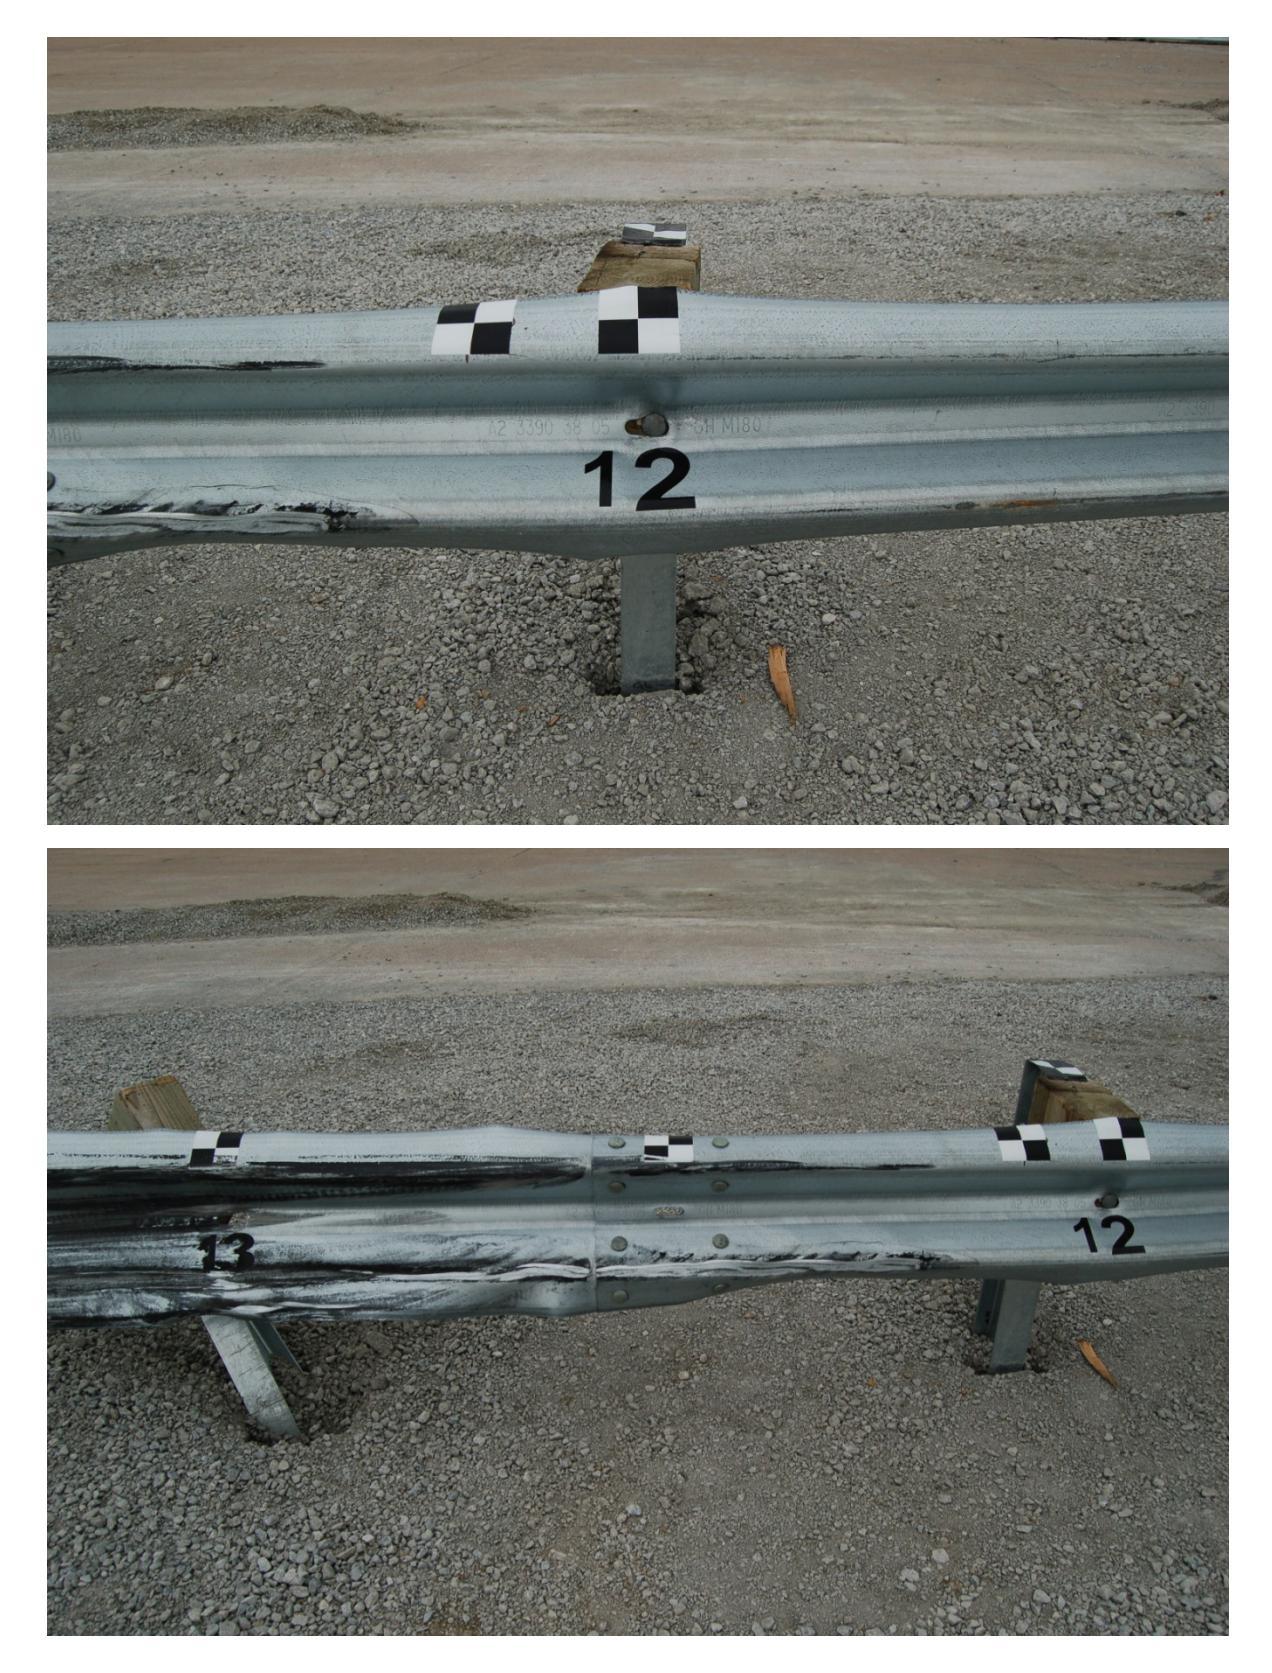
Figure 29. Rail Damage, Post Nos. 12 and 13, Test No. MGSC-5

Deformation and flattening of the W-beam guardrail occurred between post nos. 12 and 17, the primary vehicle contact region. Contact marks were visible on the guardrail beginning 12 in. (305 mm) downstream from post nos. 12 and ending at post no. 17. Additional contact marks were found on the top of the rail and included a 37-in. (940-mm) long mark beginning 25 ³/₄ in. (654 mm) downstream of post no. 20, a 77-in. (1,956-mm) long mark beginning 6 ¹/₂ in. (165 mm) downstream of post no. 21, an 18-in. (457-mm) long mark beginning 3 in. (76 mm) upstream of post no. 23, and a 96-in. (2,438-mm) long mark beginning 20 in. (508 mm) downstream of post no. 25.

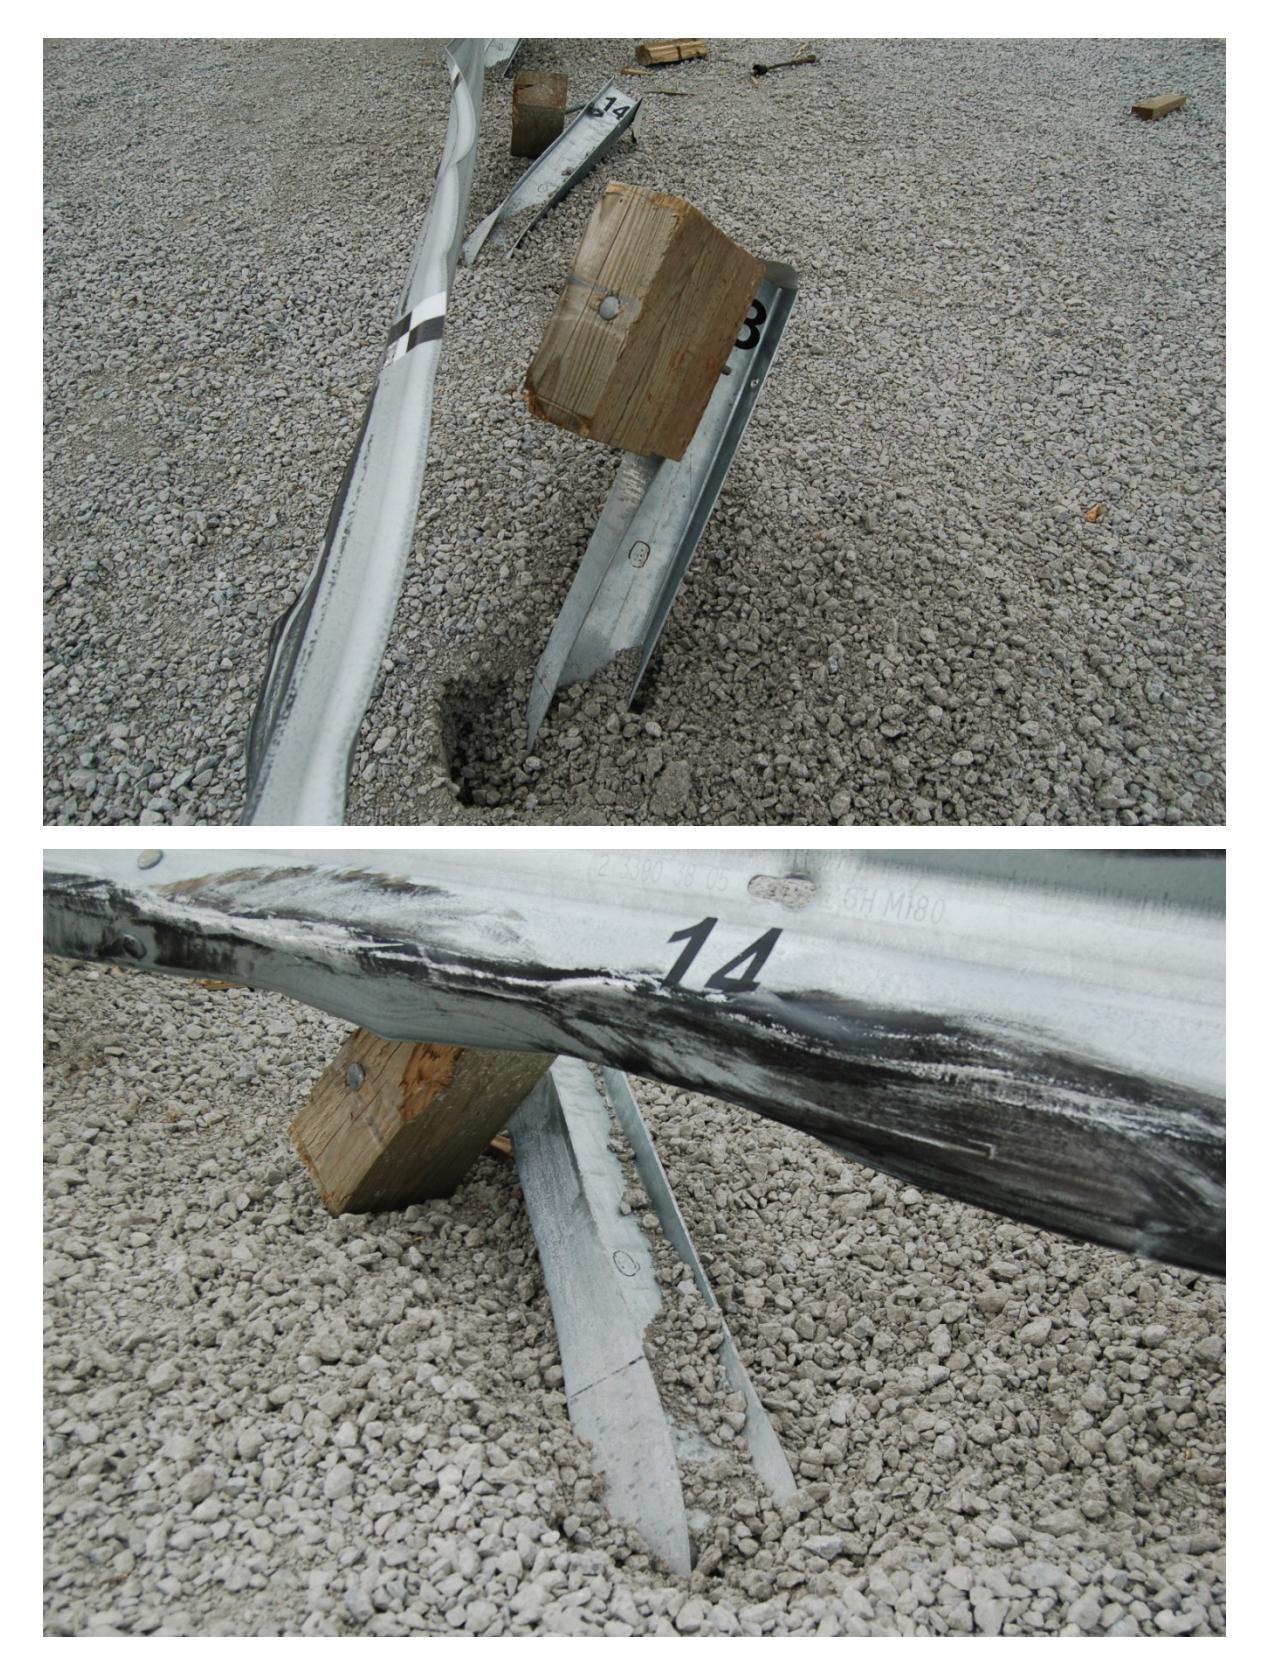
Figure 34. Post Nos. 13 and 14 Damage, Test No. MGSC-5

The blockout at post no. 13 sustained minor damage near its bottom edge due to contact with the rail. The 4-in. (102-mm) deep blockout at post no. 14 fractured and detached, while the

8-in. (203-mm) deep blockout remained attached after sustaining damage from rail contact. The blockouts at post no. 15 twisted away from the post, bending the bolt, and the 4-in. (102-mm) deep blockout sustained a small fracture at its back face. The 4-in. (102-mm) deep blockout at post no. 16 also fractured and detached, while the 8-in. (203-mm) deep blockout remained attached by the deformed guardrail bolt. The 8-in. (203-mm) deep blockout at post no. 17 twisted, but remained attached to the post. All other blockouts remained attached to the posts and undamaged.

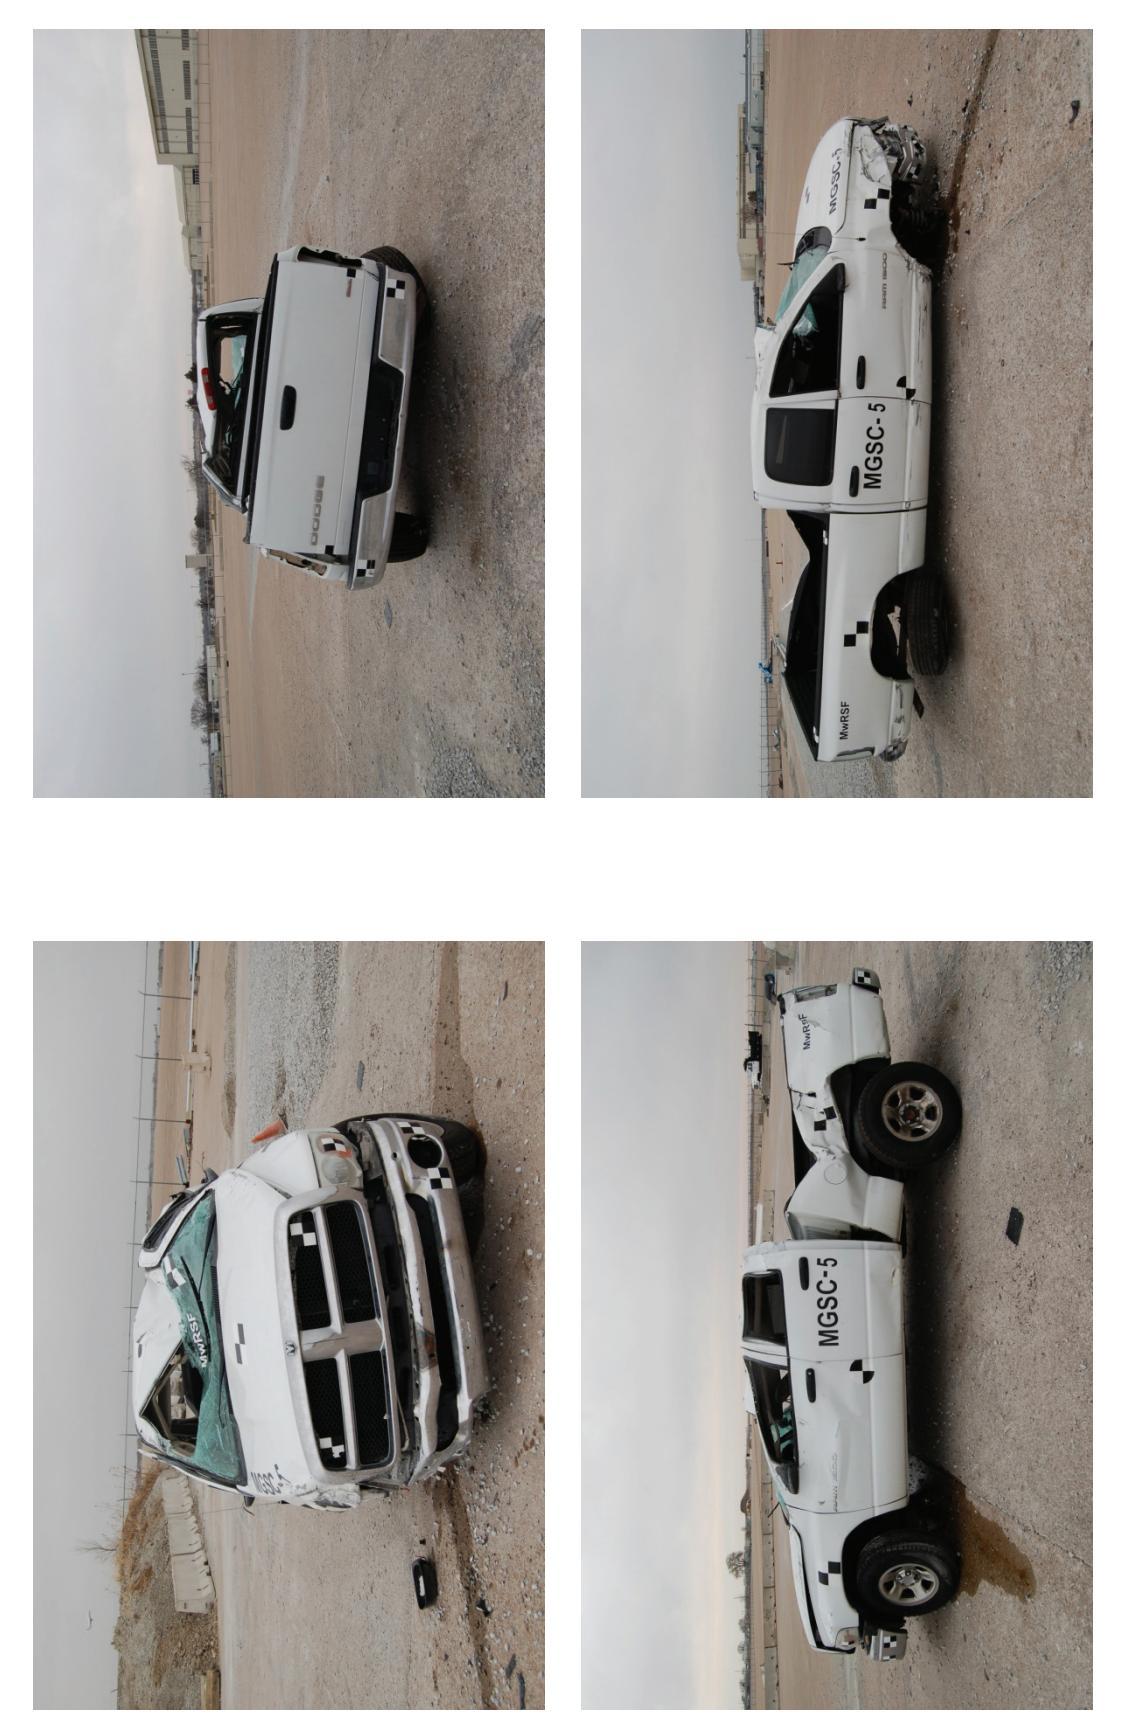
Figure 39. Vehicle Damage, Test No. MGSC-5

The damage to the vehicle was extensive, as shown in Figures 39 through 43. Occupant compartment deformations were judged to be significant to cause serious injury to vehicle occupants. Deformations to the vehicle floorboard were relatively minor, with maximum longitudinal, lateral, and vertical deflections of ¹/₄ in. (6 mm) located throughout the right-side floorboard, ¹/₂ in. (13 mm) located along the right side of the right-side floorboard, and 2 in. (51 mm) located near the center of the vehicle's floorboard, respectively. Complete occupant compartment and vehicle deformations and the corresponding locations are provided in Appendix D.

Exterior damage was located on all portions of the vehicle. Both right-side wheel assemblies were detached from the vehicle. The right-front wheel spindle and assembly detached from the suspension control arms. The rear axle fractured at the right-rear wheel. The right-front quarter panel and bumper were deformed inward toward the engine compartment. Scrapes and gouges were found along the right-side doors and right-rear quarter panel. The right-side headlight and both rear tail lights fractured. The left side of the truck box was significantly deformed and bent away from the cab. Minor deformations occurred along the left-side doors, left-front quarter panel, and rear bumper. Both the left- and right-side mirrors disengaged from the truck. The hood and grill were slightly deformed and displaced. The roof was crushed inward, especially on the left side. The windshield was severely shattered and partially displaced. The right-front door, rear, and both left-side door window glass was fractured and removed from the vehicle. The right-rear door window glass remained undamaged.
