# **EVALUATION OF CRITICAL FLARE RATES FOR**

# THE MIDWEST GUARDRAIL SYSTEM (MGS)

MwRSF Research Report No. TRP-03-191-08

July 15, 2008

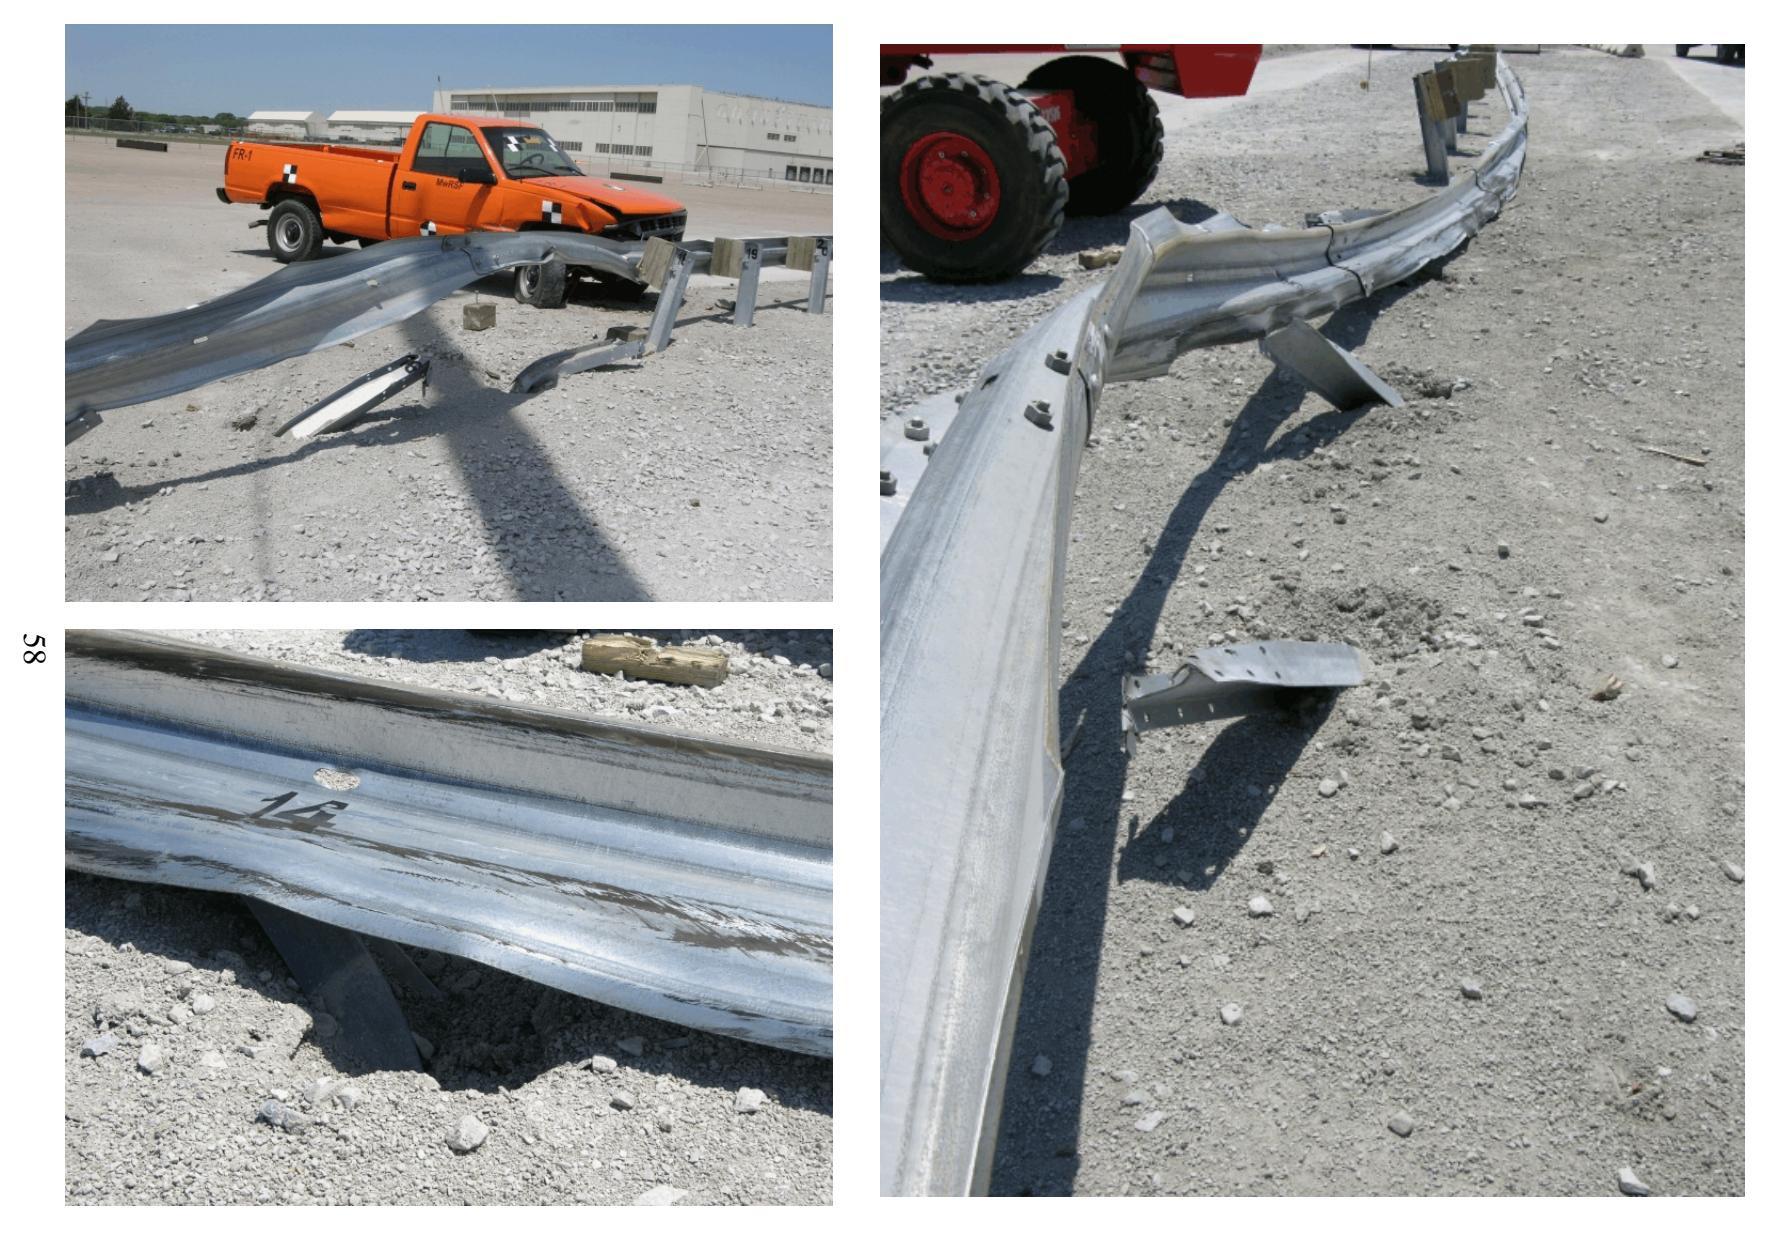
Figure 39. System Damage, Test FR-1

Barrier damage was moderate, as shown in Figures 39 through 44. Barrier damaged consisted of deformed guardrail posts, deformed W-beam rail, deformed and disengaged blockouts, and contact marks on a guardrail section. The length of vehicle contact along the system was approximately 11.4 m (37 ft - 6 in.), which spanned from the centerline of post no. 12 through the centerline of post no. 18.

Moderate deformation and flattening of the impacted section of W-beam rail occurred between post nos. 12 and 18. Contact marks were found on the rail between post nos. 12 and 18. The guardrail buckled at nearly every post location between post nos. 12 and 18. Major buckling of the guardrail occurred at the upstream side of post no. 19. The W-beam was pulled off of post nos. 1 through 19. The W-beam rail sustained significant yielding around the post bolt slots at post nos. 1 through 11, 13, 14, 18, and 19. Minor tearing of the W-beam rail occurred around the post bolt slots at post nos. 12 and 15, while the tearing of the W-beam rail around the post bolt slots at post nos. 16 and 17 was very significant. No significant guardrail damage occurred downstream of post no. 20.

The permanent set of the barrier system is shown in Figure 39. The maximum lateral permanent set rail and post deflections were 1,140 mm (44.875 in.) at the midspan between post nos. 15 and 16 and 813 mm (32 in.) at the centerline of post no. 13, respectively, as measured in the field. The maximum lateral dynamic rail and post deflections were 1,684 mm (66.3 in.) at the centerline of post no. 15 and 853 mm (33.6 in.) at the centerline of post no. 13, respectively, as determined from high-speed video analysis. The working width of the system was found to be 1,794 mm (70.6 in.).

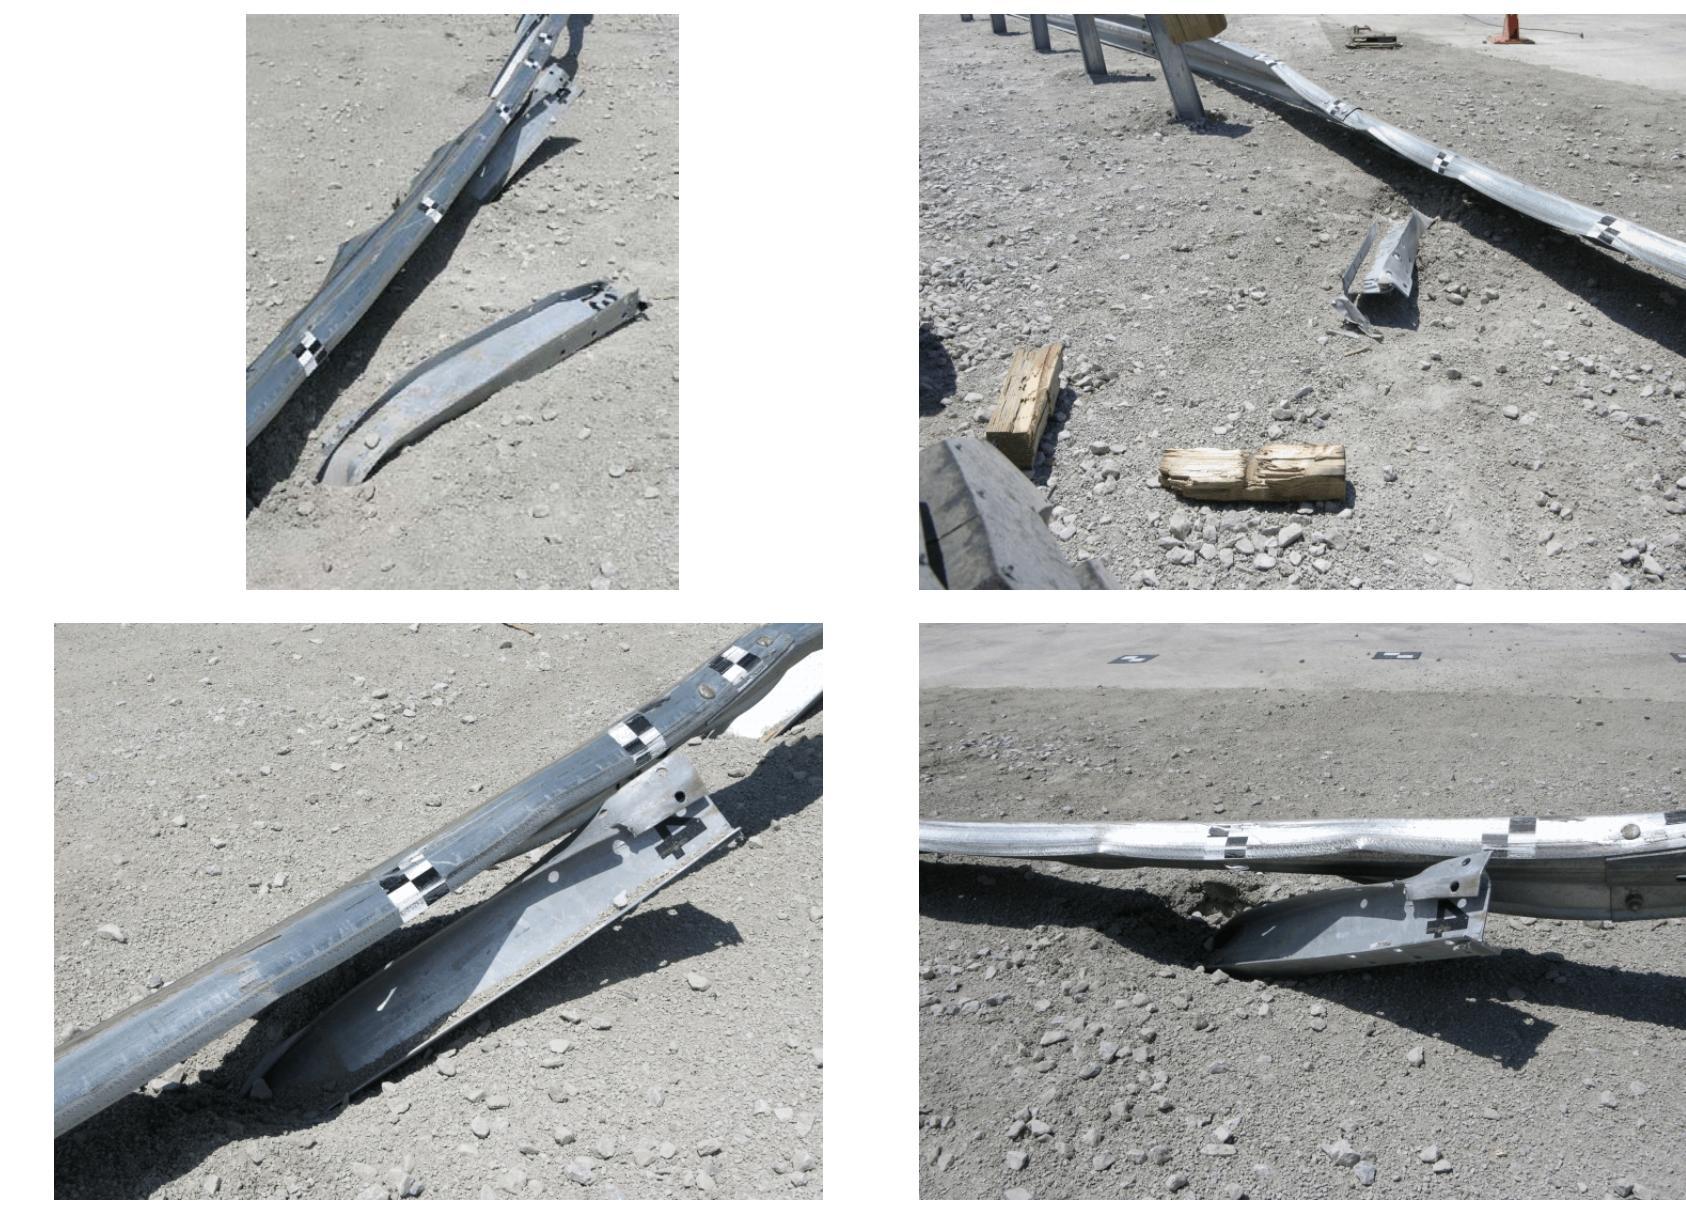
Figure 41. Post Nos. 11 and 12 Damage, Test No. FR-1

The wooden blockouts at post nos. 3 through 10 and 19 rotated slightly while still attached to the post. The wooden blockouts at post nos. 11, 12, and 18 encountered damage on the front face due to W-beam rail contact, but remained attached to the posts. The wooden blockouts at post nos. 13 through 17 were fractured and removed from the posts.

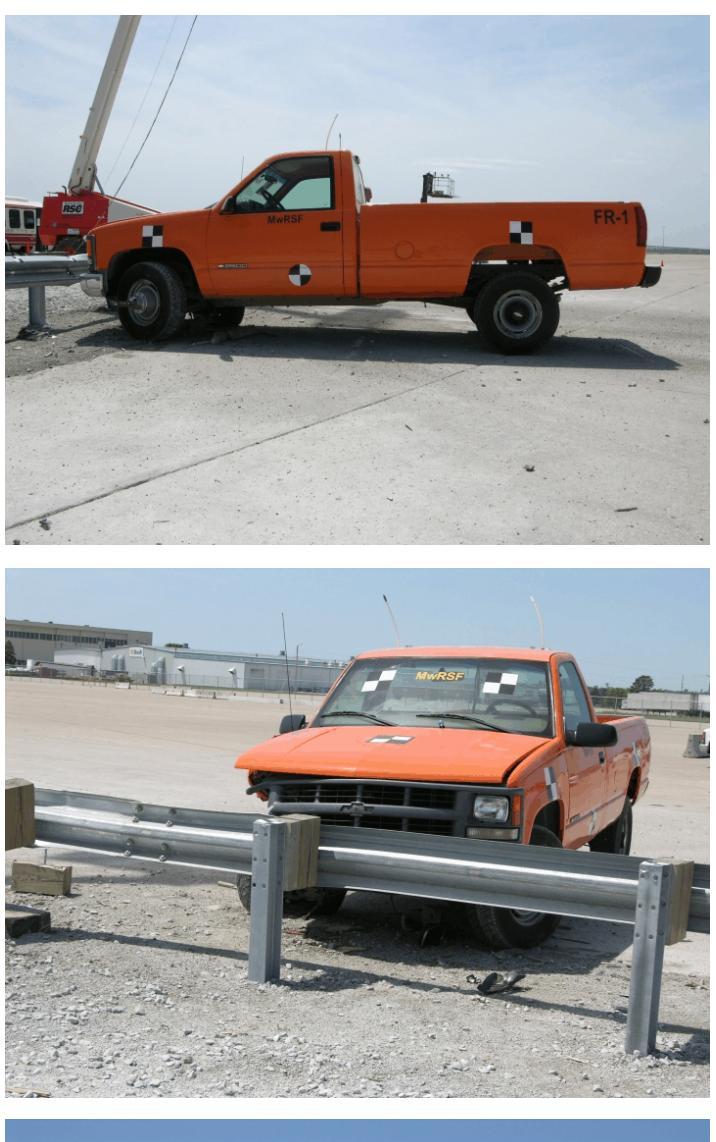
Figure 46. Vehicle Damage, Test FR-1

Exterior vehicle damage was moderate, as shown in Figures 46 through 49. Occupant compartment deformations to the right side and center of the floorboard were judged insufficient to cause serious injury to the vehicle occupants. Maximum longitudinal deflections of 6 mm (0.25 in.) were located near the front and left sides of the right-side floorpan. Maximum lateral deflections of 13 mm (0.5 in.) were located near the center of the right-side floorpan. Maximum vertical deflections of 19 mm (0.75 in.) were located near the right side of the right-side floorpan. Complete occupant compartment deformations and the corresponding locations are provided in Appendix C.

Damage was concentrated on the right-front corner of the vehicle. The right-front bumper

had a buckle point at the center. Scrape marks and deformations were found along the entire right side. The right-rear corner of the box was dented. The right-side suspension, ball joint, and control arm connections were broken. The front grill was shifted toward the left, and the right side of the grill was fractured. The hood was ajar. The right-side headlight and turn signal assembly were fractured and disengaged from the vehicle. The left side, rear, roof, and all window glass remained undamaged.

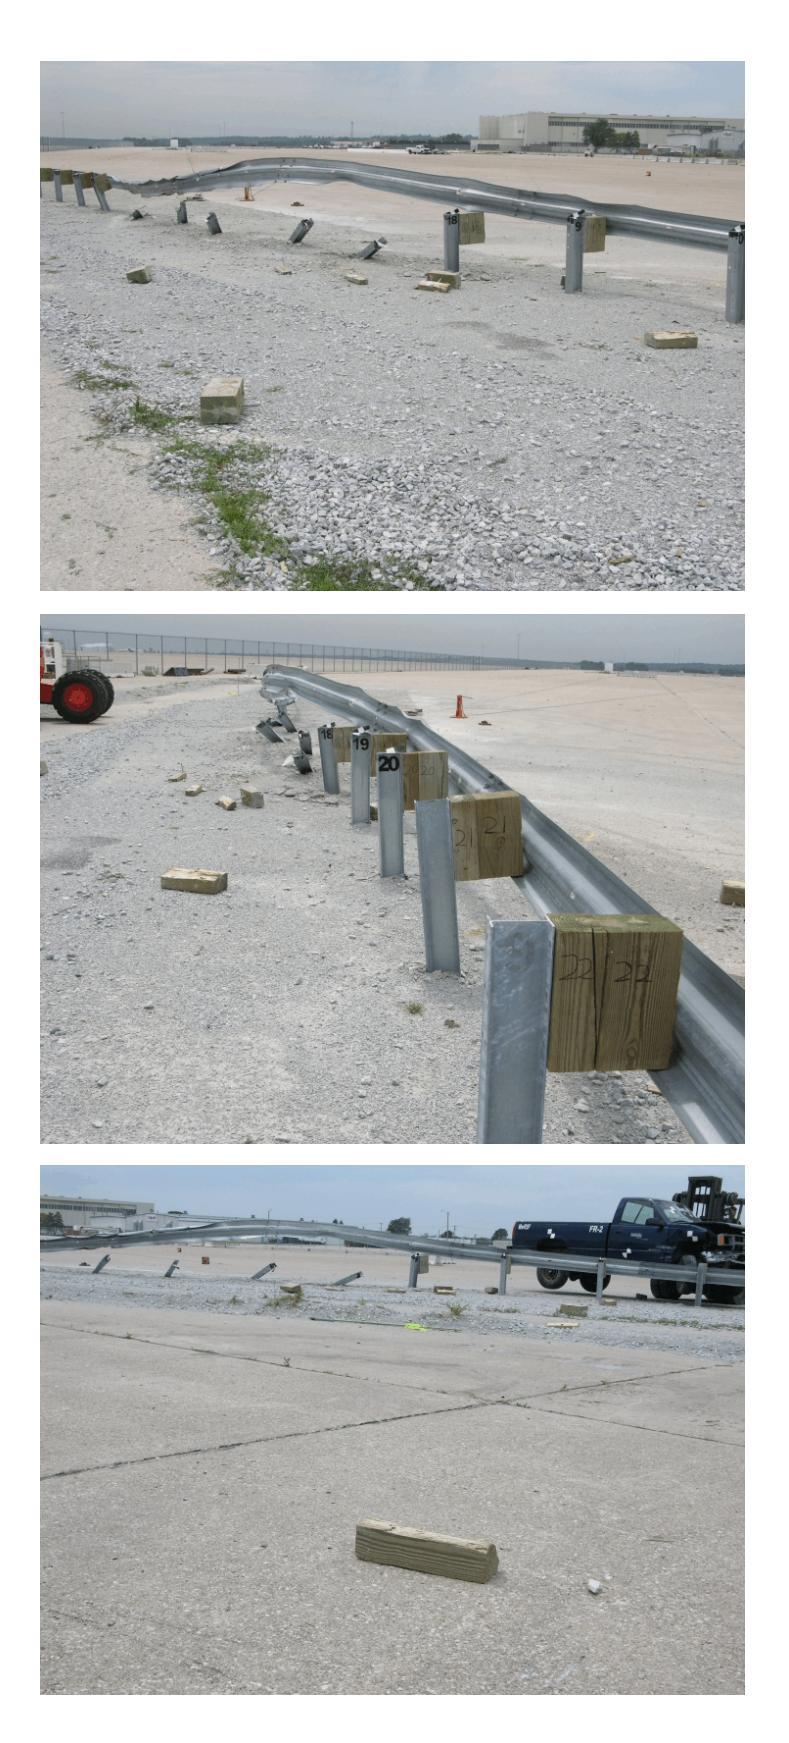
Figure 61. System Damage, Test FR-2

Damage to the barrier system was moderate, as shown in Figures 61 through 69. Barrier damage consisted of deformed guardrail posts, deformed W-beam rail, deformed and disengaged blockouts, and contact marks on a guardrail section. The length of vehicle contact along the system was approximately 16.3 m (53 ft - 6.75 in.), which spanned from 451 mm (17.75 in.) upstream from the centerline of post no. 12 through 635 mm (25 in.) downstream from the centerline of post no. 20.

Contact marks were found along the length of vehicle contact with the system. Minor guardrail deformation was found between post nos. 21 and 28. The W-beam rail was deformed and flattened between post nos. 13 and 17. The guardrail buckled at post nos. 2 and 17 through 19 and at the midspan between post nos. 11 and 12. Other guardrail buckle points were found at 432 mm (17 in.) upstream of post no. 19, 470 mm (18.5 in.) downstream of post no. 19, 203 mm (8 in.) upstream of post no. 21, and at post no. 28. The W-beam rail pulled off of post nos. 12 through 24 and 26. The W-beam rail sustained major tearing and significant yielding around the post bolt slots at post nos. 12, 15, and 26, while only minor yielding occurred around the post bolt slots at post nos. 13, 14, and 16 through 24.

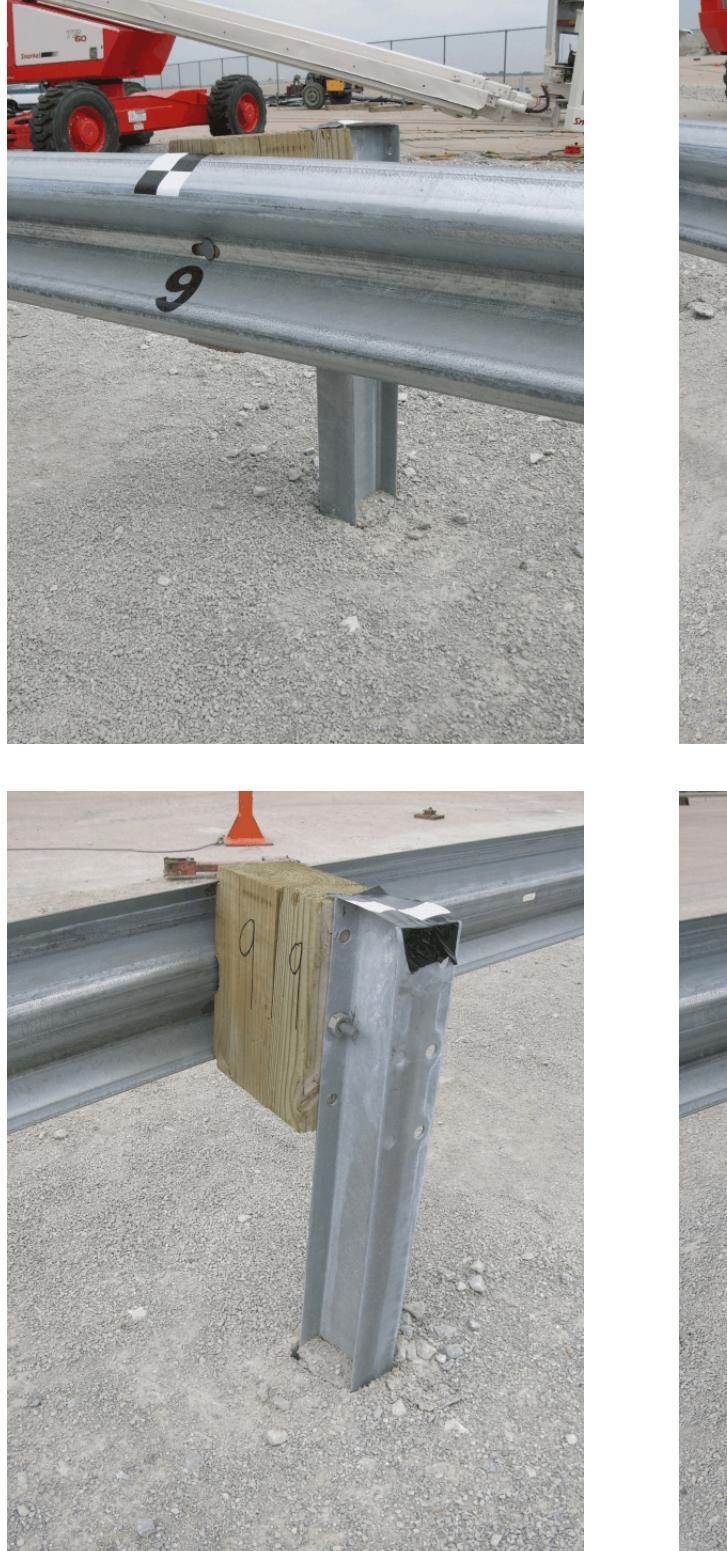
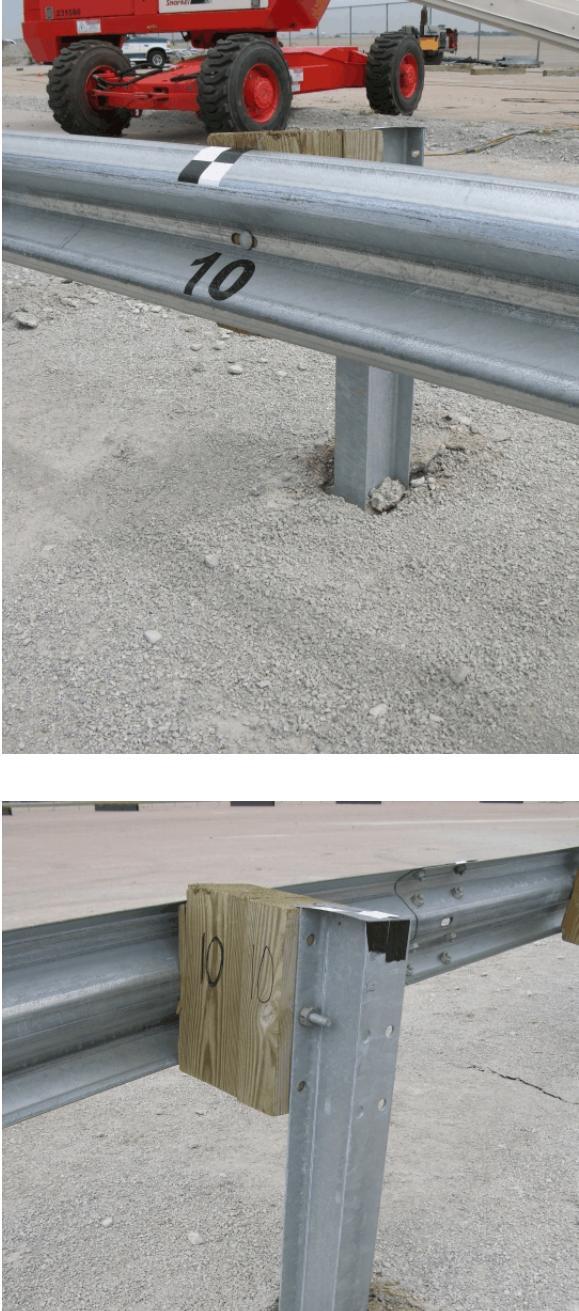
Figure 63. Post Nos. 9 and 10 Damage, Test FR-2

The wooden blockouts at post nos. 3 through 11 rotated slightly, while still attached to the post. The wooden blockouts at post nos. 12 and 18 through 21 encountered moderate damage, but remained attached to the posts. The wooden blockouts at post nos. 13 through 17 were fractured and removed from the posts.

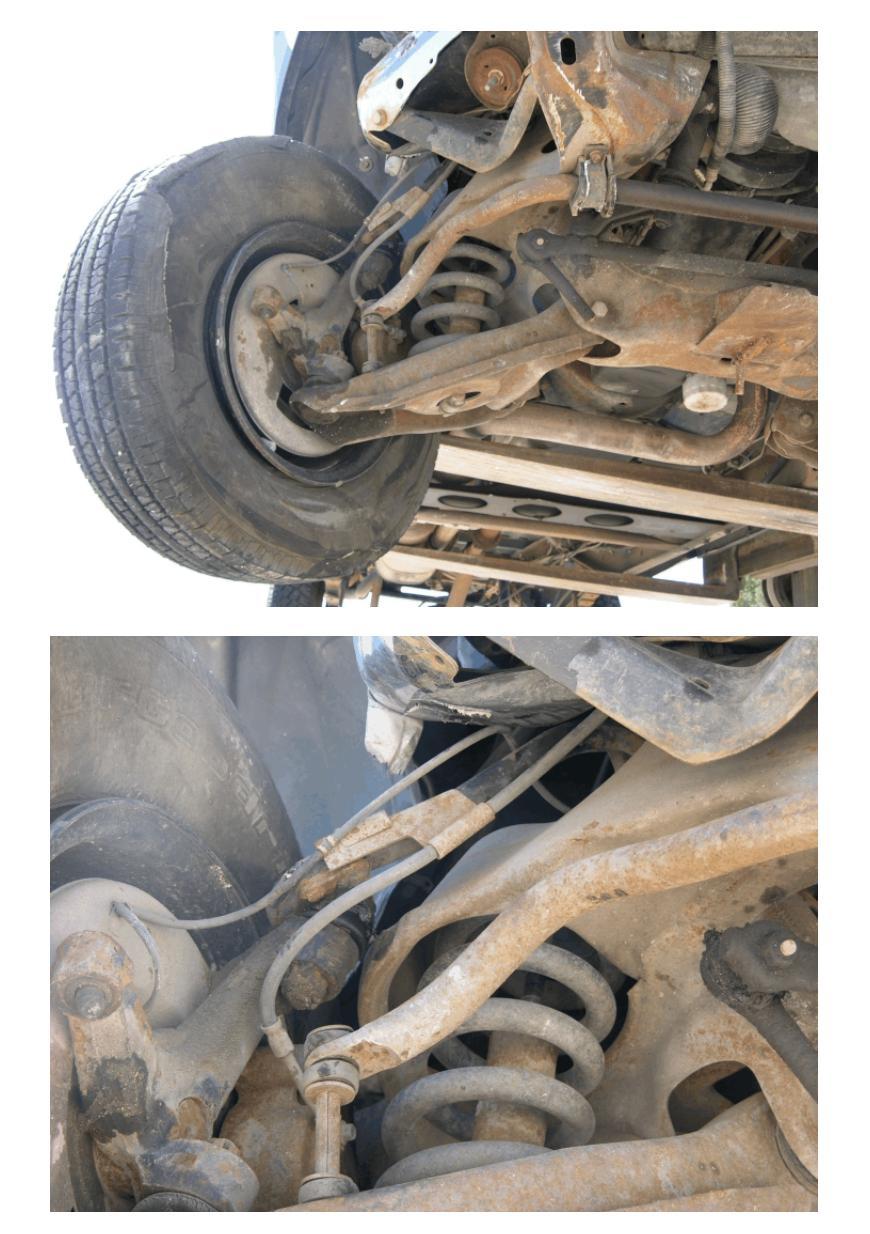
Figure 73. Undercarriage Damage, Test FR-2

Exterior vehicle damage was moderate, as shown in Figures 71 through 74. Occupant compartment deformations to the right side and center of the floorboard were judged insufficient to cause serious injury to the vehicle occupants. Maximum longitudinal deflections of 6 mm (0.25 in.) were located along the left side of the right-side floorpan. Maximum lateral deflections of 13 mm (0.5 in.) were located near the left-front corner of the right-side floorpan. Maximum vertical deflections of 6 mm (0.25 in.) were located near the left-front corner of the right-side floorpan. Complete occupant compartment deformations and the corresponding locations are provided in Appendix F.

Damage was concentrated on the right-front corner of the vehicle. The right-front quarter panel was deformed and crushed inward toward the engine compartment. Contact marks were found along the entire right side. The right side of the front bumper was crushed inward and torn. The front bumper was twisted, shifted to the left and deformed in toward the radiator. The radiator mounts were deformed backward into the engine. The top of the right-side door was ajar. The right-front corner of the frame was crushed and deformed upward. The right-front tie rod was fractured, and the control arm was bent inward toward the frame. The right-front tire was deflated, and a gouge was found on the inside of the steel rim. The left side, rear, roof, hood, and all window glass remained undamaged.
