DEVELOPMENT OF STANDARDS FOR PLACEMENT OF STEEL GUARDRAIL POSTS IN ROCK

MIDWEST ROADSIDE SAFETY FACILITY

MwRSF Research Report No. TRP-03-119-03

May 30, 2003

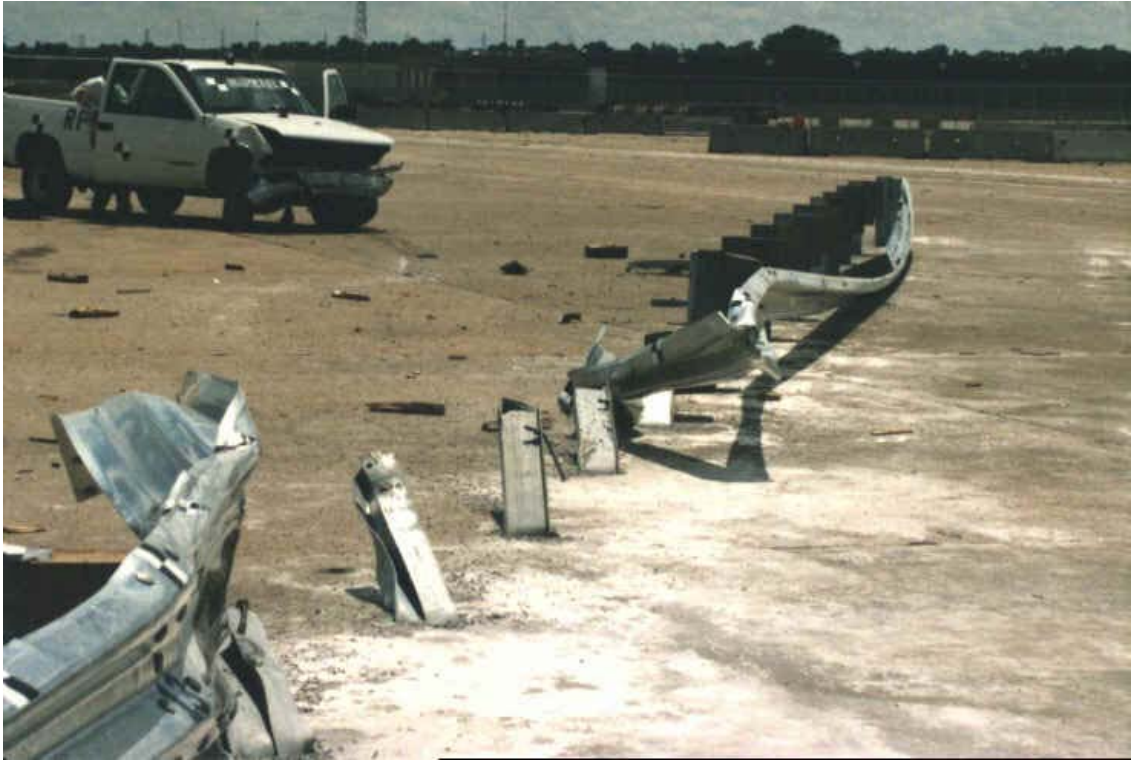
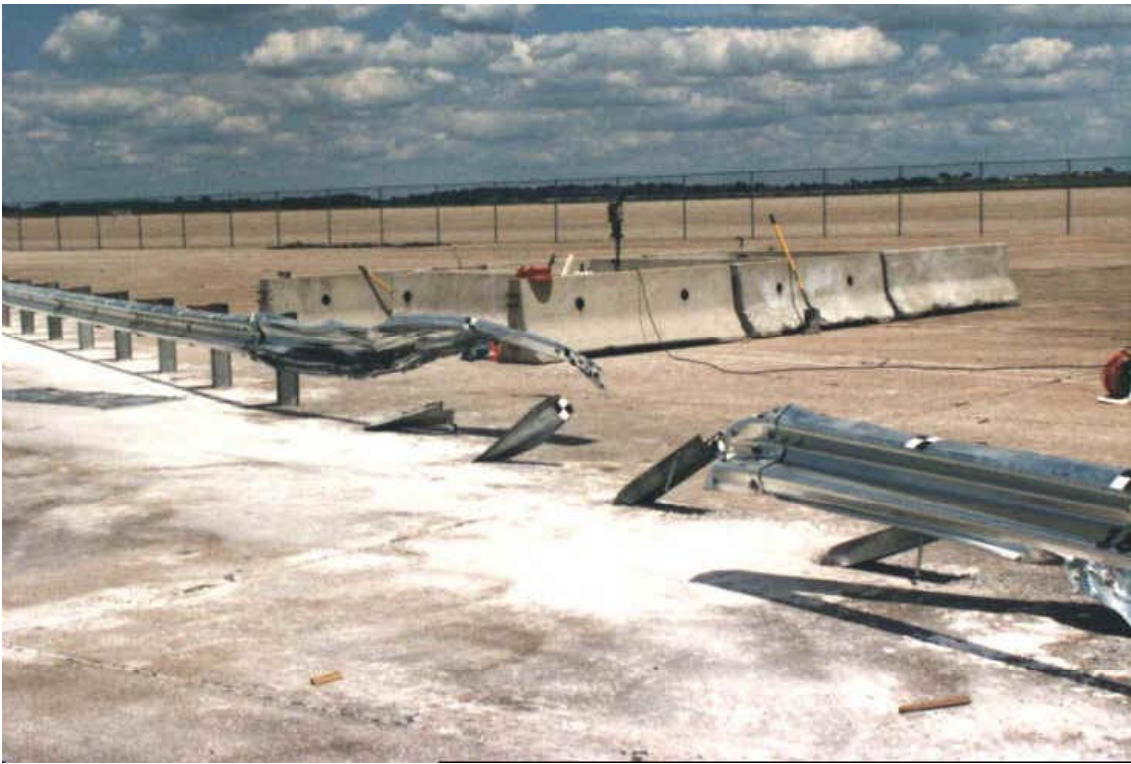
Figure 1. Full-Scale Vehicle Crash Test Sequentials

In 1999, Safety by Design, Inc. (SDI) found through crash testing that a W-beam guardrail system with posts installed in rigid foundations would not satisfy the NCHRP Report No. 350 requirements. Test RP-1, a TL-3 full-scale vehicle crash test was conducted on a W-beam guardrail system with steel posts embedded in 203-mm (8-in.) diameter rigid holes. The test failed as the guardrail ruptured at post no. 15, the location of a rail splice. Post nos. 14 through 18 were severely twisted and bent to the ground. Sequential photographs of the test are shown in Figure 1, and damage to the guardrail system is shown in Figure 2.

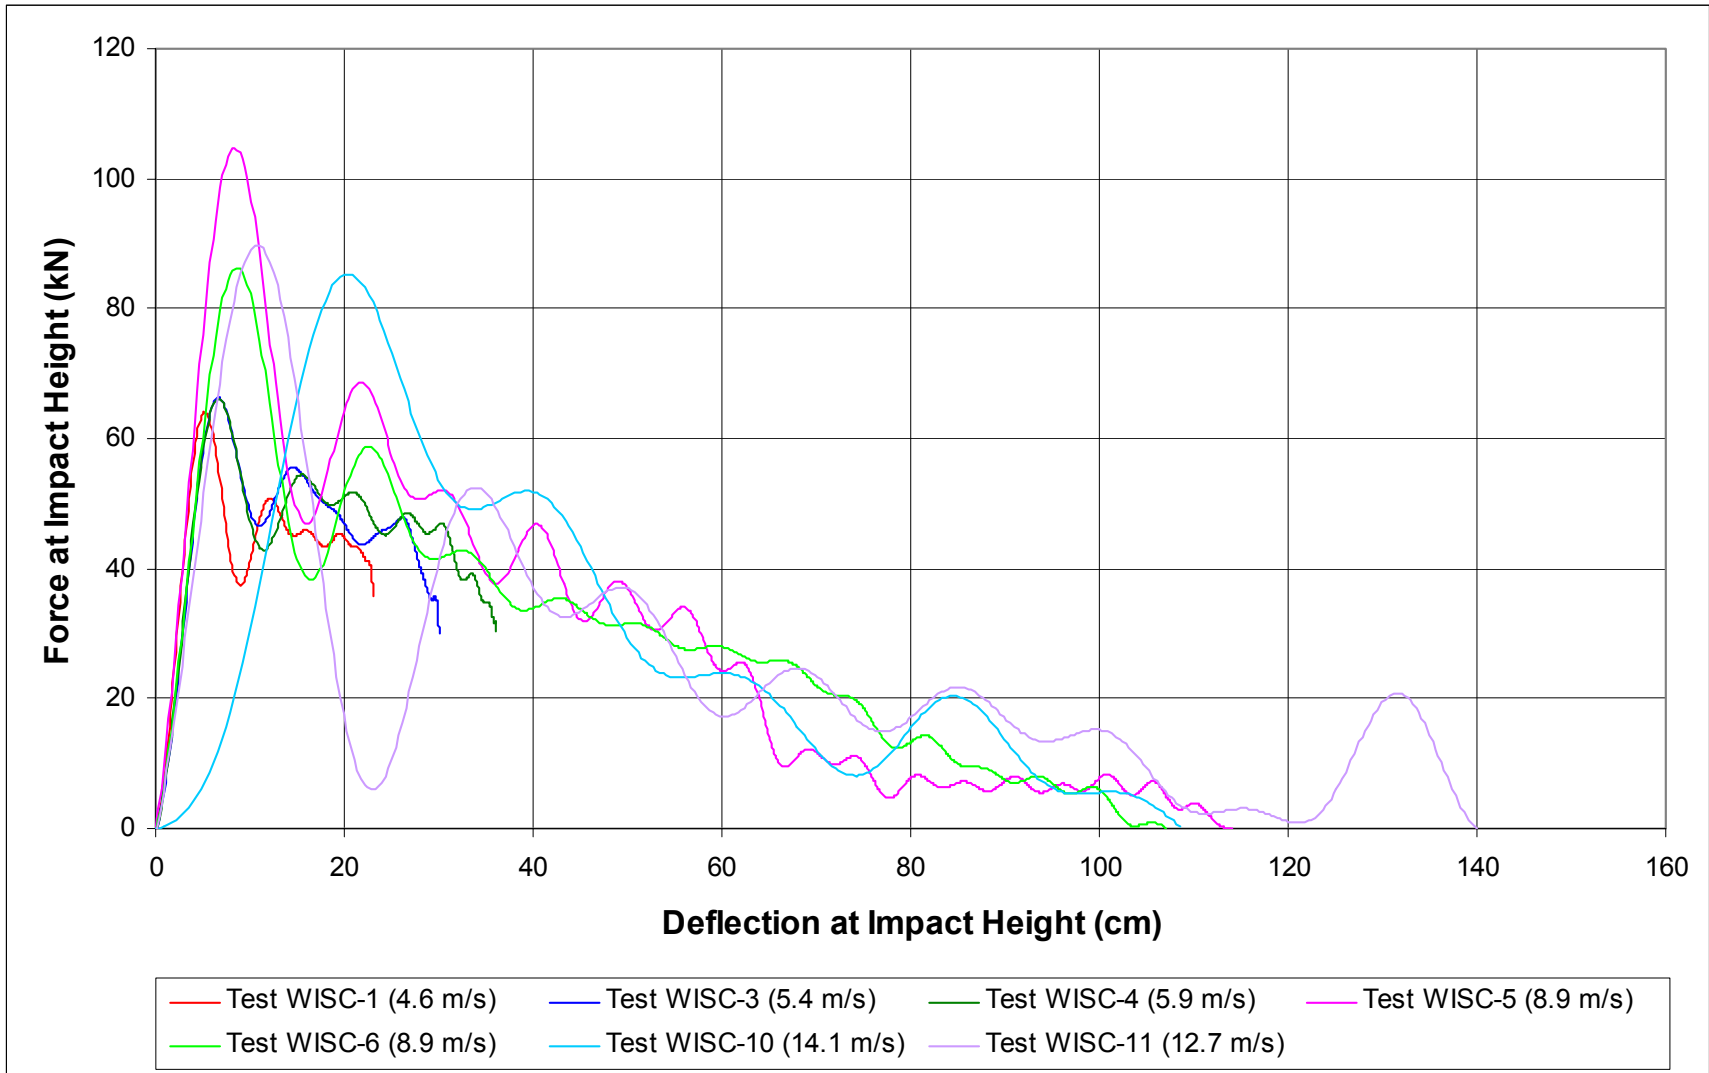
Figure 20. Force-Deflection Curves for Various Impact Speeds

Results from test MIW-1 were used to determine a real-world failure deflection for the post bending about its strong axis. Film analysis was used to determine the post deflections over time at the guardrail midpoint height while assuming that the posts rotated about a point 1/3 of the embedment depth from the bottom of the posts. This data was then used to derive post velocities as well as a plot of post velocities versus deflection at the rail midpoint height. The post velocity versus deflection curves for the first three posts impacted by the test vehicle are shown in Figure 21. It was determined that a failure deflection of 406 mm (16 in.), as found from simulation, was considered a reasonable real-world value. At this deflection, it was obvious that the post velocities had peaked. As a result, it was suggested that after the post velocities had peak, their influence on the guardrail system was determined to be negligible, and post failure was assumed to occur.

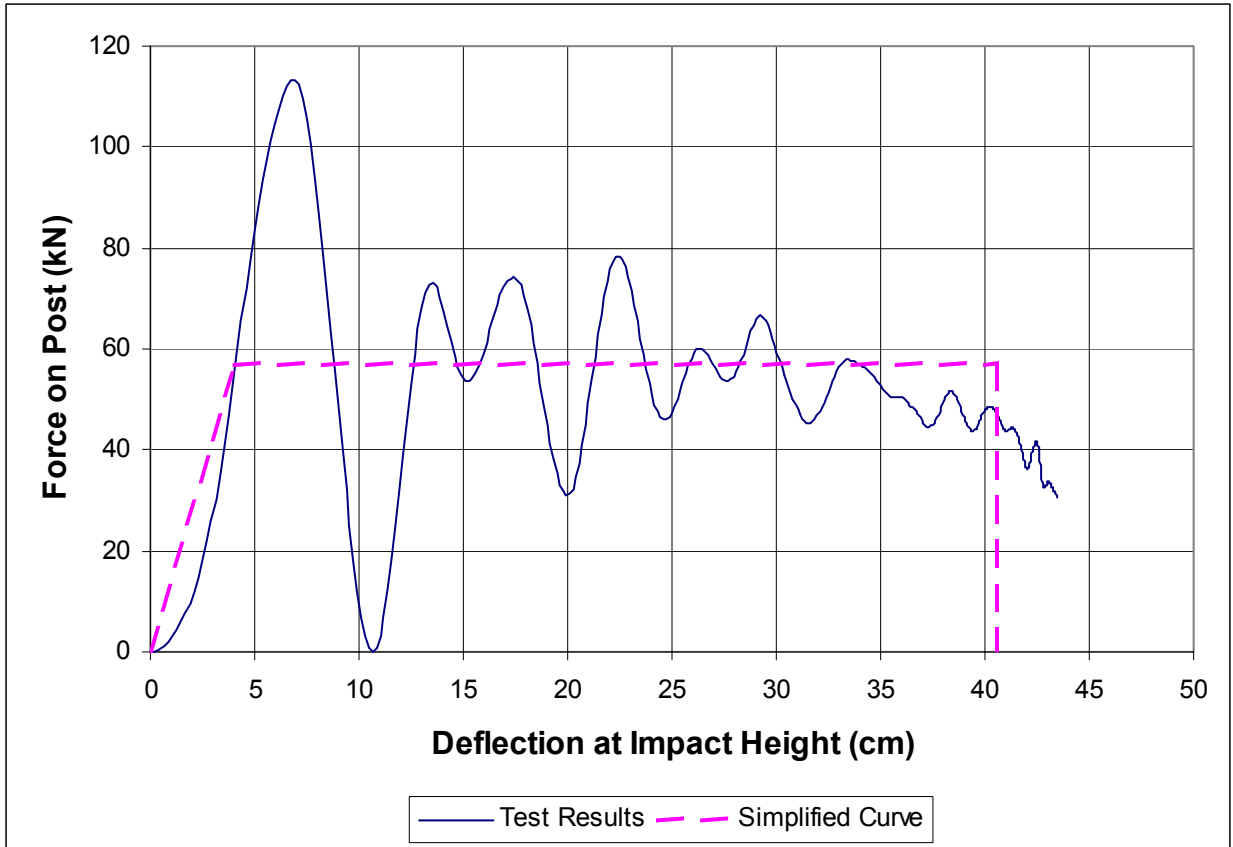
Figure 22. Force-Deflection Plot from Testing with Simplified Curve

Results from bogie test MPR-7 were chosen to get real-world post parameters for the critical post placement design. The force-deflection curve from test MPR-7 was converted to a simplified curve for input in BARRIER VII. Figure 22 shows the actual force-deflection plot as well as the simplified curve. The stiffness was fitted to the front portion of the curve and found to be 1.40 kN/mm (8 k/in.). The yield force, derived as that necessary for both the actual and simplified curves to have equal areas under the curve at a 406-mm (16-in.) deflection, was found to be 57 kN (12.8 kips). These parameters were then multiplied by the correlation factors for input into BARRIER VII. Post parameters, as determined from post bogie testing as well as the factored post parameters used in the BARRIER VII CIP analysis, are shown in Table 6.

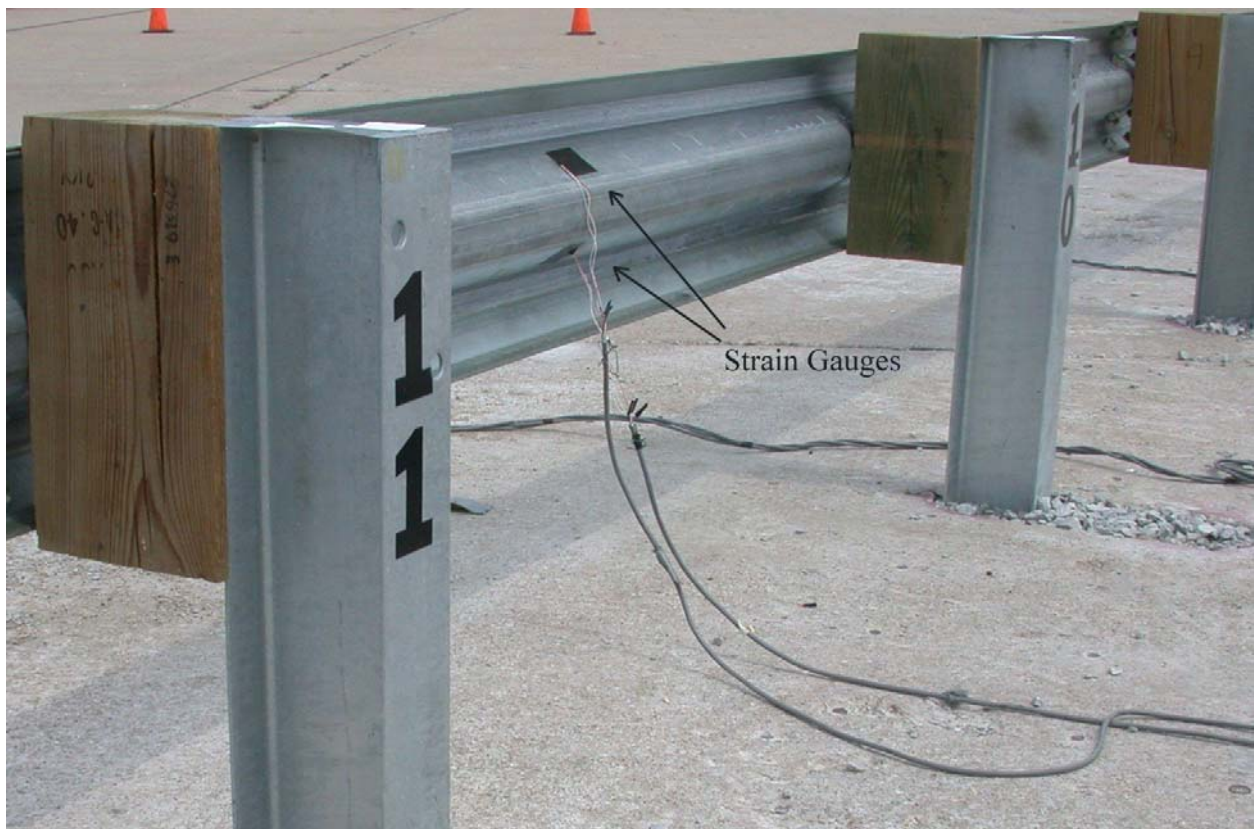
Figure 27. Location of Strain Gauges on Guardrail

Two strain gauges were placed on the back side of the guardrail and located on the vertical neutral axis, one on each side of the center hump, at the midspan between post nos. 10 and 11, as shown in Figure 27. These gauges were used to measure the dynamic axial rail strains. Two strain gauges were also applied to each post for post nos. 13 through 16, as shown in Figure 28. The gauges were placed on the inside of the front flange, one on each side of the web, 19 mm (0.75 in.) from the outside edge of the flange, and approximately 51 mm (2 in.) above the ground. Weldable strain gauges, consisting of model LWK-06-W250B-350, manufactured by Micro-Measurements Division of the Measurements Group, Incorporated, in

Raleigh, North Carolina, were used. The gauges had a nominal resistance of 350 ± 1.4 ohms and a gauge factor of 2.03. A Measurements Group Vishay Model 3210 signal-conditioning amplifier was used to power, condition, and amplify the low-level signals to high-level signals for acquisition by a Keithley-Metrabyte DAS-1802HC data acquisition board. The computer programs "Test Point" and "DADiSP" were used to record and analyze the data.
