**TPF-5(114)
Roadside Safety
Research Program
Pooled Fund Study**

Pin & Loop Barrier with Drainage Slots

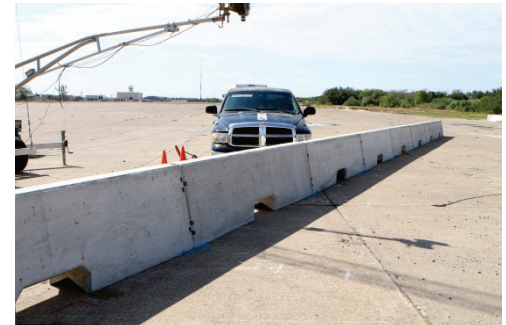
The Washington Pin and Loop Barrier system tested for this project consisted of precast concrete barrier segments that were 12 ft-6 inches in length and 34 inches in height. The barrier segment was 8 inches wide at the top and 21 inches wide at the base with a uniform single slope surface on each side face of the barrier. A 4-inch high by 15-inch wide "V" shaped cutout was centered in the base of the barrier and continuous along the entire length of the barrier segment. In addition to this longitudinal drainage slot, a drainage scupper opening was located at the center of the barrier segment. The drainage scupper opening was 9-inch high by 28 inches in width. This drainage scupper opening would permit drainage from the roadway through the barrier segment or along the barrier through the "V" shape drainage slot located in the base of the barrier. Three 3/4-inch diameter steel loops were constructed on the ends of the barrier segments. These loops overlay three loops on the end of the adjacent barrier segment. The

segments were connected together by inserting a 1 1/4-inch diameter steel rods. The 3/4-inch steel loops were fabricated using A36 material. The 1 1/4-inch diameter steel rods were fabricated from ASTM F1554 grade 105 material and were 31 inches in length.

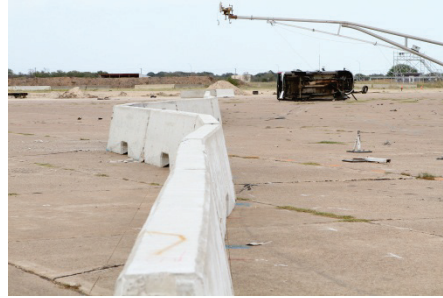
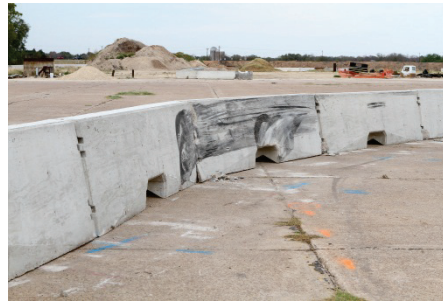
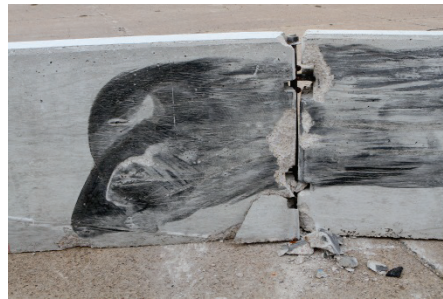
There was no visible damage to the pins. Spawling of the concrete at the joints and gouging of the traffic face of the barrier segments in the impact area was evident. Working width was 6.0 ft. Maximum dynamic deflection and maximum permanent deformation of the barrier was 5.4 ft.

Pin & Loop Barrier after test

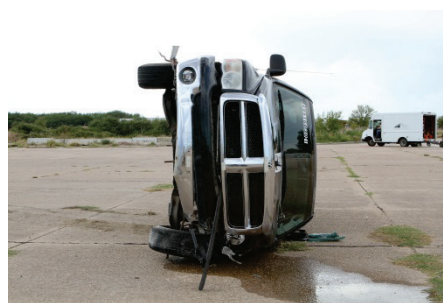
Maximum exterior crush to the vehicle was 11.0 inches at the left front corner at bumper height. The floor pan sustained a small dent measuring 4 inches \times 6 inches \times 0.5 inch deep. Maximum occupant compartment deformation was 1.0 inch in the rear passenger compartment near hip height.

Vehicle after test

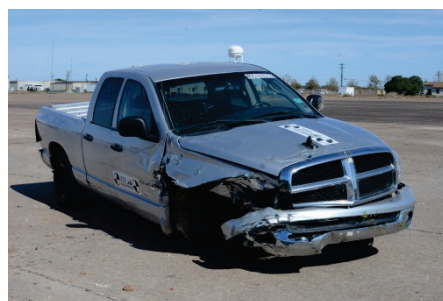
The 2003 Dodge Ram 1500 pickup truck, traveling at an impact speed of 62.0 mi/h, impacted the WSDOT pin and loop barrier with drainage slots 3.3 ft upstream of the joint between segments 6 and 7 at an impact angle of 26.1 degrees. At approximately 0.023 s, the vehicle began to redirect, and at 0.032 s, segments 6 and 7 began to deflect toward the field side. A crack appeared in segment 7 near the joint between segments 6 and 7 at 0.070 s. The truck began to roll counterclockwise at 0.184 s. At 0.201 s, the vehicle was traveling parallel with the barrier at a speed of 53.2 mi/h. As the vehicle exited the barrier, it continued to roll counterclockwise and came to rest on its left side 202 ft downstream of impact and 31 ft toward traffic lanes.

Vehicle after being uprighted
