Web-Only Document 157:

Volume I: Evaluation of Existing Roadside Safety Hardware Using Updated Criteria—Technical Report

Contractor's Final Report for NCHRP Project 22-14(03)
Submitted March 2010

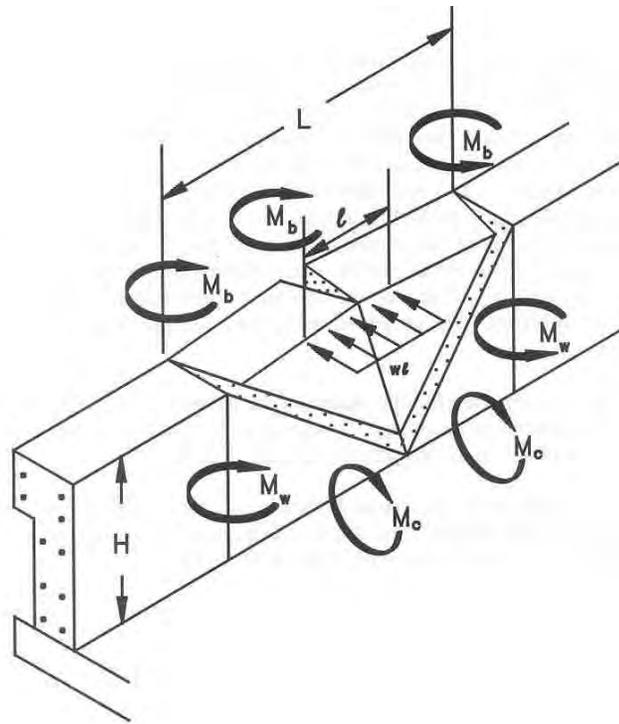
Structural adequacy of a barrier is often equated to its ultimate strength or capacity to resist lateral impact forces. Engineering analyses based on yield line theory or plastic design procedures can be used to compute the load capacity of rigid or semi-rigid barriers (e.g. bridge rails and concrete median barriers). Figure 1 illustrates such a yield line failure analysis procedure for a vertical concrete parapet. Structural adequacy can then be assessed by comparing the capacity of a barrier to a design force corresponding to a desired test or performance level.

Figure 1. Yield Line Failure Analysis for Concrete Parapet⁽⁹⁾.

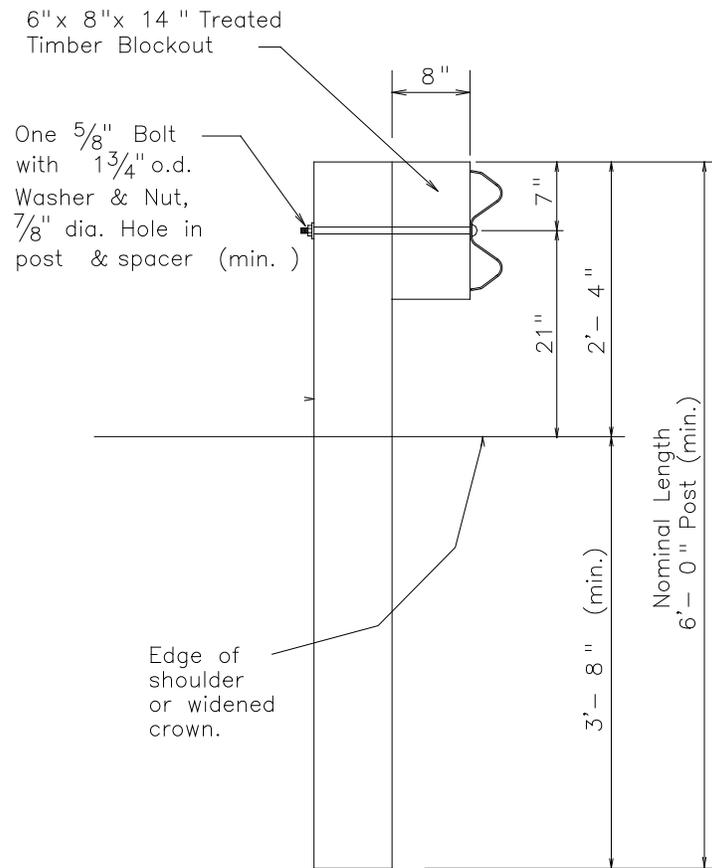
Both of these strong-post W-beam guardrail systems are national standards. A cross-section of a typical W-beam guardrail is shown in Figure 2. The guardrail is constructed with 12-gauge W-beam rail mounted at a height of 21 inches to the center on 6-ft long W6x9 steel or 6 inch x 8 inch wood posts spaced at 6 ft-3 inches. The 8-inch deep offset blocks inserted between the rail and posts may be fabricated from wood or an approved alternative.

Figure 2. Typical Cross-Section of Strong-Post W-Beam Guardrail.

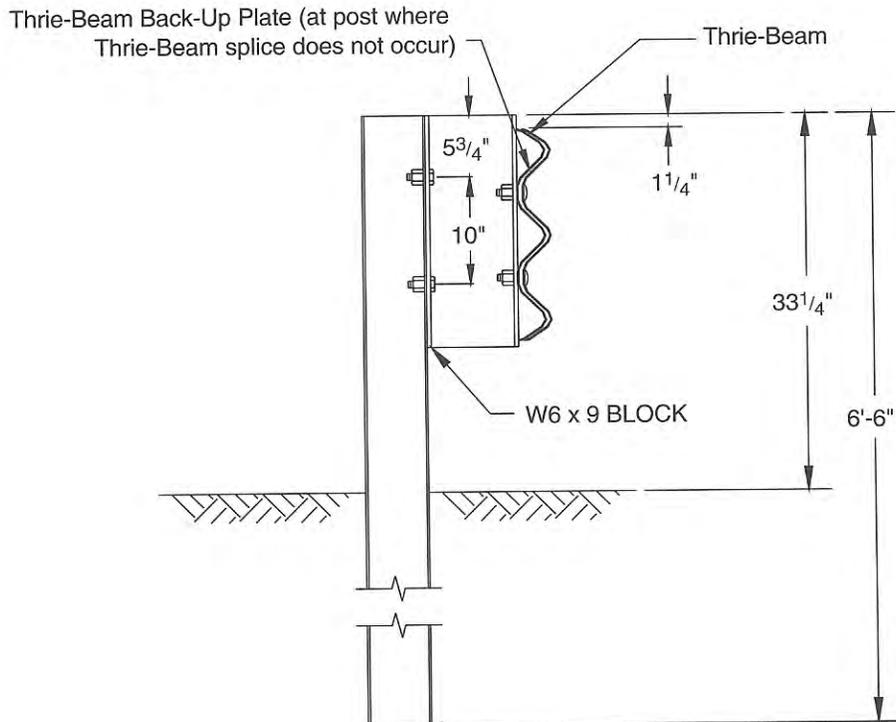
Figure 3. Typical Cross-Section of Thrie-Beam Guardrail.

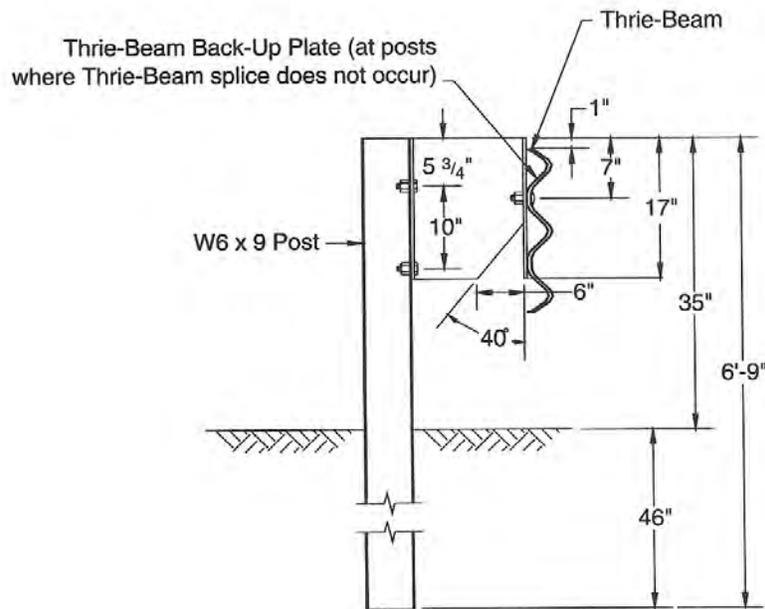
The modified thrie-beam guardrail system was originally developed by TTI researchers in the mid-1980s to contain buses⁽⁴³⁾. Changes that increase the capacity of the modified thrie-beam include raising the rail height to 34 inches and incorporating different blockouts. The M14x18 offset blocks are 17 inches long x 14 inches deep and 6 inches wide at the flanges. The blockouts are modified by cutting a section out of the blockout web measuring 6 inches at the bottom and angling up at 40 degrees to the flange upon which the thrie-beam is attached. A cross-section of a typical modified thrie-beam guardrail system is shown in Figure 4.

Figure 4. Typical Cross-Section of Modified Thrie-Beam Guardrail System.

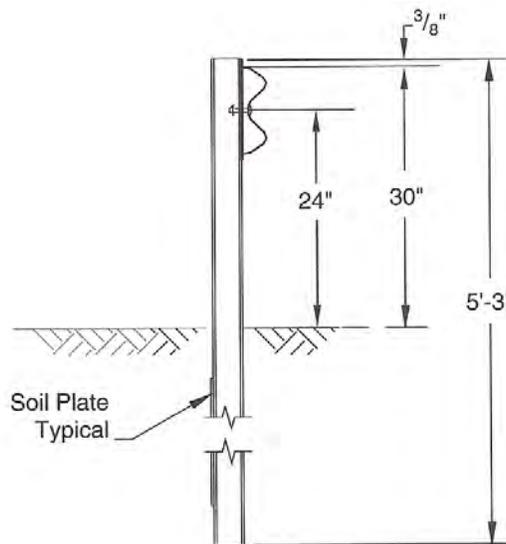
A cross-section of a typical weak-post W-beam guardrail system (G2) is shown in Figure 5. The guardrail is constructed with 12-gauge, W-beam rail mounted at a height of 30 inches to the top and supported on 5 ft-3 inch long S3x5.7 steel posts spaced at 12 ft-6 inches. The rail is attached to the posts with 5/16-inch diameter bolts. Additionally, a 1/2-inch diameter shelf bolt is used as a rail rest during construction and to provide some vertical support to the rail.

Figure 5. Typical Cross-Section of Weak Post W-Beam Guardrail System.

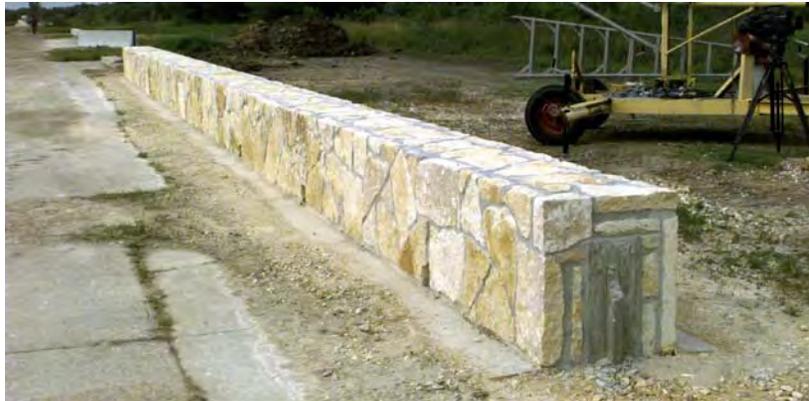
The Rough Stone Masonry Guardwall is a vertical-face rigid barrier constructed of a precast or cast-in-place concrete core that is covered with a native stone and mortar veneer. The finished dimensions of the wall are 27 inches tall x 24 inches deep. A photograph of the Rough Stone Masonry Guardwall is shown in Figure 8. The Rough Stone Masonry Guardwall contained and redirected the 2000P pickup truck vehicle under TL-3 impact conditions. The occupant compartment deformation was 5 inches and the maximum vehicle roll angle was approximately 34 degrees⁽⁴⁷⁾. The Rough Stone Masonry Guardwall performed well and it is the opinion of the researchers that despite its 27-inch height, this system would perform acceptably under Test Level 3 conditions of *MASH*.

Figure 8. Rough Stone Masonry Guardwall System.

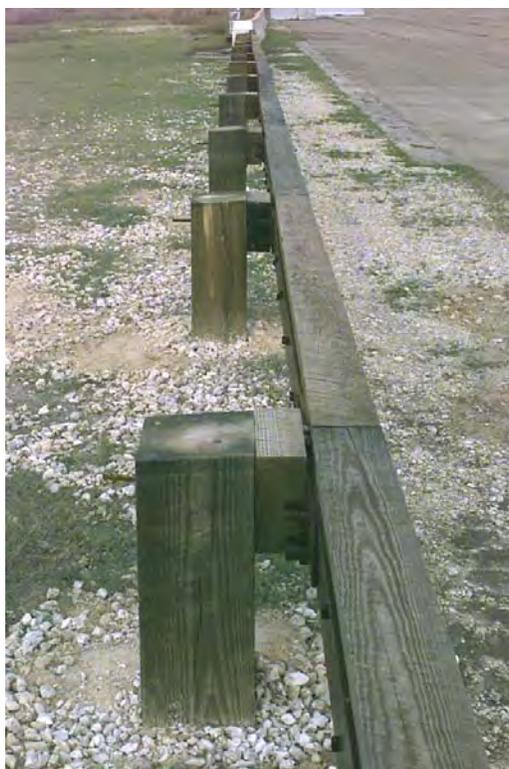
The Type A Steel-Backed Timber Guardrail is a semi-rigid rough sawn wood post, wood blockout, and wood rail element barrier with a steel plate rail bolted to the rear of the wood rail guardrail. The wood used is typically either Southern Yellow Pine or Douglas Fir. The steel plate provides the required tensile strength for the system. The wood posts are 10 inches deep x 12 inches wide x 6 ft-11 inches long and placed on 9 ft-10 inch centers. The wood rail elements are 6 inches deep x 10 inches tall x 9 ft-10 inches long. The rail is bolted to the post with a 4 inch-deep x 9 inch-tall x 12 inch-wide wood blockout mounted between the rail and the post. Each rail element is backed with a 3/8 inch x 6 inch A588 weathering steel plate attached with lag screws. The overall installed rail height is 30 inches. A photograph of the Type A Steel-Backed Timber Guardrail is shown in Figure 9.

Figure 9. Type A Steel-Backed Timber Guardrail System.

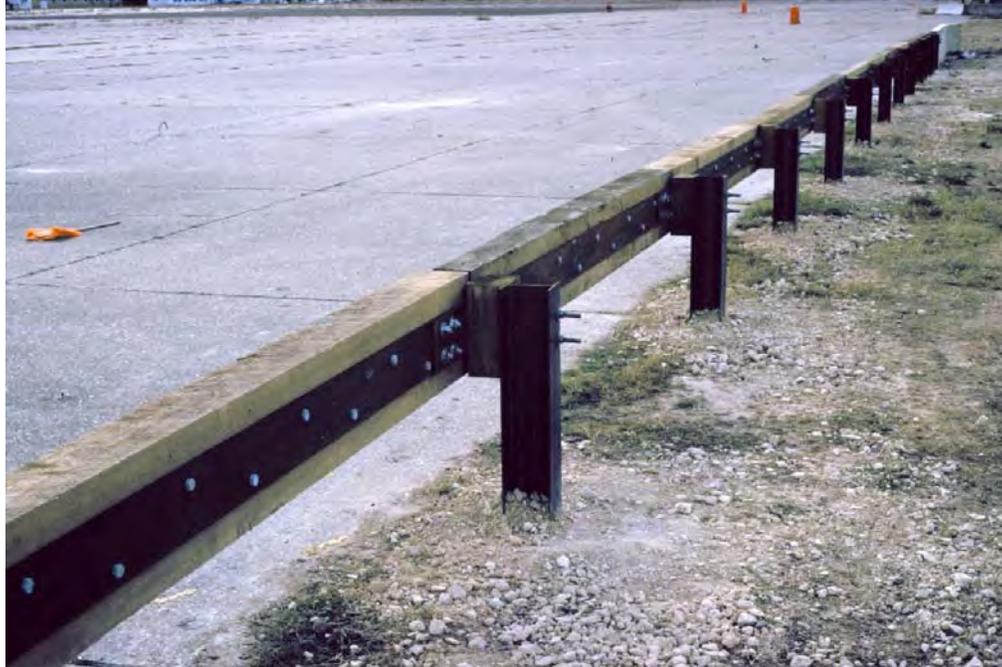
The Merritt Parkway Steel-Backed Timber Guardrail is a semi-rigid rough sawn steel post, wood blockout, and wood rail element barrier with a steel plate rail bolted to the rear of the wood rail guardrail. The wood used is typically either Southern Yellow Pine or Douglas Fir. The steel plate provides the required tensile strength for the system. The steel posts in the length of need section are W6x15 x 6 ft-6 inches long and placed on 10 ft centers. The wood rail elements are 6 inches deep x 12 inches tall x 9 ft-11-1/2 inches long. The rail is bolted to the post with a 4 inch-deep x 8 inch-wide x 11-inch tall wood blockout mounted between the rail and the post. Each rail element is backed with a 3/8 inch x 6 inch x 9 ft-6 inch A588 weathering steel plate attached with lag screws. The overall installed rail height is 30 inches. A photograph of the Merritt Parkway Steel-Backed Timber Guardrail is shown in Figure 10.

Figure 10. Merritt Parkway Steel-Backed Timber Guardrail System.

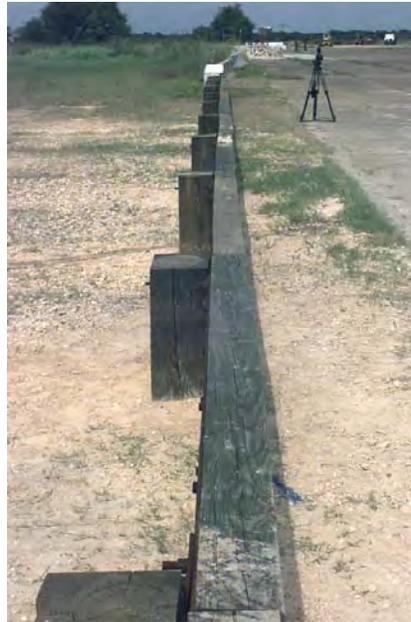
The Type B Steel-Backed Timber Guardrail is a semi-rigid rough sawn wood post and wood rail element barrier with a steel plate rail bolted to the rear of the wood rail guardrail. The Type A and Type B Steel-Backed Timber Guardrails only differ in the inclusion or omission of the wood blockout. A photograph of the Type B Steel-Backed Timber Guardrail is shown in Figure 11.

Figure 11. Type B Steel-Backed Timber Guardrail System.

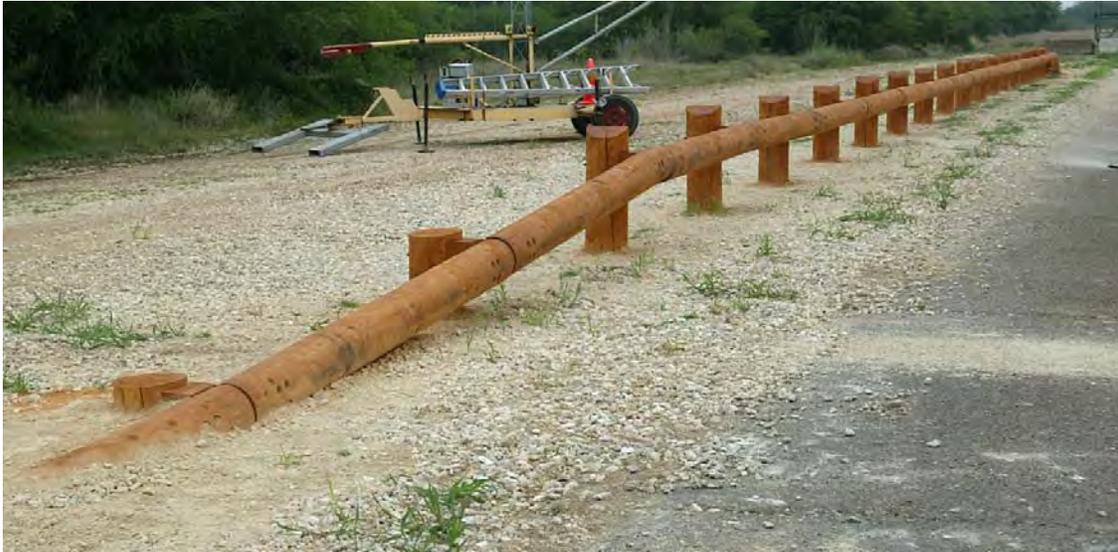
bolted to the rear of the wood rail guardrail. The wood used is typically either Southern Pine or Douglas Fir. The steel plate provides the required tensile strength for the system. The wood posts are 12-inch diameter x 6 ft-11-inches long and placed on 9 ft-10-inch centers. The wood rail elements are 10-inch diameter x nominally 9 ft-10 inches long. The rail is bolted to the post with a 5-1/2-inch deep x 8-inch tall x 8-inch wide wood blockout mounted between the rail and the post. Each rail element is backed with a 3/8-inch x 6-inch A588 weathering steel plate attached with lag screws. The overall installed rail height is 30.5 inches. A photograph of the Round Steel-Backed Timber Guardrail is shown in Figure 12.

Figure 12. Round Steel-Backed Timber Guardrail System.

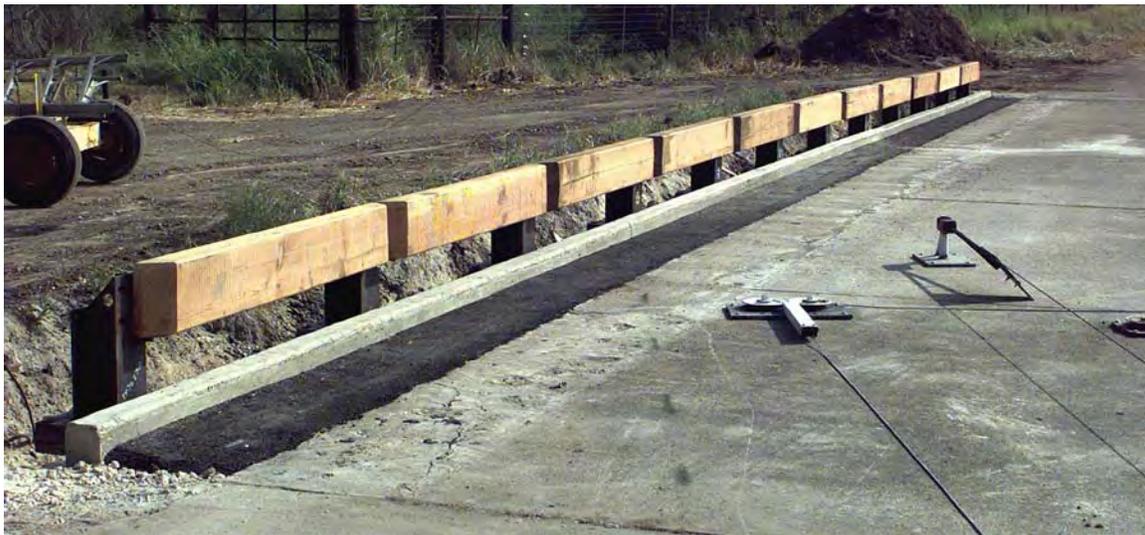
Removable guardrail posts are mounted atop foundation beams embedded in a concrete footing. The posts are fabricated from base plated W8x31 steel, are approximately 24 inches tall, and spaced 83.7 inches on center. A clamping plate and bolts are used to anchor the post to the foundation beam. The wood rail elements are 6 inches thick x 12 inches tall x 83 inches long and attached to 3/8-inch thick L-shaped bent weathering steel backup plates. The wood used is typically either Southern Pine or Douglas Fir. The L-shaped bent steel backup plates are attached with lag screws and provide the required tensile strength for the system. The overall installed rail height is 24 inches to the paved surface. A photograph of the Glacier Park Removable Timber Guardrail is shown in Figure 14.

Figure 14. Glacier Park Removable Timber Guardrail System.

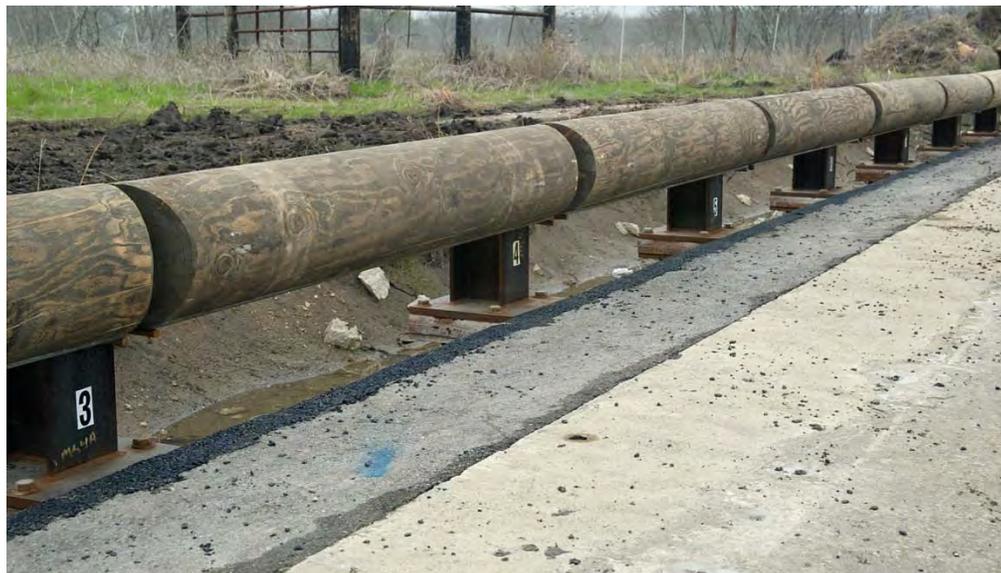
The Glacier Park Round Removable Timber Guardrail is almost identical in detail to the previously presented Glacier Park Removable Timber Guardrail with the exception of the round wood rail elements and the absence of a curb. The wood rail elements are 12.5 inches in diameter x 83 inches long and attached to 3/8-inch thick L-shaped bent weathering steel backup plates. The round logs are flat on the back and bottom sides. The wood used is typically either Southern Pine or Douglas Fir. The L-shaped bent steel backup plates are attached with lag screws and provide the required tensile strength for the system. The overall installed rail height is 24 inches to the paved surface. A photograph of the Glacier Park Round Removable Timber Guardrail is shown in Figure 15.

Figure 15. Glacier Park Round Removable Timber Guardrail System.

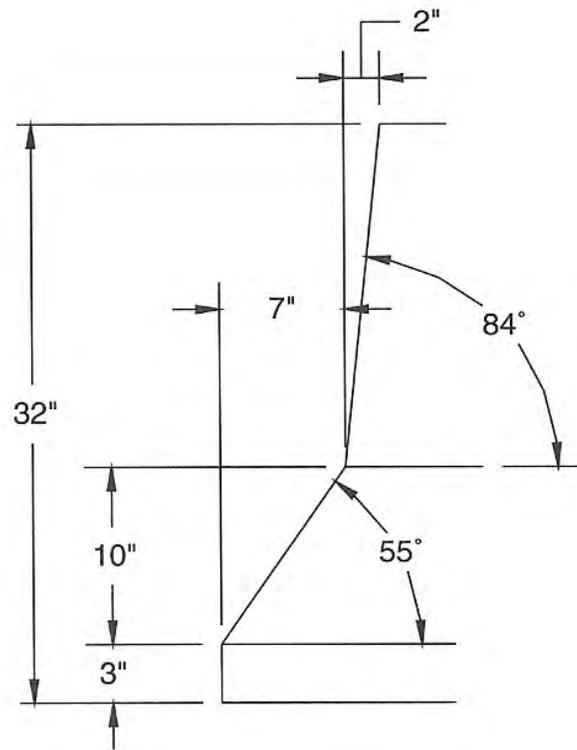
Figure 17. Typical Cross-Section of New Jersey Shape Concrete Safety Barrier.

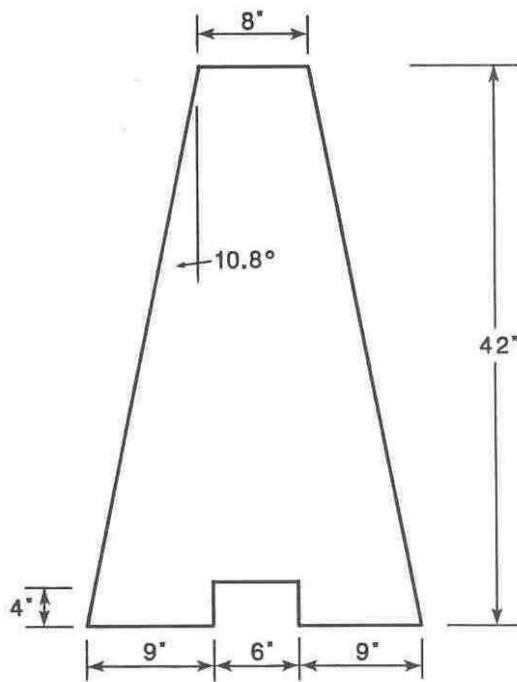
A cross-section of the single-slope concrete barrier is shown in Figure 19. The barrier is 42 inches tall and has a top width and bottom width of 8 inches and 24 inches, respectively. The taller height and constant slope profile permit this barrier to accommodate multiple pavement overlays without affecting its impact performance with passenger vehicles.

Figure 19. Typical Cross-Section of Single Slope Concrete Barrier.

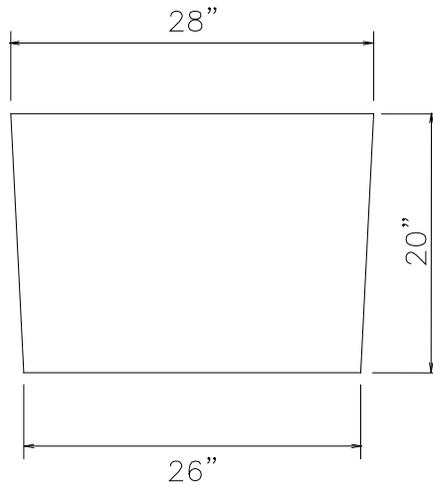
Figure 20. Typical Cross-Section of Low-Profile Barrier Segment.

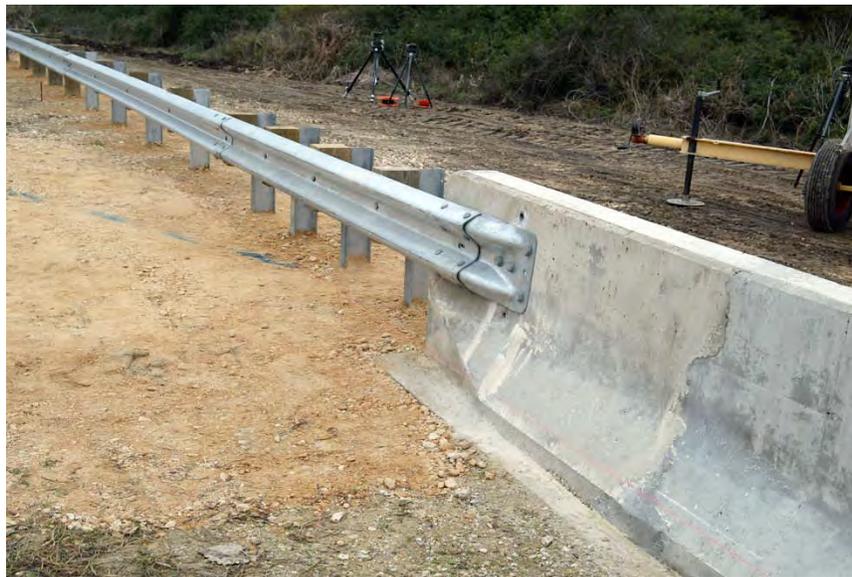
For these reasons, TxDOT developed a cost-effective TL-2 transition for use on low-speed roadways. The TL-2 transition, shown in Figure 23, is entirely comprised of standard hardware components and is significantly less expensive and complex to install than the high-speed, TL-3 transition system. This transition consists of 12 ft-6 inches of nested W-beam rail supported on 6-ft long steel or wood posts spaced at 37-1/2 inches. The 27-inch mounting height greatly simplifies the ability to connect the transition to some existing bridge rails. A W-beam terminal connector is used to attach the downstream end of the transition to the concrete bridge rail parapet. Additional details of the TL-2 transition are presented in TxDOT standard detail sheet MBSG (TL2)-05.

Figure 23. Texas TL-2 Guardrail-to-Concrete Bridge Rail Transition.

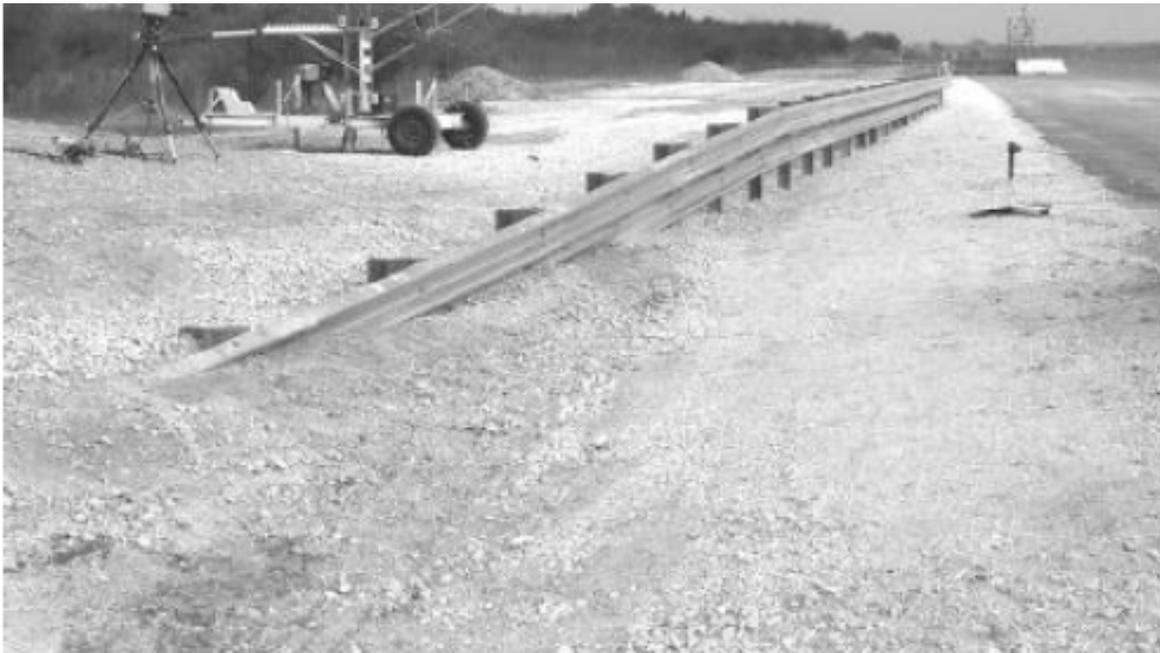
The W-beam guardrail buried-in-backslope terminal is used to terminate the G4(2W) or modified G4(1S) guardrail systems. The guardrail is flared across the ditch with its end anchored to a concrete anchor block buried in the backslope. The post height varies the last 50 ft of the installation as the rail tapers into the backslope. A W-beam rubrail is used where the bottom height of the guardrail beam exceeds 18 inches. Depending on the guardrail system it is attached to, the terminal posts are either 6 inch x 8 inch wood or W6x8.5 steel posts. A photograph of the Buried-in-Backslope Guardrail Terminal is shown in Figure 24.

Figure 24. Buried-in-Backslope Guardrail Terminal.

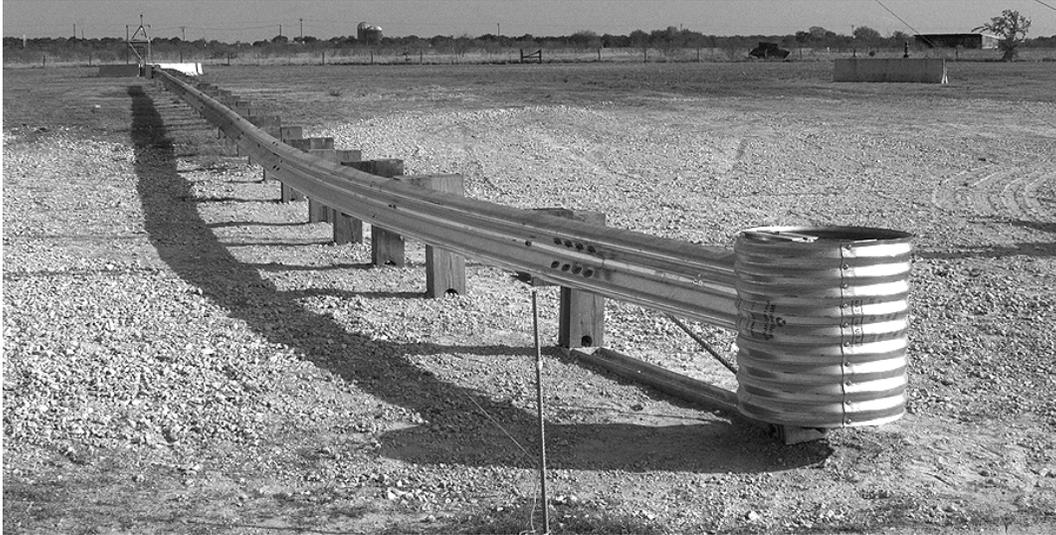
The ELT is a 37 ft-6-inch long flared W-beam guardrail terminal. The terminal head has a lateral offset of 4 ft. Attached to the end of the W-beam, at the nose of the terminal, is a vertically oriented corrugated pipe section with a fabricated structural steel loader mounted inside of the pipe section. The ELT is fabricated from three 12 ft-6-inch sections of 12-gauge W-beam mounted to two 6 inch x 8 inch Breakaway Cable Terminal (BCT) posts mounted in foundation tubes, interconnected with a ground channel strut, and 6 inch x 8 inch wood Controlled Releasing Terminal (CRT) posts in post locations 3 through 7. Posts 3 through 6 are spaced 50 inches on center. All other posts are spaced the standard 6 ft-3 inches. All posts, except the first post, are blocked out with 6 inch x 8 inch wood blocks. A photograph of the ELT is shown in Figure 25.

Figure 25. Eccentric Loader Terminal.

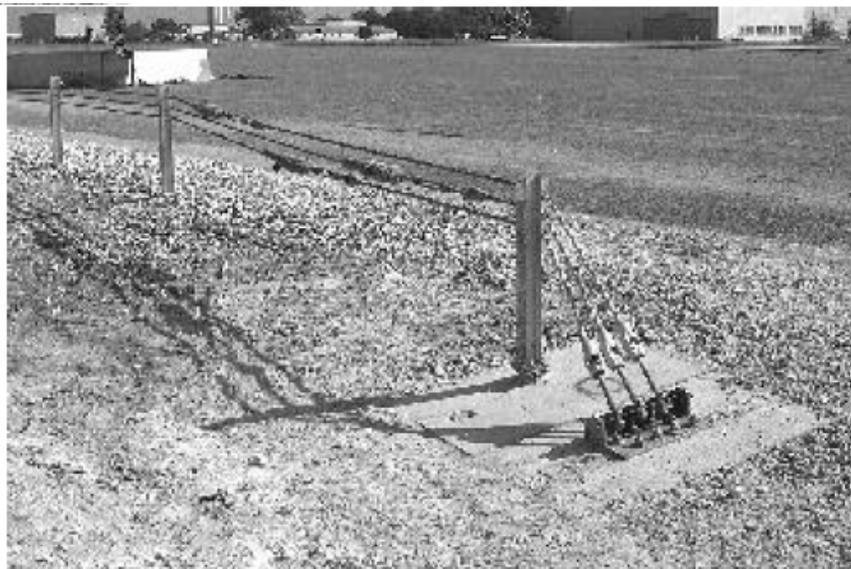
New York Cable Guardrail Terminal. The New York three-cable guardrail terminal is the only non-proprietary low-tension three-cable end anchor system crash tested and accepted for use on the NHS. The terminal was tested under a research program conducted by the New York State Department of Transportation in accordance with *NCHRP Report 230*. The research report documenting the results of this study is the March 1990 NYSDOT Research Report 148, “Cable Guiderail Breakaway Terminal Ends”⁽⁶¹⁾. A photograph of the New York Cable Guardrail Terminal is shown in Figure 26.

Figure 26. New York Cable Guardrail Terminal.

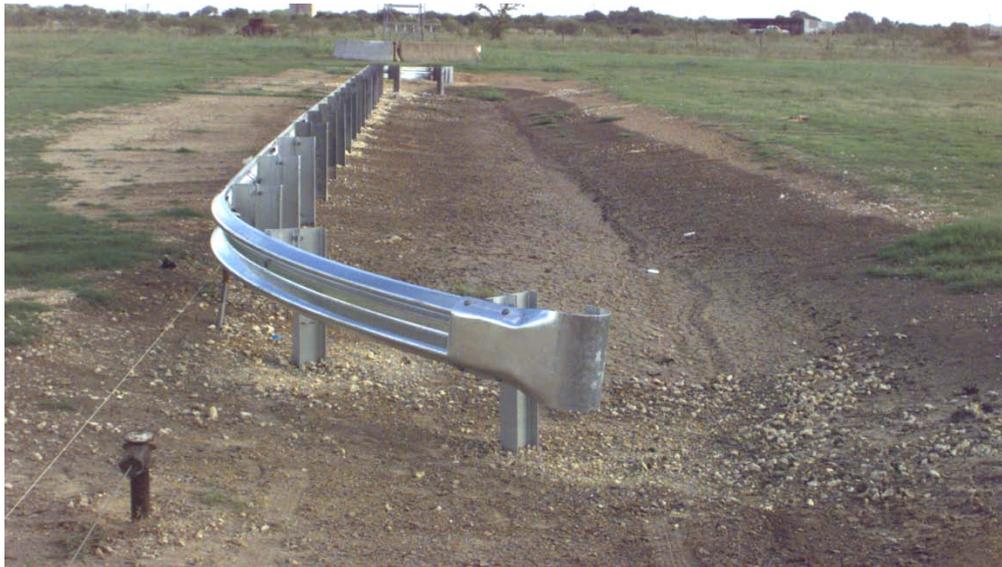
The Vermont G1-d terminal is a 12 ft-6 inch-long flared strong post W-beam guardrail terminal. The terminal end has a lateral offset of 5 ft. The first W-beam rail section is shop bent to a 16-ft radius. Post 2 is positioned at the midpoint of the curved guardrail section. The terminal is anchored using a steel rod attached to the guardrail at post 3 and anchored to a concrete block in the ground between posts 2 and 3. The W-beam terminal is supported on W6x8.5 x 72-inch steel posts. All posts are spaced the standard 6 ft-3 inches apart and blocked out with W6x8.5 x 14-inch standard G4(1S) guardrail blockouts. A photograph of the Vermont Low-Speed Guardrail Terminal is shown in Figure 27.

Figure 27. Vermont Low-Speed Guardrail Terminal.

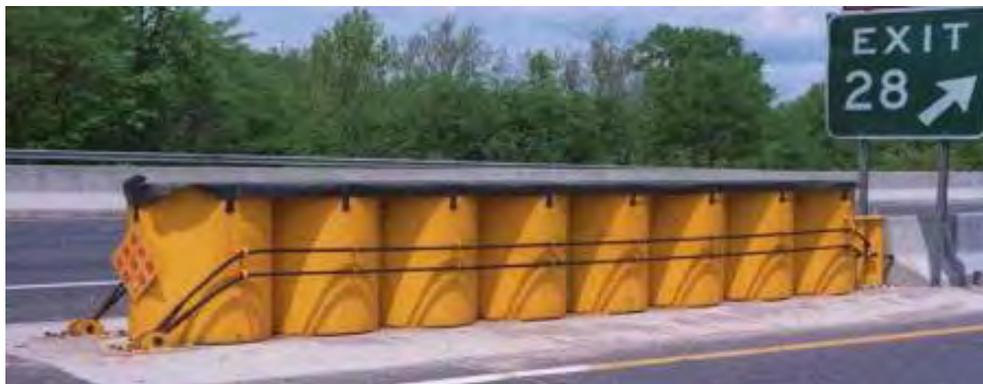
A stiffening member (compression struts) constructed of 1.5-inch diameter schedule 40 pipe is placed transversely in cylinders five through seven. Additionally, two compression struts, one near the top and one near the bottom, are used in the last cylinder (cylinder eight). All the cylinder contact points are interconnected with two 7/8-inch diameter x 2-inch long A307 bolts, washers, and nuts and cylinder eight is attached to the backup structure with four 7/8-inch diameter x 2-inch long A307 bolts, washers, and nuts. A photograph of the NCIAS is shown in Figure 30. The CDOT standard drawings should be referred to for additional construction and anchoring details.

Figure 30. Narrow Connecticut Impact Attenuator System.

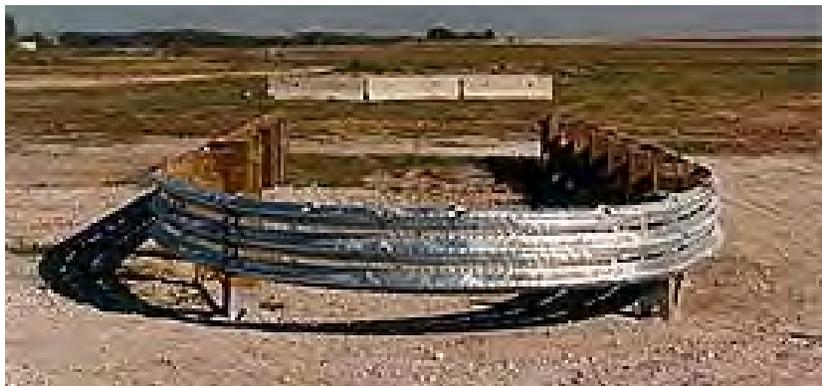
The bullnose attenuator acceptable for use on the NHS consists of 12-gauge thrie-beam rail supported by 28 wood posts, 14 posts on each side of the system. Posts 1 and 2 on each side are wood BCT-type posts set in foundation tubes with holes at ground level. Posts 3 through 8 are standard wood CRT posts. Posts 9 through 12 are standard line posts. The last two posts on each side are used to tension and anchor the terminal with anchor cables and grounds struts. Horizontal slots are cut in the valleys of five thrie-beam sections to aid in the capture of the vehicle and to reduce the buckling and bending capacities of the rail sections. Two 5/8-inch diameter 6 x 25 cables were placed behind the top and middle corrugations on the curved nose section thrie-beam rail element to replace the beam strength lost by slotting the rail, and to contain a vehicle impacting on the nose. The bullnose attenuator is a non-gating terminal. A photograph of the Bullnose Attenuator is shown in Figure 31.

Figure 31. Bullnose Attenuator.

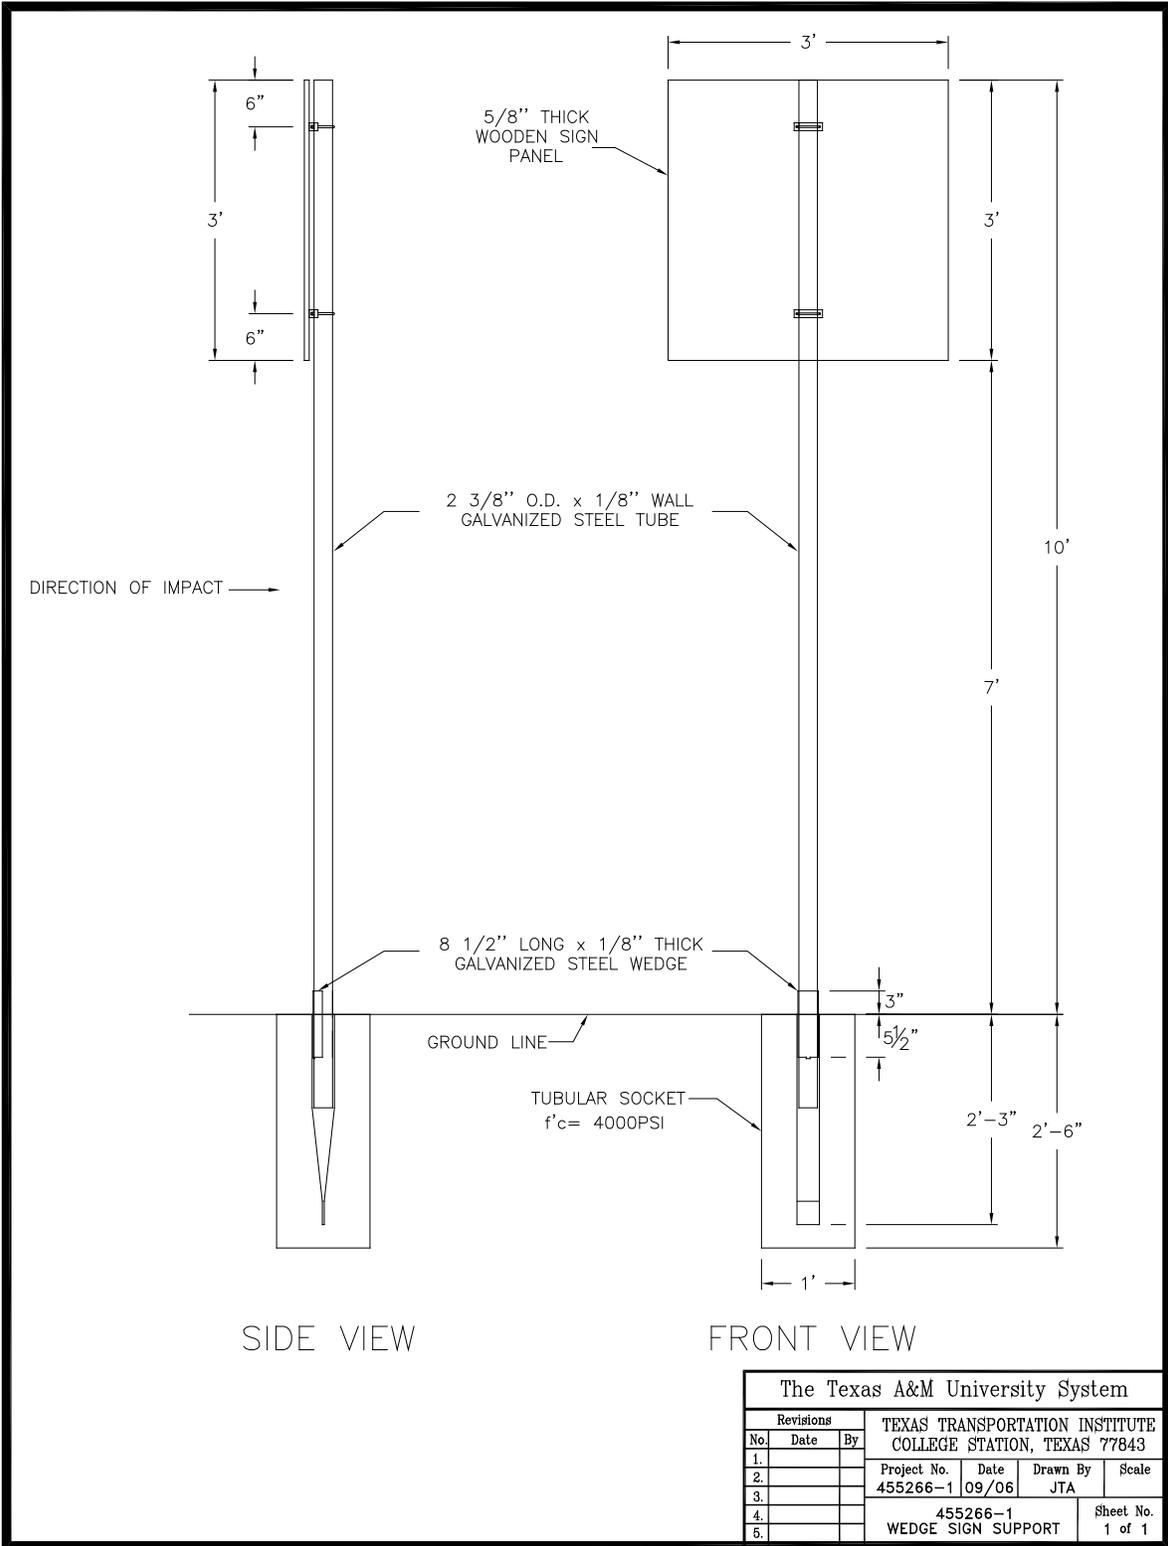
Figure 34. Details of Wedge Anchor Sign Support.

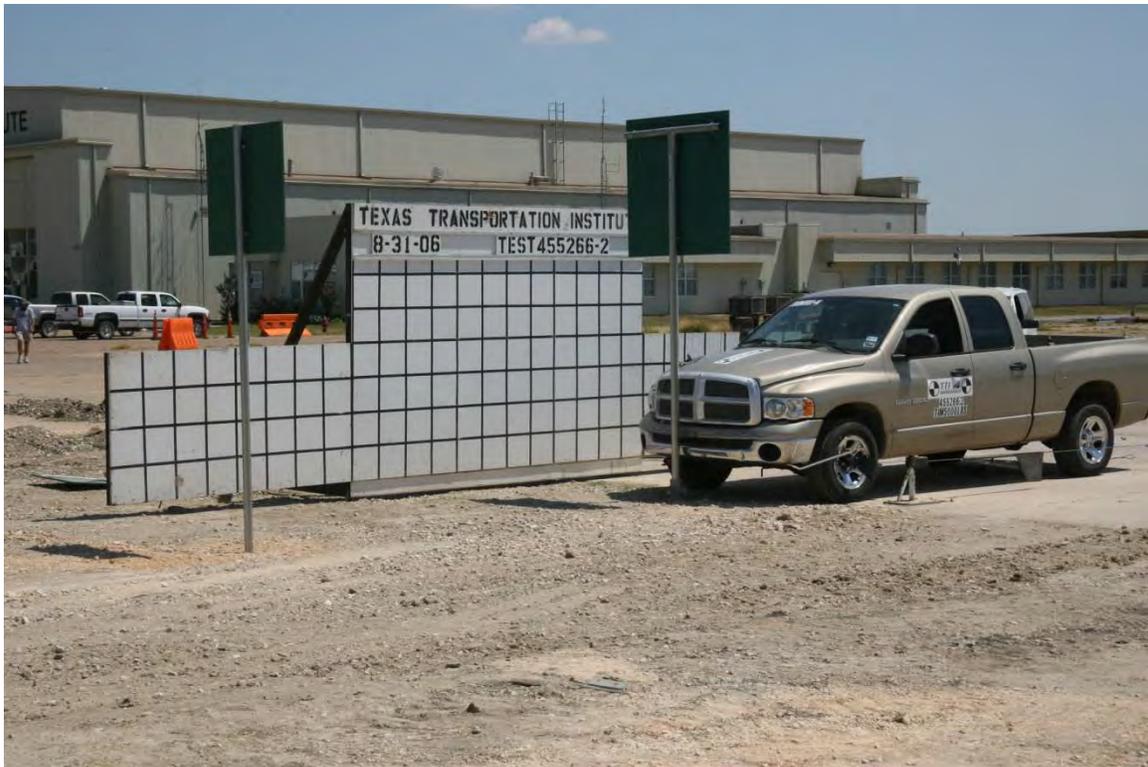
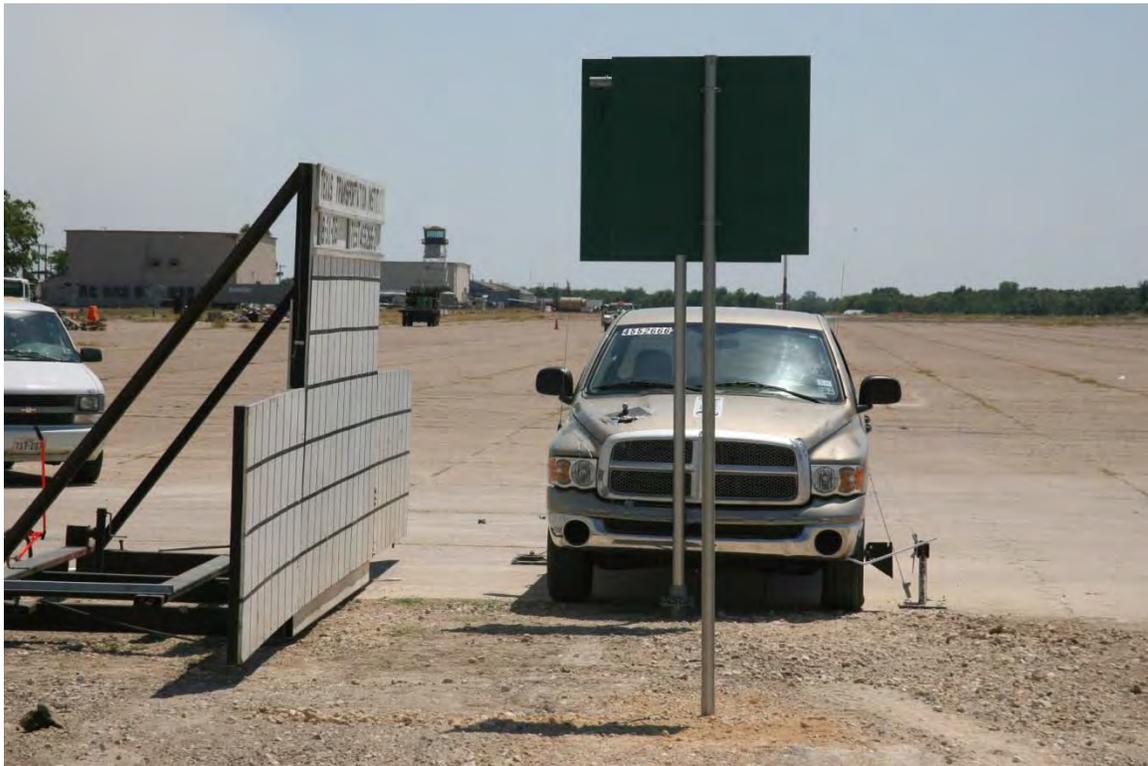
Figure 35. Vehicle/Installation Geometrics for Wedge Anchor & Triangular Slip Base Test.

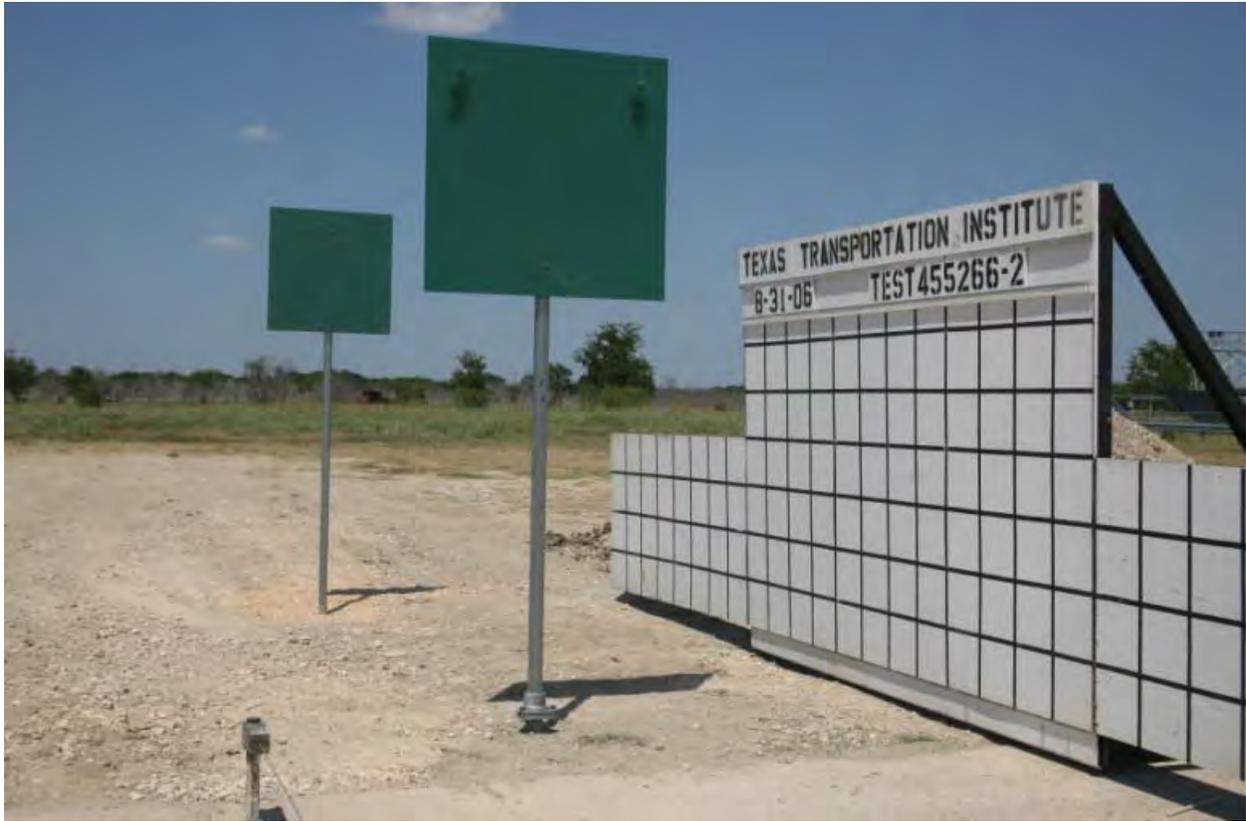
The upper slip base unit is bolted to the lower slip base unit using three 5/8-inch x 2-1/2-inch long A325 or equivalent high-strength bolts that were tightened to a prescribed torque of 38 ft-lb. The slip base was oriented such that the direction of impact was perpendicular to one of the flat faces of the triangular plate. High-strength washers were used under both the head and nut of each bolt, and an additional washer was used to offset the two slip plates. The bolts are held in place by a keeper plate which is fabricated from 30-gauge galvanized sheet steel. Set screws in the collar of the upper slip base casting were then tightened to a prescribed torque of 60 ft-lb to secure the vertical support within the casting and keep it from rotating. Figures 36 and 37 show photographs and details of the triangular slip base sign support system.

Figure 36. Photographs of Texas Triangular Slip Base.

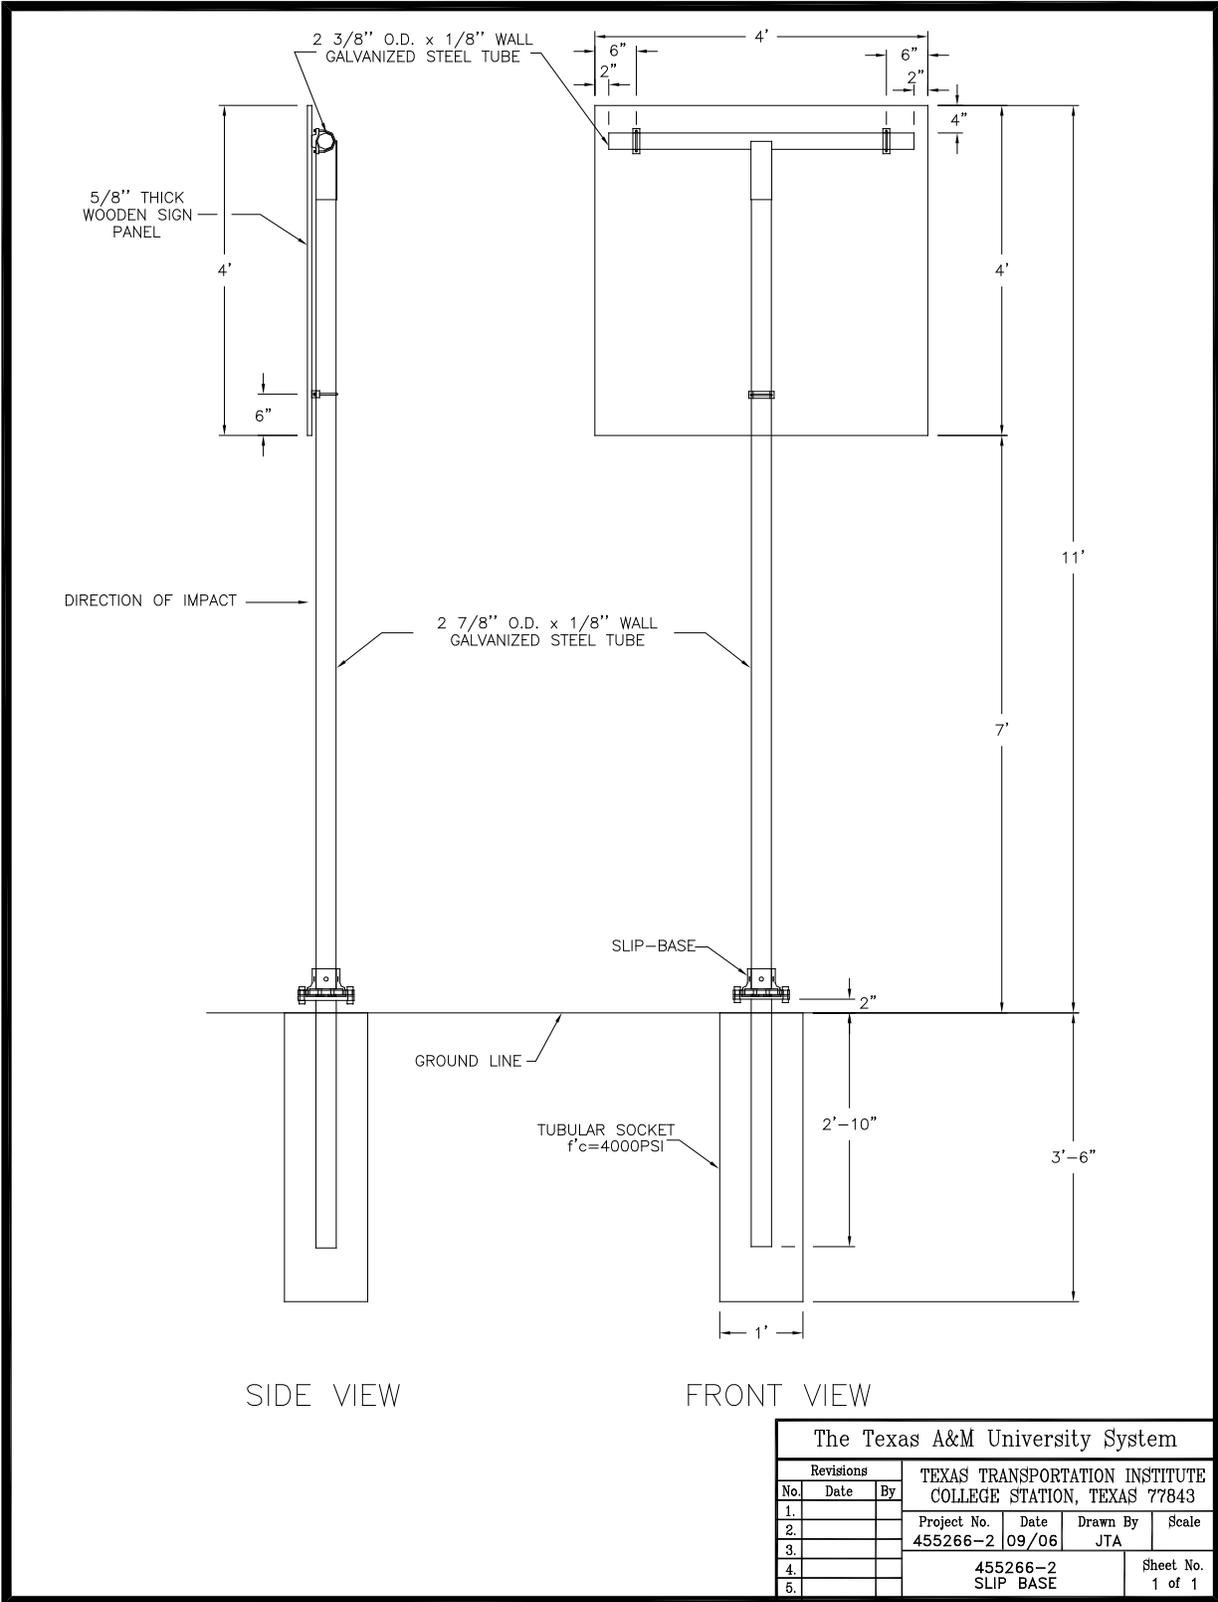
Figure 37. Details of the Texas Triangular Slip Base.

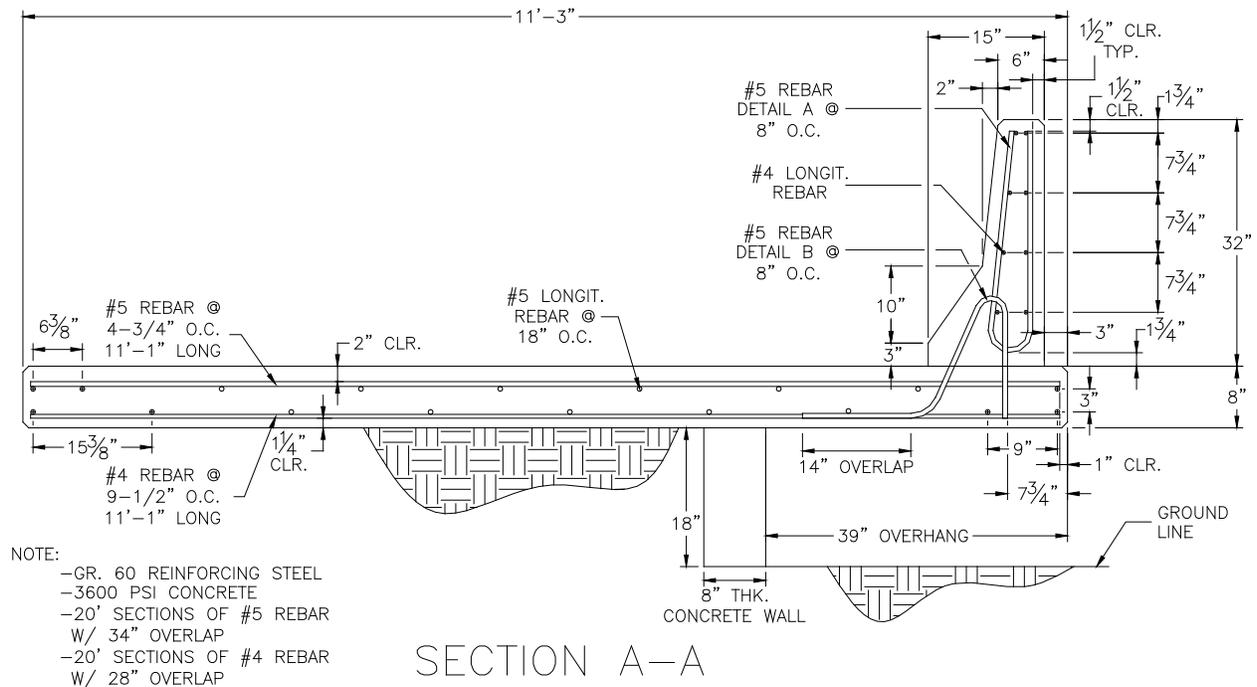
A cross section of the barrier design is shown in Figure 38. Total height of the safety shape barrier is 32 inches. The thickness of the unit is 15 inches at its base and varies along the height, tapering to a minimum of 6 inches at the top. The slope at the bottom of the rail serves to minimize the damage done to vehicles impacting at low angles by causing the front tire to ride up on the parapet and the vehicle to redirect with limited contact between the body of the vehicle and the parapet.

Figure 38. Cross Section of the 32-inch New Jersey Shape Barrier.
