Web-Only Document 157:

Volume I: Evaluation of Existing Roadside Safety Hardware Using Updated Criteria—Technical Report

Contractor's Final Report for NCHRP Project 22-14(03)
Submitted March 2010

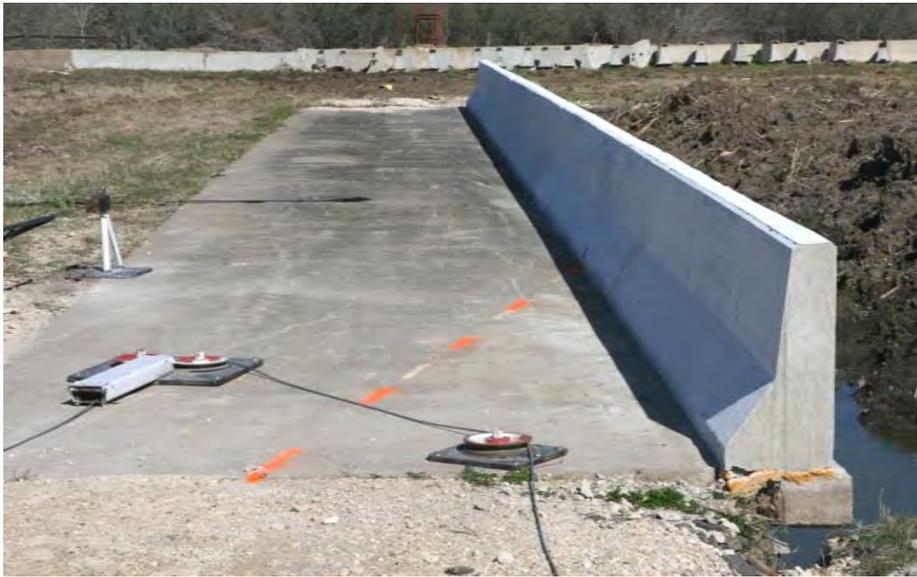
The same barrier installation was used for both 4-12 and 4-11 crash tests since the barrier only sustained cosmetic damage during the 4-12 test. Photographs of the completed installation are shown in Figure 39. More detailed information on the barrier and the two crash tests is in Appendixes B and C (available on the NCAC website, www.ncac.gwu.edu/).

Figure 39. 32-inch New Jersey Shape Barrier Prior to Testing.

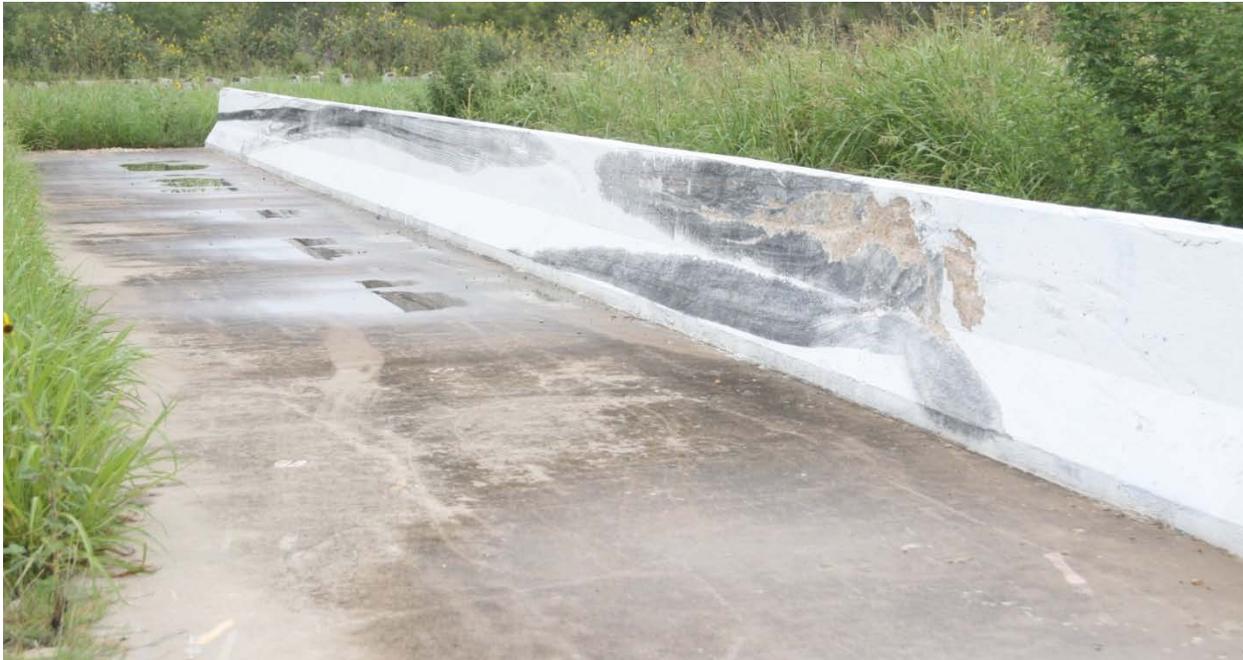
The 32-inch New Jersey Shape Barrier sustained cosmetic damage only, as shown in Figure 40. There were tire marks and gouges in the traffic face, and then about halfway down, along the top edge of the barrier and off the end of the barrier.

Figure 40. 32-inch New Jersey Shape Barrier after *MASH* Test 4-12.

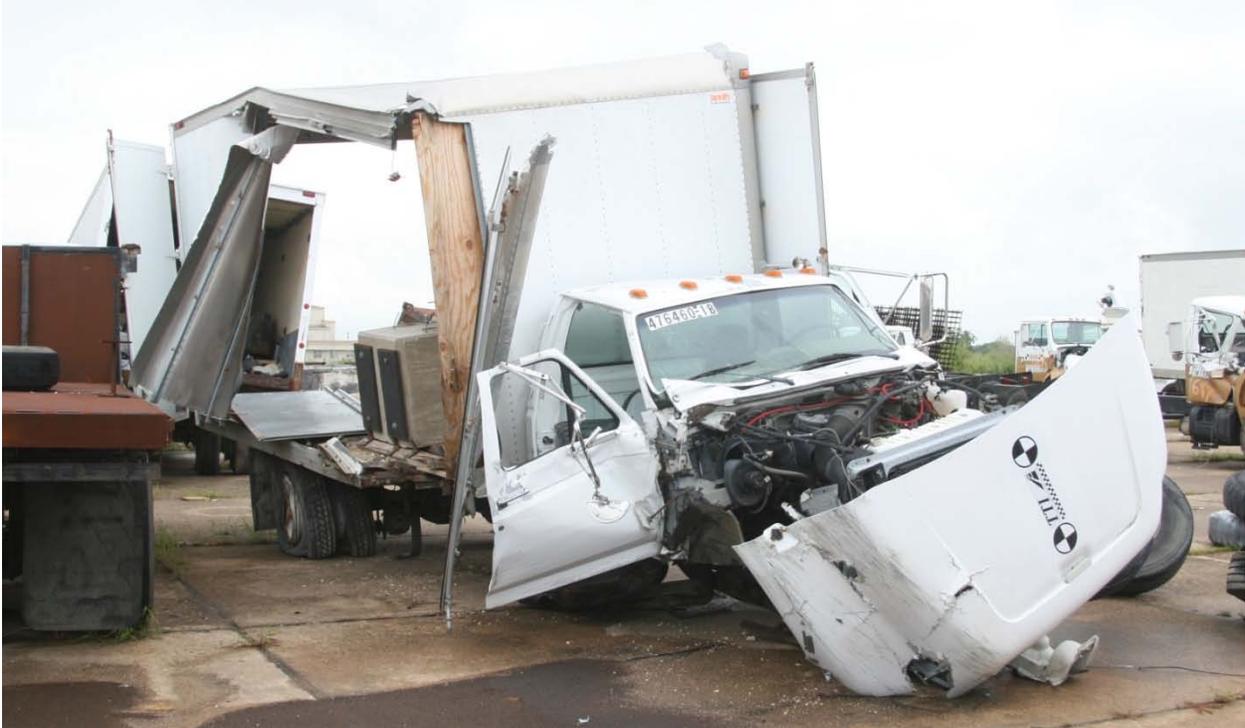
As shown in Figure 41, the SUT cargo box and truck cab sustained extensive damage due to rollover. Both right and left frame rails were deformed, the right front U-bolts broke, the front axle was deformed, the drive shaft broke, and the right rear U-bolts broke. Both front tires and rims and the right rear inner and outer tires and rims were damaged. The right A-post was deformed and the windshield was broken. Also damaged were the front bumper, hood, right door and glass, cab, and roof. The right fuel tank was deformed (but not punctured), and the right side floor pan was also deformed. Maximum exterior crush to the right front corner of the bumper was 12.0 inches, and maximum occupant compartment deformation was 4.0 inches in the right floor pan area.

Figure 41. Test Vehicle after *MASH* test 4-12 on the 32-inch New Jersey Safety Shape Barrier.

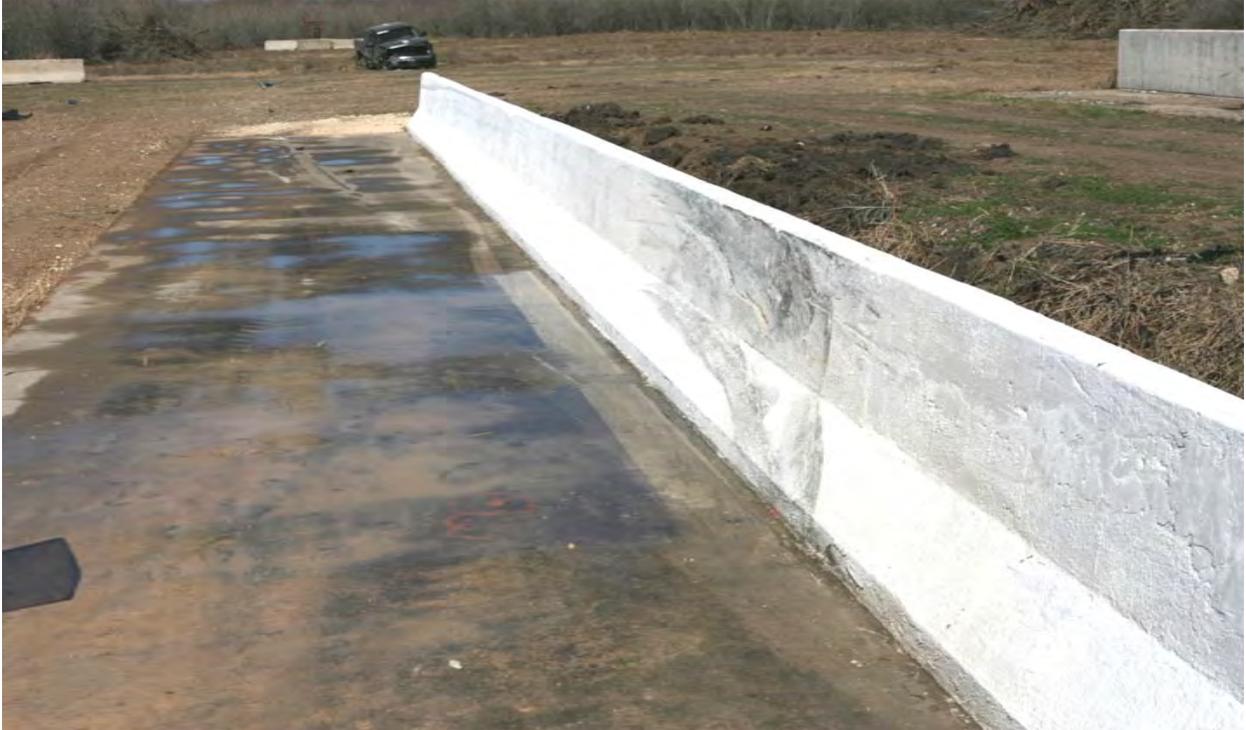
Figure 43. 32-inch New Jersey Shape Barrier after *MASH* Test 3-11.

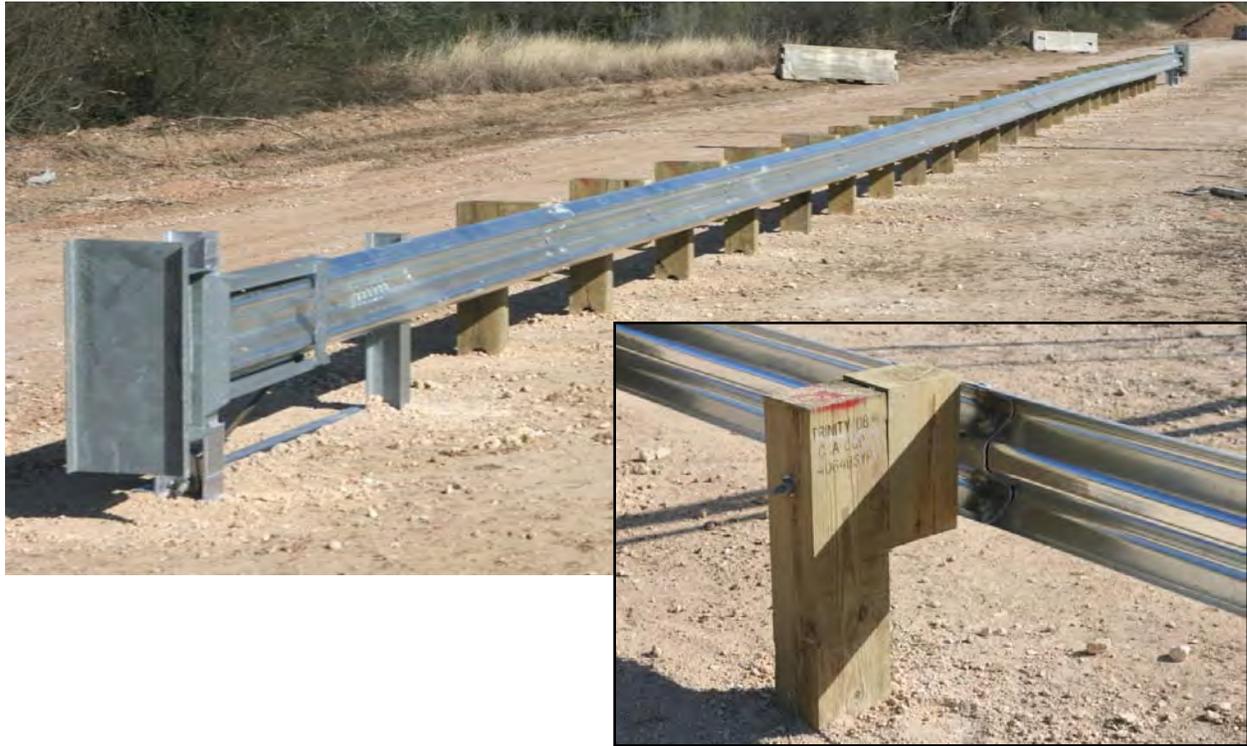
Figure 47. G4(2W) W-Beam Guardrail Prior to Testing.

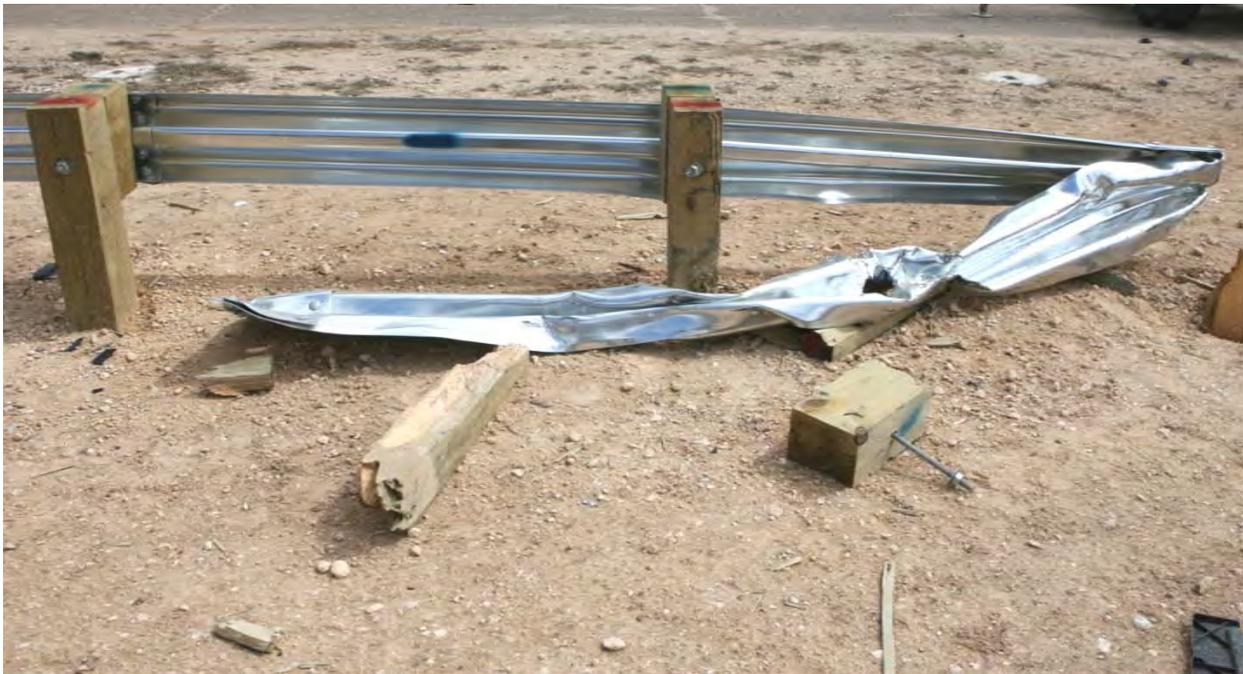
Damage to the G4(2W) W-beam guardrail is shown in Figures 48 and 49. Post 1 was displaced laterally downstream 0.4 inch, and the W-beam rail element separated from post 8. Post 10 split vertically through the rail bolt hole and the soil around the post was disturbed. Post 11 was pushed toward the field side 1.0 inch at ground level and was leaning 3 degrees. Post 12 was pushed toward field side 2 inches at ground level, and was leaning 9 degrees. The W-beam rail element ruptured at the splice on the upstream side of the bolts at post 13 and the ruptured end deformed around post 15. Posts 13 through 15 fractured below ground level, and due to fracturing and splintering, specific post resting places were not identifiable. However, all debris was on the field side of the test installation. Post 16 was pushed toward the field side and downstream 0.5 inch at ground level and the W-beam rail element separated from the post. There were tire marks on the field side of post 16. Post 17 was pushed toward the field side and downstream 0.5 inch. The soil around post 18 and 19 was disturbed. Post 21 was split vertically at the rail bolt hole. The length of contact of the vehicle with the guardrail was 24.0 ft.

Figure 48. G4(2W) W-Beam Guardrail after MASH Test 3-11.

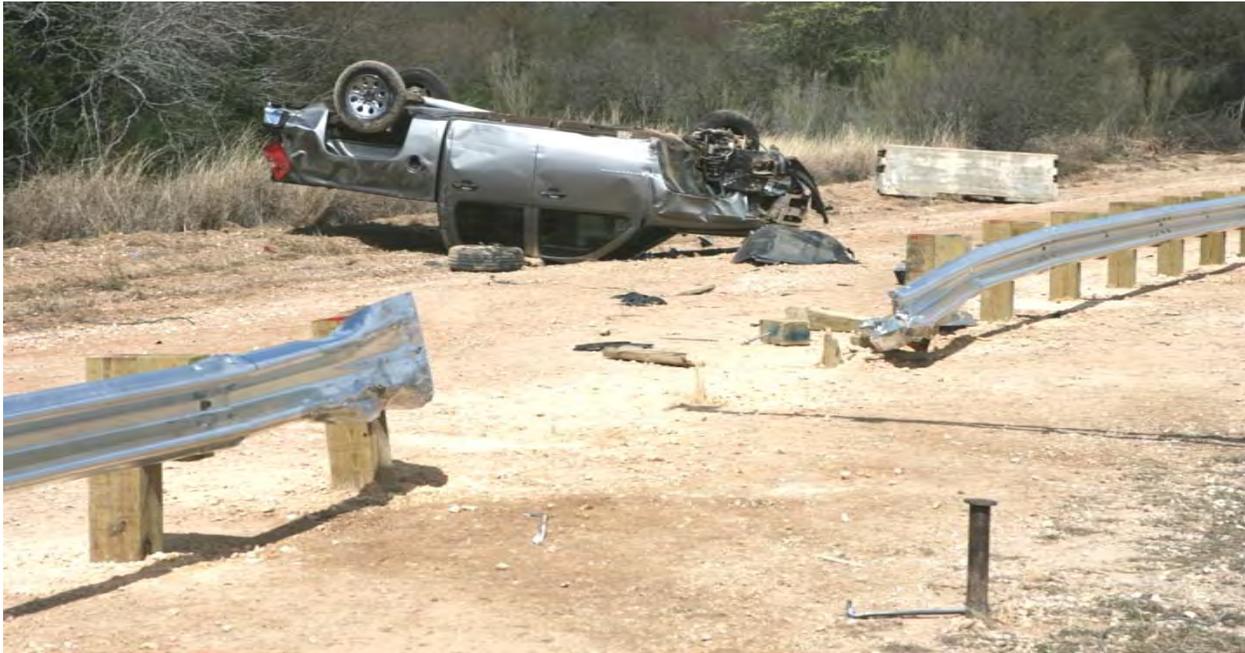
Figure 49. Test Vehicle and G4(2W) W-Beam Guardrail after MASH Test 3-11.

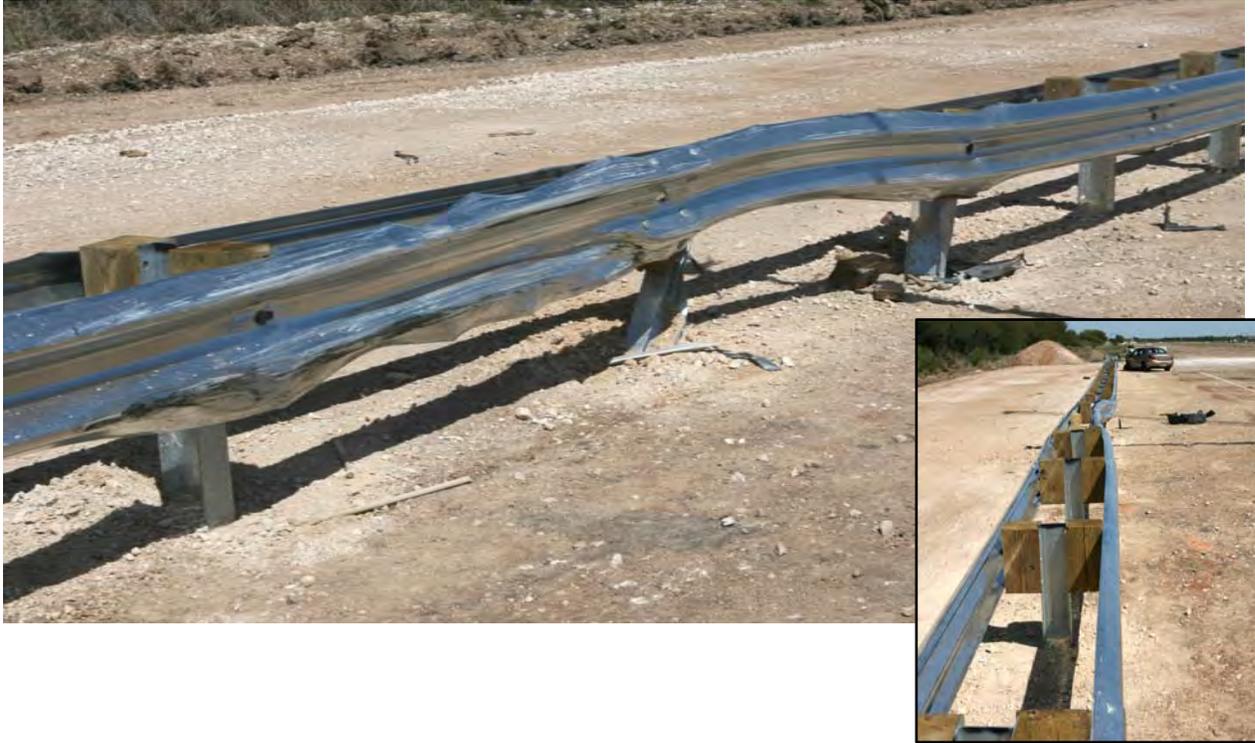
Figure 53. G4(1S) W-Beam Median Barrier after *MASH* Test 3-10.

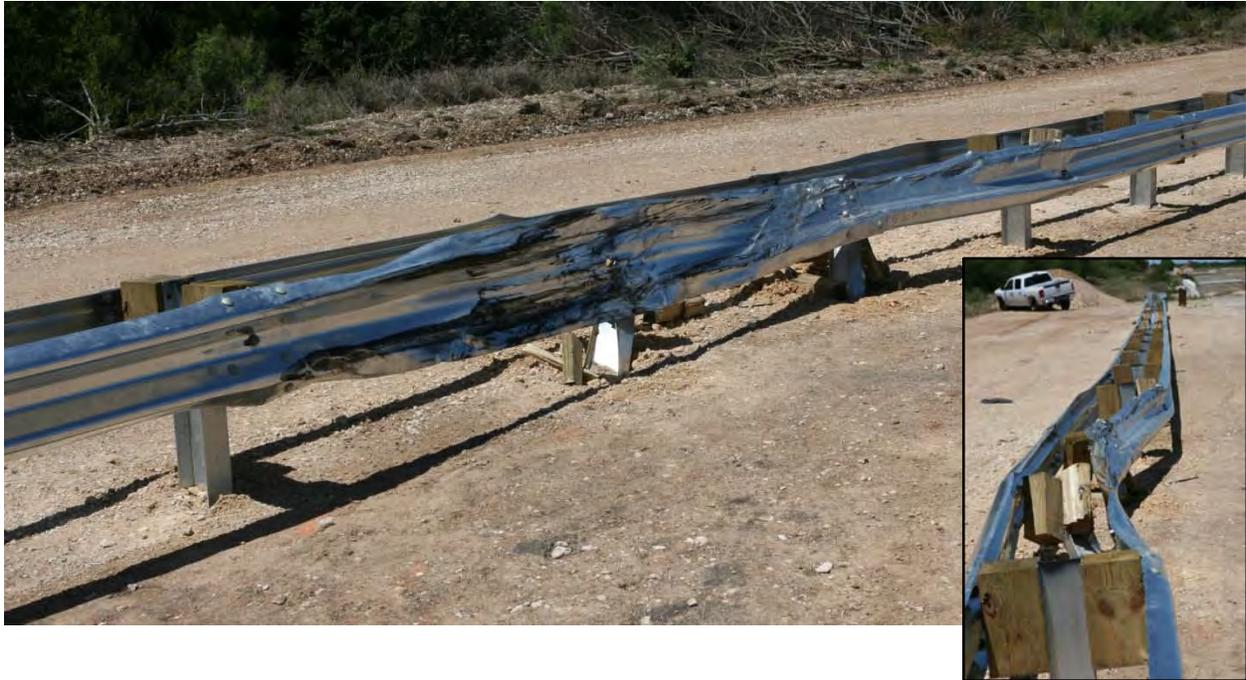
Figure 56. G4(1S) W-Beam Median Barrier after *MASH* Test 3-11.

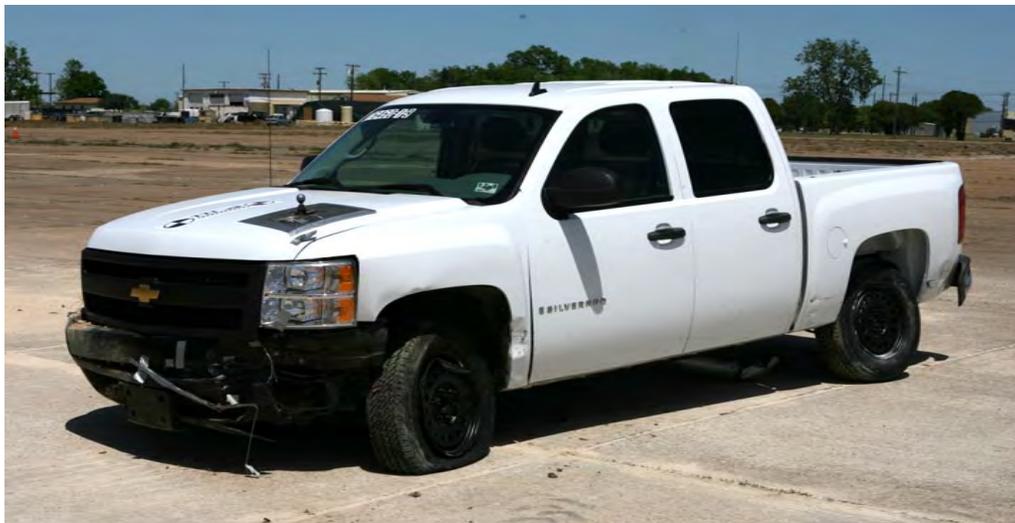
Figure 57. Test Vehicle after *MASH* Test 3-11 on the G4(1S) W-Beam Median Barrier.

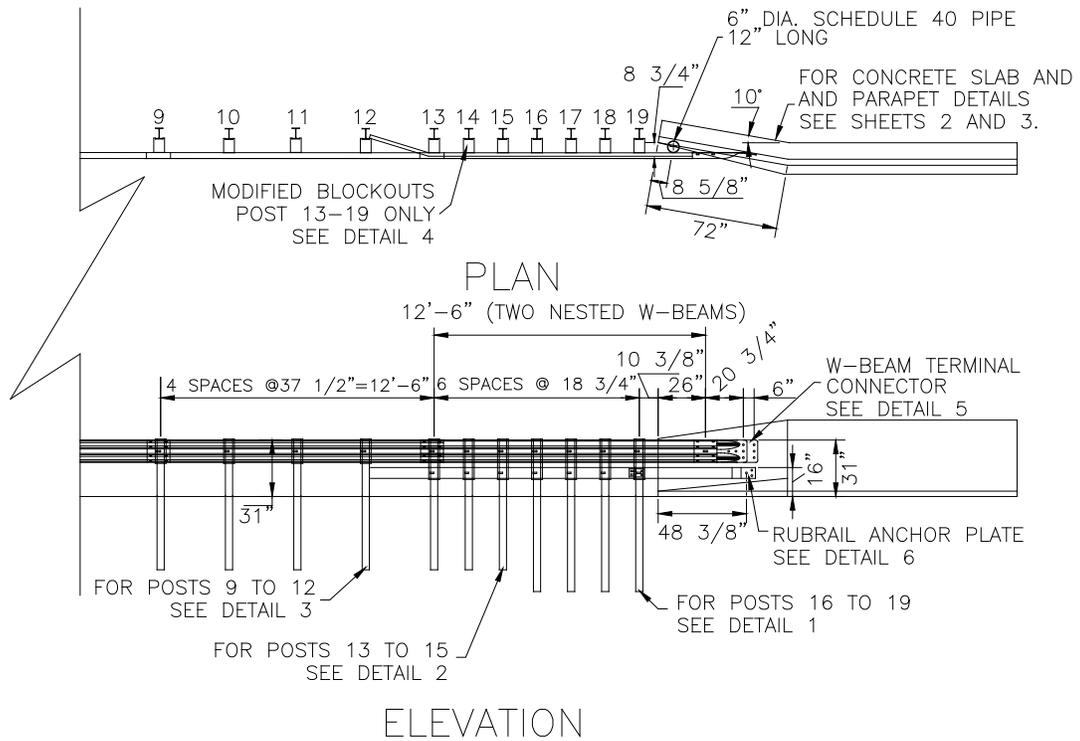
Figure 59. Details of the Pennsylvania W-Beam Transition.

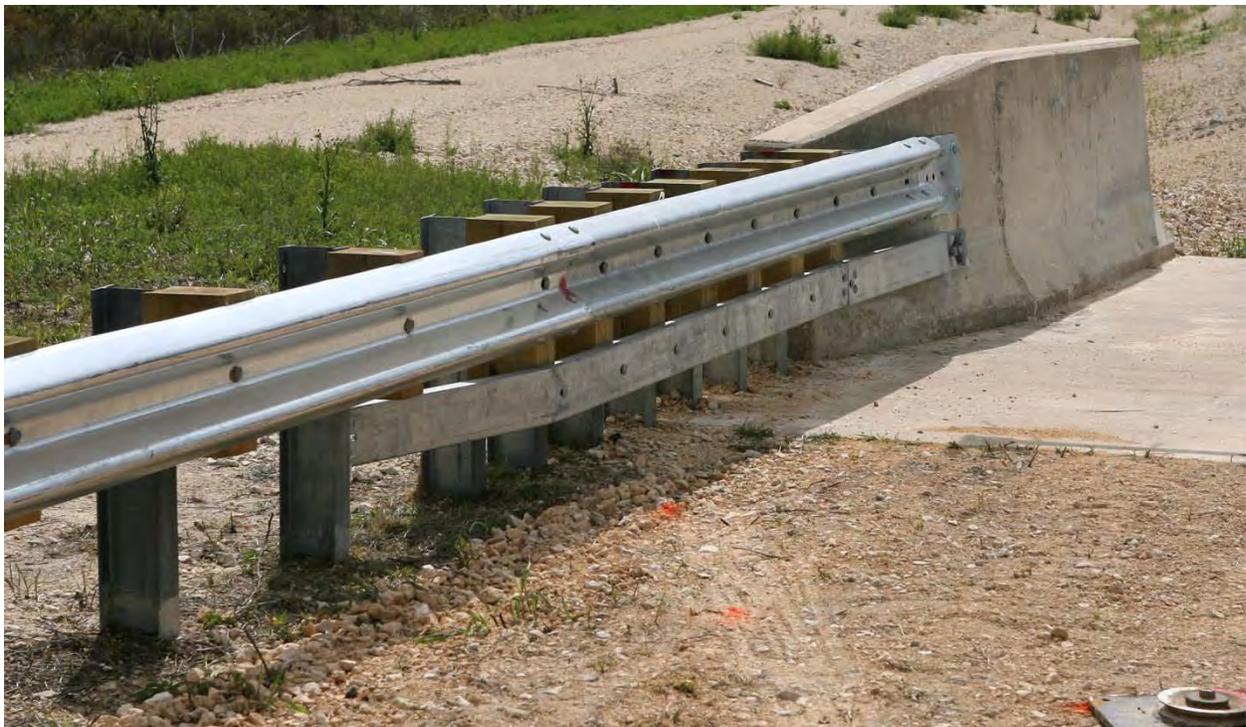
Figure 60. W-Beam Transition prior to Testing.

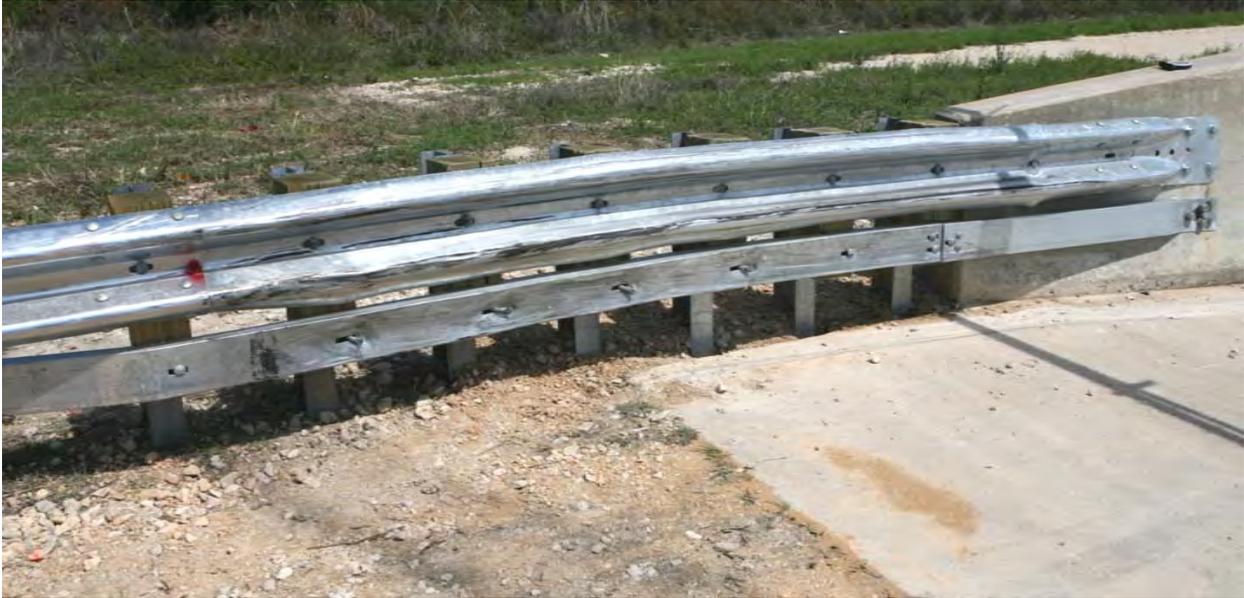
Figure 61. PennDOT W-Beam Transition after *MASH* Test 3-21.

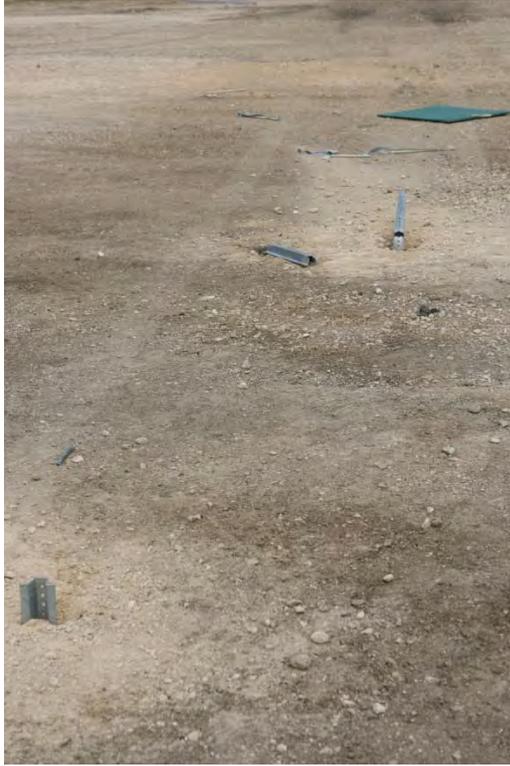
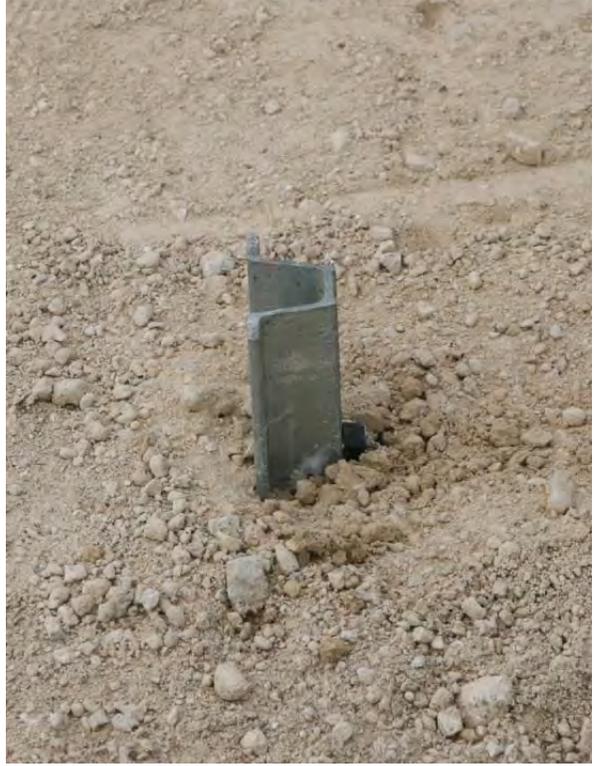
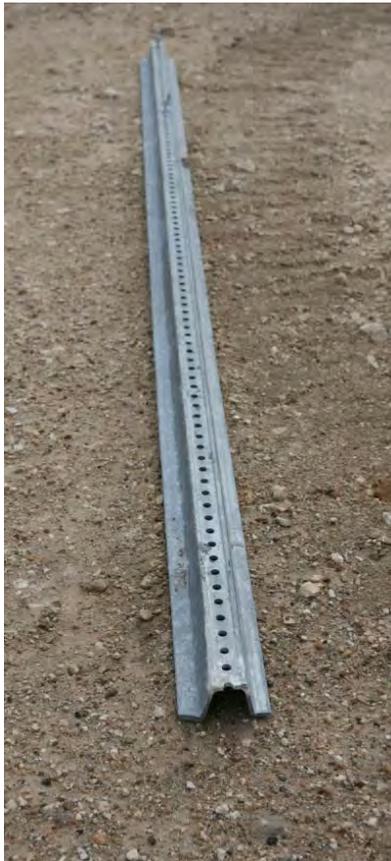
Figure 68. U-Channel Installation after *MASH* Test 3-62.

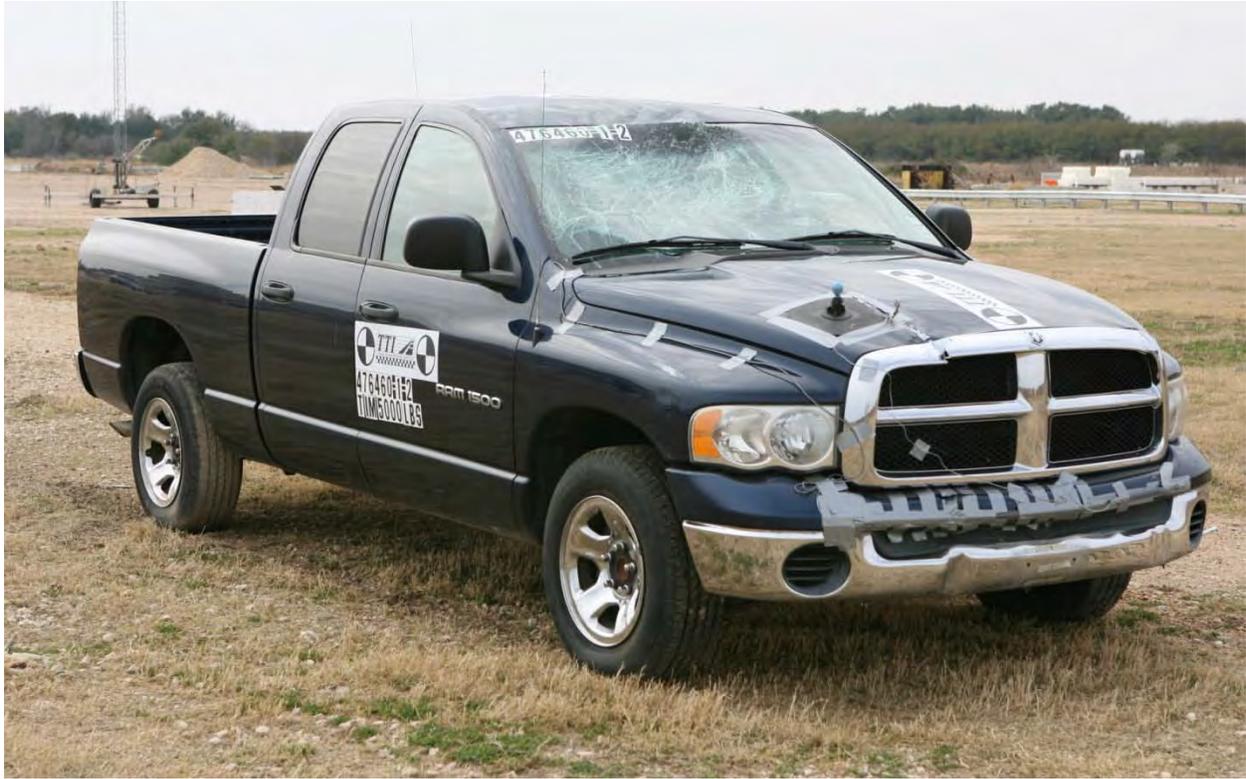
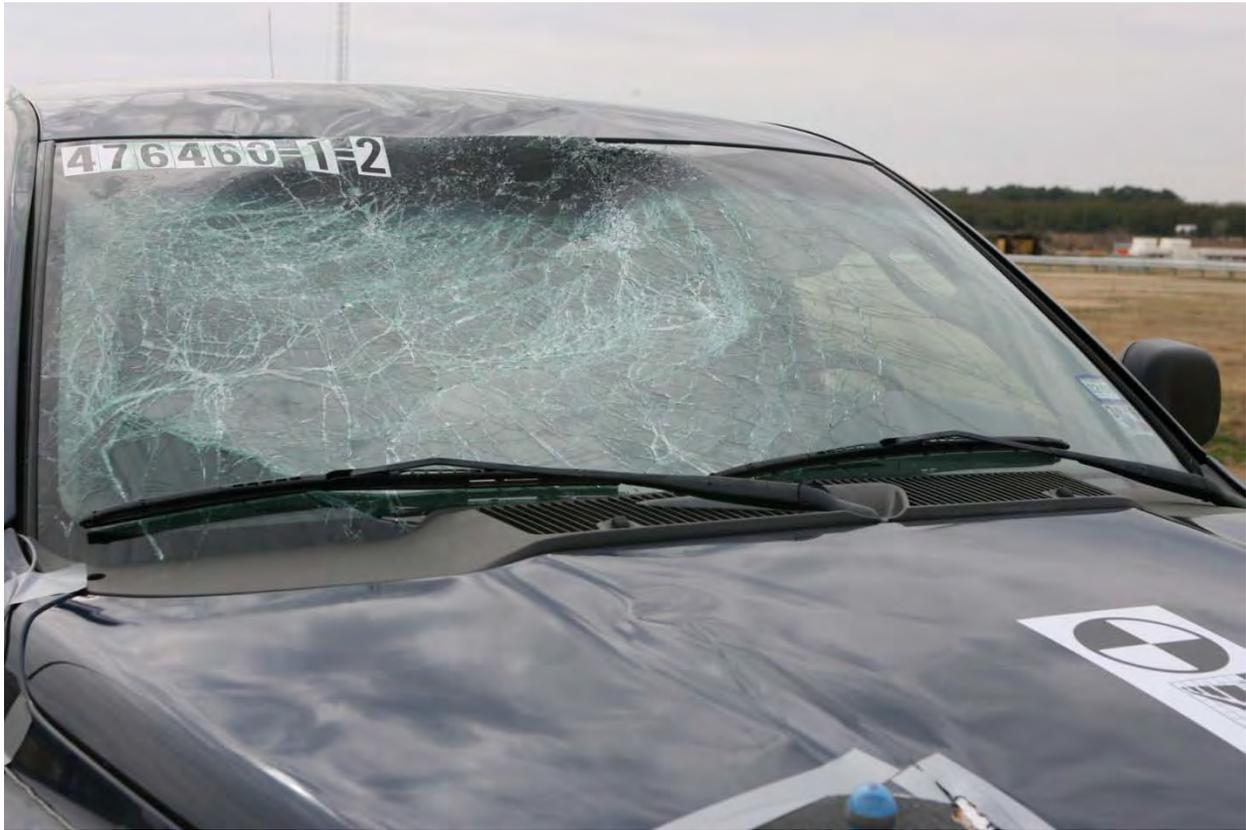
Figure 70. Vehicle after *MASH* Test 3-62 with Small Sign Supports.

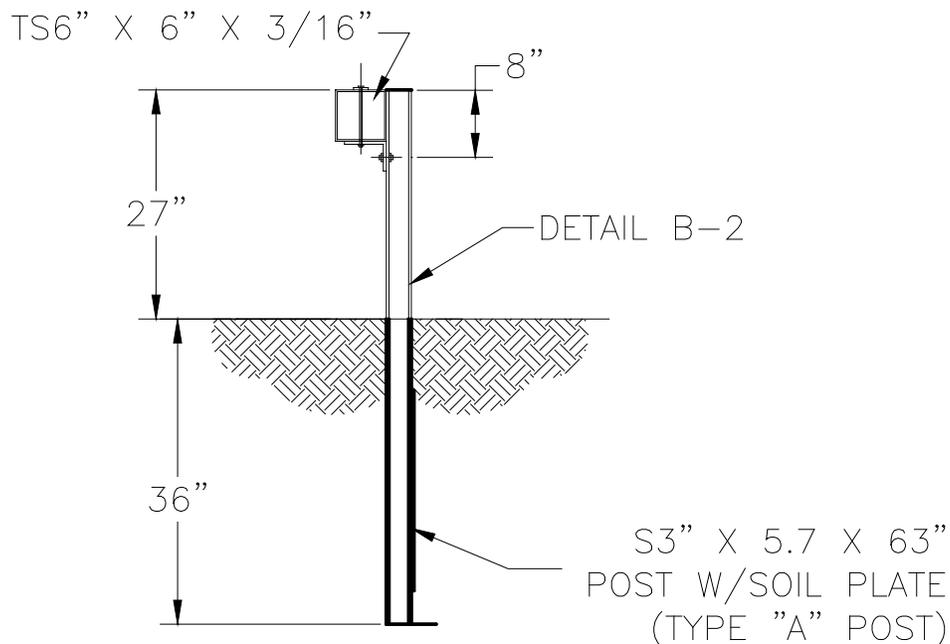
Figure 72. Cross-section of the G3 Weak Post Box-Beam guardrail.

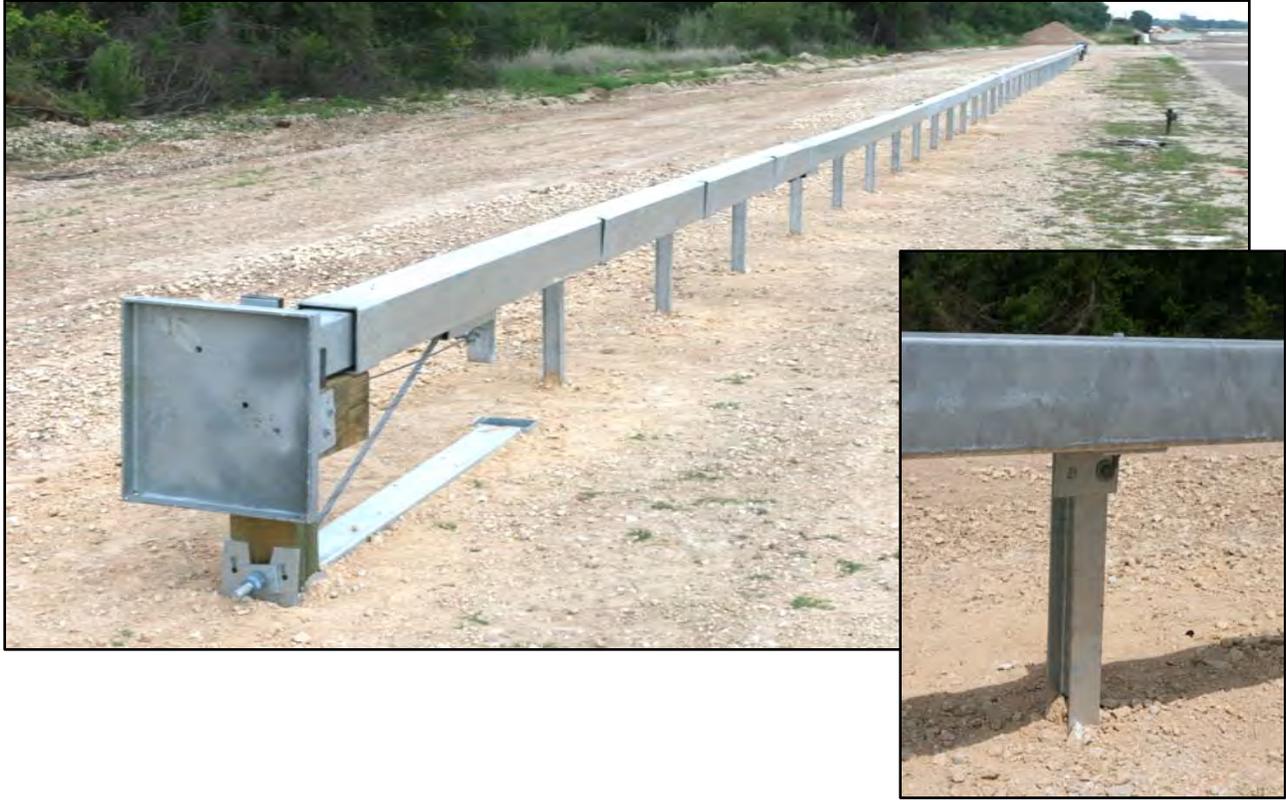
Figure 73. G3 Weak Post Box-Beam Guardrail prior to Testing.

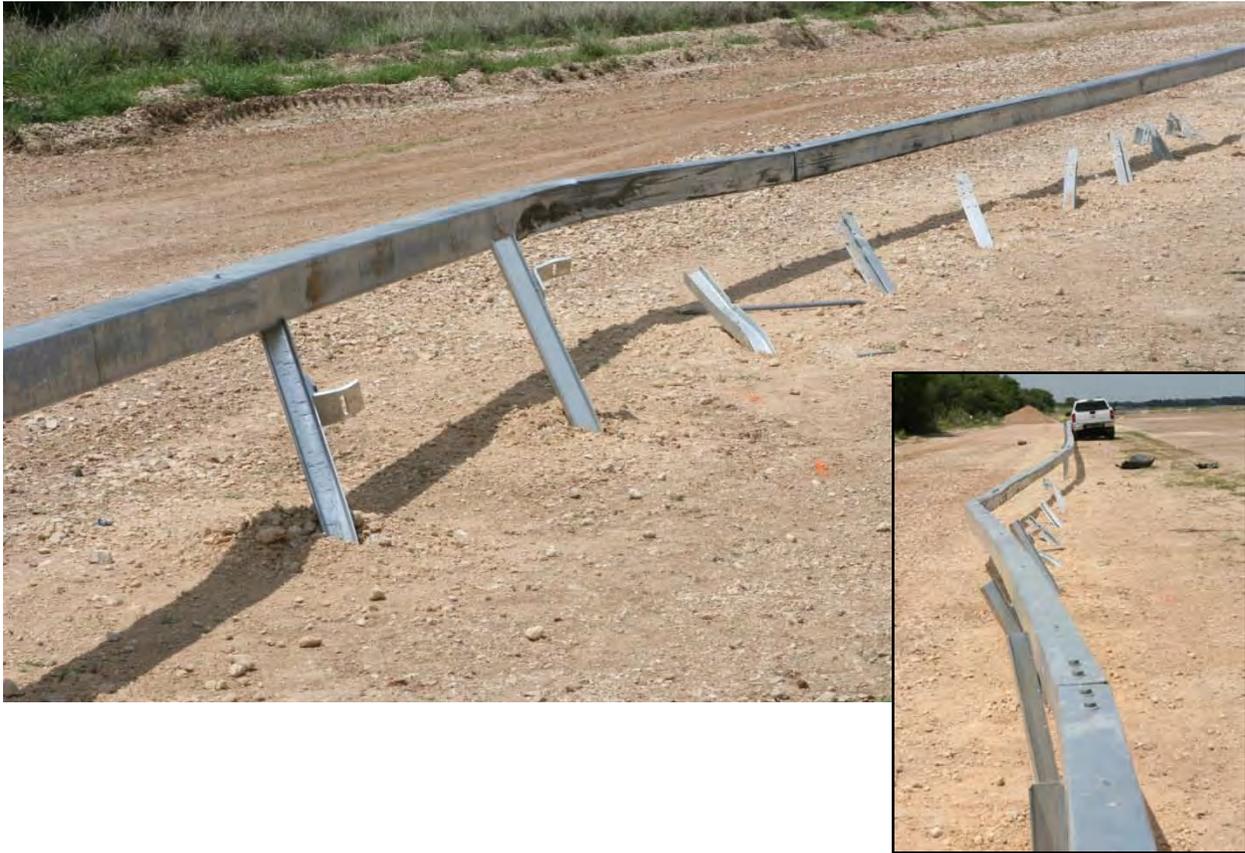
Figure 74. G3 Weak Post Box-Beam Guardrail after *MASH* Test 3-11.

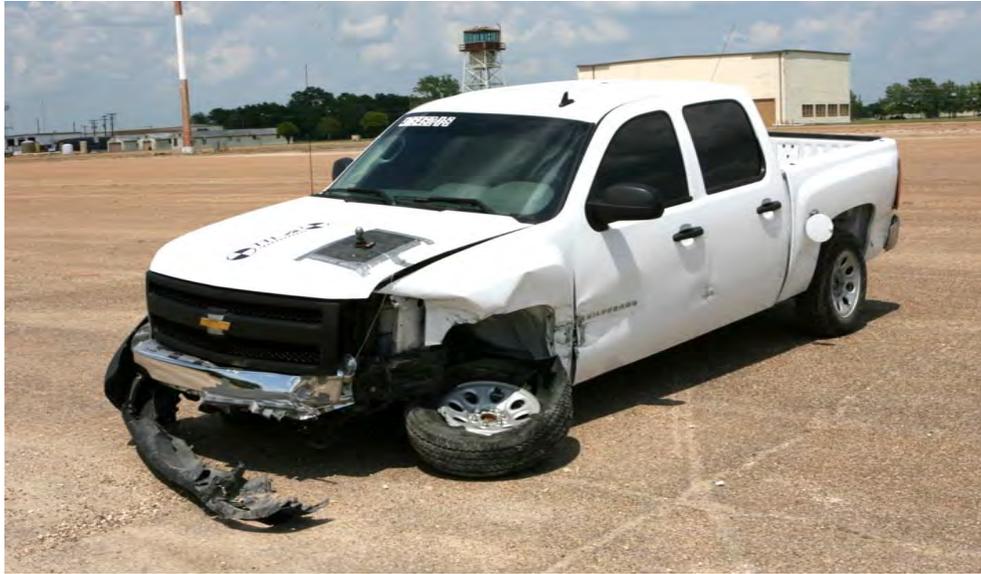
Figure 75. Test vehicle after *MASH* test 3-11 on the G3 weak post box-beam guardrail.

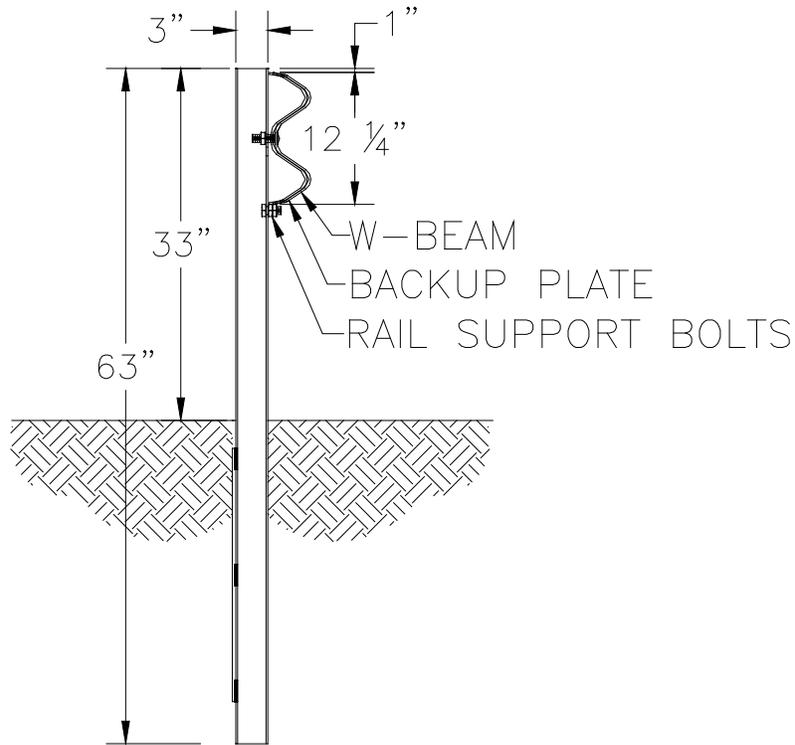
Figure 77. Cross-Section of the Modified G2 Weak Post W-Beam Guardrail.

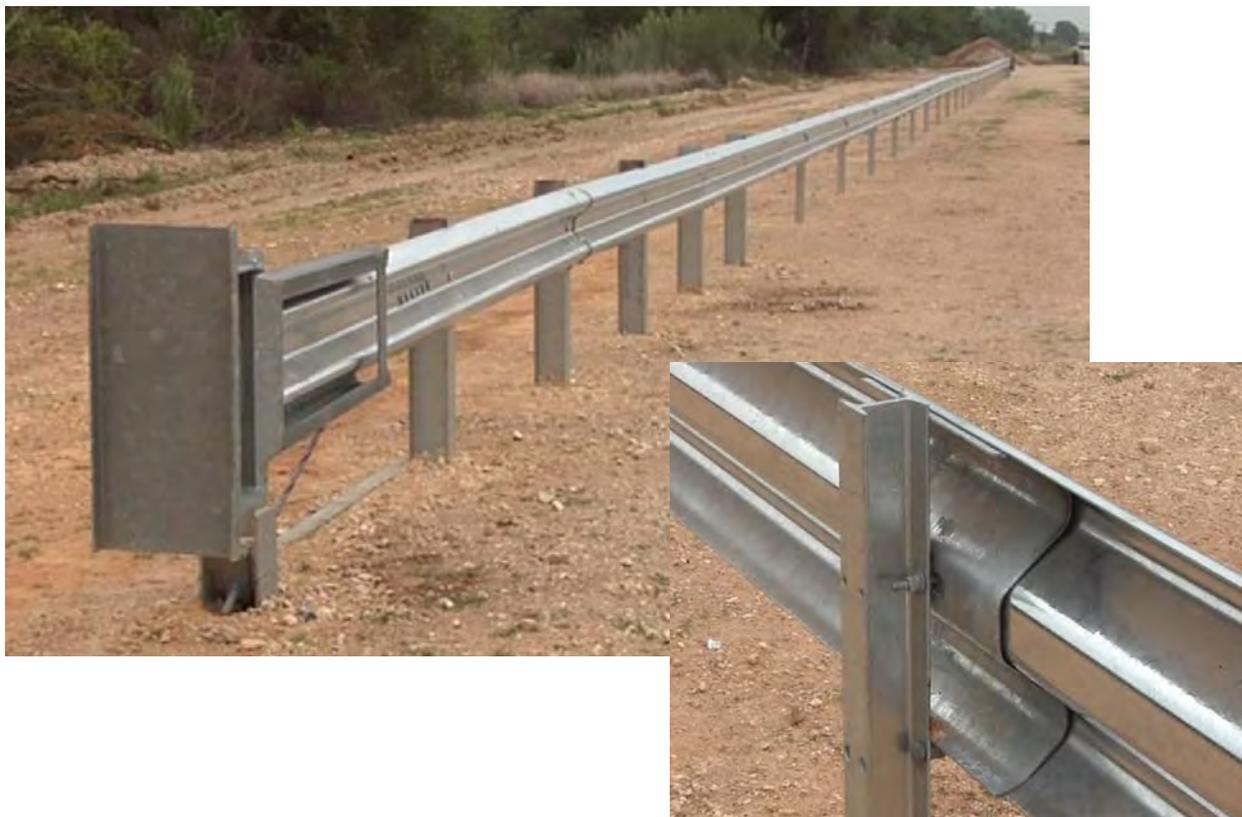
Figure 78. Modified G2 Weak Post W-Beam Guardrail prior to Testing.

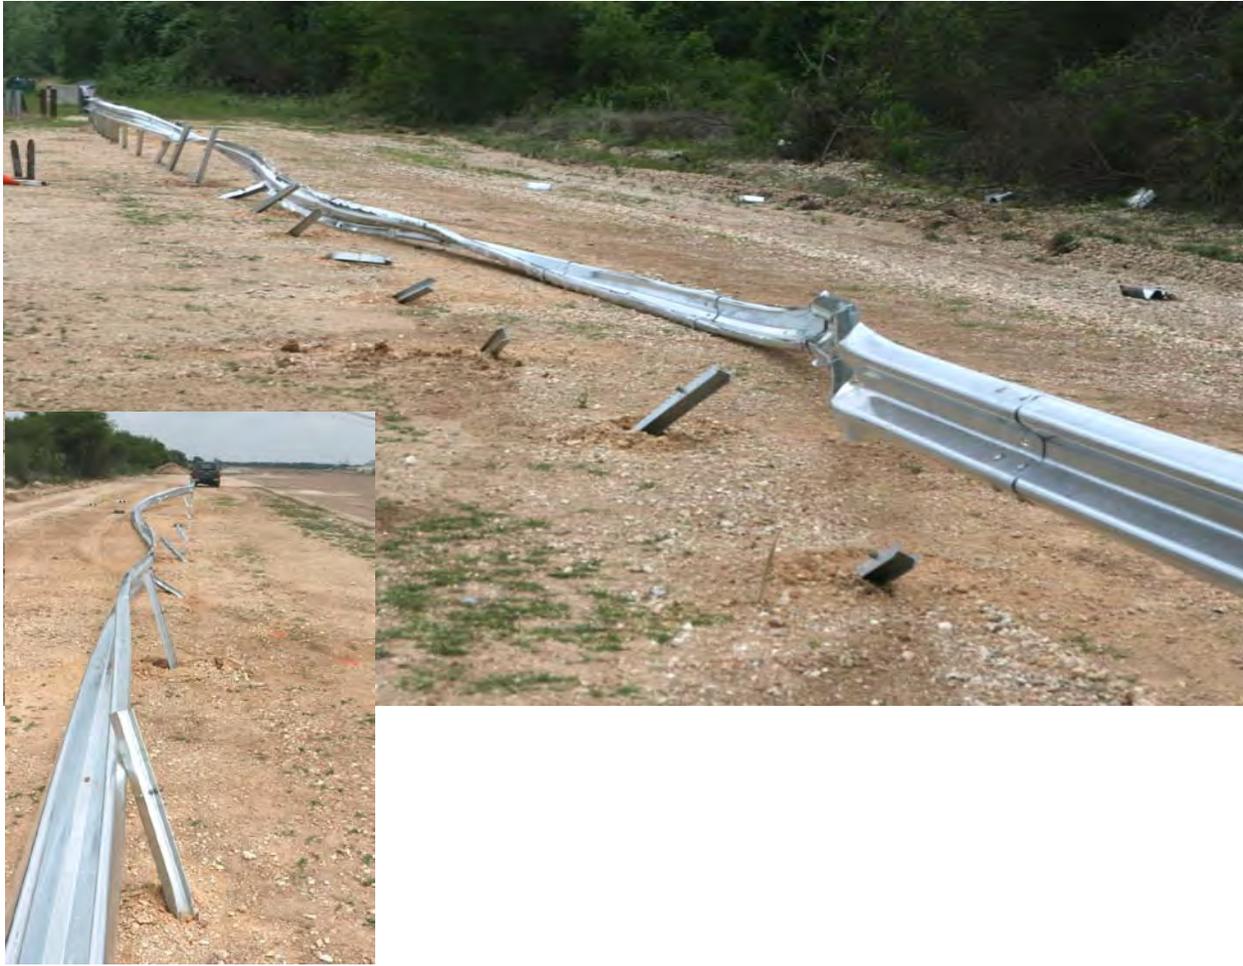
Figure 79. G2 Weak Post W-Beam Guardrail after *MASH* Test 3-11.

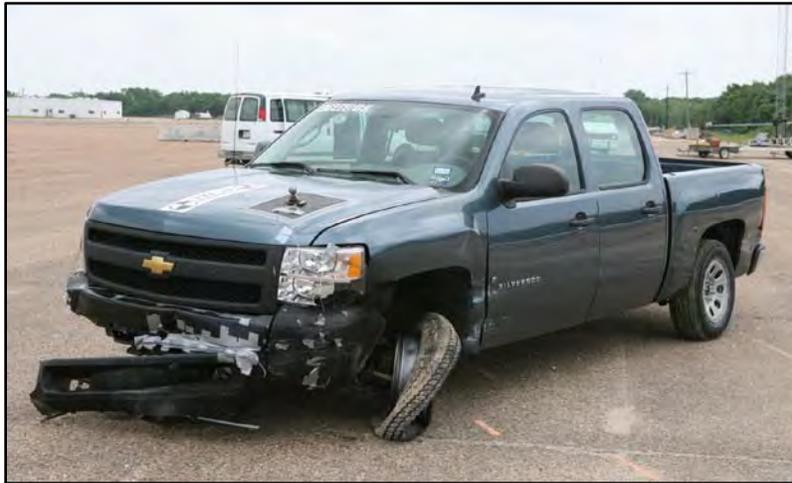
Figure 80. Test Vehicle after MASH Test 3-11 on the G2 Weak Post W-Beam Guardrail.

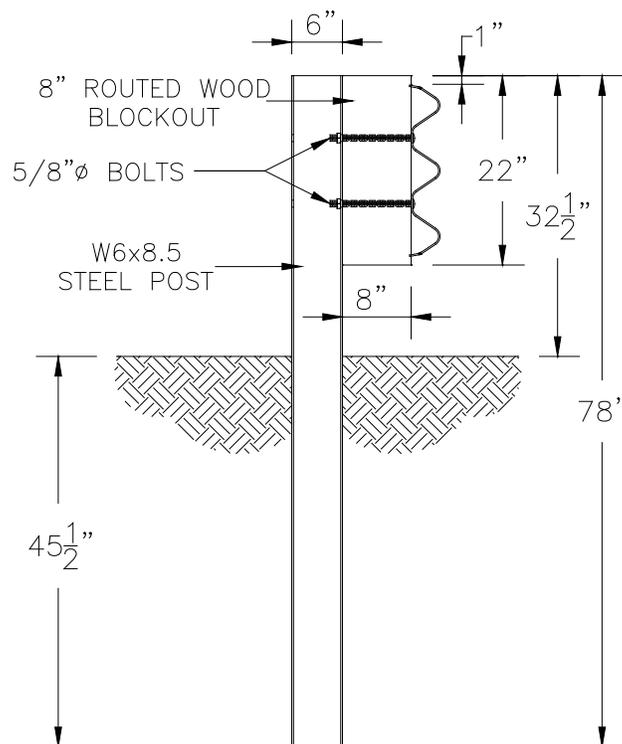
Figure 82. Cross-Section of the G9 Thrie Beam Guardrail.

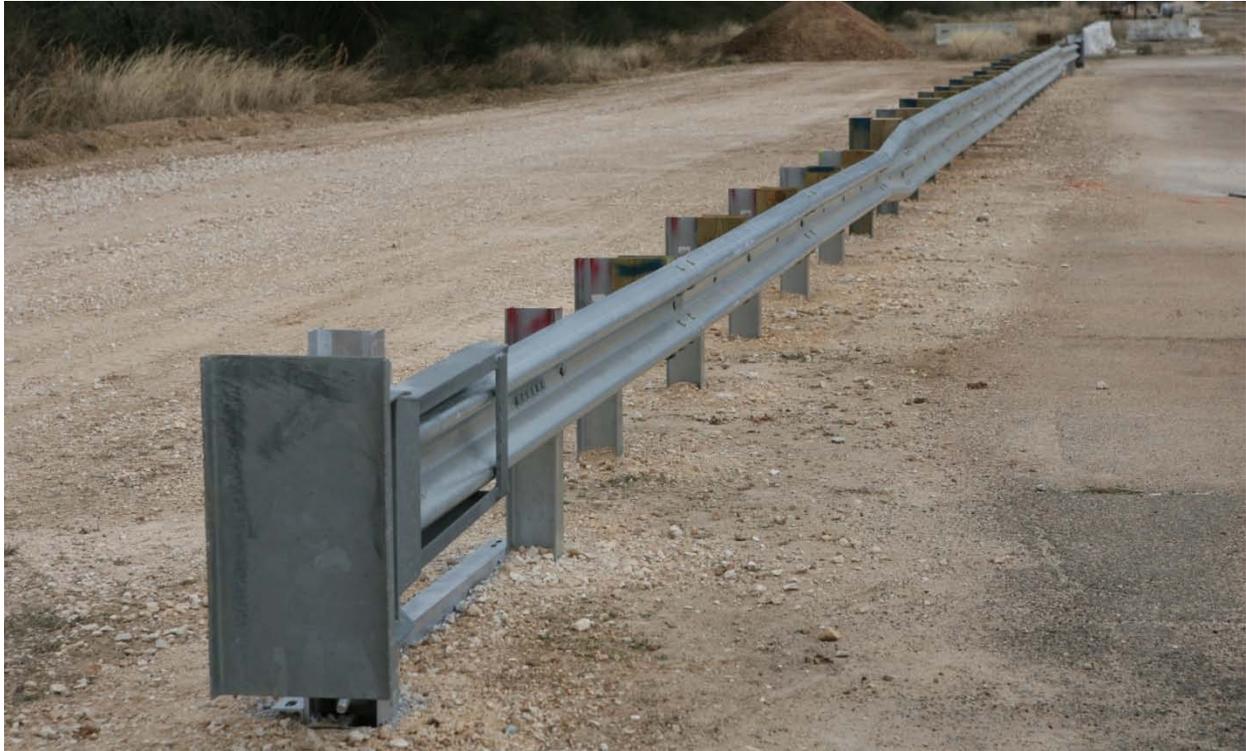
Figure 83. G9 Thrie Beam Guardrail prior to Testing.
