Web-Only Document 157:

Volume I: Evaluation of Existing Roadside Safety Hardware Using Updated Criteria—Technical Report

Contractor's Final Report for NCHRP Project 22-14(03)
Submitted March 2010

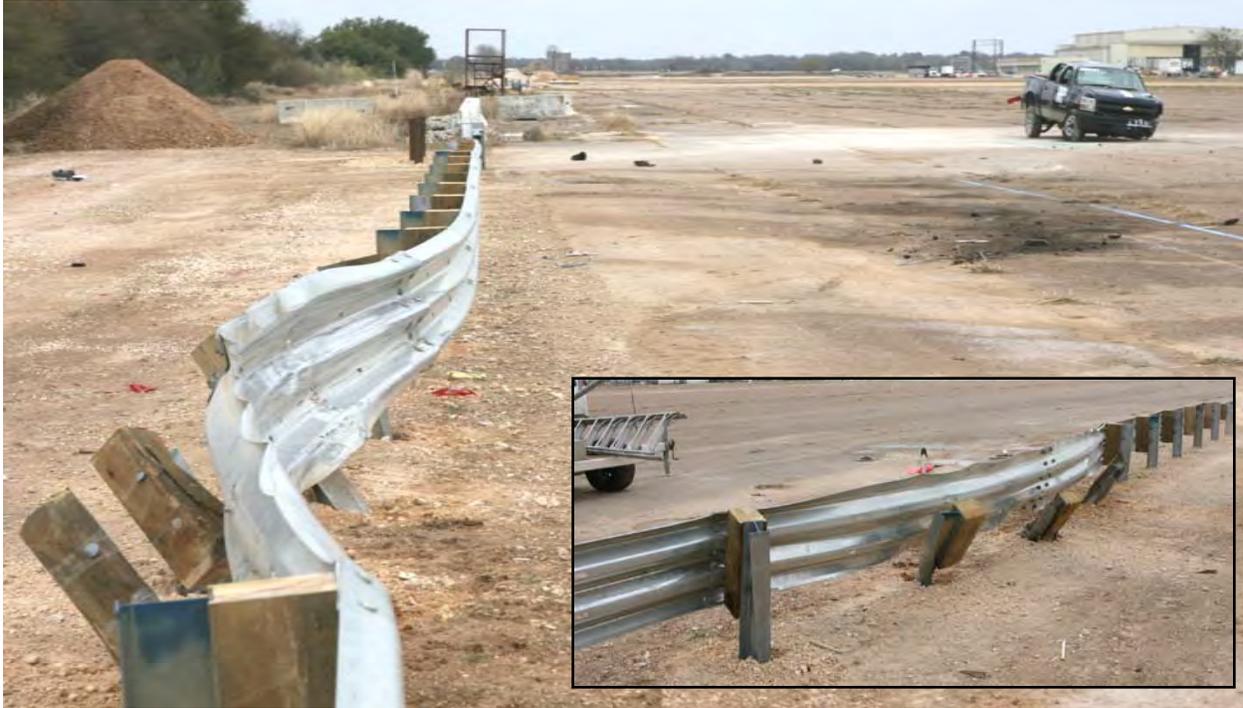
Figure 84. G9 Thrie Beam Guardrail after *MASH* Test 3-11.
