# Station Platform Height: Safety and Precedents

**TECHNICAL MEMORANDUM**

**August 2016**

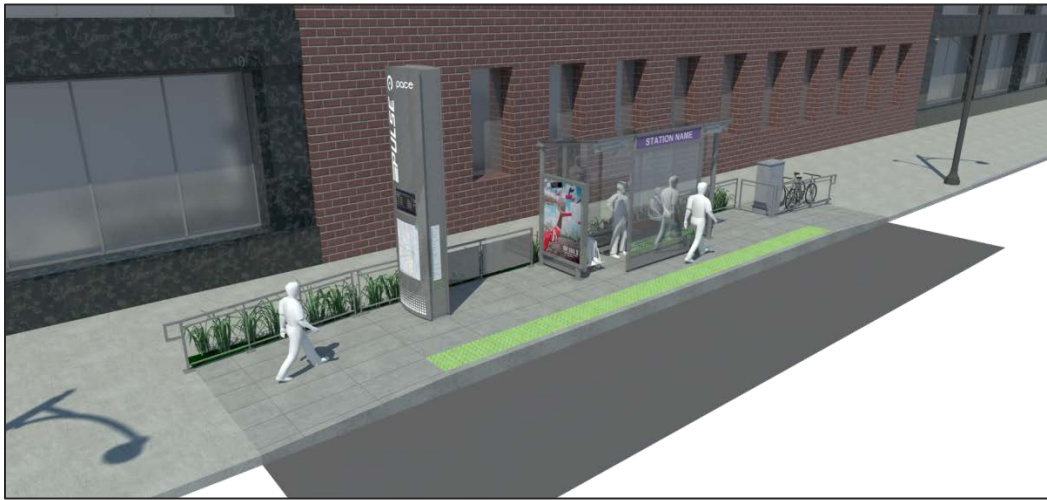
FIGURE 1-1: TYPICAL STATION RENDERING

A rendering, plan, and section of a typical Pulse station are shown in Figure 1-1, Figure 1-2, and Figure 1-3.

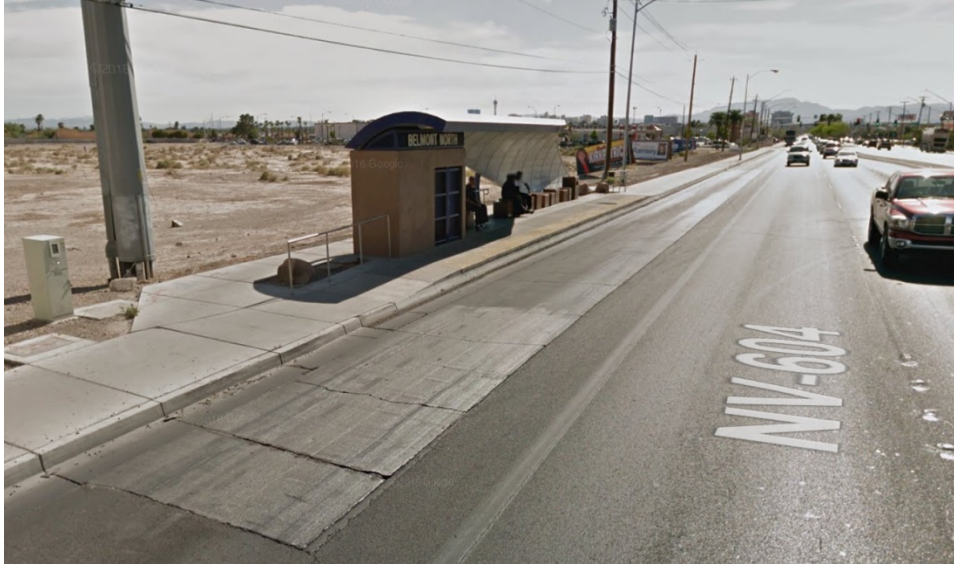
**FIGURE 3-2: MAX/ROUTE 113, BELMONT NORTH STATION, LAS VEGAS BOULEVARD  
NORTH AT BELMONT STREET, NORTHBOUND**

In Las Vegas, BRT service was first implemented in 2004 on the MAX line, which operated on Las Vegas Boulevard with the routing shown in Figure 3-1. Las Vegas Boulevard North has a posted speed of 45 miles per hour (mph). The MAX brand and some of the BRT features have since been discontinued, but the raised platforms remain in place and continue to be used by Route 113. Both MAX and current Route 113 operate in a dedicated lane for a portion of the route (primarily in downtown Las Vegas) and in mixed traffic along State Route 604 for the remainder. Additional details of the MAX service are summarized in Table 1. Examples of MAX stations are provided in Figure 3-2 through Figure 3-5.

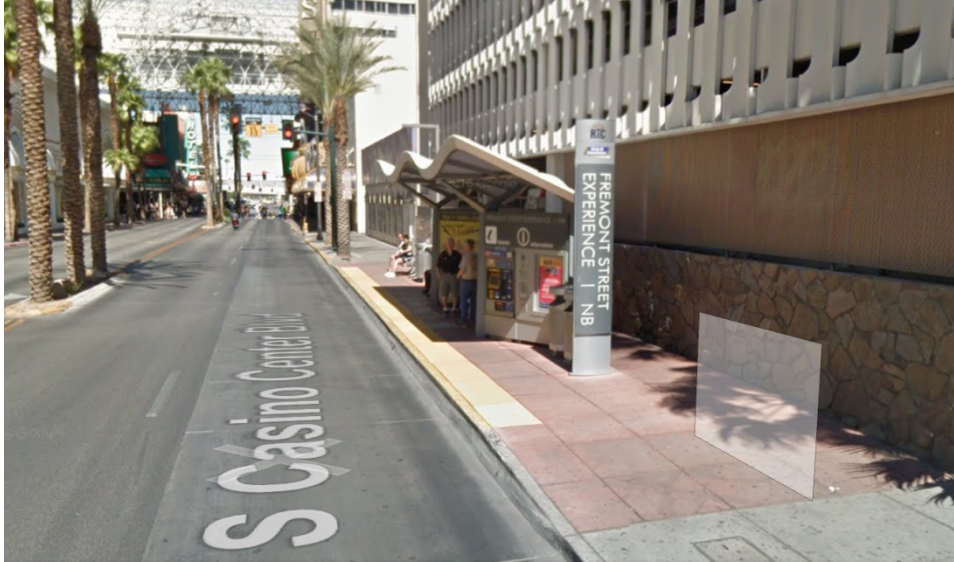
FIGURE 3-6: SDX, FREMONT EXPERIENCE STATION, S CASINO CENTER BOULEVARD AT CARSON AVENUE

Since the MAX service was implemented, additional rapid transit lines have opened and provide 12-inch platforms, including the SDX or Strip and Downtown Express, line, which is shown in Figure 3-6 and Figure 3-7.

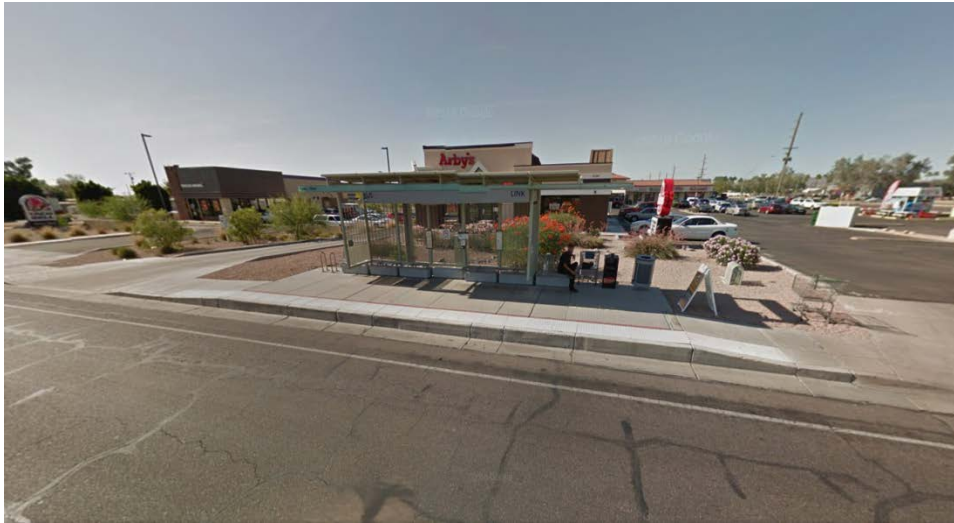
FIGURE 3-8: VALLEY METRO LINK, MAIN STREET, POWER ROAD STATION, EASTBOUND

In the Phoenix area, Valley Metro provides BRT service under the branded name LINK. Two LINK corridors use 12-inch curbs: the Main Street and Arizona Avenue/Country Club Dr. The Main Street route opened in 2008 and runs through Mesa in mixed traffic with on-street stations along Main Street, which has a posted speed of 45 mph. Examples of the LINK Main Street corridor stations are depicted in Figure 3-8 and Figure 3-9.

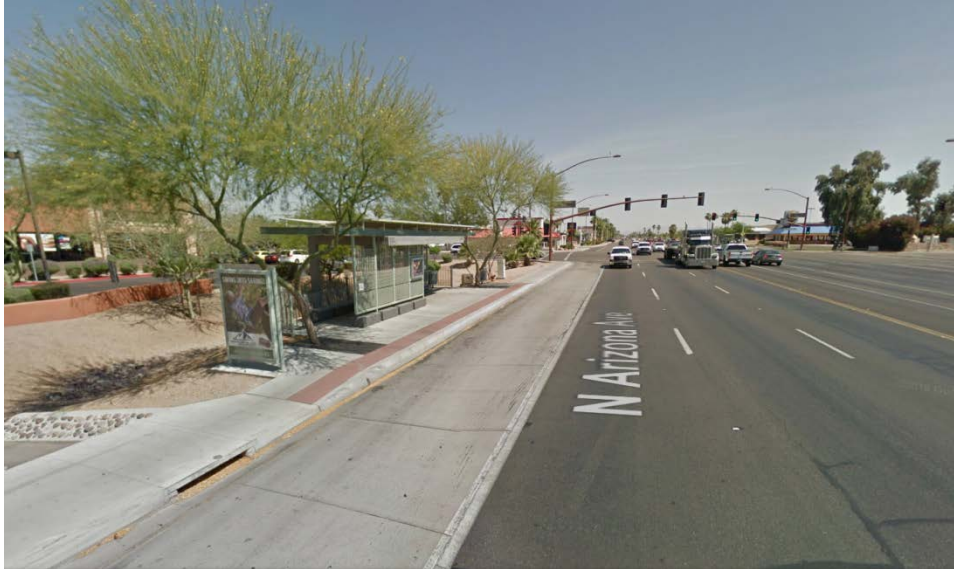
FIGURE 3-10: RAY ROAD STATION, SOUTHBOUND

The Arizona Avenue/Country Club Drive corridor runs through Chandler, operating in mixed traffic along State Route 87 which has a posted speed of 35 mph. The route uses both on-street stations as well as bus turnouts. Examples of the Arizona Avenue corridor stations are provided in Figure 3-10 through Figure 3-12. A detail of the 12-inch curb used for these stations was provided by Valley Metro and is featured in Figure 3-13.

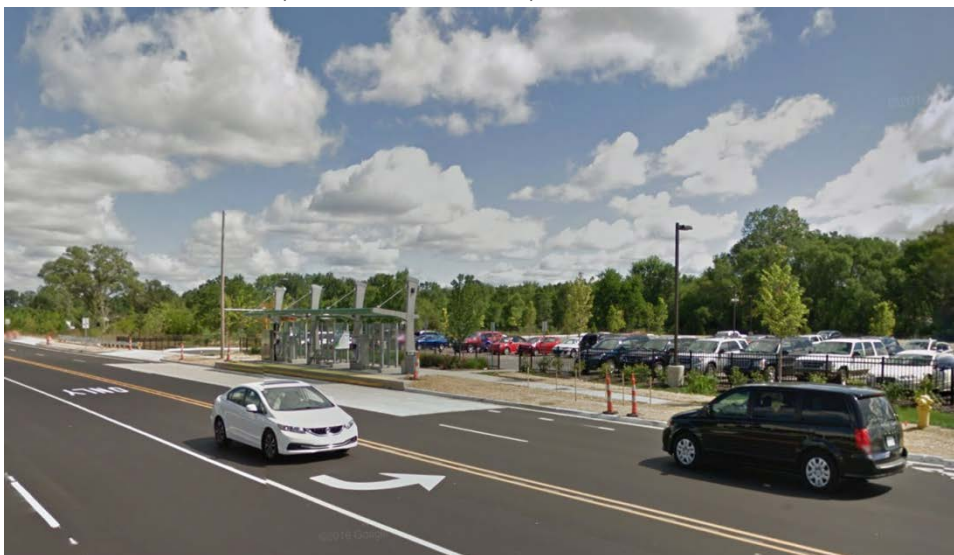
FIGURE 3-14: SILVER LINE, 60TH STREET STATION, NORTHBOUND

The Silver Line operates in both dedicated bus lanes and mixed traffic. A mixed traffic condition is shown in the two examples above.

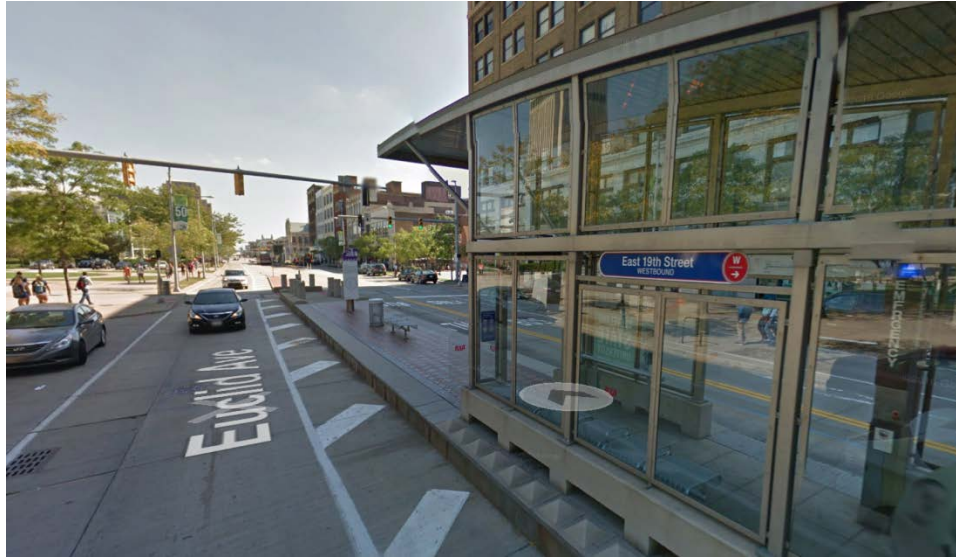
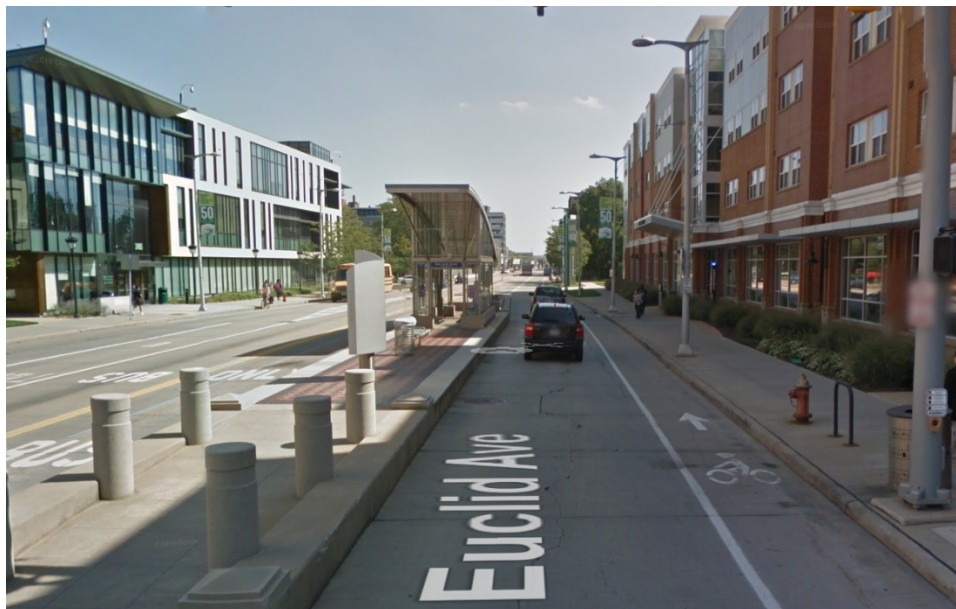
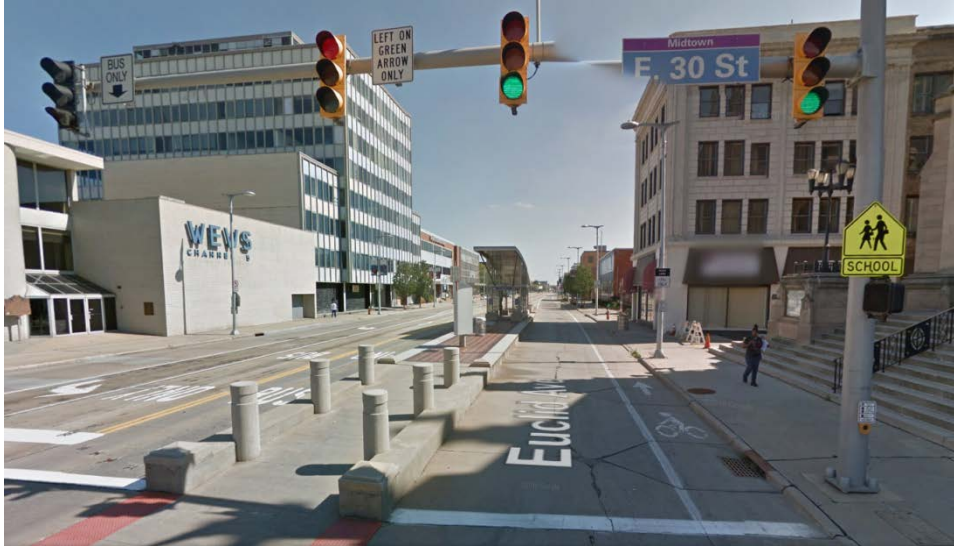
**FIGURE 3-17: HEALTHLINE, E 19TH STREET STATION, WESTBOUND**

**FIGURE 3-18: HEALTHLINE, E 24TH STREET STATION, EASTBOUND**

FIGURE 3-19: HEALTHLINE, E 30TH STREET STATION, WESTBOUND

The HealthLine operates in median dedicated bus lanes as well as in mixed traffic. As shown in the examples above, the median platforms serving the dedicated bus lanes have mixed traffic running along the backside of the raised platform.

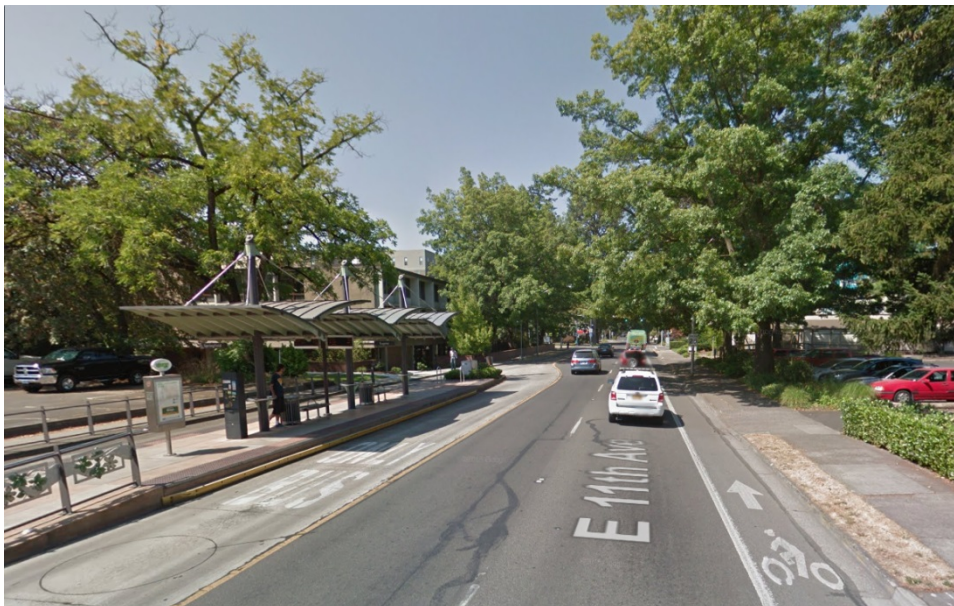
FIGURE 3-26: EMX, HILYARD STATION, NORTHBOUND

The Emerald Express (or EmX) operates in exclusive bus lanes for approximately 60% of its length, but for the remaining 40%, it operates in mixed traffic. At the Hilyard station shown in the image above, through traffic operates in the lane adjacent to the bus lane and also runs immediately adjacent to the back of the platform. At the Walnut station, shown below, the station is in a drop lane with vehicles entering mixed traffic upon exiting the station.

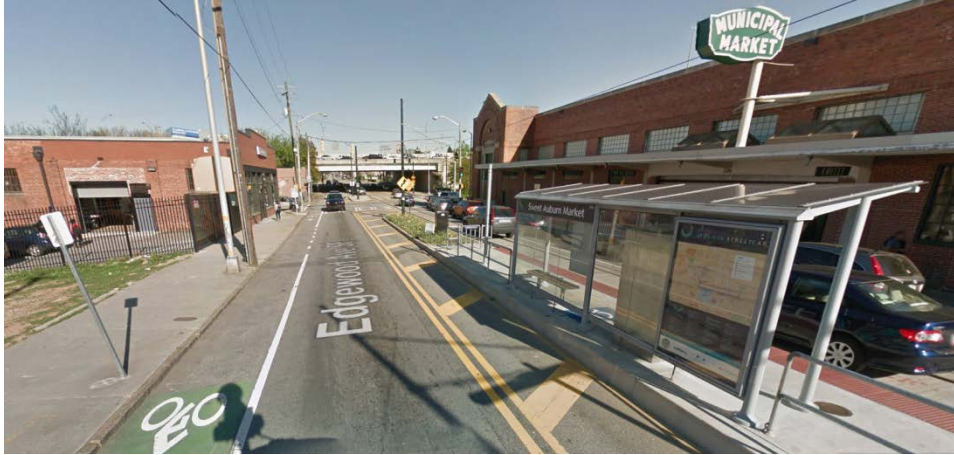
**FIGURE 3-31: ATLANTA STREETCAR, SWEET AUBURN MARKET STATION, EASTBOUND**

Like M-1 rail, the Atlanta Streetcar is a rail service operating in mixed traffic. Opened in 2015, the streetcar has both median and curbside stations constructed at a height of 14 inches. For the median stations like the Sweet Auburn Market station, mixed traffic runs alongside the backside of the raised station platform.

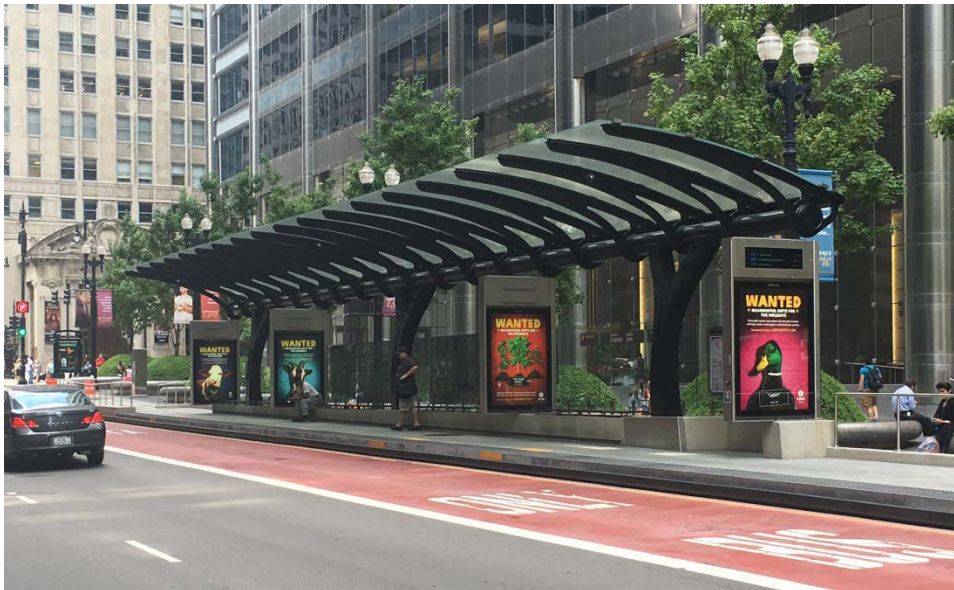
**FIGURE 3-34: LOOP LINK, MADISON STATION, WESTBOUND**

The Chicago Transit Authority's Loop Link went into service in 2015, using dedicated lanes along Washington and Madison Streets in downtown Chicago. The raised platforms are constructed at a height of 11 inches and include a bus curb.

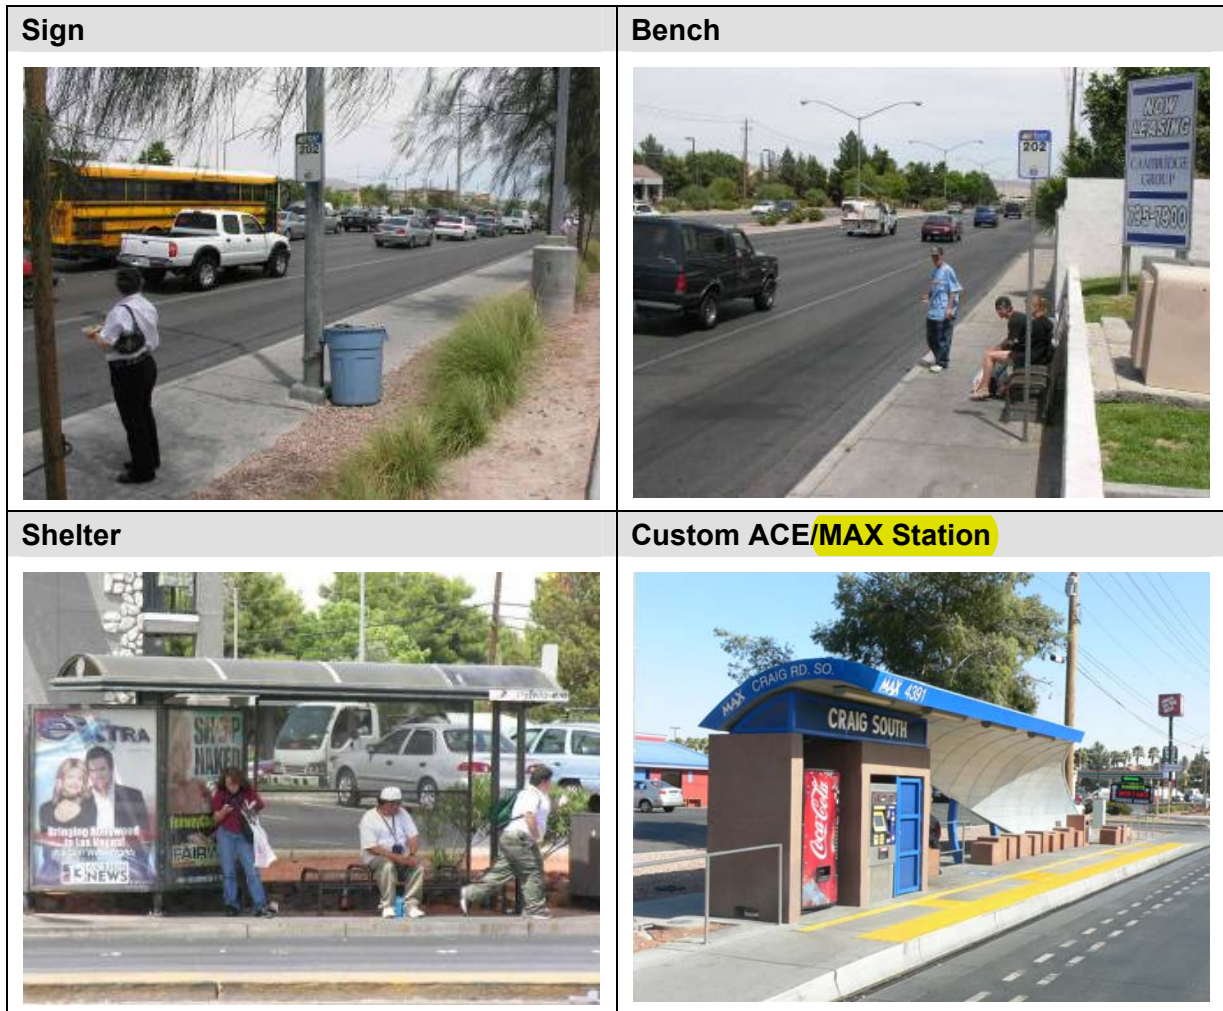
**Figure 2. Existing Transit Facility Types**

A variety of bus stop types are provided. The range of facilities includes signs marking the bus route, benches, shelters, and higher-amenity transit stops for ACE and MAX service. Examples of these facility types are shown in Figure 2.

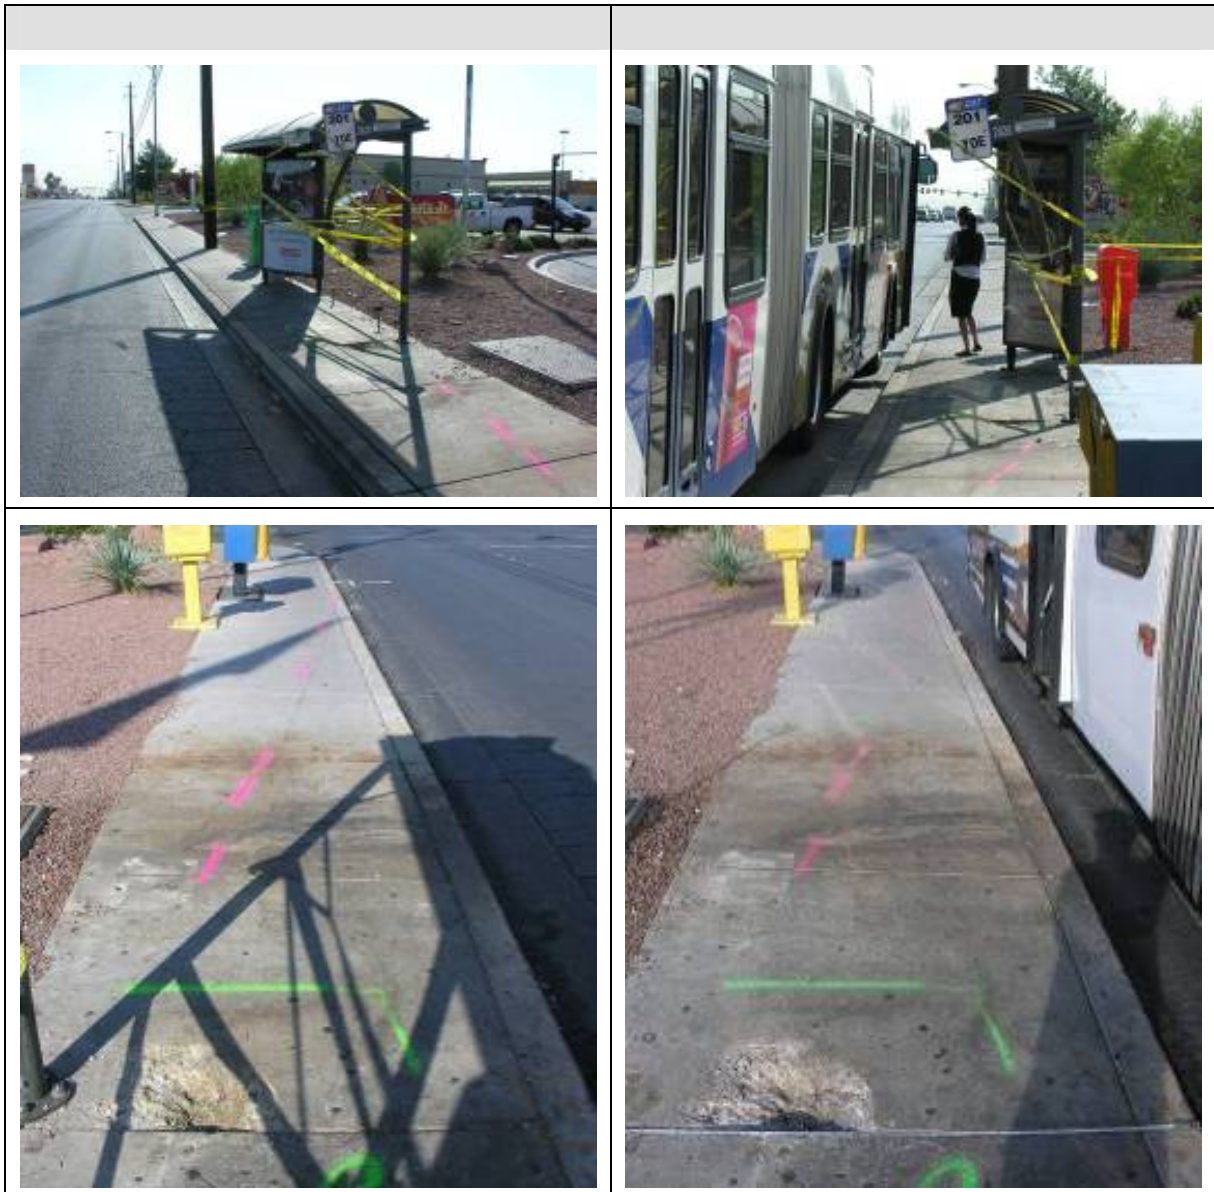
**Figure 6. Tropicana and Mojave Accident Scene**

On September 9, 2008, an automobile struck a bus shelter located on the southeast corner of Tropicana and Mojave. The crash involved a single vehicle (passenger car) that vaulted the curb and encroached into the roadside striking a bus shelter that was occupied by a single passenger. The passenger was transported to Sunrise Hospital by emergency medical personnel and was treated for injuries sustained in the accident. Figure 5 illustrates the site measurements taken at the scene on the morning of the accident. Figure 6 illustrates the accident scene at Tropicana and Mojave.

another 37 feet 4 inches coming to rest after striking the occupied bus shelter. The bus passenger was located approximately 4.5 feet behind the face of the curb. If the automobile was traveling in the outermost lane, then the car first began to deviate from its normal path approximately 20 feet prior to encroaching into the roadside. Based on the location and angle of the curb impact, it is believed that the automobile was traveling straight (eastbound) prior to the accident and would be classified as “failure to maintain lane.” The posted speed limit in this area is 45 miles per hour (mph) and the nearest NDOT traffic count location estimates an average of 50,000 ADT.

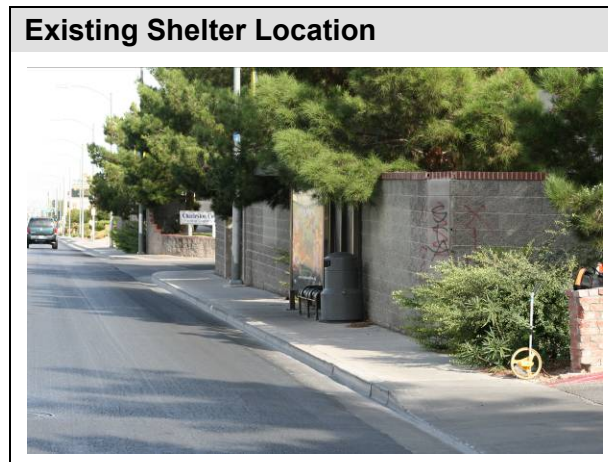
**Figure 9. Longitudinal Shelter Relocation**

The shelter in Figure 9 could be moved downstream approximately 100 feet to another location, which may increase the opportunity to set the

shelter back farther away from traffic. Other reasons for moving a transit stop in a longitudinal manner might include excessive left-turn volume before a farside stop, close proximity to a driveway or proximity to a median cut.

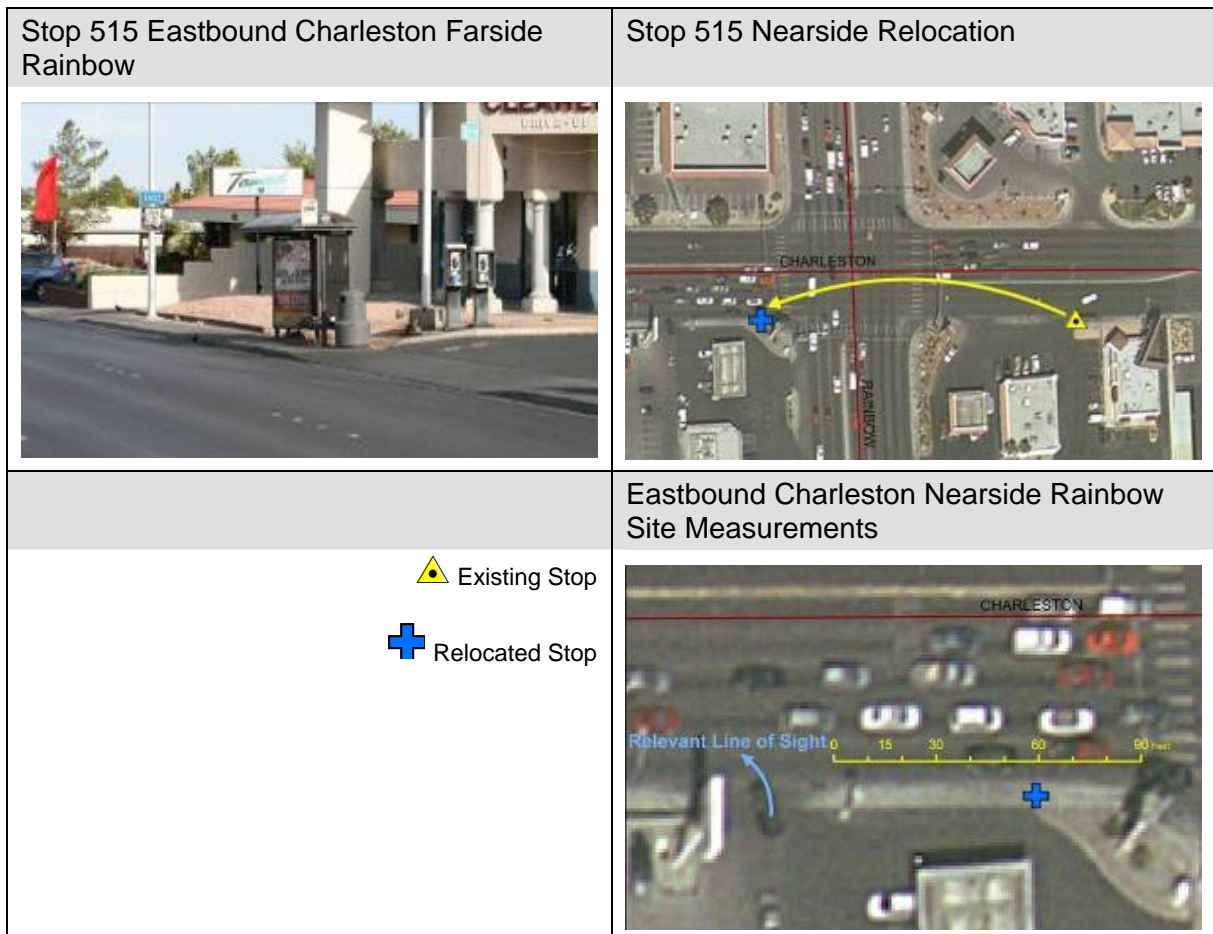
**Figure 10. Nearside Stop Reorientation at Charleston and Rainbow**

Under some circumstances, existing transit shelter safety concerns can be addressed by moving a stop from the far side of an intersection to the near side of an intersection, or visa versa. Figure 10 illustrates a stop that cannot be setback because of right-of-way constraints but could be relocated to the near side of the intersection. Figure 10 illustrates the relocation of Stop 515 that serves the Charleston 206 in the eastbound direction at Rainbow. The current location of the stop is approximately 154 feet east of the eastern crosswalk at Charleston and Rainbow. As an additional benefit, relocation from farside to nearside, in this case, would place the new stop only 30 feet away from a crosswalk, increasing the propensity for bus passengers to use the crosswalk when exiting the transit vehicle or arriving at the transit stop.

Because the stop being relocated is used as a time point, nearside orientation would be inappropriate because the bus may need to stand in an active travel lane when ahead of schedule. Standing in this active travel lane for the purpose of schedule adherence would block right turning automobiles for an unacceptable duration of time. RTC Transit Operations Planning staff would need to consider alternative operating practices relating to the use of this location as a time-point. Figure 10 illustrates some of the site level measurements of the hypothetical stop location. The Citizens Area Transit Bus Stop Guidelines require the location of nearside stops to be between 30 feet and 100 feet prior to the curb return and that 40 feet or 60 feet of clear space exist for use by transit vehicles. At the near side of Rainbow there is 90 feet of space from the curb return to a private driveway. Following RTC bus stop guidelines and leaving 30 feet of clear space from the curb return, there are 60 feet available for the transit vehicle to use while stopping. Additionally, the use of a nearside stop at this location would not adversely affect the line of sight for automobiles exiting the private

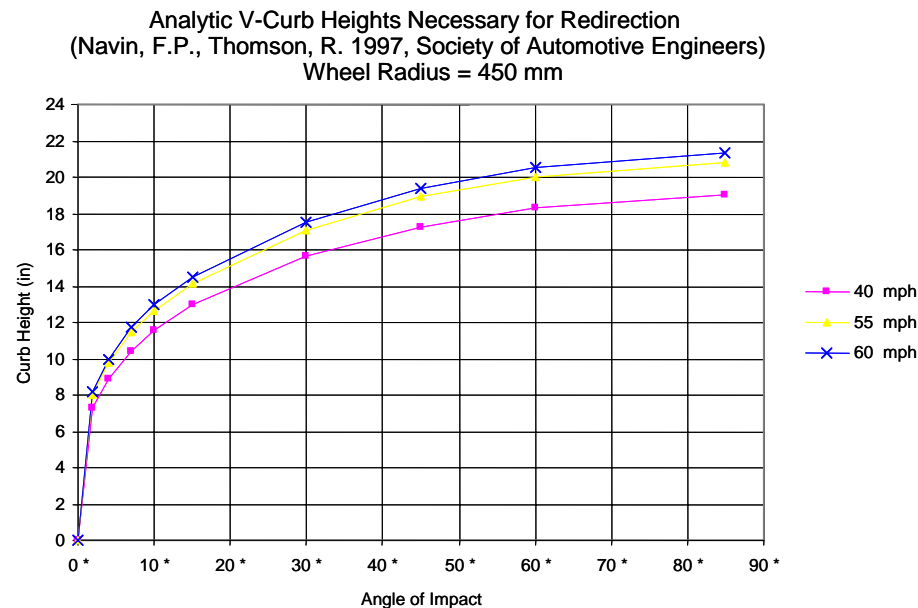
**Figure 13. Analytic Curb Height Estimates Necessary for Vehicular Redirection**

geometries. Subsequent analysis utilized the data obtained from the California Division of Highways tests. The results of the early tests form the basis of the current AASHTO policy relating to the use of vertical faced curbs—particularly regarding the use of vertical faced curb on high-speed facilities. While the distribution of vehicle types has changed considerably since the 1950s and 1960s, “the current version of the AASHTO Green Book contains substantially the same recommendations as the 1965 Green Book regarding the use of curbs.”<sup>15</sup>

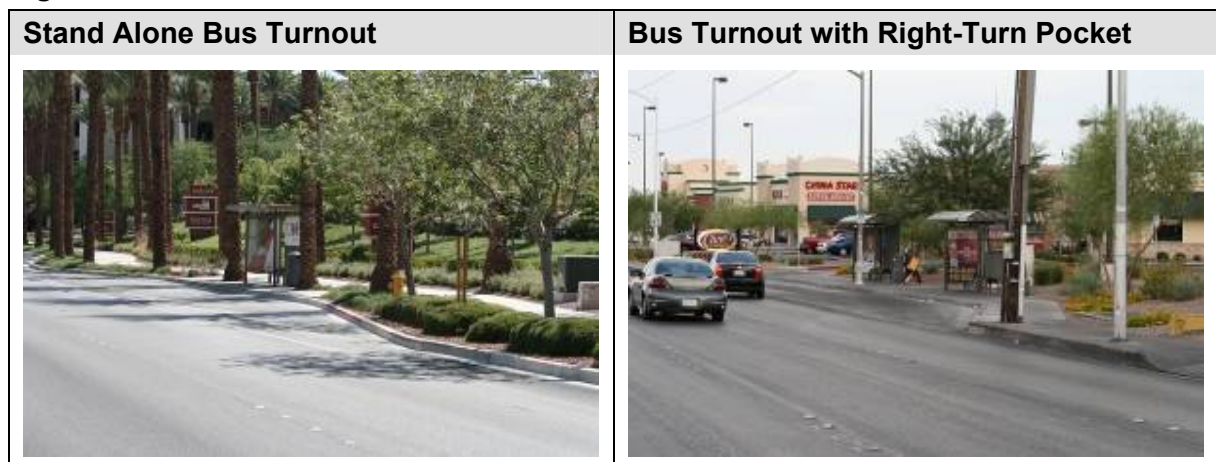
**Figure 16. Bus Turnouts**

In some jurisdictions, bus turnouts can be used as an emergency turnout for the general public to prevent blocking a lane of traffic. However, should a bus attempt to enter the turnout during this time, the automobile must make way. Figure 16 illustrates two bus turnouts on Charleston Boulevard.

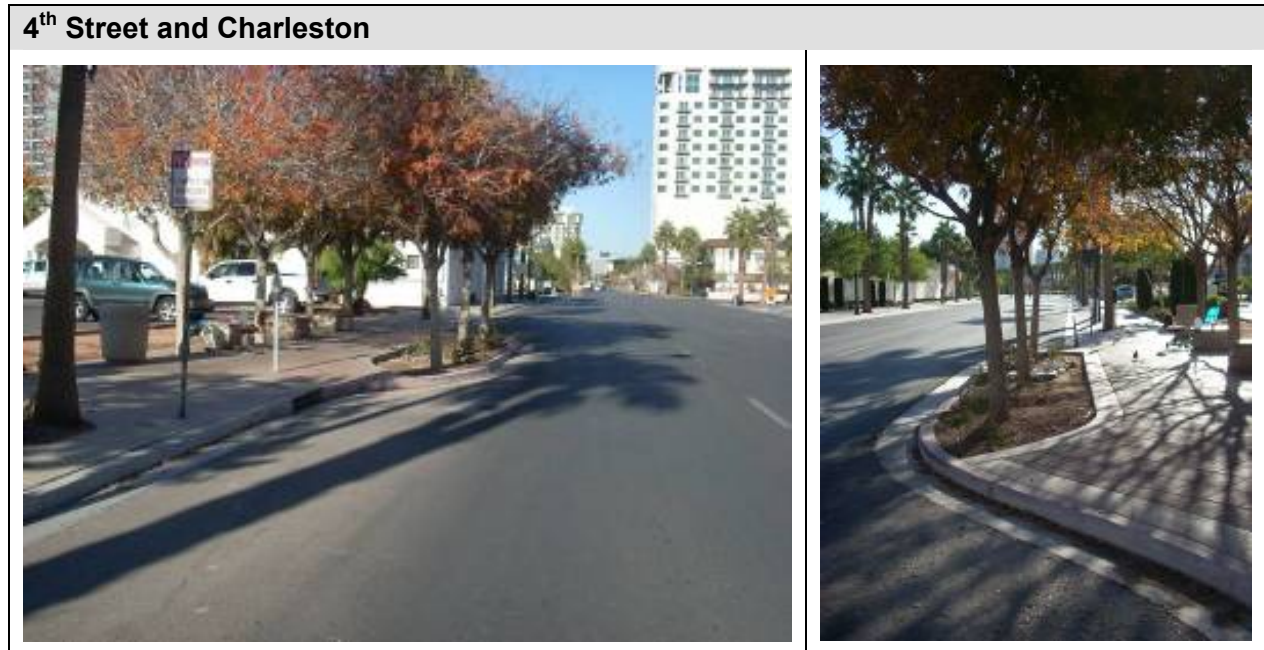
**Figure 17. Curb Extension (Bulb-Out)**

Figure 17 illustrates an existing curb extension at 4<sup>th</sup> Street and Charleston Boulevard in Las Vegas. The purpose of this curb extension is to provide a parking lane that is protected from automobiles making left turns from northbound 4<sup>th</sup> Street to westbound Charleston.

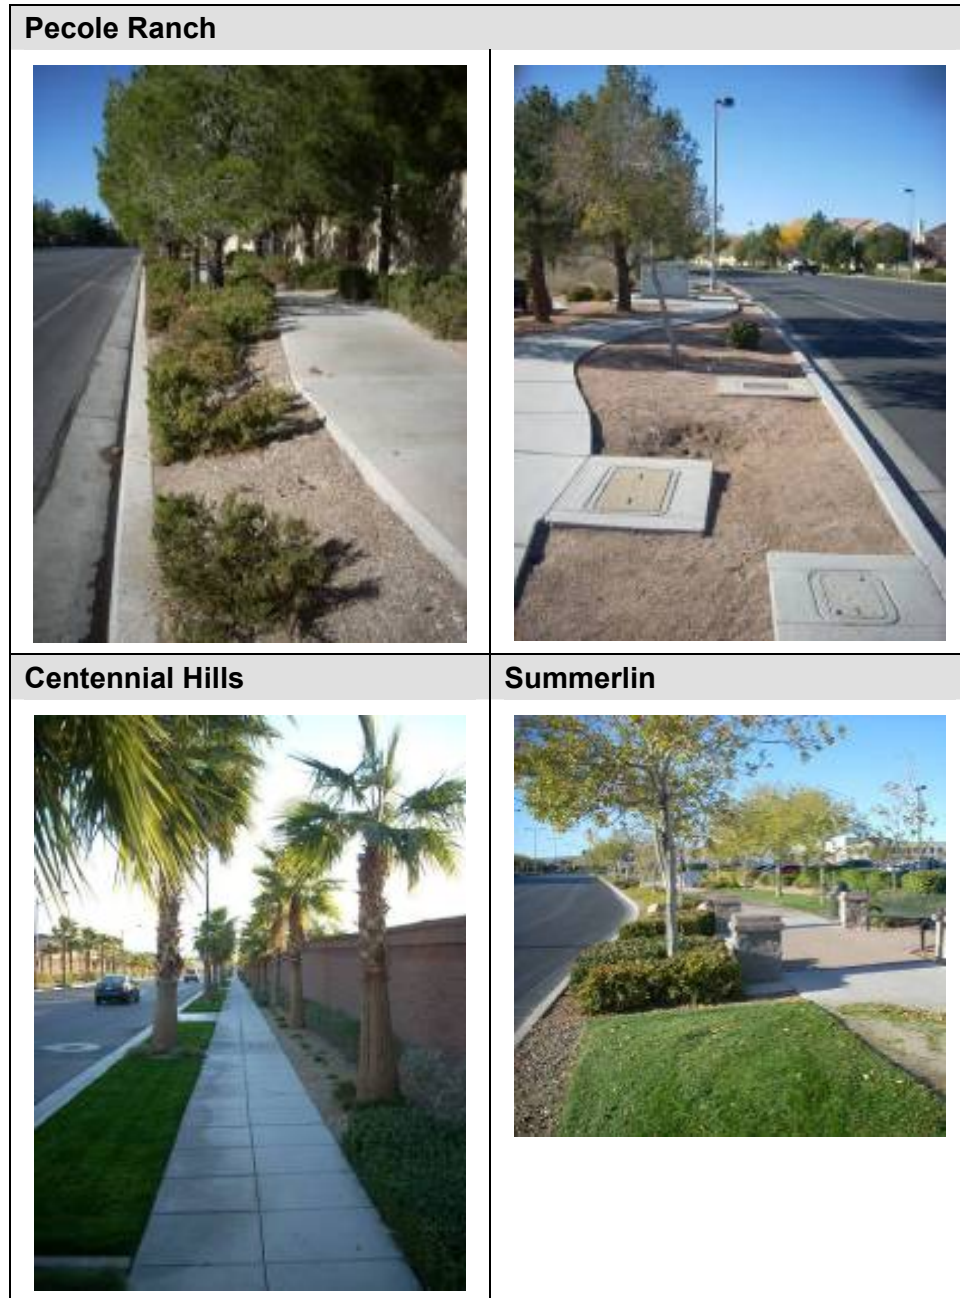
**Figure 18. Existing Pedestrian Buffers**

Figure 18 illustrates different pedestrian buffers throughout the Las Vegas area. In general, these sites are located in recently developed, upper income areas.

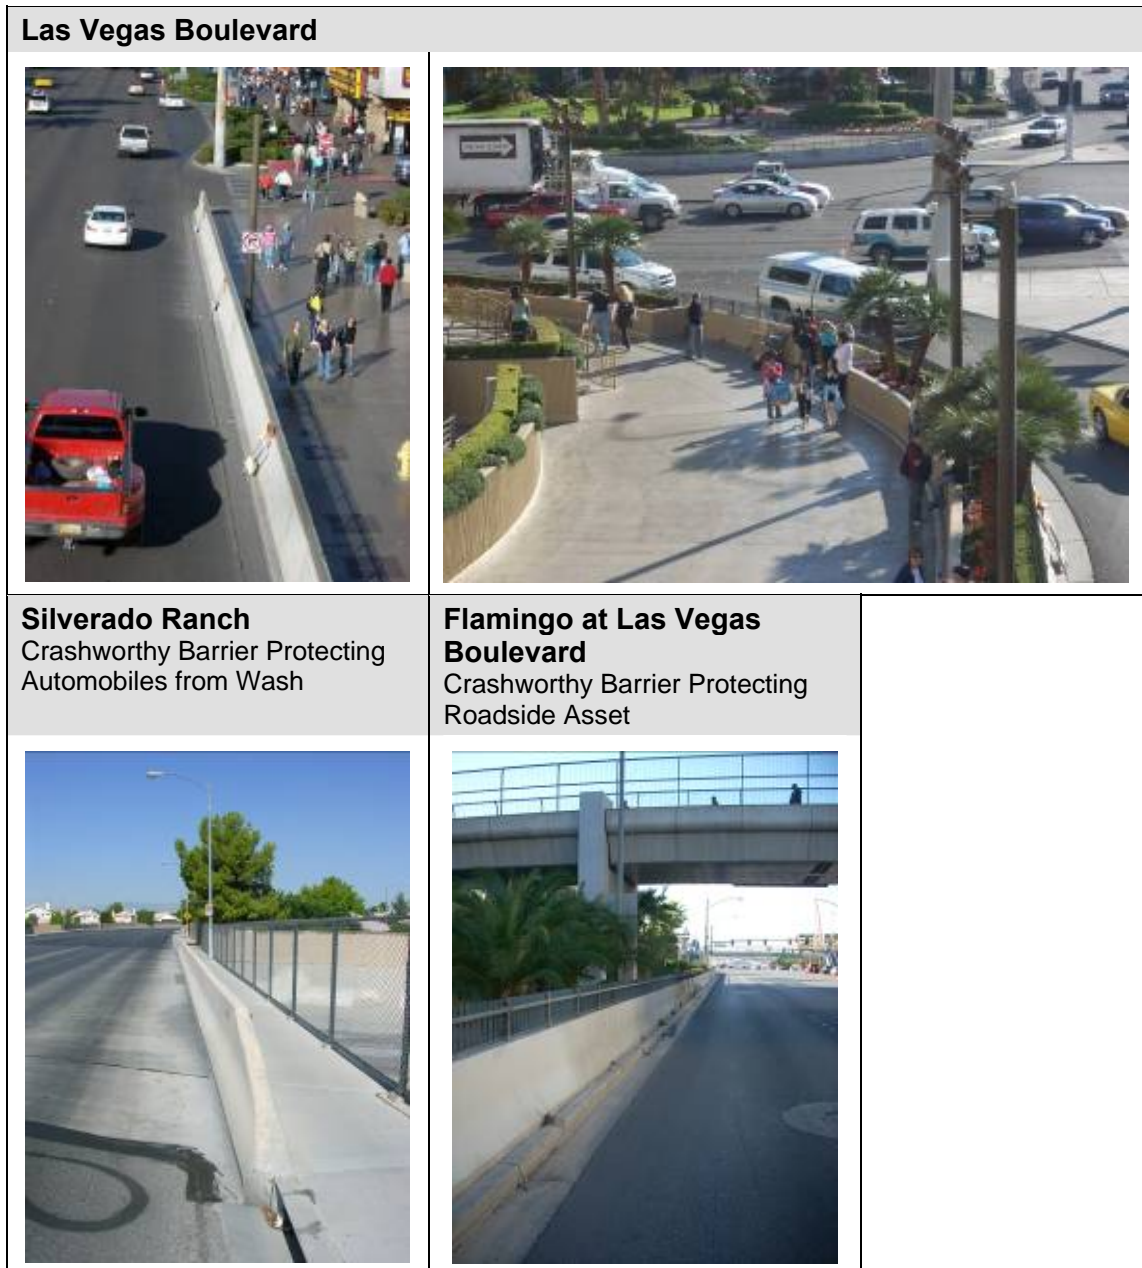
**Figure 19. Positive (Crashworthy Barriers)**

The interpretation of these categories is left to the judgment of the planner or designer, as there are no nationally recognized warrants for crashworthy pedestrian barriers. Figure 19 illustrates different crashworthy barriers throughout the Las Vegas area.

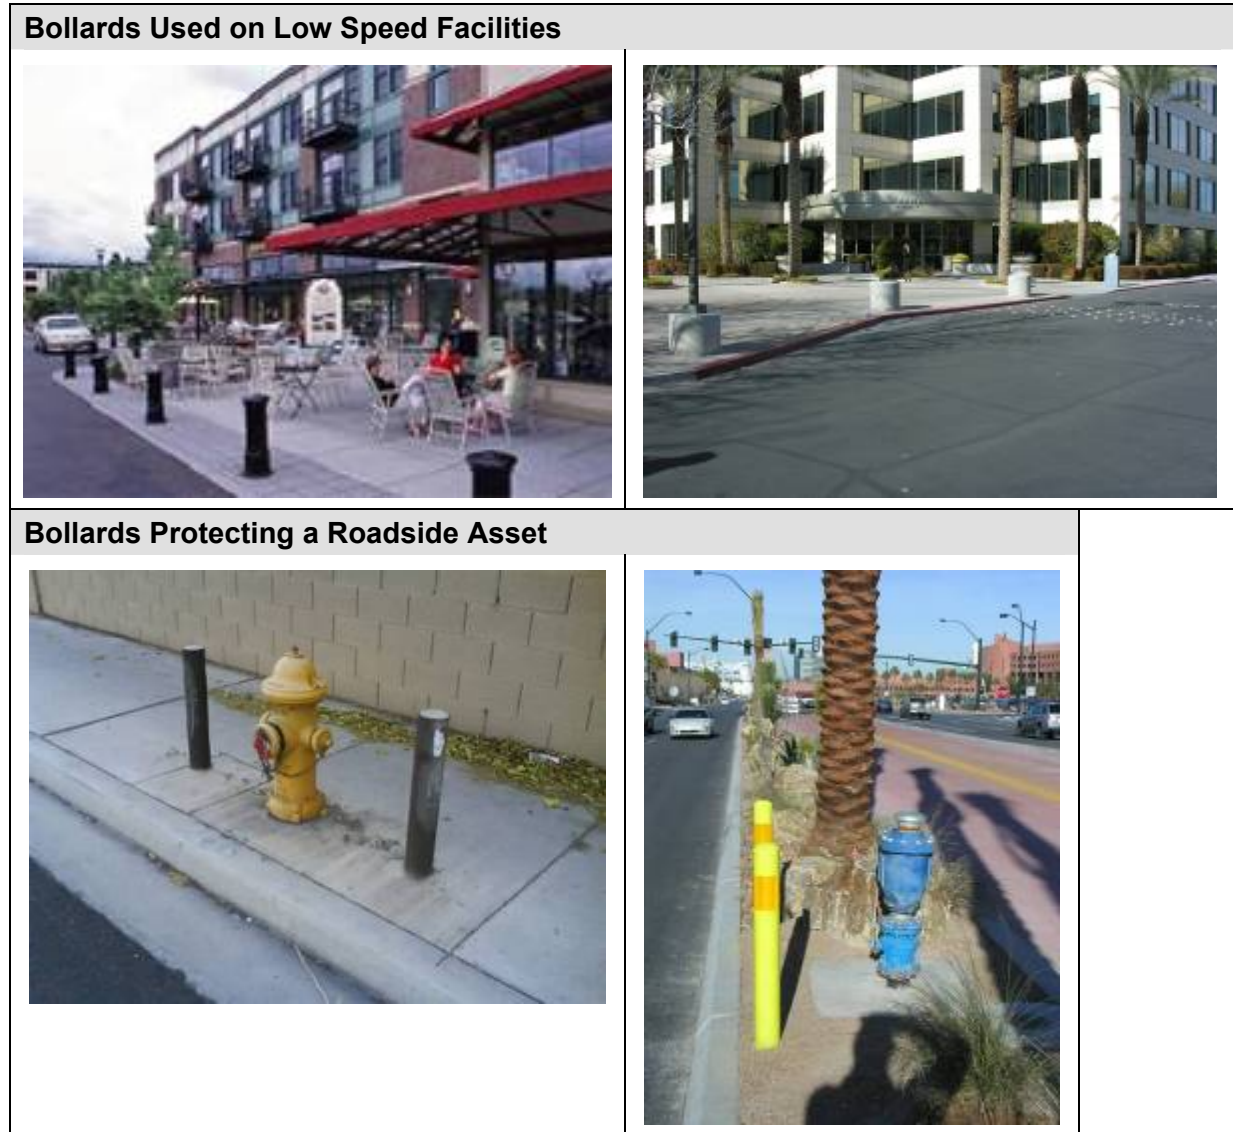
**Figure 20. Bollards in Differing Contexts**

Figure 20 illustrates the use of bollards for different purposes and on different facilities. In general, bollards should only be used on low speed facilities such as parking lots or passenger drop off areas. The presence of bollards within the Clear Zone of a roadside presents an additional roadside hazard and the use of such items should be minimized where possible. Additionally, traditional bollards are not designed to arrest an

errant vehicle traveling at 40 mph or above and the impact during such an incident may present additional hazards to pedestrians in the vicinity of the impact. The use of bollards along a roadside requires careful analysis and precise engineering judgment that includes the expected speed and general use of the roadway.

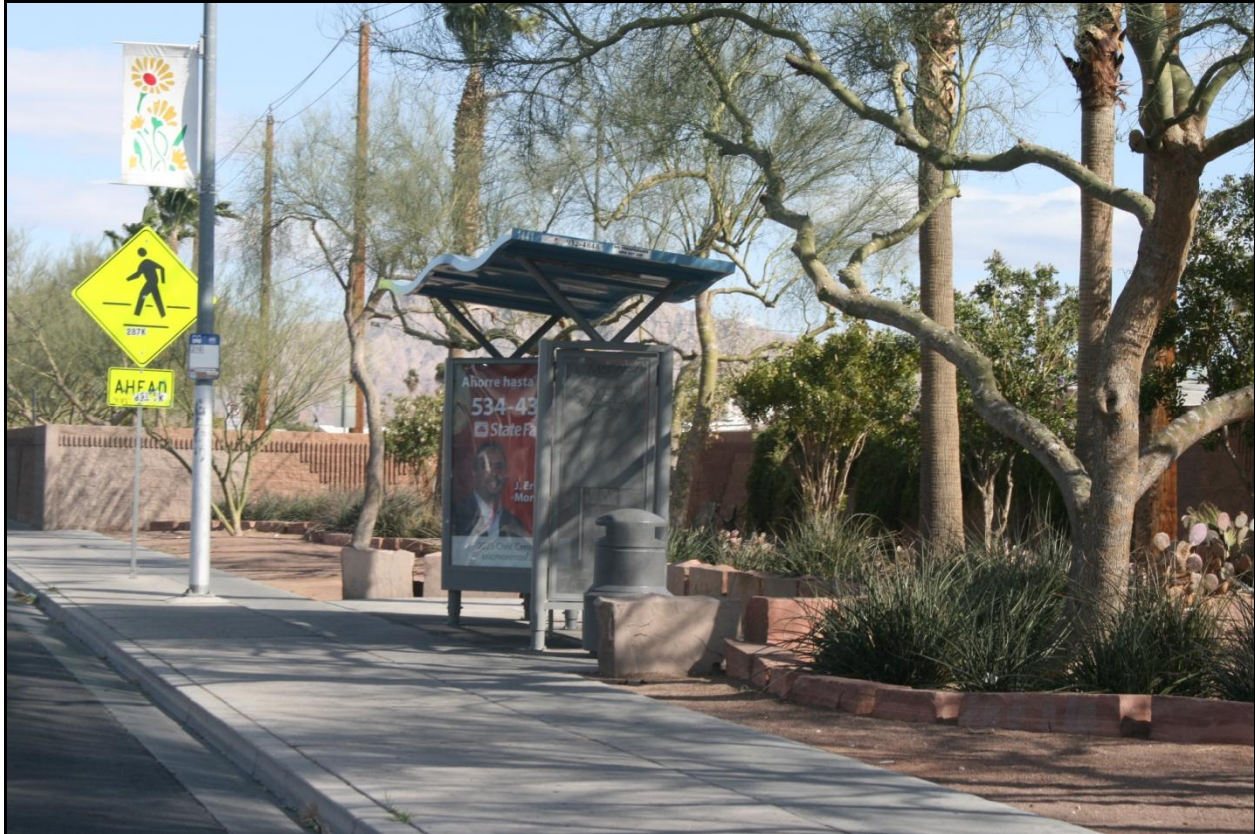
**Figure 4: Las Vegas Valley Solar-Powered Bus Shelter**

An example of a solar powered bus stop located in the Las Vegas Valley can be viewed in Figure 4.

Well-lit transit shelters will not only make transit riders feel safer, they will also help drivers locate them on the side of the road. Additionally, easier identification of transit shelters will help prevent drivers from hitting them. The RTC has made the effort to light transit shelters using solar/LED lighting, and should continue to achieve adequate lighting at all transit shelters throughout the system.

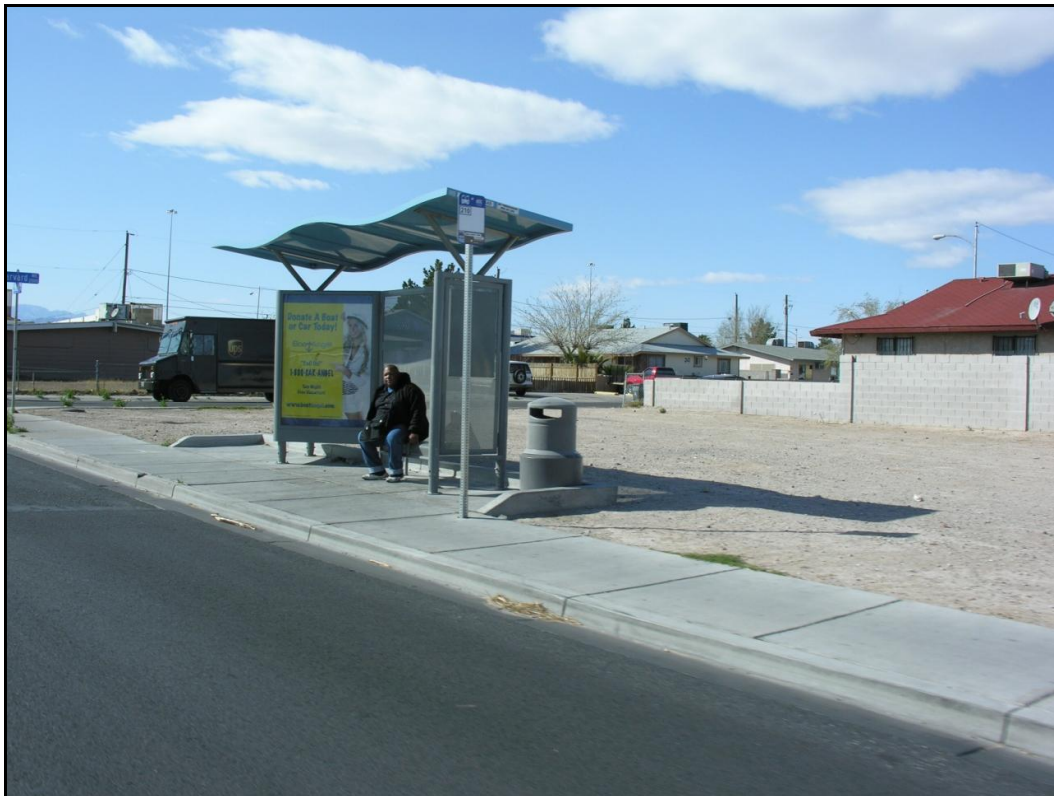
**Figure 6: Las Vegas Valley Bus Shelter Located On Bus Pad Behind Sidewalk**

way to move bus stops back.”<sup>14</sup> Figure 5 illustrates a bus stop that is located within the sidewalk, whereas Figure 6 illustrates a bus stop that is located on a bus pad behind the sidewalk.

Moving the transit shelters back behind the sidewalk will greatly reduce the number of transit shelters that are struck by a vehicle that has left the roadway. The RTC has made the effort to move transit shelters further away from the road, however there are multiple locations where easement rights or right-of-way is not available behind the sidewalk to implement this strategy. Given the economic and right-of-way constraints, strides should continue to be made to move all transit shelters at least 6-feet from the edge of the curb throughout the Las Vegas Valley.

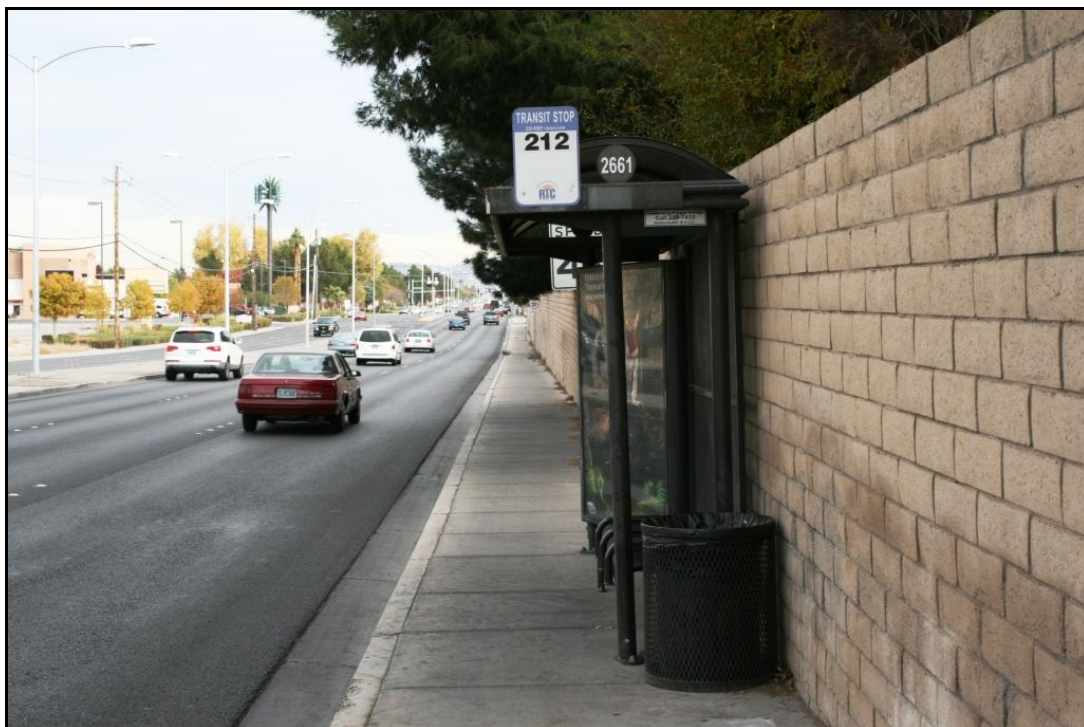
**Figure 7: Las Vegas Valley Transit Shelter Located Against A Block Wall**

The real issue of stops and shelters against block walls in the Las Vegas Valley is that the stop or shelter is often too close to the curb. All shelters against block walls should be considered for relocation or the right-of-way could be purchased to move the wall and shelter back. Positive shelter protection measures could be implemented where relocation is not feasible.

Figure 7 is an example of a transit shelter that is located against a block wall. This transit shelter could be moved to a different location that offers a greater offset distance from the curb or other positive protection measures could be implemented.
