# Station Platform Height: Safety and Precedents

**TECHNICAL MEMORANDUM**

**August 2016**

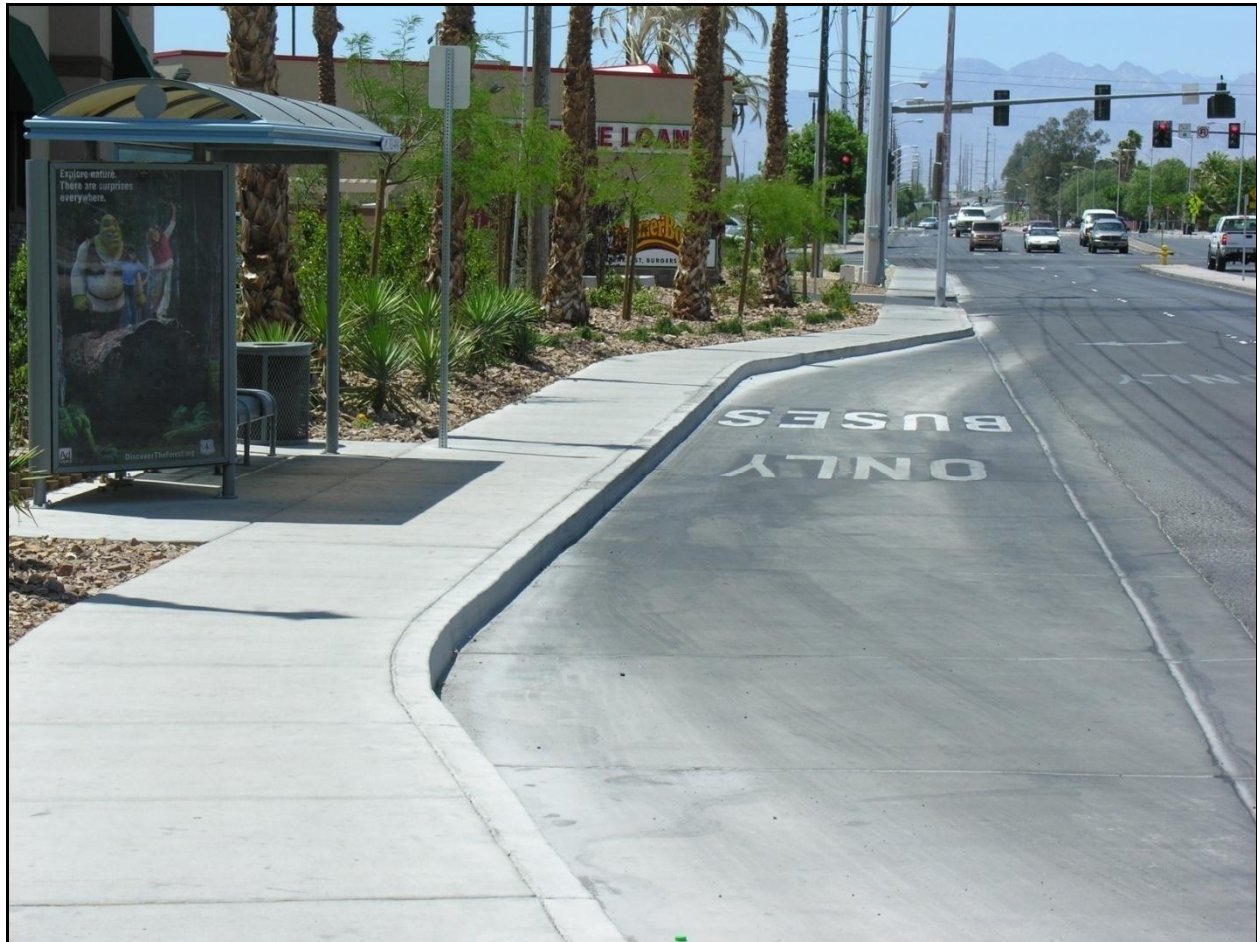
**Figure 8: Las Vegas Valley Bus Turnout**

A bus turnout, or bus bay, is a special zone on the side of the main roadway for buses to stop in order to pick up and drop off passengers. The purpose of the bus bay is to help buses avoid blocking a lane of traffic and to improve passenger safety during boarding and alighting. Additionally, bus turnouts add extra distance between the vehicles traveling on the roadway and the transit shelter. An example of a bus turnout in the Las Vegas Valley can be viewed in Figure 8.

Bus turnouts and bus bulbs help keep transit shelters further than 6-feet from the roadway, which accomplishes the same goal as moving bus shelters back behind the sidewalk. Bus turnouts are much more common in the Las Vegas Valley because there is not an abundance of on-street parking; in fact 478 bus turnouts have already been implemented. Therefore, bus turnouts should be added in all transit shelter locations where right-of-way is available.

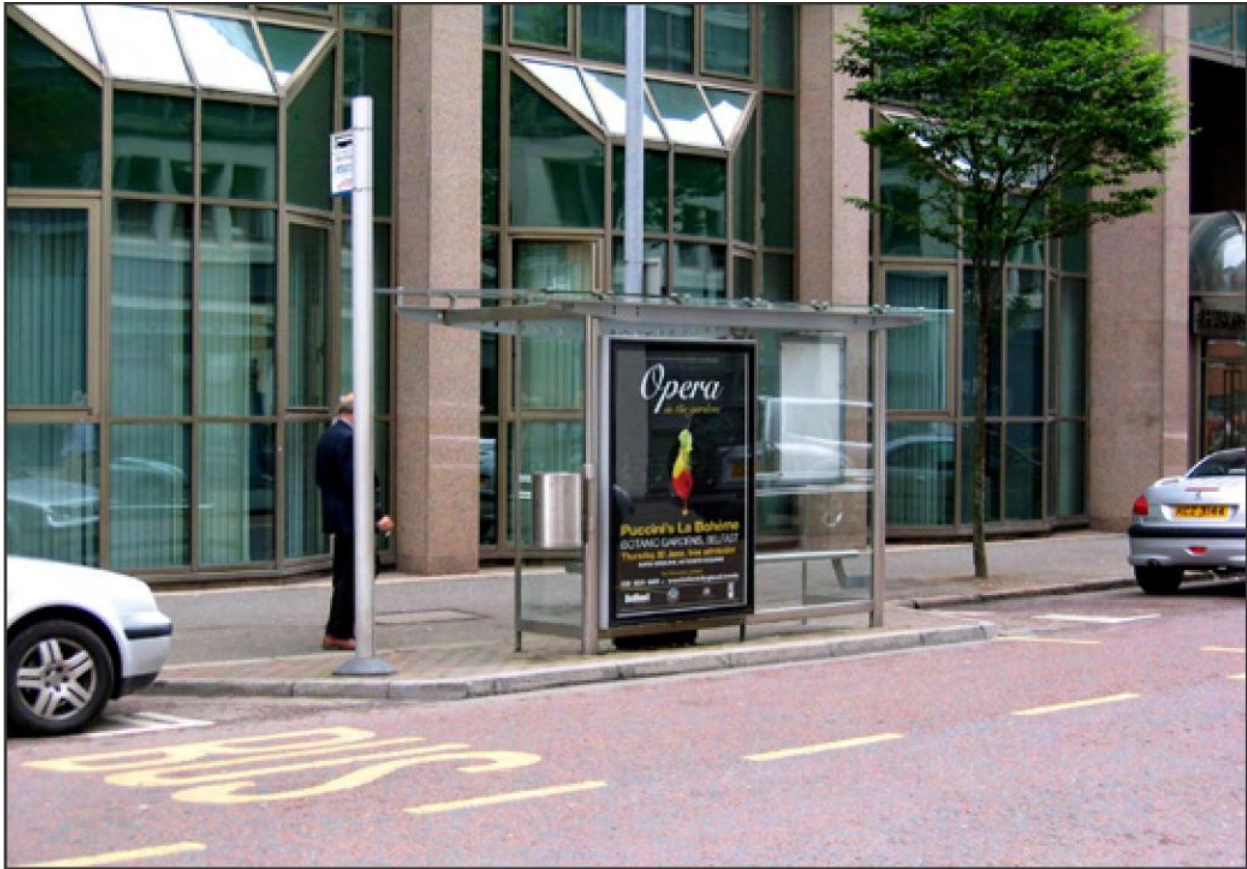
**Figure 9: Bus Bulb<sup>15</sup>**

A bus bulb, or bus boarder, is where a sidewalk is extended outwards for a bus stop and typically it replaces a portion of an existing parking lane. The purpose of the bus bulb is to allow a bus to stay in its traffic lane to pick-up and drop-off passengers, without having to pull over to the curb. Similar to bus turnouts, bus bulbs add extra distance between the vehicles traveling on the roadway and the transit shelter. An example of a bus bulb (where the transit shelter is backed up to the curb for splash protection in wet weather) can be viewed in Figure 9. Note: Bus bulbs can be configured similar to Figure 8, where the transit shelter is located behind the sidewalk and facing the roadway.

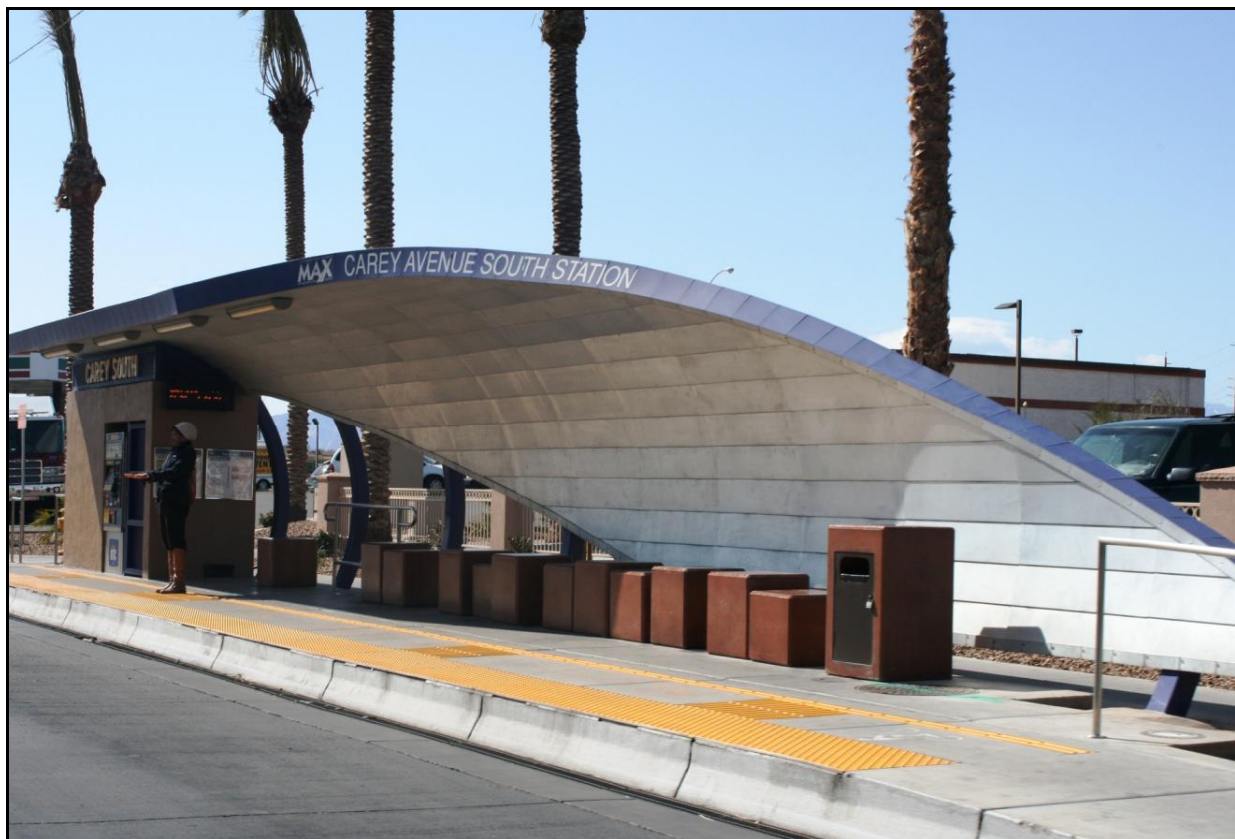
**Figure 10: Raised Curb At Las Vegas MAX Stop**

Level boarding already exists at some of the Las Vegas MAX transit shelters and along the Sahara and Boulder Highway BRT routes. The curb height along these alignments is 10 or 11 inches to accommodate the vehicles in use, and this height is much less effective in redirecting a vehicle than the 14 or 15 inch height mentioned in the APTA document. As such, raising the curb height as a safety measure is marginally effective, given the types of crash incidents experienced locally. Figure 10 illustrates the curb height at a Las Vegas MAX stop and Figure 11 illustrates the ease of riders boarding and leaving the Las Vegas MAX.

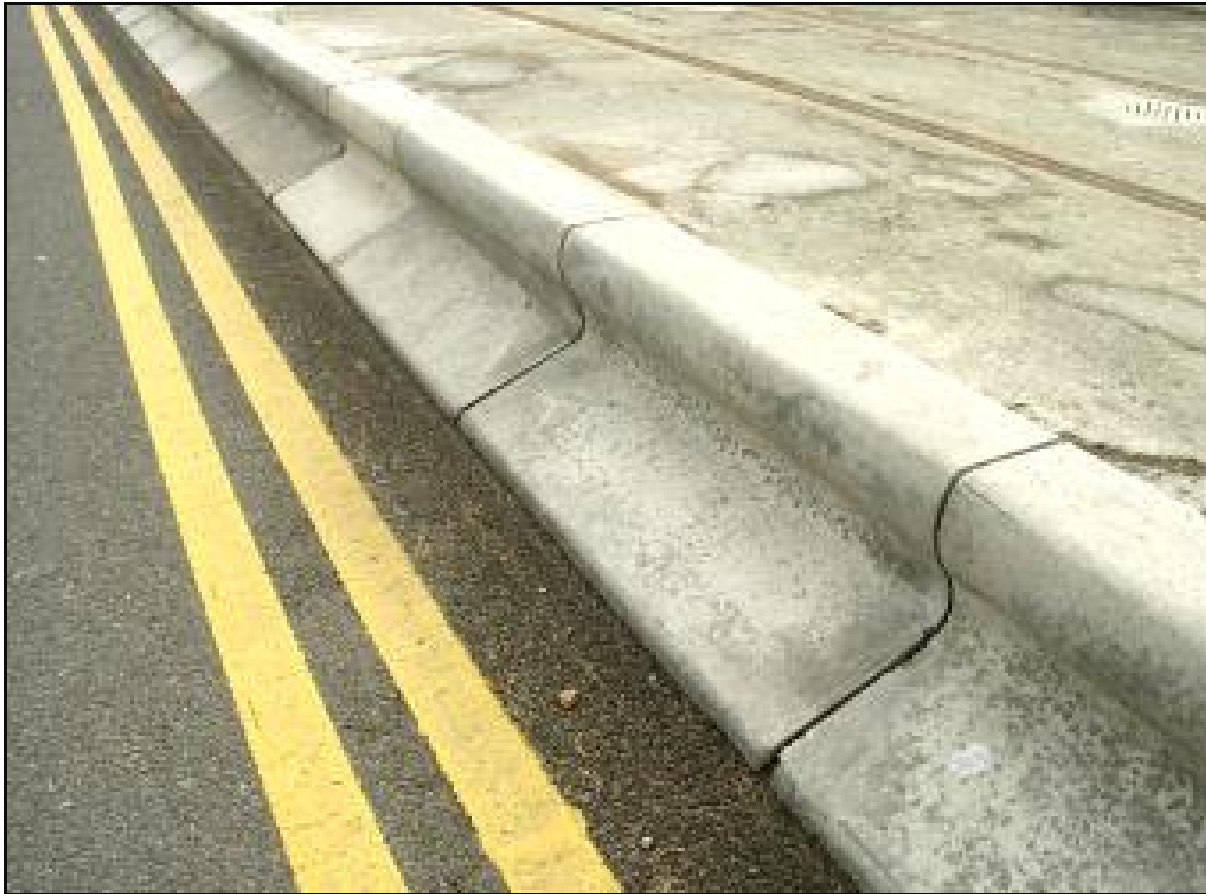
**Figure 12: High Containment Curb**

High containment curbs are an alternative to simply raising the curb and are used to not only prevent vehicles from leaving the roadway, but actually safely redirect the vehicle back onto its intended path.

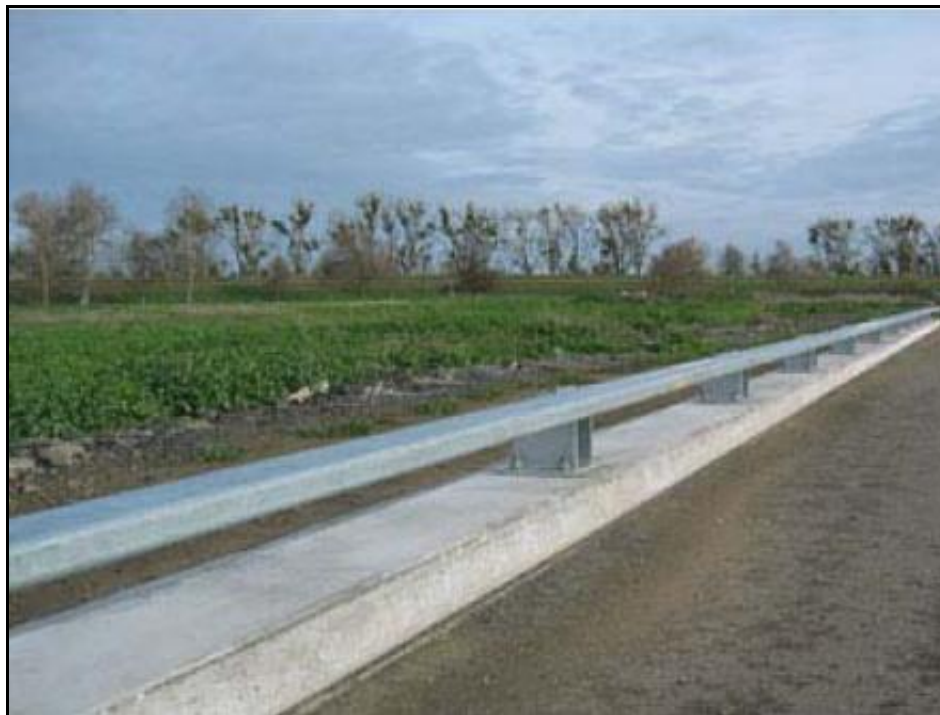
**Figure 14: Caltrans' "Test" Low Profile Barrier<sup>19</sup>**

It is important to note that barriers are “used to protect bystanders, pedestrians, and cyclists”, which is the goal of this study. Barriers are an intimidating obstruction that will help prevent drivers from leaving the roadway and crashing into transit stops. A couple of examples of barrier rails can be viewed in Figure 13 and Figure 14.

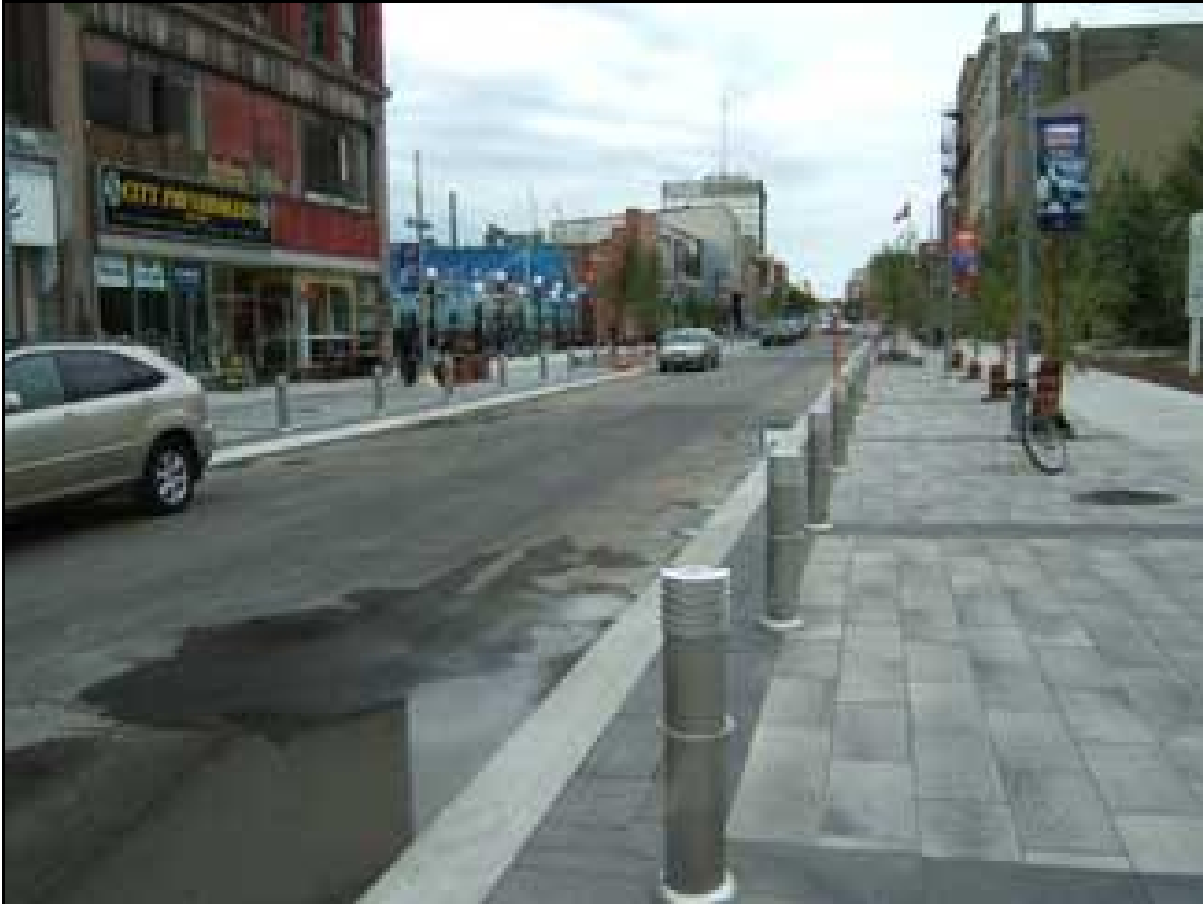
**Figure 15: Bollards Separating The Roadway And The Sidewalk<sup>23</sup>**

Bollards are an available option, when other measures cannot be implemented, to help reduce the number of vehicles crashing into transit stops. However, the safety of motorists cannot be ignored when adding bollards because little is gained by trading one type of injury for another. In addition, when determining the location of a transit stop, it would be desirable to utilize existing features to shield and protect transit passengers; such as existing utility poles, trees, and fire hydrants. Since other measures such as moving transit stops away from the curb and providing landscape buffers are recognized successful primary strategies, bollards should only be considered after these measures are not feasible. Additional bollard information can be found in the Appendix.

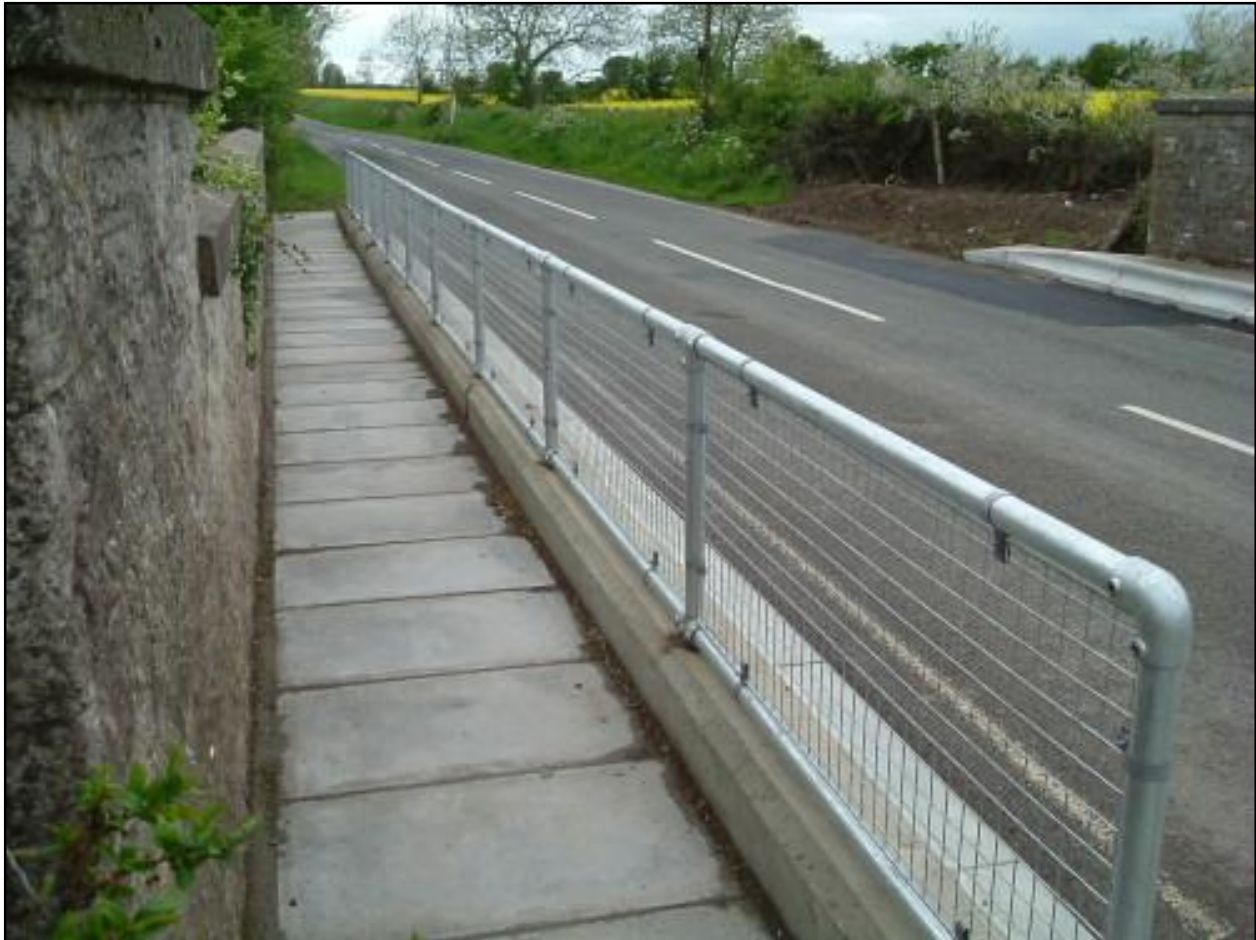
**Figure 16: Handrail Separating Sidewalk And Roadway<sup>24</sup>**

In addition to the raised curb, a handrail could help pedestrians adjust to the changing slope in the sidewalk. Furthermore, it could be a supplementary barrier between vehicles and pedestrians and can be used as an alternative to bollards. The handrail would have a similar visual affect as the bollard system, in that it would catch the eye of a driver and it would help prevent a vehicle from leaving the roadway and hitting a transit shelter. Additionally, a handrail would be more aesthetically pleasing than a traditional bollard. However, the handrail could have similar issues as the bollard system, in that it could actually endanger people by causing a shrapnel effect when impacted by a vehicle. In addition, the end of the top of the handrail would need to be designed to prevent the handrail from becoming a spear and injuring the driver of an oncoming vehicle. An example of a handrail protecting a sidewalk from a roadway can be viewed in Figure 16.

A handrail is an option to not only help reduce the number of vehicles crashing into transit stops, but as an assistance mechanism for pedestrians who need help adjusting to the change in slope of the sidewalk.

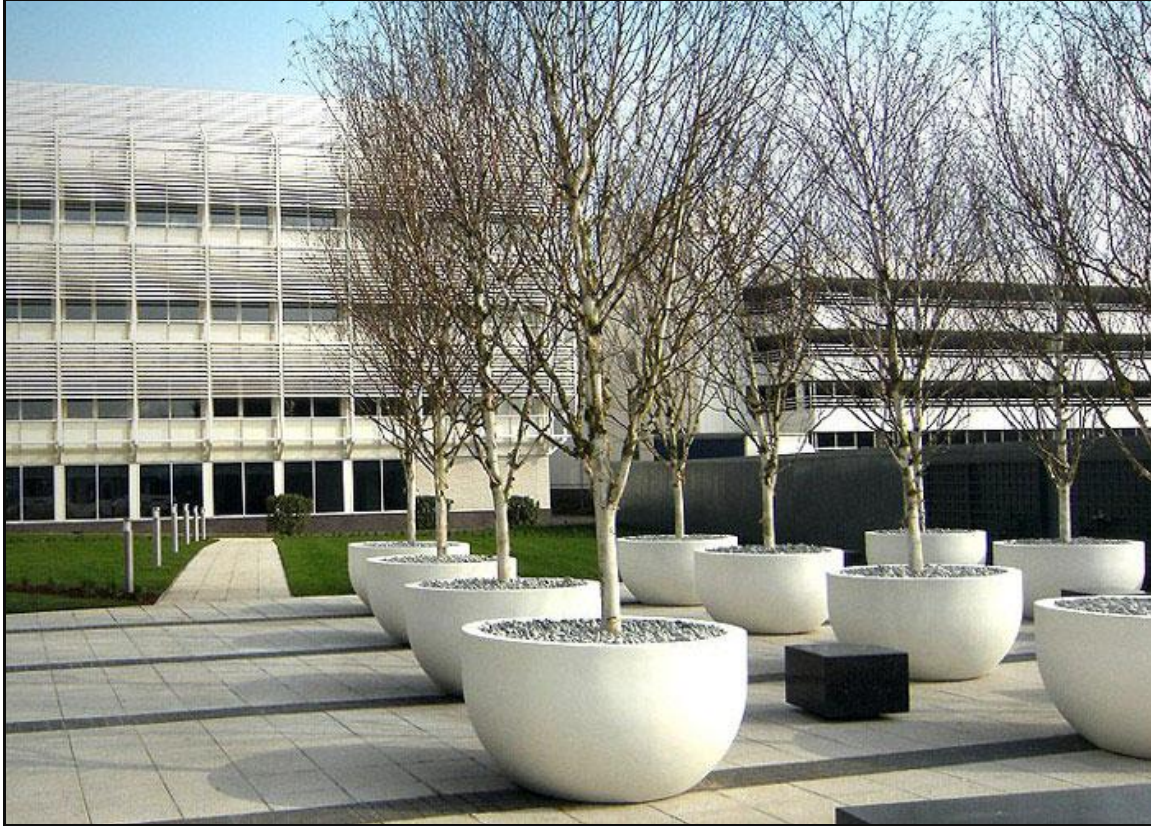
Figure 17: Concrete Planters With Trees<sup>25</sup>

Concrete planters, with trees planted inside of them, could be used as an alternative to a bollard system. The concrete planter and tree would prevent a car from hitting a shelter and provide much needed shade during the hot summer months. In addition, it would be a much more aesthetically pleasing option than a typical bollard system. However, the width required to incorporate planters behind the curb is a major consideration, moreover the RTC would need to resolve the maintenance issue. One possibility would be to give property owners an option between the concrete planters or other measures, and if the owners choose the concrete planters they must agree to maintain the trees. Figure 17 and Figure 18 are examples of concrete planters that could be used as a barrier between pedestrians and vehicles.

Concrete planters with trees, placed in front of transit shelters, would not only provide shade but they could help stop or slow down vehicles that are airborne, similar to the one described at the beginning of the document. However, the trees would have a negative effect on solar panel operation. If implemented, it is recommended that they are placed at least 6 feet from the edge of the curb.

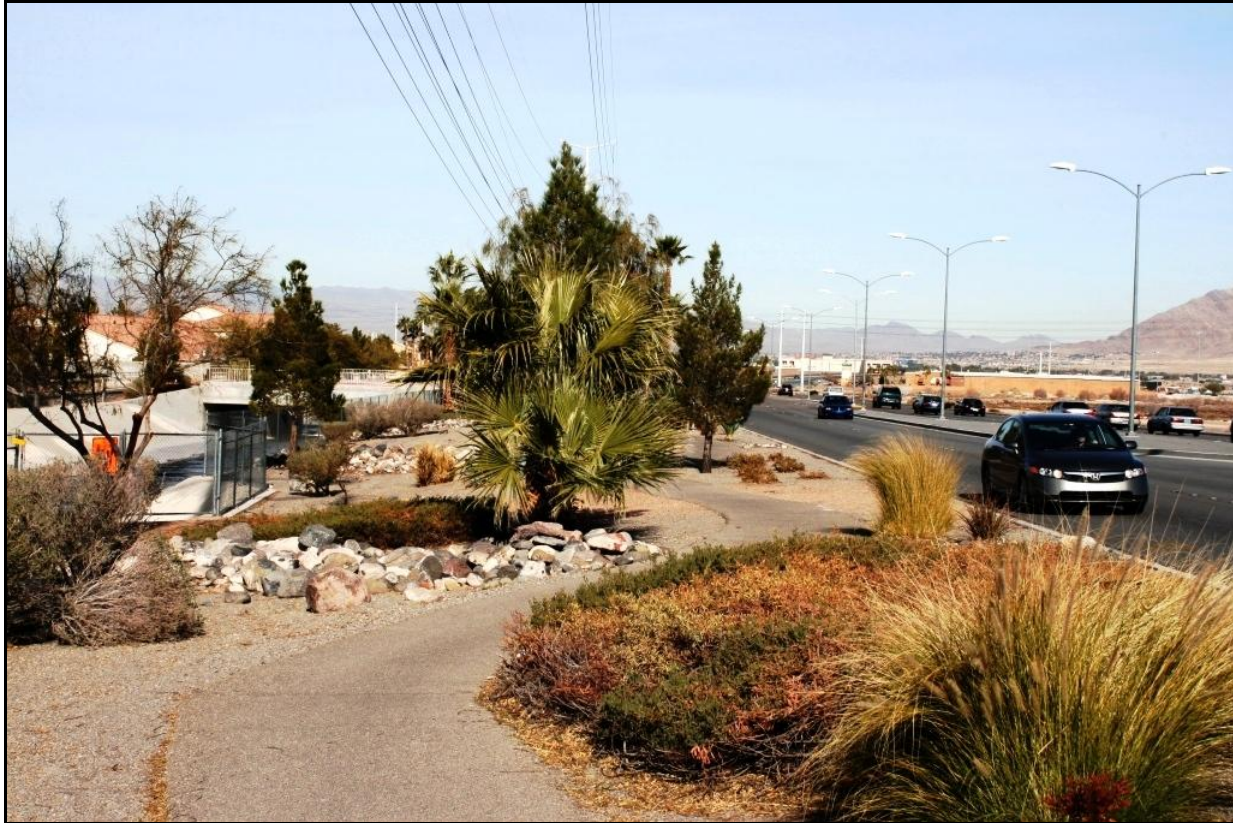
**Figure 20: Pedestrian Buffer Between Roadway And Meandering Sidewalk**

One option included in many Complete Street studies involves the implementation of a pedestrian buffer, which adds a more comfortable distance between the transit stop and the roadway, and it makes pedestrians feel safer when walking alongside a major arterial. Additionally, it is aesthetically pleasing and could be used for trees which would provide much needed shade in the hot summer months. Figure 20 is an example of a pedestrian buffer between the roadway and meandering sidewalk within the Las Vegas Valley.

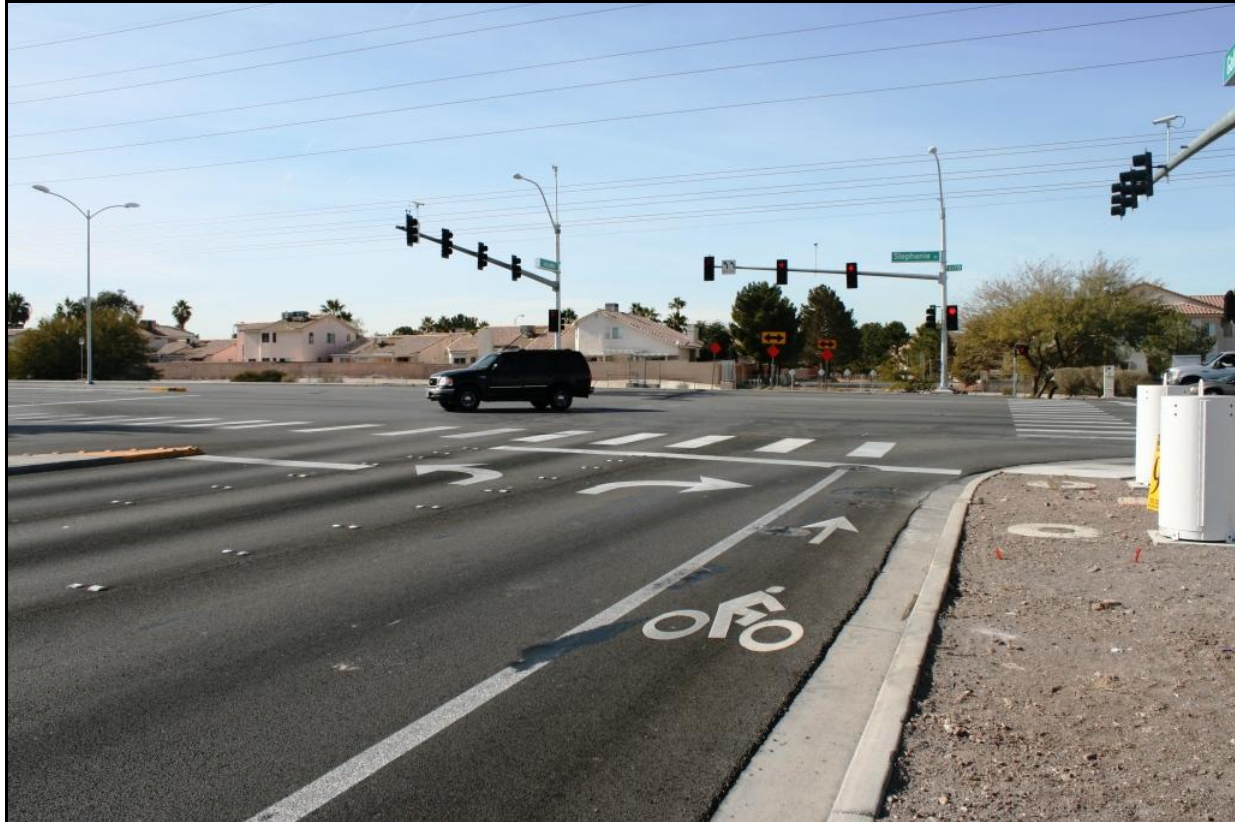
**Figure 21: Bicycle Lane Within The Roadway**

The RTC recently completed a *Regional Complete Streets Study* and is in the process of developing a *Complete Streets For Living Communities Design Guide* which will focus on improving corridors throughout the Las Vegas Valley with Complete Streets in mind. Items that have already been implemented include bicycle lanes (see Figure 21) and “Bus Only” lanes (see Figure 22). The “Bus Only” lanes are another way to add distance between passenger vehicles on the roadway and the transit stop.

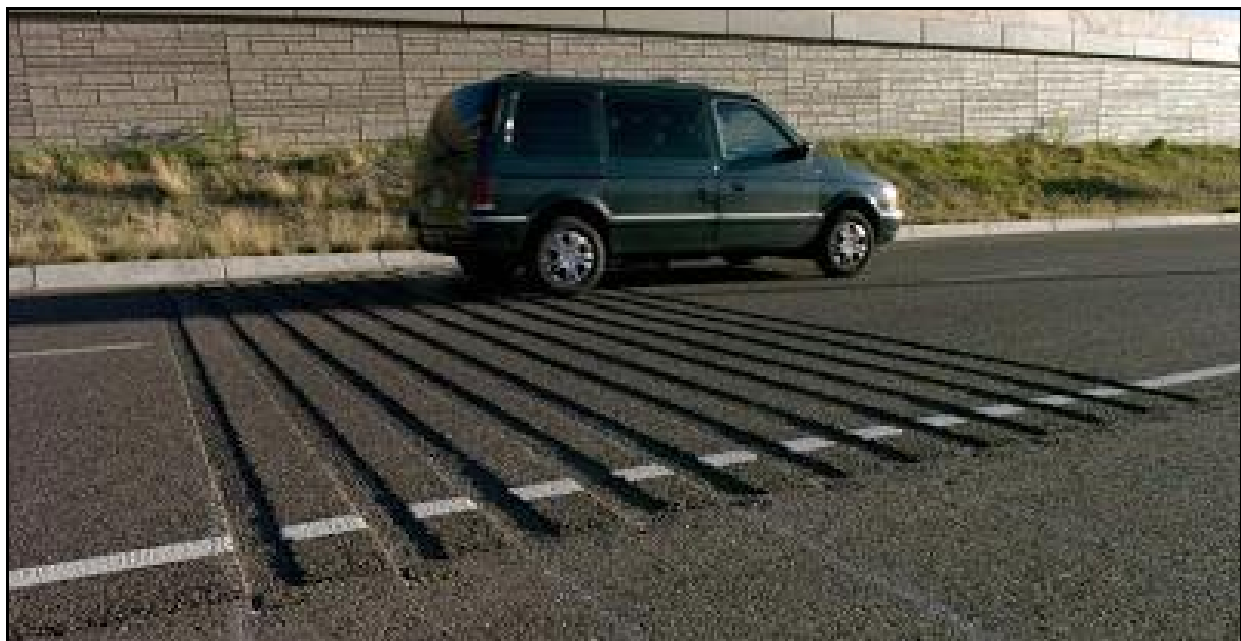
**Figure 23: Roadway Rumble Strips<sup>30</sup>**

Two types of rumble strips that could be used in this situation include transverse rumble strips and shoulder rumble strips. Transverse rumble strips are either raised bars or grooves placed across the travel lane. They would be placed on the far outside lane only, which would cause cars to avoid traveling in the lane closest to the sidewalk to steer clear of the rumble strips. The further a vehicle is away from the curb, the less likely it is to run off of the road. An example of transverse rumble strips can be viewed in Figure 23.

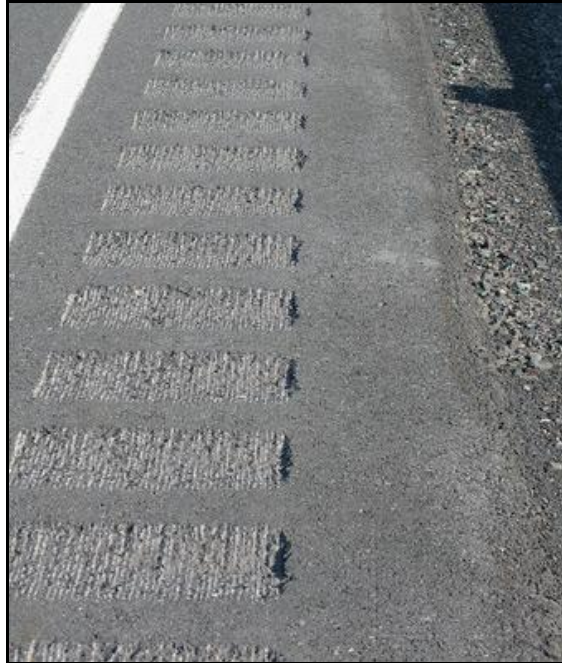
Shoulder rumble strips are either raised bars or grooves placed along the edge of the curb. They would help alert drivers if they started to get too close to the edge of the curb and the sidewalk. If a driver is alerted that they are too close to the curb, they will adjust their vehicle and avoid running off of the road and crashing into a transit shelter. An example of a shoulder rumble strip along the edge of the road can be viewed in Figure 24, an example of a shoulder rumble strip separating the edge of a roadway and a bicycle lane can be viewed in Figure 25, and an example of a shoulder rumble strip at a bus stop in the United Kingdom can be viewed in Figure 26. Due to the impact to bicycle riders and the types of transit shelter crashes experienced locally, rumble strips should be used only where other measures are not available, or where site conditions demonstrate a driver lane drift problem.

Figure 24: Shoulder Rumble Strips<sup>31</sup>

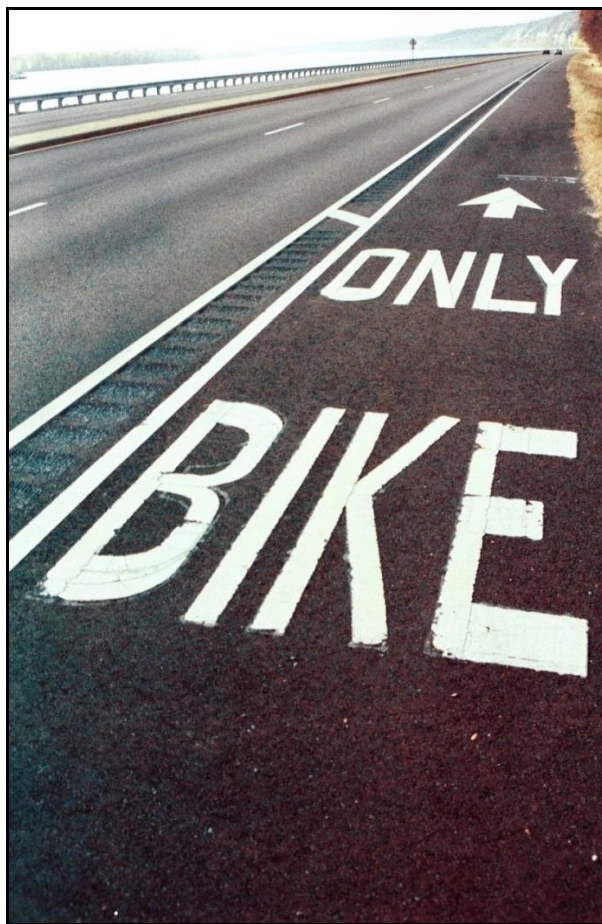
Figure 25: Shoulder Rumble Strips Between Roadway And Bike Lane<sup>32</sup>

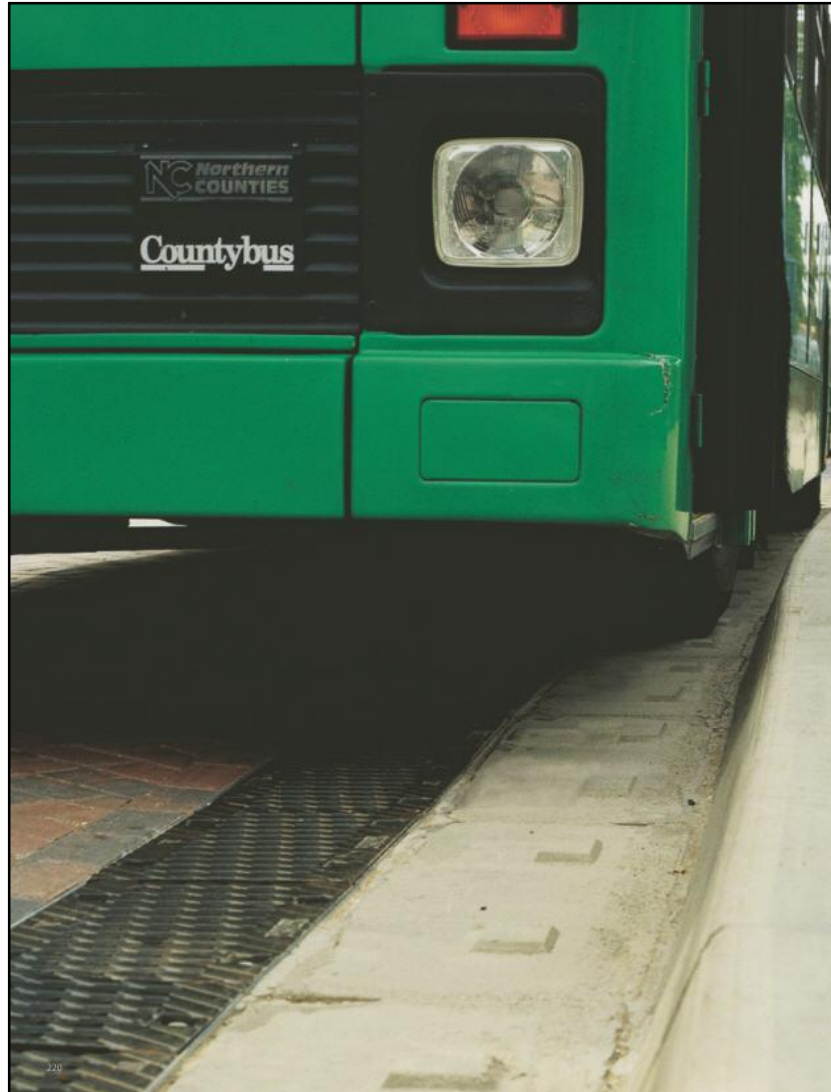
**Figure 26: Shoulder Rumble Strips At Bus Stop In The United Kingdom<sup>33</sup>**

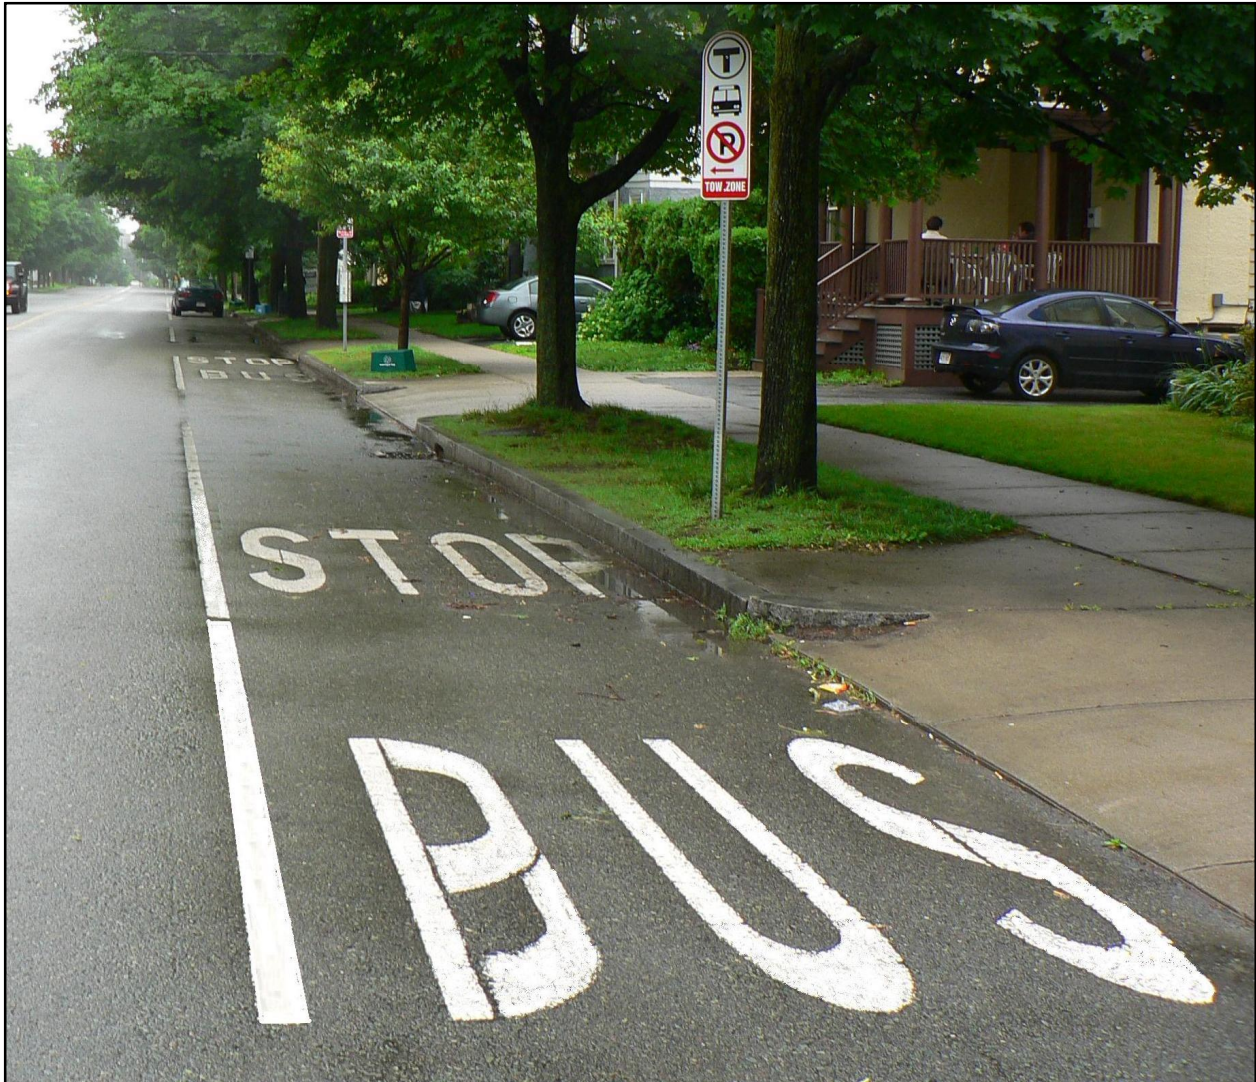
In addition to or an alternative to the rumble strips would be “Bus Stop Ahead” pavement markings. The pavement markings would alert drivers that a transit stop is ahead. Similar to the rumble strips, if a driver is alerted that a transit stop is ahead, they will become more aware of the transit stop location and be less likely to run off the road and crash into a transit stop. The implementation of pavement markings should be used only where considered site-appropriate. An example of a “Bus Stop” pavement marking that exists in Massachusetts can be viewed in Figure 27.

**Figure 27: “Bus Stop” Pavement Markings In Massachusetts<sup>34</sup>**

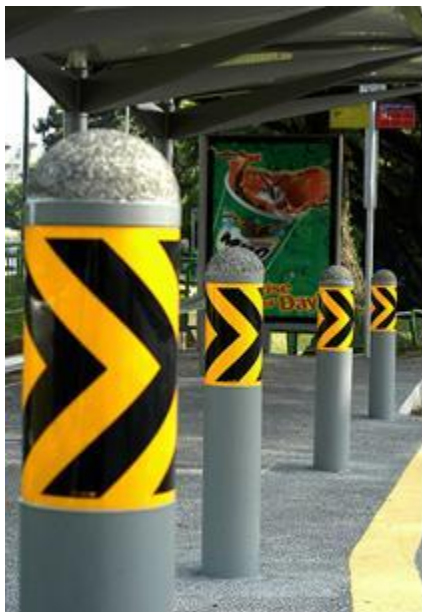
The safety bollards are located at bus stops along high speed roads. The main function is to reduce the severity of impact from errant vehicles. They also alert drivers to the presence of bus stops, especially during night time, and this protect commuters at bus stops. The photo below shows the bollards being used at bus stops in Singapore. According to LTA, safety bollards have proven to be effective in deterring impact from errant vehicles that mount into the bus stop. Singapore has first installed safety bollards at bus stops in 1999.

Left: Bollard installed at bus stops in Singapore.

Right: Excerpt from Standard Detail of Road Elements – Bollard (2001)

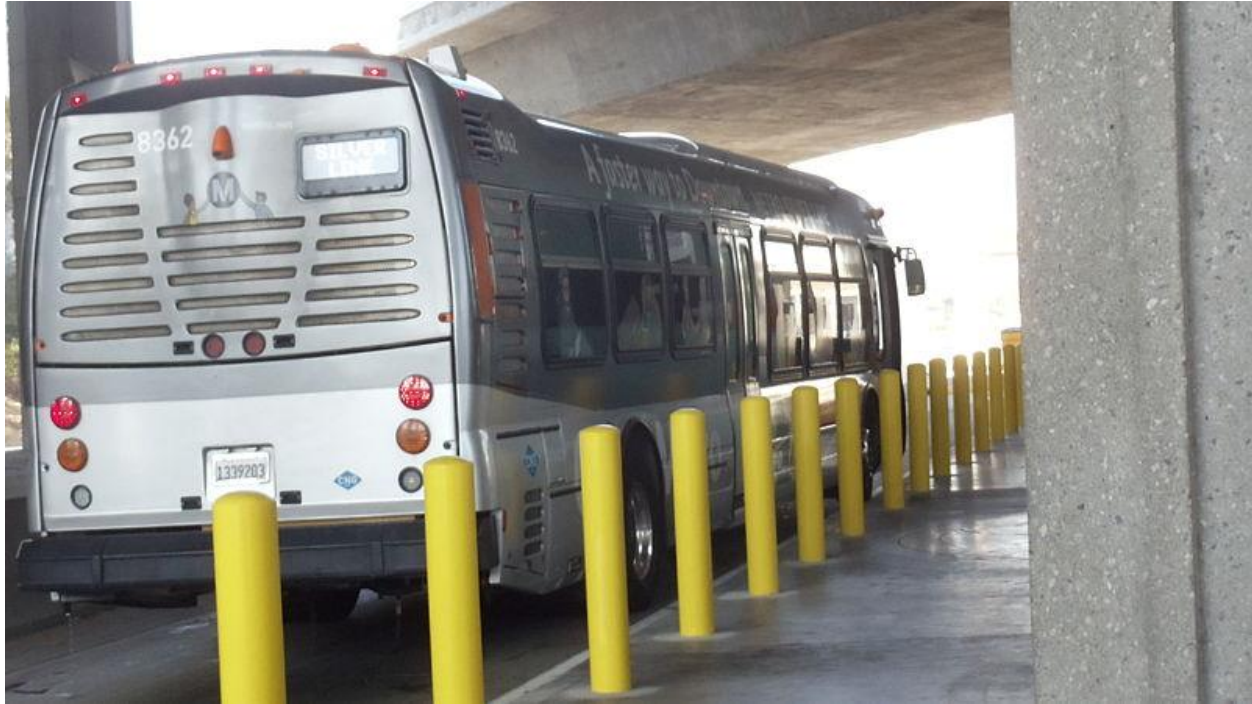
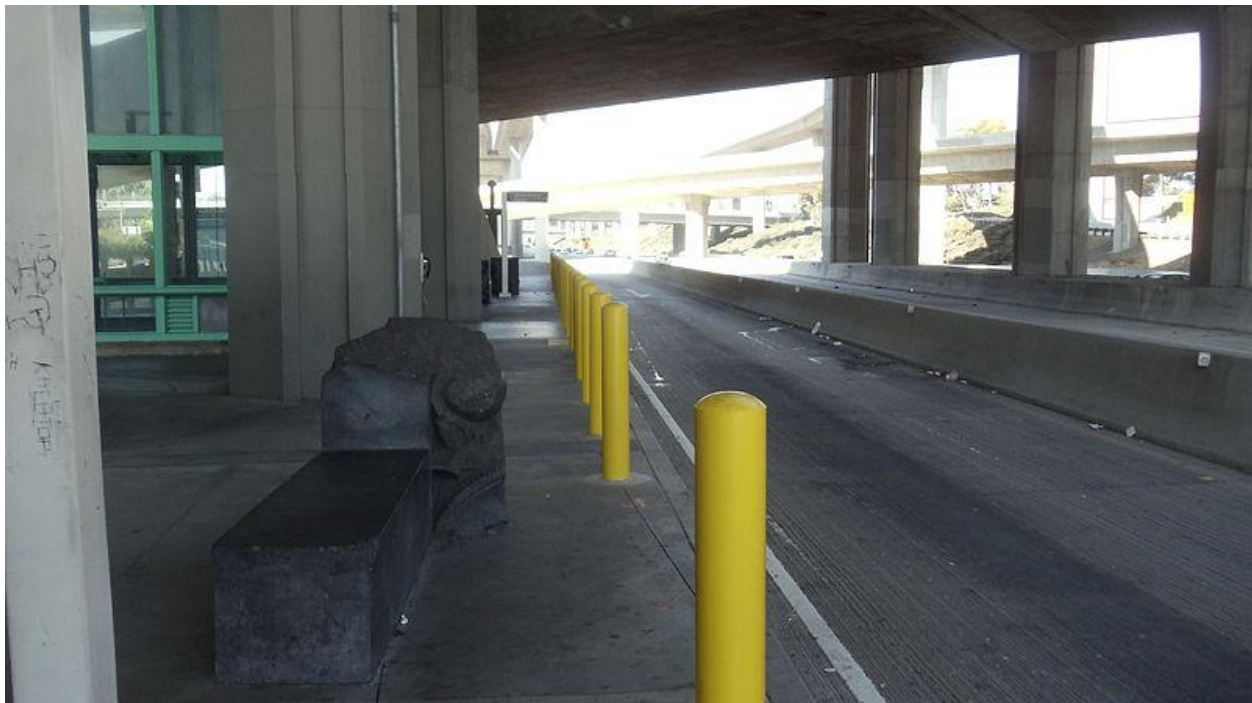
Bollards installed at Harbor Freeway, Silver Line Station to enhance pedestrian safety
