DYNAMIC IMPACT TESTING OF S76X8.5 (S3X5.7) STEEL POSTS FOR USE IN CABLE GUARDRAIL SYSTEMS

MIDWEST ROADSIDE SAFETY FACILITY

MwRSF Research Report No. TRP-03-186-07

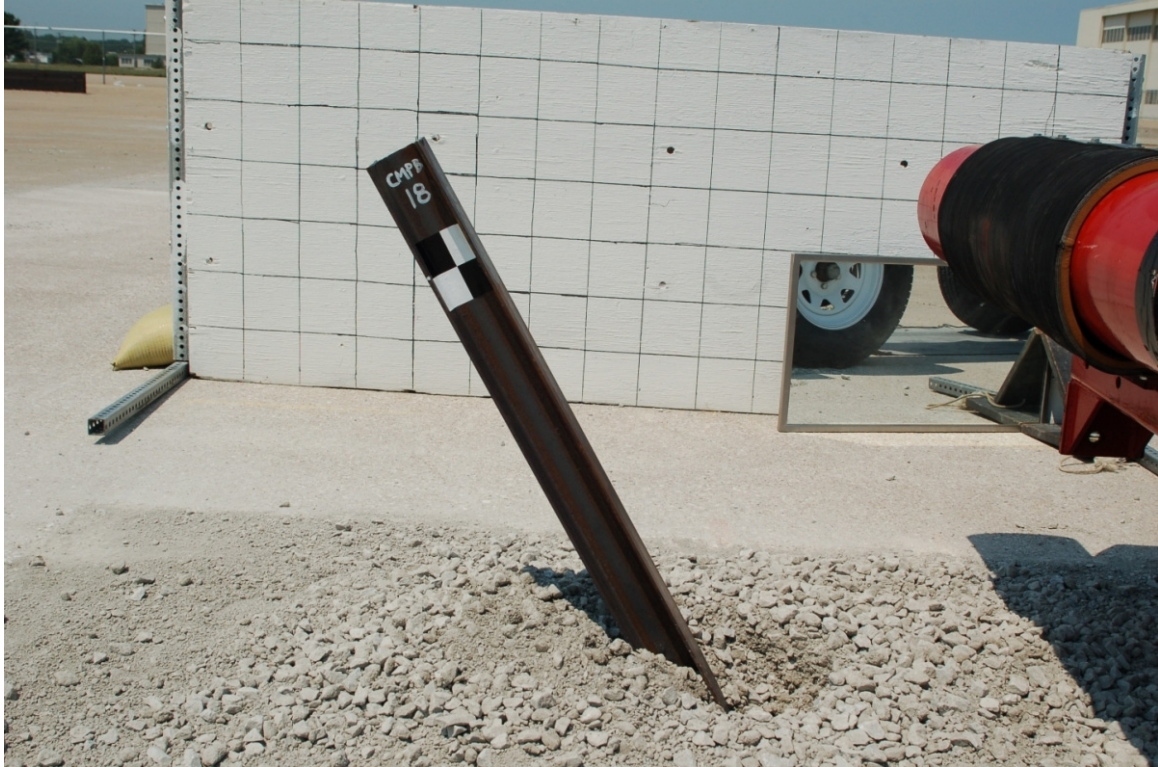
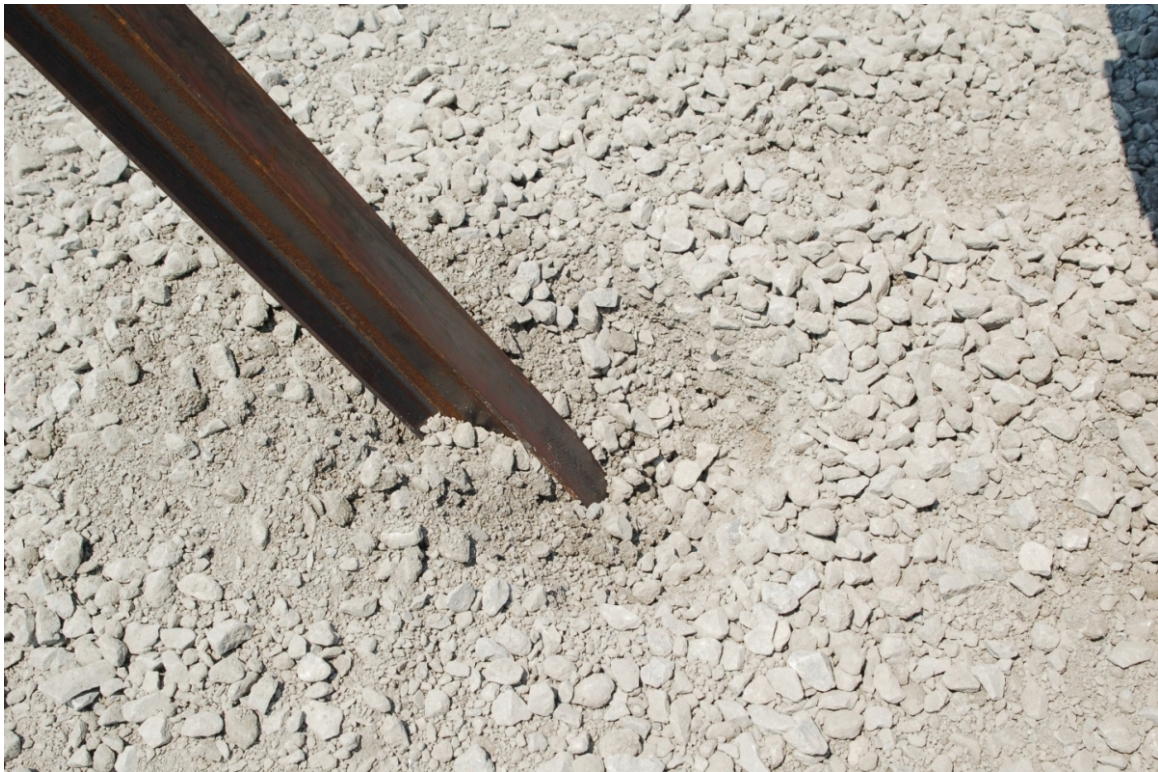
Figure 10. Post Damage, Test No. CMPB-18

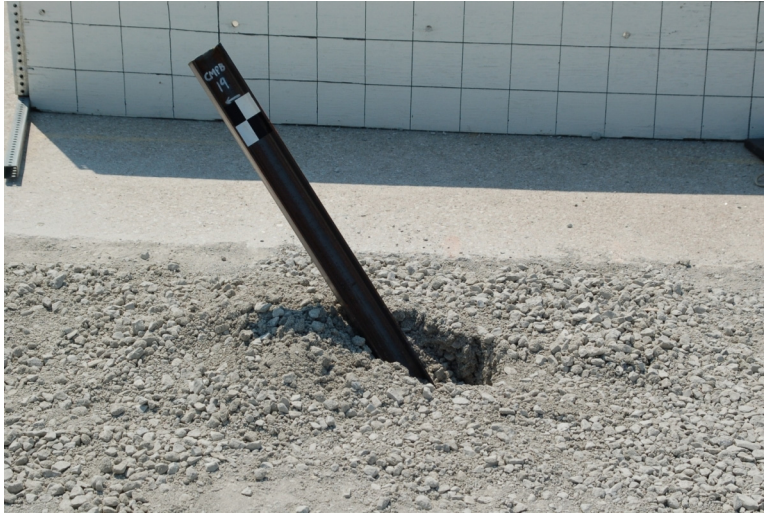
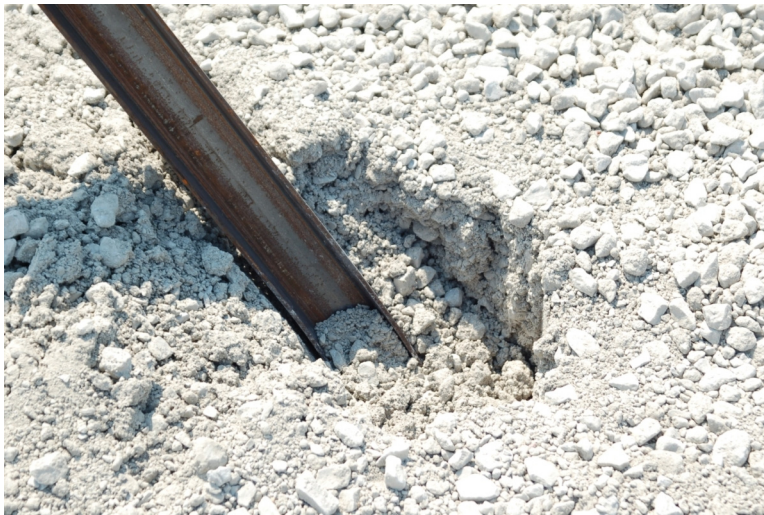
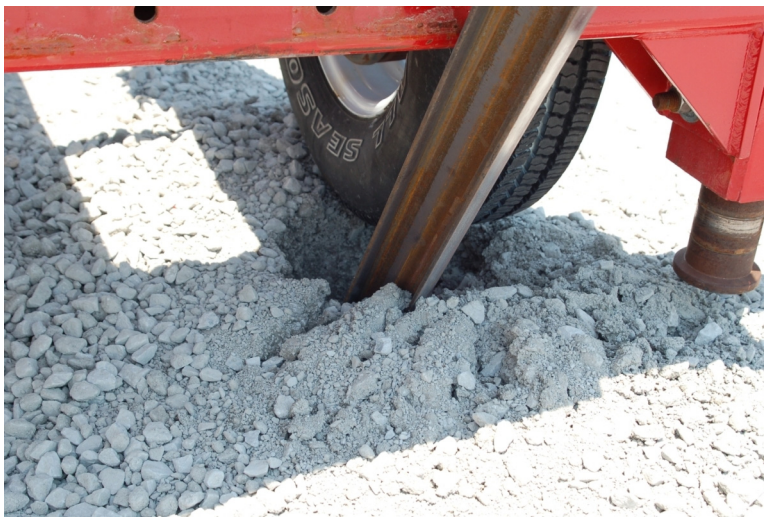
Figure 11. Post Damage, Test No. CMPB-19

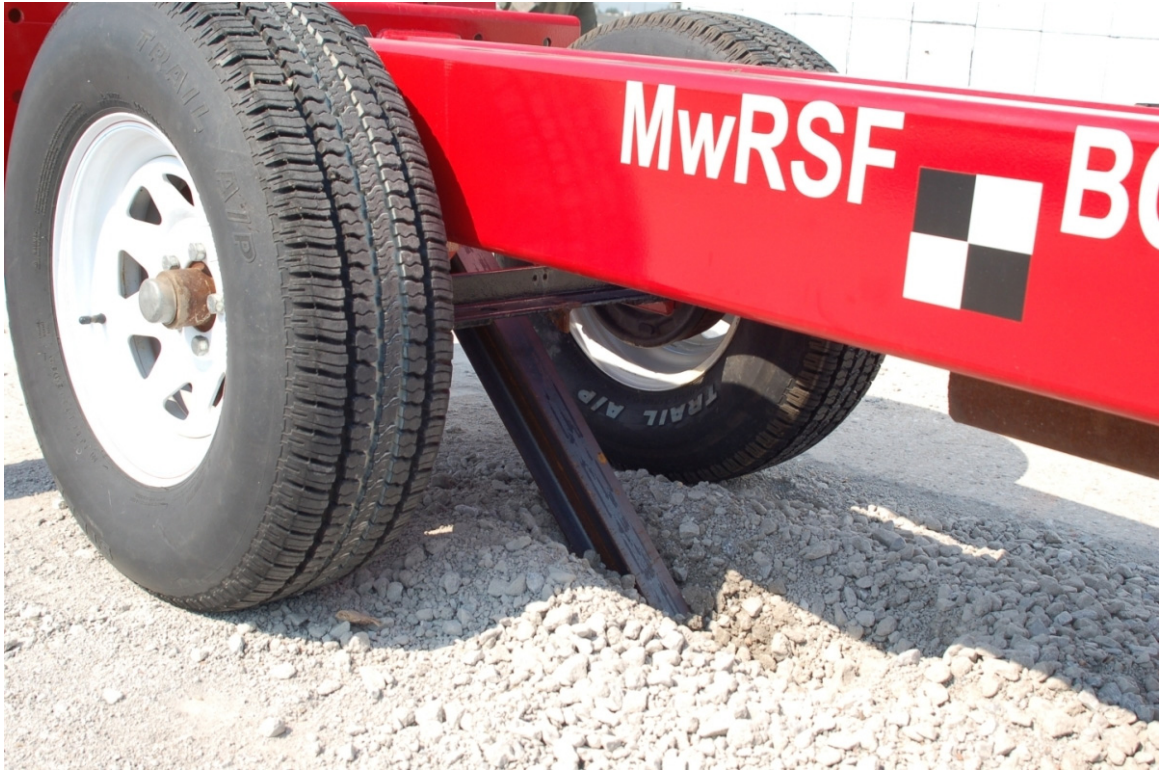
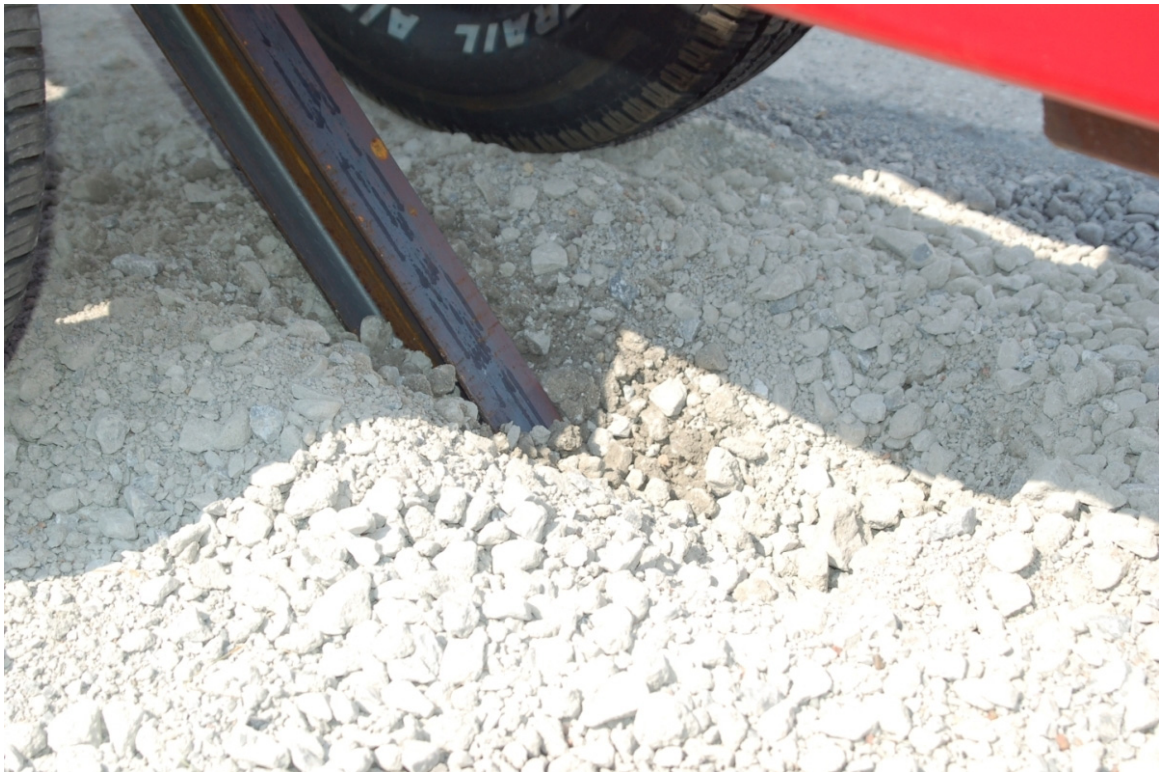
Figure 14. Post Damage, Test No. CMPB-16

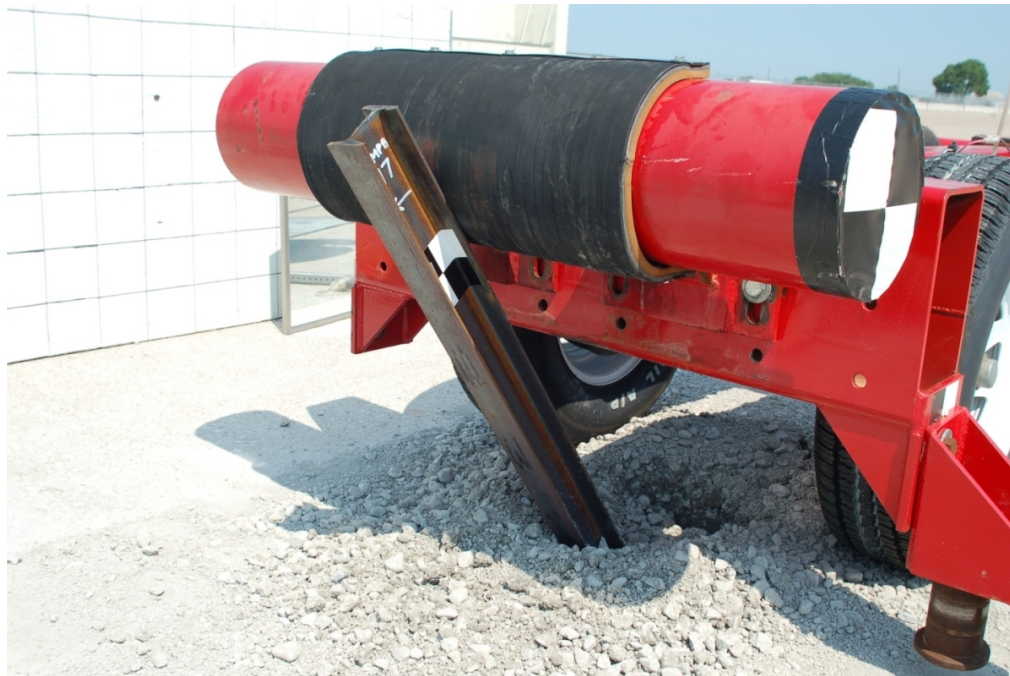
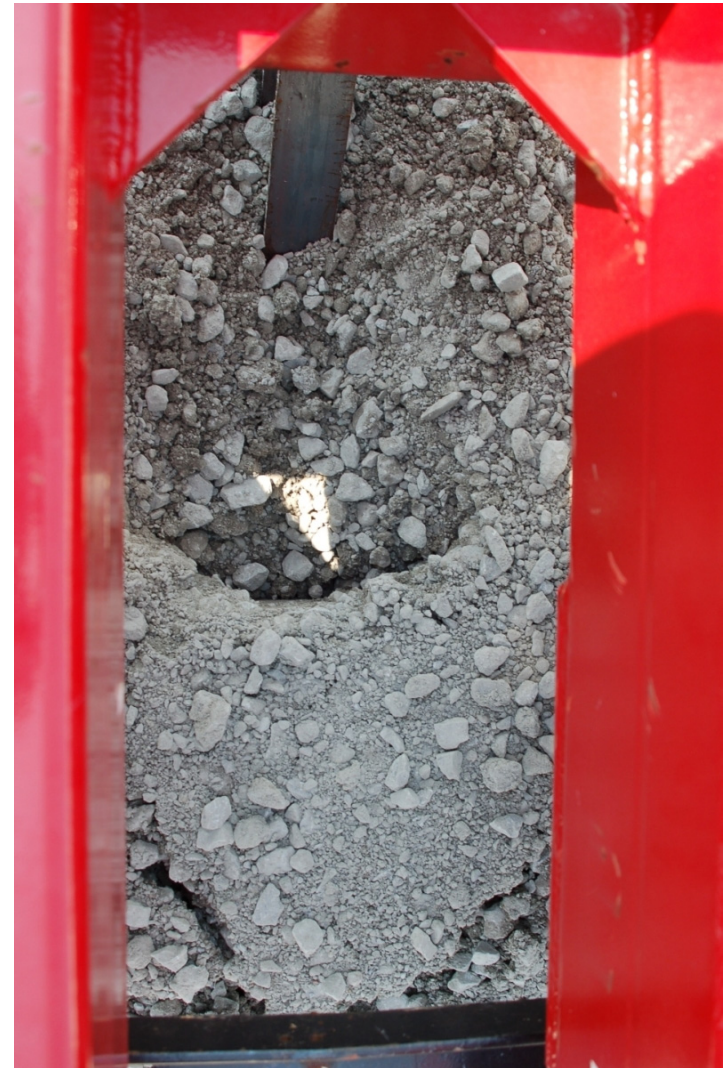
Figure 15. Post Damage, Test No. CMPB-17

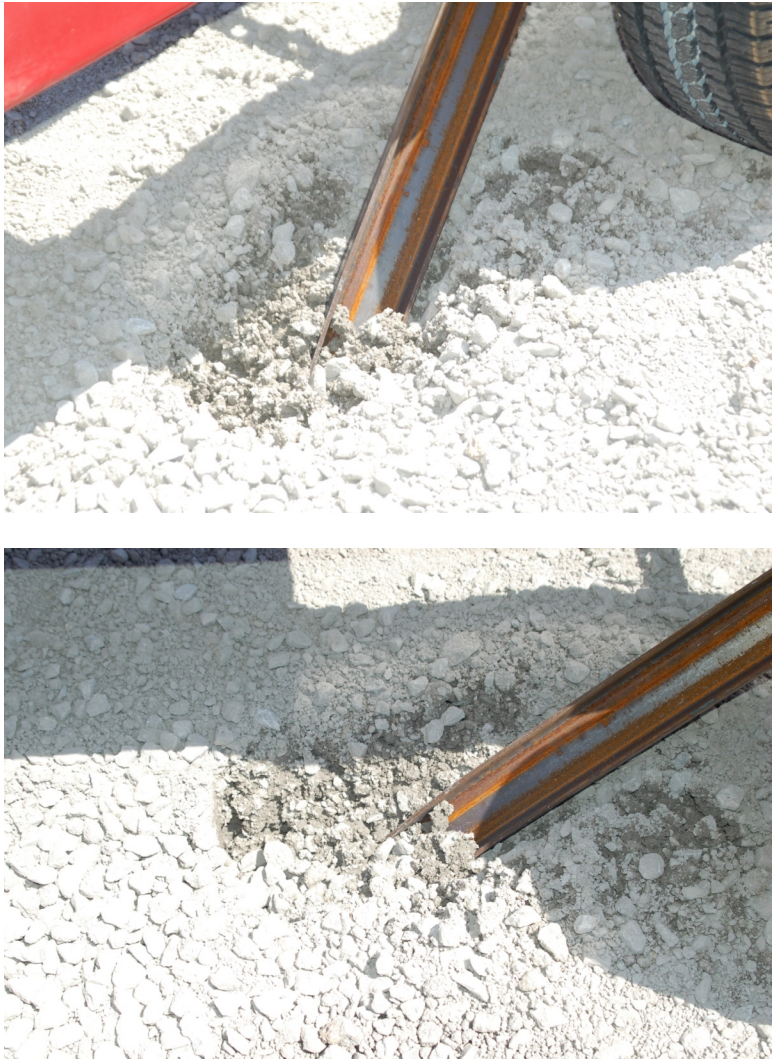
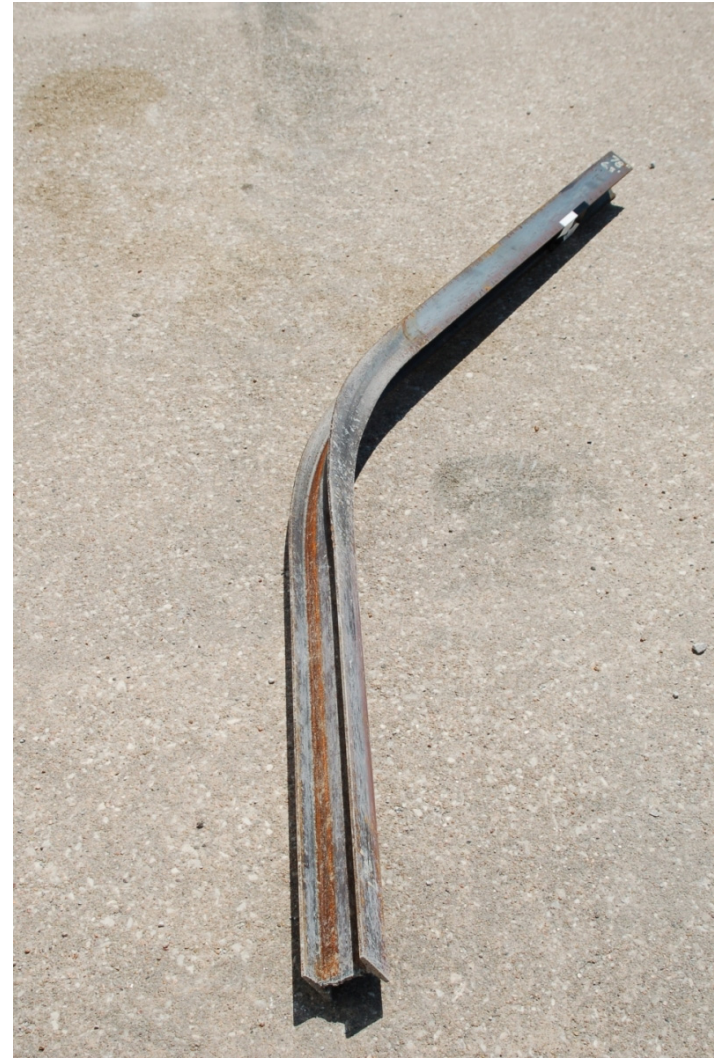
Figure 18. Post Damage, Test No. CMPB-20

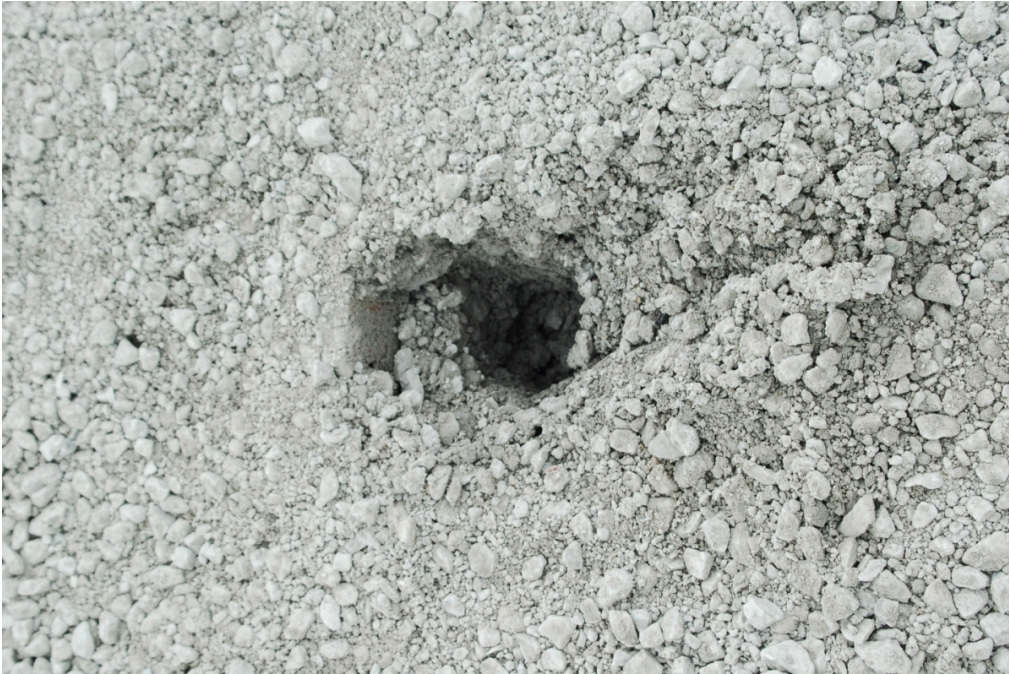
Figure 19. Post and Soil Damage, Test No. CMPB-21 (with Post from Test No. CMPB-20)

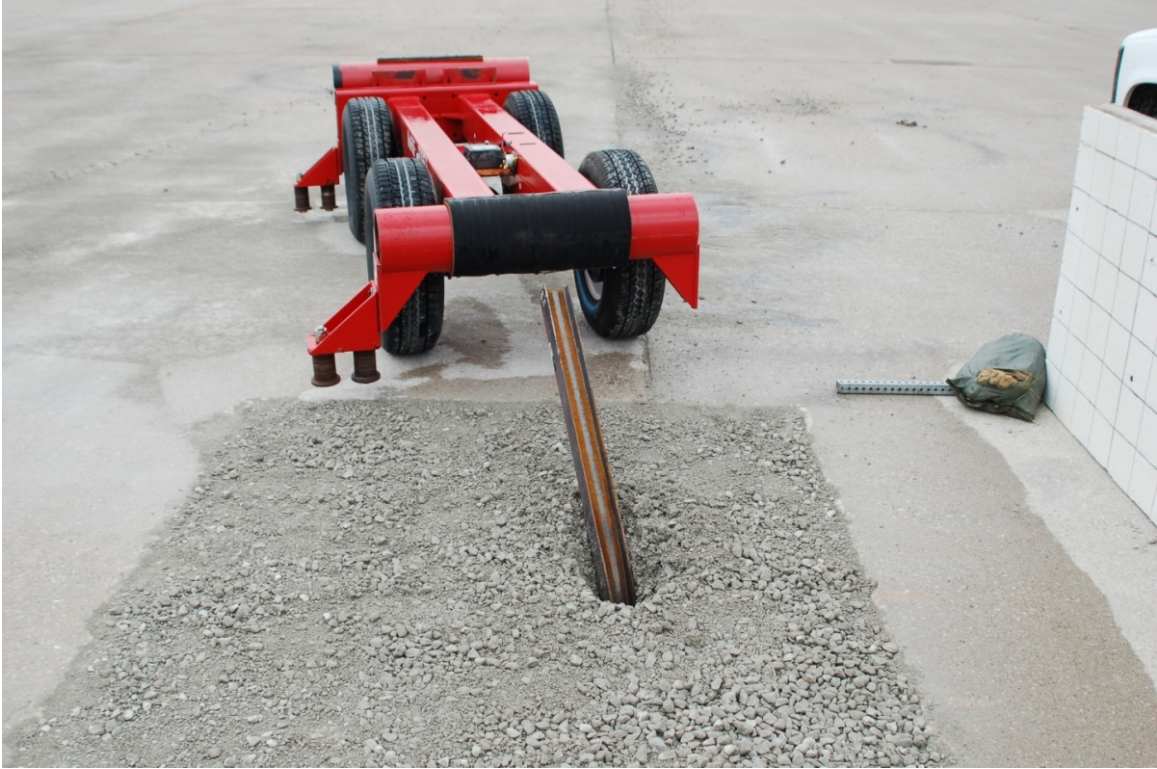
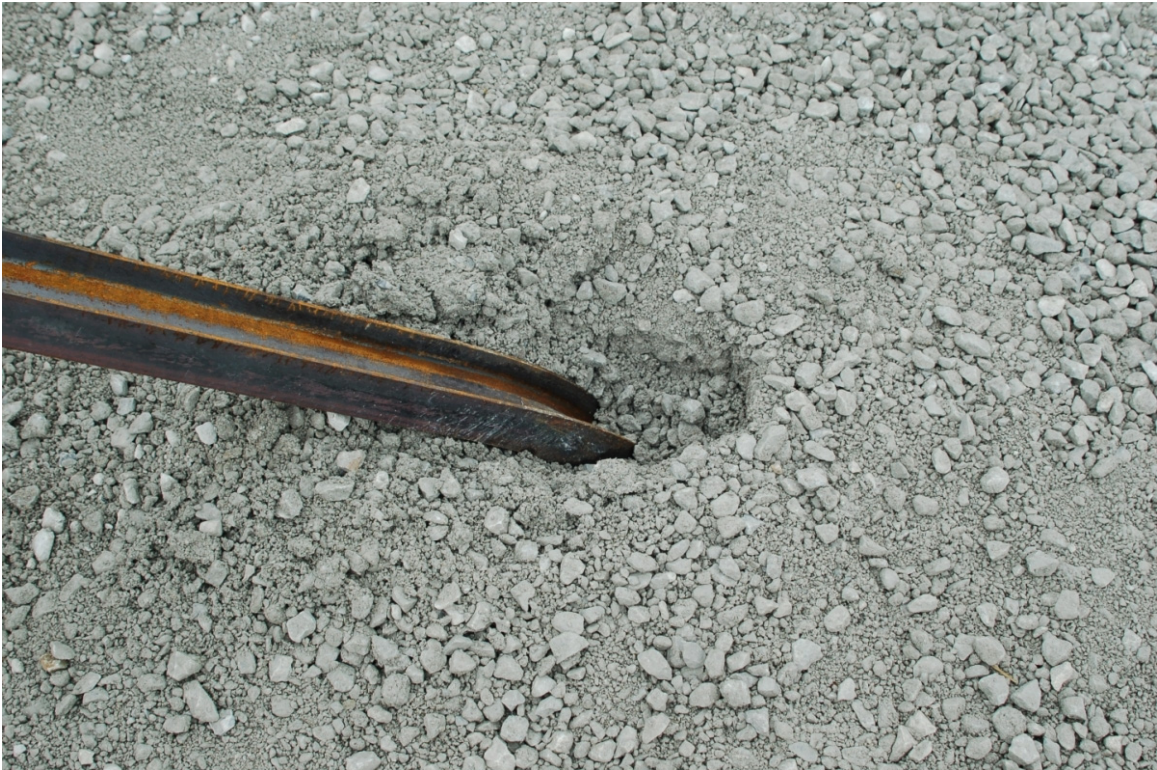
Figure 22. Post Damage, Test No. CMPB-22

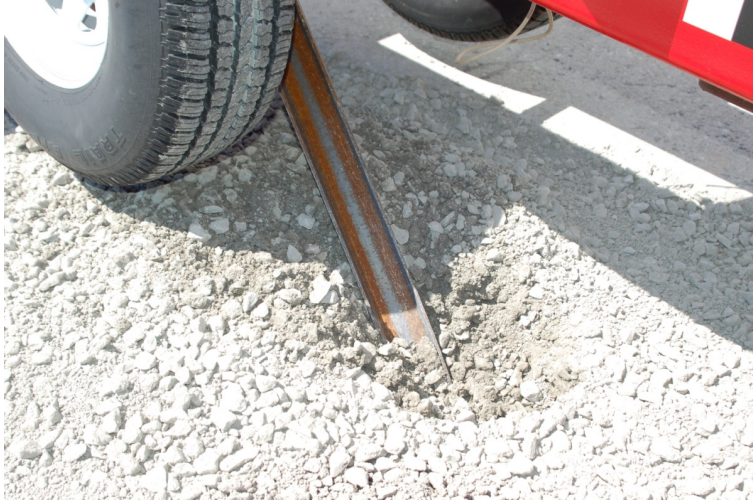
Figure 23. Post Damage, Test No. CMPB-23 (with Posts from Test Nos. CMPB 20 through CMPB-22)

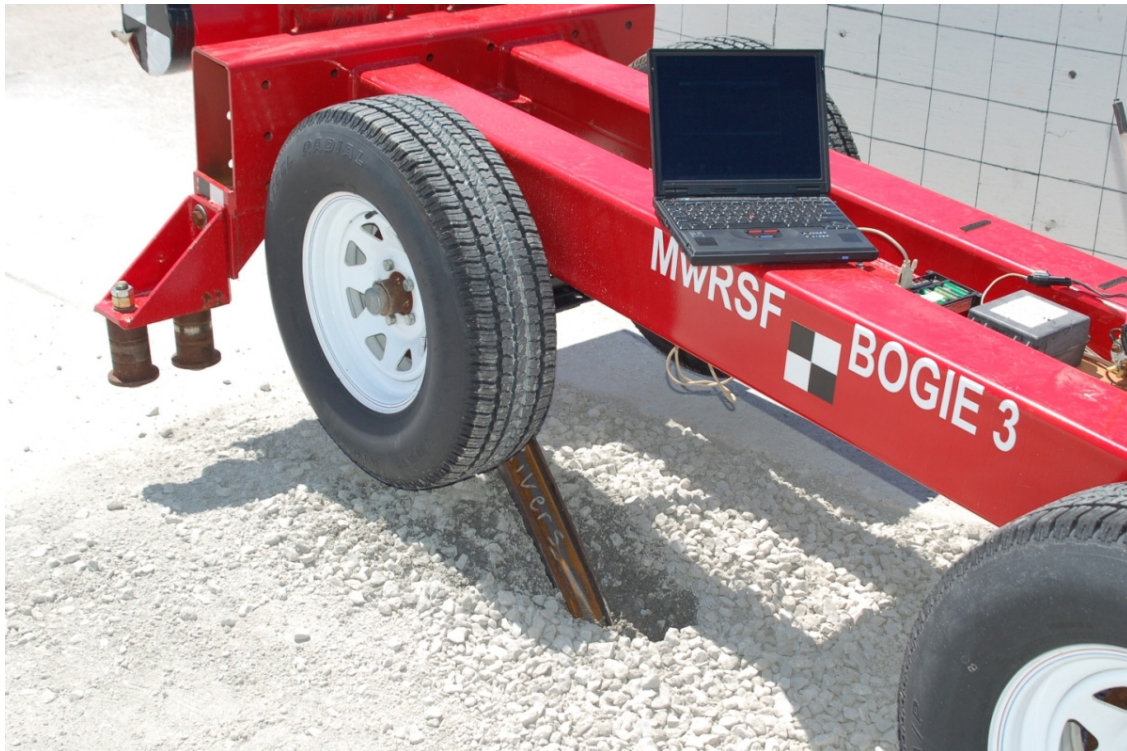
Figure 26. Post Damage, Test No. CMPB-24 (with Posts from Test Nos. CMPB-20 through CMPB-25)

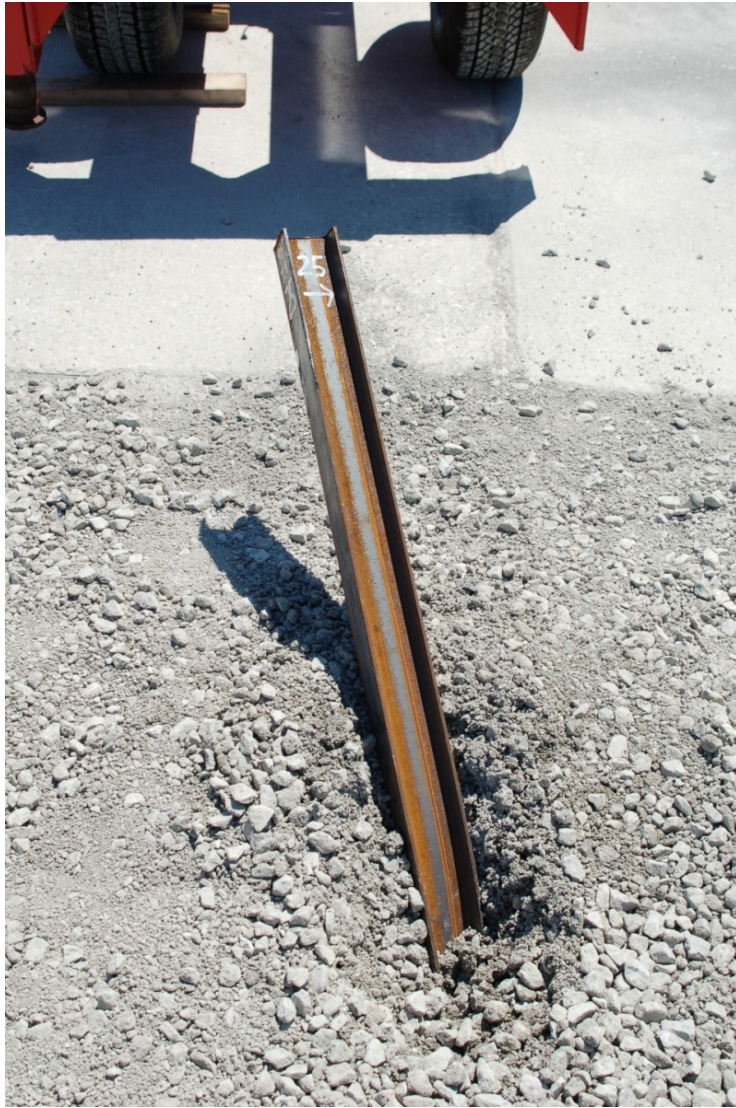
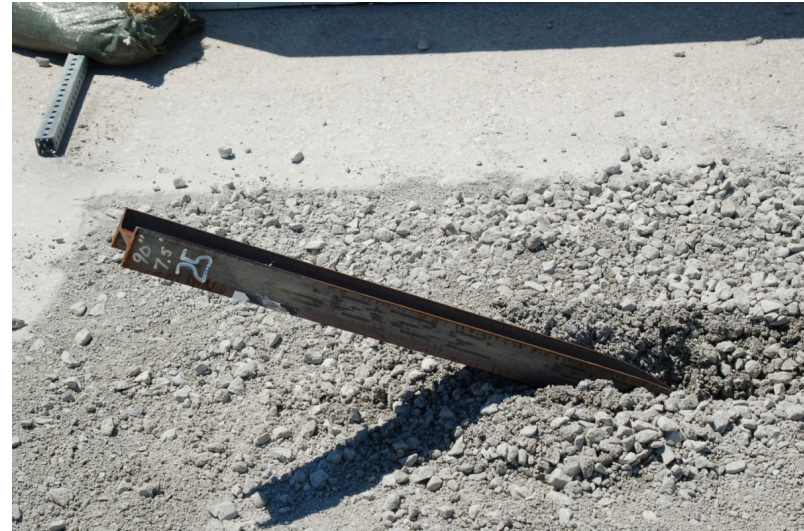
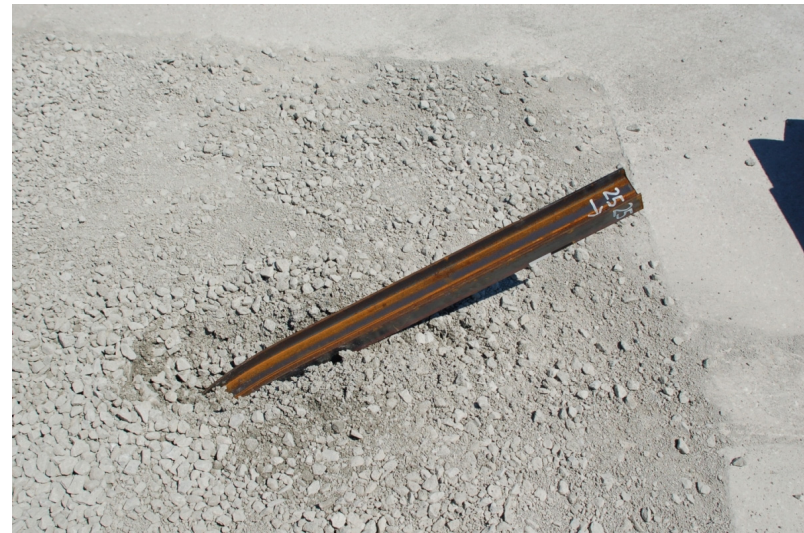
Figure 27. Post Damage, Test No. CMPB-25

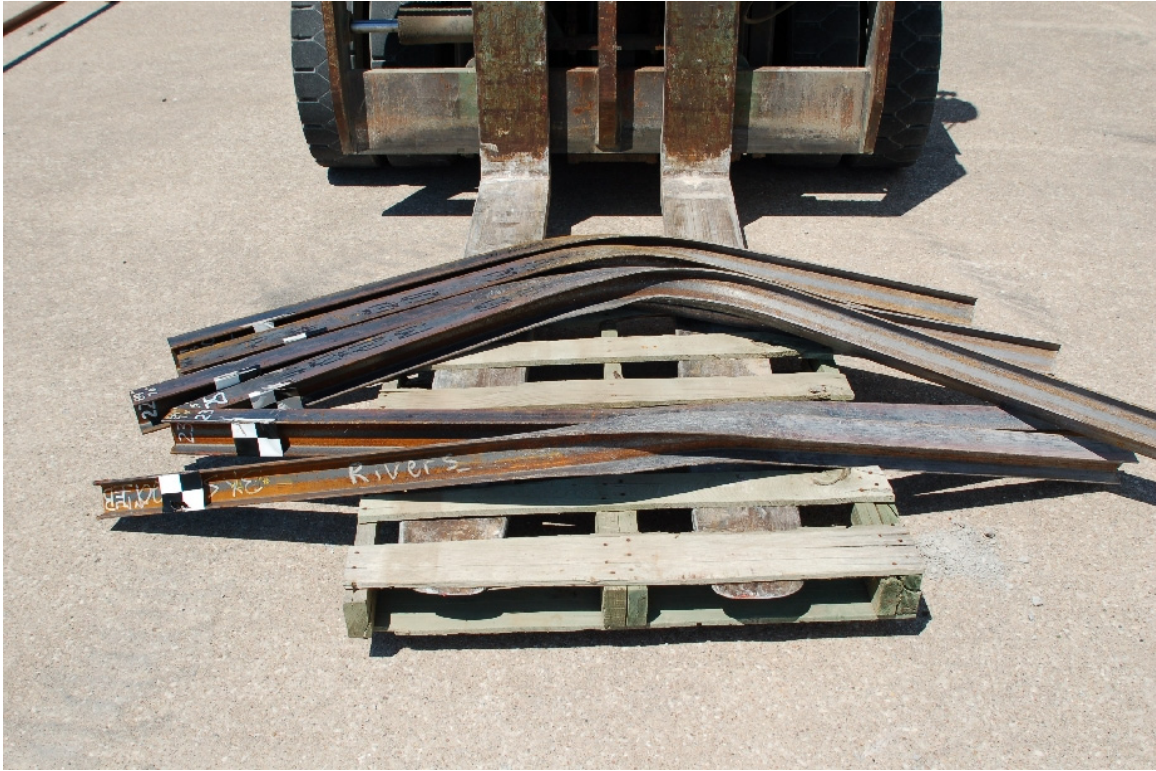
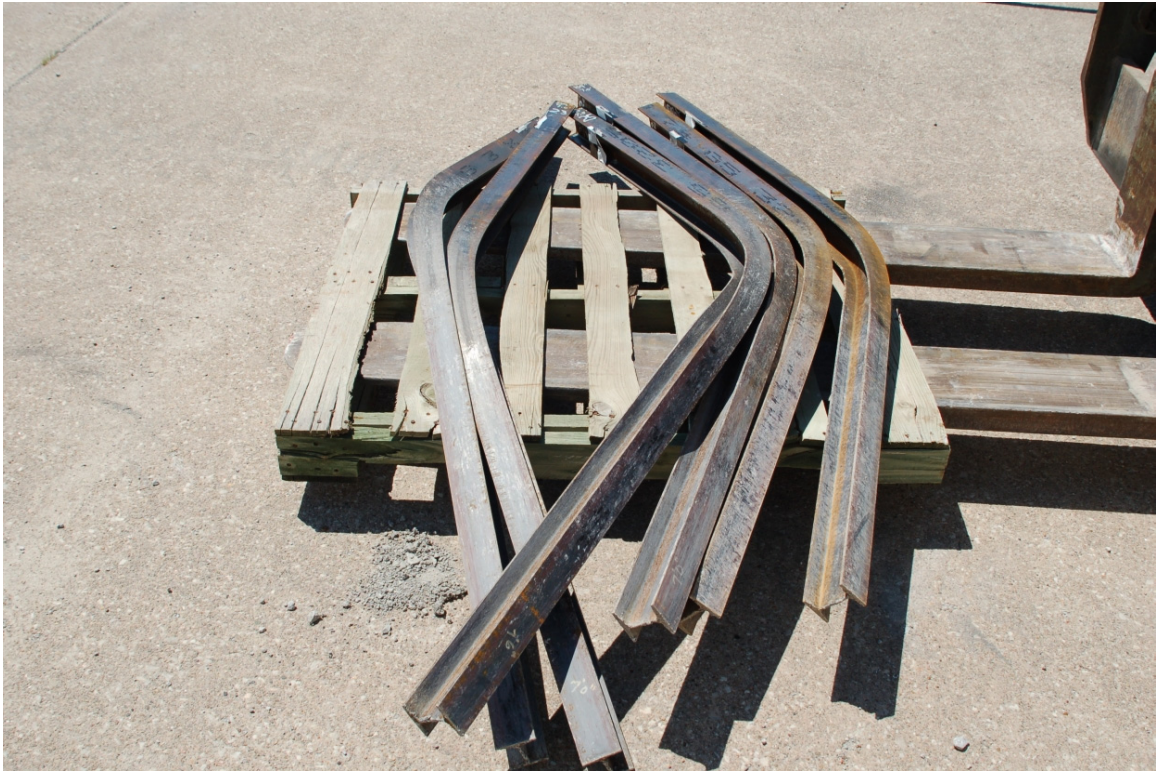
Figure 28. Post Deformation Comparison, Test Nos. CMPB-20 through CMPB-25
