EVALUATION OF ALTERNATE CABLE ANCHOR DESIGNS AND THREE-CABLE GUARDRAIL ADJACENT TO STEEP SLOPE

MIDWEST ROADSIDE SAFETY FACILITY

MwRSF Research Report No. TRP-03-155-05

February 3, 2005

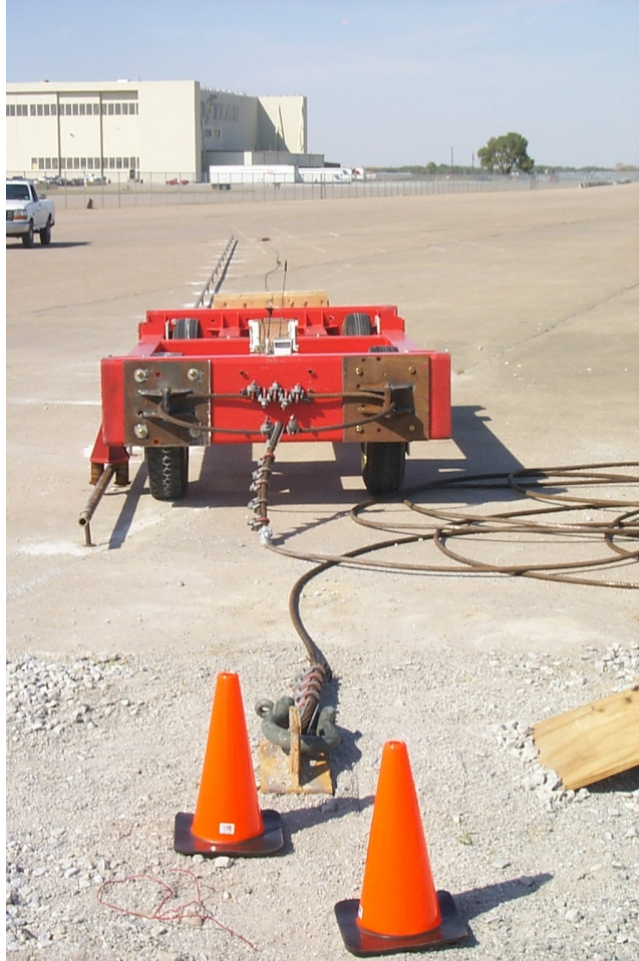
Figure 5. Bogie Test Vehicle and Guidance System

The bogie vehicle test configuration is shown in Figures 5 and 6. The rigid-frame bogie vehicle was to be towed to a target speed of 35.4 km/h (22 mph) for all three anchor tests.

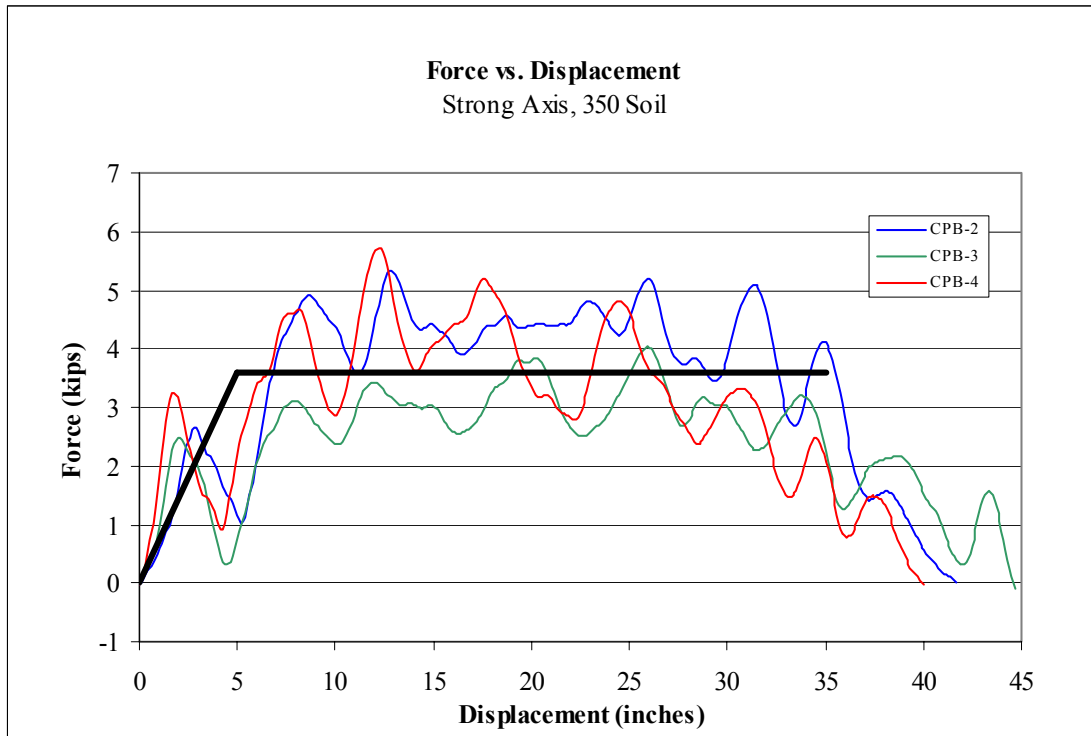
Figure 11. Force-Displacement Curve for Bogie Tests CPB-2 through CPB-4

Dynamic behavior and material properties of line posts were derived from dynamic bogie testing similar to that performed on the anchor alternatives as well as video footage from previous cable tests. The dynamic bogie testing studied cable barrier posts in various foundation conditions, including soil conditions meeting the specifications of NCHRP Report No. 350. Additional details related to the dynamic bogie testing are provided in the referenced MwRSF research report (26). Similar to that of the anchor bogie tests, the results of the post tests were interpreted through linear approximations of the force-deflection plots. Results of the bogie testing are summarized in Table 4 and in Figures 11 and 12.

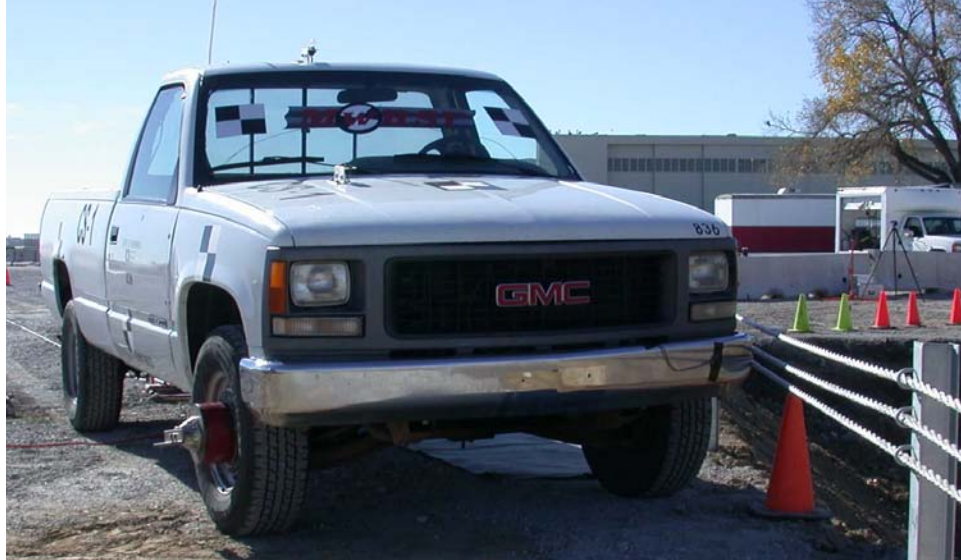
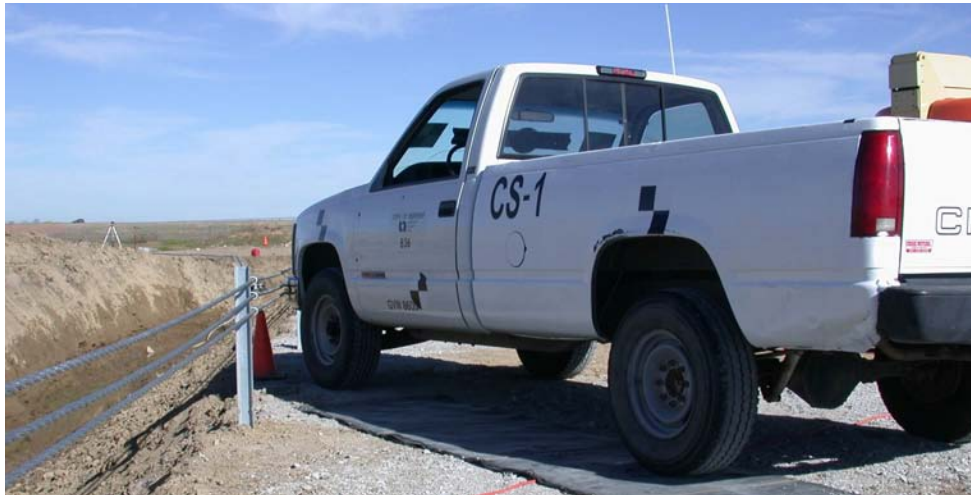
Figure 20. Test Vehicle, Test CS-1

For test CS-1, a 1995 GMC 2500 $\frac{3}{4}$ -ton pickup truck was used as the test vehicle. The test inertial and gross static weights were 2,034 kg (4,484 lbs). The test vehicle is shown in Figure 20, and vehicle dimensions are shown in Figure 21.

The longitudinal component of the center of gravity was determined using the measured axle weights. The location of the final center of gravity is shown in Figures 20 and 21.

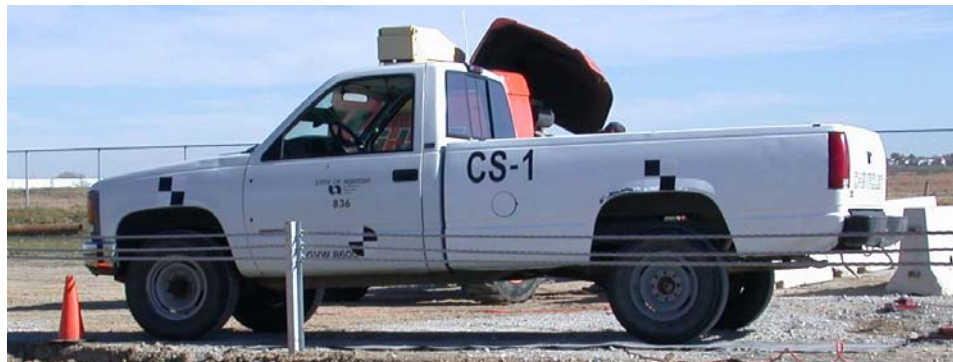
Date: 11/1/01 Test Number: CS-1 Model: 2500
 Make: GMC Vehicle I.D.#: 1GDGC24K8SE519215
 Tire Size: 245/75 R16 Year: 1995 Odometer: 223207

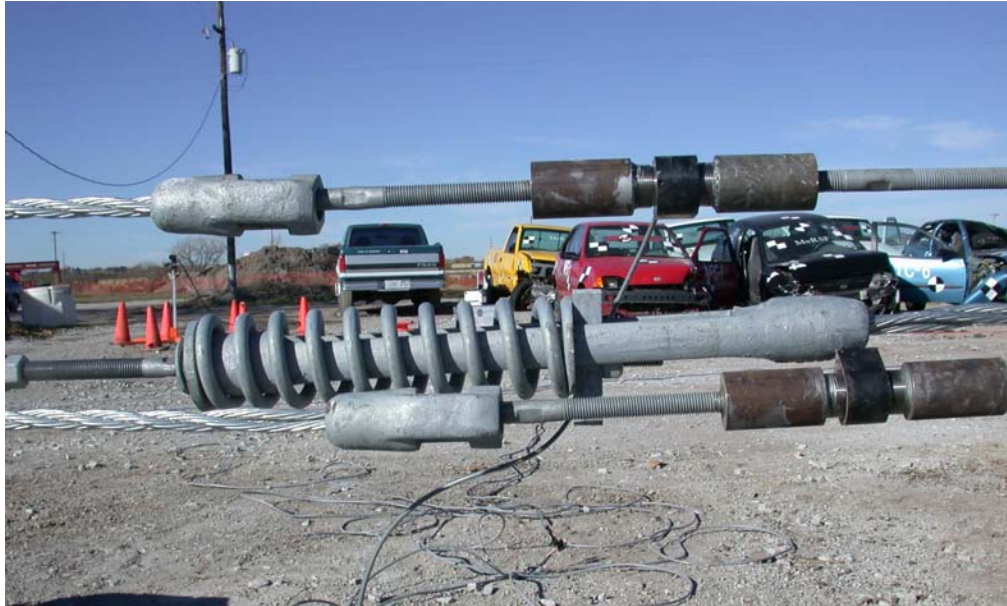
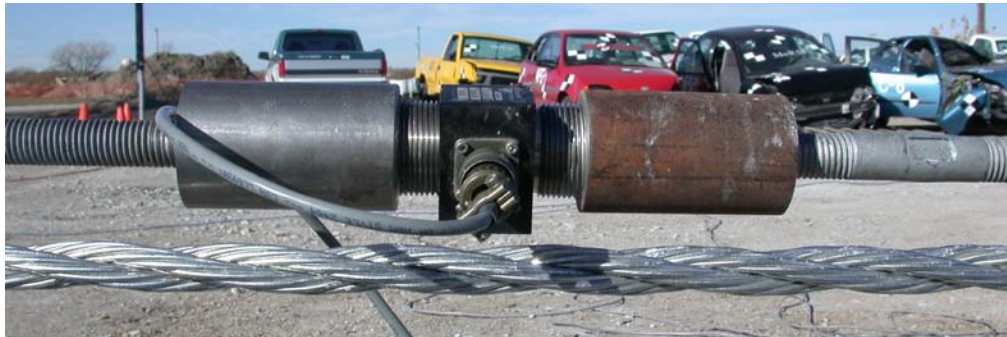
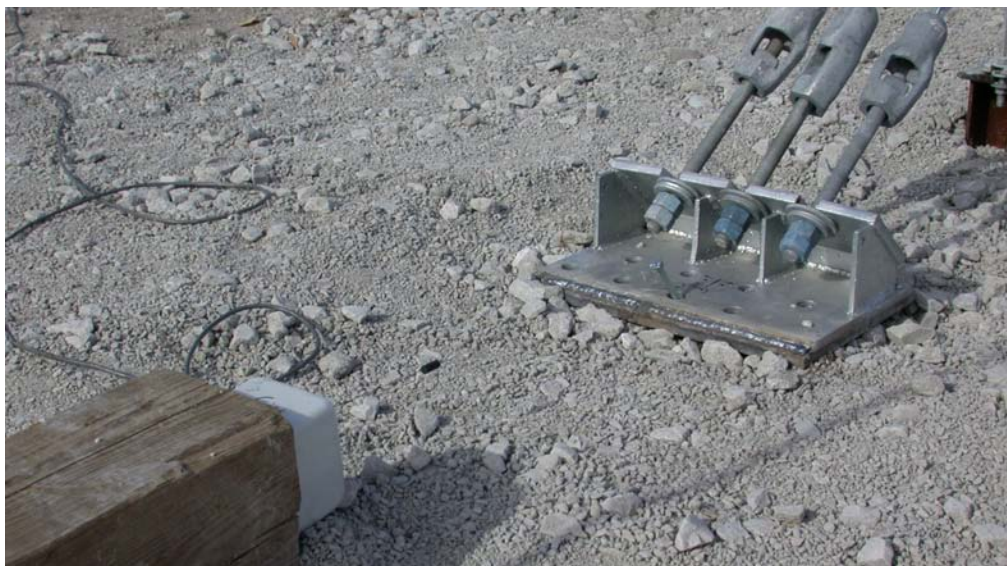
Figure 24. Three-Cable End Terminal Instrumentation

A string potentiometer (linear variable displacement transducer) was installed on the end terminal anchor to monitor longitudinal displacement of the anchor. The positioning of the string potentiometer is shown in Figure 24.

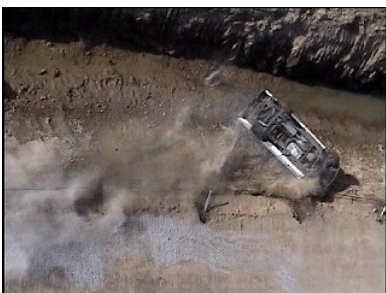
Figure 29. Additional Sequential Photographs, Test CS-1

0.867 sec

The 2,034-kg (4,484-lb) pickup truck impacted the three-cable guardrail system at a speed of 98.1 km/h (61.0 mph) and at an angle of 26.2 degrees. A summary of the test results and the sequential photographs are shown in Figure 25. The summary of the test results and sequential photographs in English units are shown in Appendix E. Additional sequential photographs are shown in Figures 26 through 29. Documentary photographs of the crash test are shown in Figure 30.

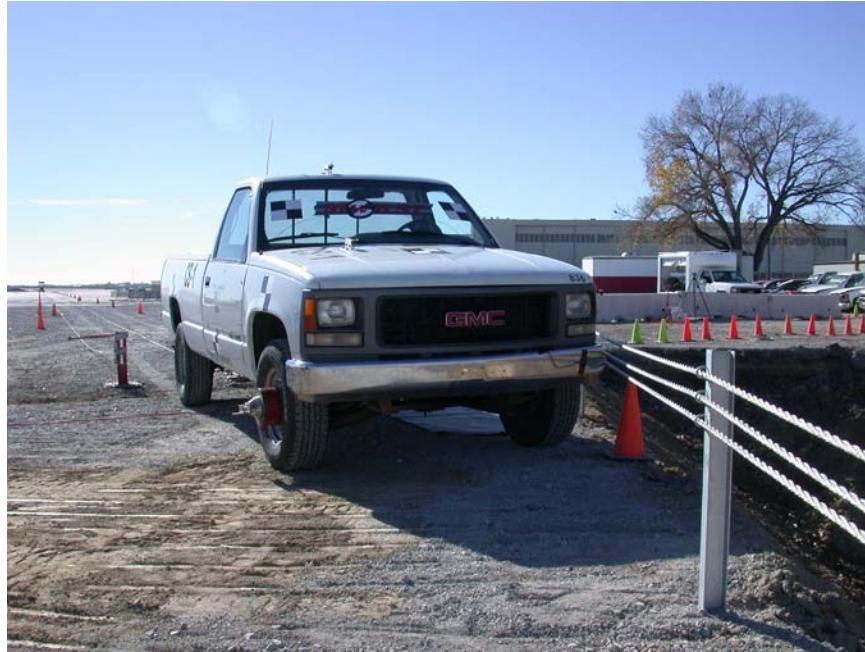
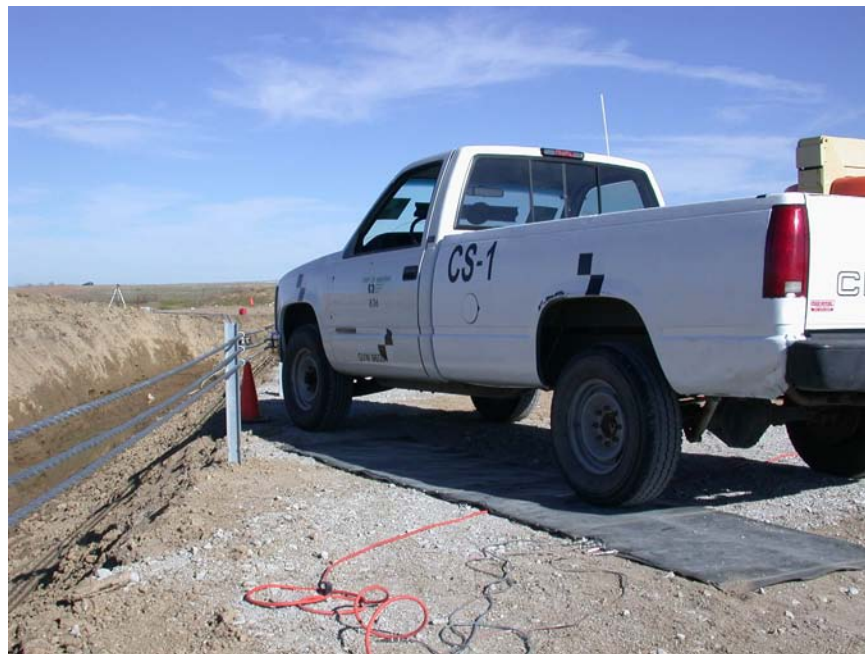
Figure 31. Impact Location, Test CS-1

Initial impact was to occur 2,134 mm (84 in.) downstream from post no. 12, as shown in Figure 31. Actual vehicle impact occurred 2,743 mm (108 in.) downstream from post no. 12. At 0.046 sec, post nos. 12 and 13 showed lateral and downstream longitudinal deflection. At 0.076 sec, the truck contacted post no. 13. At this same time, the cables began to wrap around the truck's left-front corner while the left-front tire traveled off the slope breakpoint. At 0.176 sec, the left-front tire became airborne as the right-front tire reached the slope breakpoint. It is noted that post nos. 12 through 15 showed continued lateral deflection while the cables released from post no. 14 which had rotated to a 45-degree angle. At 0.234 sec, the truck began to yaw as both left tires and the right-front tire became airborne. At this same time, post no. 14 deflected to nearly parallel with the traveled surface. At 0.274 sec, post no. 14 pulled out of the ground, and post no. 16 began to deflect. At 0.330 sec, the top, middle, and bottom cables were positioned at the headlight, above the bumper, and on the bumper, respectively. It was at this time that the vehicle became completely airborne and pitched downward, rolled counter-clockwise (CCW)

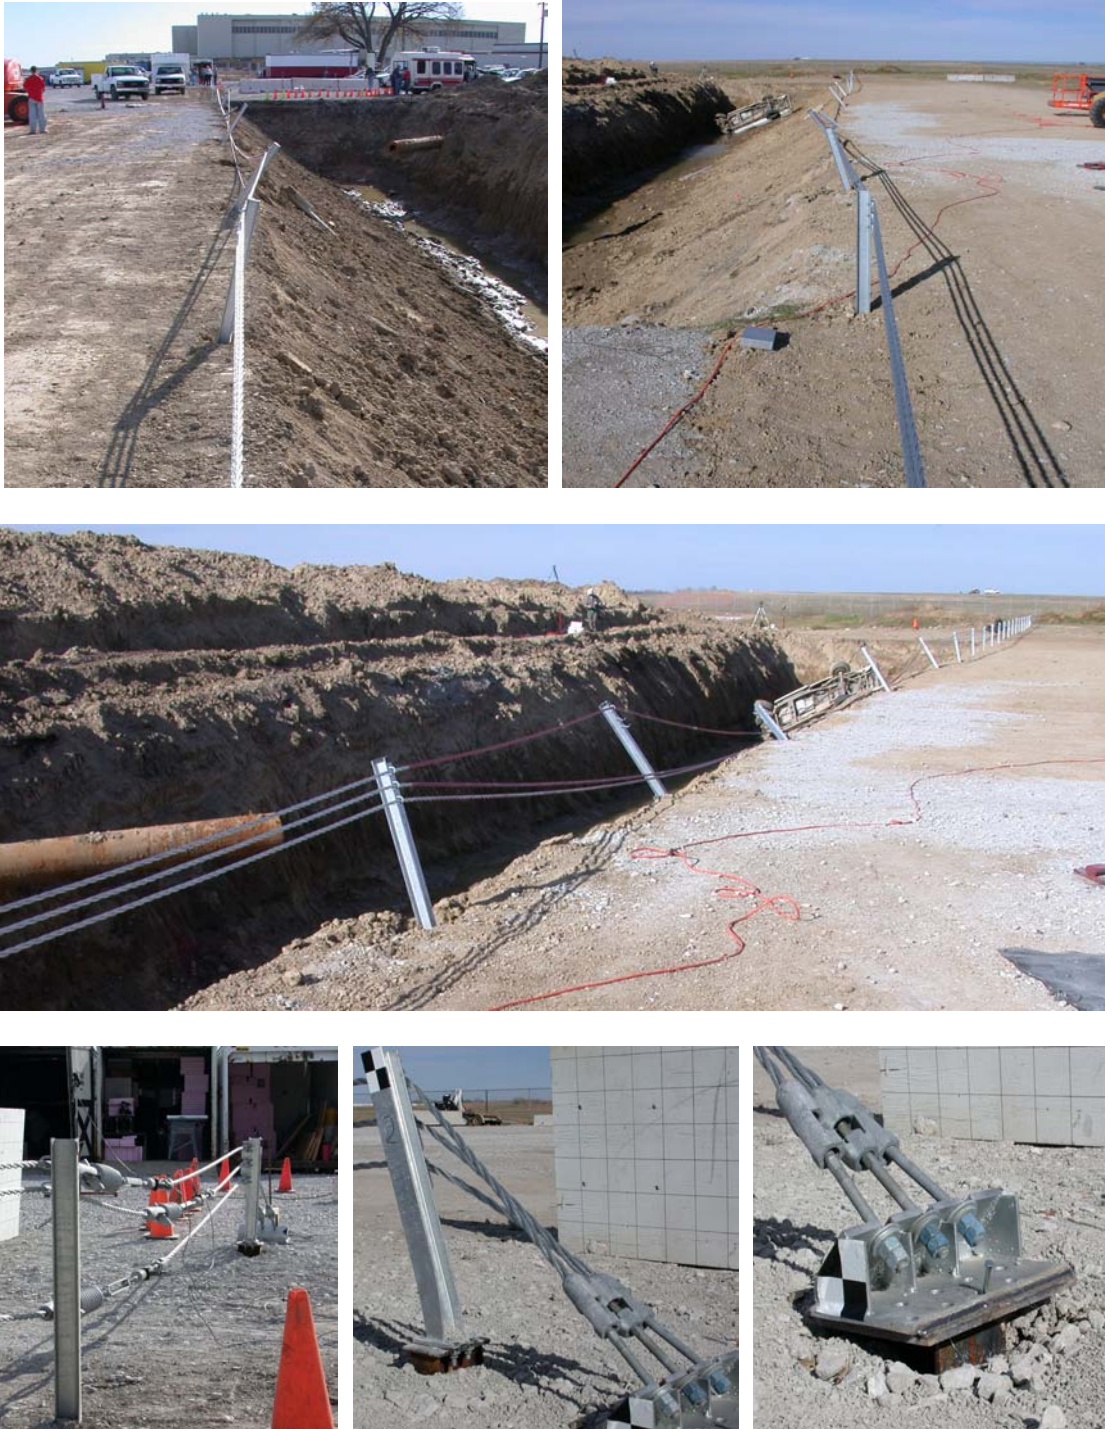
Figure 33. System Damage, Test CS-1

Damage to the barrier was moderate, as shown in Figures 33 through 35. Barrier damage consisted mostly of damaged line posts, stretched cable, and soil failure. The maximum permanent set deflection of the upstream anchor was 45 mm (1.75 in.). Diagonal soil cracks, 406-mm (16-in.) long, and soil disturbance was found around the upstream anchor, as shown in Figure 33. Post no. 2 demonstrated twisting and bending at the base, resulting in weld failure on the tension side. Permanent set was not visible below grade at post no. 2. Post no. 3 illustrated only slight twisting and bending at the grade line. No damage or soil movement was noted for post nos. 4 through 11. Post no. 12 deflected 140 mm (5.5 in.) at the ground and the cables remained attached. Post no. 13 deflected 330 mm (13 in.) at the ground. The two lower cables released from post no. 13, with the respective hook bolts deformed. Post no. 14 was pushed

backward 254 mm (10 in.) at the ground and bent above the soil plate in the downstream direction. All three cables disengaged from post no. 14. Post no. 15 pulled completely out of the ground and was found at the bottom of the pit. Post no. 16 deflected 330 mm (13 in.) at the ground without any post bending. All three cables disengaged from post no. 16. Post no. 17 pulled completely out of the ground and was found 914-mm (36-in.) downstream and 1,219-mm (48-in.) laterally down the slope. Post no. 18 remained undamaged, but was pushed back 279 mm (11 in.) at the ground with the top cable unattached. Posts no. 19 and 20 rotated slightly, with deflections of 102 mm (4 in.) and 25 mm (1 in.) at the ground level, respectively. The remainder of the downstream posts showed no evidence of movement.

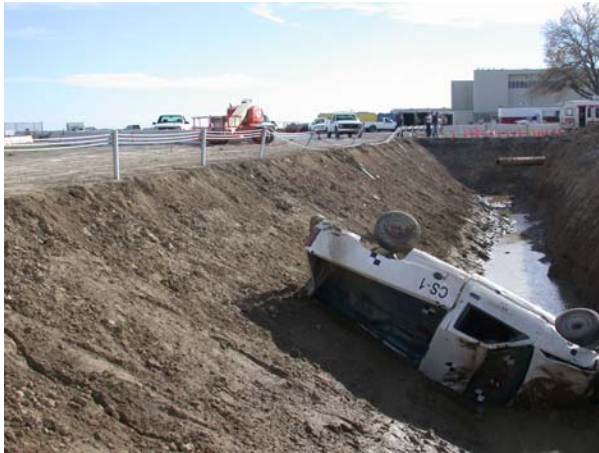
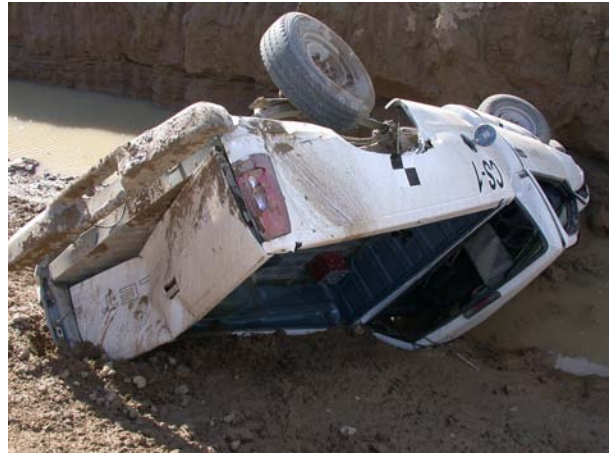
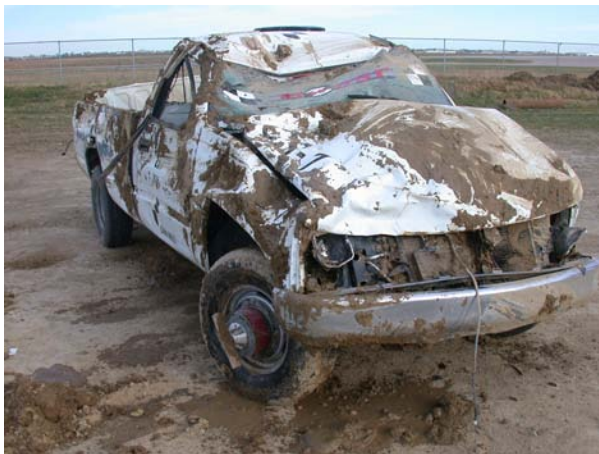
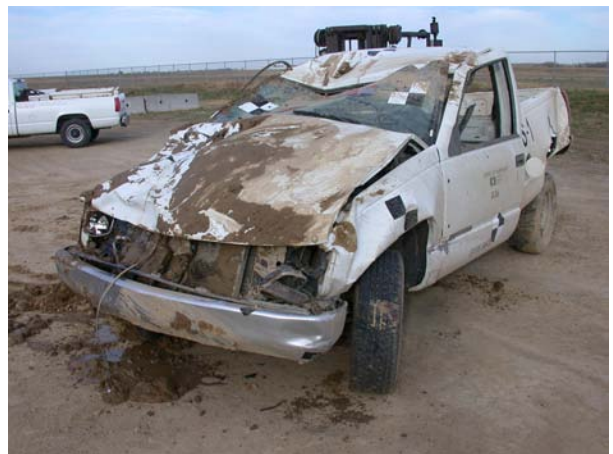
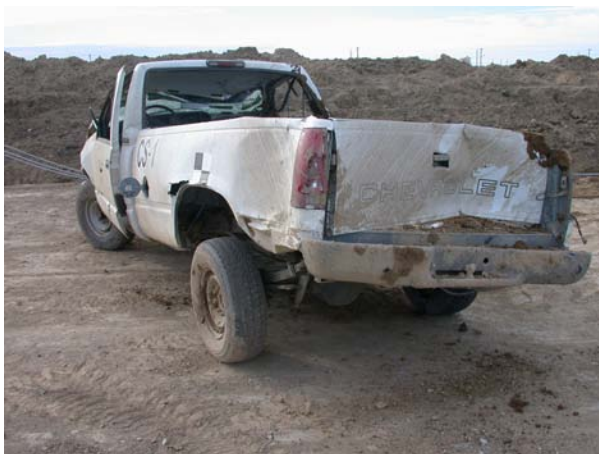
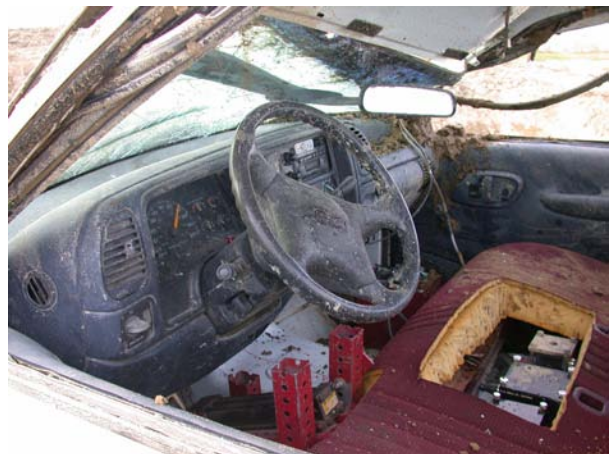
Figure 36. Vehicle Damage, Test CS-1

The entire vehicle exterior and occupant compartment was severely damaged, as expected from a rollover on a steep slope. Vehicle damage is illustrated in Figure 36. Occupant compartment deformations for given locations are provided in Appendix F. It should be noted that the impact side showed the least amount of damage.
