**FULL-SCALE 1,800 LB. VEHICLE CRASH TESTS
ON A
4-BOLT BREAKAWAY SLIPBASE DESIGN**

Project RES1(0099) P452

TRANSPORTATION RESEARCH REPORT TRP-03-25-91

Midwest Roadside Safety Facility
Civil Engineering Department
W348 Nebraska Hall
University of Nebraska-Lincoln
Lincoln, Nebraska 68588-0531

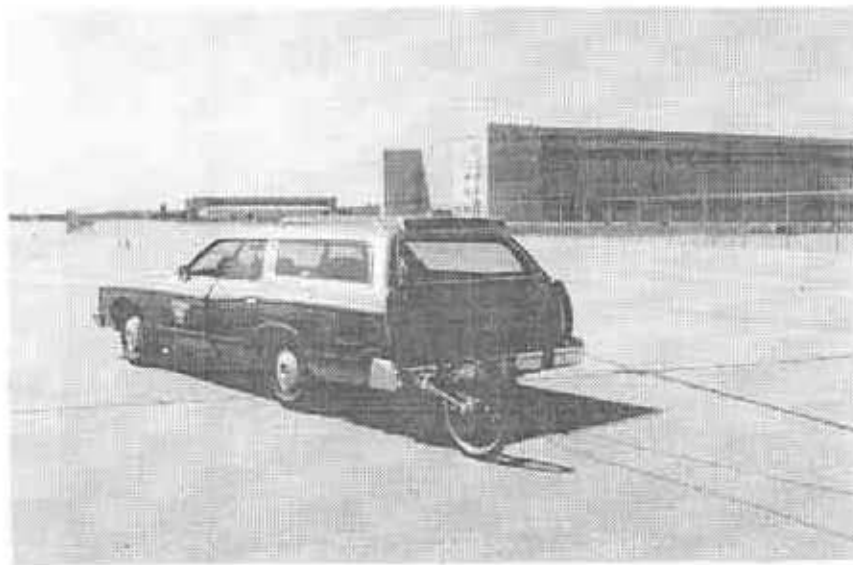
FIGURE 3. Tow Vehicle and Fifth Wheel.

A reverse cable tow, with a 1:2 mechanical advantage, was used to propel the test vehicle. The distance traveled and the speed of the tow vehicle are one-half that of the test vehicle. A sketch of the cable tow system is shown in Figure 2. The test vehicle was released from the tow cable 10 feet before impact with the 4-bolt Breakaway Slipbase Luminaire Support. Photographs of the tow vehicle and the attached fifth-wheel are shown in Figure 3. The fifth-wheel, built by the Nucleus Corporation, was used for accurately towing the test vehicle at the required target speed with the aid of a digital speedometer in the tow vehicle.

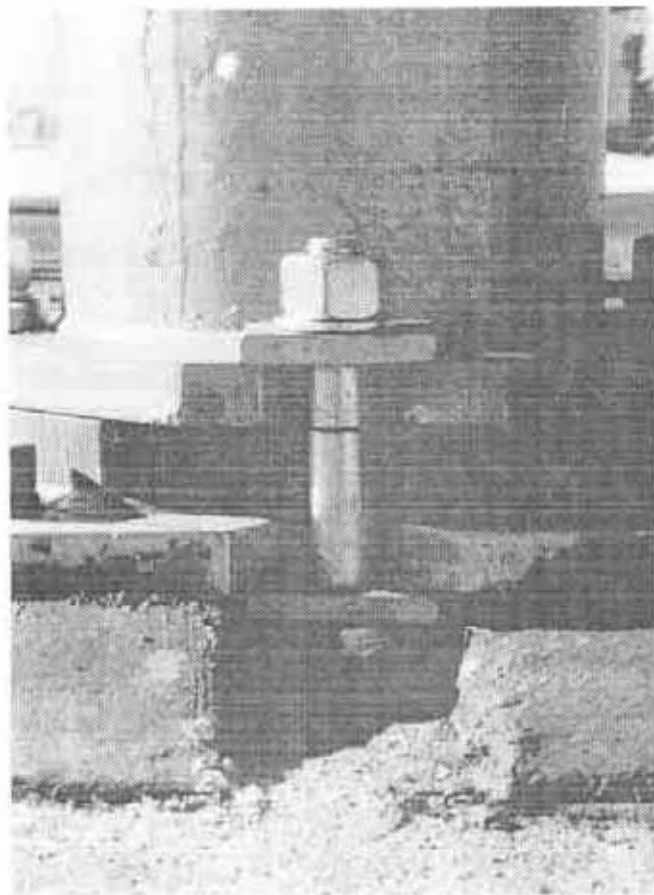
FIGURE 5. 4-Bolt Breakaway Slipbase.

The 4-bolt breakaway slipbase luminaire support design details are shown in Figure 4, and photographs of the slipbase are shown in Figure 5. The luminaire support consisted of three major structural components: the luminaire support pole, the two mast arms, and the permanent lower slipbase assembly (photographs are shown in Figure 6).

The 50-ft 0-in. luminaire pole was mounted on the permanent lower slipbase assembly with four 1-in. diameter ASTM A325 slip bolts. The high-strength slip bolts, nuts, and washers were electroplated cadmium in accordance with ASTM A165. The four slip bolts were torqued to 80 foot-pounds, and then released and retorqued to 70 foot-pounds. The Utah Department of Transportation conducted torque versus tension tests on four 1-in. diameter A325 high-strength bolts. It was determined that a torque of 70 foot-pounds would develop approximately 4,300 lbs of tension per bolt. The results of the test are presented in Appendix B.

The four 1-in. diameter slip bolts were held in place within the slots with a slip bolt gasket. The slip bolt gasket conformed to ASTM A446 Grade A steel with a 0.0149 in. thickness (gauge 28) before coating.

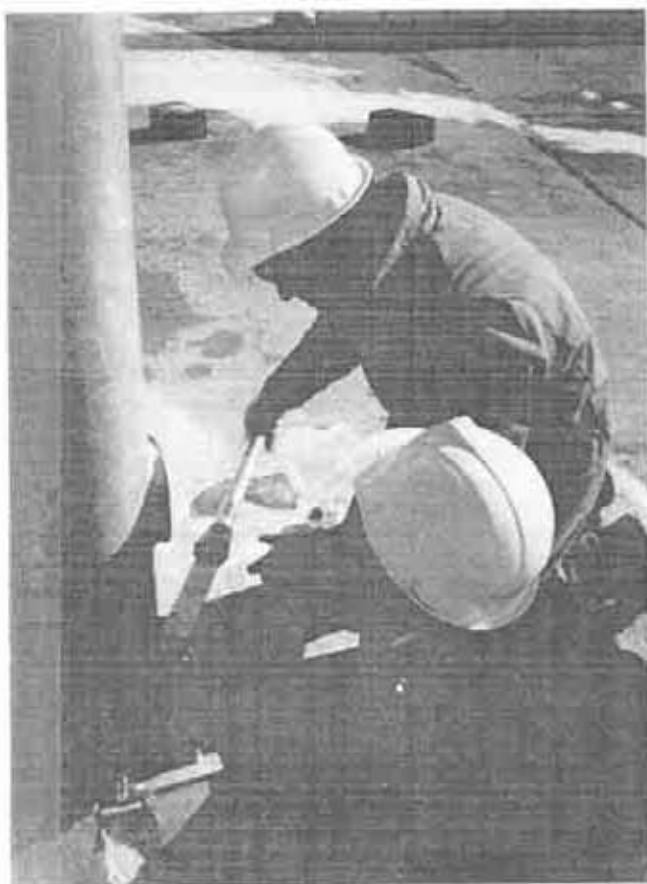
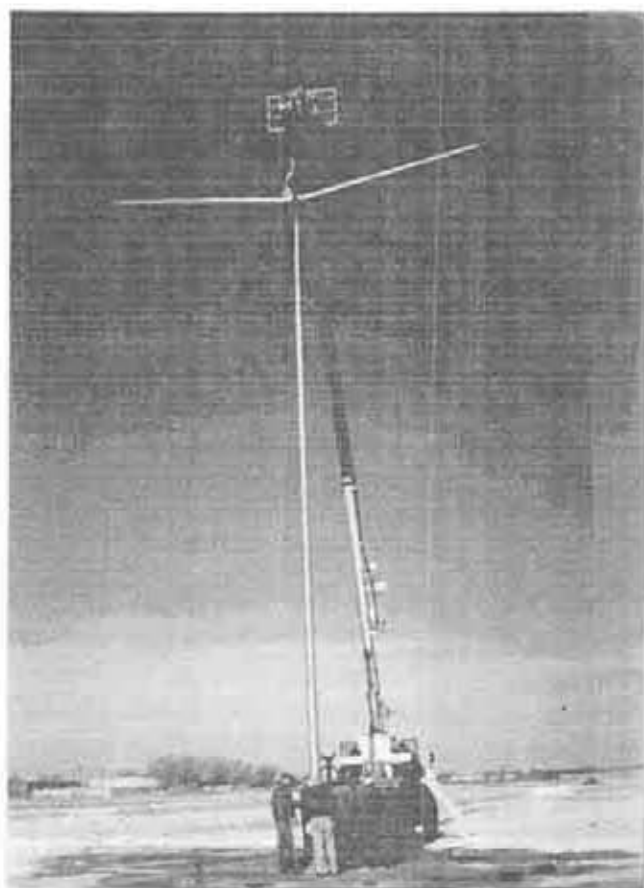
FIGURE 6. Luminaire Support Installation.

The luminaire support had a maximum mounting height of 52-ft 0-in. from the ground to the top of the mast arms. The height to the top of the luminaire pole (excluding rain cap) was 50-ft 4-in. from the ground. The permanent lower slipbase assembly had a stub height of 4 in.

The permanent lower slipbase assembly was held in place with four 1-in. diameter by 12 in. ASTM A325 threaded rods doweled into the existing concrete apron with a high-modulus, high-strength epoxy bonding/grouting adhesive. The embedment depth of the threaded rods was 8.25 in. The threaded rods extended 3.75 in. above the existing concrete surface. The bottom and top surfaces of the permanent lower slipbase assembly were mounted at a height of 1.5 in. and 4 in., respectively, above the existing concrete apron. The permanent lower slipbase assembly manufacturing requirements are with a steel with a minimum of 36 ksi yield strength. The steel assembly was hot-dipped galvanized in accordance with ASTM A123. A concrete grout mix was placed below the lower edge of the permanent lower slipbase assembly.

The slipbase was oriented with one of the slip bolts directly in line with the test vehicle impact location. This orientation was determined to give the maximum resistance to the breakaway action.

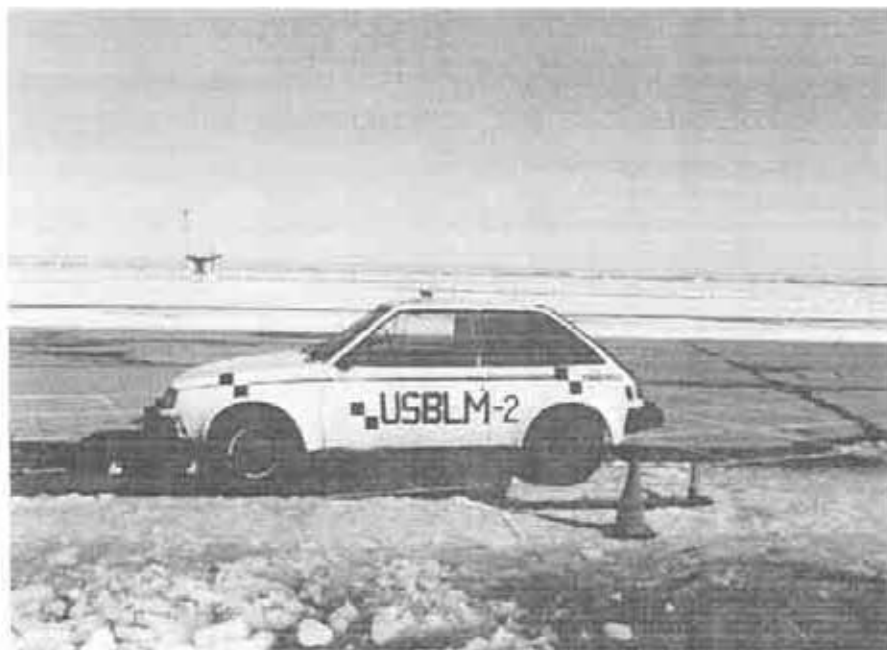
FIGURE 7. Test Vehicle.

One test vehicle was used to evaluate the 4-bolt breakaway slipbase design. After test USBLM-1, the vehicle was repaired and used for test USBLM-2. The test vehicle was a 1984 Dodge Colt weighing 1,750 lbs. Photographs of the test vehicle are shown in Figure 7. Dimensions of the test vehicle are shown in Figure 8.

Three 8-in. square, black and white checkered targets were placed on the driver's side of the vehicle to aid in the analysis of the high-speed film. The center target was placed over the center of gravity of the vehicle, while the front target was placed 3 ft ahead and the rear target 5 ft. behind the center target. Targets were also placed on the top and back of the vehicle to aid in the evaluation process.

Two No. 5 flash bulbs were mounted on the roof of the test vehicle to pinpoint the time of impact with the luminaire support on the highspeed film. The flash bulbs were fired by a pressure tape switch mounted on the front face of the bumper.

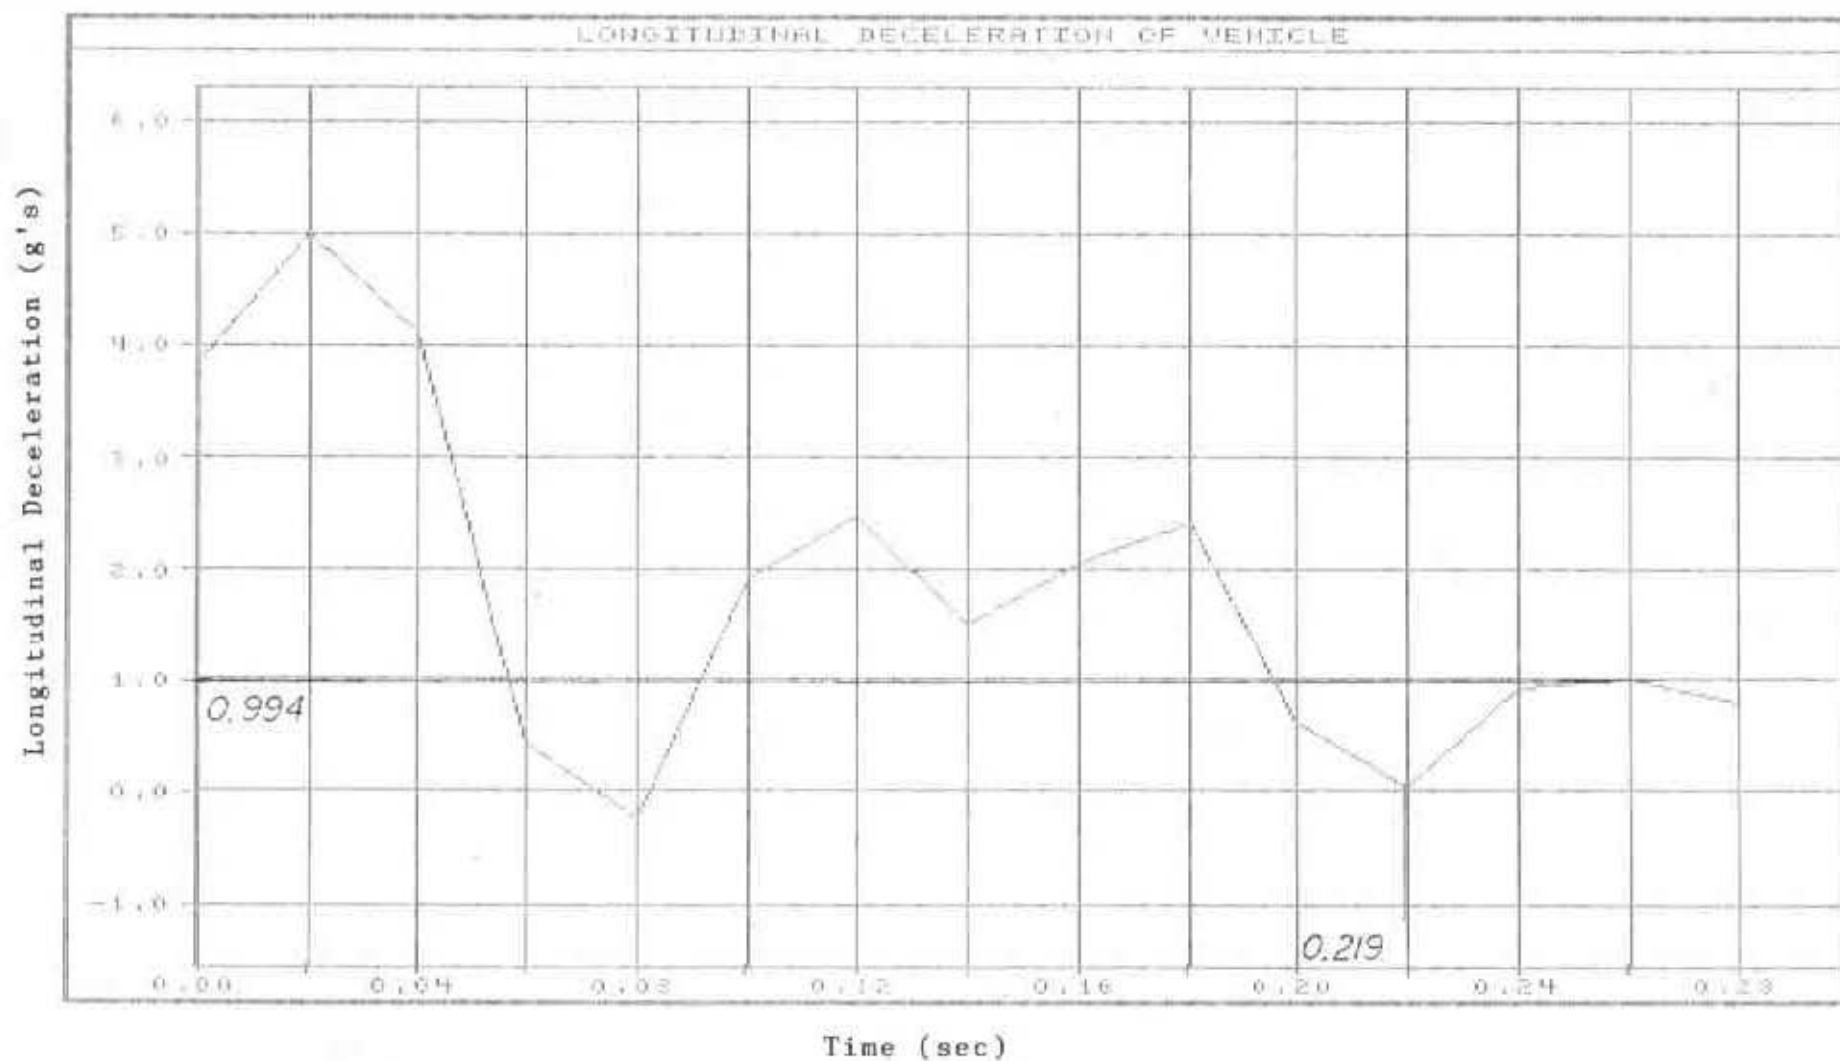
Figure C-4. Graph of Longitudinal Deceleration, Test USBLM-2.

5. The longitudinal occupant ridedown decelerations for Test USBLM-1 (3.5 g's) and Test USBLM-2 (1.0 g) were less than 15 g's as recommended by NCHRP 230 (1).

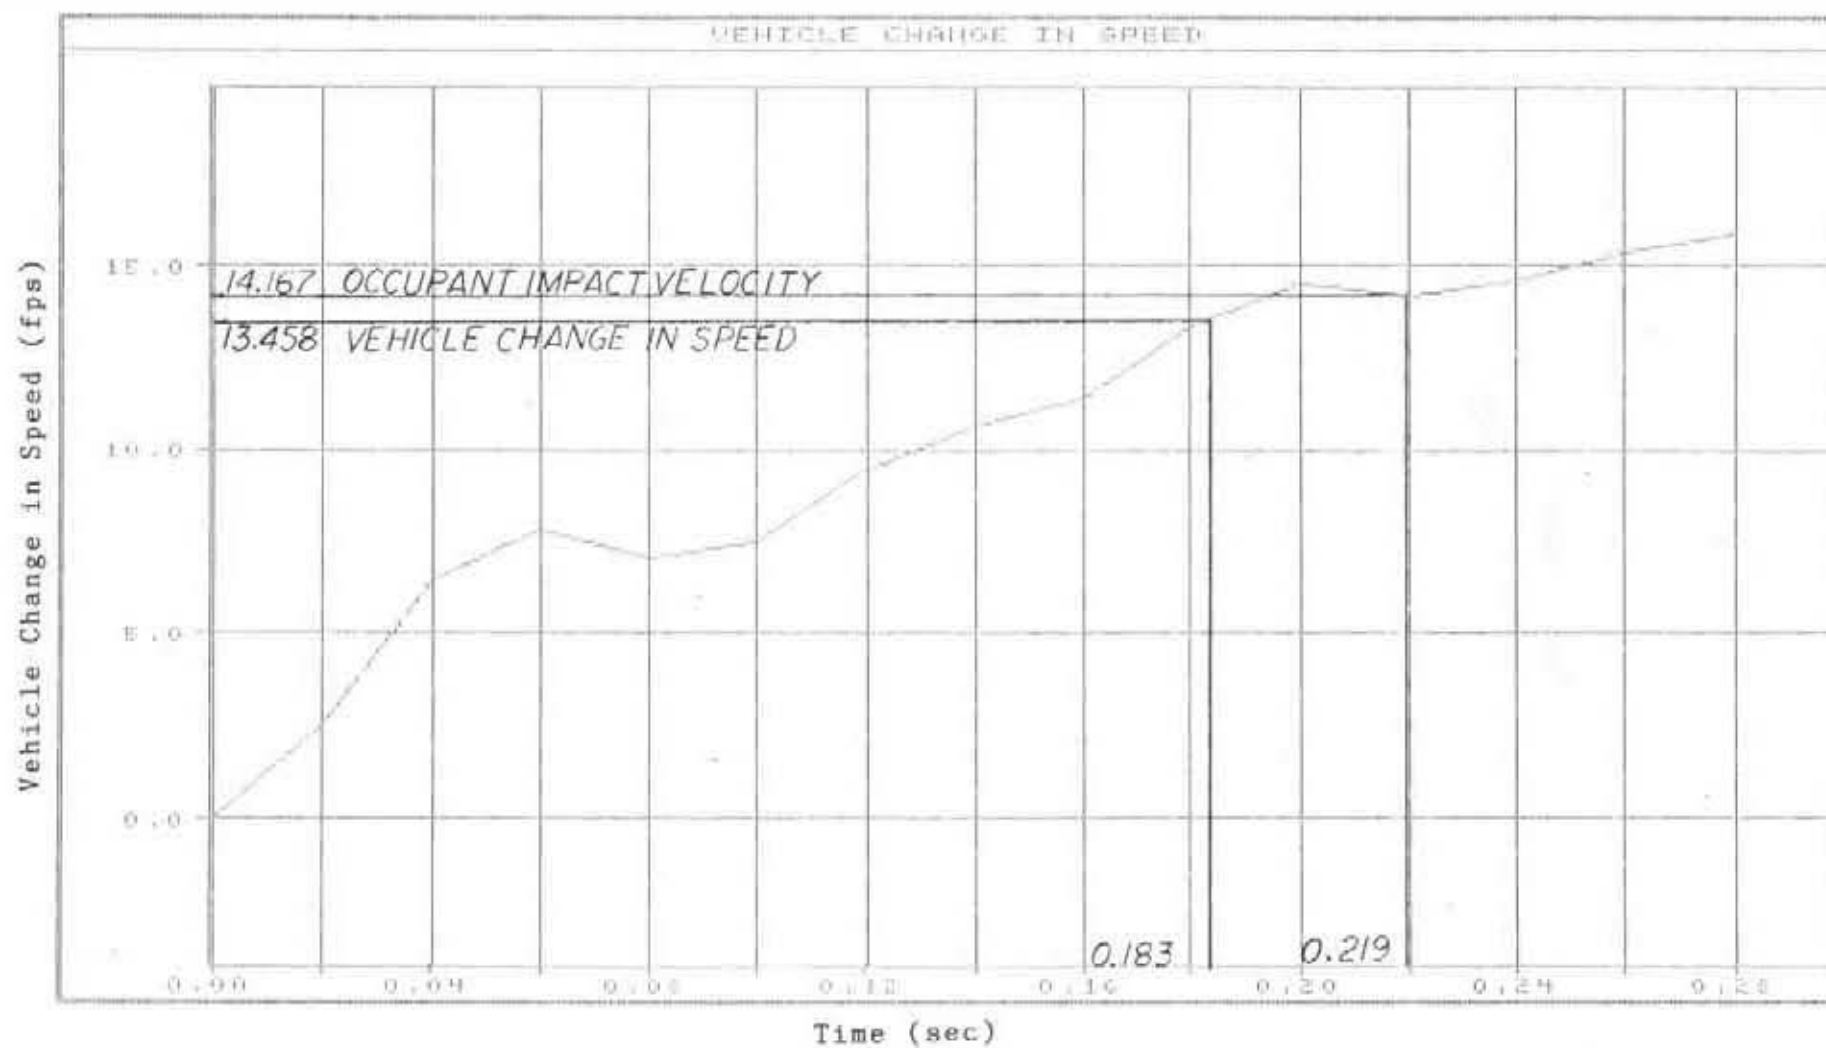
Figure C-5. Graph of Vehicle Change in Speed, Test USBLM-2.

6. The vehicle change-in-speed for Test USBLM-1 (6.1 fps) and Test USBLM-2 (13.5 fps) were less than the 15 fps recommended by AASHTO (2), and the 16 fps recommended by the Federal Register (3).
