**SAFETY PERFORMANCE EVALUATION OF  
THE STEEL-BACKED LOG RAIL**

Midwest Roadside Safety Facility  
Civil Engineering Department  
University of Nebraska-Lincoln  
1901 "Y" St.  
P.O. Box 880601  
Lincoln, Nebraska 68588-0601  
(402) 472-6864

Transportation Research Report No. TRP-03-35-92

December 1992

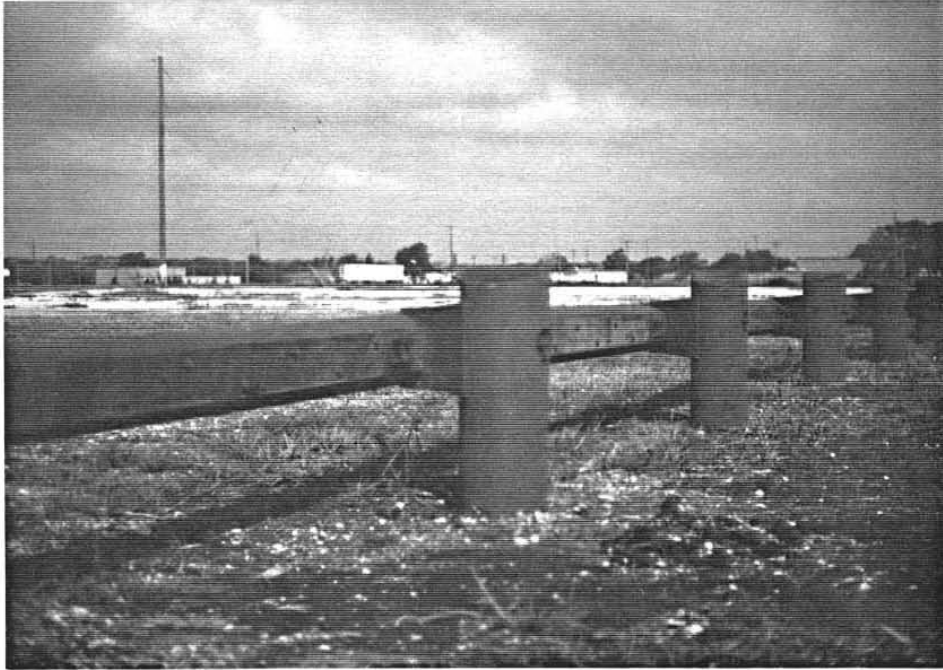
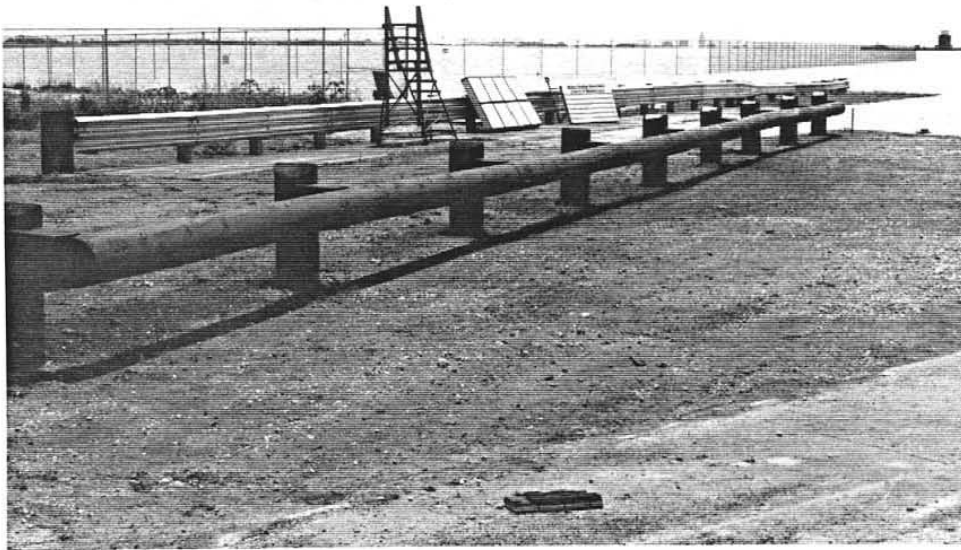
**FIGURE 1.** Photographs of the Steel-Backed Log Rail

Both the posts and rail elements of this 80 ft long system consisted of ponderosa pine. All fastener hardware was manufactured from steel conforming to ASTM A588. Photographs of the Steel-Backed Log Rail are shown in Figures 1 and 2. Design details are shown in Figures 3 and 4.

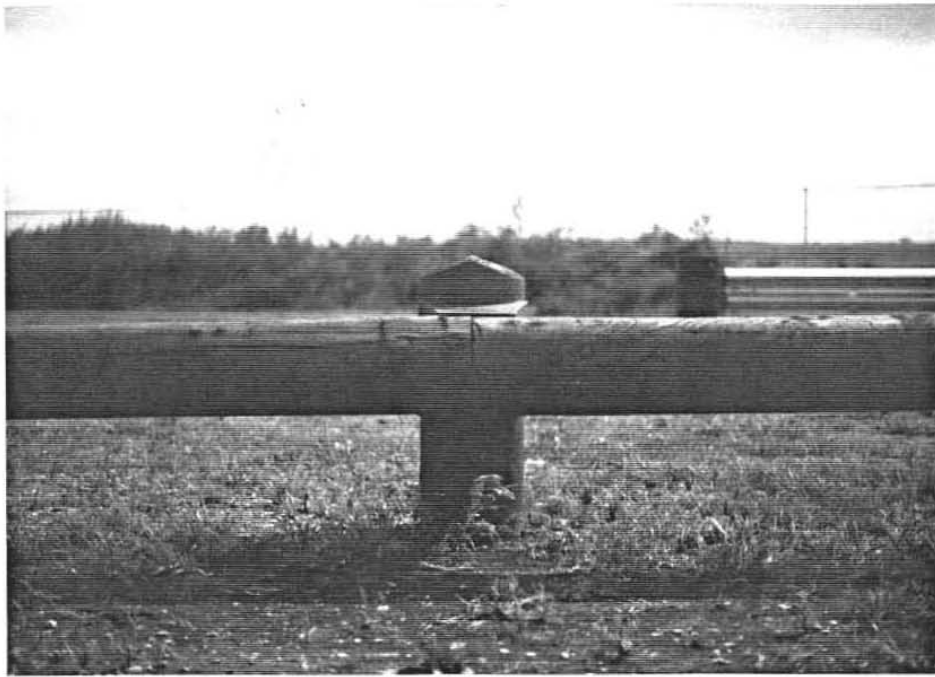
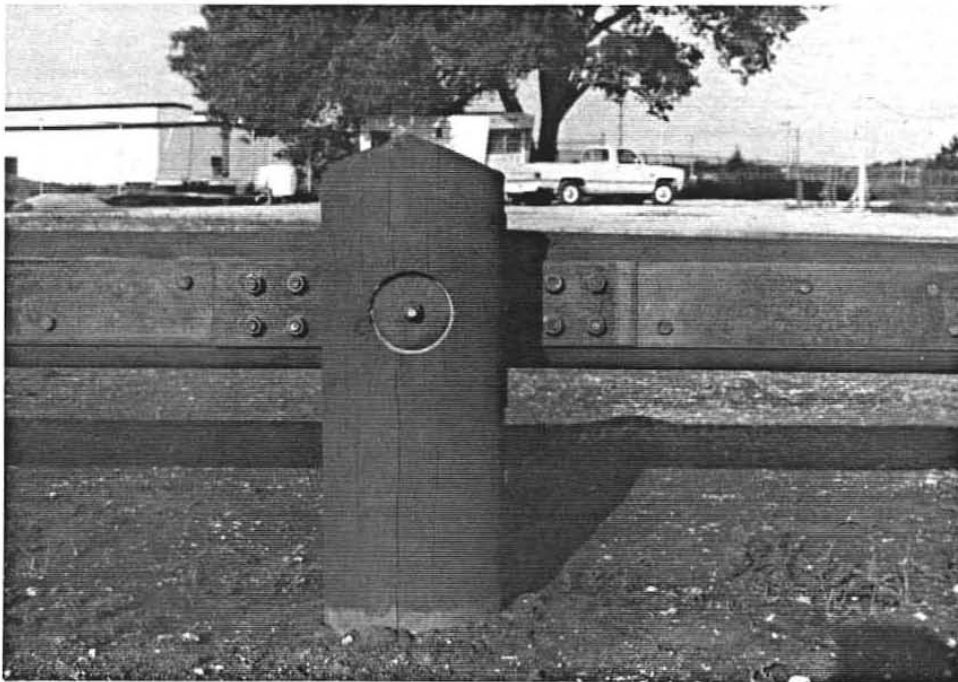
**FIGURE 2.** Photographs of the Steel-Backed Log Rail (continued)

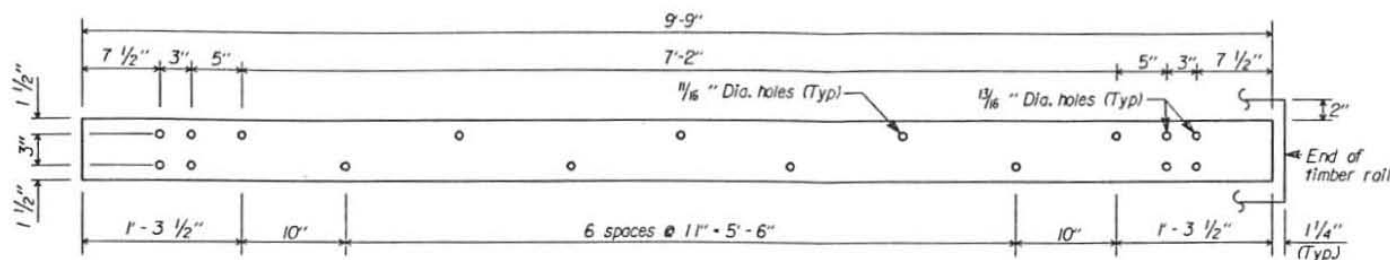
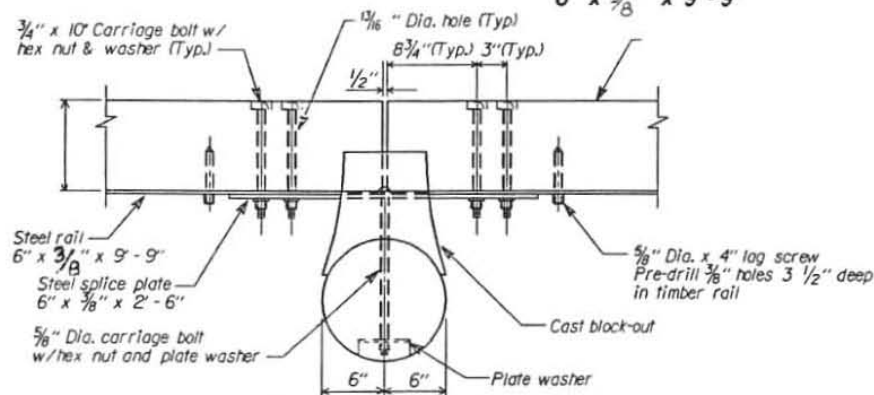
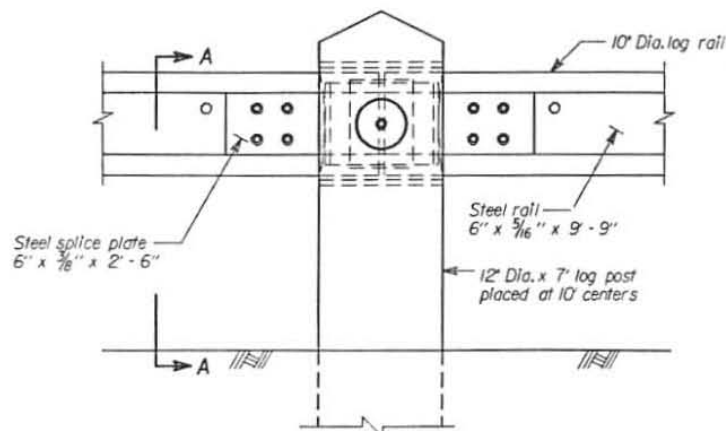
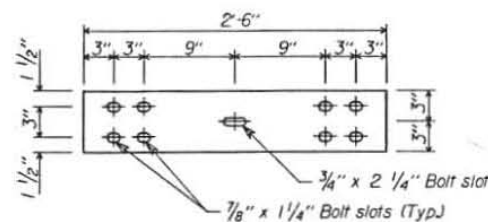
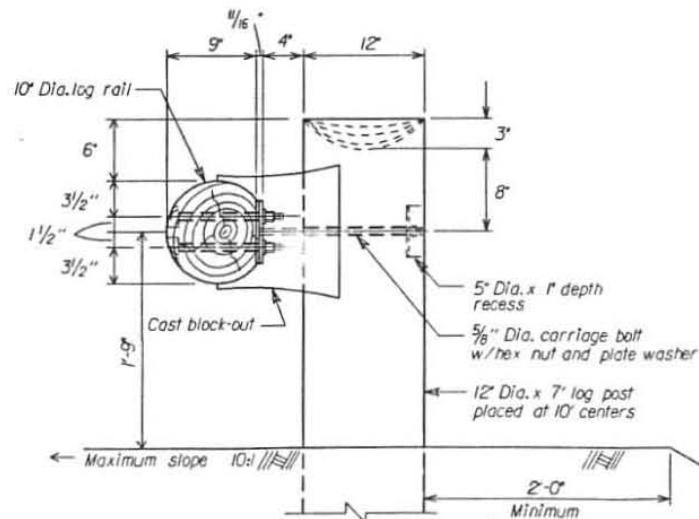
**STEEL RAIL DETAIL**  
6" x 3/8" x 9'-9"

**POST CONNECTION PLAN**

**POST CONNECTION ELEVATION**

**STEEL SPLICE PLATE DETAIL**  
6" x 3/8" x 2'-6"

**SECTION A-A**

**FIGURE 3. Details of the Steel-Backed Log Rail System**

The Steel-Backed Log Rail was constructed from 10-in. diameter logs backed by 6-in. x  $\frac{3}{8}$ -in. x 9-ft 9-in. ASTM A588 steel plates. Backup plates were attached to the log rails with  $\frac{3}{8}$ -in. x 4-in. lag screws and the 10 ft long rail elements were connected with 6 in. x  $\frac{3}{8}$  in. x 2-ft. 6-in. ASTM A588 steel splice plates. The railing was mounted on 12 in. diameter round posts with cast steel blockouts placed at each splice joint. The center of the rail elements was placed at a height of 1 ft - 9 in.

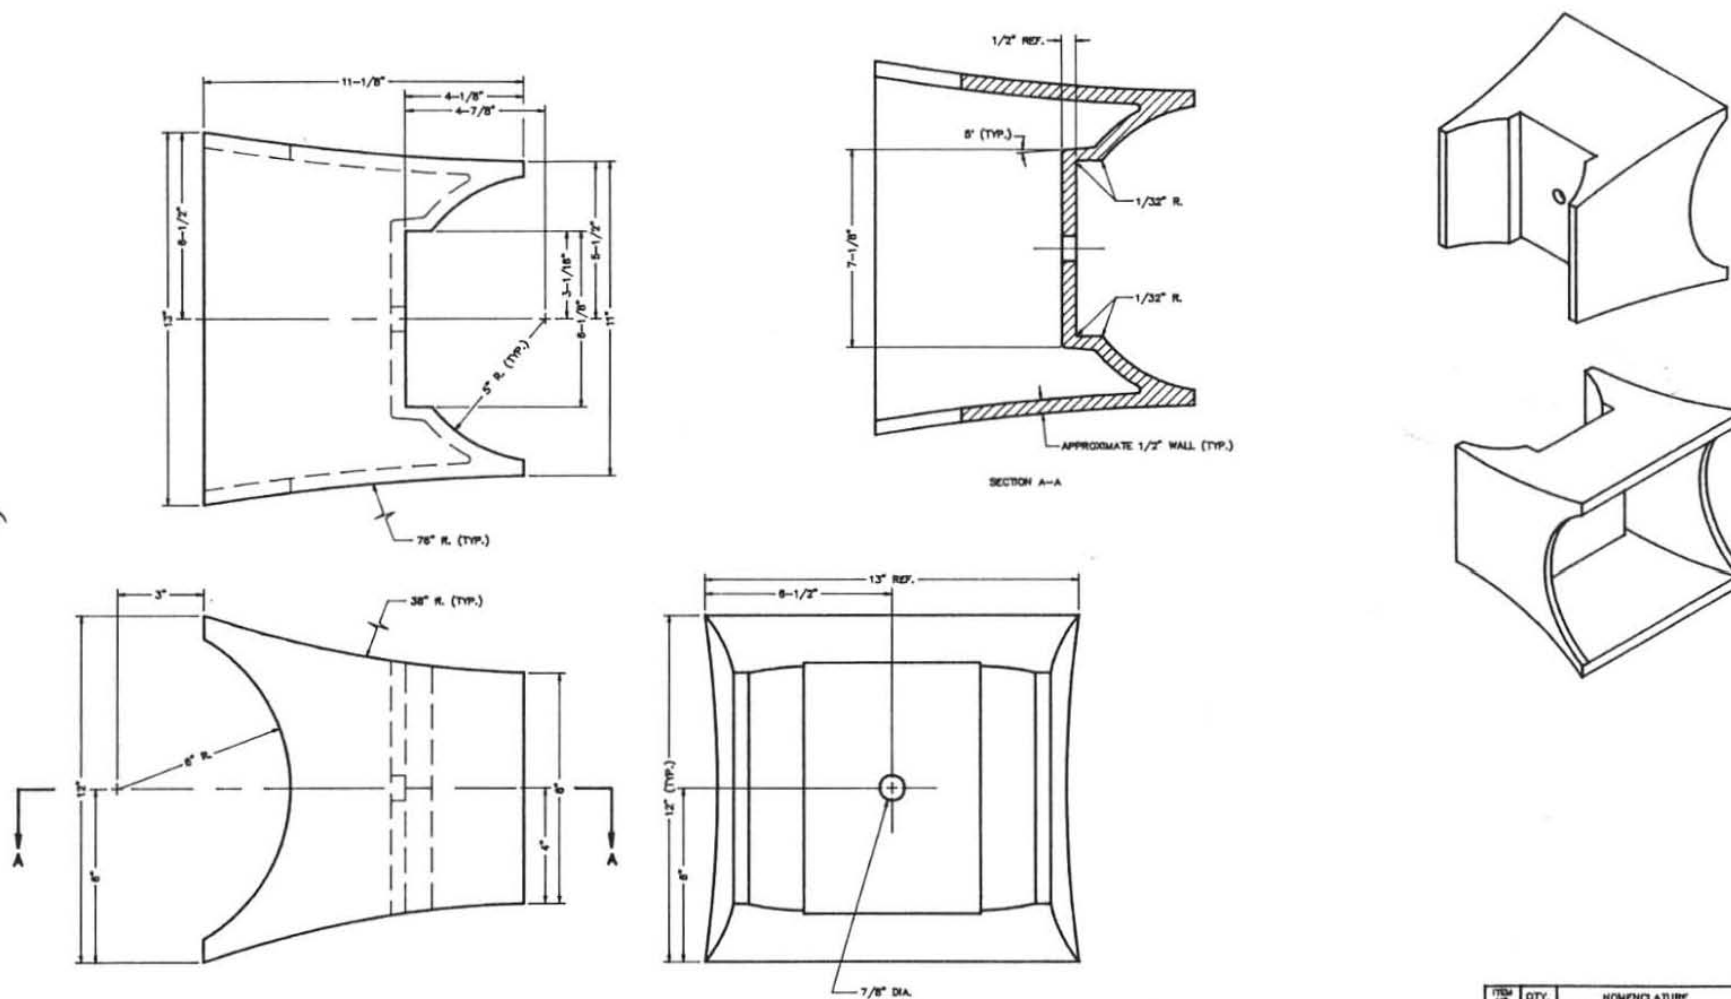
FIGURE 4. Details of the Cast Steel Blockout used in the Steel-Backed Log Rail System

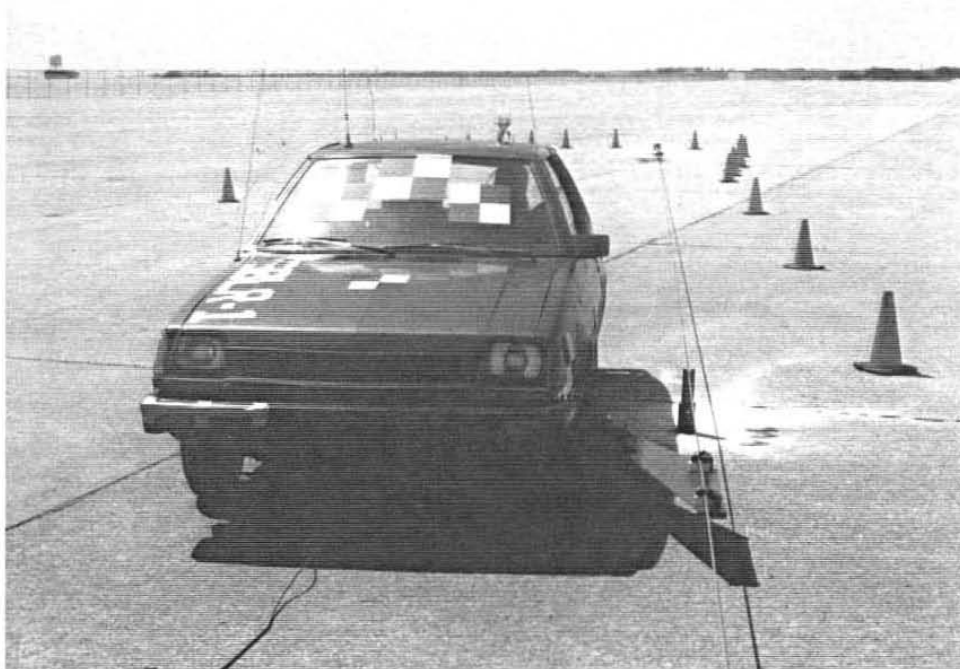
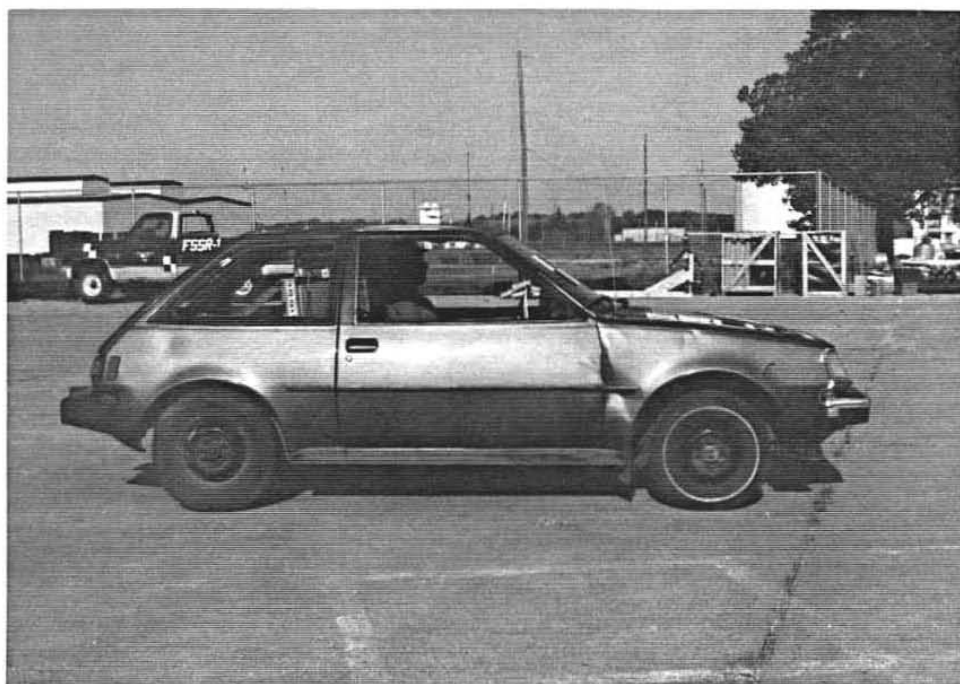
**FIGURE 5.** Test Vehicle, Test SBLR-1

A 1984 Dodge Colt, shown in Figure 5, was used as a test vehicle in Test SBLR-1. As shown in Figure 6, the vehicle had a test inertial and a gross static weight of 1850 lbs and 2015 lbs, respectively.

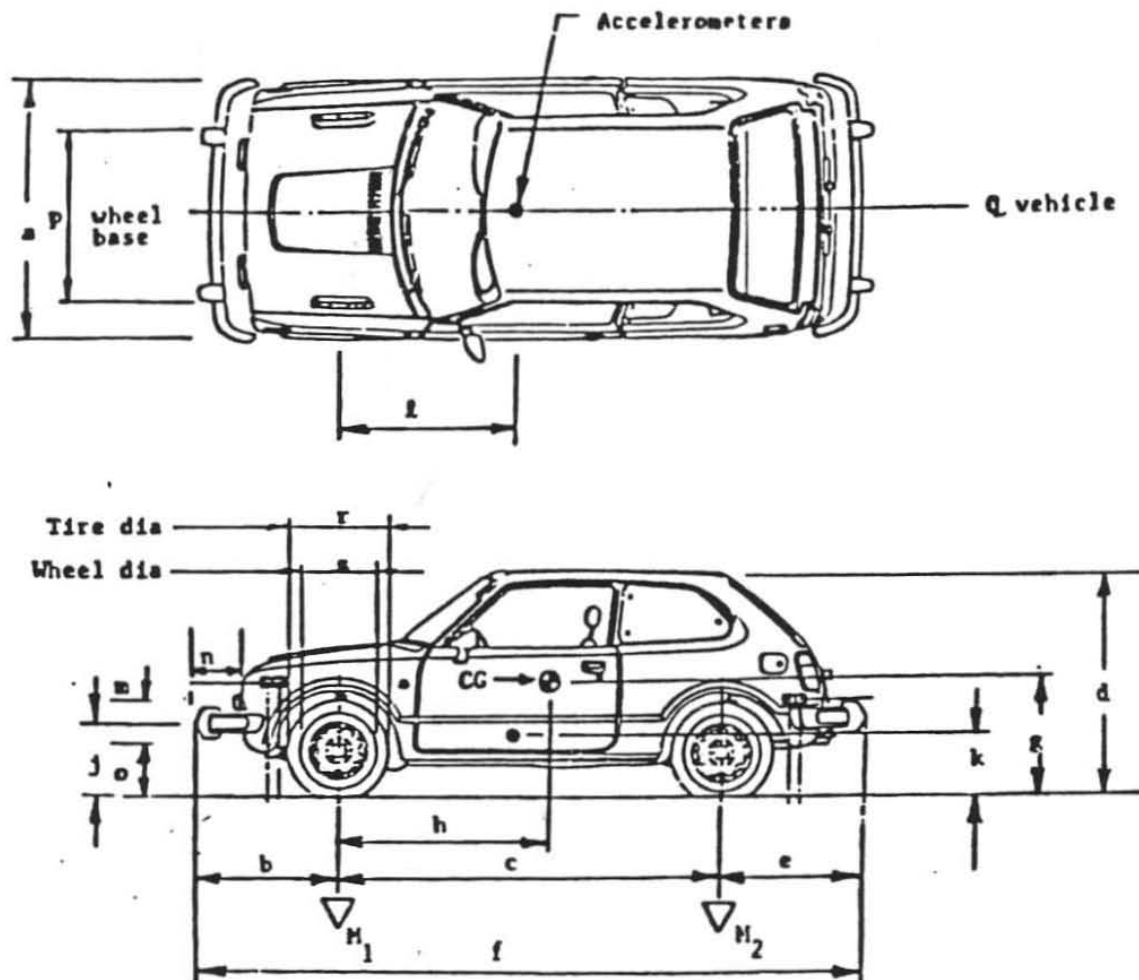
a	62.0	d	52.0	j	18.0	m	5.0	p	54.0
b	33.5	e	32.0	k	17.0	n	6.25	r	22.5
c	90.0	f	155.5	l	46.5	o	15.5	s	14.0

<u>Mass - lb</u>	<u>Curb</u>	<u>Test Inertial*</u>	<u>Gross Static**</u>
M <sub>1</sub>	1107	1205	1290
M <sub>2</sub>	552	645	725
M <sub>T</sub>	1659	1850	2015
h - in. (m)	31.75	31.75	31.75
g - in. (m)	21.0	21.0	21.0

FIGURE 6. Vehicle Dimensions, Test SBLR-1

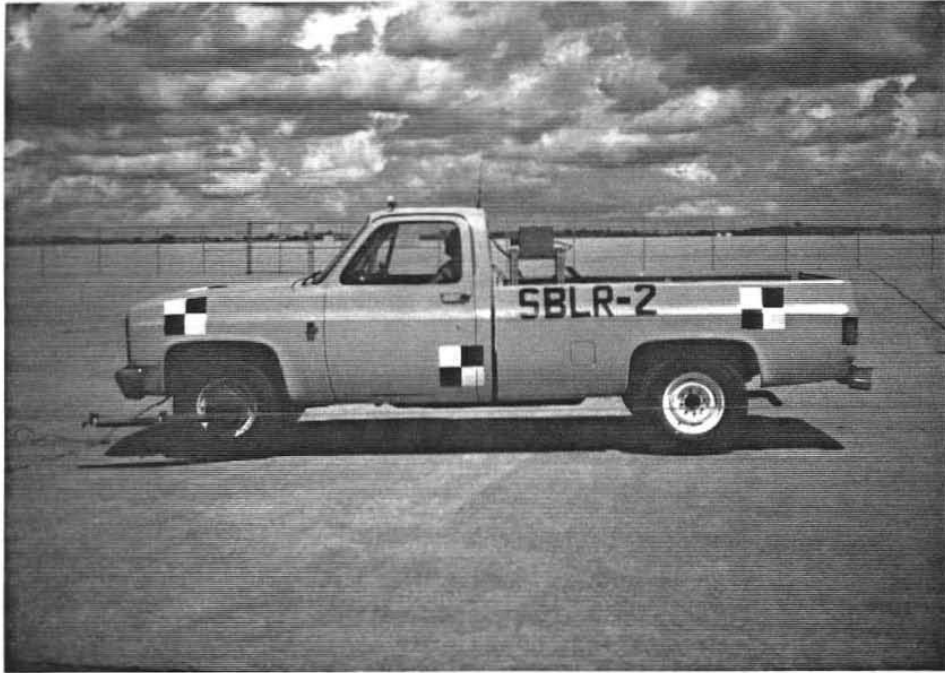
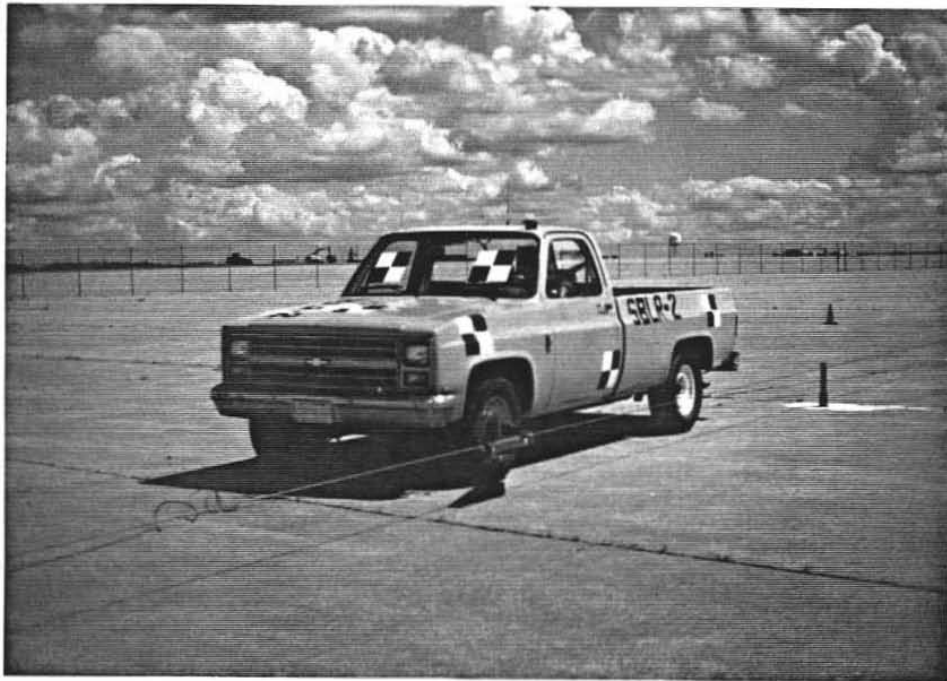
**FIGURE 7.** Test Vehicle, Test SBLR-2

A 1986 3/4 ton Chevrolet pickup, shown in Figure 7, was used as a test vehicle in Test SBLR-2. This vehicle had test inertial and gross static weights of 5400 lbs and 5565 lbs, respectively. Vehicle weights and dimensions are shown in Figure 8.

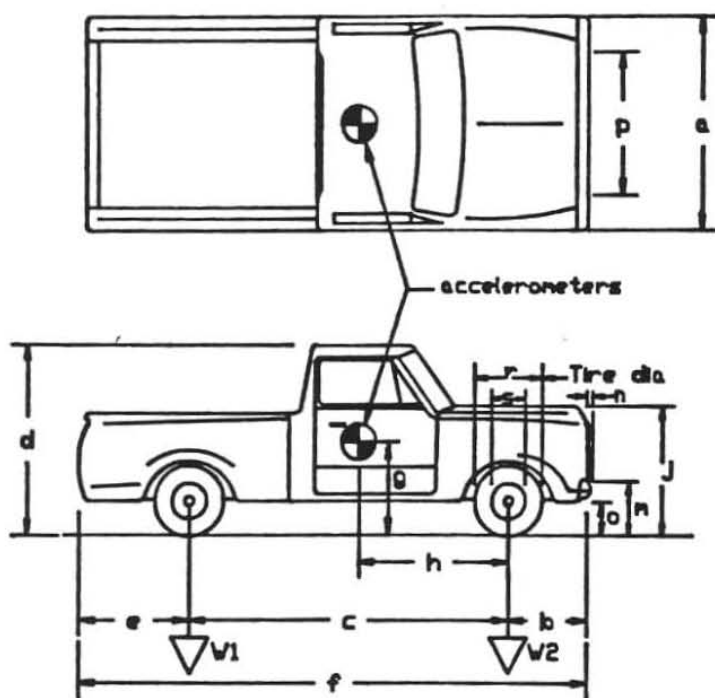
a	<u>78</u>	b	<u>31.5</u>
c	<u>132</u>	d	<u>72</u>
e	<u>52</u>	f	<u>215.5</u>
g	<u>27</u>	h	<u>67</u>
i	<u>--</u>	j	<u>45</u>
k	<u>--</u>	l	<u>--</u>
m	<u>27</u>	n	<u>3</u>
o	<u>18.5</u>	p	<u>66</u>
r	<u>30.5</u>	s	<u>17</u>

Weight - pounds	Curb	Test Inertial	Gross Static
W1	<u>2600</u>	<u>2760</u>	<u>2840</u>
W2	<u>2000</u>	<u>2640</u>	<u>2725</u>
Wtotal	<u>4600</u>	<u>5400</u>	<u>5565</u>

FIGURE 8. Vehicle Dimensions, Test SBLR-2

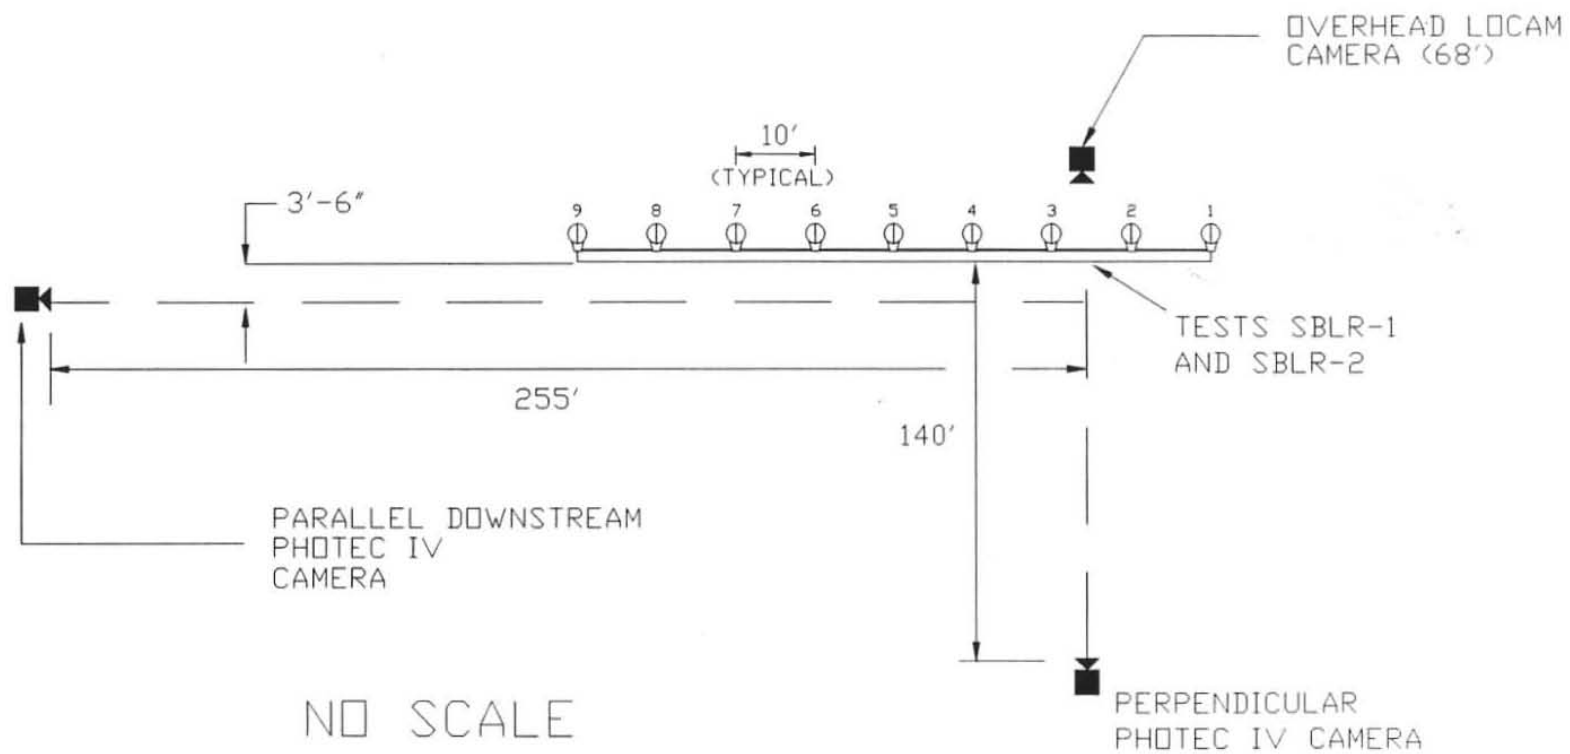
**FIGURE 9.** Layout of High-Speed Cameras

Four high-speed 16-mm cameras, with operating speeds of approximately 500 frames/sec were used to film the crash tests. A Red Lake Locam with a 12.5 mm lens was placed above the test installation to provide a field of view perpendicular to the ground. A Photec IV, with an 80-mm lens, was placed downstream from the impact point and had a field of view parallel to the barrier. A second Photec IV, with a 55-mm lens, was placed on the traffic side of the bridge rail and had a field of view perpendicular to the barrier. Another Red Lake Locam with a 5.7-mm lens was placed onboard the vehicle to record dummy motions during the test. A schematic of the camera locations for each test is shown in Figure 9. A white-colored backboard with a 2-ft by 2-ft grid was placed behind the rail in view of the overhead camera. This backboard provided a visible reference system to use in the analysis of the overhead high-speed film. The film was analyzed using a Vanguard Motion Analyzer.

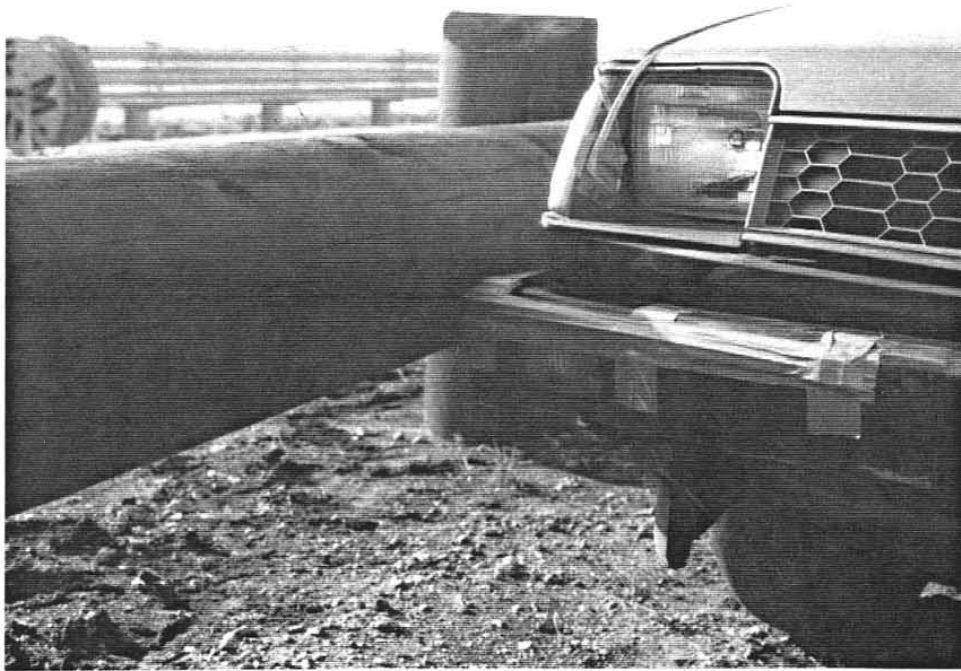
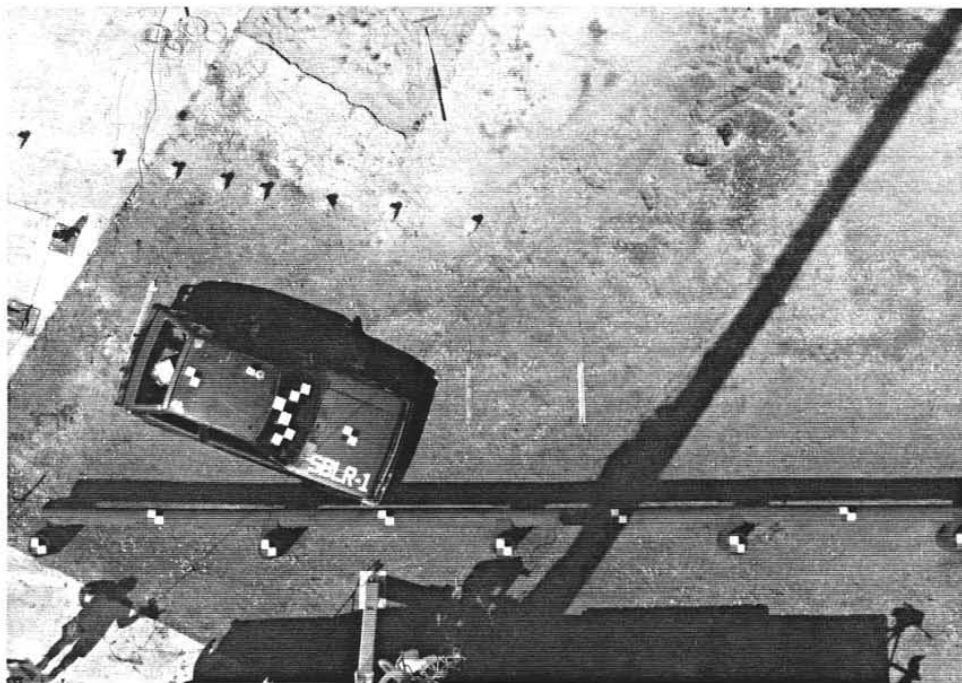
**FIGURE 10.** Vehicle Impact Location, Test SBLR-1

The 1984 Dodge Colt was directed into the Steel-Backed Log Rail using a reverse tow and cable guidance system (4). The vehicle was released from the tow cable and guidance system and was free wheeling at impact. The speed of the vehicle at impact was 50.6 mph and the angle of impact was 19.2 degrees. The impact point, shown in Figure 10, was located midspan between Post Nos. 2 and 3, or 15 ft from the upstream end of the installation. A summary of the test results and sequential photographs is shown in Figure 11. Additional sequential photographs are shown in Figures 12 through 14.

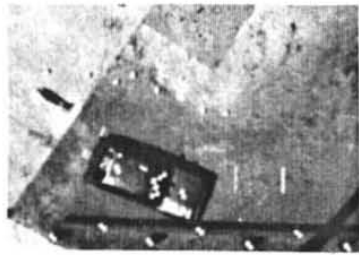
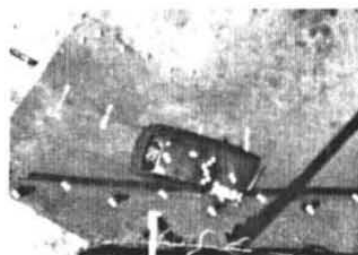
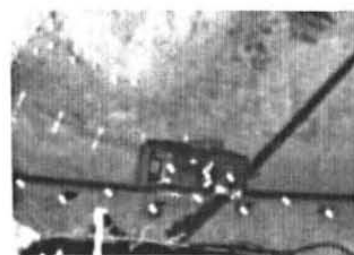
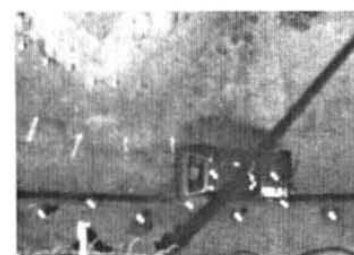
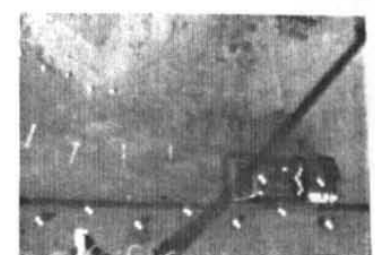
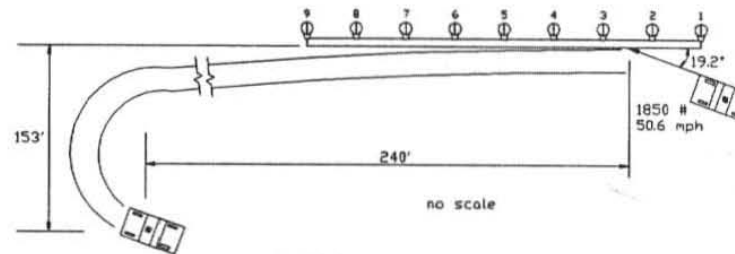
Test Number . . . . . SBLR-1  
 Date . . . . . 6/18/92  
 Installation . . . . . Steel Backed Log Guardrail  
 Installation Length . . . . . 80 ft  
 Post  
     Material . . . . . Ponderosa Pine  
     Diameter . . . . . 12 in.  
     Length . . . . . 7 ft  
 Rail Sections  
     Material . . . . . Ponderosa Pine  
     Diameter . . . . . 10 in.  
     Length . . . . . 10 ft  
 Backup Plate  
     Material . . . . . ASTM A588 Steel  
     Dimensions . . . . . 6 in. x 3/8 in. x 9 ft-9 in.  
 Splice Plate  
     Material . . . . . ASTM A 588 Steel  
     Dimensions . . . . . 6 in. x 3/8 in. x 30 in.  
 Cast Blockout  
     Material . . . . . ASTM A588 Steel

Test Vehicle . . . . . 1984 Dodge Colt  
 Weight  
     Test Inertial . . . . . 1850 lbs  
     Gross Static . . . . . 2015 lbs  
 Impact Speed . . . . . 50.6 mph  
 Impact Angle . . . . . 19.2 deg  
 Exit Speed . . . . . 28.2 mph  
 Exit Angle . . . . . 2 deg  
 Occupant Impact Velocity  
     Longitudinal . . . . . 24.3 fps  
     Lateral . . . . . 21.1 fps  
 Occupant Ridedown Deceleration  
     Longitudinal . . . . . 3.9 g's  
     Lateral . . . . . 4.8 g's  
 Vehicle Damage  
     TAD . . . . . 1-RFQ-4  
     VDI . . . . . 01RYES2  
 Vehicle Rebound Distance . . . . . 6 ft-11 in. @ 113 ft  
 Coefficient of Friction . . . . . 1.02

FIGURE 11. Test SBLR-1 Summary

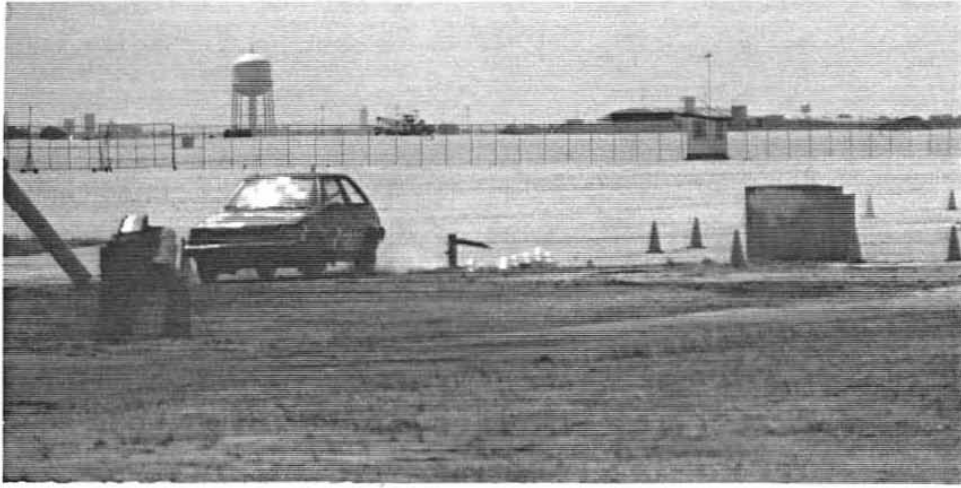
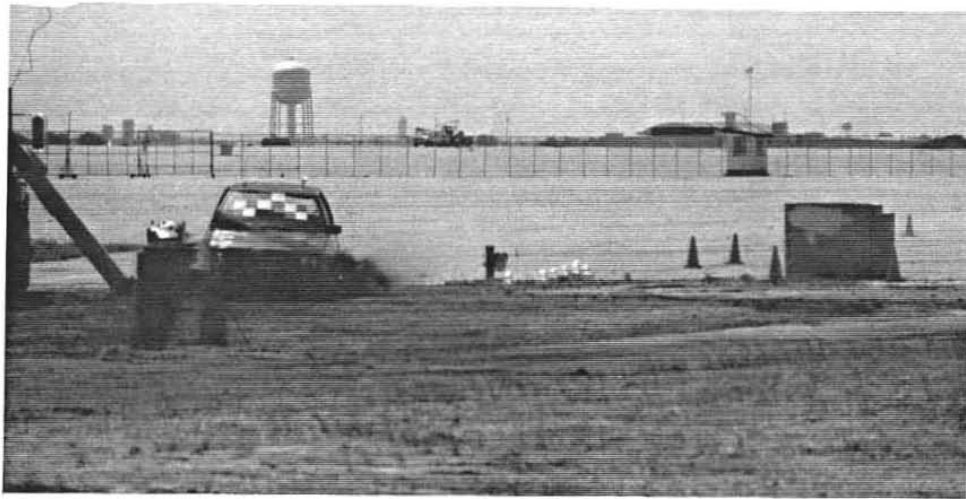
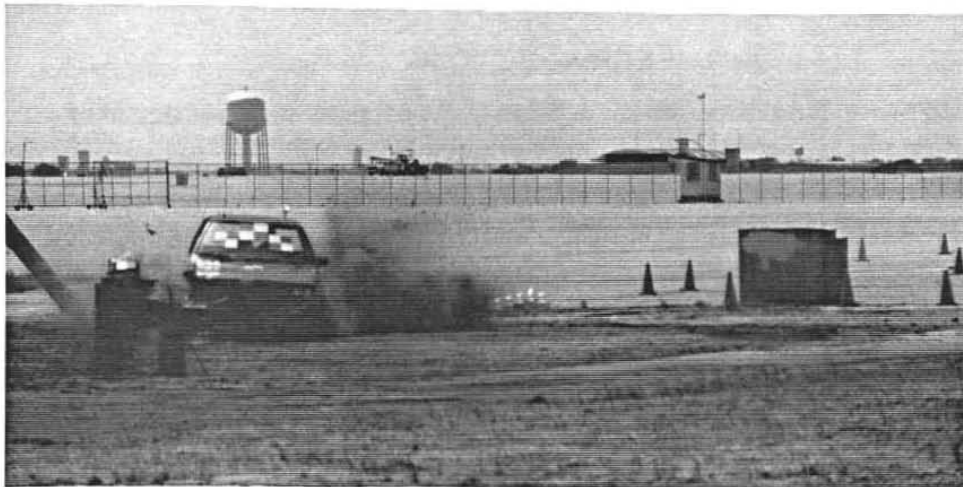
**FIGURE 12.** Downstream Sequential Photographs, Test SBLR-1

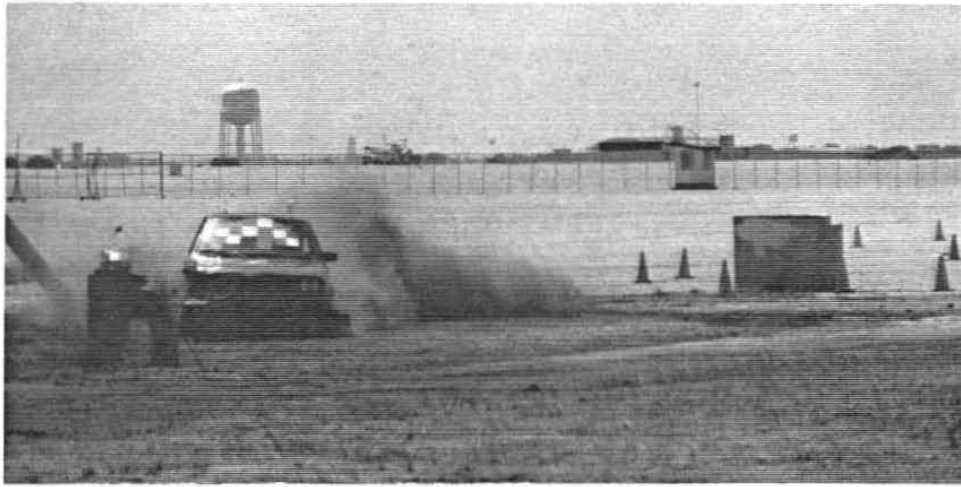
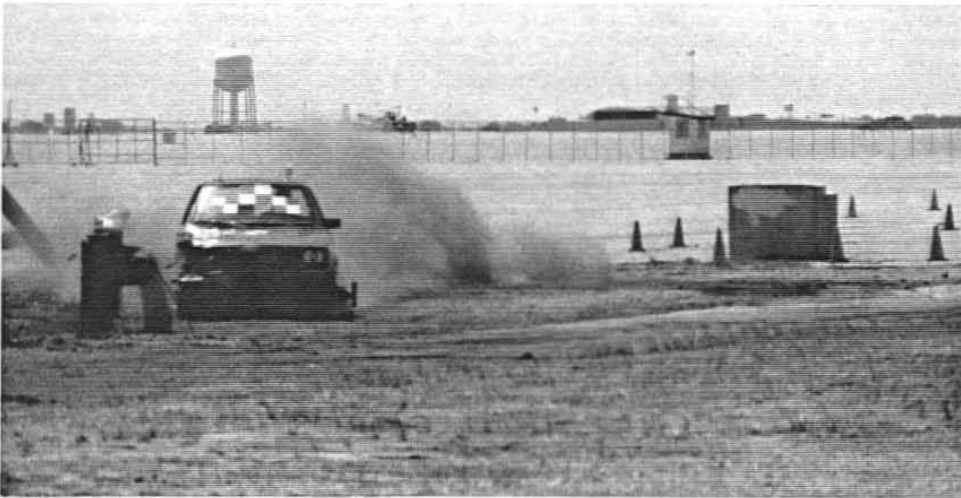
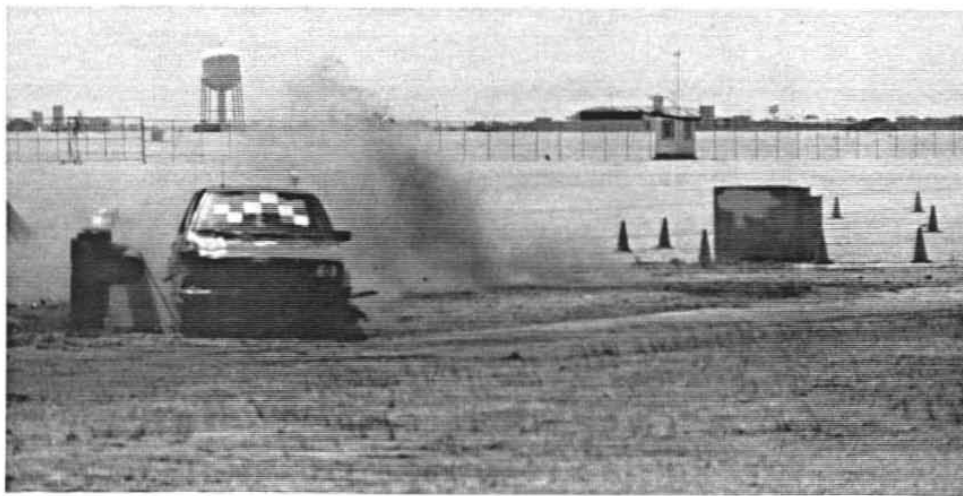
**FIGURE 13.** Downstream Sequential Photographs, Test SBLR-1 (continued)

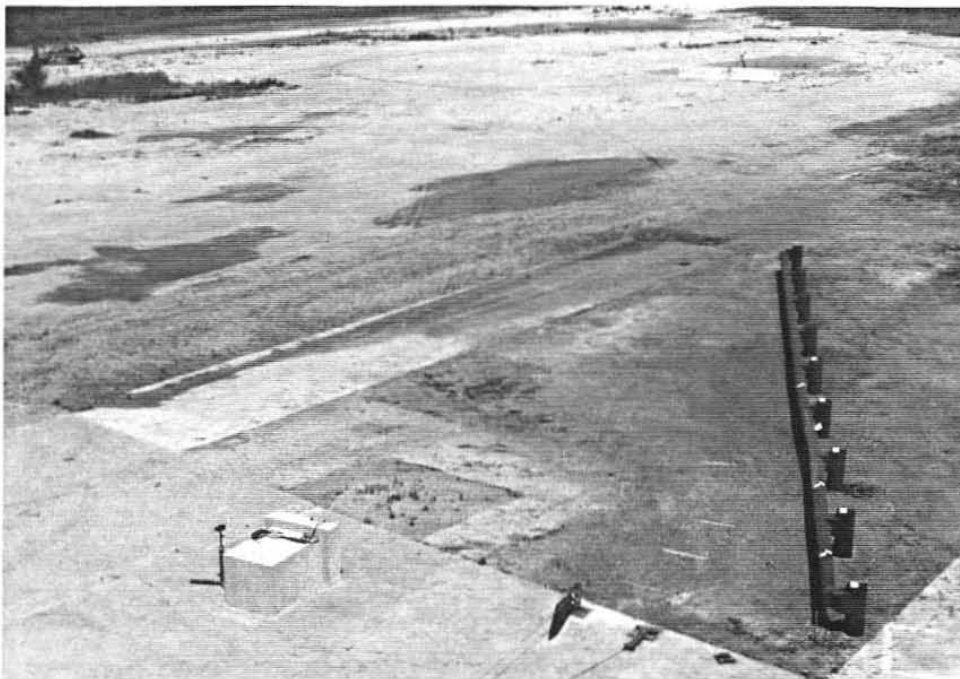
**FIGURE 15.** Vehicle Trajectory, Test SBLR-1

Upon impact with the log rail, the front bumper slipped under the rail, and the front right corner of the vehicle began to crush inward. The vehicle slid along the log rail and reached Post No. 3 approximately 64 ms after impact. 216 ms after impact the vehicle reached Post No. 4 and became parallel to the rail at approximately 352 ms. The vehicle exited the rail at an angle of 2 degrees approximately 503 ms after impact. After exiting the rail, the vehicle continued to travel downstream and to the left, coming to a rest 240 ft downstream from impact and 153 ft to the left of a line parallel to the railing face. This vehicle trajectory is shown in Figure 15.

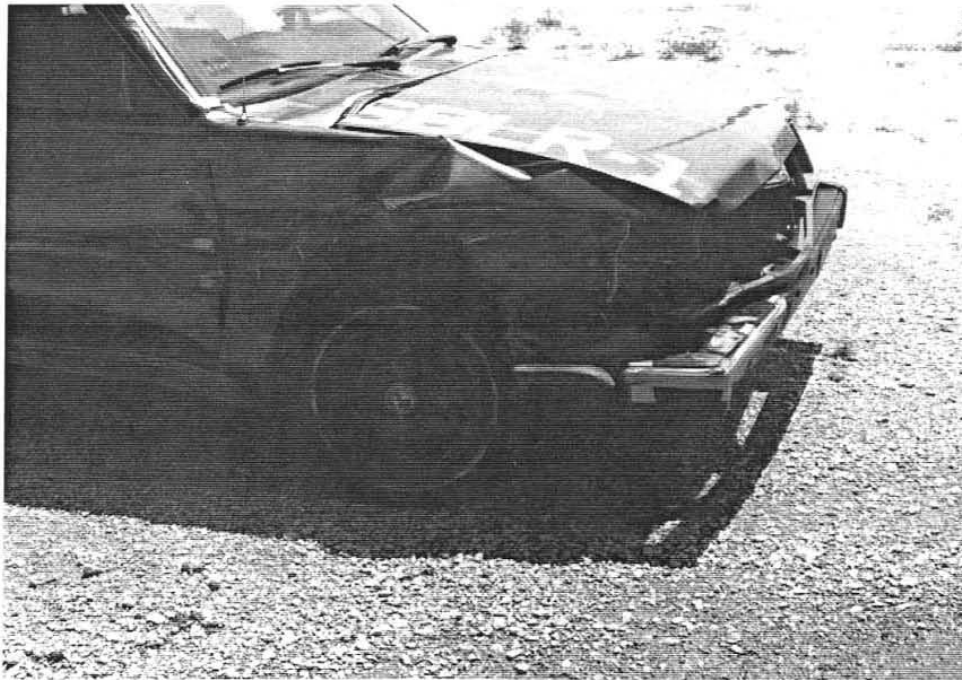
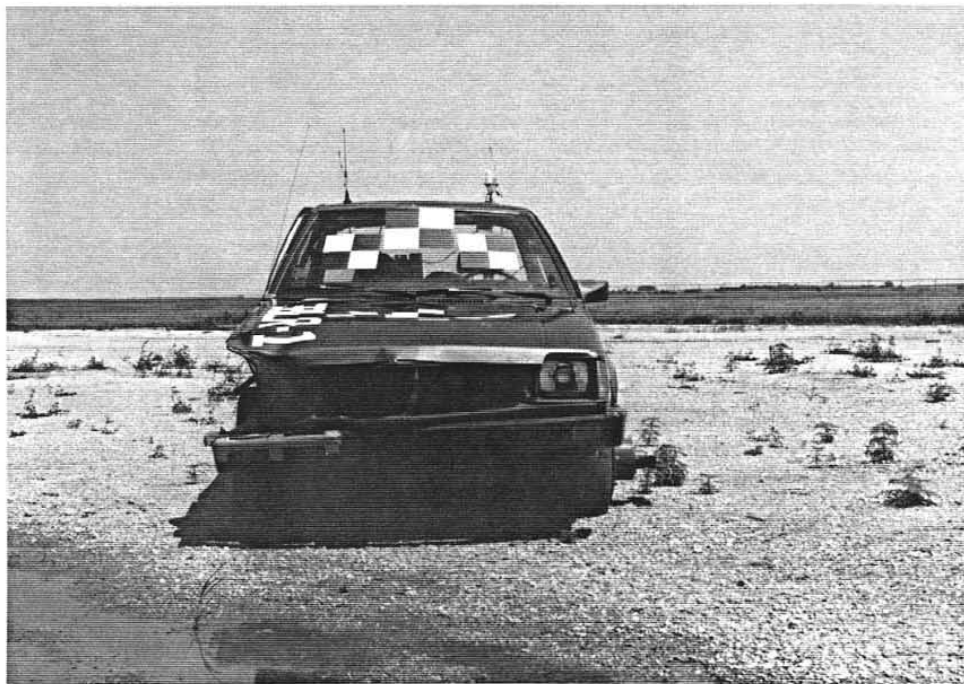
**FIGURE 16.** Vehicle Damage, Test SBLR-1

Test vehicle damage was relatively minor and was largely limited to the right-front quarter panel and passenger door, as shown in Figure 16. There was no intrusion or deformation of the occupant compartment. Vehicle crush measurements are shown in Figure 17.

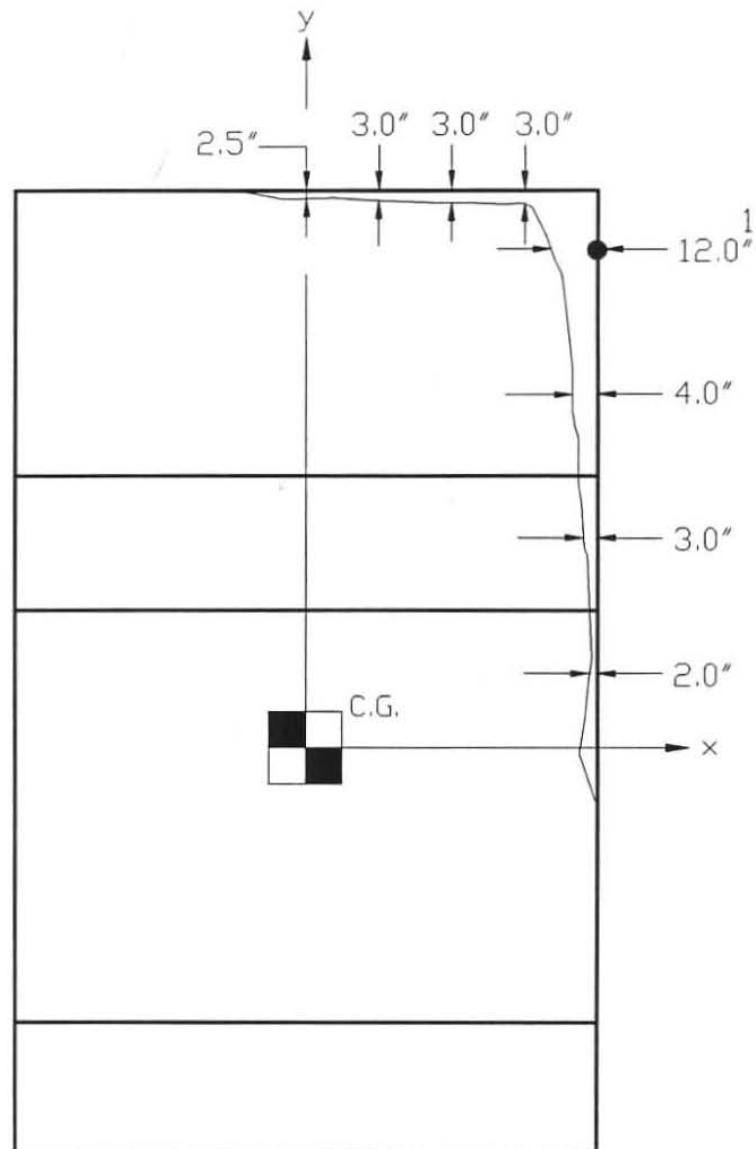
<sup>1</sup> - Maximum static crush distance of 12" occurred at (24", 54") marked by the point.

**FIGURE 17. Vehicle Crush Measurements, Test SBLR-1**

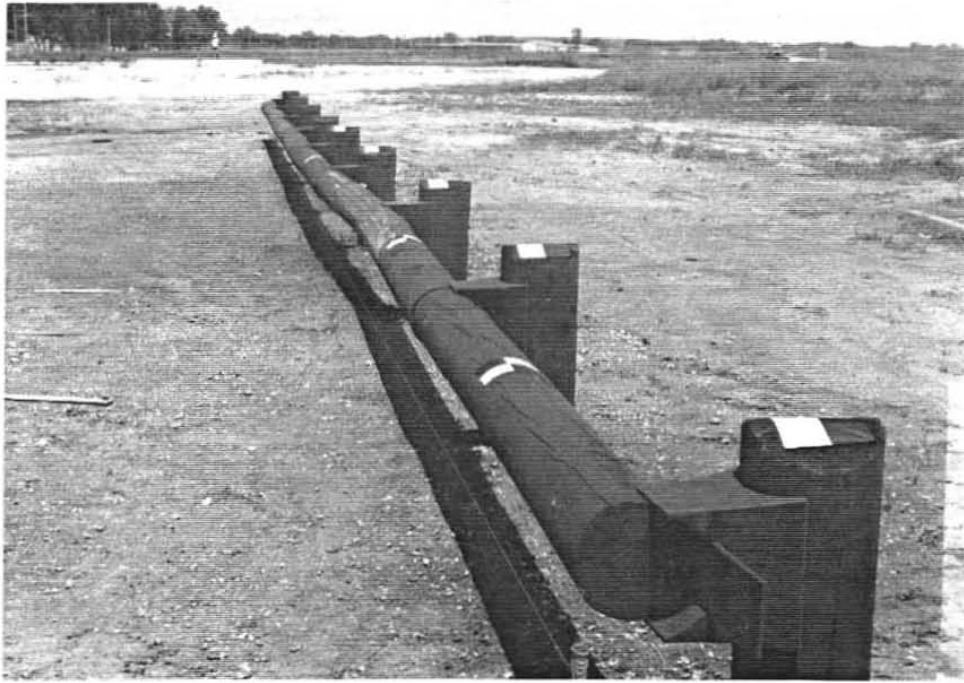
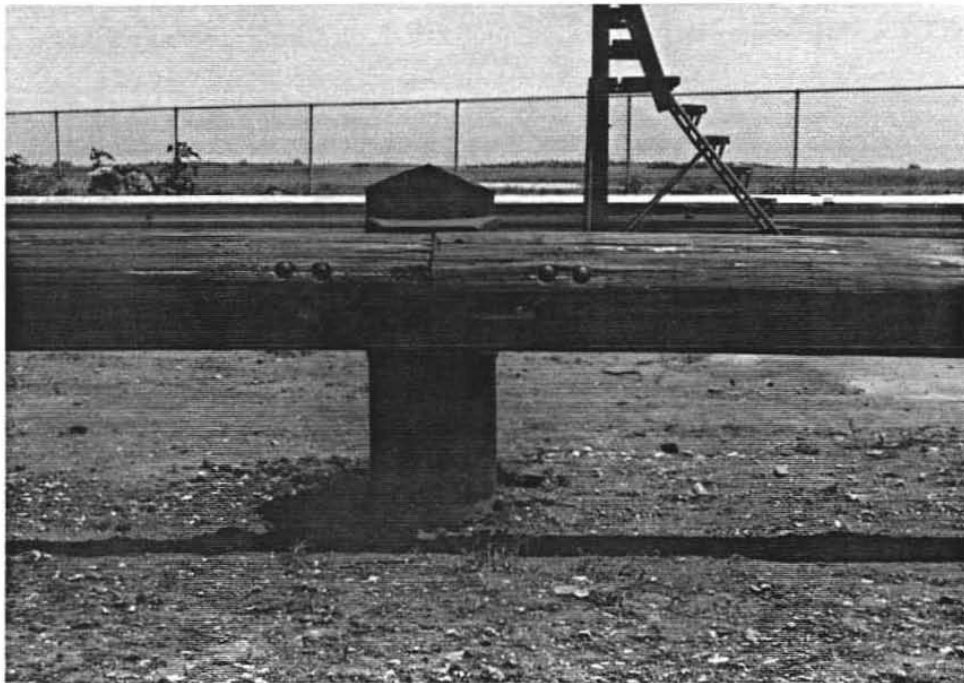
**FIGURE 18.** Log Rail Damage, Test SBLR-1

Damage to the Log Rail consisted of minor scrapes on the surface of the rail and a maximum permanent deflection of  $2\frac{1}{16}$  in. at the first post after impact. This damage can be seen in Figure 18. The effective coefficient of friction was found to be 1.02 and would be classified as "marginal" according to the AASHTO Guide Specifications for Bridge Railings (5).
