**SAFETY PERFORMANCE EVALUATION OF  
THE STEEL-BACKED LOG RAIL**

Midwest Roadside Safety Facility  
Civil Engineering Department  
University of Nebraska-Lincoln  
1901 "Y" St.  
P.O. Box 880601  
Lincoln, Nebraska 68588-0601  
(402) 472-6864

Transportation Research Report No. TRP-03-35-92

December 1992

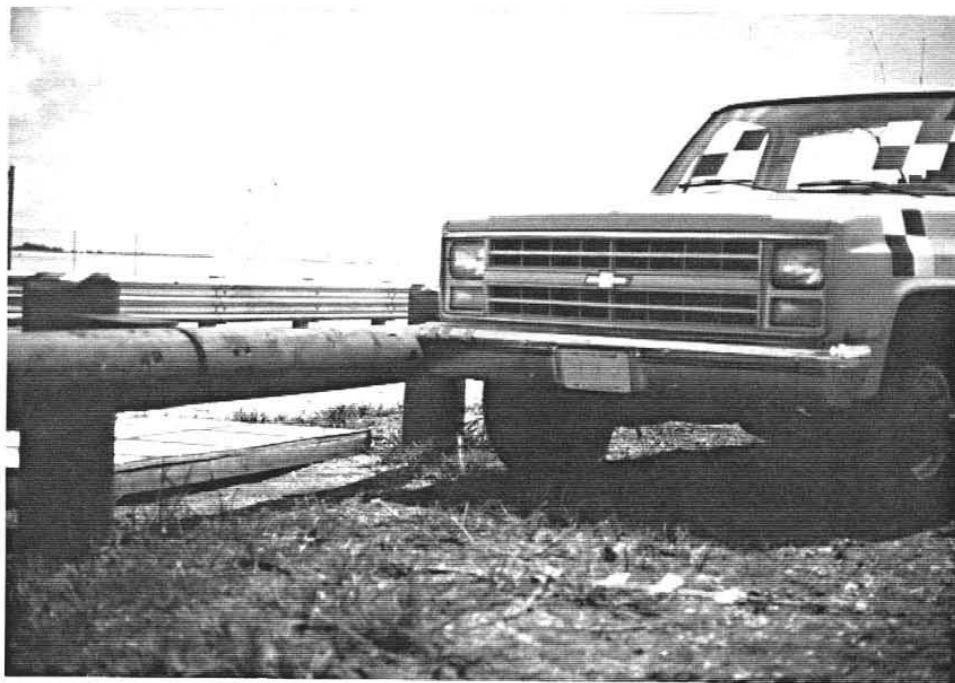
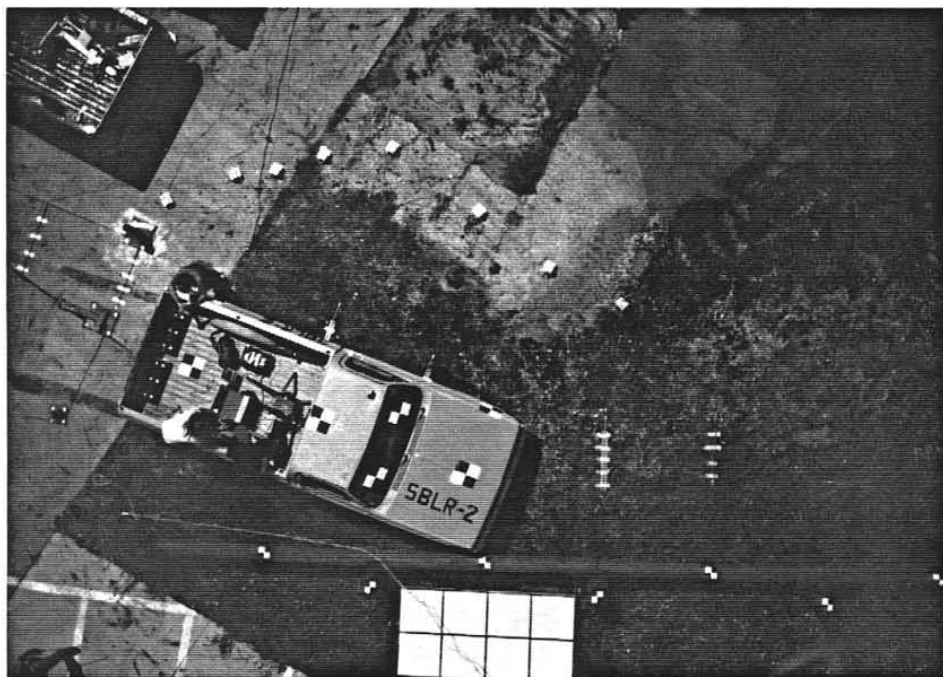
**FIGURE 19.** Vehicle Impact Location, Test SBLR-2

A 1986 3/4 ton Chevrolet Pickup was directed into the steel-backed log rail using a reverse tow and cable guidance system (4). The vehicle was released from the tow cable and guidance system and was free wheeling at impact. The speed of the vehicle at impact was 46.1 mph and the angle of impact was 20.9 degrees. The impact point, shown in Figure 19, was located midspan between Post Nos. 2 and 3, or 15 ft from the upstream end of the rail. A summary of the test results and sequential photographs is shown in Figure 20. Additional sequential photographs are shown in Figures 21 and 22.

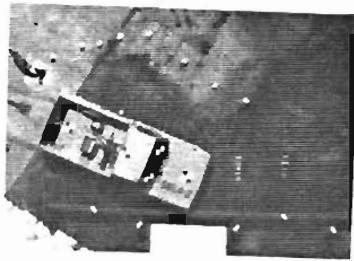
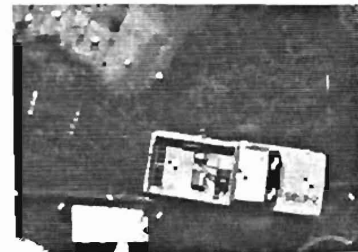
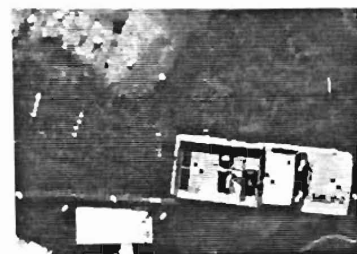
**FIGURE 21.** Overhead Sequential Photographs, Test SBLR-2

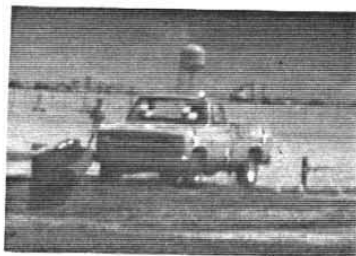
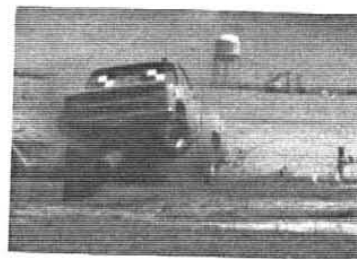
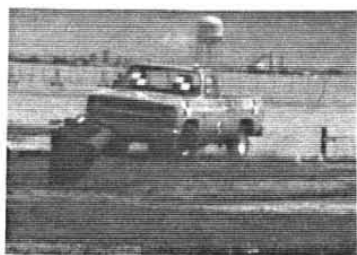
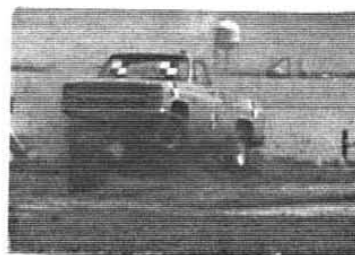
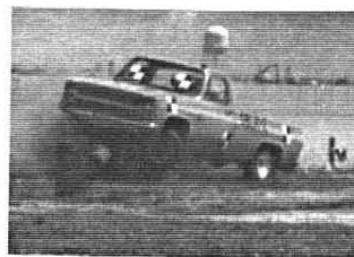
**FIGURE 22.** Downstream Sequential Photographs, Test SBLR-2

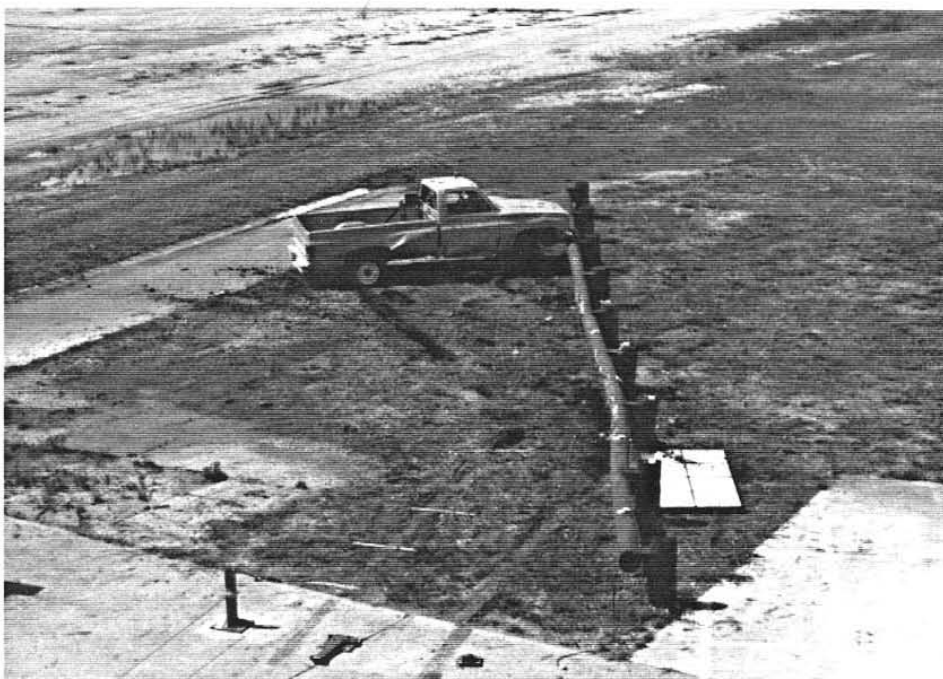
**FIGURE 23.** Vehicle Trajectory, Test SBLR-2

Upon impact, the bumper of the test vehicle began to ride up onto the log rail. The vehicle traveled along the top of the log rail until it reached Post No. 5 approximately 448 ms after impact. After impacting Post No. 5, the vehicle began to rotate clockwise, coming to rest perpendicular to the rail, 45 ft downstream from impact. The vehicle trajectory is shown in Figure 23.

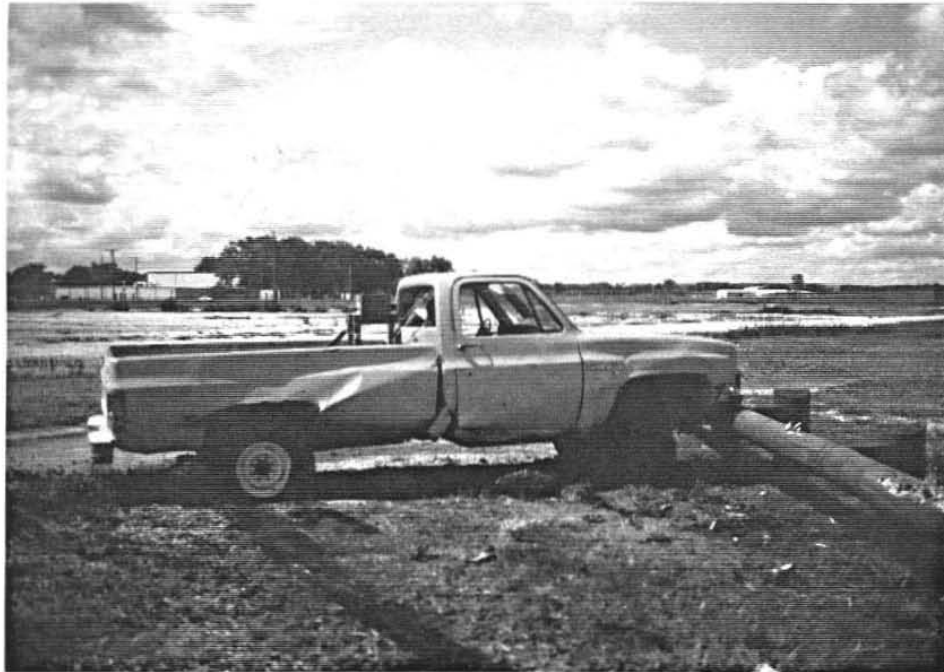
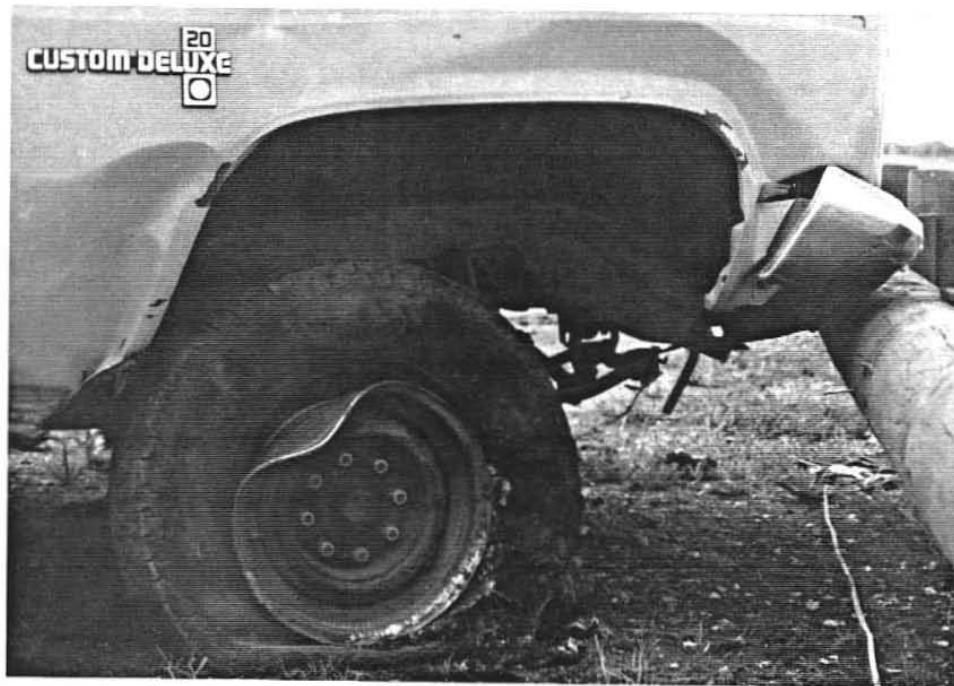
**FIGURE 24.** Vehicle Damage, Test SBLR-2

Test vehicle damage, shown in Figure 24, was limited to the undercarriage on the right-front corner and along the right side. Vehicle crush measurements are shown in Figure 25. The vehicle remained upright both during and after the test, and there was no intrusion of the occupant compartment.

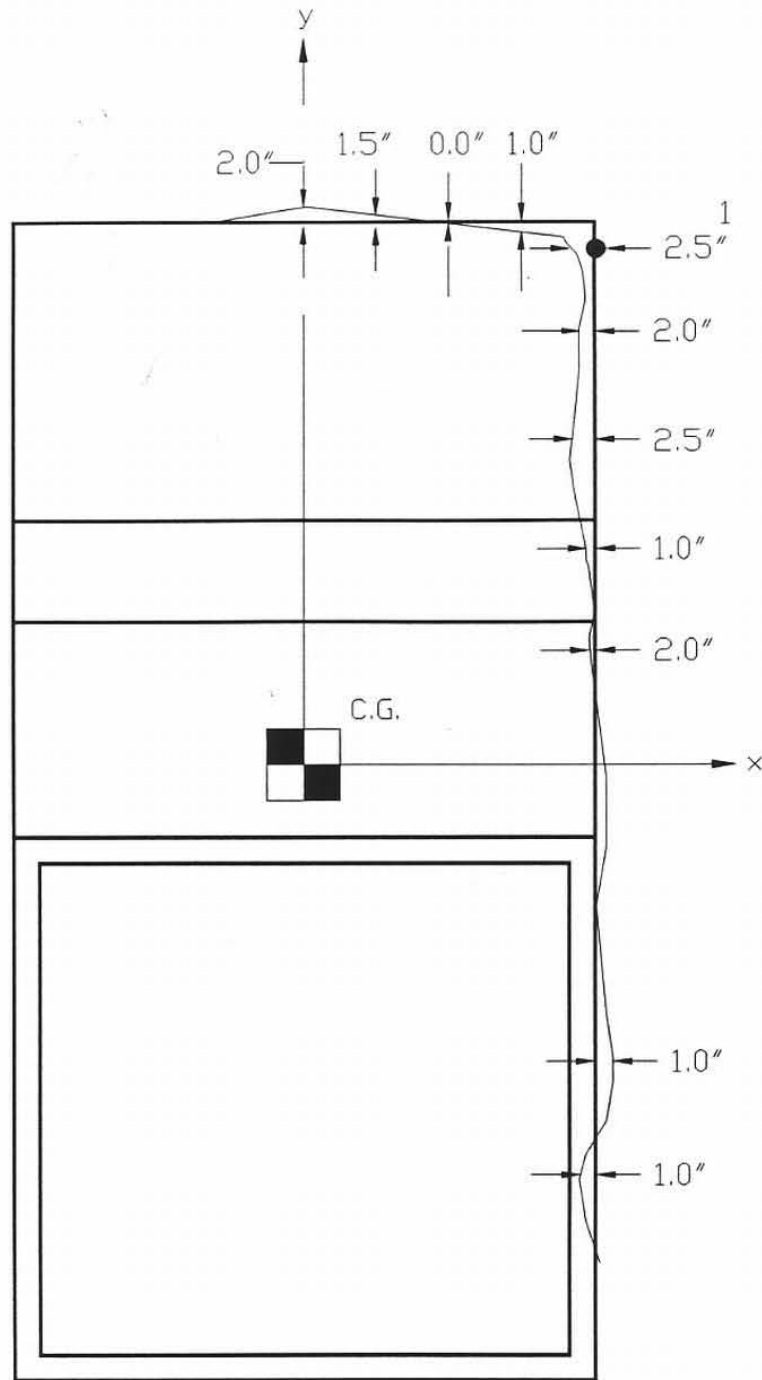
<sup>1</sup>-Maximum static crush distance of 2.5" occurred at (36",96") marked by the point.

**FIGURE 25. Vehicle Crush Measurements, Test SBLR-2**

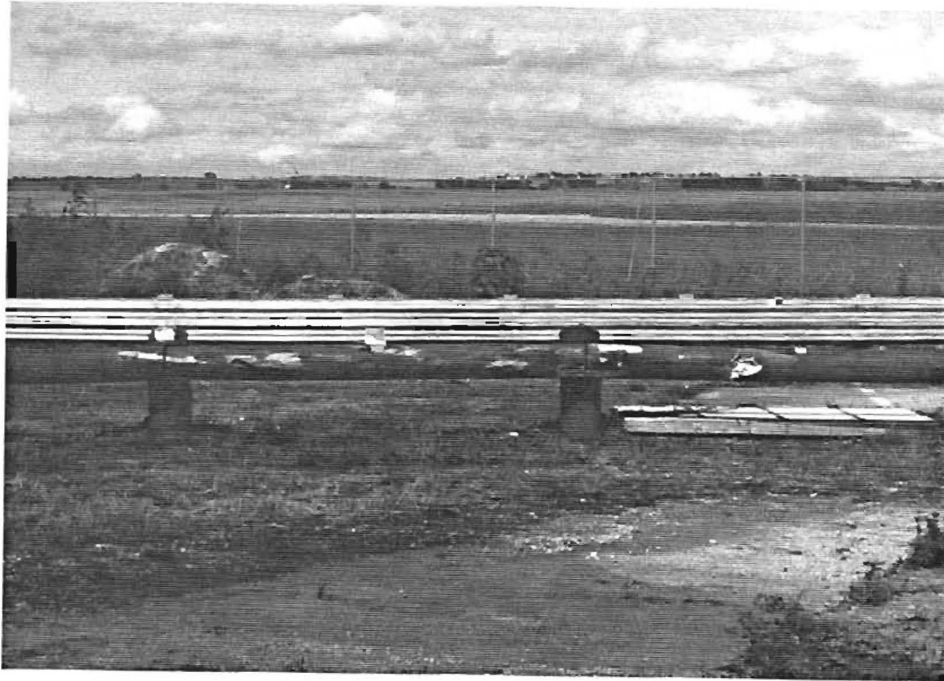
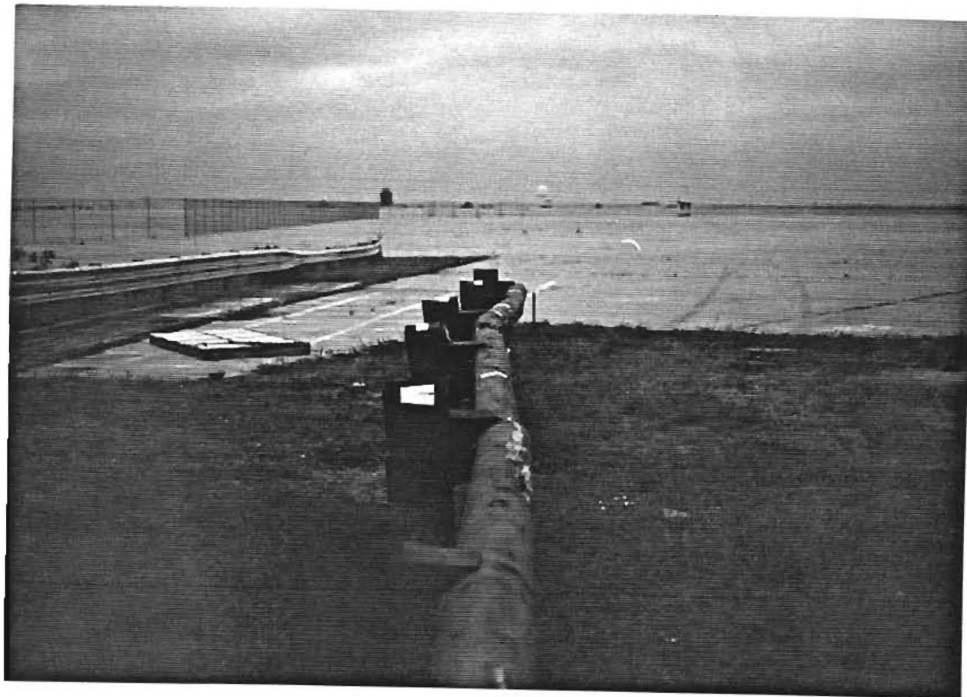
**FIGURE 26.** Log Rail Damage, Test SBLR-2

Damage to the log rail consisted of scrapes and gouges along the traffic face and at some of the posts. A maximum permanent deflection of 9 1/8 in. was measured at Post No. 3. The damaged barrier is shown in Figure 26.

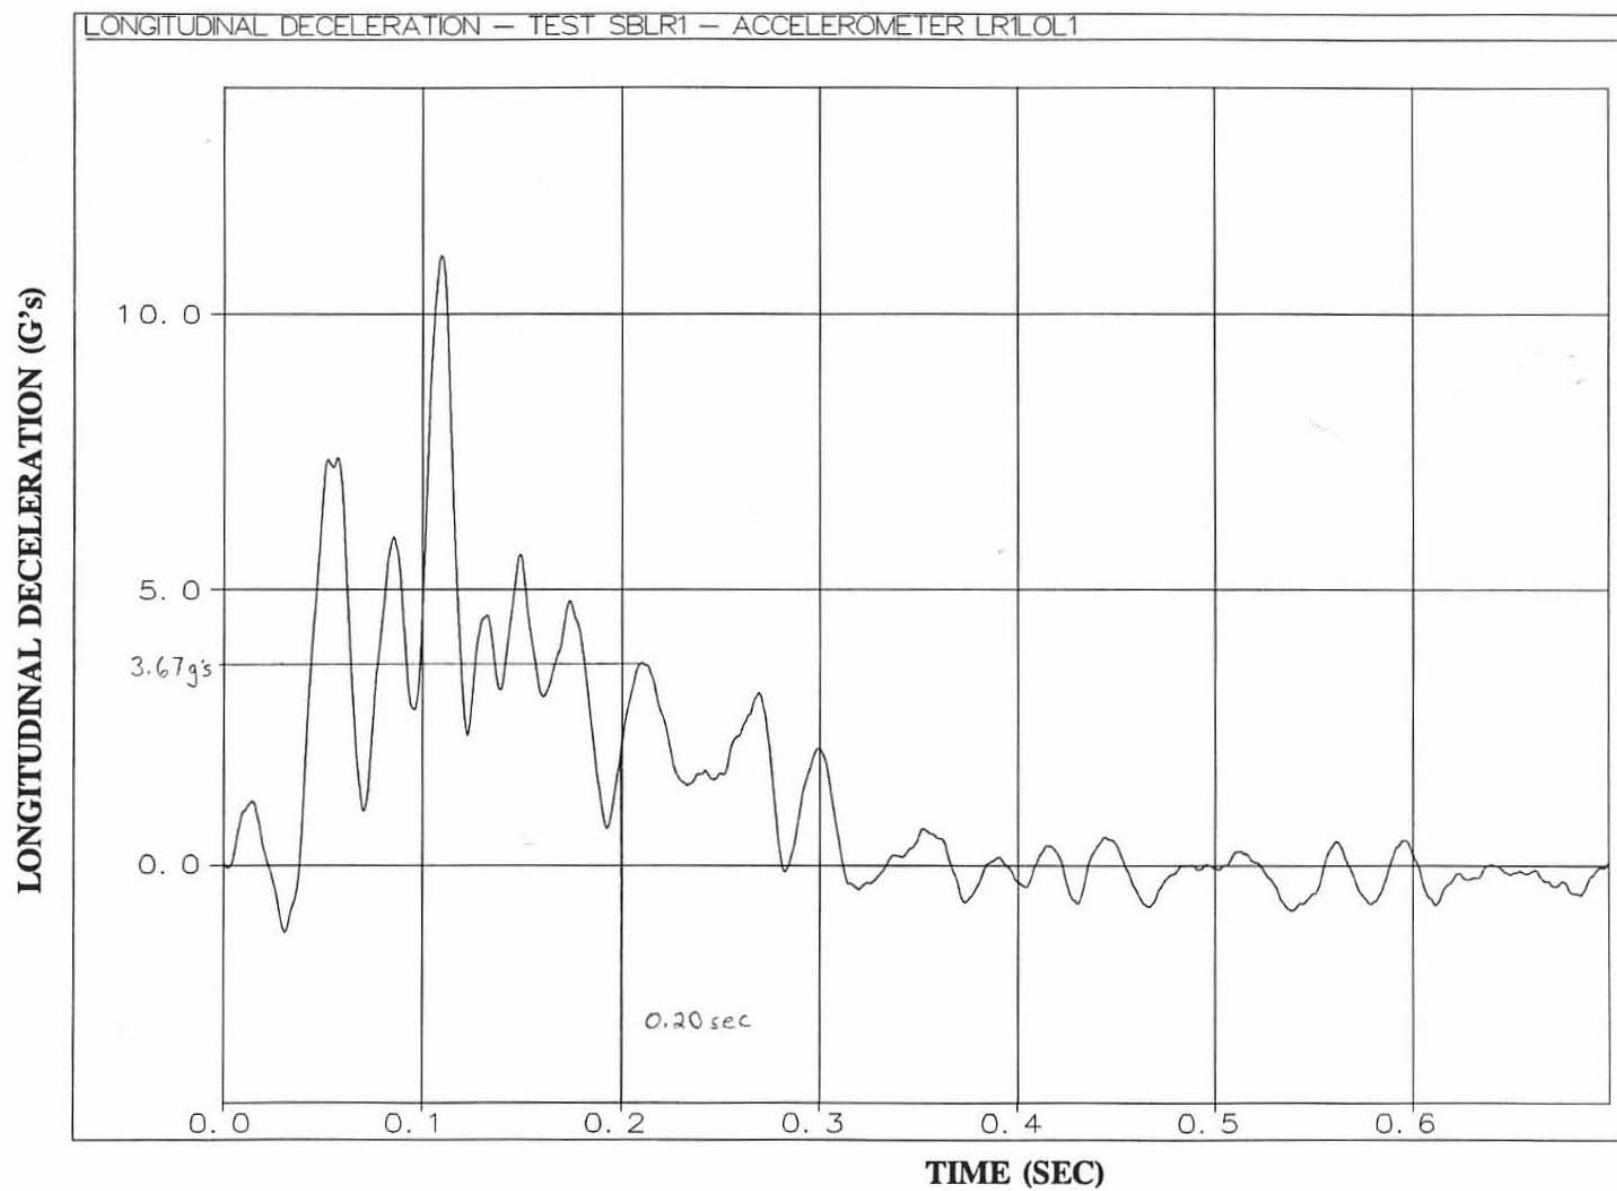
Figure A-1 Graph of Longitudinal Deceleration, Acc. #1

The longitudinal and lateral occupant impact velocities as determined from accelerometer data were 24.3 fps and 21.1 fps, respectively. The highest 10-ms average occupant ridedown decelerations were 3.9 g's (longitudinal) and 4.8 g's (lateral). Accelerometer traces from Test SBLR-1 are shown in Appendix A.

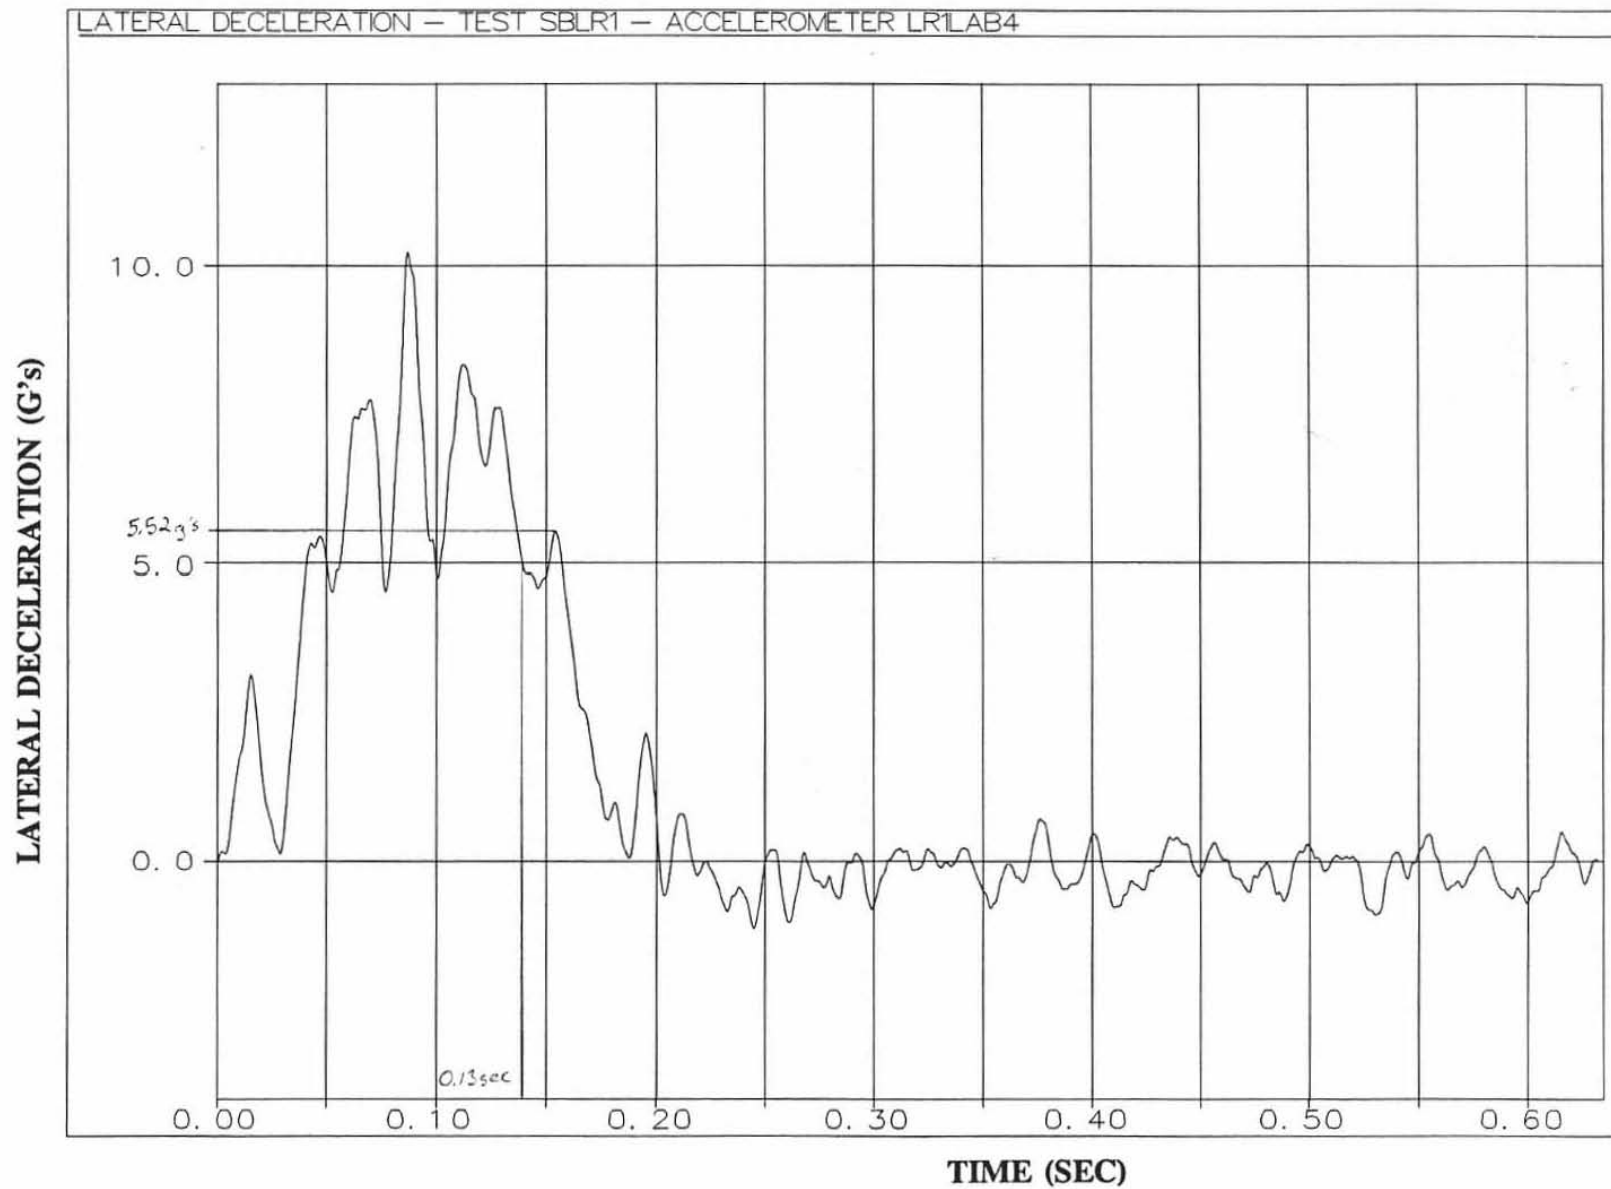
Figure A-2 Graph of Lateral Deceleration, Acc. #3
