DEVELOPMENT AND EVALUATION OF A TIE-DOWN SYSTEM FOR THE REDESIGNED F-SHAPE CONCRETE TEMPORARY BARRIER

MIDWEST ROADSIDE SAFETY FACILITY

MwRSF Research Report No. TRP-03-134-03

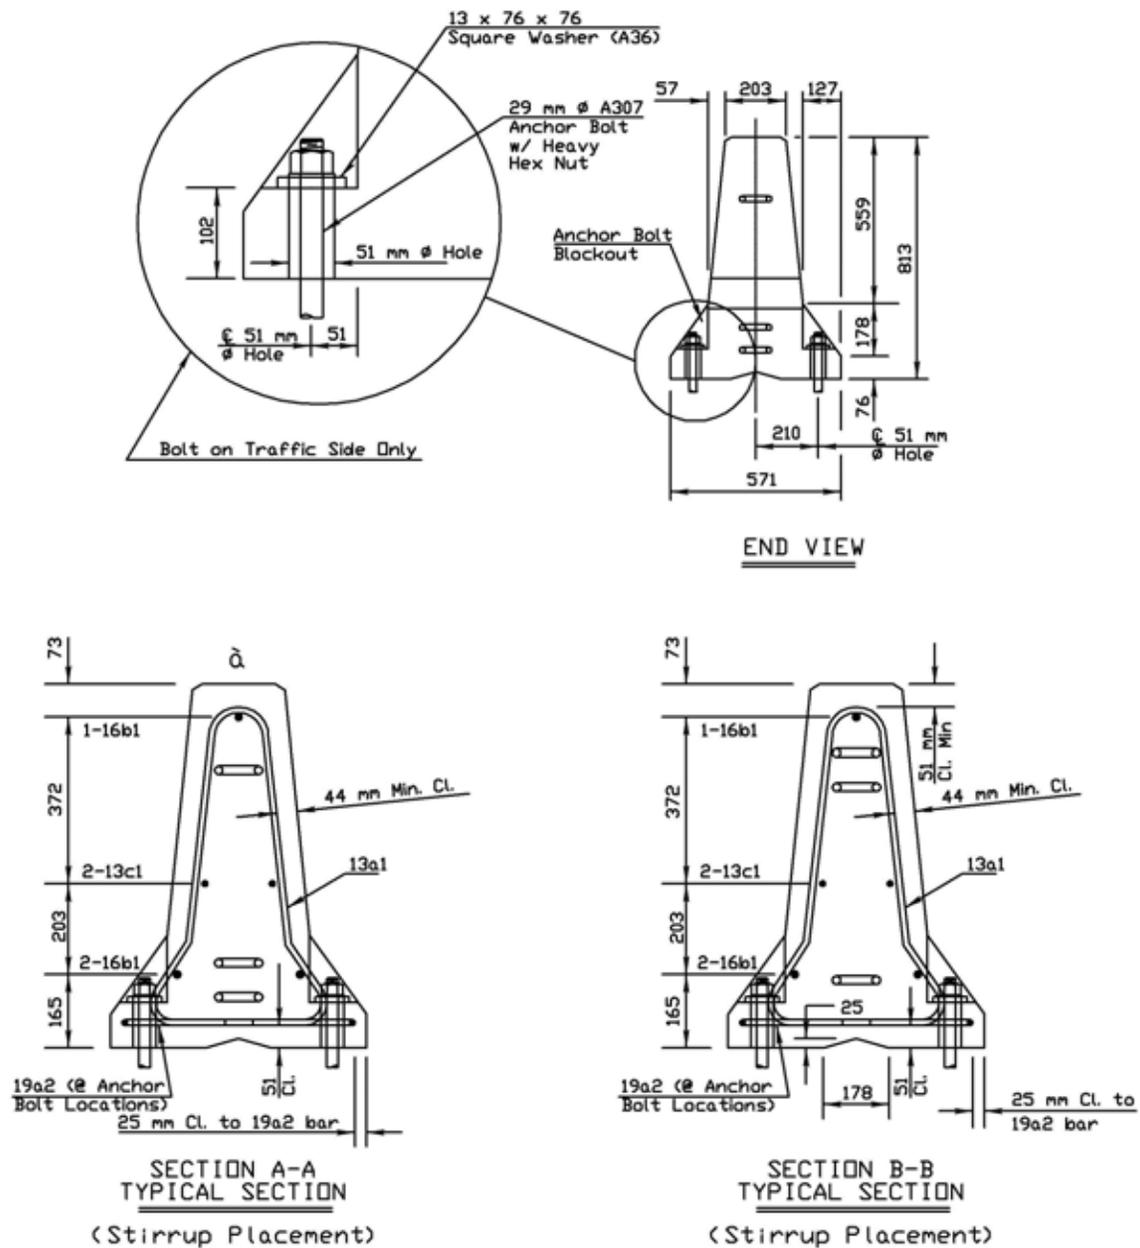
Figure 2. Temporary Barrier Profile and Tie-Down Details

The barriers were fastened to the concrete bridge deck with a 29-mm (1.125-in.) diameter

ASTM A307 anchor bolt with heavy hex nut and a 76-mm (3-in.) x 76-mm (3-in.) x 13-mm (0.5-in.) thick washer at each of the anchor bolt blockout positions, as shown in Figures 2 and 10. Each anchor bolt was epoxied into the concrete to an embedment depth of approximately 305 mm (12 in.), as shown in Figure 11. The epoxy's specifications are shown in Appendix C. Note that the bolt-through tie-down system was only used on the traffic side of the barrier in order to reduce the propensity for barrier tipping and subsequent vehicle climbing and vaulting.

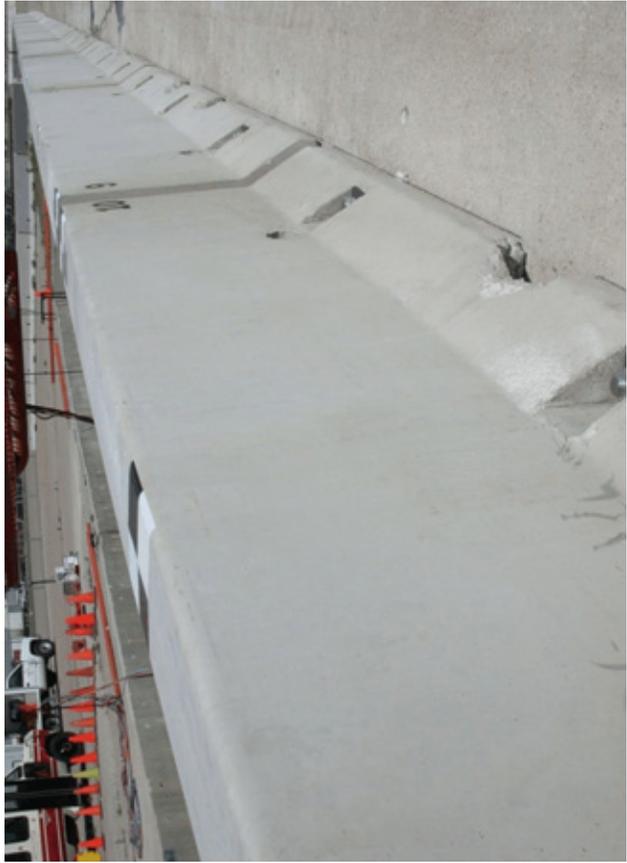
Figure 7. Barrier System

The test installation consisted of 62.23 m (204 ft) of temporary concrete barriers attached to a concrete bridge deck, as shown in Figures 1 through 6. The corresponding drawings in English units are shown in Appendix A. The KDOT's state plans are shown in Appendix B. Photographs of the test installation are shown in Figures 7 through 11.

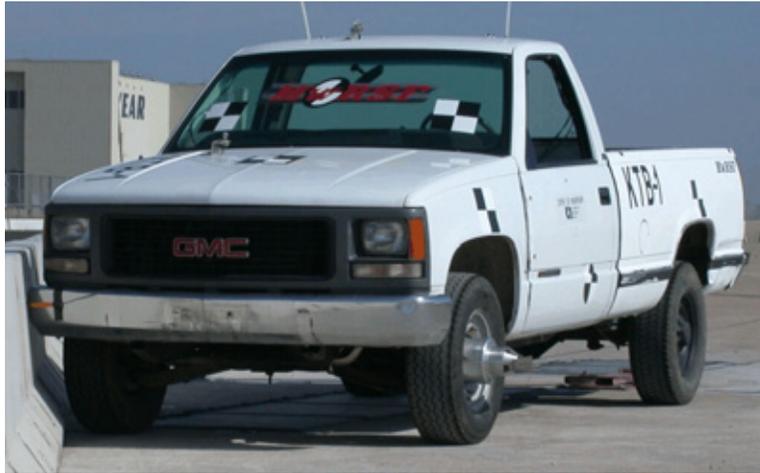
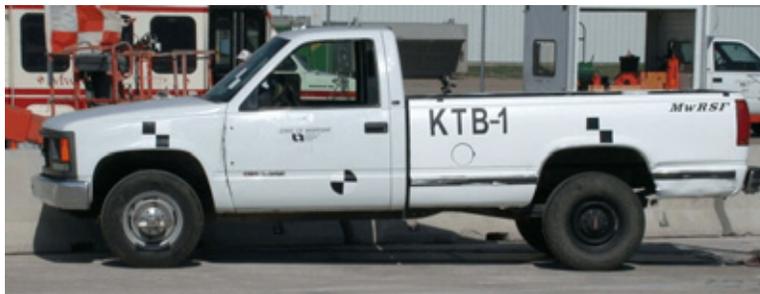
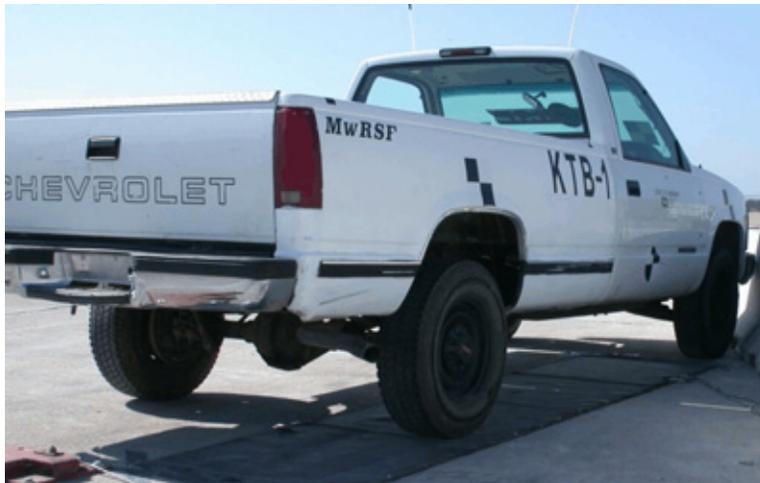
Figure 12. Test Vehicle, Test KTB-1

For test KTB-1, a 1997 Chevrolet 2500 ³/₄-ton pickup truck was used as the test vehicle. The test inertial and gross static weights were 2,018 kg (4,448 lbs). The test vehicle is shown in Figure 12, and vehicle dimensions are shown in Figure 13.

The longitudinal component of the center of gravity was determined using the measured axle weights. The location of the final centers of gravity are shown in Figures 12 and 13.

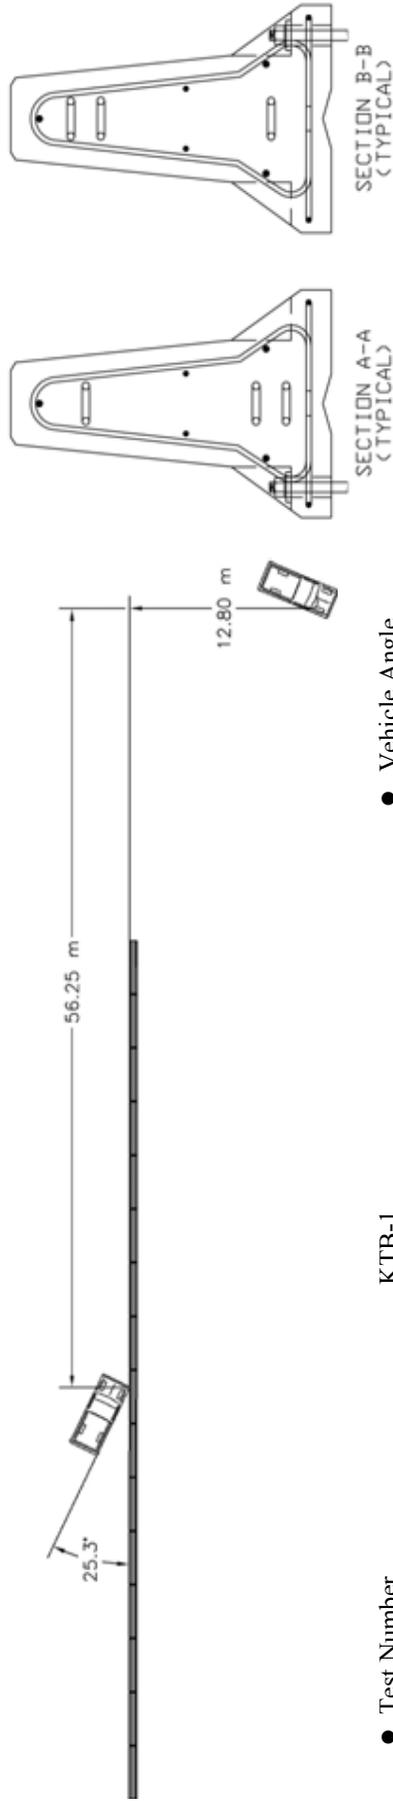
- Test Number KTB-1
- Date 7/31/02
- Appurtenance Kansas Temporary Barrier Tie Down System
- Total Length 62.23 m
- Placement 25 mm from concrete bridge deck edge

- Key Elements Nine 3,810-mm long Kansas Temporary Barriers
- Barrier Joint Pin Connections Seven 3,810-mm long Iowa F-Shape Temporary Barriers
- Tie-Down Anchors 32-mm diameter by 712-mm long A36 steel rod with 64x102x132-mm plate

- Lateral (not required) 10.60 G's
- Occupant Impact Velocity
- Longitudinal 5.68 m/s < 12 m/s
- Lateral (not required) 7.01 m/s
- Vehicle Damage Moderate
- TAD¹⁴ 1-RFQ-3

- SAE¹⁵ 1-RFAW3
- Vehicle Stopping Distance 56.25 m downstream
- Barrier Damage 12.80 m laterally behind
- Maximum Rail Deflections
- Permanent Set Moderate

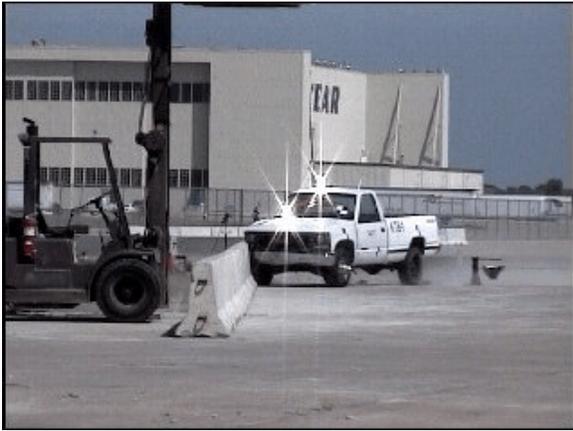
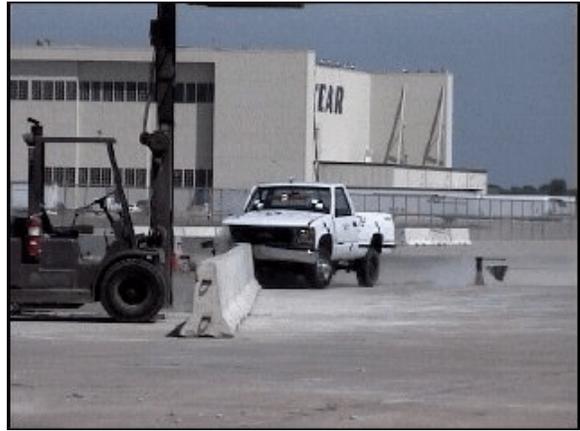
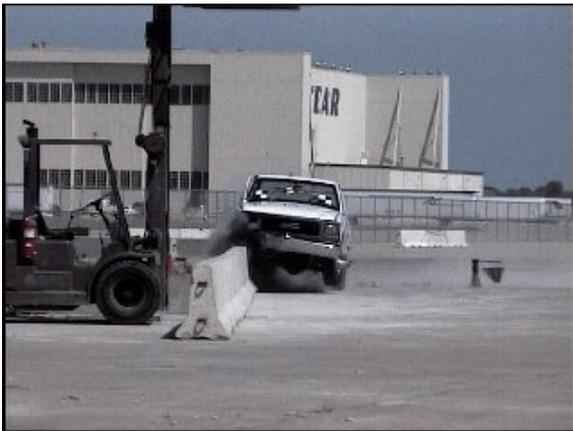
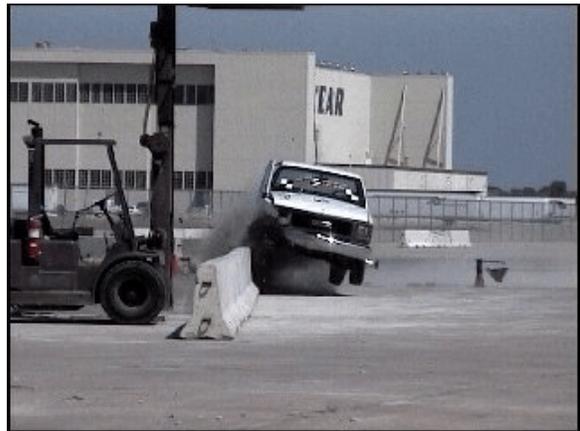
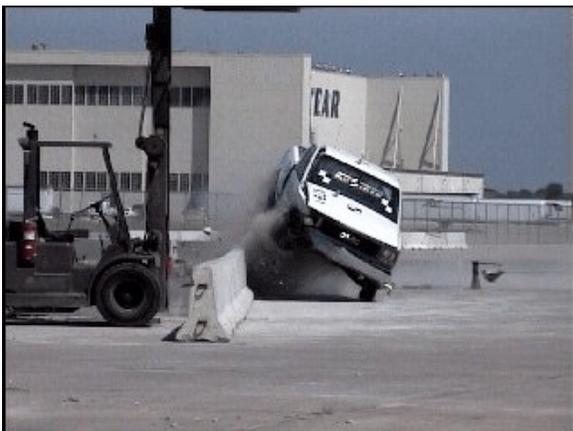
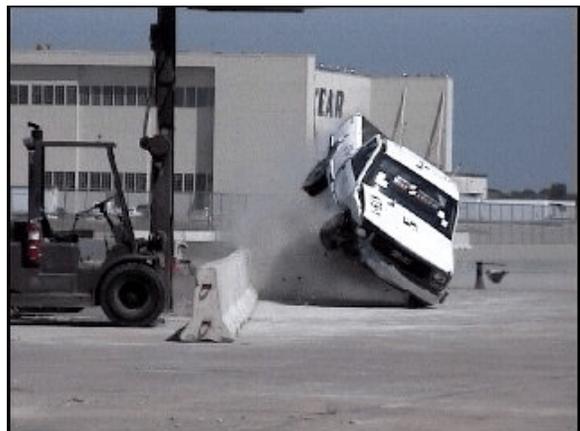
Figure 20. Documentary Photographs, Test KTB-1

The 2,018-kg (4,448-lb) pickup truck impacted the temporary barrier tie-down system at a speed of 99.8 km/hr (62.0 mph) and at an angle of 25.3 degrees. A summary of the test results and the sequential photographs are shown in Figure 16. The summary of the test results and sequential photographs in English units is shown in Appendix D. Additional sequential photographs are shown in Figures 17 through 19. Documentary photographs of the crash test are shown in Figures 20 and 21.

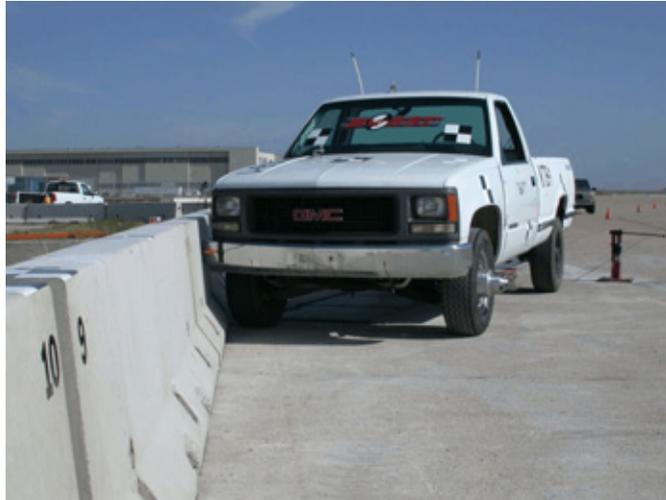
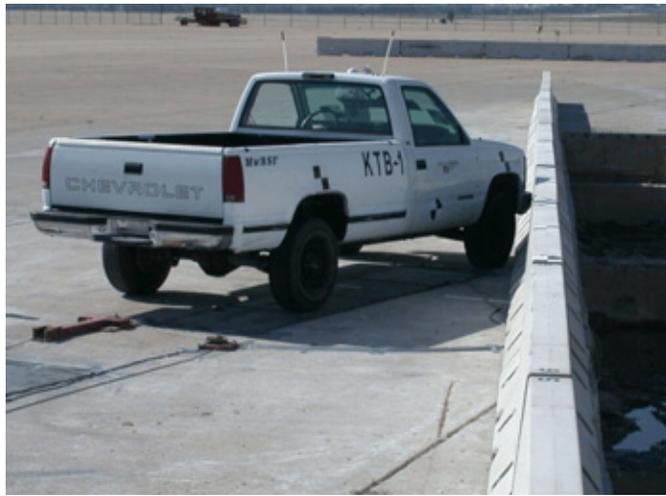
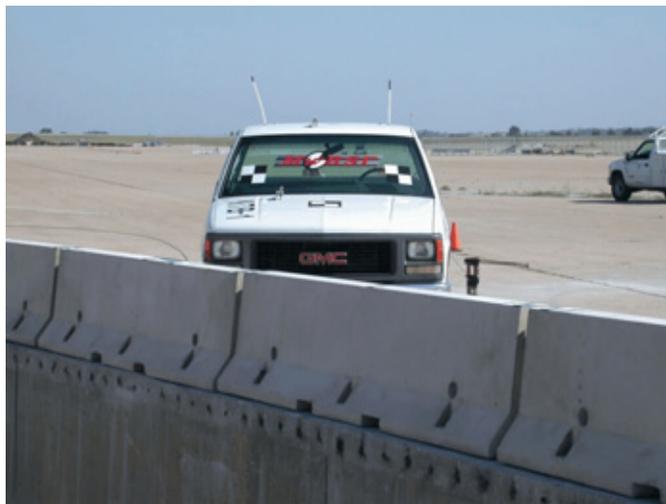
Figure 22. Impact Location, Test KTB-1

Initial impact was to occur 1,295-mm (51-in.) upstream from the center of the gap between barrier nos. 8 and 9, as shown in Figure 22. Actual vehicle impact occurred 1,651-mm (65-in.) upstream from the center of the gap between barrier nos. 8 and 9. At 0.026 sec after impact, the right-front corner of the vehicle was positioned over the top of the barrier. At 0.044 sec, the right-front corner of the vehicle protruded over the barrier as the top of the right-side door became ajar. At this same time, barrier no. 8 began to deflect backward. At 0.050 sec, the right-front corner was crushed inward toward the engine compartment and the right-front corner of the hood was positioned at the joint between barrier nos. 8 and 9. At 0.058 sec, barrier no. 9 began to deflect as the top tipped backward. At 0.066 sec, the right-front corner continued to crush inward as the vehicle began to redirect. At 0.084 sec, the hood's right-front corner remained over the top of the barrier. At this same time, a crack formed at the midspan of barrier no. 9 on the top and back sides. At 0.101 sec, the right-front corner of the vehicle reached its maximum intrusion of 534 mm (21 in.) beyond the front face of the barrier which had deflected and tipped 203 mm (8 in.) by this time. At

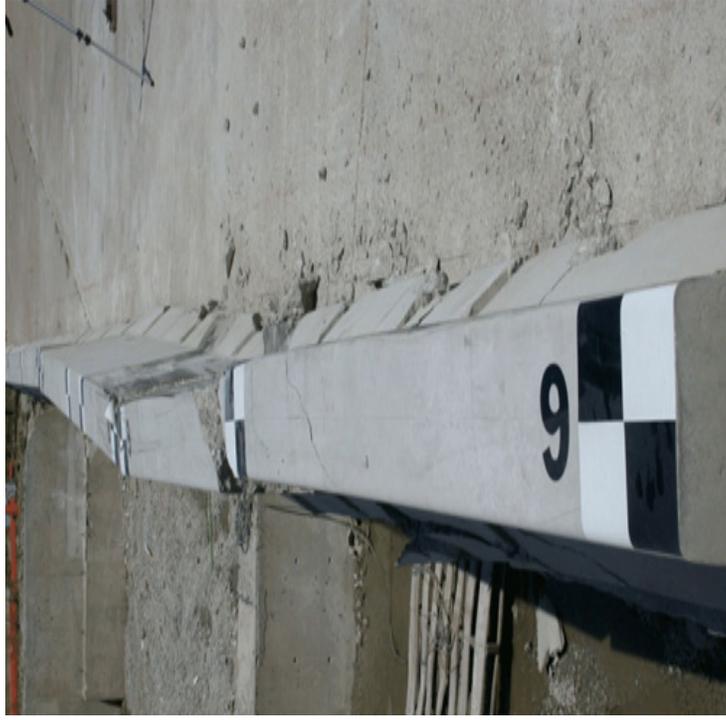
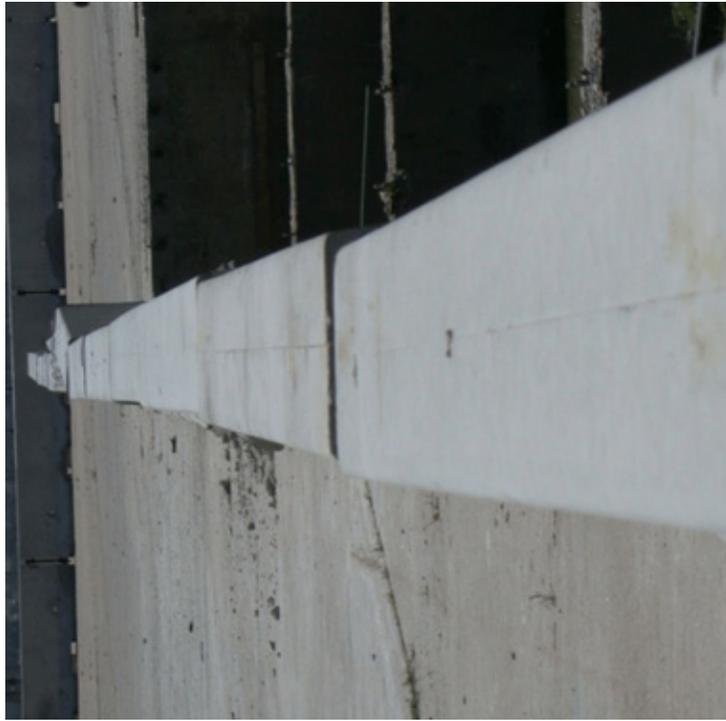
Figure 24. System Damage, Test KTB-1

Damage to the barrier was moderate, as shown in Figures 24 through 29. Barrier damage

consisted of contact marks on the front concrete face, spalling of the concrete, and concrete cracking and failure. The length of vehicle contact along the barrier was approximately 5.6 m (18.4 ft) which spanned from 1,651 mm (65 in.) upstream from the center of the joint between barrier nos. 8 and 9 to the upstream end of barrier no. 10.

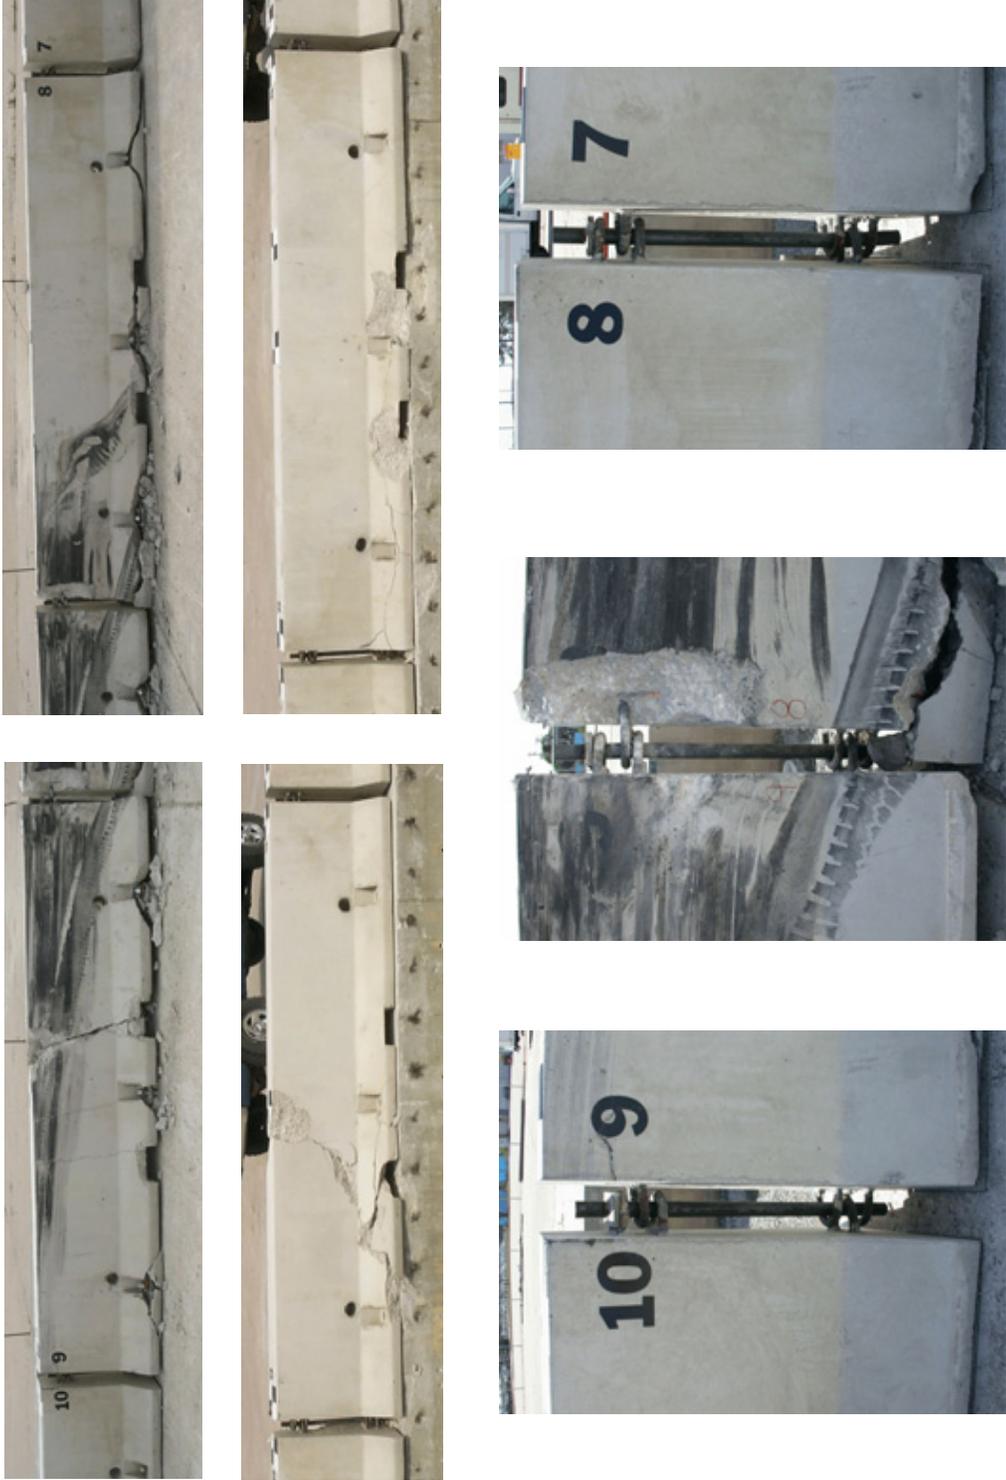
Figure 26. Barrier Nos. 8 and 9 Damage, Test KTB-1

Tire marks were visible on the front face of barrier nos. 8 and 9 and the upstream edge of barrier no. 10. Concrete failure was found at all of the tie-down anchors of barrier nos. 8 and 9, as shown in Figures 28 and 29. A 152-mm (6-in.) wide x 152-mm (6-in.) long x 89-mm (3.5-in.) deep piece of concrete was removed from the downstream end of barrier no. 8. Major concrete failure was found 457-mm (18-in.) upstream from the center of barrier no. 9 due to torsional loading. In addition, two larger cracks were found downstream from the center of barrier no. 9. Detailed sketches of the concrete failure and cracking of barrier nos. 8 and 9 are shown in Appendix E. The anchor dowels at the middle and downstream end of barrier no. 8 and the upstream end of barrier no. 9 were deformed. No major concrete spalling was found on the front face of barrier no. 9. Concrete deck failure did not occur at any of the anchor locations. No noticeable deformations were found on the connection pins nor the loops.

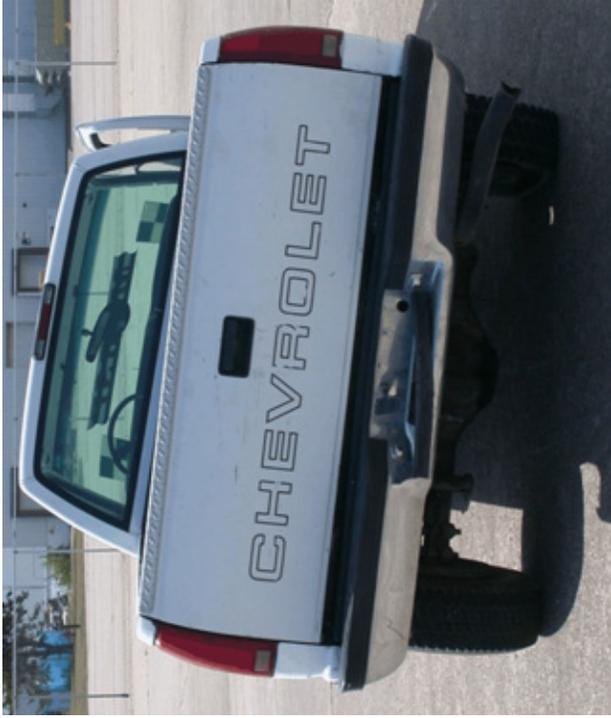
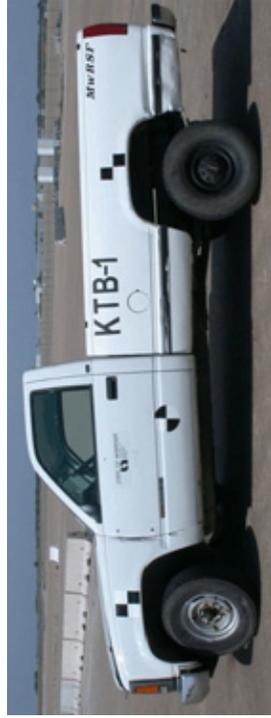
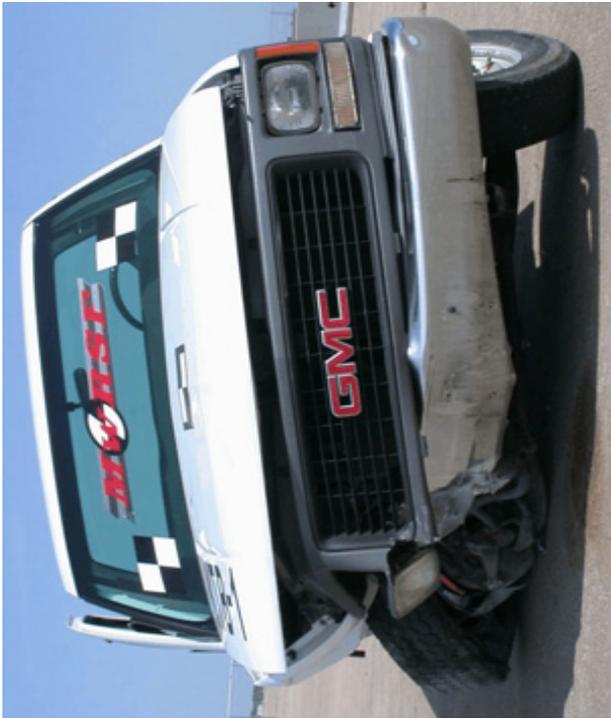
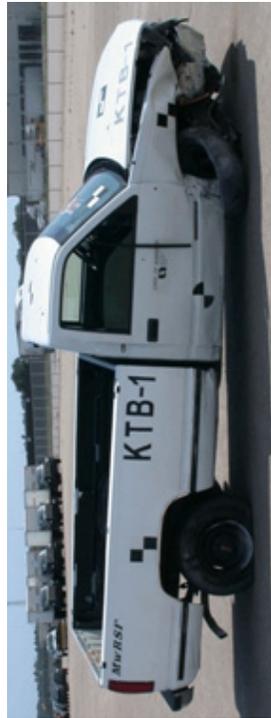
Figure 30. Vehicle Damage, Test KTB-1

Exterior vehicle damage was moderate, as shown in Figures 30 through 34. Damage was

concentrated on the right-front corner and right side of the vehicle where the impact occurred. The right-front corner of the vehicle was crushed inward and back, including the fender, bumper, and frame rail. A buckling point was found at the center of the front bumper with a minor tear near the right-front frame horn. Major frame damage was observed, including deformation to the right-side frame horn. The outer right-front tie-rod disengaged completely. The right-front tire disengaged from the rim, and the inner wall was torn. In addition, the right-front outer rim disengaged from the remainder of the hub and was severely deformed. Scuff marks were found on the right-rear wheel well, and the side wall of the right-rear tire encountered a 76-mm (3-in.) wide tear. The right-rear steel rim also received significant deformations and scrape marks. Minor scrapes and dents were also observed on the right-side door and the right side of the truck bed from the contact with the barriers. The top of the right-side door was jarred open with a 127 mm (5 in.) gap. Moreover, the door was jammed shut and could not be opened. The grill was broken and deformed around the right-side headlight assembly. The truck's box twisted and produced an inconsistent gap between the box and cab portions. The roof, the hood, the left side and rear of the vehicle, and all the window glass remained undamaged.

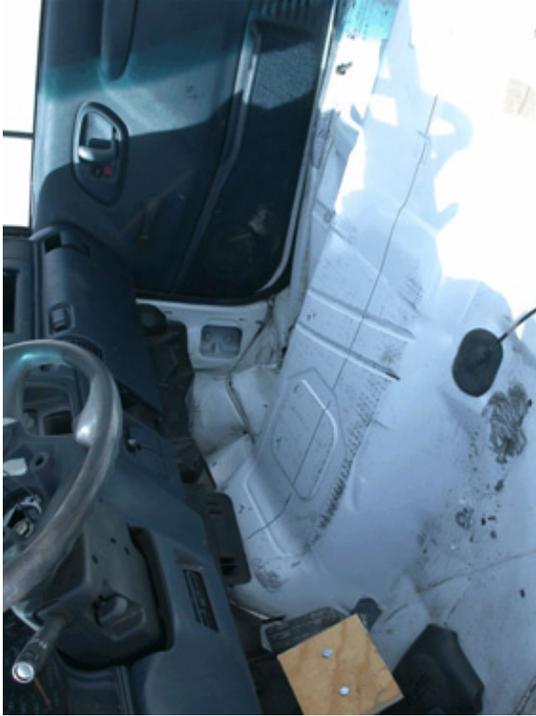
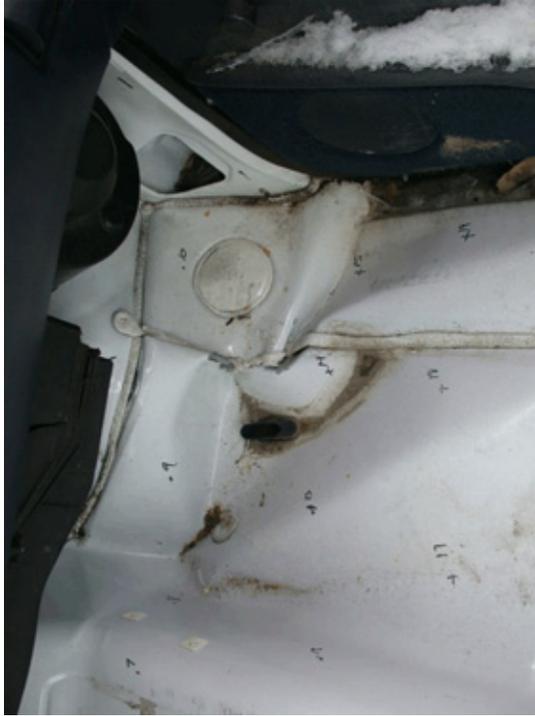
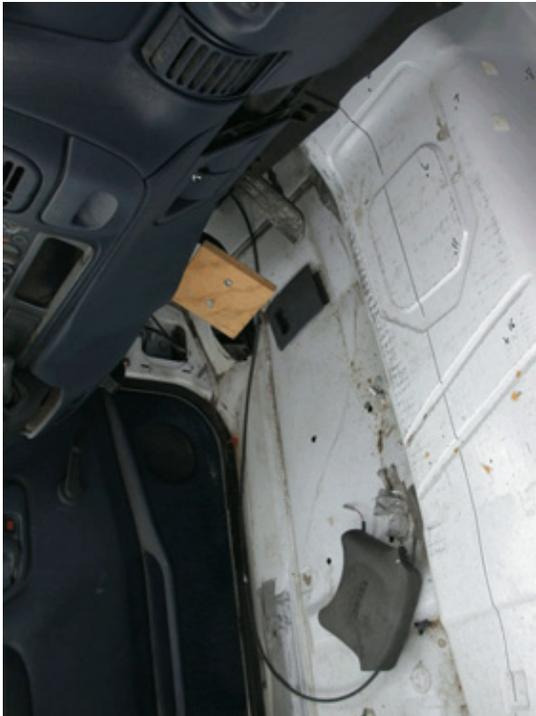
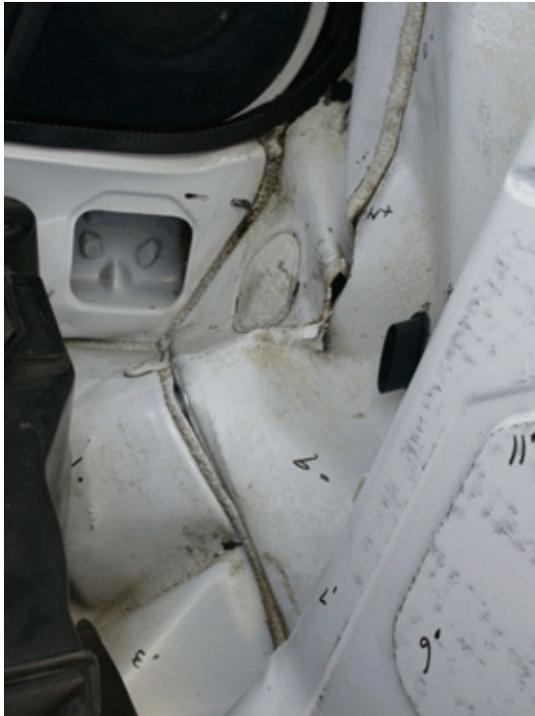
Figure 34. Occupant Compartment Damage, Test KTB-1

Moderate occupant compartment deformations occurred with deformations to the right-side floor pan and firewall, as shown in Figure 34. Occupant compartment deformations and the corresponding locations are provided in Appendix F. A maximum vertical deflection of 121 mm (4.75 in.) was found near the firewall at the center of the right side. Another significant vertical deflection of 76 mm (3 in.) was found near the center of the floor on the right side. Maximum longitudinal and lateral deflections of the floor pan were measured as 121 mm (4.75 in.) and 83 mm (3.25 in.), respectively. Maximum dash deflection was found to be approximately 25 mm (1 in.).

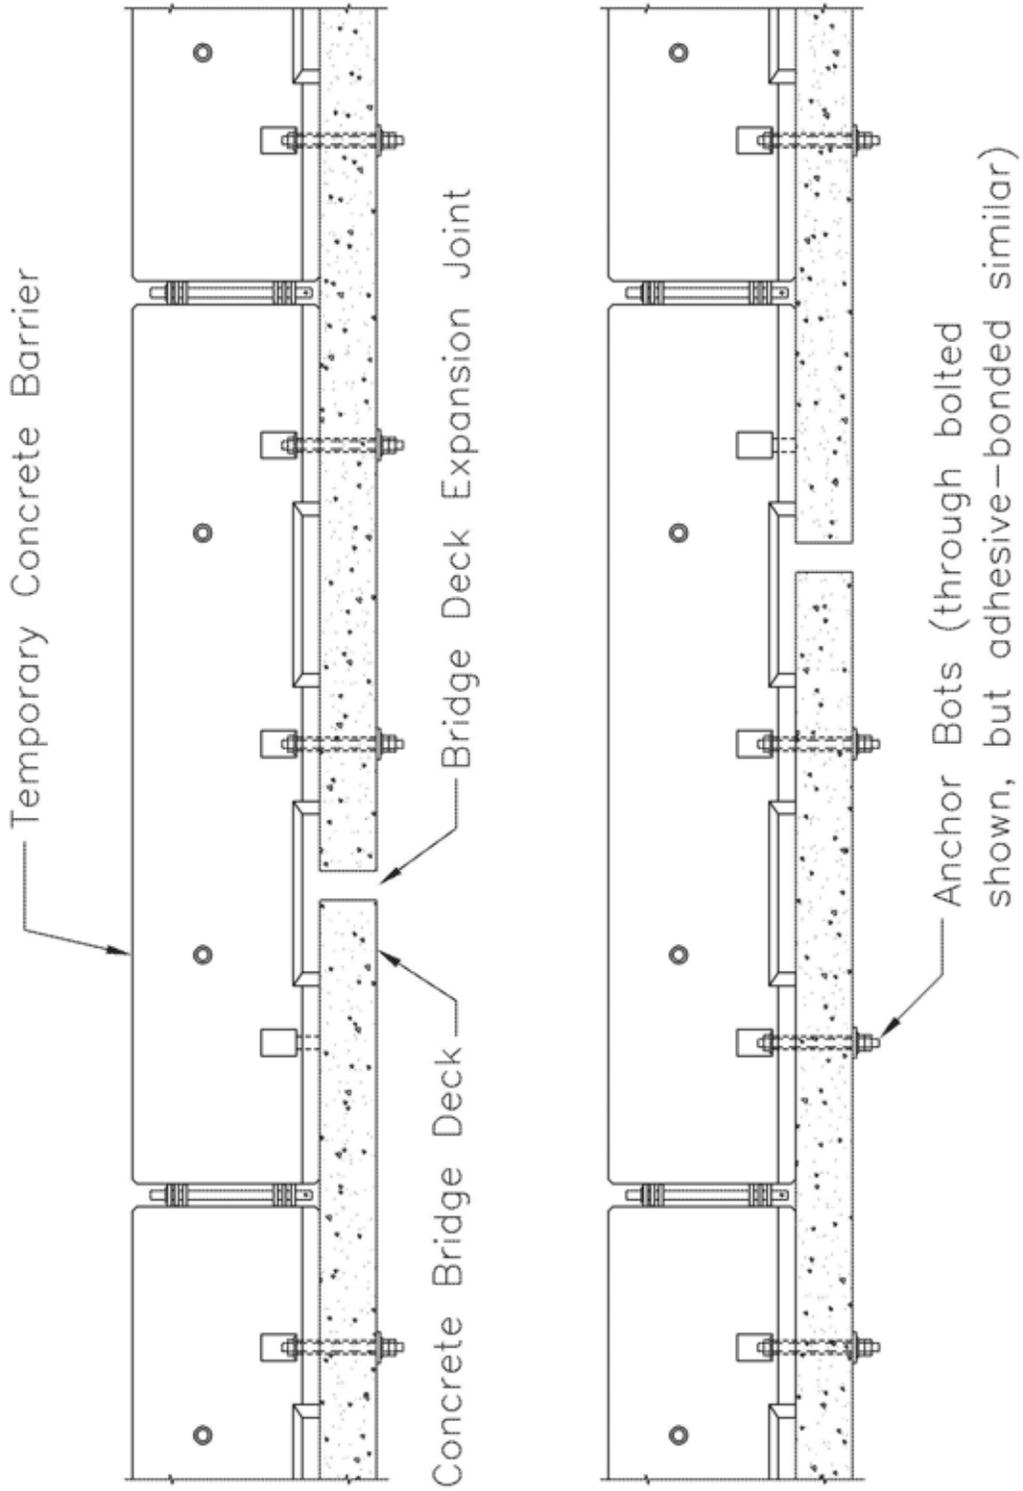
Figure 35. Treatment at Bridge Deck Thermal Expansion Joints

In some real-world applications, an expansion joint may fall between two anchor bolts within a single barrier unit. In this situation, omitting one anchor bolt is not believed to compromise the barrier performance. It is recommended that the one anchor bolt adjacent to the joint, as shown in Figure 35, should be left out of the barrier spanning the thermal expansion joint. It should be noted that the adjacent barrier units must each be installed with the standard three anchor bolts.

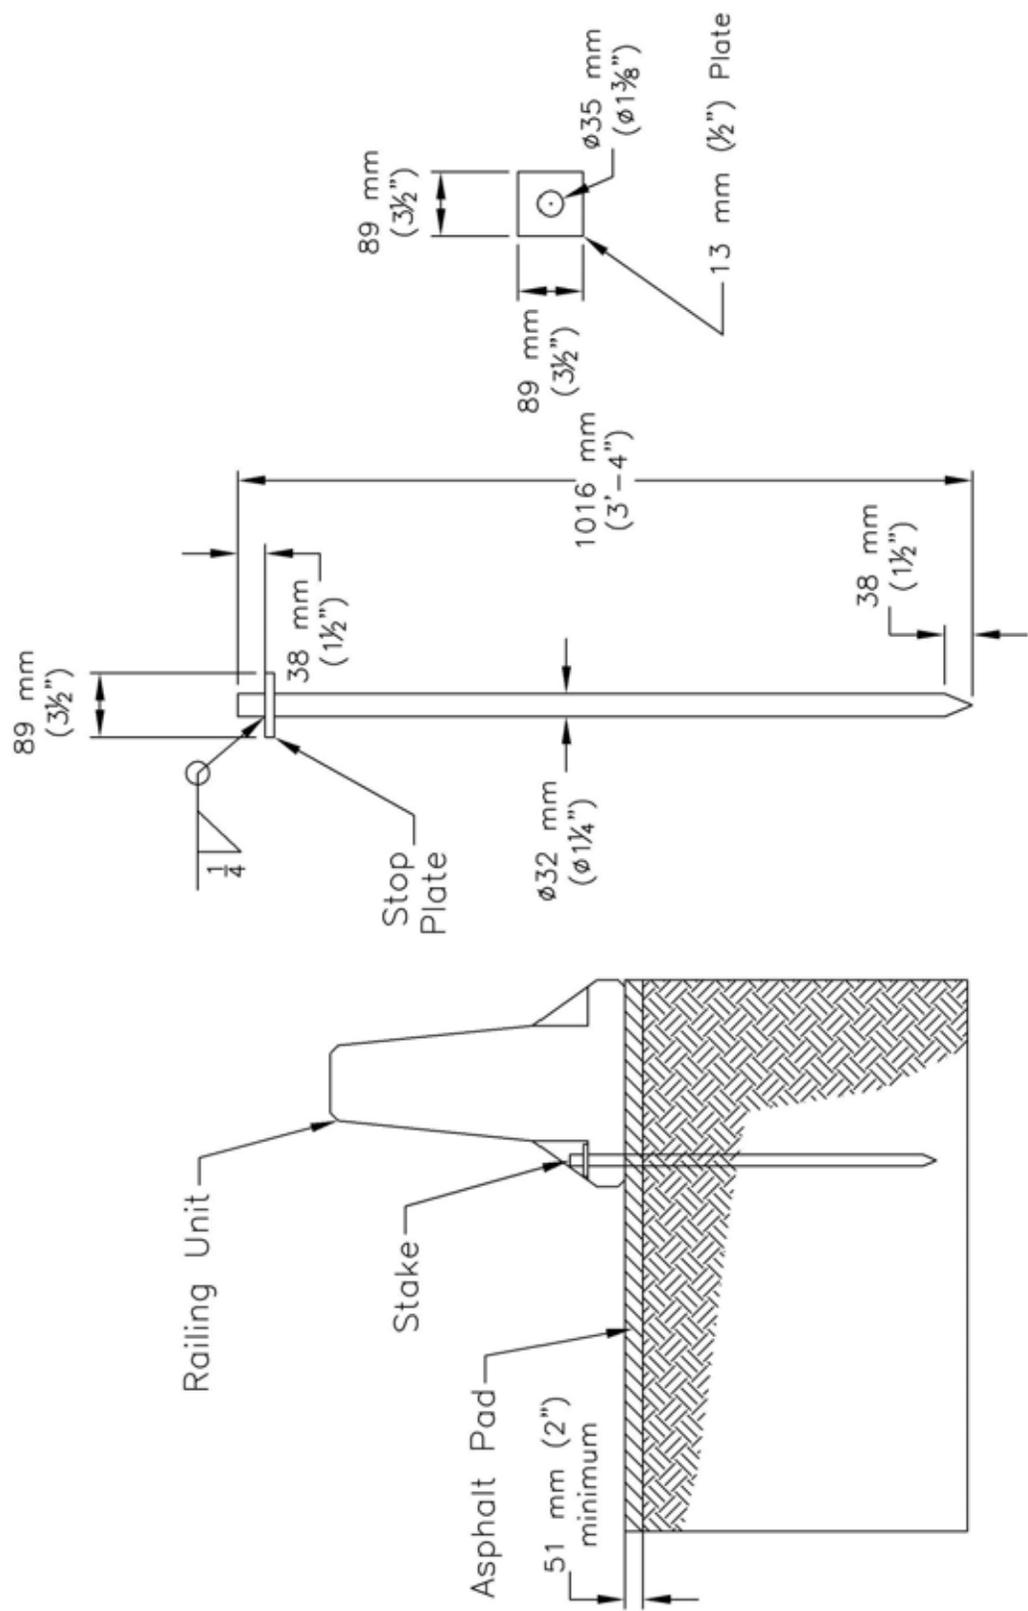
Figure 36. Staked Down Installation into an Asphalt Road Surface (Transitioning to Free-Standing Sections at the End of a Bridge)

Since the anchored F-shape rail has substantially lower deflections than the free-standing section, it is recommended that a transition between bolted and free-standing barriers be made to reduce the propensity for vehicle pocketing. Therefore, it is suggested that the transition region always be placed in a tangent section of the barrier (that lies parallel to the roadway). In some situations, this transition section will occur on a structural slab or on a relatively thick concrete

section. In these cases, it is recommended that the first barrier adjacent to the bolted down section have two anchor bolts similar to the bolted down section and that the next barrier have one bolt placed in the end hole closest to the bolted down section.

In many situations, the bolted rail section will end adjacent to the end of the bridge, and the stiffness transitioning of the rail section will be accomplished over an asphalt paving surface. In this case, until further evaluation under a current study is completed, it is recommended to utilize the driven steel pin system of reinforcement similar to the one developed for the K-Rail by CALTRANS (5). It is recommended that the 32-mm (1.25-in.) diameter by 1,016-mm (40-in.) long steel stakes with stop plates, as detailed in Figure 36, driven into the asphalt road surface be utilized to stiffen the barriers upstream of the bolted down barrier sections. It is recommended that three stakes be utilized in the first barrier upstream of the bolted section, two stakes in the outer two locations in the second barrier upstream, and one stake in the downstream end in the third barrier upstream. Until a time when the currently funded study of this transition is completed, this recommended practice will serve as the best engineering assessment available.

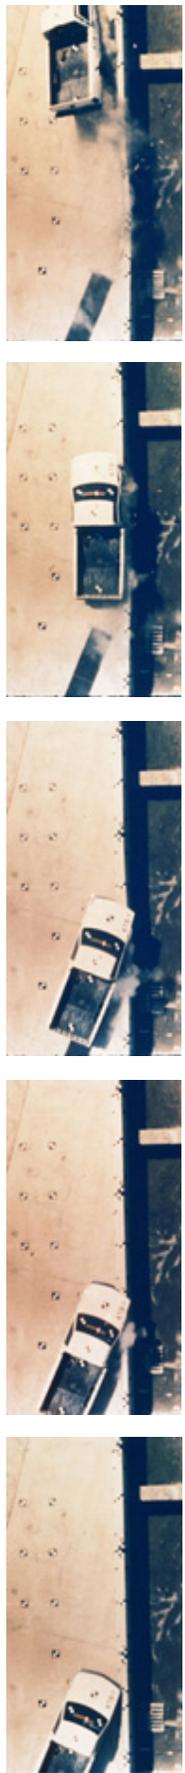
Figure D-1. Summary of Test Results and Sequential Photographs (English), Test KTB-1

0.000 sec 0.044 sec 0.084 sec 0.231 sec 0.469 sec

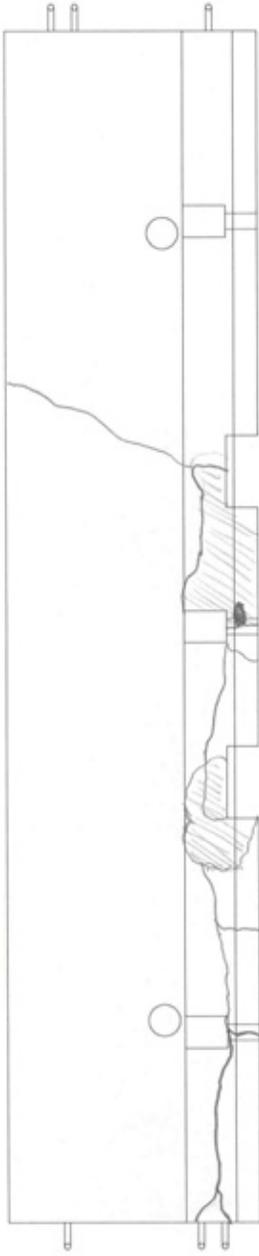
Figure E-2. Concrete Damage – Back Face Barrier No. 8, Test KTB-1

Major Barrier Damage; Barrier No. 8 - Back Face

ELEVATION VIEW

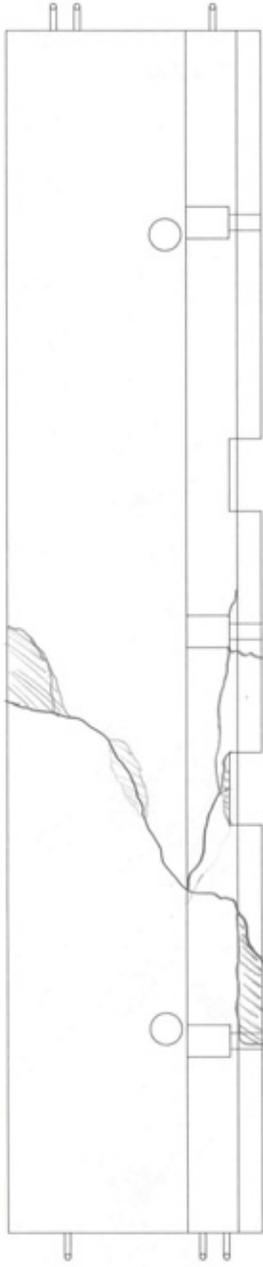
Figure E-4. Concrete Damage – Back Face Barrier No. 9, Test KTB-1

Major Barrier Damage: Barrier no 9 back face

ELEVATION VIEW
