**TESTING OF M203x9.7 (M8x6.5) AND
S76x8.5 (S3x5.7) STEEL POSTS -
POST COMPARISION STUDY FOR
THE CABLE MEDIAN BARRIER**

MIDWEST ROADSIDE SAFETY FACILITY

MwRSF Research Report No. TRP-03-143-03

October 24, 2003

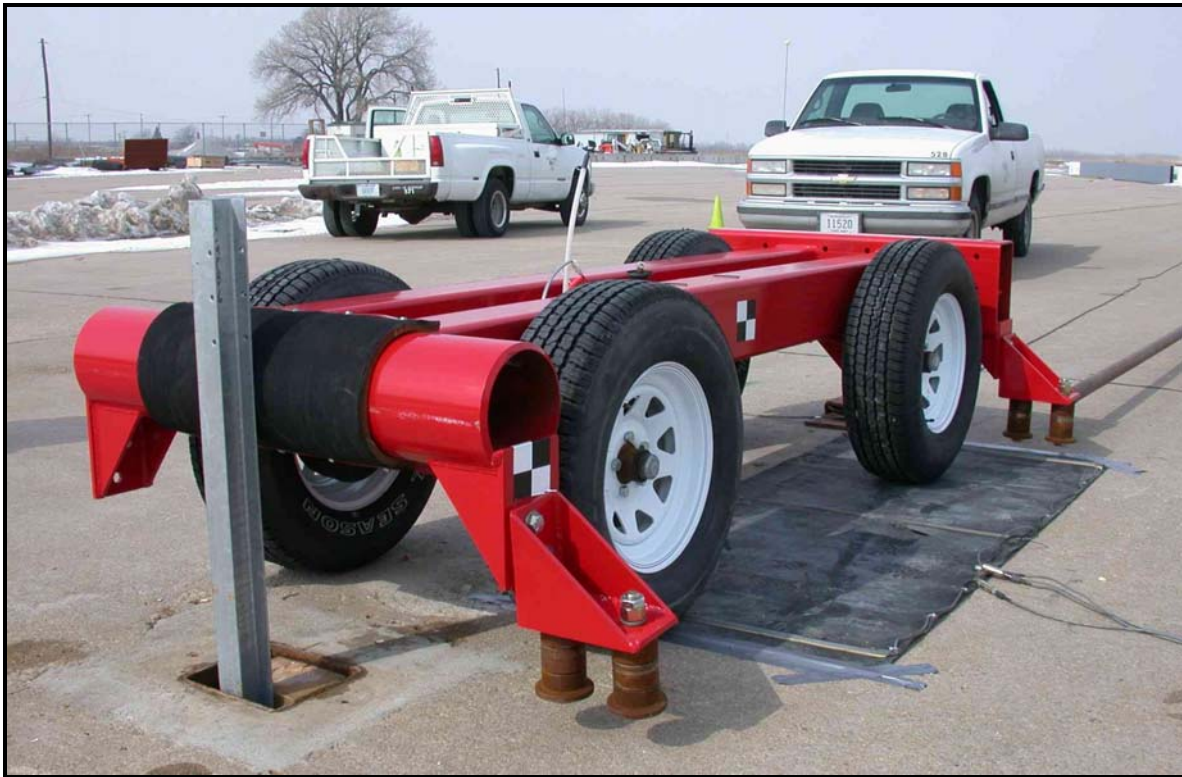
A rigid frame bogie, constructed by MwRSF under the direction of Dr. John Rohde, was used to impact the posts. An impact head, made of a 203 mm (8 in.) standard steel pipe, was mounted to the bogie at the height of 550 mm (21.65 in.) above the ground. Neoprene belting, 19 mm (3/4 in.) thick, was attached to the steel pipe to minimize the local damage to the post from the impact. The bogie is shown in Figure 2.

Figure 2. Bogie and Test Setup

The bogie weight was 613.7 kg (1353 lbs). Calculations and computer simulations prior to testing indicate that this weight, in combination with a velocity of approximately 32 kilometers per hour (20 mph or 8.9 m/s), would closely replicate the actual impact conditions that a post as a part of the guardrail system would be subjected to in a 96 kilometers per hour (60 mph), 25 deg impact with a 2040 kg (4500 lbs) car.

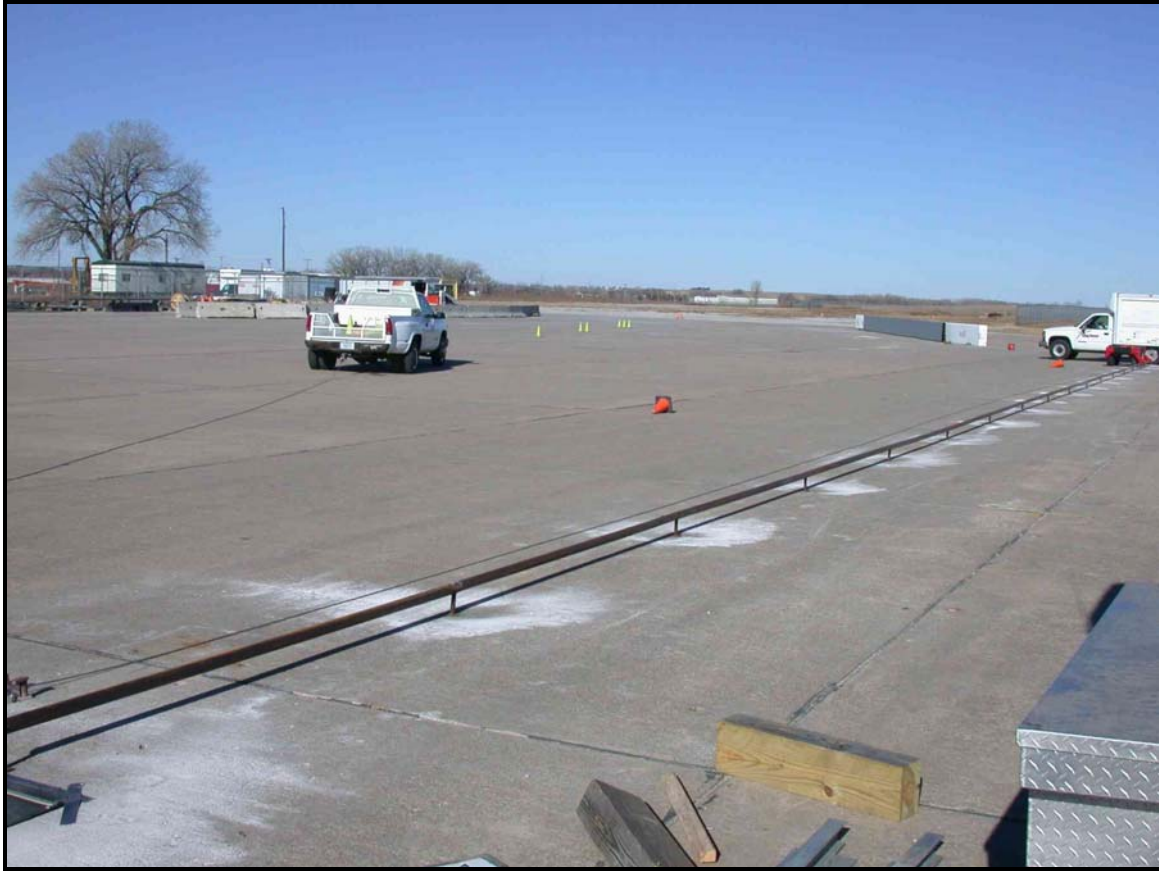
In all of the tests conducted the bogie wheels were aligned for caster and toe-in values of zero so that the bogie would track properly along the guidance system. A remote braking system was installed on the bogie to allow the bogie to be brought safely to a stop after the test. Accelerometers located at the bogie's center of gravity, recorded lateral, horizontal, and vertical acceleration data.

Figure 3. Bogie Positioned on the Guide Track

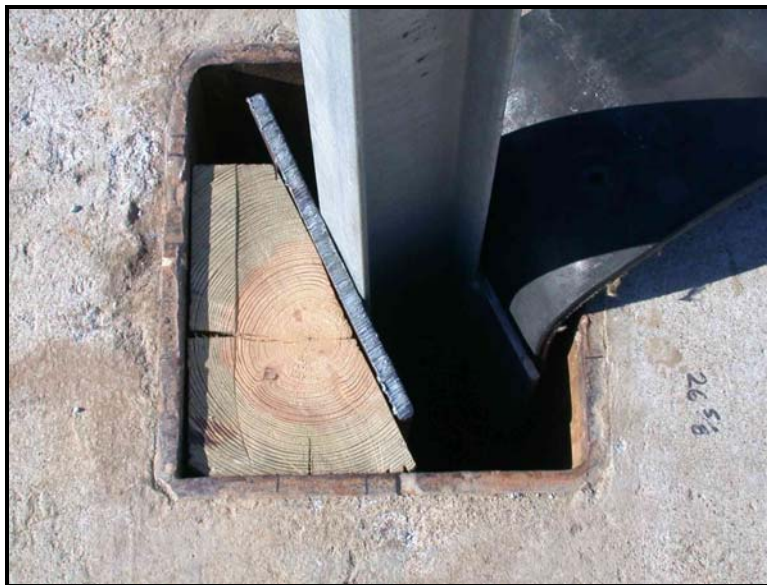
The setup for the testing of the S76x8.5 (S3x5.7) posts in the concrete is very similar, but accommodations were made for the attached soil plate. The installation setup prior to test CMPB-4 can be seen in Figure 5. The addition of the neoprene was to prevent damage from the impact that may have affected the post properties subsequently determined.

Figure 5. Typical Post and Wood Block Setup for Tests CMPB-1 through CMPB-6

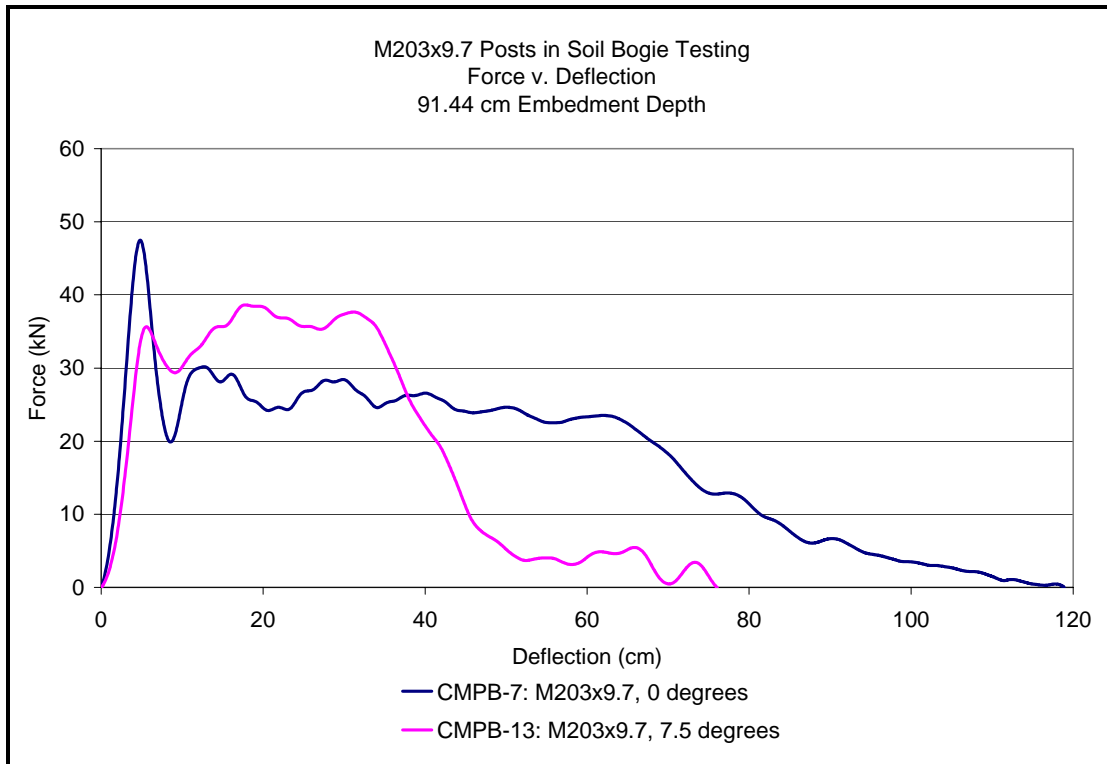
Figure 11a. Force-Deflection Curves for CMPB-7 and 13 - Metric

Figure 11b. Force-Deflection Curves for CMPB-7 and 13 - English

Examination of the Force v. Deflection curve, Figure 11, is a further indication that the post rotated in the soil, due to the uniform force level observed over the duration of the impact. A drop in the force level was observed in the range of 35-37.5 cm (13.78 – 14.76 in.) for test CMPB-7.

Examination of the Force v. Deflection curve, Figure 11, also indicates a change in the force level at 34.77 cm (13.7) in of deflection. The force level observed while the post was rotating in the soil, during CMPB-13 is larger than in CMPB-7, due to the amount of soil behind the post, previously discussed, while the duration is comparable.

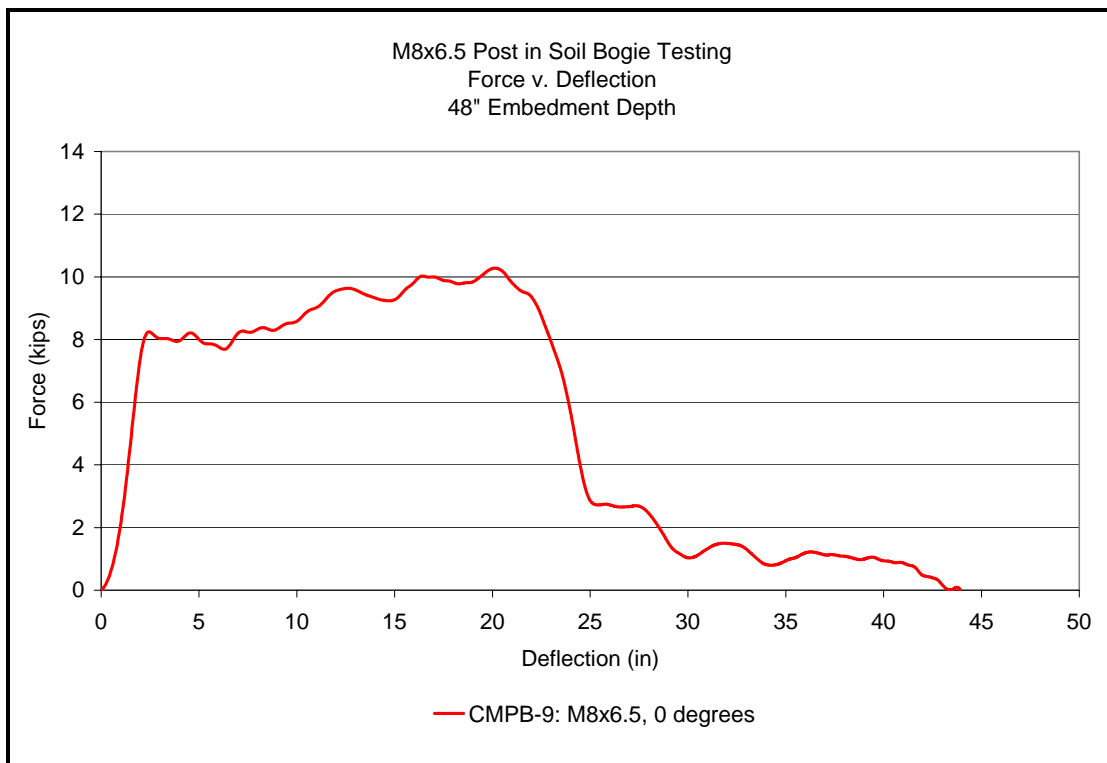
Figure 13b. Force-Deflection Curve for CMPB-9 - English

Examination of the Force v. Deflection curve, Figure 13, indicates a uniform force level until 55 cm (21.7 in) of deflection. At this point the post began to twist and thus the force level decreased significantly due to the change in failure mode. The duration of the force levels is less than observed in test CMPB-8, although the uniform force level is larger.

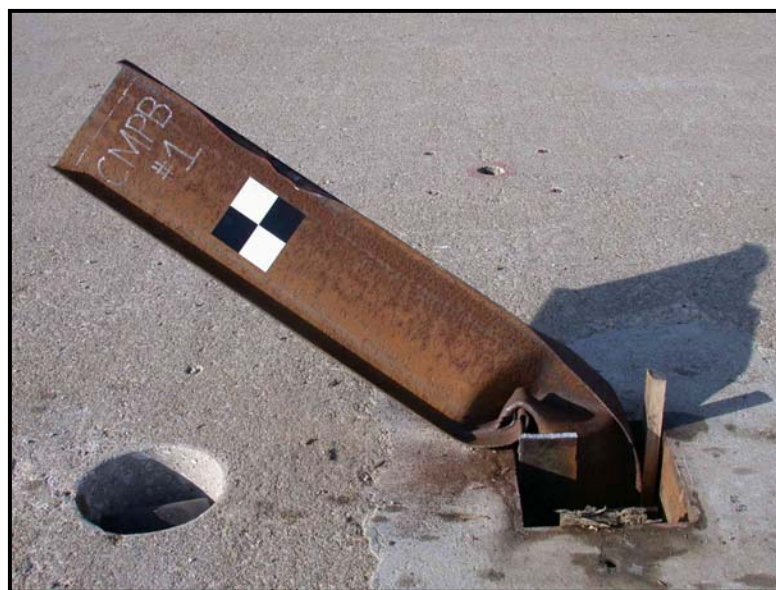
Test CMPB-1 was a strong axis impact at 0 degrees on the M203x9.7 (M8x6.5) steel post embedded in a concrete sleeve. The post was observed to bend at ground level. At 76 ms the bogie began to be lifted, a result of the impact cylinder head sliding up the slope of the bent post. The impact cylinder head lost contact with the post at 113 ms, resulting in the termination of the test and corresponds to a deflection of 88.92 cm (35.0 in).

Figure 17. Post-Impact Image of CMPB-1, M203x9.7 (M8x6.5) Post in Concrete

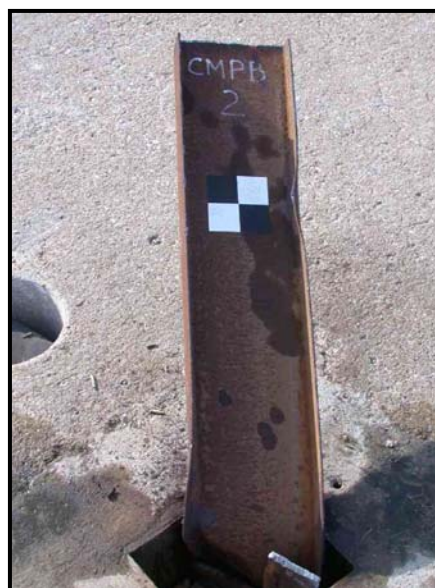
Test CMPB-2 was a strong axis impact at 15 degrees on the M203x9.7 (M8x6.5) steel post embedded in a concrete sleeve. The post was observed to bend at ground level for the first 8 ms, corresponding to a deflection of 7.42 cm (2.9 in). From 8 ms to 32 ms, the post twisted approximately 75 degrees, resulting in the weak axis of the post being parallel to the impact cylinder and 20.64 cm (8.1 in) of further deflection. The post then continued to fail by bending at ground level, with the impact cylinder losing contact with the post at 112 ms, resulting in the termination of the test and a deflection of 89.56 cm (35.3 in).

Figure 18. Post-Impact Image of CMPB-2, M203x9.7 (M8x6.5) Post in Concrete

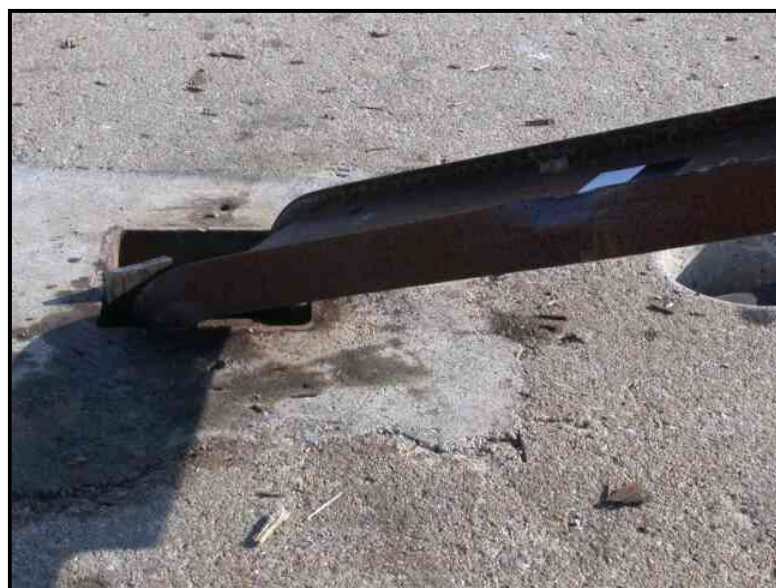
Test CMPB-3 was a strong axis impact at 30 degrees on the M203x9.7 (M8x6.5) steel post embedded in a concrete sleeve. The post was observed to bend at ground level and twist simultaneously for the first 28 ms, corresponding to a deflection of 24.75 cm (9.7 in). The post twisted approximately 60 degrees, resulting in the weak axis of the post being parallel to the impact cylinder. The post then continued to fail by bending at ground level, with the impact cylinder losing contact with the post at 114 ms, resulting in the termination of the test and a deflection of 93.00 cm (36.6 in).

Figure 19. Post-Impact Image of CMPB-3, M203x9.7 (M8x6.5) Post in Concrete

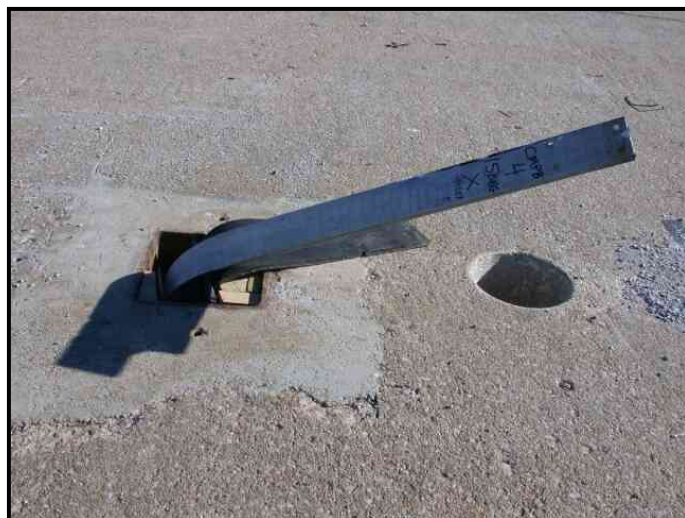
Test CMPB-4 was a strong axis impact at 15 degrees on the S76x8.5 (S3x5.7) steel post embedded in a concrete sleeve. The post was observed to undergo a combination of twisting and bending for the duration of the test. For the first 20 ms of the impact, corresponding to a deflection of 18.77 cm (7.4 in), the twisting aligned the strong axis of the post to impact cylinder. The post then twisted in the opposite direction, past its original orientation, causing the weak axis to become nearly parallel to the impact cylinder at 60 ms, corresponding to a deflection of 52.72 cm (20.8 in). The impact cylinder lost contact with the post at 102 ms and a deflection of 86.83 cm (34.2 in).

Figure 20. Post-Impact Image of CMPB-4, S76x8.5 (S3x5.7) Post in Concrete

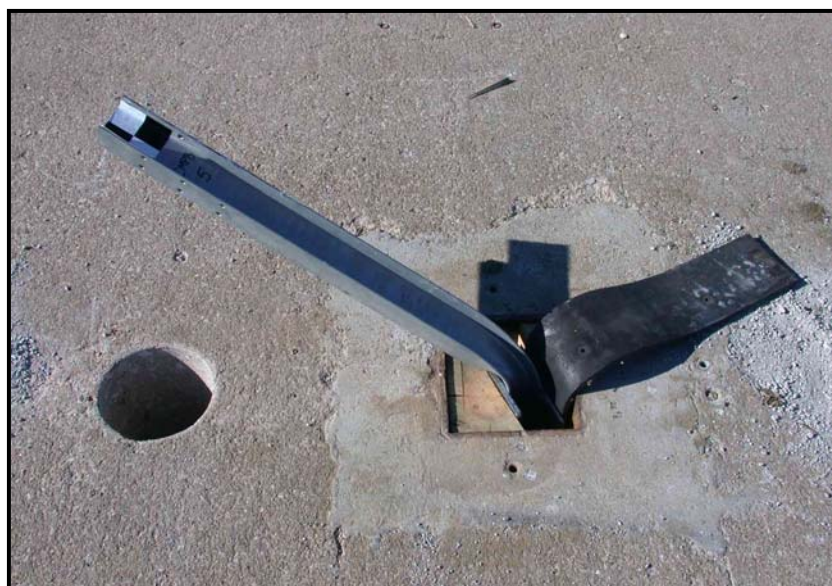
Test CMPB-5 was a strong axis impact at 30 degrees on the S76x8.5 (S3x5.7) steel post embedded in a concrete sleeve. The observed dynamic behavior of the post was very similar to test CMPB-4 and a similar explanation is offered. However only 14 ms, corresponding to a deflection of 12.75 cm (5.0 in), was required to have the strong axis of the post parallel to the cylinder head.

Figure 21. Post-Impact Image of CMPB-5, S76x8.5 (S3x5.7) Post in Concrete

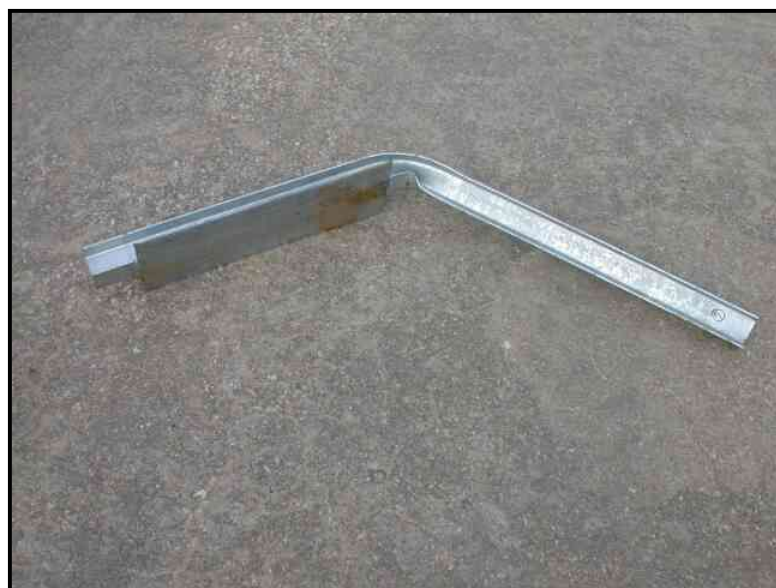
Test CMPB-6 was a strong axis impact at 0 degrees on the S76x8.5 (S3x5.7) steel post embedded in a concrete sleeve. The post was observed to bend at ground level for the first 40 ms, corresponding to 32.34 cm (12.7 in) of deflection. After 40 ms, the post continues to fail in a combination of twisting and bending. The impact cylinder lost contact with the post at 127 ms and a deflection of 88.45 cm (34.8 in).

Figure 22. Post-Impact Image of CMPB-6, S76x8.5 (S3x5.7) Post in Concrete

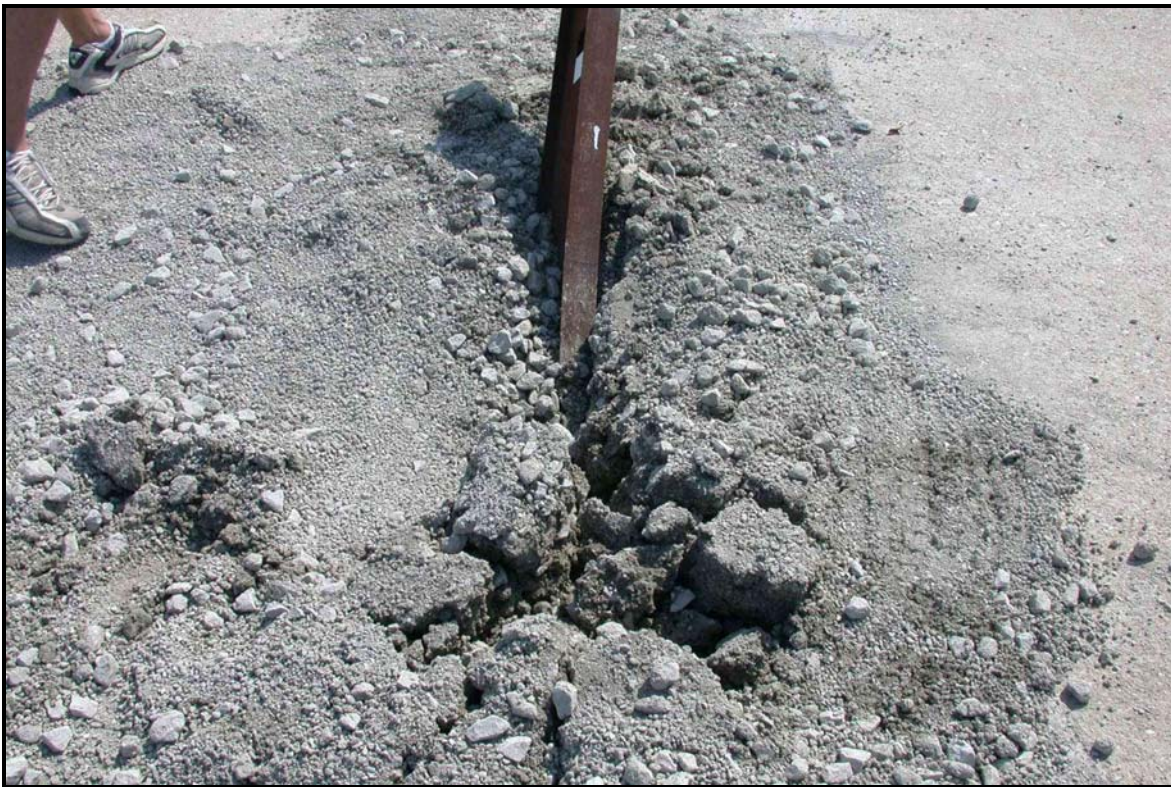
Test CMPB-7 was a strong axis impact at 0 degrees on the M203x9.7 (M8x6.5) steel post embedded 91.44 cm (36 in.) in NCHRP 350 soil. The post was observed to rotate in the soil, with only slight yielding. It has been previously shown that analyzed accelerometer data with slight post yielding is similar to data when no yielding occurs (2). Specific timing details and sequential photographs are unavailable due to video recording problems.

Figure 23. Post-Impact Image from CMPB-7, M203x9.7 (M8x6.5) Post in Soil

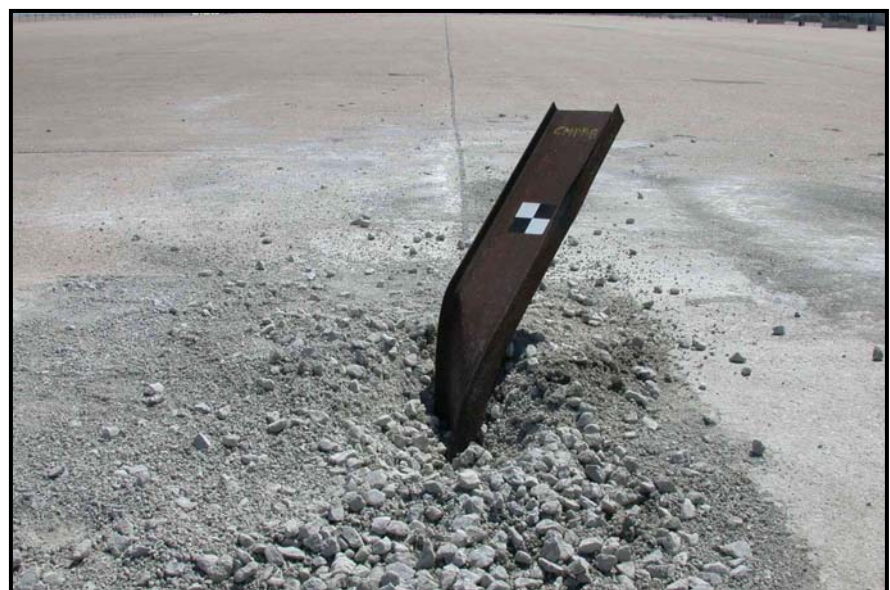
Test CMPB-8 was a strong axis impact at 0 degrees on the M203x9.7 (M8x6.5) steel post embedded 106.7 cm (42 in) in NCHRP 350 soil. The post was observed to rotate in the soil for the first 92 ms, corresponding to a deflection of 67.7 cm (26.7 in), after which the post twisted and bent simultaneously for 84 ms, causing a further 32.3 cm (12.7 in) of deflection. At this point the bogie was undergoing significant lifting, resulting in the termination of the test, before the impact cylinder lost contact with the post at 242 ms.

Figure 24. Post-Impact Image of CMPB-8, M203x9.7 (M8x6.5) Post in Soil

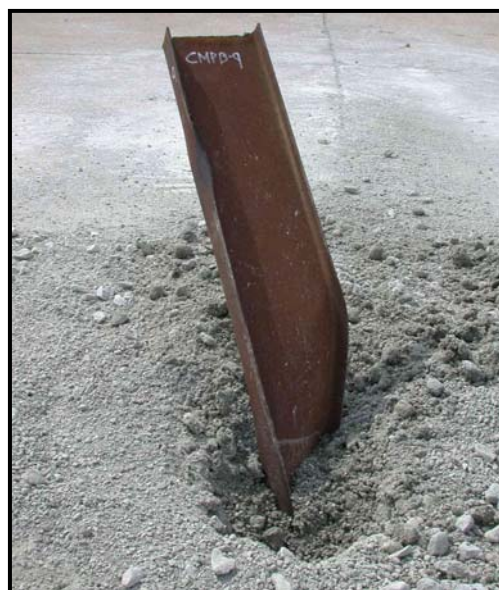
Test CMPB-9 was a strong axis impact at 0 degrees on the M203x9.7 (M8x6.5) steel post embedded 121.92 cm (48 in) in NCHRP 350 soil. The post was observed to rotate in the soil for the first 74 ms, corresponding to a deflection of 55.05 cm (21.7 in). The post was then observed to twist for 20 ms, corresponding to a further 8.65 cm (3.4 in) of deflection. The post then began to twist and bend simultaneously until the impact cylinder lost contact with the post after 253 ms and 111.55 cm (43.9 in) of deflection.

Figure 25. Post-Impact Image of CMPB-9, M203x9.7 (M8x6.5) Post in Soil

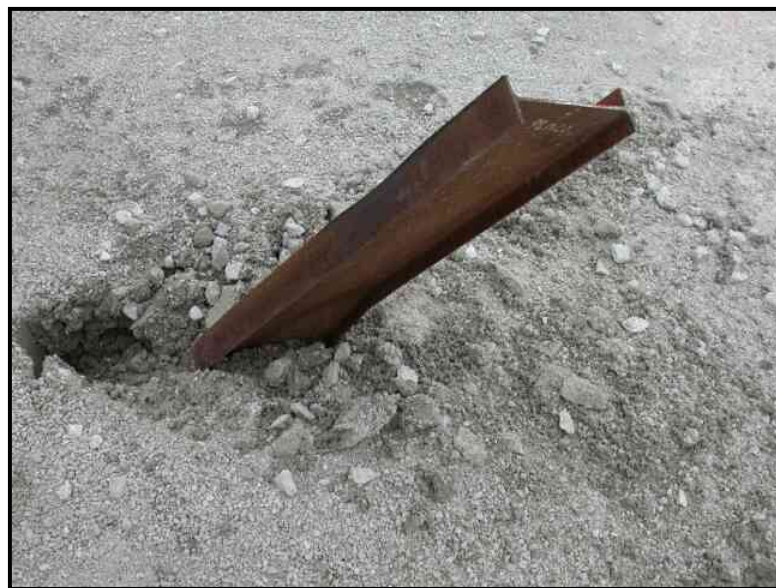
Test CMPB-10 was a strong axis impact at 0 degrees on the M203x9.7 (M8x6.5) steel post embedded 106.7 cm (42 in) in NCHRP 350 soil. The observed dynamic behavior in CMPB-10 was very similar to that seen in CMPB-8 and a similar explanation is offered. However test CMPB-10 was shorter with a duration time of 206 ms, but the total deflection was still similar at 95.57 cm (37.6 in).

Figure 26. Post-Impact Image of CMPB-10, M203x9.7 (M8x6.5) Post in Soil

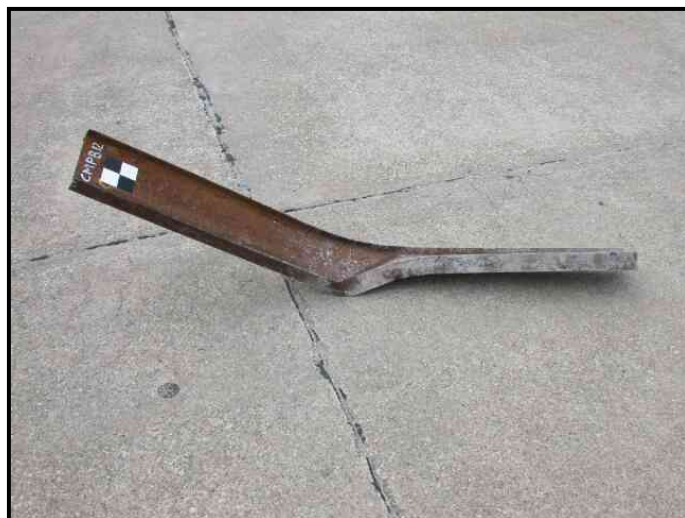
Test CMPB-12 was a strong axis impact at 7.5 degrees on the M203x9.7 (M8x6.5) steel post embedded 106.7 cm (42 in) in NCHRP 350 soil. The post was observed to rotate in the soil for the first 46 ms, corresponding to a deflection of 38.40 cm (15.1 in), after which the post twisted and bent simultaneously for 62 ms, causing a further 41.11 cm (16.2 in) of deflection, and orienting the weak axis of the post nearly parallel to the impact cylinder. The post then bent at the ground level until the impact cylinder lost contact with the post at 136 ms and a final deflection of 97.56 cm (38.4 in).

Figure 28. Post-Impact Image of CMPB-11, M203x9.7 (M8x6.5) Post in Soil

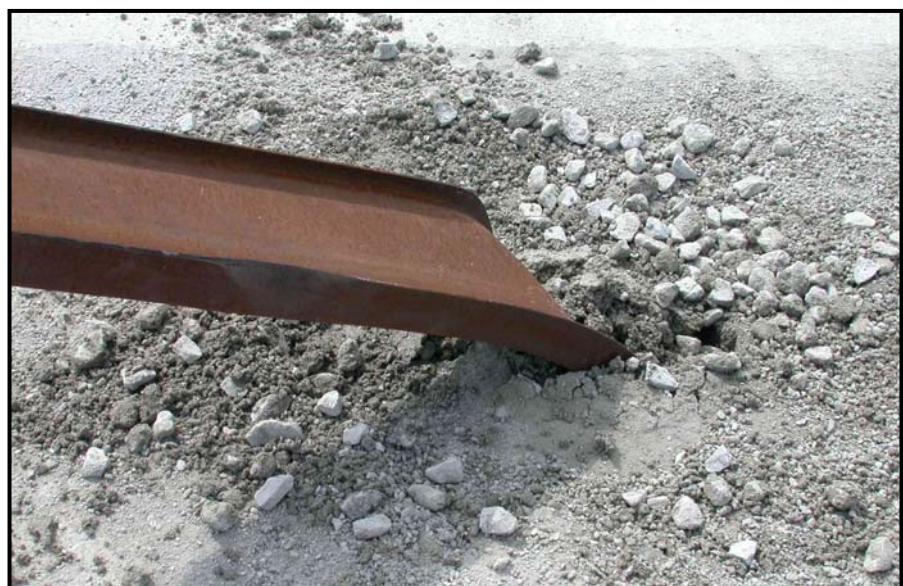
Test CMPB-7 was a strong axis impact at 7.5 degrees on the M203x9.7 (M8x6.5) steel post embedded 91.44 cm (36 in.) in NCHRP 350 soil. The post was observed to rotate in the soil for 42 ms, corresponding to a deflection of 34.77 cm (13.7 in), after which the post twisted and bent simultaneously for 44 ms, causing a further 28.49 cm (11.2 in) of deflection, and orienting the weak axis of the post parallel to the impact cylinder. The post then bent at the ground level until the impact cylinder lost contact with the post at 106 ms and a final deflection of 76.07 cm (29.9 in).

Figure 29. Post-Impact Image of CMPB-13, M203x9.7 (M8x6.5) Post in Soil

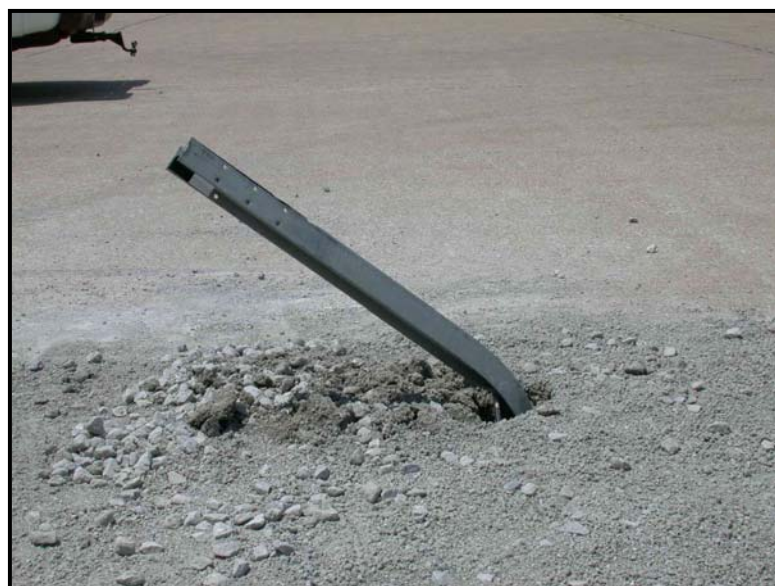
Test CMPB-14 was an impact on the S76x8.5 (S3x5.7) steel post with attached soil plate embedded 76.2 cm (30 in.) in soil at 0 degrees. The post was observed to rotate in the soil for 52 ms, corresponding to a deflection of 46.16 cm (18.2 in). The post then twisted and bent simultaneously until the impact cylinder lost contact with the post at 118 ms and a deflection of 96.74 cm (38.1 in).

Figure 30. Post-Impact Image of CMPB-14, S76x8.5 (S3x5.7) Post in Soil

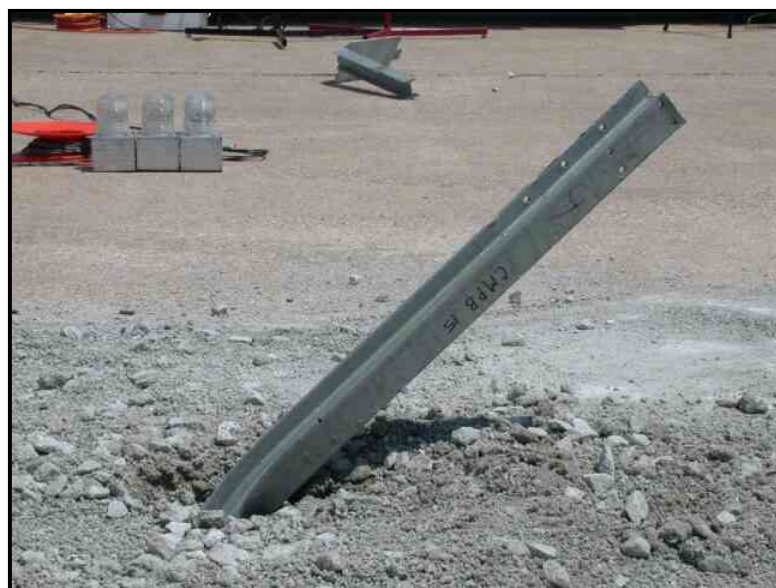
Test CMPB-15 was an impact on the S76x8.5 (S3x5.7) steel post with attached soil plate embedded 76.2 cm (30 in.) in soil at 7.5 degrees. The post was observed to rotate in the soil for 50 ms, corresponding to a deflection of 41.65 cm (16.4 in). The post then twisted and bent simultaneously until the impact cylinder lost contact with the post at 128 ms and a deflection of 97.87 cm (38.5 in).

Figure 31. Post-Impact Image of CMPB-15, S76x8.5 (S3x5.7) Post in Soil
