PERFORMANCE ANALYSIS OF WELCH PRODUCTS RECYCLED RUBBER SPACER BLOCK

MIDWEST ROADSIDE SAFETY FACILITY

MwRSF Research Report No. TRP-03-132-03

Subject: Summary Report on the Performance Analysis of Welch Products Recycled Rubber Spacer Block

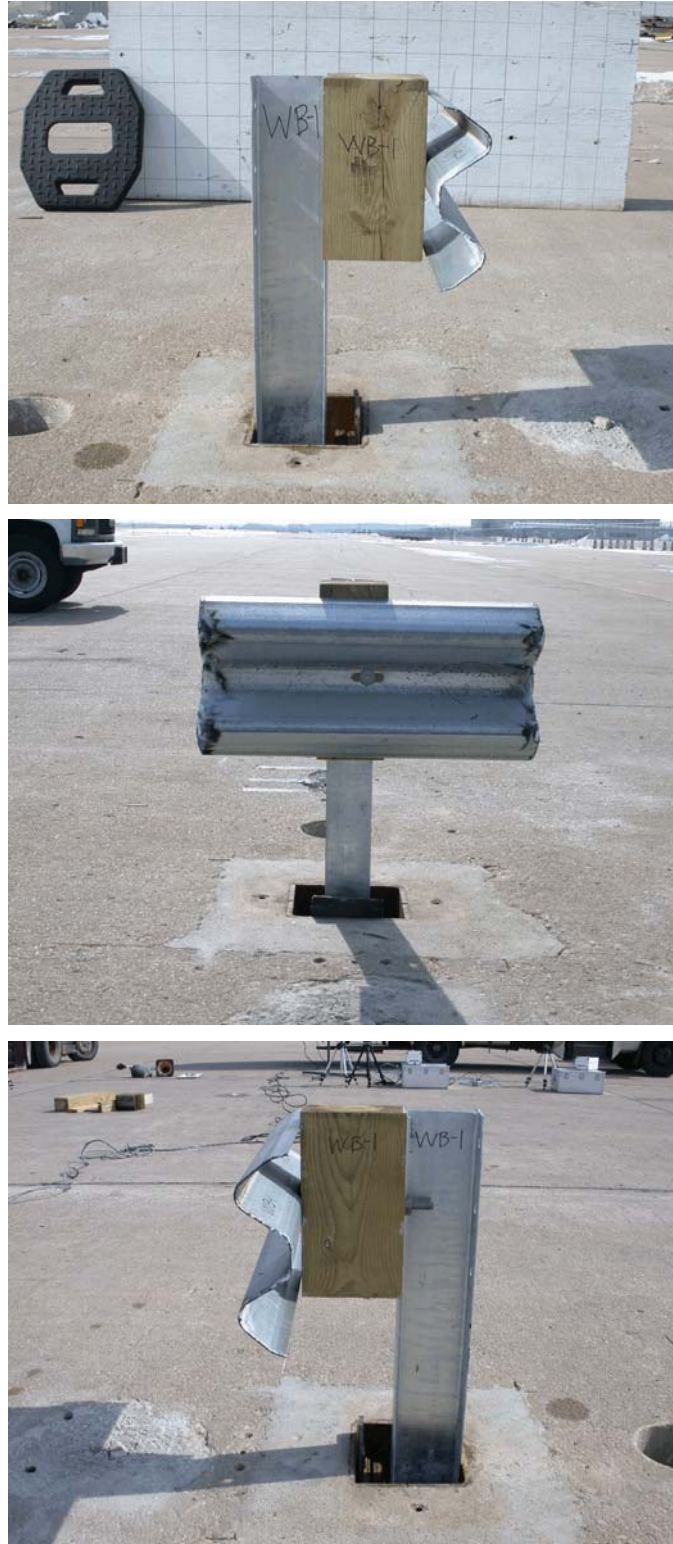
Figure 2. Wooden Spacer Block, Test WB-1

1. System:
 - Wood spacer block for steel post W-beam system
 - 200-mm x 150-mm x 360-mm spacer block with 10-mm x 100-mm x 360-mm router on back face
 - Southern Yellow Pine

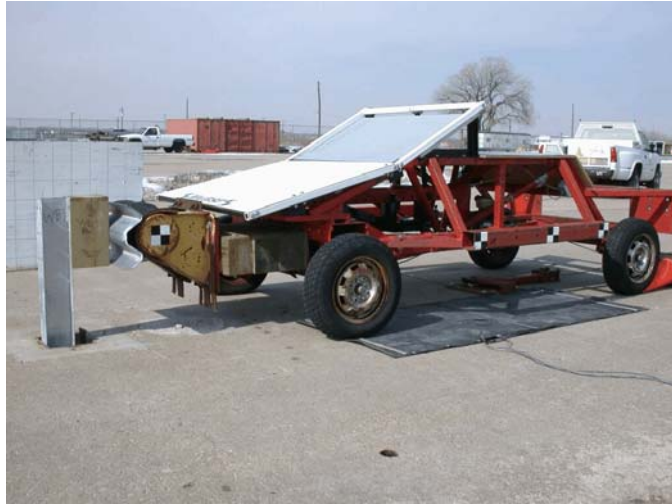
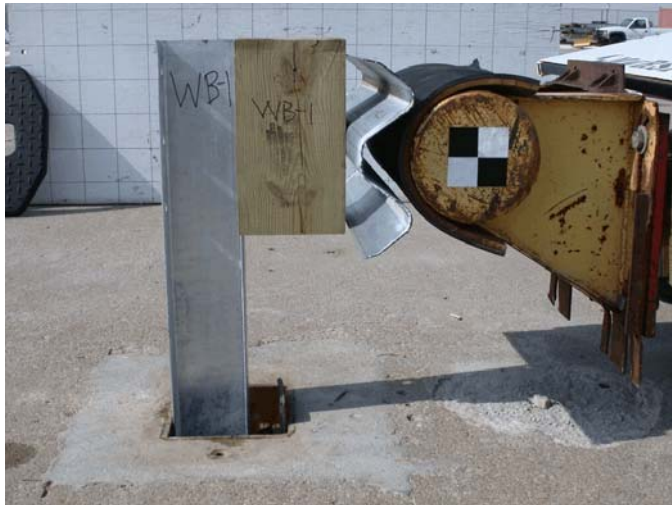
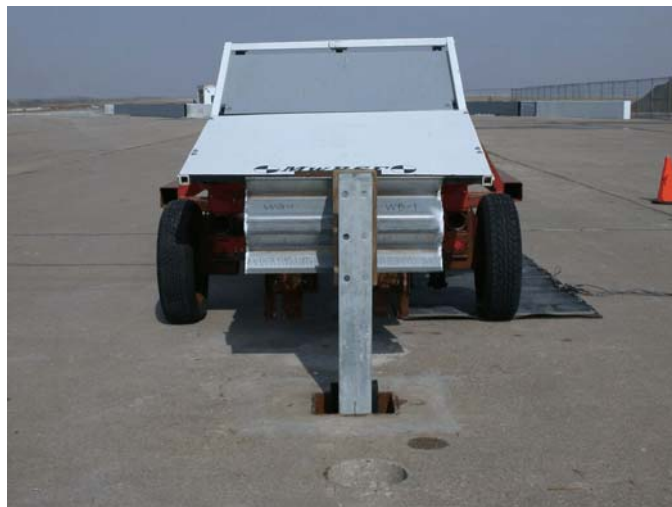
Figure 3. Wooden Spacer Block Impact Location, Test WB-1

Bogie test no. WB-1 was performed at 32.2 km/h and 0 degrees on a routed, wood spacer block mounted on a W150x13.5 steel post at a mounting height of 550 mm. A 305-mm long piece of W-beam guardrail was mounted on the front of the spacer block. The system description, design details, and test results for the routed, wood spacer block are included in Attachment No. 1.

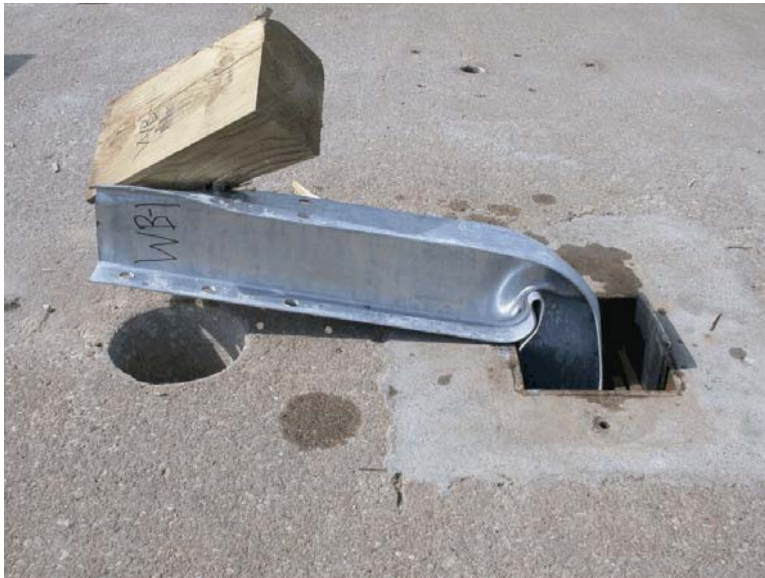
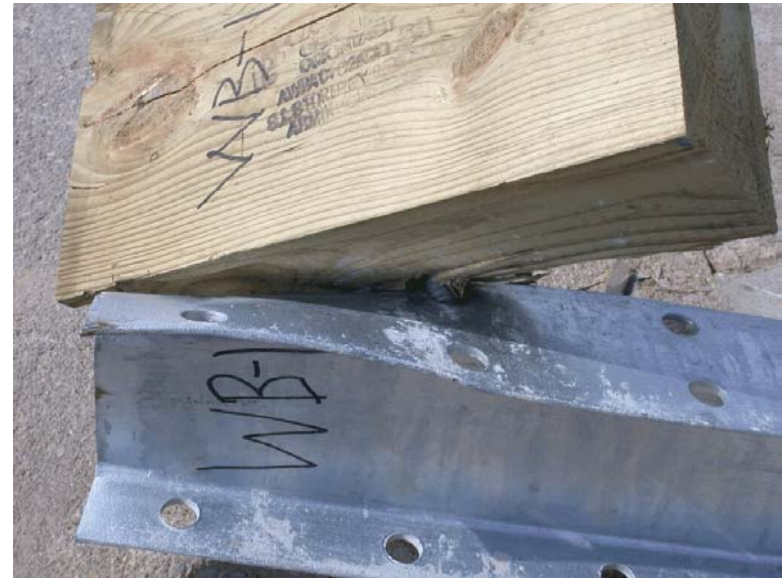
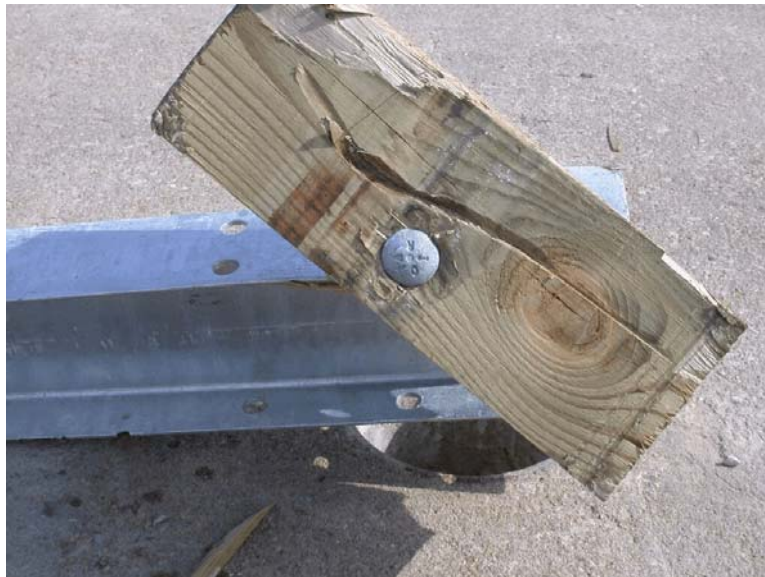
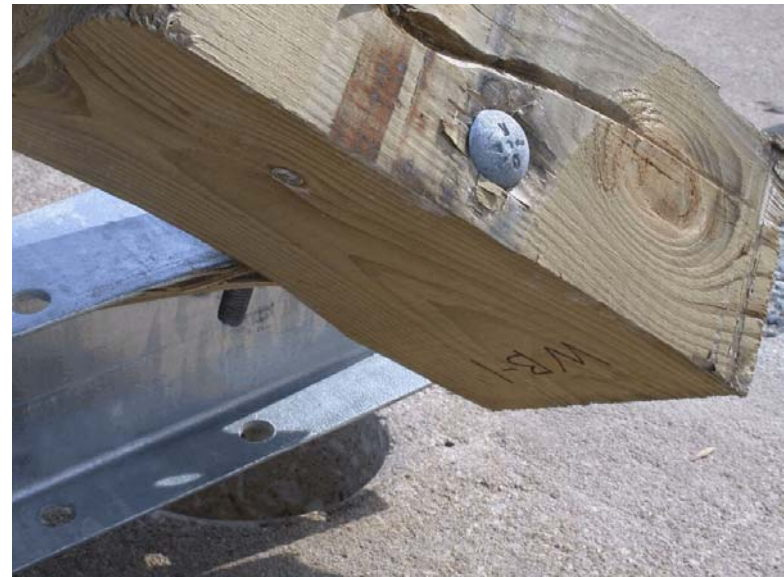
Figure 4. System Damage, Bogie Test WB-1

2. Bogie Vehicle Weight: 992 kg
3. Impact speed: 32.2 km/hr
Impact orientation: 0 degrees
Bogie Impact Height: 550 mm
4. System performance – The wood spacer block displayed minor damage due to the impact of the bogie vehicle. Some cracking and chipping of the wood on the front face of the block was observed. A portion of the routed edge on the rear of the block was disengaged as to bogie rolled over the post. No crushing or change in the depth of the spacer block was observed during the impact. The spacer block remained attached to the post.

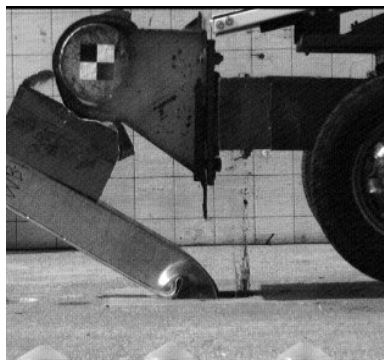
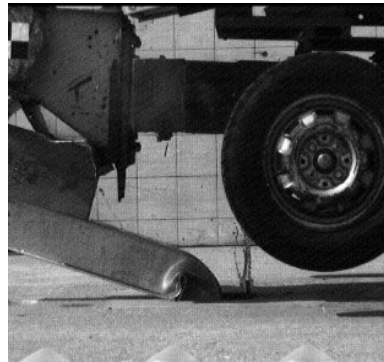
Figure 5. Sequential Photographs, Test WB-1

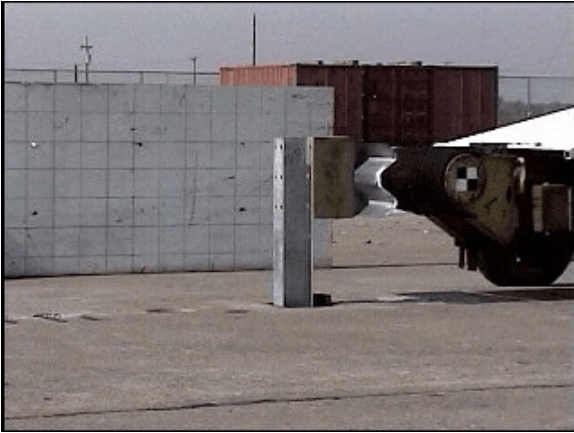
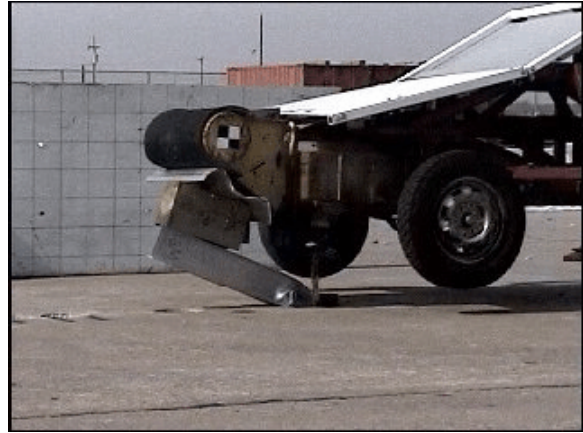
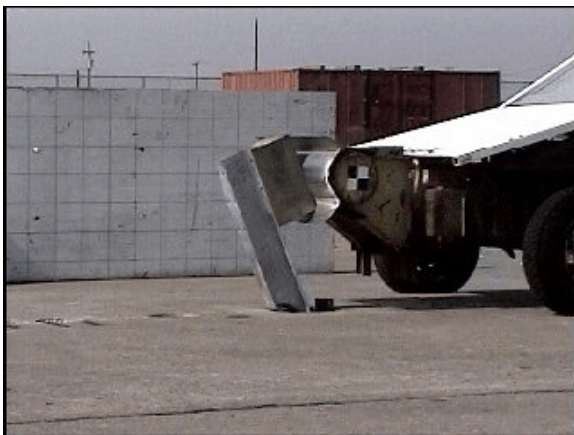
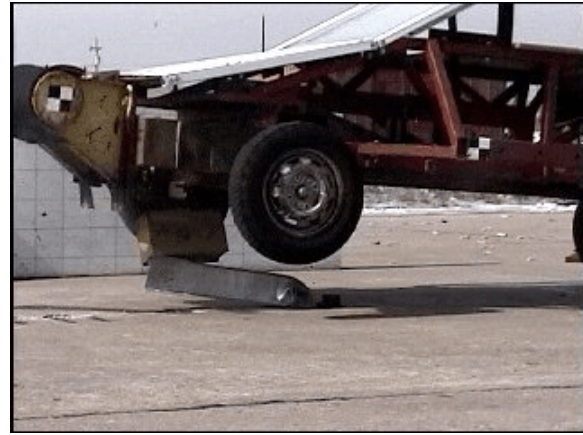
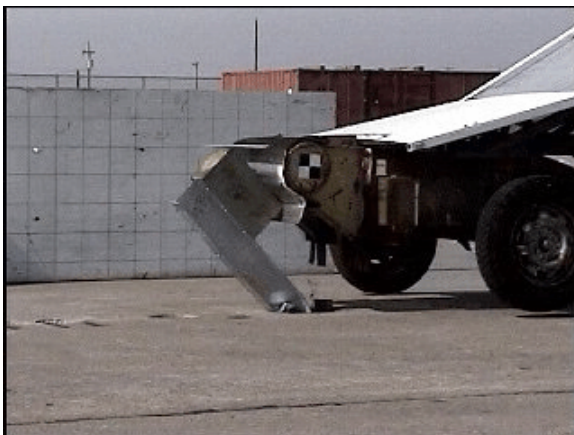
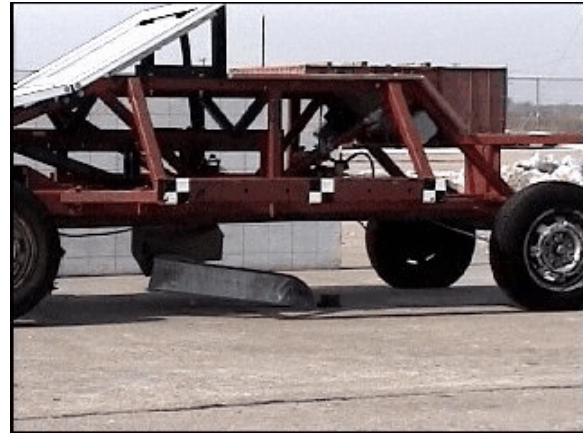
Figure 6. Documentary Photographs, Test WB-1

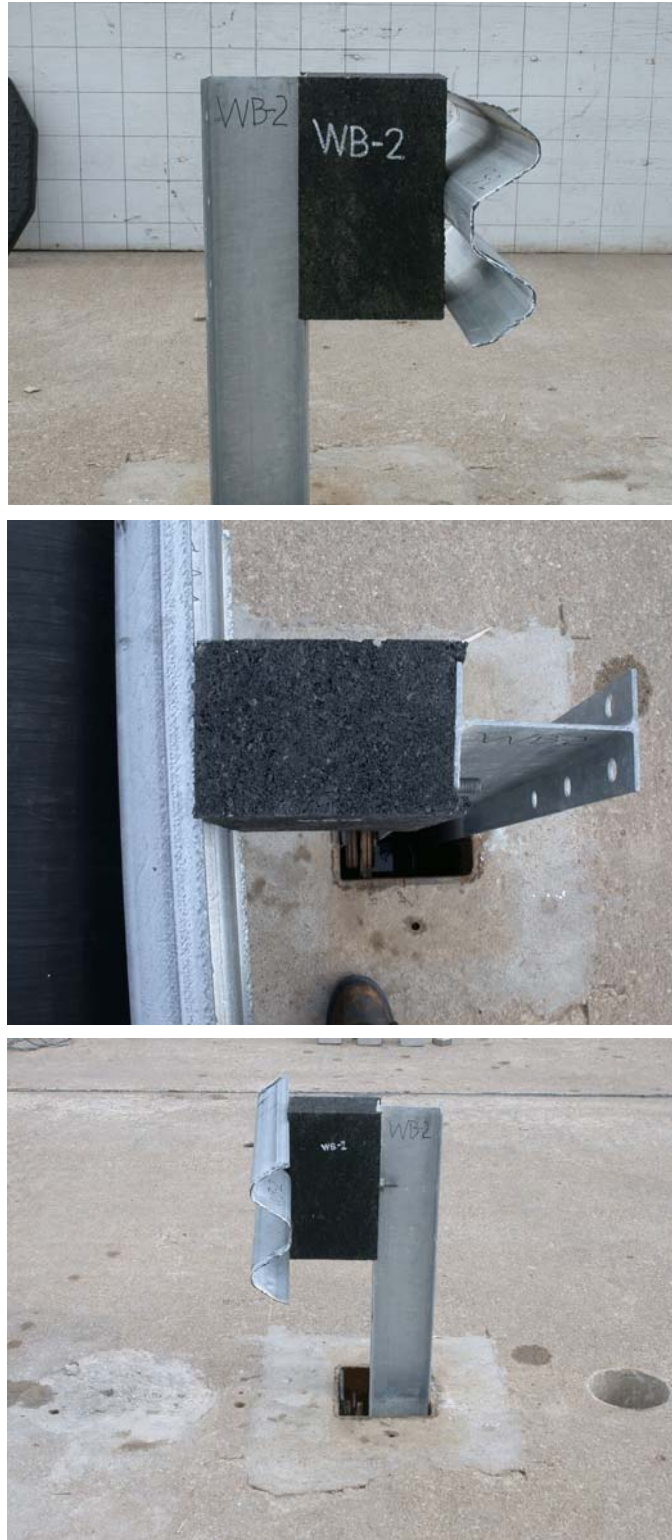
Figure 16. Recycled Rubber Spacer Block, Test WB-2

It should be noted that the field crew noticed that the W-beam rail would not mount perpendicular to the W150x13.5 post. The relatively low stiffness of the spacer block, combined with the offset post bolt location on the steel post, caused one side of the spacer block to compress more than the other. This prevented installation of the W-beam at the correct angle.

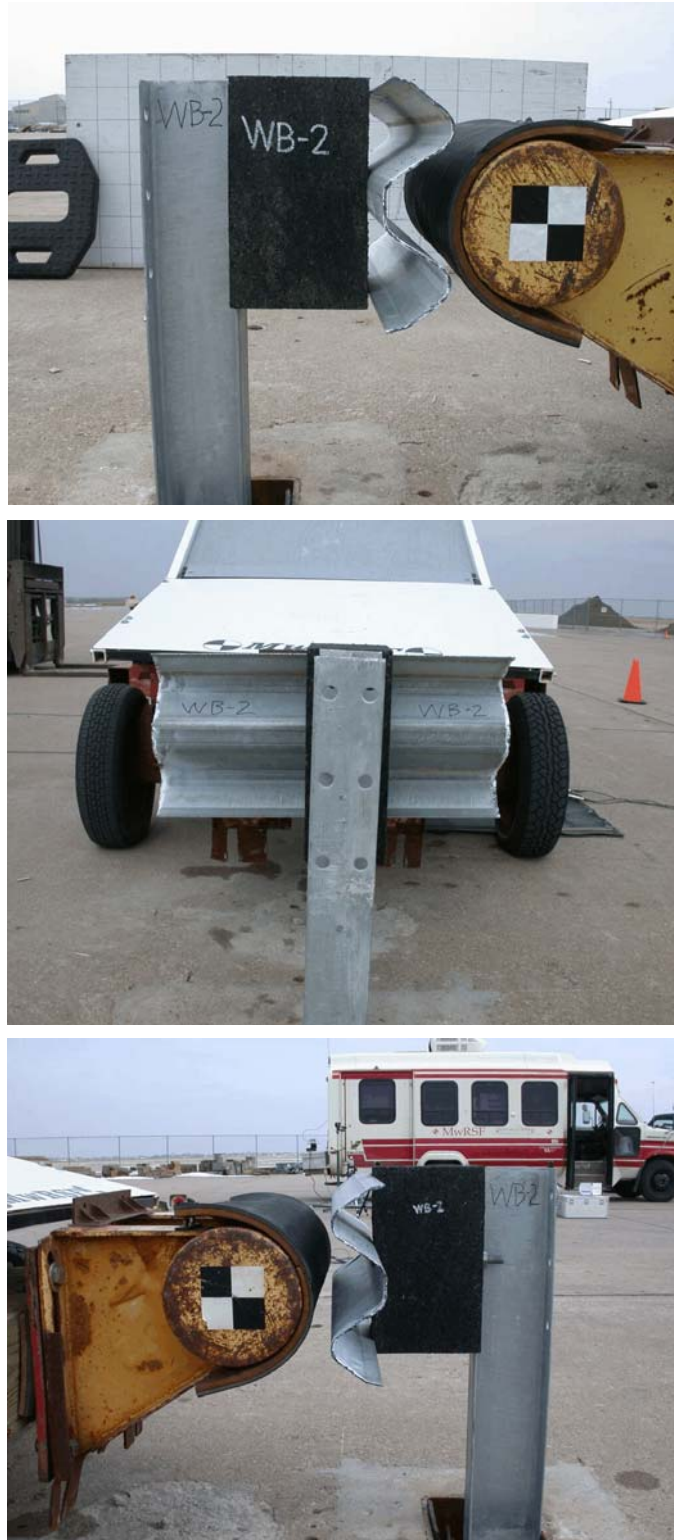
Figure 17. Recycled Rubber Spacer Block Impact Location, Test WB-2

Bogie test no. WB-2 was performed at 31.9 km/h and 0 degrees on a routed, recycled rubber spacer block mounted on a W150x13.5 steel post at a mounting height of 550 mm. A 305-mm long piece of W-beam guardrail was mounted on the front of the spacer block. The system description, design details, and test results for the routed, recycled rubber spacer block are included in Attachment No. 1.

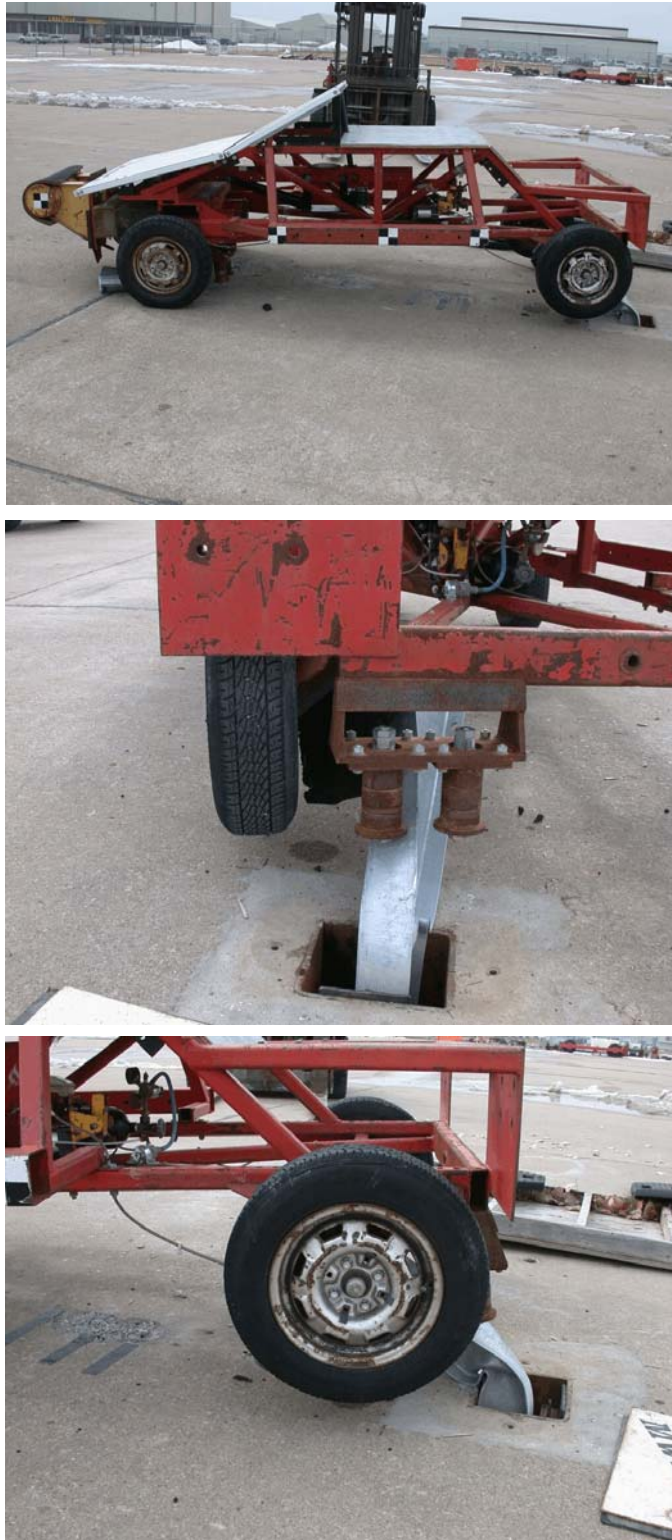
Figure 18. System Damage, Bogie Test WB-2

4. System performance – The recycled rubber spacer block displayed minor damage due to the impact of the bogie vehicle. The front face displayed slices near the top and bottom of the block where the W-beam guardrail penetrated into the rubber during impact. An approximately 76 mm x 76 mm section of the block near the top-left corner on the rear of the block was disengaged as the bogie vehicle rolled over the post. Significant crushing of the spacer block was observed during the impact. The depth of the spacer block was reduced a maximum of approximately 76 mm. The spacer block remained attached to the post.

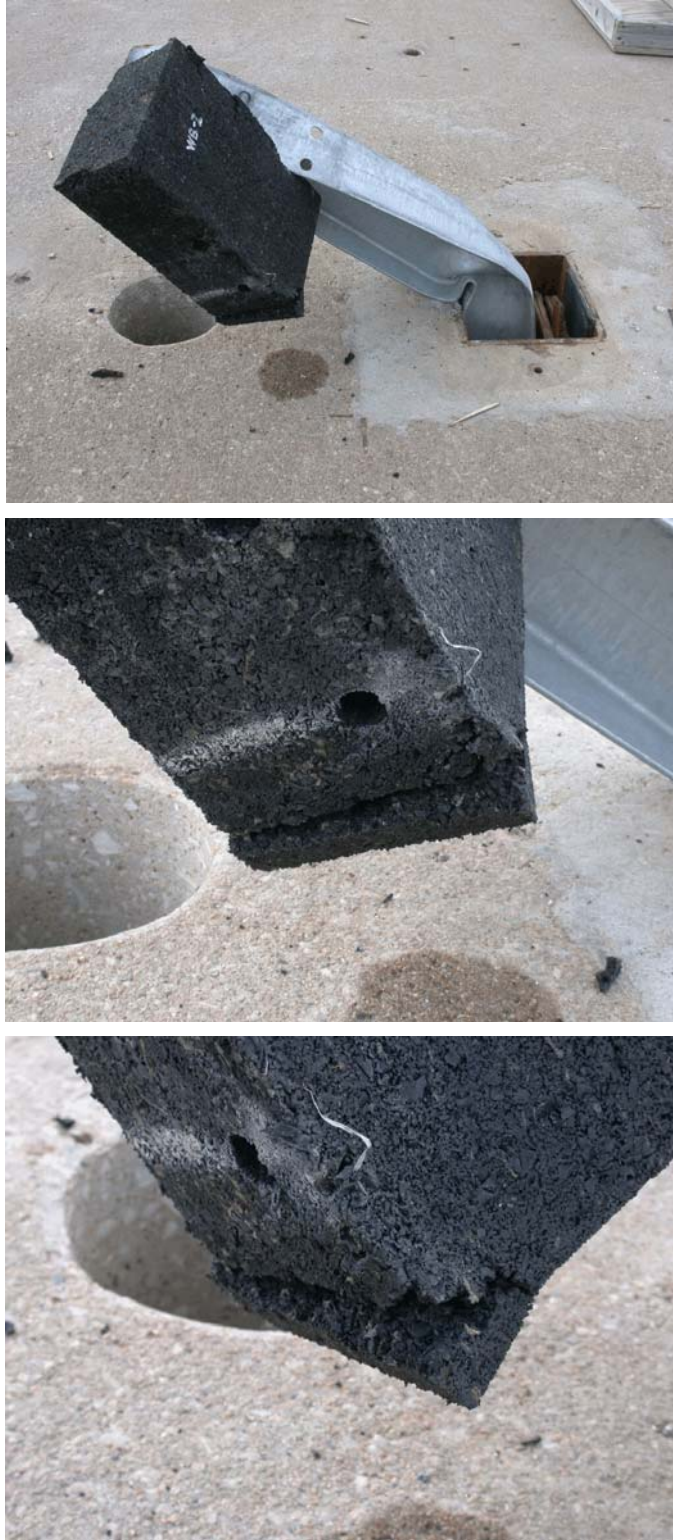
Figure 19. System Damage, Bogie Test WB-2

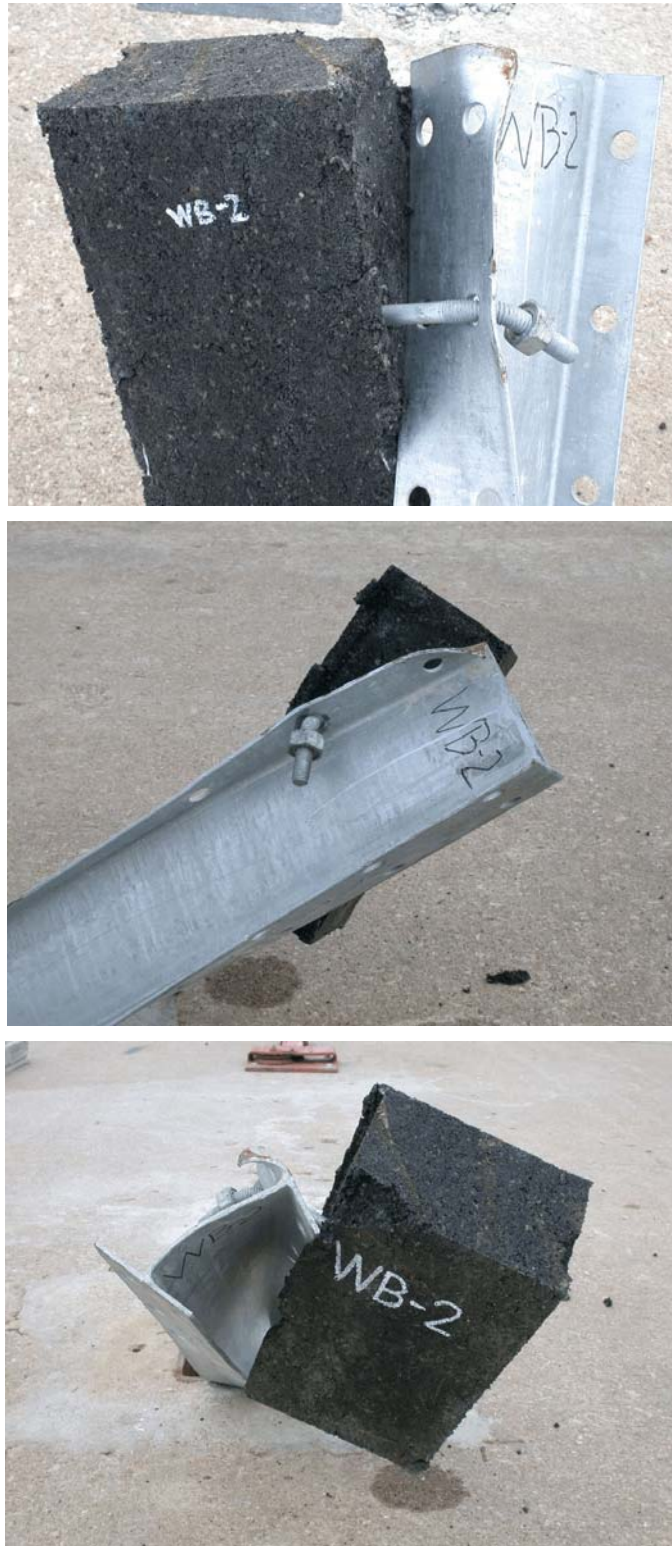
Figure 20. System Damage, Bogie Test WB-2

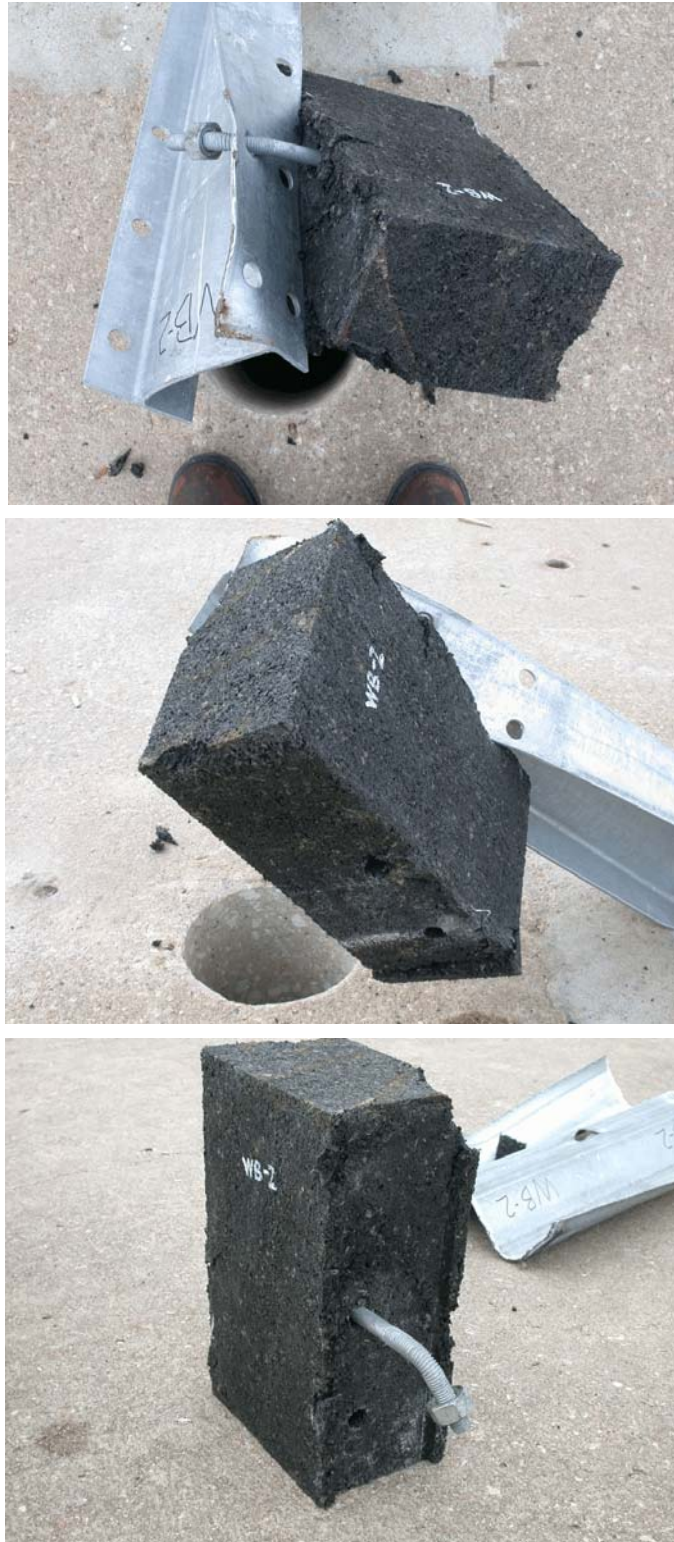
Figure 21. System Damage, Bogie Test WB-2

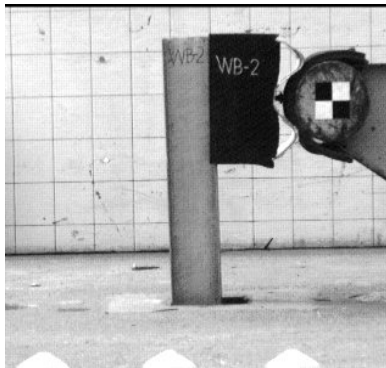
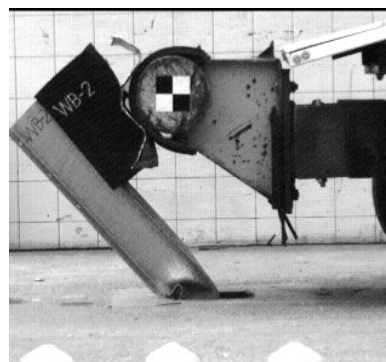
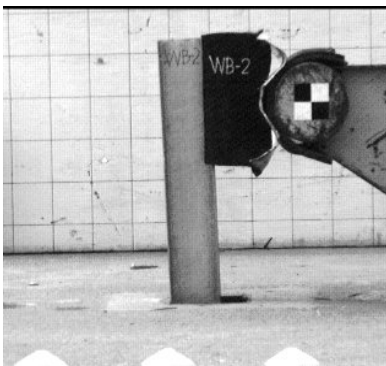
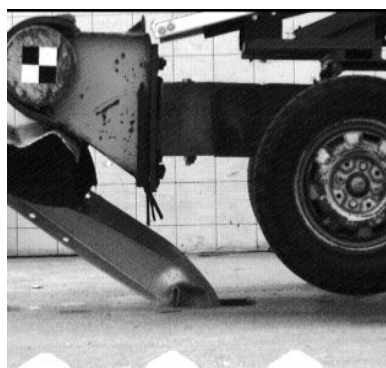
Figure 22. Sequential Photographs, Test WB-2

Based on the results of the crash tests, obvious differences were observed in the performance of the wood and recycled rubber blockouts. While both blockouts displayed similar levels of permanent damage after impact, the recycled rubber blockout was observed to be much less stiff than the wood blockout during the impact. Analysis of the high speed film showed that the recycled rubber blockout crushed approximately 76 mm during the impact, thereby reducing the effective depth of the spacer block to 127 mm. The reduced depth of the spacer block causes an increased potential for wheel snag because the guardrail would no longer be spaced 203 mm in front of the post as in standard W-beam guardrail systems. It is believed that the increased potential for wheel snag may pose a hazard if the recycled rubber blockout were installed on a standard W-beam guardrail.

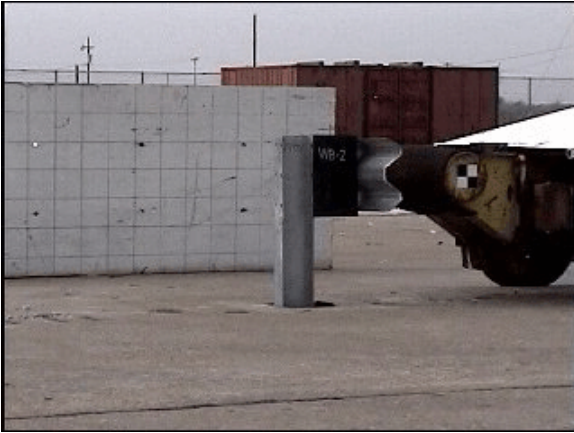
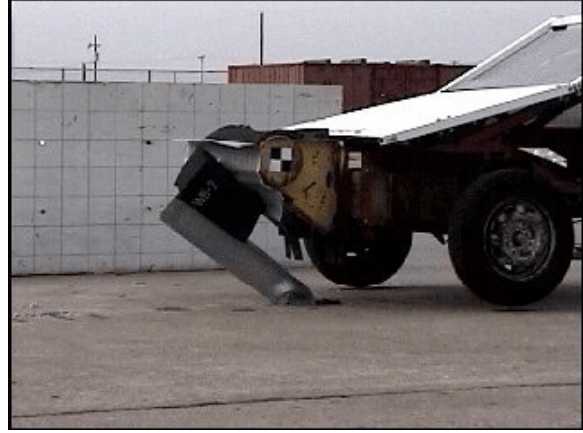
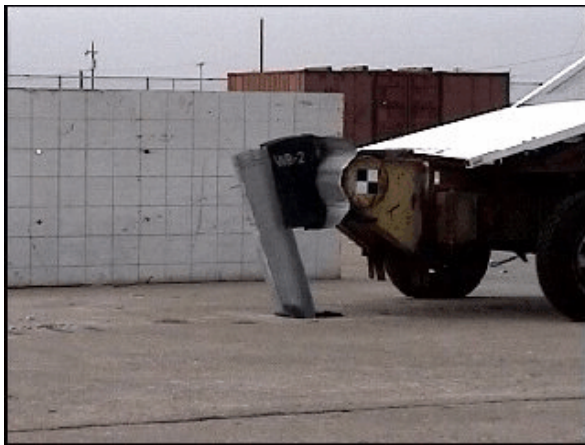
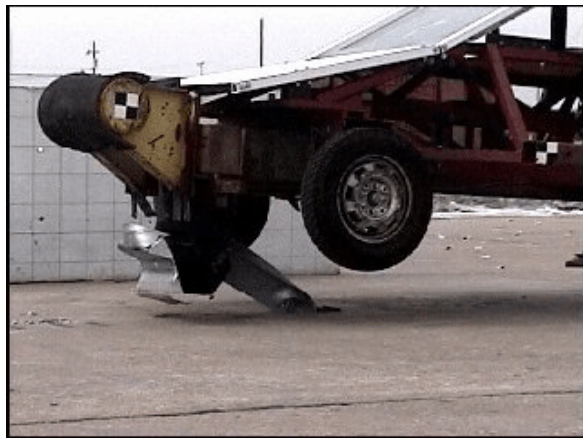
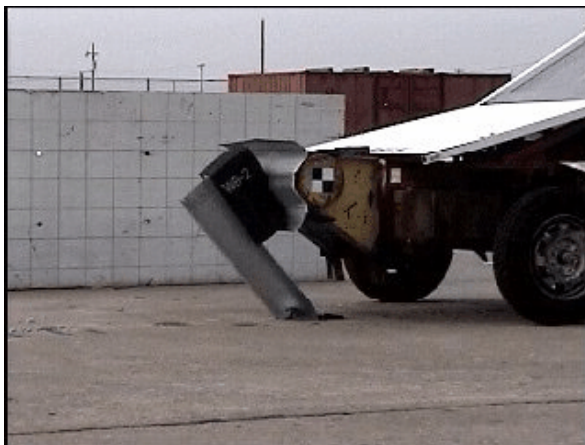
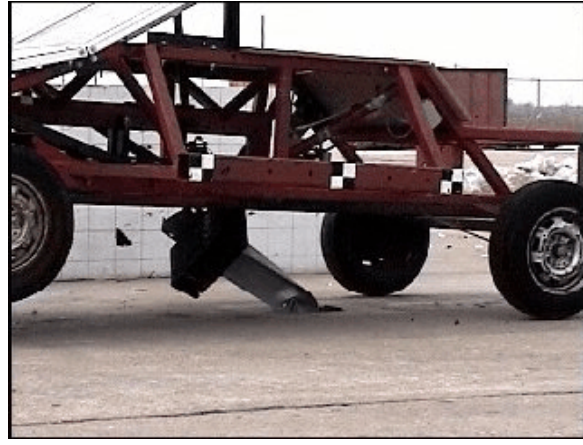
Figure 23. Documentary Photographs, Test WB-2

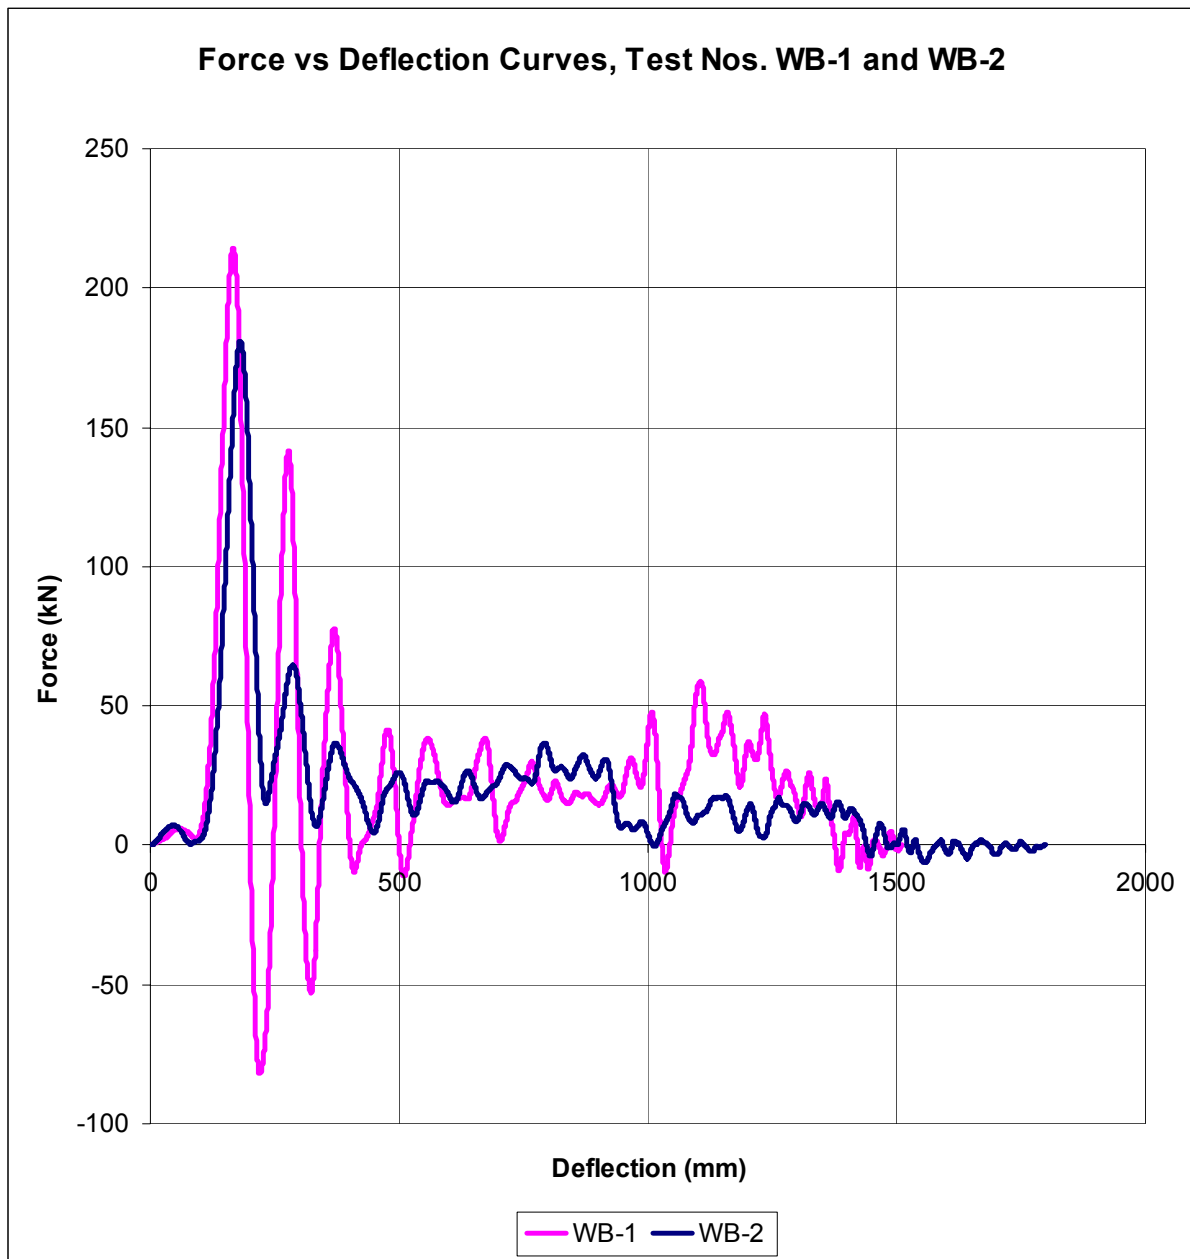
Figure 24. Force vs Deflection, Test Nos. WB-1 and WB-2
