# **DEVELOPMENT OF A RETROFIT, LOW-DEFLECTION, TEMPORARY CONCRETE BARRIER SYSTEM**

## **MIDWEST ROADSIDE SAFETY FACILITY**

MwRSF Research Report No. TRP-03-295-14

March 31, 2014

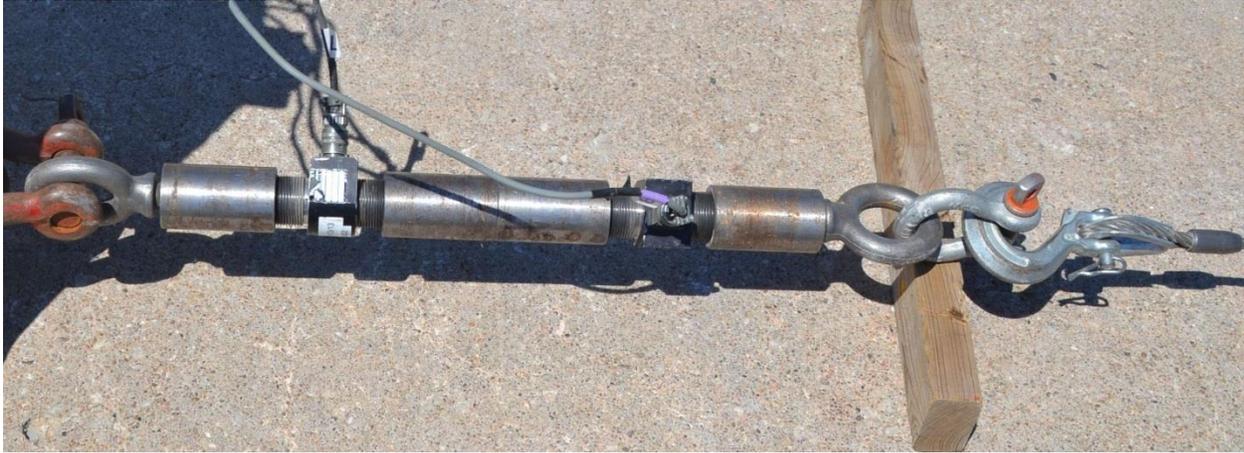
Figure 36. Load Cell Arrangement, Test Nos. TCBF-1 through TCBF-6

Two load cells were mounted in line with the pull cable to measure the tension in the cable for test nos. TCBF-1 through TCBF-6. The positioning of the load cells is shown in Figure 36. The data from both load cells was processed and compared to ensure accuracy of the readings. The load cells were manufactured by Transducer Techniques and conformed to model no. TLL-50K with a load range up to 50 kips (222 kN). During testing, output voltage signals were sent from the load cells to a National Instruments data acquisition board, acquired with LabView software, and stored permanently on a personal computer. The data collection rate for the load cells was 1,000 samples per second (1,000 Hz).

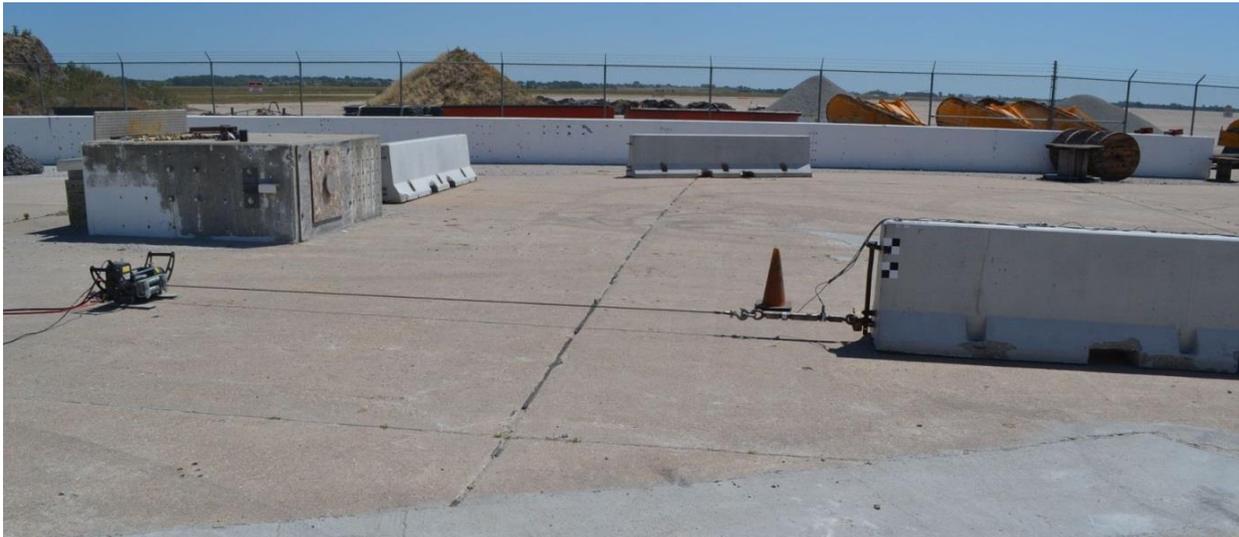
Figure 37. Pull Test Setup, Test No. TCBF-1

In test no. TCBF-1, a 4,976 lb (2,257 kg) F-shape TCB segment with no additional rubber bearing pad was pulled on the concrete tarmac using an electric winch. The test setup is shown in Figure 37 and the corresponding force vs. time data is shown in Figure 38. During test no. TCBF-1, the barrier and winch setup did not achieve a constant-velocity pull required to establish the kinetic friction coefficient. Instead, the barrier winch loaded the barrier segment in a start-and-stop motion. The start-and-stop oscillation in the motion was observed in the video analysis and was apparent on the force vs. time graph. The motion of the barrier prevented determination of a consistent sliding force as the barrier moved, thus the data from the test was not usable for determination of friction coefficients.

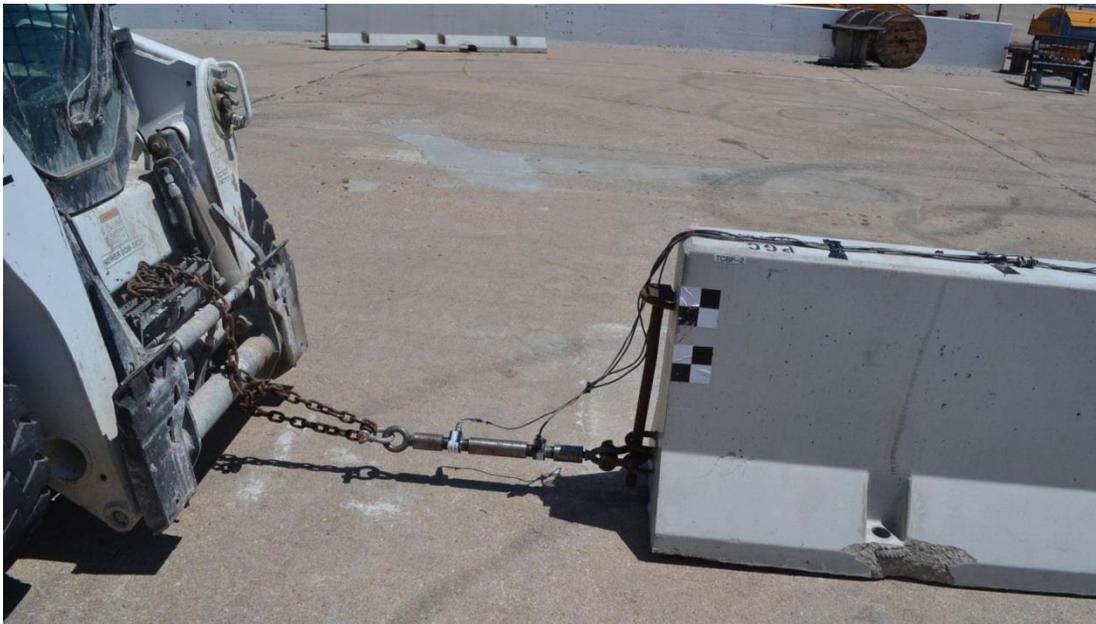
Figure 39. Pull Test Setup, Test No. TCBF-2

In test no. TCBF-2 the test setup was modified to address the stop and start motion observed in test no. TCBF-1. In test no. TCBF-2 the winch was replaced with a skid-steer loader in order to provide a more consistent velocity and displacement to the barrier segment. The loader was connected to the barrier segment similar to the winch setup. The operator then pulled the barrier at a constant speed for the test. The test setup is shown in Figure 39. The skid-steer was able to produce a much steadier barrier velocity throughout the test. The force vs. time graphs are shown for both load cells in Figure 40. The static and kinetic coefficients of friction between the concrete surfaces were determined to be 0.72 and 0.44, respectively.

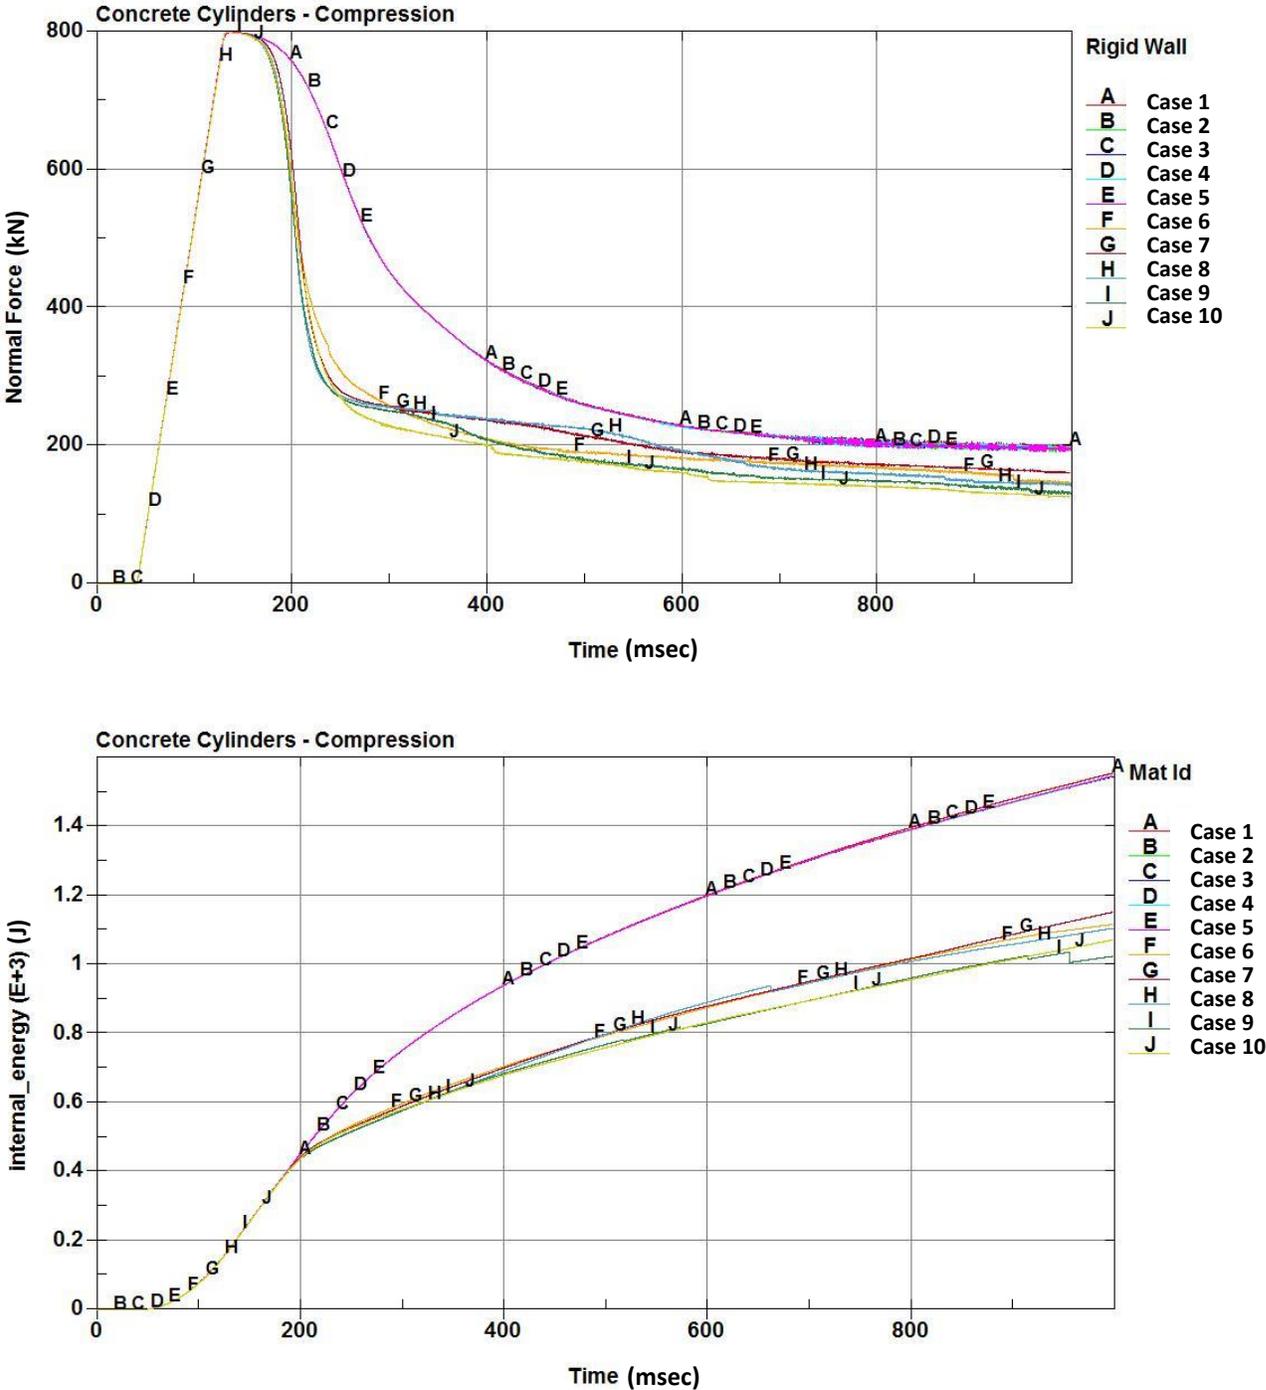
Figure 47. Force and Internal Energy Vs. Time, Concrete Cylinder Compression – Run 1

A second simulation model of the ten cylinder compressions, Run 2, was conducted using  $IRATE = 1$  and  $RECOV = 10$ . Previous  $MAT\_159\_CSCM$  modeling by TTI suggested that these values could improve the model response.  $IRATE$  would turn on rate effects in the material model and  $RECOV$  would alter the recovery modulus in compression. Results from the second simulation found that all ten cases provided reasonable and accurate compression strengths. The maximum compressive stress varied from 7,079 psi to 7,194 psi (0.049 to 0.050 GPa). These values were close to the input compressive strength of 6,705 psi (0.046 GPa) and were expected to be slightly increased due to the inclusion of rate effects in this simulation. Variation of the constraints on the cylinder had a minor effect on peak compressive load in these models, and it did not affect the post-peak loading and overall internal energy of the cylinder to the degree observed in the previous model, as shown in Figure 49. Deformation of the concrete cylinders seemed to be slightly improved in this simulation and element erosion was observed in some of the cases, as shown in Figure 50. However, the deformation of the cylinders still showed instability, and high hourglass energies were observed in case nos. 2 and 5.

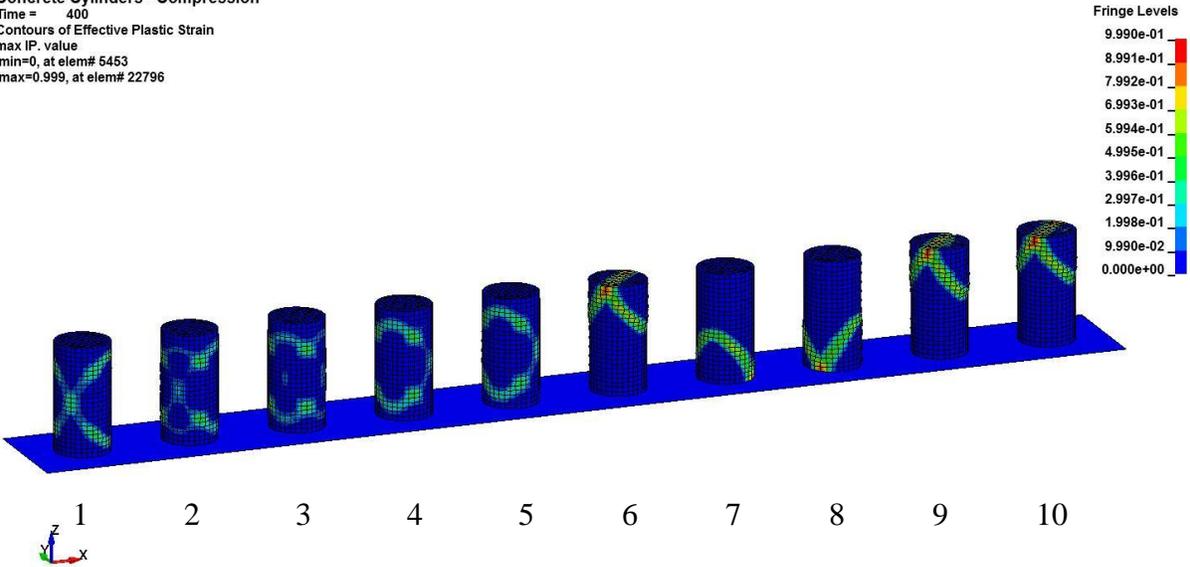
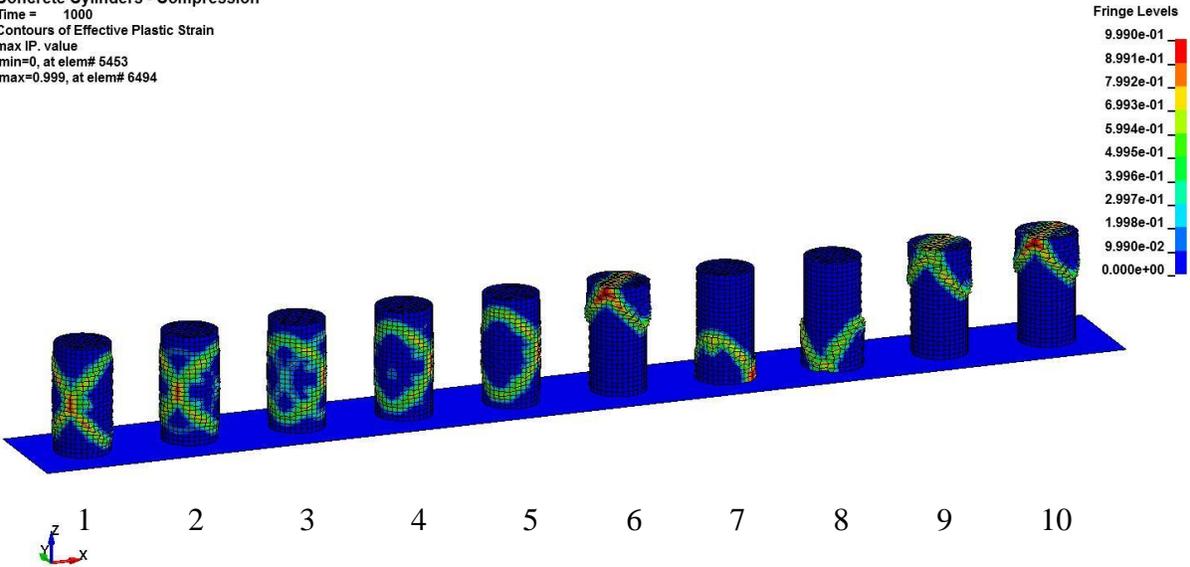
Figure 51. Deformation and Damage, Concrete Cylinder Compression – Run 3

Two additional simulation runs were conducted by repeating the first two simulation runs described above, with the mesh size reduced by one half. Thus, Run 3 was a repeat of Run 1 and Run 4 was a repeat of Run 2. The results from Run 3 found that reduced mesh size improved the model response somewhat. The compressive strength for all ten cylinder models in Run 3 was found to be an average of 6,498 psi (0.045 GPa), which was closer to the input compressive strength of 6,705 psi (0.046 GPa) than the value observed in Run 1. This suggested that reduction of the mesh size improved the compression strength response. Variation of the cylinder constraints had similar effects on the material response in Runs 1 and 3. The deformation of the cylinders still appeared to be somewhat unstable, but hourglass energies remained low, as shown in Figure 51. Element erosion was not observed in any of the ten cylinders in the simulation. The damage of the concrete cylinders in the model did appear to improve in displaying the characteristic “X” bands of damage to the material that are expected for the cylinders with constrained ends [16]. These bands were not evident at the larger mesh sizes.

Concrete Cylinders - Compression  
Time = 400  
Contours of Effective Plastic Strain  
max IP. value  
min=0, at elem# 5453  
max=0.999, at elem# 22796

Concrete Cylinders - Compression  
Time = 1000  
Contours of Effective Plastic Strain  
max IP. value  
min=0, at elem# 5453  
max=0.999, at elem# 6494

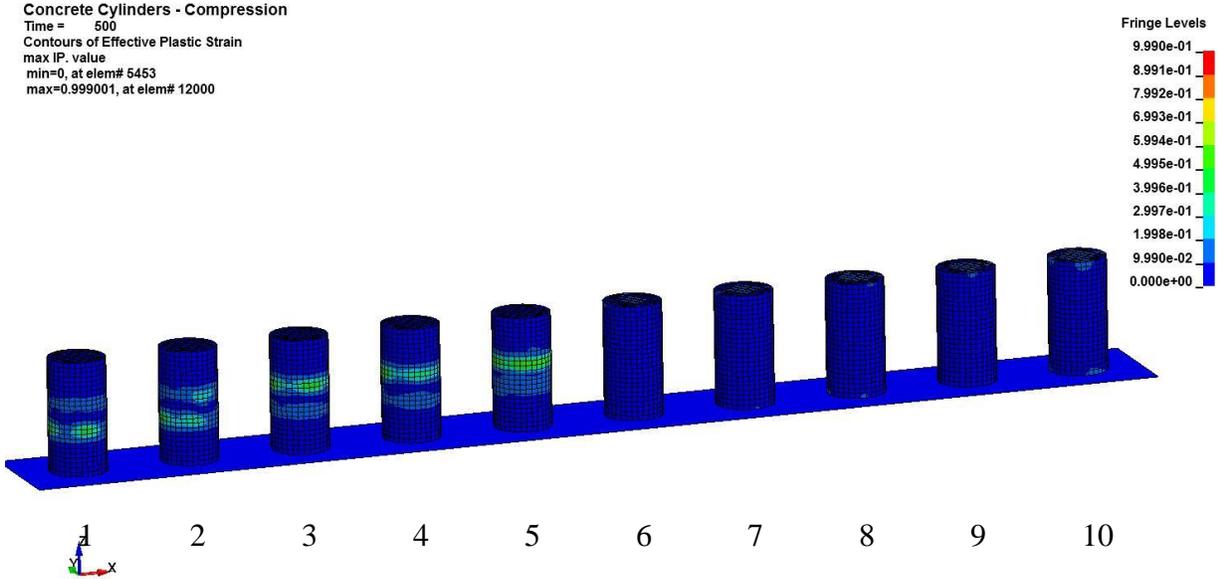
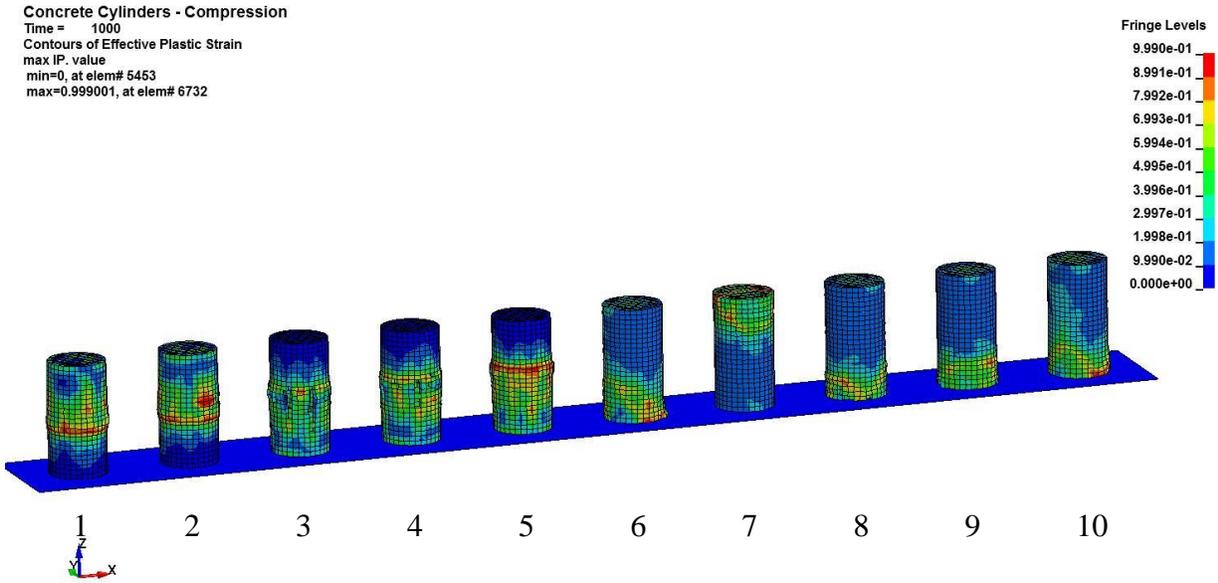
Figure 52. Deformation and Damage, Concrete Cylinder Compression – Run 4

The results from Run 4 also showed that reduced mesh size affected the material model response. Mesh size appeared to affect compression strength slightly as the compressive strength of the concrete cylinders increased to 7,321 psi (0.051 GPa) as compared to the range of 7,079 psi to 7,194 psi (0.049 to 0.045 GPa) observed in Run 2. Deformation of the concrete cylinders seemed to be slightly improved with reduced mesh size and element erosion was observed in some of the cases, as shown in Figure 52. However, the deformation of the cylinders still showed instability, and high hourglass energies were observed in case nos. 3 and 5. The concrete cylinders with reduced mesh size in Run 4 demonstrated a much different post-peak force reduction from previous models, as shown in Figure 53. This resulted in significantly higher energy levels for Run 4 as compared to the previous models.

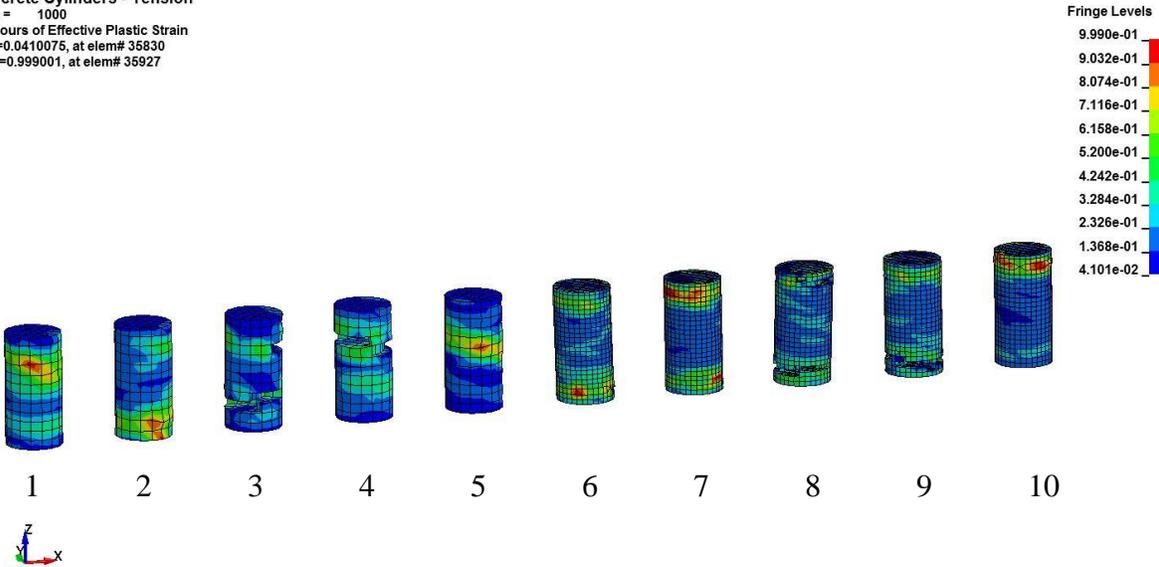
Figure 56. Deformation and Damage, Concrete Cylinder Tension – Run 5

The simulation run of the tension cylinder models, Run 5, found that the MAT\_159\_CSCM material model provided reasonable results for the tensile capacity of the cylinders. Tensile capacity for concrete is typically found to be 8 to 15 percent of the peak compressive strength. Thus, one would expect peak tensile stresses in the 536 psi to 1,006 psi range (0.0037 GPa to 0.0070 GPa). Results from the tensile simulations returned lower-than-expected peak tensile stress values between 461 psi to 473 psi range (0.0032 GPa to 0.0033 GPa), as shown in Figure 55. Cylinder deformations appeared reasonable and similar erosion of the elements was observed for both mesh sizes, as shown in Figure 56. The smaller mesh size did demonstrate more consistent results and higher internal energies while providing reduced hourglass energies. Case no. 5 with  $REPOW = 0$  demonstrated high hourglass energy and very low internal energy.

Concrete Cylinders - Tension  
Time = 1000  
Contours of Effective Plastic Strain  
min=0.0410075, at elem# 35830  
max=0.999001, at elem# 35927

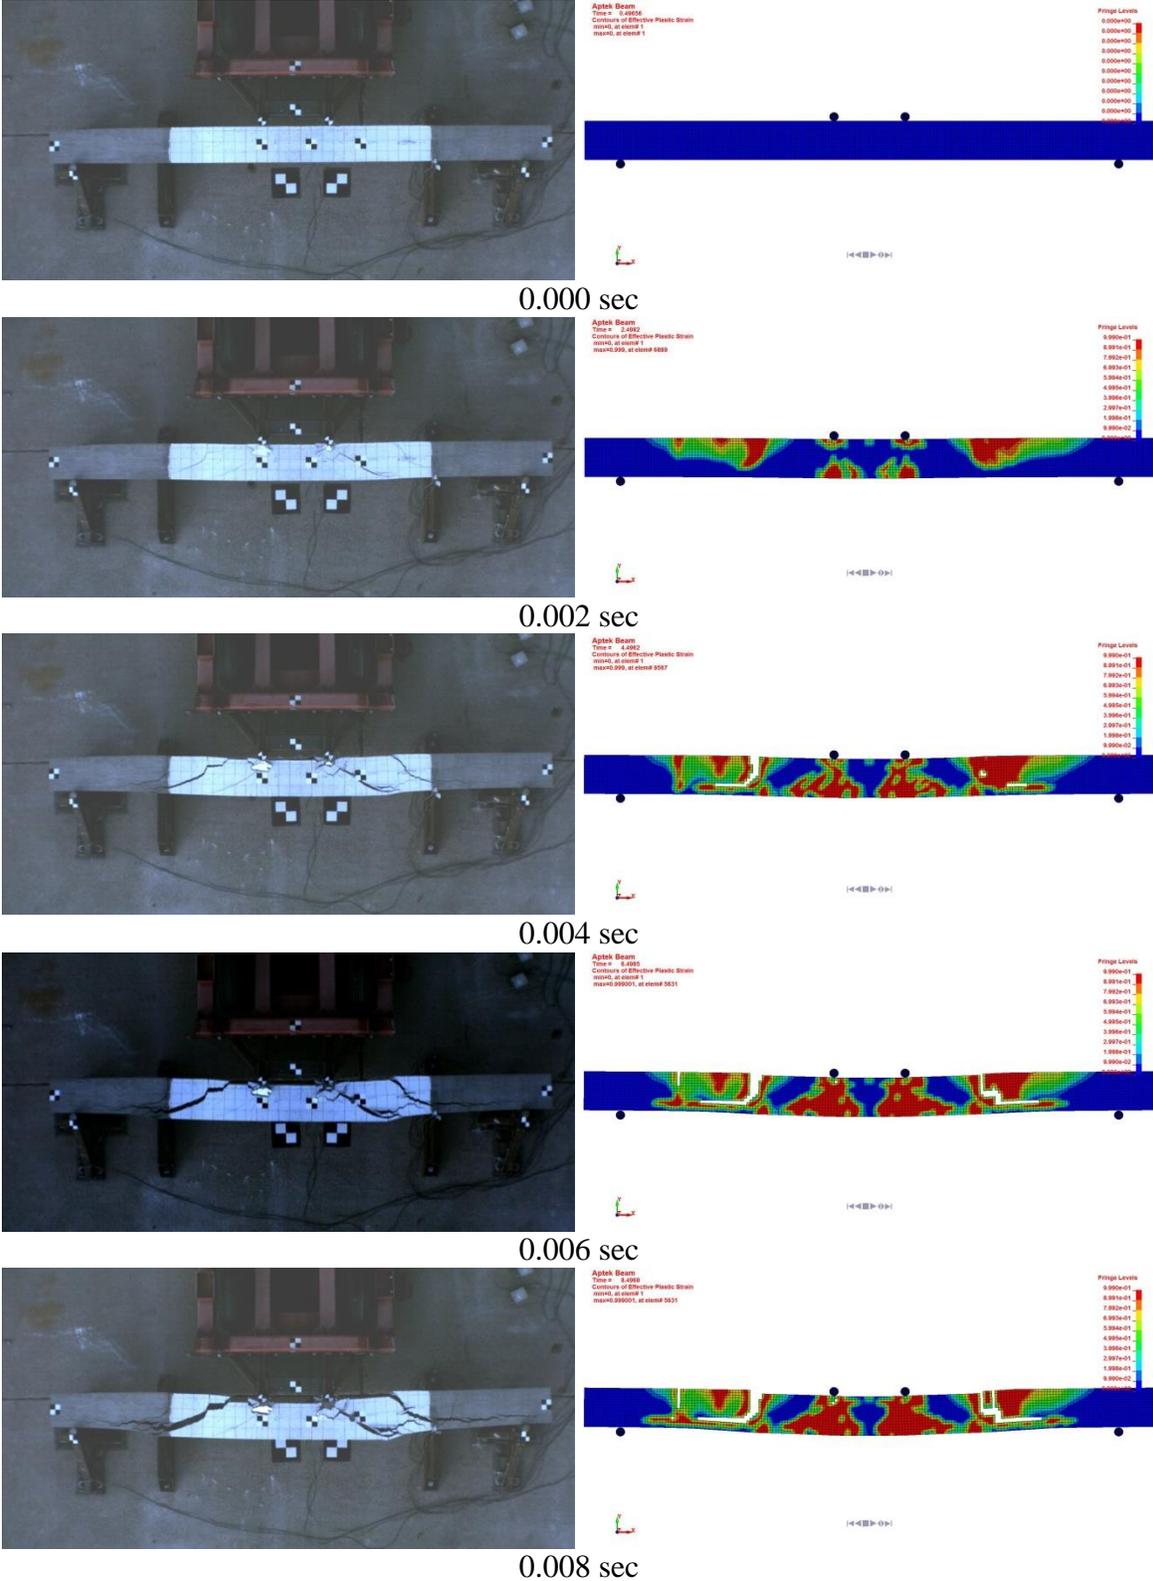
Figure 62. Deformation and Damage, Simulation and Test No. ABC-2

A simulation of test no. ABC-2 was also performed to determine if the MAT\_159\_CSCM material model was capable of capturing the alternate shear failure mode observed at increased impact velocity. Graphical comparison of the simulation and test no. ABC-2 is shown in Figure 62. The comparison shows that the simulation model captured the change in the failure mode as the impact velocity increased. Both the simulation and the model displayed shear cracking and damage which led to fracture of the reinforced concrete beam. The simulation demonstrated initial damage and cracking along the 45 degree shear planes similar to the test. As the simulation continued, the damage resulted in erosion of the elements in a lateral crack in beam rather than a 45 degree angle crack. It was believed that the element erosion did not proceed in the same angle due to the size and direction of the reinforced concrete beam finite element mesh.

Thus, while the model did not completely replicate the failure mode observed in test no. ABC-2, the failure modes were similar, and the model did predict the change in the failure mode. Accurate impact loads and moments were not obtained for ABC-2 simulation due to the short duration of the impact event and thus were not compared.

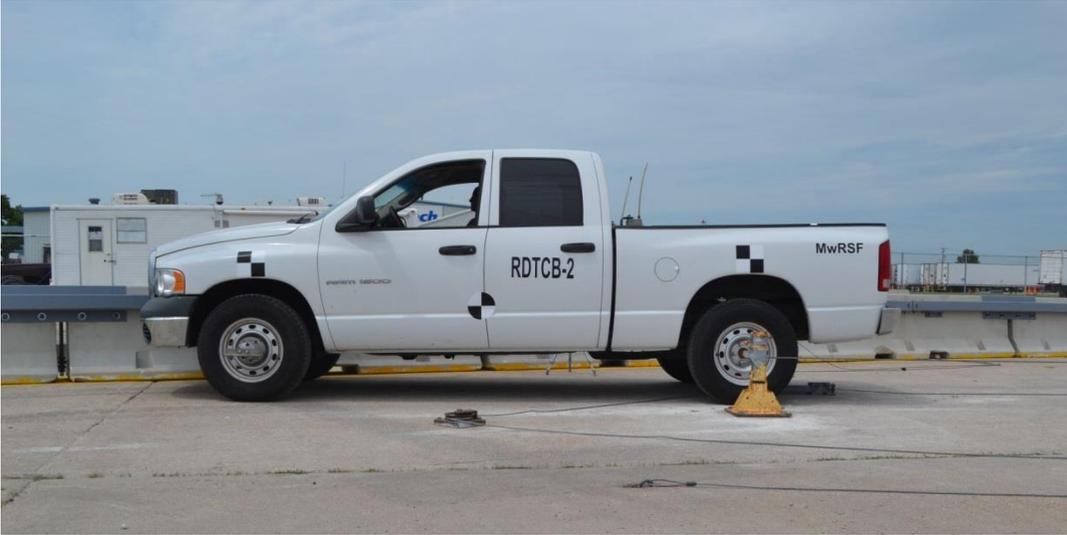
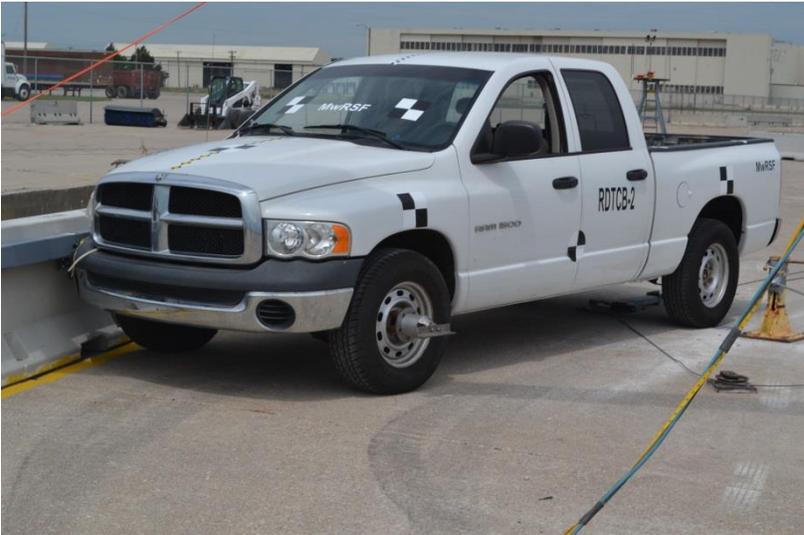
Figure 65. Test Vehicle, Test No. RDTCB-2

The front wheels of the test vehicle were aligned to vehicle standards except the toe-in value was adjusted to zero so that the vehicles would track properly along the guide cable. A 5B flash bulb was mounted on the right side of the vehicle's dash and was fired by a pressure tape switch mounted at the impact corner of the bumper. The flash bulb was fired upon initial impact with the test article to create a visual indicator of the precise time of impact on the high-speed videos. A remote-controlled brake system was installed in the test vehicle so the vehicle could be brought safely to a stop after the test.

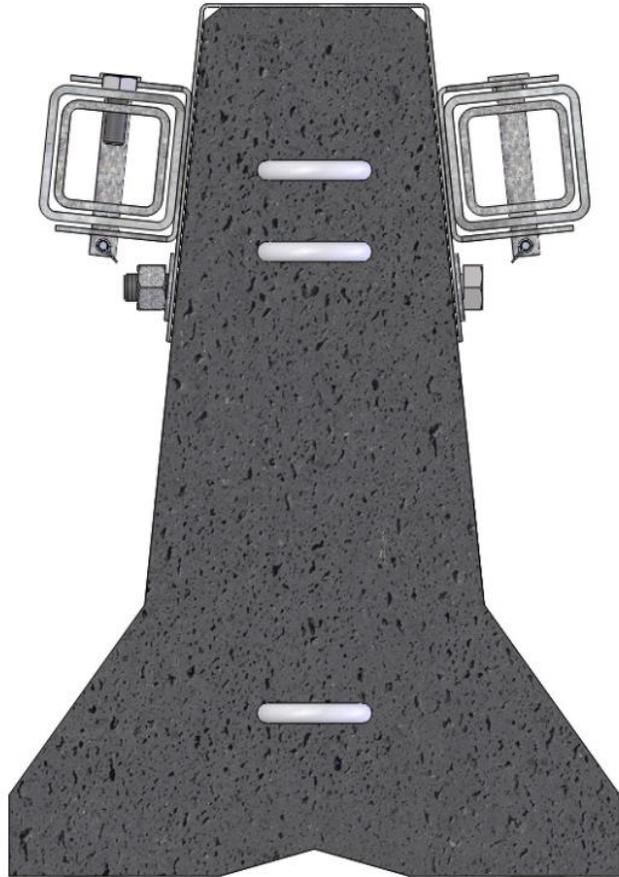
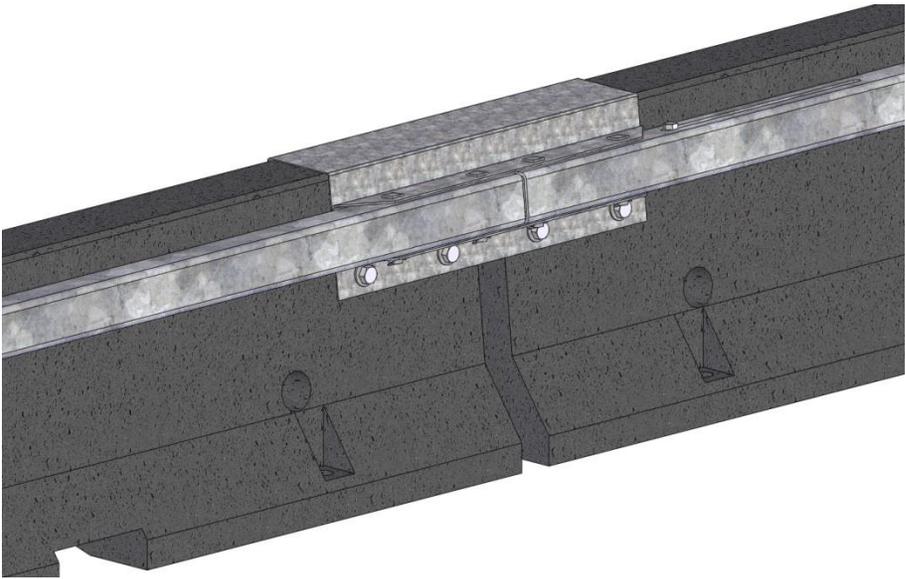
Figure 71. Low-Deflection TCB Prototype, Version 3

A few remaining design considerations were deliberated for the low-deflection TCB system. First, it was noted that the design would need to account for construction tolerances and variability in the gap between the barrier segments as well as the barrier segment geometry. Thus, slotted holes were included in the various connection pieces and slight oversizing of the steel cap plate were included in the design to accommodate these variations. Second, the system was not designed for use on small-radius curvatures at this time. It was anticipated that the

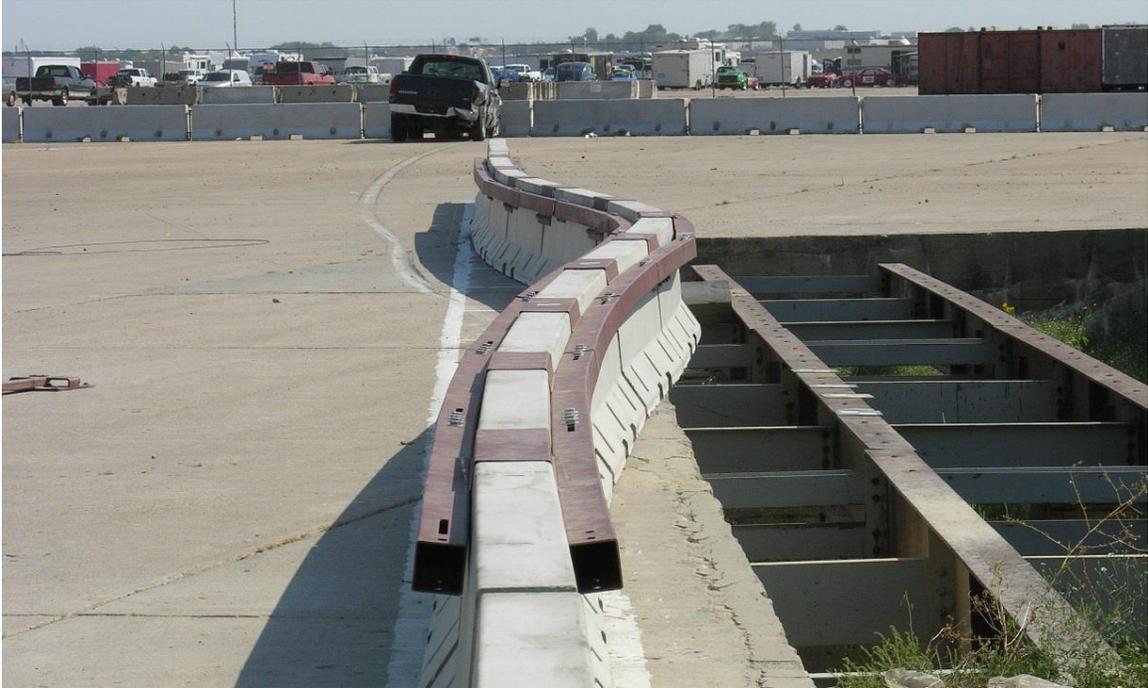
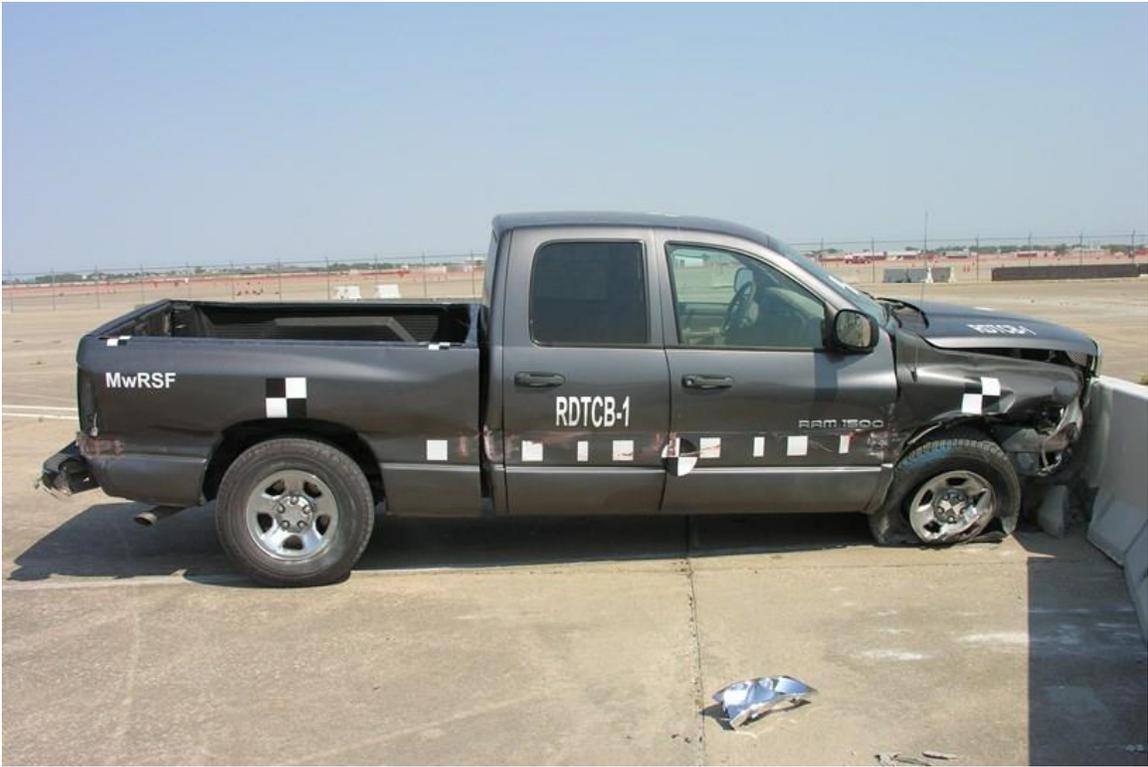
Figure 96. Impact Location, Test No. RDTCB-1

Initial vehicle impact was to occur  $51\frac{3}{16}$  in. (1.3 m) upstream of the center of the joint between barrier nos. 8 and 9, as shown in Figure 96, which was selected using the CIP guidance found in Section 2.3 of MASH or Table 2.6 of MASH. The actual point of impact was 10 in. (254 mm) upstream of the target impact point. A sequential description of the impact events is contained in Table 10. The vehicle came to rest approximately 153 ft (46.6 m) past the

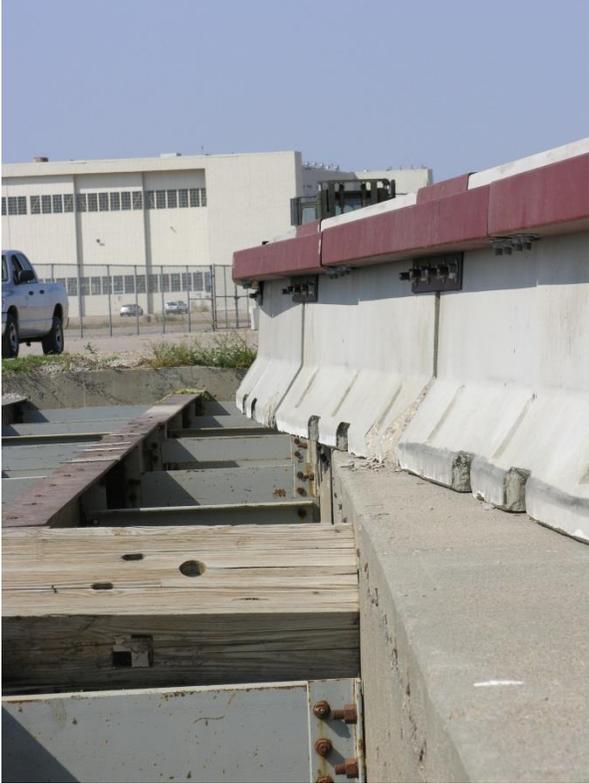
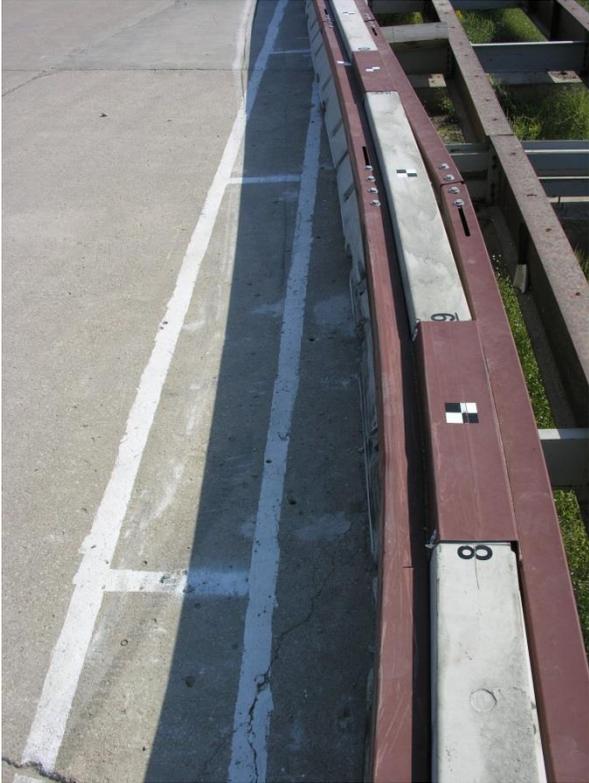
Figure 100. Rail Splice at Barrier Nos. 8 and 9, Test No. RDTCB-1

Damage to the barrier was moderate, as shown in Figure 99 through Figure 101. Barrier damage consisted of contact marks on the front face of the concrete segments, spalling of the concrete, concrete cracking and failure, and permanent deformation of the steel tube rails. The length of vehicle contact along the barrier was approximately 36.7 ft (11.2 m) which spanned from 5.1 ft (1.6 m) upstream from the center of the joint between barrier nos. 8 and 9, to 5.8 ft (1.8 m) downstream from the center of the joint between barrier nos. 10 and 11.

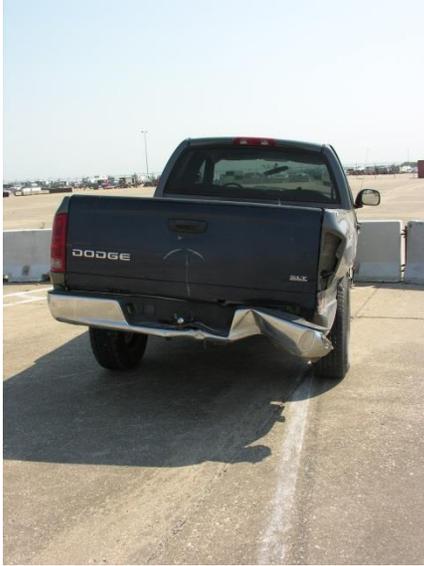
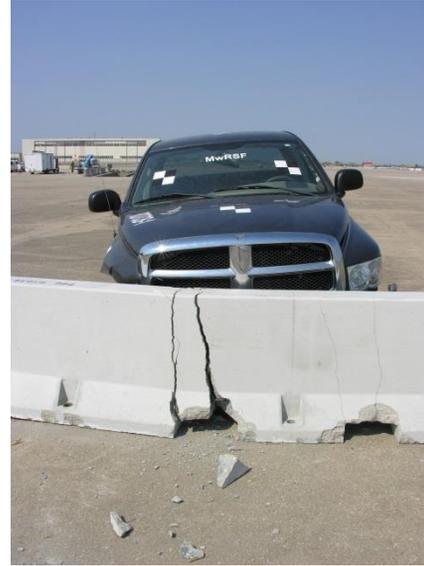
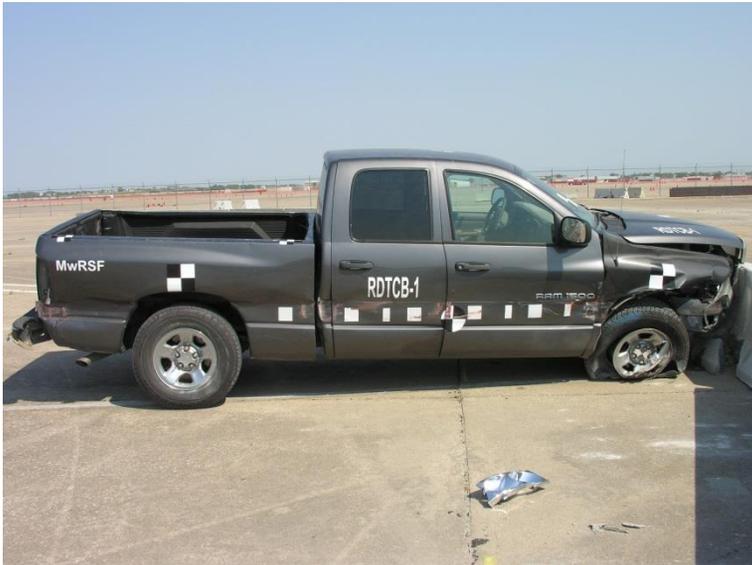
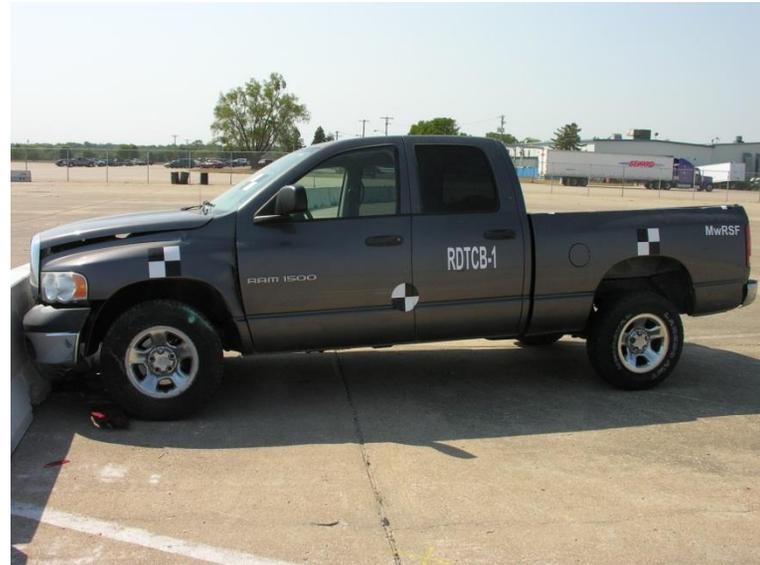
Figure 101. Permanent Barrier Deflection, Test No. RDTCB-1

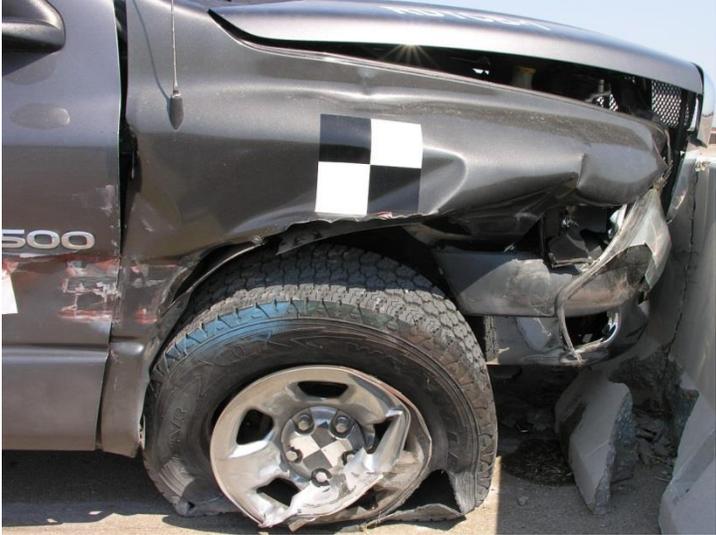
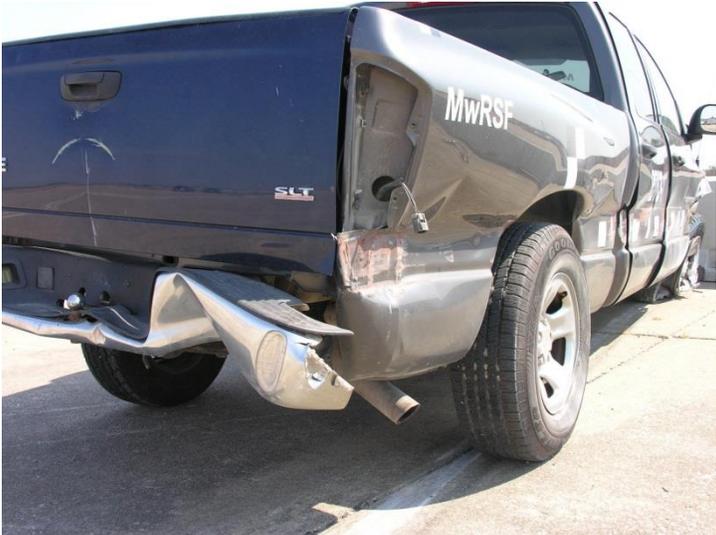
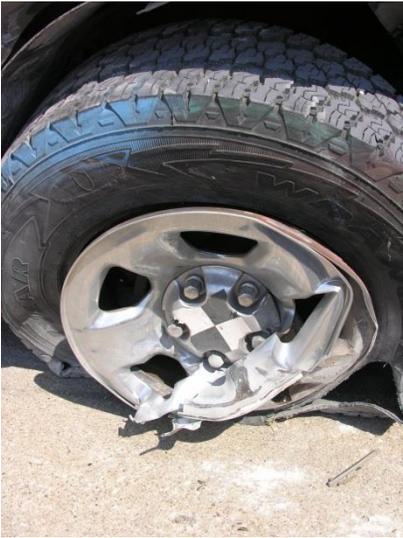
Figure 102. Vehicle Damage, Test No. RDTCB-1

The damage to the vehicle was moderate, as shown in Figure 102 and Figure 103. The maximum occupant compartment deformations are listed in Table 11 along with the deformation limits established in MASH for various areas of the occupant compartment. Note that none of the MASH-established deformation limits were violated. Complete occupant compartment and vehicle deformations and the corresponding locations are provided in Appendix E.

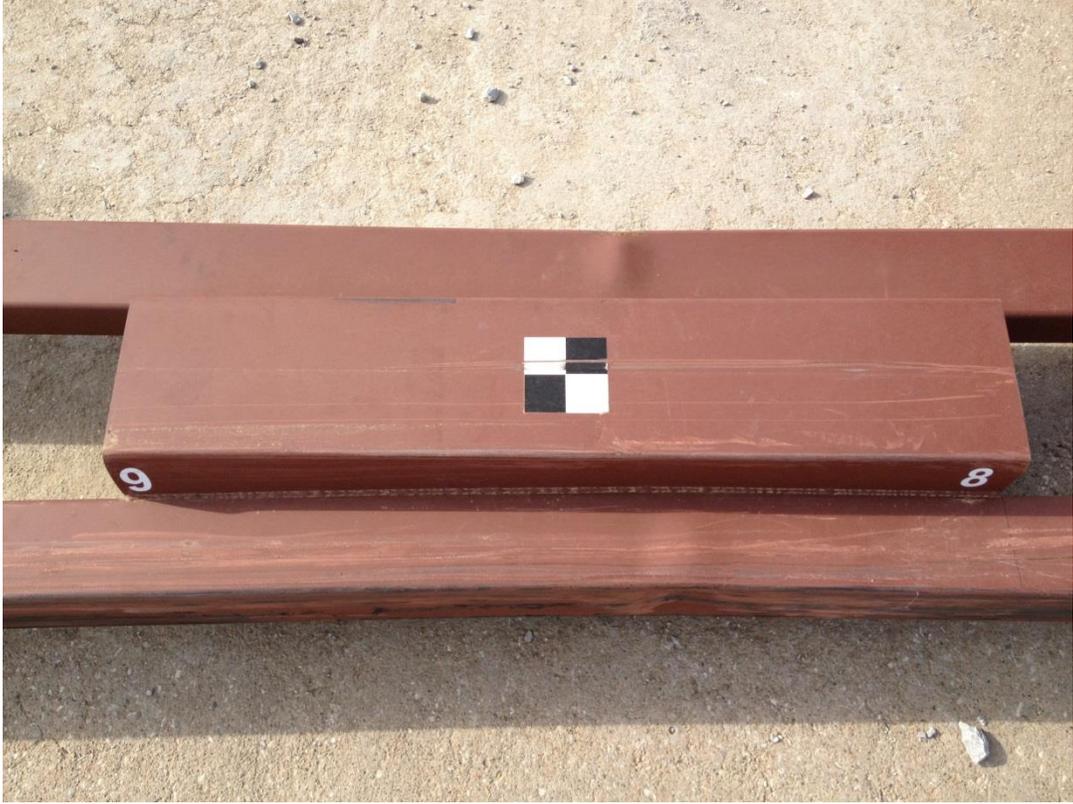
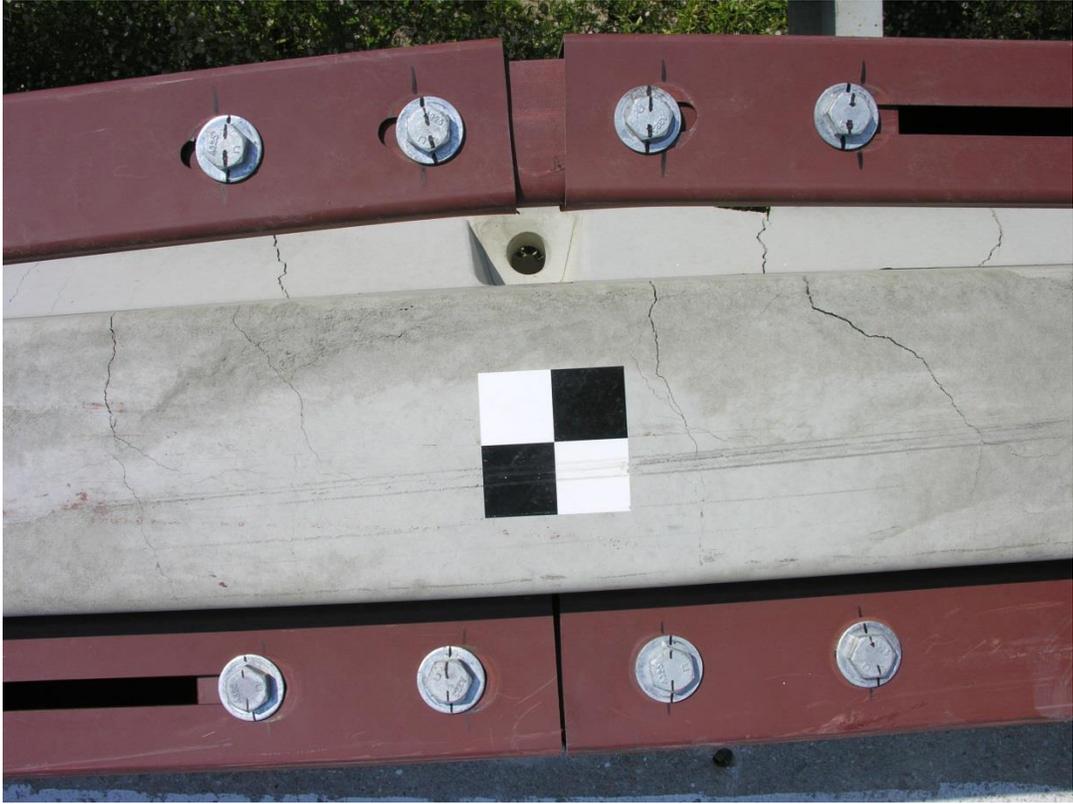
Figure 104. Steel Tube Deformation and Deflection, Test No. RDTCB-1

Second, the tubes used in the low-deflection TCB system evaluated in test no. RDTCB-1 displayed permanent deformation and bending that was not observed in the simulation model. However, the simulation model utilized a significantly larger tube section which did not display that degree of damage. The continuous tubes in the tested low-deflection design also appeared to flex away from the barrier due to the distance from their attachment to the steel cap plate and opening of the splice connection in the tubes at the midspan of the TCB segment. The deformation and deflection of the steel tubes in test no. RDTCB-1 is shown in Figure 104. It was believed that the combination of the tube deformation and the displacement/flex of the tubes away from the side of the TCB further added to the dynamic deflection of the tested system.

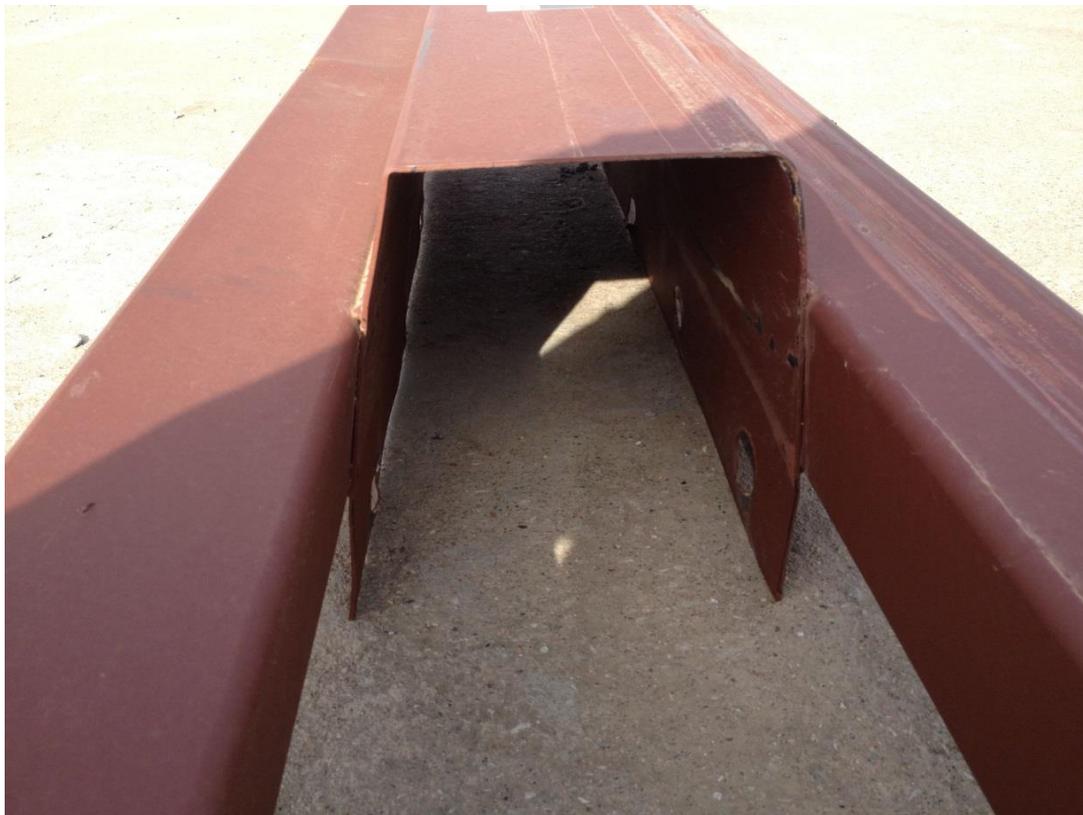
Figure 105. Steel Cap Deformation, Test No. RDTCB-1

Finally, deformation of the steel cap plate that was mounted across the barrier joint was observed, as shown in Figure 105. The deformation of this component was also a contributor to the deflections observed in the test.
