# **DEVELOPMENT OF A RETROFIT, LOW-DEFLECTION, TEMPORARY CONCRETE BARRIER SYSTEM**

## **MIDWEST ROADSIDE SAFETY FACILITY**

MwRSF Research Report No. TRP-03-295-14

March 31, 2014

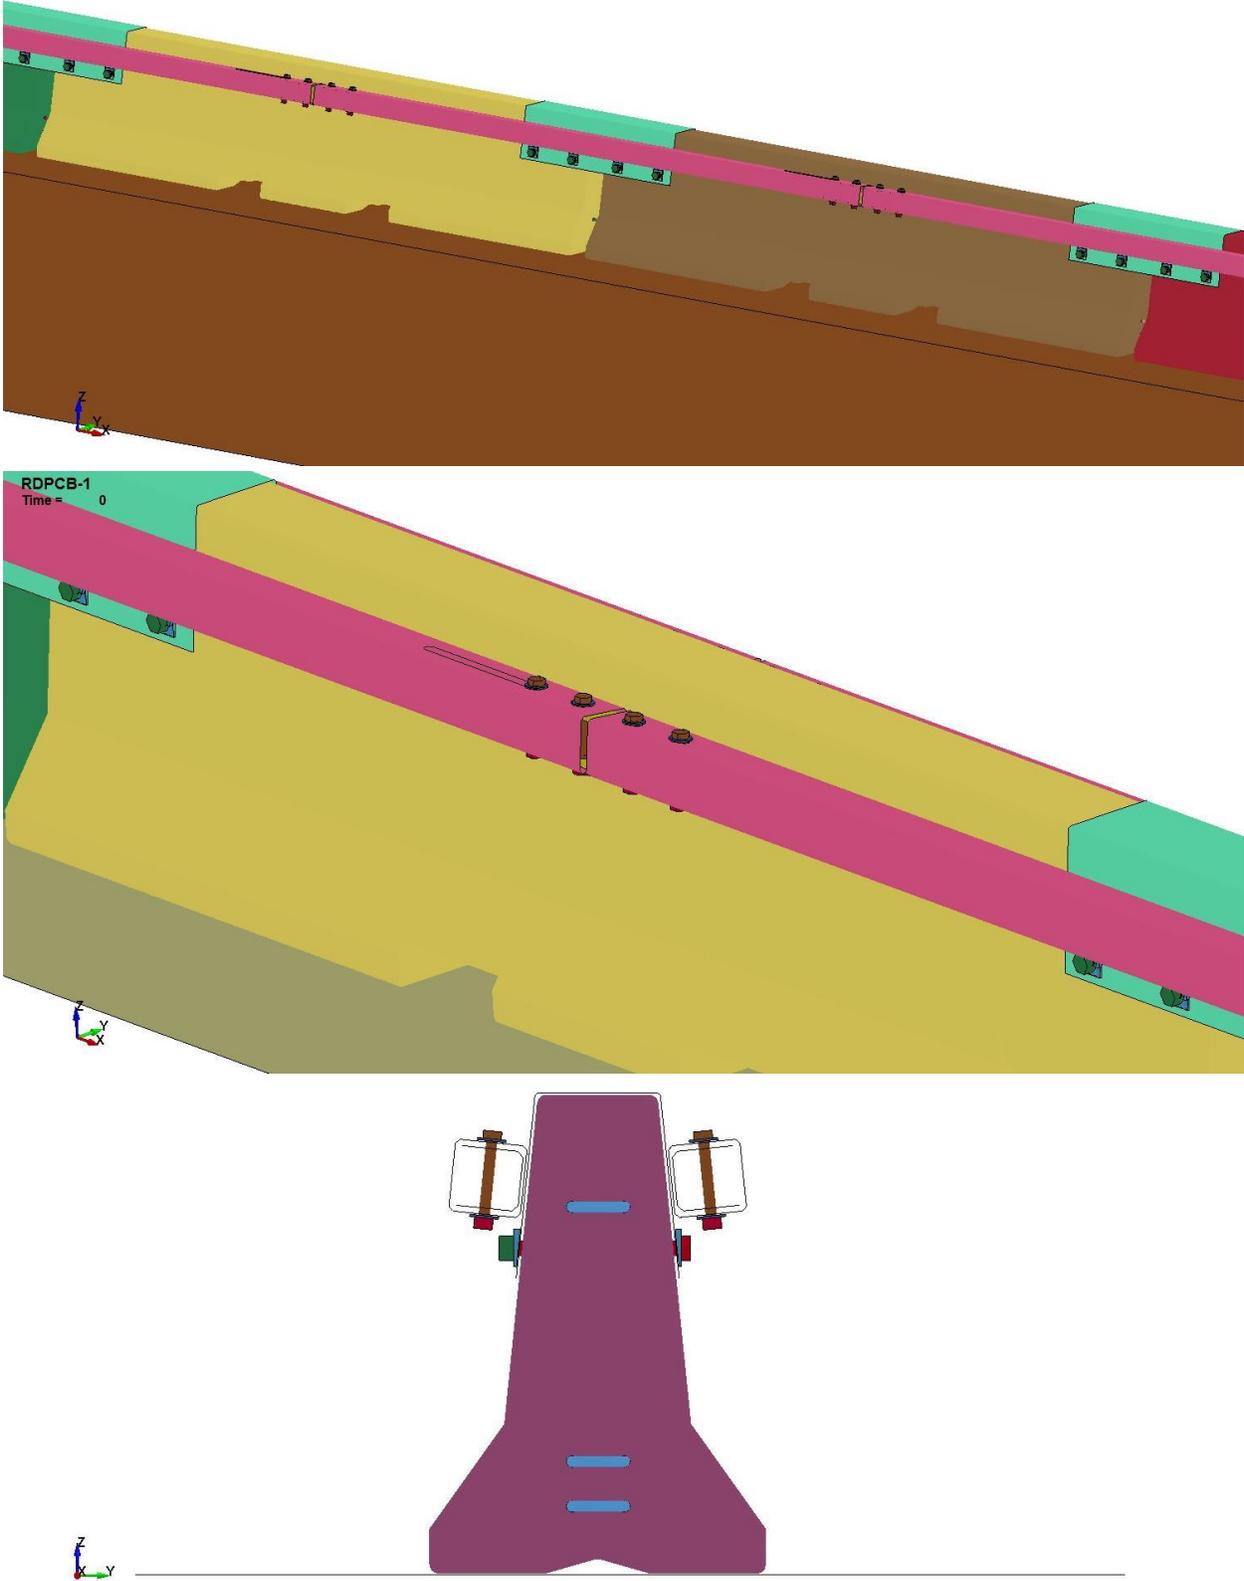
Figure 106. RDTCB-1 Baseline Model

Comparison of the simulation results with the full-scale crash test no. RDTCB-1 found that the model provided good correlation with the full-scale test and was appropriate for use in evaluation of the deflection-limiting mechanisms. Graphical comparison of the simulation model and test no. RDTCB-1, as shown in Figure 107 through Figure 110, found that the behavior of the vehicle and the barrier were very similar. The dynamic deflection of the simulation model was found to be 35.9 in. (912 mm) at the upstream end of the ninth barrier segment. This compared reasonably well with the dynamic deflection of test no. RDTCB-1, which was measured from high-speed film to be 43.0 in. (1,092 mm) at the upstream end of the ninth barrier segment. The decreased deflection in the simulation model was believed to be due largely to concrete damage in the physical test that was not reproducible in the simulation. However, the peak system deflections in the simulation and test were still within 16.7

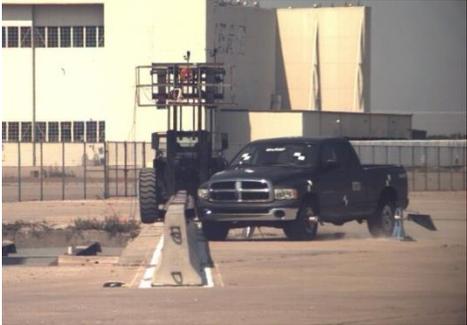
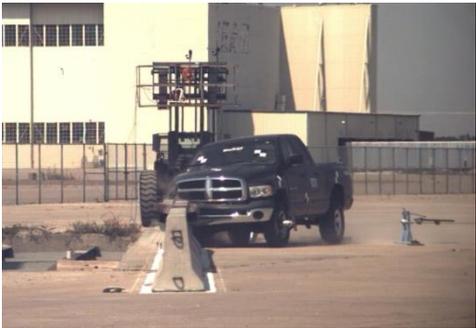
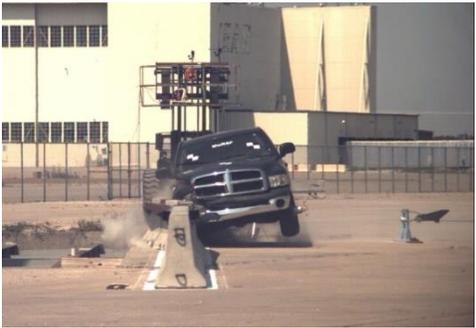
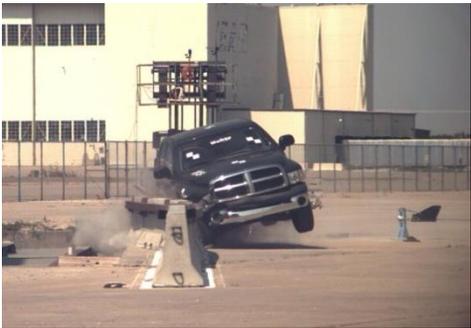
Figure 109. Downstream Sequential Views, Simulation Model and Test No. RDTCB-1

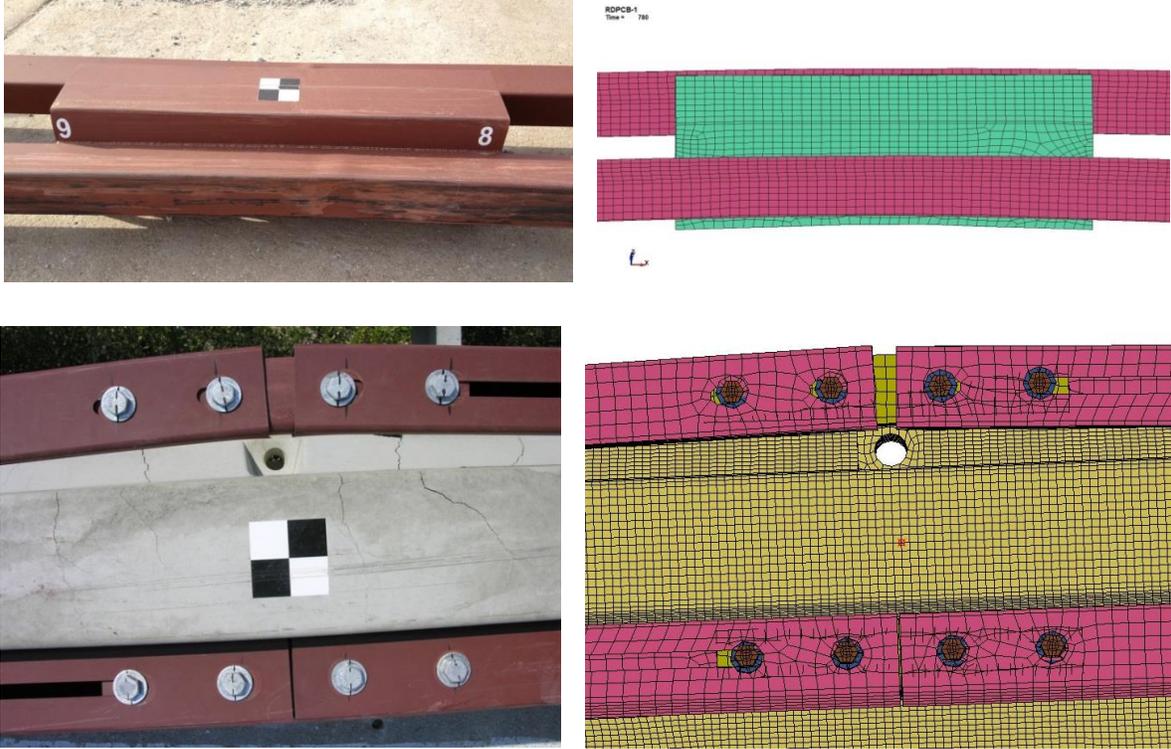
Figure 111. System Damage and Deformation, Simulation Model and Test No. RDTCB-1

Based on this comparison, it was believed that the simulation model was providing a valid representation of the system behavior in test no. RDTCB-1. Thus, the simulation model was used to investigate the proposed system modifications. It should be noted that for evaluation of the system modifications, all of the models, including the baseline simulation of the design evaluated in test no. RDTCB-1, were simulated with the standard MASH TL-3 impact conditions of 62.1 mph (100.0 km/h) and an angle of 25 degrees in order to provide a consistent comparison basis. The baseline model simulation with these impact conditions resulted in a peak dynamic lateral barrier deflection of 34.1 in. (866 mm).

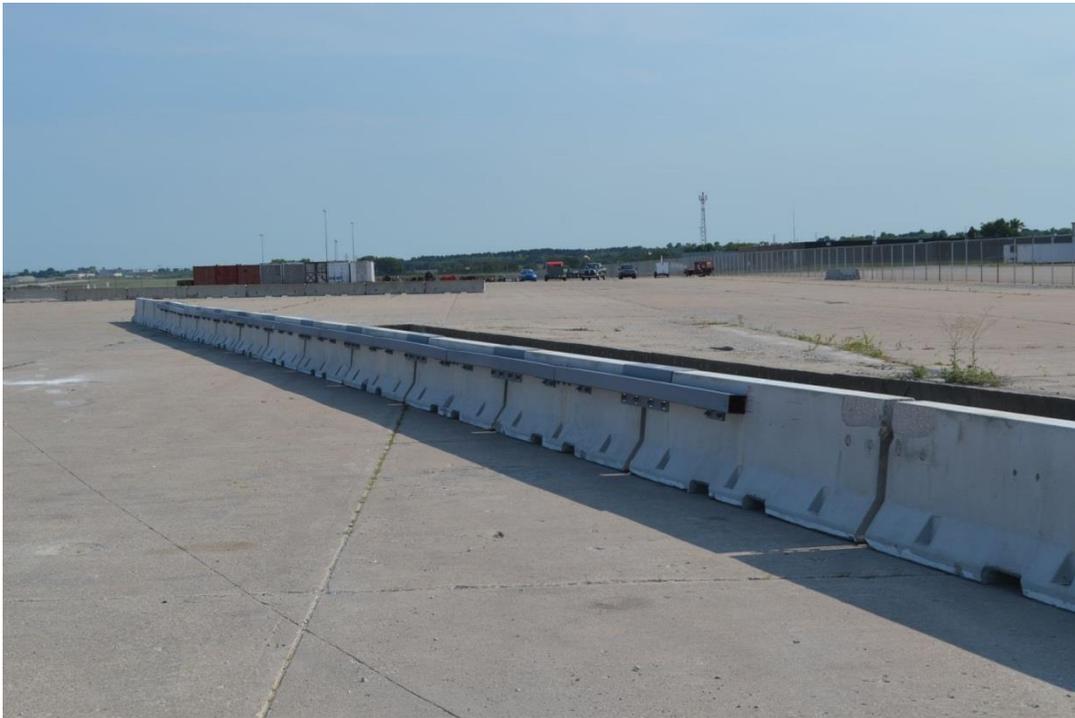
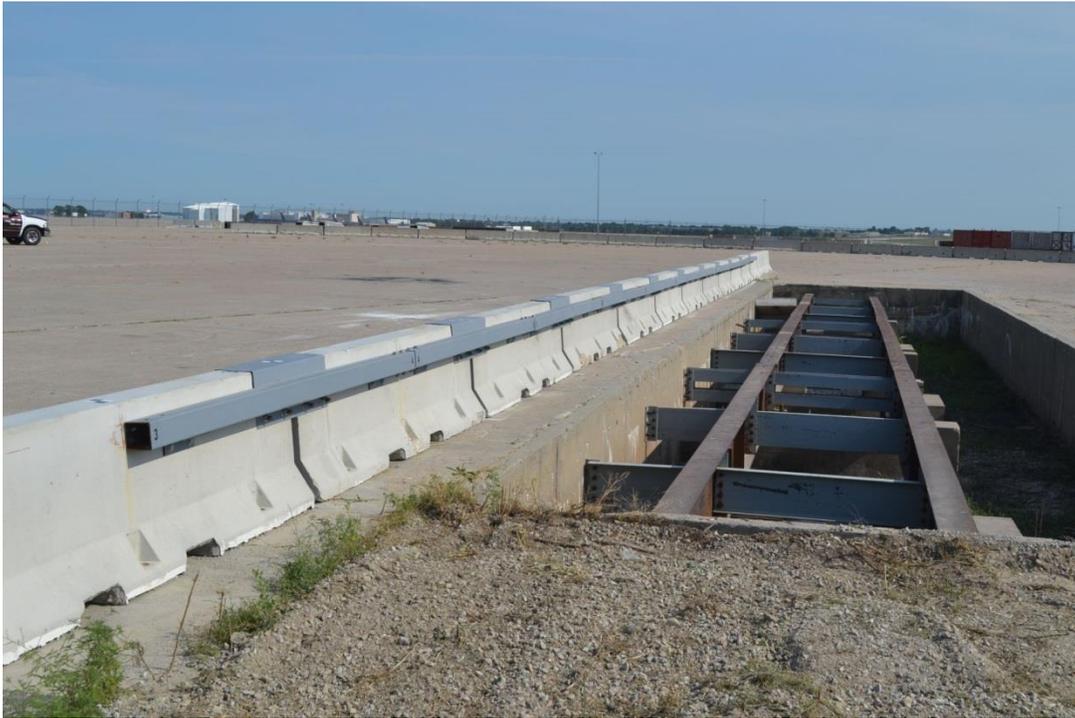
Figure 139. Test Installation, Test No. RDTCB-2

The design details for test no. RDTCB-2 are shown in Figure 120 through Figure 138. Photographs of the test installation are shown in Figures 139 and 140. Material specifications,

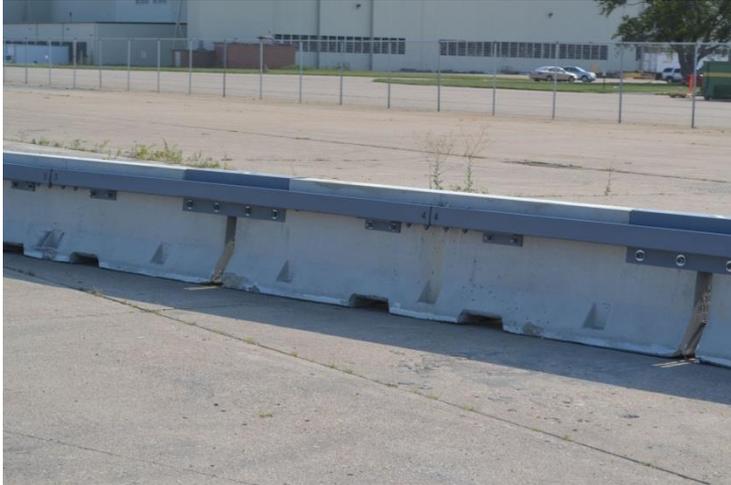
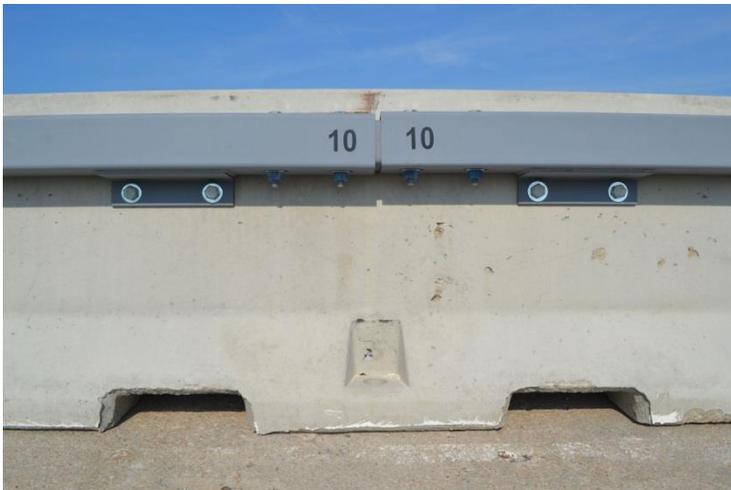
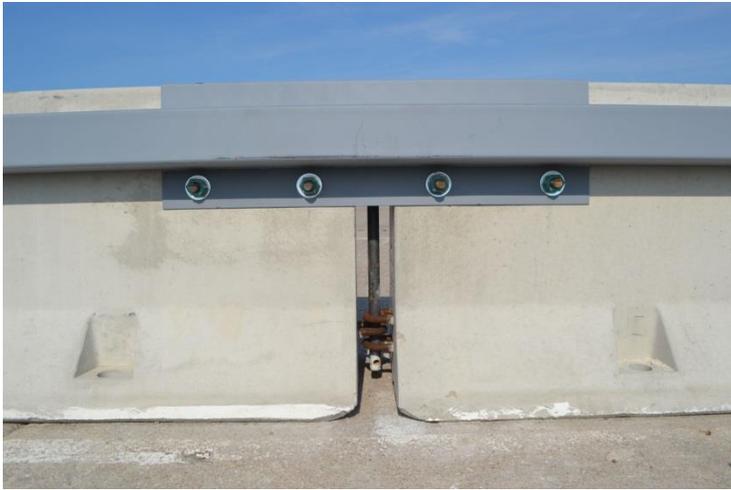
Figure 140. Barrier Segment Connection Designs, Test No. RDTCB-2

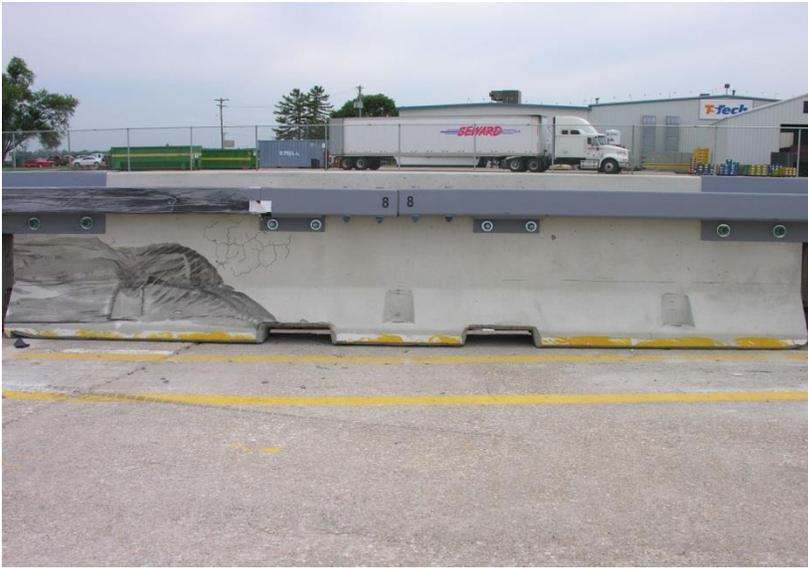
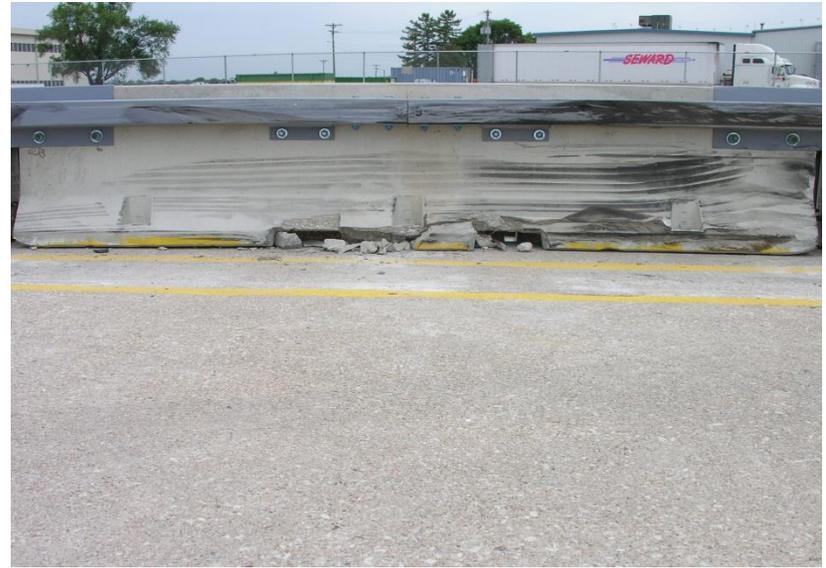
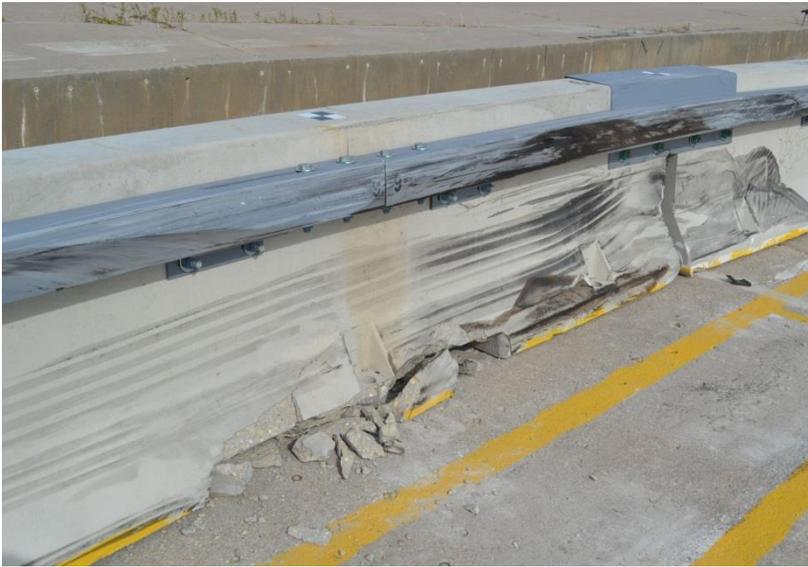
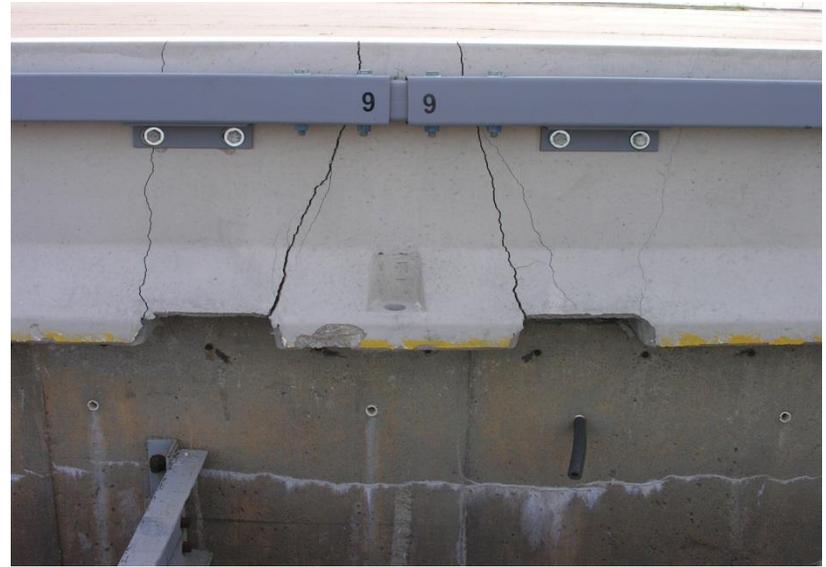
Figure 148. System Damage at Barrier Nos. 8 and 9, Test No. RDTCB-2

Damage to the system was moderate, as shown in Figures 147 through 151. Barrier damage consisted of contact marks on the front face of the concrete segments and box-beams, spalling of the concrete, and concrete cracking. The vehicle initially came into contact with barrier no. 8 a distance of 2 1/4 in. (57 mm) upstream from the target impact point and maintained contact until separating from the barrier at the downstream end of barrier no. 11. The vehicle then began to yaw toward the barrier and again made contact with barrier nos. 13 through 16.

Several of the TCB segments displayed cracking and damage following the test. Barrier nos. 4 through 7 had vertical cracks on the impact side of the TCB segments near the midspan due to reverse bending loads generated during the impact event. Barrier nos. 8 through 10 had significant vertical cracks on the backside of the barrier segments. Barrier no. 8 developed three vertical cracks extending from lifting pockets on the back side of the barrier. Barrier no. 9 showed four vertical cracks on the backside which extended from the lifting pockets and extended to the top and through the width of the barrier, as shown in Figure 148. The cracking of barrier no. 9 was sufficient to permanently deform the barrier segment. Barrier no. 9 also had significant spalling on the front downstream toe between the lifting pockets and minor spalling on the backside. Barrier nos. 10 and 11 showed vertical cracks on the front and back of the barriers that nearly penetrated the width of the barriers. Barrier no. 12 showed vertical cracks on the front face of the barrier from reverse bending that were sufficient to form a permanent bend in the TCB segment, as shown in Figure 150. Spalling occurred along 12 ½ in. (318 mm) of the downstream backside toe of barrier no. 12 along with vertical cracks near the middle of the barrier.

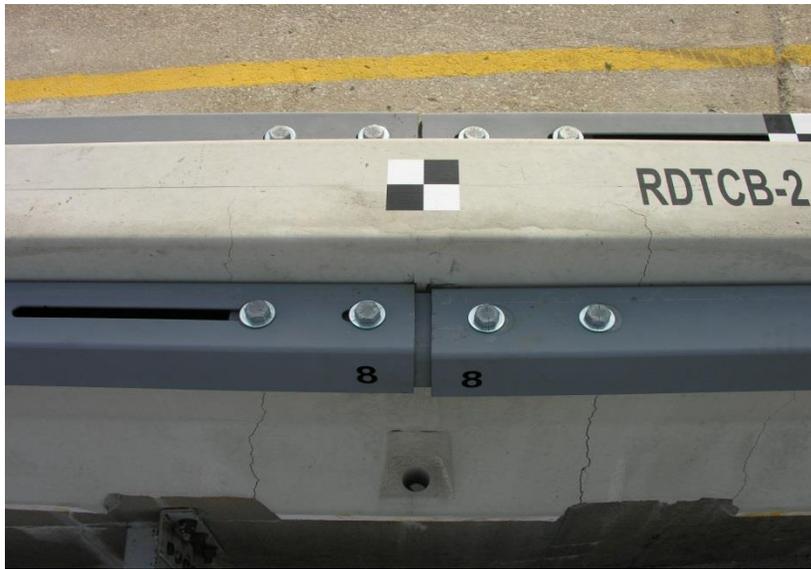
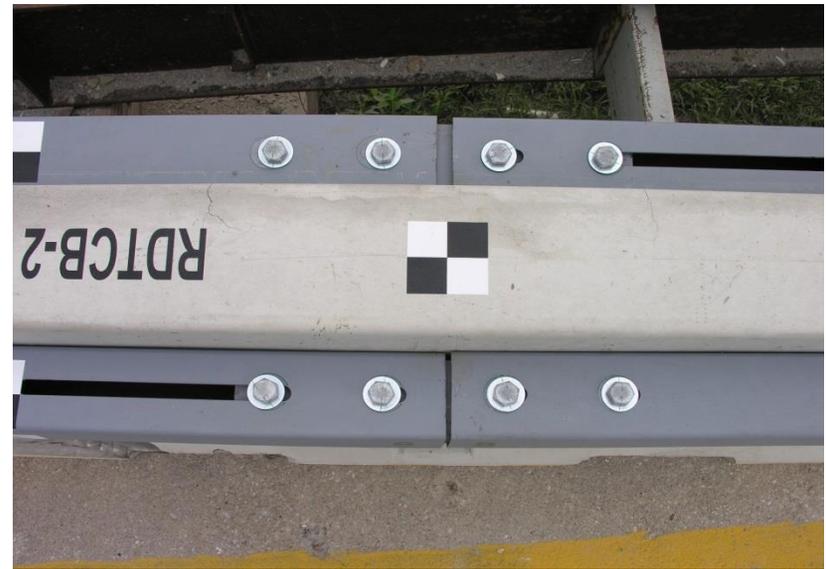
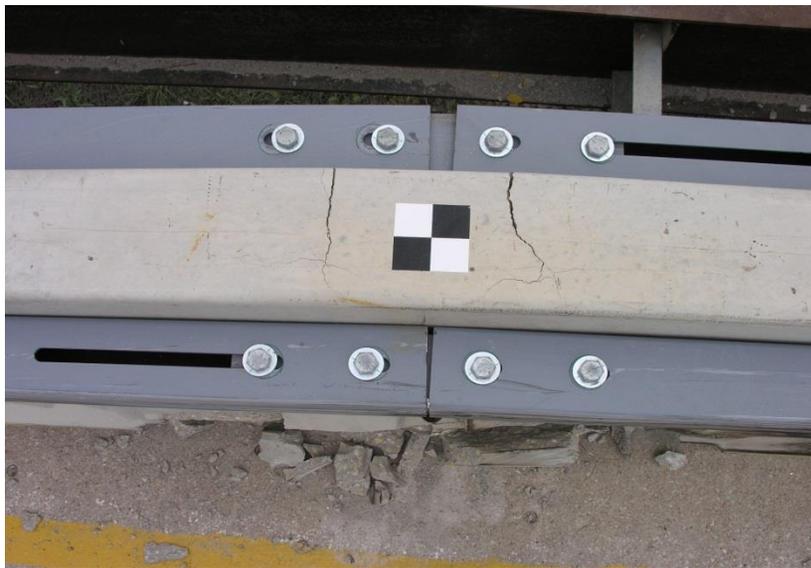
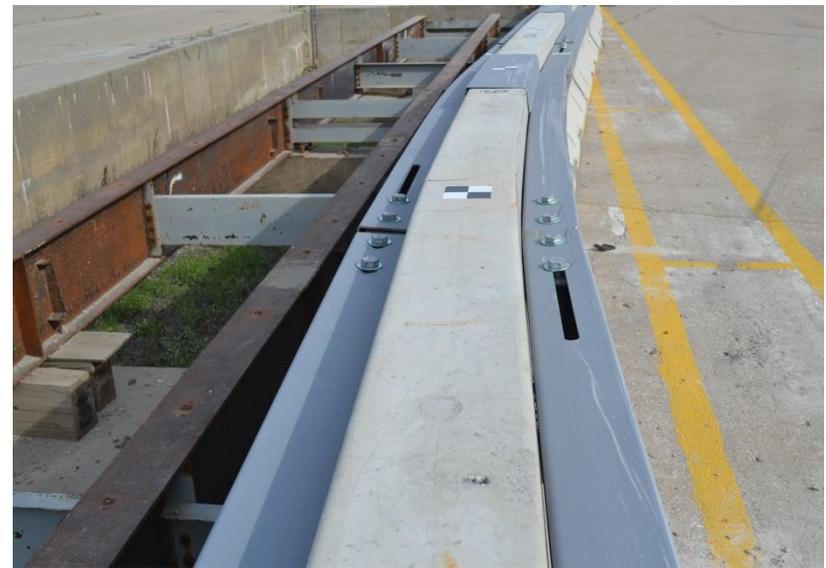
Figure 149. Rail Splices at Barrier Nos. 8 and 9, Test No. RDTCB-2

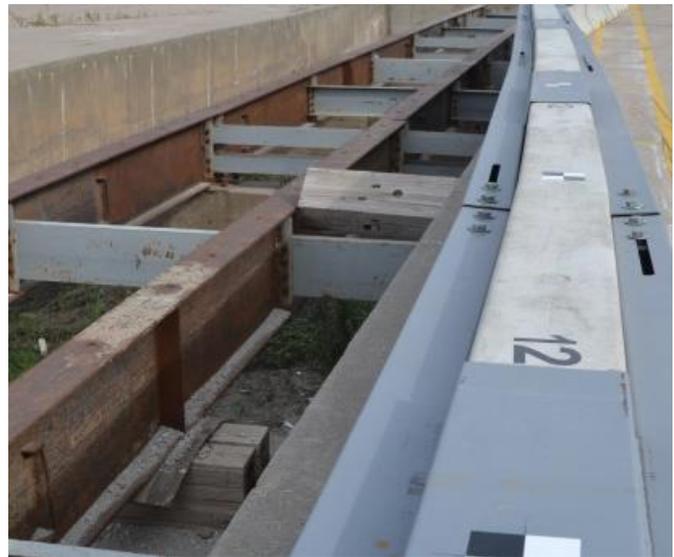
Figure 150. Barrier Segment Damage Due to Reverse Bending, Test No. RDTCB-2

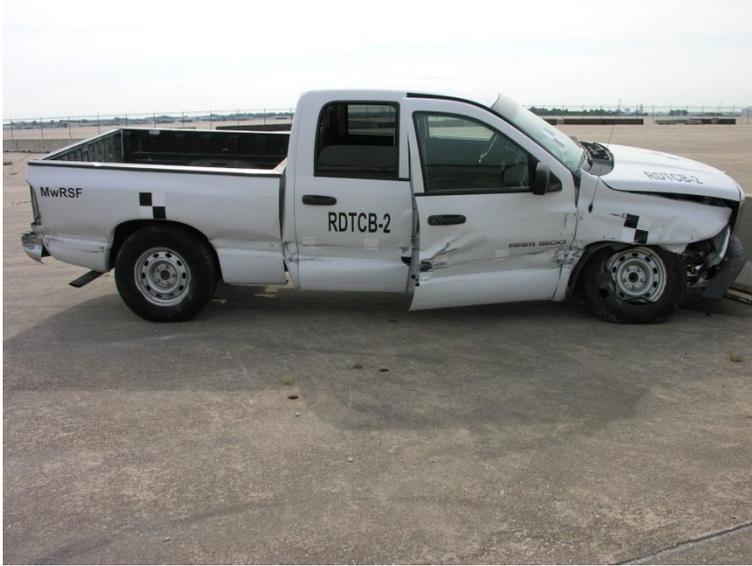
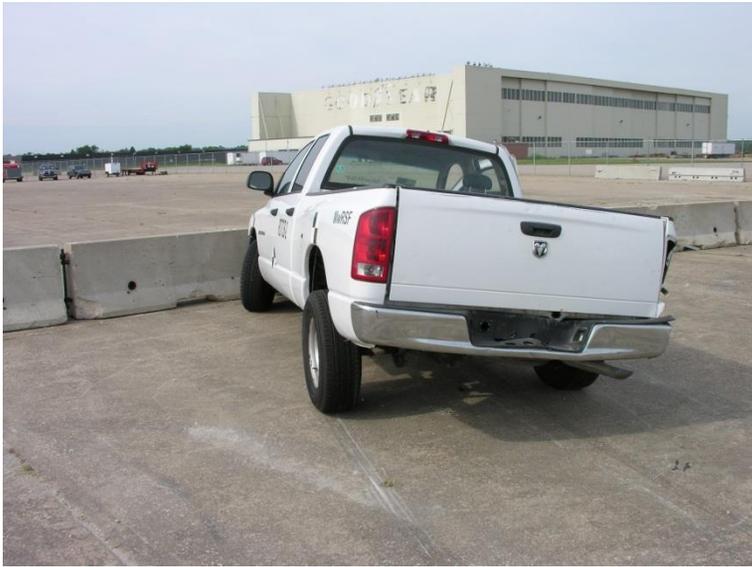
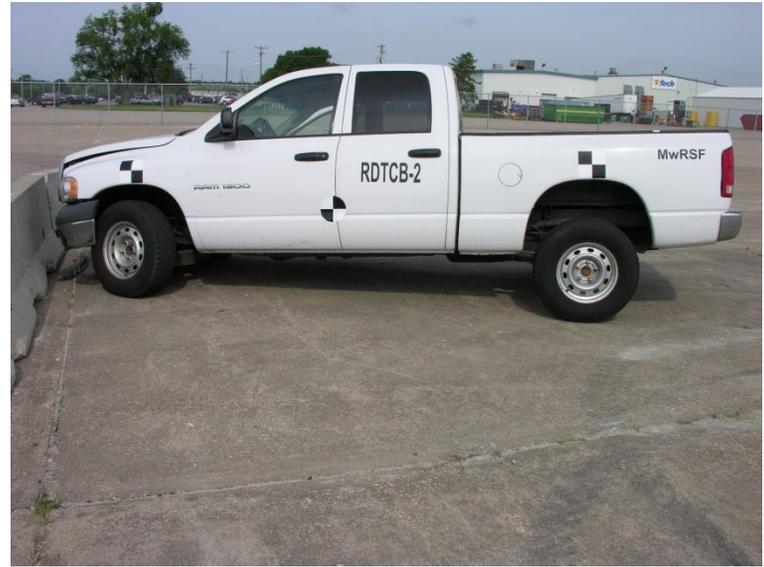
Figure 152. Vehicle Damage, Test No. RDTCB-2

The damage to the vehicle was moderate, as shown in Figures 152 and 153. The maximum occupant compartment deformations are listed in Table 16 along with the deformation limits established in MASH for various areas of the occupant compartment. Note that none of the MASH-established deformation limits were violated. Complete occupant compartment and vehicle deformations and the corresponding locations are provided in Appendix E.

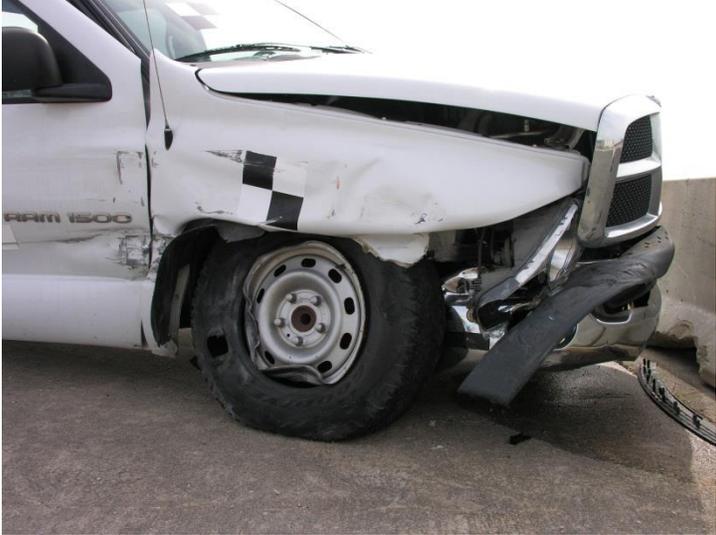
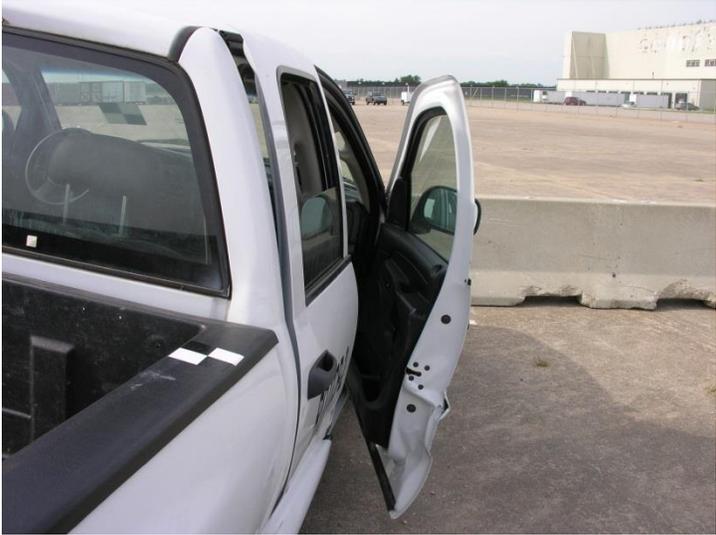
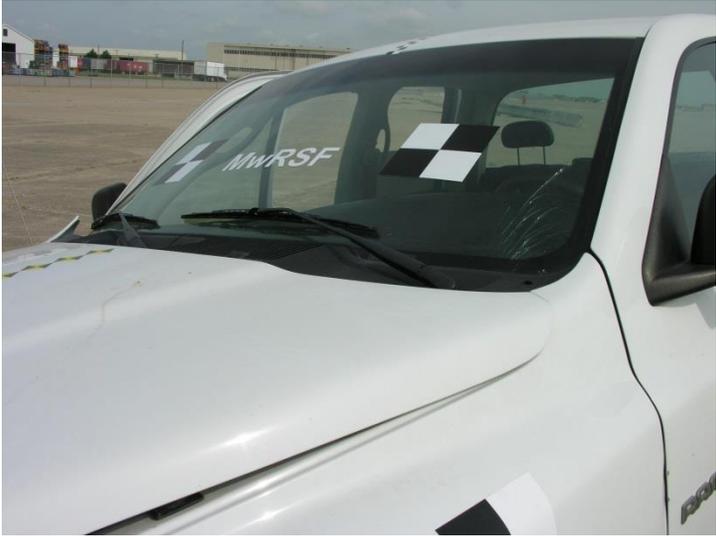
Figure 153. Vehicle Damage, Test No. RDTCB-2

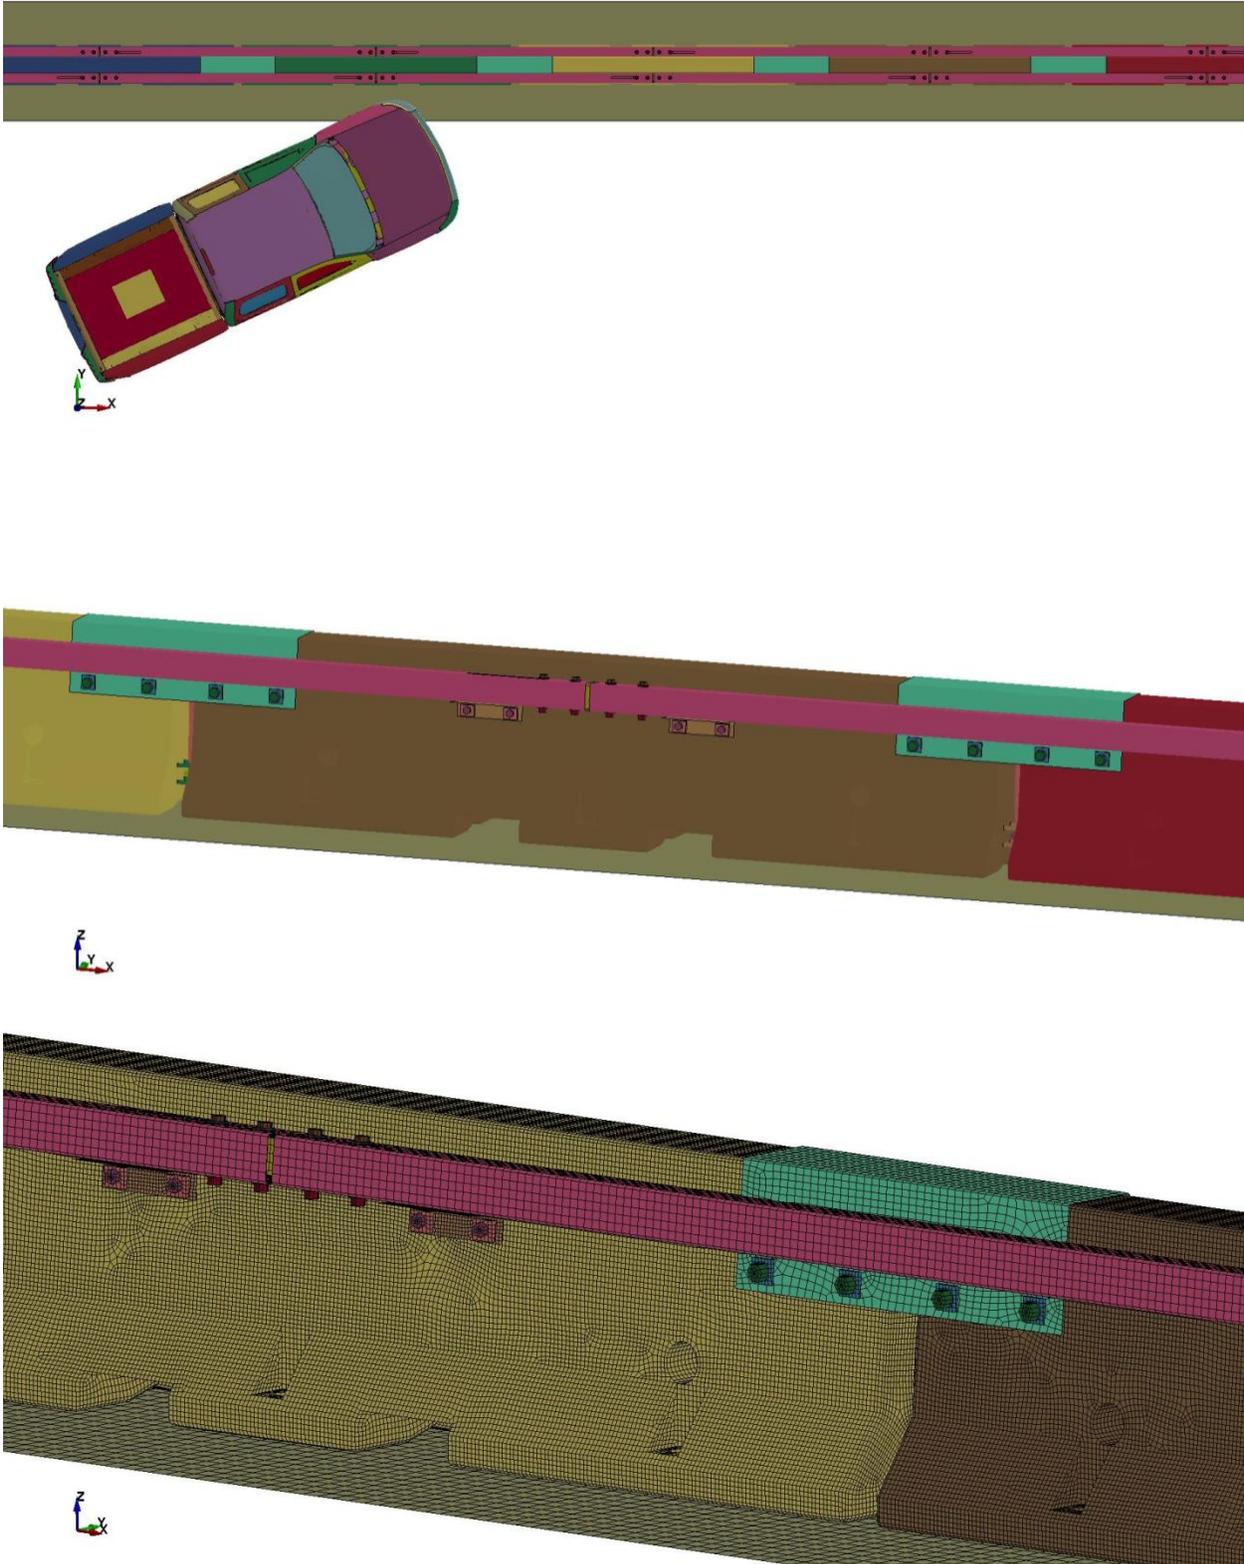
Figure 155. Simulation Model of System, Test No. RDTCB-2

Thus, a simulation model of the reduced-deflection TCB system tested in test no. RDTCB-2 was simulated using a reduced barrier-to-ground friction coefficient of 0.24. The results from this model estimated a dynamic lateral barrier deflection of 41.1 in. (1,044 mm).

This value correlated very well with the 39.5 in. (1,003 mm) permanent set deflection and 40.7 in. (1,034 mm) dynamic lateral barrier deflection from test no. RDTCB-2.

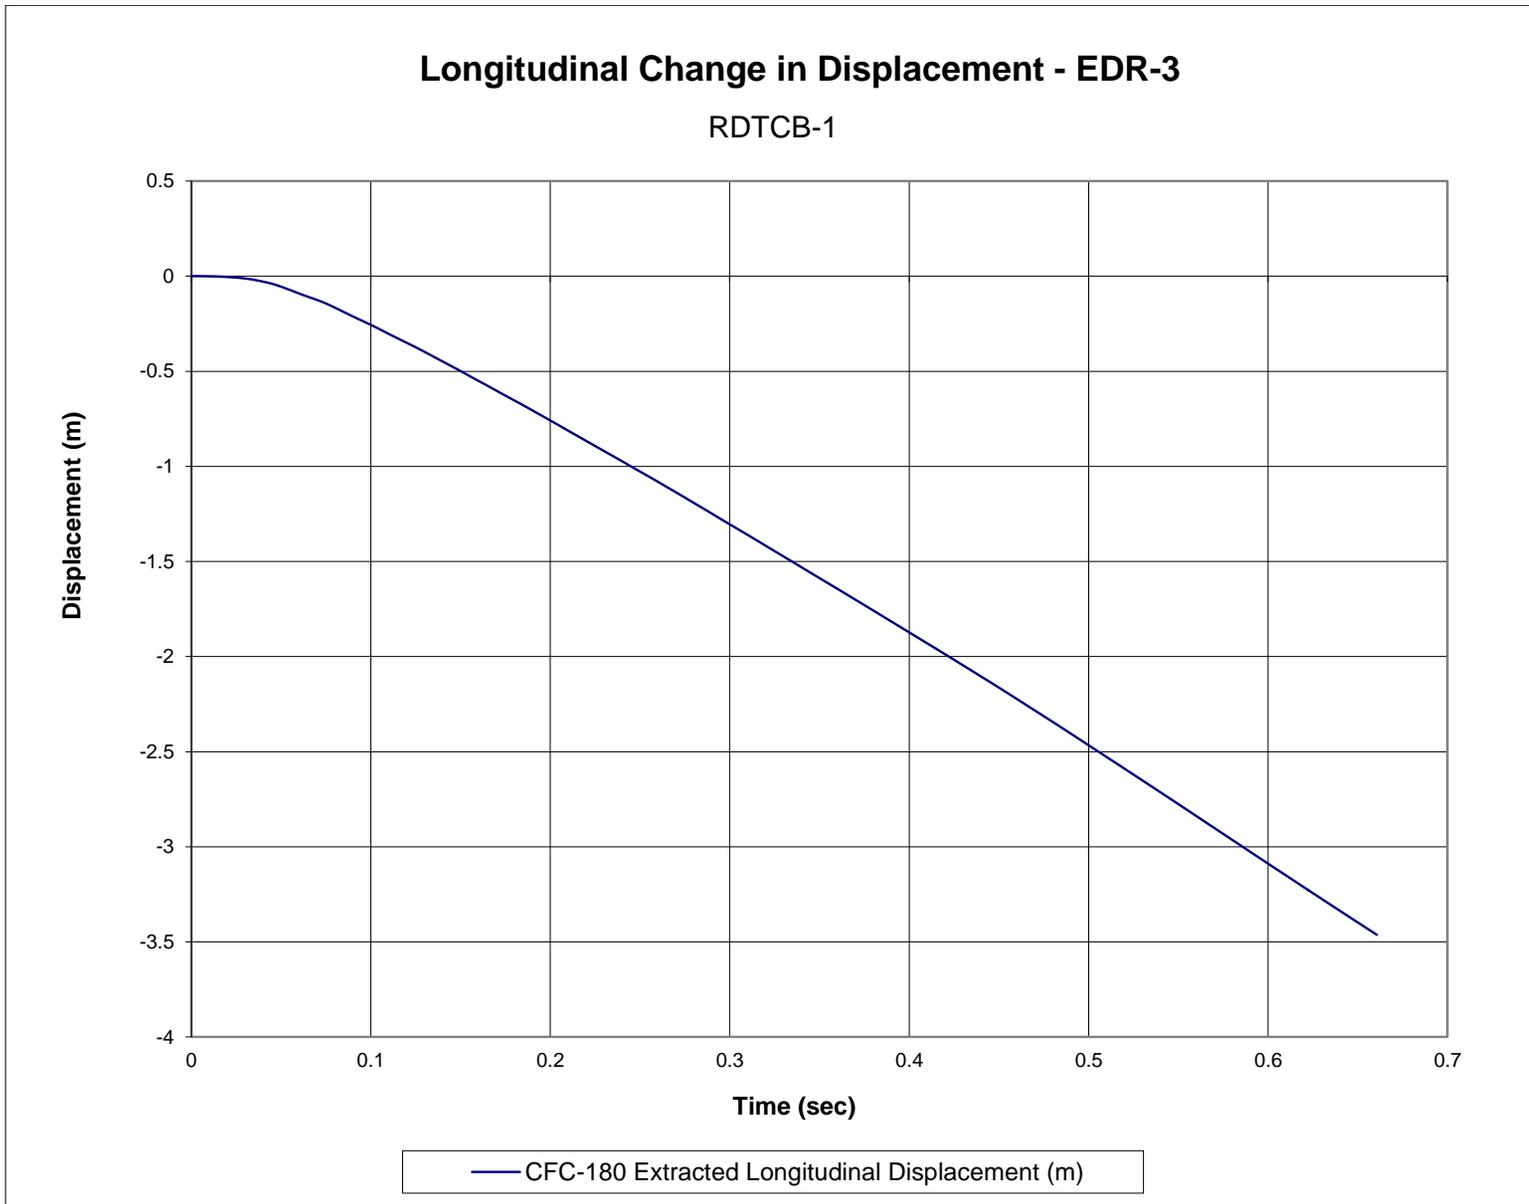
Figure F-19. Longitudinal Change in Displacement (EDR-3), Test No. RDTCB-1

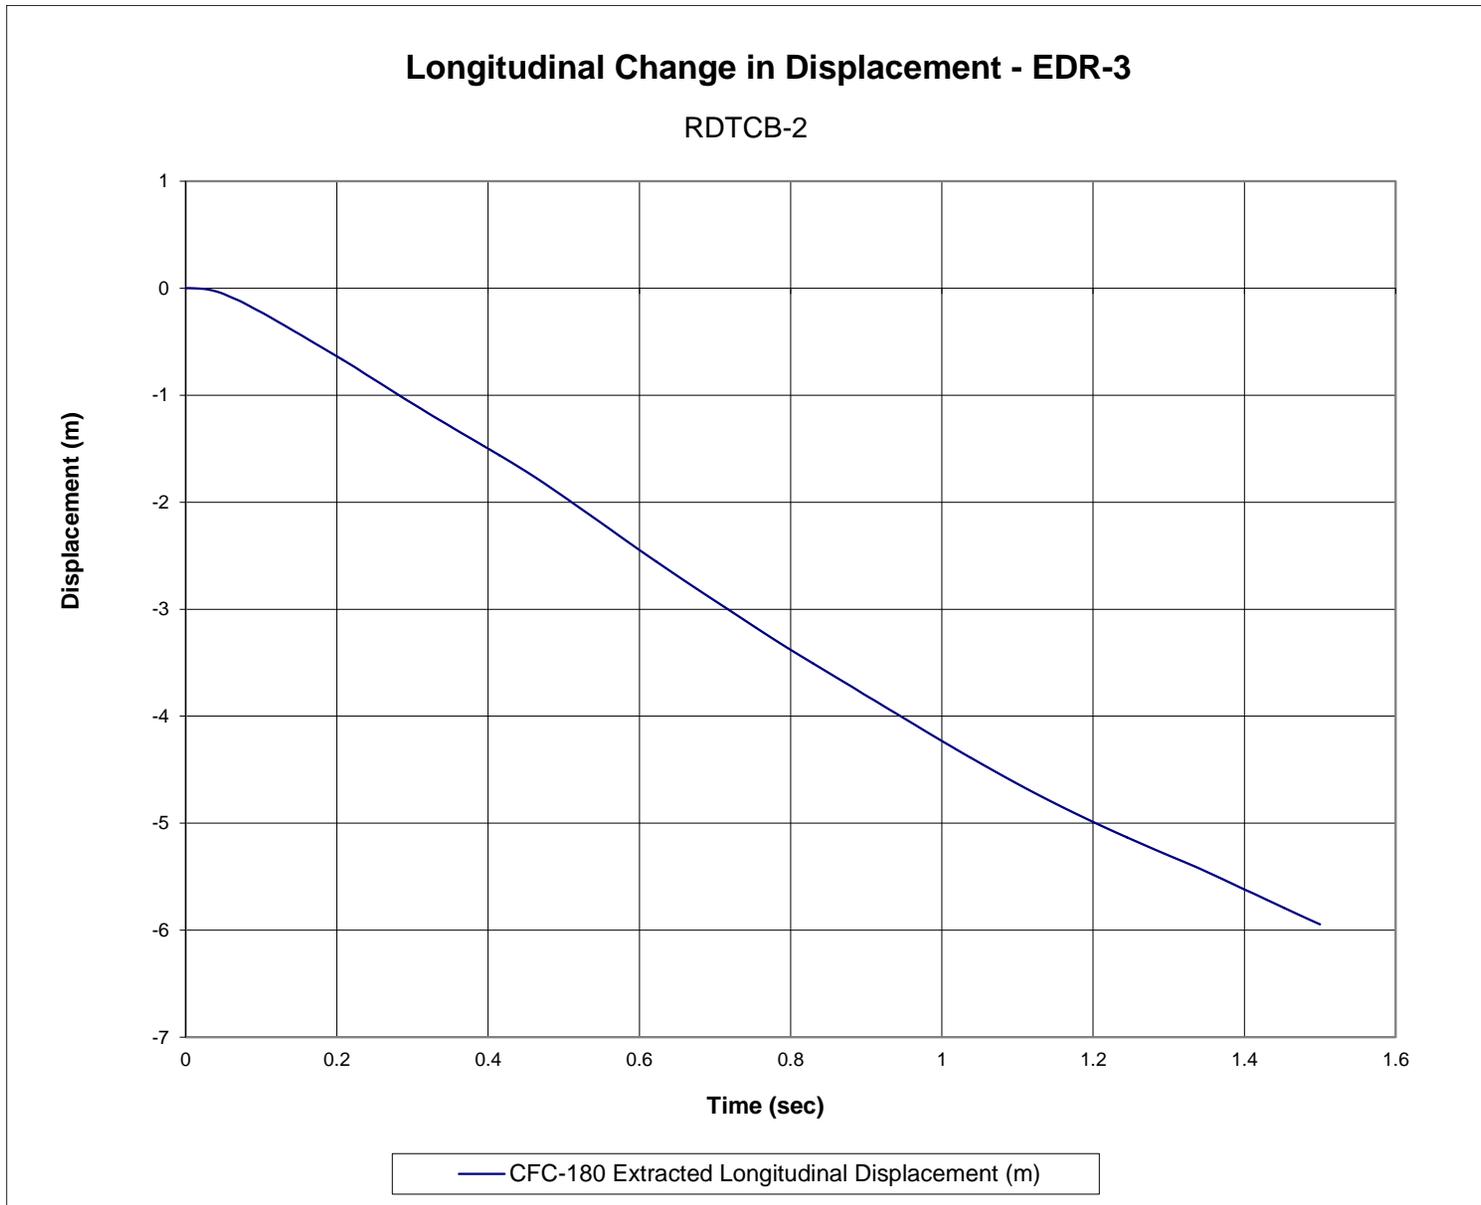
Figure G-19. Longitudinal Change in Displacement (EDR-3), Test No. RDTCB-2
