Midwest States Regional Pooled Fund Research Program Fiscal Year 2010 (Year 20) Research Project Number TPF-5(193) Suppl. #21 NDOR Sponsoring Agency Code RPFP-10-CABLE-3

DYNAMIC TESTING OF A NON-PROPRIETARY, HIGH-TENSION, CABLE END TERMINAL SYSTEM

MwRSF Research Report No. TRP-03-294-14

March 21, 2014

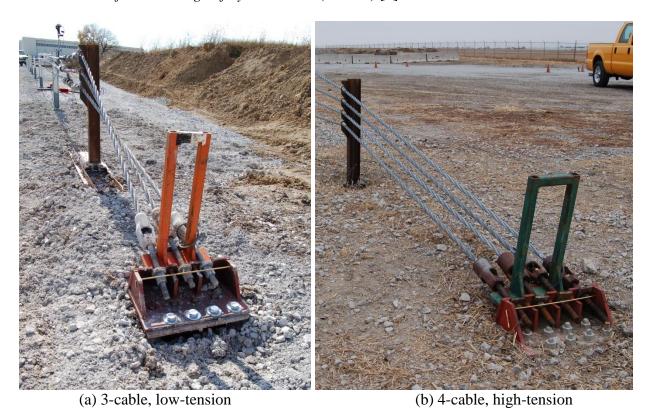
Figure 1. Cable End Terminal Systems

A three-cable, low-tension end terminal system, shown in Figure 1a, was previously developed and successfully tested at the Midwest Roadside Safety Facility [1] according to the safety performance criteria specified in the National Cooperative Highway Research Program (NCHRP) Report No. 350 [2]. The low-tension end terminal system was modified to add a fourth cable, shown in Figure 1b, during the development of a four-cable, high-tension cable median barrier [3-5]. However, the high-tension end terminal was never subjected to full-scale crash testing according to the safety performance criteria specified in NCHRP Report No. 350 or the current *Manual for Assessing Safety Hardware* (MASH) [6].

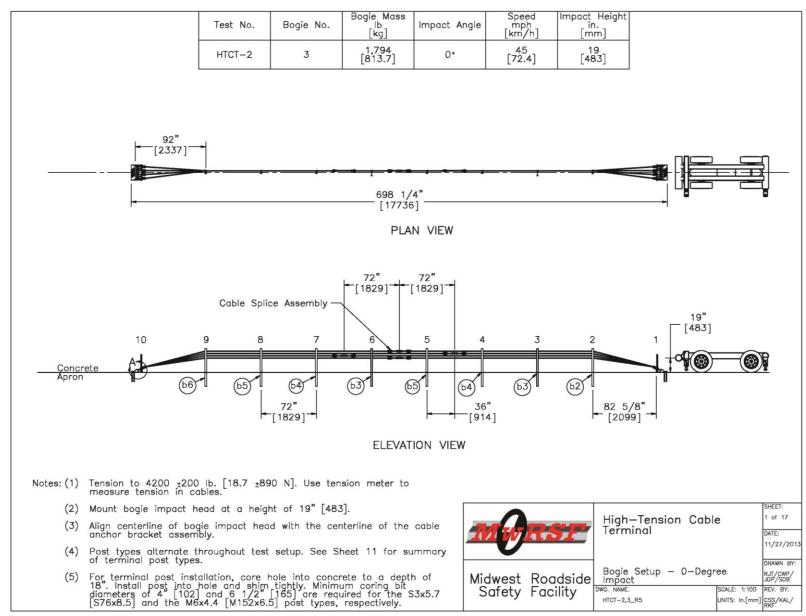
Figure 2. Bogie Testing Matrix and Setup, Test No. HTCT-2

Two dynamic tests were conducted on the redesigned high-tension cable end terminal at the MwRSF Proving Grounds in Lincoln, Nebraska. In test no. HTCT-2, the target impact conditions were a speed of 45 mph (72 km/h) and an angle of 0 degrees, which is end-on to the terminal. In test no. HTCT-3, the target impact conditions were a speed of 45 mph (72 km/h) and an angle of 25 degrees. Since the activation of the cables should behave similarly at 45 mph (72 km/h) and 60 mph (100 km/h), the lower impact speed was selected for component testing. The impact height was 19 in. (483 mm) above the groundline. The test matrix is shown in Figures 2 and 3 for test nos. HTCT-2 and HTCT-3, respectively.

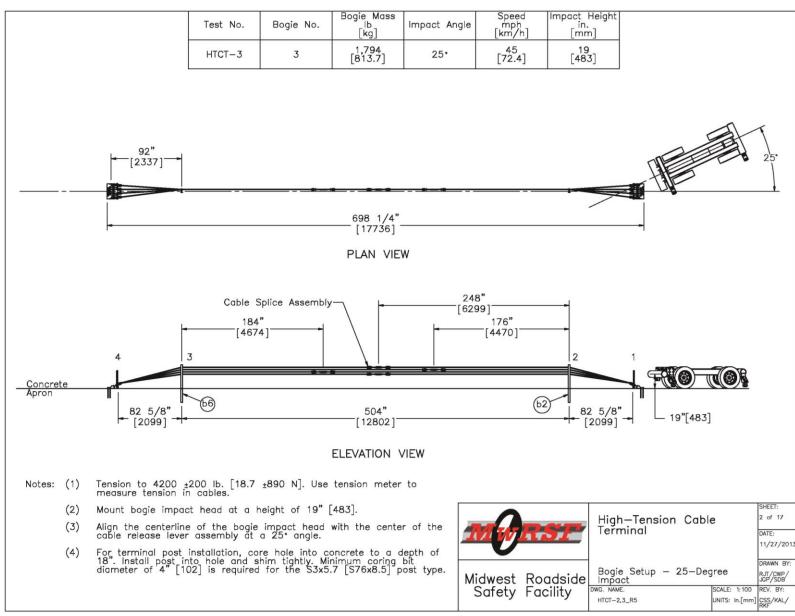
Figure 3. Bogie Testing Matrix and Setup, Test No. HTCT-3

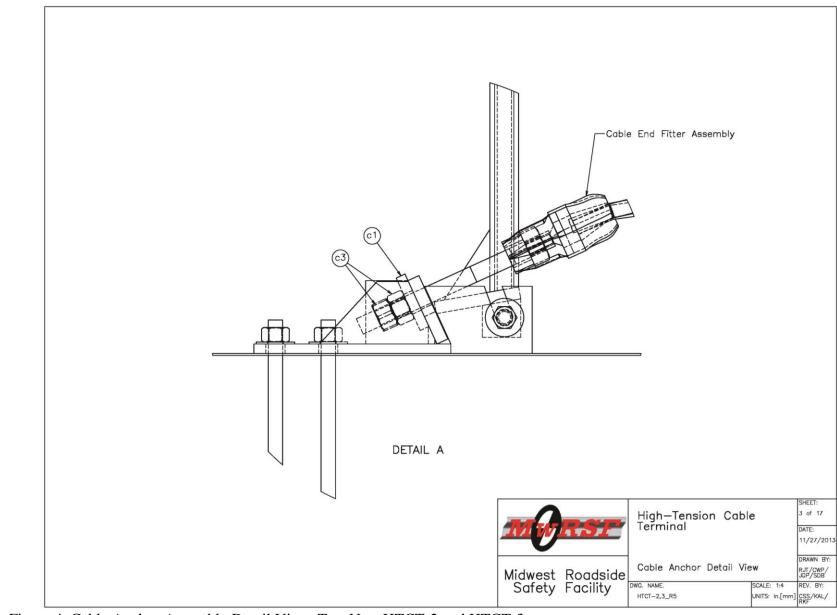
Figure 4. Cable Anchor Assembly Detail View, Test Nos. HTCT-2 and HTCT-3

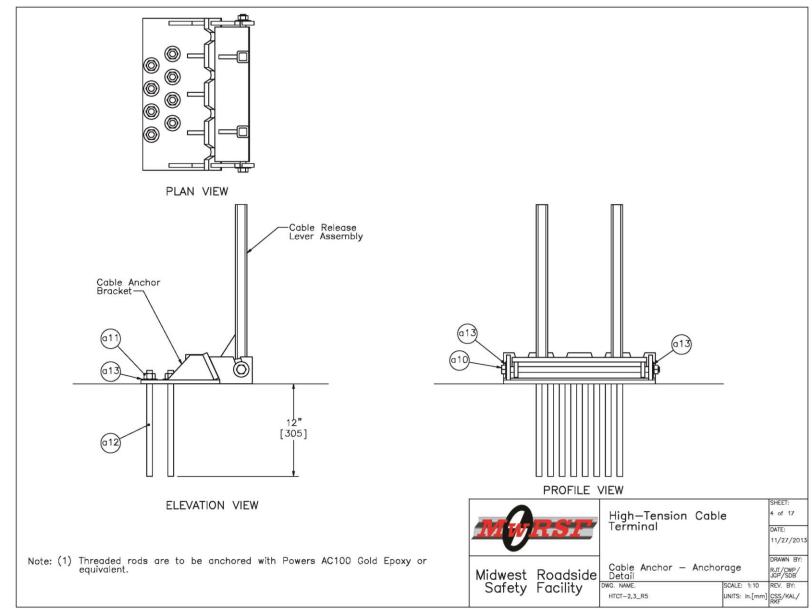
Figure 5. Cable Anchor Anchorage Detail, Test Nos. HTCT-2 and HTCT-3

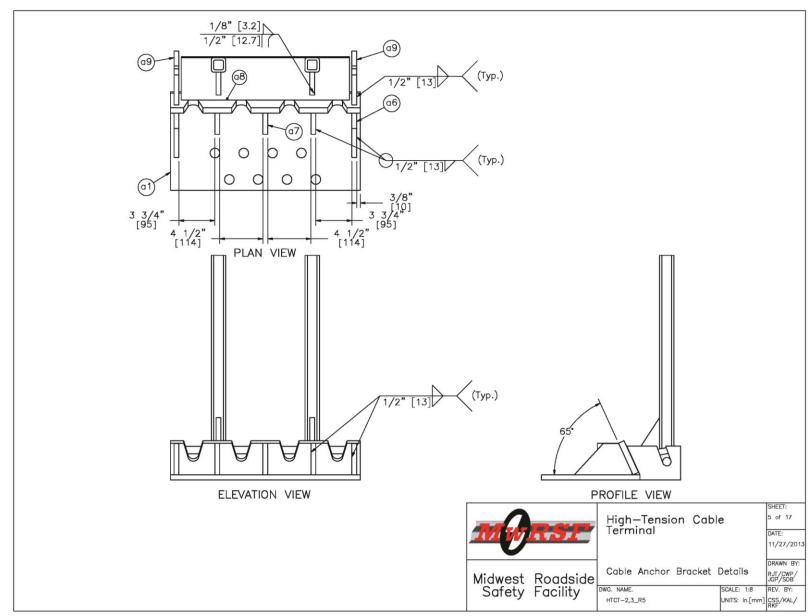
Figure 6. Cable Anchor Bracket Details, Test Nos. HTCT-2 and HTCT-3

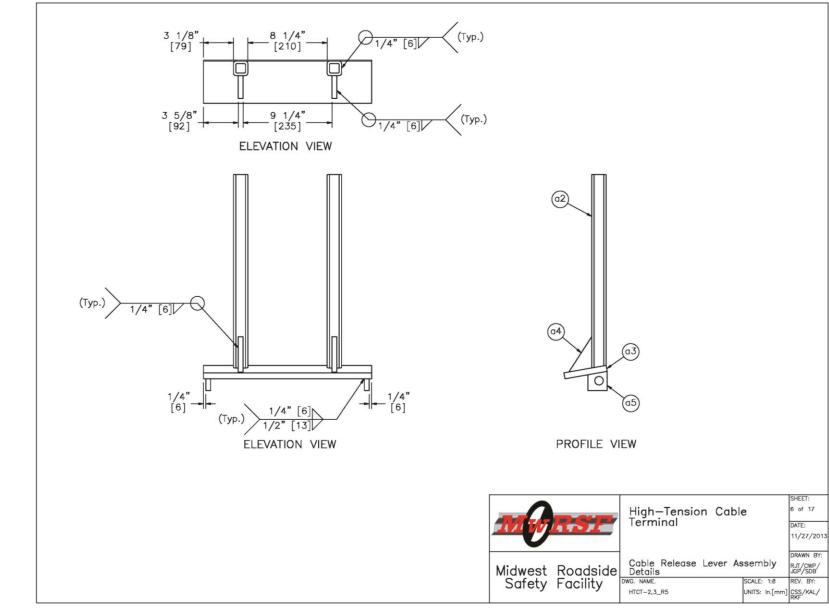
Figure 7. Cable Release Lever Assembly Details, Test Nos. HTCT-2 and HTCT-3

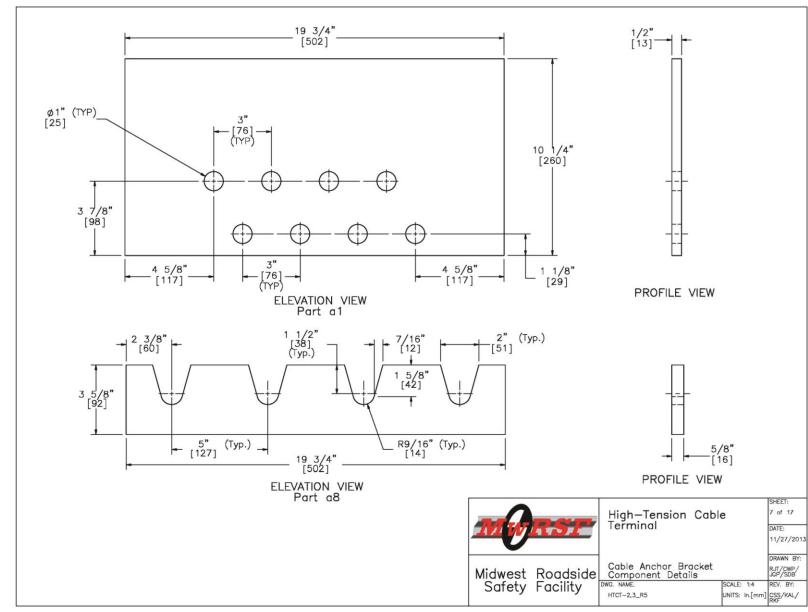
Figure 8. Cable Anchor Bracket Component Details, Test Nos. HTCT-2 and HTCT-3

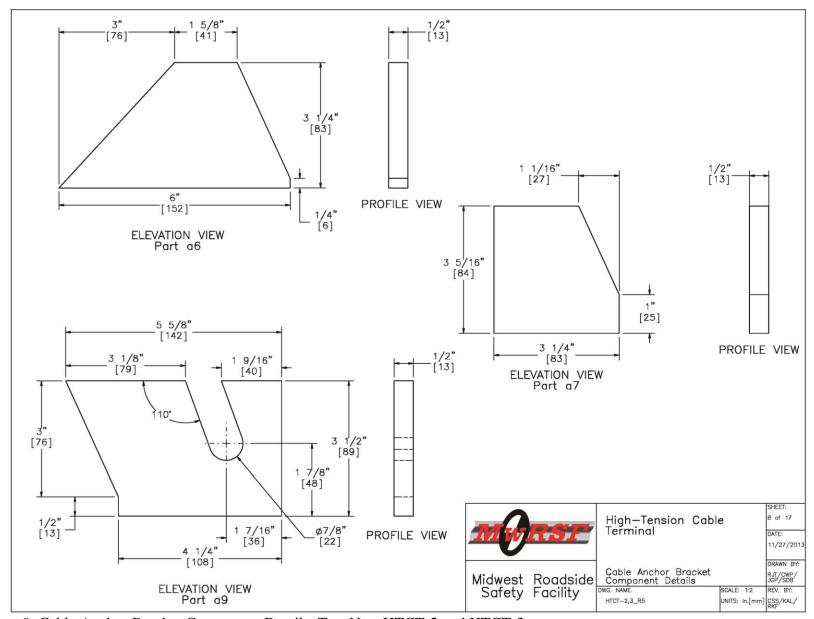
Figure 9. Cable Anchor Bracket Component Details, Test Nos. HTCT-2 and HTCT-3

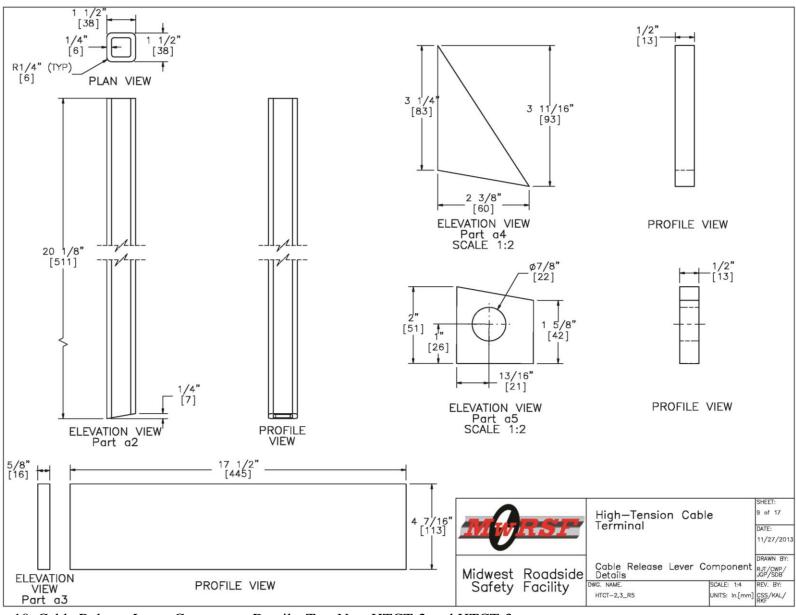
Figure 10. Cable Release Lever Component Details, Test Nos. HTCT-2 and HTCT-3

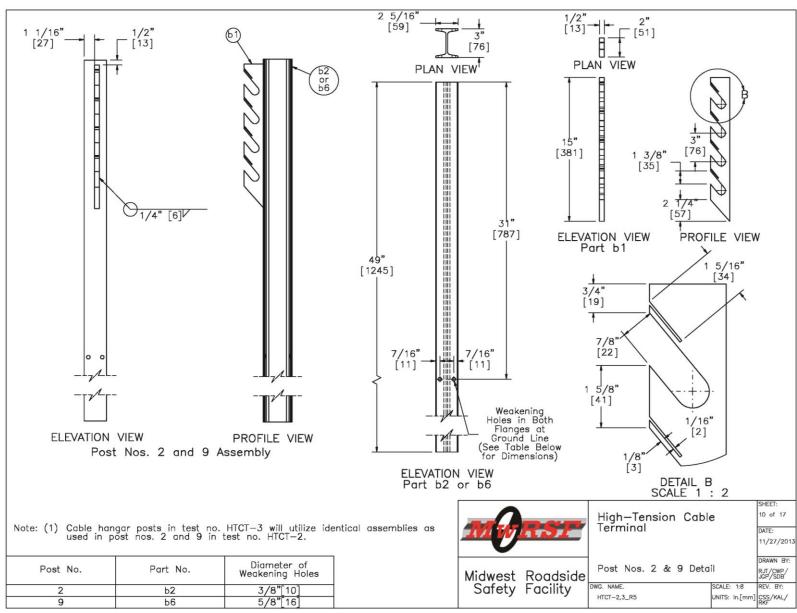
Figure 11. Post Nos. 2 and 9 Details, Test Nos. HTCT-2 and HTCT-3

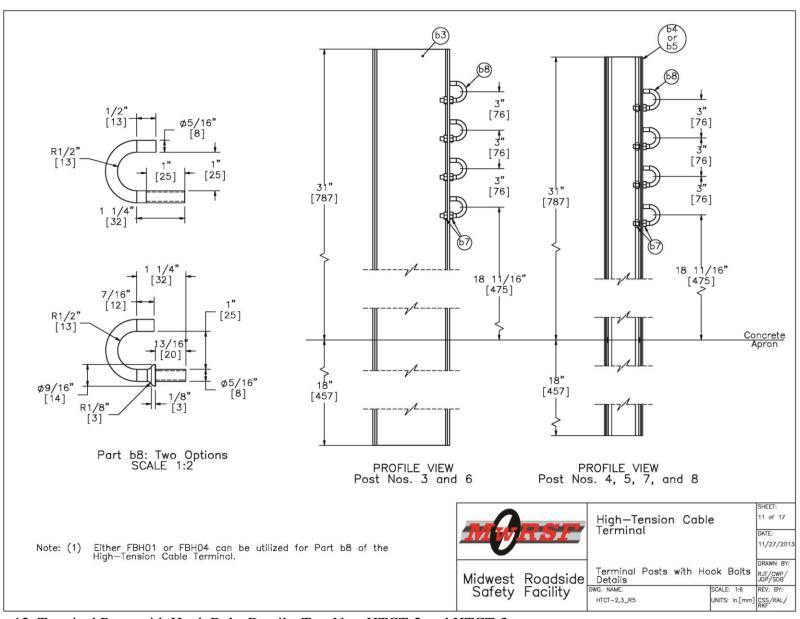
Figure 12. Terminal Posts with Hook Bolts Details, Test Nos. HTCT-2 and HTCT-3

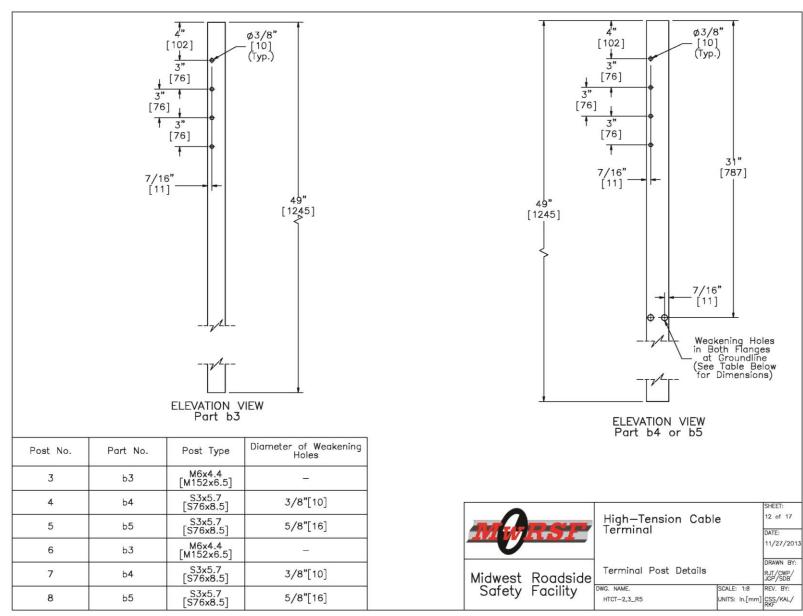
Figure 13. Terminal Post Details, Test Nos. HTCT-2 and HTCT-3

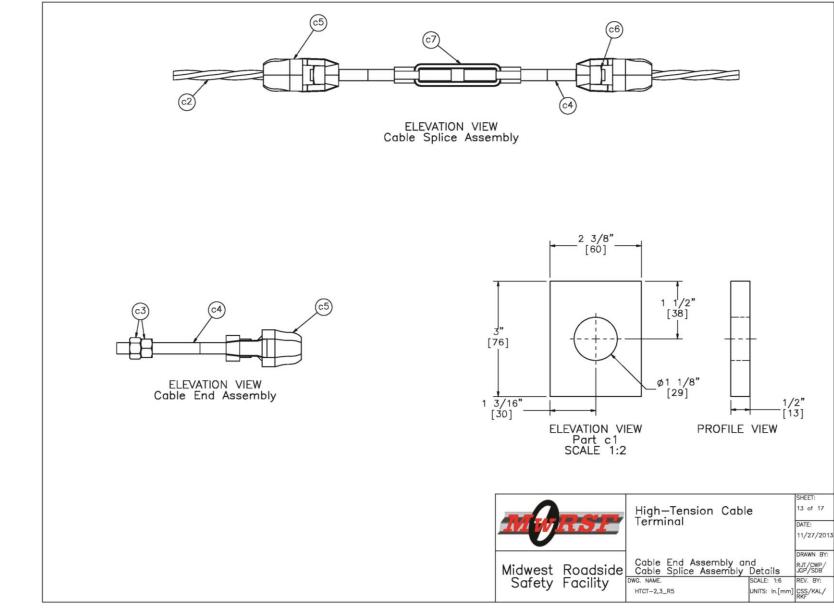
Figure 14. Cable End Assembly and Cable Splice Assembly Details, Test Nos. HTCT-2 and HTCT-3

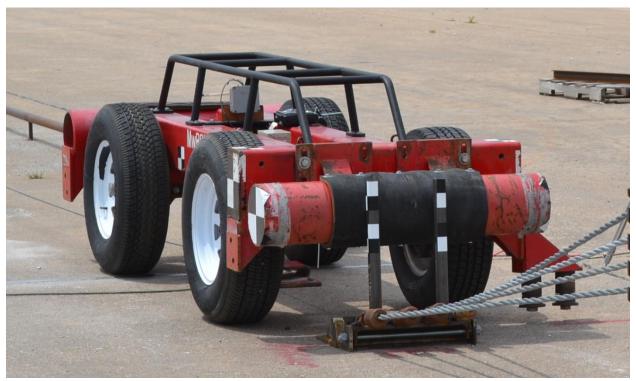
A rigid frame bogie was used to impact the cable end terminal. A variable height, detachable impact head was used in the testing. The bogie head was constructed of 8-in. (203-mm) diameter, ½-in. (13-mm) thick standard steel pipe, with ¾-in. (19-mm) neoprene belting wrapped around the pipe to prevent local damage to the post from the impact. The impact head was bolted to the bogie vehicle, creating a rigid frame with an impact height of 19 in. (483 mm). The bogie with the impact head is shown in Figure 21. The weight of the bogie with the addition of the mountable impact head and accelerometers was 1,861 lb (844 kg) in test no. HTCT-2 and 1,853 lb (841 kg) in test no. HTCT-3.

Figure 21. Rigid Frame Bogie on Guidance Track

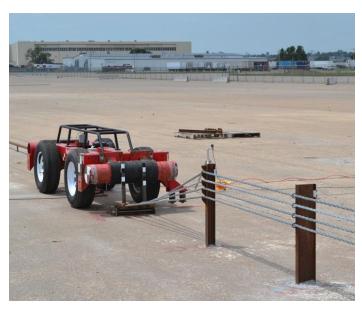
Figure 22. Impact Location, Test No. HTCT-2

The 1,861-lb (844-kg) bogie impacted the high-tension cable terminal system at a speed of 52.8 mph (85.0 km/h) and at an angle of 0 degrees. The impact location is shown in Figure 22. The cables were tensioned to approximately 4,300 lb (19 kN). The cables were numbered from 1 to 4 as shown in Figure 23. Cable no. 1 corresponded to the bottom cable, and cable no. 4 corresponded to the top cable. A sequential description of the impact events is contained in Table 2. The times are approximate as the bogie wheel obstructed the view of the cable releases. Sequential photographs are shown in Figures 24 through 26.

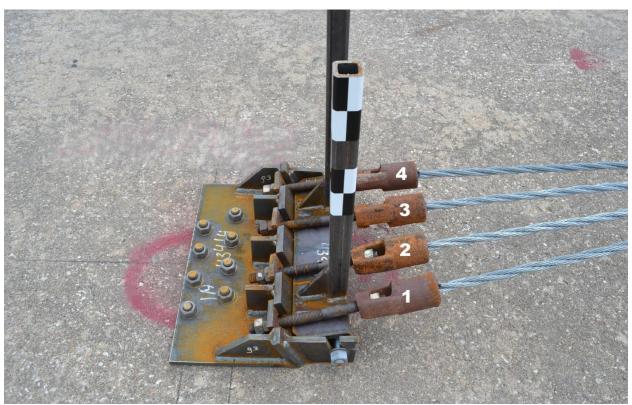
Figure 23. Cable Numbers at Upstream Cable Anchor Bracket, Test No. HTCT-2

Cable nos. 1, 3, and 4 released from the upstream cable anchor bracket early on the event, However cable no. 2 did not release until the cable lost tension and the stress wave propagation caused the cable to lift out, which occurred very late in the event. Cable no. 2 not releasing and post no. 2 bending downstream may have contributed to the bogie becoming airborne during most of the event.

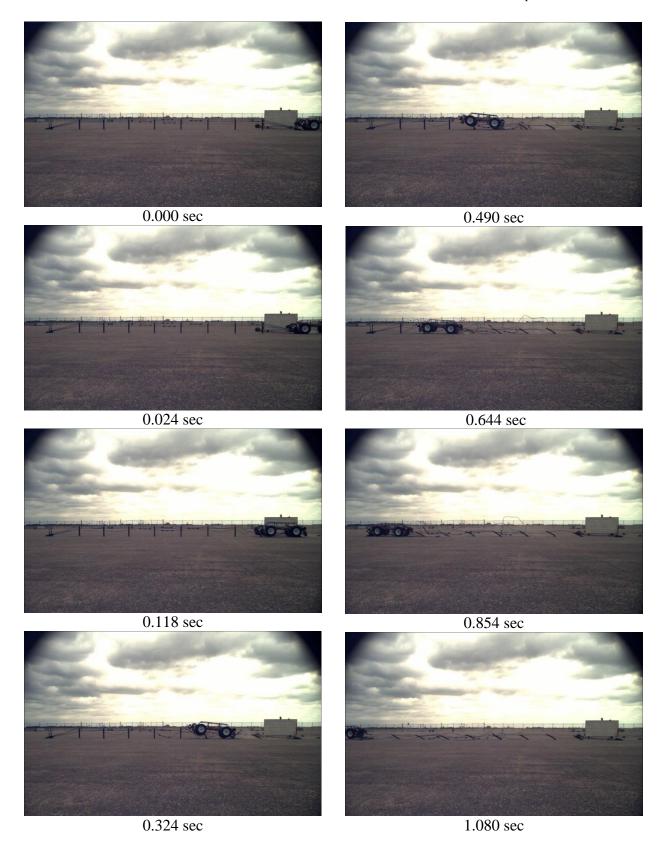
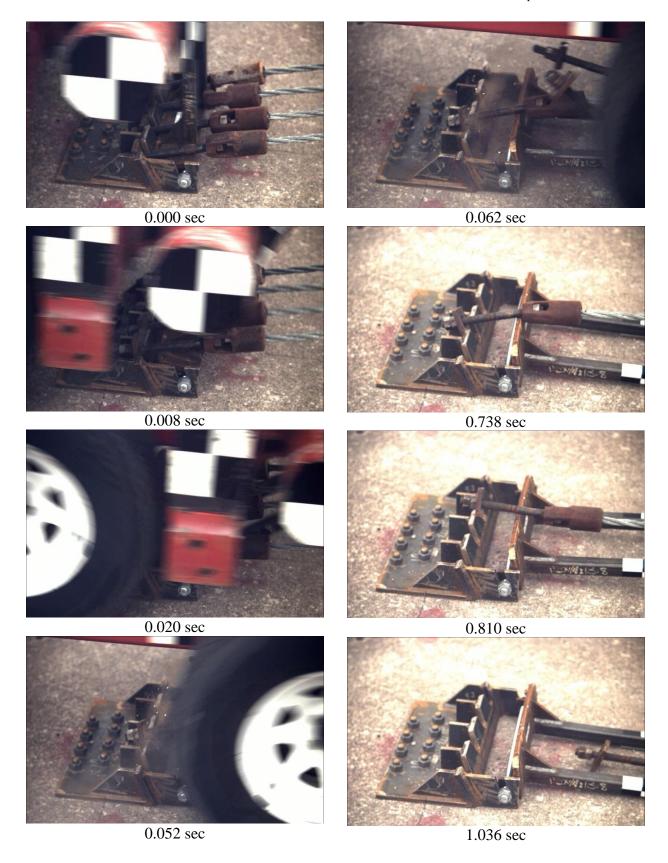
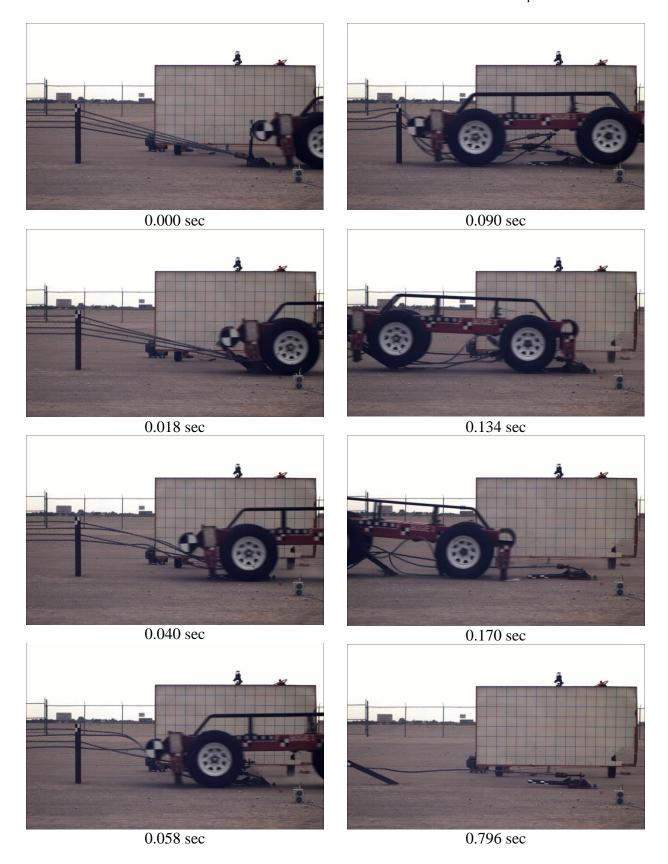
Figure 24. Sequential Photographs, Test No. HTCT-2

Figure 25. Sequential Photographs, Test No. HTCT-2

Figure 26. Sequential Photographs, Test No. HTCT-2

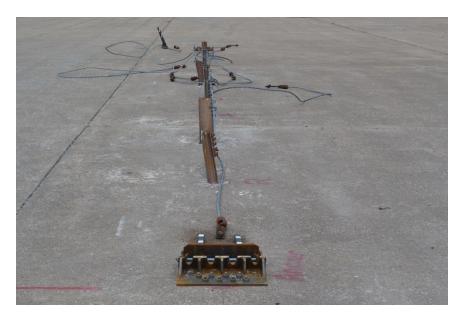
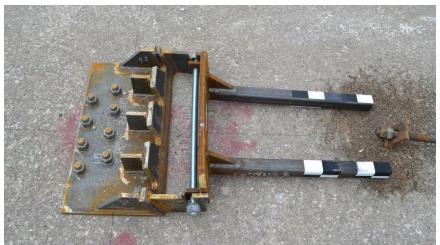
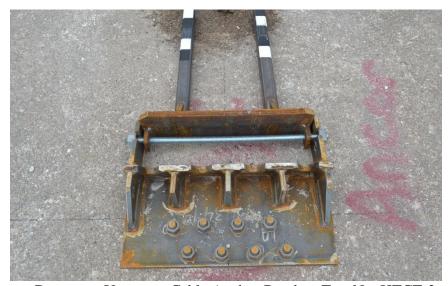
Damage to the end terminal system was moderate, as shown in Figures 27 through 30. The cable release lever was retained in the upstream cable anchor bracket. The kick plate had some minor permanent deformation. Post nos. 2 through 9 were all bent downstream. Posts with holes in the flanges at groundline all buckled at the holes, and the flanges tore from the upstream edge to the location of the weakening holes.

Figure 27. System Damage – Upstream Cable Anchor Bracket, Test No. HTCT-2

In test no. HTCT-2, cable nos. 1, 3, and 4 released quickly from the end terminal as desired. However, the second cable did not release until 0.766 seconds after the first three cables, and cable no. 2 only lifted out due to the stress wave that propagated through the cable after tension was released. Some slight permanent bending was found in the kick plate, which may have contributed to cable no. 2 not releasing as quickly as the other cables. The washer snagging on the cable plate notch may have also contributed to the delayed release.

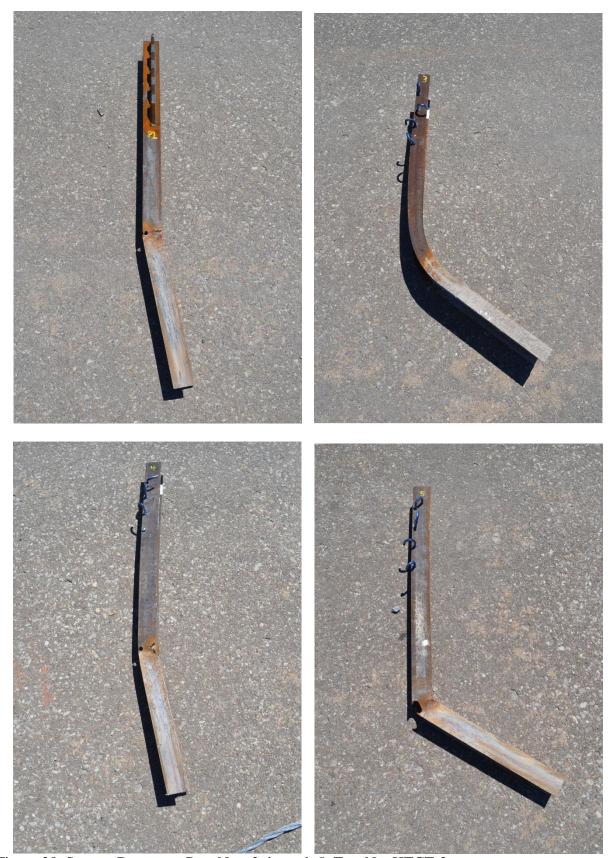
Figure 28. System Damage – Post Nos. 2 through 5, Test No. HTCT-2

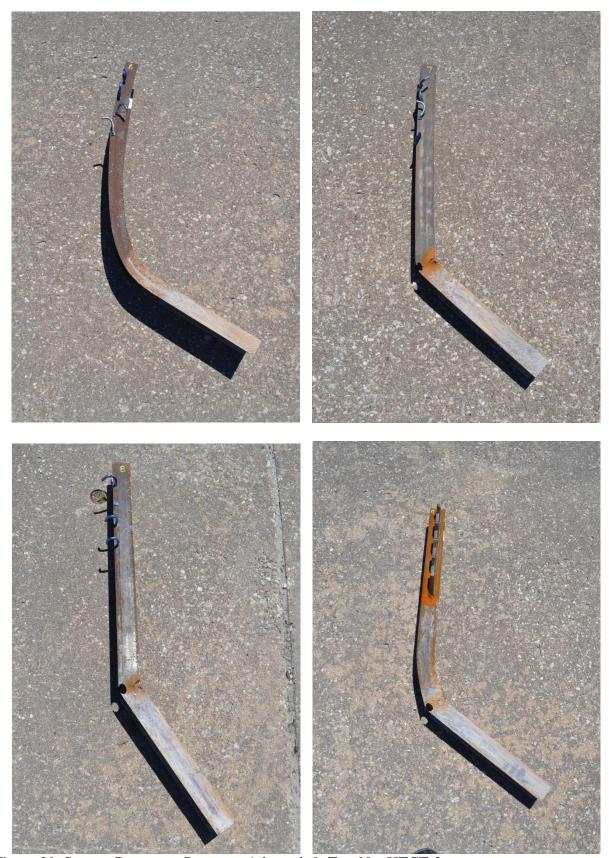
Figure 29. System Damage – Post nos. 6 through 9, Test No. HTCT-2

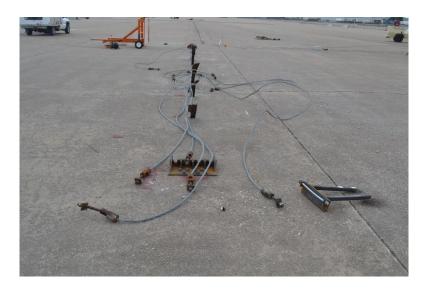
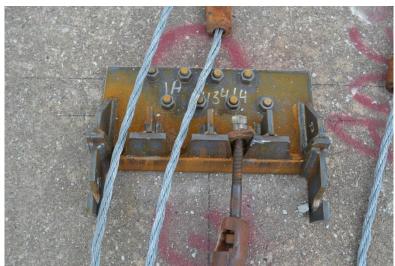
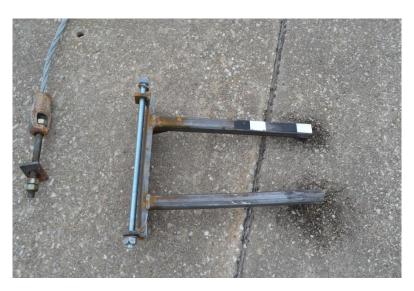
The cable release lever released from the downstream cable anchor bracket. Cable nos. 1, 3, and 4 released from the downstream cable anchor bracket. Gouging was found in the steel plate around the second cable notch on the downstream cable anchor bracket. The kick plate had some minor permanent deformation. The bogie also sustained minor damaged to the tires and tow pin.

$Figure\ 30.\ System\ Damage-Downstream\ Cable\ Anchor\ Bracket,\ Test\ No.\ HTCT-2$

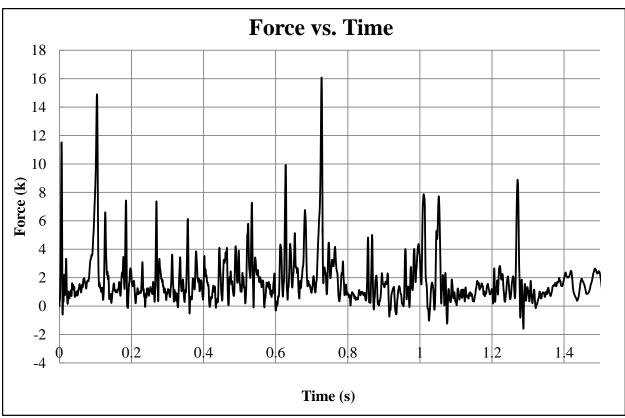
The force vs. time is shown in Figure 31 and the peak forces from each post impact are shown in Table 3. A peak force of 11.5 k (51.2 kN) occurred during the initial impact with the cable release lever. Three combinations of post type and weakening hole size were explored, but it was difficult to draw any conclusions about which combination performed the best. The peak

forces from the accelerometer data varied significantly, even for the same post type, because the bogie was airborne during much of the event, which changed the impact type and direction on each post.

Figure 31. Force vs. Time, Test No. HTCT-2

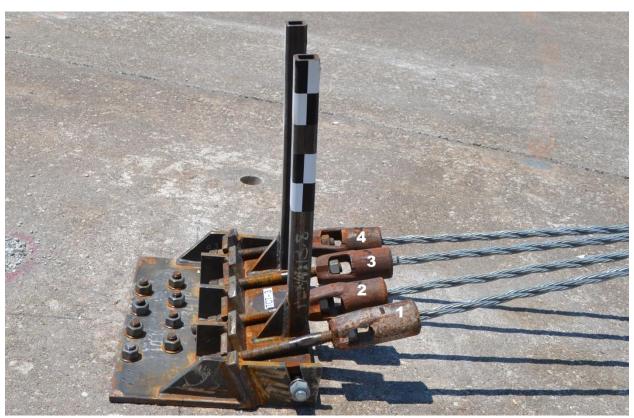
Figure 33. Cable Numbers at Upstream End Terminal, Test No. HTCT-3

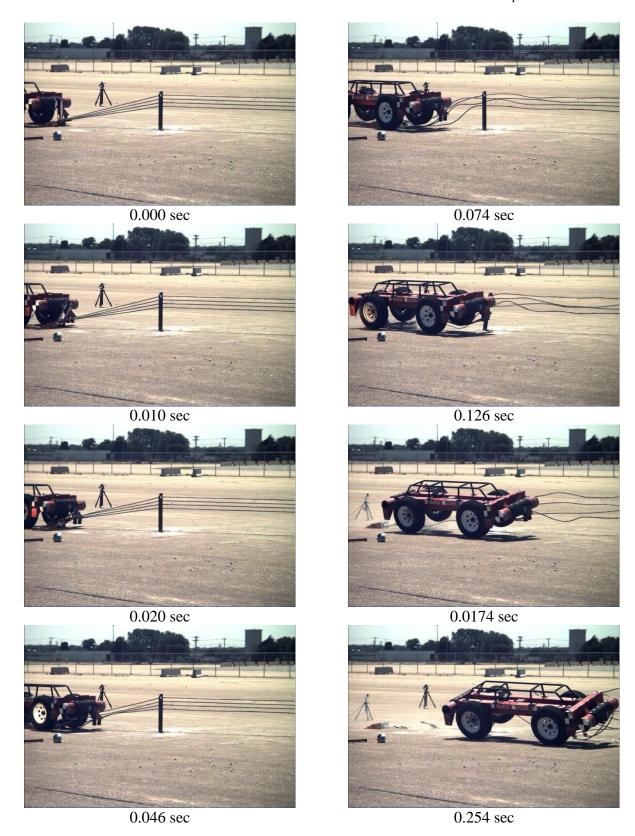
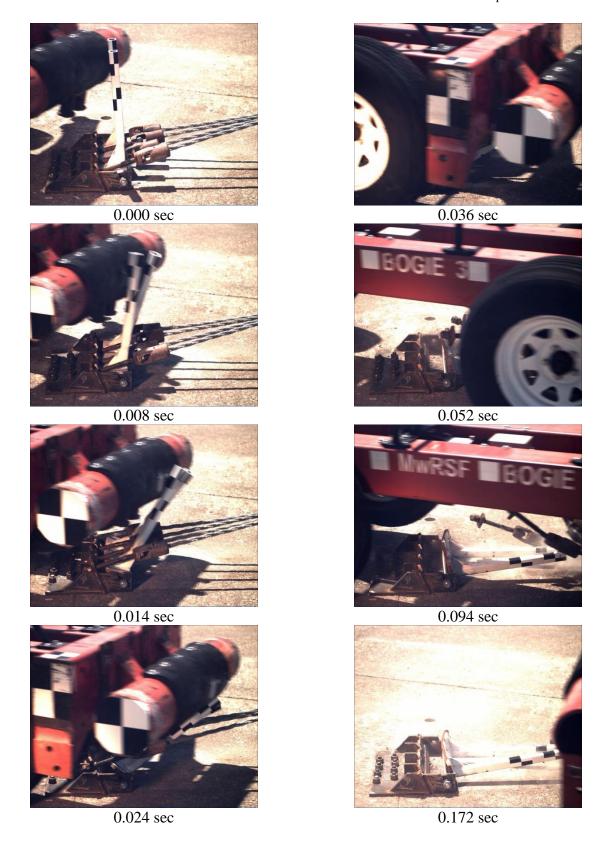
Figure 34. Sequential Photographs, Test No. HTCT-3

Figure 35. Sequential Photographs, Test No. HTCT-3

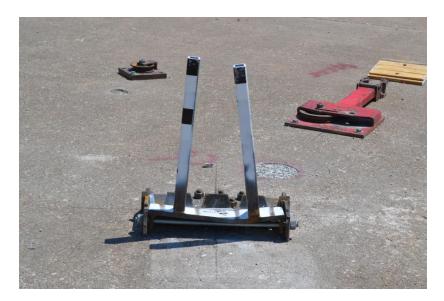
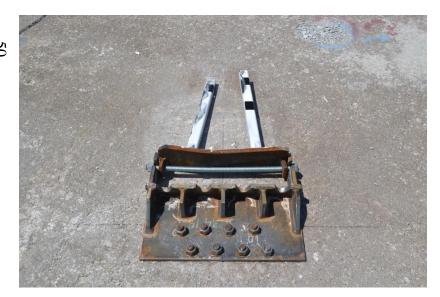
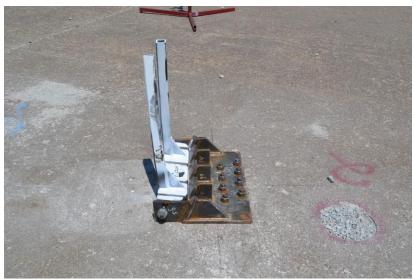
Damage to the cable end terminal system was moderate, as shown in Figures 38 and 39. The cable release lever was retained in the upstream cable anchor bracket. The kick plate had

Figure 38. System Damage – Overall and Upstream Cable Anchor Bracket, Test No. HTCT-3

Minimal permanent deformation was found in the kick plate in test no. HTCT-2, which may have contributed to the second cable not releasing from the terminal as desired. More significant permanent deformation was found in the kick plate and vertical tubes in test no. HTCT-3. However, no permanent deformation was found in the fixed portion of the cable anchor bracket.

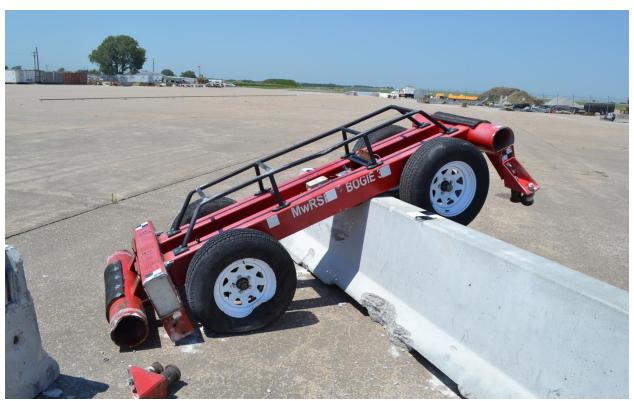
Figure 40. Bogie Damage, Test No. HTCT-3

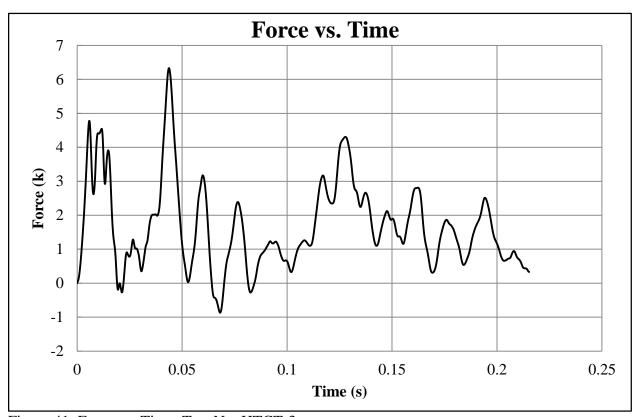
Figure 41. Force vs. Time, Test No. HTCT-3

seconds, or between 0.026 seconds and 0.056 seconds when the cables were releasing.

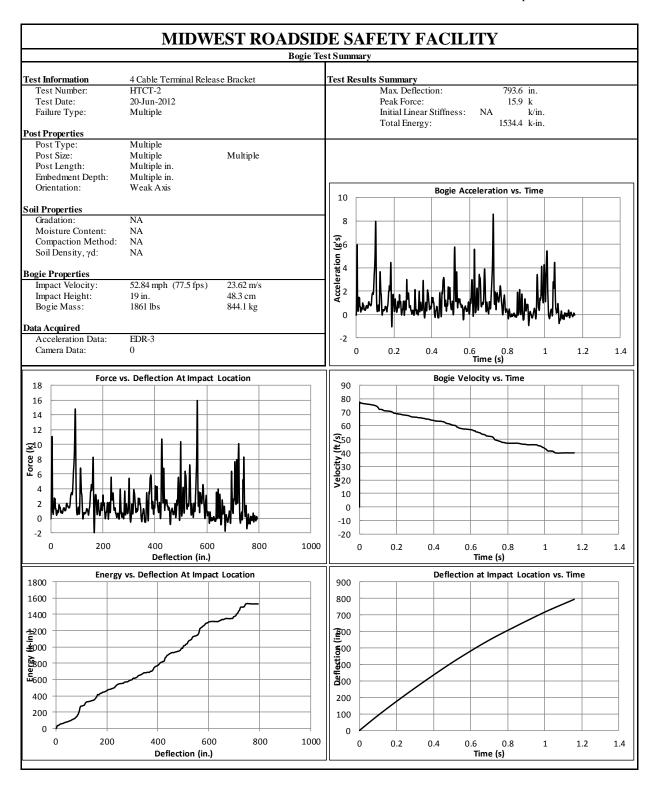
The results of the recorded data from each accelerometer for every dynamic bogie test are provided in the summary sheets found in this appendix. Summary sheets include acceleration, velocity, and deflection vs. time plots as well as force vs. deflection and energy vs. deflection plots.

Figure B-1. Test No. HTCT-2 Results (EDR-3)

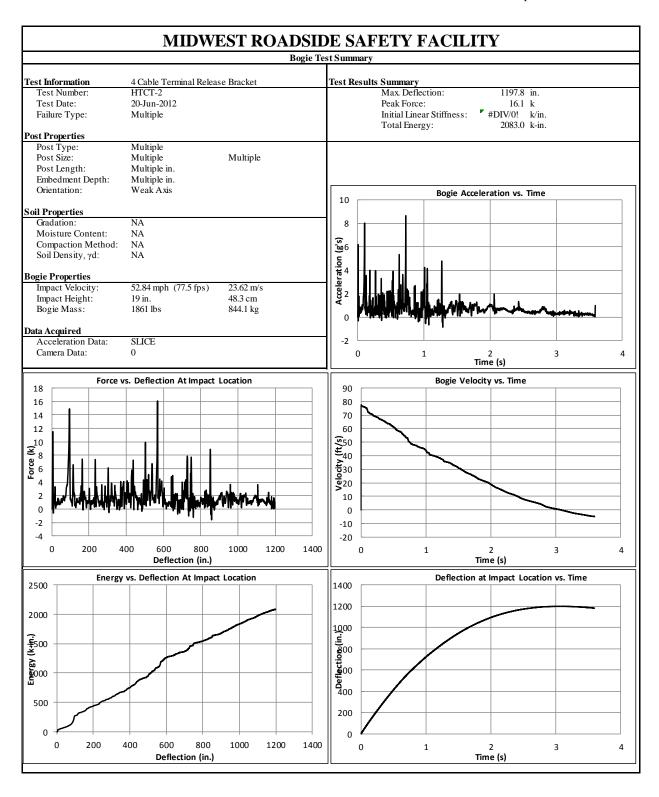
Figure B-2. Test No. HTCT-2 Results (SLICE)

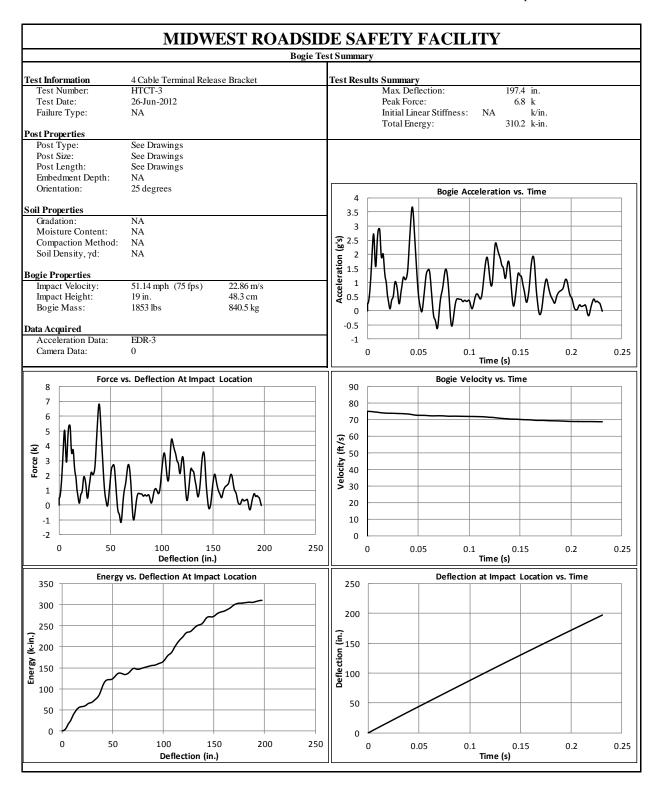
Figure B-3. Test No. HTCT-3 Results (EDR-3)

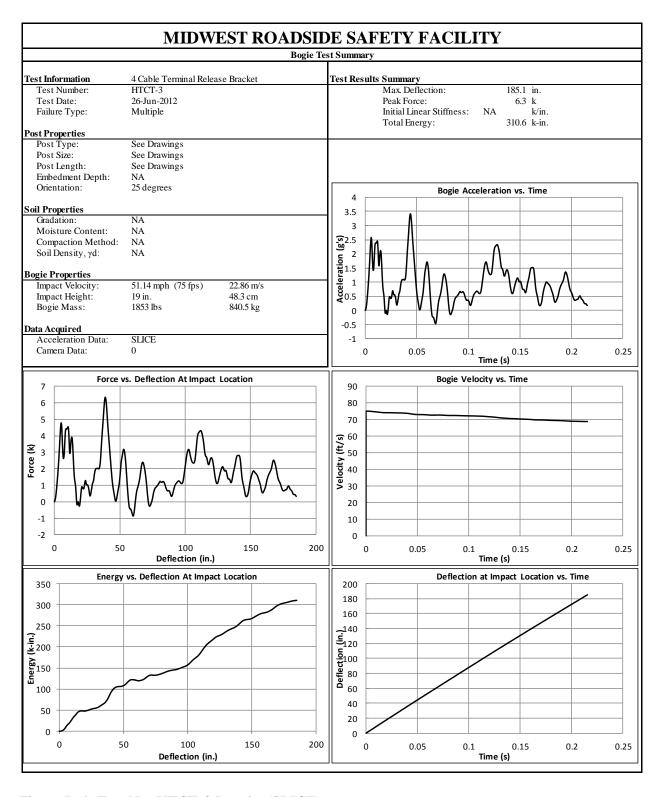
Figure B-4. Test No. HTCT-3 Results (SLICE)
