*NDOR Project No. SPR-P1(07) P596*

## **PHASE I DEVELOPMENT OF AN AESTHETIC, PRECAST CONCRETE BRIDGE RAIL**

MwRSF Research Report No. TRP-03-239-12

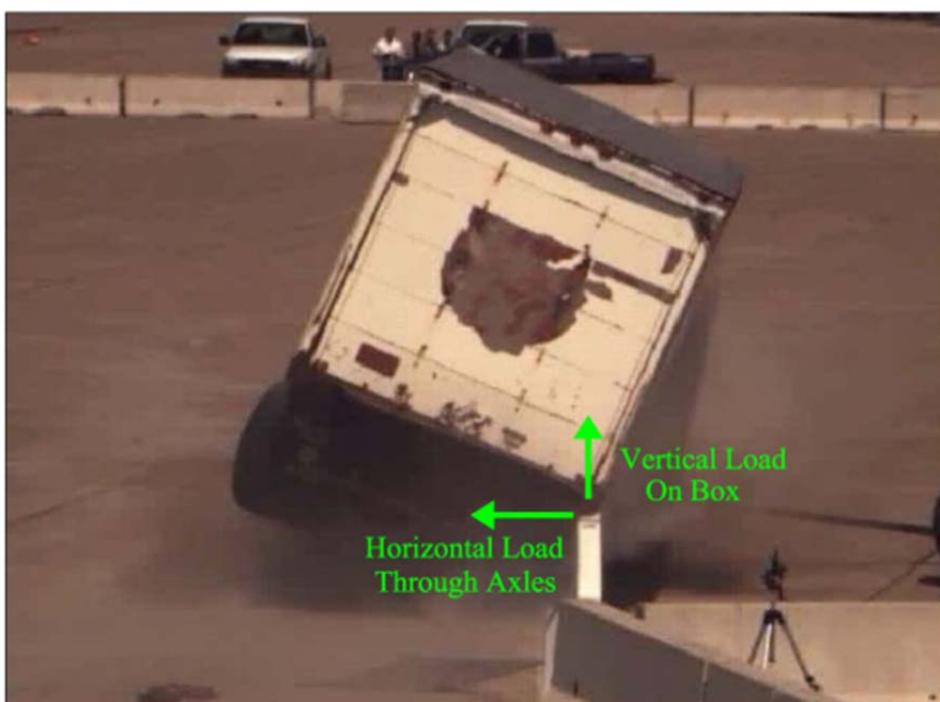
shorter barriers during impact events. For example, the MASH 10000S single-unit truck (SUT) has a ballast center of gravity (c.g.) height of 63 in. (1,600 mm). Thus, these heavier and taller vehicles, such as single-unit trucks, are redirected and prevented from rolling over the top of rigid barriers due to a combination of a vertical barrier load being applied to the outer underside of the cargo box and a lateral barrier resistance imparted to the wheels and axle assemblies, as shown in Figure 3.

**Figure 3. Barrier Forces Acting on Single-Unit Truck During Impact**

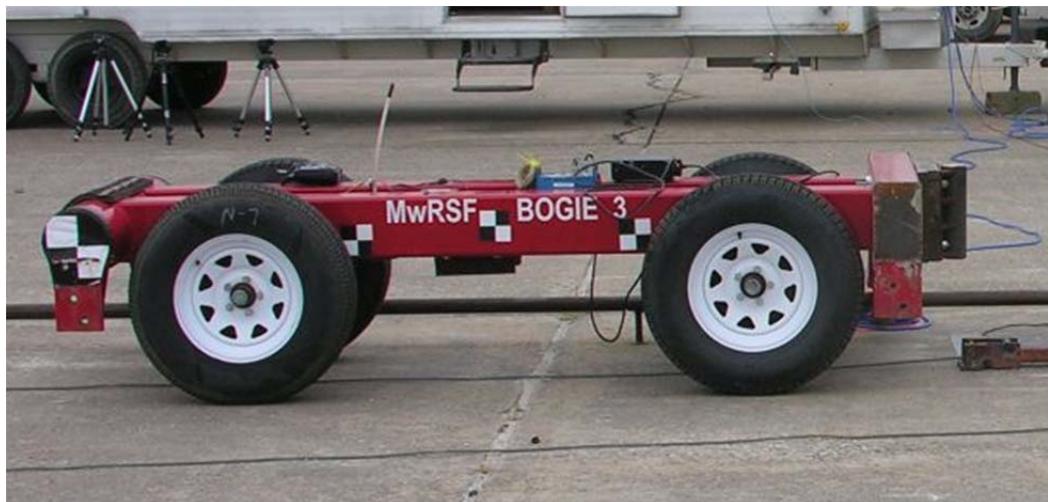
**Figure 49. Bogie Vehicle (a) Impact Head and (b) on Guidance Track**

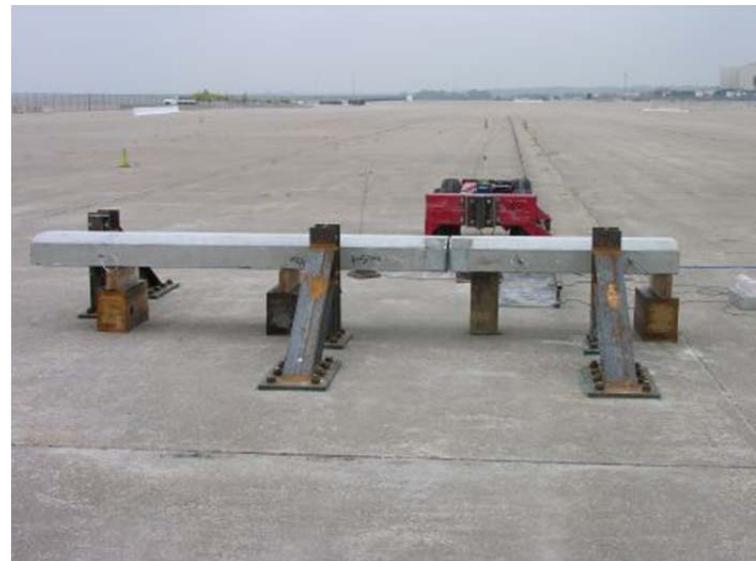
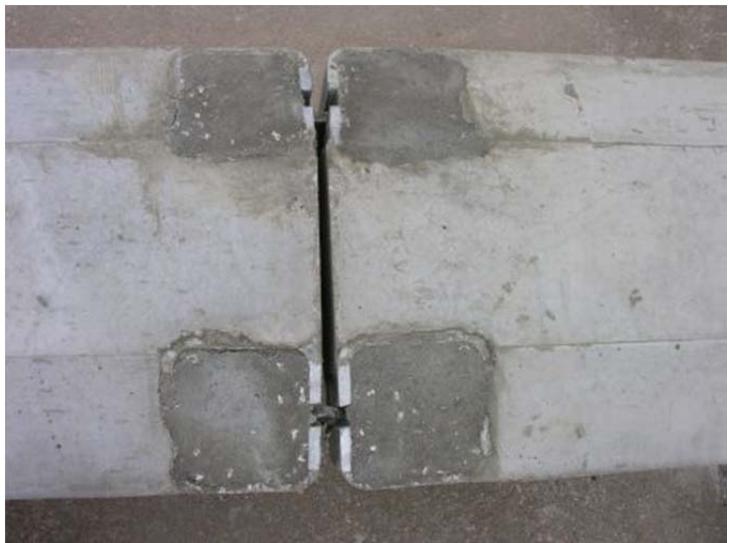
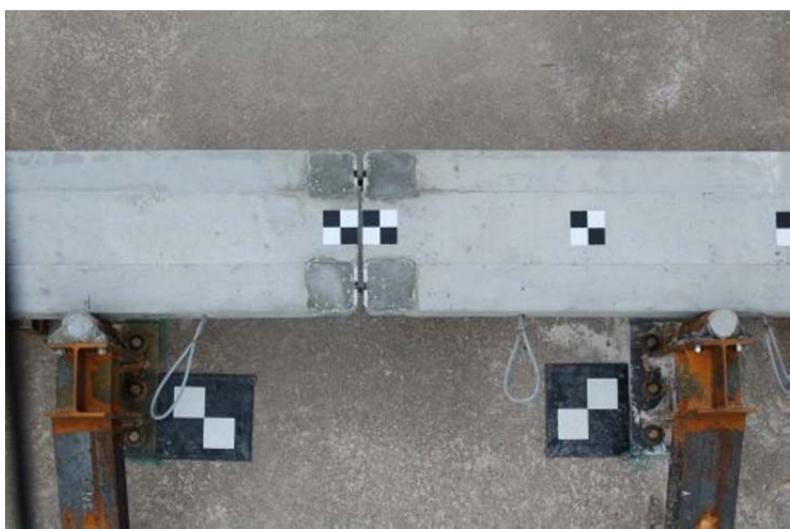
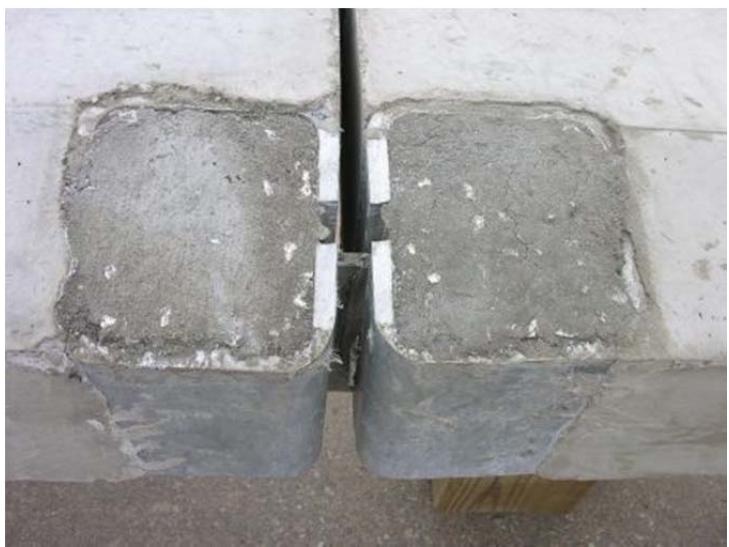
Figure 62. Rail Component Photographs, Test No. PCR-B-1

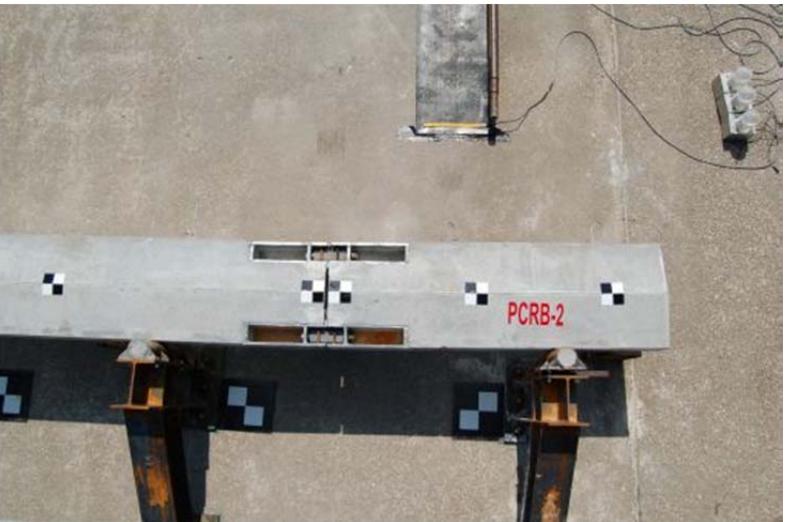
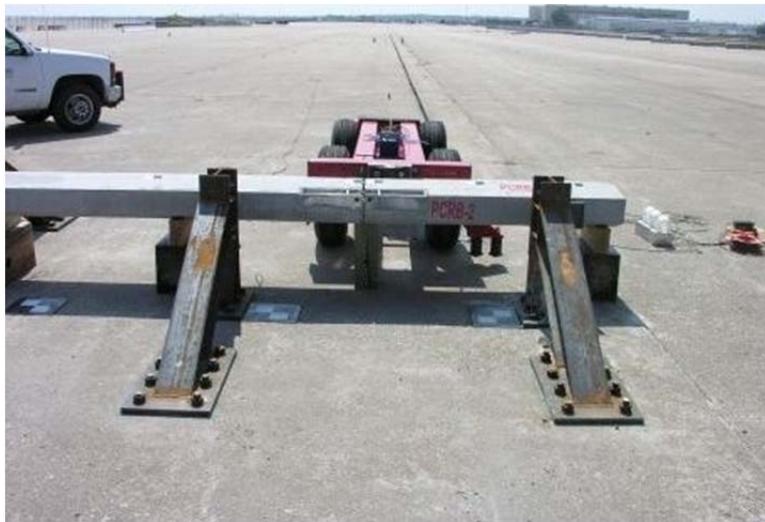
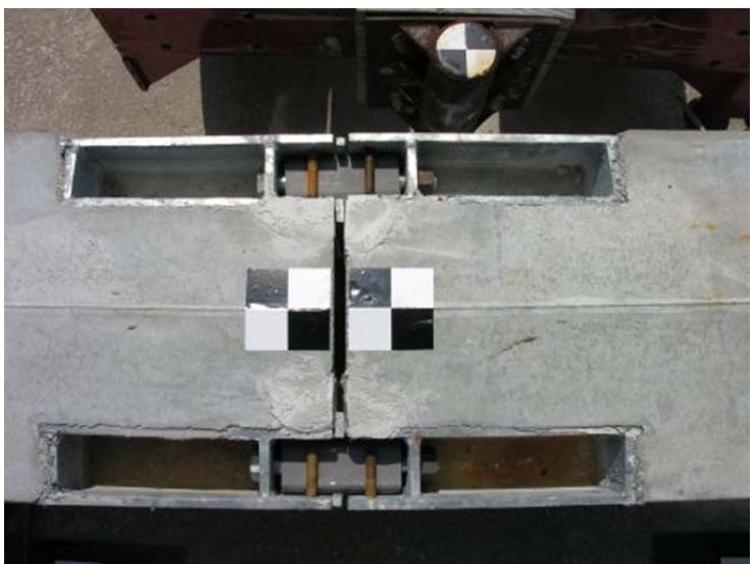
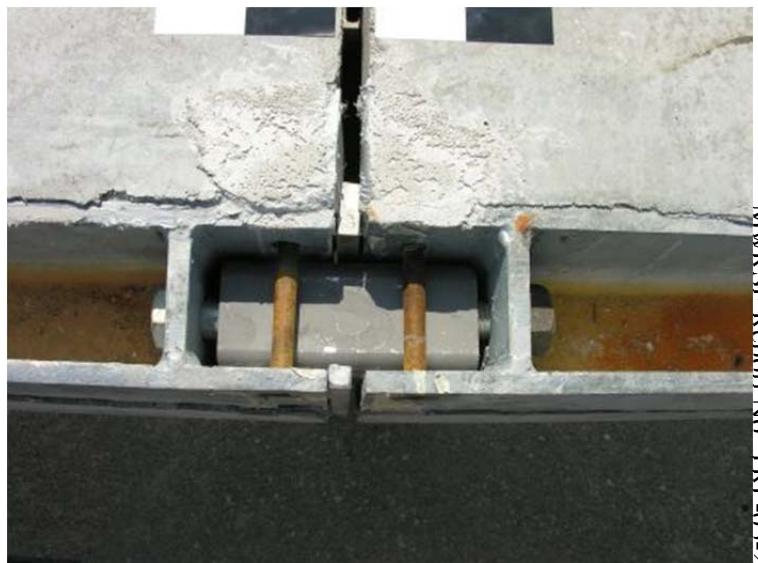
Figure 75. Rail Component Photographs, Test No. PCR-B-2

The segments were set in the same positions as the segments in test no. PCR-B-1, only the rail system was flipped upside down so that the joint hardware could be viewed from the overhead video during the test. Photographs of the assembled joint specimen for test no. PCR-B-2 are shown in Figure 75.

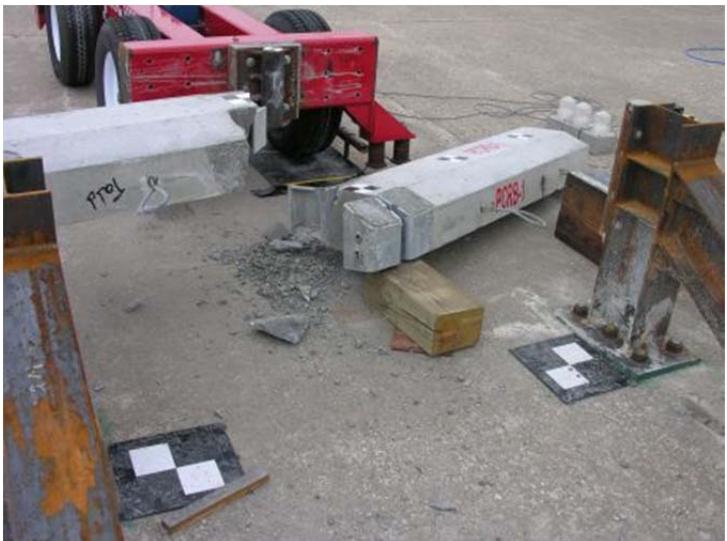
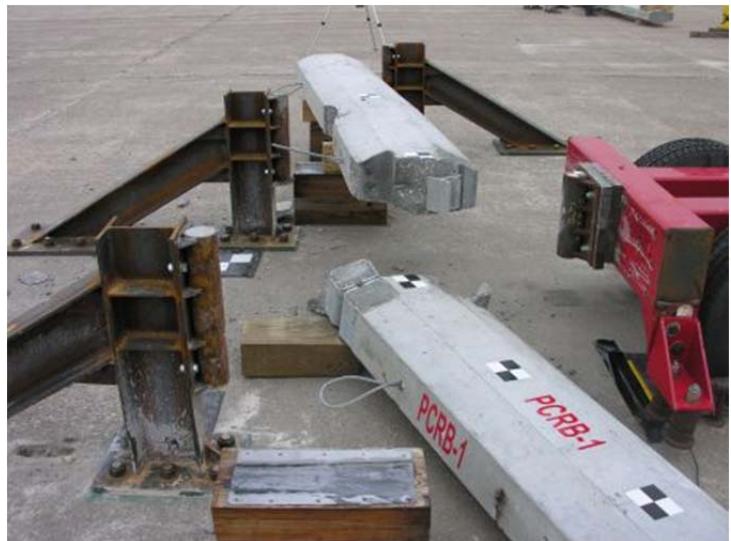
During bogie test no. PCRB-1, the joint failed and the rail segments completely separated, as shown in Figure 78. After the joint failed, the short rail segment (e.g., impact side) spun off of the wood block supports and fell to the ground. The long rail segment (e.g., non-impact side) remained on top of its supports, but had rotated away from the anchor posts following the redirection of the bogie vehicle.

**Figure 78. Component Damage, Test No. PCRB-1**

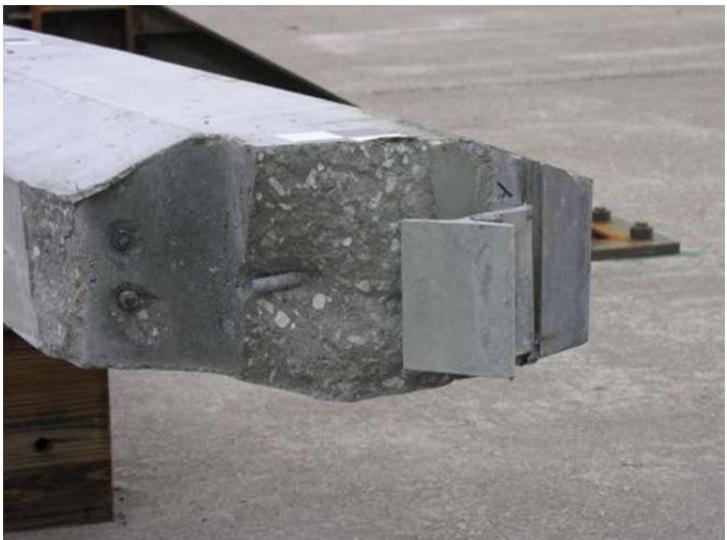
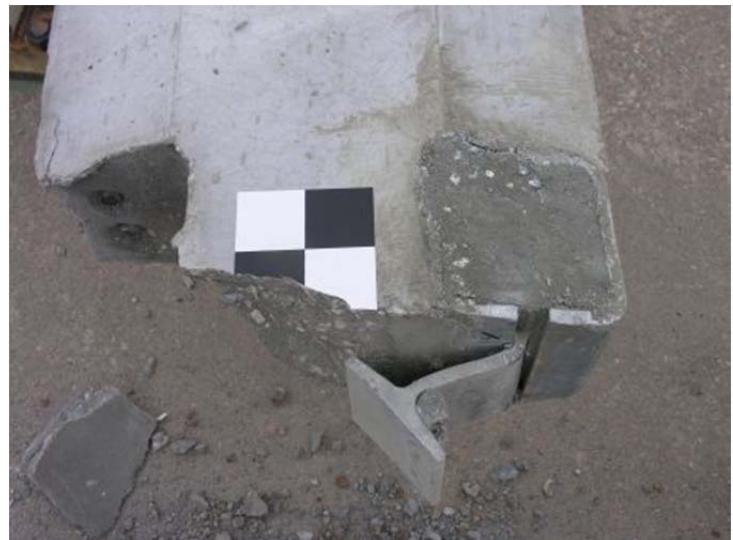
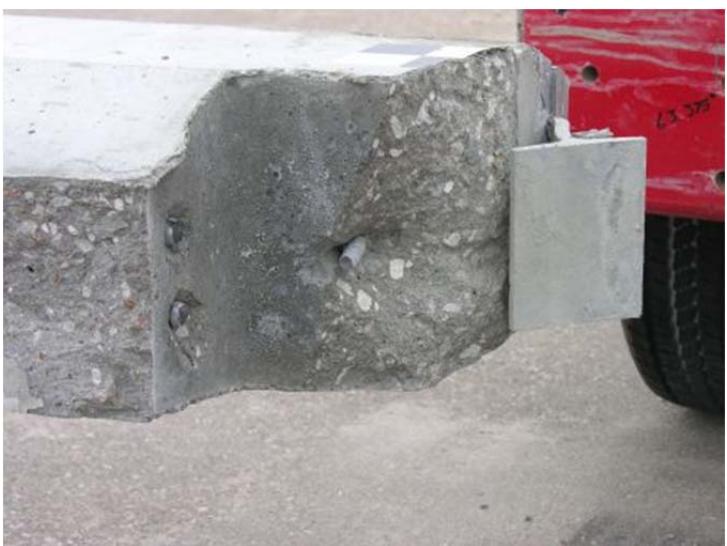
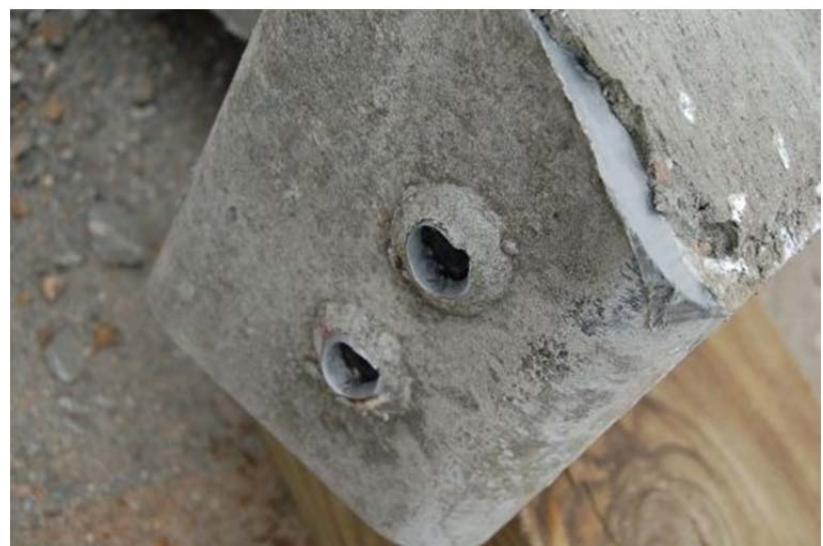
As shown in Figure 79, the I-shape connector used to connect the front grout pockets remained attached to the long rail segment. However, it was bent nearly 90 degrees toward the center of the rail. The back grout pocket of the long rail segment had completely broken away from the rest of the rail. Both of the butt welds attaching the pocket to the longitudinal reinforcement of the rail segment had failed. Also, the rebar running between the grout pockets was bent out toward the joint and the butt weld connecting the rebar to the back pocket had failed. Concrete spalling was located around the area in which the back grout pocket was originally positioned.

**Figure 79. Component Damage – Long Rail Segment, Test No. PCR-B-1**

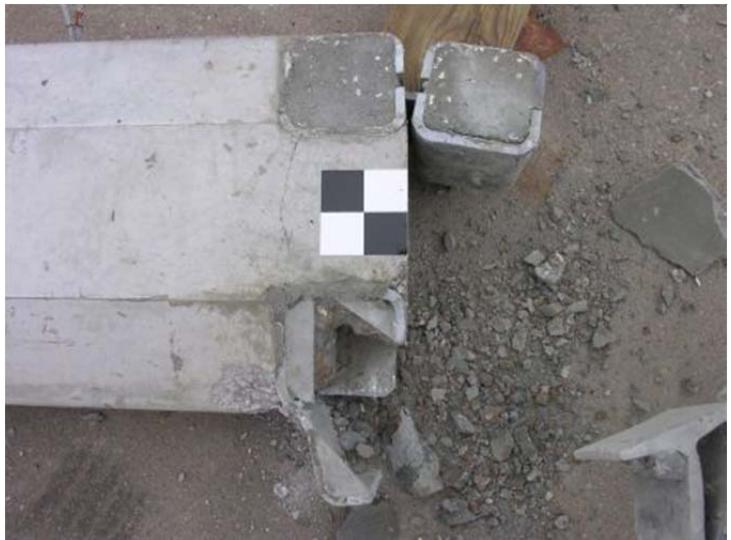
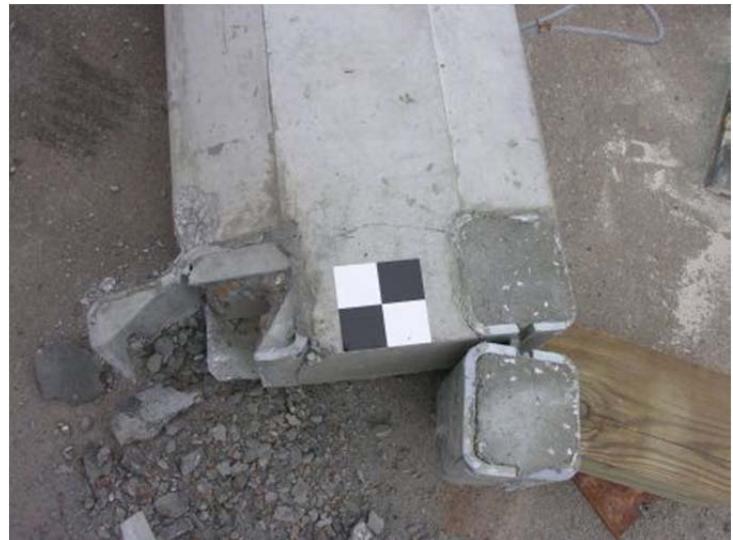
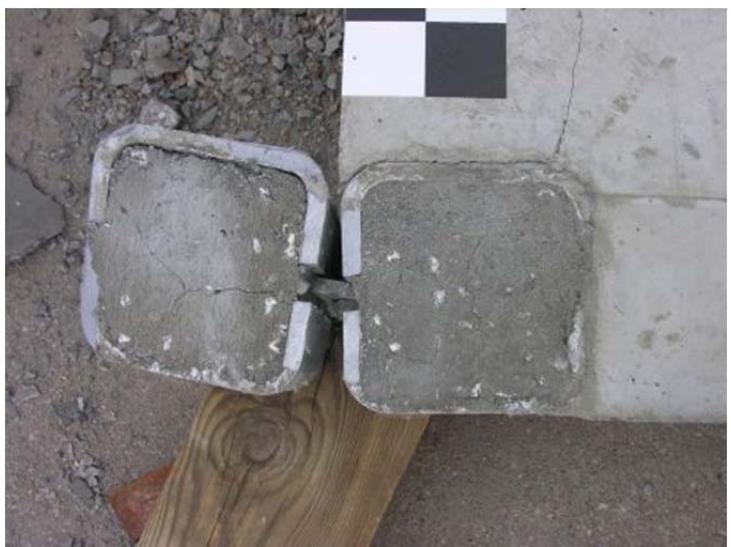
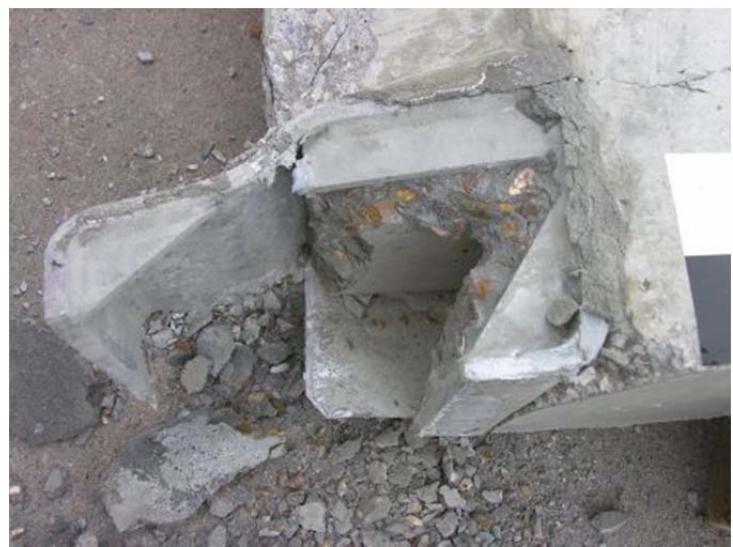
The front grout pocket on the short rail segment was pried open, as shown in Figure 80. Subsequently, the I-shape connector and fragments of grout had been pulled out of the pocket. Concrete shear cracks were found running from the front grout pocket to the back grout pocket. The back grout pocket remained intact. Only minor cracks had formed between the steel pocket and the surrounding concrete rail. The back grout pocket that had been removed from the long rail segment remained attached to the back grout pocket of the small rail segment via the steel I-

**Figure 80. Component Damage – Short Rail Segment, Test No. PCR-B-1**

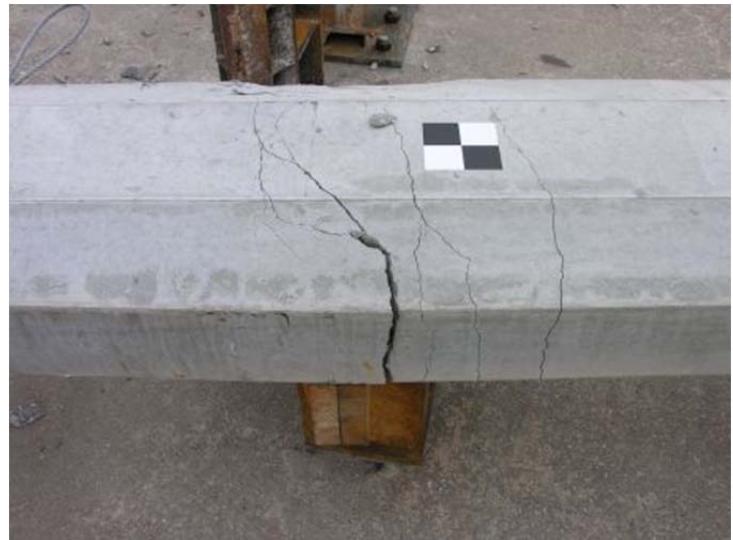
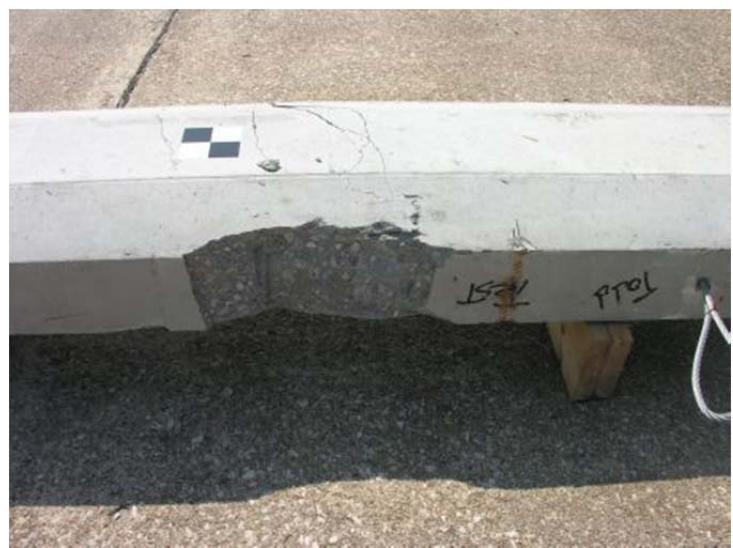
Bending cracks were found in the long rail segment, as shown in Figure 81. Also, a large amount of spalling was observed on the back face of the rail segment. Both the spalling and the bending cracks were located near the middle anchor post and were caused by the bogie frame impacting the long rail segment after the joint had failed. Although this damage was not directly related to the strength of the joint, it was documented to demonstrate that the strength of the rail cross section was adequate to carry the design load with only minor damage.

**Figure 81. Bending Damage of Long Rail Segment, Test No. PCRB-1**

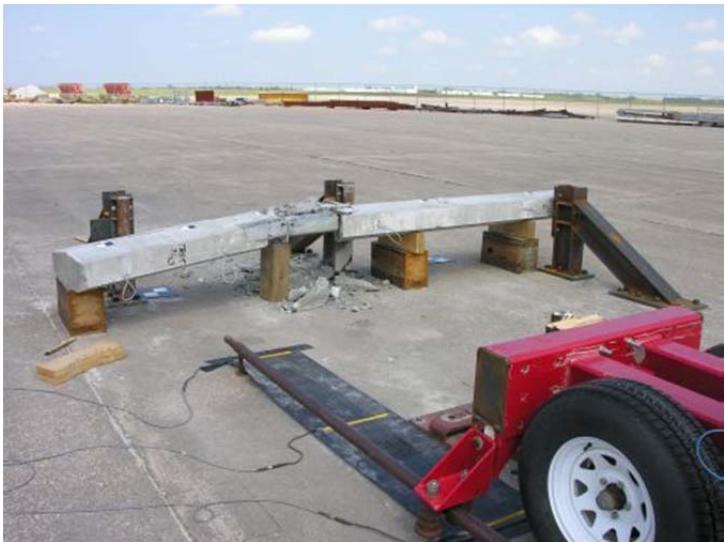
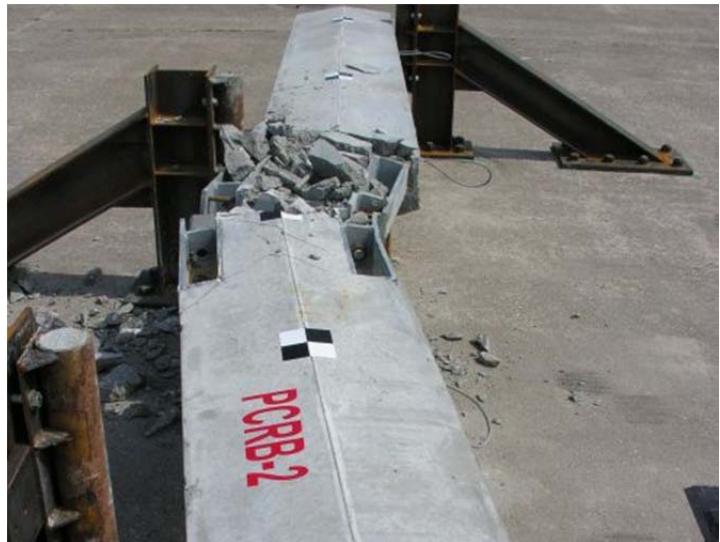
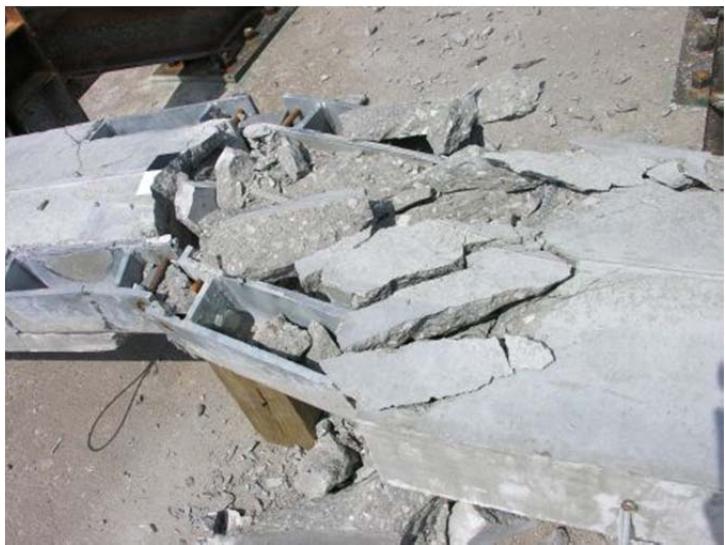
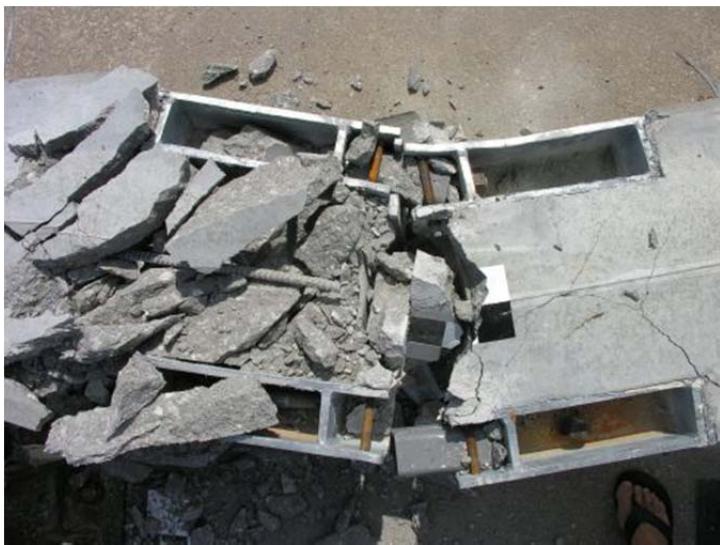
During bogie test no. PCRB-2, the rail-to-rail joint was severely damaged, but it held together, as shown in Figure 86. The concrete between the steel pockets of the long rail segment had completely broken apart. Only the internal steel rebar was preventing the loose concrete from falling to the ground. Due to the loss of concrete, the rebar anchoring the steel pockets to the rest of the long rail segment had bent. This allowed the pockets to rotate backward slightly. Concrete fragments had also broken off of the short rail segment near the joint and on the bottom face (as oriented in the test). Additional concrete cracks were found stemming from the steel pockets of both rail segments.

**Figure 86. Component Damage, Test No. PCRB-2**

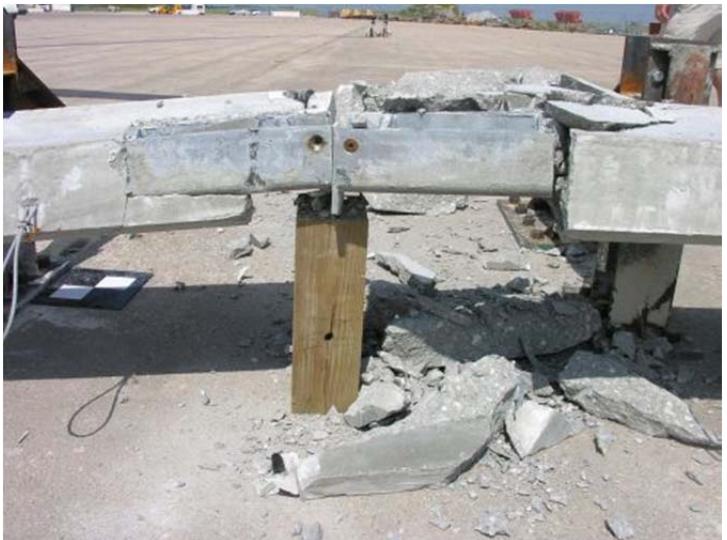
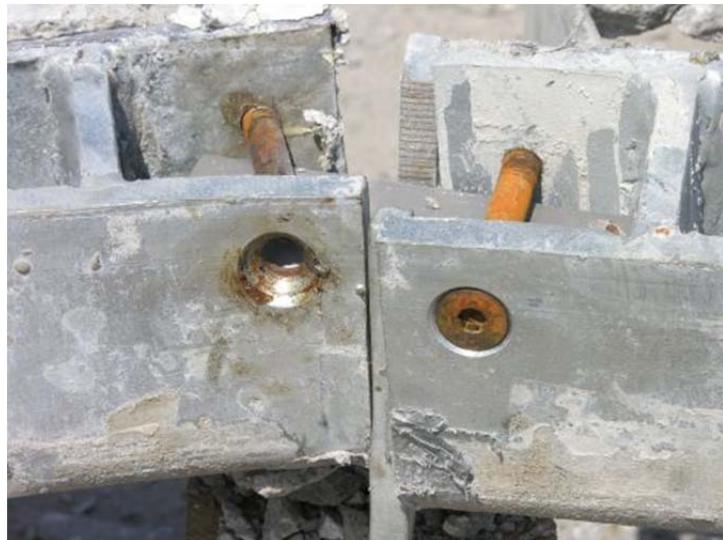
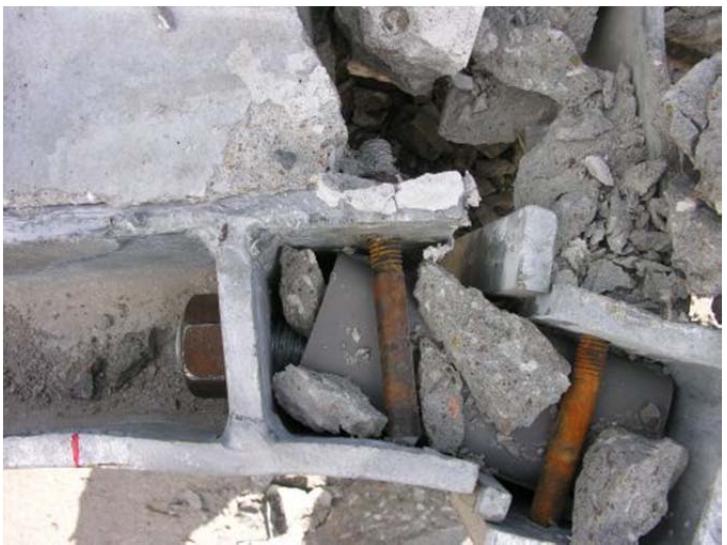
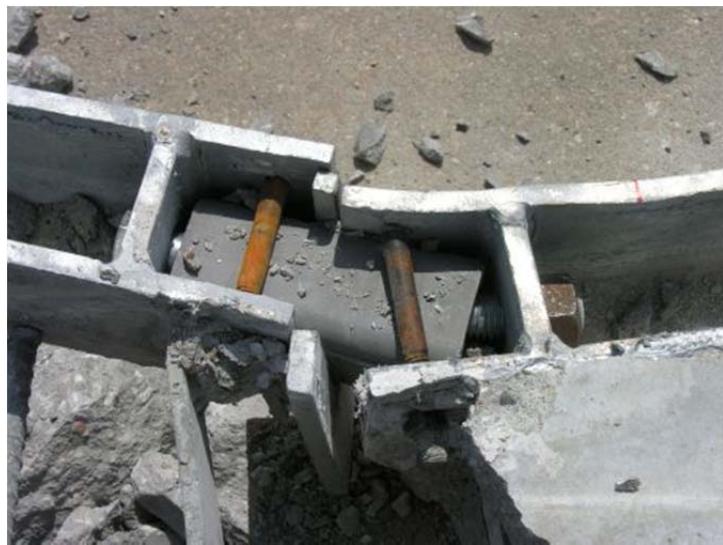
Damage to the front pocket assembly consisted mostly of deformations to the steel pocket walls. The exposed pocket wall of the short rail segment was bent outward, while the inner pocket wall of the long rail segment was bent toward the center of the rail, as shown in Figure 87. The bogie impact head had caused the pocket to pinch together slightly at the point of impact, and the shear bolt on the front pocket of the short rail segment had fractured at the base of the head. Also, the deformation in the joint caused the longitudinal bolt connecting the front pockets to bend.

**Figure 87. Component Damage - Front Pocket Assembly, Test No. PCR-B-2**

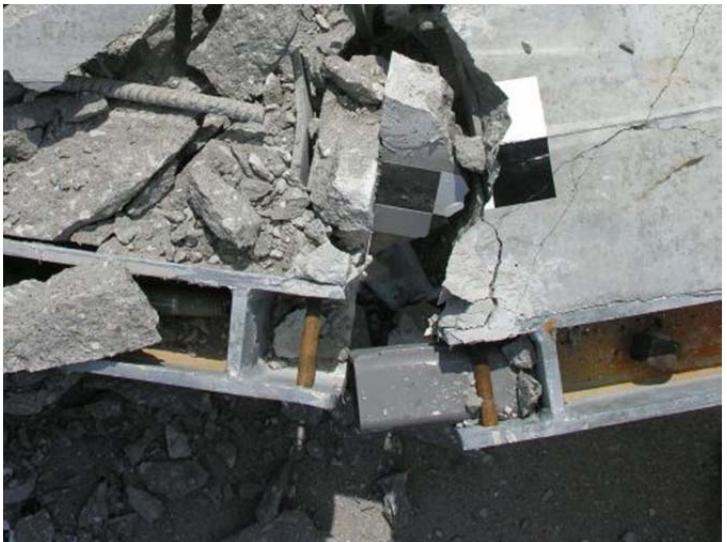
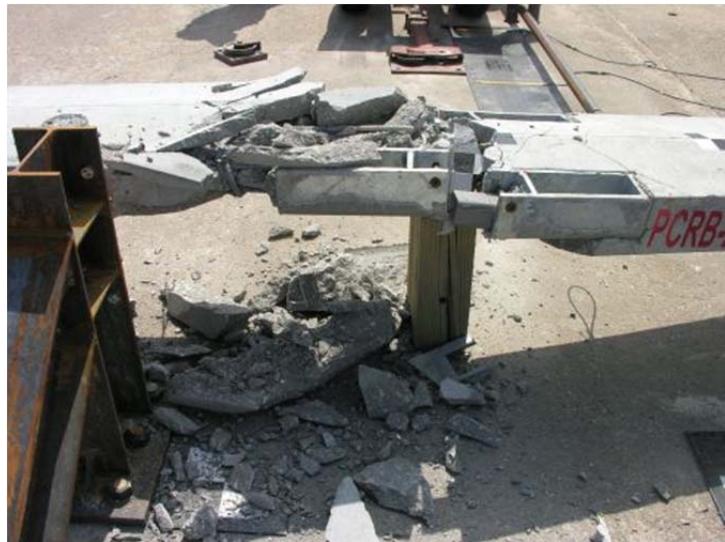
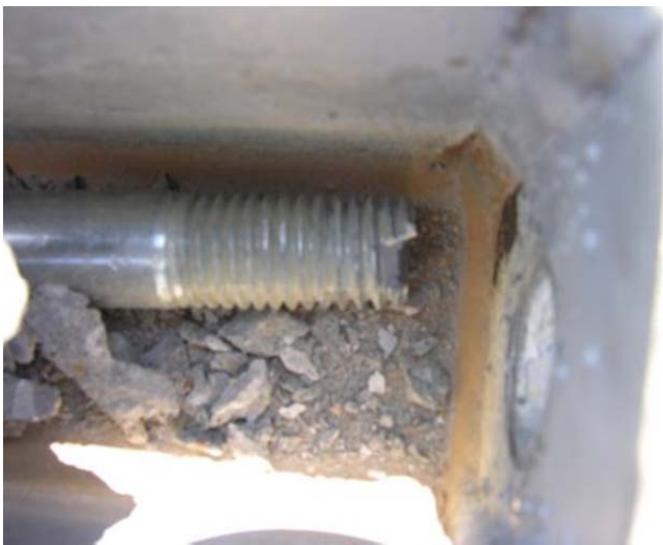
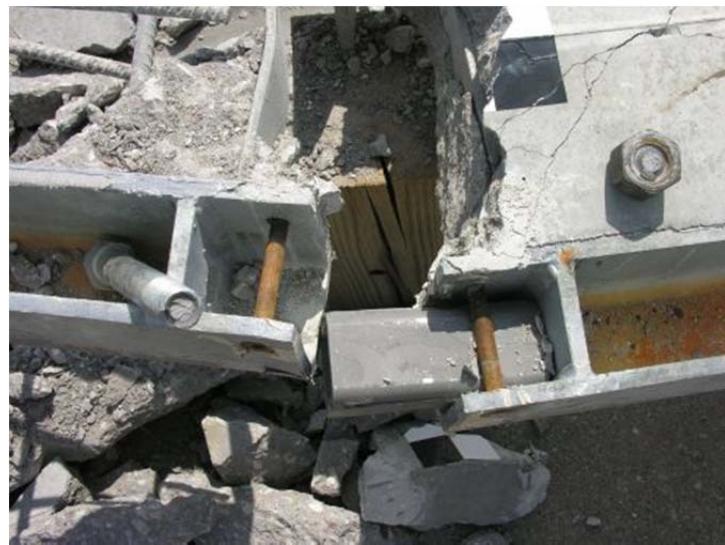
The tension bolt connecting the back pockets had completely fractured, as shown in Figure 88. The bolt had fractured through the threaded portion near the nut. The back side of the joint had widened apart, and the shear tube had popped out of the back pocket of the long rail segment.

**Figure 88. Component Damage – Back Pocket Assembly, Test No. PCRB-2**

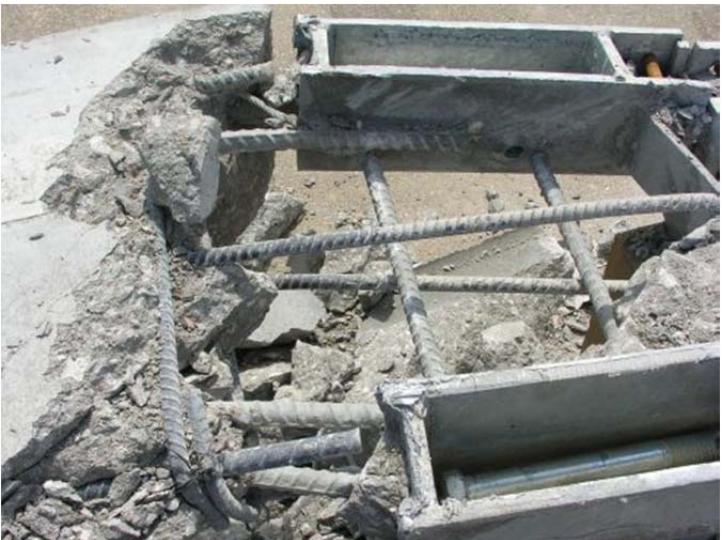
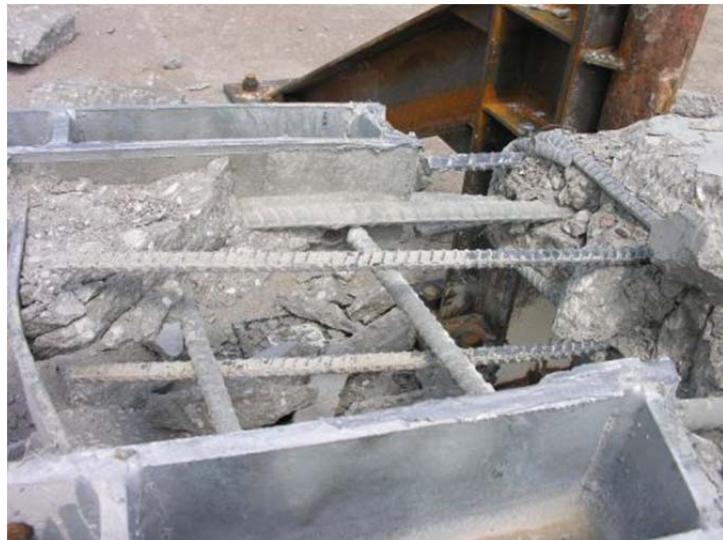
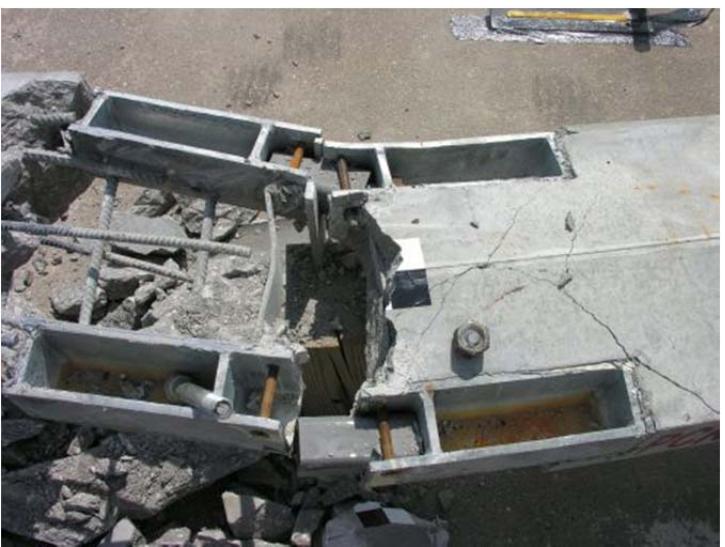
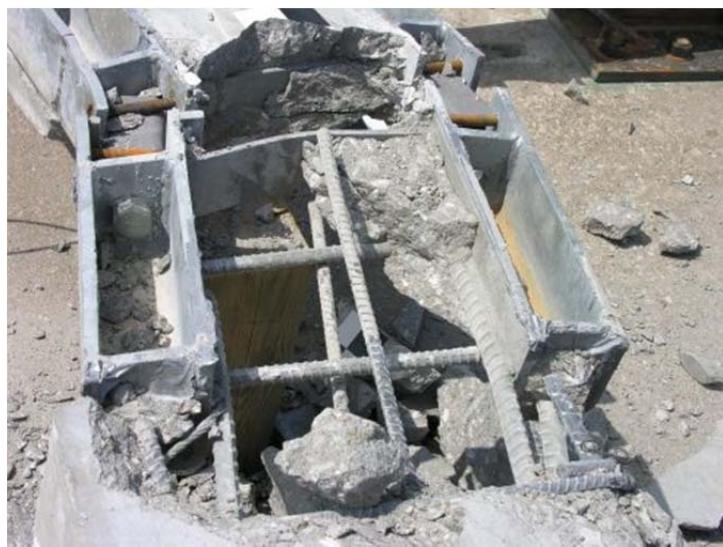
The loose concrete remaining on the rails was removed revealing damage to the interior steel reinforcement of the long rail segment. Similar to test no. PCRB-1, the butt welds used to attach rebar between the steel pockets had failed, as shown in Figure 89. The welds holding the shear plate to the steel pockets remained intact, but the shear plate itself was bent.

**Figure 89. Component Damage – Loose Concrete Removed, Test No. PCR-B-2**

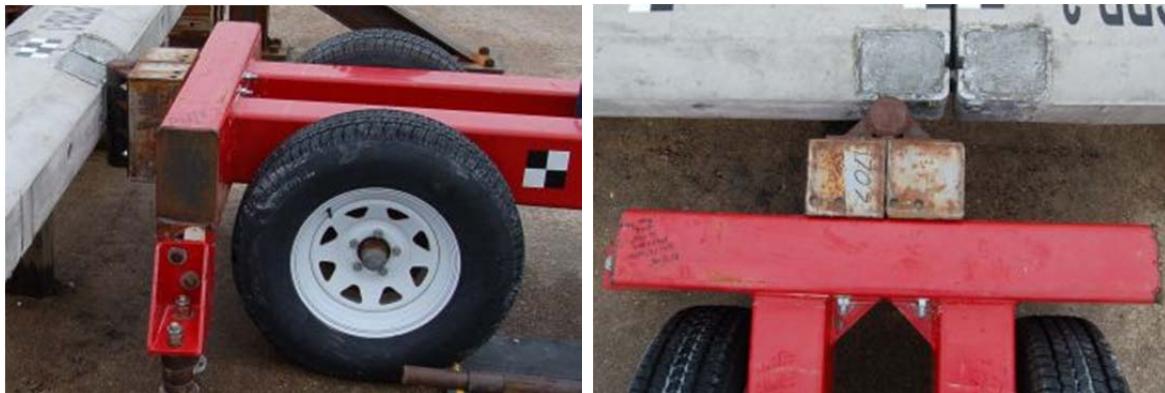
The same bogie vehicle from the first round of bogie testing was used during the second round of testing. However, the wooden blockouts used to offset the bogie head from the vehicle frame were damaged during test no. PCRB-2. As such, steel tubes were used instead of wooden blockouts to provide a more robust bogie head. These steel tubes were filled with concrete and capped with a steel plate, as shown in Figure 95. The weight of the bogie with the addition of concrete filled steel tubes to the impact head was 1,707 lbs (774 kg).

**Figure 95. Bogie Impact Head with Steel Tube Blockouts**

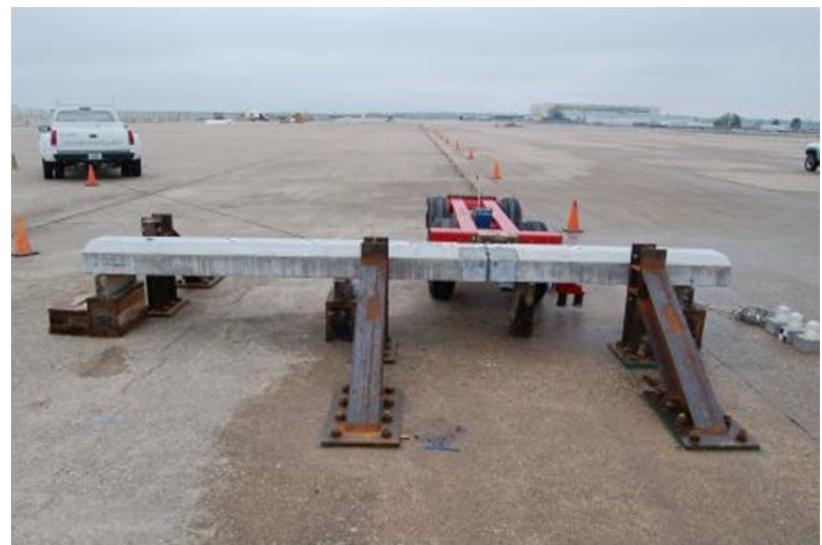
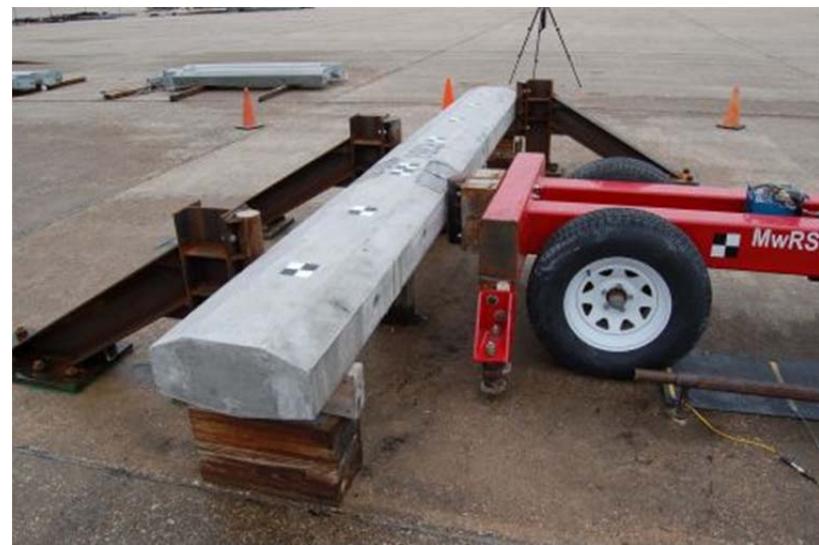
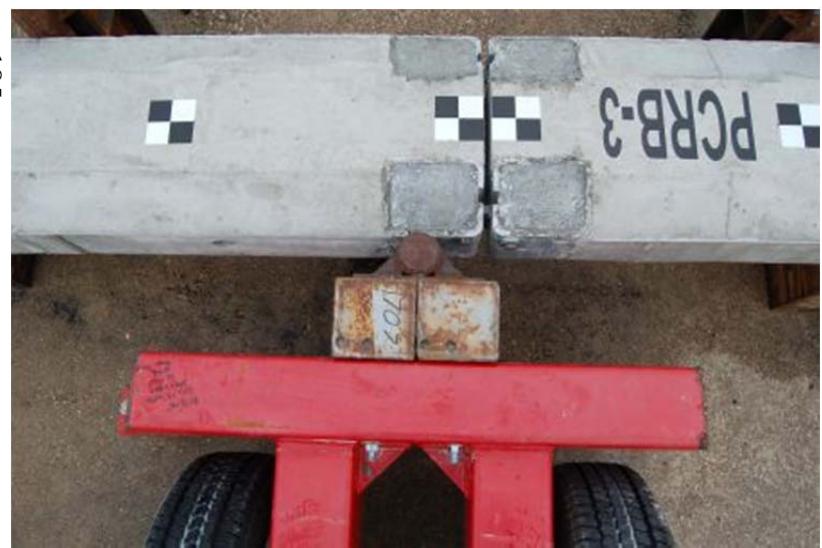
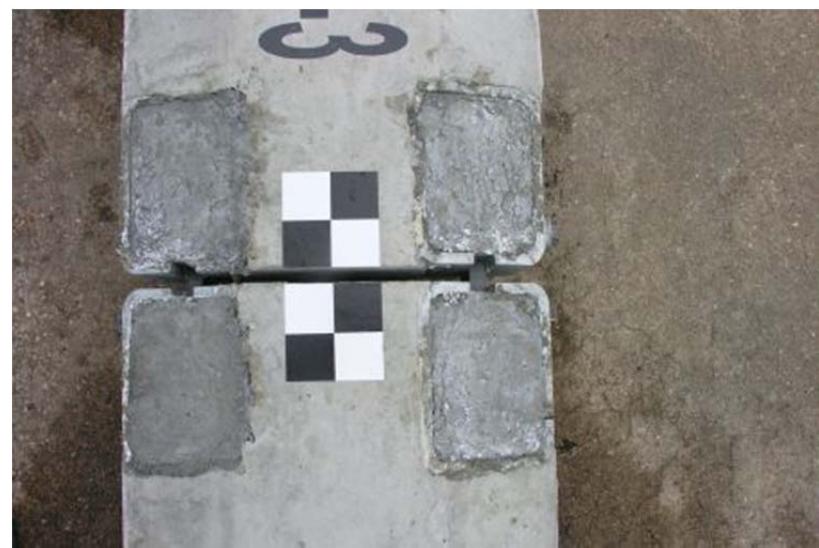
**Figure 111. Rail Component Photographs, Test No. PCRB-3**

The rail segments were placed on wooden support blocks and positioned as prescribed by Section 6.2 and Figure 48. To assemble the rail joint, two I-shape connectors were dropped into the pockets with the web spanning across the  $\frac{1}{2}$ -in. (13-mm) wide gap between rail ends. Next, a  $\frac{5}{8}$ -in. (16-mm) diameter shear bolt was inserted through the  $1\frac{11}{16}$ -in. (17-mm) diameter holes of each pocket and turned through the fixed nut on the inside surface of each pocket. Once the connectors and shear bolts were in place, L&M Crystex grout with a strength of 10,000 psi (69 MPa) was used to fill the pockets and secure the steel I-shape connectors. Photographs of the assembled joint specimen are shown in Figure 111.

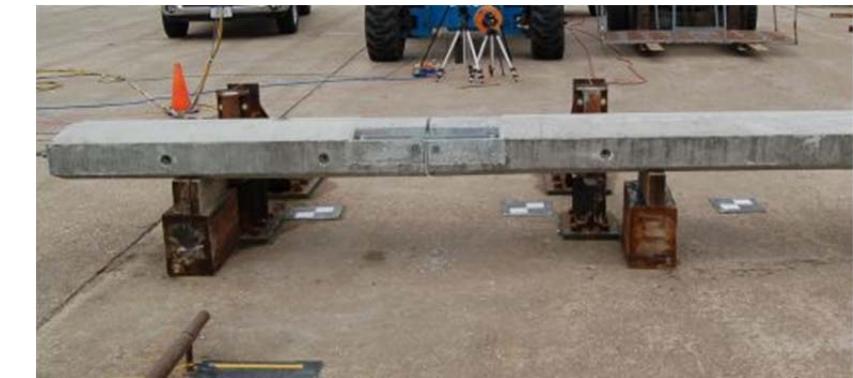
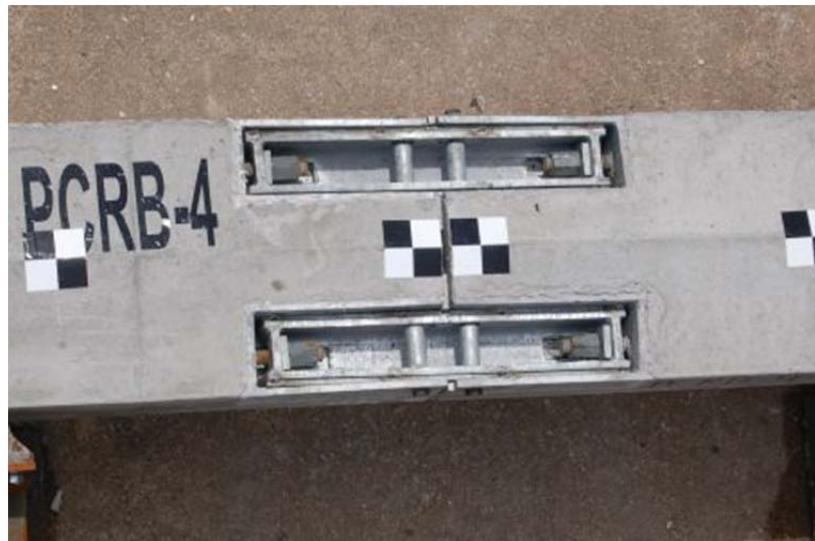
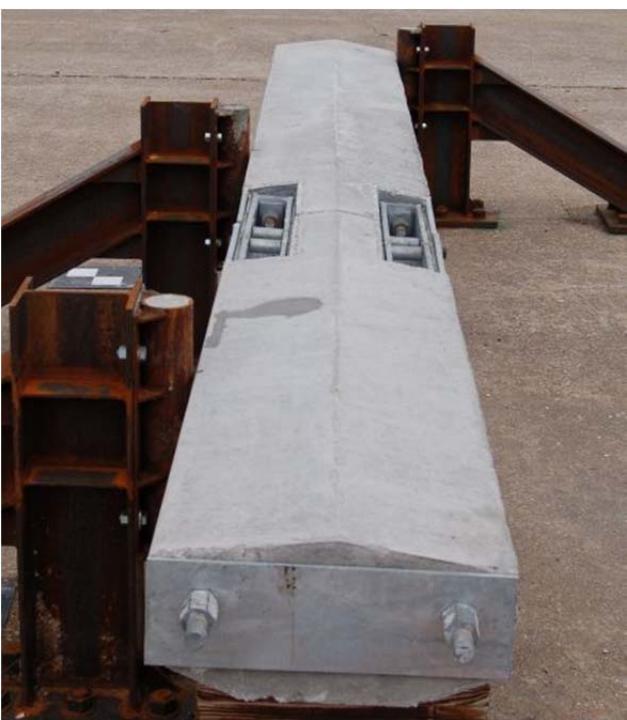
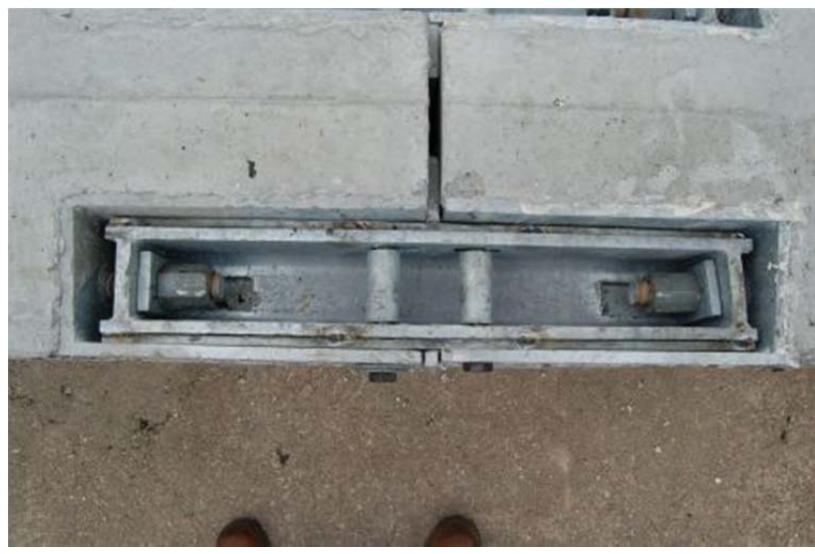
**Figure 132. Rail Component Photographs, Test No. PCRB-4**

Assembly of the joint began with the shear tube connector being inserted into adjacent pockets such that the longitudinal rail steel (i.e., threaded no. 8 bars) passed through the slots cut into the top of the connector and gusset plates. Next, washers and nuts were placed on the threaded no. 8 bars inside the shear tube connector to hold the connector in place. Shims were dropped into the ½-in. (13-mm) gap between rail ends and over the connectors. Then, the nuts were tightened which pulled the rail ends together on the shim plates and tied the longitudinal steel from adjacent rails together through the shear tube connector. Finally, shear bolts were slid into place through the pocket, shear tube connector, and collars and were fastened to the pocket by the nut welded to the inside of the pocket. Photographs of the assembled joint specimen are shown in Figure 132.
