*NDOR Project No. SPR-P1(07) P596*

## **PHASE I DEVELOPMENT OF AN AESTHETIC, PRECAST CONCRETE BRIDGE RAIL**

MwRSF Research Report No. TRP-03-239-12

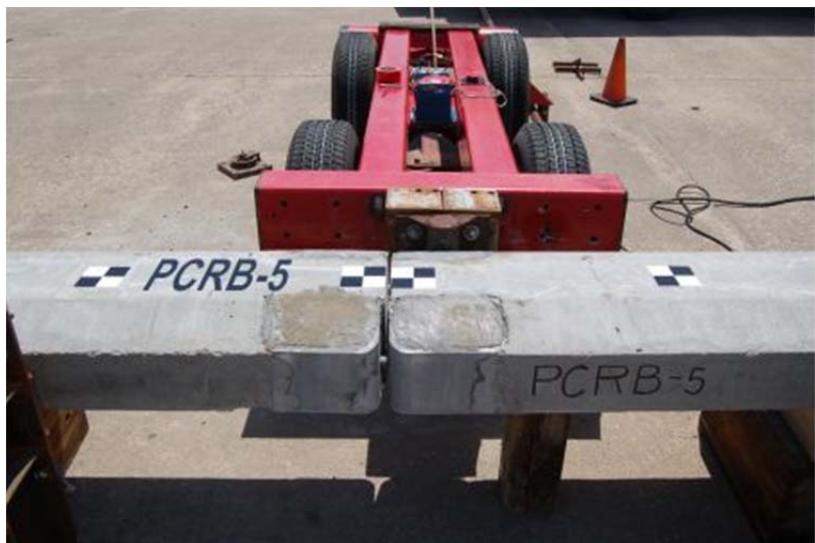
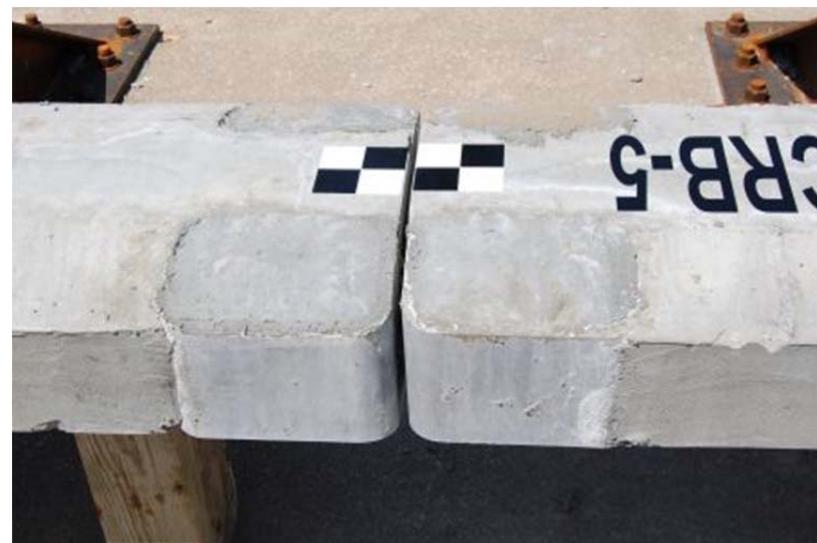
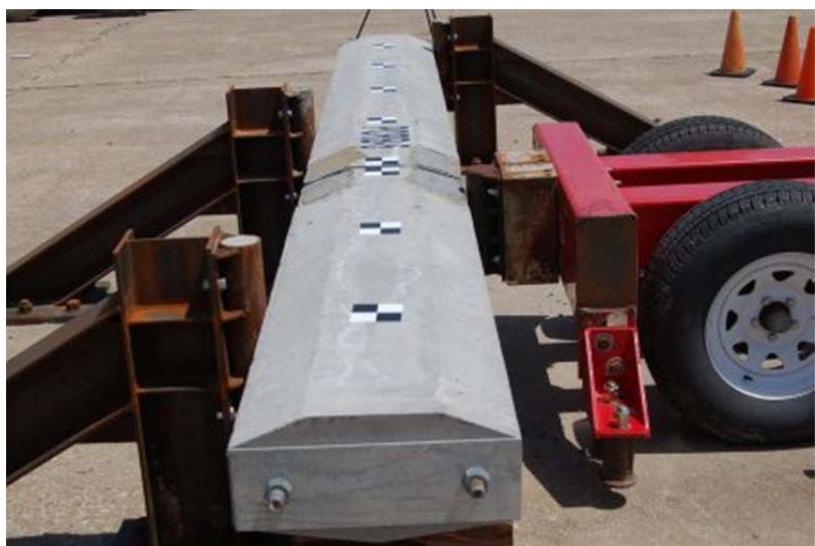
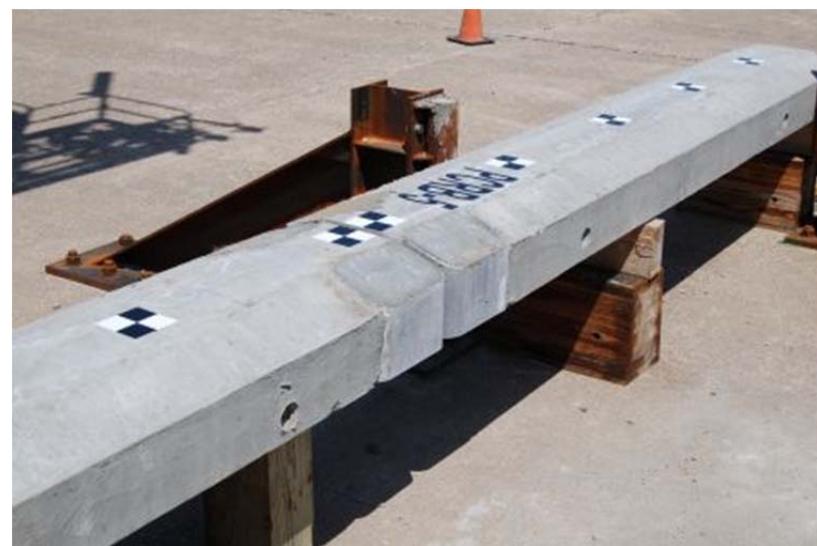
Figure 146. Rail Component Photographs, Test No. PCR-B-5

Photographs of the assembled joint specimen are shown in Figure 146.

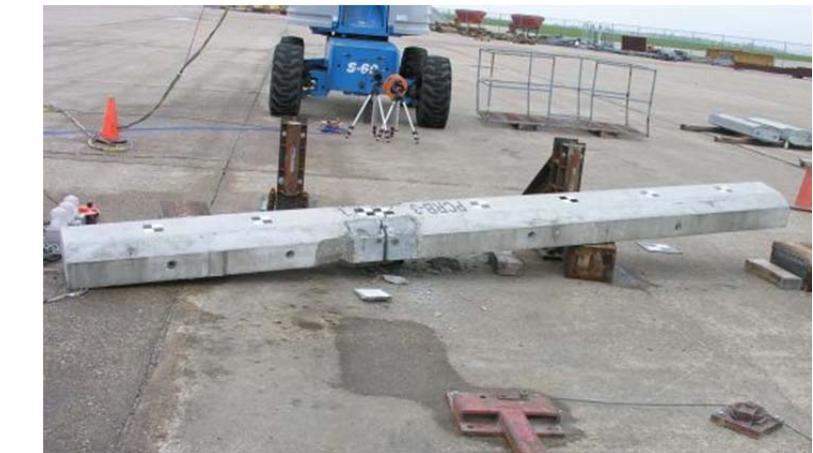
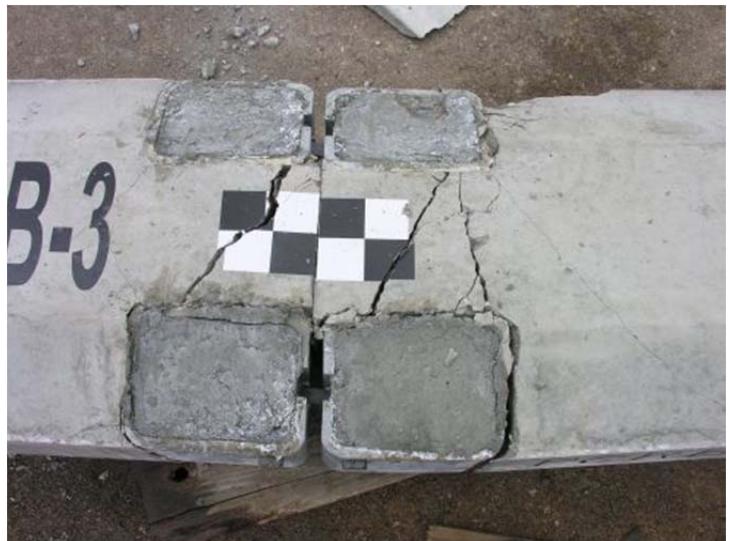
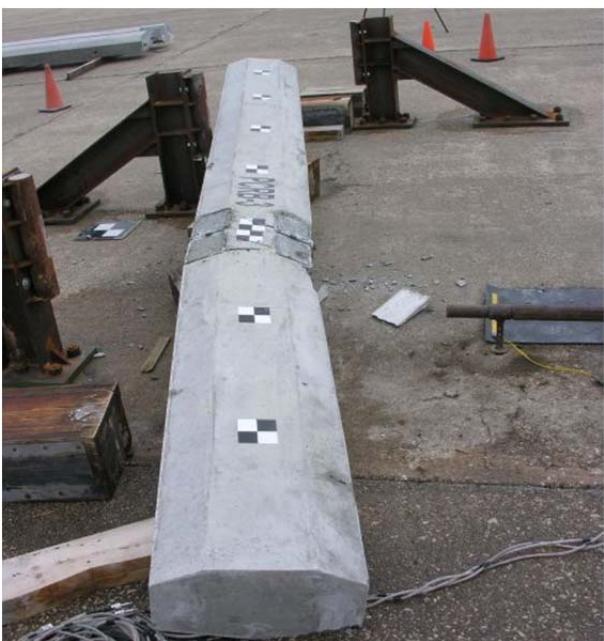
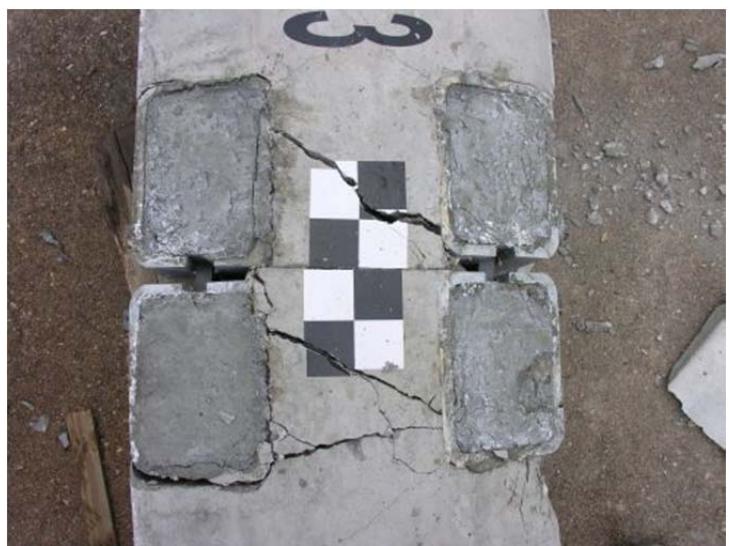
**Figure 148. Component Damage, Test No. PCR-B-3**

Damage to the rail component consisted mainly of cracks and concrete spalling, as shown in Figures 148 through 150. Both rail segments suffered large shear cracks running between the front and back steel pockets. Also, the back pockets of both rails had separation cracks along the

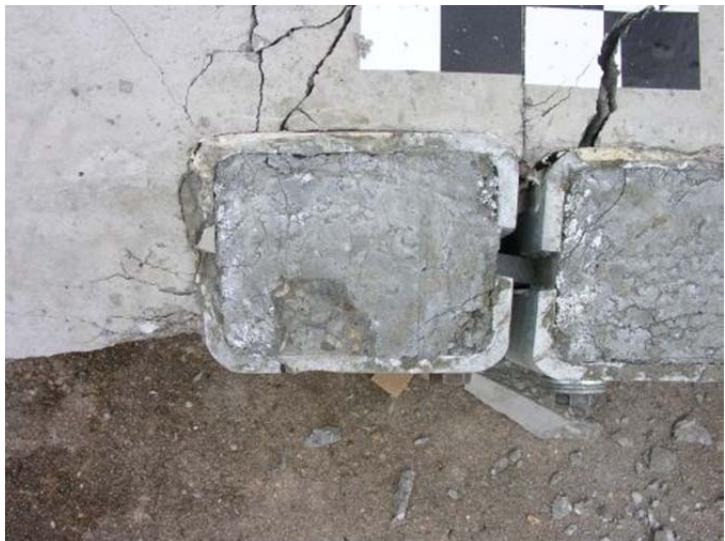
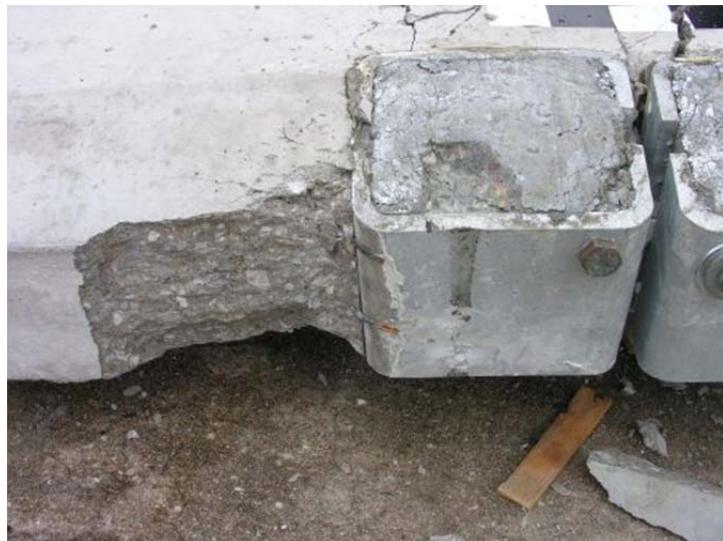
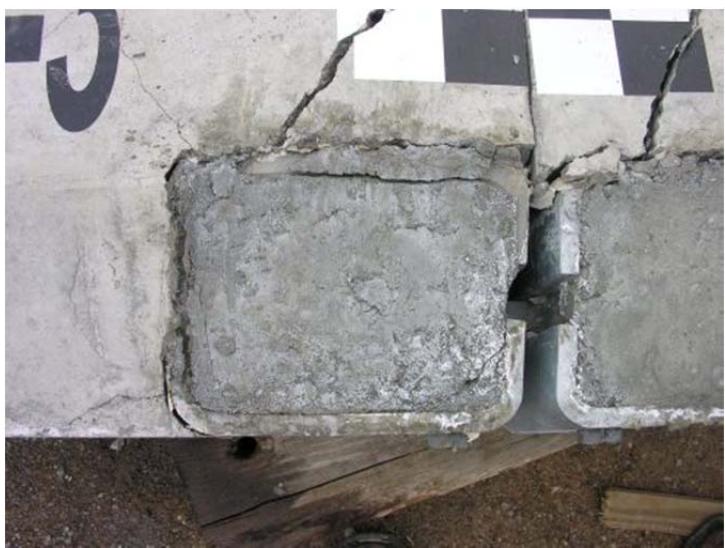
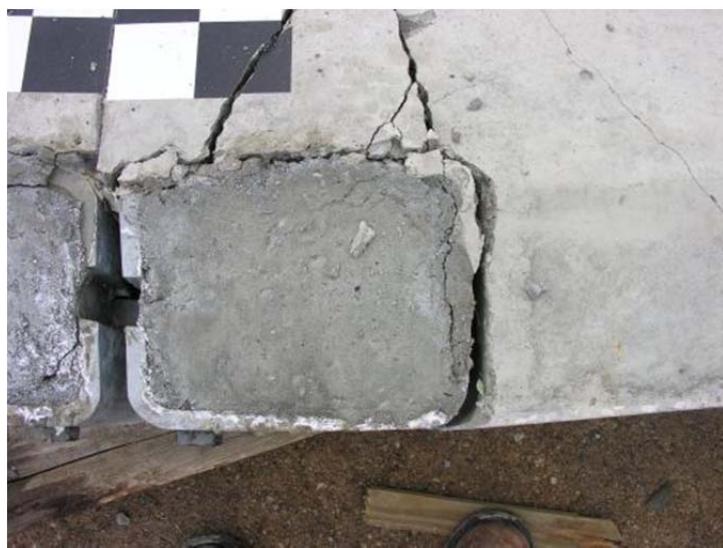
**Figure 149. Component Damage – Steel Pockets, Test No. PCRB-3**

The front pocket of the short rail segment was slightly indented from direct contact with the bogie impact head. Also, a small piece of grout had chipped off from the top surface of this grout pocket, as shown in Figure 149. A 6 x 6 in. (152 x 152 mm) area of concrete spalling was located on the front face of the short rail segment adjacent to the steel pocket. Finally, tension cracks were found in the long rail segment near the location of the middle anchor post support, as shown in Figure 150.

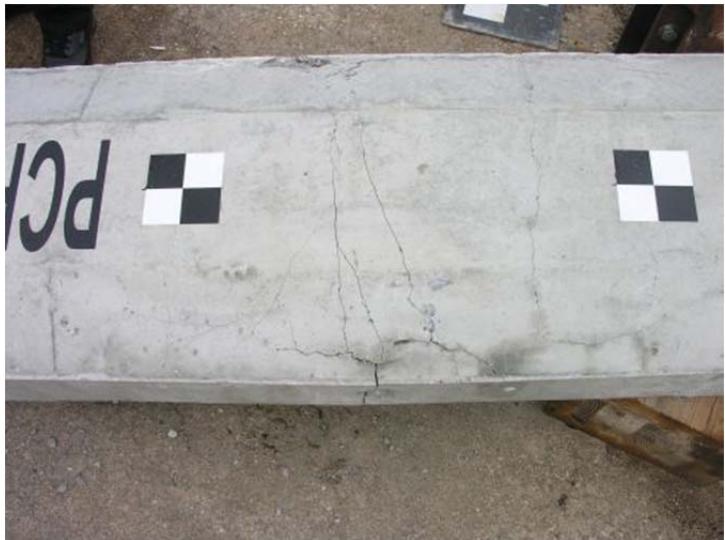
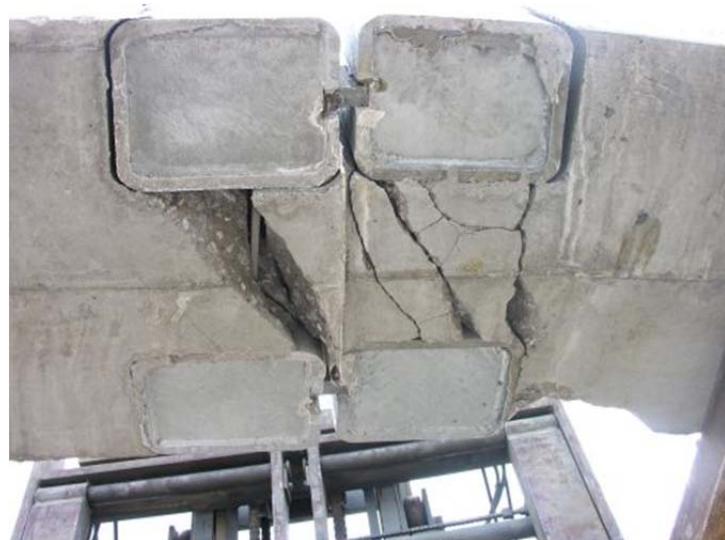
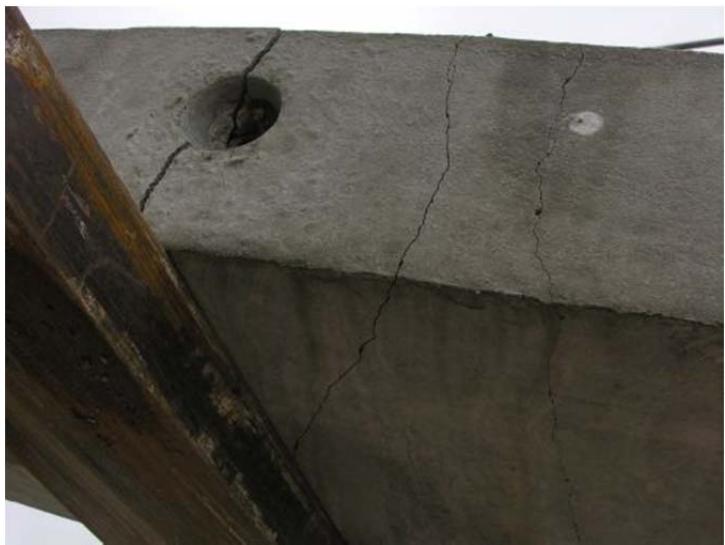
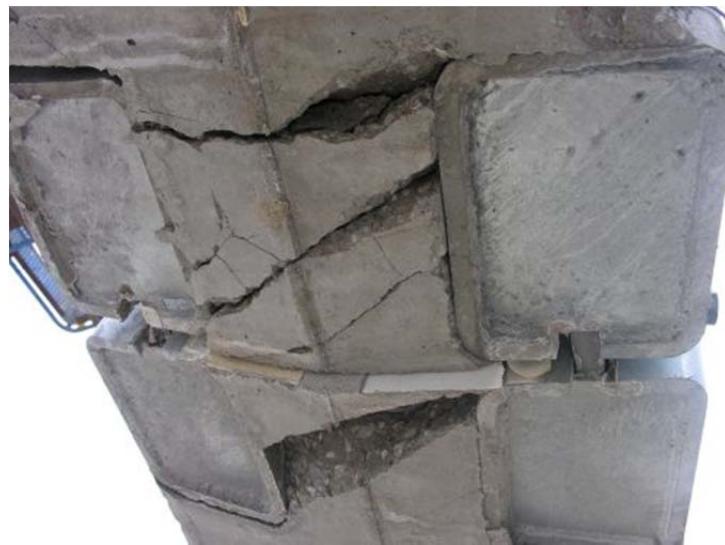
**Figure 150. Rail Tension Cracks and Damage to Bottom of Joint, Test No. PCRB-3**

interface between the steel and concrete. However, the threaded rebar remained intact with the joint and was still able to anchor the back pockets. Small separation cracks were also found on the inside of the pocket along the interface between the steel and grout. Both separation cracks and the shear cracks running between the pockets were found on the bottom surface of the rail component as well, as shown in Figure 150.

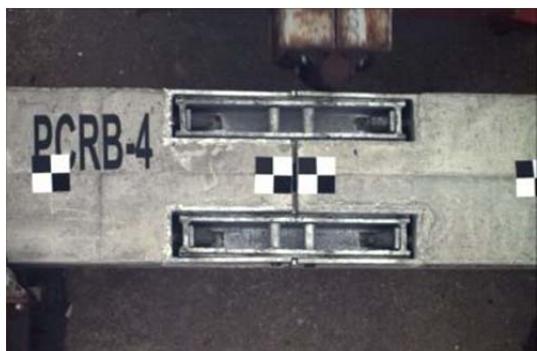
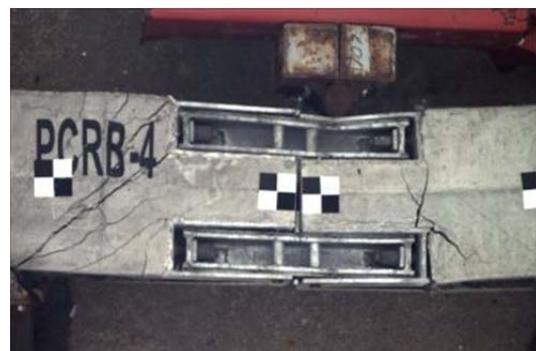
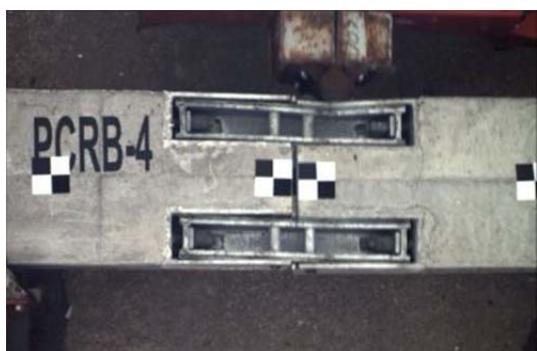
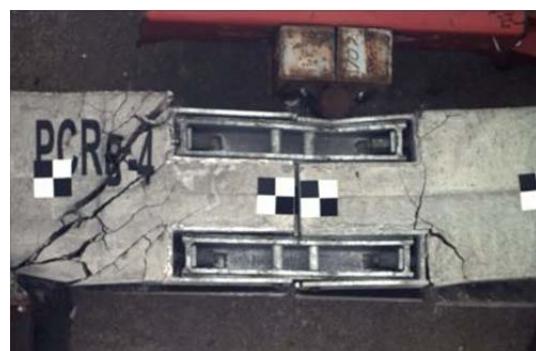
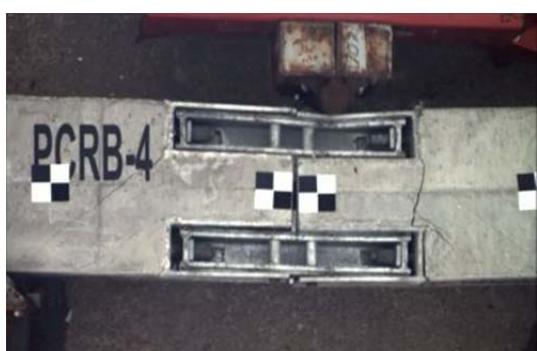
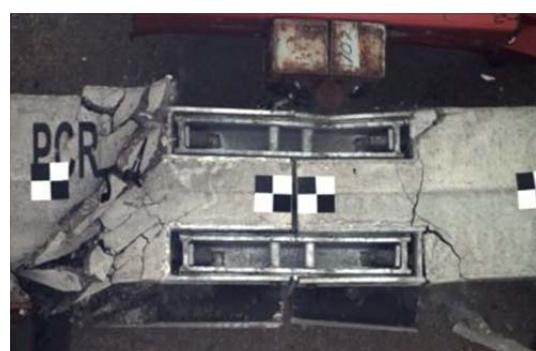
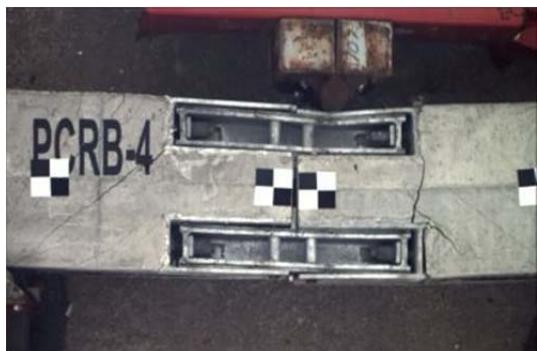
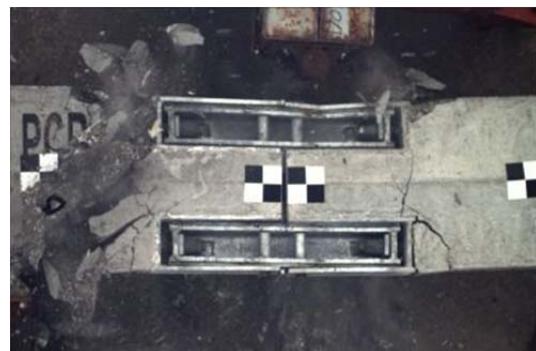
**Figure 152. Sequential Photographs, Test No. PCRB-4**

plate slipped out of the joint and fell to the ground. Sequential photographs of the impact event are shown in Figures 152 and 153.

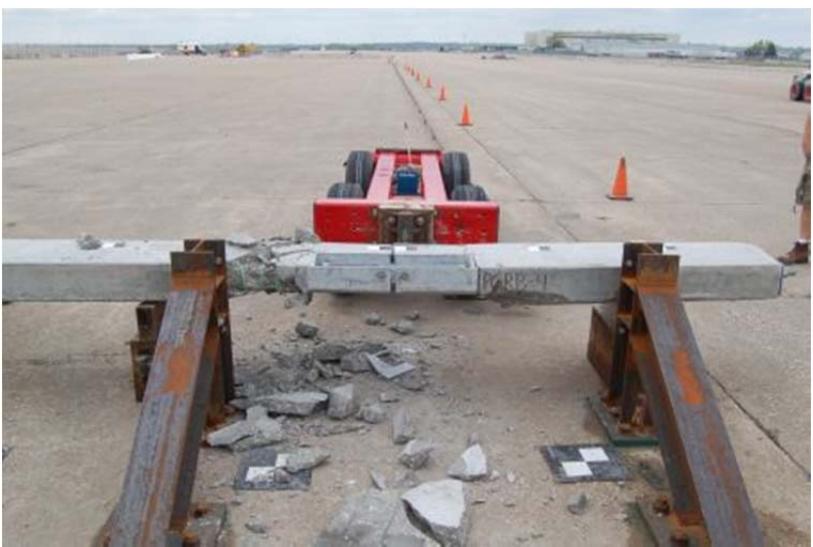
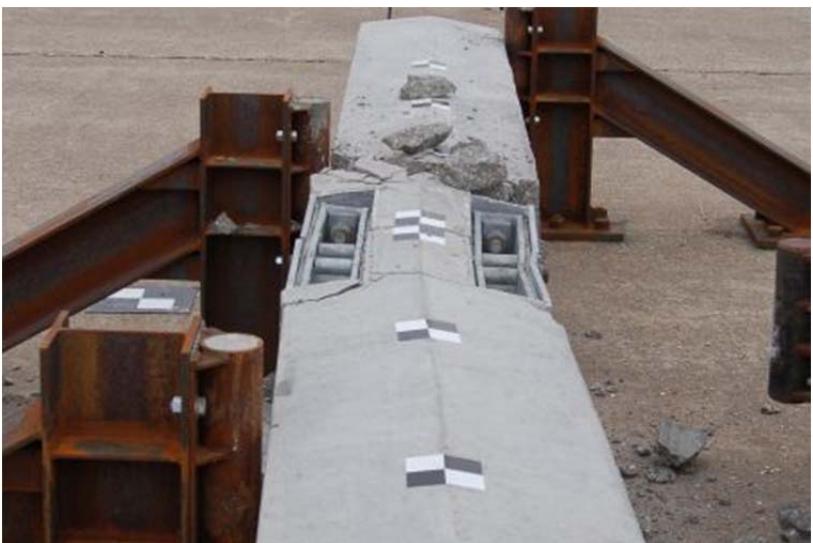
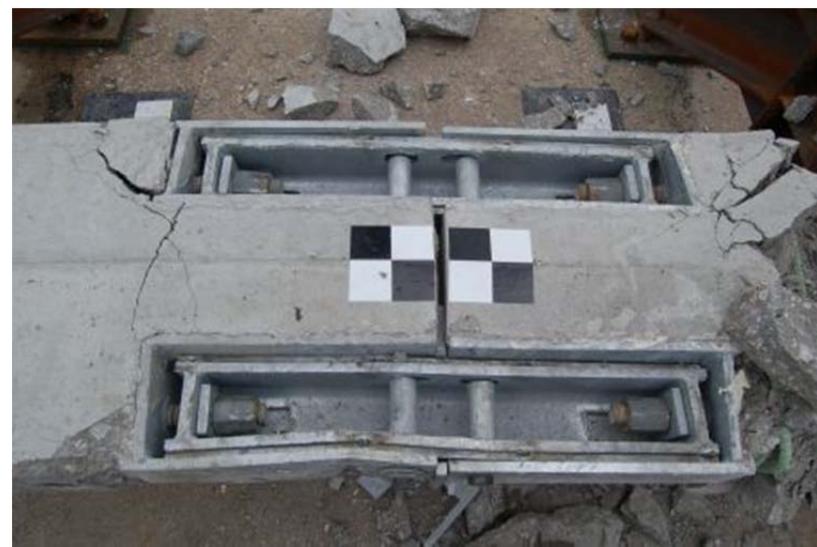
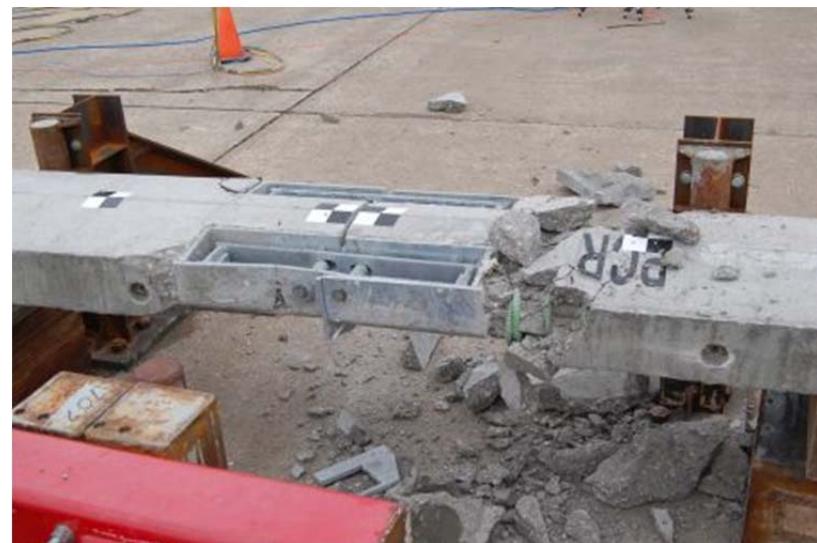
Figure 154. Component Damage, Test No. PCR-B-4

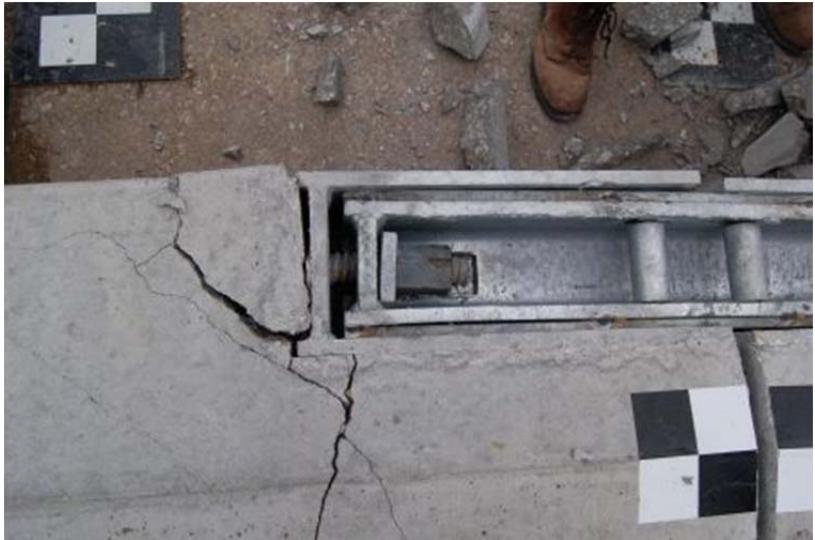
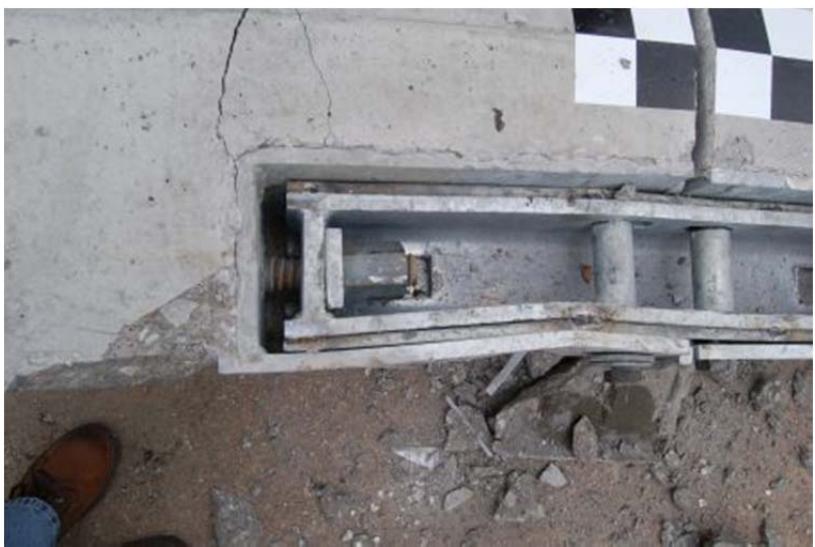
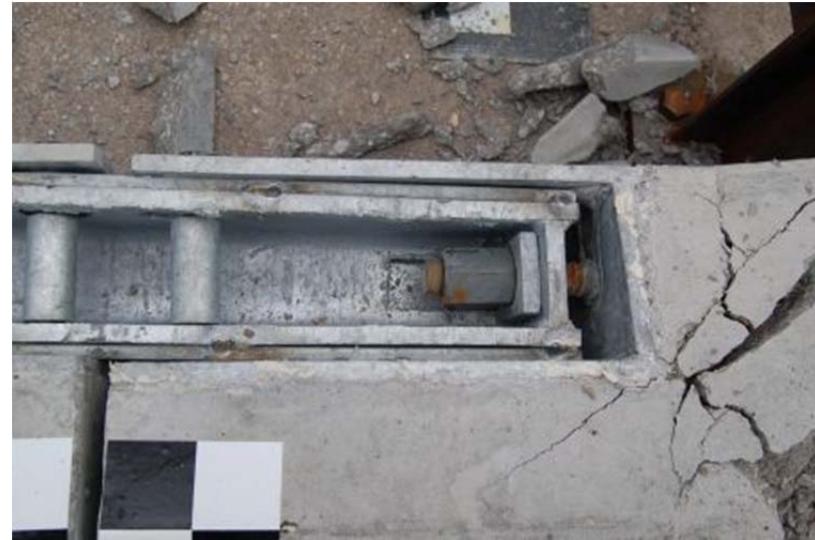
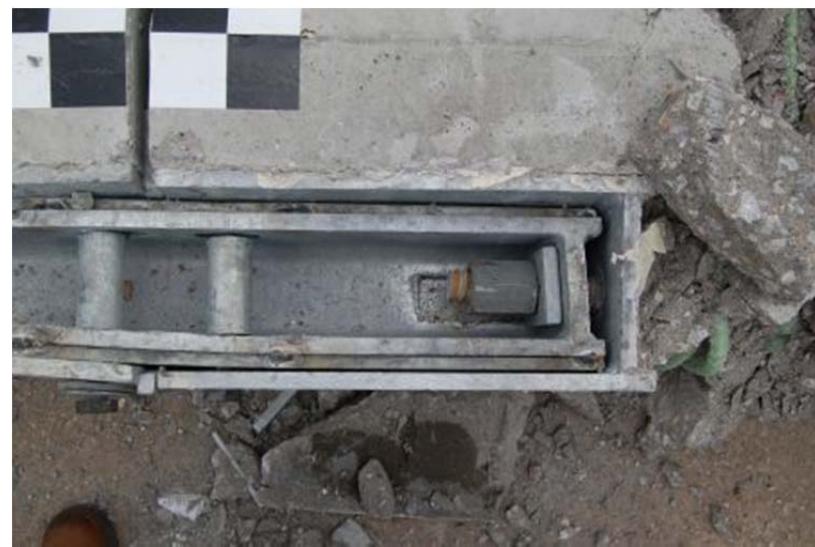
**Figure 155. Component Damage – Steel Pockets, Test No. PCR-B-4**

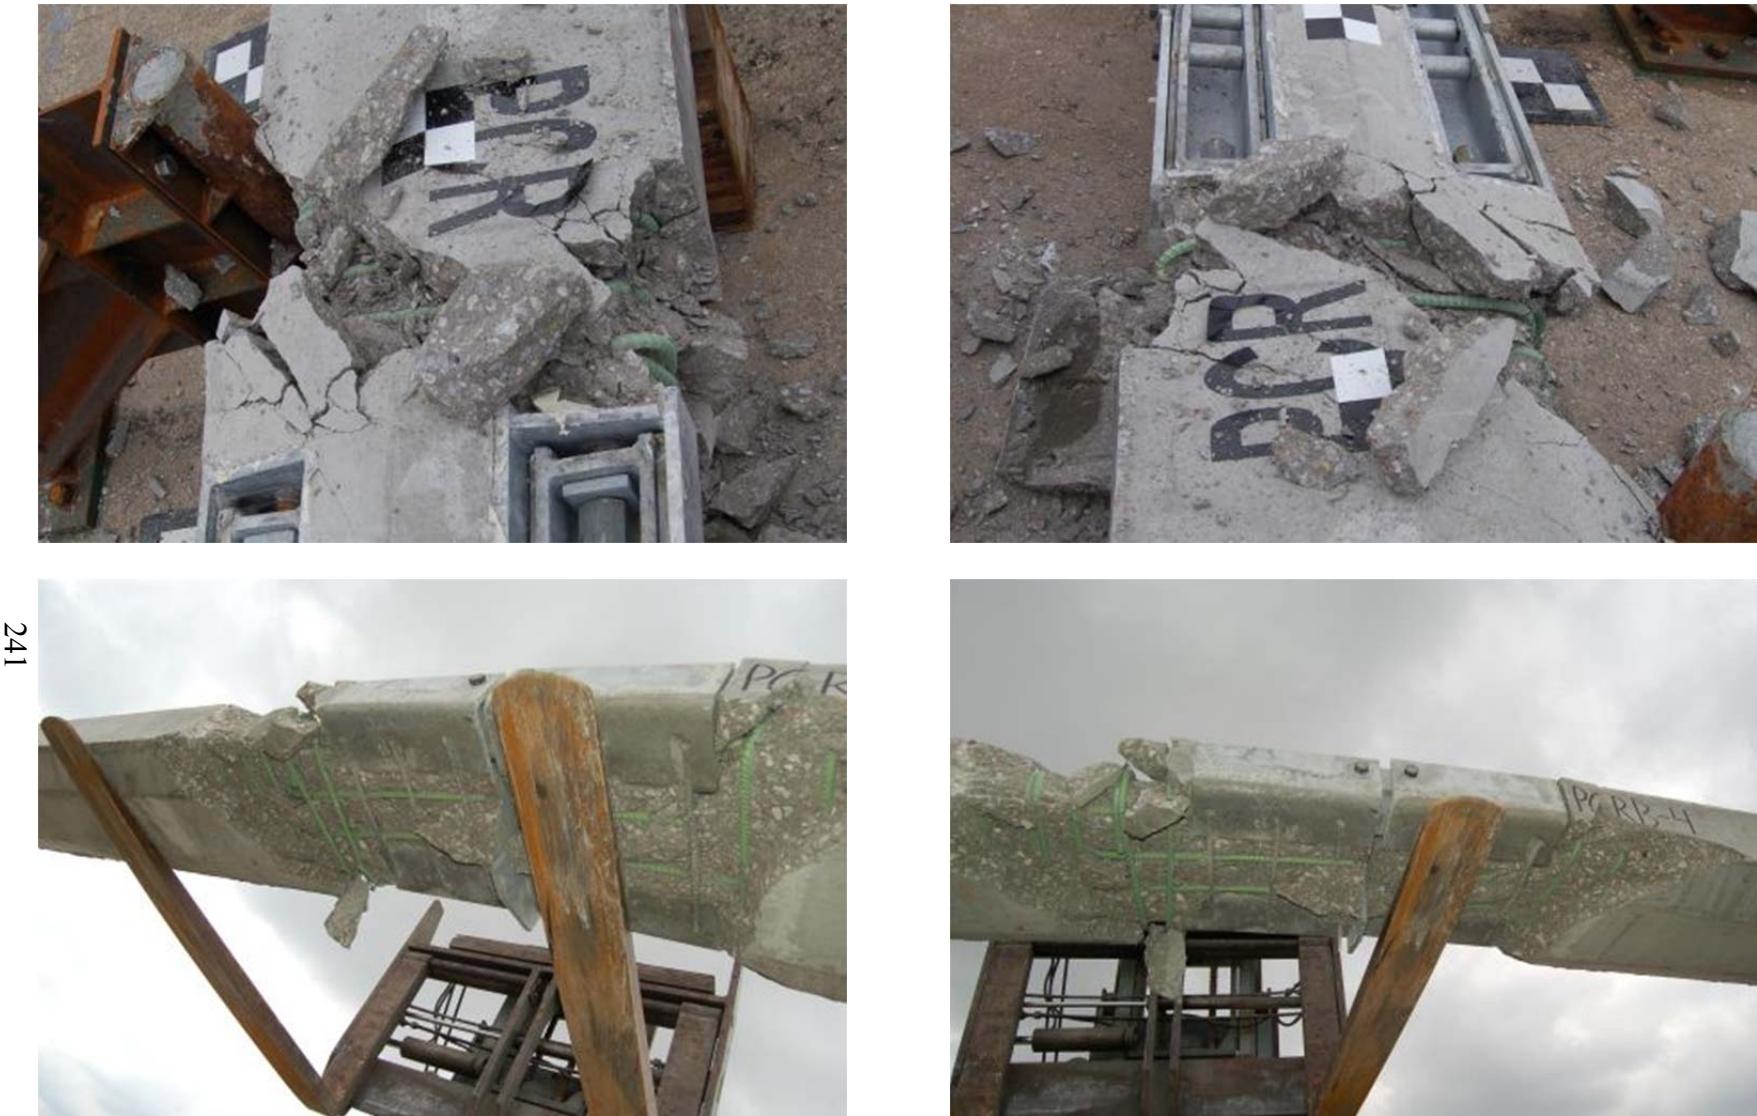
**Figure 156. Component Damage – Concrete Damage, Test No. PCRB-4**

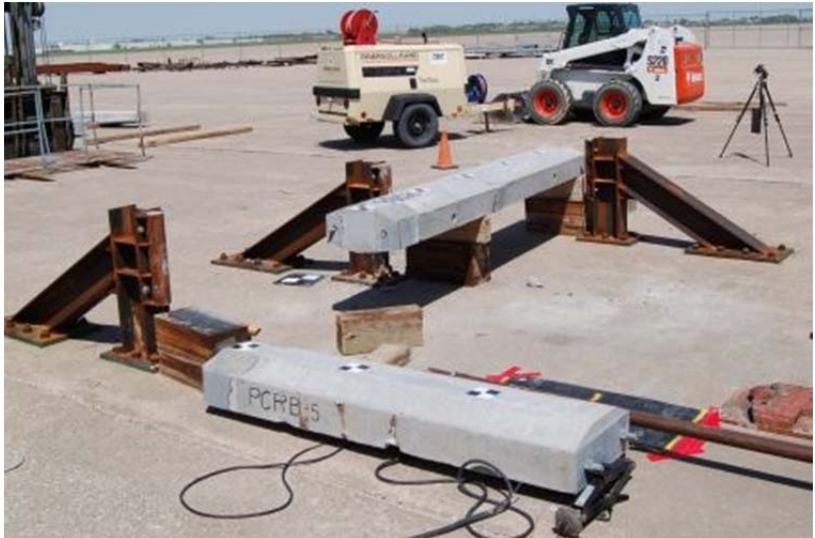
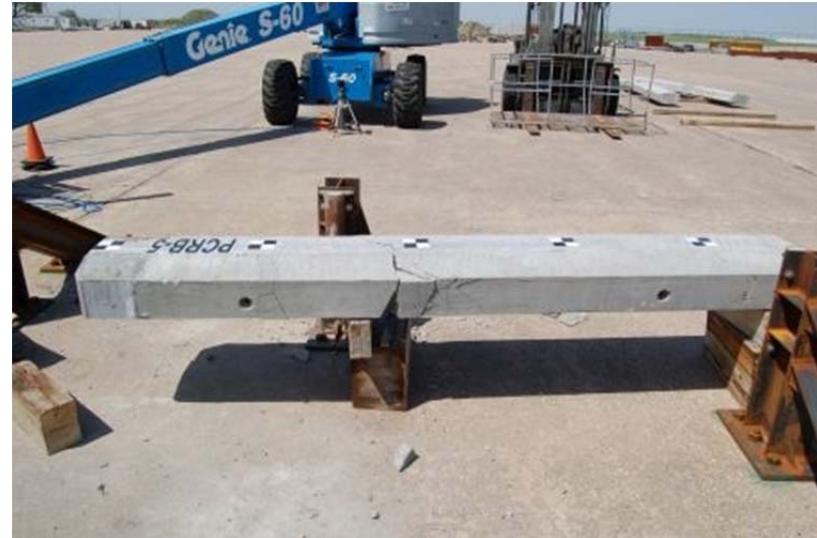
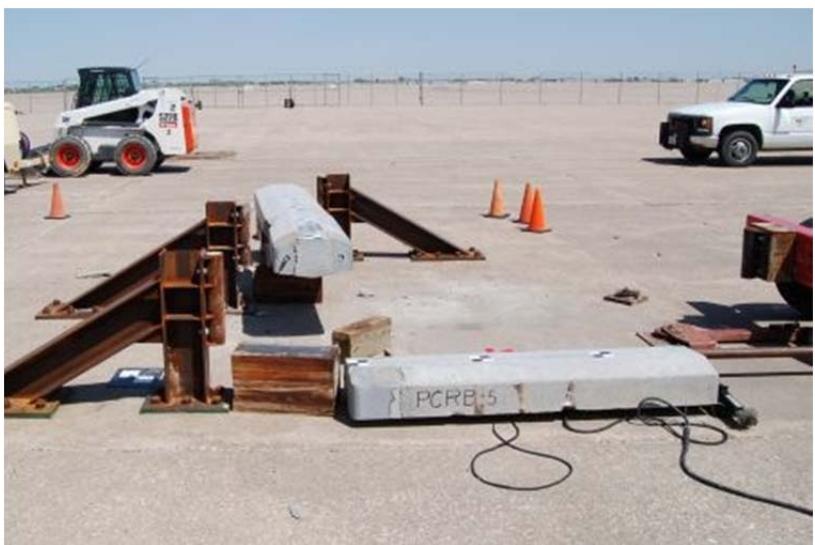
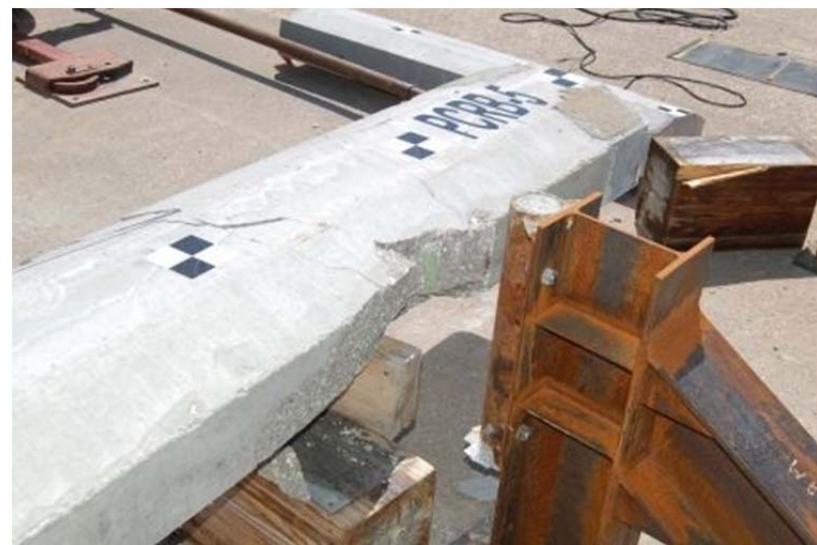
Figure 160. Component Damage, Test No. PCR-B-5

The joint for bogie test no PCRB-5 failed during the impact event. This caused the two rail segments to separate. As a result, the short rail segment ended up laying on the ground, perpendicular to its original position, as shown in Figure 160. The long rail segment remained atop the wooden support blocks, but had rotated slightly away from the anchor posts. Analysis of the threaded rods fracture patterns, as shown in Figure 162, revealed that the front threaded rod failed in shear, while the back threaded rod failed from a combination of tension and shear. Then combination tension and shear failure of the back threaded from was evidenced by the 45-degree fracture plane and the bending in the rod.

Damage to the long rail segment consisted mainly of bending cracks and concrete spalling, as shown in Figures 160 and 162. This damage was the result of the long rail segment absorbing all of the impact energy from the bogie after the joint failed. The concrete cracks spanned from the middle anchor post to the front face of the rail. Small fragments of concrete had broken off of the rail where the cracks met the front face of the segment. Concrete spalling was found on the back face of the segment around the middle anchor post bearing location. This

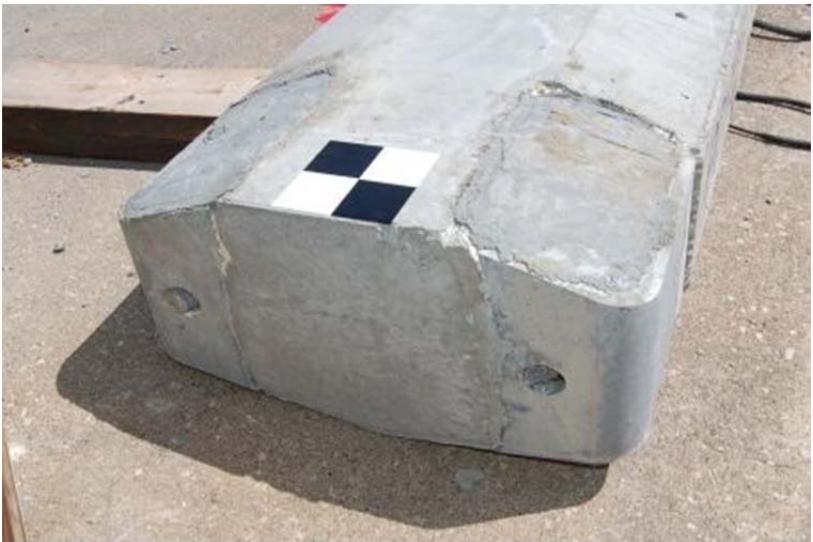
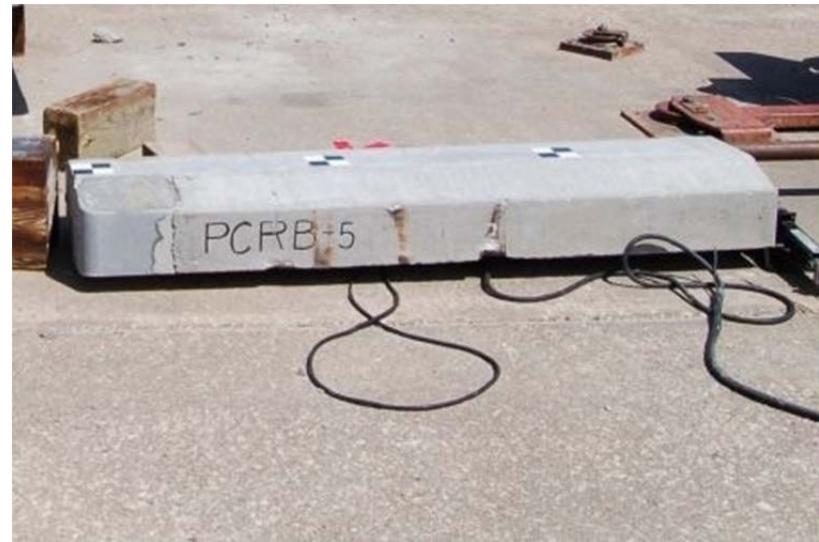
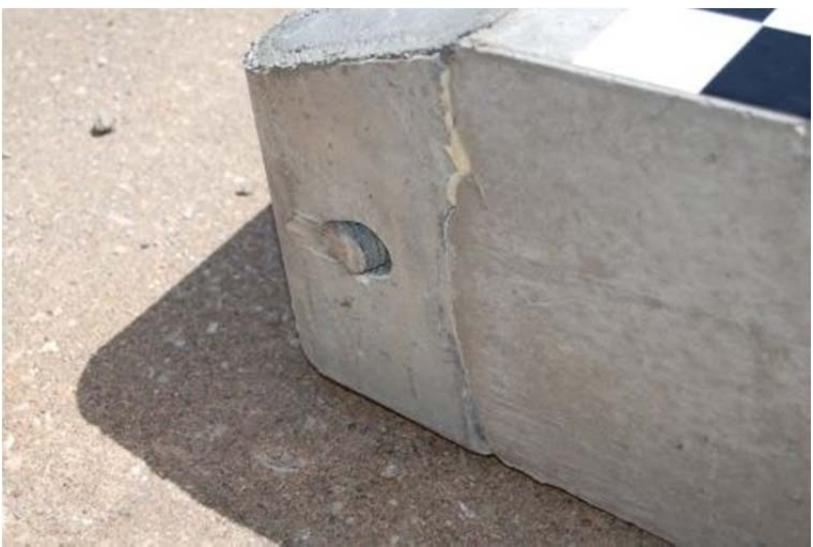
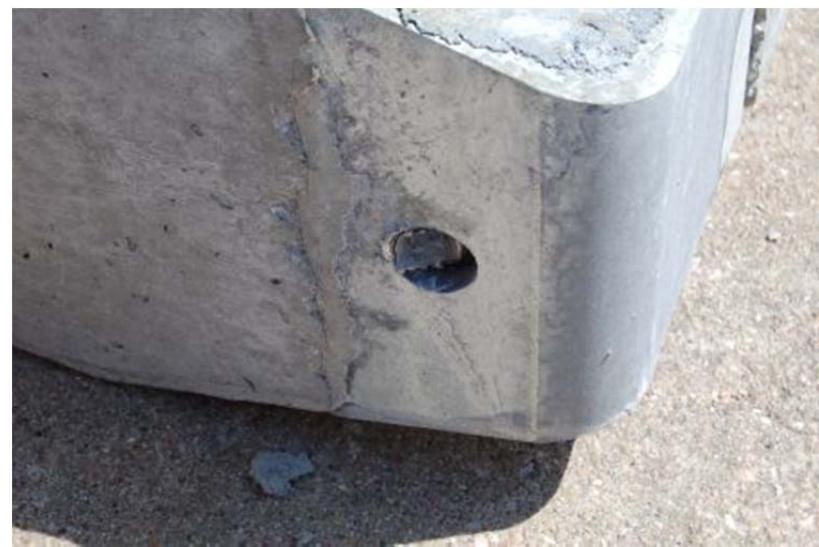
**Figure 161. Component Damage – Short Rail Segment, Test No. PCR-B-5**

Damage to the short rail segment was minimal, as shown in Figure 161. A few concrete cracks were found in the middle of the segment near the original position of the anchor post, and another concrete crack was found spanning between the steel pockets. Also, contact marks on the short rail segment were located at the impact point and along the back face where the segment contacted the anchor post assembly while rotating.

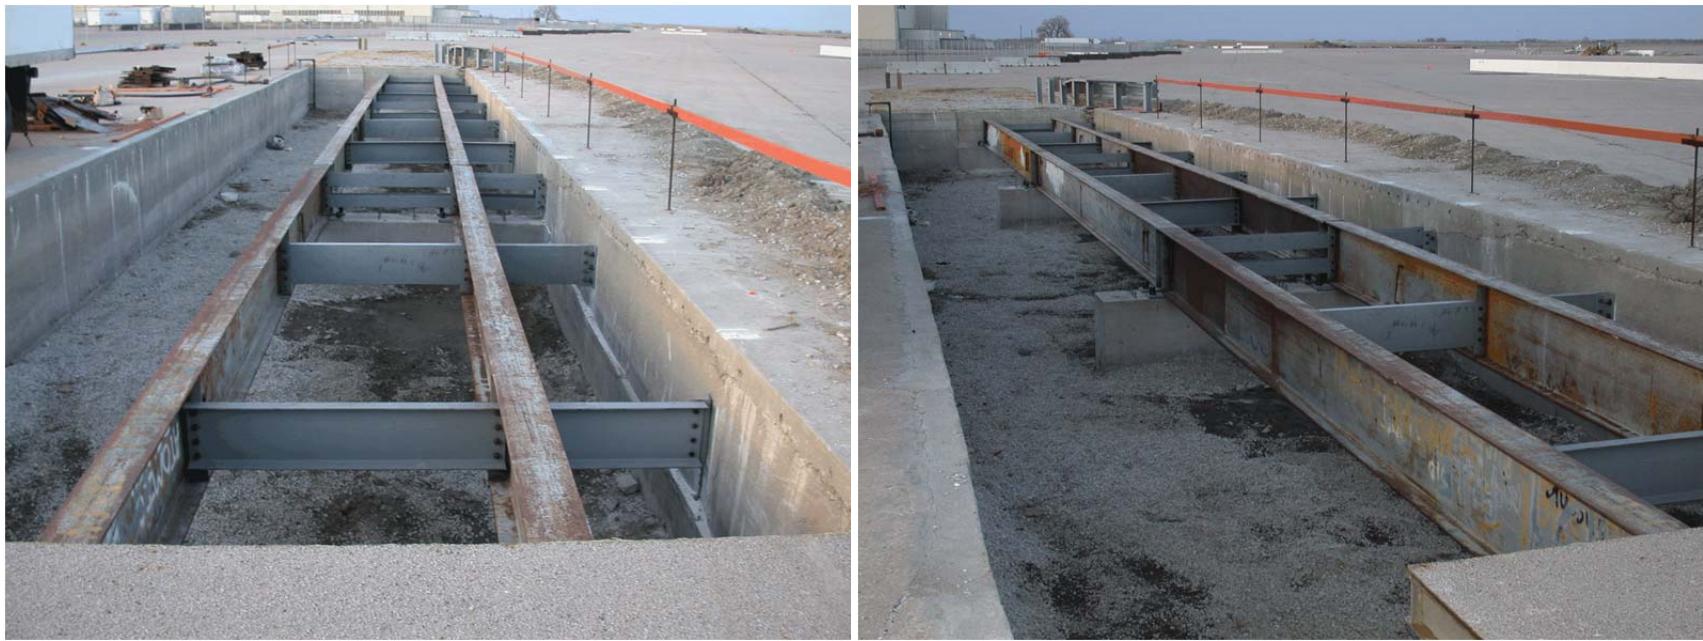
**Figure 210. MwRSF Simulated Bridge Test Pit**

The system details shown for the precast concrete bridge rail prototype were developed for implementation and installation of the system at the MwRSF test facility. As such, the bridge deck and system length are configured for full-scale crash testing in the MwRSF simulated bridge pit on an existing girder system, as shown in Figure 210. Actual field installation details would vary from what is shown herein.

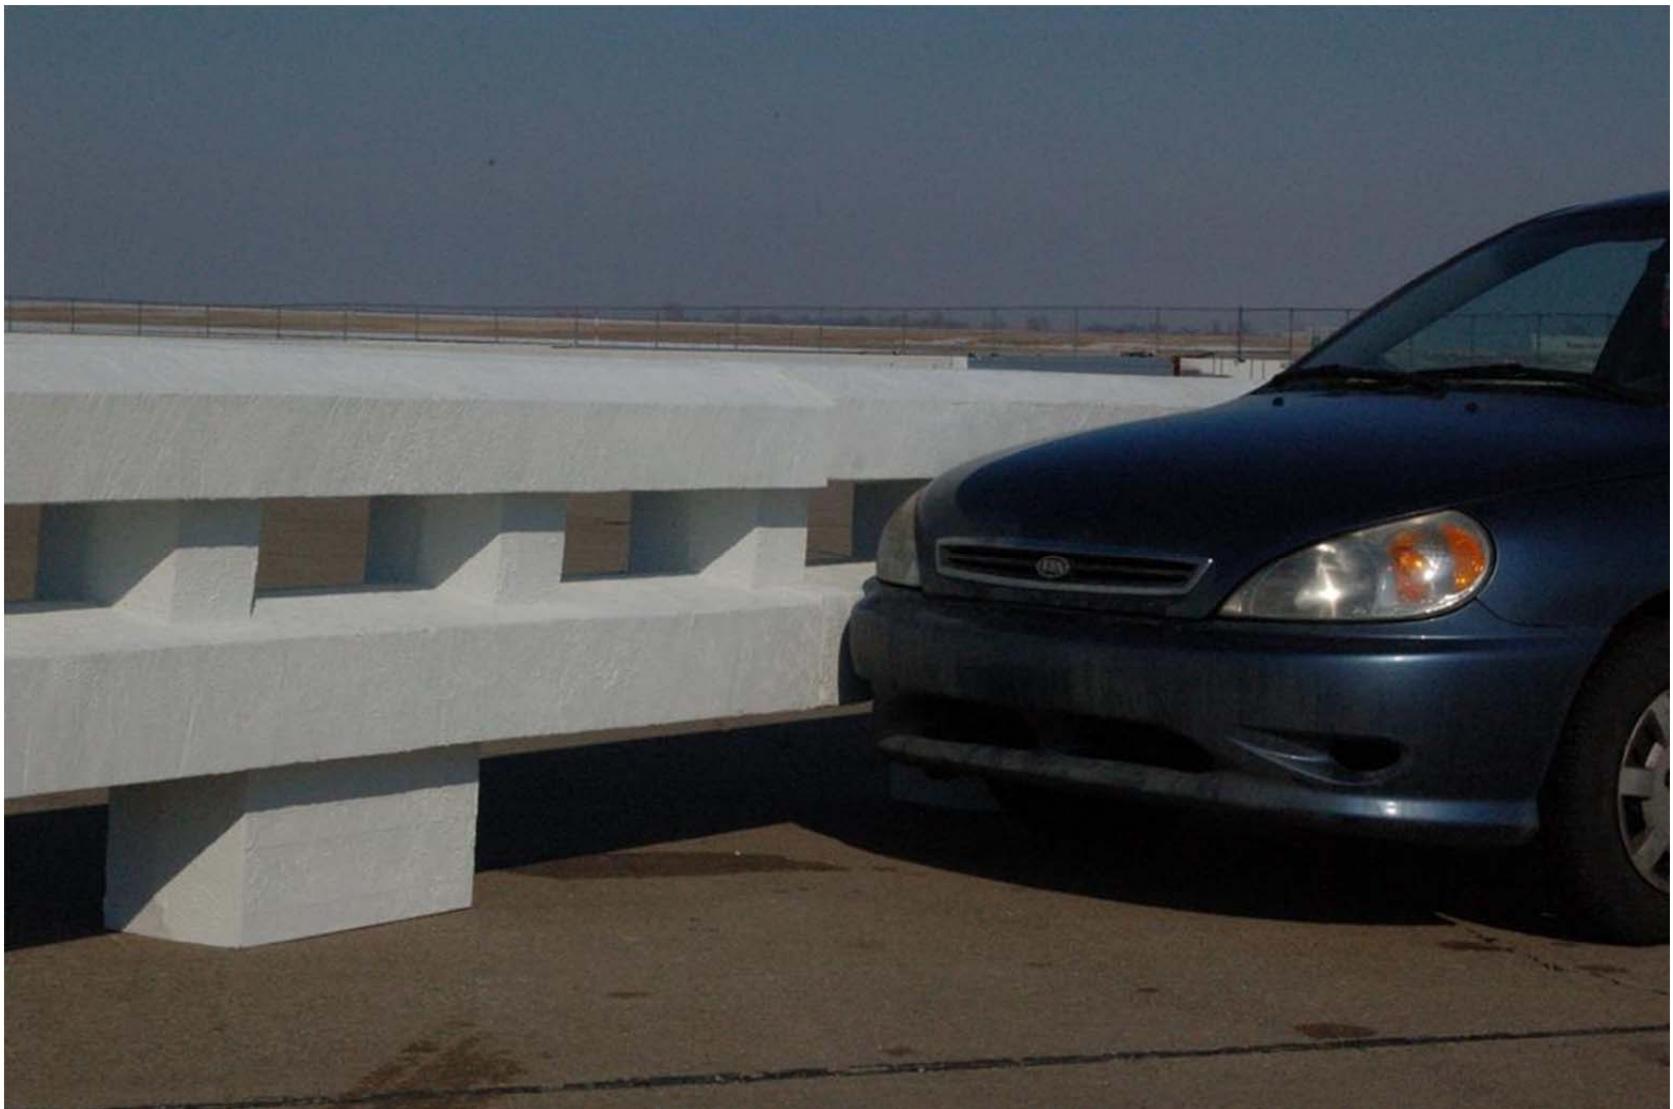
**Figure 211. Precast Bridge Rail Foam Model with 1100C Vehicle**

Finally, it should be noted that the new, precast bridge rail system was developed with considerations for aesthetic treatments including the shape of the rail itself, additional surface treatments, dyes, and medallions. In order to evaluate the potential aesthetics of the new bridge rail design, a full-scale model of a single rail section was formed from Styrofoam and photographs with various vehicle types to provide a better feel for the actual aesthetics of the design, as shown in Figures 211 through 213. In addition to the full-scale model, renderings were prepared of potential aesthetic treatments for both the open and closed rail sections, shown in Figures 214 through 220. Many of these aesthetic treatments would not be possible without the use of precast concrete construction techniques. These efforts demonstrated the improved aesthetic qualities of the new design as compared to more conventional concrete bridge rails.
