# **DEVELOPMENT OF SOCKETED FOUNDATIONS FOR S3X5.7 POSTS**

## **MIDWEST ROADSIDE SAFETY FACILITY**

MwRSF Research Report No. TRP-03-293-15

April 28, 2015

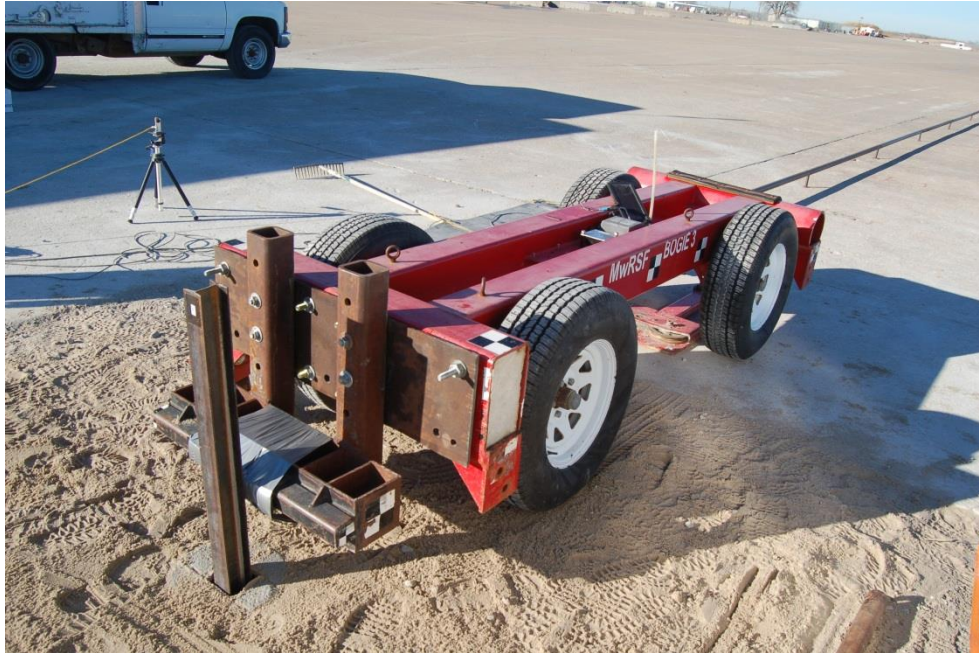
Figure 1. Rigid-Frame Bogie on Guidance Track

A rigid-frame bogie was used to impact the posts. A variable-height, detachable impact head was used in the testing. The bogie impact head consisted of a 2½-in. x 2½-in. x ¼-in. (64-mm x 64-mm x 6-mm) square tube mounted onto the outside flange of a W6x25 (W152x37.2) steel beam with reinforcing gussets. A ¾-in. (19-mm) neoprene pad was attached to the front of the square tube to prevent local damage to the post from the impact. The impact head was bolted to the bogie vehicle, creating a rigid frame with an impact height of 11 in. (279 mm), except for test no. HTC-B-5 when the impact height was 15 in. (381 mm). The bogie with the impact head is shown in Figure 1. The weight of the bogie with the addition of the mountable impact head and accelerometers was approximately 1,800 lb (816 kg).

A pickup truck with a reverse cable tow system was used to propel the bogie to a target impact speed of 20 mph (32 km/h). When the bogie approached the end of the guidance system, it was released from the tow cable, allowing it to be free-rolling when it impacted the post. A remote-control braking system was installed on the bogie, allowing it to be brought safely to rest after the test.

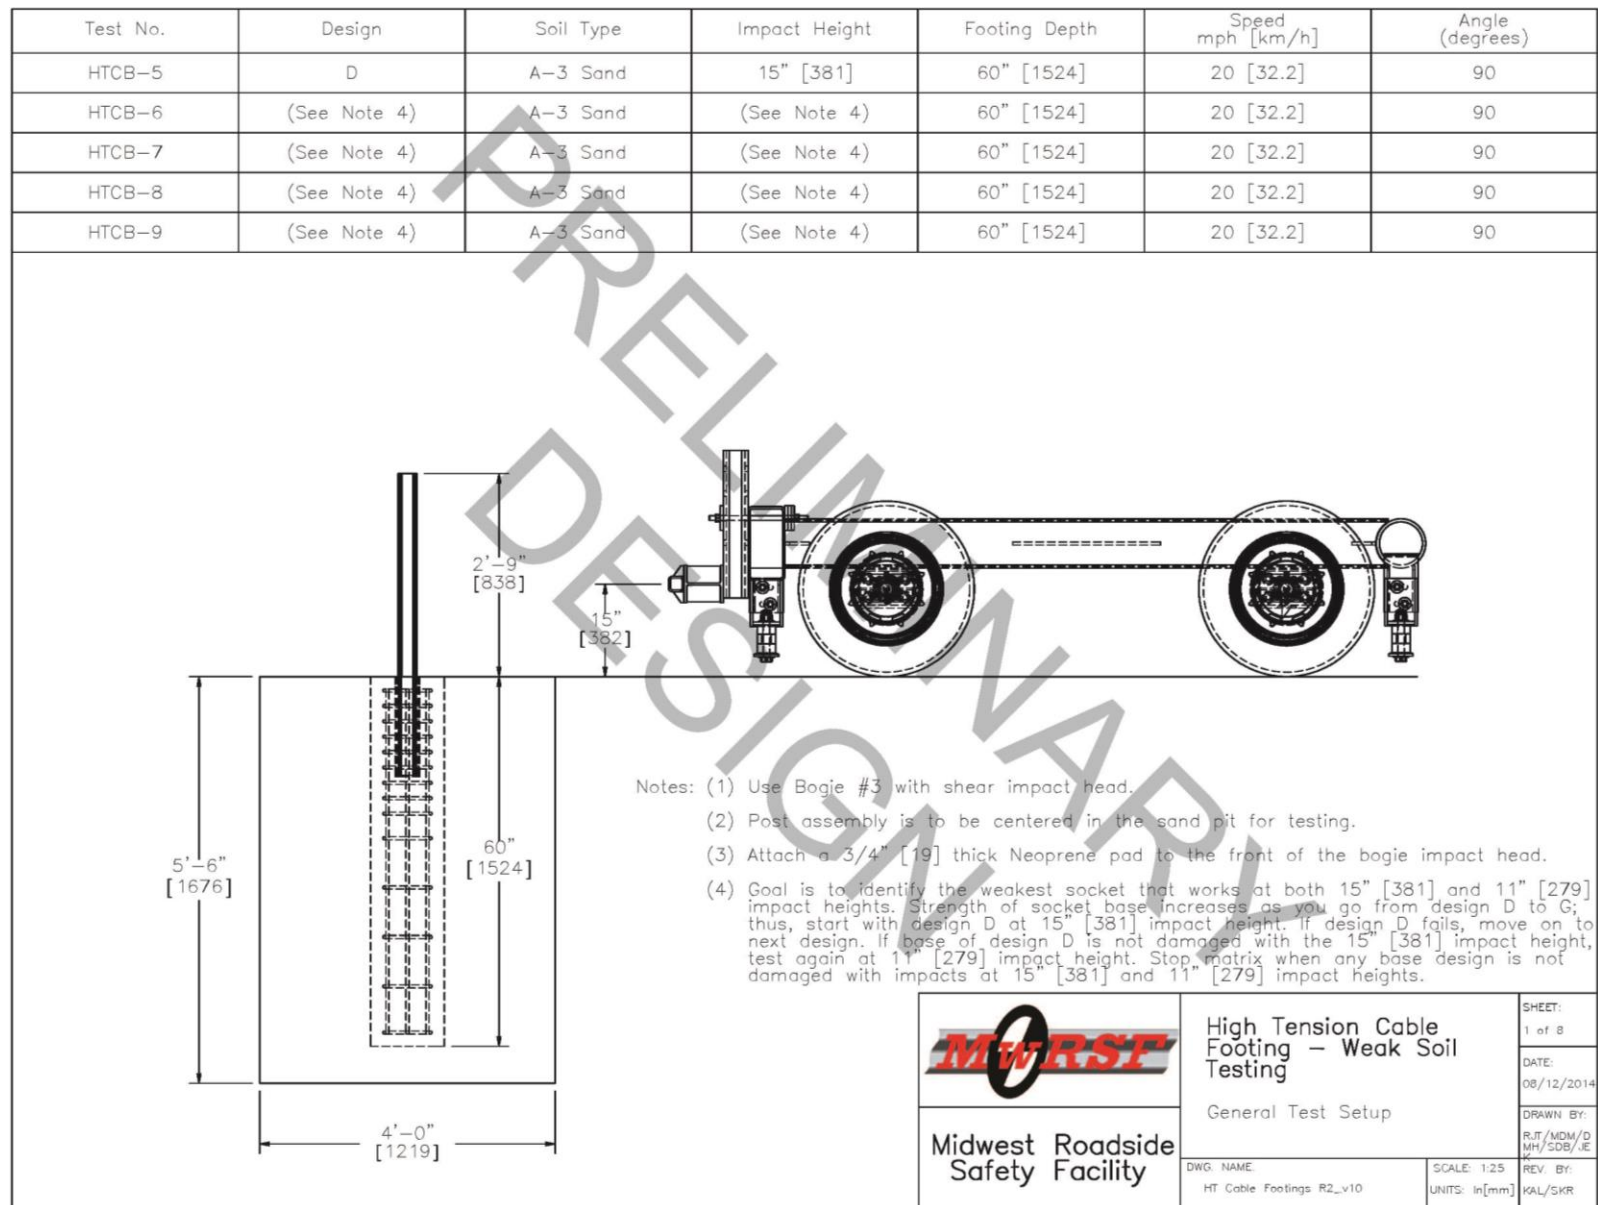
Figure 2. Bogie Testing Matrix and Setup, Test Nos. HTCB-5 through HTCB-9

Each socketed foundation consisted of a 12-in. (305-mm) diameter concrete cylinder and had a 60-in. (1,524-mm) embedment depth. The concrete was specified to a minimum 28-day compressive strength of 3,500 psi (24 MPa). All of the foundations were reinforced with both circumferential and vertical grade 60 steel rebar. However, the quantity and spacing of the steel reinforcement varied between designs. A 16-in. (406-mm) long, 4-in. x 4-in. x ¼-in. (102-mm x 102-mm x 6-mm) steel tube was located at the top-center of each foundation to act as a socket for the S3x5.7 (S76x8.5) posts. Finally, all of the foundations were installed within a test pit filled with a weak soil material conforming to the AASHTO Grade A-3 sand requirements [7].

Each foundation design had a unique mechanism for increasing the shear capacity of the foundation, and the designs were labeled and tested in order of increasing strength (from Design D to Design G). Design D utilized 4½-in. (114-mm) spacings between transverse steel hoops throughout the top portion of the foundation, while Design E utilized a reduced spacing of 2½ in. (64 mm). The foundation of Design F was nearly identical to that of Design E, except Design F

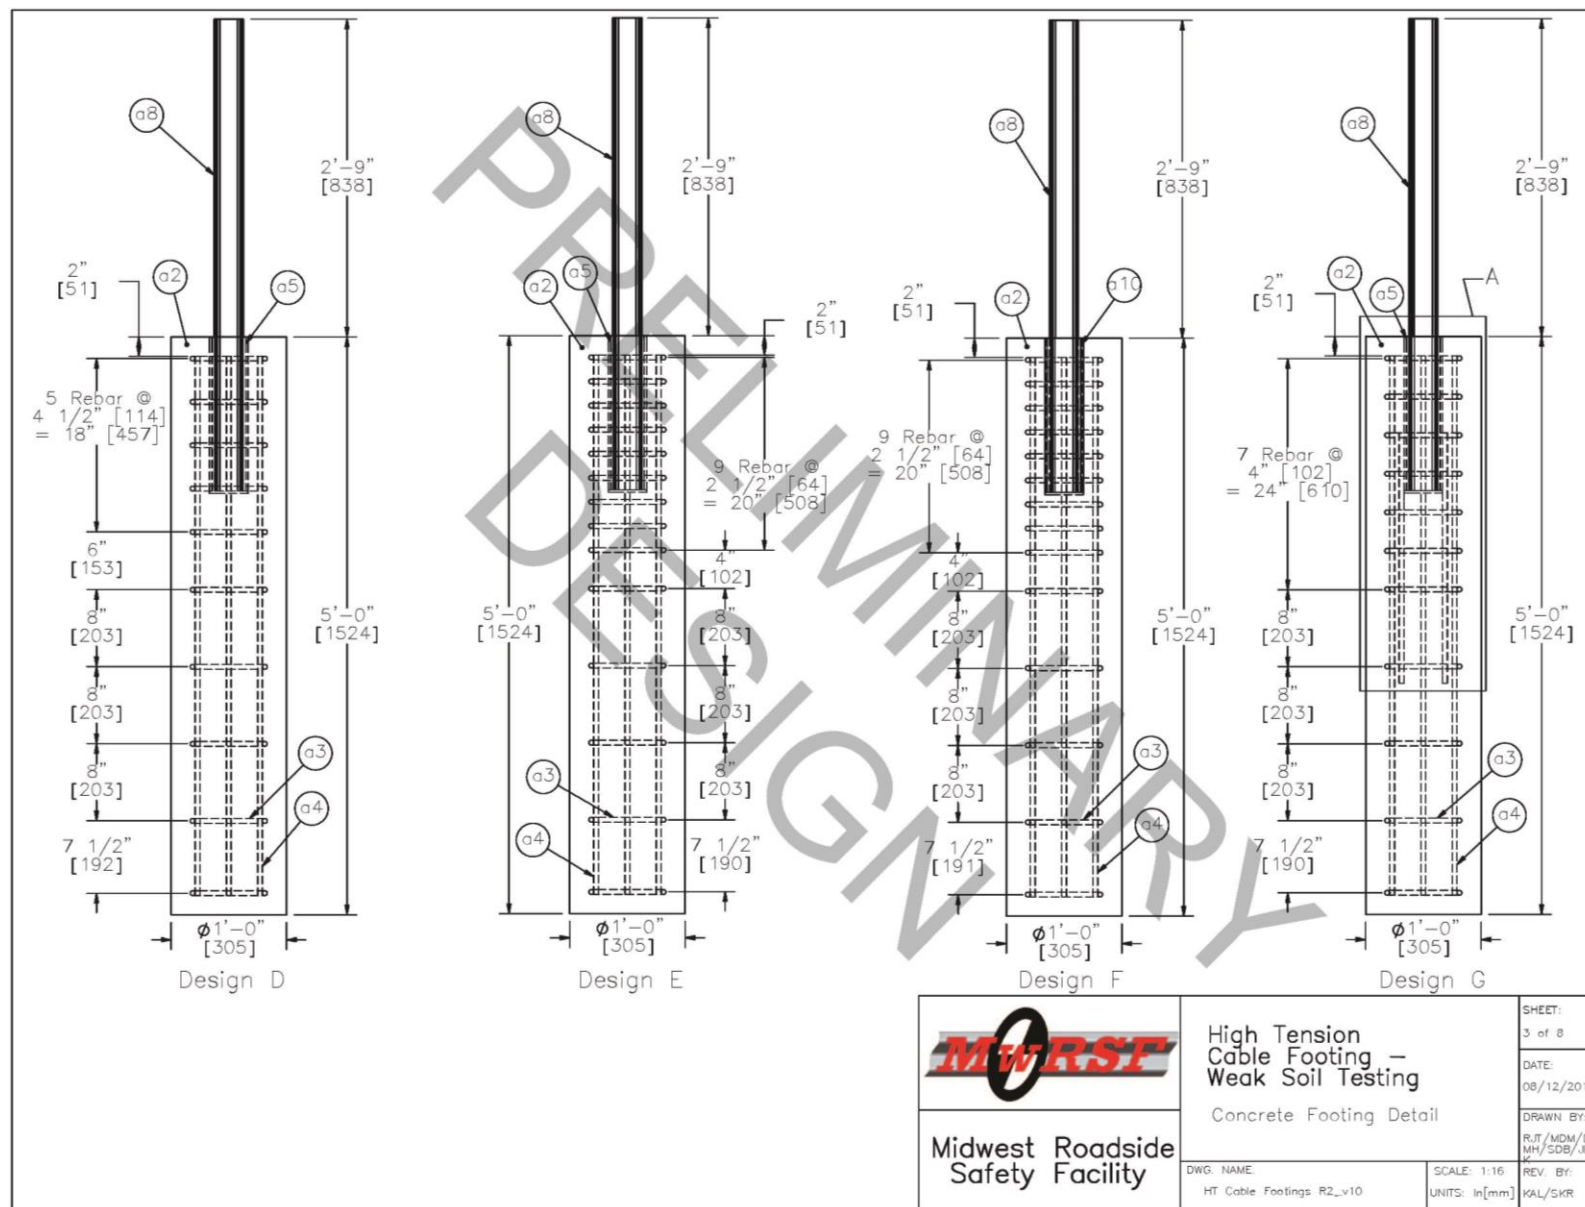
Figure 4. Post Assemblies and Reinforcement Configurations, Test Nos. HTCB-5 through HTCB-9

incorporated 1/4-in. (6-mm) thick shim plates welded on the outside of the post flanges. These plates were intended to bear against the inside of the sockets below the surface of the foundation, thus reducing the propensity for shear cracking at the top of the foundation. Additionally, the moment arm of the post is increased, resulting in a decrease in shear load and further reducing the propensity of concrete cracking. Note, the socket thickness had to be reduced from 1/4 in. (6 mm) to 1/8 in. (3 mm) in order to accommodate the shear plates in Design F. Finally, Design G utilized 4-in. (102-mm) spacings between transverse steel hoops and incorporated no. 4 vertical bars welded to the front and back faces of the socket. These additional vertical bars would provide extra strength and stiffness to the socket against rotational displacements.

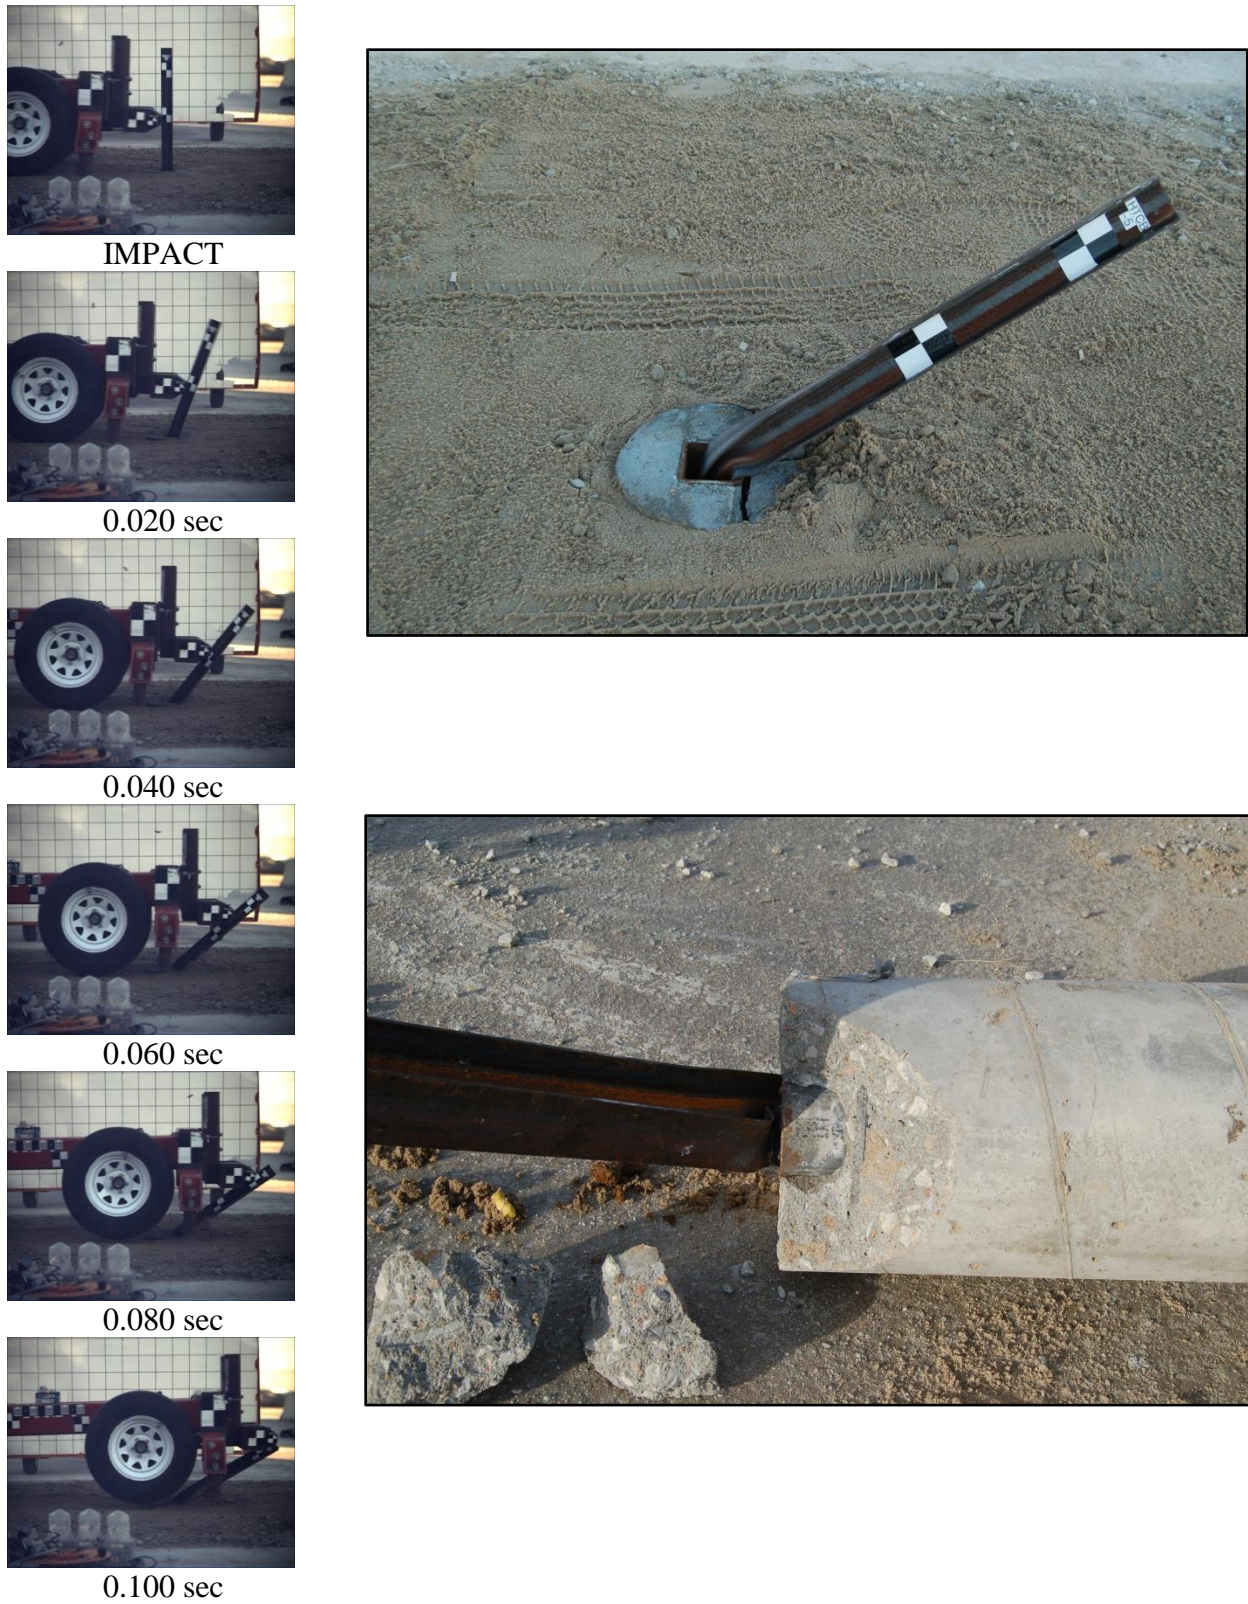
Figure 12. Time-Sequential and Post-Impact Photographs, Test No. HTCB-5

Damage to the test article consisted of plastic bending to the steel post and cracking to the back side of the concrete foundation. Concrete shear cracking resulted in a 7-in. (178-mm) deep piece of concrete fracturing off the top-back edge of the concrete foundation. Subsequently, a portion of the steel socket and one transverse steel stirrup were exposed. Time-sequential and post-impact photographs are shown in Figure 12. Based on these results with a 15-in. (381-mm) impact height, the rest of the tests were to be conducted with an impact height of 11 in. (279 mm).

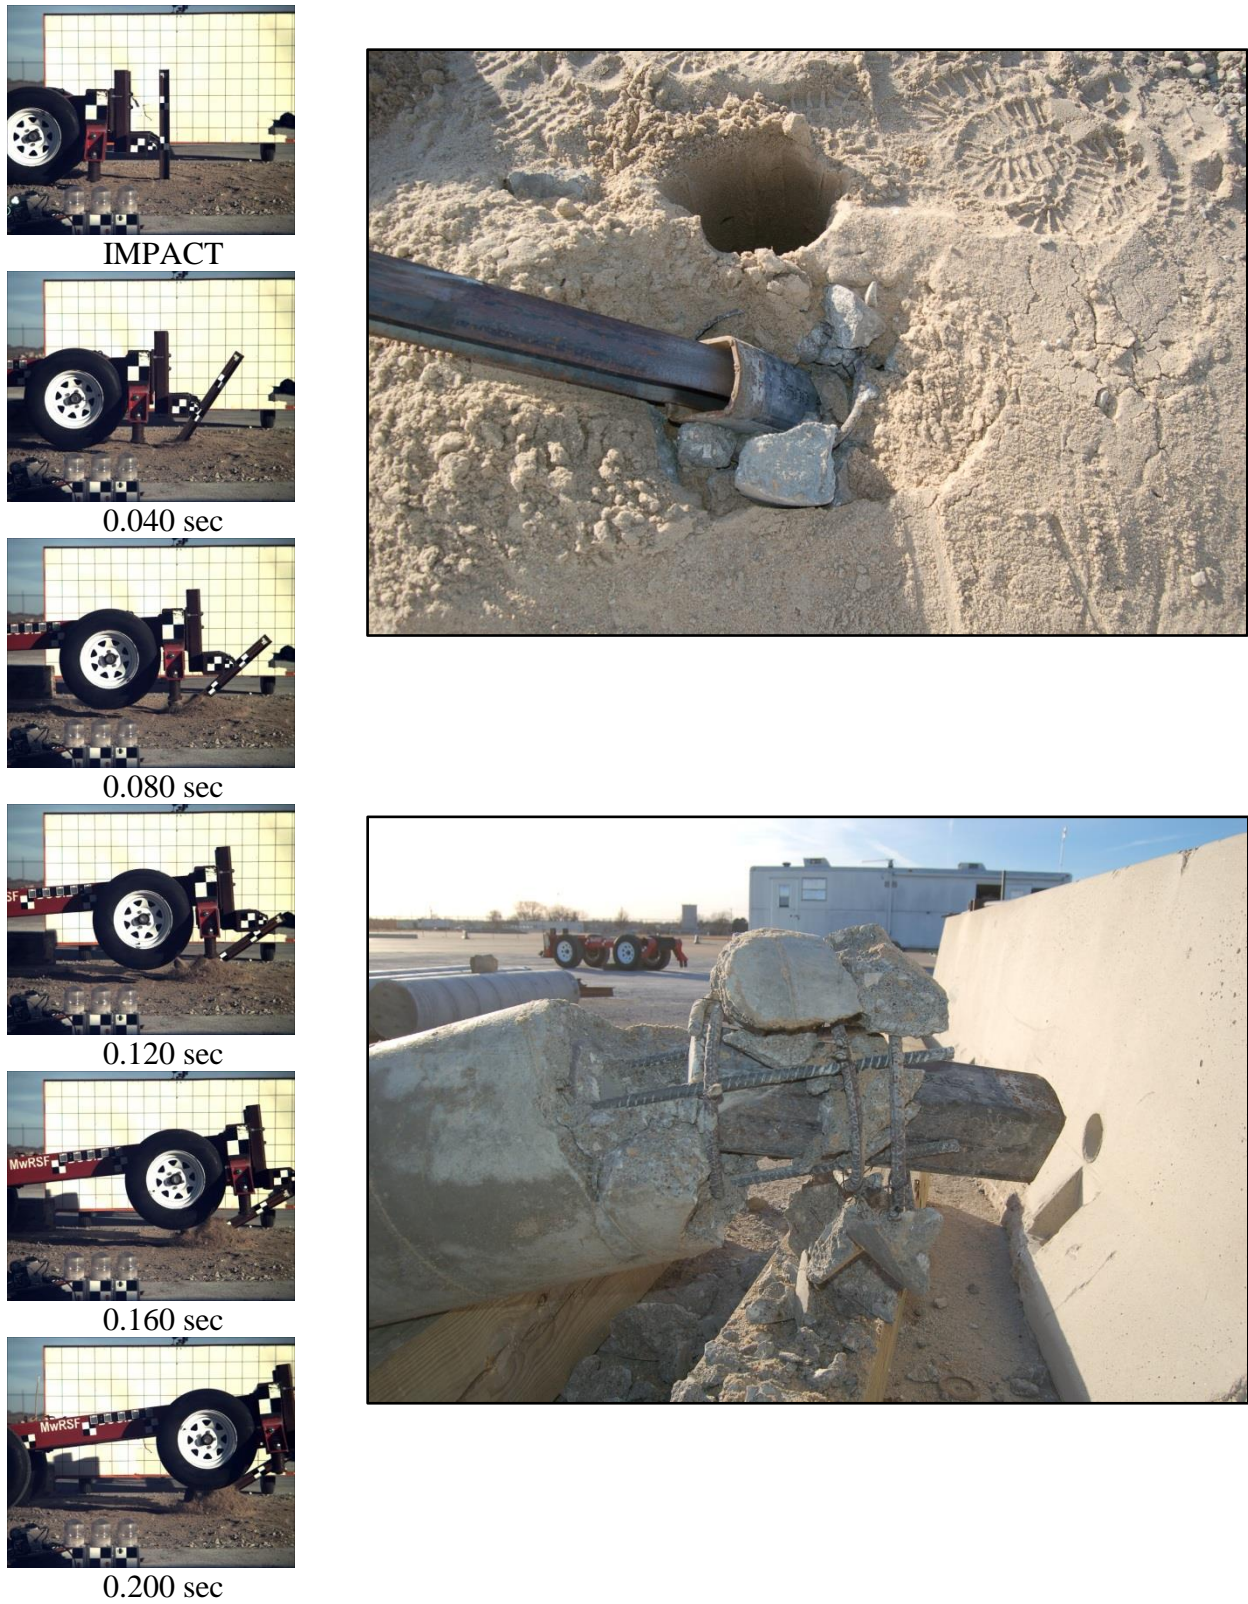
Figure 14. Time-Sequential and Post-Impact Photographs, Test No. HTCB-6

Damage to the test article consisted of plastic bending in the post and fracturing of the foundation. The post was bent at groundline, but not to the extent observed during test no. HTCB-5. The top 16 in. (406 mm) of the concrete foundation was fractured, and chunks of concrete were scattered around the impact location. The steel socket and several reinforcing bars were exposed and bent backward. Time-sequential and post-impact photographs are shown in Figure 14.

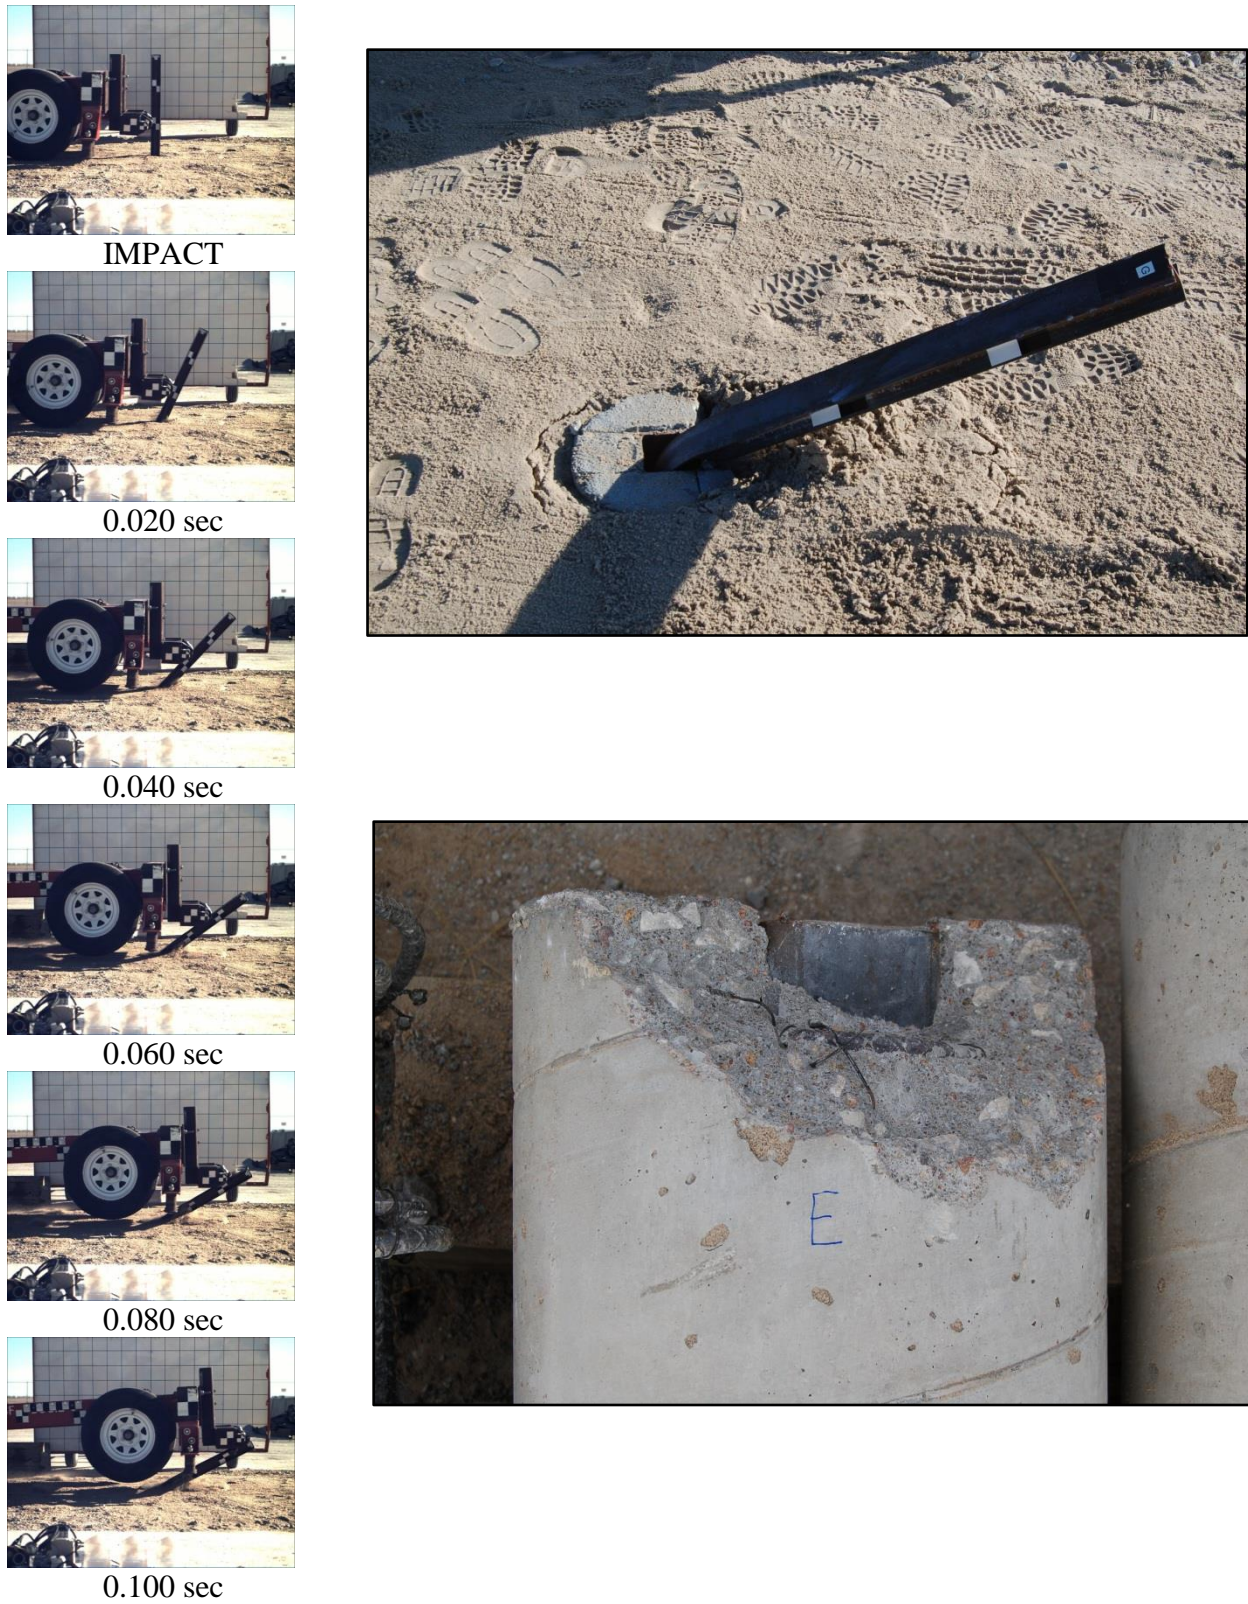
Figure 16. Time-Sequential and Post-Impact Photographs, Test No. HTCB-7

Damage to the test article consisted of plastic bending to the steel post at groundline and concrete cracking. The foundation experienced concrete shear cracking, which caused a 5.3-in. (135-mm) deep piece of concrete to fracture off the top-back edge of the foundation. Subsequently, a portion of the steel socket and one transverse steel stirrup were exposed. Time-sequential and post-impact photographs are shown in Figure 16.

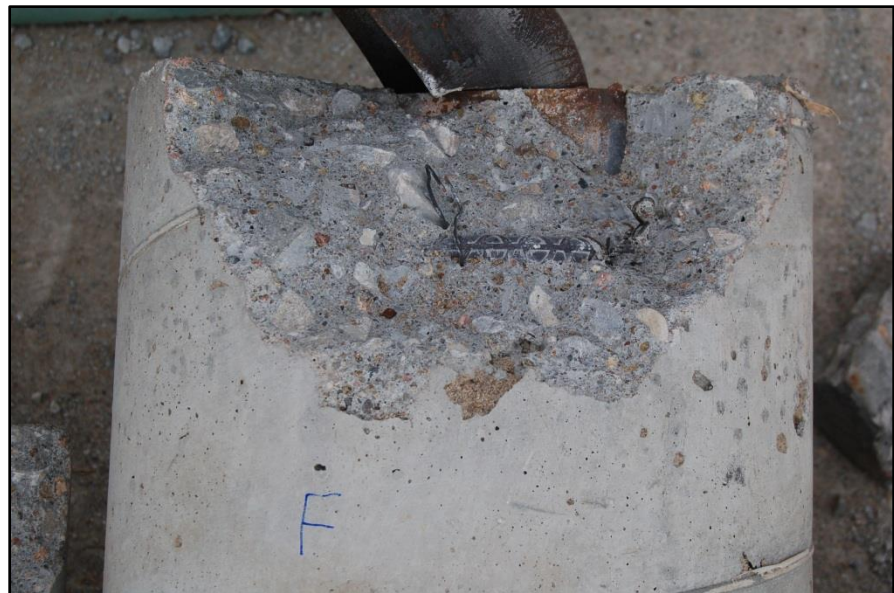
Figure 18. Time-Sequential and Post-Impact Photographs, Test No. HTCB-8

Damage to the test article consisted of plastic bending of the post at groundline and concrete cracking. The foundation experienced concrete shear cracking, which caused a 4.8-in. (122-mm) deep chunk of concrete to fracture off the top-back edge of the foundation. Subsequently, a small portion of the steel socket and one transverse steel stirrup were exposed. Time-sequential and post-impact photographs are shown in Figure 18.

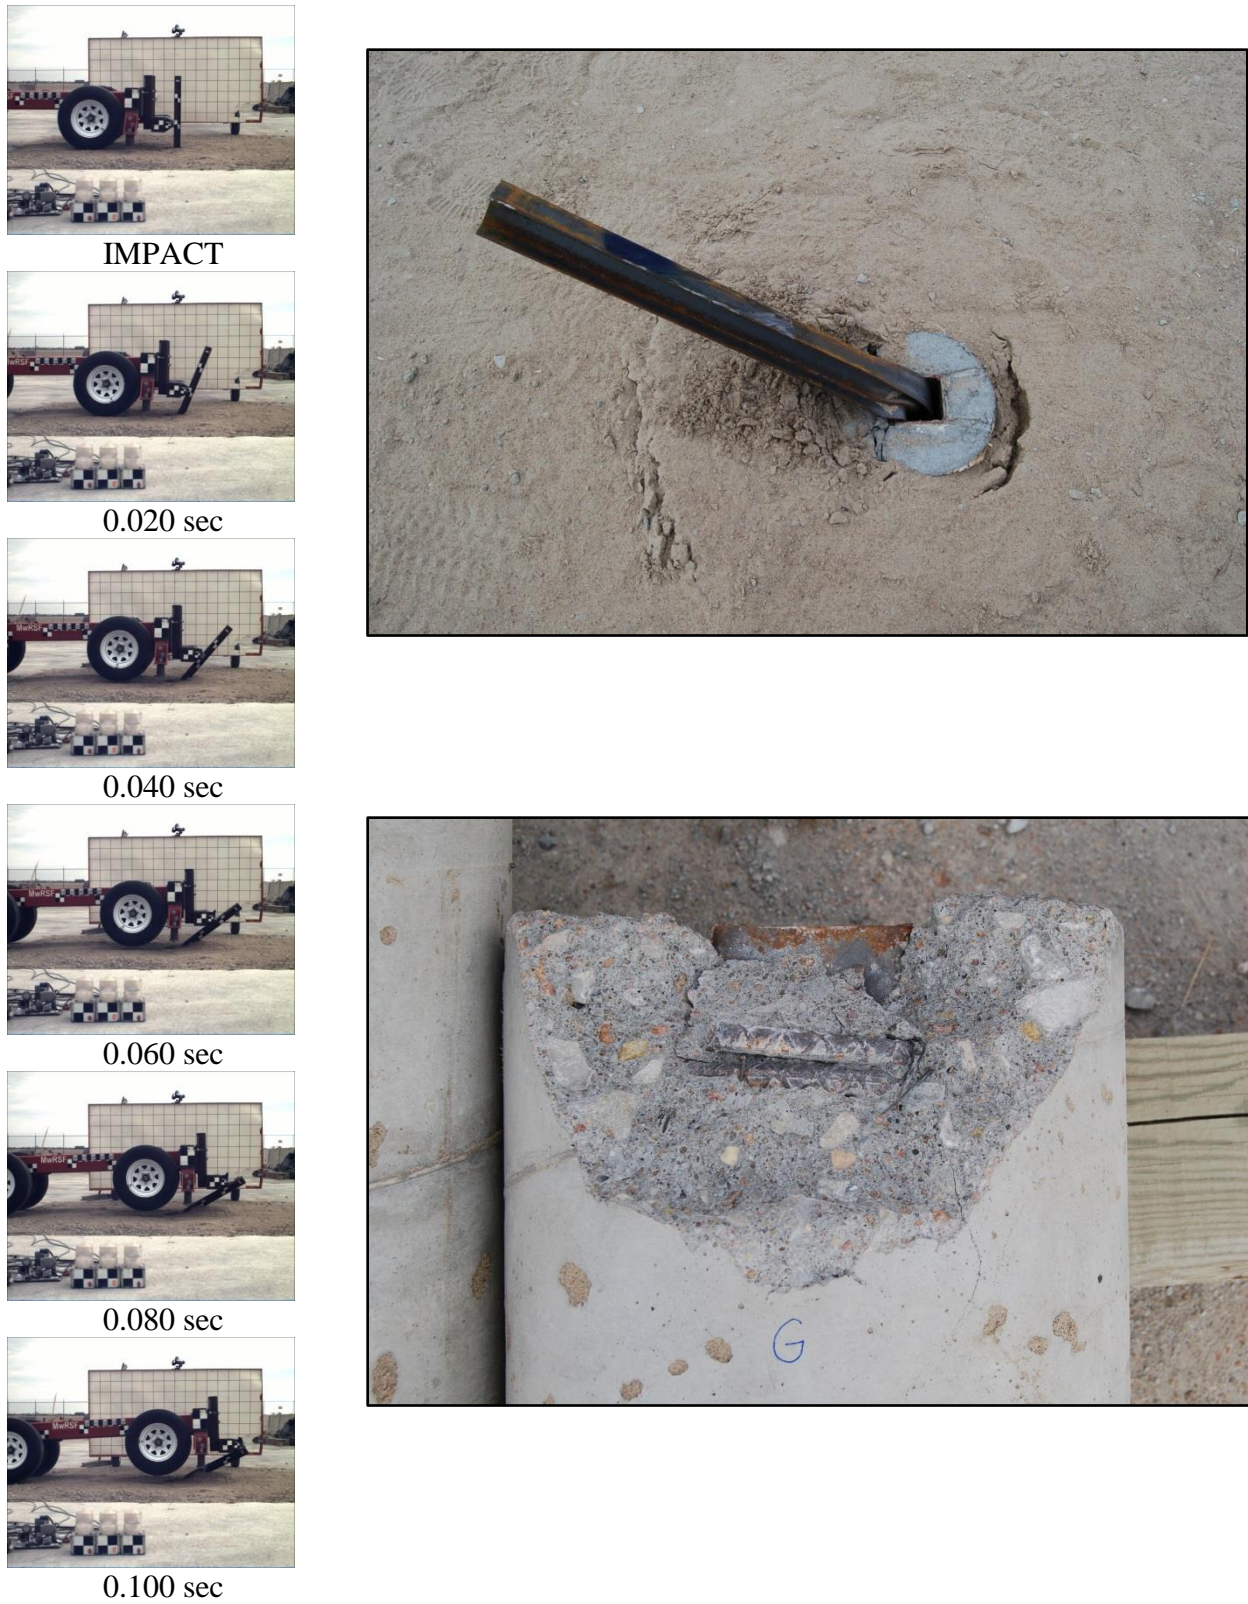
Figure 20. Time-Sequential and Post-Impact Photographs, Test No. HTCB-9

Damage to the test article consisted of plastic bending of the post at groundline and concrete cracking. The foundation experienced concrete shear cracking, which caused a 4.8-in. (122-mm) deep chunk of concrete to fracture off the top-back edge of the foundation. Subsequently, a small portion of the steel socket and one transverse steel stirrup were exposed. Time-sequential and post-impact photographs are shown in Figure 20.

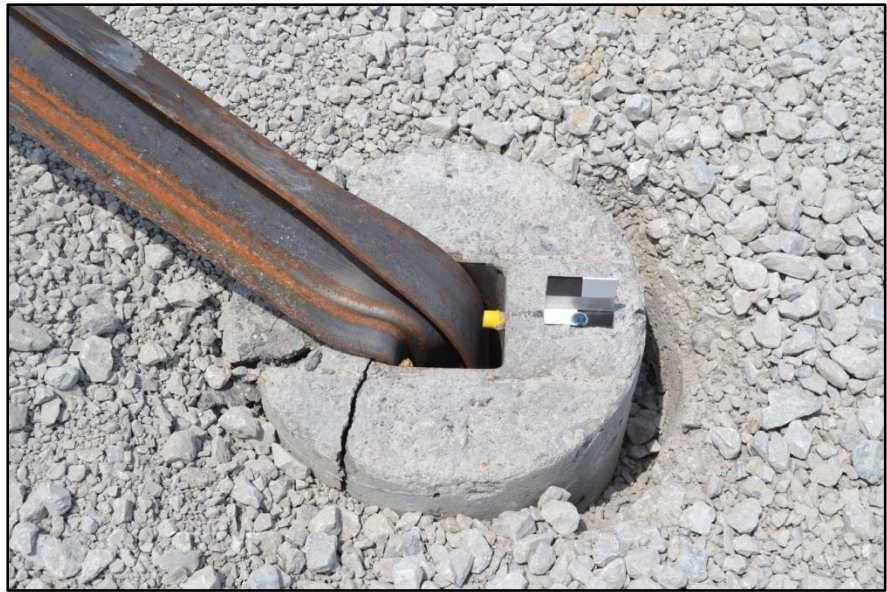
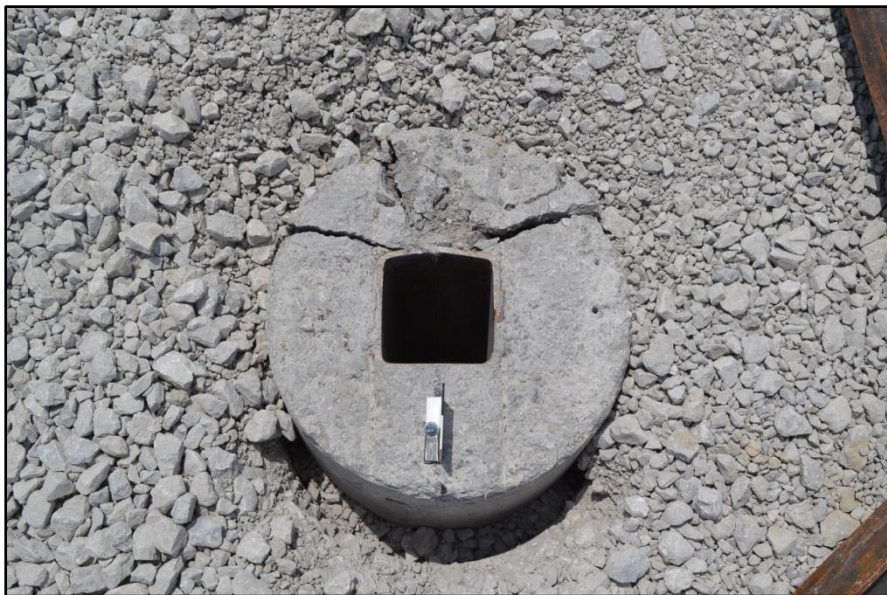
Figure 35. Time-Sequential and Post-Impact Photographs, Test No. HTCB-10

Damage to the test article consisted of plastic bending of the post at groundline and concrete cracking. The foundation experienced concrete shear cracking, which caused a 5-in. (127-mm) deep chunk of concrete to fracture off the top-back edge of the foundation. Subsequently, a small portion of the steel socket and one transverse steel stirrup were exposed. Time-sequential and post-impact photographs are shown in Figure 35.

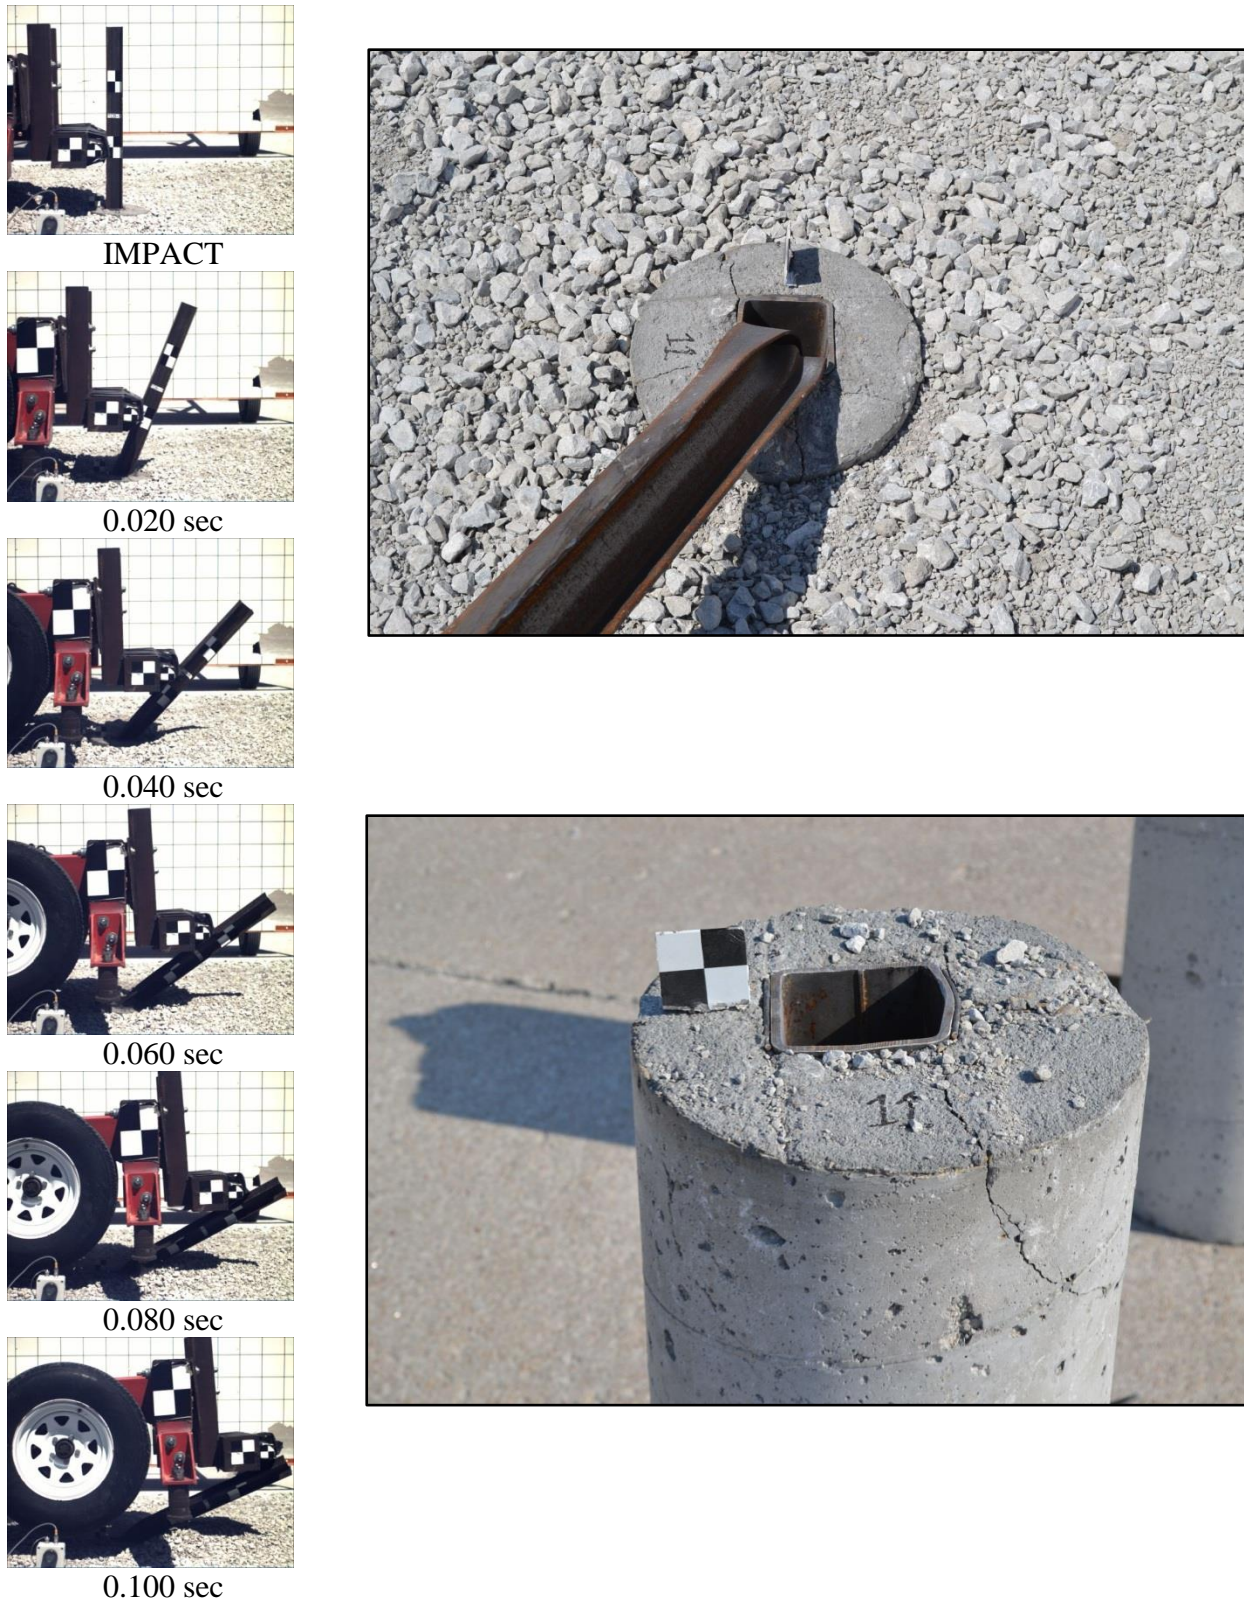
Figure 37. Time-Sequential and Post-Impact Photographs, Test No. HTCB-11

Damage to the test article consisted of plastic bending of the post at groundline and concrete cracking. The foundation experienced concrete shear cracking on the back side of the foundation, similar to the previously tested 12-in. (305-mm) diameter foundations. However, the concrete on the back edge of the foundation did not fracture away as seen previously. Time-sequential and post-impact photographs are shown in Figure 37.

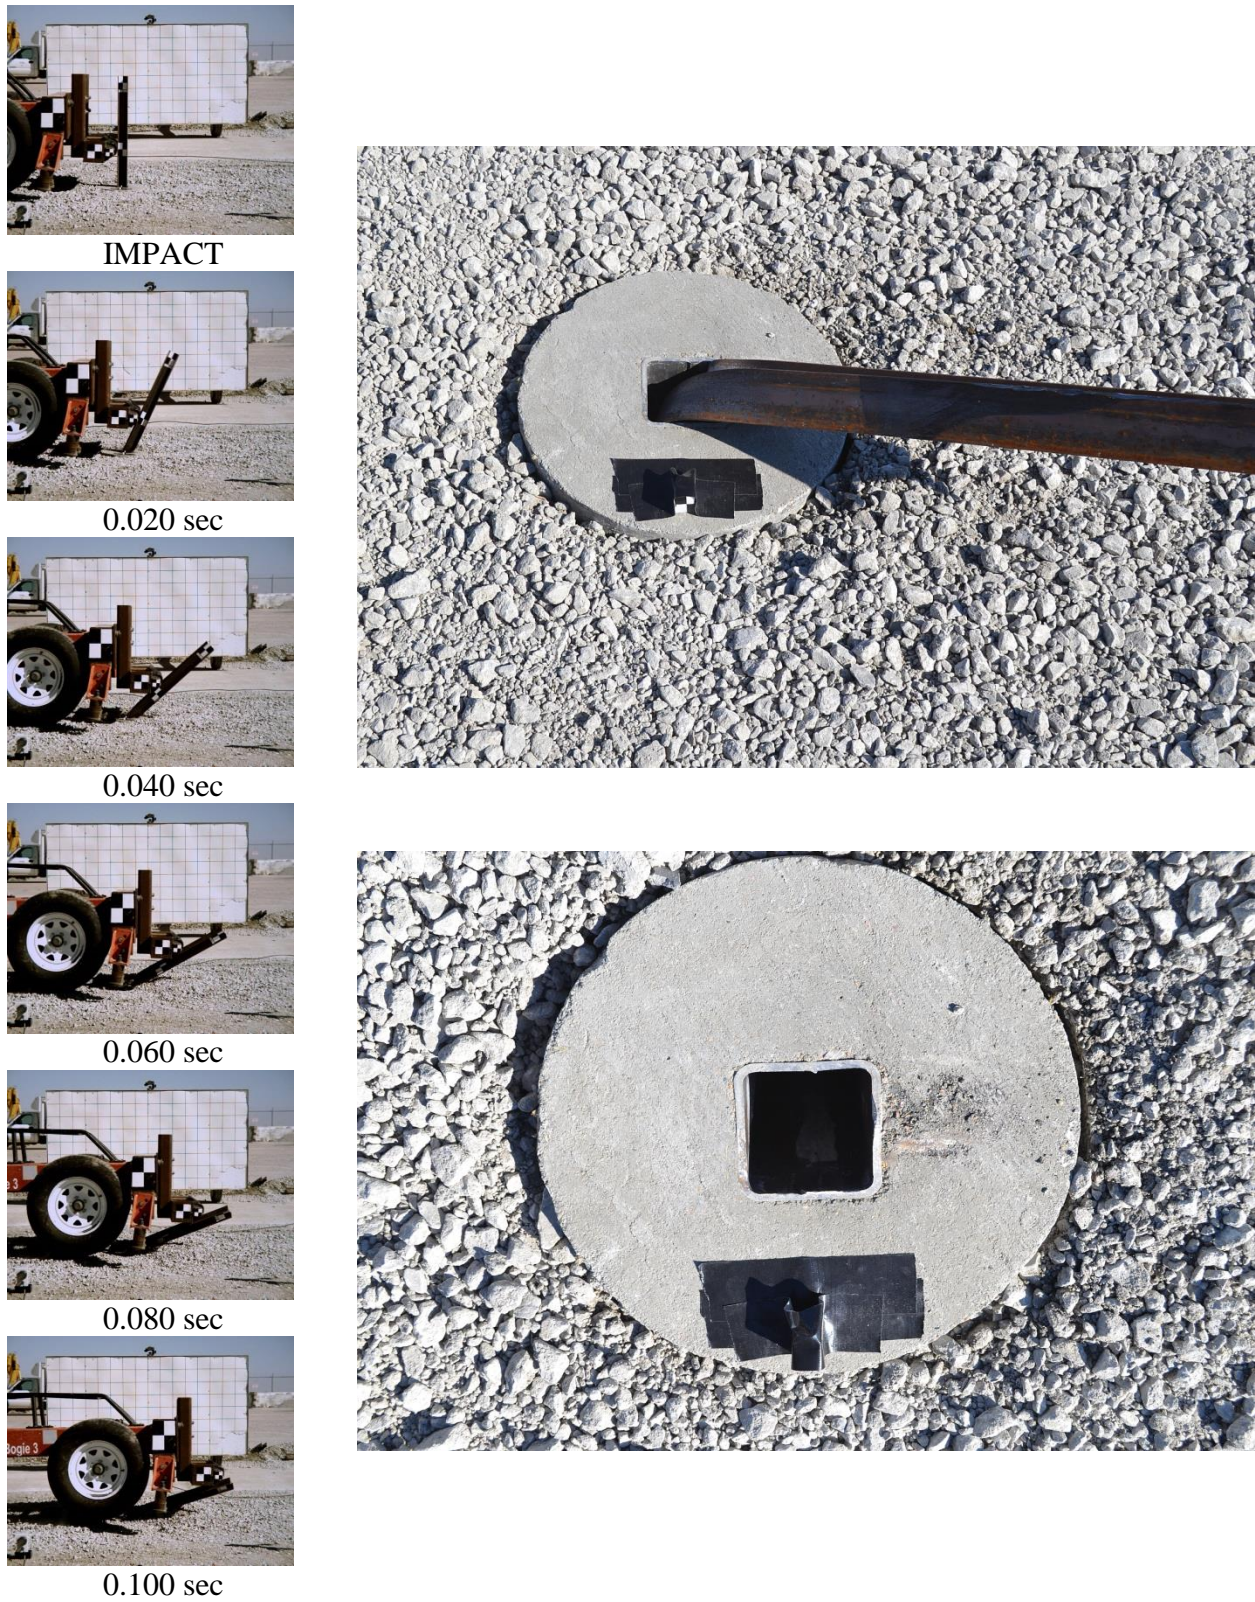
Figure 39. Time-Sequential and Post-Impact Photographs, Test No. HTCB-17

Damage to the test article consisted of plastic bending of the post at groundline. The concrete foundation remained whole and free of cracks. Only minor scrapes resulting from contact with the post were observed on the top surface of the foundation. Time-sequential and post-impact photographs are shown in Figure 39.

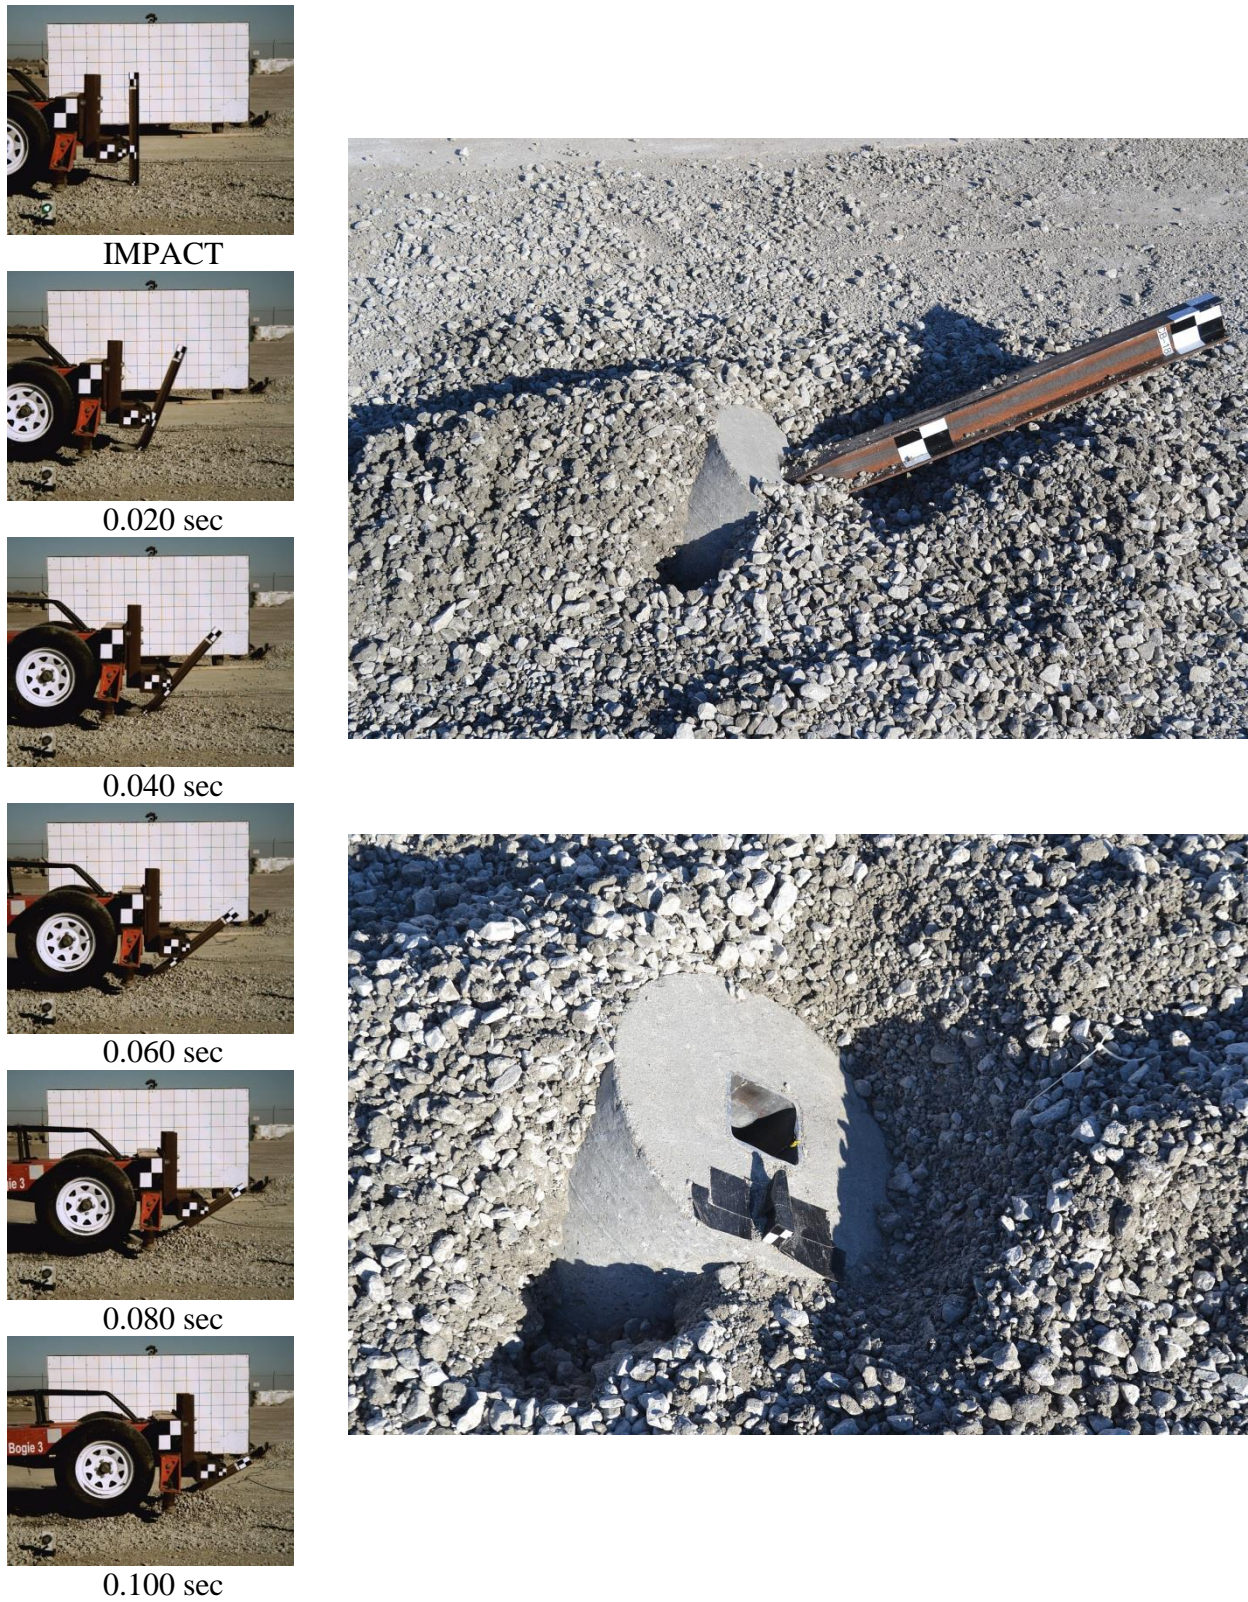
Figure 41. Time-Sequential and Post-Impact Photographs, Test No. HTCB-18

Damage to the test article consisted of plastic bending of the post at groundline, excessive foundation deflection, and significant soil displacements. Aside from the large displacements, the concrete foundation remained whole and free of cracks. Time-sequential and post-impact photographs are shown in Figure 41.
