# **DEVELOPMENT OF SOCKETED FOUNDATIONS FOR S3X5.7 POSTS**

## **MIDWEST ROADSIDE SAFETY FACILITY**

MwRSF Research Report No. TRP-03-293-15

April 28, 2015

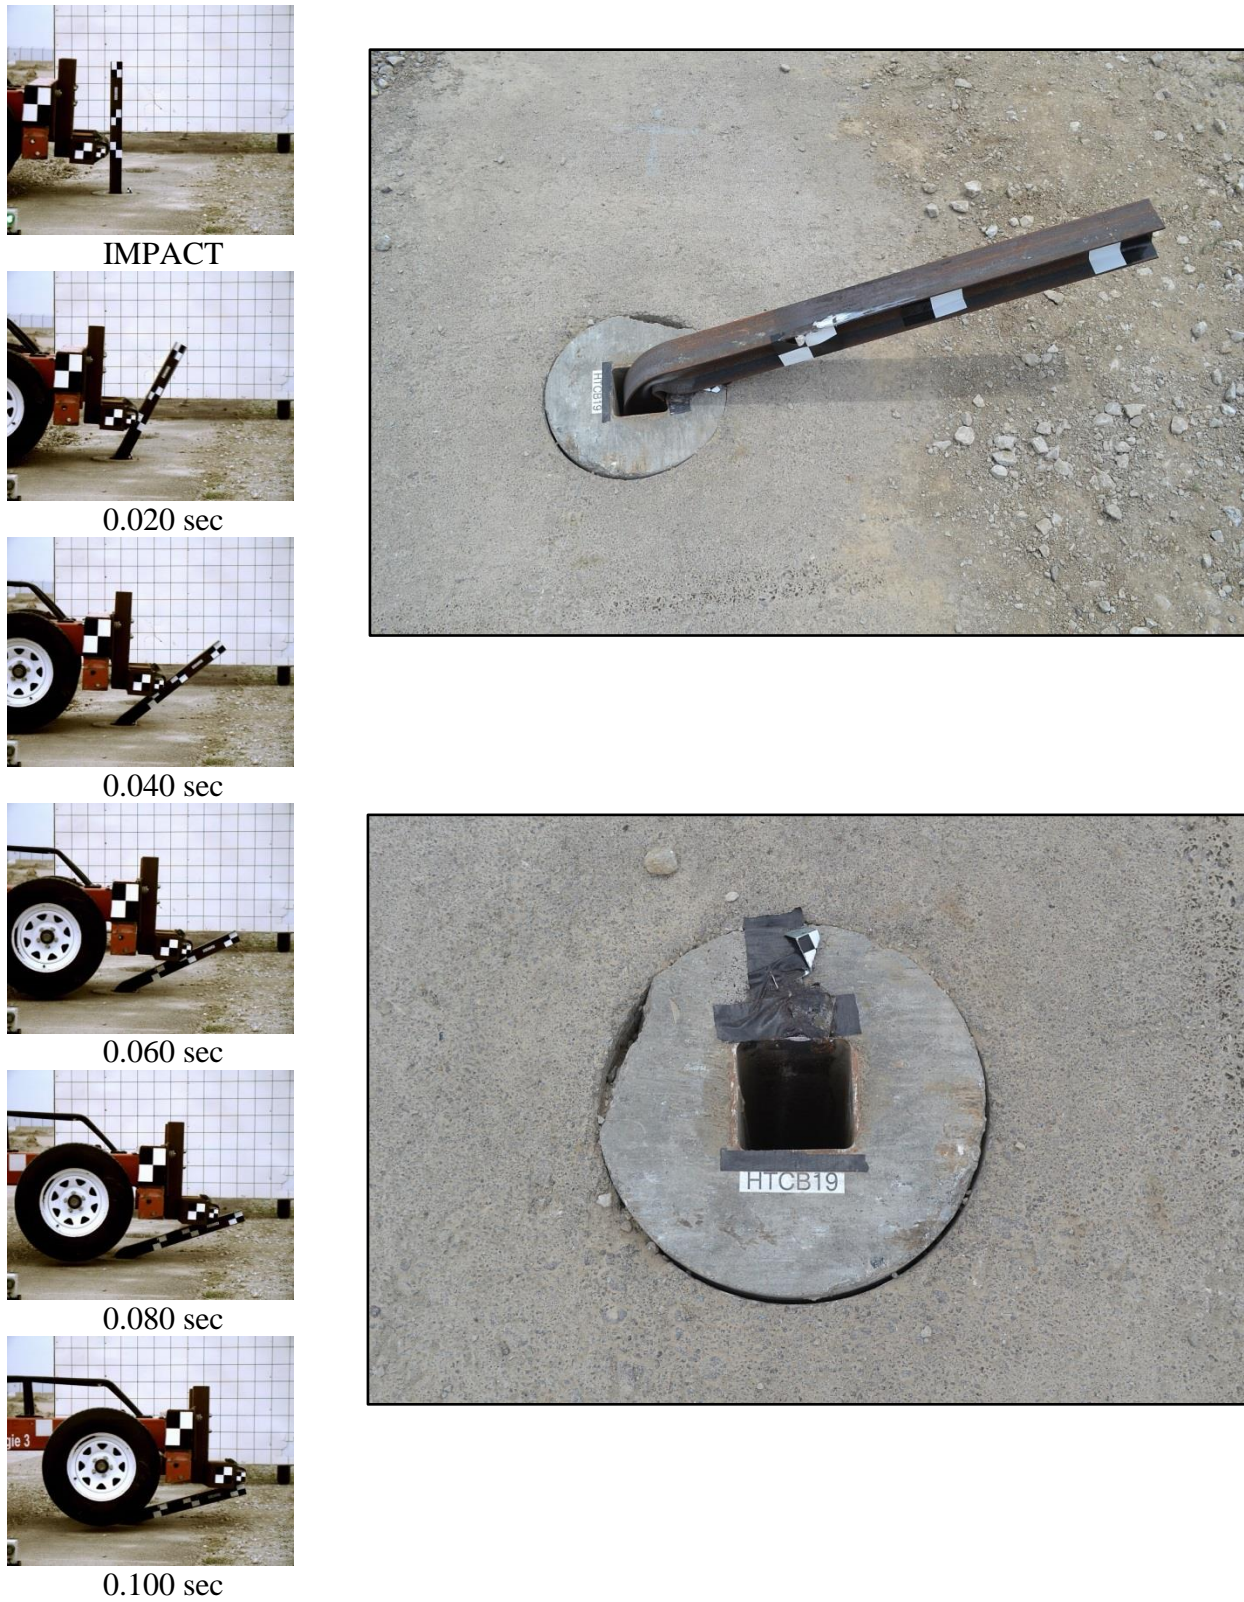
Figure 51. Time-Sequential and Post-Impact Photographs, Test No. HTCB-19

Damage to the test article consisted of only plastic bending of the post at groundline. The foundation experienced no visible damage. Note, the concrete spalling on the top-left side of the foundation had occurred during installation. Time-sequential and post-impact photographs are shown in Figure 51.

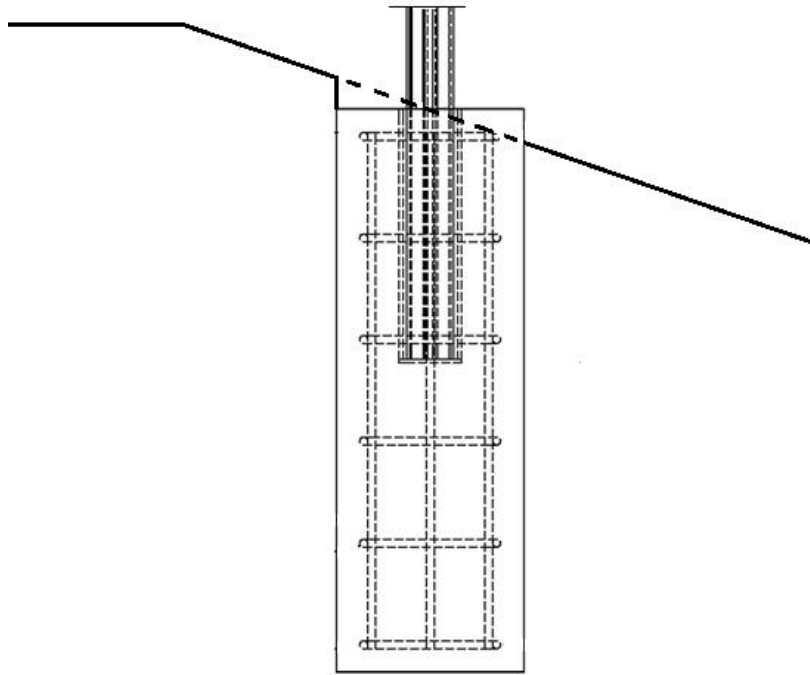
Figure 58. Placement of Foundation on Slope

Some guardrail systems are installed within medians and on roadsides with cross slopes, e.g., cable barriers. If the top of the socketed foundation is not poured to match the surrounding terrain, it would result in the downslope side of the foundation protruding above the groundline. To minimize the extent of this protrusion, it is recommended to install the top center of the foundation level with the surrounding slope, as shown in Figure 58. Additionally, this configuration ensures that the post and cables remain at the correct height. Casting the foundation on-site to match the surrounding terrain would also be acceptable.
