CABLE-TO-POST ATTACHMENTS FOR A NON-PROPRIETARY HIGH-TENSION CABLE BARRIER – PHASE II

MwRSF Research Report No. TRP-03-313-15

June 2, 2015

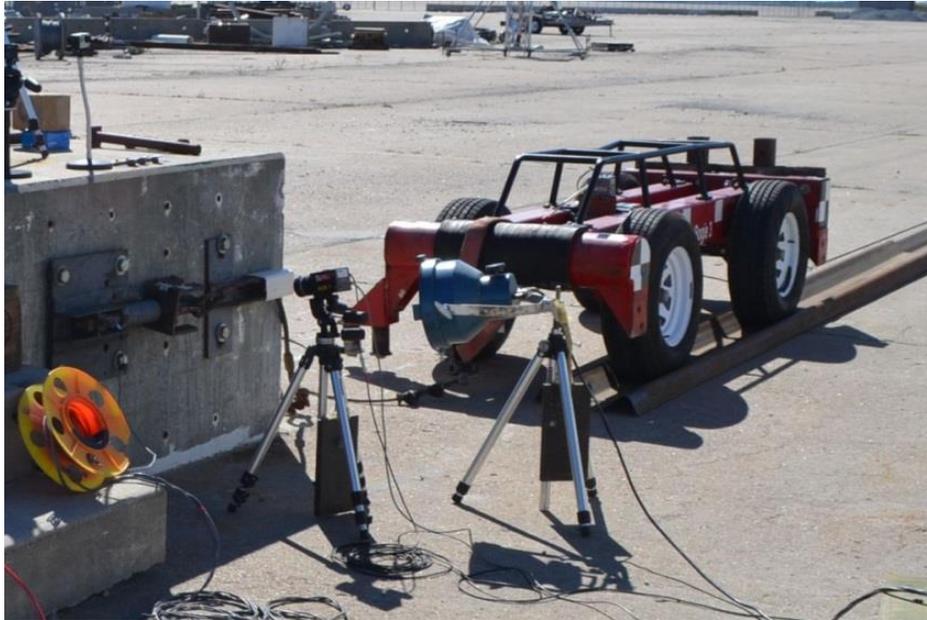
Figure 53. Rigid-Frame Bogie on Guidance Track

A rigid-frame bogie was used to pull the cable that was attached to the various tabbed bracket designs. The weight of the bogie was 1,916 lb (869 kg). A pickup truck was used to

propel the bogie along a guidance track to a target speed of 5 mph (8 km/h). The pickup truck braked, allowing the bogie to be free-rolling as it approached the end of the guidance system and applied the load to the cable-to-post attachment. A remote braking system was installed on the bogie, allowing it to be brought safely to rest after the test. The bogie with the test setup is shown in Figure 53.

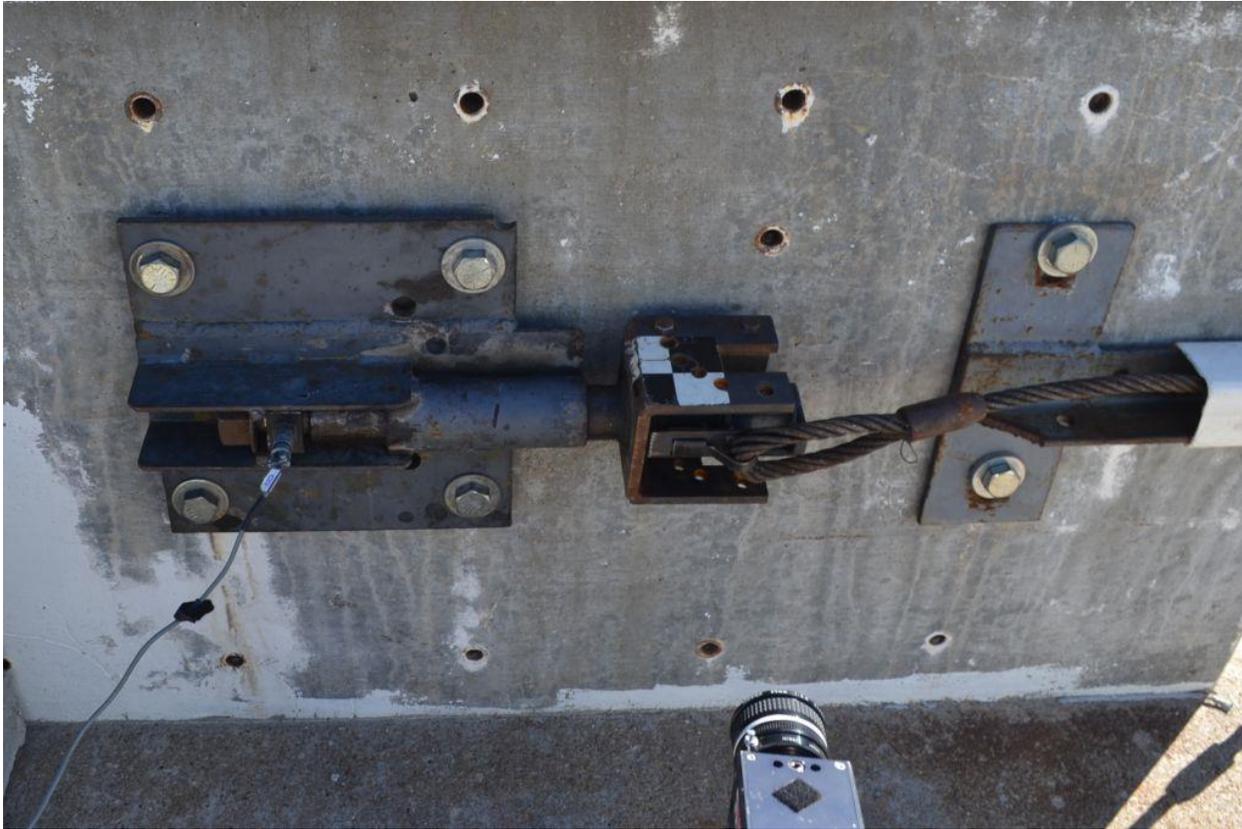
Figure 54. Test Jig

A test jig was utilized to support and anchor the test article. The short post section was bolted to a mounting plate, which could be adjusted to change the angle at which the cable pulled on the post-bracket assembly. A steel rod was used to connect and transfer loads from the mounting plate to the load cell. The steel rod was encased by a cylindrical steel tube to restrict motion to only the direction of loading. A looped cable was placed through the tabbed bracket and through a feeder tube in line with the load cell and mounting plate. The other end of the cable was attached to the bogie. The test jig was mounted to the side of a rigid concrete block, as shown in Figure 54.

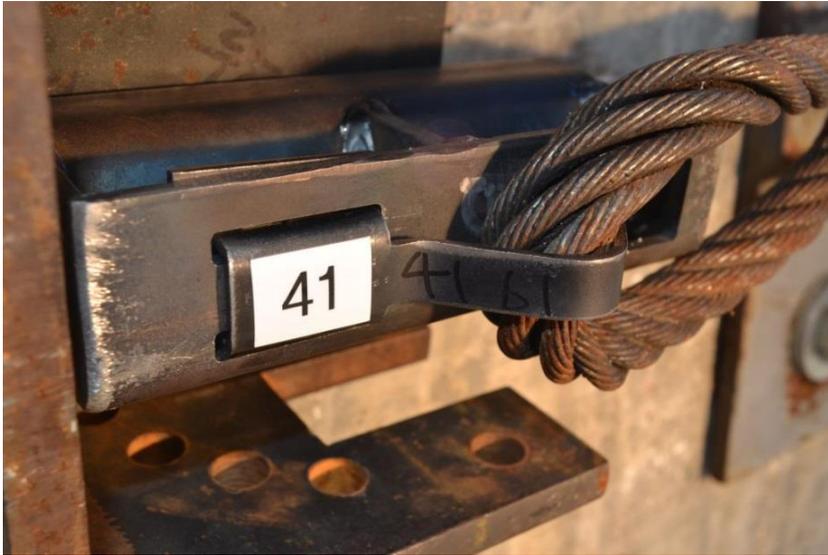
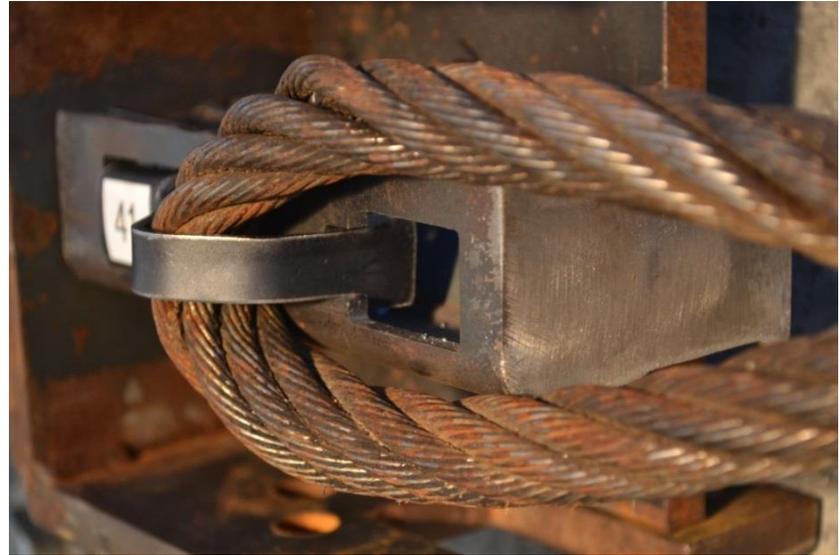
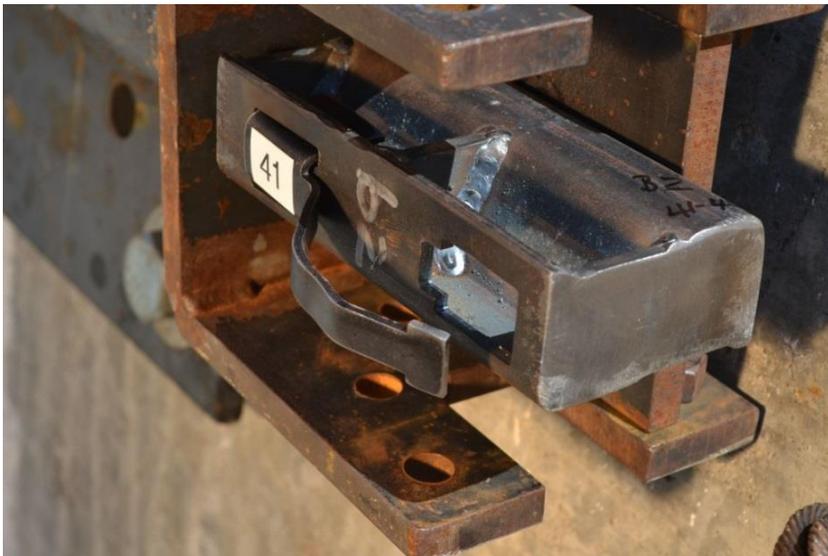
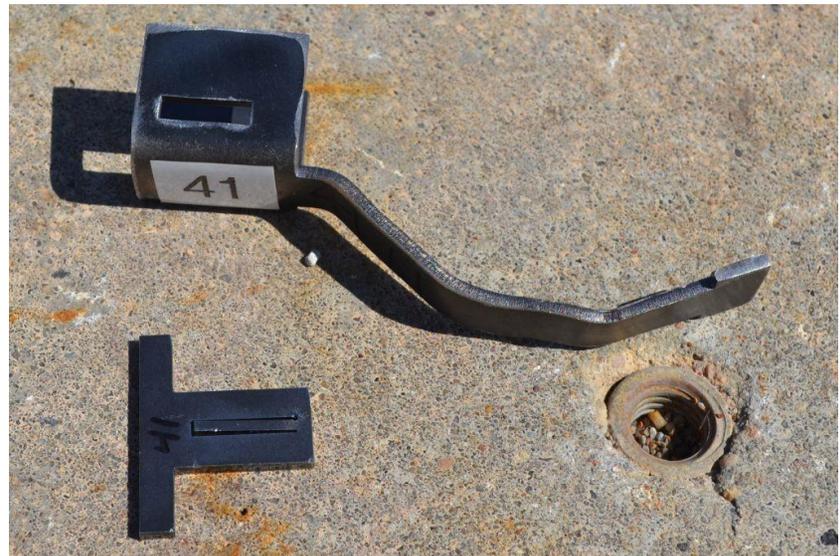
Figure 56. Pre-Test (Upper) and Post-Test (Lower) Photographs, Test No. HTTPB-41

Test no. HTTB-41 evaluated the tabbed bracket with the lateral shear plate attachment by loading the bracket vertically, or at an angle of 0 degrees relative to the face of the post. Once the cable was pulled into tension, the construction tolerances within the lateral shear plate connection allowed the bracket to rotate slightly outward. As the load imparted to the tabbed bracket increased, the spine of the bracket began to bend, and the bracket opened. At 0.076 seconds after the initial loading, a peak load of 0.31 kips (1.37 kN) was reached. After this peak, the force fell quickly as the bracket continued to open and the tabs were lifted out of the keyway. By 0.096 seconds, the tabs had completely exited the keyway. The two peaks occurring after this time were caused by the cable briefly catching on the tabs as it released from the bracket. These two trailing peaks had loads of 0.24 kips and 0.23 kips (1.08 kN and 1.03 kN), respectively. The force vs. time curve is shown in Figure 55. Pre- and post-test photographs and sequential photographs are shown in Figures 56 and 57, respectively.

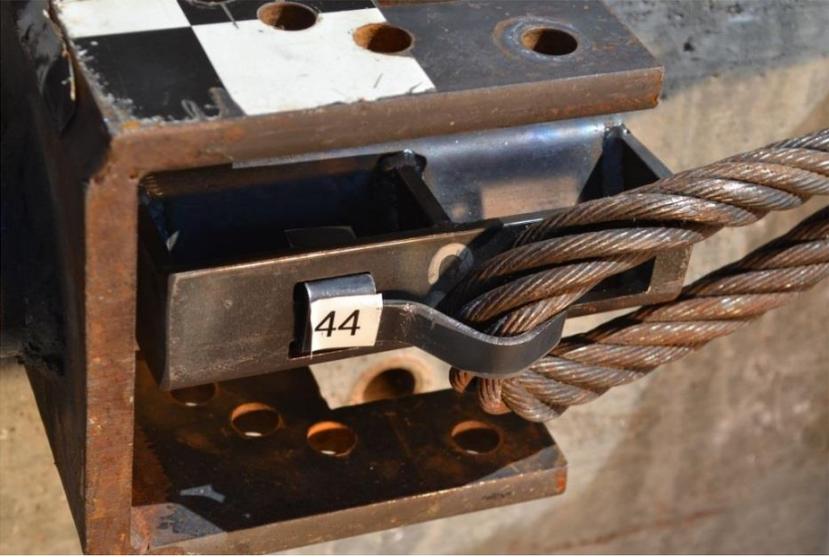
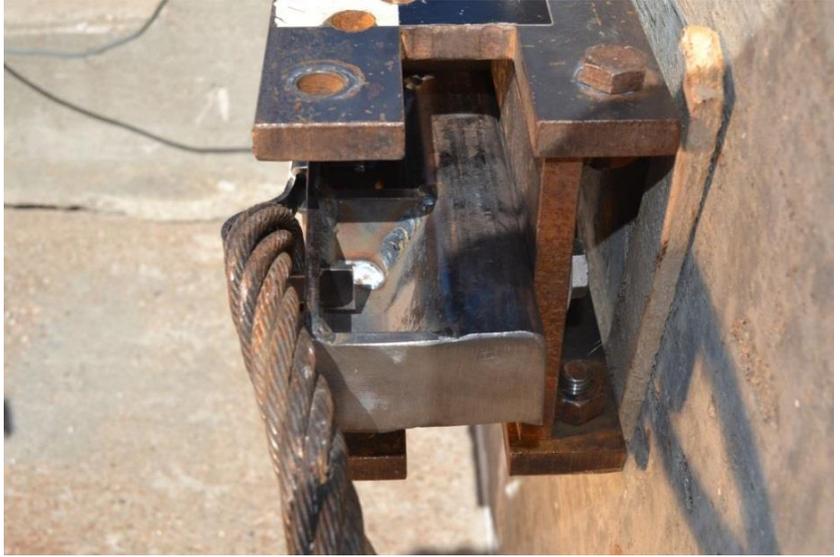
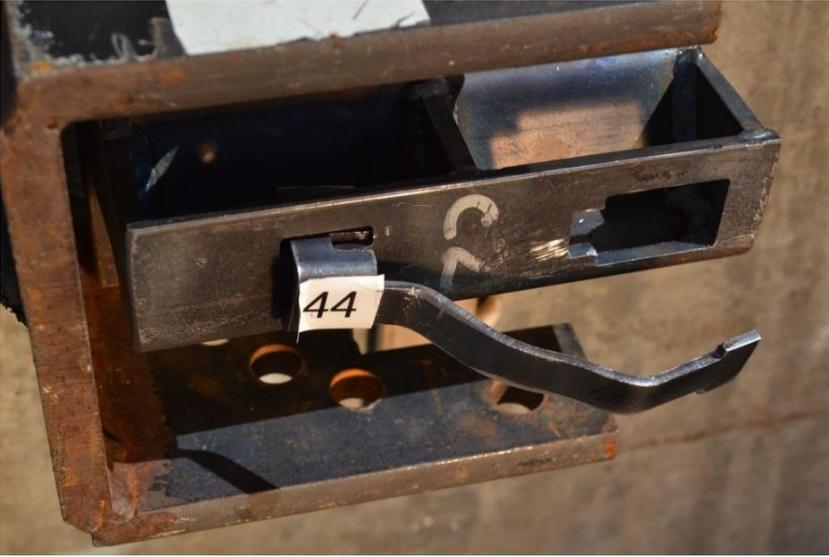
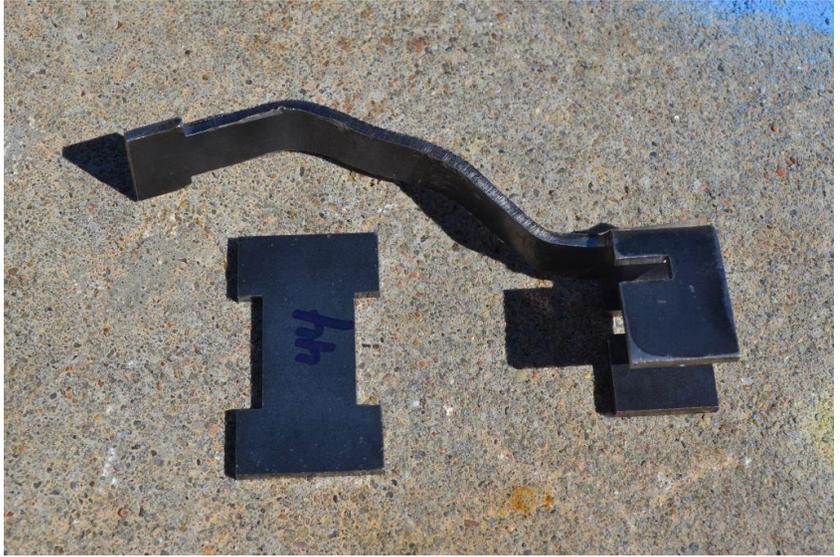
Figure 65. Pre-Test (Upper) and Post-Test (Lower) Photographs, Test No. HTTPB-44

Test no. HTTPB-44 evaluated the tabbed bracket with the drop-in shear plate attachment by loading the bracket vertically, or at an angle of 0 degrees relative to the face of the post. Once the cable was pulled into tension, the construction tolerances within the connection allowed the bracket to shift and rotate outward until the tabs pressed against the inside of the post flange. As the load imparted to the tabbed bracket increased, the spine of the bracket began to bend. However, the tabs were snagged against the inside of the flange, which prevented the bracket from opening. At 0.218 seconds after the initial loading, a peak load of 1.03 kips (4.56 kN) was reached. After this peak, the tabs finally slid up and through the keyway, and the force fell quickly. By 0.232 seconds, the tabs had completely exited the keyway. The force vs. time curve is shown in Figure 64. Pre- and post-test photographs and sequential photographs are shown in Figures 65 and 66, respectively.

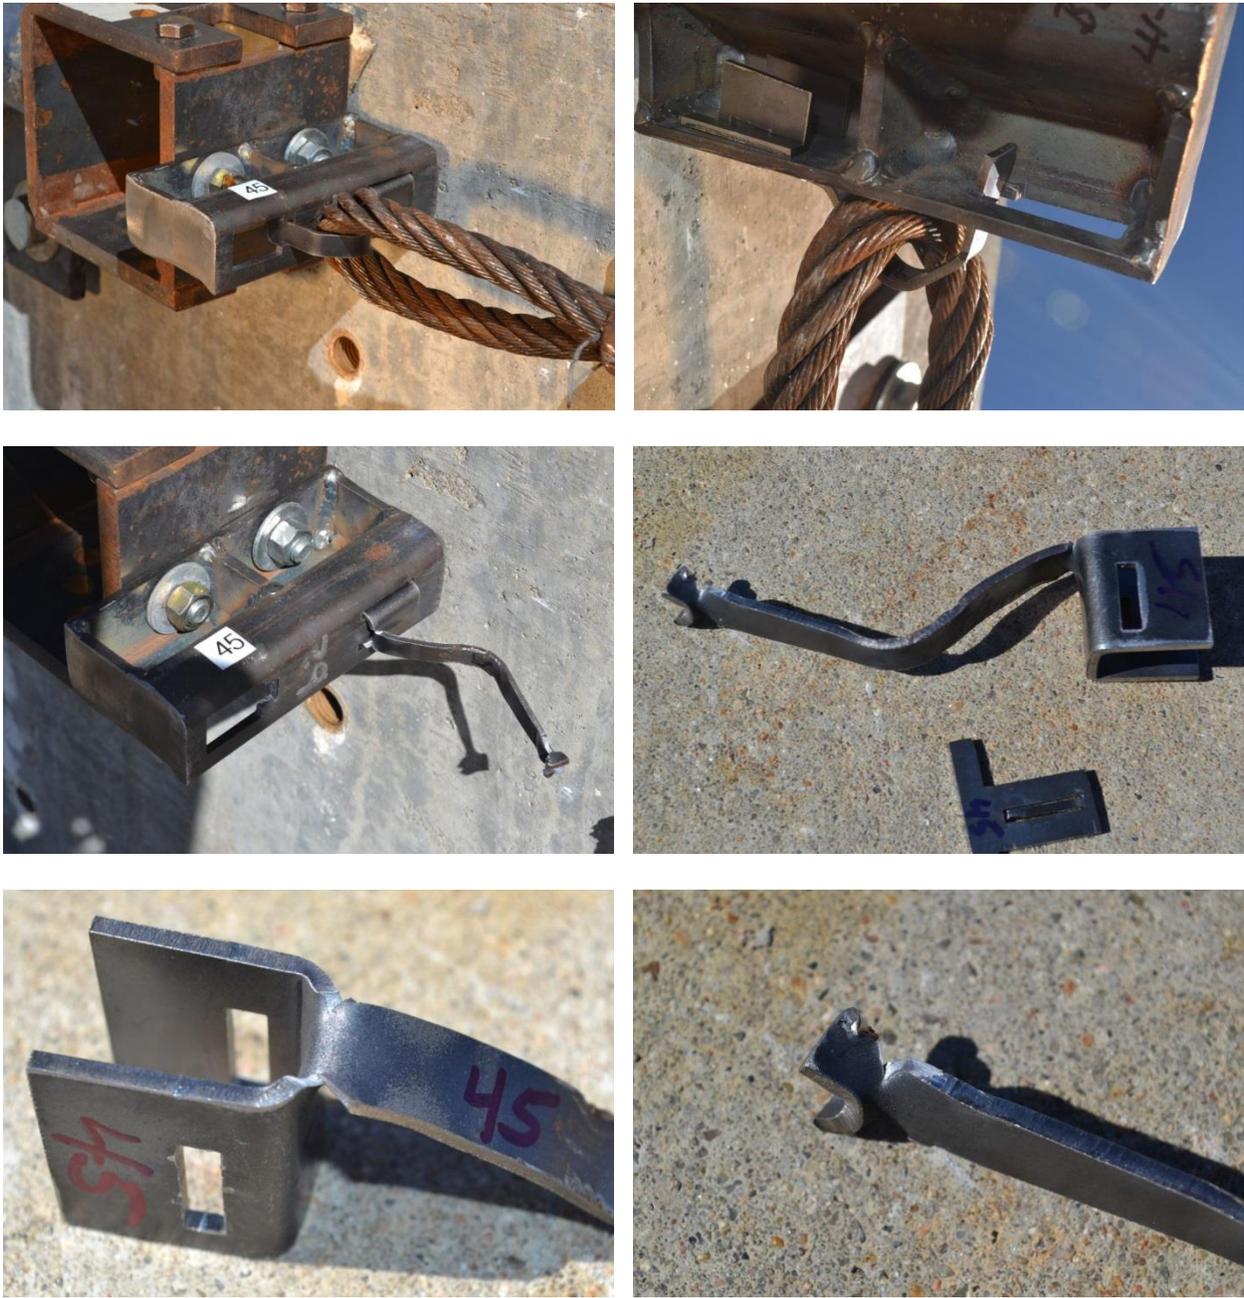
Figure 68. Pre-Test (Upper) and Post-Test (Lower) Photographs, Test No. HTTB-45

Test no. HTTPB-45 evaluated the tabbed bracket with the lateral shear plate attachment by loading the bracket laterally, or normal to the flange of the post. As the cable was pulled into tension, the tabs were pulled against the post flange at the bottom of the keyway. As the load increased, the spine of the bracket began to bend and stretch. At 0.168 seconds after loading began, small tears began to form in the tabs in the area where the spine meets the tabs. Additional tears formed in the base of the bracket where the spine met the lower legs. At 0.178 seconds, a peak load of 6.21 kips (27.61 kN) was reached, and further tearing and bending of the tabs resulted in the tabs being pulled through the lower portion of the keyway. Subsequently, the spine of the bracket bent open, and the cable was released at 0.182 seconds. The force vs. time curve is shown in Figure 67. Pre- and post-test and photographs and sequential photographs are shown in Figures 68 and 69, respectively.

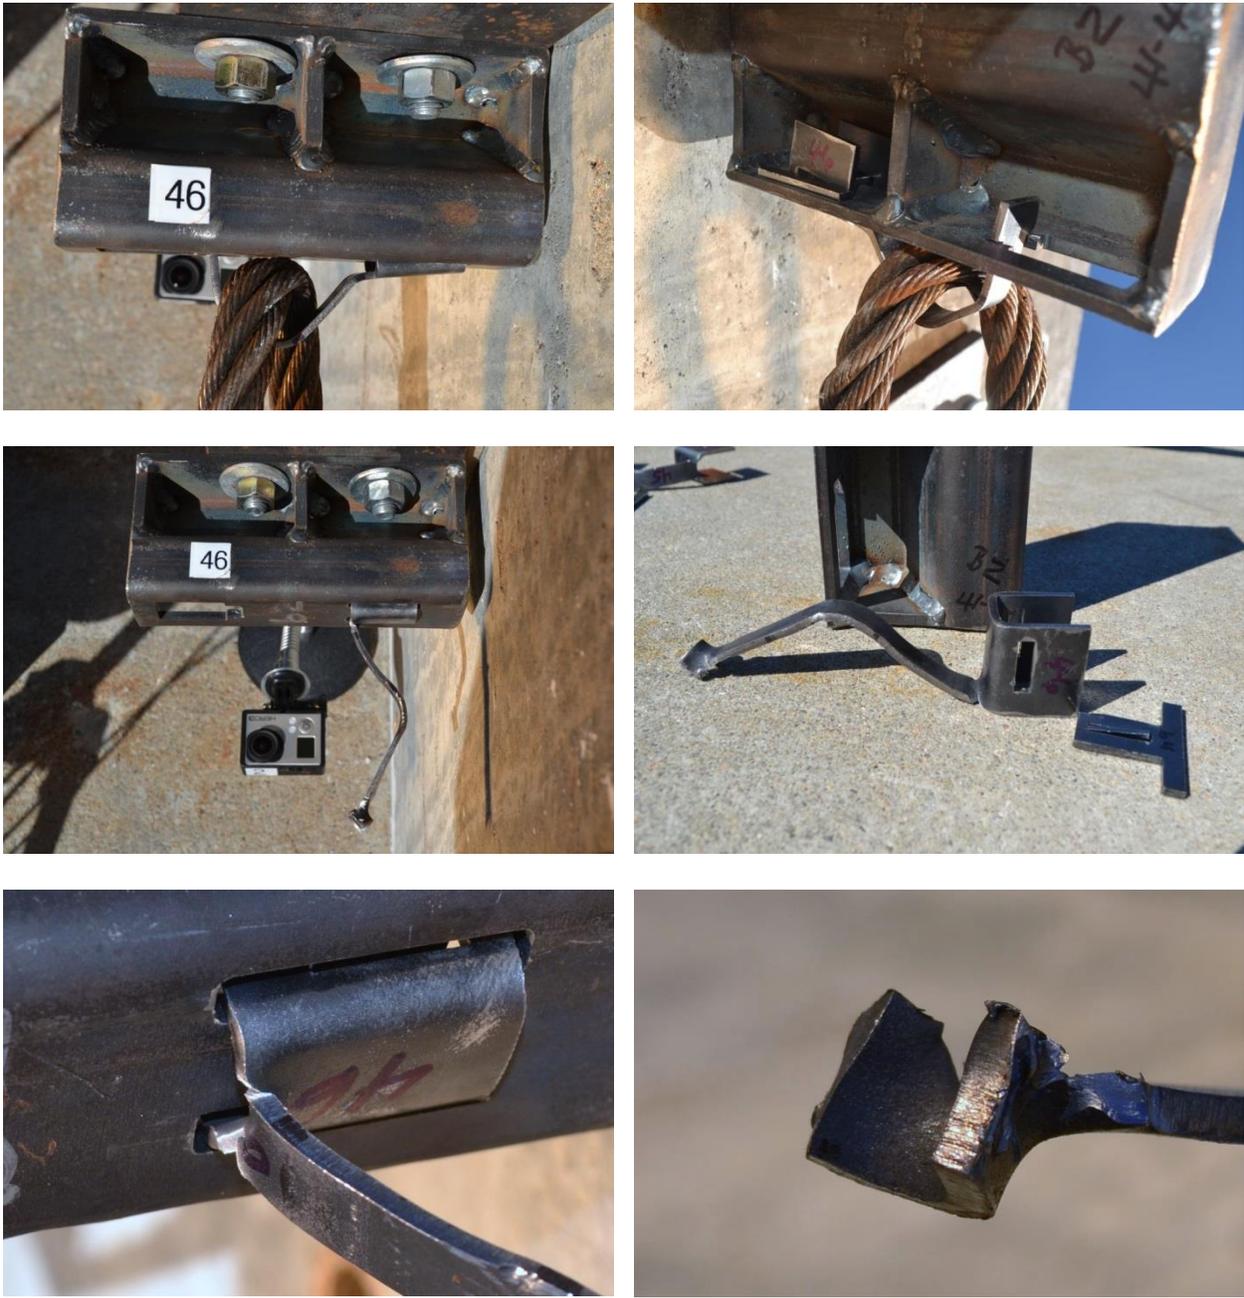
Figure 71. Pre-Test (Upper) and Post-Test (Lower) Photographs, Test No. HTTB-46

Test no. HTTPB-46 evaluated the tabbed bracket with the lateral shear plate attachment by loading the bracket laterally, or normal to the flange of the post. As the cable was pulled into tension, the tabs were pulled against the post flange at the bottom of the keyway. As the load increased, the spine of the bracket began to bend and stretch. At 0.206 seconds after loading began, small tears began to form in the base of the bracket where the spine met the lower legs. Additional tears formed in the tabs by 0.224 seconds. At 0.230 seconds, a peak load of 6.26 kips (27.84 kN) was reached, and further tearing and bending of the tabs resulted in the tabs being pulled through the lower portion of the keyway. Subsequently, the spine of the bracket bent open, and the cable was released at 0.234 seconds. The force vs. time curve is shown in Figure 70. Pre- and post-test photographs and sequential photographs are shown in Figures 71 and 72, respectively.

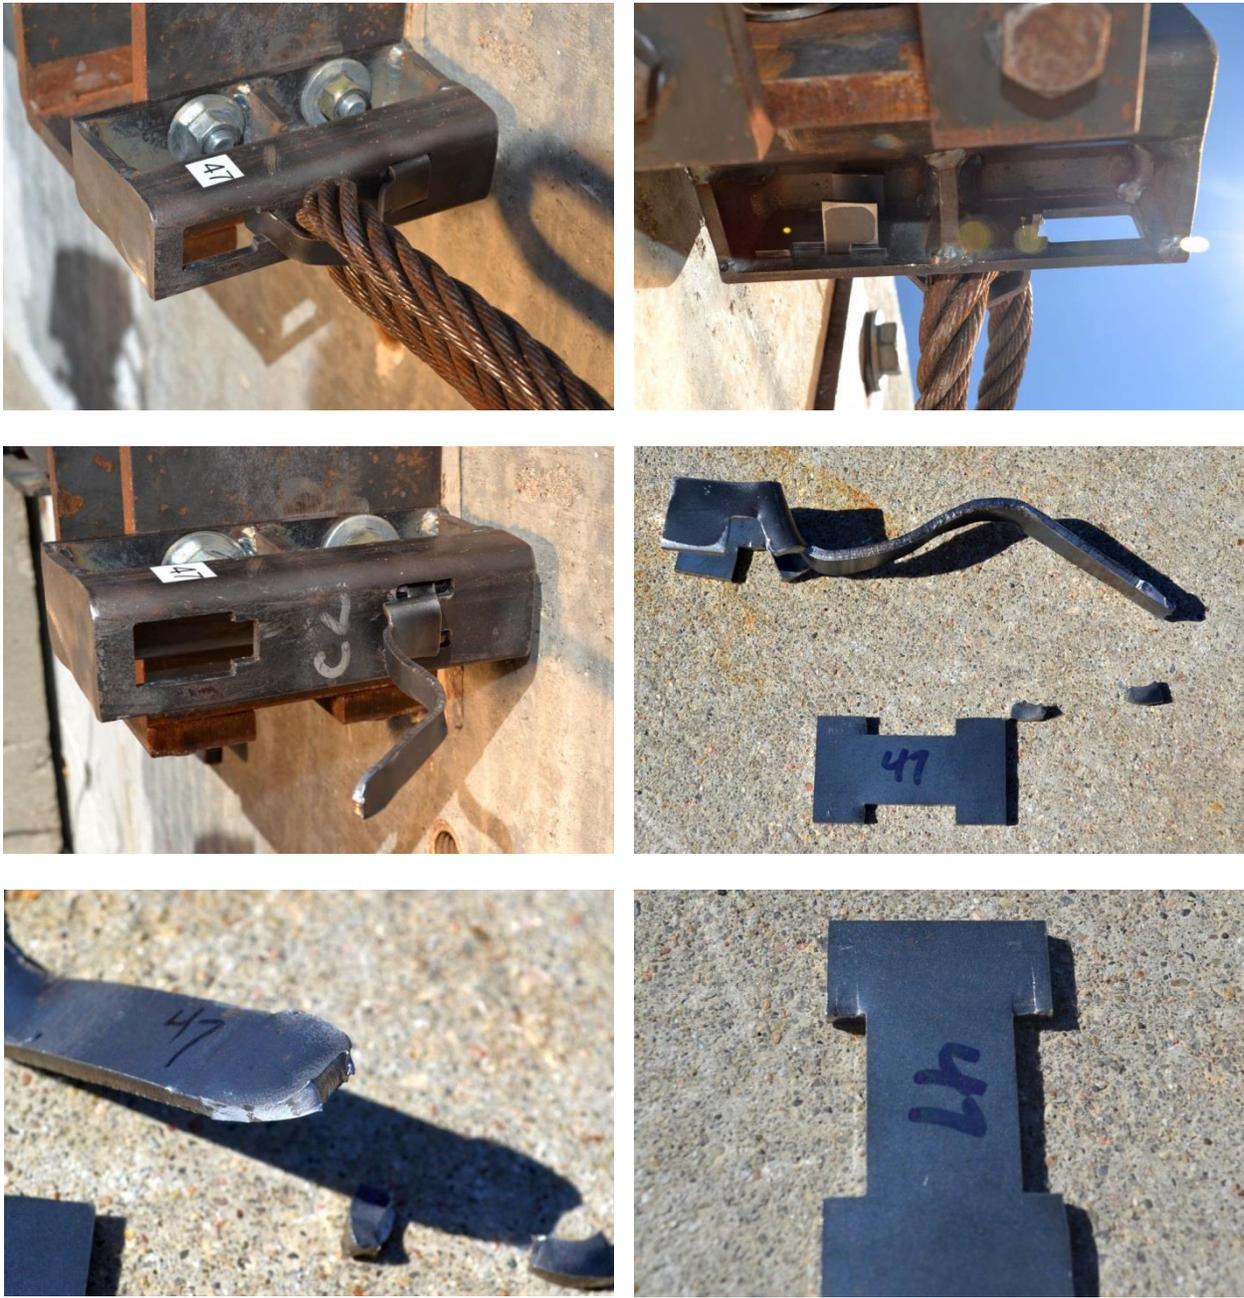
Figure 74. Pre-Test (Upper) and Post-Test (Lower) Photographs, Test No. HTTB-47

Test no. HTTPB-47 evaluated the tabbed bracket with the drop-in shear plate attachment by loading the bracket laterally, or normal to the flange of the post. As the cable was pulled into tension, the tabs were pulled against the post flange at the bottom of the keyway. As the load increased, the spine of the bracket began to bend and stretch. At 0.238 seconds after initial loading, the bracket legs began to bend such that the notches in the legs were opening. By 0.240 seconds, small tears formed in the tabs. At 0.244 seconds, the notches in the legs opened and the base of the bracket slid upward over the post flange. At 0.249 seconds, a peak load of 5.30 kips (23.59 kN) was reached, and the tabs sheared off. Subsequently, the top of the bracket pulled through the lower portion of the keyway, the spine was bent open, and the cable was released by 0.254 seconds. The force vs. time curve is shown in Figure 73. Pre- and post-test photographs and sequential photographs are shown in Figures 74 and 75, respectively.

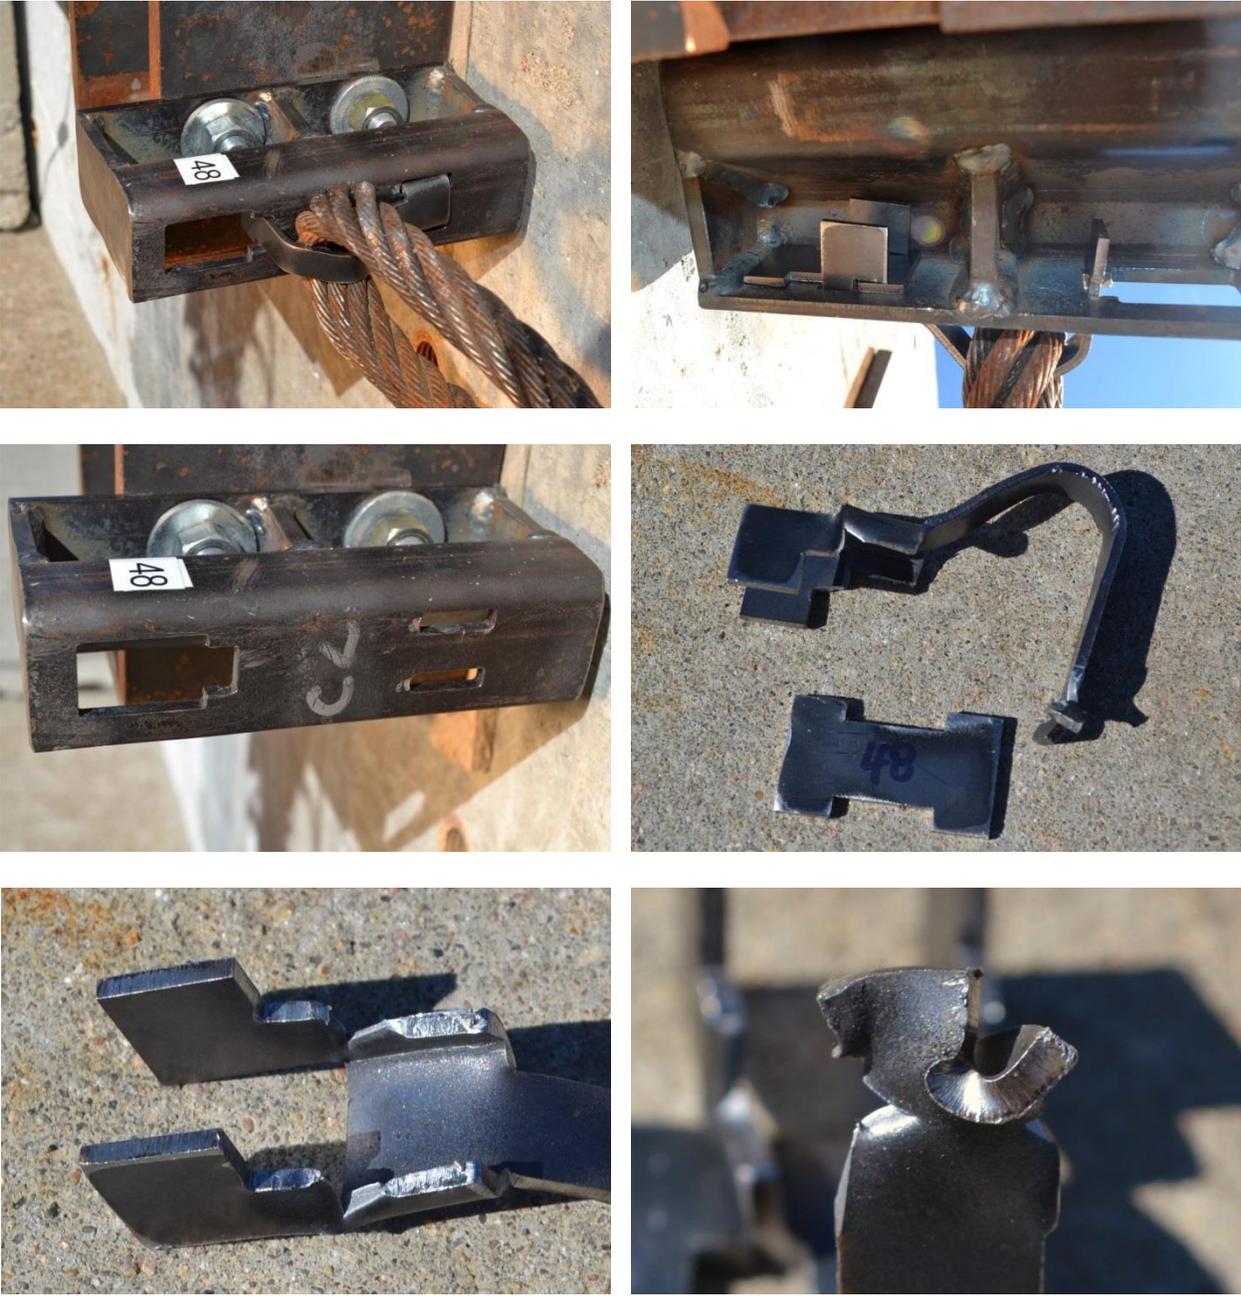
Figure 77. Pre-Test (Top Two) and Post-Test (Bottom Four) Photographs, Test No. HTTP-48

Test no. HTTPB-48 evaluated the tabbed bracket with the drop-in shear plate attachment by loading the bracket laterally, or normal to the flange of the post. As the cable was pulled into tension, the tabs were pulled against the post flange at the bottom of the keyway. As the load increased, the spine of the bracket began to bend and stretch. Around 0.210 seconds after initial loading, the bracket legs began to bend such that the notches in the legs were opening. Additionally, small tears formed in the tabs. At 0.220 seconds, the notches in the legs opened and the base of the bracket slid upward over the post flange. At 0.225 seconds, a peak load of 5.40 kips (24.03 kN) was reached before further tearing and bending of the tabs resulted in the top of the bracket being pulled through the keyway. Immediately following the release of the tabs, tearing began at the bottom of the notches in the bracket legs. As the notches opened to nearly 90 degrees, the legs were pulled through the slots in the post, and the cable pulled the entire bracket away at 0.235 seconds. The force vs. time curve is shown in Figure 76. Pre- and post-test photographs and sequential photographs are shown in Figures 77 and 78, respectively. Due to a faulty trigger, the AOS high-speed digital video camera failed to record the test. Thus, video from a GoPro Hero 3 digital camera was used for sequential photographs.

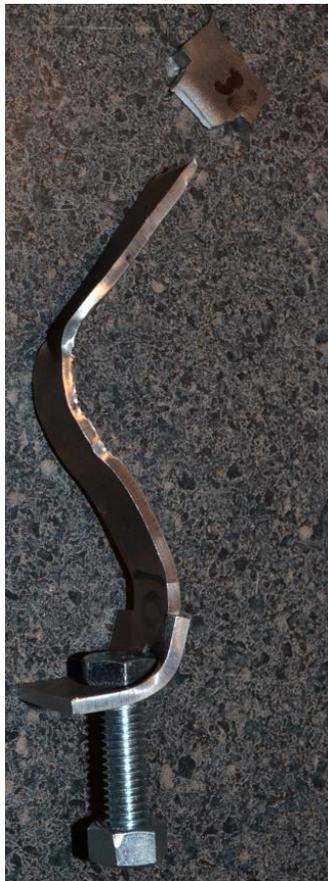
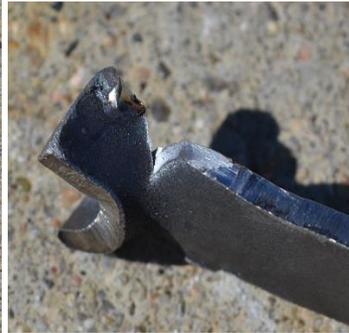
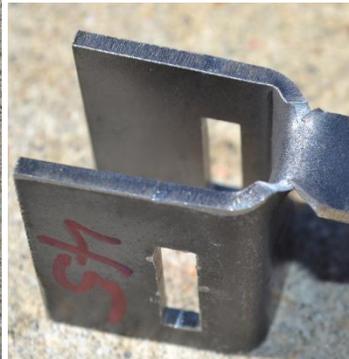
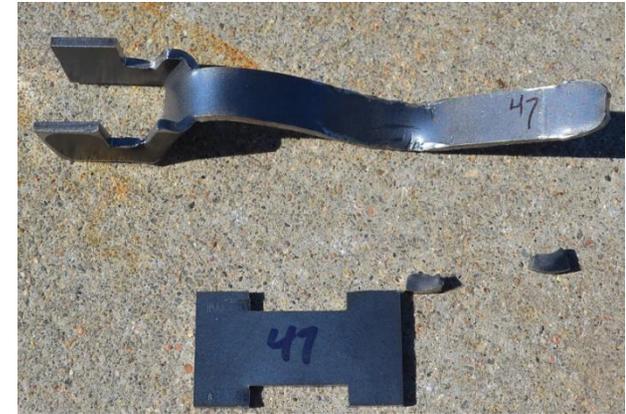
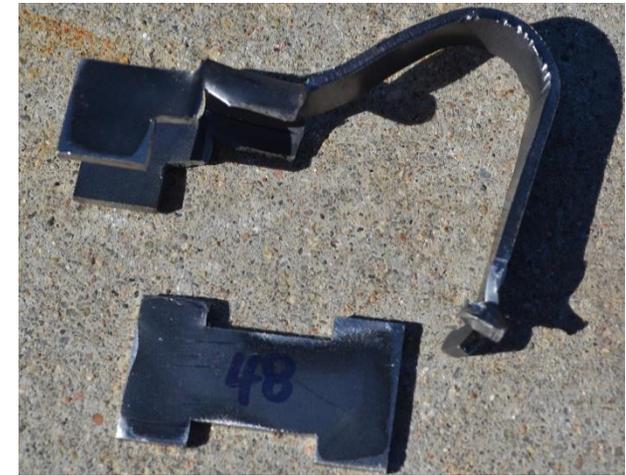
Figure 79. Lateral Test Fracture/Failure Mechanisms for Various Bracket Designs

The location of the bracket fracture/failure during the lateral tests varied between the original bolted bracket and the new shear plate brackets, as shown in Figure 79. This finding may be explained in part by the small bracket rotations allowed by the shear plate attachments. These rotations may have led to tabs contacting the post flange at an angle and causing tab bending and out-of-plane tearing that would not have occurred if the tabs were normal to the flange. Or put more simply, the difference in the constraints at the base of the bracket may have changed the loading and failure of the drop-in shear plate design. However, this variation in fracture/failure locations was not a major concern. The bolted tabbed bracket was designed with the same failure/fracture strength for failures around the bolt hole, through the spine of the bracket, and at the tabbed portion of the bracket. Consequently, the release load between the bolted bracket and the lateral shear plate bracket remained nearly identical. The bending/tearing of the bracket legs in the drop-in shear plate design was not intended and potentially lowered the release loads.

Tearing was also initiated in the lateral shear plate brackets at the junction between the bracket spine and the bottom legs, as shown in Figure 79. This out-of-plane tearing (mode III fracture) was considered a possibility before the tests were conducted. However, the tearing was minor, and this additional failure mechanism did not affect the release loads in the brackets. Thus, it is no longer a concern.

All lateral tests resulted in the tabs being caught by the narrow end of the keyway. As the load in the cable was increased, the brackets eventually released as the tabs were torn/bent, which allowed the top of the bracket to pull through the keyway. Additional bending and tearing deformations were found in the brackets around the bottom legs. The lateral shear plate design provided loads very similar to the original bolted bracket, at just over 6 kips (26.7 kN). However, the release loads for the drop-in shear plate design were lower than expected at 5.4 kips (24.0

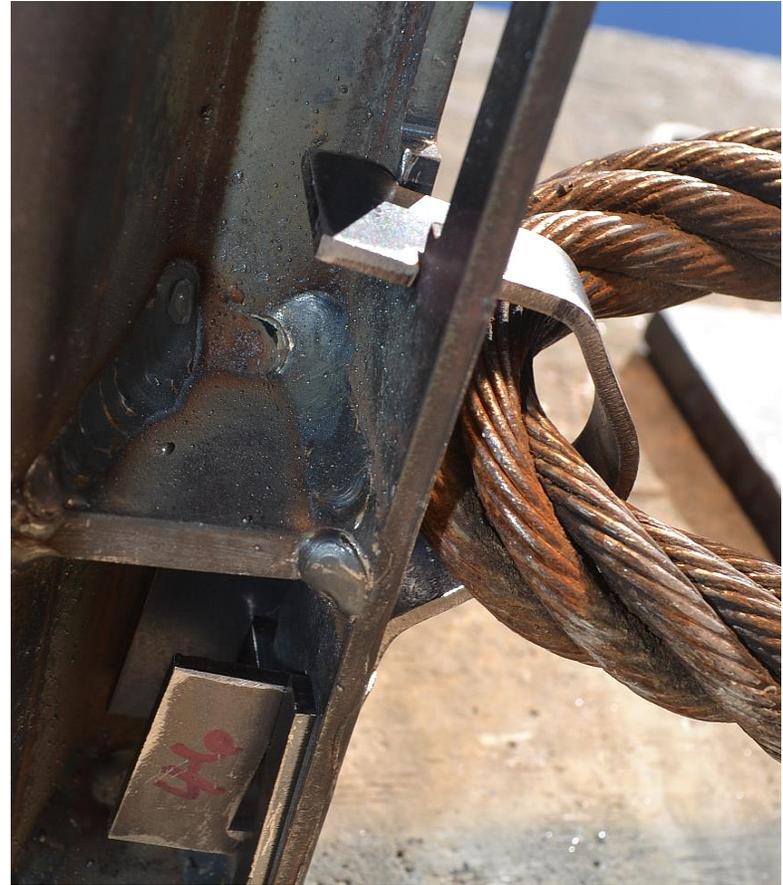
Figure 81. Lateral Shear Plate Bracket, Pre-Test Tab Locations Relative to Post Flange

The initial locations of the tabbed brackets after installation but prior to component testing are shown in Figures 80 through 82. The bolted tabbed brackets have the intended offset between the tabs and the inside of the post-flange as shown in Figure 80. This seating of the tabbed bracket can be attributed to the rigidity of the bolted attachment which prevented any “wobble” in the bracket. The initial position of the tabbed bracket with the lateral shear plate attachment is much closer to the inside of the post flange than in the bolted brackets due to the allowed rotation and displacement of the shear plate attachment as shown in Figure 81. In the lateral test setup photograph shown in Figure 81, the base of the bracket rotated around the shear plate enough to bring the tabbed top adjacent to the inside of the flange, even prior to loading. These same issues with the drop-in shear plate design as the tabs appear to be directly adjacent to the flanges prior to loading are shown in Figure 82. To summarize, two factors in the tabbed bracket design give potential for issues. First, multiple slots and interlocking parts cause excess slip in the attachment, potentially allowing rotation of the bracket. Second, the lack of a bolted constraint prevents preloading the base of the bracket to hold the bracket in position regardless of tolerance.

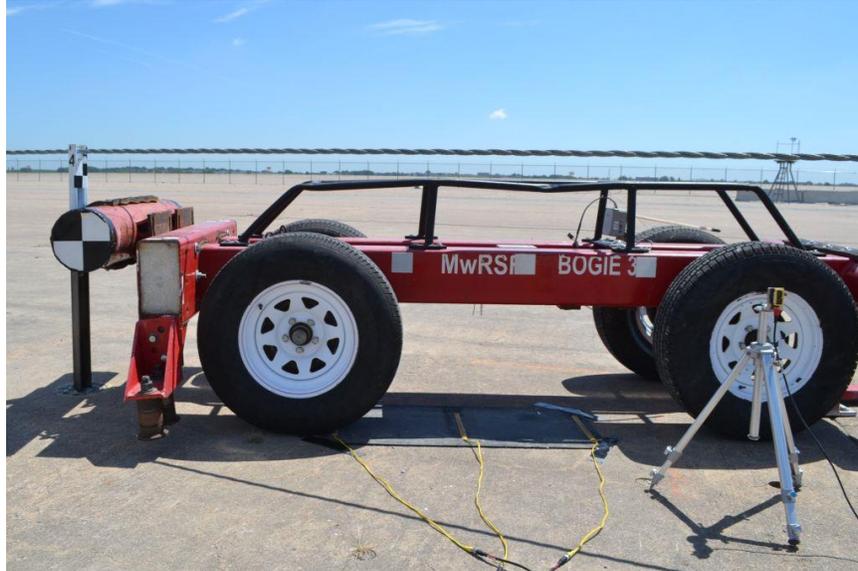
Figure 99. Rigid-Frame Bogie on Guidance Track

A rigid-frame bogie was used to impact the posts. A variable-height detachable impact head was used in the testing. The bogie head was constructed of 8-in. (203-mm) diameter, ½-in. (13-mm) thick standard steel pipe, with ¾-in. (19-mm) neoprene belting wrapped around the pipe to prevent local damage to the post from the impact. The impact head was bolted to the bogie vehicle, creating a rigid frame with an impact height of 24⁷/₈ in. (632 mm). The bogie, with impact head, is shown in Figure 99. The weight of the bogie with the addition of the mountable impact head and accelerometers was 1,861 lb (844 kg).

A pickup truck with a reverse cable tow system was used to propel the bogie to a target impact speed of 45 mph (72.4 km/h). When the bogie approached the end of the guidance system, it was released from the tow cable, allowing it to be free-rolling when it impacted the post. A remote braking system was installed on the bogie, allowing it to be brought safely to rest after the test.

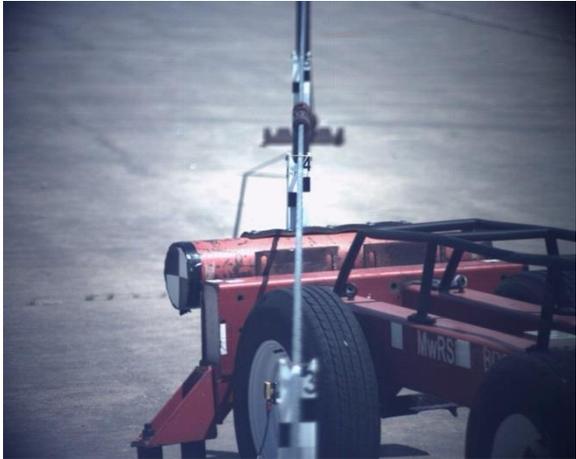
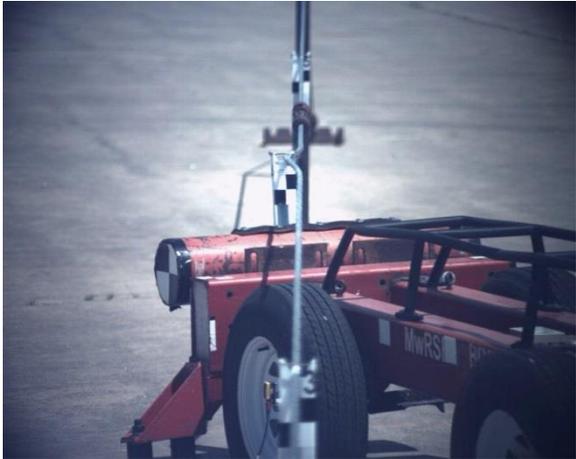
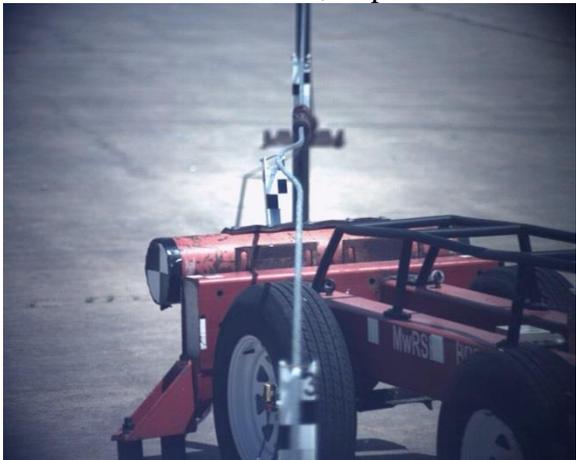
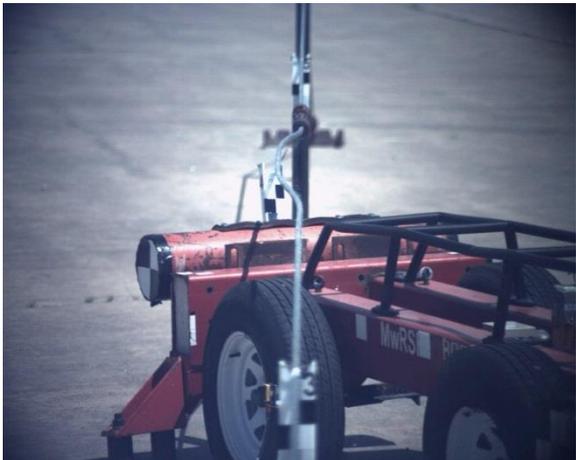
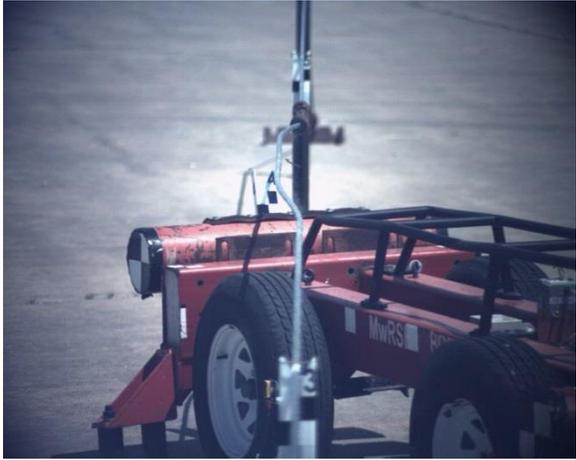
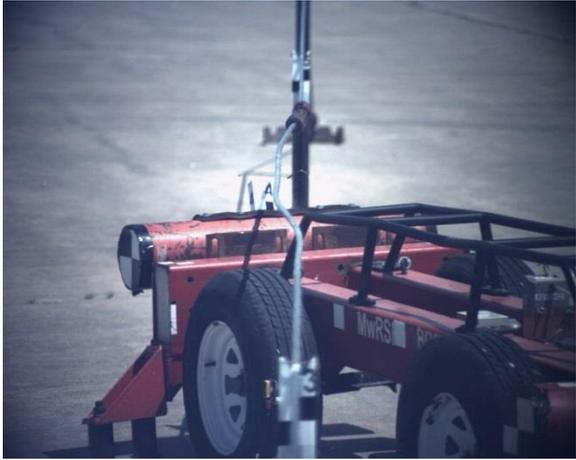
Figure 100. Sequential Photographs, Test No. HTTC-2

During test no. HTTC-2, the bogie impacted post no. 4 at a speed of 46.5 mph (74.8 km/h) and an angle of 25 degrees. Upon impact, the post began to bend, and a plastic hinge formed in the post near the groundline. By 0.002 seconds after impact, the impact side of the notch impacted the cable and began to move the cable laterally away from impact. At 0.006 seconds, the cable rode up the slope of the notch and bent the center of the brass rod upward. The brass rod fractured at 0.010 seconds, releasing the cable after displacing it 3.0 in. (76 mm) laterally. The lateral pulse wave in the cable traveled along the cable until it reached the adjacent posts 0.046 seconds after impact. The lateral pulse wave in the cable caused post nos. 3 and 5 to displace laterally approximately 0.5 in. (13 mm). The posts adjacent to the impacted post immediately returned to their original positions after the cable wave passed. The bogie vehicle traveled underneath the cable without any direct cable contact and eventually overrode post no. 4 as it traveled along its original trajectory. Sequential photographs of the test are shown in Figures 100 through 102.

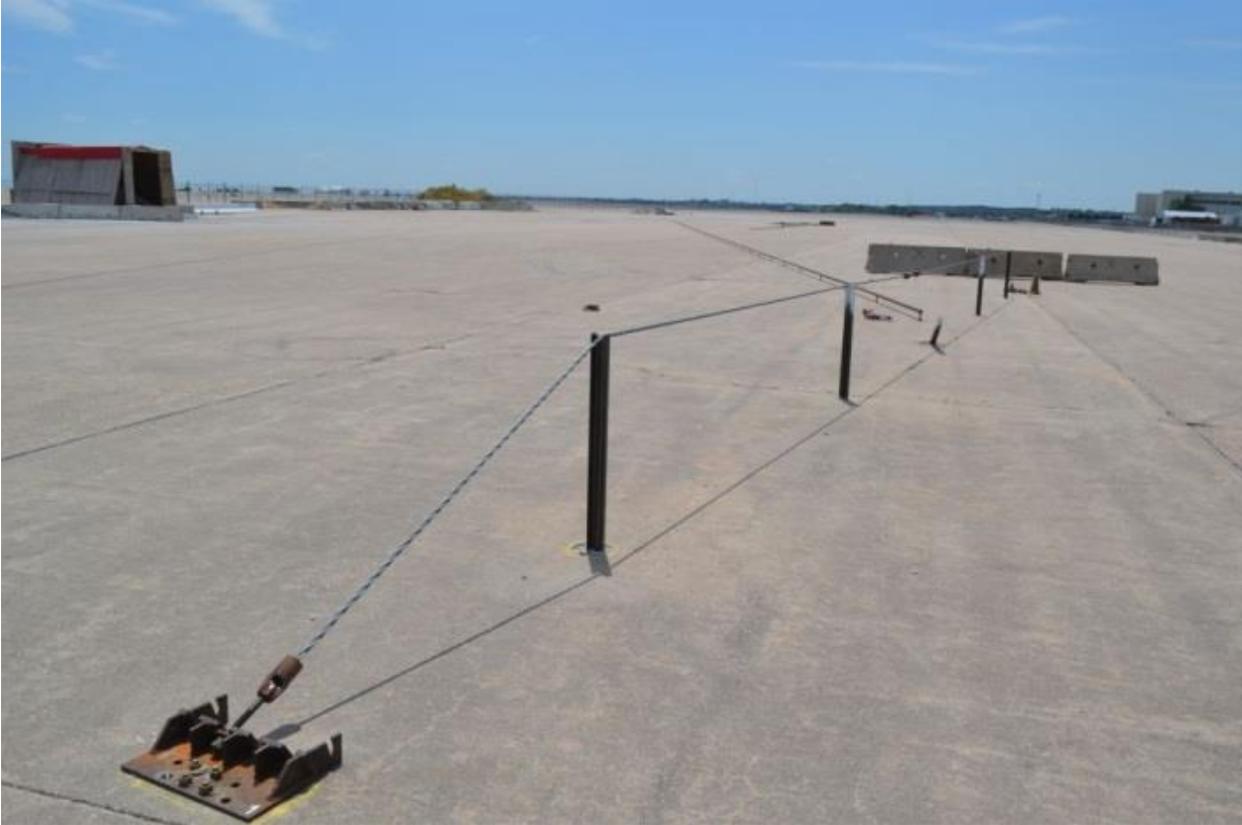
Figure 103. Post-Test Photograph, Test No. HTTC-2

Post-test examination revealed minimal damage to the test article, as shown in Figures 103 and 104. A plastic hinge had developed in post no. 4 near the groundline, and the post was bent over along the 25-degree angle of the bogie vehicle's path. The brass rod fractured on the non-impact side. Additionally, the brass rod was bent upward on the impact side, as shown in Figure 104. Examination of the adjacent posts revealed no significant damage to the posts or the brass keeper rods.

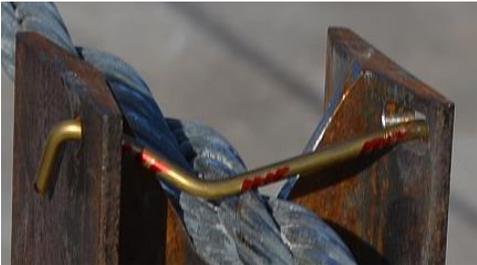
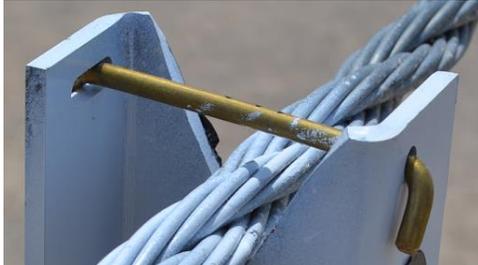
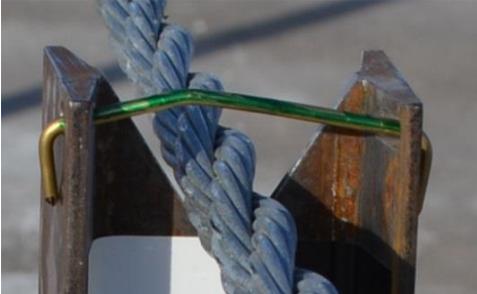
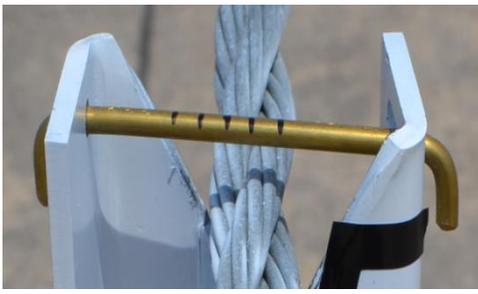
Table 3. Top Cable-to-Post Attachment Bogie Impact Testing Results

However, a significant difference in performance was found in the keeper rods located on the posts adjacent to the impacted post. As shown in Table 3, the $\frac{1}{8}$ -in. (3.2-mm) diameter rods on post nos. 3 and 5 were bent and damaged from the lateral displacement wave that traveled along the cable after it released from post no. 4. The $\frac{3}{16}$ -in. (4.8-mm) diameter rods located in the same positions during test no. HTTC-2 appeared undamaged after the test, even though they were subjected to a larger displacement wave in the cable. This finding indicates that the larger-diameter keeper rods would decrease the propensity for cable whip to cause premature release of the top cable during a vehicle redirection event. Thus, the larger rods would better distribute the lateral impact loads to adjacent posts and aid in limiting deflections. Subsequently, the $\frac{3}{16}$ -in. (4.8-mm) diameter brass keeper rod was recommended for use over the original $\frac{1}{8}$ -in. (3.2-mm) diameter design. Brass rods with diameters larger than $\frac{3}{16}$ -in. (4.8-mm) were not chosen for further testing, due to the static test release loads exceeding 1 kip (4.4 kN) [2].

Test No.	HTTC-1	HTTC-2
Brass Rod Diameter	1/8 in. (3.2 mm)	3/16 in. (4.8 mm)
Cable Tension	4300 lb (19.1 kN)	2480 lb (11.0 kN)
Release Time	0.008 sec	0.010 sec
Release Distance	2.5 in. (64 mm)	3.0 in. (76 mm)
Adjacent US Post

A comparison of the brass rods on the posts adjacent to impact illustrated a significant difference between the two rod sizes. The smaller brass rods were bent upward over 0.5 in. (13 mm), while the larger brass rods showed no signs of deformation. This finding indicated that the larger-diameter keeper rods decrease the propensity for cable whip to cause premature release of the top cable during a vehicle redirection event. Consequently, the larger rods would better distribute impact loads to adjacent posts and reduce system deflections. Therefore, the $\frac{3}{16}$ -in.
