## Performance Characteristics of Posts Embedded in Soil

# PERFORMANCE CHARACTERISTICS OF POSTS EMBEDDED IN SOIL

MwRSF Research Report No. TRP-03-301-15

August 12, 2015

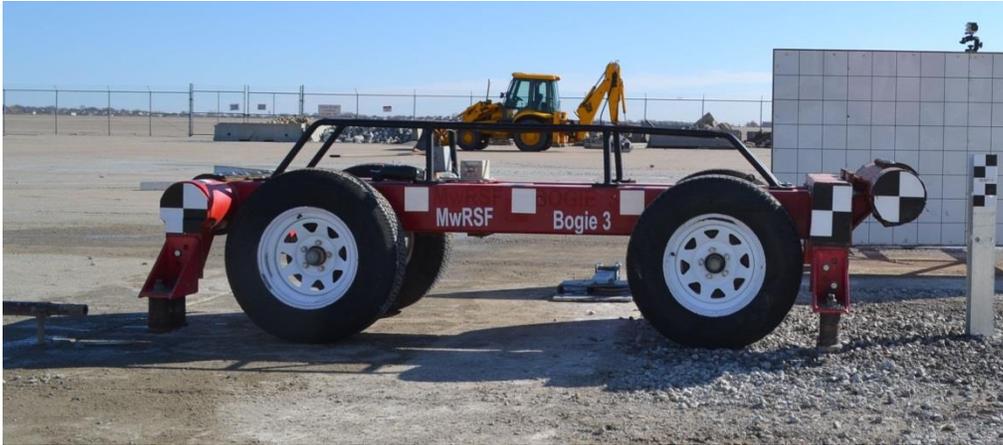
Figure 1. Rigid-Frame Bogie on Guidance Track

A rigid-frame bogie was used to impact the posts. A variable-height detachable impact head was used in the testing. The bogie head was constructed of an 8-in. (203-mm) diameter, 1/2-in. (13-mm) thick standard steel pipe, with 3/4-in. (19-mm) neoprene belting wrapped around the pipe to prevent local damage to the post from the impact. The impact head was bolted to the bogie, creating a rigid frame with an impact height of 24<sup>7</sup>/<sub>8</sub> in. (632 mm). The bogie with the impact head is shown in Figure 1. The weight of the bogie with the addition of the mountable impact head and accelerometers was 1,893 lb (859 kg) for tests nos. WAP-1 through WAP-5 and 1,891 lb (858 kg) for tests nos. SYPW-1 through SYPW-4.

A pickup truck with a reverse cable tow system was used to propel the bogie to a target impact speed of 20.0 mph (32.2 km/h). When the bogie approached the end of the guidance system, it was released from the tow cable, allowing it to be free-rolling when it impacted the post. A remote braking system was installed on the bogie, allowing it to be brought safely to rest after the test.

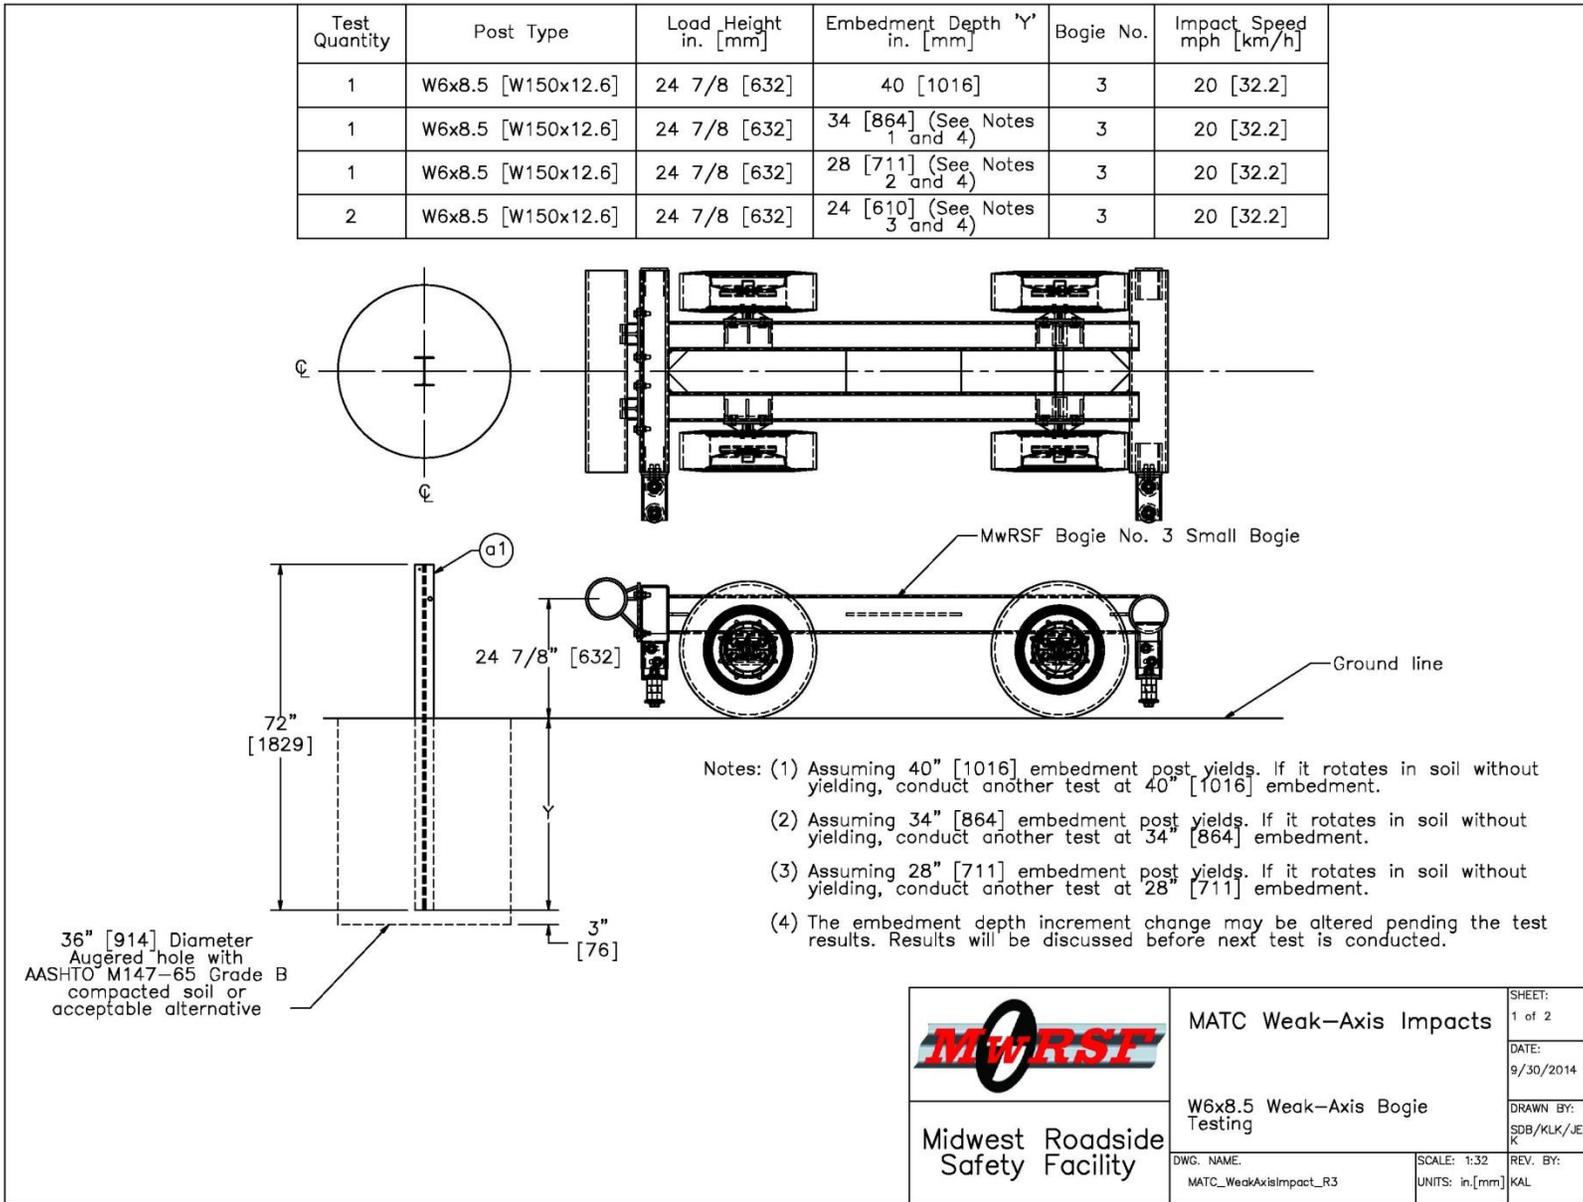
Figure 2. Bogie Test Matrix and Setup, W6x8.5 (W150x12.6) Steel Posts

Five bogie tests were conducted on 72-in. (1,829-mm) long W6x8.5 (W150x12.6) A992 steel posts with embedment depths ranging from 24 to 40 in. (610 to 1,016 mm), as shown in Figures 2 and 3. Also, four bogie tests were conducted on 72-in. (1,829-mm) long 6-in. x 8-in. (152mm x 203mm) SYP posts embedded at depths ranging from 30 to 40 in. (762 to 1,016 mm), as shown in Figures 4 and 5. A compacted, coarse crushed limestone material, as recommended by the Manual for Assessing Safety Hardware (MASH), was utilized for all tests [1].

The target impact conditions were an impact speed of 20 mph (32.2 km/h) and an impact angle of 0 degrees, creating weak-axis bending. The posts were impacted 24<sup>7</sup>/<sub>8</sub> in. (632 mm) above the groundline and perpendicular to the web of the post. The dynamic component testing matrix and the test setup are shown in Table 1. Material specifications, mill certifications, and certificates of conformity for the posts and soil specifications are shown in Appendix A.

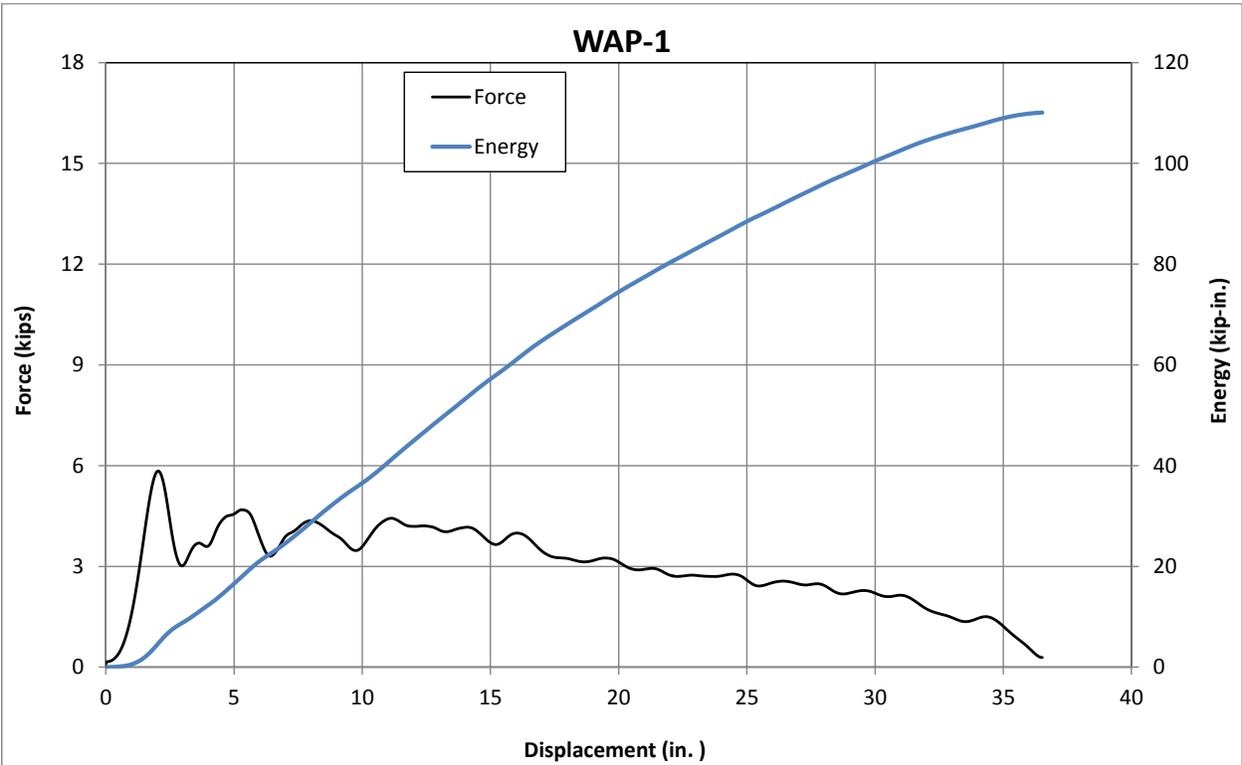
Figure 6. Force vs. Deflection and Energy vs. Deflection, Test No. WAP-1

Force vs. deflection and energy vs. deflection curves created from the SLICE accelerometer data are shown in Figure 6. The forces rose to a peak force of 5.8 kips (25.8 kN) at 2.0 in. (51 mm) of deflection. The average resistive force decreased to approximately 4 kips (17.8kN). A total of 110.1 kip-in. (12.4 kJ) of energy was absorbed by the system before the bogie overrode the post at 36.5 in. (927 mm). Time-sequential and post-impact photographs are shown in Figure 7.

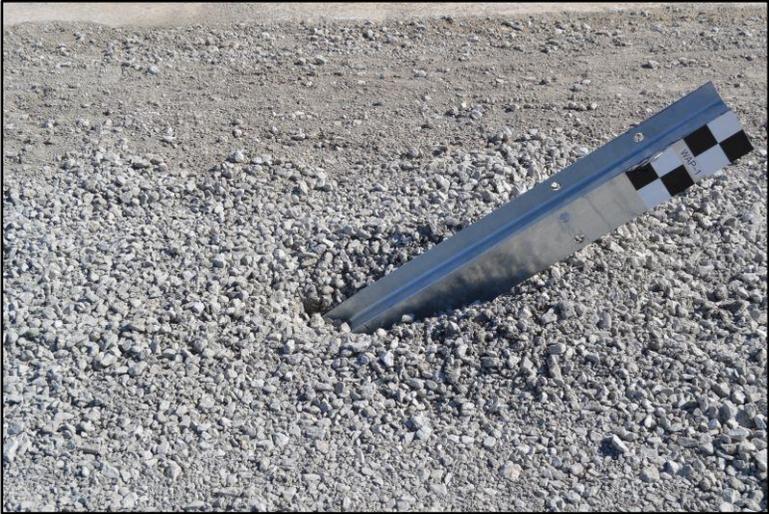
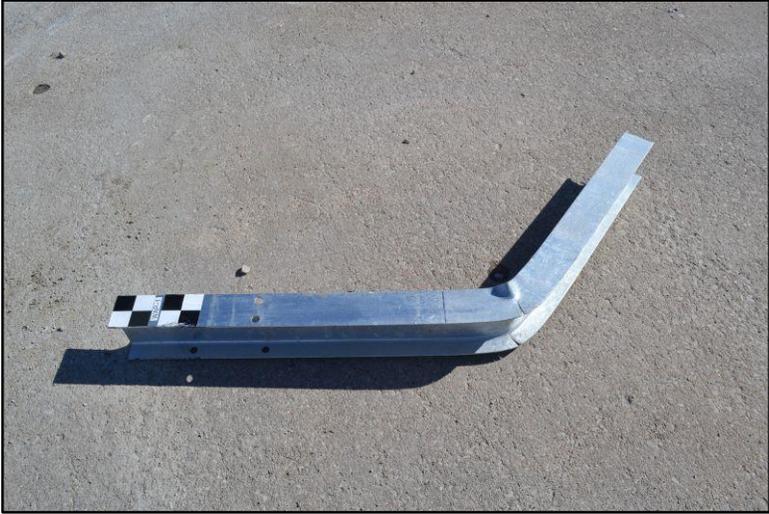
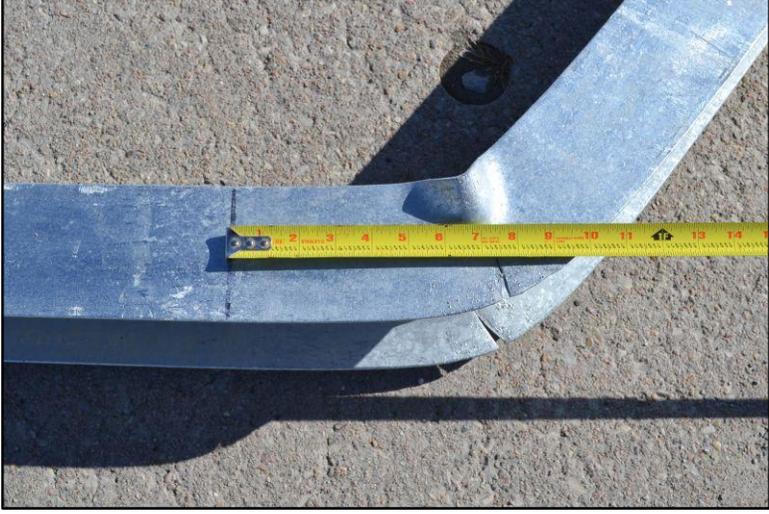
Figure 7. Time-Sequential and Post-Impact Photographs, Test No. WAP-1

During test no. WAP-1, the bogie impacted the W6x8.5 (W150x12.6) steel post embedded 40 in. (1,016 mm) at a speed of 20.4 mph (32.8 km/h). Upon impact, the post began to rotate through the soil. Post rotation continued until the bogie overrode the post at a displacement of 36.5 in. (927 mm). The post bent and yielded approximately 8 in. (203 mm) below the groundline.

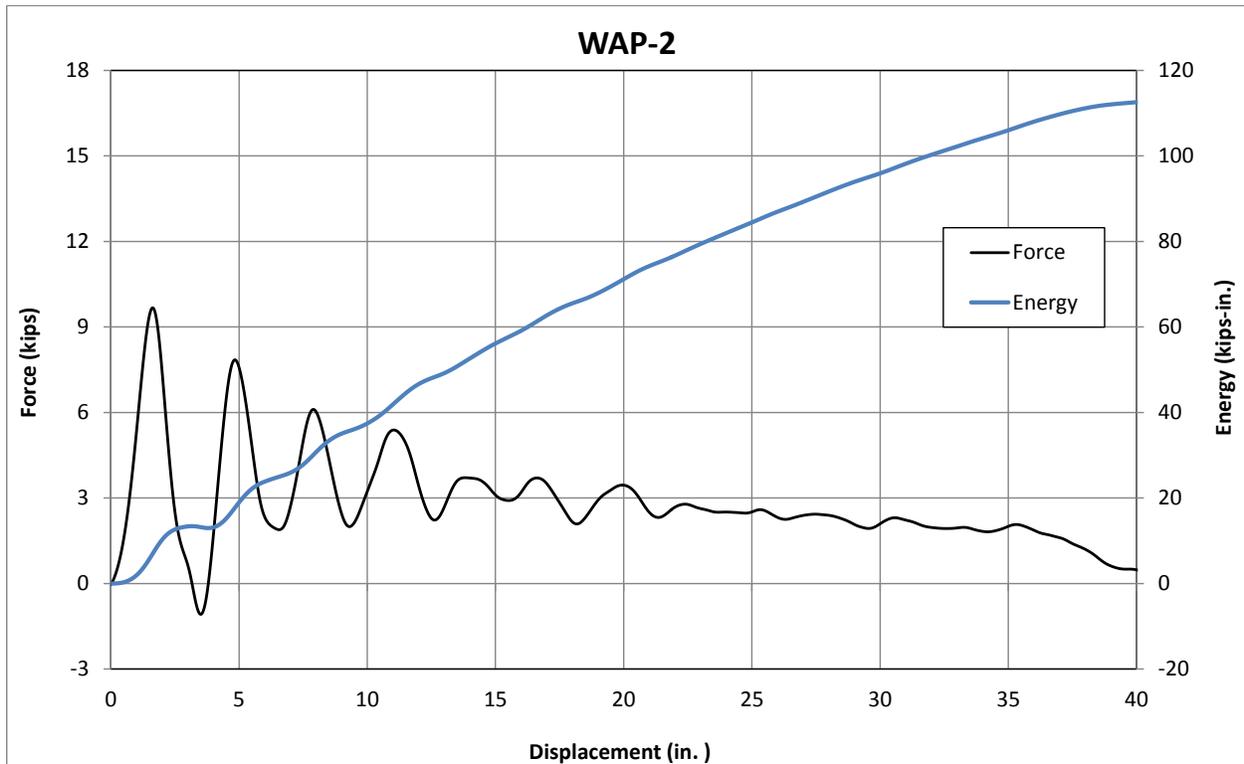
Figure 8. Force vs. Deflection and Energy vs. Deflection, Test No. WAP-2

Force vs. deflection and energy vs. deflection curves created from the SLICE accelerometer data are shown in Figure 8. The forces rose to a peak force of 9.7 kips (43.1 kN) at 1.7 in. (43 mm) of deflection. The posts provided an average resistive force of around 4.0 kips (17.8 kN) through 12.0 in. (305 mm) of deflection. A total of 113.1 kip-in. (12.8 kJ) of energy was absorbed by the system before the bogie overrode the post at 41.5 in. (1,054 mm). Time-sequential and post-impact photographs are shown in Figure 9.

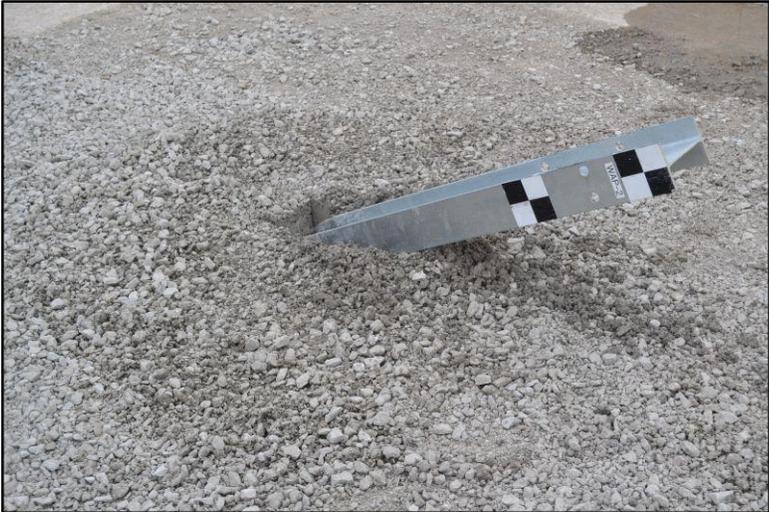
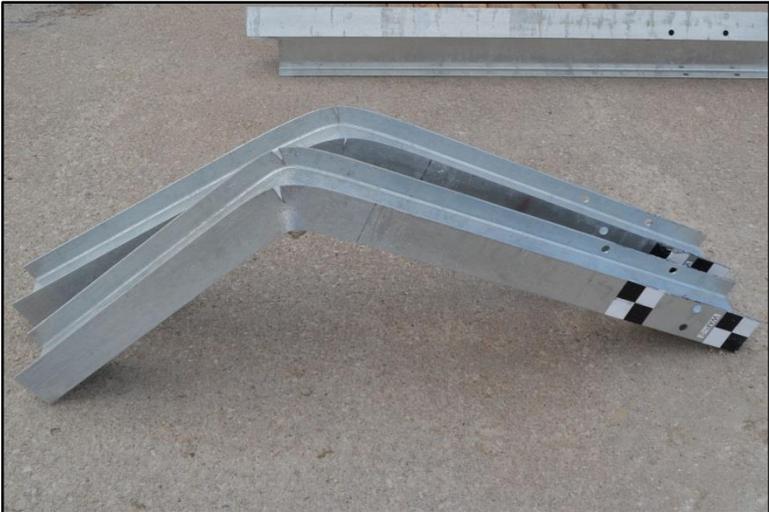
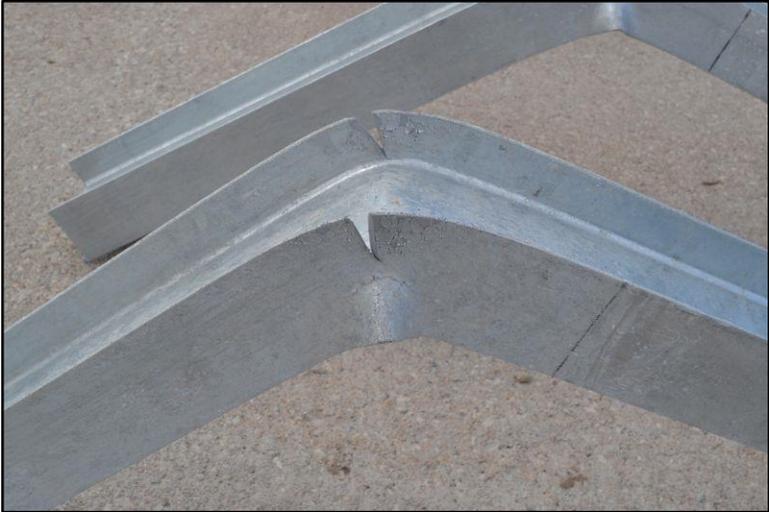
Figure 9. Time-Sequential and Post-Impact Photographs, Test No. WAP-2

During test no. WAP-2, the bogie impacted the W6x8.5 (W150x12.6) steel post embedded 34 in. (864 mm) at a speed of 20.2 mph (32.5 km/h). Post rotation continued until the bogie overrode the post at a displacement of 41.5 in. (1,054 mm). The post bent and yielded approximately 8 in. (203 mm) below the groundline.

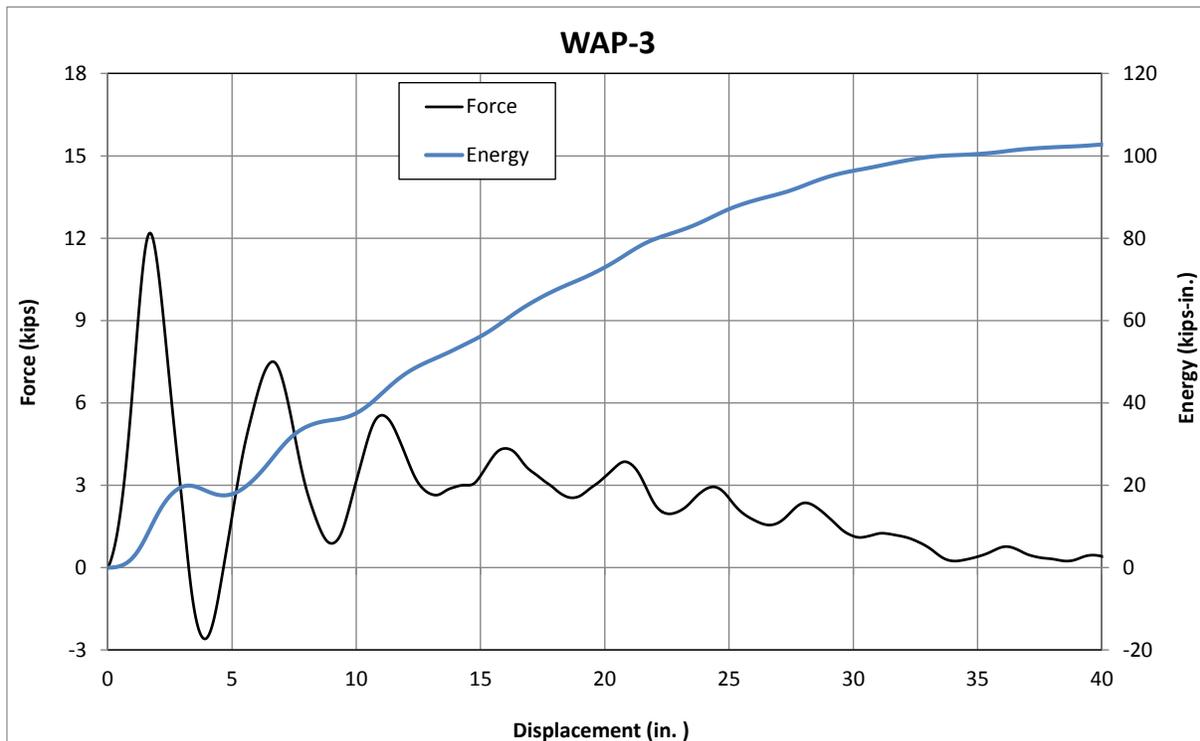
Figure 10. Force vs. Deflection and Energy vs. Deflection, Test No. WAP-3

Force vs. deflection and energy vs. deflection curves created from the SLICE accelerometer data are shown in Figure 10. The forces rose to a peak force of 12.2 kips (54.3 kN) at 1.7 in. (43 mm) of deflection. The post provided an average resistive force of 4.0 kips (17.8kN) through 12.0 in. (305 mm) of deflection. The force then steadily decreased for the remainder of the impact event. A total of 103.1 kip-in. (11.6 kJ) of energy was absorbed before the bogie overrode the post at 41.5 in. (1,054 mm). Time-sequential and post-impact photographs are shown in Figure 11.

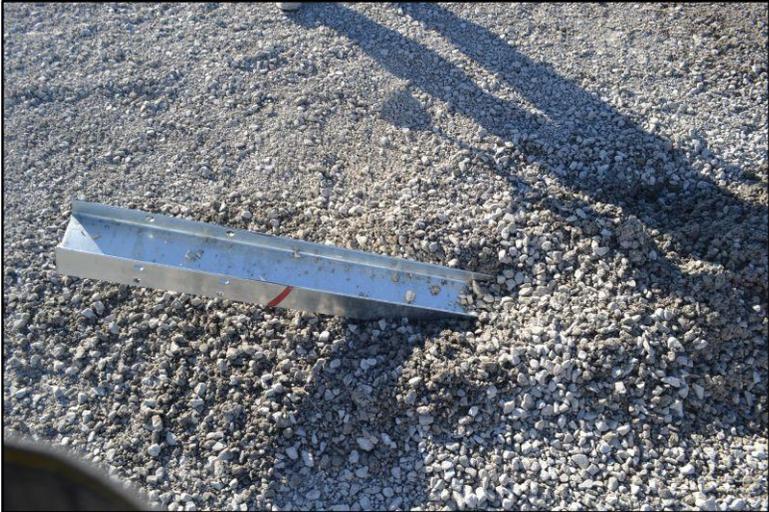
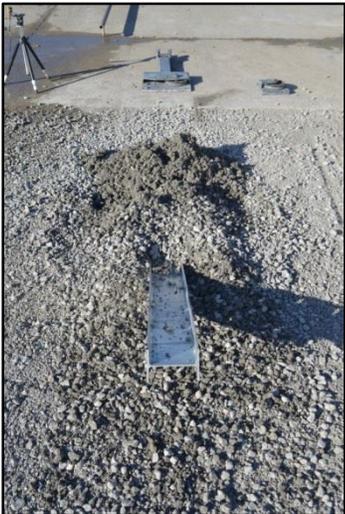
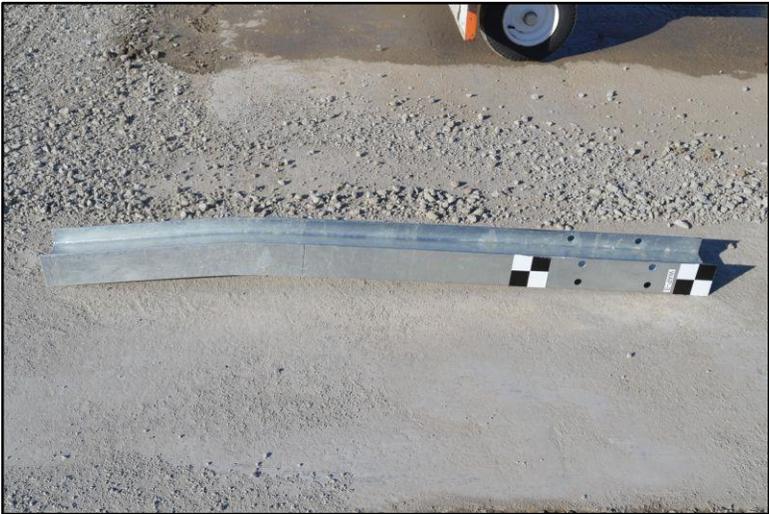
Figure 11. Time-Sequential and Post-Impact Photographs, Test No. WAP-3

During test no. WAP-3, the bogie impacted the W6x8.5 (W150x12.6) steel post embedded 28 in. (711 mm) at a speed of 20.6 mph (33.2 km/h). Upon impact, the post began to rotate through the soil. Post rotation continued until the bogie overrode the top of the post at a displacement of 41.5 in. (1,054 mm). The post bent slightly and encountered minor yielding below the groundline.

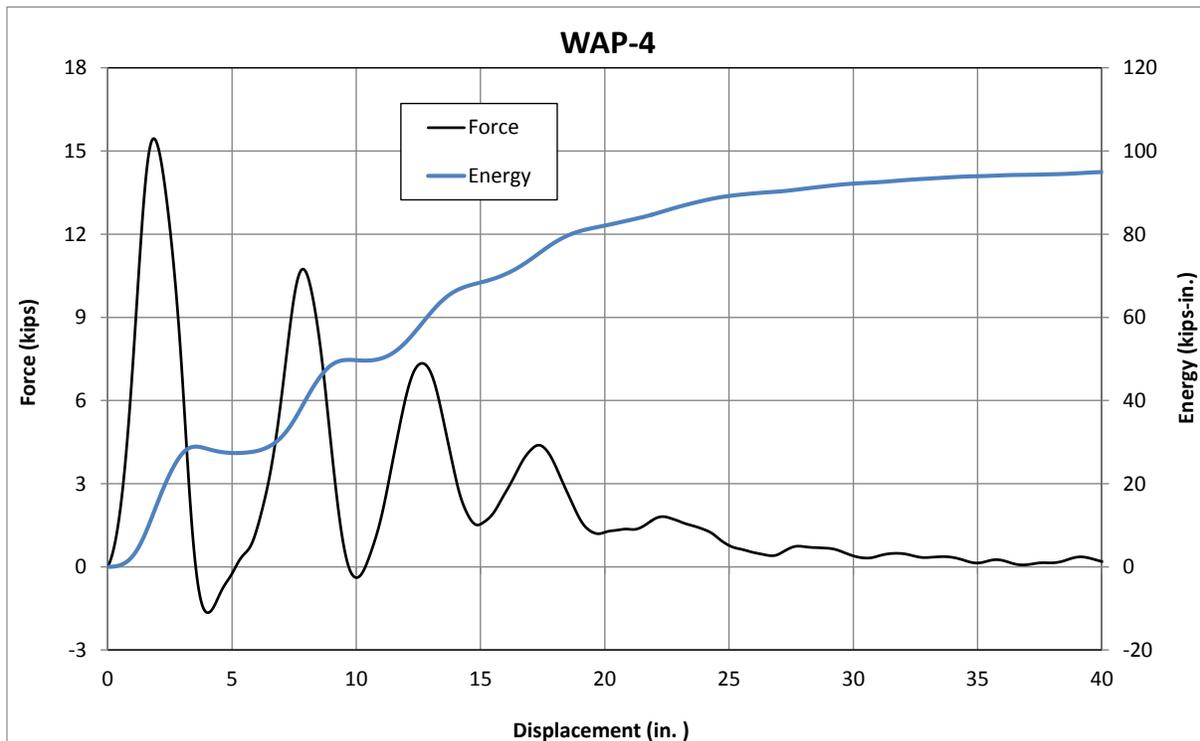
Figure 12. Force vs. Deflection and Energy vs. Deflection, Test No. WAP-4

Force vs. deflection and energy vs. deflection curves created from the SLICE accelerometer data are shown in Figure 12. The forces rose to a peak force of 15.4 kips (68.5 kN) at 1.8 in. (46 mm) of deflection. The post provided an average force of approximately 3.8 kips (16.9 kN) through 27 in. (686 mm) of deflection. The force then steadily decreased for the remainder of the impact event. A total of 95.1 kip-in. (10.7 kJ) of energy was absorbed by the system before the bogie overrode the post at 41.2 in. (1,046 mm). Time-sequential and post-impact photographs are shown in Figure 13.

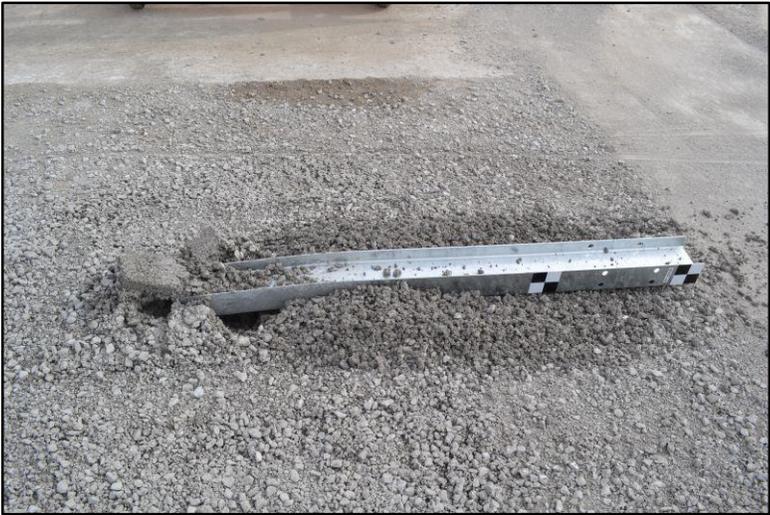
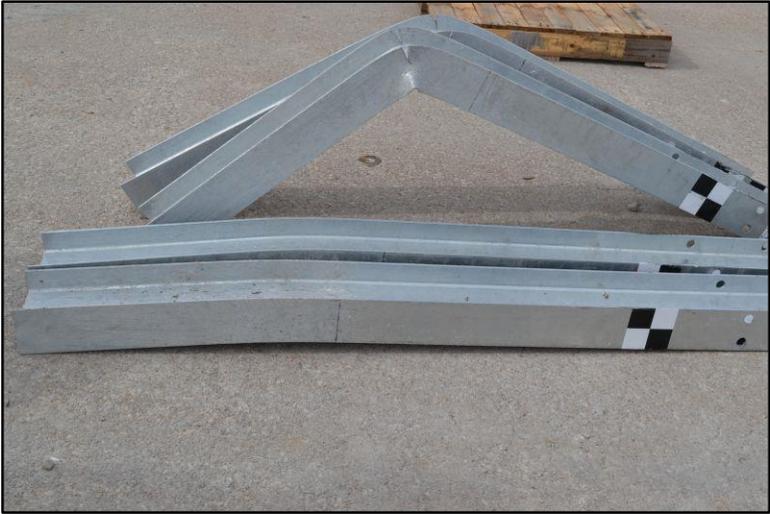
Figure 13. Time-Sequential and Post-Impact Photographs, Test No. WAP-4

During test no. WAP-4, the bogie impacted the W6x8.5 (W150x12.6) steel post embedded 24 in. (610 mm) at a speed of 20.5 mph (33.0 km/h). Upon impact, the post began to rotate through the soil. The post continued to rotate until the bogie overrode the post at a displacement of 41.2 in. (1,046 mm). The post bent slightly and encountered minor yielding below the groundline.

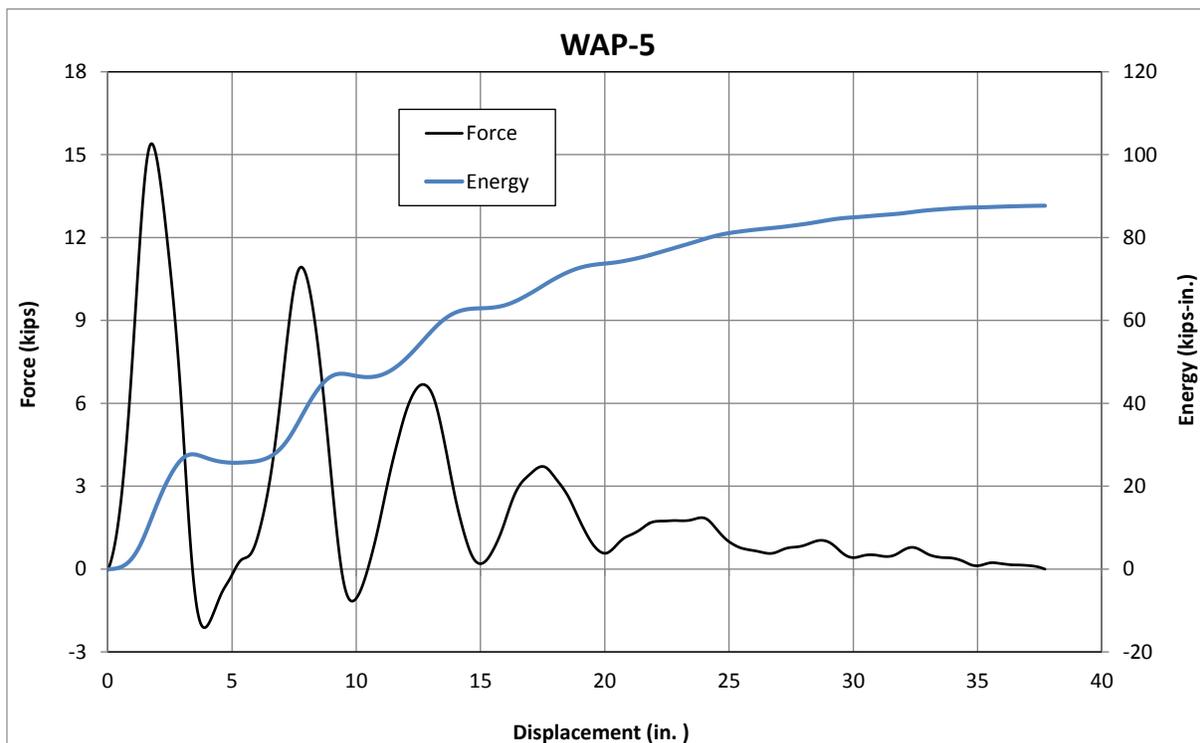
Figure 14. Force vs. Deflection and Energy vs. Deflection, Test No. WAP-5

Force vs. deflection and energy vs. deflection curves created from the accelerometer data are shown in Figure 14. The force rose to a peak force of 15.4 kips (68.5 kN) at 1.7 in. (43 mm) of deflection. The post provided an average resistive force of 4.4 kips (19.6 kN) through 16 in. (406 mm) of deflection. The force then steadily decreased for the remainder of the impact event. A total of 87.7 kip-in. (9.9 kJ) of energy was absorbed by the system before the bogie overrode the post at 37.7 in (958 mm). Time-sequential and post-impact photographs are shown in Figure 15.

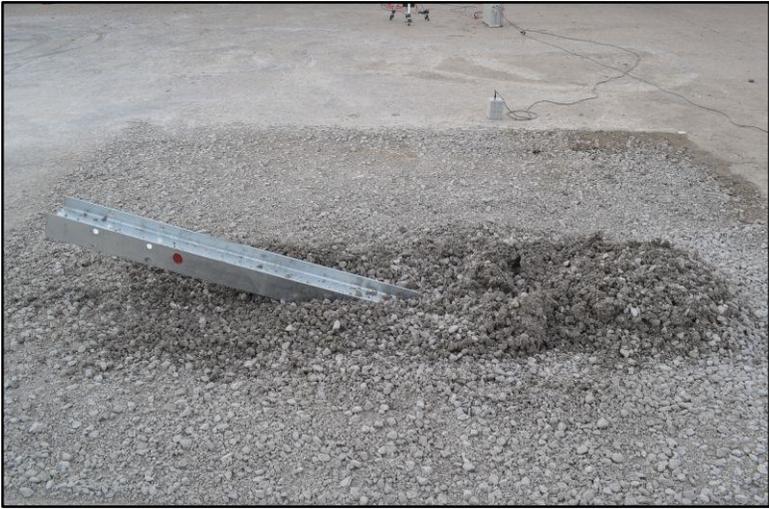
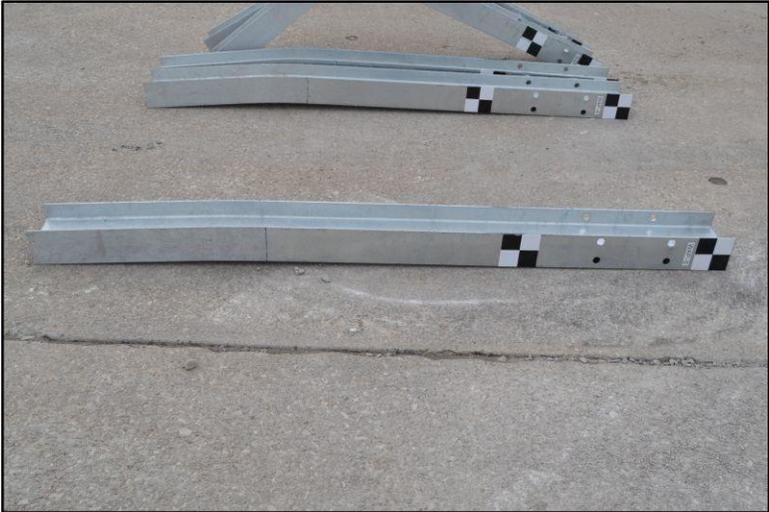
Figure 15. Time-Sequential and Post-Impact Photographs, Test No. WAP-5

During test no. WAP-5, the bogie impacted the W6x8.5 (W150x12.6) steel post embedded 24 in. (610 mm) at a speed of 20.3 mph (32.7 km/h). Upon impact, the post began to rotate through the soil. The post continued to rotate until the bogie overrode the post at a displacement of 37.7 in. (958 mm). The post bent backwards slightly and encountered minor yielding below the groundline.

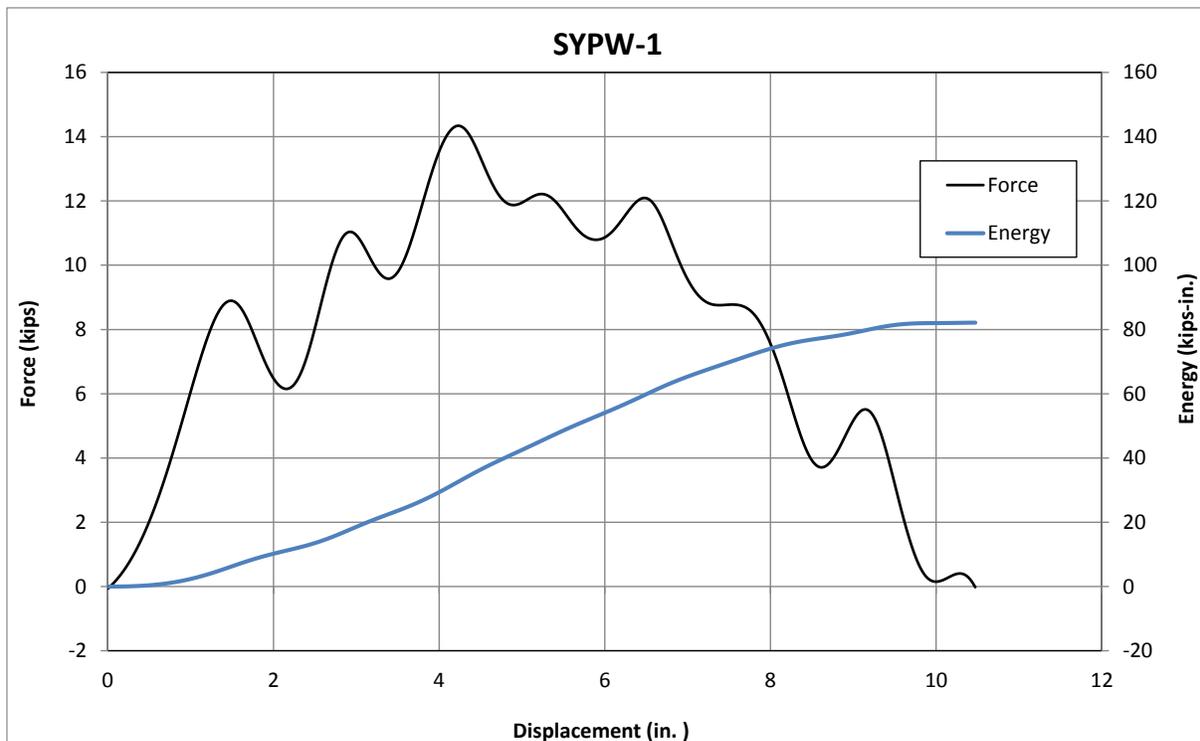
Figure 16. Force vs. Deflection and Energy vs. Deflection, Test No. SYPW-1

Force vs. deflection and energy vs. deflection curves created from the SLICE accelerometer data and are shown in Figure 16. A peak force of 14.3 kips (63.6 kN) was observed at 4.2 in. (107 mm) of deflection. At this point, the post began to fracture, and the resistive forces declined. The post continued to provide resistance until fracture was completed at a deflection of 10.5 in. (267 mm). A total of 82.1 kip-in. (9.3 kJ) of energy was absorbed by the post and soil by the conclusion of post fracture. Time-sequential and post-impact photographs are shown in Figure 17.

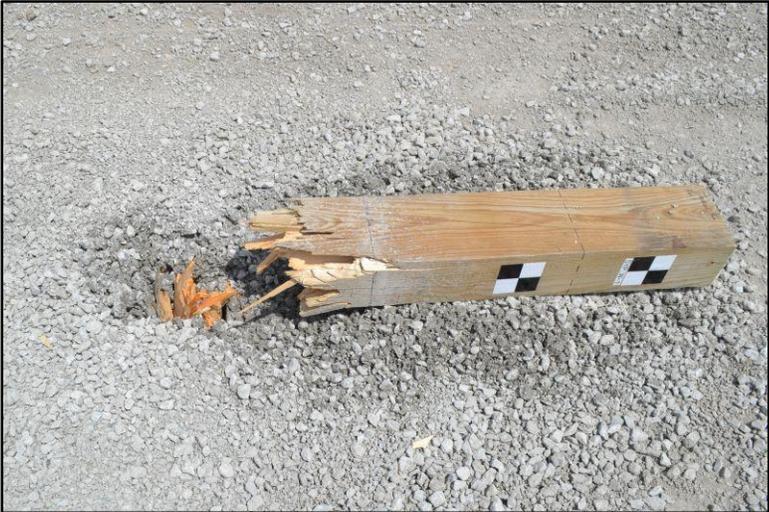
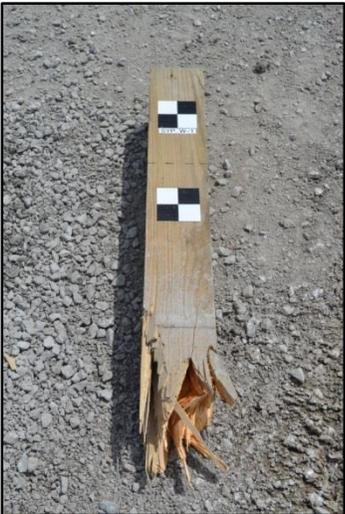
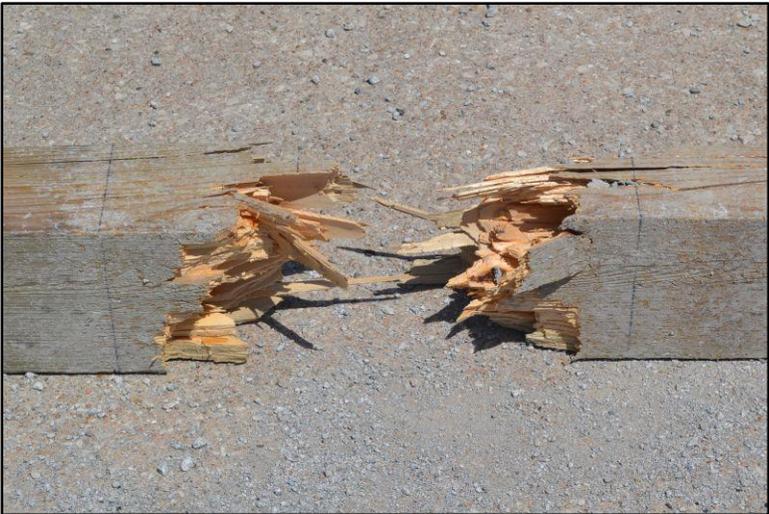
Figure 17. Time-Sequential and Post-Impact Photographs, Test No. SYPW-1

During test no. SYPW-1, the bogie impacted the 6-in. x 8-in. (152-mm x 203-mm) SYP post embedded 40 in. (1016 mm) at a speed of 20.5 mph (33.0 km/h). Upon impact, the post began to rotate through the soil. The post continued to rotate until it fractured at a displacement of 10.5 in. (267 mm). The post fractured approximately 6 in. (152 mm) below the groundline.

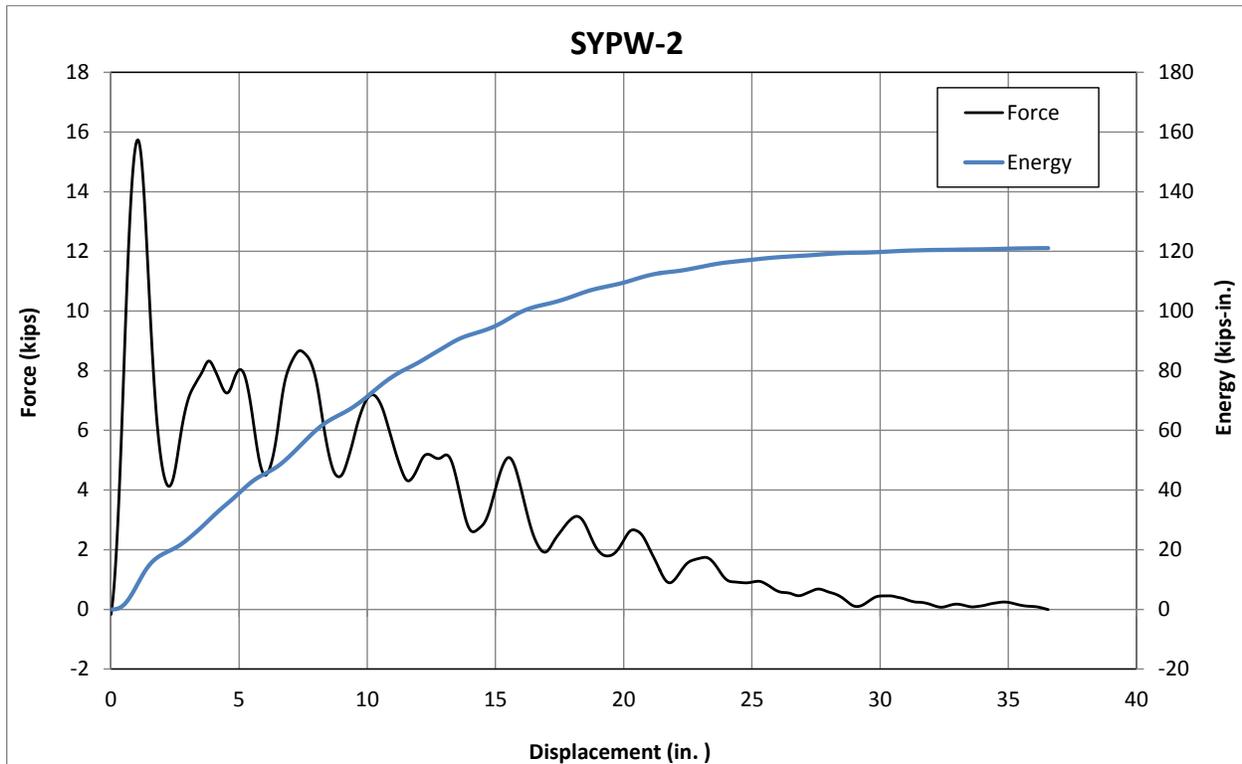
Figure 18. Force vs. Deflection and Energy vs. Deflection, Test No. SYPW-2

Force vs. deflection and energy vs. deflection curves created from the SLICE accelerometer data are shown in Figure 18. Initially, the resistive force increased and reached a peak force of 15.7 kips (69.8 kN) at 1.0 in. (25 mm) of deflection. After this peak, the resistive force steadily decreased for the remainder of the impact event. A total of 121 kip-in. (13.7 kJ) of energy was absorbed by the system before the bogie overrode the post at 36.6 in. (930 mm). Time-sequential and post-impact photographs are shown in Figure 19.

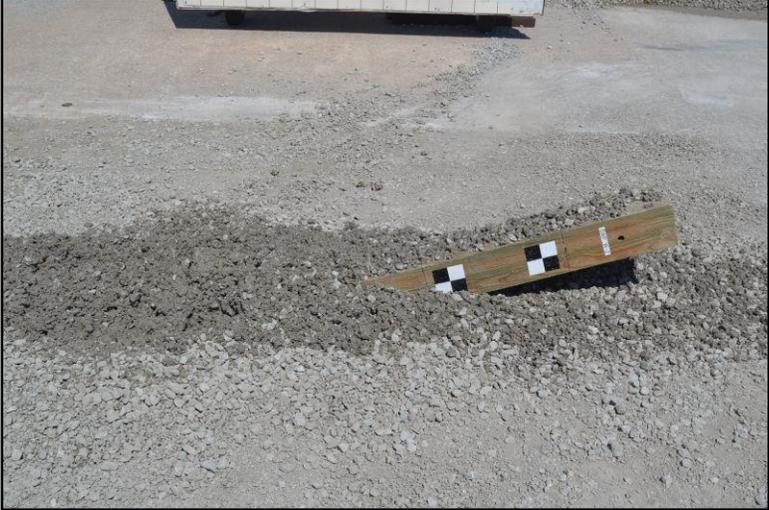
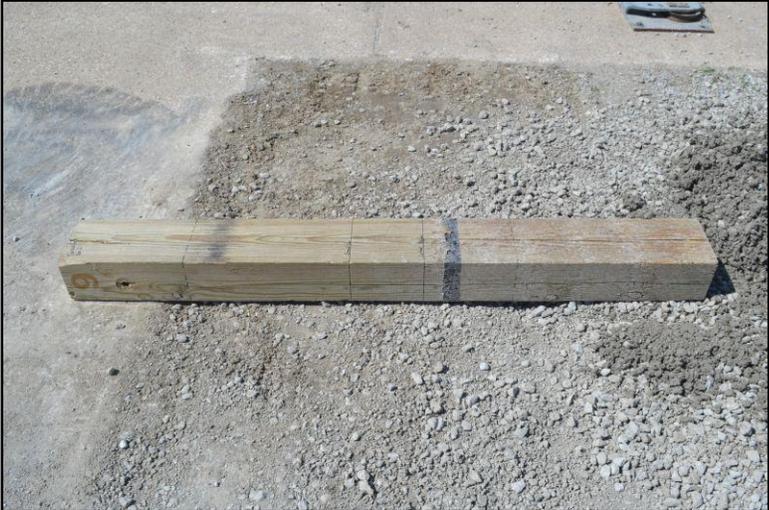
Figure 19. Time-Sequential and Post-Impact Photographs, Test No. SYPW-2

During test no. SYPW-2, the bogie impacted the 6-in. x 8-in. (152-mm x 203-mm) SYP post embedded 30 in. (762 mm) at a speed of 20.8 mph (33.5 km/h). Upon impact, the post began to rotate through the soil. The post continued to rotate until it fractured at a displacement of 36.6 in. (930 mm). The SYP post showed no signs of fracture.

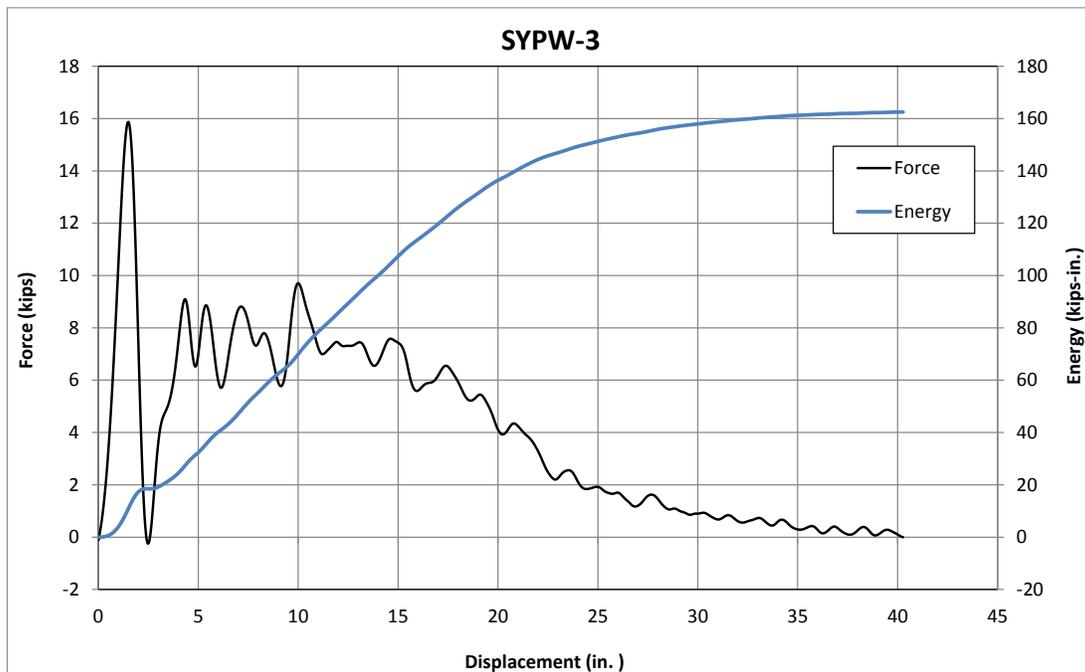
Figure 20. Force vs. Deflection and Energy vs. Deflection, Test No. SYPW-3

Force vs. deflection and energy vs. deflection curves created from the SLICE accelerometer data are shown in Figure 20. Initially, the resistive force increased and reached a peak force of 15.9 kips (70.7 kN) at 1.5 in. (38 mm) of deflection. After this peak, the post provided an average resistive force of approximately 7.6 kips (33.8 kN) through 13 in. (330 mm) of deflection. The force then steadily decreased for the remainder of the impact event. A total of 162.5 kip-in. (18.4 kJ) of energy was absorbed by the system before the bogie overrode the post at 40.3 in. (1024 mm). Time-sequential and post-impact photographs are shown in Figure 21.

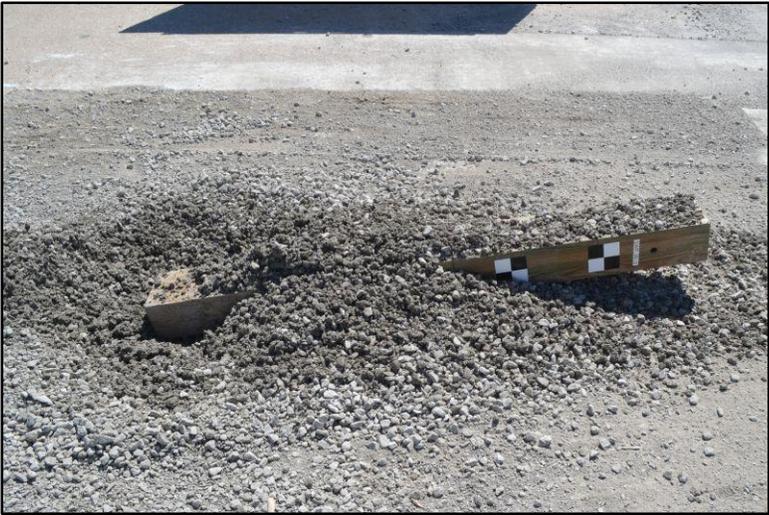
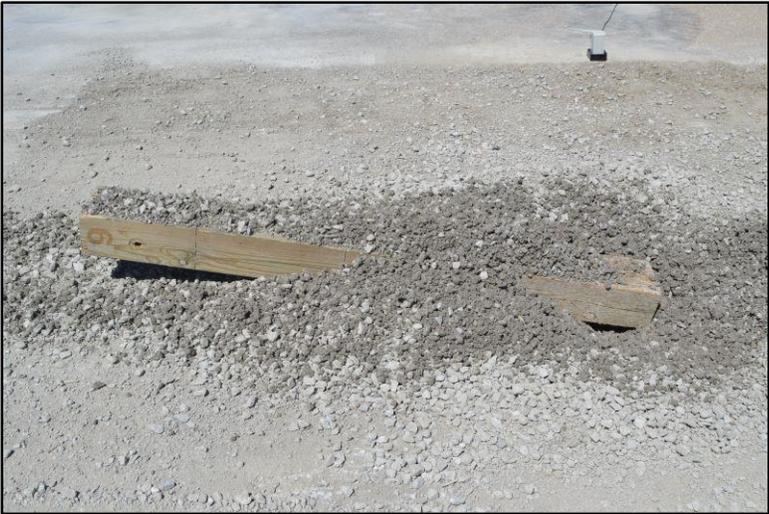
Figure 21. Time-Sequential and Post-Impact Photographs, Test No. SYPW-3

During test no. SYPW-3, the bogie impacted the 6-in. x 8-in. (152-mm x 203-mm) SYP post embedded 34 in. (864 mm) at a speed of 20.0 mph (32.2 km/h). Upon impact, the post began to rotate through the soil. Post rotation continued until the bogie overrode the post at a displacement of 40.3 in. (1,024 mm). The SYP post showed no signs of fracture.

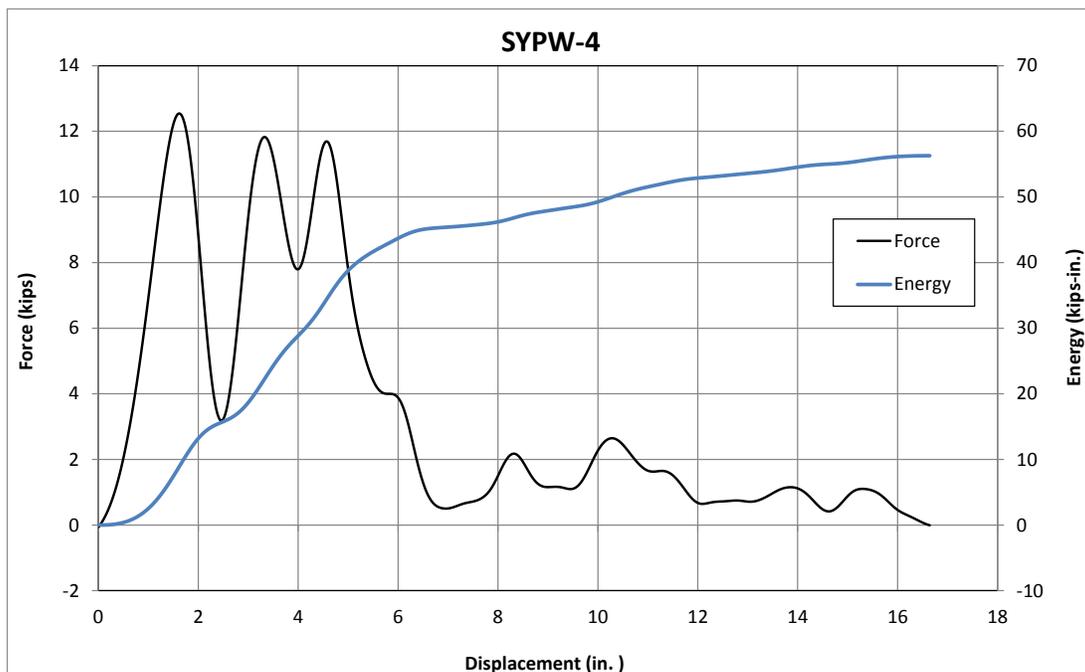
Figure 22. Force vs. Deflection and Energy vs. Deflection, Test No. SYPW-4

Force vs. deflection and energy vs. deflection curves created from the SLICE accelerometer data are shown in Figure 22. Initially, the resistive force increased and reached a peak force of 12.5 kips (55.6 kN) at 1.6 in. (41 mm) of deflection. Two additional peaks of approximately 12 kips (53.4 kN) occurred through 4.6 in. (117 mm) of deflection. At this point, the post began to fracture and resistive forces declined. The post continued to provide resistance until fracture was completed at a deflection of 6.9 in. (175 mm). A total of 45.4 kip-in. (5.1 kJ) of energy was absorbed by the system by the conclusion of the post fracture. Time-sequential and post-impact photographs are shown in Figure 23.

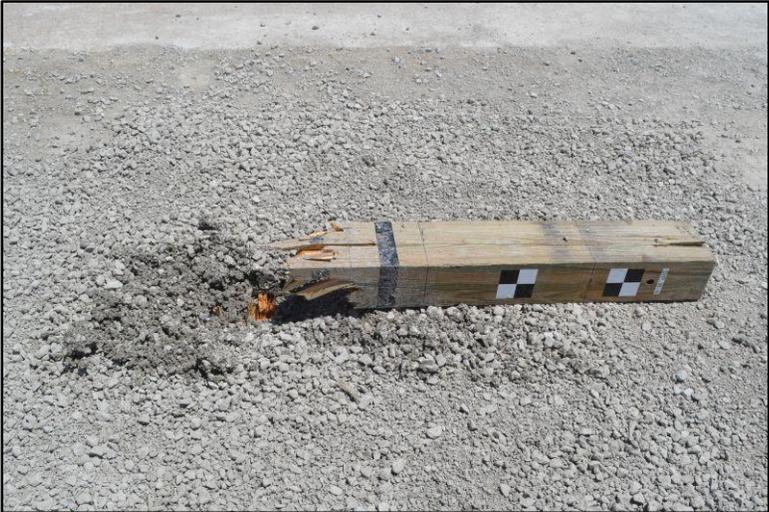
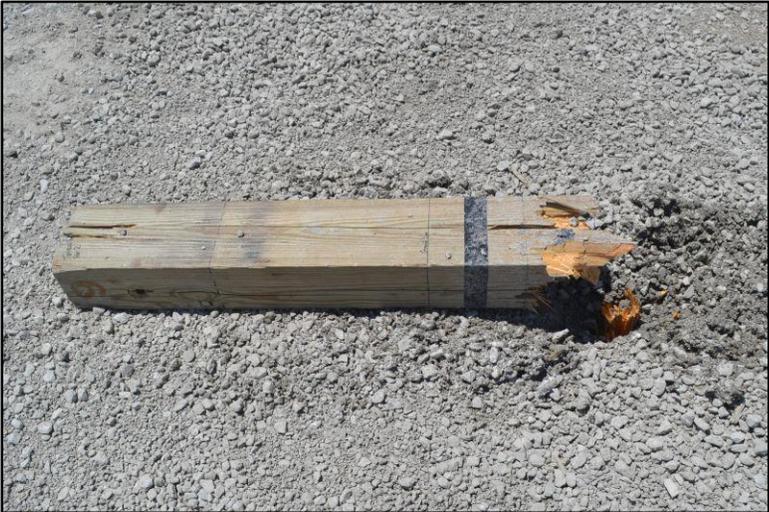
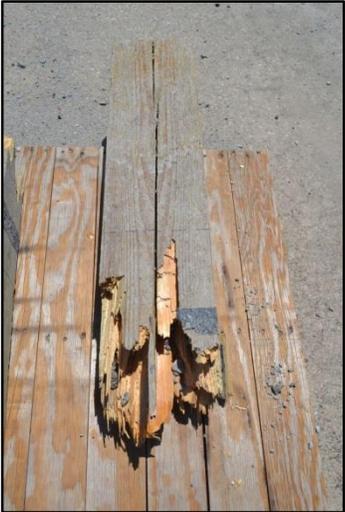
Figure 23. Time-Sequential and Post-Impact Photographs, Test No. SYPW-4

During test no. SYPW-4, the bogie impacted the 6-in. x 8-in (152-mm x 203-mm) SYP post embedded 37 in. (940 mm) at a speed of 20.3 mph (32.7 km/h). Upon impact, the post began to rotate through the soil. The post continued to rotate until it fractured at a displacement of 6.9 in. (175 mm). The post fractured approximately 8 in. (203 mm) below the groundline.
