## Performance Characteristics of Posts Embedded in Soil

# PERFORMANCE CHARACTERISTICS OF POSTS EMBEDDED IN SOIL

MwRSF Research Report No. TRP-03-301-15

August 12, 2015

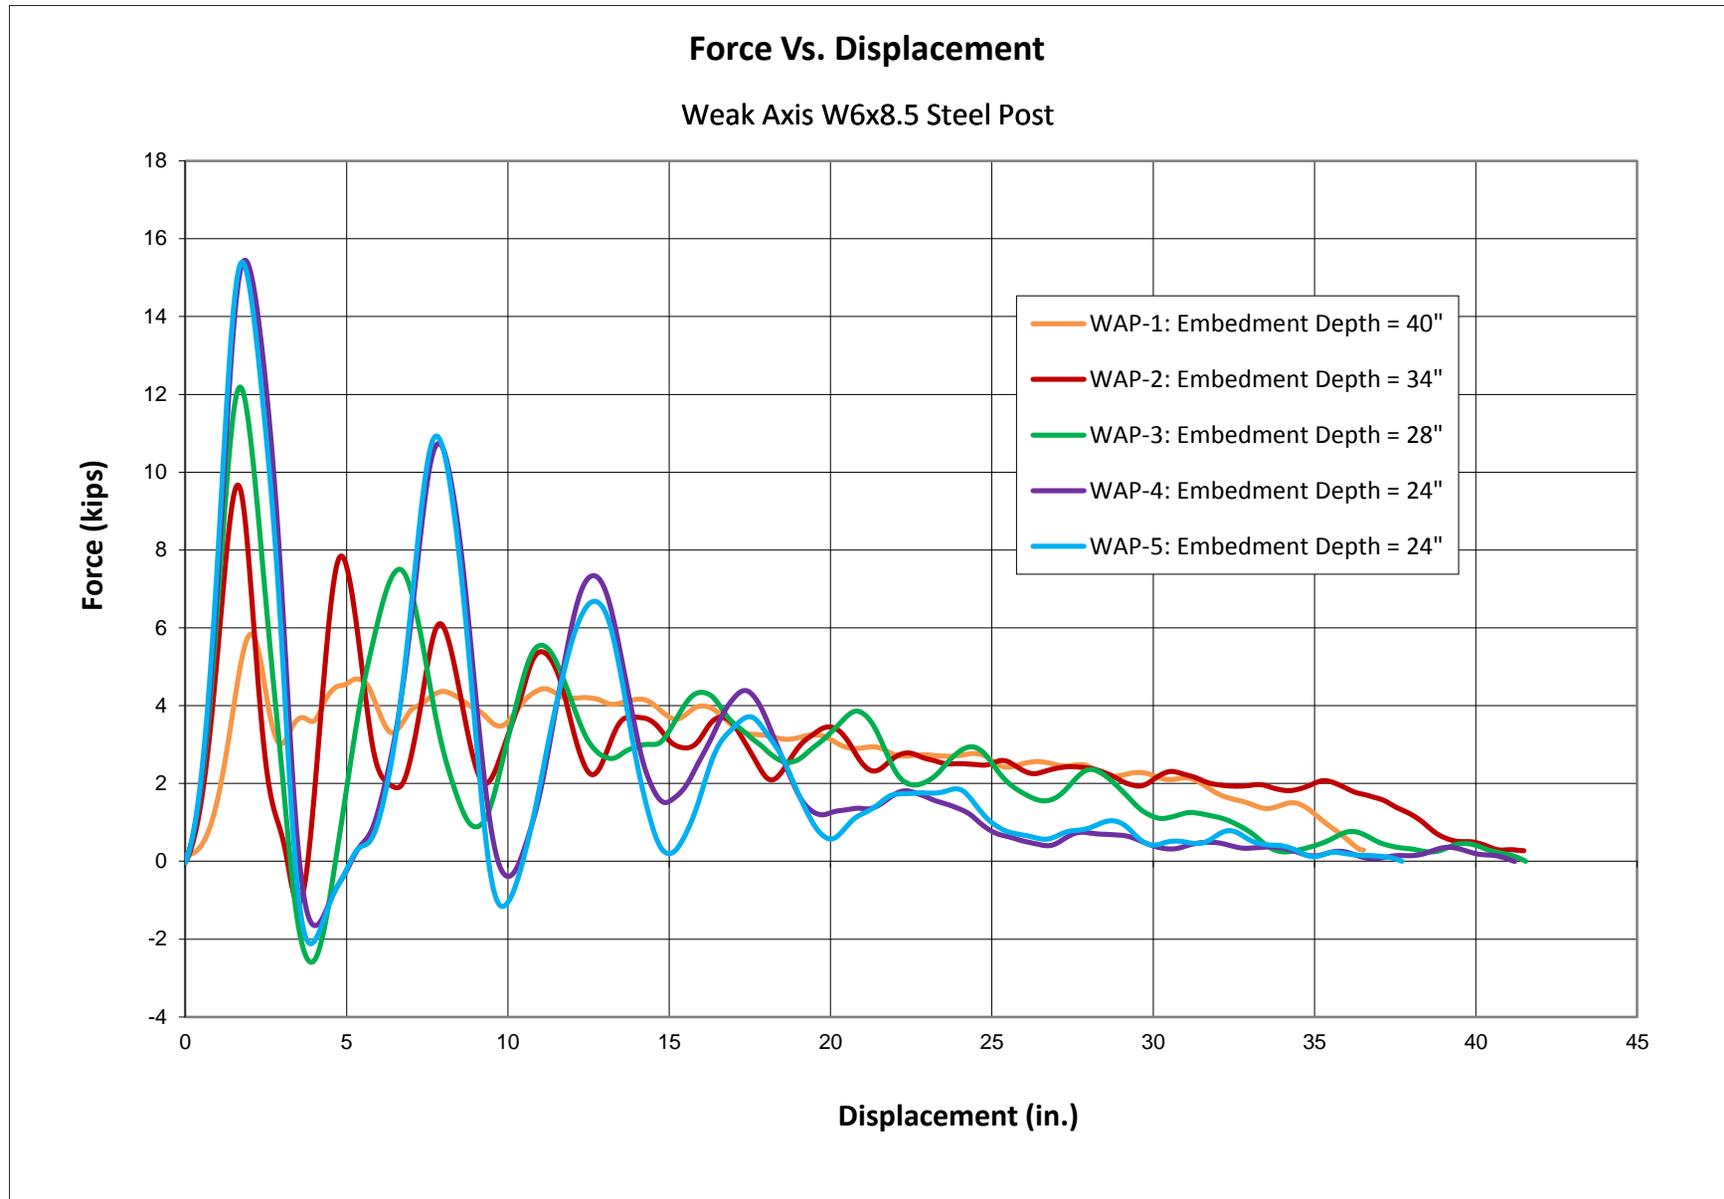
Figure 24. Force vs. Deflection Comparison, WAP-1 through WAP-5

When embedment depths of 24 and 28 in. (610 and 711 mm) were used, as observed in test nos. WAP-3 through WAP-5, the posts rotated through the soil with minor post bending. The shallower embedded posts, which rotated through the soil, absorbed noticeably less energy than the posts that bent with plastic deformation, as reported in Table 2.

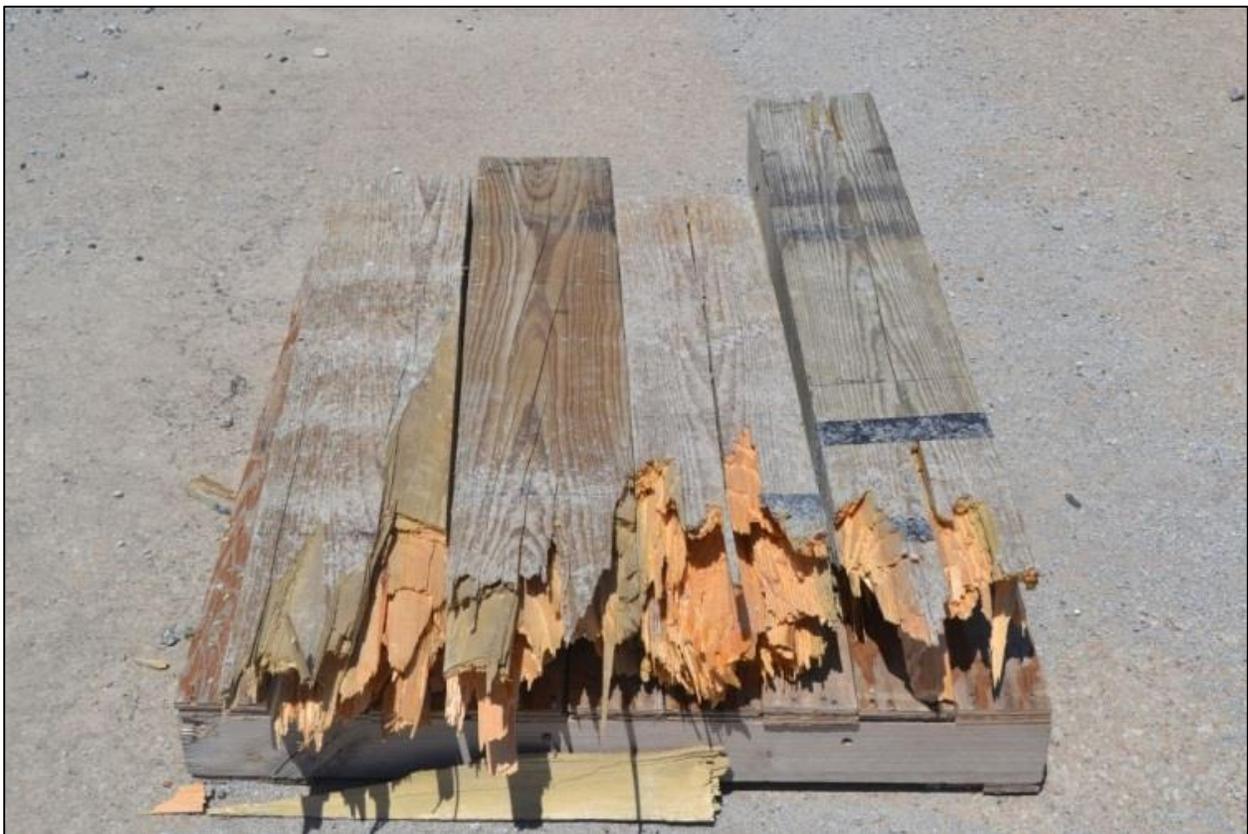
Figure 26. Comparison of Post Fractures, Test Nos. SYPW-1 (Left) and SYPW-4 (Right)

When deeper embedment depths of 37 and 40 in. (940 and 1016 mm) were used, such as in test nos. SYPW-1 and SYPW-4, the post fractured completely with little rotation through the soil. The values of the peak force were relatively similar regardless of post behavior, as reported in Table 2. However, the deeper embedded posts, which fractured, did not provide resistive forces for as long of a duration as the posts that rotated through the soil, as seen in Figure 27. As a result, the posts that fractured absorbed noticeably less energy than the posts that rotated through the soil.

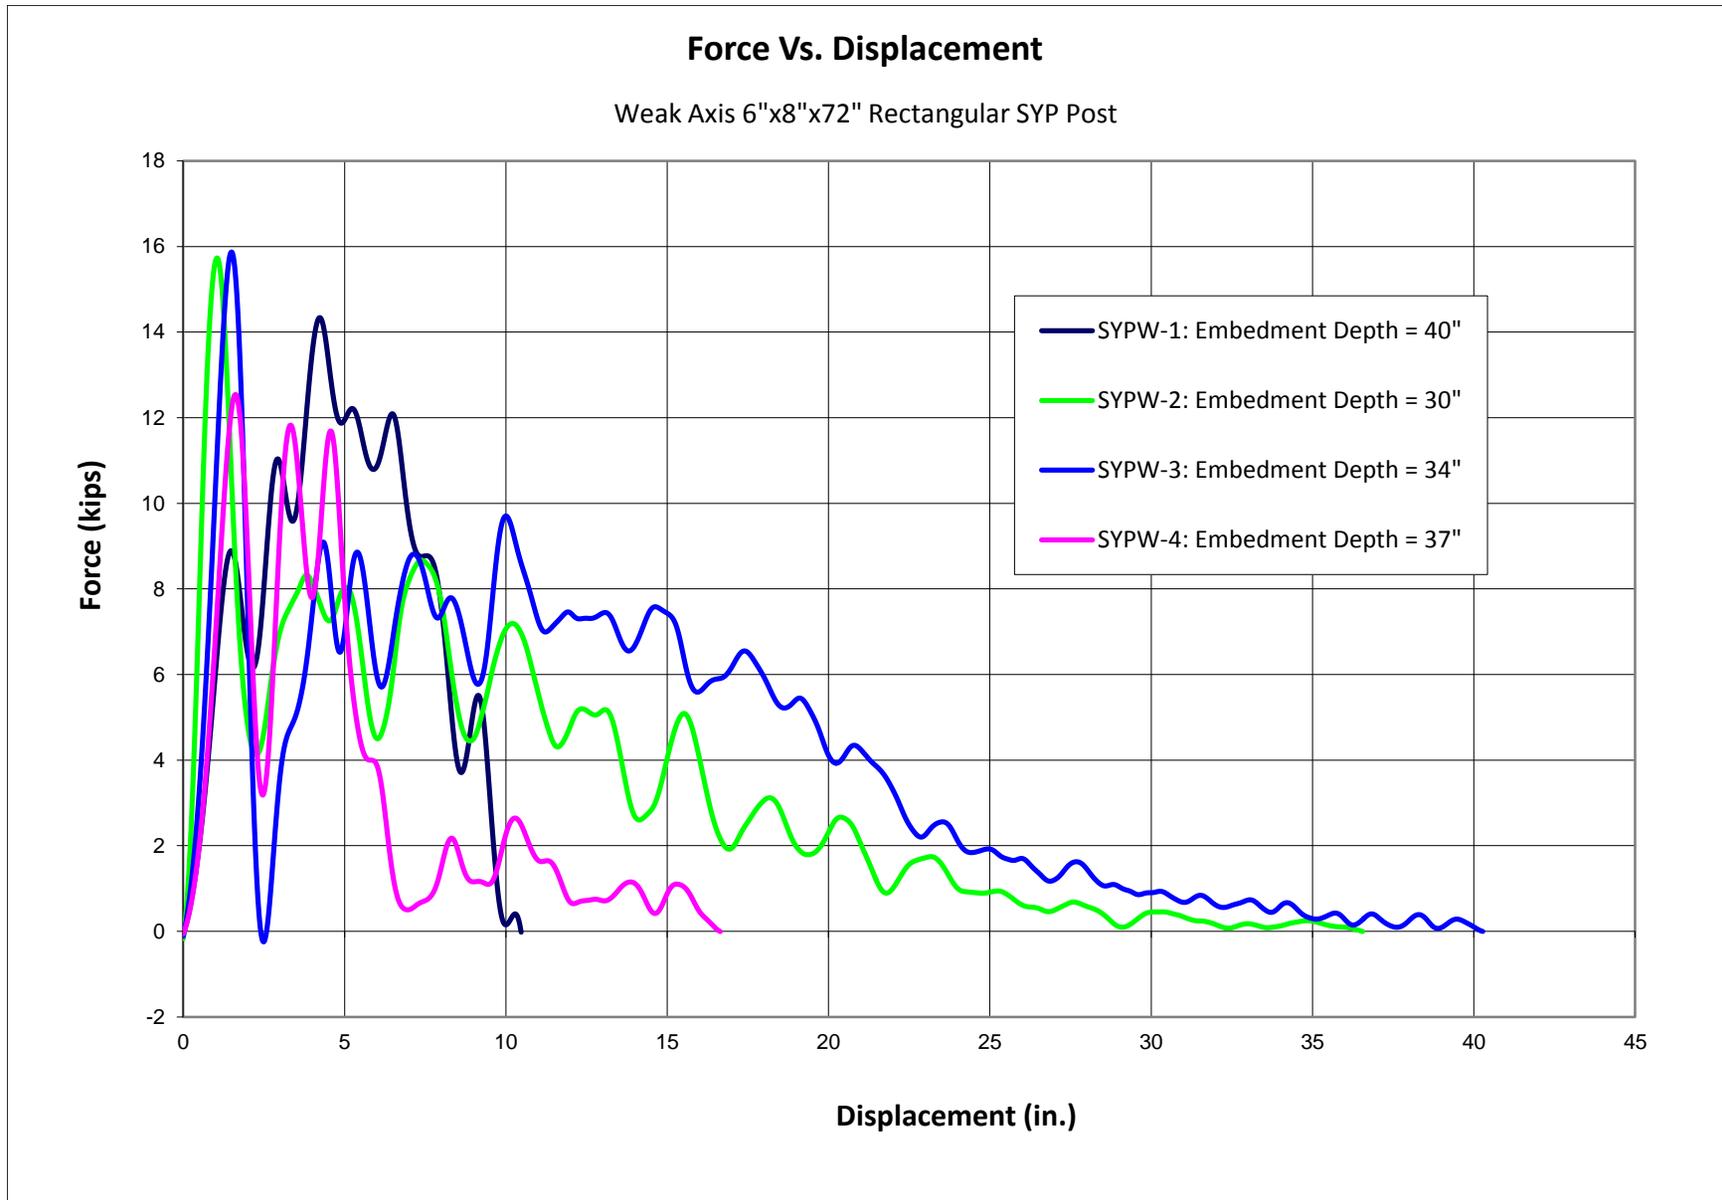
Figure 27. Force vs. Deflection Comparison, Test Nos. SYPW-1 through SYPW-4

Four tests were conducted on 6-in. x 8-in. (152-mm x 203-mm) SYP post with different embedment depths ranging between 30 and 40 in. (762 and 1,016 mm). All four posts were impacted perpendicular to the weak axis of the post, creating weak-axis bending in order to determine the weak-axis characteristics of the wood post. All four posts rotated through the soil. However, the posts in test nos. SYPW-1 and SYPW-4 fractured completely, as shown in Figure 26. The results are summarized in Table 2. Force vs. deflection and energy vs. deflection curves are shown in Figures 27 and 28, respectively.

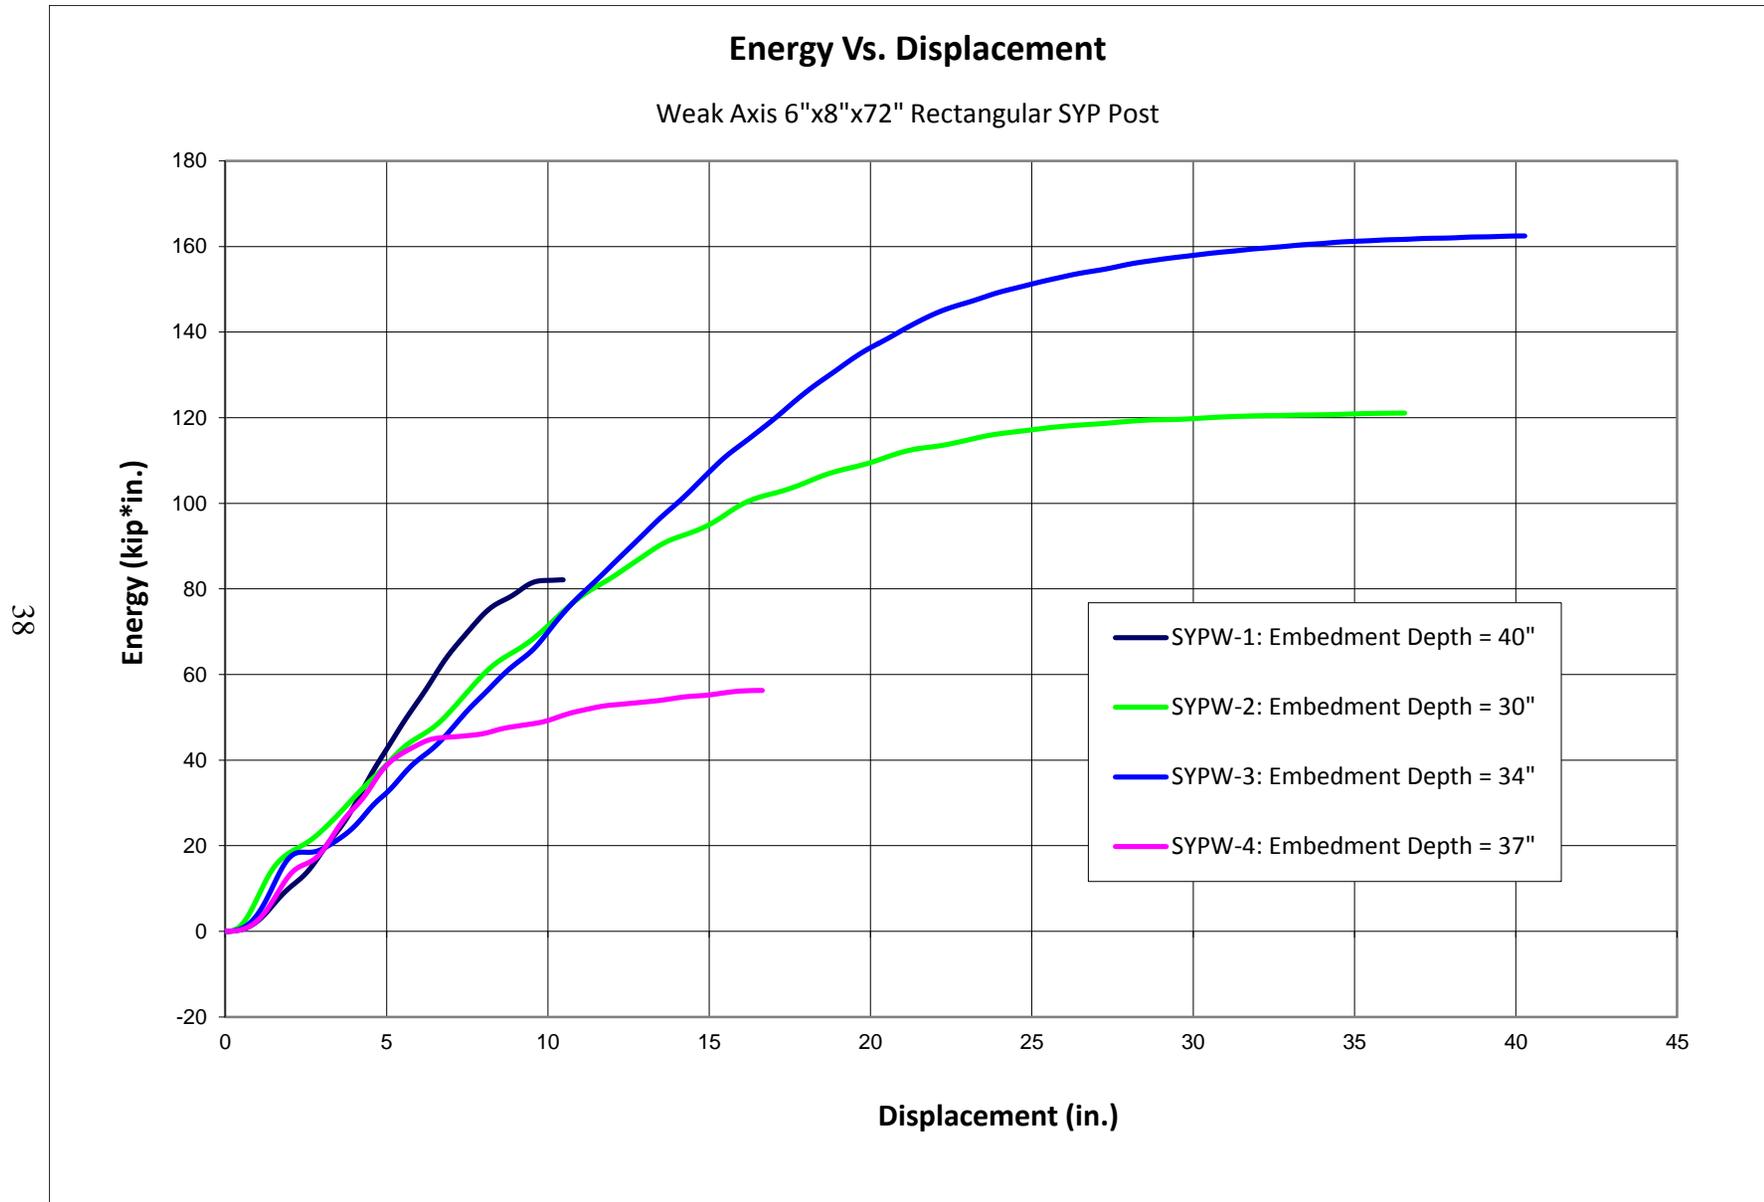
Figure 28. Energy vs. Deflection Comparison, Test Nos. SYPW-1 through SYPW-4

It is important to understand the process and factors that reduce the bogie's kinetic energy. The energy in the system begins in the form of kinetic energy from the bogie moving in relation to the post system. When the bogie impacts the post, the bogie's kinetic energy is converted into other forms of energy. The two most prominent being the energy transferred from the bogie to the soil when the post rotates through the soil and the energy absorbed by the wood post bending and fracturing. Other less prominent energies include friction between the bogie and the post and rolling friction. The system behavior resulted in varying amounts of energies absorbed by the system with total absorbed energies ranging between 45.4 kip-in. and 162.5 kip-in. (5.1 and 18.4 kJ).

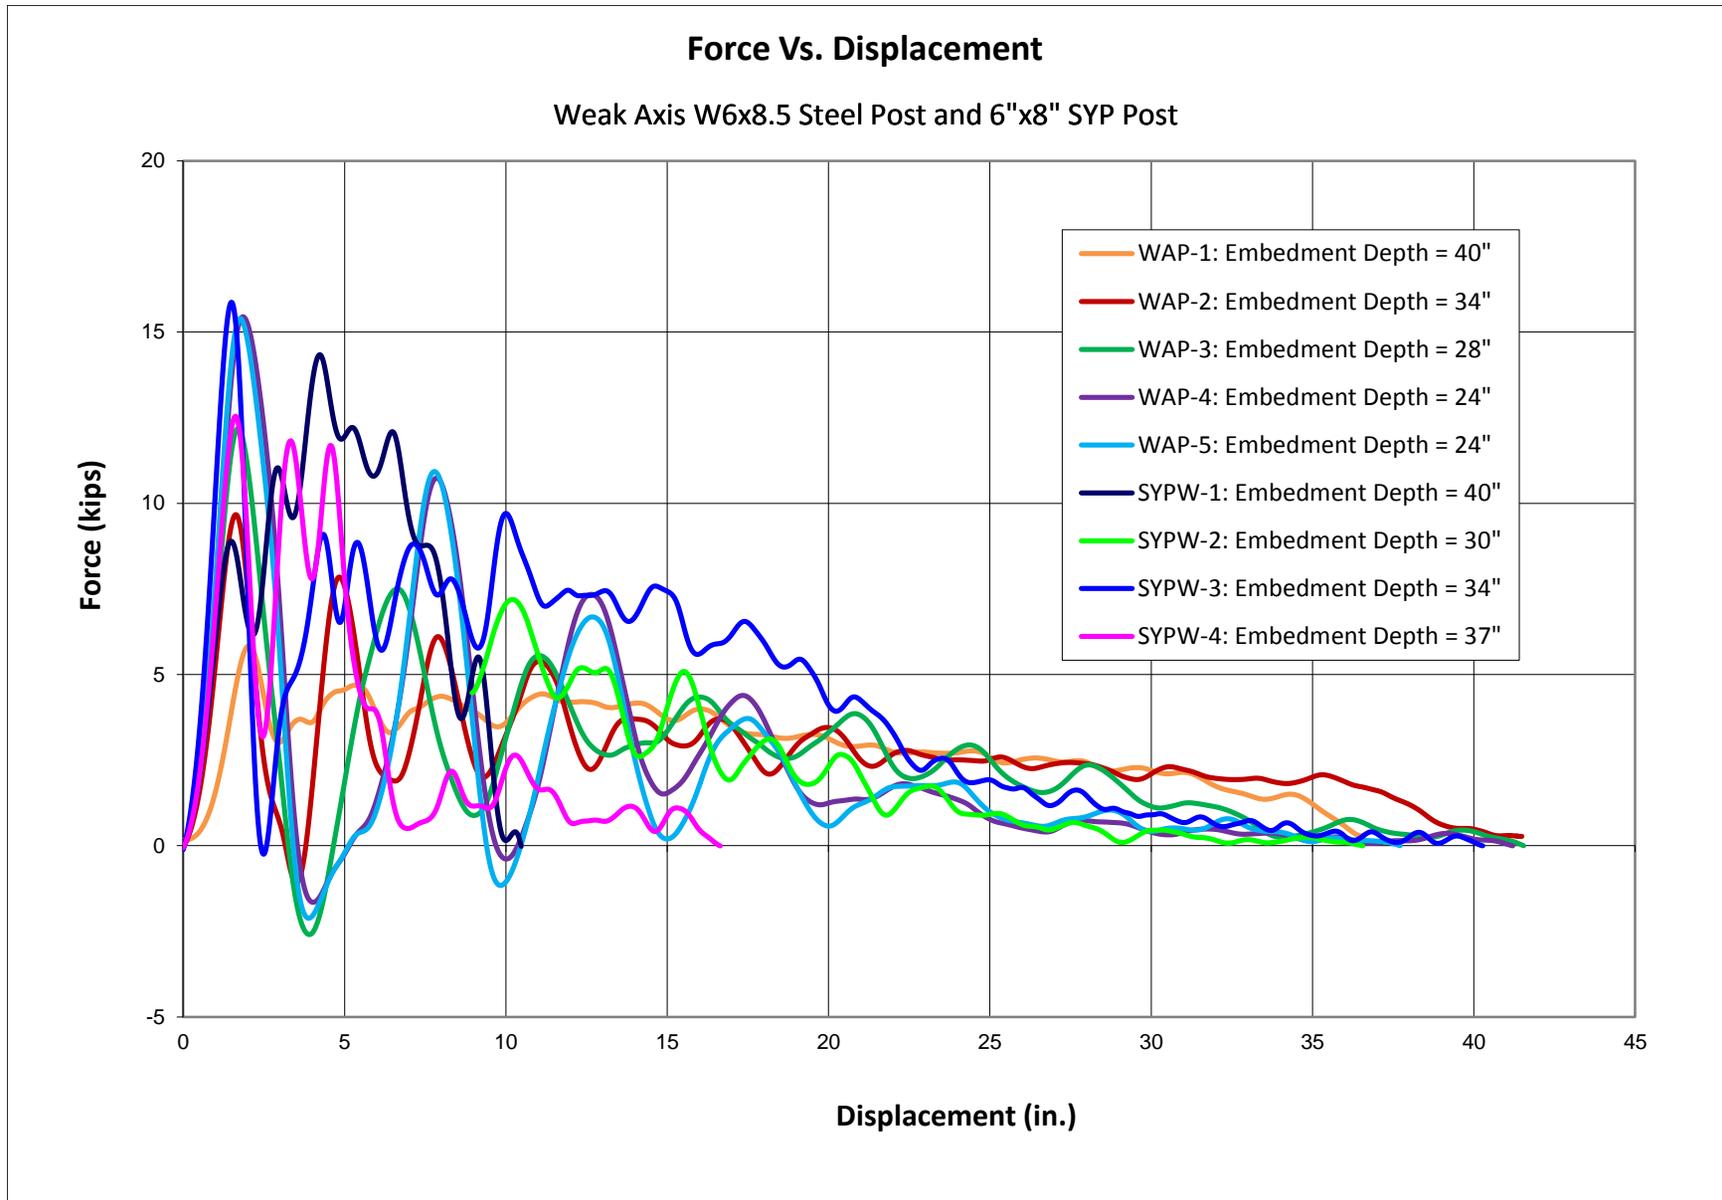
Figure 29. Combined Force vs. Deflection Comparison, All Bogie Tests

In summary, the wood post systems absorbed more energy when rotation through the soil was witnessed compared to the wood post systems that fractured. However, the steel post system absorbed more energy when the post yielded compared to when the steel post rotated through the soil.

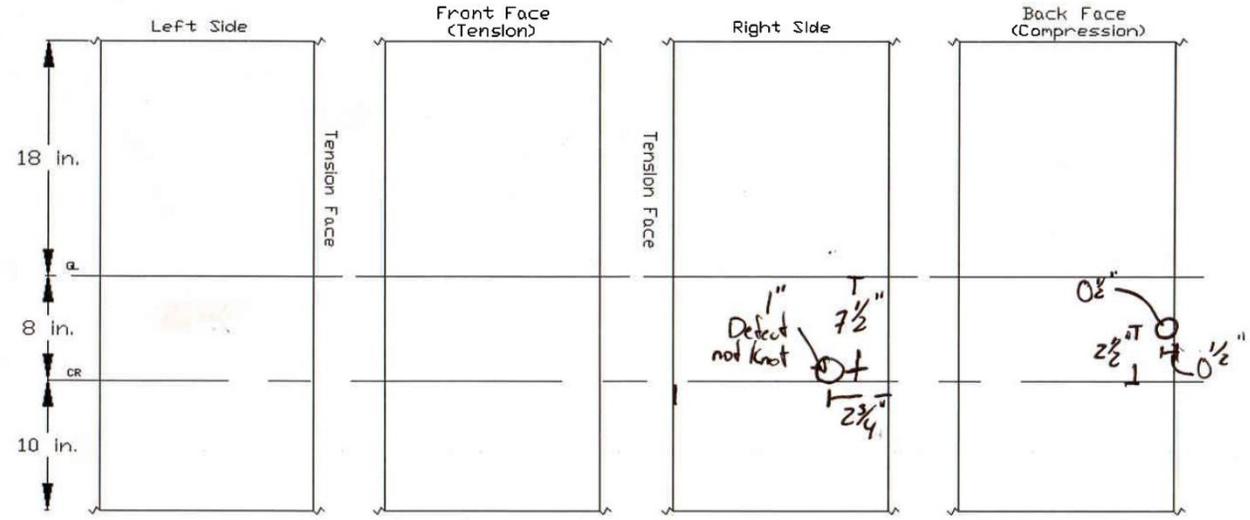
Post 1

On right side the defect is a small impression

Top	GL	CR	Bottom
Width	<u>7 3/4</u>	<u>7 3/4</u>	<u>7 3/8</u>	<u>7 3/4</u>
Depth	<u>5 3/4</u>	<u>5 2/8</u>	<u>5 3/8</u>	<u>6</u>
Moisture	<u>14</u>	<u>14</u>	<u>14</u>	<u>14</u>

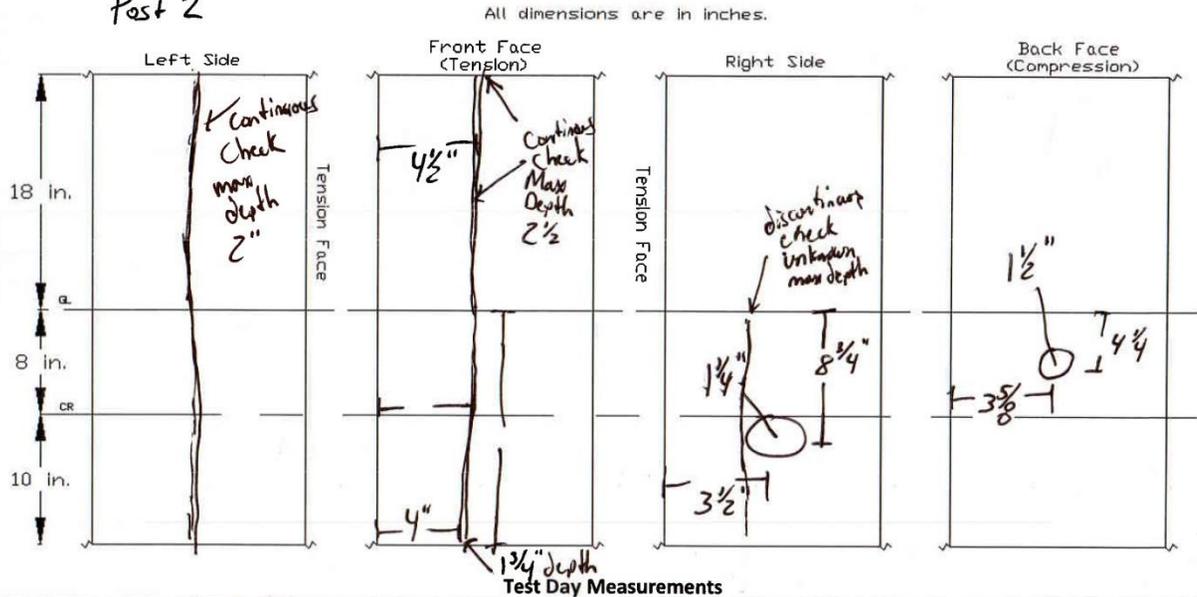
Test No.: Post 2

Post Length: 72 1/8"  
 Post Weight: 72 lbs.  
 Ring Density: 20% = 6 2/3 ring/inch  
 Additional Notes:

Top	GL	CR	Bottom
Width	<u>7 5/8</u>	<u>7 1/4</u>	<u>7 1/4</u>	<u>7 3/8</u>
Depth	<u>5 1/4</u>	<u>5 3/4</u>	<u>5 3/4</u>	<u>5 1/4</u>
Moisture
