# **DEVELOPMENT OF THE MGS APPROACH GUARDRAIL TRANSITION USING STANDARDIZED STEEL POSTS**

## **MIDWEST ROADSIDE SAFETY FACILITY**

MwRSF Research Report No. TRP-03-210-10

December 21, 2010

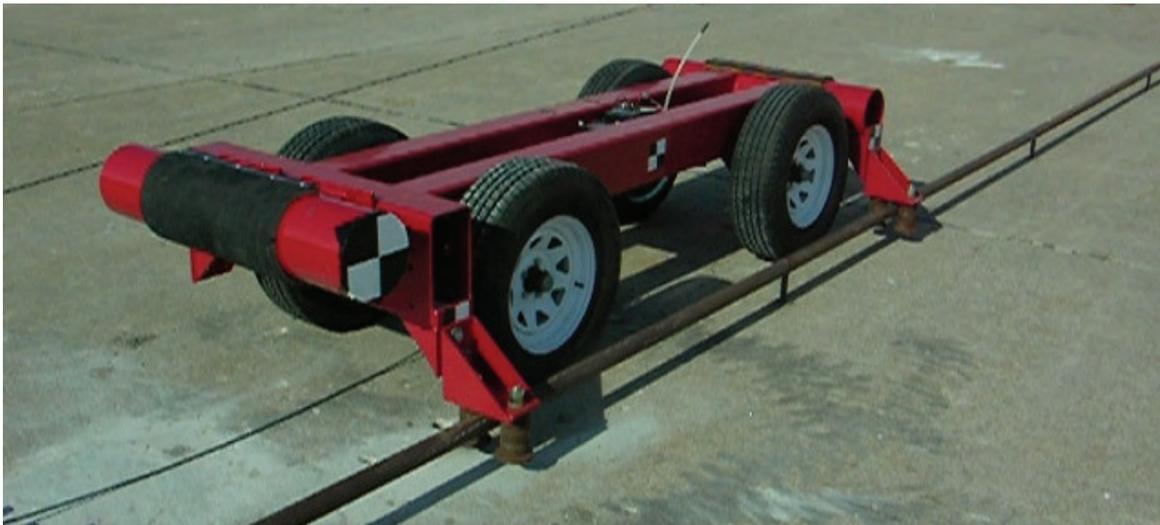
A rigid frame bogie was used to impact the posts. A variable height, detachable impact head was used in the testing. The bogie head was constructed of 8-in. (203-mm) diameter, ½-in. (13-mm) thick standard steel pipe, with ¾-in. (19-mm) neoprene belting wrapped around the pipe to prevent local damage to the post from the impact. The impact head was bolted to the bogie vehicle, creating a rigid frame with an impact height of 24<sup>7</sup>/<sub>8</sub> in. (632 mm). The bogie with impact head is shown in Figure 2. The weight of the bogie with the addition of the mountable impact head was 1,810 lb (821 kg).

A pickup truck with a reverse cable tow system was used to propel the bogie to a target impact speed of 20 mph (32 km/h). When the bogie approached the end of the guidance system, it was released from the tow cable, allowing it to be free rolling when it impacted the post. A remote braking system was installed on the bogie allowing it to be brought safely to rest after the test.

Figure 2. Rigid Frame Bogie on Guidance Track

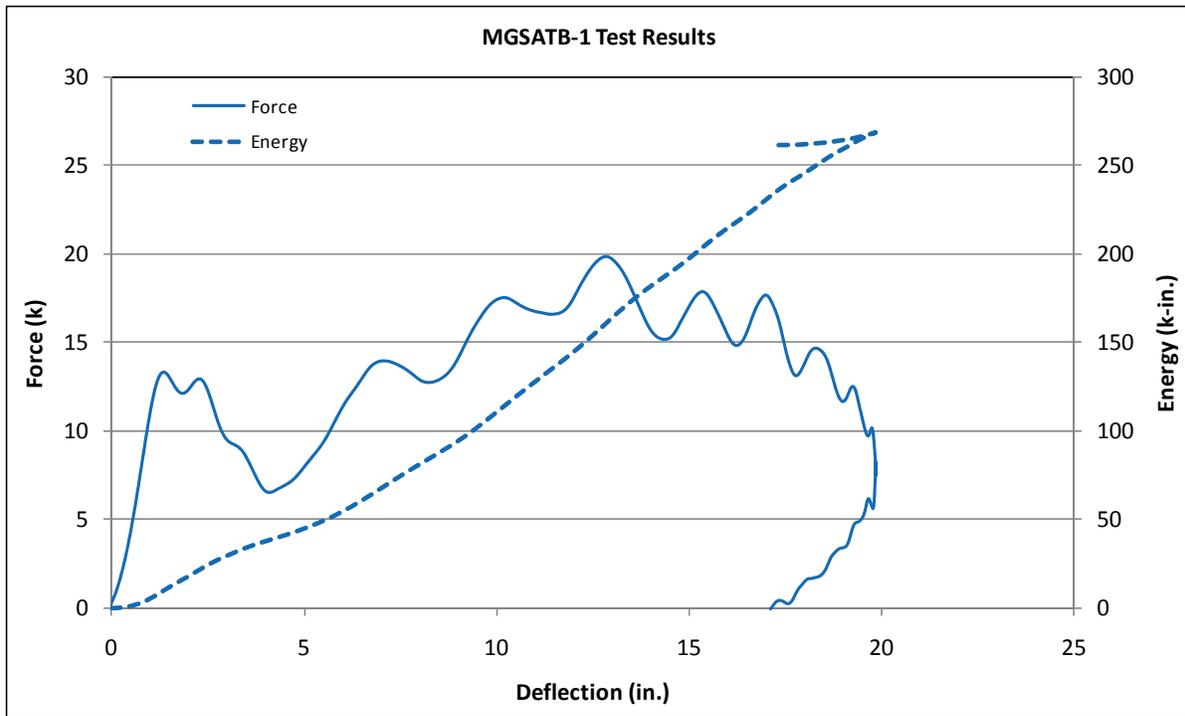
Force vs. deflection and energy vs. deflection curves are shown in Figure 3. Initially, inertial effects resulted in a peak force of 13.6 kips (60.5 kN) over the first 2 in. (51 mm) of deflection. An average force of around 15 kips (67 kN) was observed through the rest of the impact event, with a peak force of 20.1 kips (89.4 kN). The post absorbed 269 kip-in. (30.4 kJ) of energy and had a maximum deflection of 19.5 in. (495 mm).

Figure 3. Force vs. Deflection and Energy vs. Deflection, Test No. MGSATB-1 [W6x15 (W152x22.3) Post]

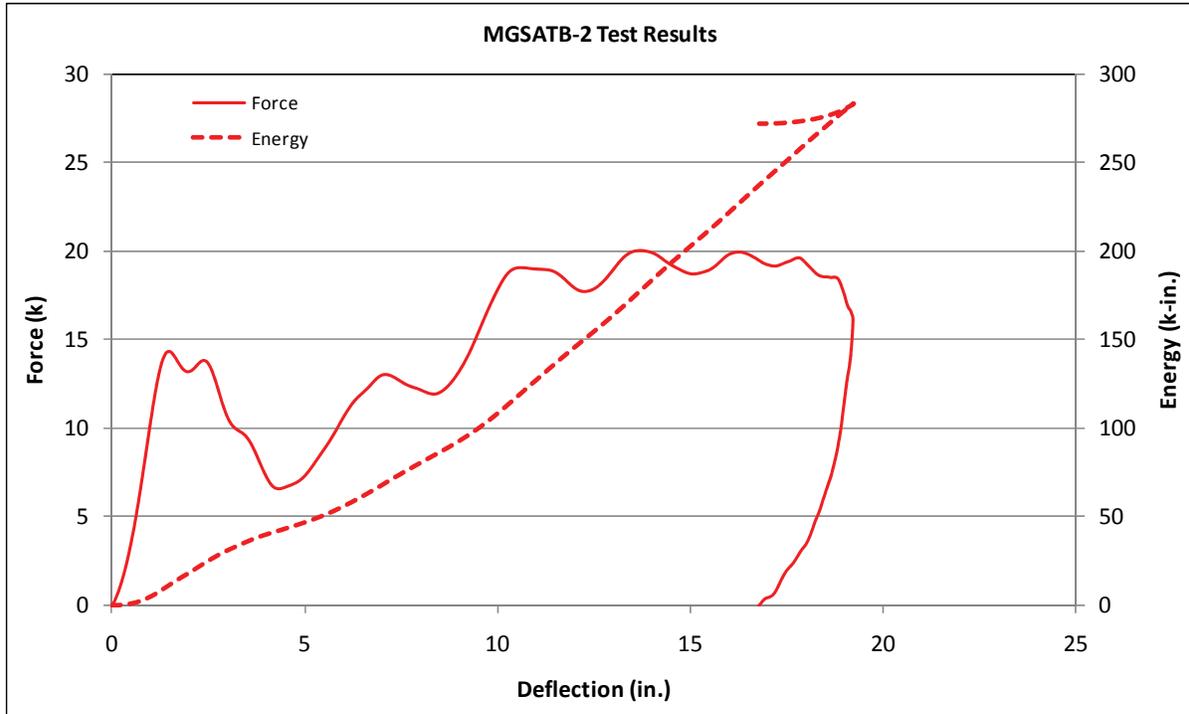
Figure 5. Force vs. Deflection and Energy vs. Deflection, Test No. MGSATB-2 [W6x15 (W152x22.3) Post]

Two bogie tests were performed on W6x15 (W152x22.3) steel posts embedded 54 in. (1,372 mm) in soil, as summarized in Table 1. Soil failure (i.e., post rotation) was the primary mode of failure in test nos. MGSATB-1 and MGSATB-2, even though both posts experienced post yielding and compression flange buckling. The data analysis for each test showed very similar results with maximum deflections of approximately 19.5 in. (495 mm) and peak forces around 20 kips (89 kN). The force vs. deflection curves, as shown in Figure 7, were similar in shape and magnitude. Both tests showed an inertial spike over the first 2 in. (51 mm) of deflection and a relatively constant force between 15 and 20 kips (65 and 90 kN) from 10 in. (250 mm) of deflection until reaching their respective maximum displacements. Detailed results from all accelerometers are shown in Appendix A.

With these two tests producing similar results, the researchers believed that the typical response of a W6x15 (W152x22.3) steel post embedded 54 in. (1,372 mm) in strong soil could be predicted by averaging the results. Therefore, further bogie testing was not conducted.

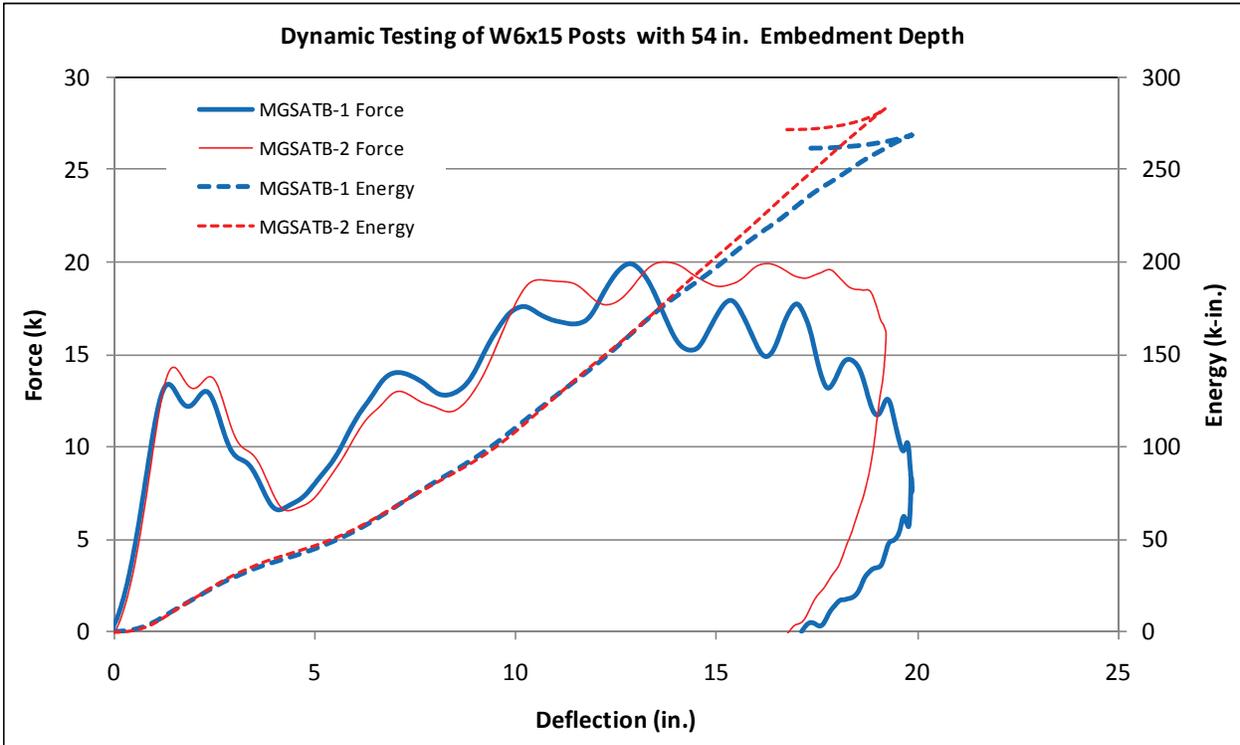
Figure 7. Force and Energy vs. Deflection Results Comparison

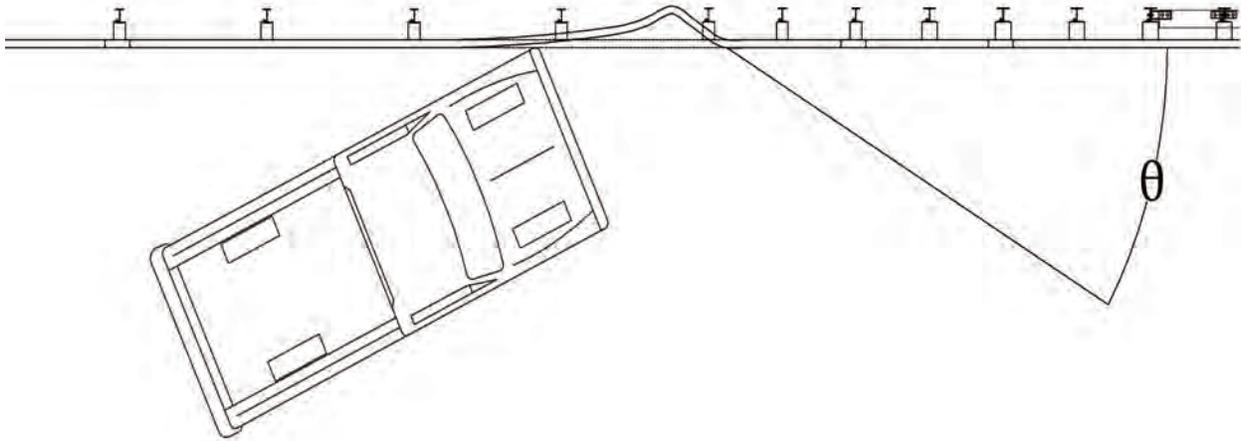
A 2-D computer simulation program, BARRIER VII [16], was utilized to predict the severity of pocketing on various transition configurations by quantifying the pocketing angle associated with each configuration and impact condition combination. The pocketing angle was defined as the angle between the guardrail region just in front of the impacting vehicle and the downstream section of rail, as shown in Figure 8. The critical pocketing angle,  $\theta_p$ , was defined such that at angles smaller than  $\theta_p$ , the bend in the guardrail would not cause serious pocketing. However, at pocketing angles more severe than  $\theta_p$ , where the difference between the guardrail and the transition regions was more abrupt, the vehicle would not be able to escape the pocket, and an undesirable vehicle response could be expected. This definition of  $\theta_p$  is only applicable where there is a sharp bend in the guardrail, and the pocketing angle is essentially a measure of the magnitude of that angle. The depth of the pocket may also have a significant impact on the performance of a guardrail system. However, for the purposes of using BARRIER VII to design a guardrail stiffness transition, MwRSF researchers have assumed that the depth of the pocket will always be sufficient to create a problem, provided the critical pocketing angle is attained.

Figure 8. Critical Pocketing Angle

As a vehicle approaches the stiffened, semi-rigid approach guardrail transition region from the relatively flexible guardrail region, a potential for rail pocketing exists. Pocketing occurs when the lateral deflection of one region of a guardrail system is much less than the adjacent region, thus creating a sharp bend in the guardrail system as the impacting vehicle approaches the stiffer region. This sharp bend produces a high longitudinal force on the vehicle that can create excessive decelerations or force the vehicle to override the barrier near the pocket and/or roll over.

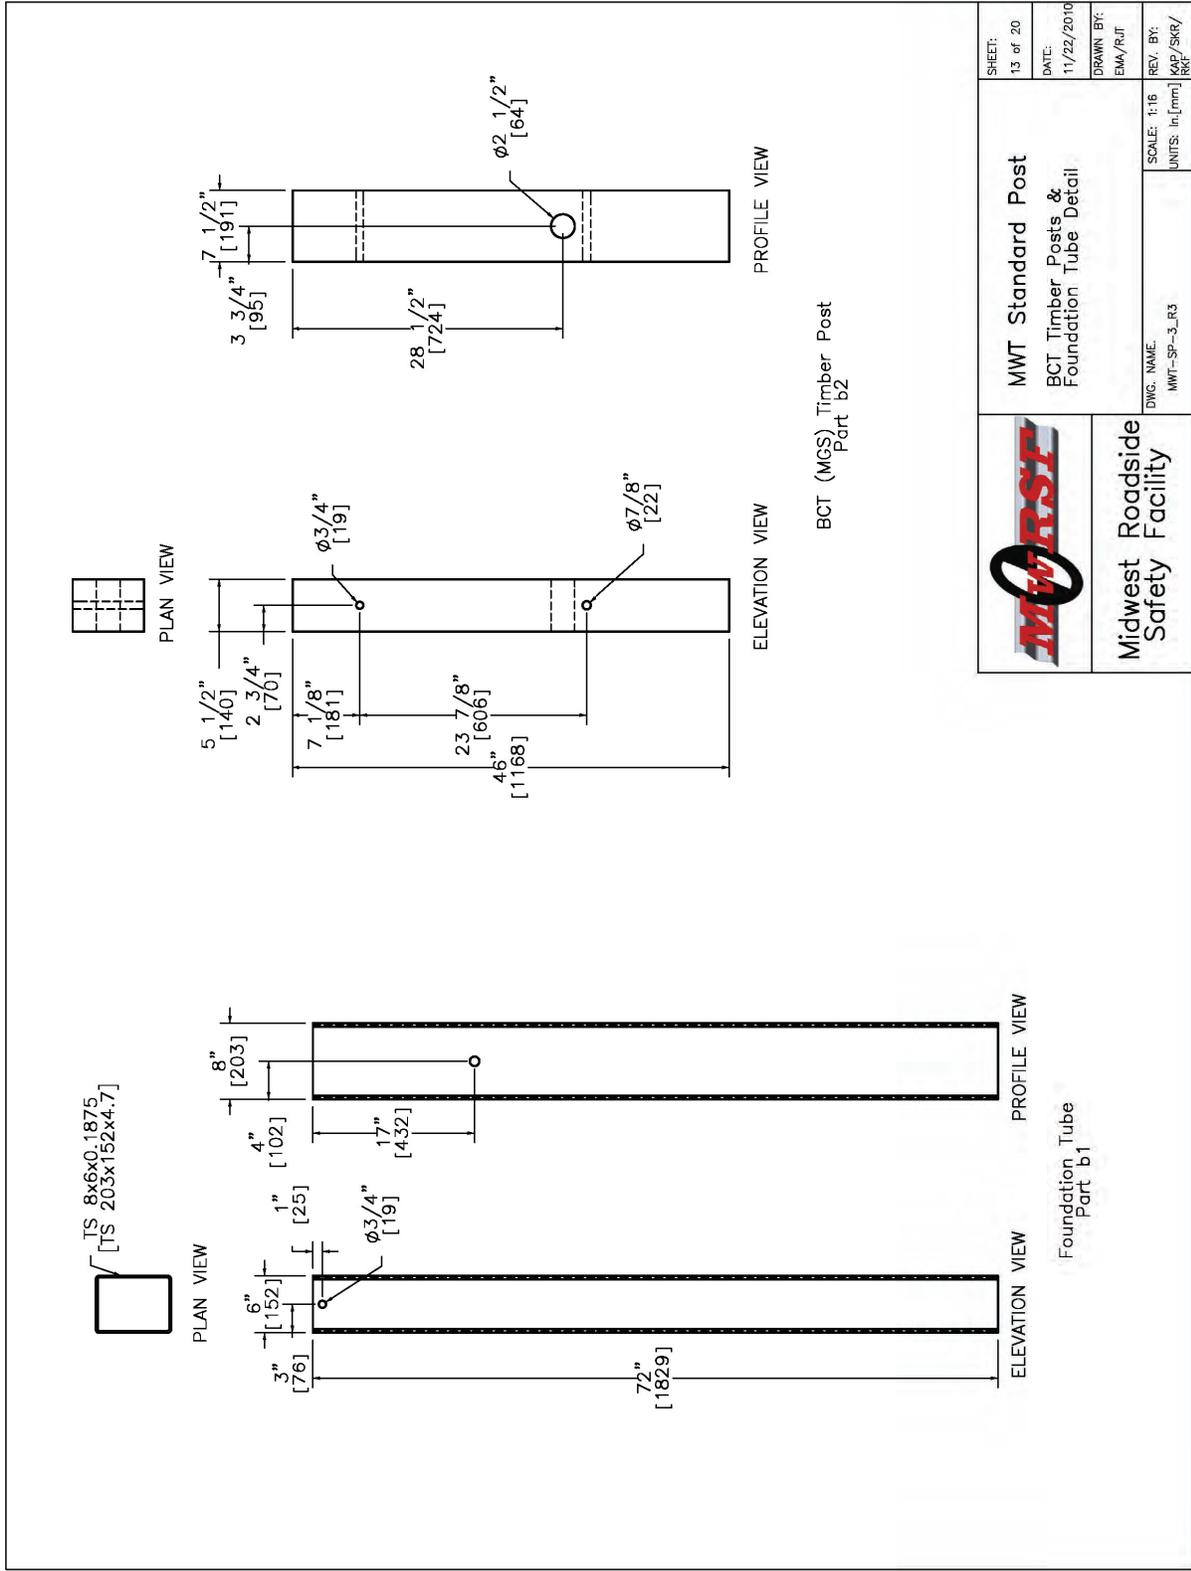
Figure 23. BCT Post and Foundation Tube Details, Test Nos. MWTSP-1 through 3

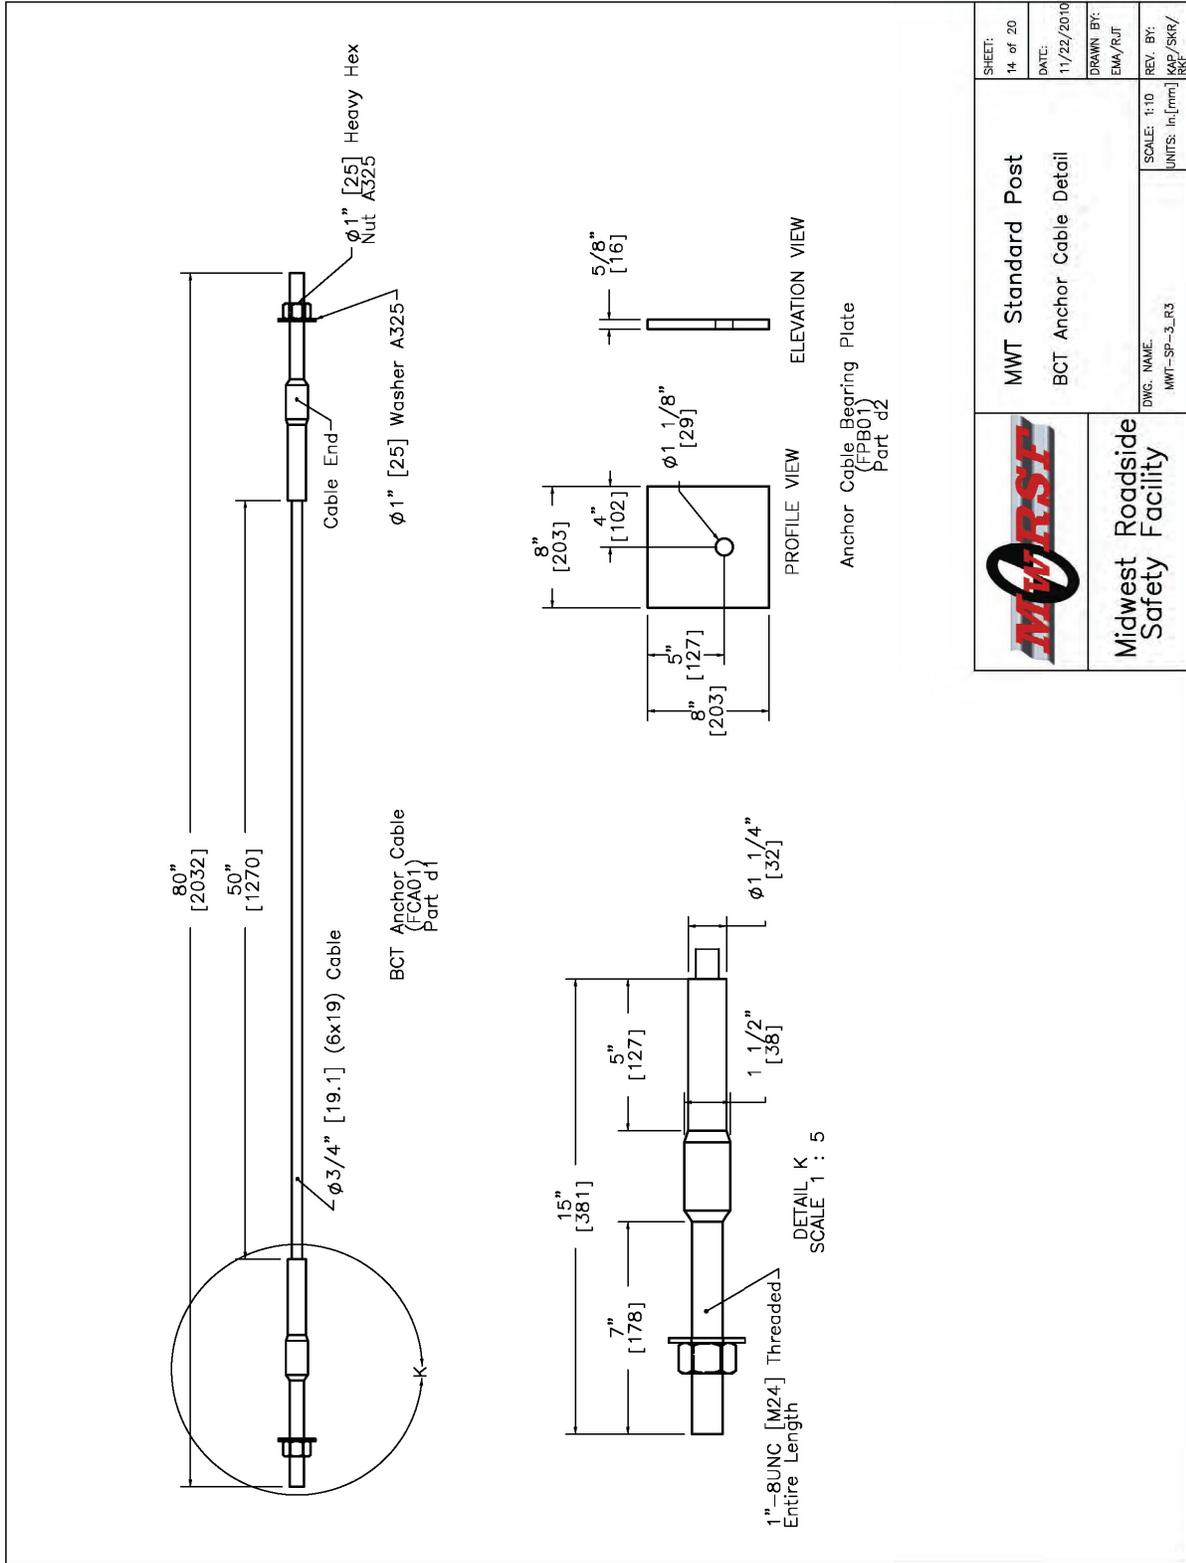
Figure 24. BCT Anchor Cable Details, Test Nos. MWTSP-1 through 3

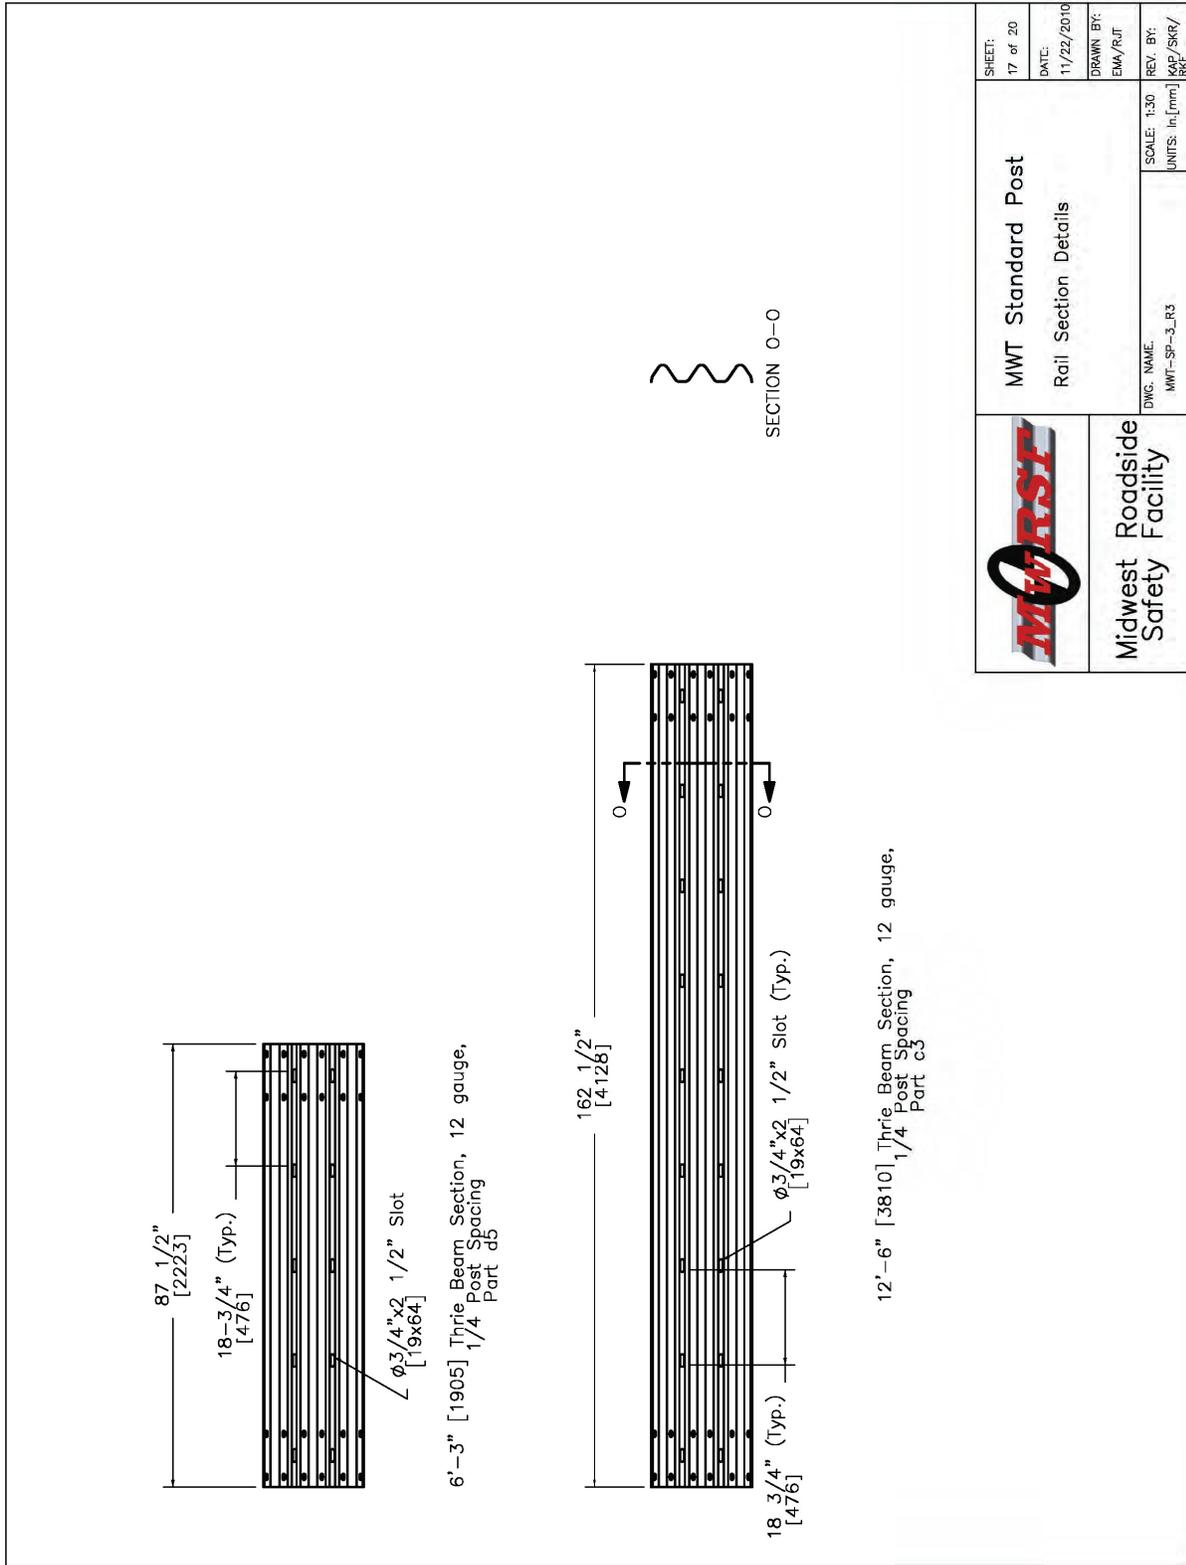
Figure 27. Thrie Beam Rail Section Details, Test Nos. MWTSP-1 through 3

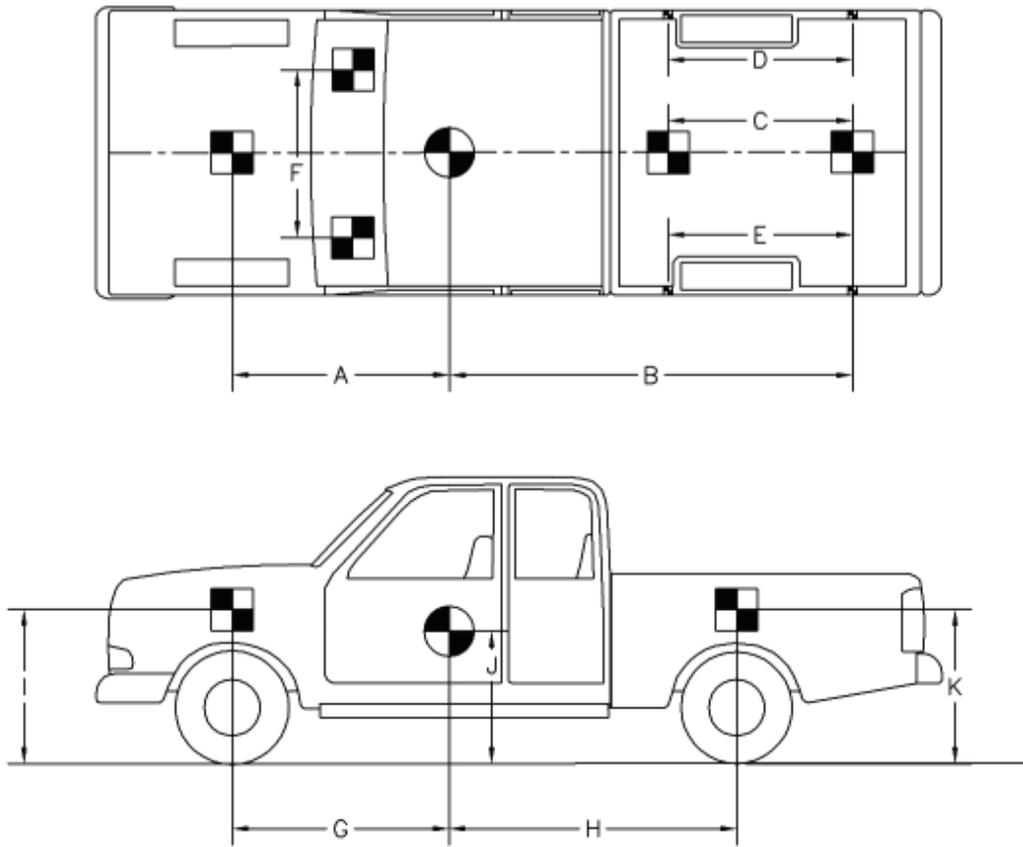
<b>TEST #: MWTSP-1</b>					
<b>TARGET GEOMETRY-- in. (mm)</b>					
<b>A</b>	<b>75 3/8</b>	<b>(1915)</b>	<b>E</b>	<b>63 7/8</b>	<b>(1622)</b>
<b>B</b>	<b>109</b>	<b>(2769)</b>	<b>F</b>	<b>34 3/4</b>	<b>(883)</b>
<b>C</b>	<b>48 1/4</b>	<b>(1226)</b>	<b>G</b>	<b>63 1/2</b>	<b>(1613)</b>
<b>D</b>	<b>63 7/8</b>	<b>(1622)</b>	<b>H</b>	<b>76 3/4</b>	<b>(1949)</b>
			<b>I</b>	<b>39 1/8</b>	<b>(994)</b>
			<b>J</b>	<b>28 1/8</b>	<b>(714)</b>
			<b>K</b>	<b>42</b>	<b>(1067)</b>

Figure 42. Target Geometry, Test No. MWTSP-1

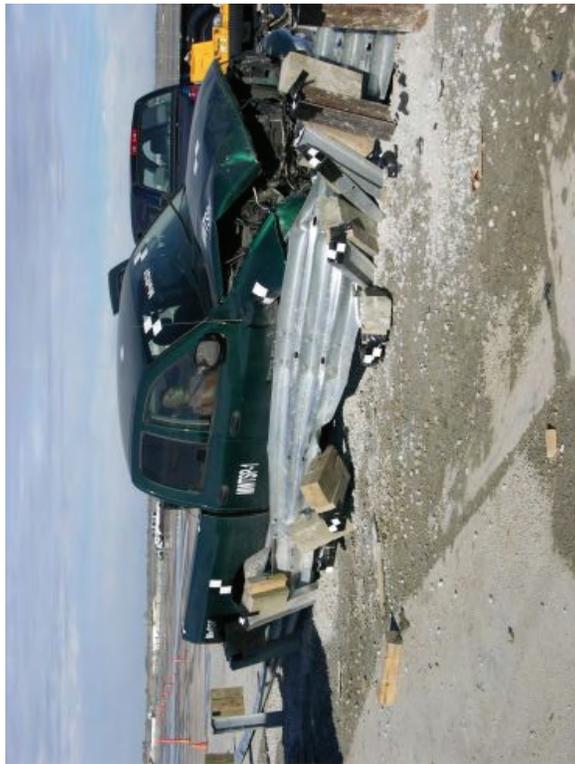
The entire length of guardrail was detached from the posts due to all of the bolts pulling through the guardrail slots, as shown in Figure 55. Only three of the guardrail slots were found to have tears resulting from bolt pullout. Both slots on post no. 21 were torn ½ in. (13 mm) on the upstream side, and the lower slot on post no. 12 was torn 3½ in. (89 mm) on the upstream side. A severe kink, measuring nearly 90 degrees, was found just upstream of the nested thrie beam segment, as shown in Figure 57. A deformed guardrail pocket was found upstream of the major kink extending to post no. 9. Throughout this region contact marks, rail flattening, and minor buckling was observed on the guardrail segments, as shown in Figure 56.

Figure 55. System Damage, Test No. MWTSP-1

Damage to the barrier was moderate, as shown in Figures 55 through 61. System damage consisted of deformed guardrail and posts, fractured wooden posts, soil displacement, fractured wooden spacer blockouts, and contact marks on the guardrail. The length of vehicle contact on the barrier system was approximately 17 ft – 11 in. (5.46 m), which spanned from 71 in. (1,803 mm) upstream from the centerline of post no. 9 to the upstream end of the nested thrie beam guardrail segment near post no. 14.

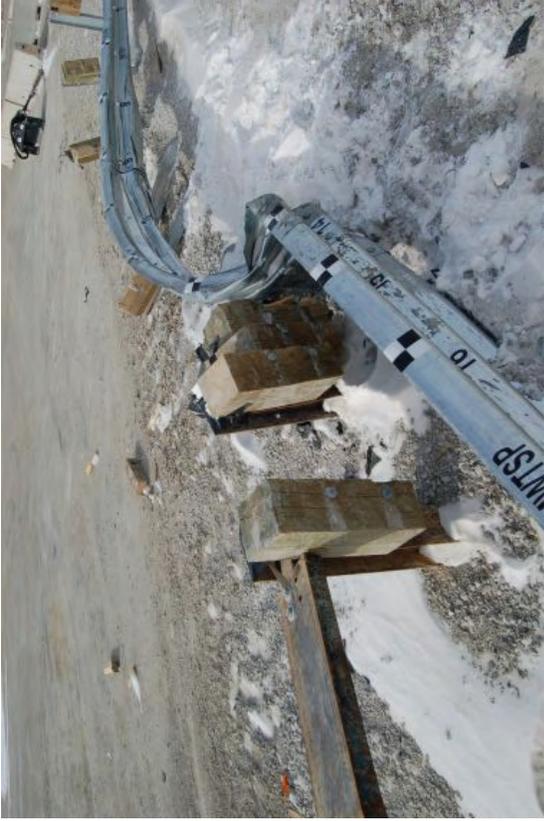
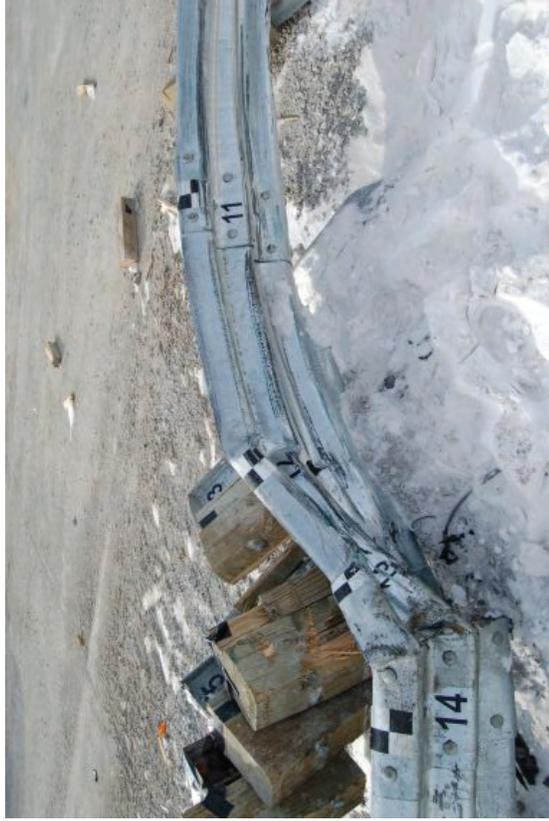
Figure 56. Rail Deformation, Test No. MWTSP-1

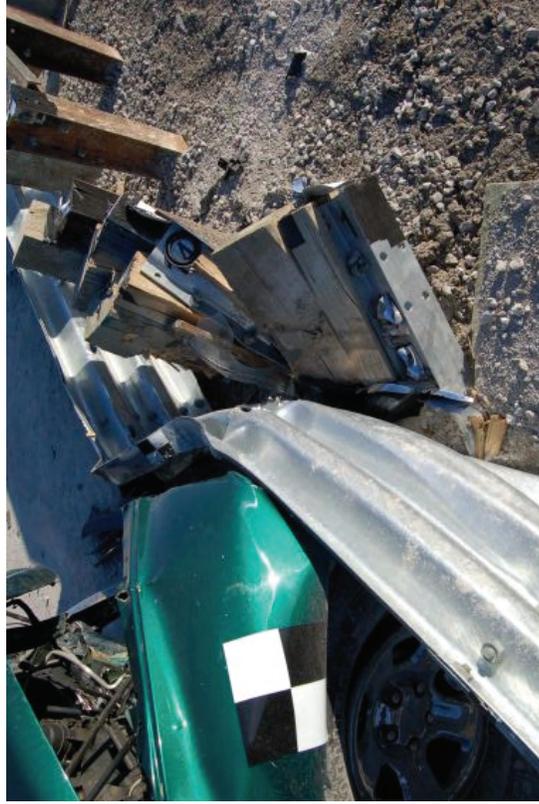
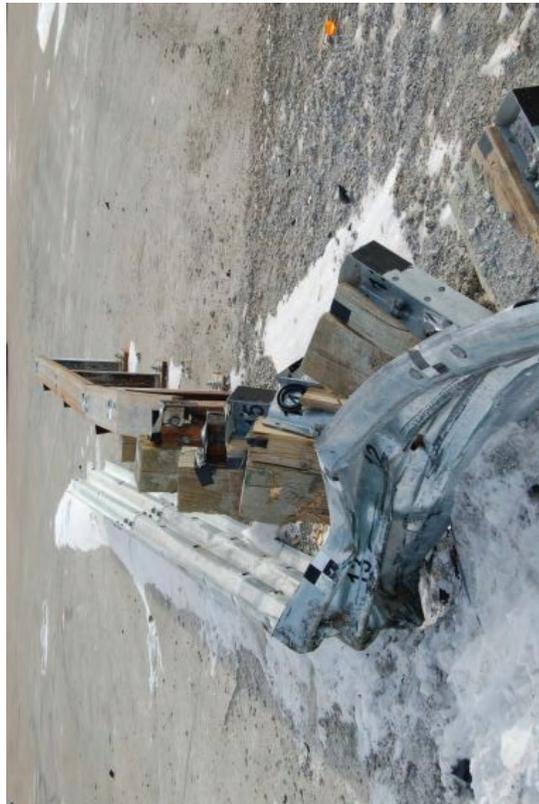
Figure 59. Posts Nos. 13 through 16 Damage, Test No. MWTSP-1

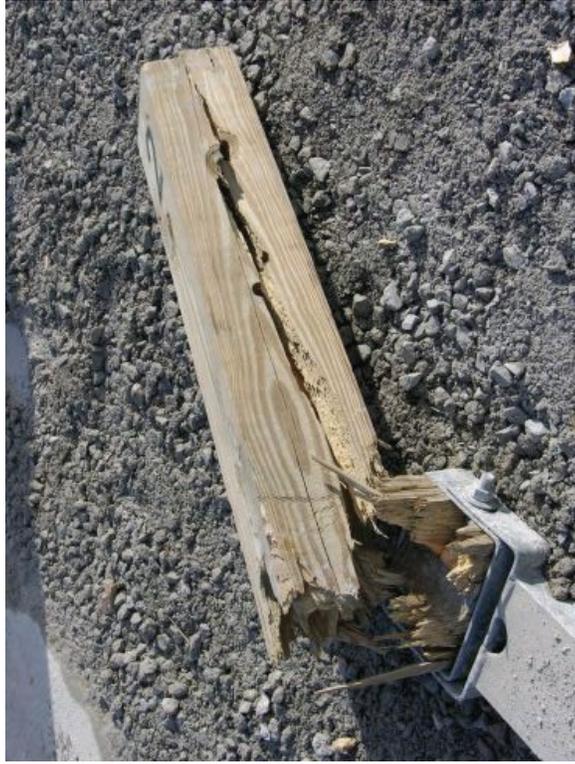
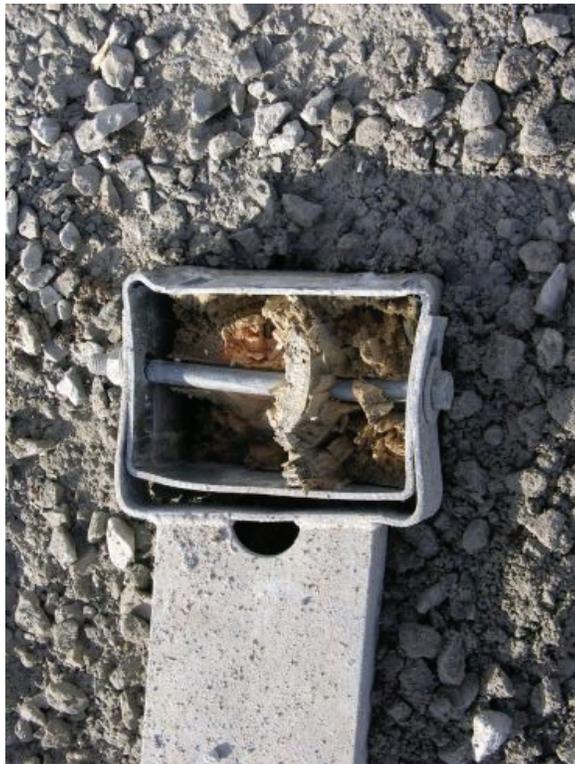
Figure 60. Upstream Anchorage Damage, Test No. MWTSP-1

0.144	Post no. 1 fractured near ground level, allowing the guardrail upstream of impact to be pulled downstream. Post nos. 3 through 7 continued to rotate downstream.

0.150	Post no. 2 fractured near ground level and split in half from the bolt pulling up and through the post.
0.156	The guardrail disengaged from post no. 12, and the vehicle pitched downward extensively.

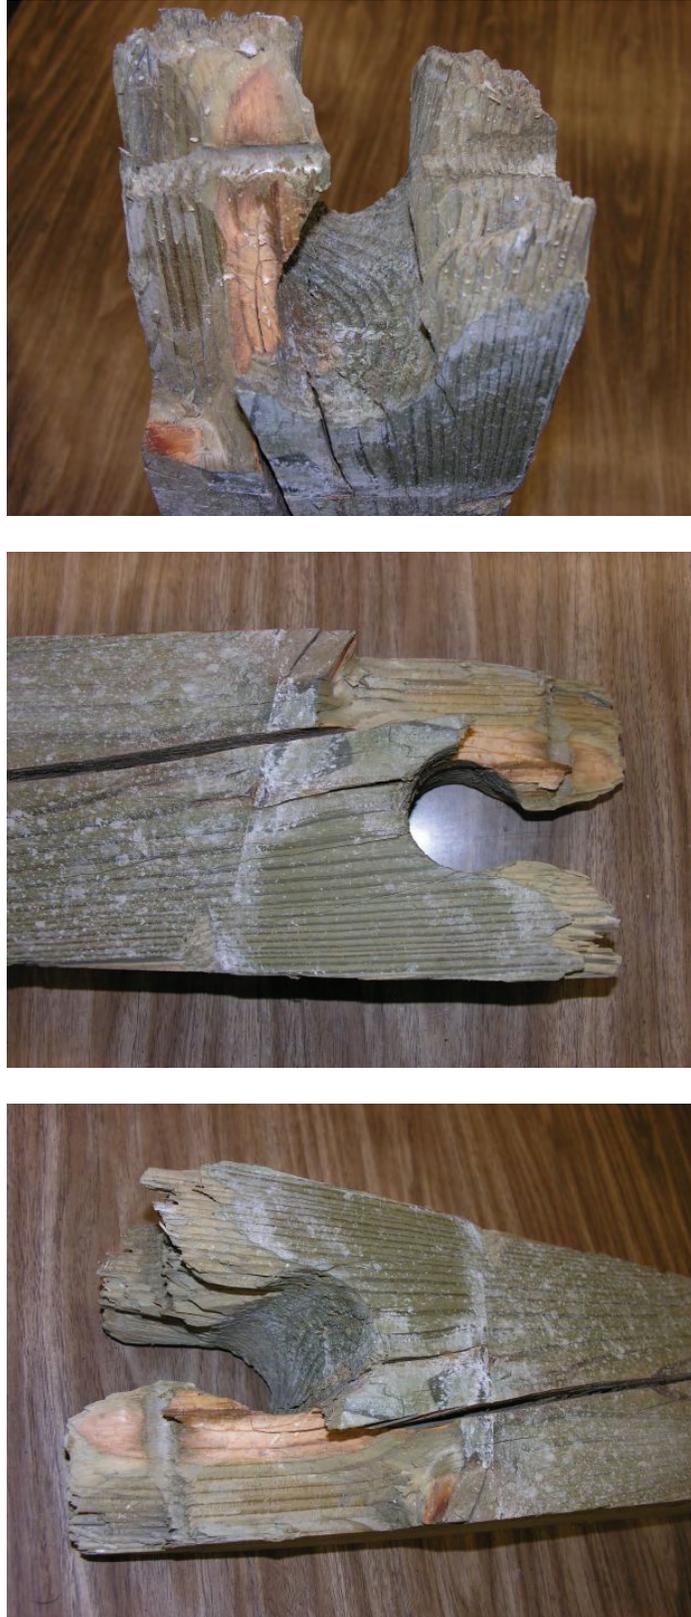
Figure 61. Anchorage Post No. 1 Damage, Test No. MWTSP-1

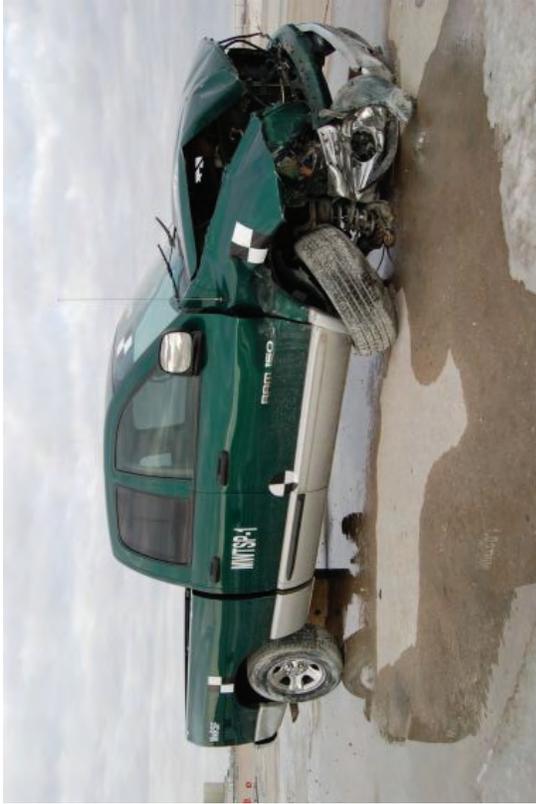
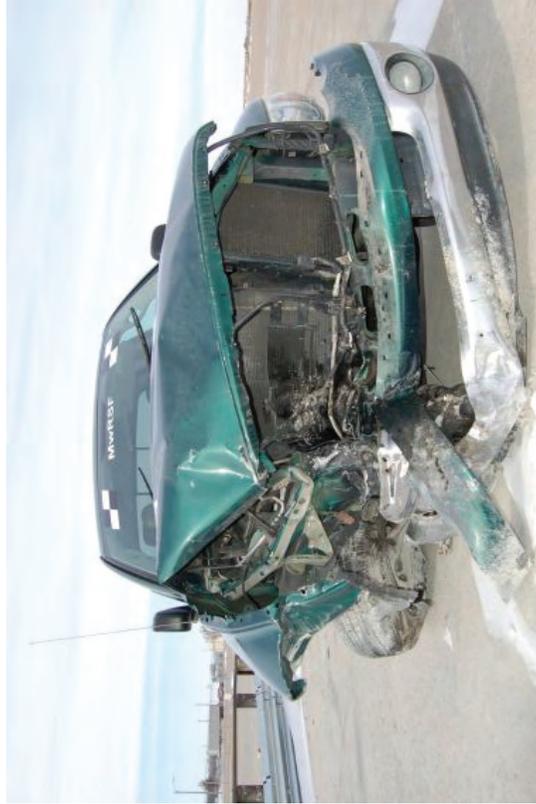
Figure 62. Vehicle Damage, Test No. MWTSP-1

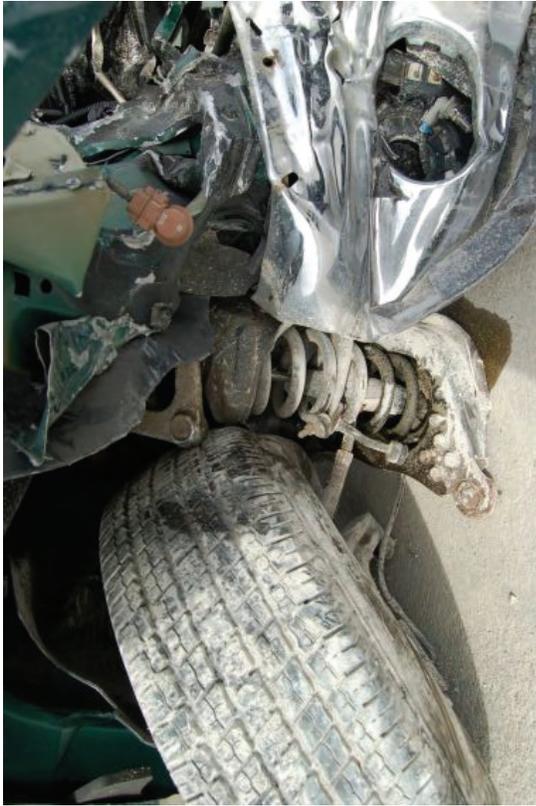
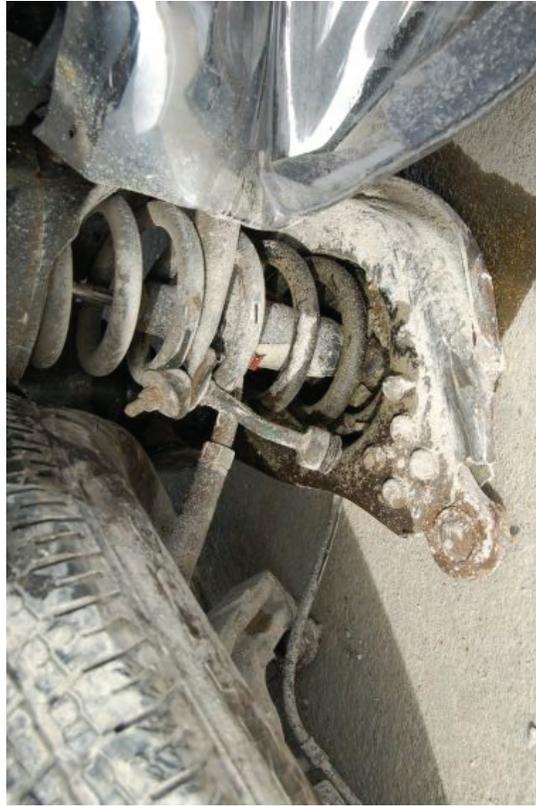
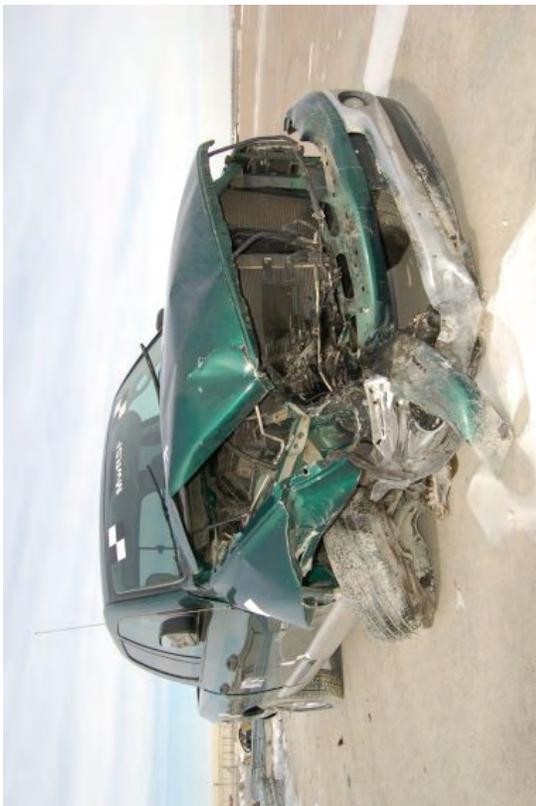
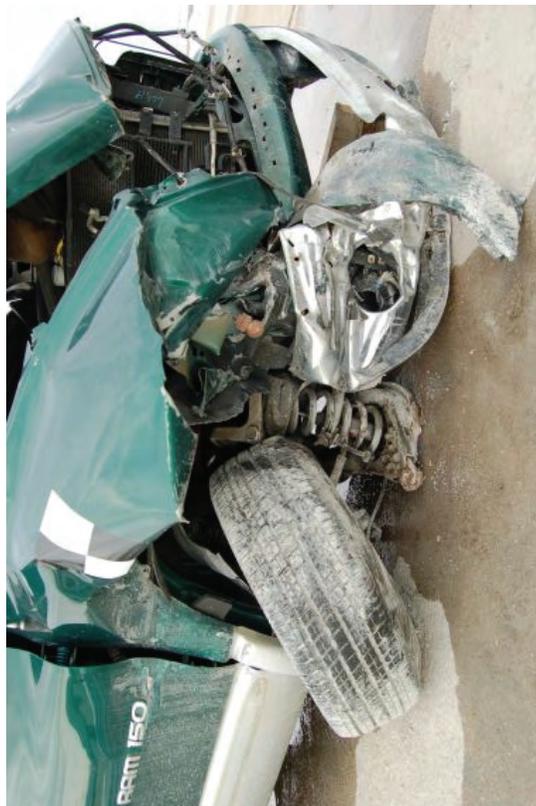
Figure 63. Right-Front Wheel Assembly Damage, Test No. MWTSP-1

0.100	The guardrail disengaged from post no. 11, and the right headlight shattered.
0.134	The right-front tire contacted post no. 10, causing the wheel assembly to bend and the blackout to fracture.

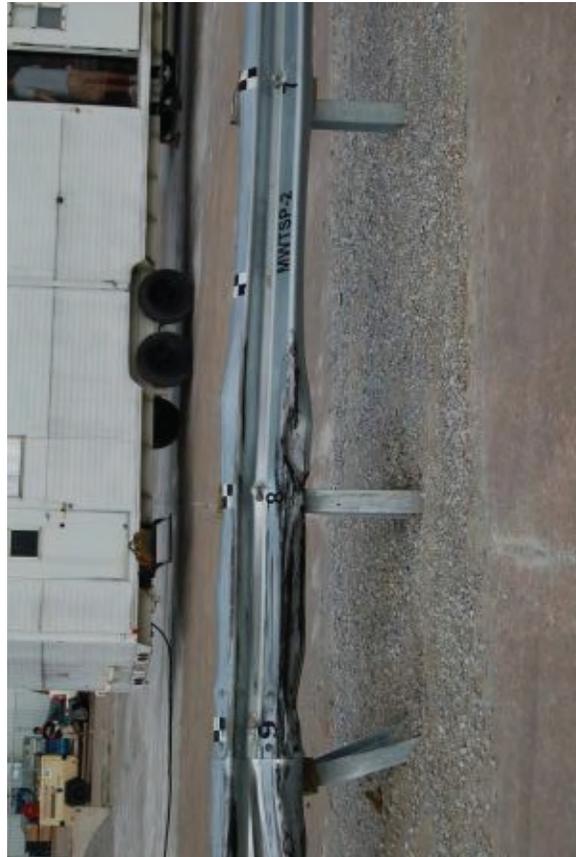
Figure 72. Post Nos. 7 through 9 Damage, Test No. MWTSP-2

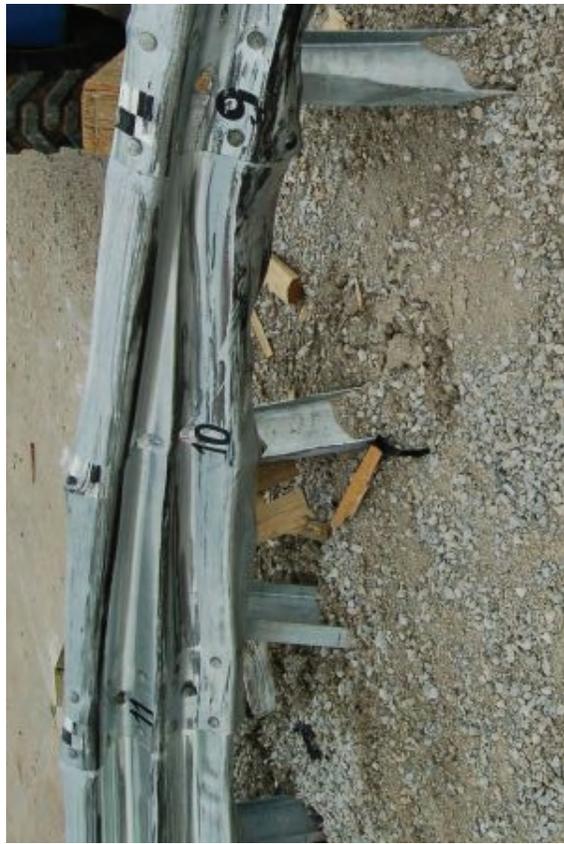
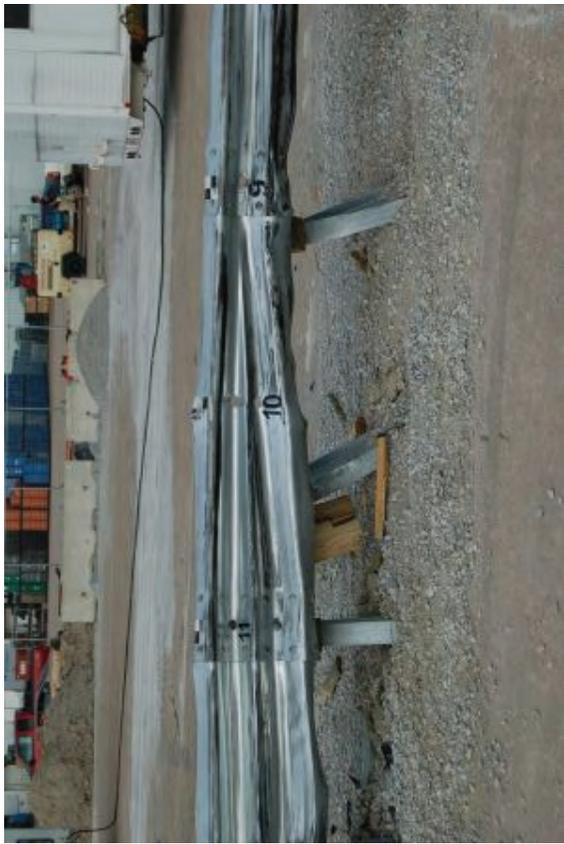
Figure 73. Post Nos. 10 and 11 Damage, Test No. MWTSP-2

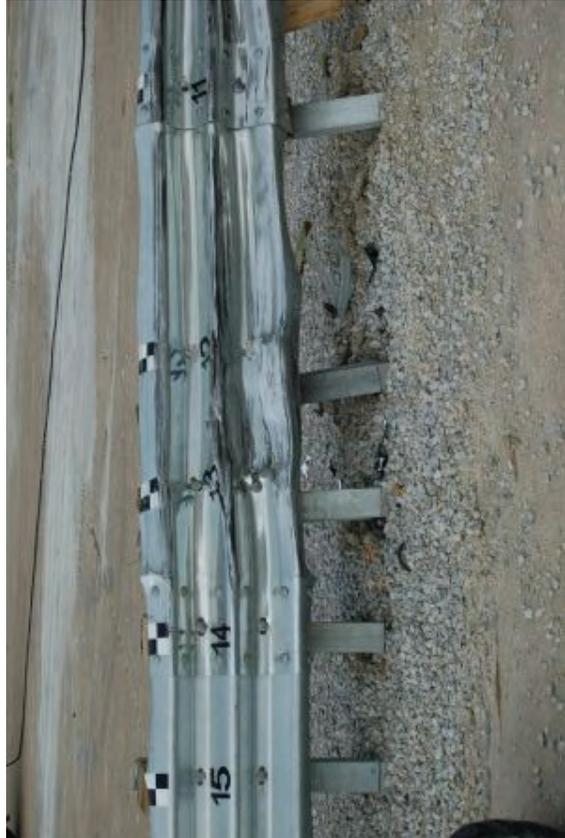
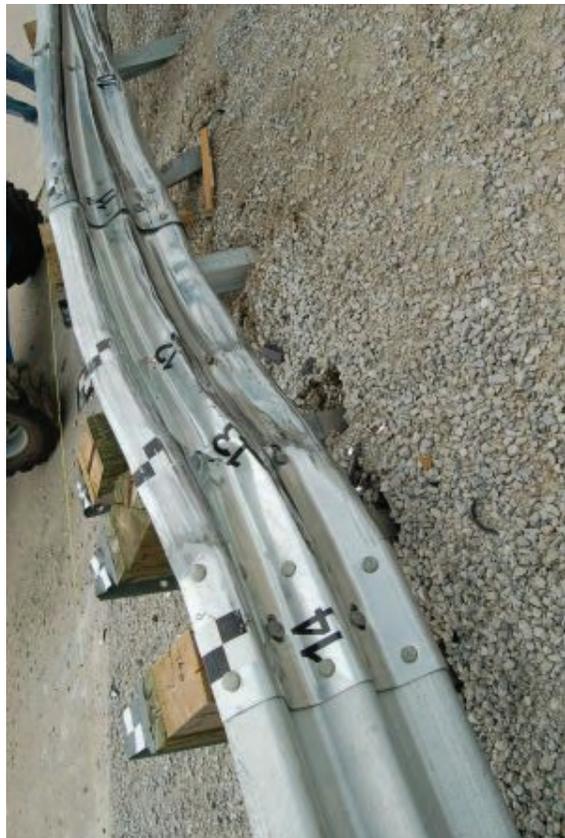
Figure 74. Post Nos. 12 through 14 Damage, Test No. MWTSP-2
