# **DEVELOPMENT OF THE MGS APPROACH GUARDRAIL TRANSITION USING STANDARDIZED STEEL POSTS**

## **MIDWEST ROADSIDE SAFETY FACILITY**

MwRSF Research Report No. TRP-03-210-10

December 21, 2010

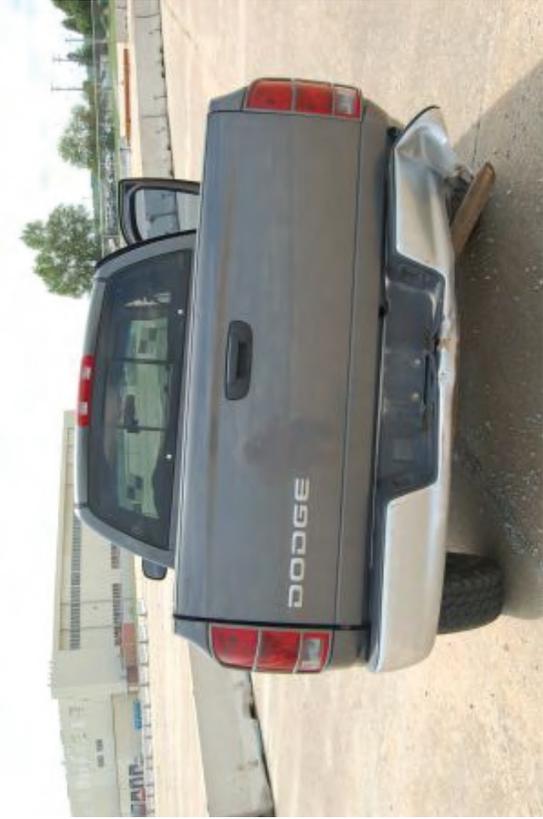
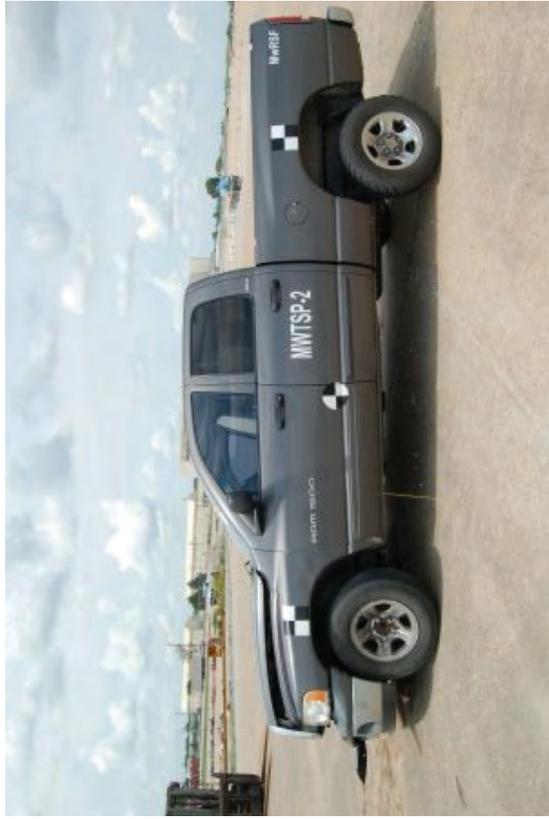
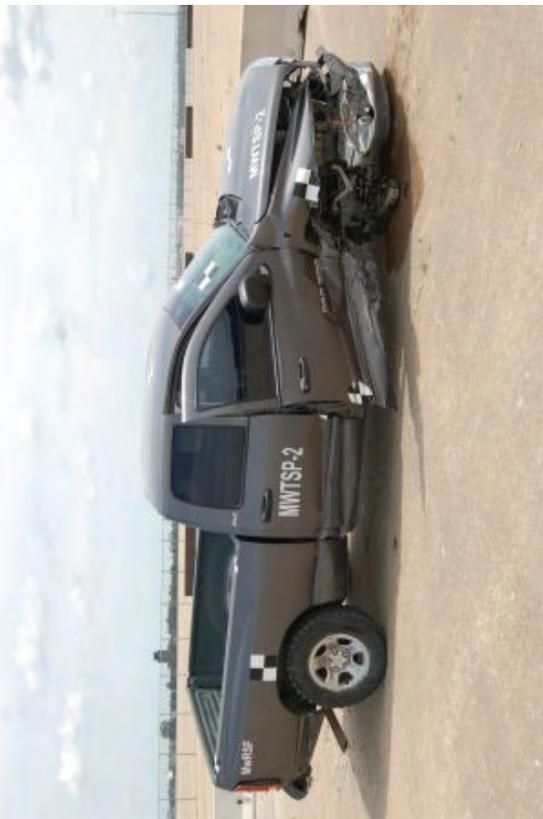
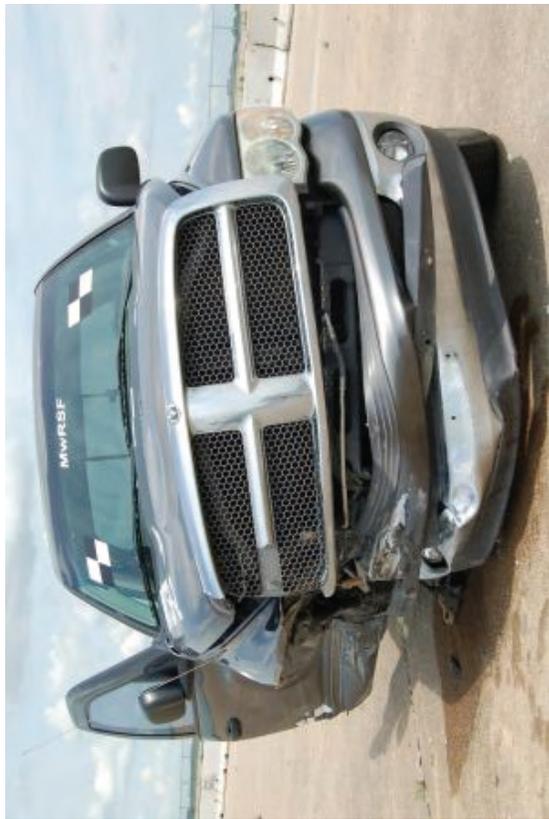
Figure 75. Vehicle Damage, Test No. MWTSP-2

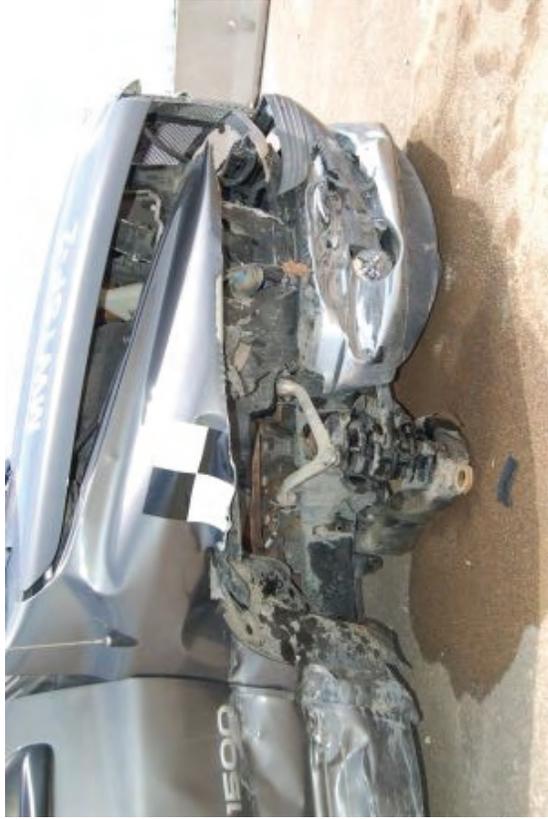
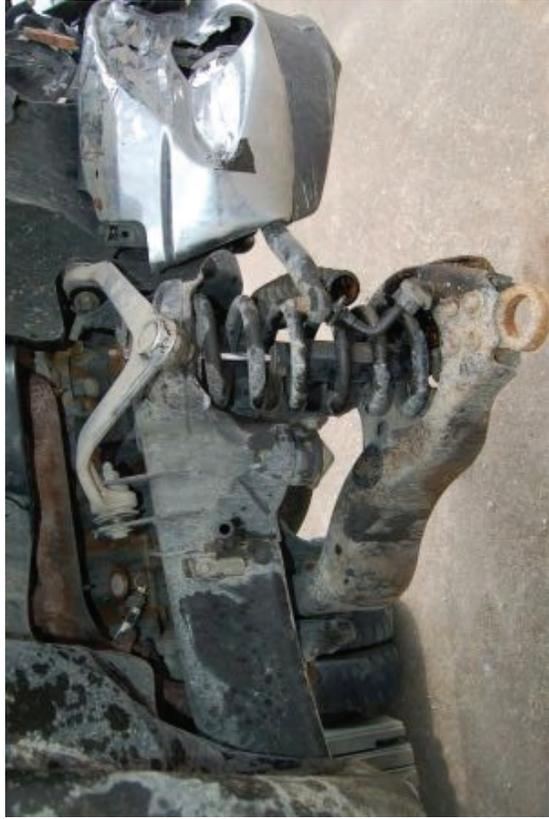
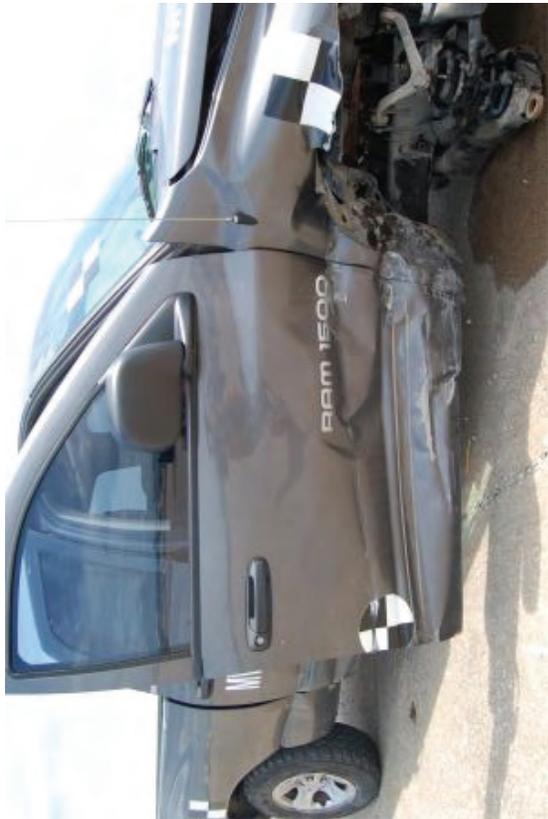
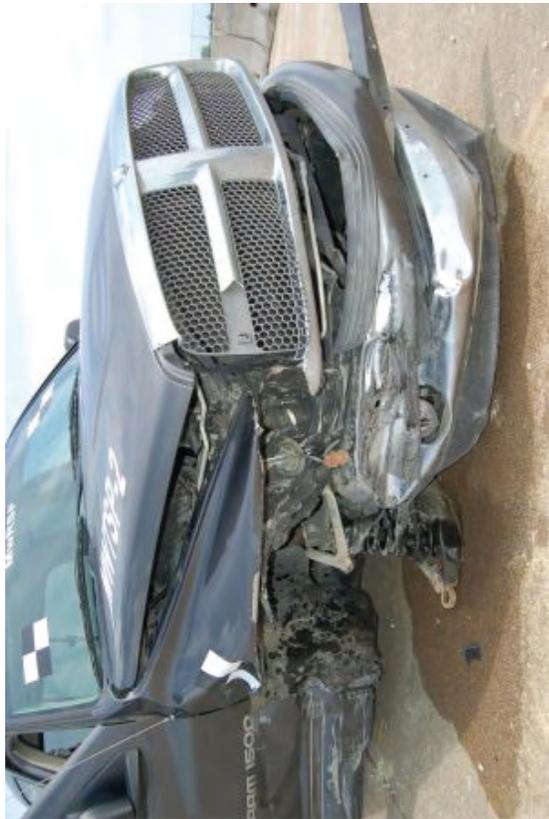
Figure 76. Vehicle Damage, Test No. MWTSP-2

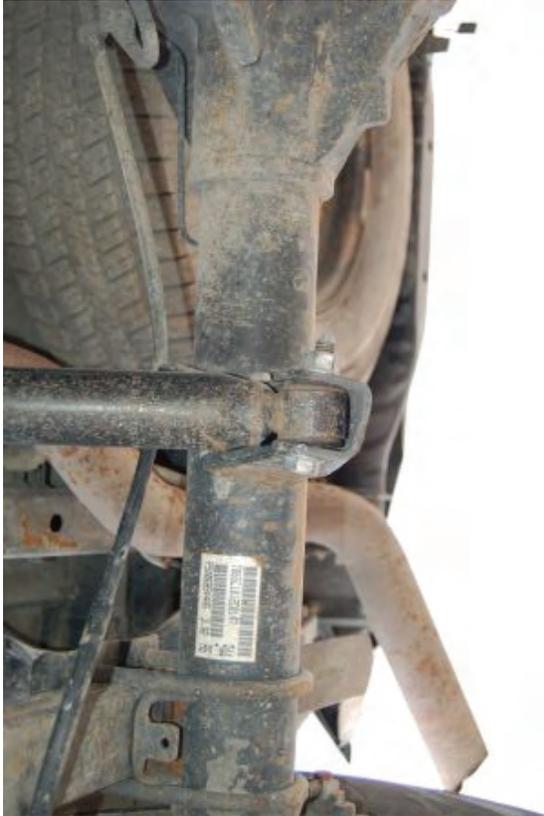
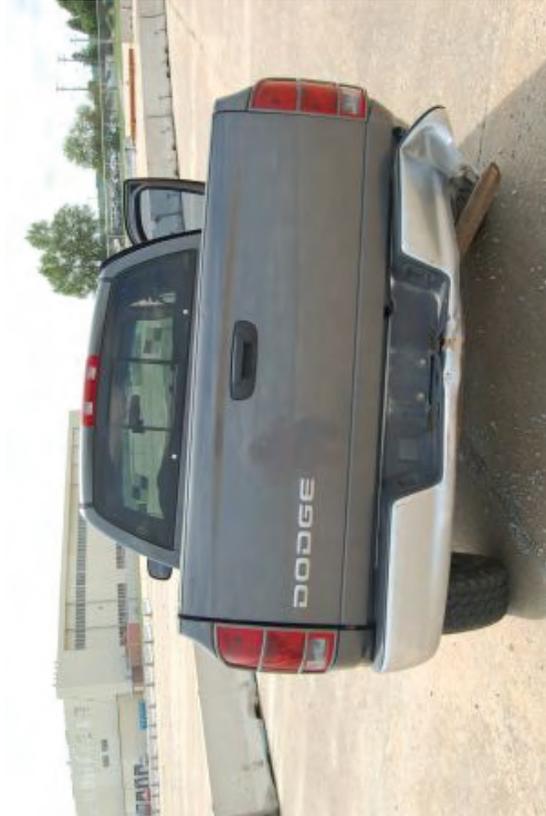
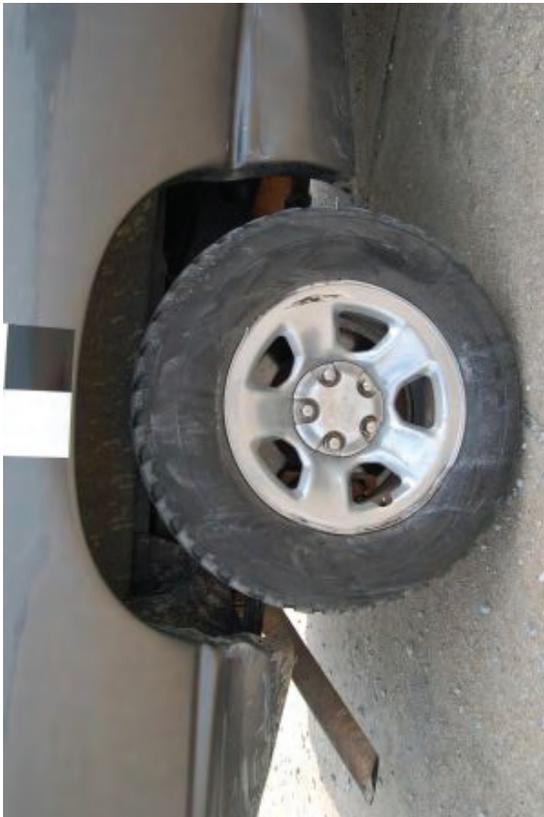
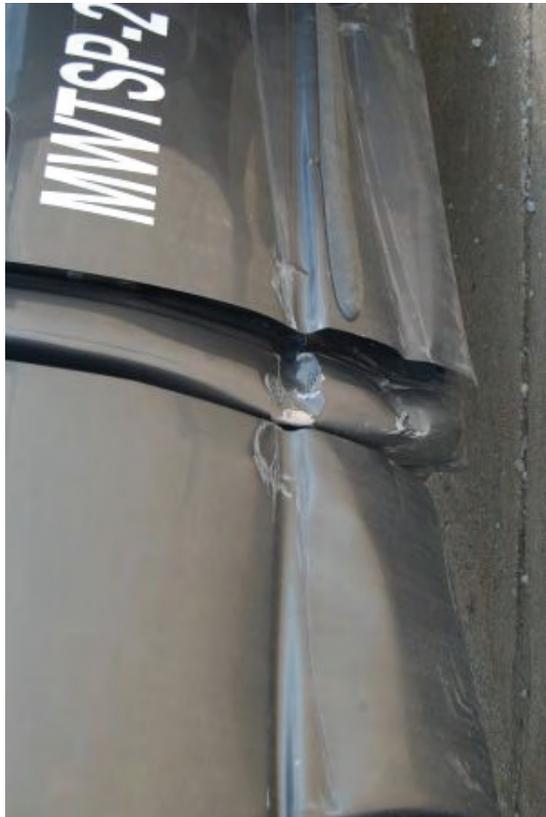
Figure 77. Vehicle Damage, Test No. MWTSP-2

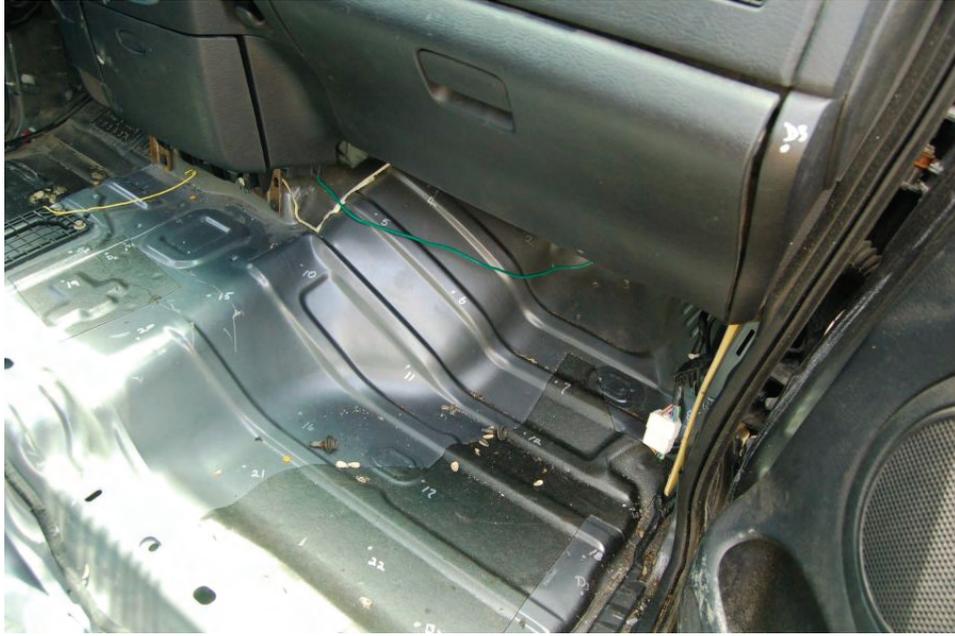
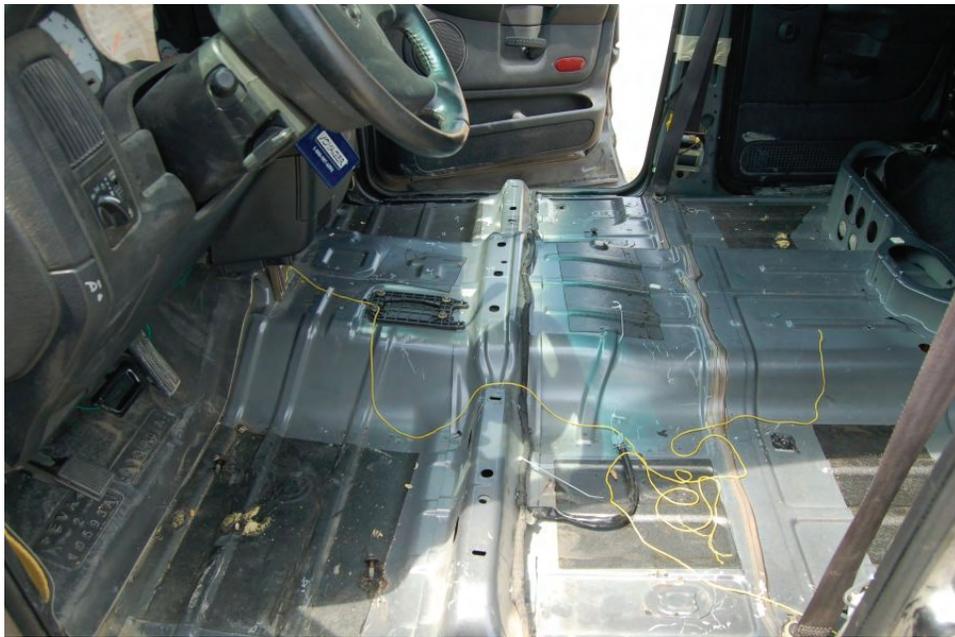
Figure 78. Occupant Compartment Damage, Test No. MWTSP-2

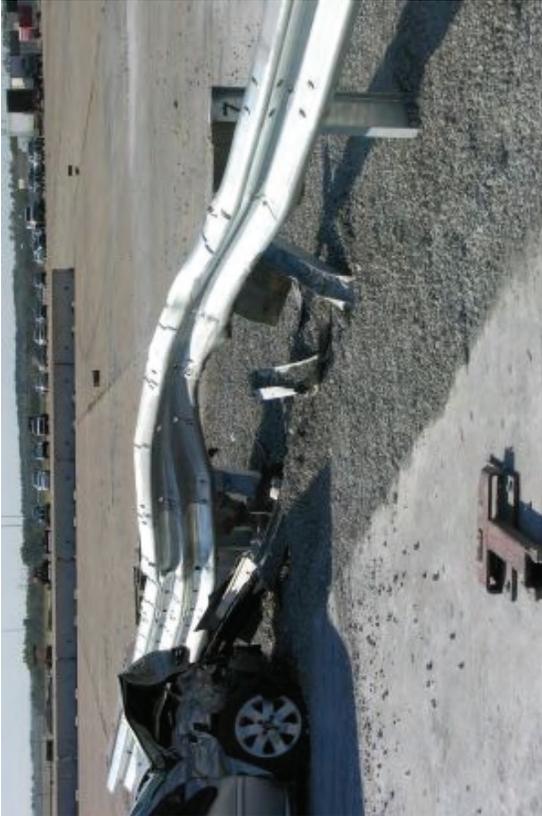
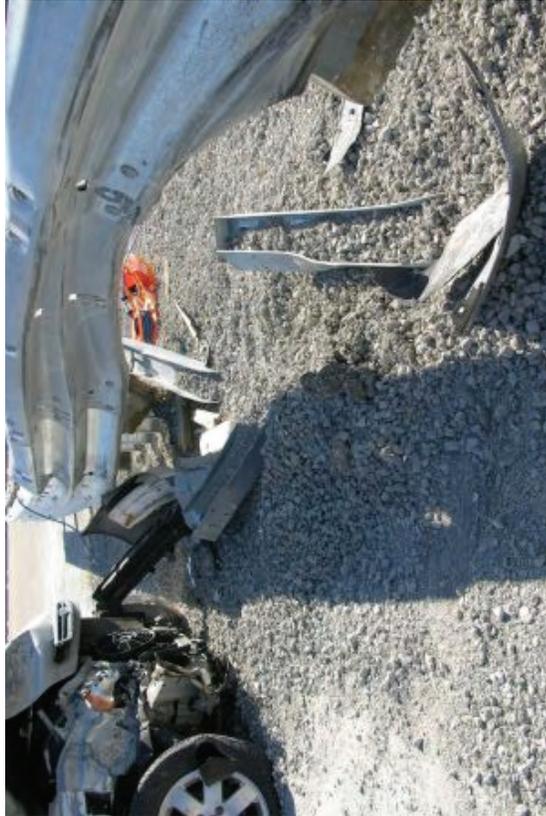
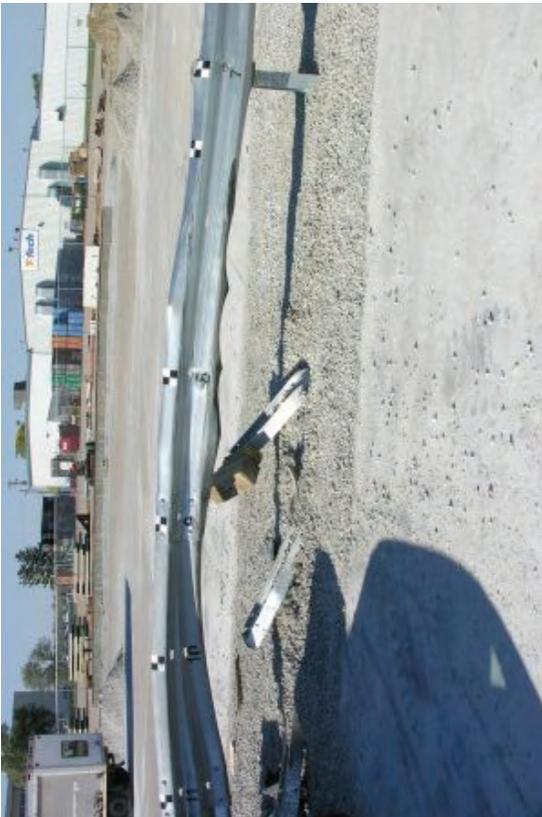
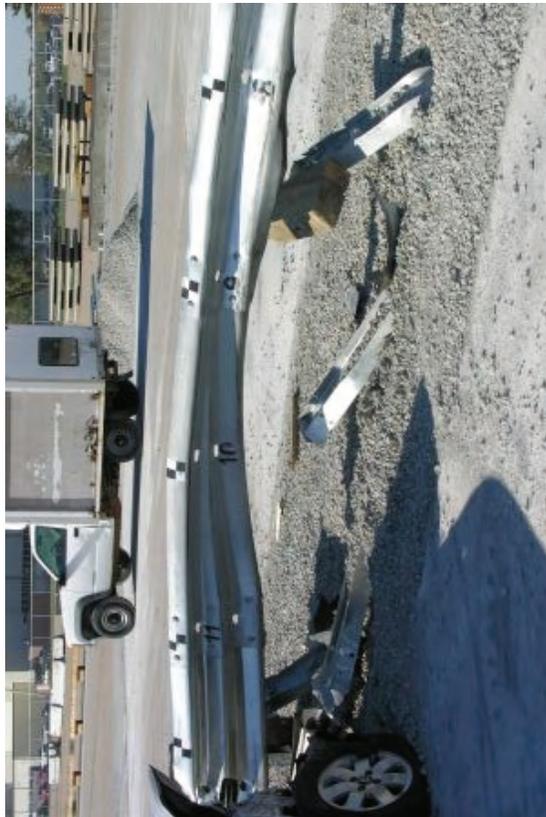
Figure 85. System Damage, Test No. MWTSP-3

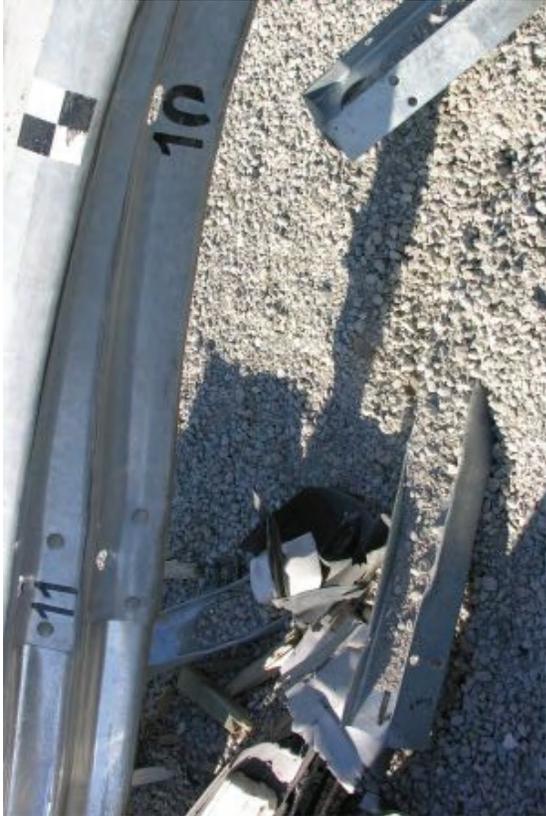
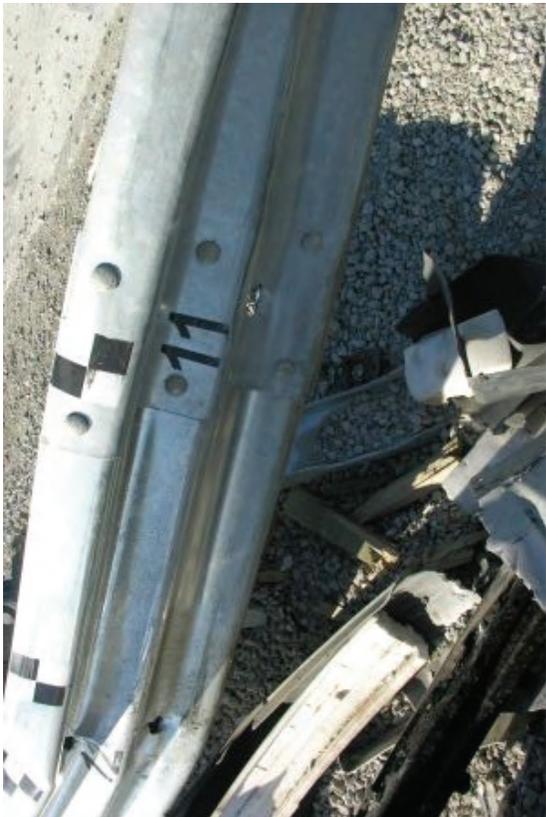
Figure 87. Posts Nos. 10 and 11 Damage, Test No. MWTSP-3

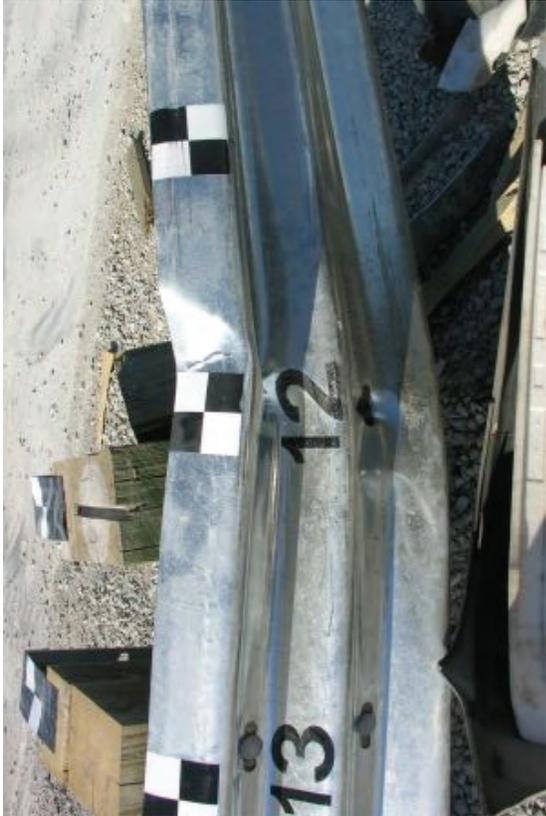
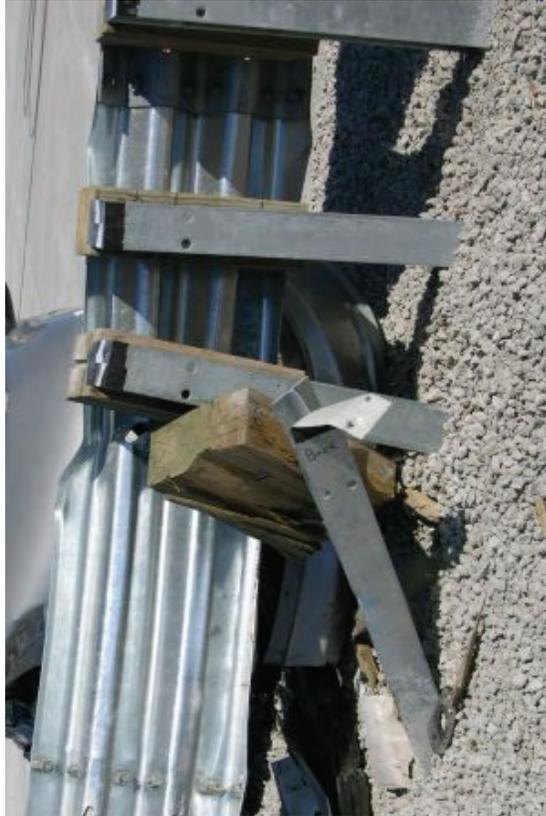
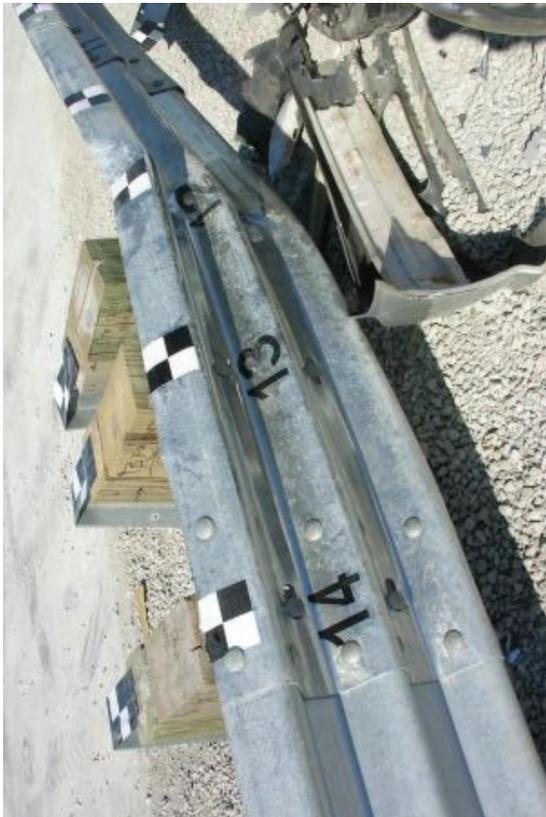
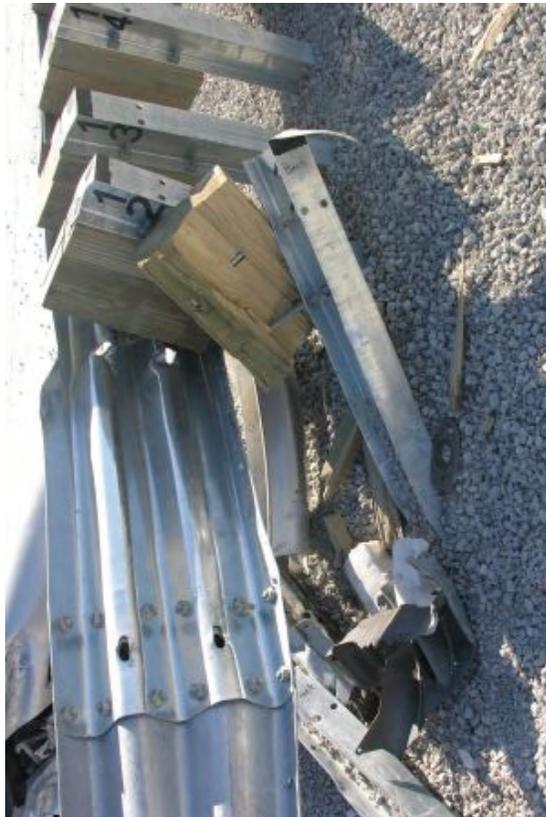
Figure 88. Post Nos. 12 through 14 Damage, Test No. MWTSP-3

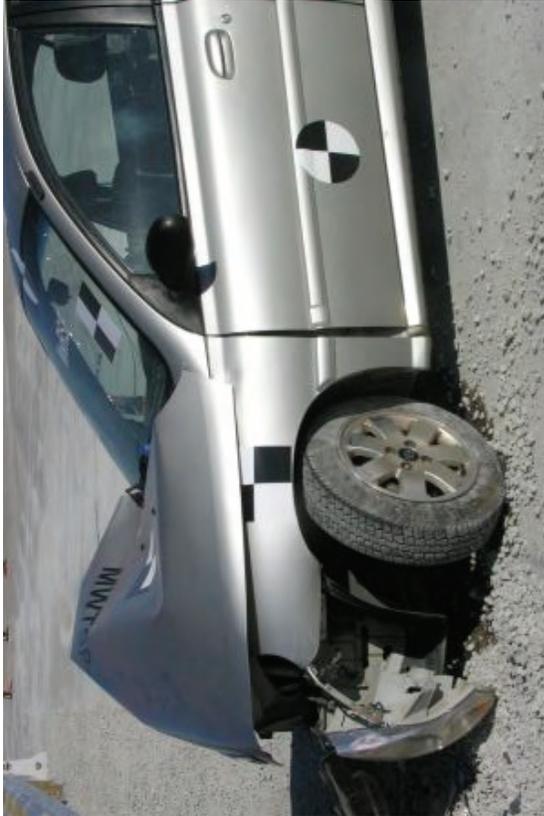
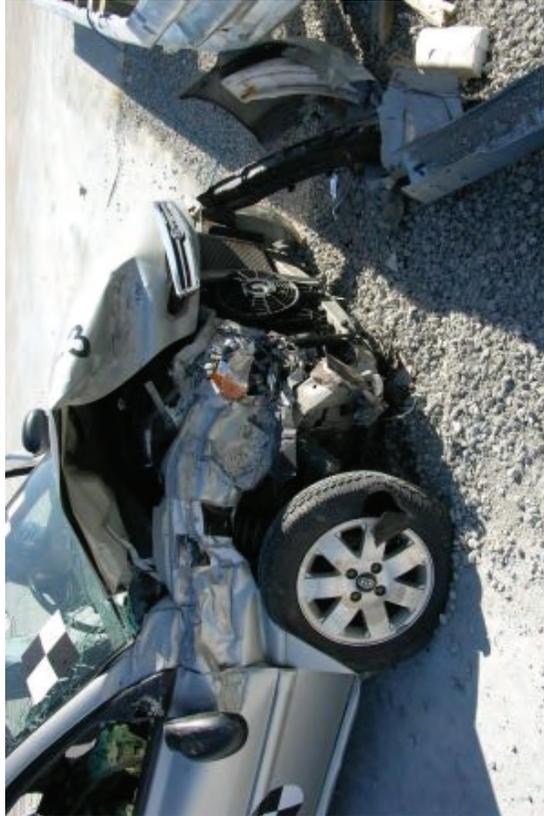
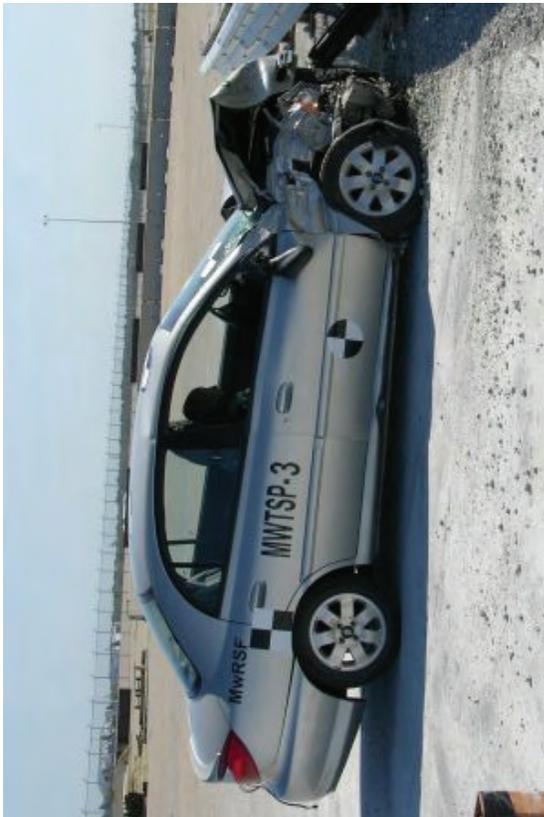
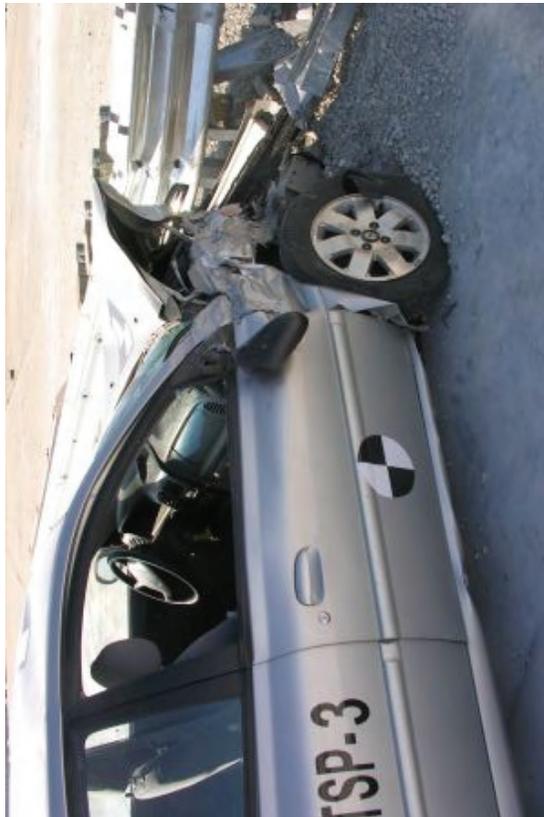
Figure 89. Vehicle Damage, Test No. MWTSP-3

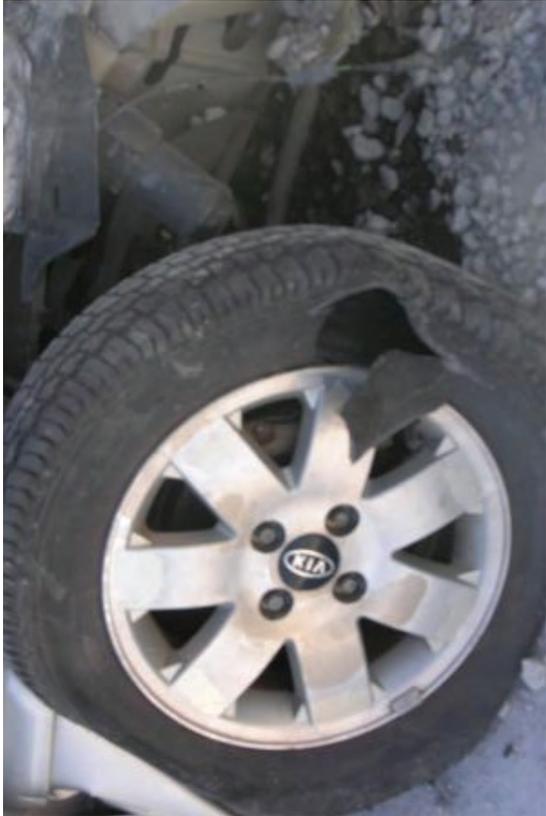
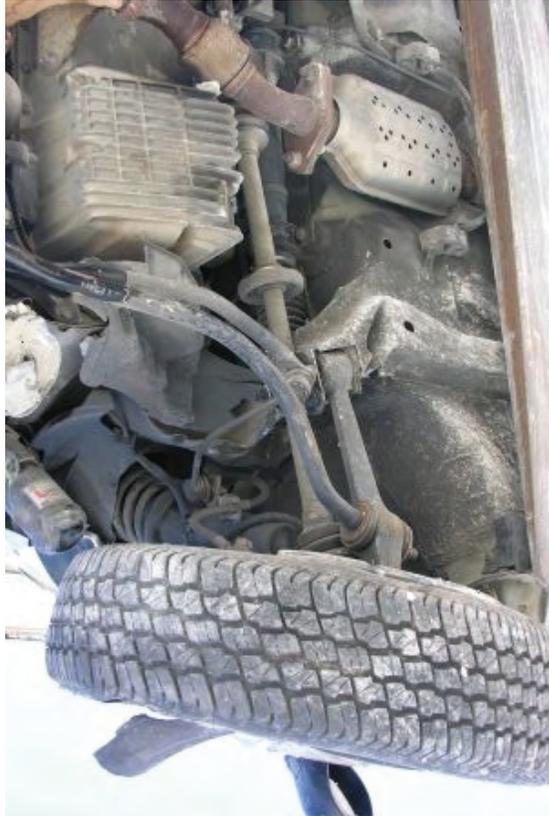
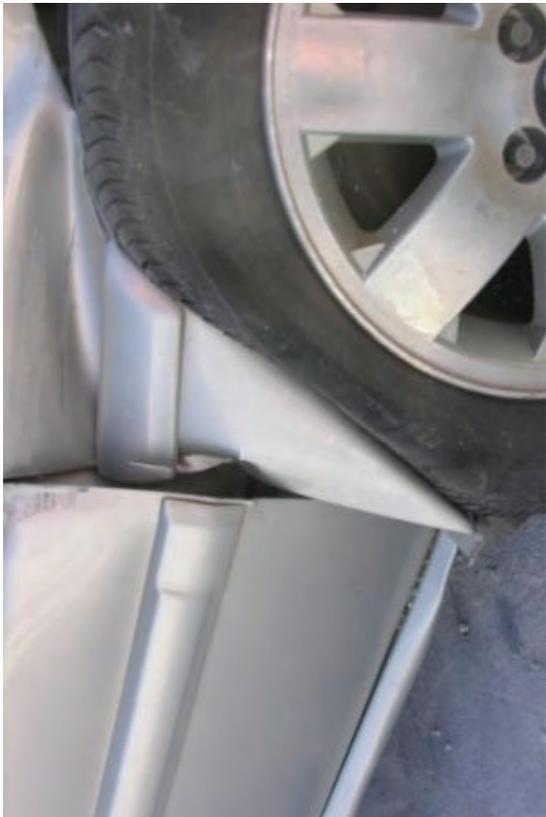
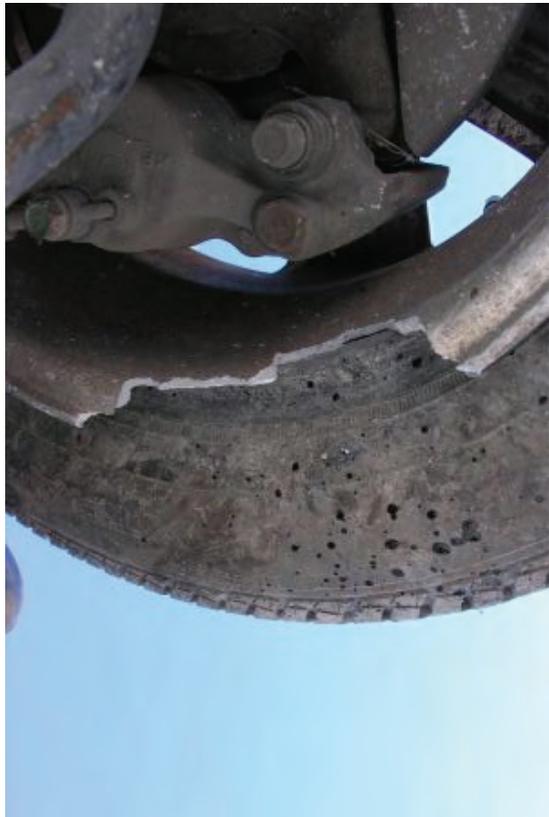
Figure 90. Vehicle Damage, Test No. MWTSP-3

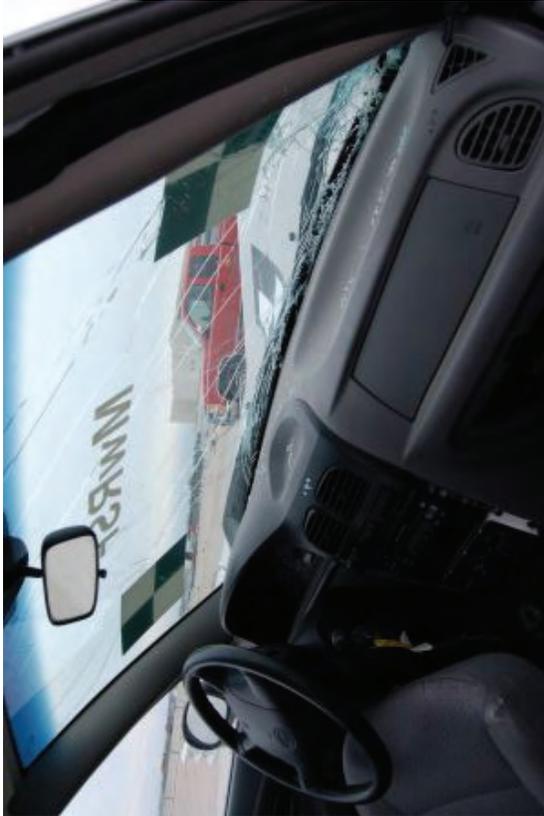
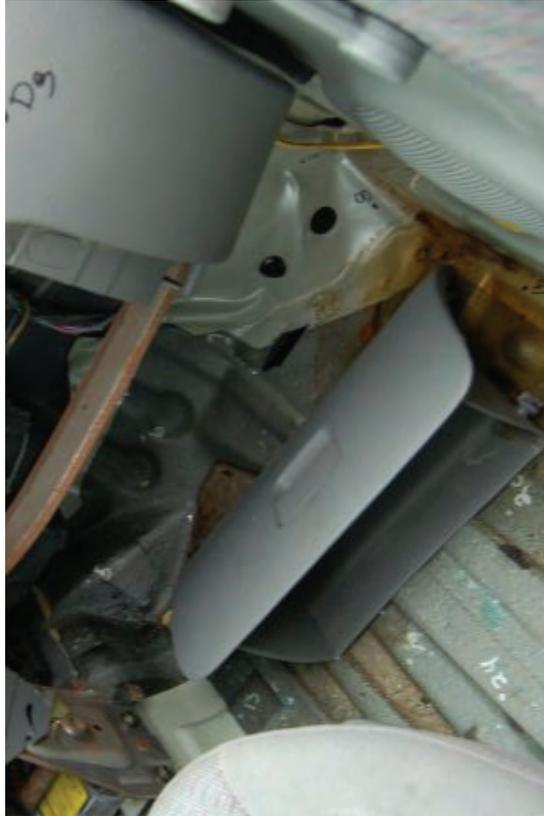
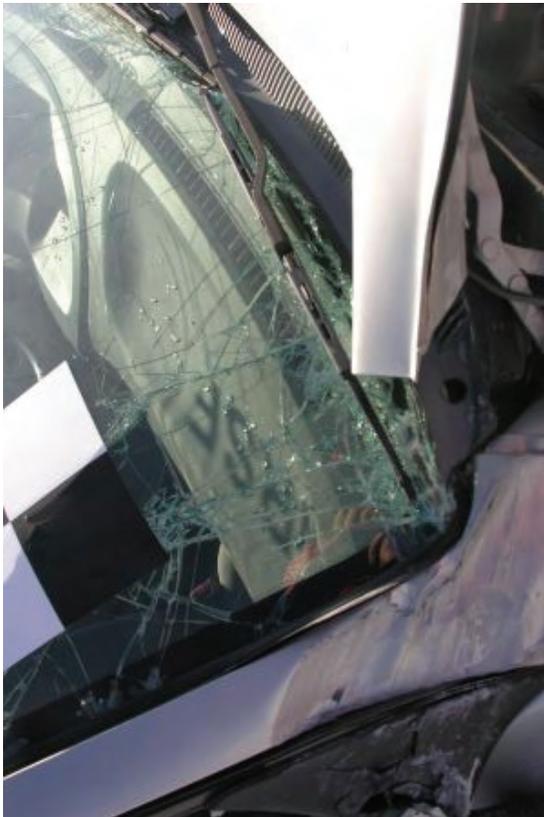
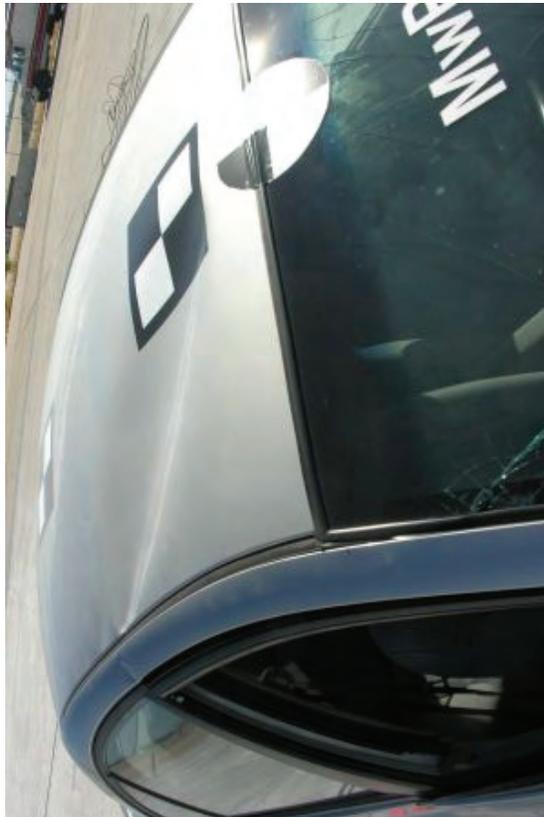
Figure 91. Occupant Compartment Deformation and Windshield Damage, Test No. MWTSP-3

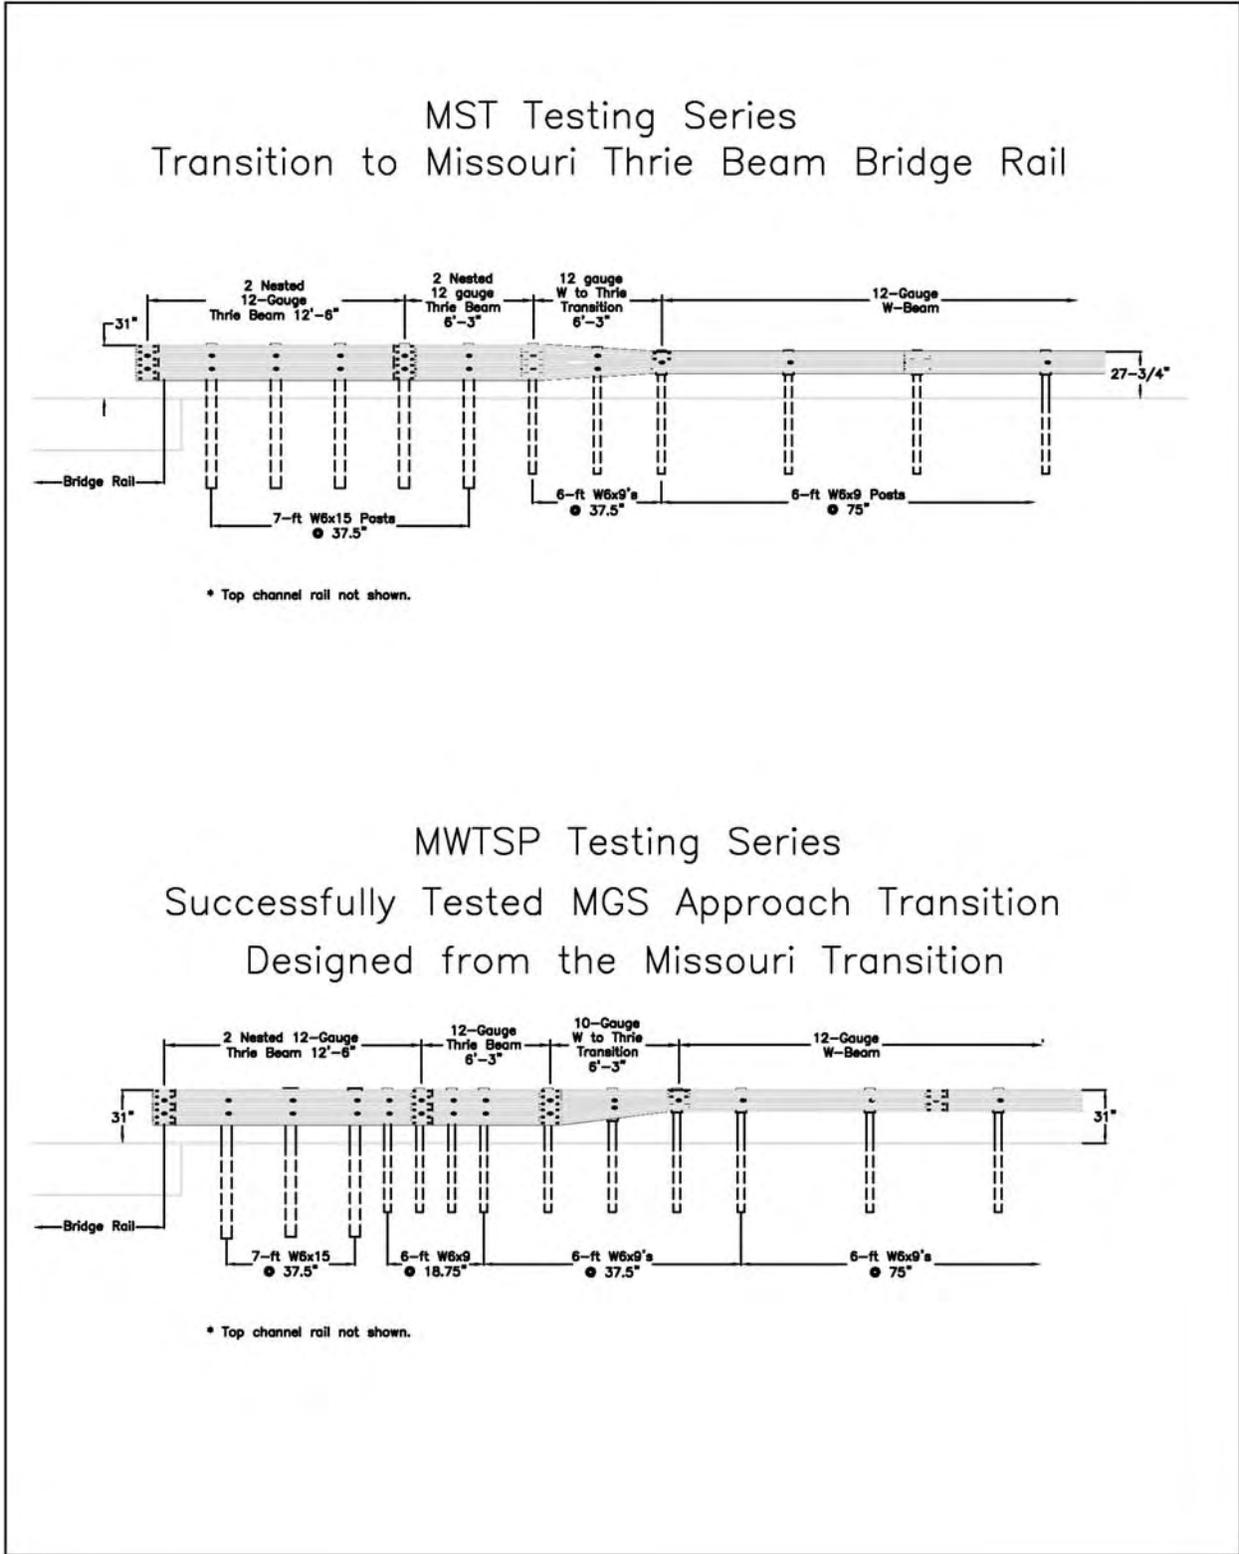
Figure 92. Attachment to Missouri Transition to Thrie Beam Bridge Rail, MST Testing Series [10-11]

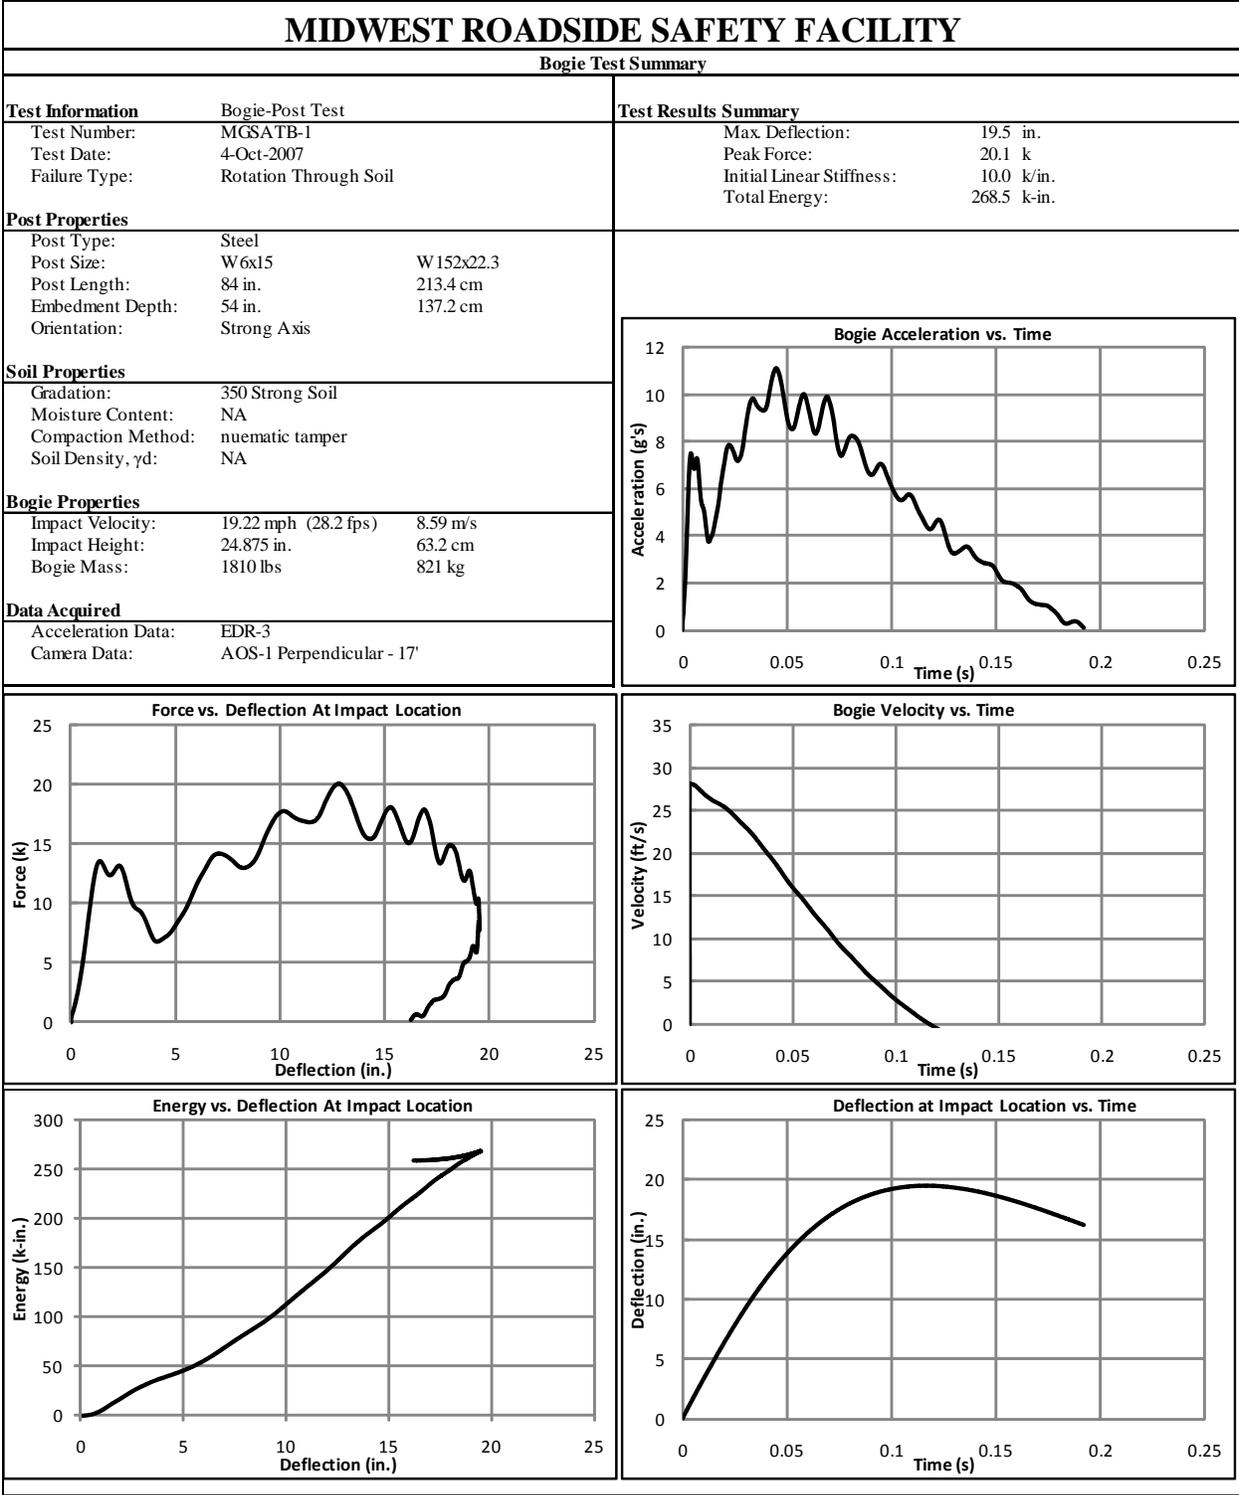
The results of the recorded data from each transducer and both dynamic bogie tests are provided in the summary sheets found in this appendix. Summary sheets include acceleration, velocity, and displacement versus time plots as well as force and energy versus displacement plots.

Figure A-1. Results of Test No. MGSATB-1 (EDR-3)
