DESIGN AND EVALUATION OF A HIGH- TENSION CABLE MEDIAN BARRIER ATTACHMENT

MIDWEST ROADSIDE SAFETY FACILITY

MwRSF Research Report No. TRP-03-228-11

May 11, 2011

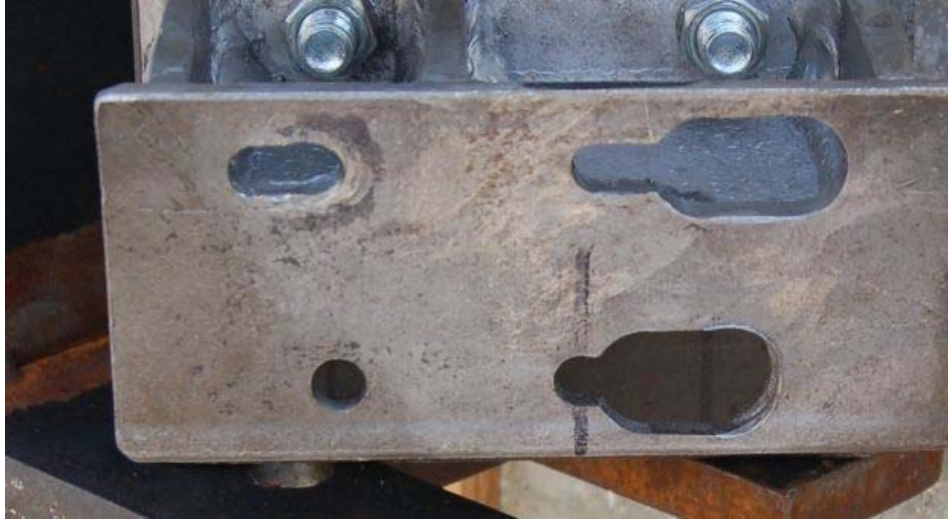
Figure 1. Slot and Keyway Designs (Top=Type 1, Bottom=Type 2)

Two different keyway designs were used in the tests. The first design, denoted slot and keyway design type 1, consisted of a slot to hold the threaded end of the keyway bolt and a keyway to hold the button end as shown in the top of Figure 1. This design was modified for several tests by grinding off some of the steel around the slot. The “elongated” remark in Tables 1 through 3 indicates that the slot was modified in the field to slightly enlarge the slot. The second design, denoted slot and keyway design type 2, consisted of a hole slightly larger than the diameter of the keyway bolt to hold the threaded end and a keyway to hold the button end as shown in the bottom of Figure 1. Detailed drawings of both keyway designs are shown in Appendix A.

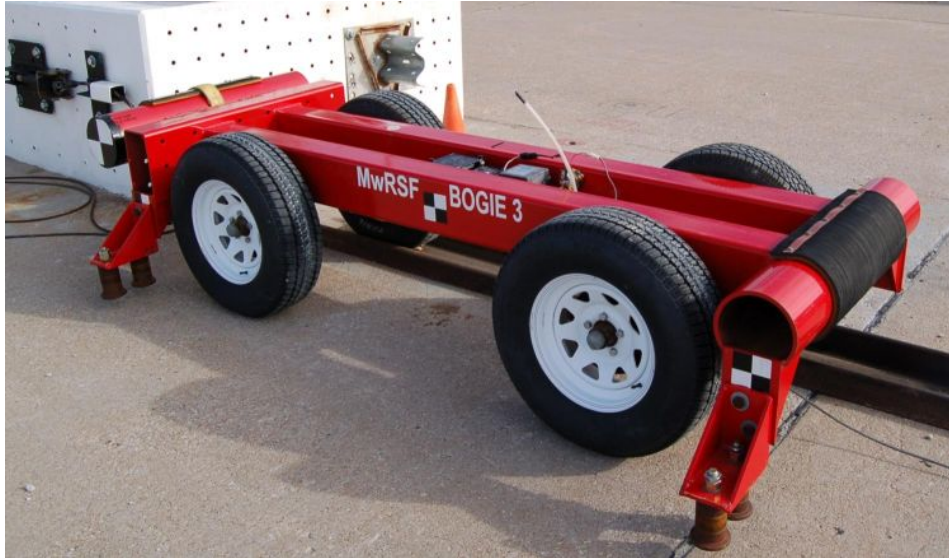
Figure 5. Rigid Frame Bogie on Guidance Track

A rigid frame bogie was used to pull a cable attached to the keyway bolt attachment as shown in Figure 5. The weight of the bogie was 1,831 lb (831 kg) for test nos. HTCUB-1 through HTCUB-6, 1,827 lb (829 kg) for test nos. HTCUB-7 through HTCUB-10, 1,819 lb (825 kg) for tests nos. HTCUB-11 through HTCUB-20, 1,727 lb (783 kg) for test nos. HTCUB-21 through HTCUB-30, and 1,816 lb (824 kg) for test nos. HTCUB-31 through HTCUB-37.

The bogie guidance track used in test nos. HTCUB-1 through HTCUB-37 consisted of a corrugated steel beam railing to guide the right-side tires of the bogie. A pickup truck was attached to the bogie by a cable and was used to pull the bogie to a target speed of approximately 5.0 mph (8.0 km/h). When the bogie approached the end of the guidance system, the pickup truck braked allowing the bogie to be free rolling when it applied the load to the keyway bolt.

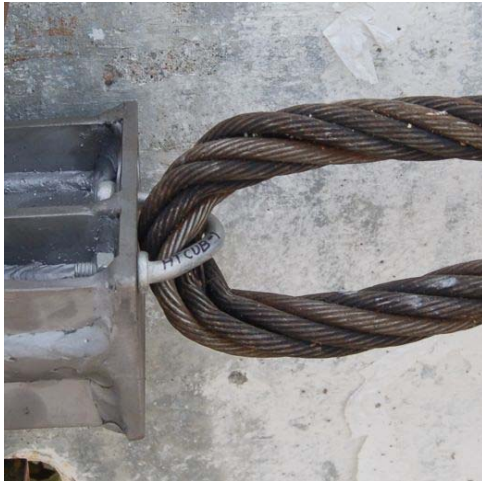
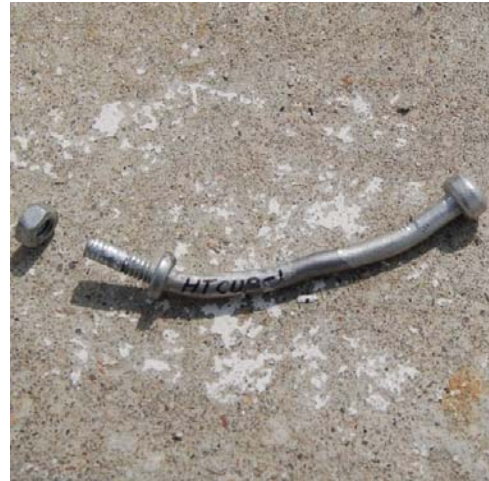
Figure 8. Pre-Test and Post-Test Photographs, Test No. HTCUB-1

For test no. HTCUB-1, the cable applied a load to the keyway bolt at an angle of 90 degrees from the face of the flange. The keyway bolt was attached with one grade 2 nut positioned at the center of the slot. Force data was measured with the load cell transducer and the data was processed with the Channel Frequency Class (CFC) 60 filter in accordance with the Society of Automotive Engineers (SAE) J211. The start of the test was determined as the first data point opposite in sign from the polarity of the main acceleration signal. The cable released at a load of 5.34 kips (23.75 kN). The nut stripped off the threads and the keyway bolt straightened out. The force versus time plot is shown in Figure 7. Pre- and post-test photographs are shown in Figure 8. Sequential photographs are shown in Figure 9.

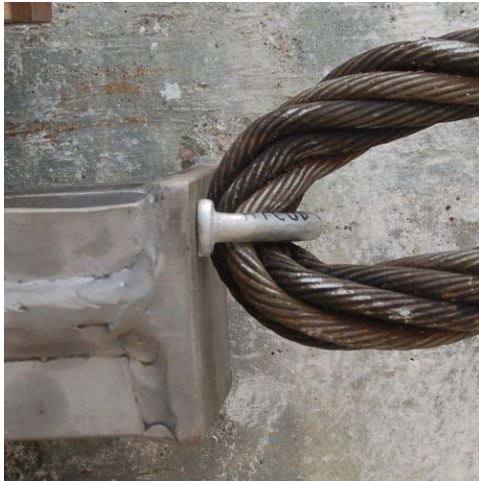
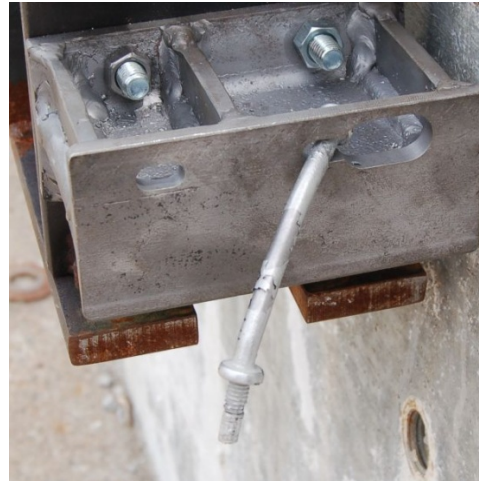
Figure 11. Pre-Test and Post-Test Photographs, Test No. HTCUB-2

For test no. HTCUB-2, the cable applied a load the keyway bolt at an angle of 90 degrees from the face of the flange. The keyway bolt was attached with one grade 2 nut positioned at the center of the slot. The cable released at a load of 4.87 kips (21.66 kN). The nut stripped off the threads and the keyway bolt straightened out. The force versus time plot is shown in Figure 10. Pre- and post-test photographs are shown in Figure 11. Sequential photographs are shown in Figure 12.

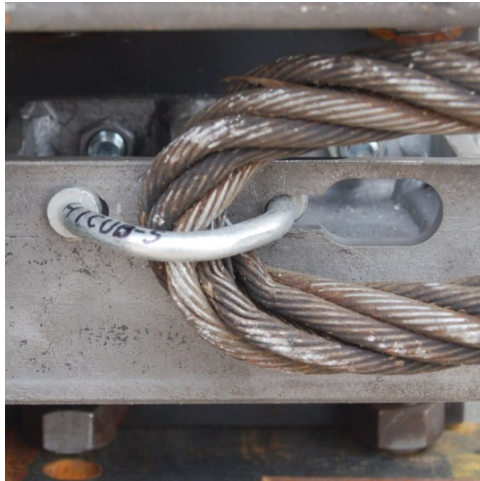
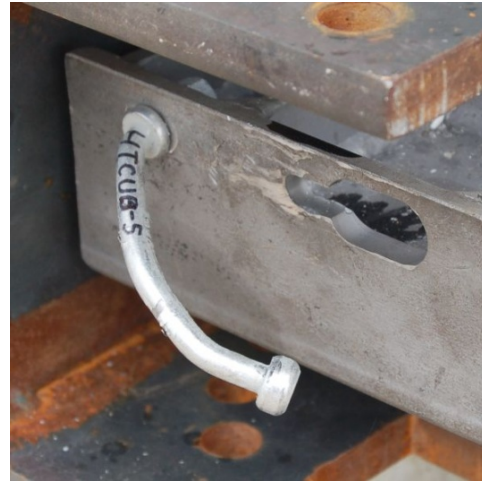
Figure 20. Pre-Test and Post-Test Photographs, Test No. HTCUB-5

For test no. HTCUB-5, the cable applied a load to the keyway bolt at an angle of 0 degrees, parallel to the face of the flange. The keyway bolt was attached with two grade 2 nuts positioned at the bottom of the slot and the button head of the bolt was at the lowest position in the keyway. The cable released at a load of 2.25 kips (10.01 kN). The button slipped out of the keyway while the threaded end remained attached to the flange and the keyway bolt straightened out. The force versus time plot is shown in Figure 19. Pre- and post-test photographs are shown in Figure 20. Sequential photographs are shown in Figure 21.

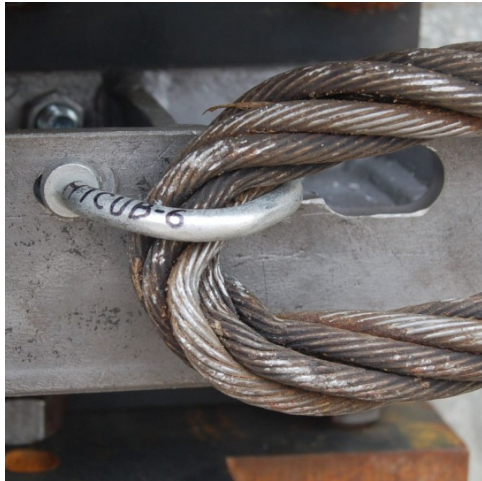
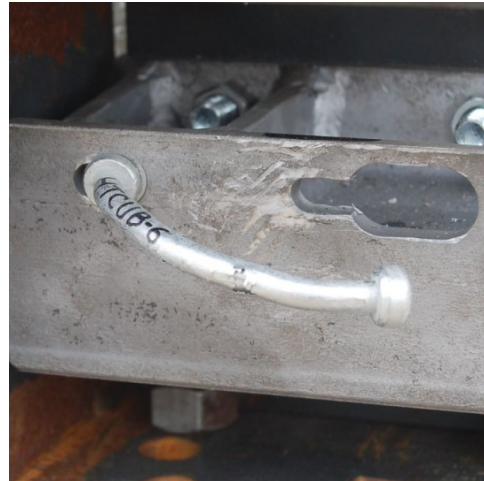
Figure 23. Pre-Test and Post-Test Photographs, Test No. HTCUB-6

For test no. HTCUB-6, the cable applied a load to the keyway bolt at an angle of 0 degrees, parallel to the face of the flange. The keyway bolt was attached with two grade 2 nuts positioned at the upper-center of the slot. The cable released at a load of 1.71 kips (7.61 kN). The button slipped out of the keyway while the threaded end remained attached to the flange and the keyway bolt straightened out. The force versus time plot is shown in Figure 22. Pre- and post-test photographs are shown in Figure 23. Sequential photographs are shown in Figure 24.

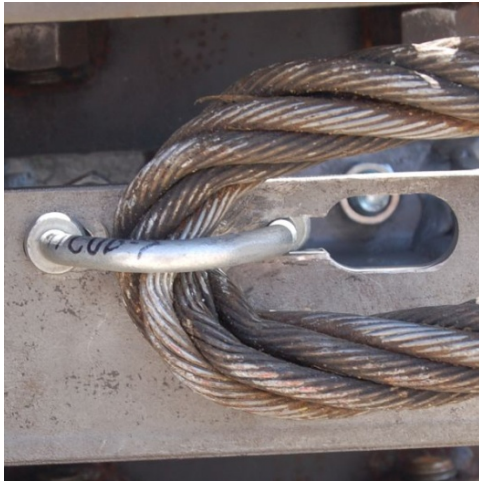
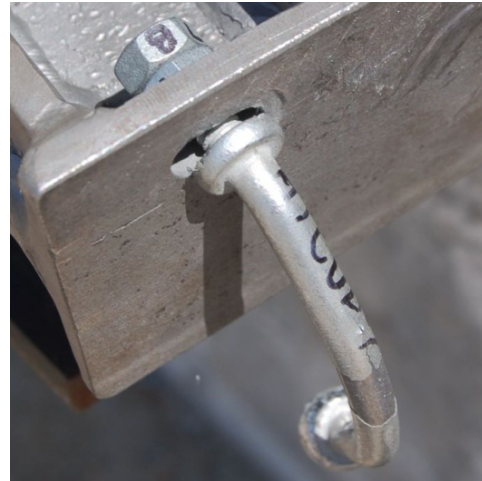
Figure 25. Pre-Test and Post-Test Photographs, Test No. HTCUB-7

For test no. HTCUB-7, the cable applied a load to the keyway bolt at an angle of 0 degrees, parallel to the face of the flange. The keyway bolt was attached with a small gap between the two grade 2 nuts and the flange. The threaded end was positioned at the lower-center of the slot. Due to technical difficulties, the load cell did not collect load data. The button slipped out of the keyway while the threaded end remained attached to the flange and the keyway bolt straightened out. Pre- and post-test photographs are shown in Figure 25. Sequential photographs are shown in Figure 26.

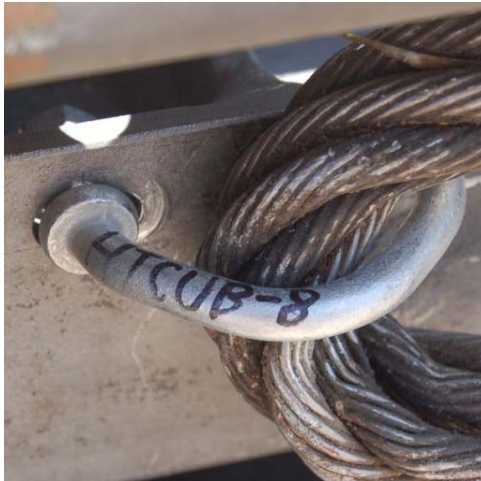
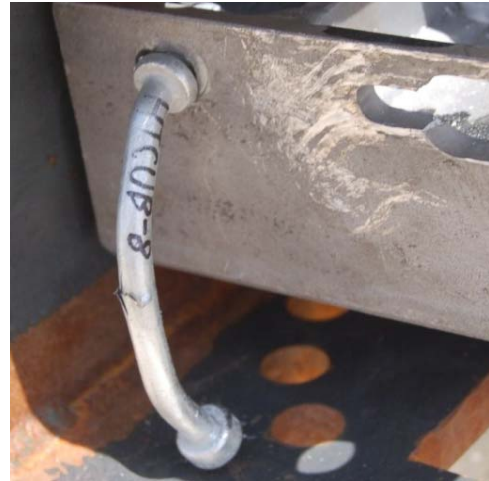
Figure 28. Pre-Test and Post-Test Photographs, Test No. HTCUB-8

For test no. HTCUB-8, the cable applied a load to the keyway bolt at an angle of 0 degrees, parallel to the face of the flange. The keyway bolt was attached with a small gap between the two grade 2 nuts and the flange. The threaded end was positioned at the lower-center of the slot. The cable released at a load of 1.04 kips (4.63 kN). The button slipped out of the keyway while the threaded end remained attached to the flange and the keyway bolt straightened out. The force versus time plot is shown in Figure 27. Pre- and post-test photographs are shown in Figure 28. Sequential photographs are shown in Figure 29.

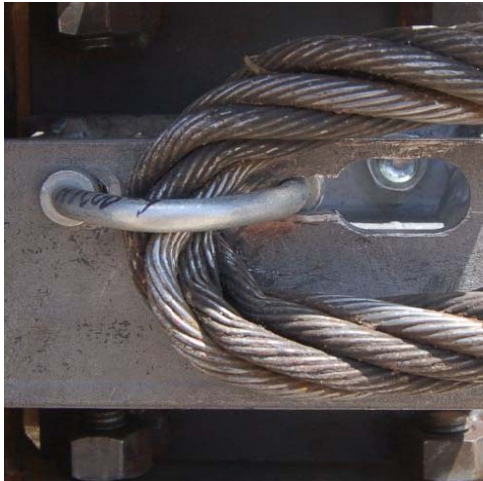
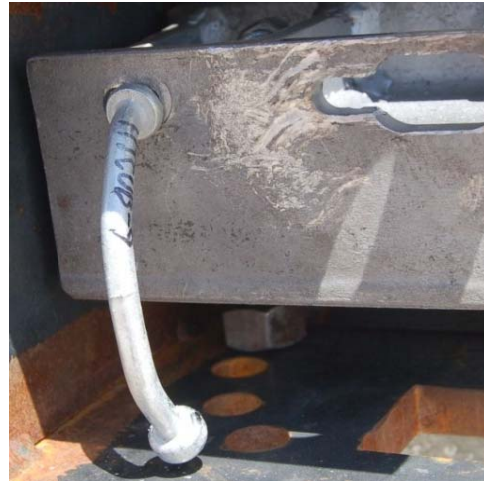
Figure 31. Pre-Test and Post-Test Photographs, Test No. HTCUB-9

For test no. HTCUB-9, the cable applied a load to the keyway bolt at an angle of 0 degrees, parallel the face of the flange. The keyway bolt was attached with a small gap between the two grade 2 nuts and the flange. The threaded end was positioned at the lower-center of the slot. The cable released at a load of 1.02 kips (4.54 kN). The button slipped out of the keyway while the threaded end remained attached to the flange and the keyway bolt straightened out. The force versus time plot is shown in Figure 30. Pre- and post-test photographs are shown in Figure 31. Sequential photographs are shown in Figure 32.

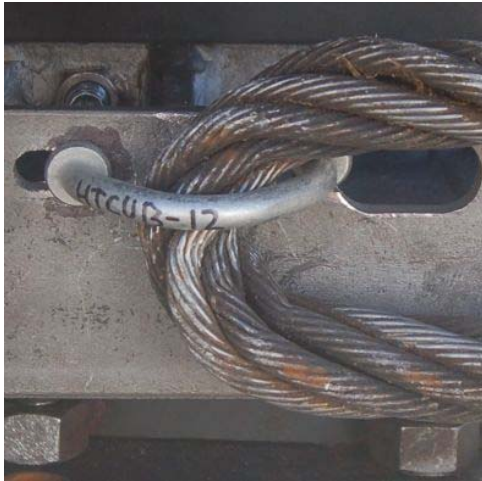
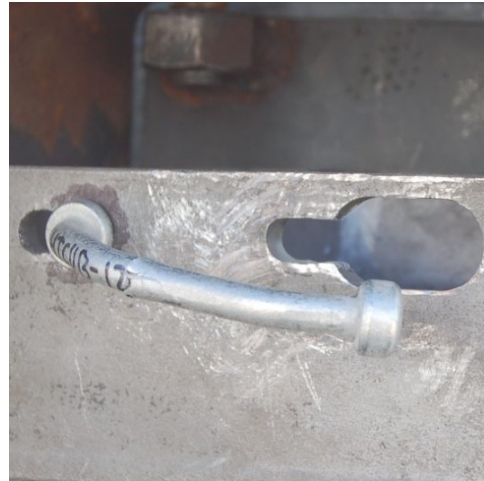
Figure 40. Pre-Test and Post-Test Photographs, Test No. HTCUB-12

For test no. HTCUB-12, the cable applied a load to the keyway bolt at an angle of 0 degrees, parallel to the face of the flange. The keyway bolt was attached with two grade 2 nuts tightened with a wrench that were positioned at the top of the elongated, lower slot. The slot that held the threaded end of the keyway bolt was slightly elongated. The cable released at a load of 0.56 kips (2.49 kN), but the cable snagged on the button and released at a load of 0.58 kips (2.58 kN). The button slipped out of the keyway while the threaded end remained attached to the flange and the keyway bolt straightened out. The force versus time plot is shown in Figure 39. Pre- and post-test photographs are shown in Figure 40. Sequential photographs are shown in Figure 41.

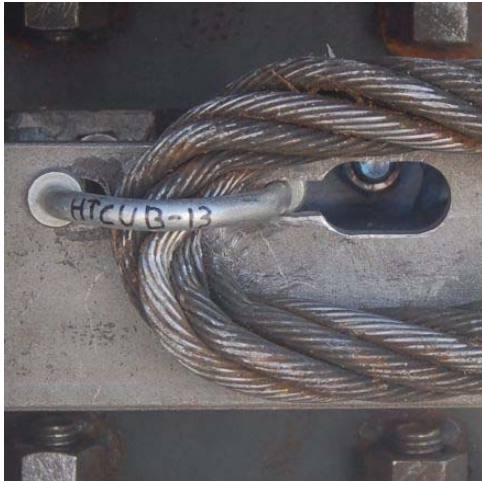
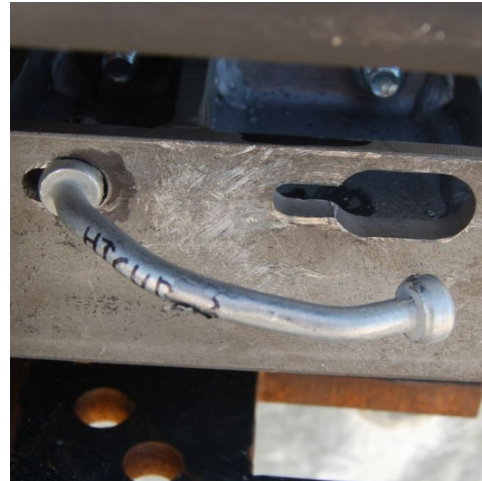
Figure 43. Pre-Test and Post-Test Photographs, Test No. HTCUB-13

For test no. HTCUB-13, the cable applied a load to the keyway bolt at an angle of 0 degrees, parallel to the face of the flange. The keyway bolt was attached with two grade 2 nuts tightened with a wrench that were positioned at the bottom of the slot. The slot that held the threaded end of the keyway bolt was slightly elongated. The cable released at a load of 0.85 kips (3.78 kN), but the cable snagged on the button and released at a load of 1.56 kips (6.94 kN). The button slipped out of the keyway while the threaded end remained attached to the flange and the keyway bolt straightened out. The force versus time plot is shown in Figure 42. Pre- and post-test photographs are shown in Figure 43. Sequential photographs are shown in Figure 44.

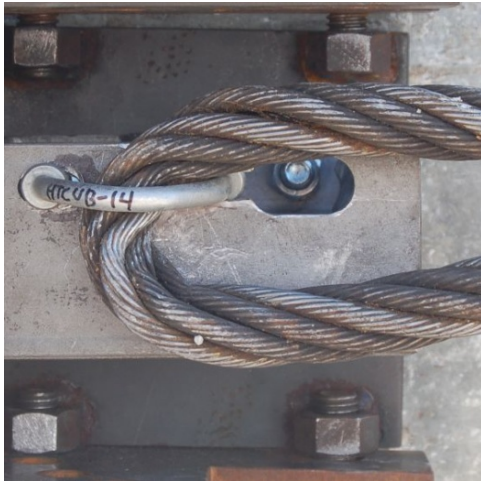
For test no. HTCUB-14, the cable applied a load to the keyway bolt at an angle of 0 degrees, parallel to the face of the flange. The keyway bolt was attached with two grade 2 nuts tightened with a wrench that were positioned at the bottom of the slot. The slot that held the threaded end of the keyway bolt was slightly elongated. The cable released at a load of 1.42 kips (6.32 kN). The button of the keyway bolt slipped out of the keyway while the threaded end remained attached to the flange and the keyway bolt straightened out. The force versus time plot is shown in Figure 45. Pre- and post-test photographs are shown in Figure 46. Sequential photographs are shown in Figure 47.

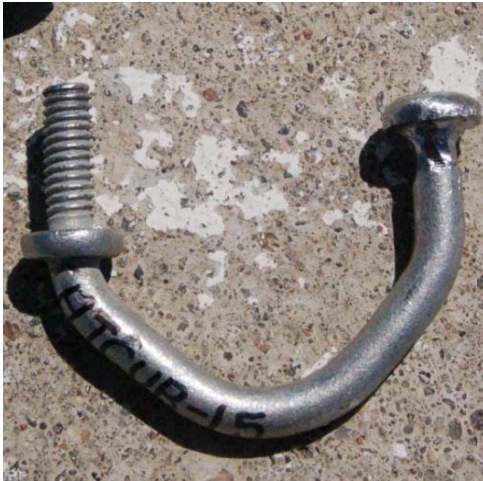
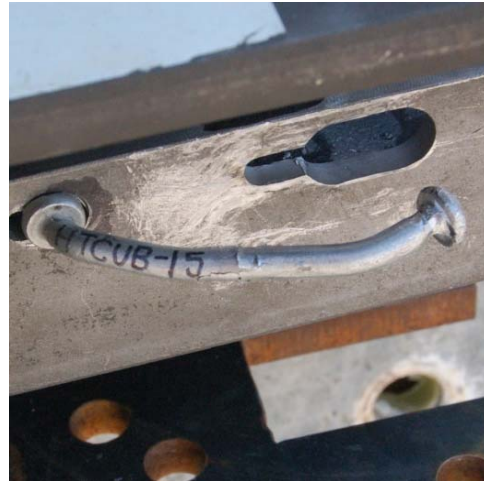
Figure 49. Pre-Test and Post-Test Photographs, Test No. HTCUB-15

For test no. HTCUB-15, the cable applied a load to the keyway bolt at an angle of 0 degrees, parallel to the face of the flange. The keyway bolt was attached with two grade 2 nuts tightened with a wrench that were positioned at the bottom of the slot. The slot that held the threaded end of the keyway bolt was slightly elongated and the size of the button was slightly reduced. The cable released at a load of 0.88 kips (3.91 kN), but the cable snagged on the button and released at a load of 1.00 kips (4.45 kN). The button slipped out of the keyway while the threaded end remained attached to the flange and the keyway bolt straightened out. The force versus time plot is shown in Figure 48. Pre- and post-test photographs are shown in Figure 49. Sequential photographs are shown in Figure 50.

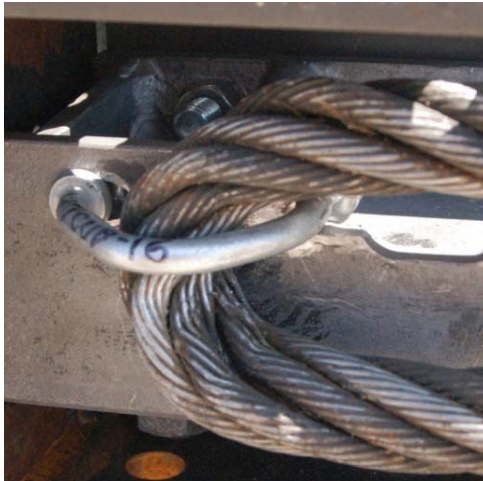
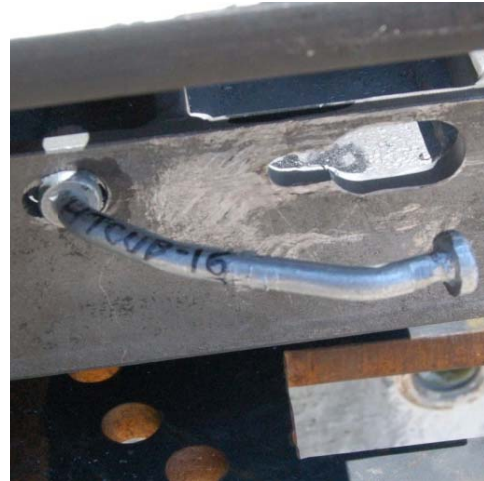
Figure 52. Pre-Test and Post-Test Photographs, Test No. HTCUB-16

For test no. HTCUB-16, the cable applied a load to the keyway bolt at an angle of 0 degrees, parallel to the face of the flange. The keyway bolt was attached with two grade 2 nuts tightened with a wrench that were positioned at the bottom of the slot. The slot that held the threaded end of the keyway bolt was slightly elongated and the size of the button was slightly reduced. The cable released at a load of 1.14 kips (5.07 kN). The button slipped out of the keyway while the threaded end remained attached to the flange and the keyway bolt straightened out. The force versus time plot is shown in Figure 51. Pre- and post-test photographs are shown in Figure 52. Sequential photographs are shown in Figure 53.

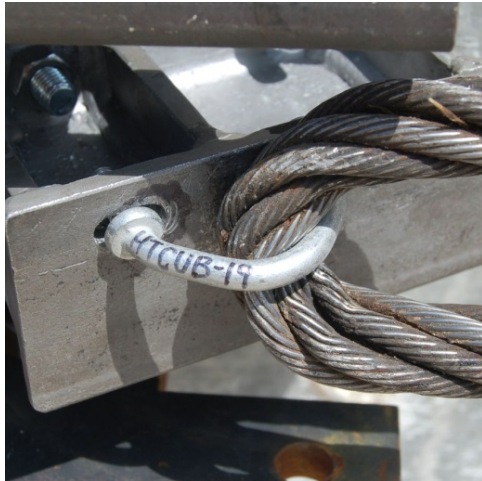
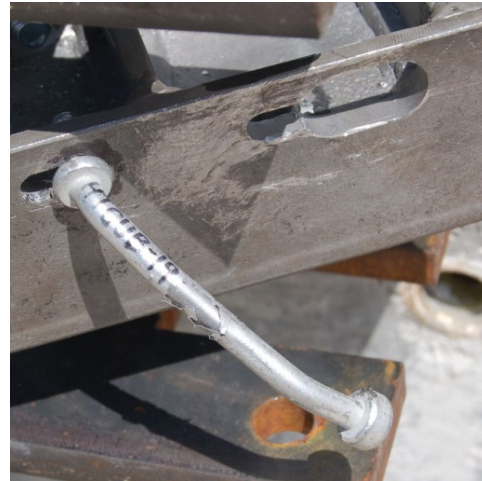
Figure 61. Pre-Test and Post-Test Photographs, Test No. HTCUB-19

For test no. HTCUB-19, the cable applied a load to the keyway bolt at an angle of 30 degrees from the face of the flange. The keyway bolt was attached with a small gap between one grade 5 nut and the flange. The threaded end was positioned at the center of the slot, which was slightly elongated. The cable released at a load of 0.67 kips (2.98 kN), but the cable snagged on the button and released at a load of 1.35 kips (6.01 kN). The button slipped out of the keyway while the threaded end remained attached to the flange and the keyway bolt straightened out. The force versus time plot is shown in Figure 60. Pre- and post-test photographs are shown in Figure 61. Sequential photographs are shown in Figure 62.

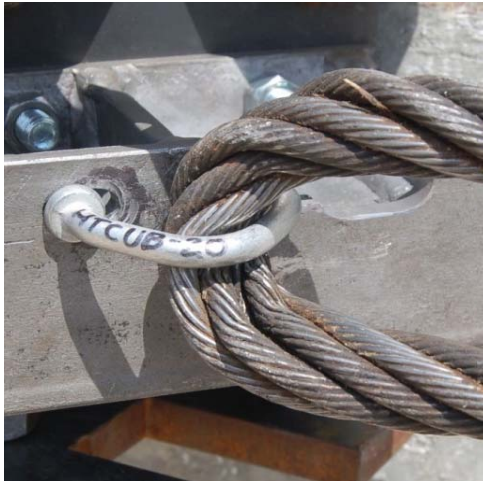
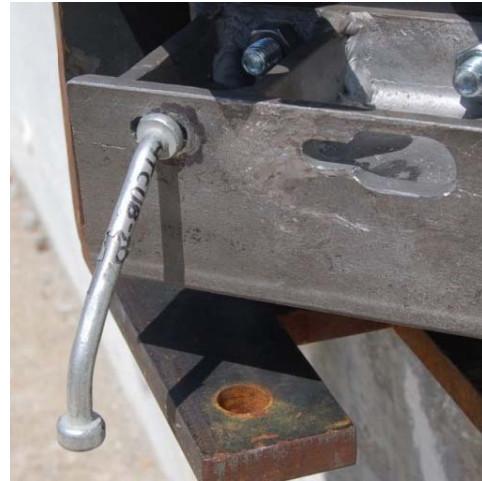
Figure 64. Pre-Test and Post-Test Photographs, Test No. HTCUB-20

For test no. HTCUB-20, the cable applied a load to the keyway bolt at an angle of 45 degrees from the face of the flange. The keyway bolt was attached with a small gap between one grade 5 nut and the flange. The threaded end was positioned at the bottom of the slot, which was slightly elongated. The cable released at a load of 0.66 kips (2.94 kN), but the cable snagged on the button and released at a load of 0.68 kips (3.02 kN). The button slipped out of the keyway while the threaded end remained attached to the flange and the keyway bolt straightened out. The force versus time plot is shown in Figure 63. Pre- and post-test photographs are shown in Figure 64. Sequential photographs are shown in Figure 65.

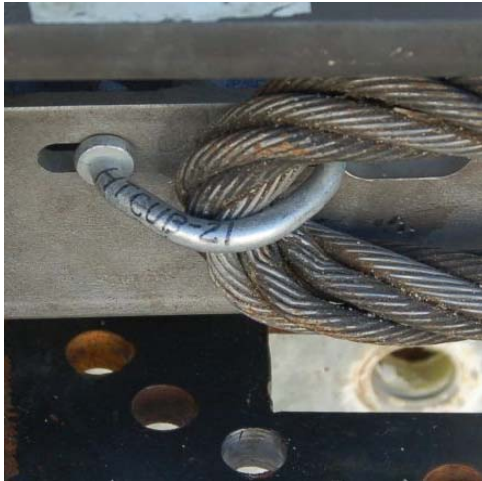
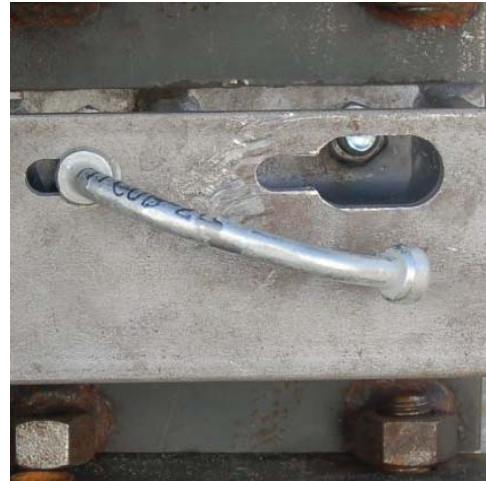
Figure 67. Pre-Test and Post-Test Photographs, Test No. HTCUB-21

For test no. HTCUB-21, the cable applied a load to the keyway bolt at an angle of 0 degrees, parallel to the face of the flange. The keyway bolt was attached with two grade 2 nuts tightened with a wrench that were positioned at the top of the slot. The slot that held the threaded end of the keyway bolt was slightly elongated. The cable released at a load of 0.94 kips (4.18 kN). The button slipped out of the keyway while the threaded end remained attached to the flange and the keyway bolt straightened out. The force versus time plot is shown in Figure 66. Pre- and post-test photographs are shown in Figure 67. Sequential photographs are shown in Figure 68.

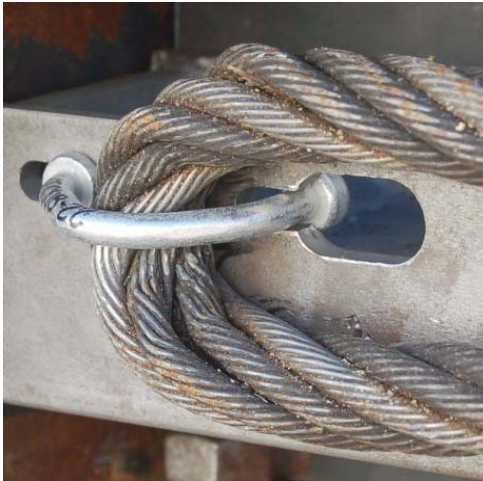
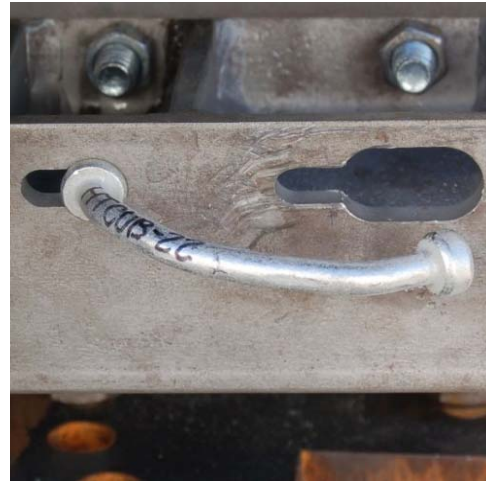
Figure 70. Pre-Test and Post-Test Photographs, Test No. HTCUB-22

For test no. HTCUB-22, the cable applied a load to the keyway bolt at an angle of 0 degrees, parallel to the face of the flange. The keyway bolt was attached with two grade 2 nuts tightened with a wrench that were positioned at the top of the slot. The slot that held the threaded end of the keyway bolt was slightly elongated. The cable released at a load of 0.90 kips (4.00 kN). The button slipped out of the keyway while the threaded end remained attached to the flange and the keyway bolt straightened out. The force versus time plot is shown in Figure 69. Pre- and post-test photographs are shown in Figure 70. Sequential photographs are shown in Figure 71.

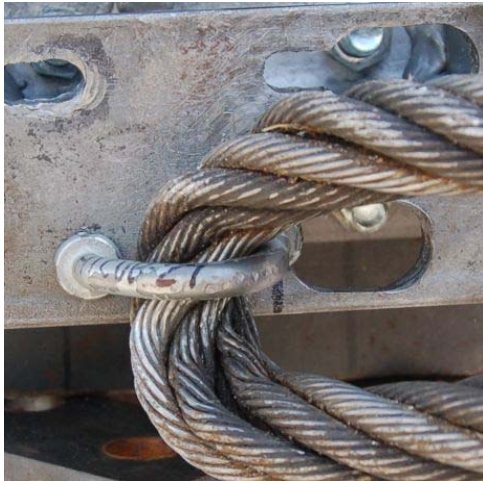
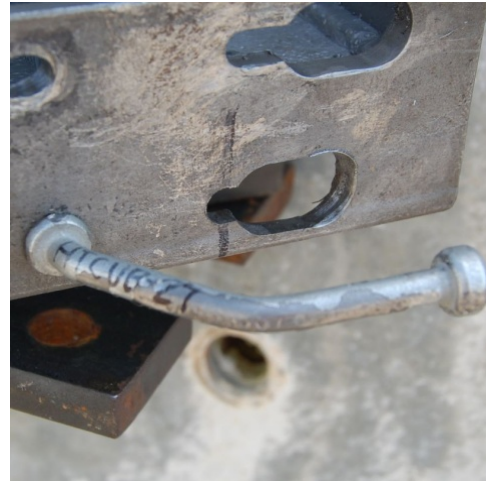
Figure 85. Pre-Test and Post-Test Photographs, Test No. HTCUB-27

For test no. HTCUB-27, the cable applied a load to the keyway bolt at an angle of 45 degrees from the face of the flange. The keyway bolt was attached with two grade 2 nuts tightened with a wrench and the slot and keyway design type 2 was used. The cable released at a load of 0.47 kips (2.09 kN), but the cable snagged on the button and released at a load of 0.49 kips (2.18 kN). The button slipped out of the keyway while the threaded end stayed attached and the keyway bolt straightened out. The force versus time plot is shown in Figure 84. Pre- and post-test photographs are shown in Figure 85. Sequential photographs are shown in Figure 86.

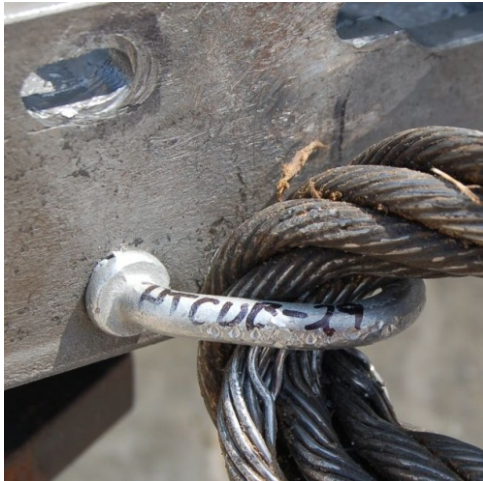
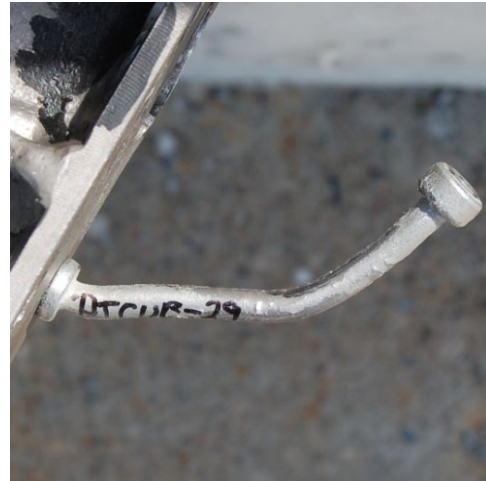
Figure 91. Pre-Test and Post-Test Photographs, Test No. HTCUB-29

For test no. HTCUB-29, the cable applied a load to the keyway bolt at an angle of 60 degrees from the face of the flange. The keyway bolt was attached with two grade 2 nuts tightened with a wrench and the slot and keyway design type 2 was used. The cable released at a load of 0.53 kips (2.36 kN). The button slipped out of the keyway while the threaded end remained attached to the flange and the keyway bolt straightened out. The force versus time plot is shown in Figure 90. Pre- and post-test photographs are shown in Figure 91. Sequential photographs are shown in Figure 92.

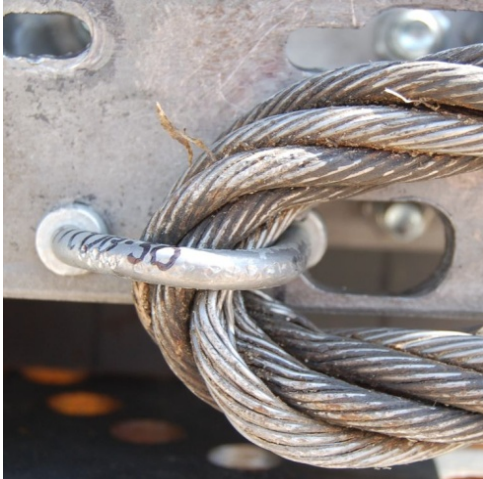
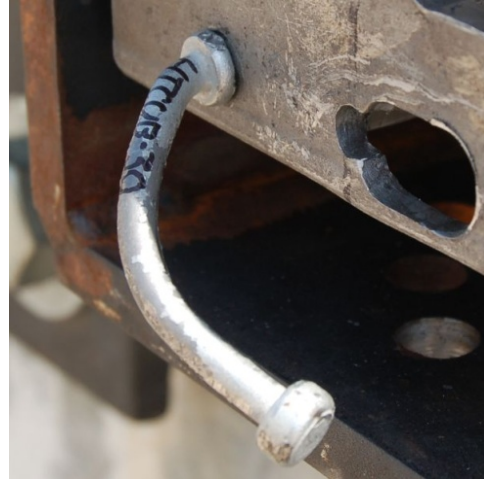
Figure 94. Pre-Test and Post-Test Photographs, Test No. HTCUB-30

For test no. HTCUB-30, the cable applied a load to the keyway bolt at an angle of 0 degrees, parallel to the face of the flange. The keyway bolt was attached with two grade 2 nuts tightened with a wrench and the slot and keyway design type 2 was used. The cable released at a load of 0.58 kips (2.58 kN), but the cable snagged on the button and released at a load of 0.68 kips (3.02 kN). The button slipped out of the keyway while the threaded end remained attached to the flange and the keyway bolt straightened out. The force versus time plot is shown in Figure 93. Pre- and post-test photographs are shown in Figure 94. Sequential photographs are shown in Figure 95.

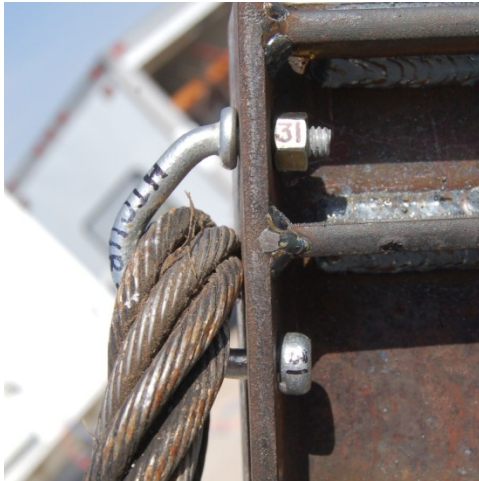
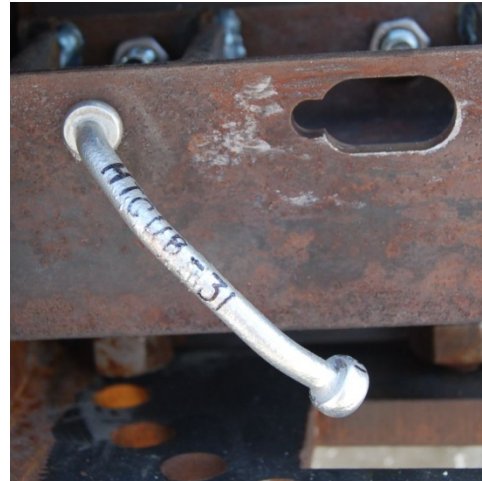
Figure 96. Pre-Test and Post-Test Photographs, Test No. HTCUB-31

For test no. HTCUB-31, the cable applied a load to the A449 keyway bolt at an angle of 0 degrees, parallel the face of the flange. The keyway bolt was attached with one grade 8 high-topped nut tightened with a wrench and the slot and keyway design type 2 was used. Due to technical difficulties, the load cell did not collect data. The button slipped out of the keyway while the threaded end remained attached to the flange and the keyway bolt straightened out. Pre- and post-test photographs are shown in Figure 96. Sequential photographs are shown in Figure 97.

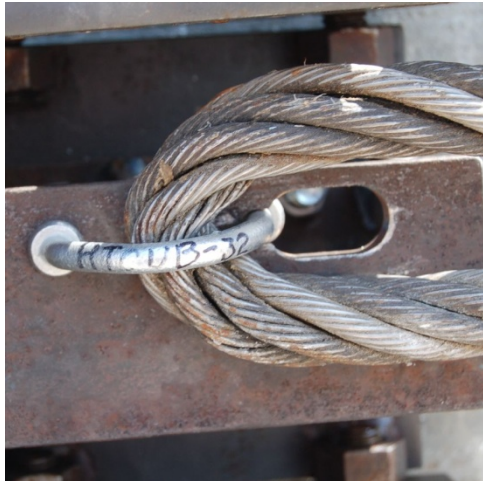
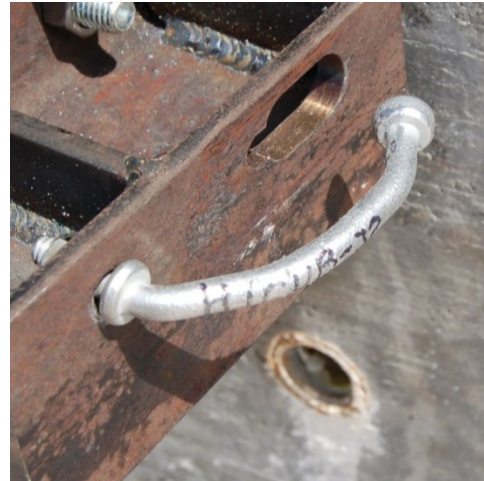
Figure 99. Pre-Test and Post-Test Photographs, Test No. HTCUB-32

For test no. HTCUB-32, the cable applied a load to the A449 keyway bolt at an angle of 0 degrees, parallel to the face of the flange. The keyway bolt was attached with one grade 8 high-topped nut tightened with a wrench and the slot and keyway design type 2 was used. The cable released at a load of 1.11 kips (4.94 kN). The button slipped out of the keyway while the threaded end remained attached to the flange and the keyway bolt straightened out. The force versus time plot is shown in Figure 98. Pre- and post-test photographs are shown in Figure 99. Sequential photographs are shown in Figure 100.

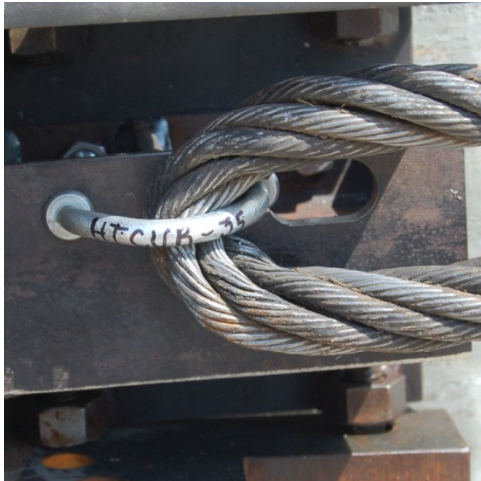
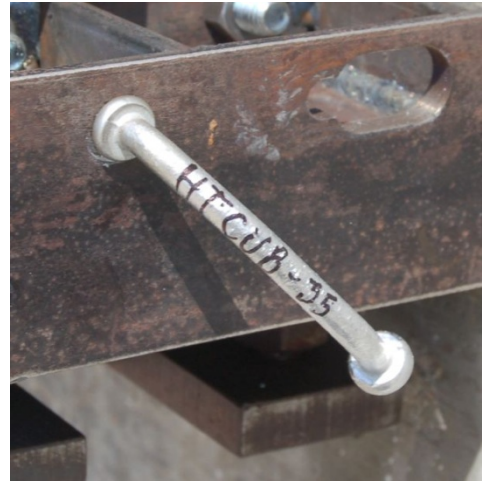
Figure 108. Pre-Test and Post-Test Photographs, Test No. HTCUB-35

For test no. HTCUB-35, the cable applied a load to the A449 keyway bolt at an angle of 0 degrees, parallel to the face of the flange. The keyway bolt was attached with one grade 8 high-topped nut tightened with a wrench and the slot and keyway design type 2 was used. The cable released at a load of 1.41 kips (6.27 kN). The button slipped out of the keyway while the threaded end remained attached to the flange and the keyway bolt straightened out. The force versus time plot is shown in Figure 107. Pre- and post-test photographs are shown in Figure 108. Sequential photographs are shown in Figure 109.

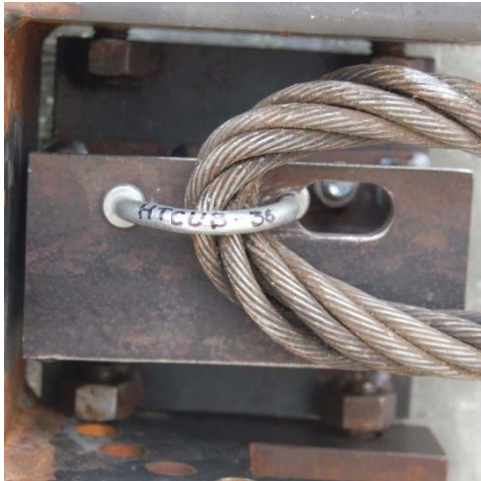
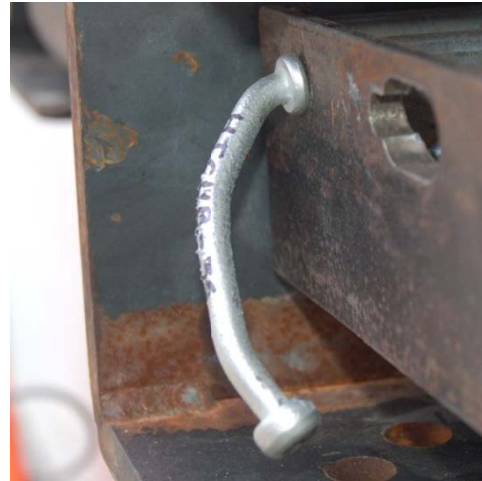
Figure 111. Pre-Test and Post-Test Photographs, Test No. HTCUB-36

For test no. HTCUB-36, the cable applied a load to the A449 keyway bolt at an angle of 0 degrees, parallel to the face of the flange. The keyway bolt was attached with one grade 8 high-topped nut tightened with a wrench and the slot and keyway design type 2 was used. The cable released at a load of 1.27 kips (5.65 kN). The button slipped out of the keyway while the threaded end remained attached to the flange and the keyway bolt straightened out. The force versus time plot is shown in Figure 110. Pre- and post- test photographs are shown in Figure 111. Sequential photographs are shown in Figure 112.

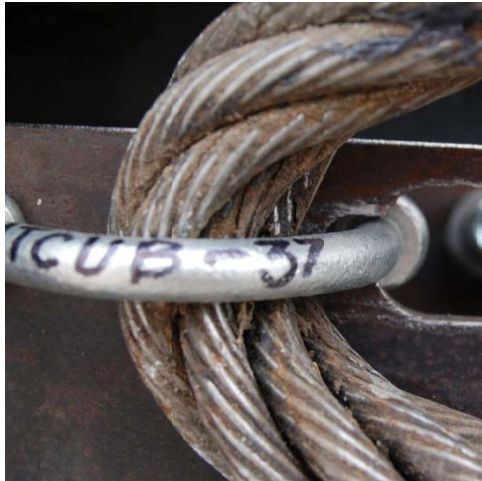
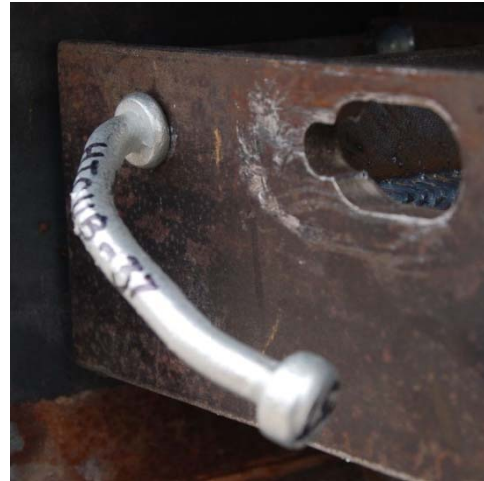
Figure 114. Pre-Test and Post-Test Photographs, Test No. HTCUB-37

For test no. HTCUB-37, the cable applied a load to the A449 keyway bolt at an angle of 0 degrees, parallel to the face of the flange. The keyway bolt was attached with one grade 8 high-topped nut tightened with a wrench and the slot and keyway design type 2 was used. The cable released at a load of 0.92 kips (4.09 kN). The button slipped out of the keyway while the threaded end remained attached to the flange and the keyway bolt straightened out. The force versus time plot is shown in Figure 113. Pre- and post-test photographs are shown in Figure 114. Sequential photographs are shown in Figure 115.

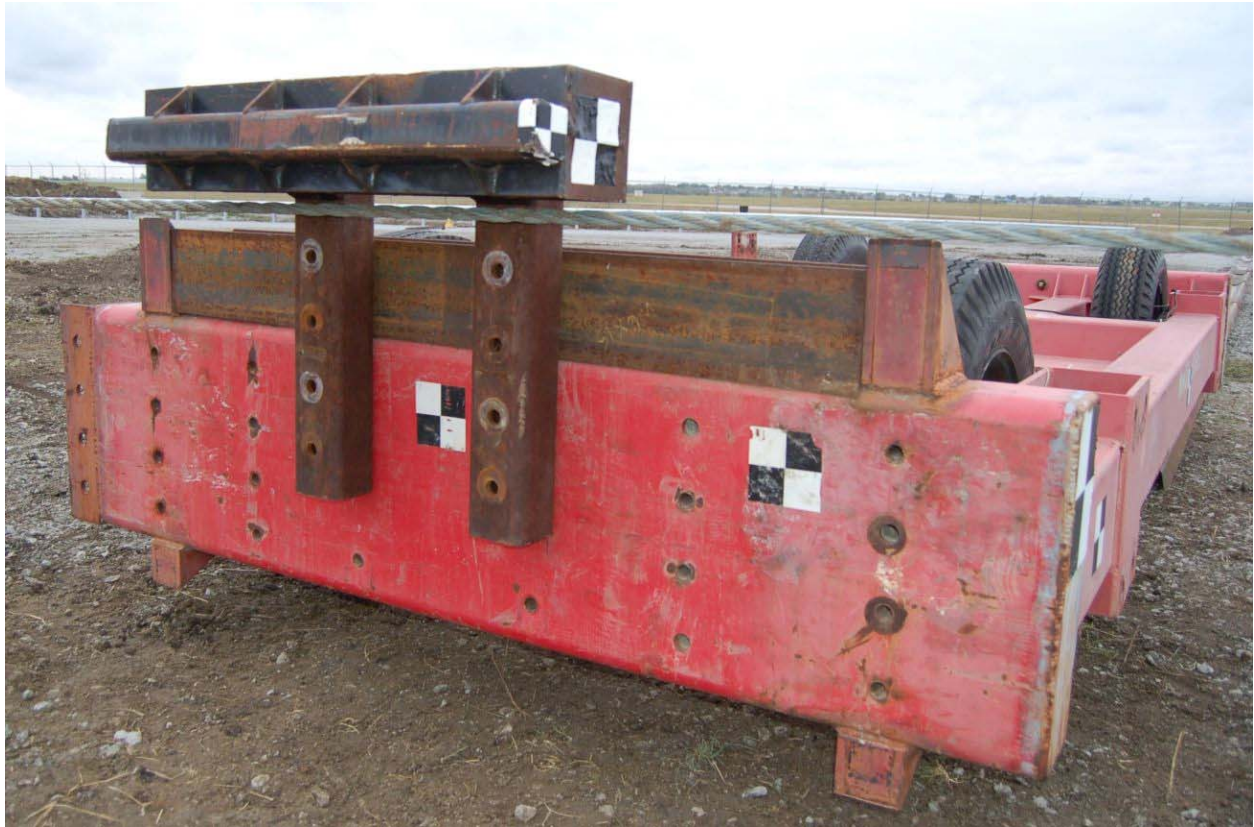
A rigid frame bogie with a variable height, detachable head was used to impact the cable barrier. The bogie impact head was attached to the front of the bogie, with the horizontal tube oriented above the cable. A photograph of the bogie with the head in position relative to the height of the cable is shown in Figure 120.

Figure 120. Rigid Frame Bogie with Head Attachment and Cable Height

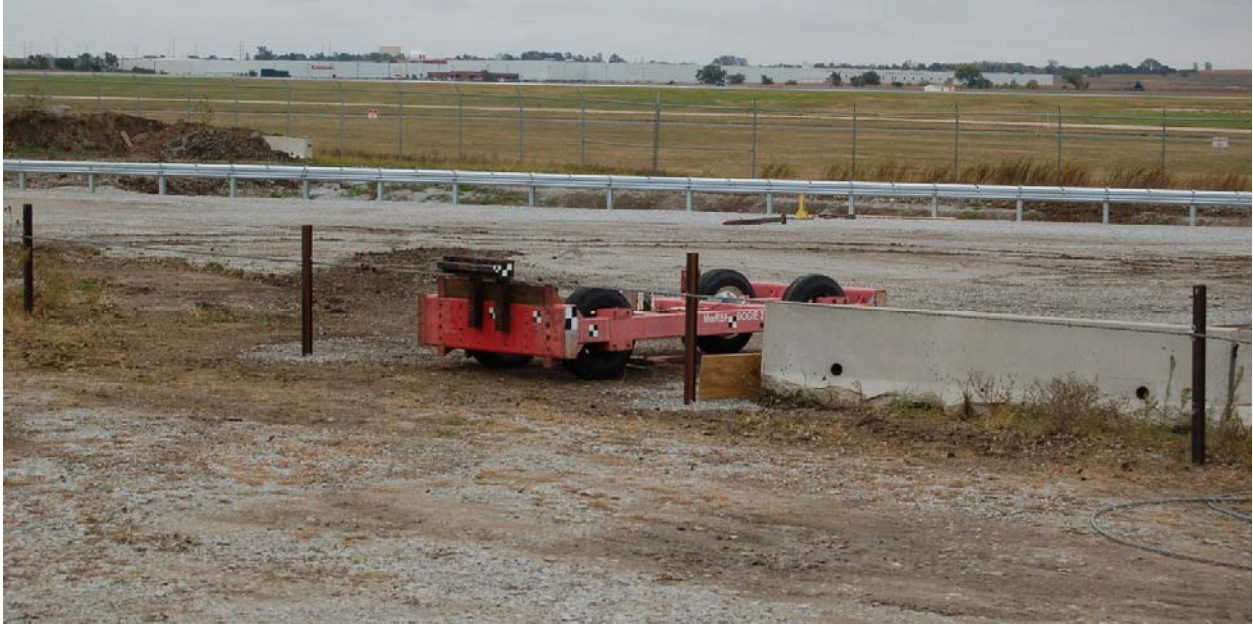
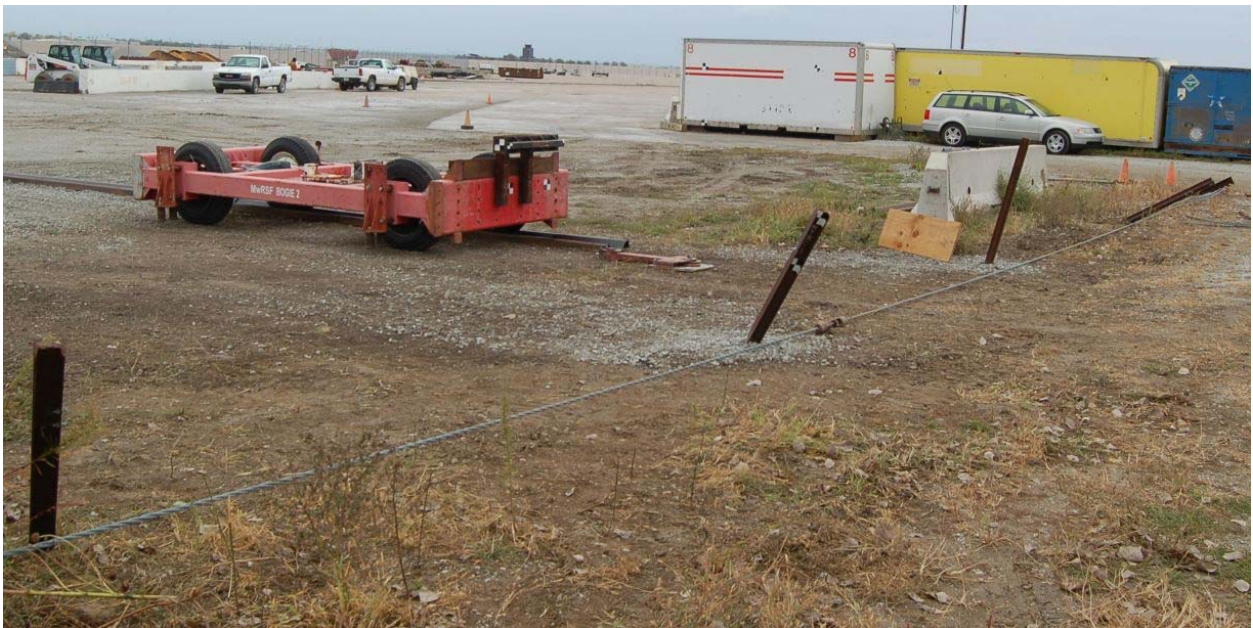
Figure 121. Pre-Test and Post Test Photographs, Test No. HTCC-1

For test no. HTCC-1, a tensile pre-load of 4.12 kips (18.33 kN) was applied to the cable. The 4,913 lb (2,228 kg) bogie impacted the cable barrier at a speed of 19.6 mph (31.5 km/h) at the midspan between post nos. 4 and 5 at an angle of 90 degrees from the cable. The C1018 keyway bolt that was installed on post no. 4 fractured in tension through the threads at the base of the shoulder while the keyway bolt that was installed on post no. 5 released the cable when the button slipped out of the keyway. All of the posts yielded near the ground line and experienced some slight twisting deformation. Pre- and post-test photographs of the bogie and system are shown in Figure 121. Pre- and post-test photographs of the attachments are shown in Figures 122 and 123, and sequential photographs are shown in Figure 124. There was significant scraping damage to the keyway on post no. 5, as shown in Figure 123. The cable also scraped the edge of the flange from the keyway location to the top of the post. There was no significant damage to the keyway on post no. 4. The maximum angle of rotation of the posts was 18 degrees, as shown in Figure 125.

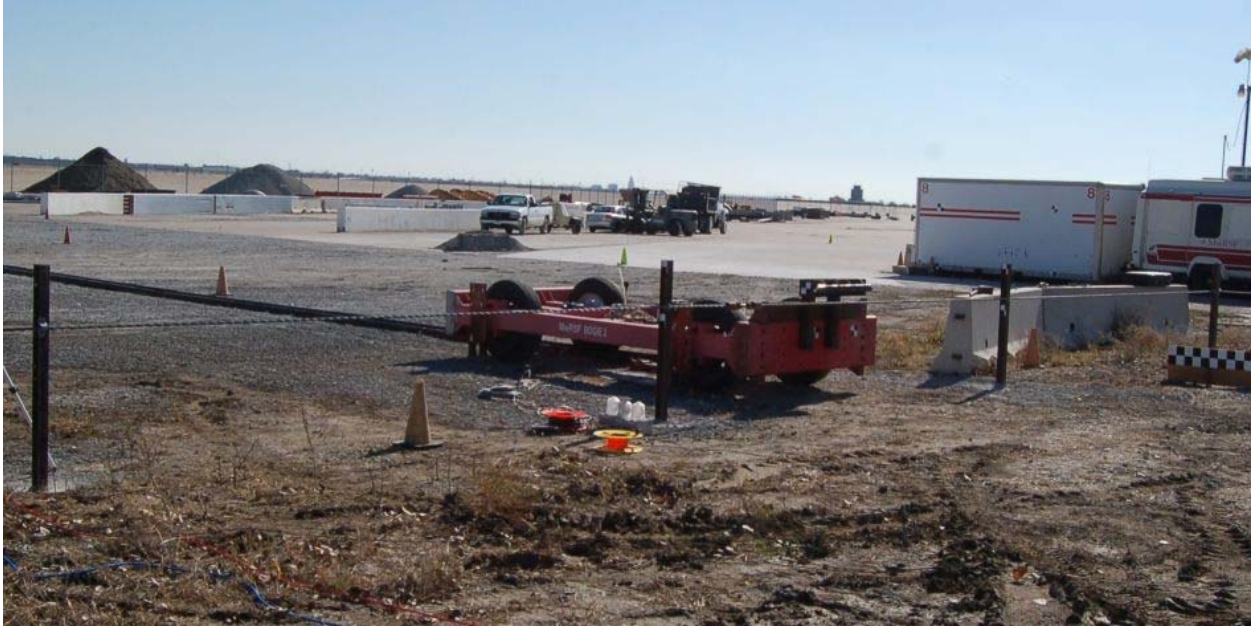
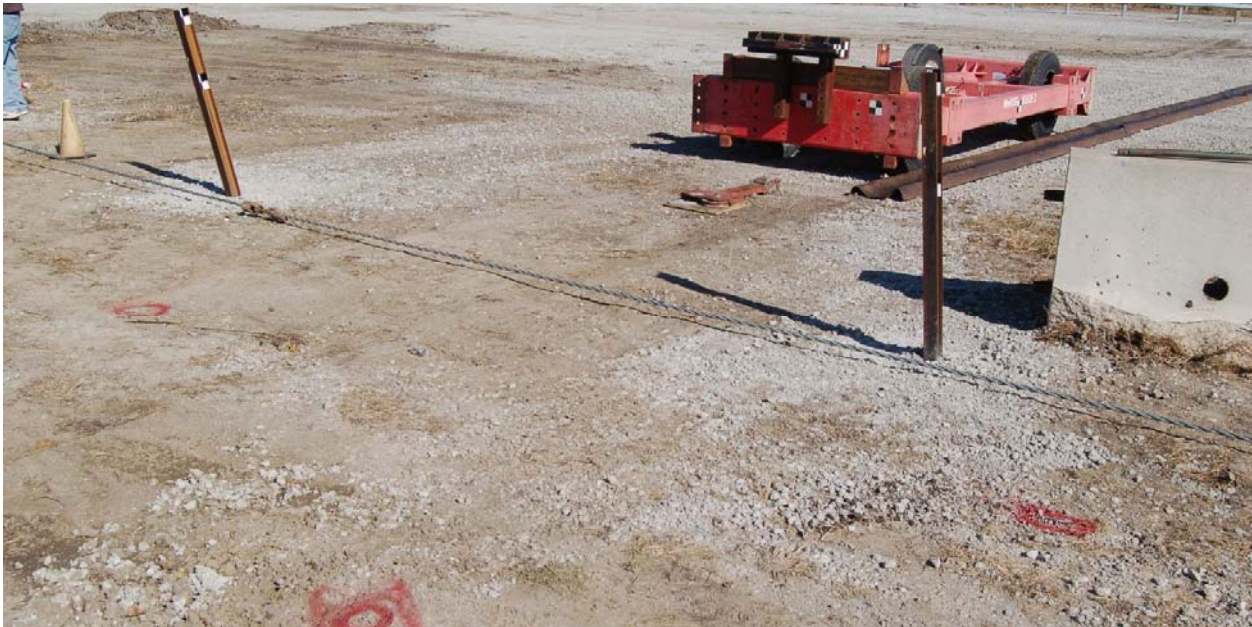
Figure 126. Pre-Test and Post-Test Photographs, Test No. HTCC-2

For test no. HTCC-2, a tensile pre-load of 3.98 kips (17.70 kN) was applied to the cable. The 4,926 lb (2,234 kg) bogie impacted the cable barrier at a speed of 18.5 mph (29.8 km/h) at the midspan between post nos. 4 and 5 at an angle of 90 degrees from the cable. Both of the C1018 keyway bolts on post nos. 4 and 5 fractured in tension through the threads at the base of the shoulder. All of the posts yielded near the ground line and experienced some slight twisting deformation. There were slight contact marks around the edges of the slots and keyways that were caused by the impact with the keyway bolt. The angle of post rotation was not able to be determined for this test because there was not a camera aligned along the line of the posts. However, the post behavior was very similar to the post deformation observed in test no. HTCC-1. Pre- and post-test photographs of the bogie and system are shown in Figure 126. Pre- and post-test photographs of the attachments are shown in Figures 127 and 128. Sequential photographs are shown in Figure 129.
