DESIGN AND EVALUATION OF A HIGH- TENSION CABLE MEDIAN BARRIER ATTACHMENT

MIDWEST ROADSIDE SAFETY FACILITY

MwRSF Research Report No. TRP-03-228-11

May 11, 2011

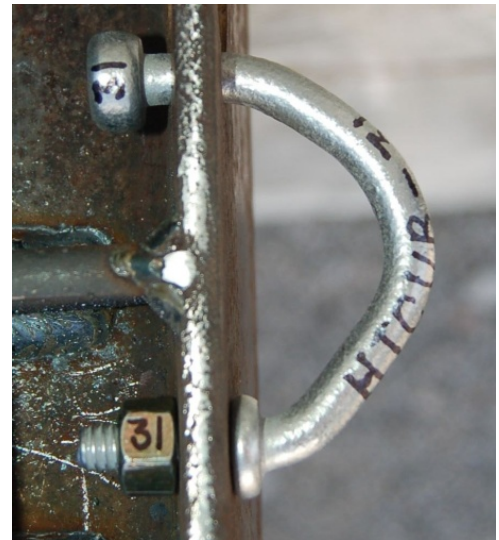
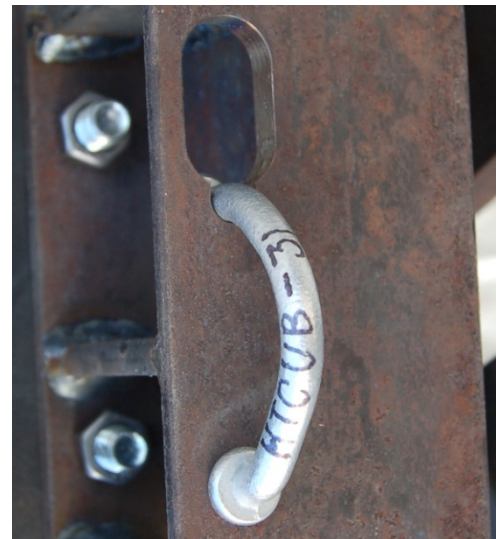
Figure 150. Final A449 Keyway Bolt Connection Design

the angle of the keyway bolt arm should preclude cable would snag on the keyway bolts. Further, the design of the keyway bolt should be much simpler and less expensive than the previously used curved keyway bracket design. Details and pictures of the recommended keyway bolt attachments are shown in Figure 150.

Based on the results from the dynamic cable barrier bogie tests, the A449 keyway bolt with the grade 8 high-topped nut used in conjunction with the type 2 slot and keyway design was recommend for use in a full-scale crash test. Three criteria were used to support this design: (1) the keyway bolt attachment exhibited similar post deflection as the curved keyway bracket used in test no. HTCC-6 and test nos. 4CMB-1 through 4CMB-3, (2) there was no evidence that the keyway bolt would cause significant snagging of the cable that would restrict the cable from releasing, and (3) the keyway bolt attachment design was a simpler, less expensive design as compared to the curved keyway bracket attachment.

Therefore, the A449 keyway bolt was considered an acceptable design replacement for the curved keyway bracket that performed well in test nos. 4CMB-1 and 4CMB-2. The keyway bolt cable-to-post attachments showed similar cable release behavior as the previous design and
