# **DYNAMIC EVALUATION OF NEW YORK STATE'S ALUMINUM PEDESTRIAN SIGNAL POLE SYSTEM**

## **MIDWEST ROADSIDE SAFETY FACILITY**

## **NEW YORK STATE DEPARTMENT OF TRANSPORTATION**

MwRSF Research Report No. TRP-03-223-09

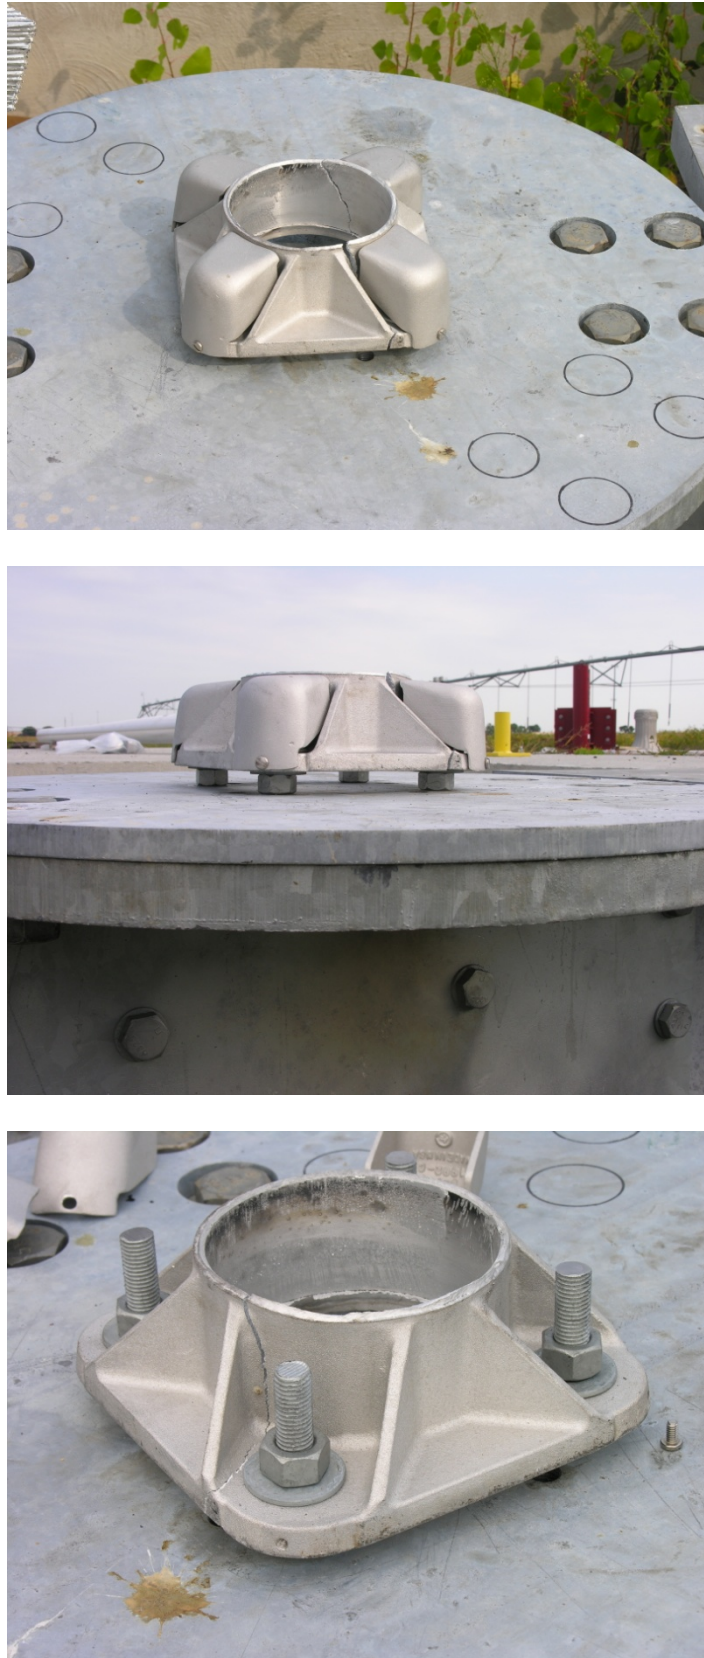
Figure 34. System Damage - Base Plate Cracks and Fractures, Test No. NYPP-1

As a result of the pendulum impact, the pedestrian signal pole system was broken into four separate pieces, as shown in Figure 31. The base plate assembly remained attached to the simulated rigid foundation and extended 4½ in. (114 mm) above the ground surface, as shown in Figure 34. Two cracks were found in the base plate assembly. The first crack was located on the

cylinder between the gussets surrounding the back-left anchor bolt and extended from the top of the cylinder to the base plate. The second crack began on the top of the cylinder between the gussets surrounding the back-right anchor bolt and continued through the base plate and out the back-right corner. The anchor bolts and nuts remained undamaged.

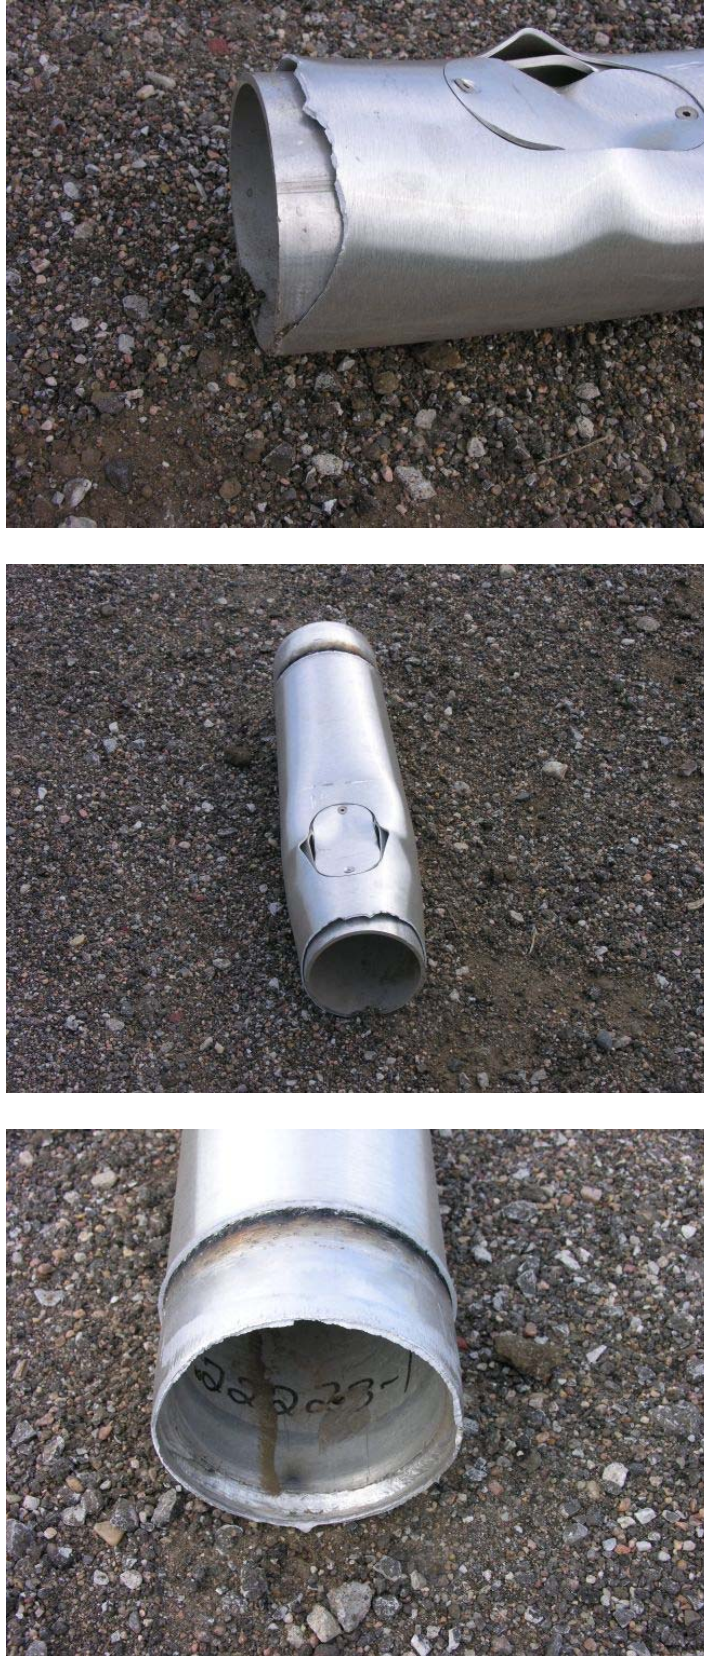
Figure 35. System Damage - Bottom Piece of Pole and Internal Sleeve, Test No. NYPP-1

The aluminum pole was detached from the base plate assembly and fractured into two pieces, as shown in Figures 35 and 36. The bottom piece came to rest 17 ft (5.2 m) behind the pole's original position. The bottom piece of the pole was 24 in. (610 mm) long and contained both the lower portion of the pole and the internal reinforcing sleeve. The bottom end of this segment contained the remains of the welds originally used to connect the pole to the base plate assembly. At the top of this segment, the pole was jagged along the fracture surface. The handhole cover was deformed and pushed inward from the impact, and local buckling of the pole was found on both sides of the handhole.

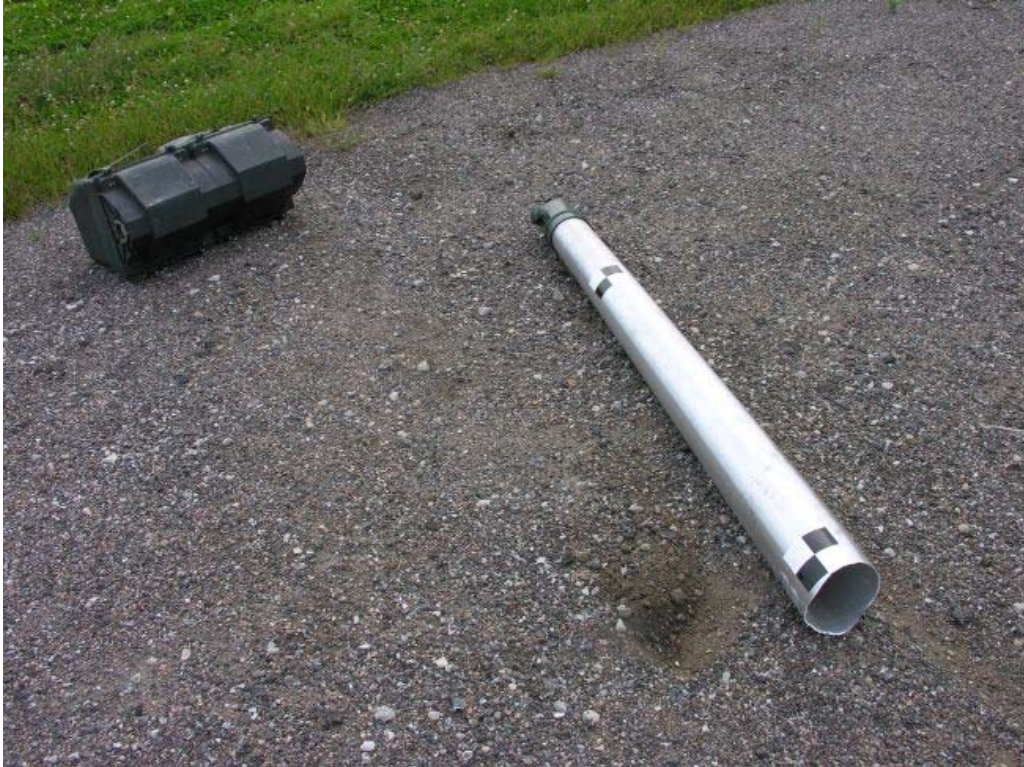
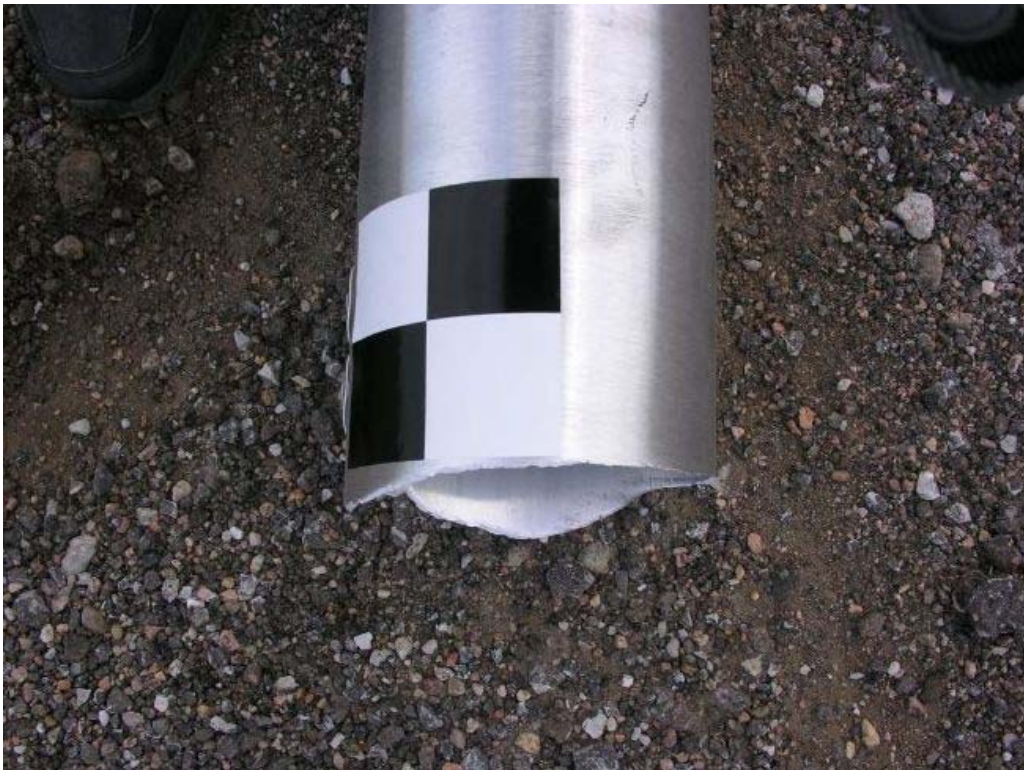
Figure 36. System Damage - Upper Portion of Pole, Test NYPP-1

The top portion of the pole remained largely undamaged and came to rest 34 ft (10.4 m) from the pole's original position. The only damage was the jagged fracture surface located at the bottom end of this segment.

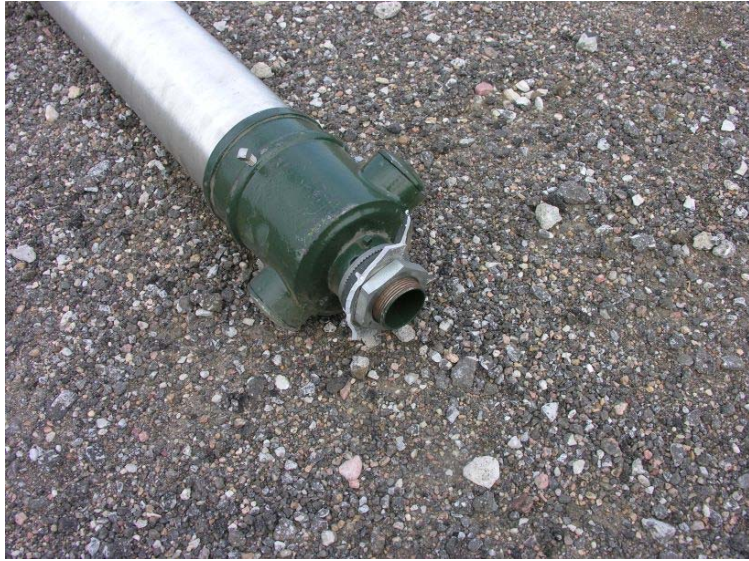
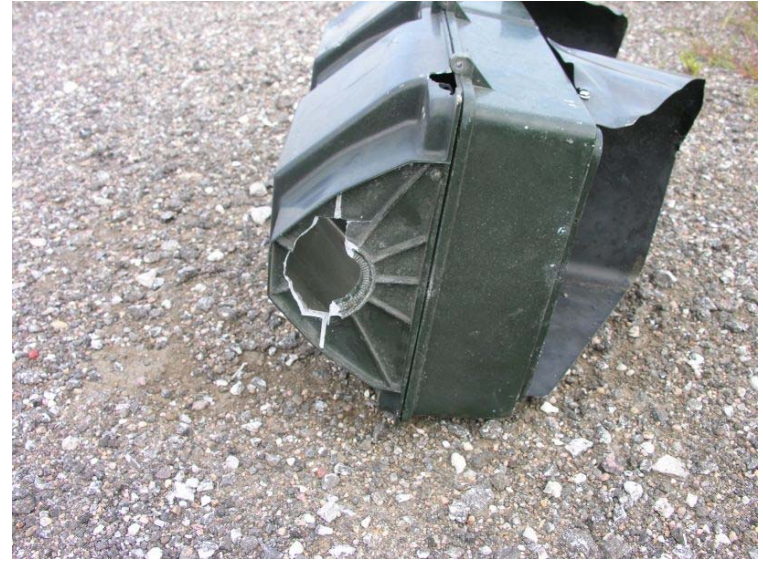
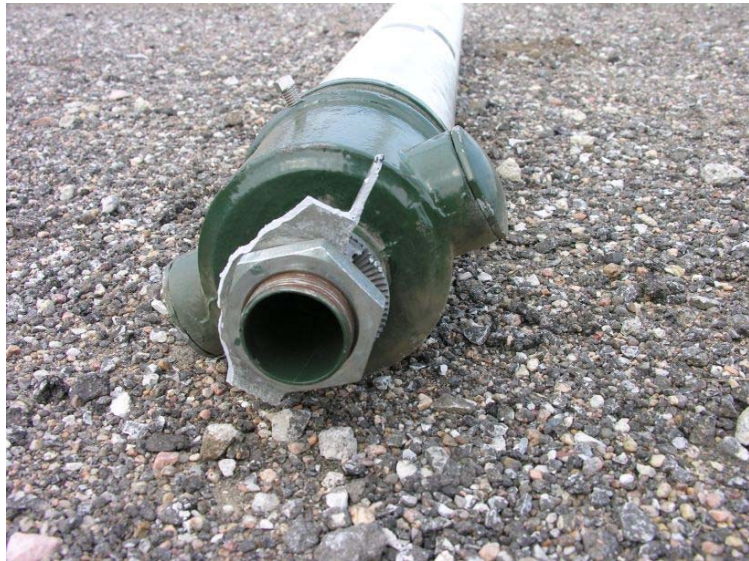
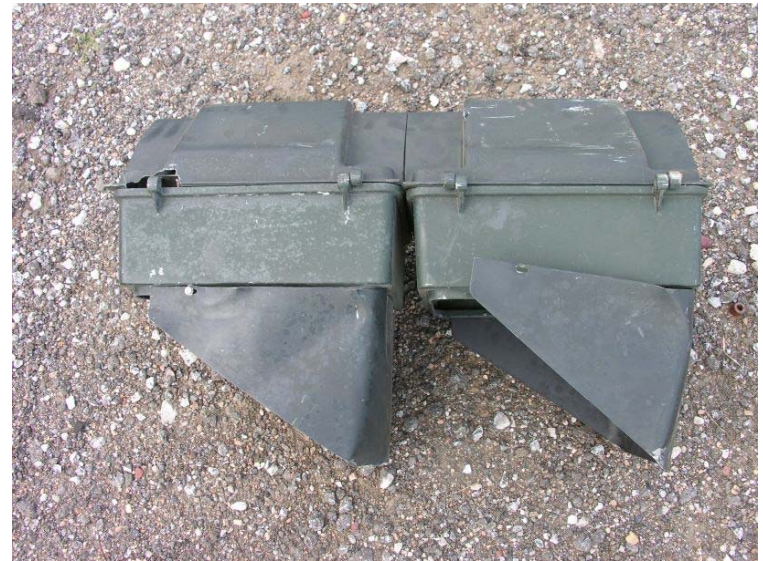
Figure 37. System Damage - Signal and Attachment Bracket, Test No. NYPP-1

The pedestrian signal was detached from the attachment bracket and came to rest 38 ft (11.6 m) behind the pole's initial position. A piece of the plastic surrounding the attachment bracket at the bottom of the signal had fractured off, as shown in Figure 37. This small piece remained wedged between the bracket and the attachment nut. The attachment bracket itself remained undamaged and fixed to the top end of the pole.
